**SLOPE STABILITY EVALUATION IN AND AROUND
KODAIKANAL TOWN, TAMILNADU**

Ph.D THESIS

**DEPARTMENT OF EARTH SCIENCES
INDIAN INSTITUTE OF TECHNOLOGY ROORKEE
ROORKEE- 247667, INDIA
MARCH, 2018**

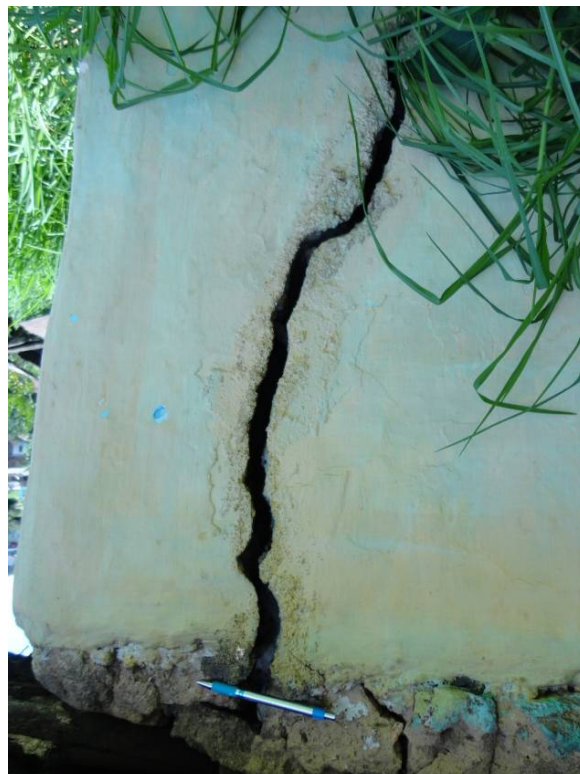
Fig. 2.9 Crack found in a house at Gandhipuram Slope

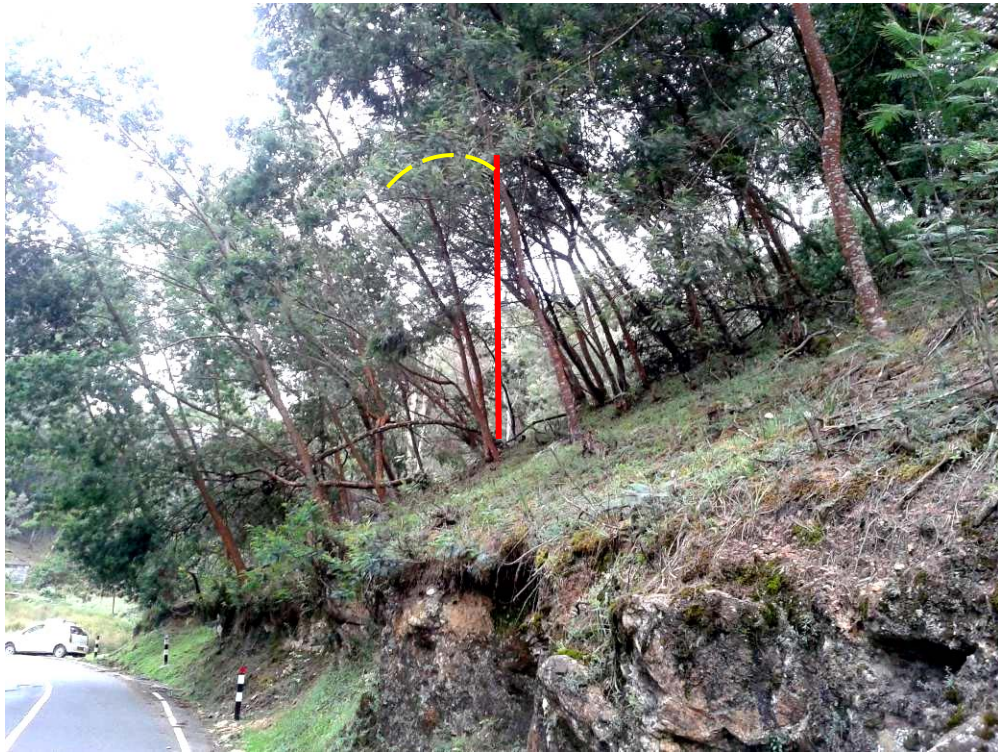
Fig 2.18 Tilted Trees along the Pillar Rocks Road

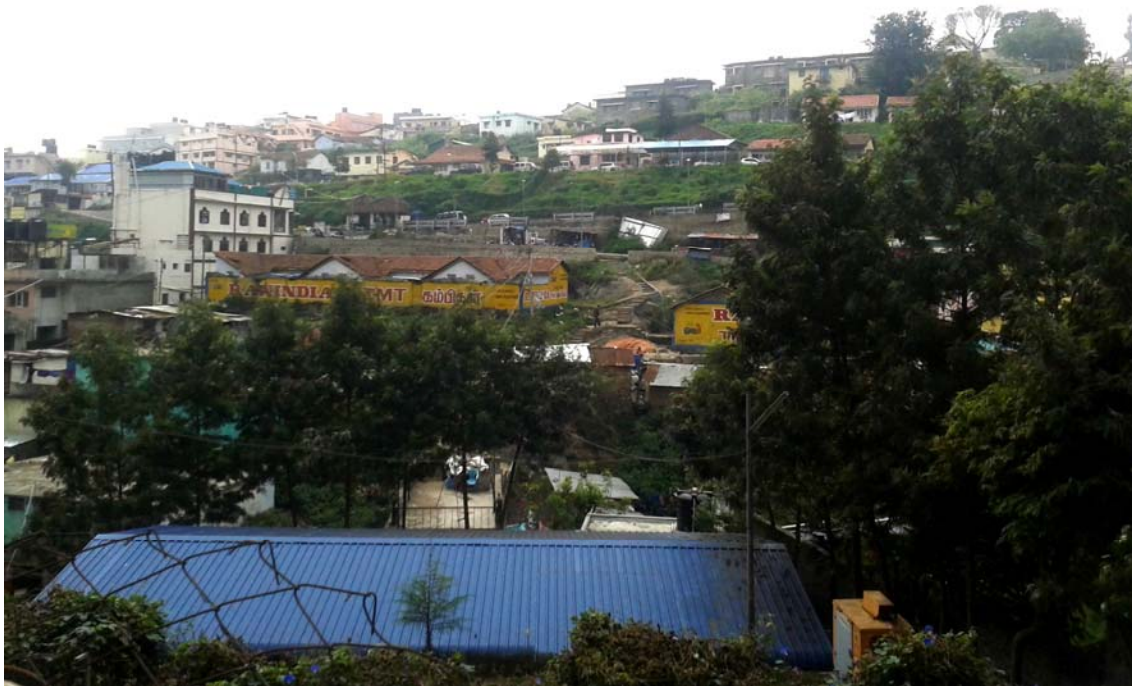
Fig 5.11 Ananthagiri Slope showing cramped building, both residential and commercial

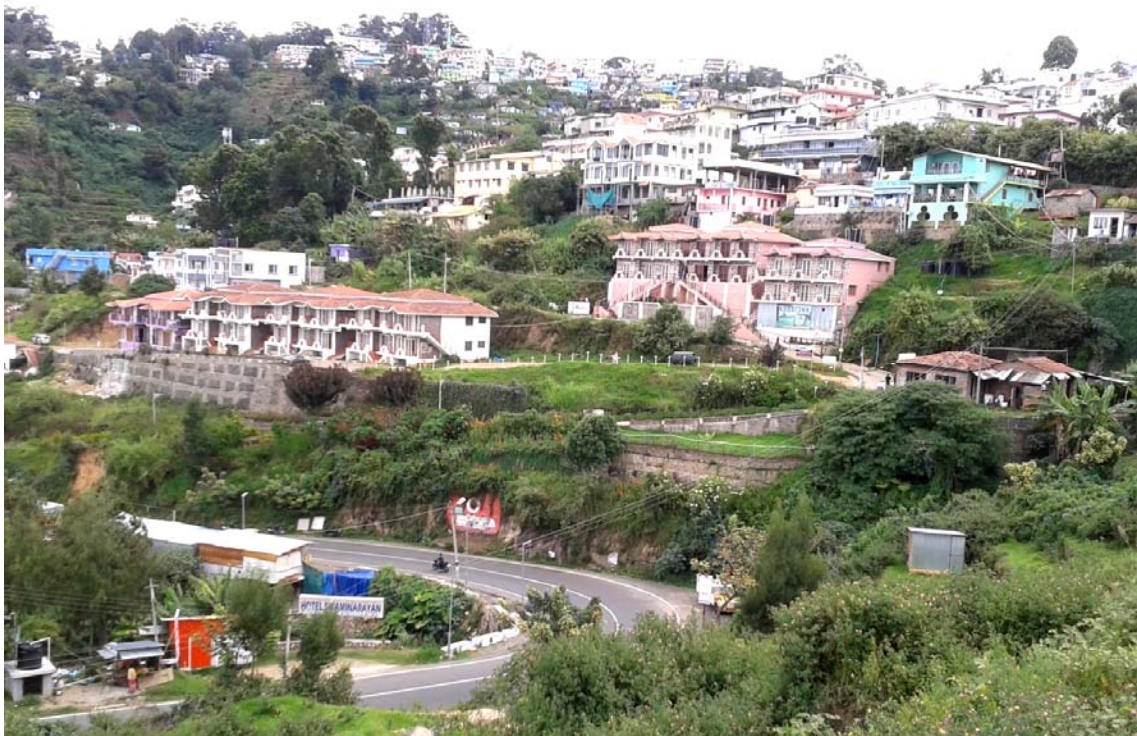
Fig 5.13 Ananthagiri Slope 1 showing heavy urbanization on the slope

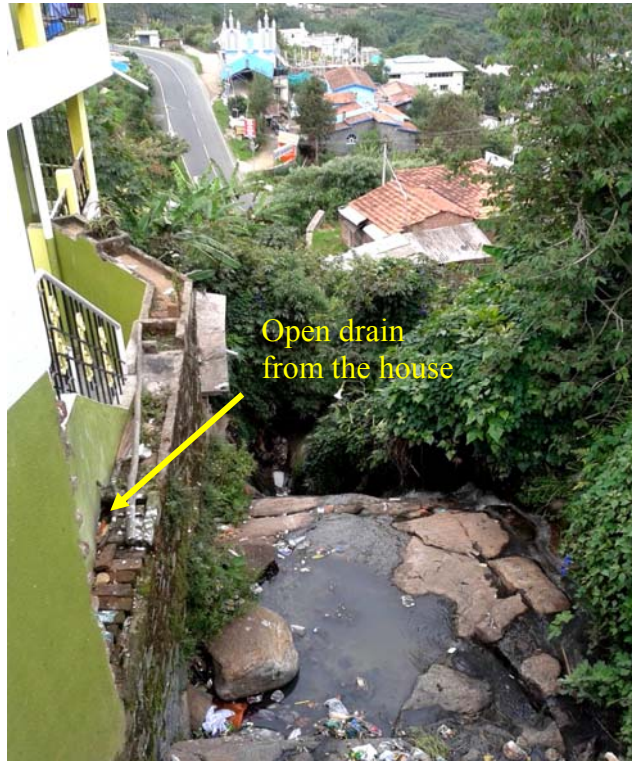
of the urbanized slopes, the domestic waste water was disposed directly on to the slope (Fig 5.14).

Fig 5.14 Improper waste water management seen at the slope

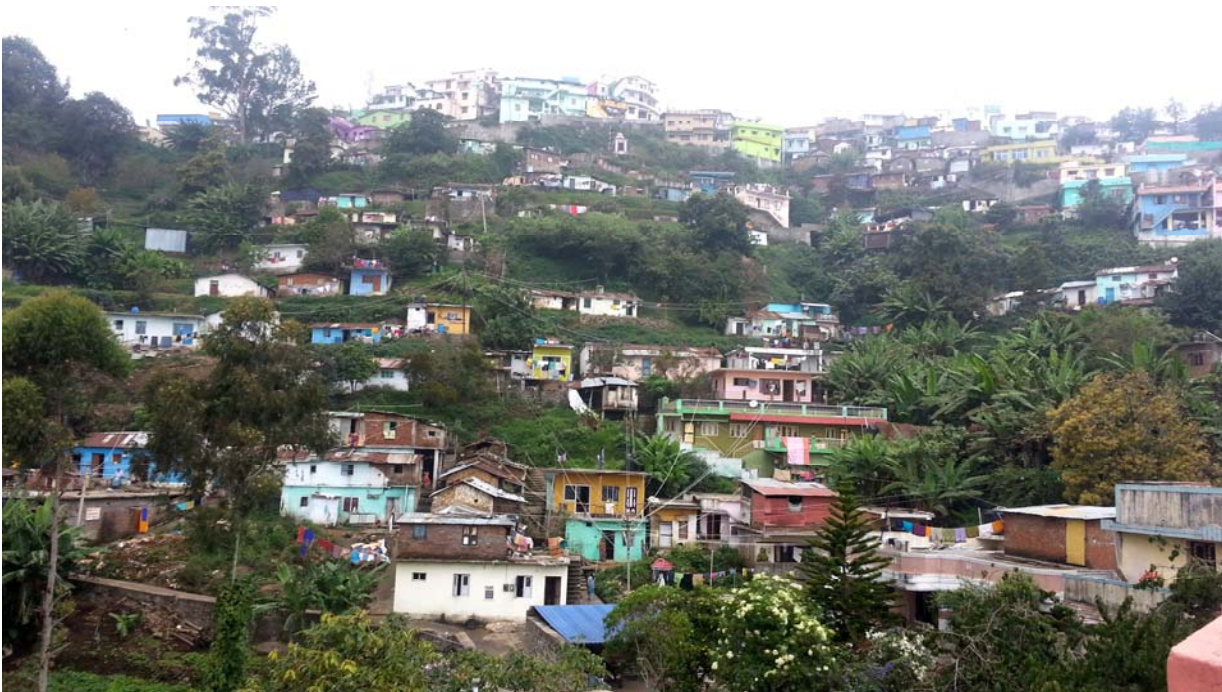
Fig 5.16 Urbanization on the steep slope of the Gandhipuram Slope, Facet no. 34

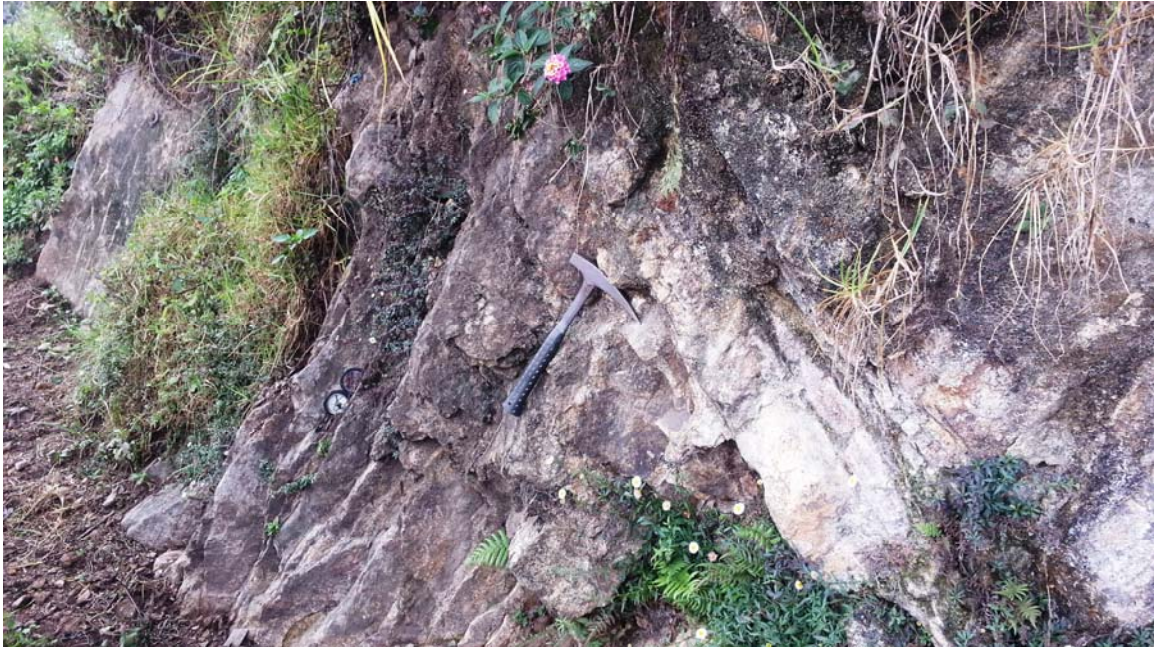
Fig 5.17 Weathered rock exposure seen on the Gandhipuram Slope

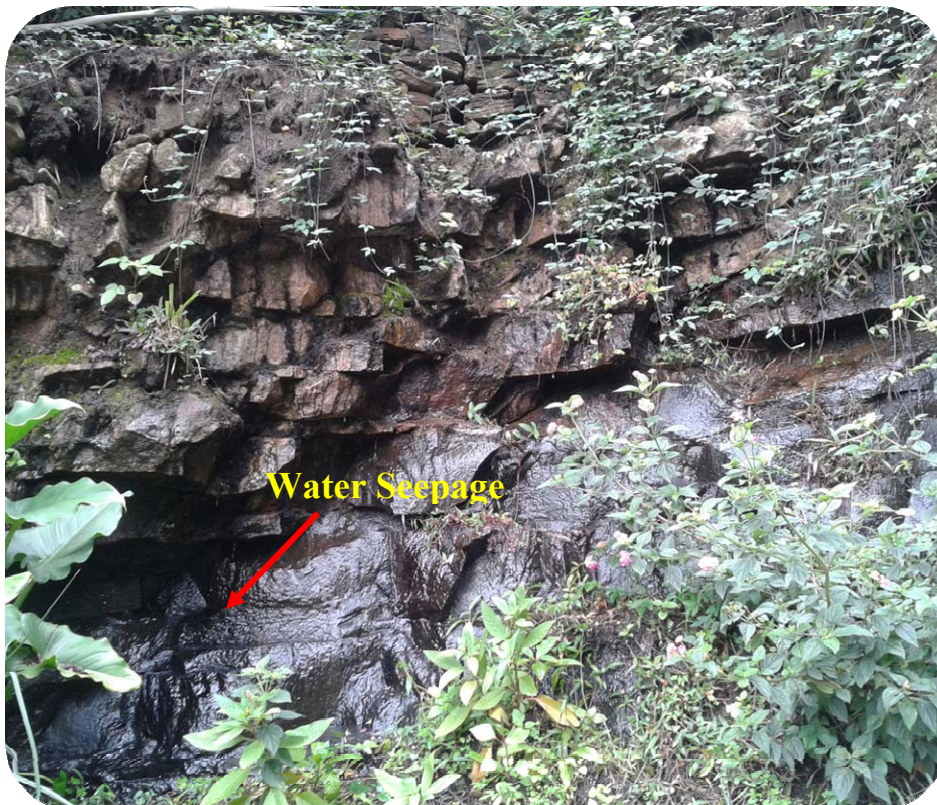
Fig 5.26 Water dampening the highly jointed rock exposure in Pudukkad Slope

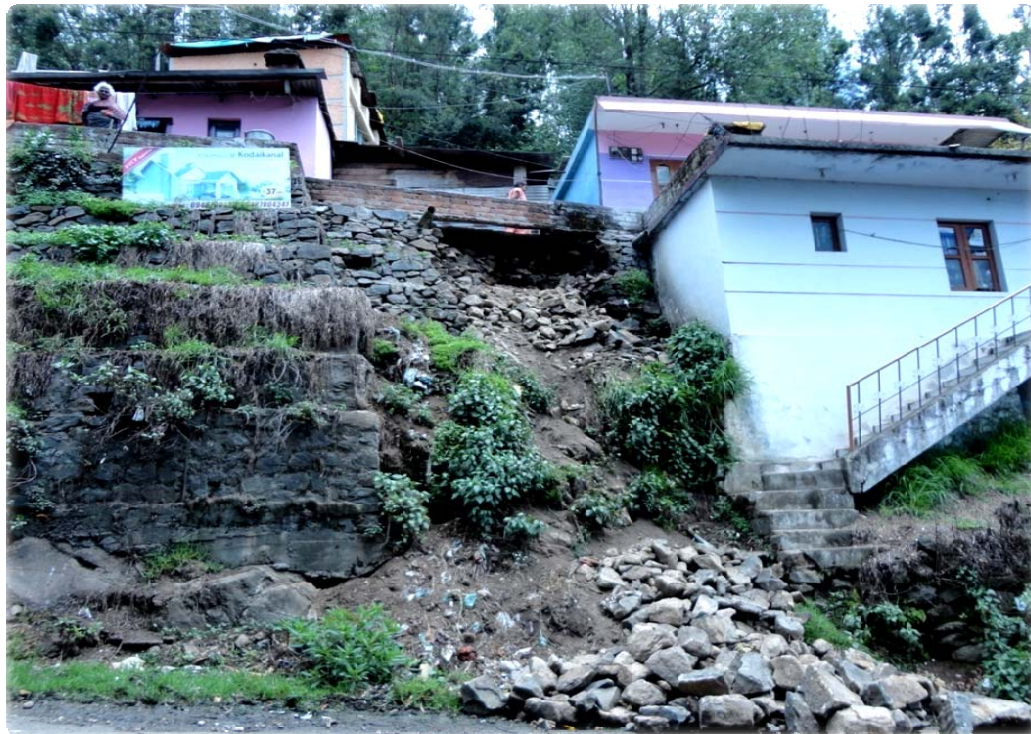
Fig 5.30 A small slide on the urbanized slope of the Pudukkad slope

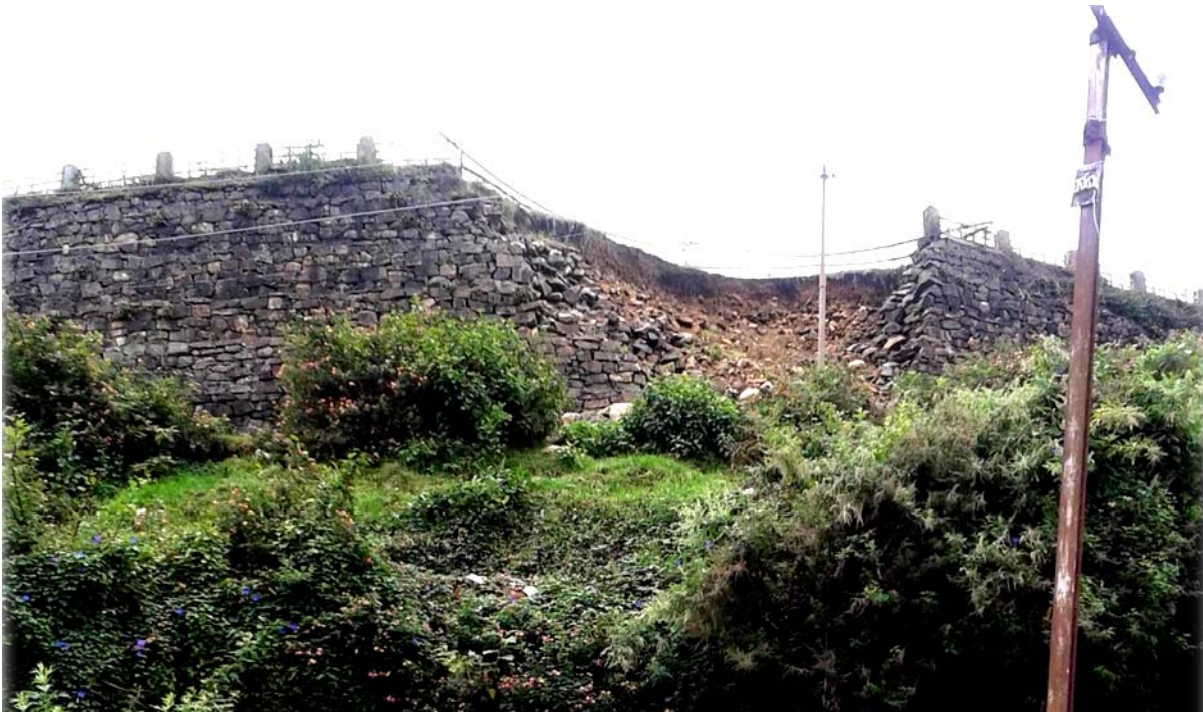
Fig 5.31 Collapse of retaining wall at Observatory road
