ANALYSIS OF FAILURE AND RENOVATION OF PANSHET DAM

A Dissertation
submitted in partial fulfilment
of the requirements for the degree
of
MASTER OF ENGINEERING
in
WATER RESOURCES DEVELOPMENT

by
N.P. DUSE

WATER RESOURCES DEVELOPMENT TRAINING CENTRE
UNIVERSITY OF ROORKEE
ROORKEE
September 1971

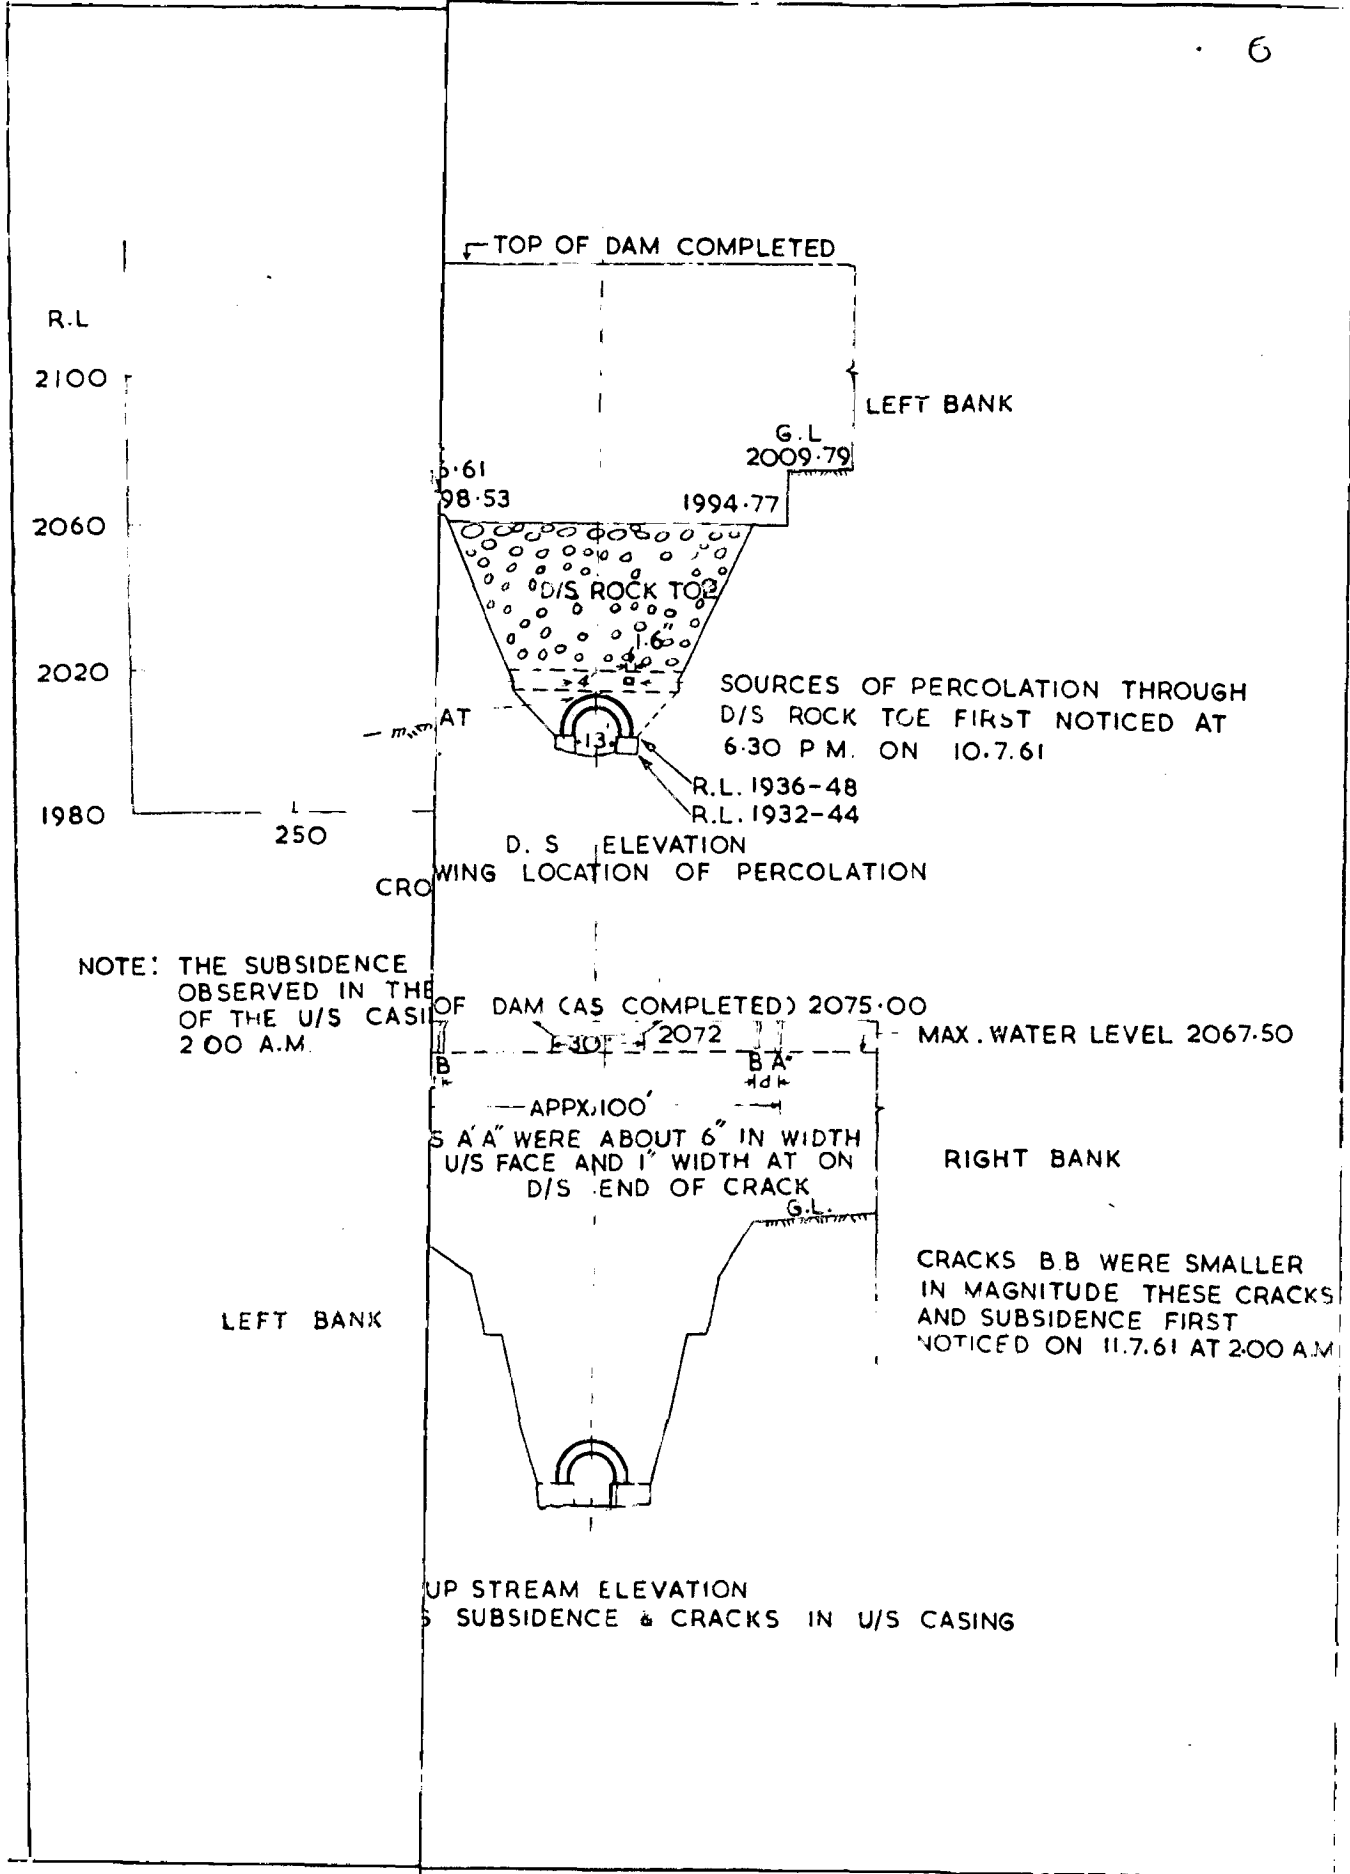
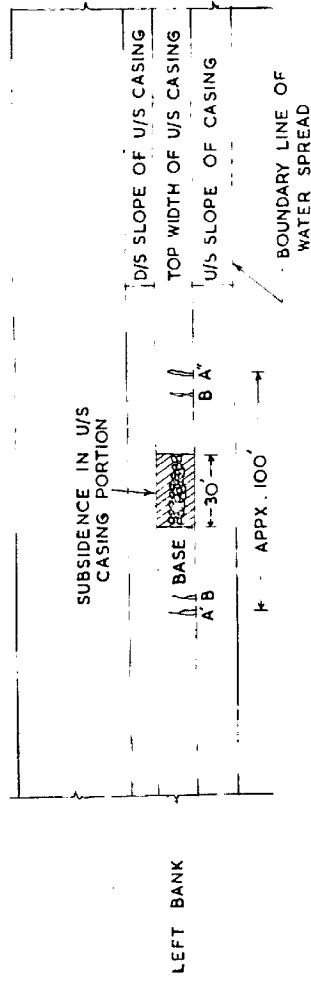
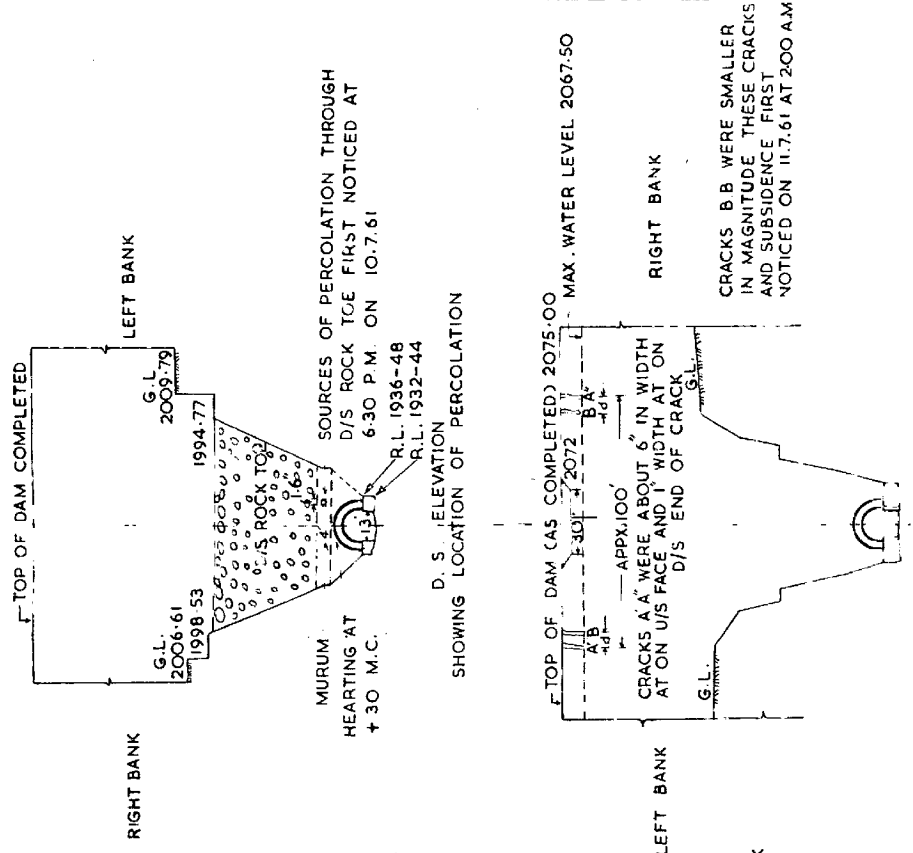
DRAWING SHOWING POSITION OF CRACKS IN T. W. W. PORTION
 (OBSERVED ON 11.7.61)

Transverse cracks appeared 100 ft. (30.48 m) apart i.e. approximately over the conduit trench edges. These cracks were in half the top width of the casing and were wedge shaped being 1 foot wide (0.3 m) at the upstream edge. Cracks were noticed on 11th morning in the downstream casing also. These cracks were also 100 feet (30.48 m) apart, (i.e. over the edges of the trench) but were thinner being about $\frac{1}{4}$ inch wide. Transverse cracks in the upstream portion were wider on the left side than those on the right side. (Refer Drawing No.6).

NOTE: THE SUBSIDENCE
OBSERVED IN THE
OF THE U/S CASING
2.00 A.M.

S A A WERE ABOUT 6" IN WIDTH
U/S FACE AND 1" WIDTH AT ON
D/S END OF CRACK

CRACKS B B WERE SMALLER
IN MAGNITUDE THESE CRACKS
AND SUBSIDENCE FIRST
NOTICED ON 11.7.61 AT 2.00 A.M.

NOTE: (a) THE CRACKS A A' B B' WERE WEDGE SHAPED BEING WIDER ON U.S. FACE.
 (b) A' CRACK SLIGHTLY SMALLER THAN A.

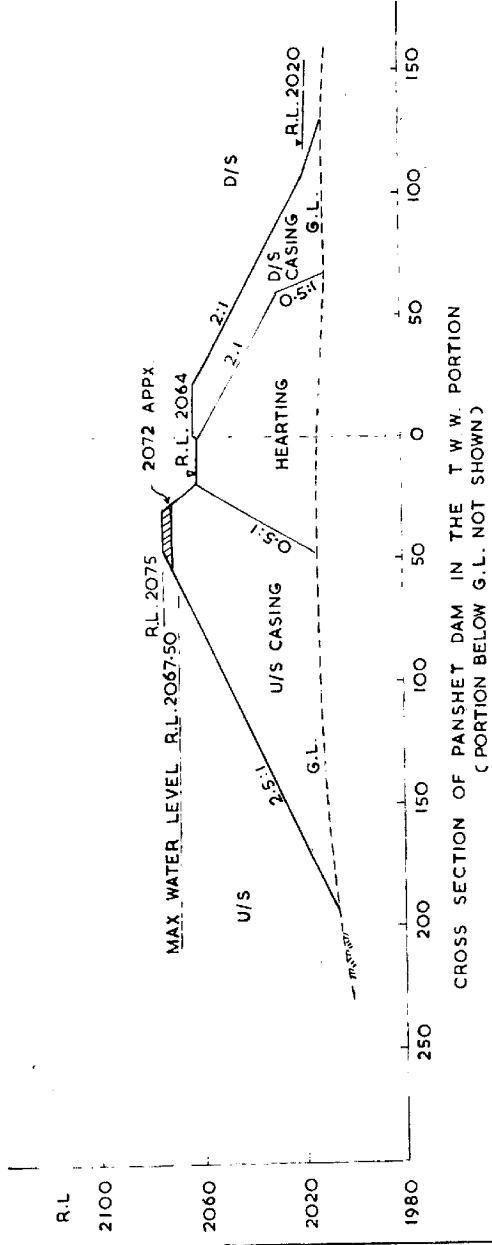
CROSS SECTION OF PANSHET DAM IN THE T.W.W. PORTION
 (PORTION BELOW G.L. NOT SHOWN)

NOTE: THE SUBSIDENCE WAS FIRST OBSERVED IN THE HATCHED PORTION OF THE U/S CASING ON 11.7.61 AT ABOUT 2.00 A.M.

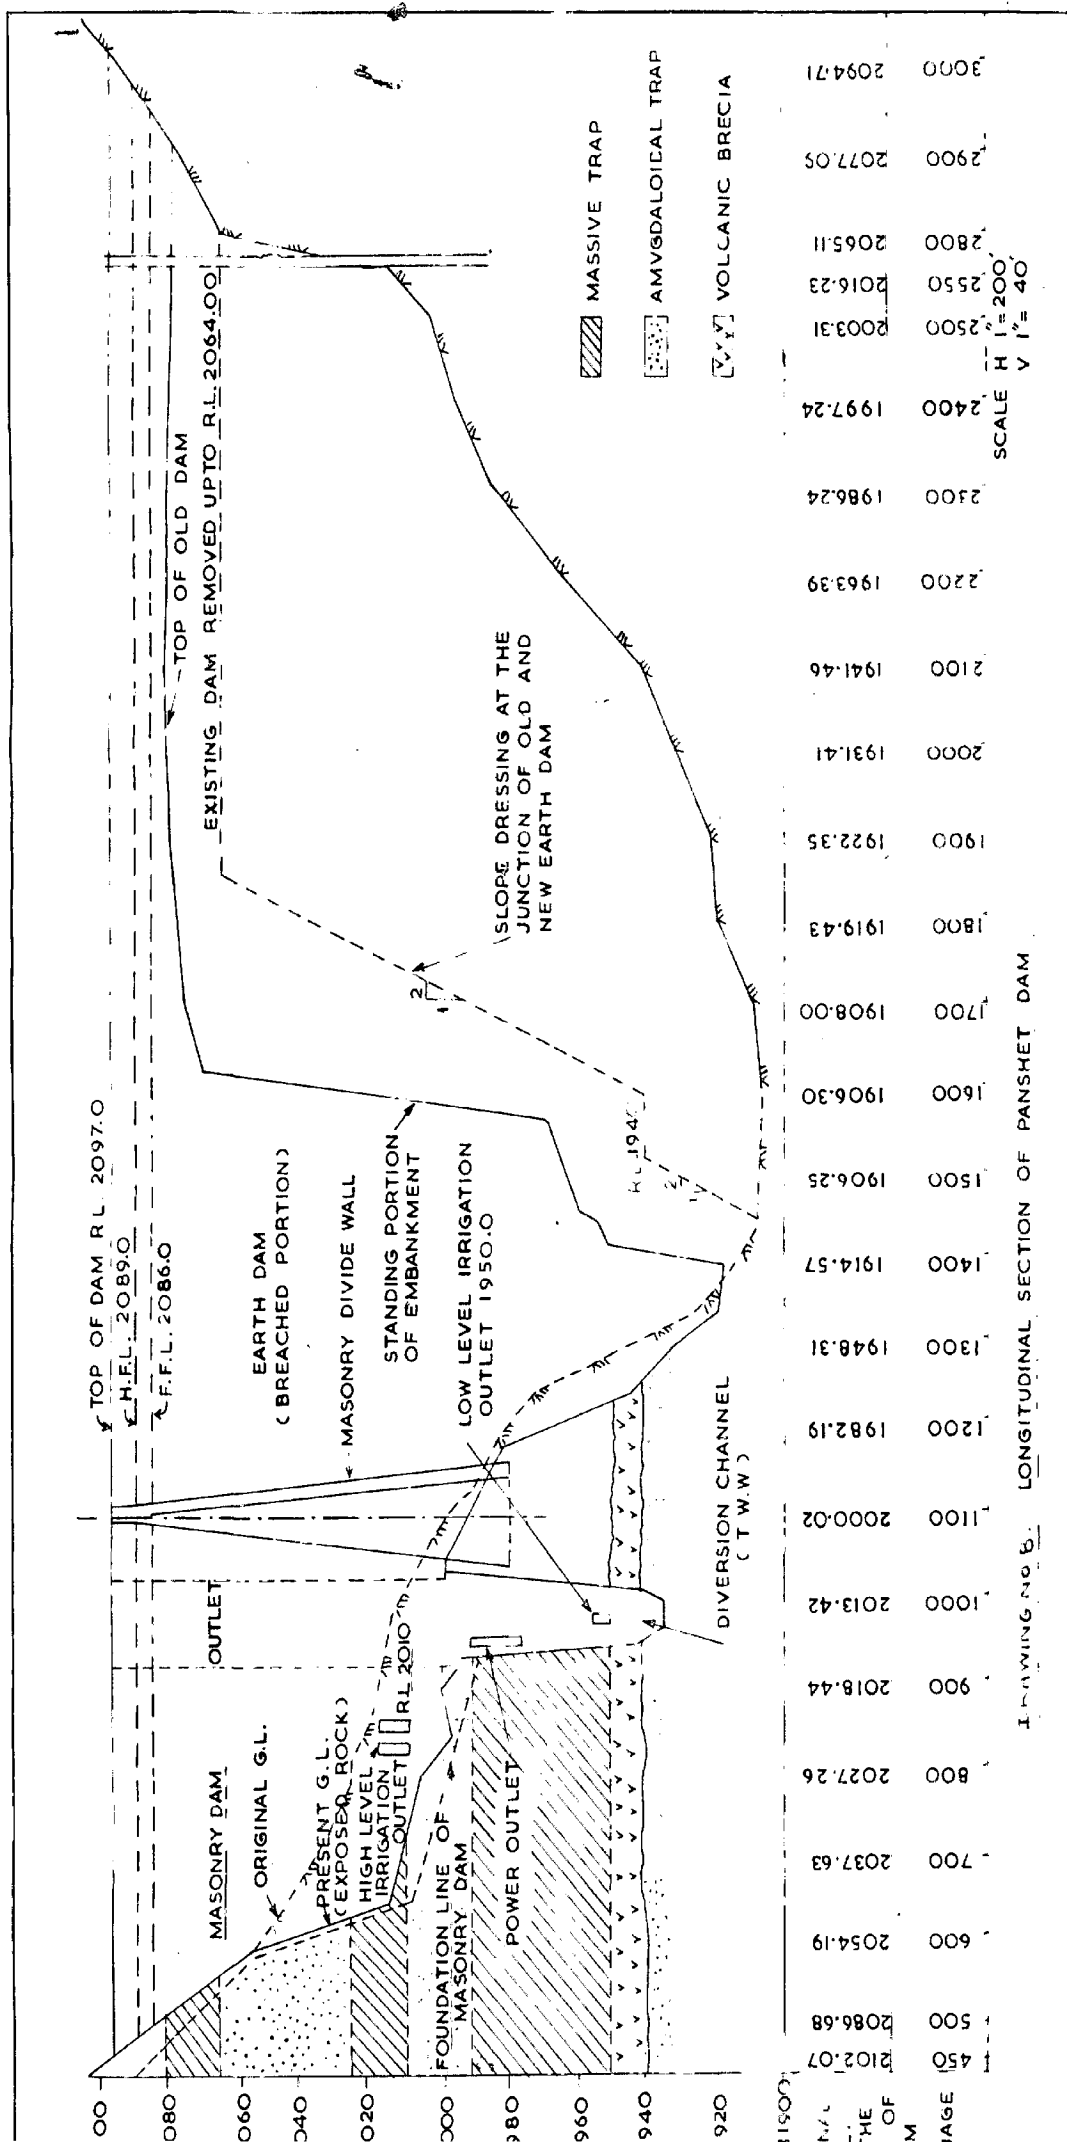
- (i) The earth work of the dam between Ch.700 to 1600 was washed away leaving nearly a vertical face at Ch.1600 as shown in Drawing No.8.
- (ii) All the overburden of soil and murum on the left flank had been washed away by the cascading flow after the breach leaving exposed bare rock (including the portion between the waste weir cut and the natural river course)
- (iii) The natural river course was re-established.
- (iv) The upstream casing zone near Ch.1600 had slightly bulged and slushy material was lying in the natural river course.
- (v) Some longitudinal cracks were observed at the top of dam.
