ENVIRONMENT MANAGEMENT OF A RIVER IN MYANMAR

A DISSERTATION

MASTER OF TECHNOLOGY

CONSERVATION OF RIVERS AND LAKES

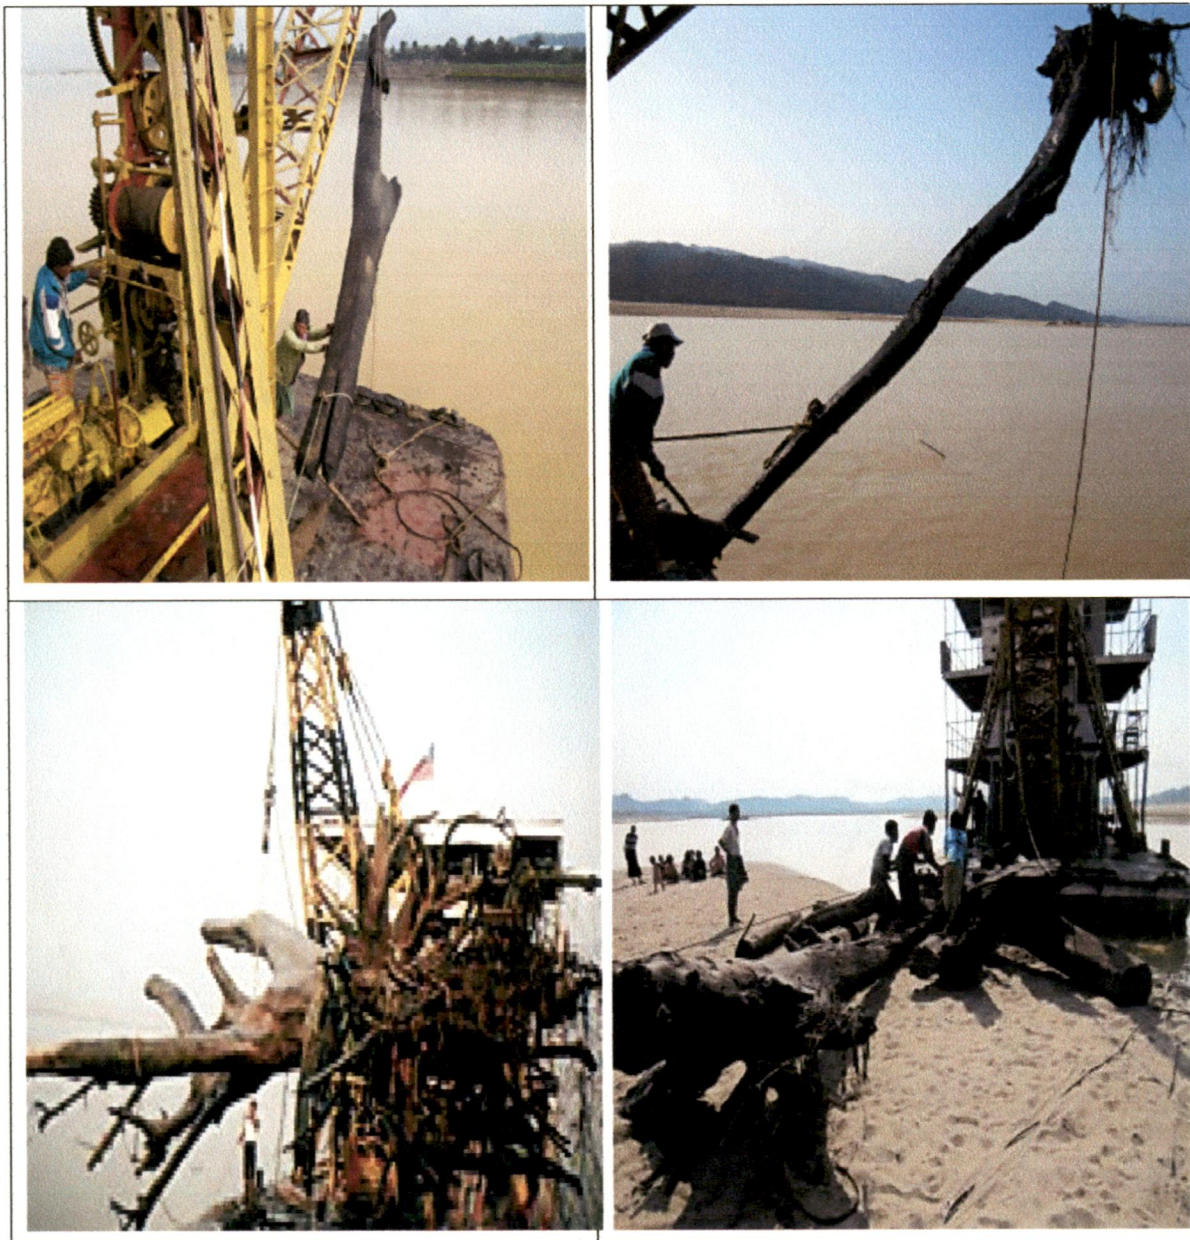
Snags are very dangerous for water transportation. A large number of snags and great amount of silt are brought into the Chindwin River by its tributaries. The annual volume of work with regard to the channel clearing from snags which is done at present chiefly in the middle and in the upper course of the Chindwin river amounts to 100 tons. The annual cost of the fairwater clearing work is 10, 000, 00 kyats. Snags removing works should be taken for water transportation yearly.

Fig 8.1 Snags Removing Work
