ANALYSIS OF WELDING FAILURE OF AMMONIA SYNTHESIS CONVERTOR

A DISSERTATION

This work is an attempt to find the reasons which have lead to cracking of weld seam no. 6 of **Ammonia Synthesis Convertor** of Tata Chemicals Limited, Babrala. Failure of convertor occurred after six months of service in hydrogen atmosphere.

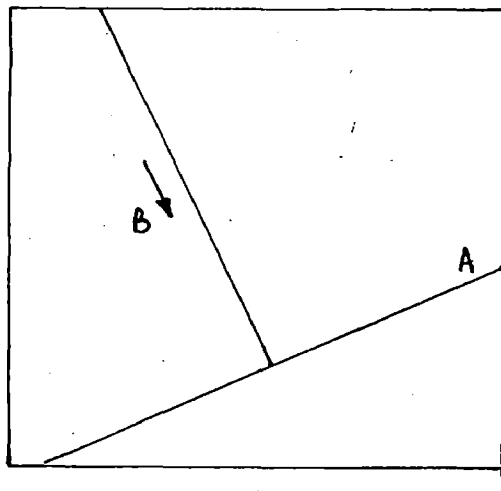
FIG 2.4 Schematic illustration of the sequencing of cracking by the T-JUNCTION procedure where crack A precedes and arrests fracture B

be detected from marks on the surface. The typical sequence of fractures is shown in fig. 2.4, where A and B represent fractures that intersect at a point. It is clear about the sequence of the cracks, fracture A must have occurred prior to fracture B because the presence of fracture A served to arrest fracture B. This method of sequencing is called T-junction procedure and is an important technique in wreckage analysis.

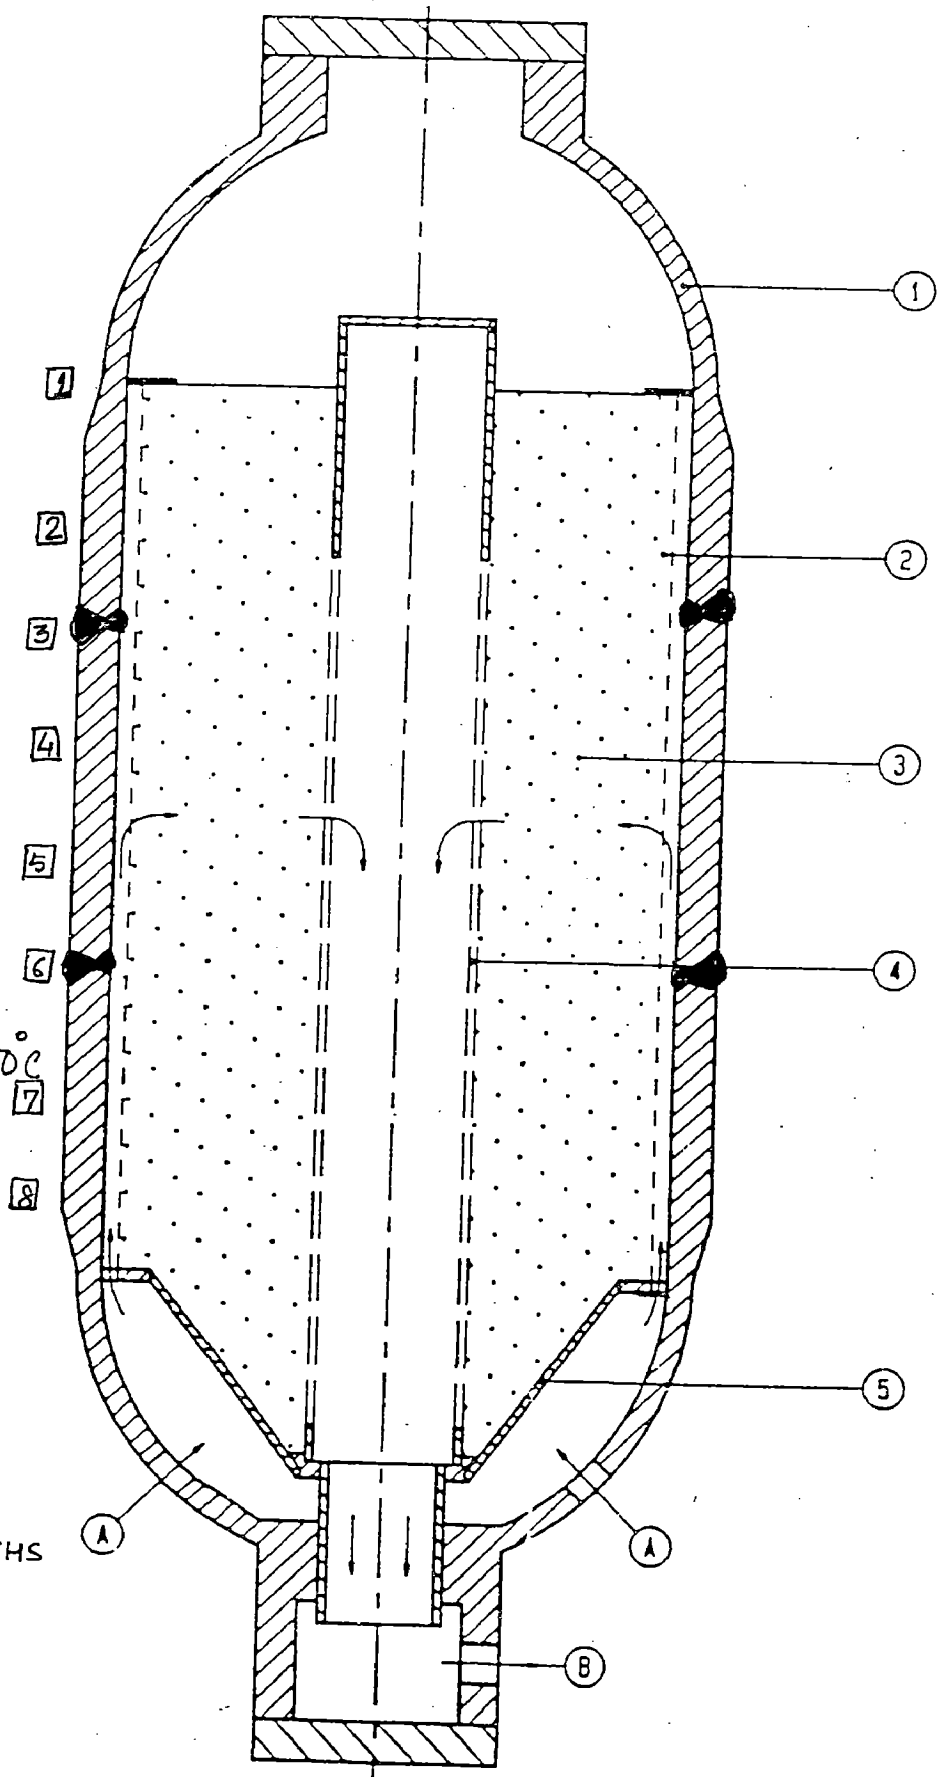
A : GAS INLET
 B : GAS OUTLET

- 1 : PRESSURE SHELL
- 2 : SCREEN PANELS
- 3 : CATALYST BED
- 4 : CENTRE SCREEN
- 5 : CATALYST SUPPORT

Design temp of shell = -450°C

SITE JOINT
 WELD SEAM

SEAM NO. 6 WAS FOUND
 CRACKED AFTER SIX MONTHS
 OF SERVICE.

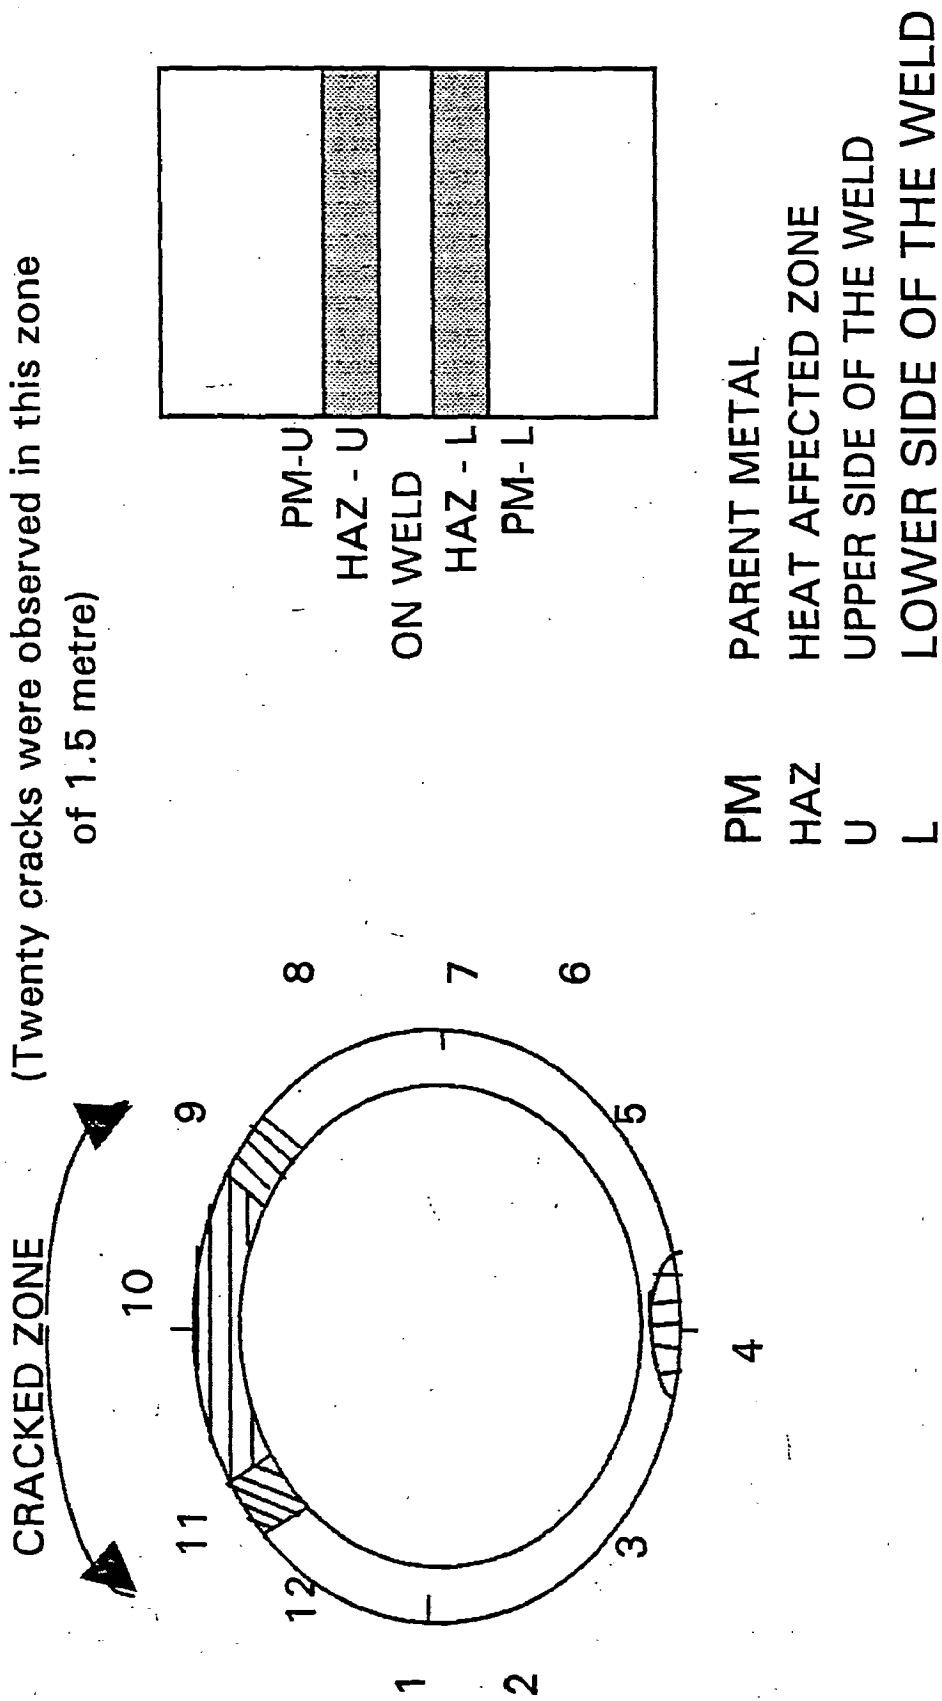
Fig. 5.5 Positions are marked on the weld seam for taking the hardness at various location.

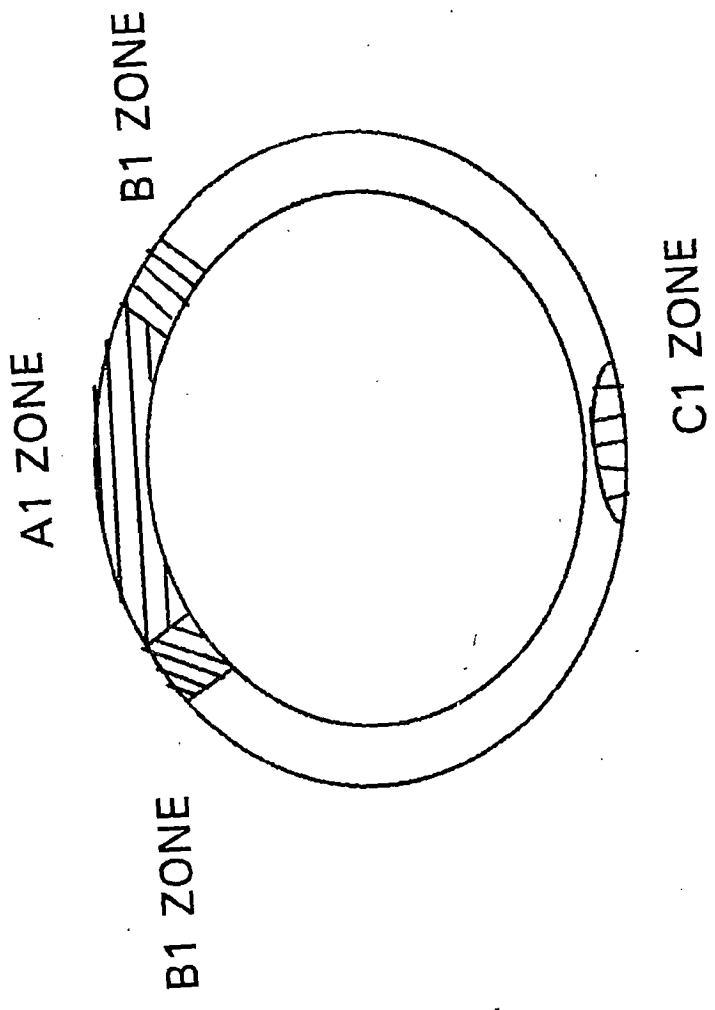
- A1 ZONE : Zone in which cracks were observed.
- B1 ZONE : Zone adjacent to A1 zone.
- C1 ZONE : Zone opposite to A1 zone.

Fig. 5.6 Weld seam showing the location of various zones for further analysis

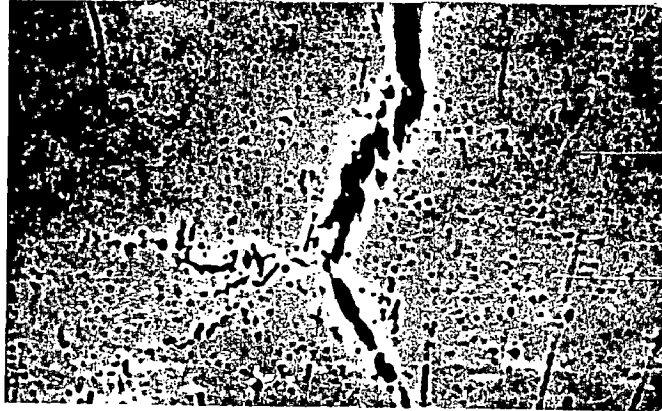
Fig. 5.7 Cracks following course prior austenitic grain boundaries. Porosity is also visible (unetched; X 30).

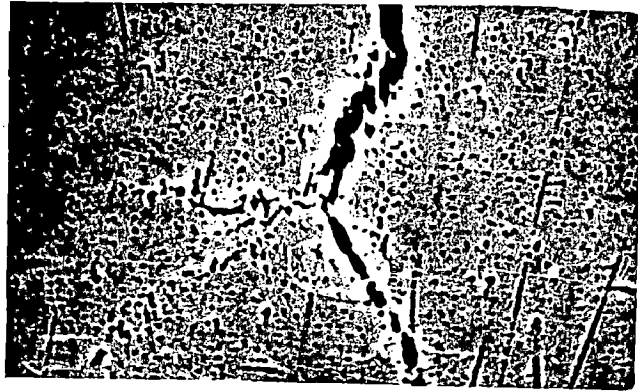
Fig. 5.9 Cracks following course prior austenitic grain boundaries. Porosity is also visible (unetched; X 30).

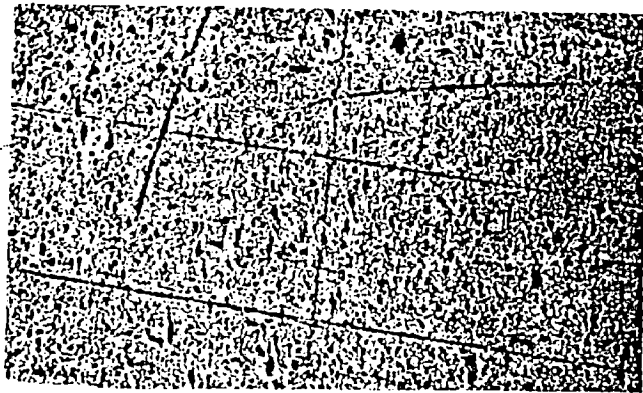
Fig. 5.15 Microstructure of parent metal showing carbide precipitation (Etched in nital; X 30).

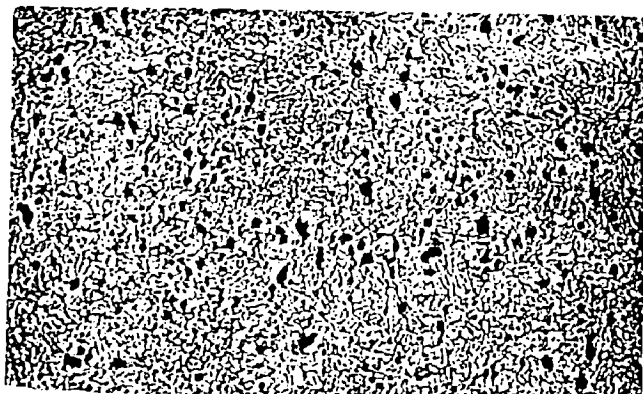
Fig. 5.16 Microstructure of parent metal showing carbide precipitation (Etched in nital; X 100).

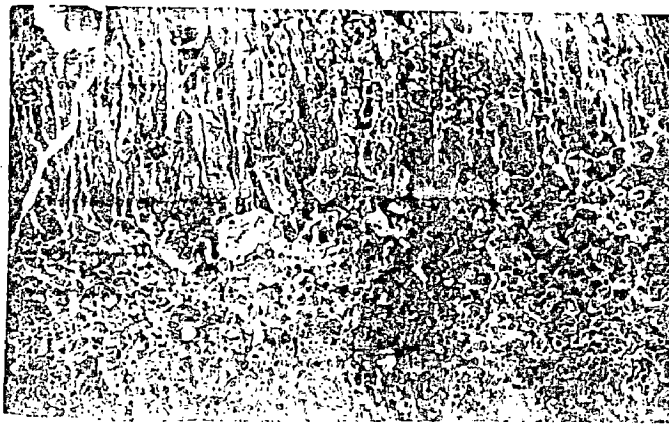
Fig. 5.20 Columnar grains and equiaxed grains. Cracking has occurred mainly by dimple rupture with some sign of tear ridges. (40X1.3)

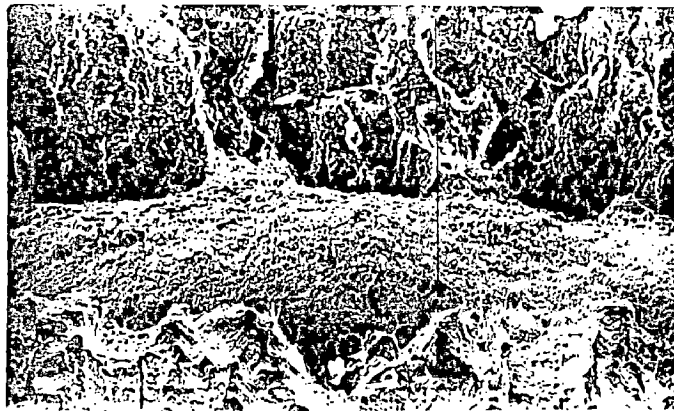
Fig. 5.23 Structure variation observed along the cracked regions. It shows the ductile portion of the fracture surface. At the lower portion, microvoid coalescence is visible. (80X1.4)

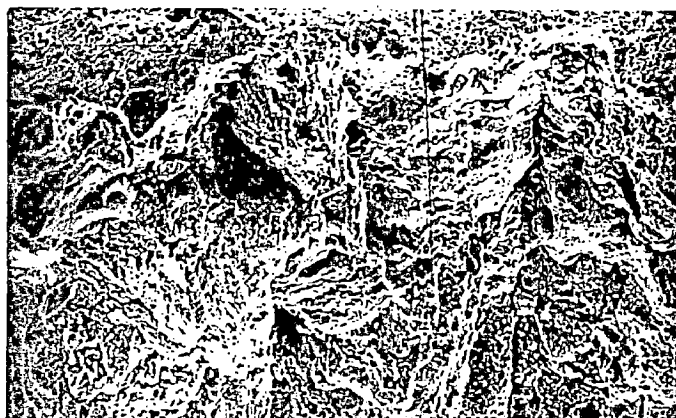
Fig. 5.24 Enlarged view of the bottom portion of Fig. 5.23. Channeling which has occurred due to coalescence of voids is visible, surrounded by large tear ridges, secondary cracks are also visible. (160X1.4)

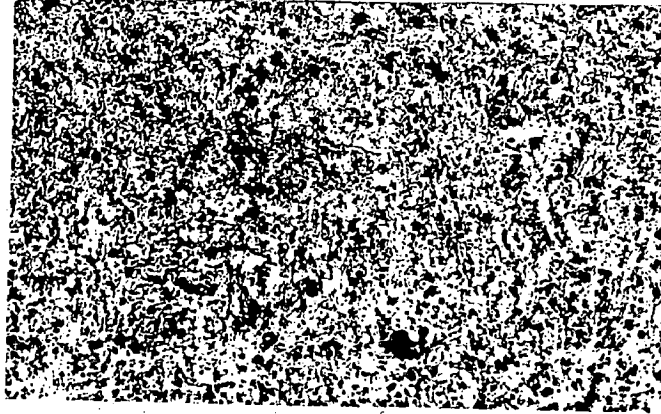
Fig. 5.31 Micrograph of weld zone showing quenched and tempered martensite structure of C₁ zone (Etched in nital; X 200).

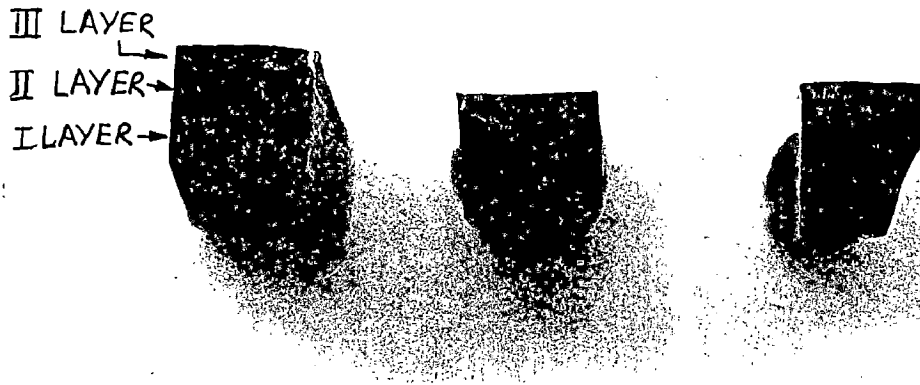
Fig. 5.32 :- Fractured surface of sample piece taken from A₁ zone for SEM analysis.

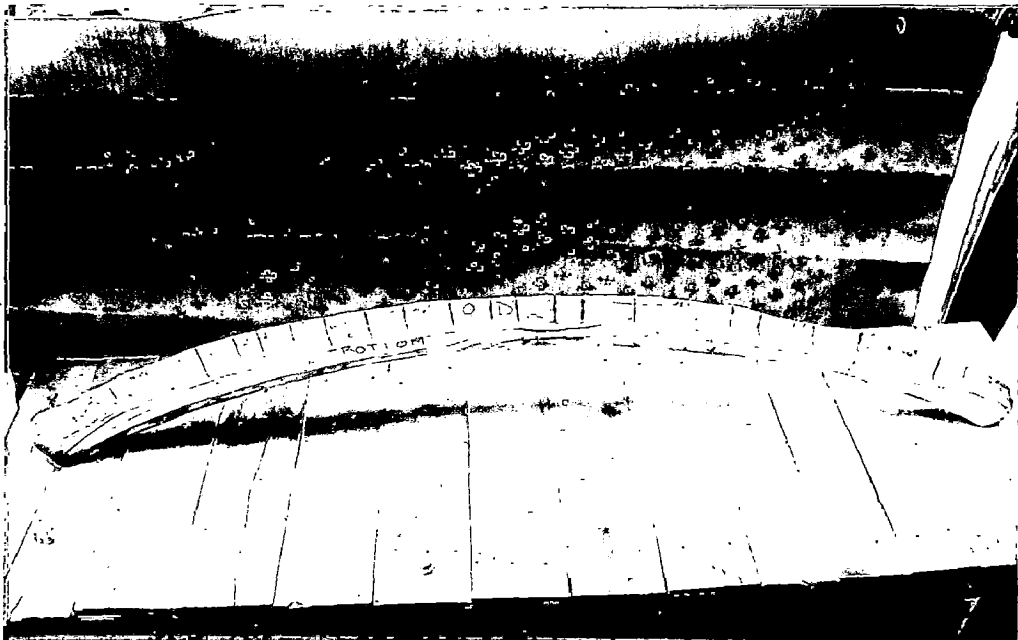
Fig. 5.33 :- A zone of weld₁ seam, where cracks were observed. Photograph is taken after Dye Penetration test. Nineteen distinct radial cracks are visible (Photograph : By country of TCL, Babrala).

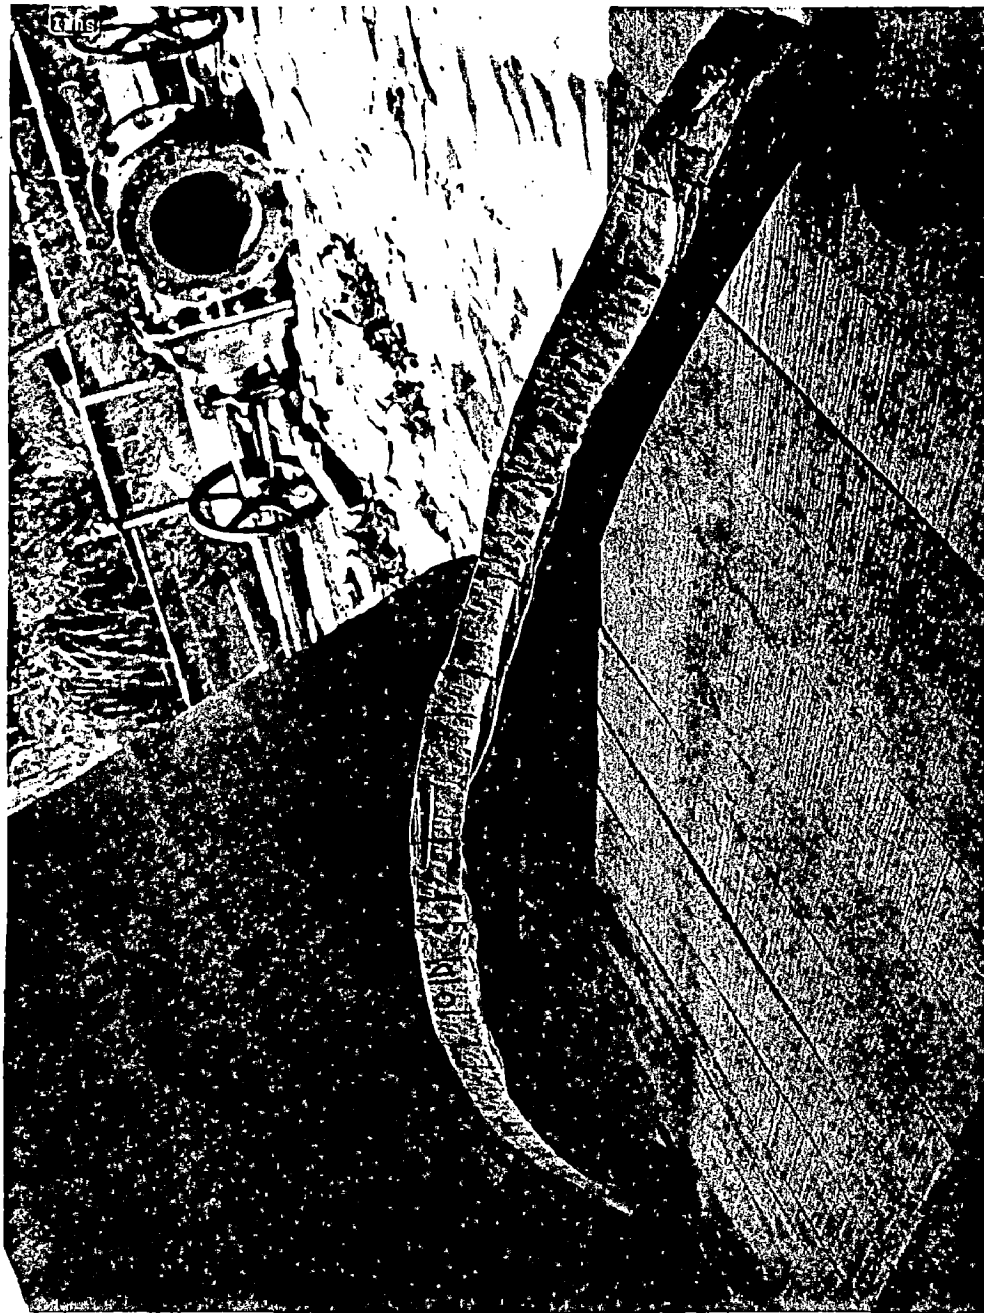
Fig. 5.34 :- Same as Fig. 5.33, but different view.

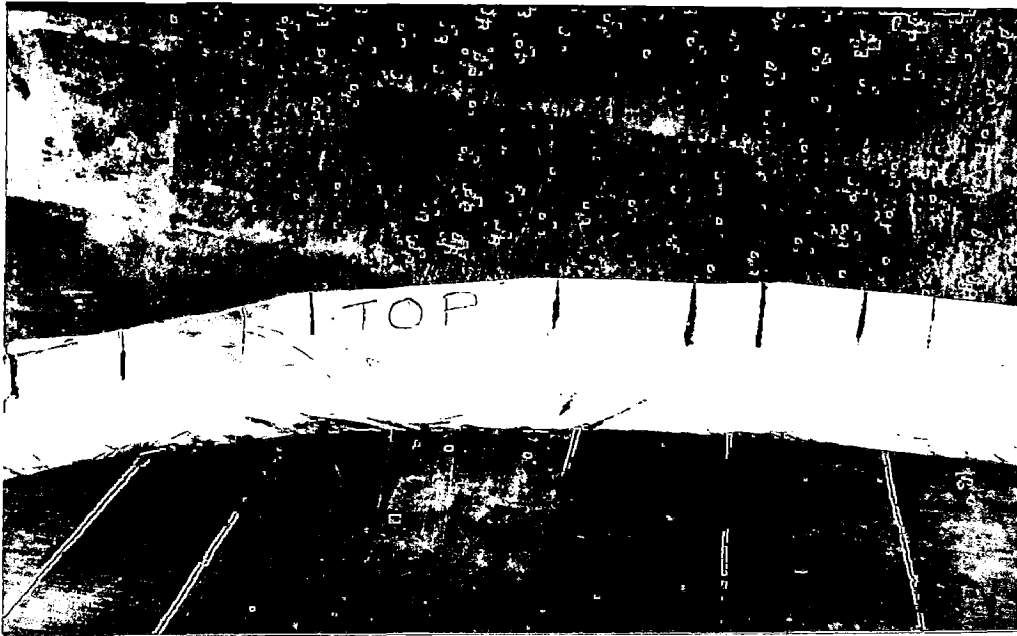
Fig. 5.35 :- Top portion of the segment of weld seam taken from A₁ zone Radial cracks are visible (Photograph : By country of TCL. Babrala).

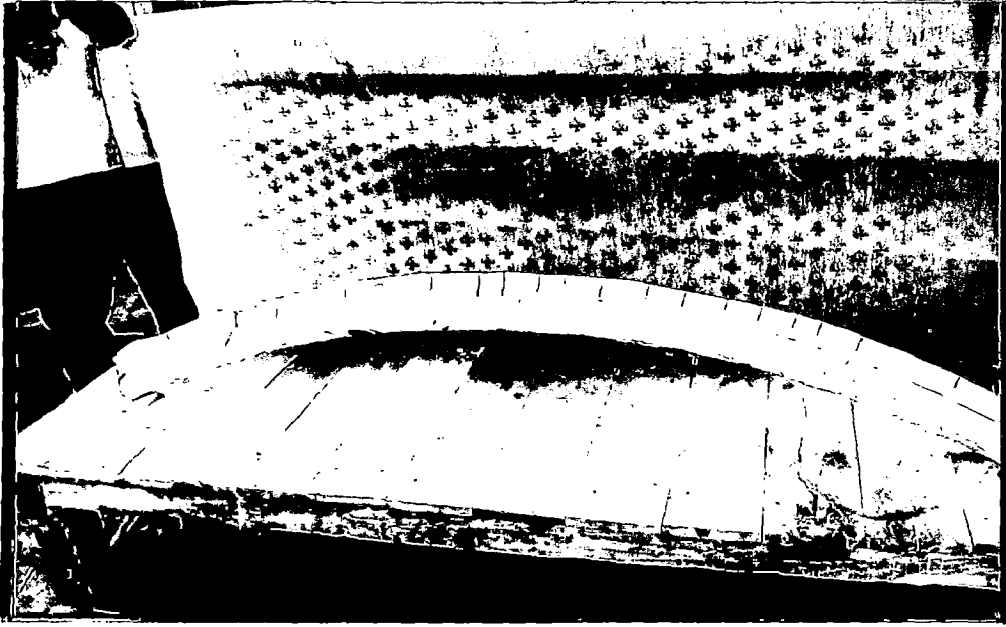
Fig. 5.38 :- Top portion of the segment of weld seam from A_1 zone.
Showing twenty radial cracks (Photograph : By country
of TCL, Babrala).
