**DEVELOPMENT OF EROSION - CORROSION
WEAR RESISTANT COATINGS ON
SUPERALLOYS**

A THESIS

DOCTOR OF PHILOSOPHY

METALLURGICAL AND MATERIALS ENGINEERING

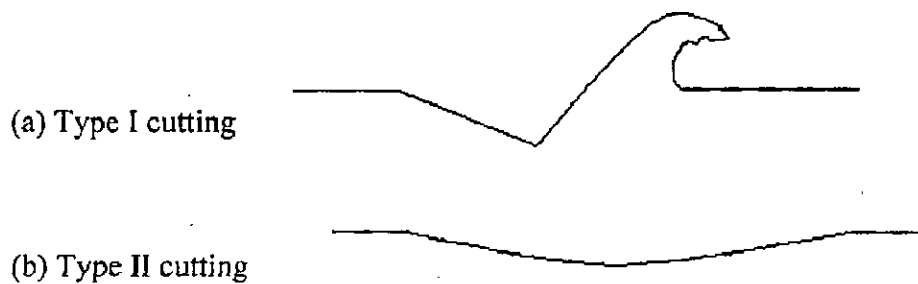
Fig. 2.3 Schematic view of (a) type I cutting by an angular particle, rotating forwards during impact; (b) type II cutting by an angular particle, rotating backwards during impact (Hutchings, 1979).

mode which has been termed type I cutting (Fig. 2.3 (a)), the particle rolls forward, indenting the surface and raising material into a prominent lip, which is vulnerable to removal by subsequent nearby impacts. He further suggested that if the particle rolls backward (Fig. 2.3 b), a true machining action can occur, in which the sharp corner of the abrasive grain cuts a chip from the surface. The type II cutting occurs over only in a narrow range of particles geometries and impact orientations as suggested by him.

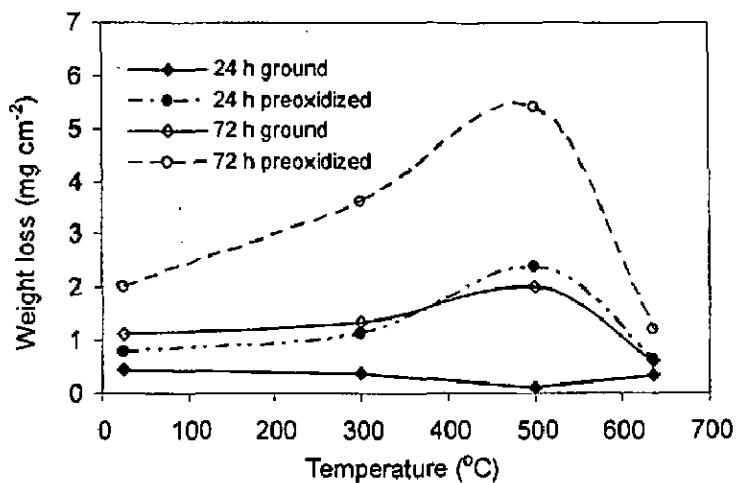
Fig. 2.10 Weight loss against temperature for IN 800 H and IN 800 H preoxidized in H₂-10% H₂O after exposure for 24 and 72 h in the UMIST erosion-corrosion apparatus (Stack et al, 1992)

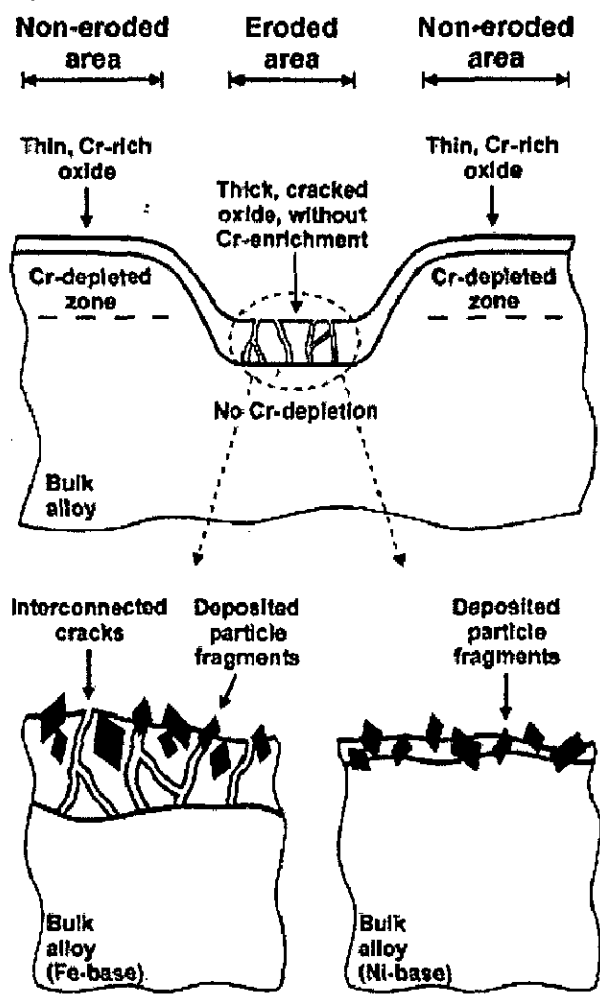
Fig. 2.11 Model illustrating the oxide formation during oxidation and erosion-corrosion at 550 °C (Norling and Olefjord, 2003).

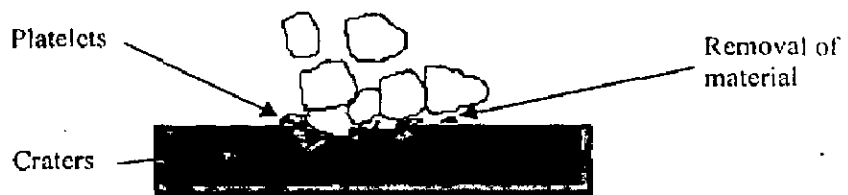
(c) Removal of material from superalloy surface by sand particle impact

Fig. 5. 48 A schematic diagram showing probable erosion mechanism of superalloy when impacted by silica sand particles at a velocity of 40 ms^{-1} and impact angle of 90° .
