SEISMIC EVALUATION AND RETROFITTING TECHNIQUES OF BRIDGE COLUMNS

A DISSERTATION

MASTER OF TECHNOLOGY

EARTHQUAKE ENGINEERING

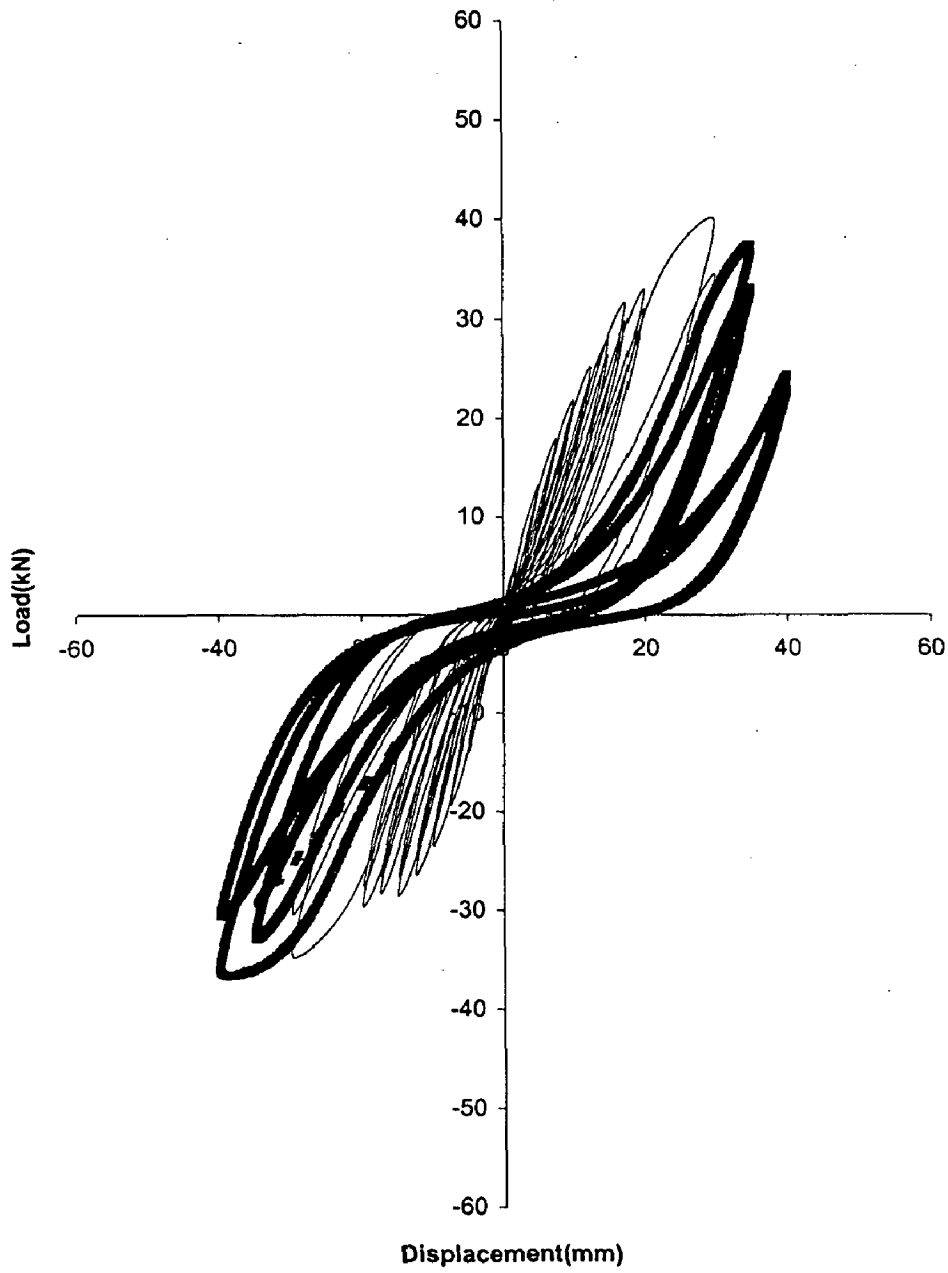
Fig.5.1 Hysteretic Response of as-built Model M1

Hysteretic envelope in Figure 5.1 shows the relation between load and displacement. Loading was applied in different number of cycles. Relation between load and displacement remains linear up to ± 13.8 mm, beyond that model has started yielding. Model M1 experienced first flexural cracks at the bottom of the column during the third cycle at 21 kN and increased as the load was increased as shown in Plate 5.1. At the theoretical yield load of 28 kN, initial vertical cracks were noticed on the column. These cracks spread over the mid-height length at displacement ductility (μ_{Δ}) = 1.1 and the peak lateral load of 32 kN were recorded at this level as shown in Figure 5.2. As testing continued, the lateral capacity progressively decreased, the cover concrete just above the special confining region fell off and the lateral load resistance was reduced to 24 kN as shown in Plate 5.3. The model was tested up to 40 mm stroke (displacement), it has taken maximum of 40 kN load at 30 mm displacement with μ_{Δ} = 2.12. The maximum loads at different displacements are

shown in Table 5.1. The hysteresis loops shown in Figure 5.1 show very significant degradation of stiffness of model M1.

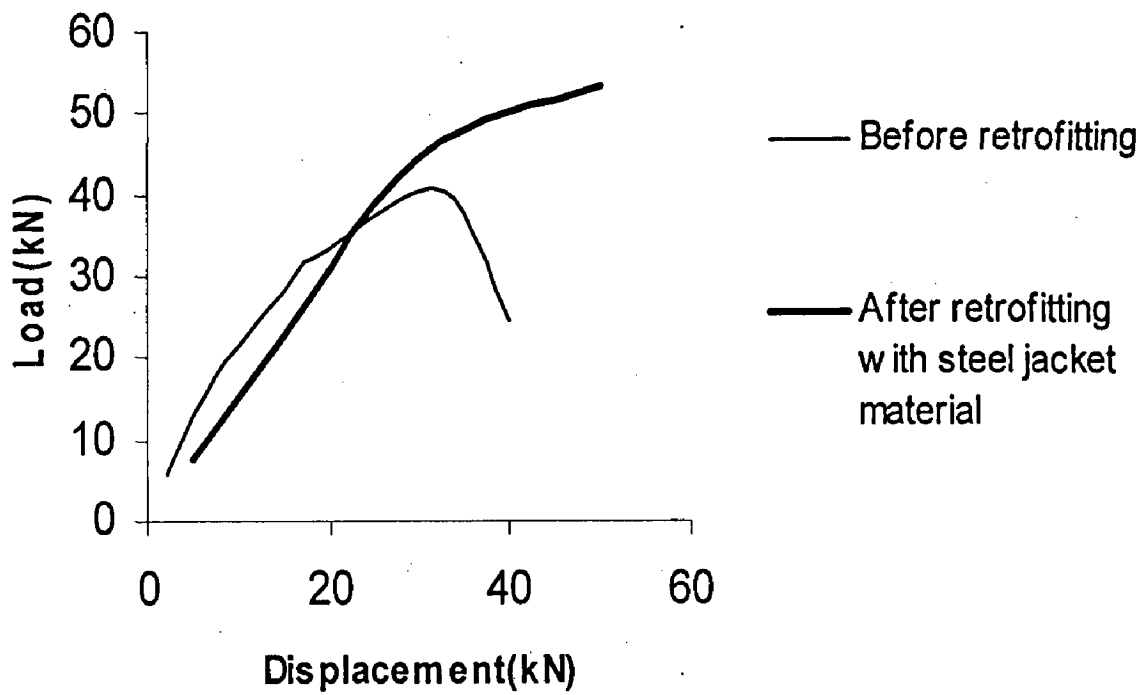
Fig.5.5 Maximum Loads at Different Displacements for Model M1

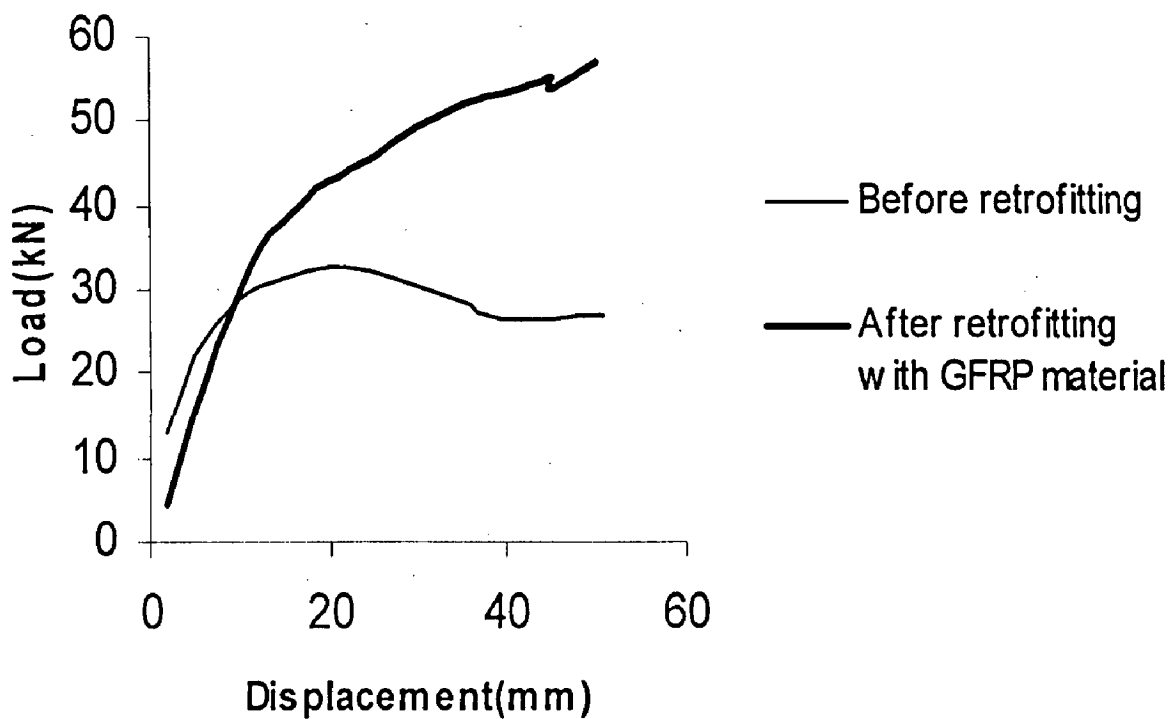
Fig.5.6 Maximum Loads at Different Displacements for Model M2

Hysteretic envelop in Figure.5.4 gives the relation of load-displacement of model M2 after retrofitting with GFRP jacketing. Up to ± 15 mm the curve is linear and after that yielding has started. The loading was carried out up to a displacement of 50 mm corresponds to a ratio of lateral displacement to column height of approximately 3.33%. The confinement with GFRP material wrapping increased the load carrying capacity of circular bridge column. It has taken the maximum load of 56 kN at 50 mm displacement with $\mu_{\Delta} = 3.33$. Cracks are not visible within the jacketing area but small cracks are visible at top of jacketing at load level 45 kN at 25 mm displacement as shown in plate 5.15 without any degradation of capacity. Cracks got widened and are visible clearly at displacement 50 mm at load level 56 kN as shown in plate 5.16. The maximum loads at different displacement levels are given in Table 5.2 and Figure.5.6.

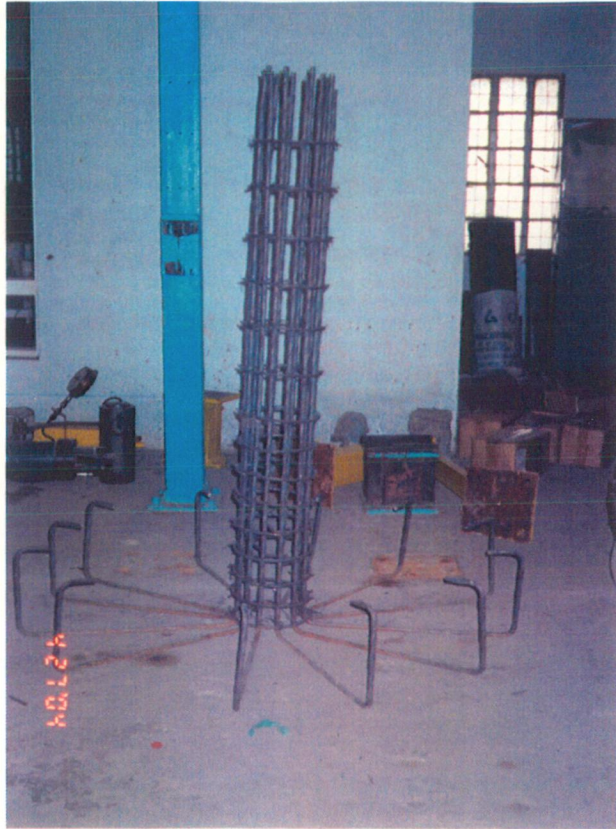
Plate 3.1 Reinforcement Detailing of Models M1 and M2

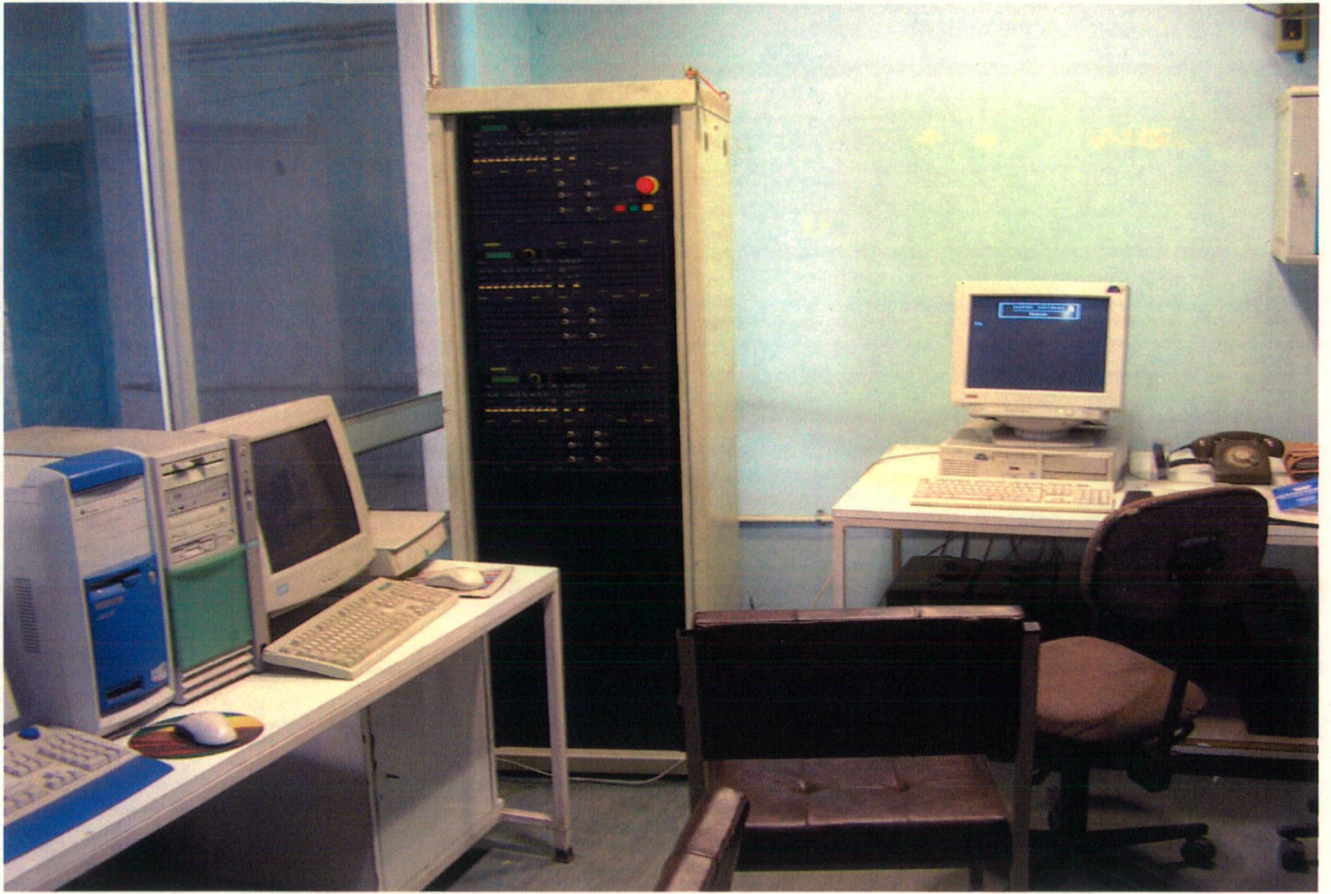
Plate 3.5 Closed-loop Servo Control Hydraulic Actuator

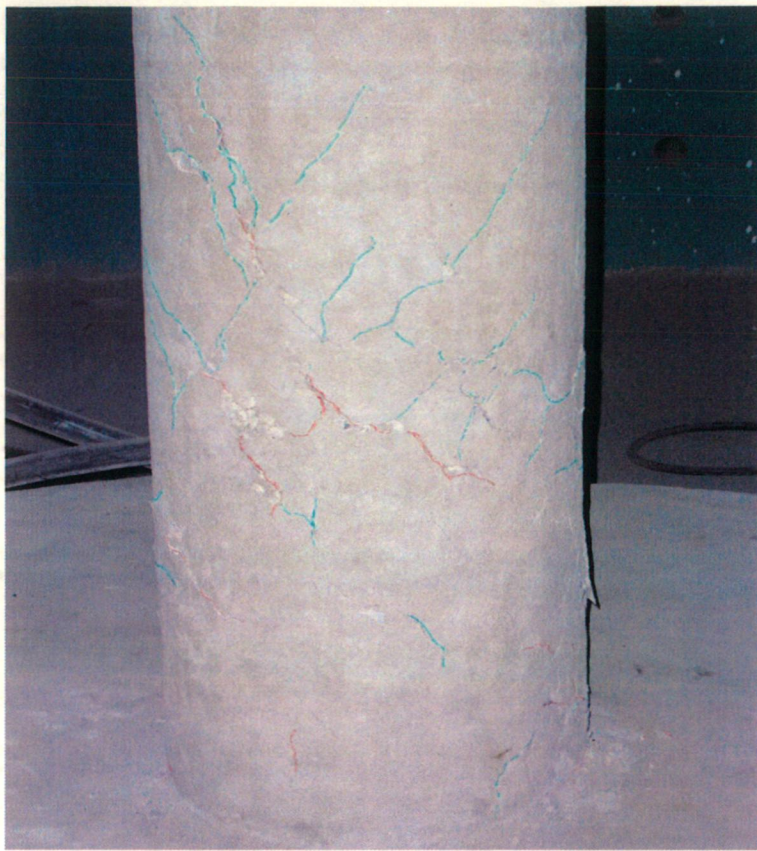
Plate 5.2 Cracks extended to mid height in Model M1

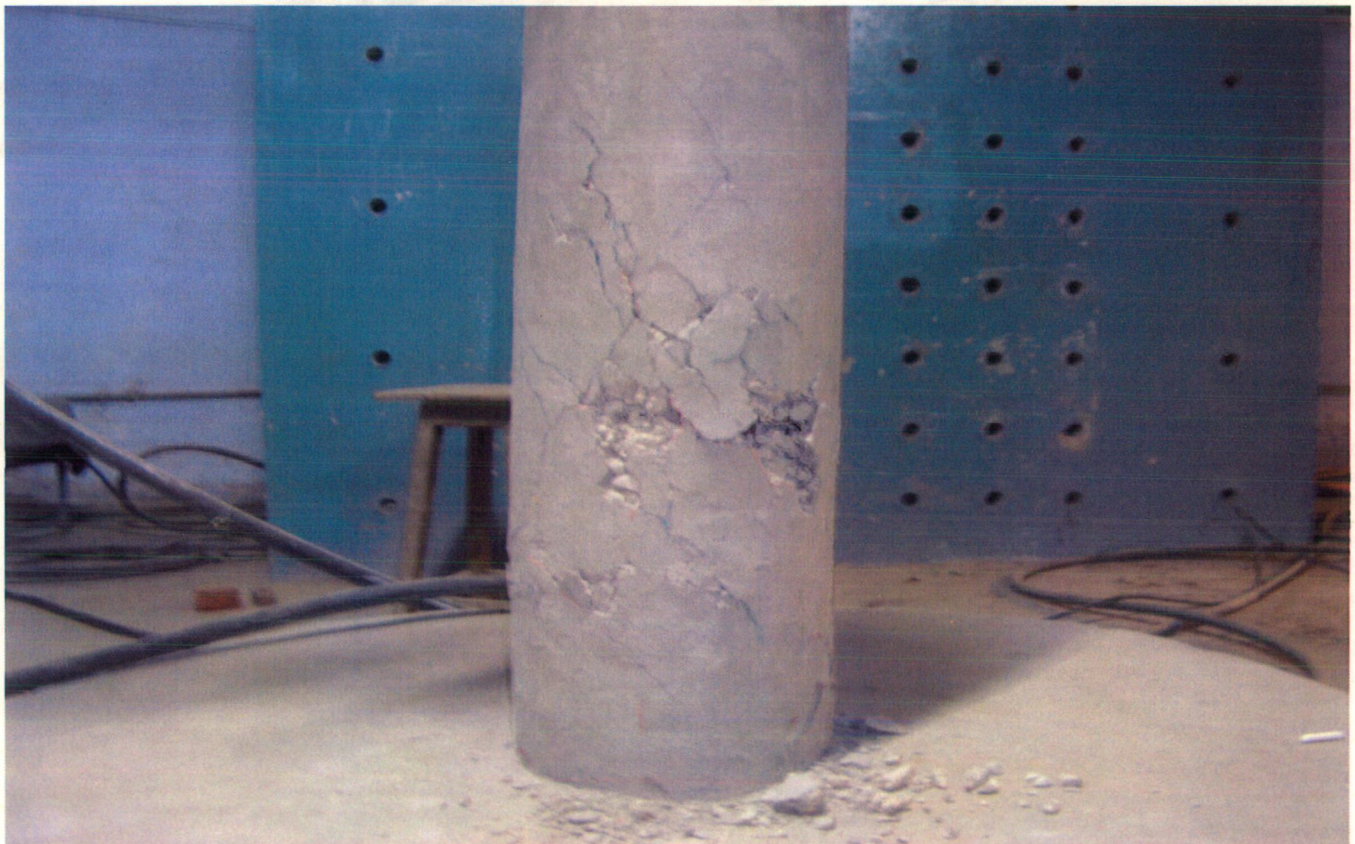
Plate 5.3 Spalling of Concrete in Model M1

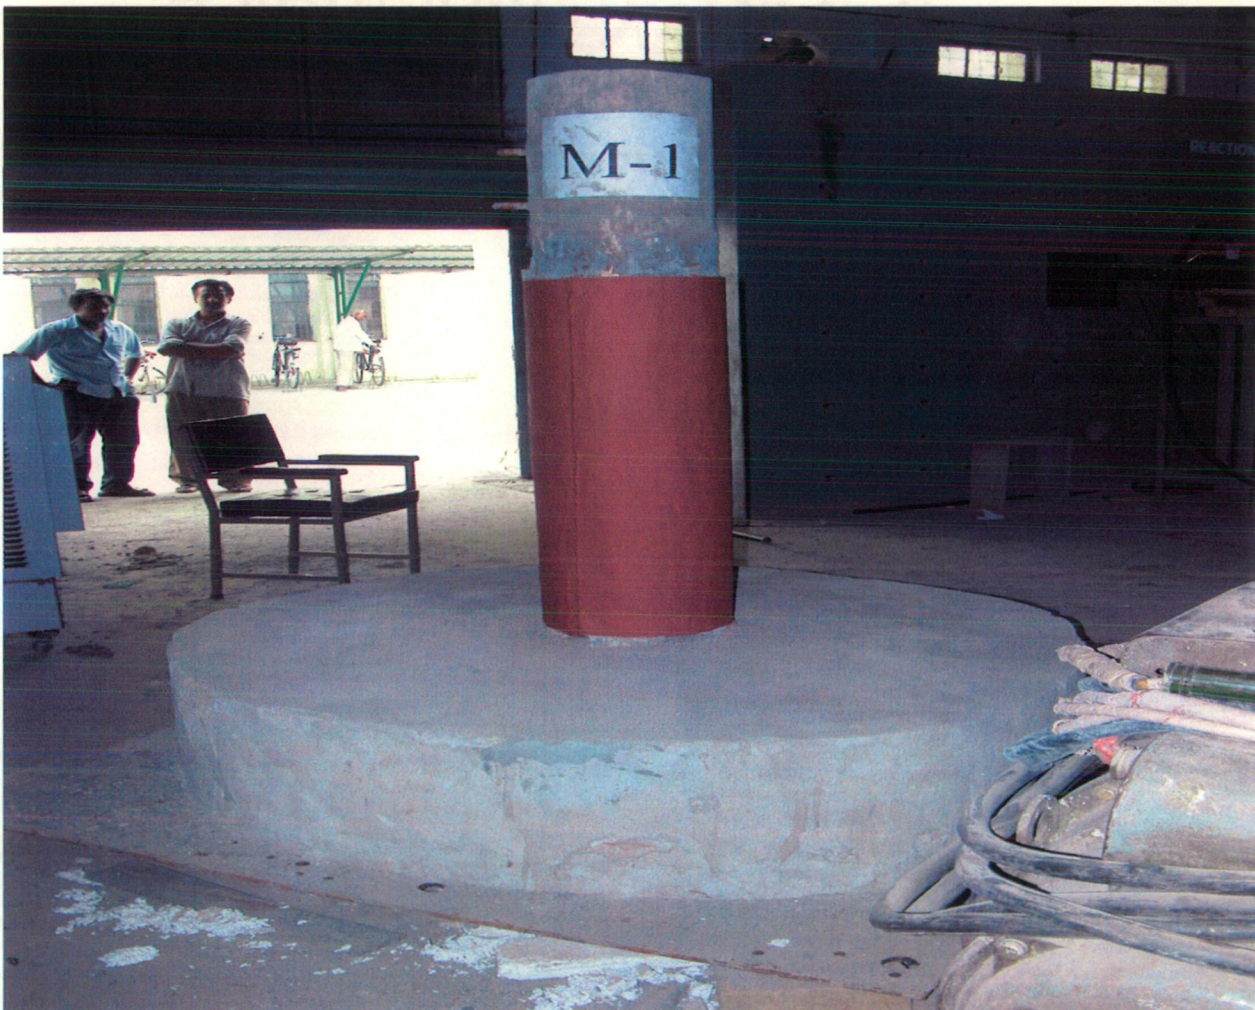
Plate 5.5 Model M1 after Retrofitting with steel jacking

Repair and retrofit of column M1 involved chipping off the cover concrete of the column in the vicinity of the plastic hinge region and wherever cracks are noticeable. After that two half shells of steel plate of thickness 2.5 mm rolled to radius of 15 mm larger than the column radius are positioned over the height of 800 mm and are welded up the vertical seams to provide a continuous tube as shown in Plate 5.5. This gap is grouted with a pure cement grout of 1:3, after flushing with water. A space of about 45mm is provided between the jacket and the footing, to avoid the possibility of the jacket acting as compression reinforcement by bearing against the footing at large drift angles. The plastic hinge length has found to be 310 mm after retrofitting. It was left for 10 days for curing. The retrofitted column was then tested to quasi-static cyclic lateral loading. Plates 5.6 to 5.9 show different stages of retrofitting of model M1 with steel jacketing.

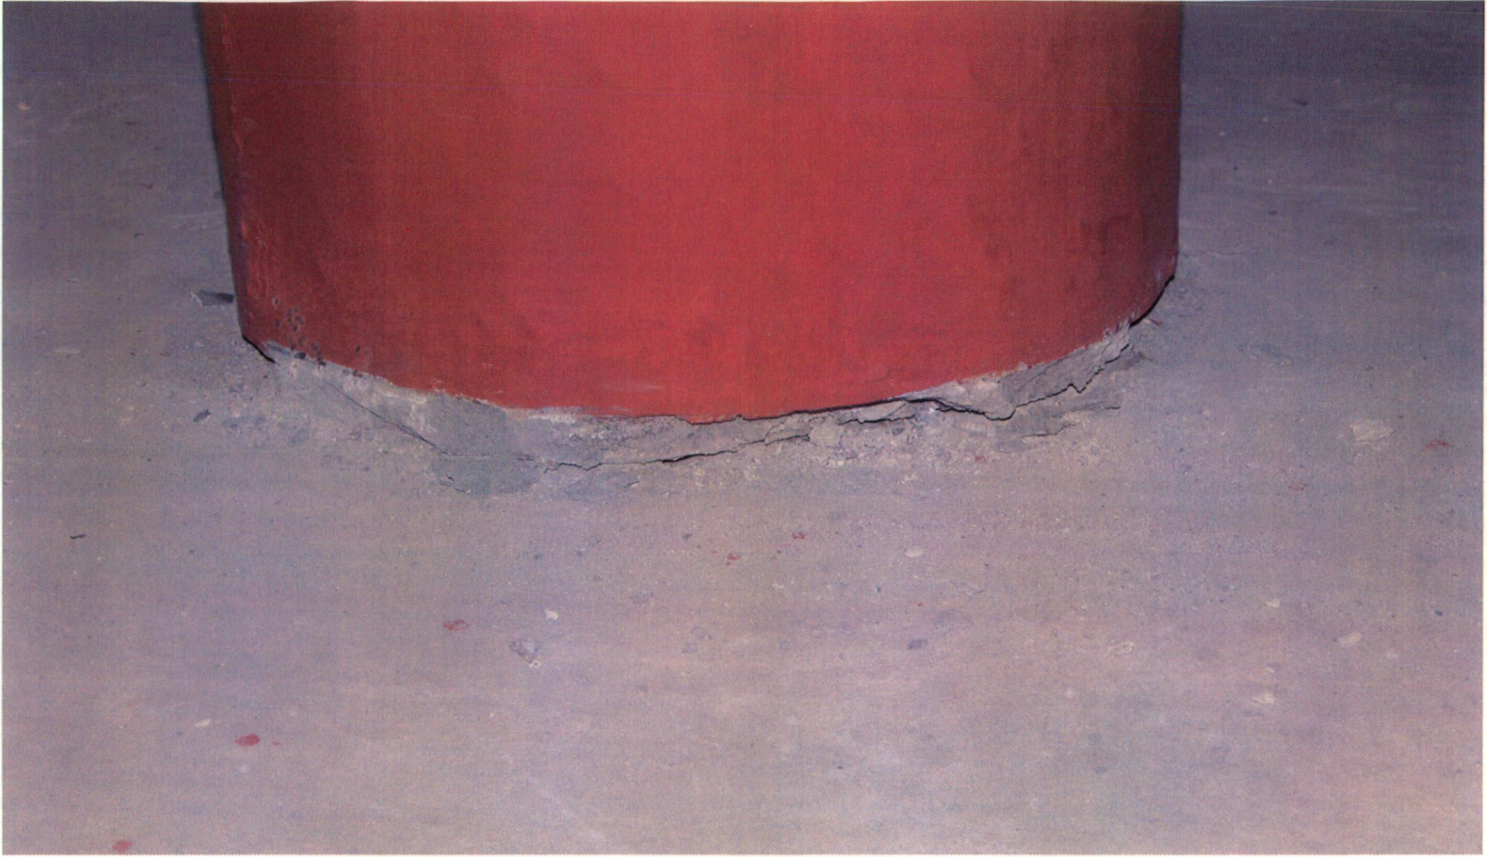
Plate 5.10 Concentric Cracks in Model M1 after Retrofitting

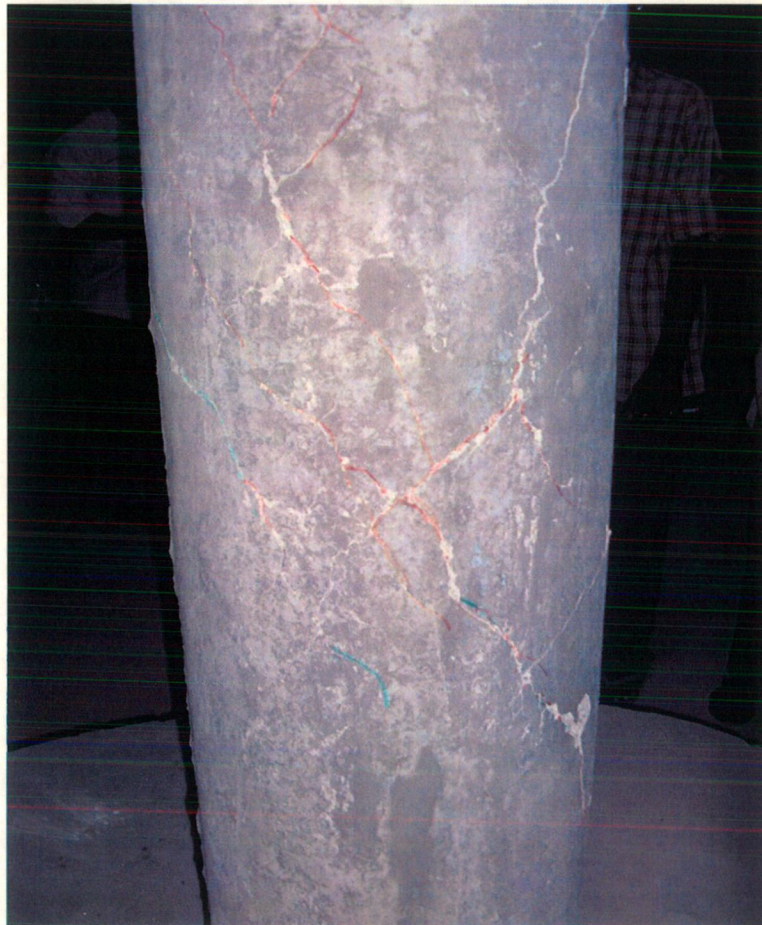
Plate 5.11 Cracks in Model M2

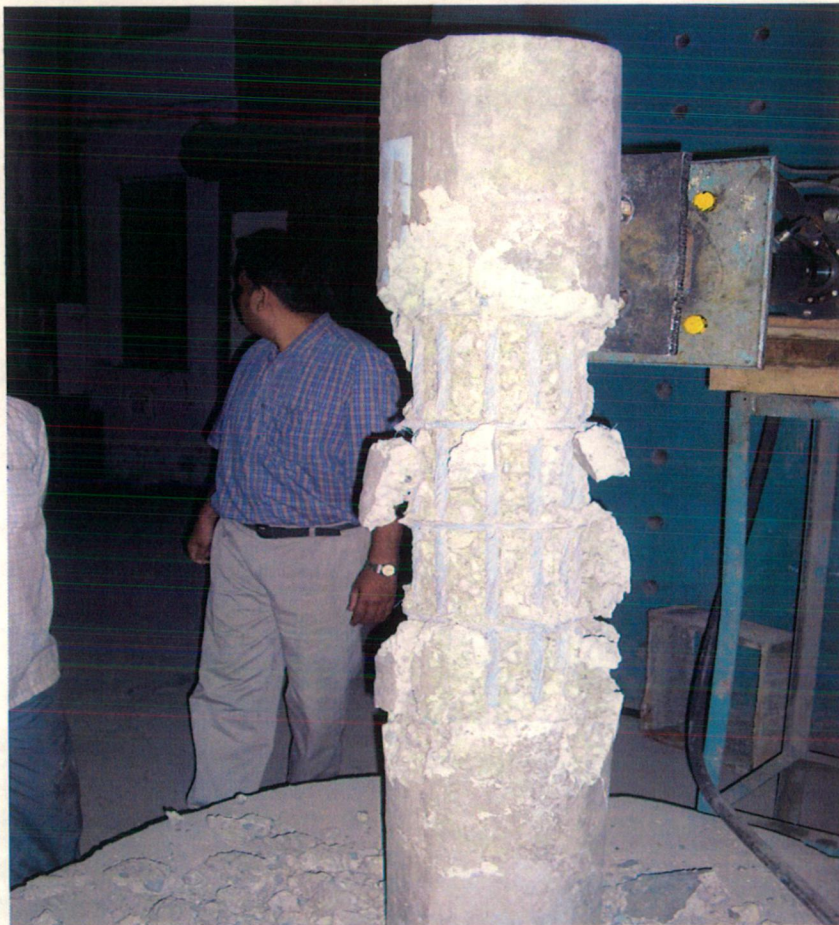
Plate 5.13 Model M2 after Testing

complete damage has taken place as spalling of cover concrete as shown in plate 5.13 at load level 26 kN at 50 mm stroke.

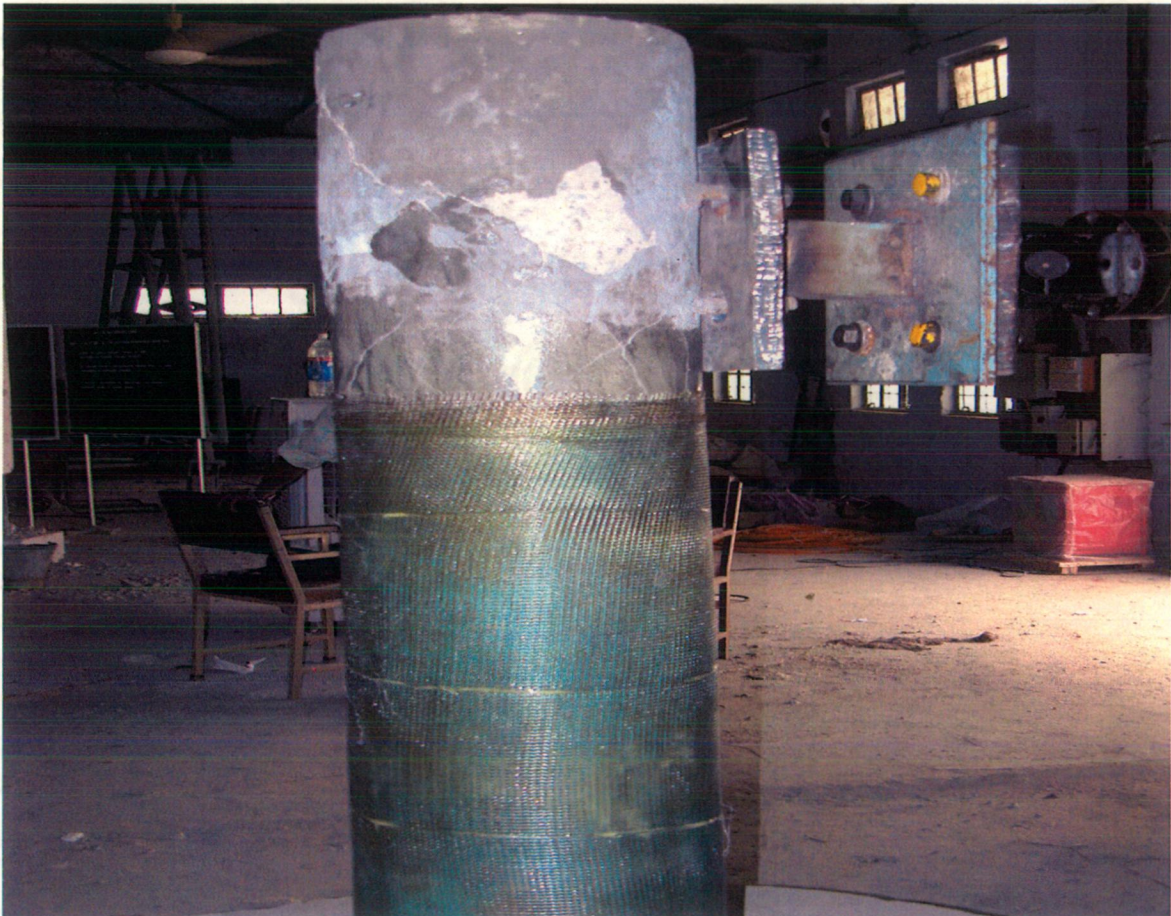
Plate 5.15 Cracks in Model M2

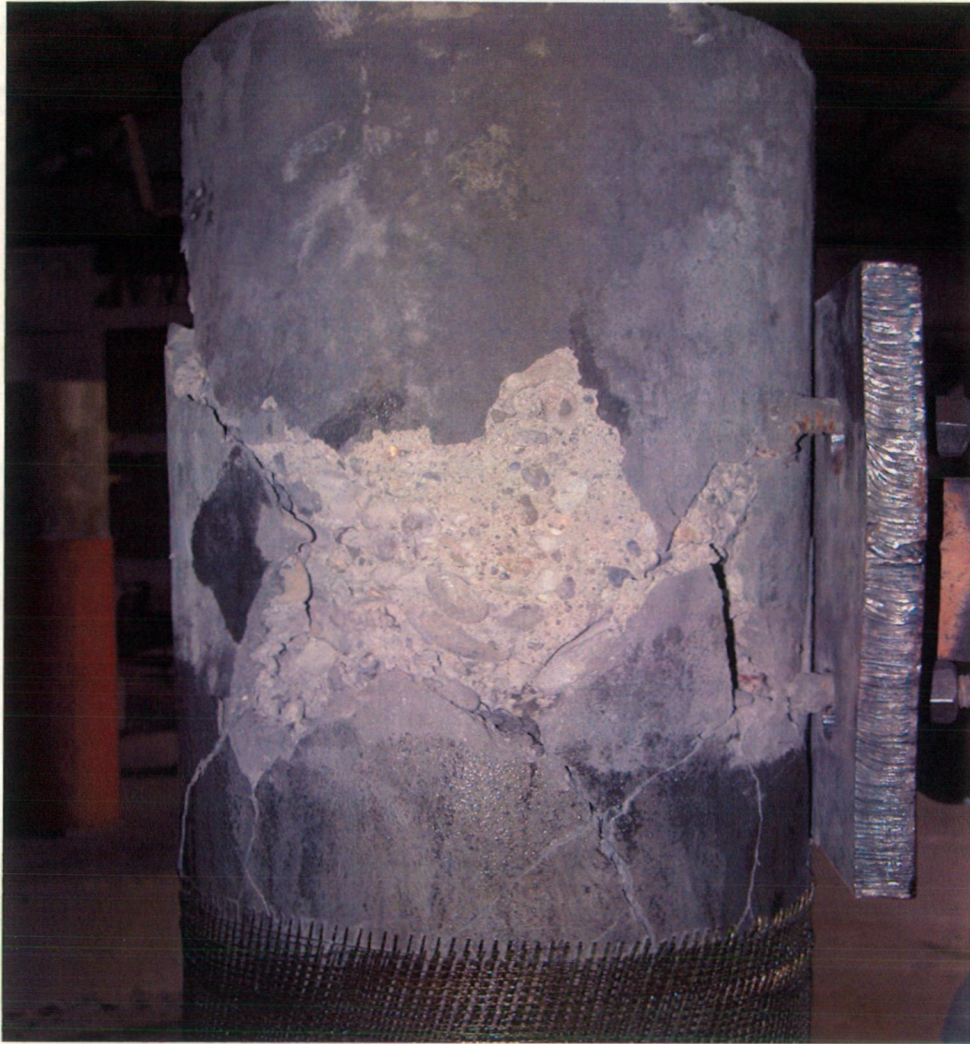
Plate 5.16 Spalling of Concrete at top of the Model M2
