GEOTECHNICAL INVESTIGATIONS OF VISHNUGAD- PIPALKOTI HYDEL PROJECT, GARHWAL, INDIA

Ph.D THESIS

The Vishnugad–Pipalkoti Hydroelectric Project, a run-of-the river (ROR) Scheme envisages construction of a 65m high diversion dam near village Helong (79°29'30" E and 30°30'50" N), a 13.4 km long Power tunnel (PT) and an underground power house to the south of village Hat (79°24'56" E and 30°25'31"N) to produce 444 MW of power (4 x 111 MW). The project is located on Alaknanda River, a major tributary of river Ganga, in Chamoli District in the state of Uttarakhand. A detailed Engineering Geological evaluation of the project has been carried out, to understand various Engineering Geological problems, which may arise during construction and to find suitable control measures.

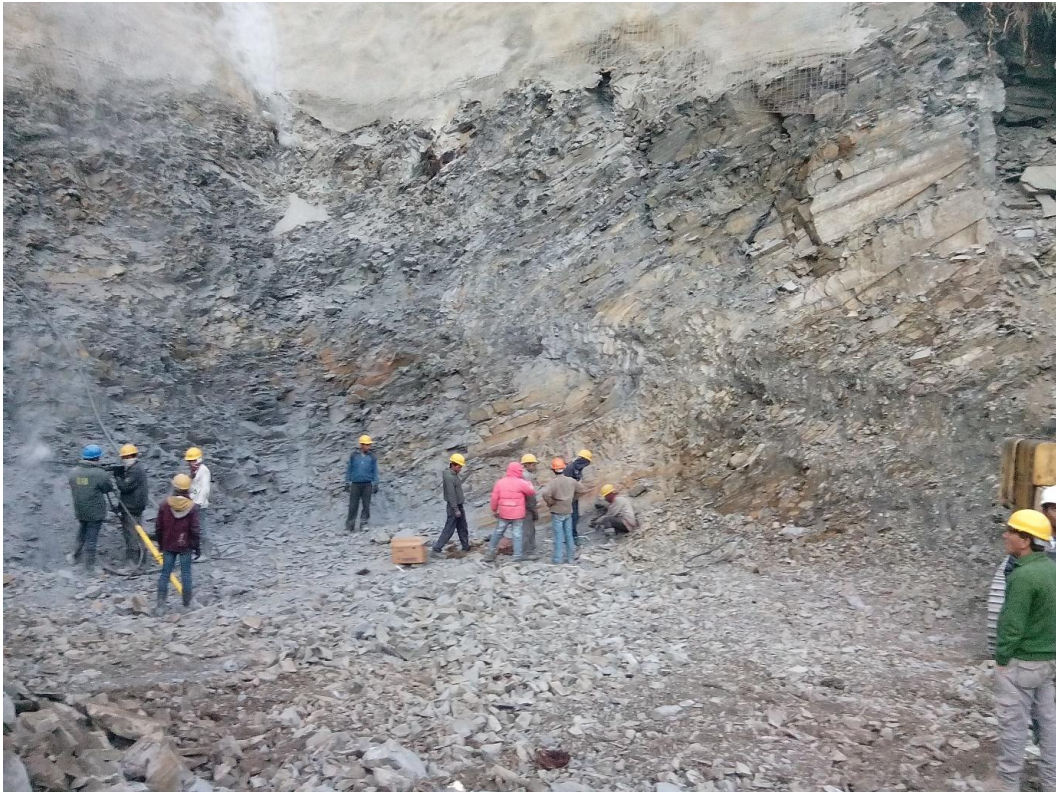
Fig 3.4 Presence of slate just above the drift opening at Hat village

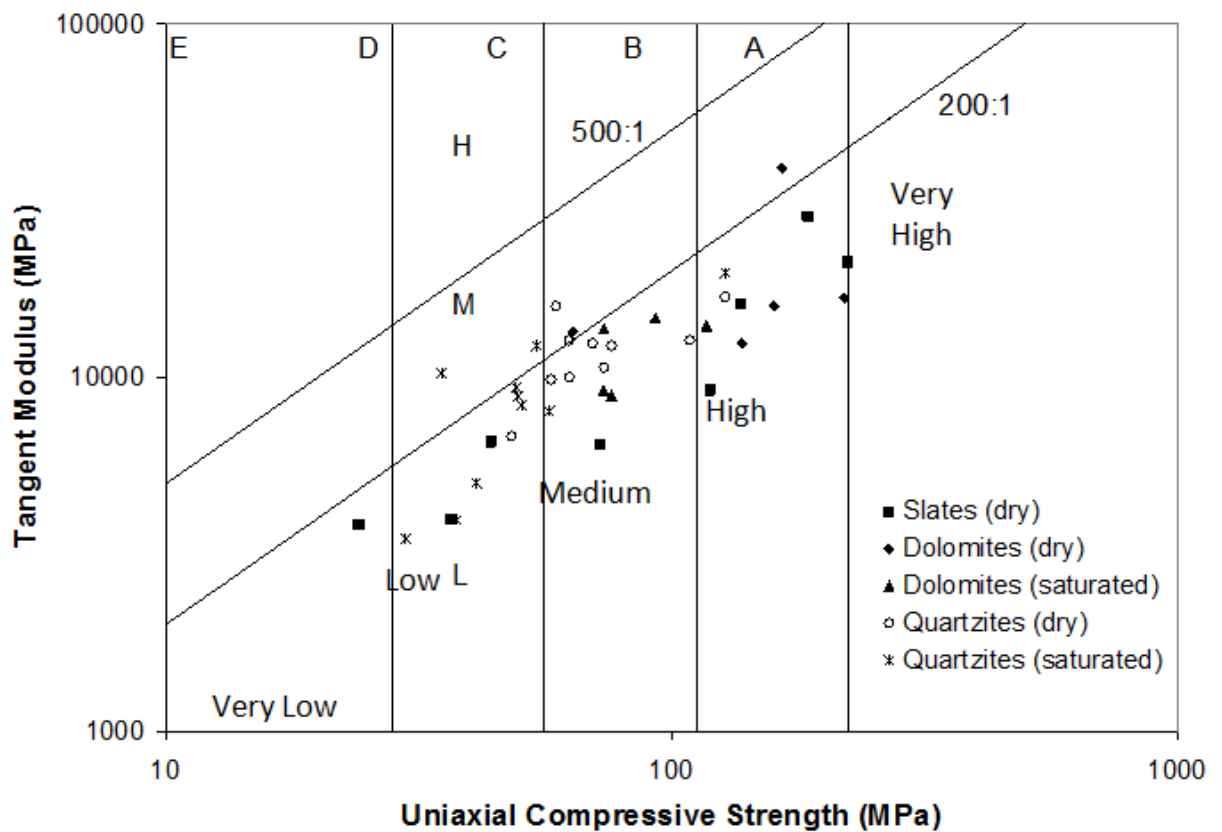
In order to understand the relation between the UCS (σ_c) and the tangent modulus of deformation, E_t (at 50% of σ_c), it is plotted on Modulus-Strength Classification of Deere and Miller (1966) (Fig 3.8) for representative rock samples (Table 3.20). This logarithmic plot illustrates that a wide overlap in strength and deformation properties can be seen for individual rock types. In case of slates, the tests on dry samples indicate that they fall under the category of low to medium, though sporadic values fall under high category also. The dry dolomitic limestone samples shows high UCS values, while the saturated samples fall between medium to high range.

Fig 3.8 Deere–Miller (1966) Classification of Rocks

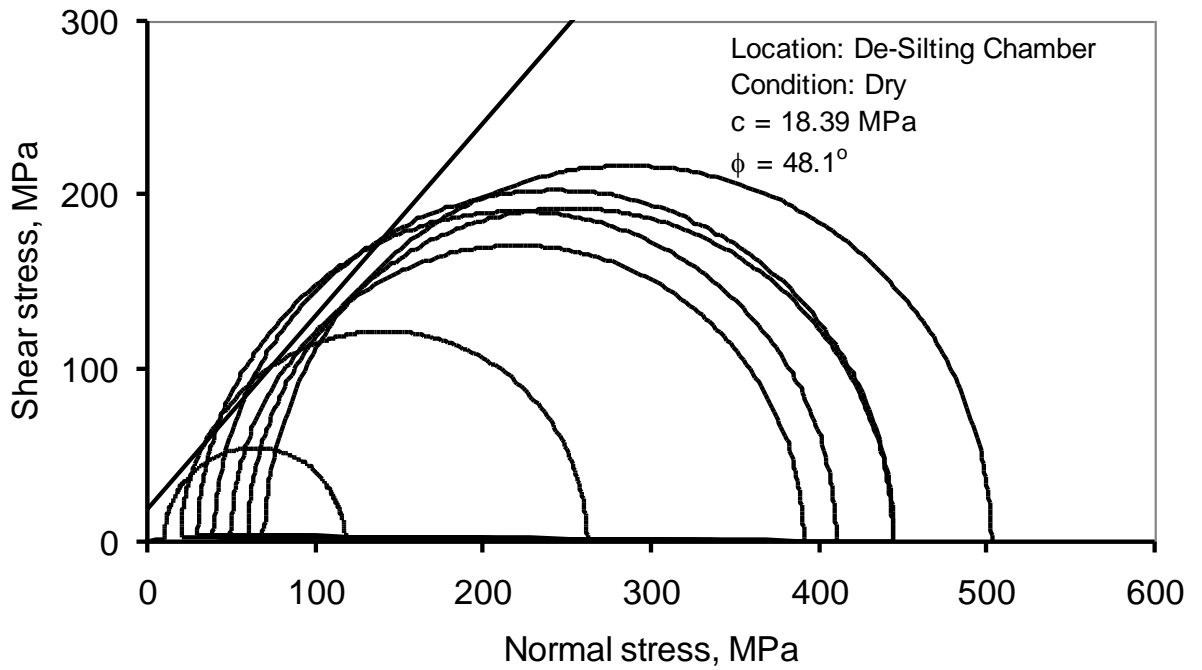
Fig 3. 9a Mohr's Envelope for Quartzites (Dry)-Desilting Chambers Area

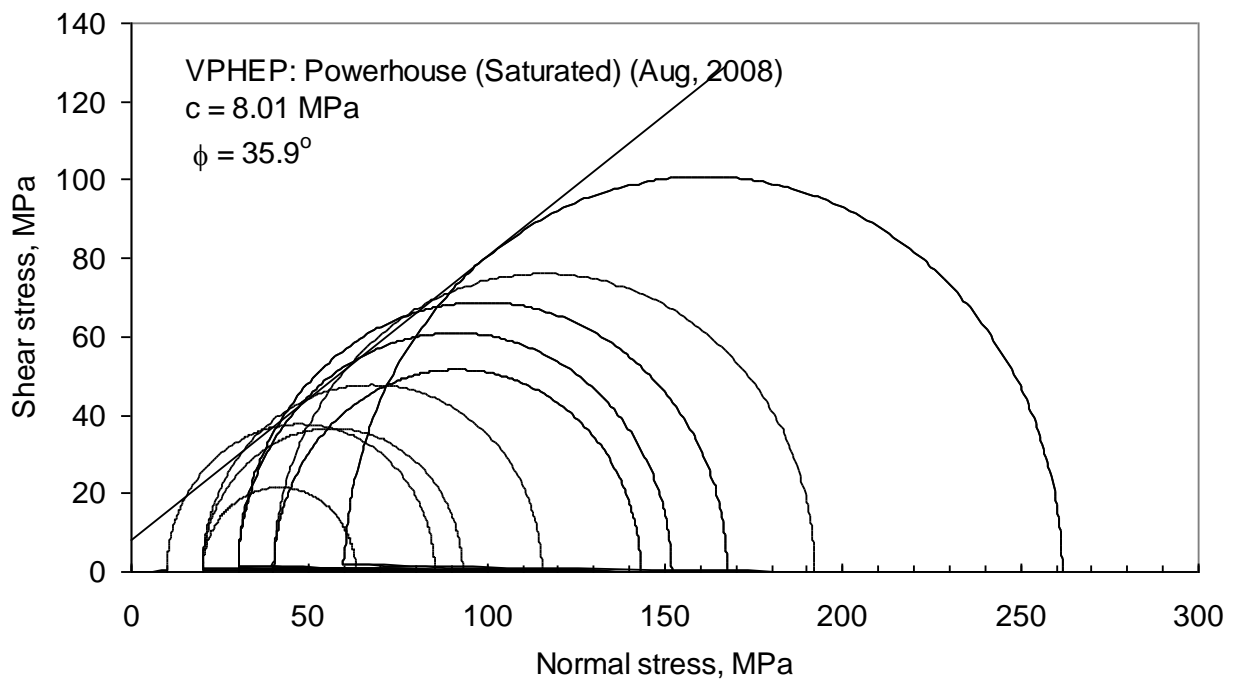
Fig 3.11b Mohr's Envelope for Slates (Saturated)-Powerhouse

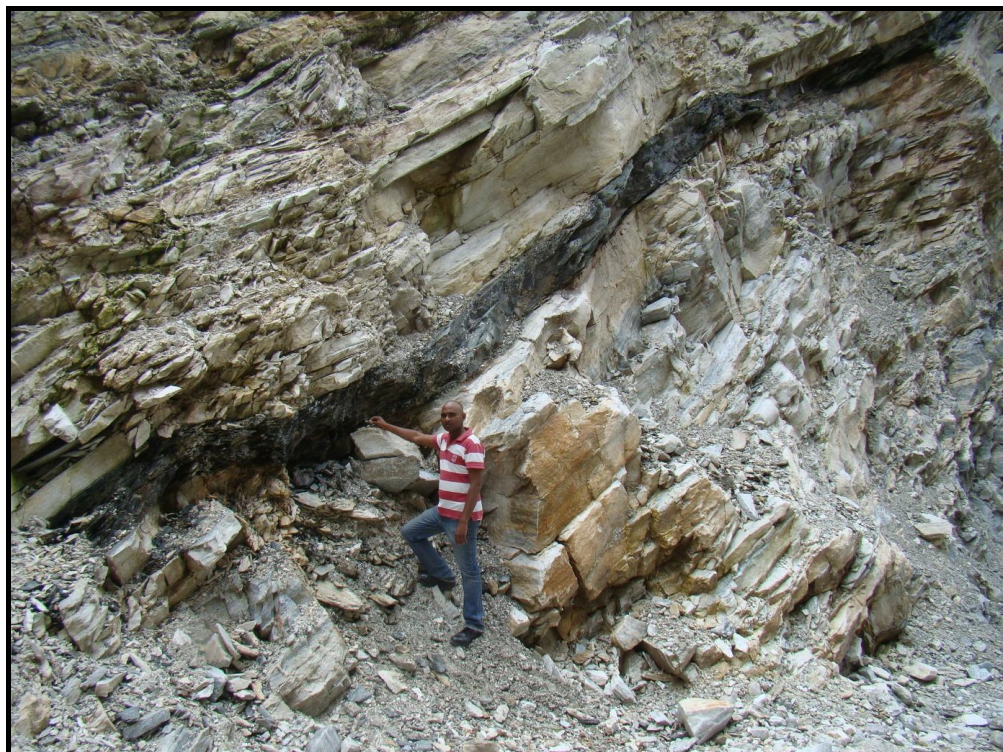
Fig 4.4 Garhwal Group Quartzites with bands of chlorite schist exposed on the left abutment

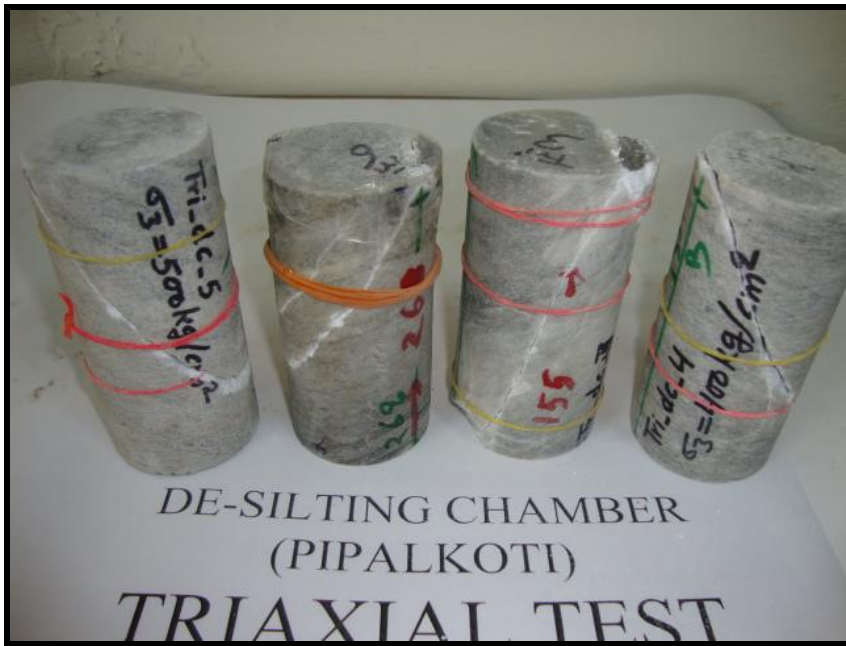
Fig 4.5 Quartzite Core samples from Dam area showing foliation traces

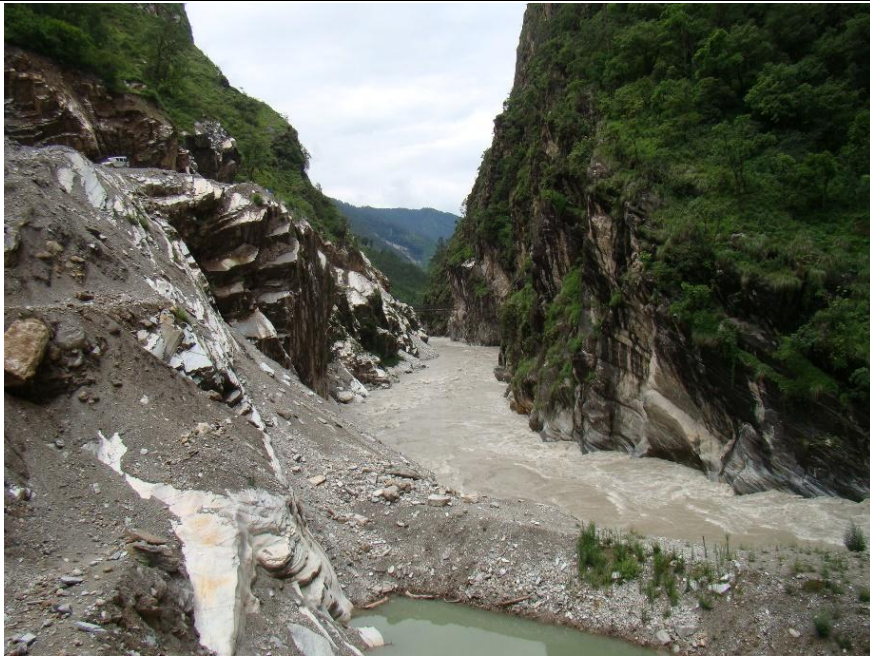
Fig 4.8 Quartzite of Gulabkoti Formation Exposed at Dam site

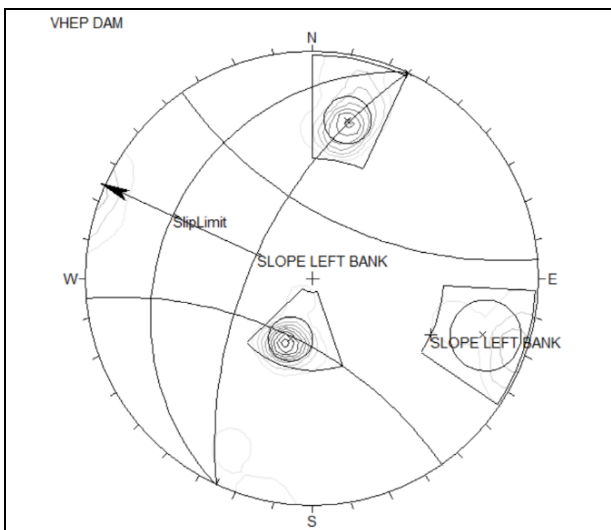
The kinematic analysis for toppling failure was carried out using Dips software. It follows the method as indicated by Goodman, 1980, which is based on i) Variability cones indicating the extent of the joint set population. ii) Slip limit based on the joint friction angle and slope angle and iii) Kinematic considerations. The topple analysis were carried out for joint J1 only as it dips at very steep angles (85°).

Fig 4.19 Topple Analysis result for left Bank

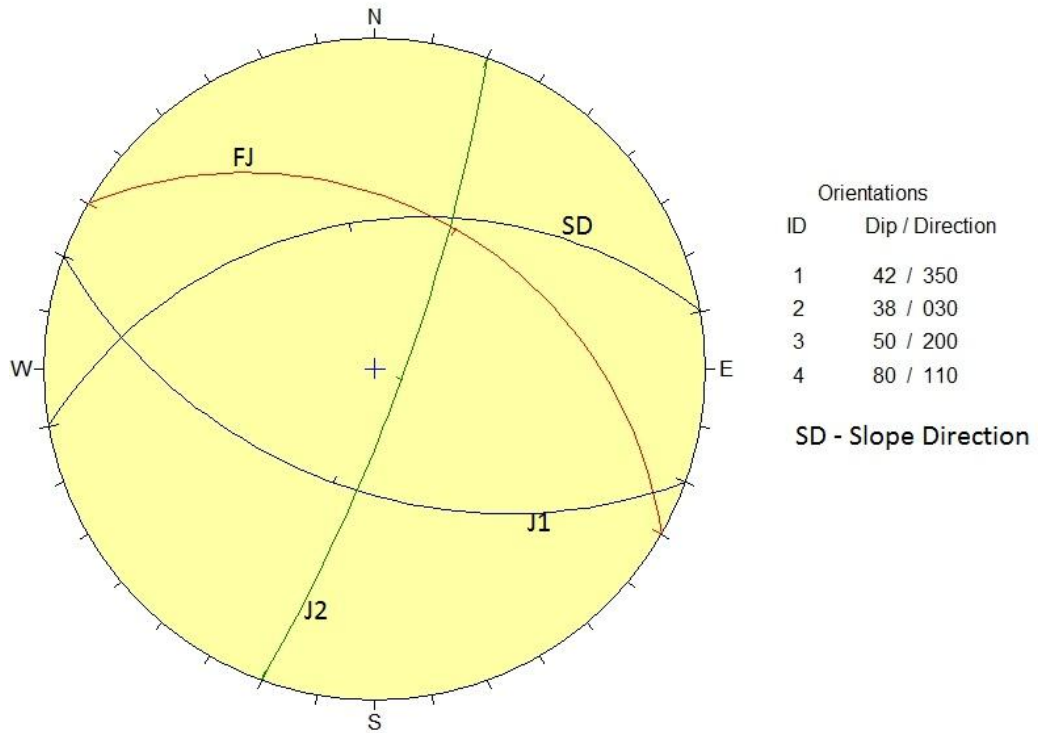
Fig 8.23 Stereonet and kinematic analysis for Slope L5

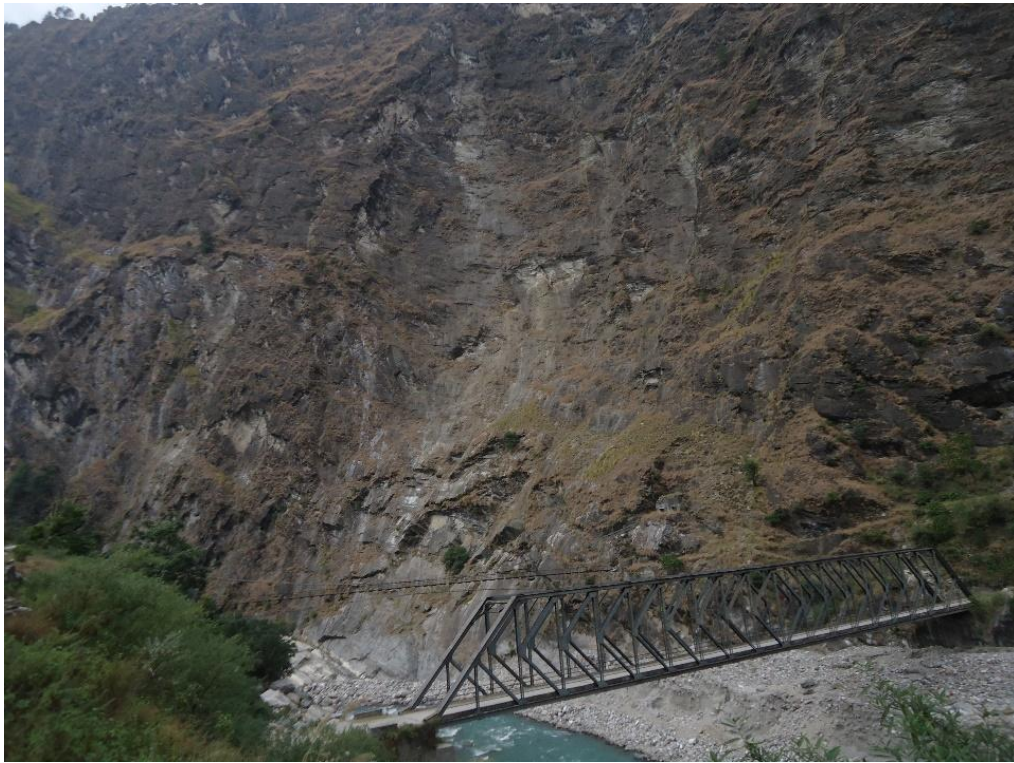
Fig. 8.26 Foliated stained granitic gneissic rocks exposed near Urgam bridge

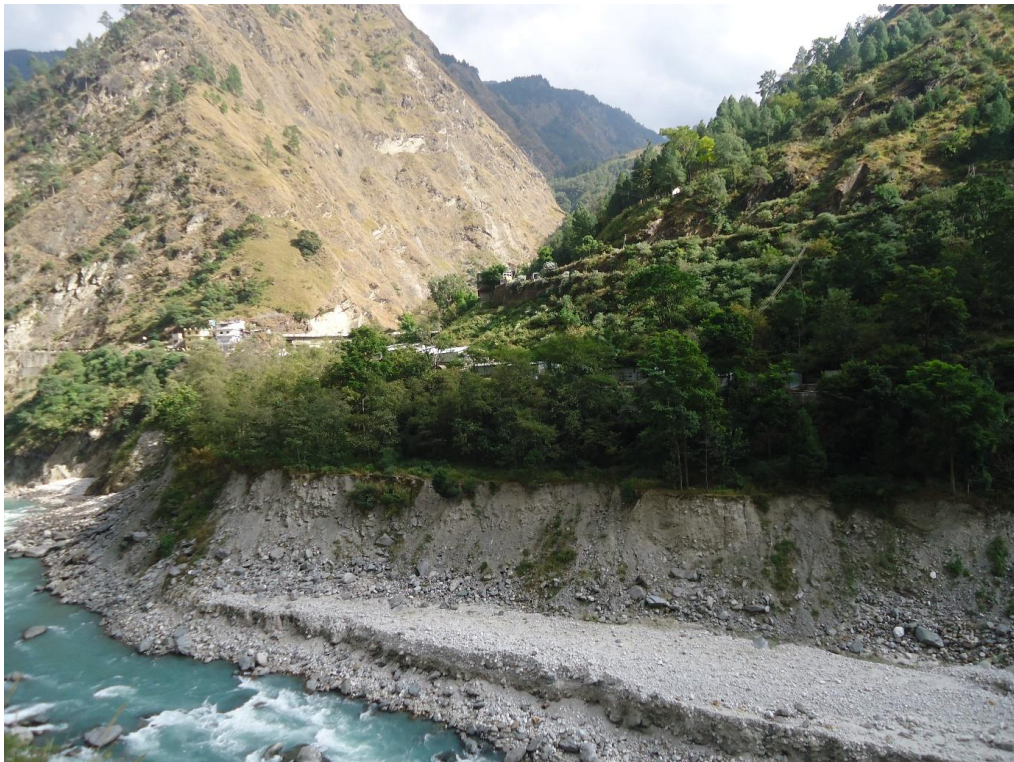
Fig. 8.27 Debris and RBM material present upstream of Urgam bridge on Left bank

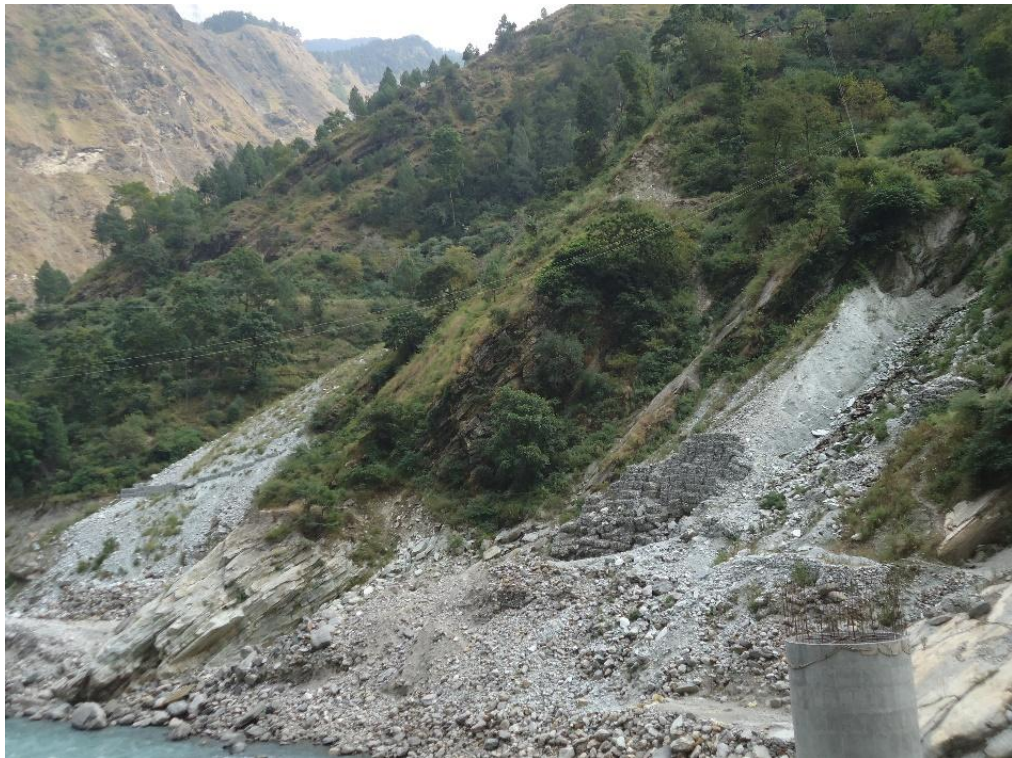
Fig 8.29 Debris and RBM material present along section L6
