**RESPONSE OF RC FRAMED STRUCTURES SUBJECT TO
POST - EARTHQUAKE FIRE**

Ph.D. THESIS

**DEPARTMENT OF CIVIL ENGINEERING
INDIAN INSTITUTE OF TECHNOLOGY ROORKEE
ROORKEE - 247667, INDIA
MARCH, 2014**

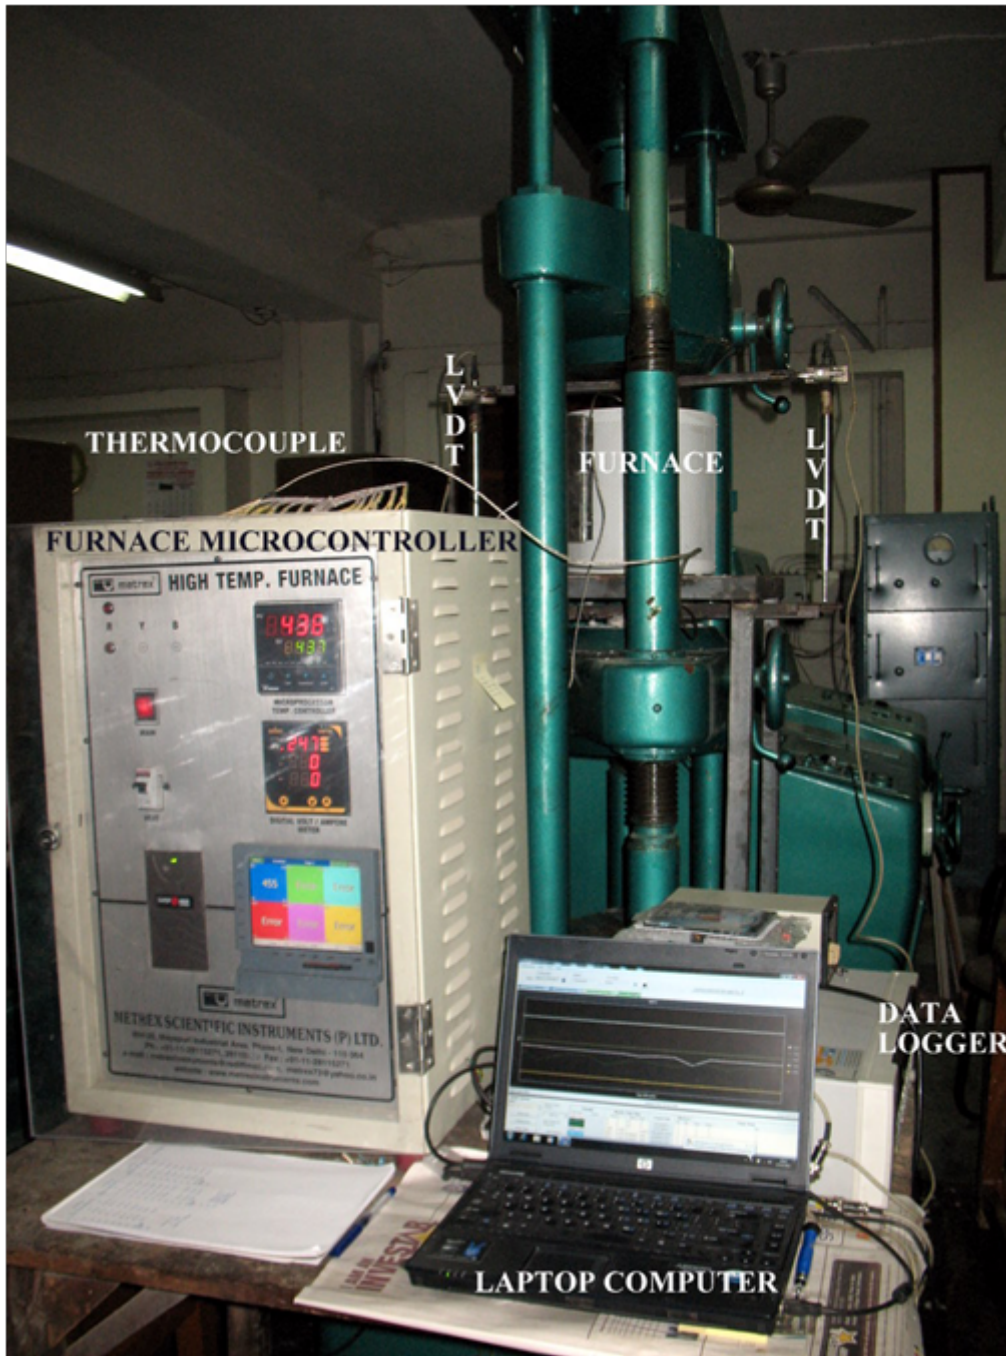
Fig. 2.3: Tensile test setup for steel rebars at elevated temperature

In steady state elevated temperature tensile test, the rebar specimen was initially exposed to three different temperatures: 250 °C, 500 °C and 750 °C. A heating rate of 5 °C/minute was employed to achieve the target temperature. Figure 2.4 shows typical input temperature-time curves, to which

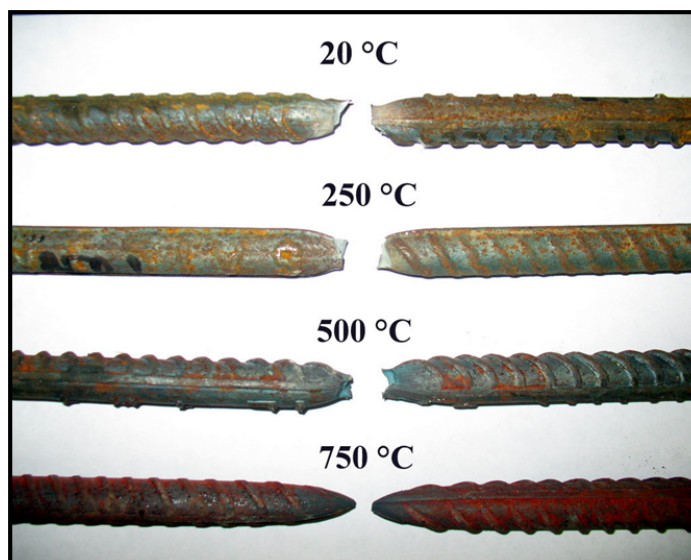
Fig. 2.10: Failure modes of reinforcing bars at different elevated temperatures

Failure in steel rebars typically occurs in a cup and cone failure mode. At 20°C , the rebar specimens failed just outside the furnace either near the top jaw or the bottom jaw. At 250°C , failure occurred usually at the junction of furnace opening, normally just outside the furnace. This fact can be attributed to strengthening of the thermo-mechanically treated rebars at temperatures around 250°C . Due to this, a stress concentration is developed at the portion of rebar just outside the furnace. At 500°C , rebar becomes more ductile and a plastic softening is observed. Cross-sectional dimensions of the rebar inside the furnace show a decrement and failure normally occurs at the middle third of the specimen inside the furnace. However, the cup and cone mode of failure is still observed. Failure at 750°C follows a different trend. The rebar becomes very soft and continues elongating until it fails. Essentially the bar loses almost 80-90% of its strength and fails with a pointed tip at the centre inside the furnace. Figure 2.10 shows typical failure modes of rebars at 20°C , 250°C , 500°C and 750°C . No difference in failure modes were observed between steel rebar specimens tested with and without pre-load.

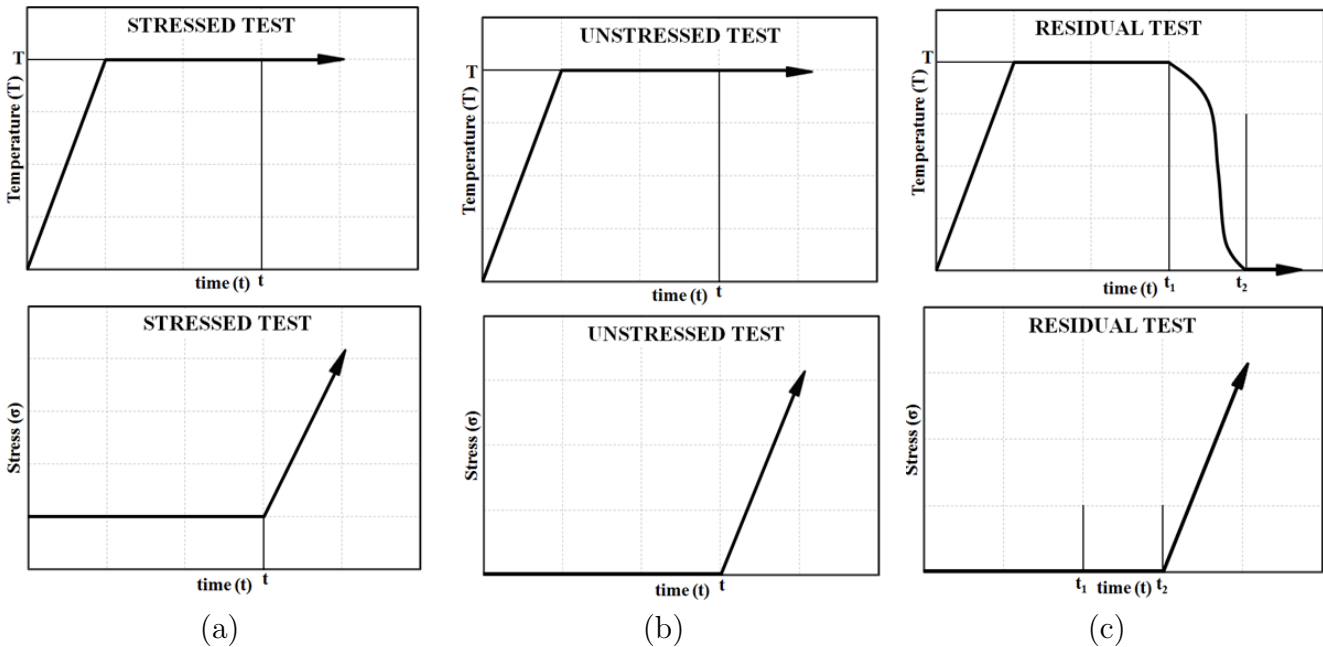
Fig. 3.2: Schematics of different test methods (a) Stressed Test (b) Unstressed Test (c) Residual Test

Testing of concrete specimens at elevated temperatures can be performed using three different methods: stressed test, unstressed test and residual test, based on the loading scenario [66,87] Figures 3.2 (a), (b) and (c) show the schematic of the three test methods. In stressed tests, a pre-load

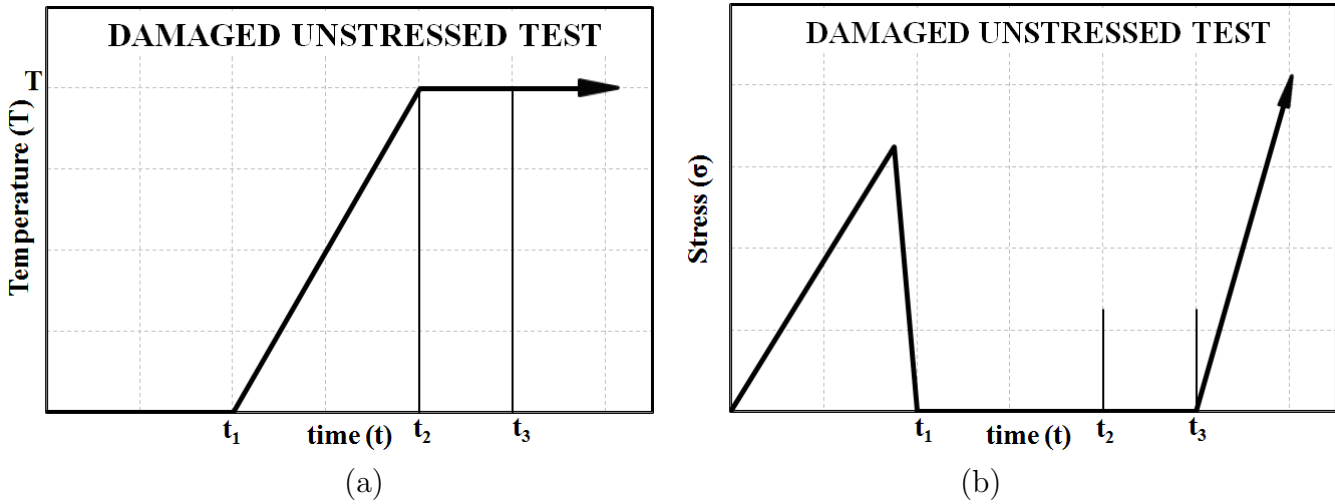
Fig. 3.3: Schematics of damaged unstressed tests (a) Temperature-time (b) Stress-time

method of testing confined concrete. In this test, the specimens are basically pre-loaded to the load corresponding to a desired level of strain (0.0033, 0.0056 and 0.008) to simulate the damage caused either by earthquake or any other external factors acting on it. After inducing the desired level of damage, the specimen is heated to the target temperature and the temperature is maintained until the steady state is reached. The specimen is then re-loaded to failure in heated state. Such tests find the application of their results in reinforced concrete members damaged in earthquake. Figures 3.3 (a) and (b) show the schematics of the damaged unstressed tests, which is carried out at elevated temperatures.

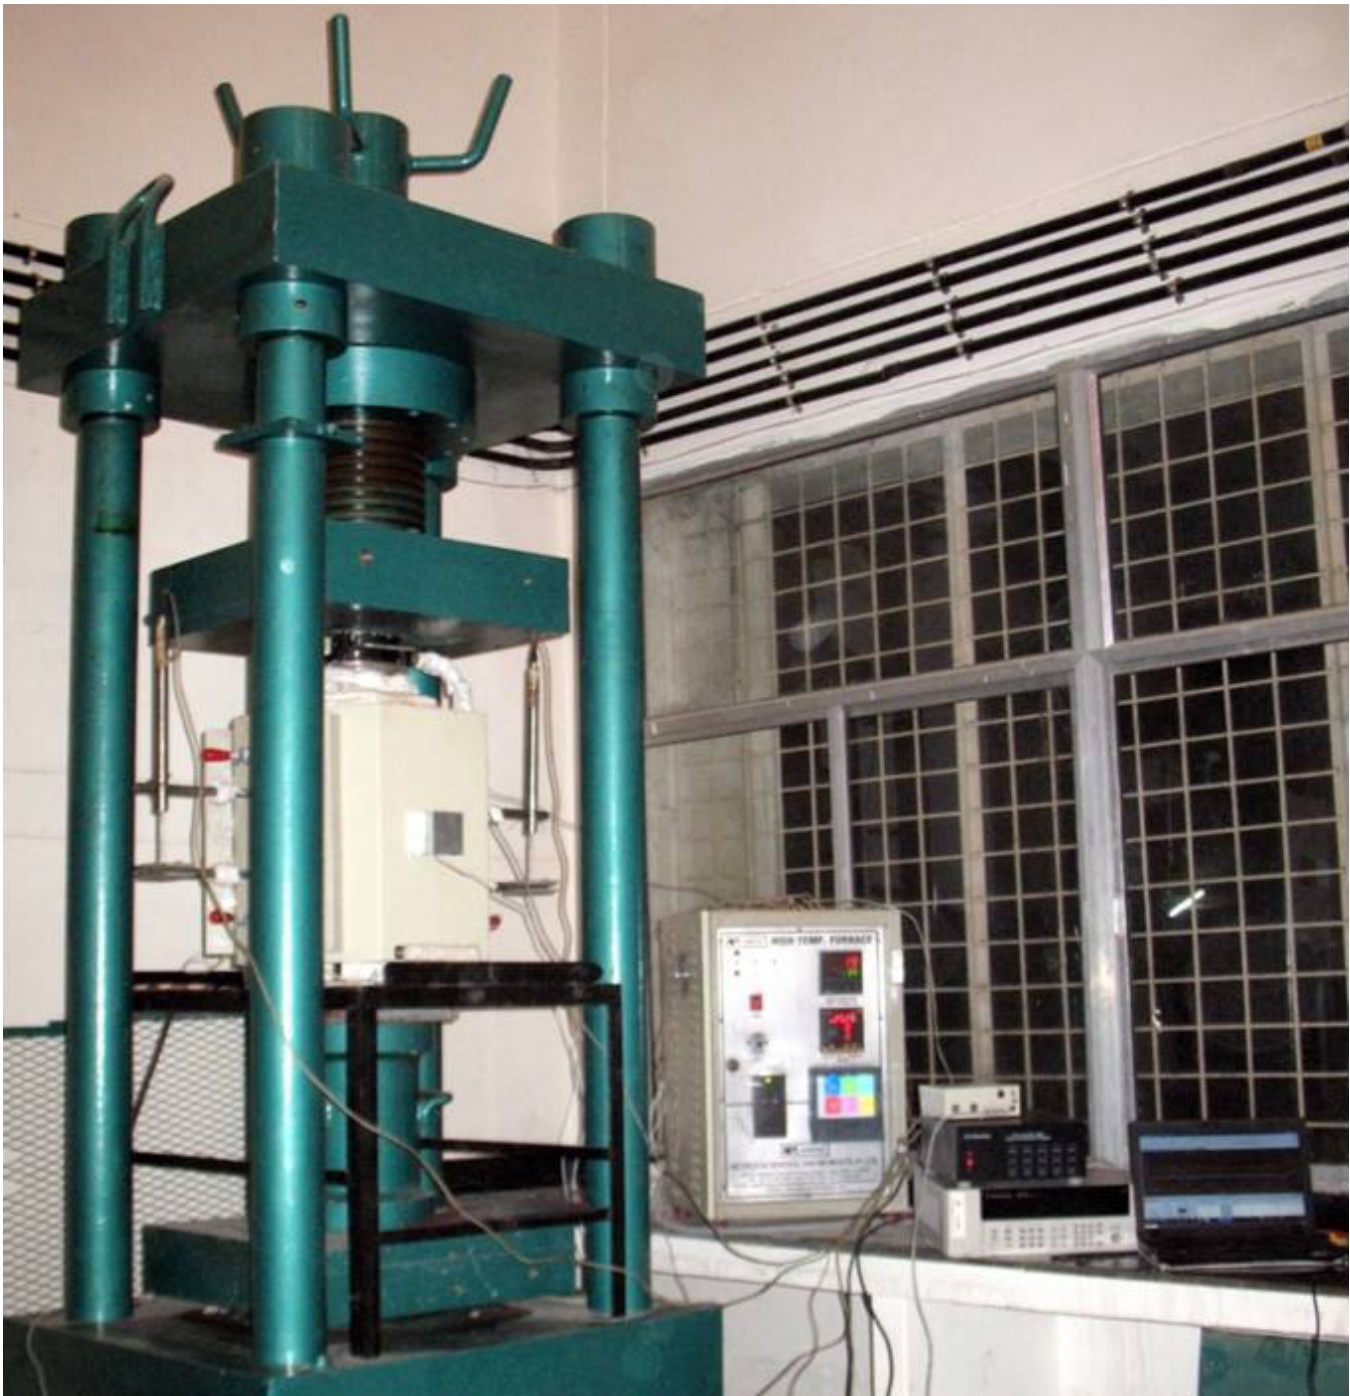
Fig. 3.8: Actual test setup with elevated temperature testing in progress

target displacement was observed, the load was released and the specimen was then exposed to the target elevated temperature. After achieving the target temperature, the specimen was loaded to failure under uniaxial loading similar to the specimens under the undamaged category. In both the categories, the temperature, load, displacement and strain were acquired automatically by the data acquisition system programmed at an interval of *2seconds*. The loading was allowed to continue beyond cracking to capture the behaviour of the descending branch of the load-displacement plot. Figure 3.8 shows the damaged unstressed test at elevated temperature in progress.

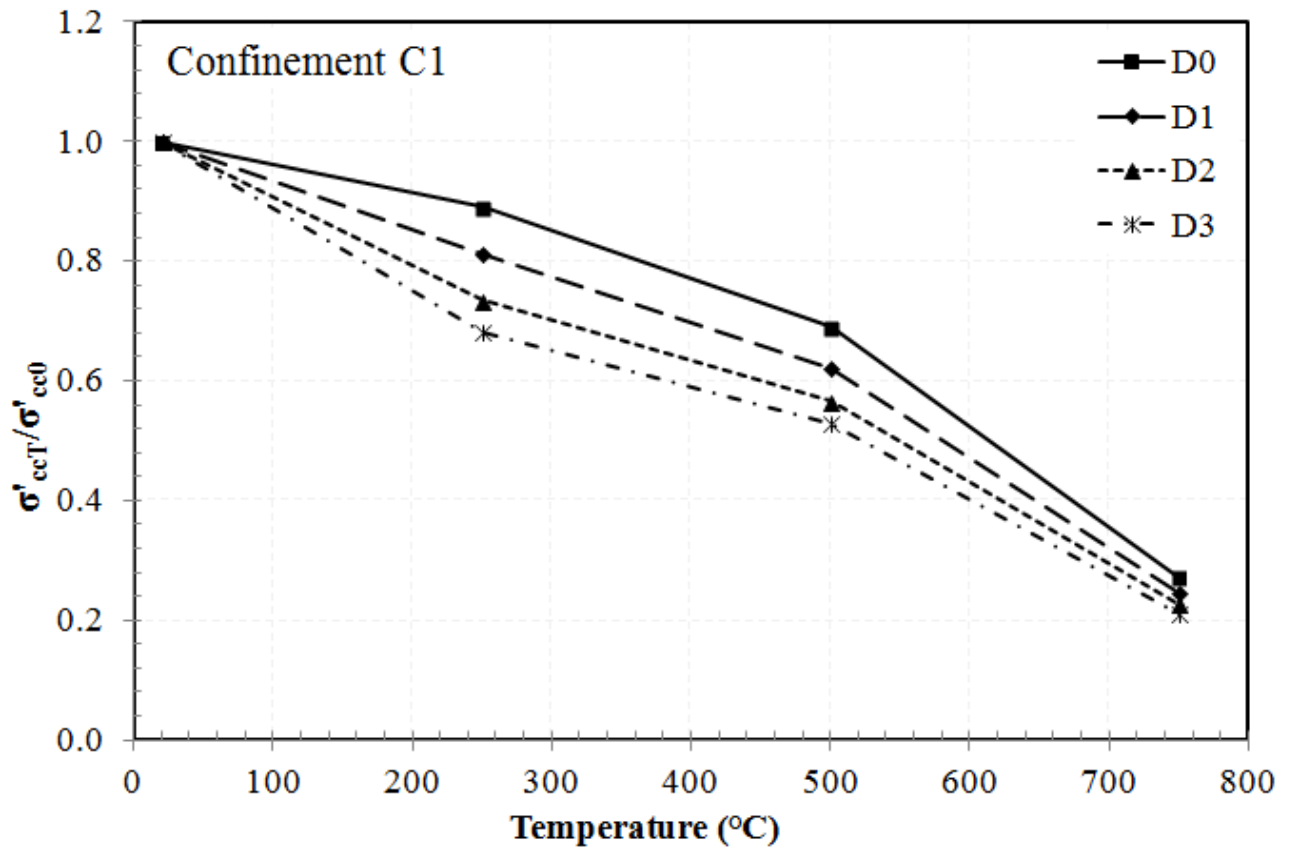
Fig. 3.14: Peak stress at elevated temperature for confined concrete with confinement C1

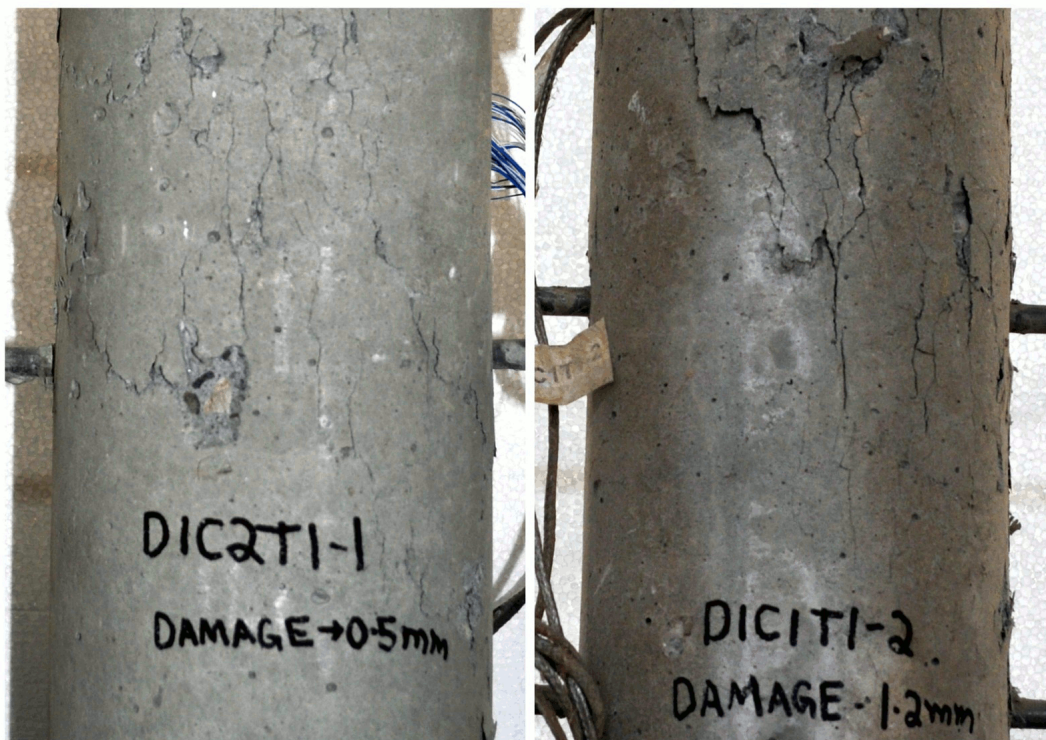
Fig. 3.16: Cracks induced in damage cycle

The damage was induced in confined concrete specimens by means of pre-loading it prior to exposing it to the elevated temperature. At damage level D1, a load corresponding to the displacement 0.5 mm was imparted. The specimen experienced an internal damage of very low order. Lightly visible cracks were formed on the surface of the specimen at this damage level. However, a few micro-cracks are anticipated to occur in the specimen that hardly affects the integrity of the specimen. Occasional cracks were observed at the contact surfaces near the loading platens which were due to surface irregularities in the specimen. Significant cracking occurred at damage level D2 when the strains reached the yield. Cracking of concrete initiated at this stage. Several micro-cracks appeared at the surface of the specimen. However the location of cracks varied from specimen to specimen depending on the formation of first crack. Generally the cracks were much pronounced in and around the gauge length at the mid-height. Confinement effect is anticipated to play a major role at this damage level. At damage level D3, a great deal of cracking was visualized in the specimen. Since the stresses reached beyond the yield stress, the cracks started growing with the increasing load. Wide longitudinal cracks were observed all over the specimen. Figure 3.16 shows the cracks formed in the specimens during the damage cycle. The increasing stresses were well-handled by the confinement in the specimen. Occasional spalling of cover concrete was observed due to excessive cracking in some specimens.

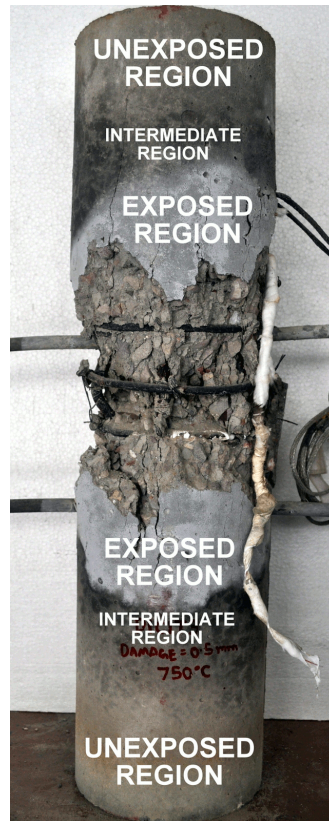
Fig. 3.17: Thermal Gradient evident from color change

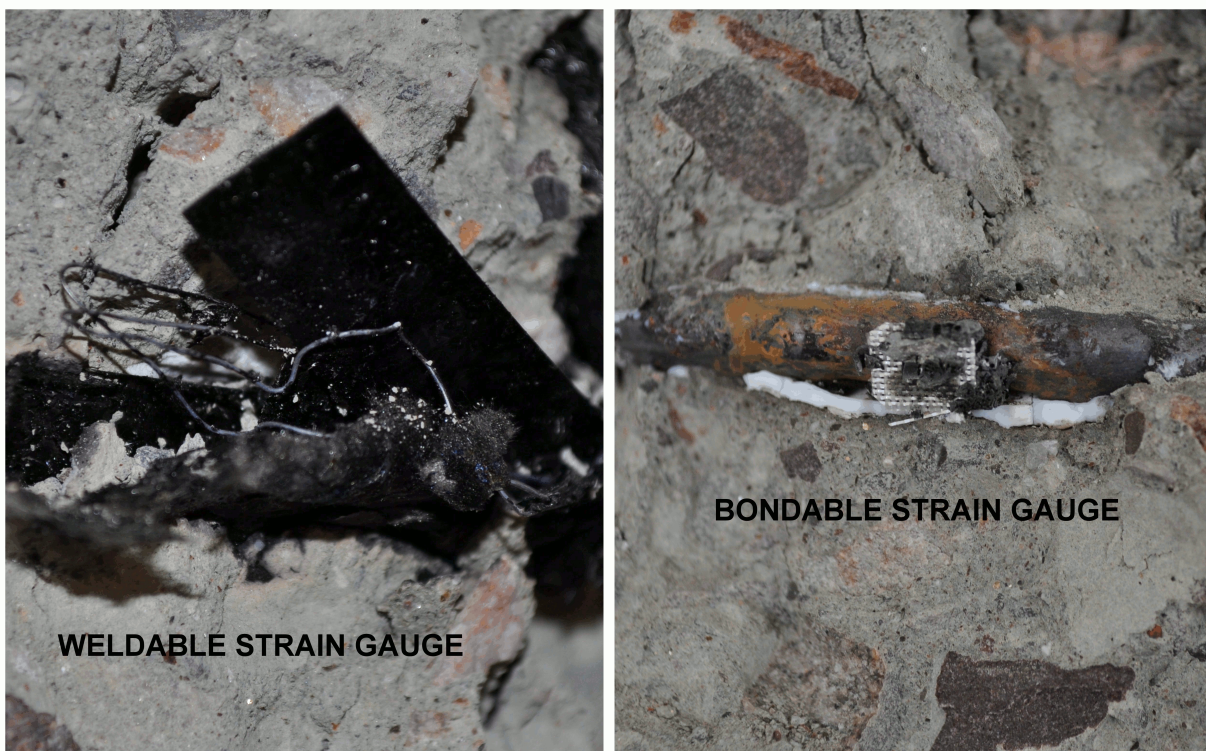
Fig. 3.18: Failure of Strain Gauges

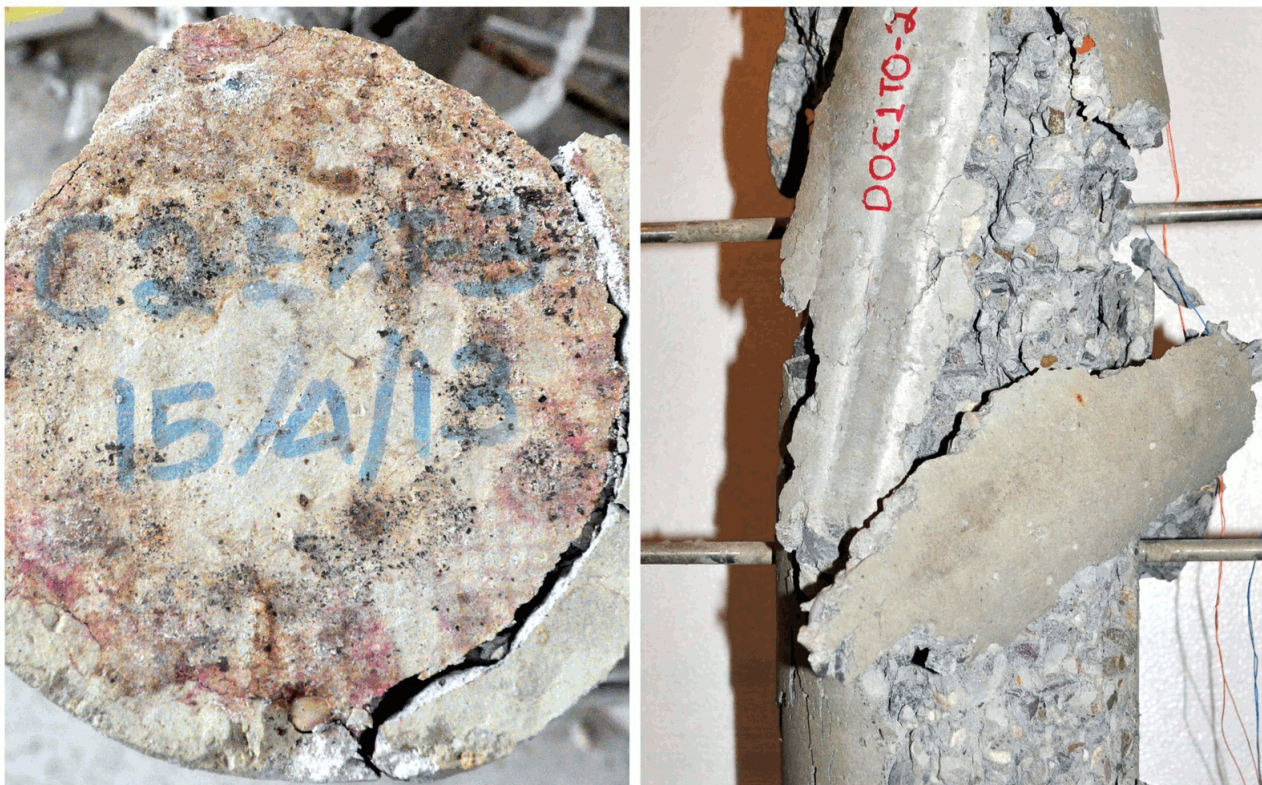
Fig. 3.21: Loss of cover concrete

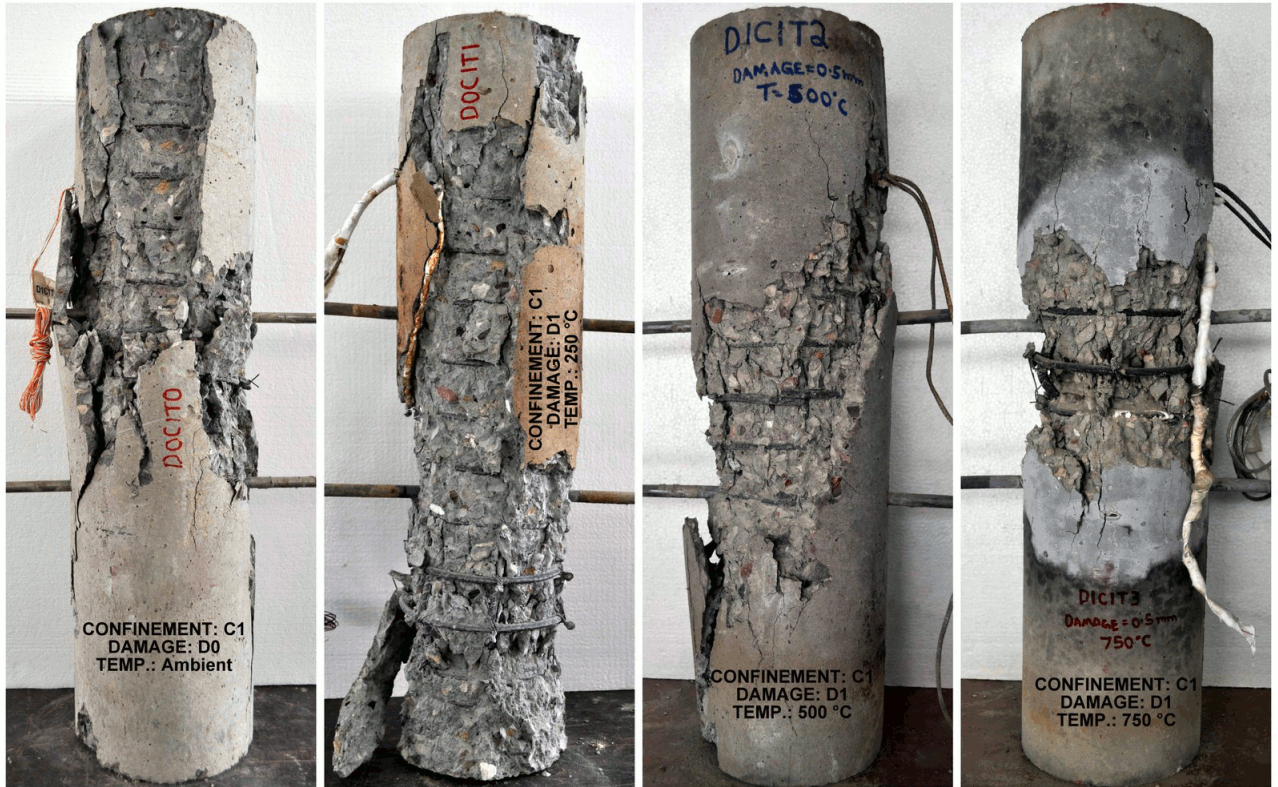
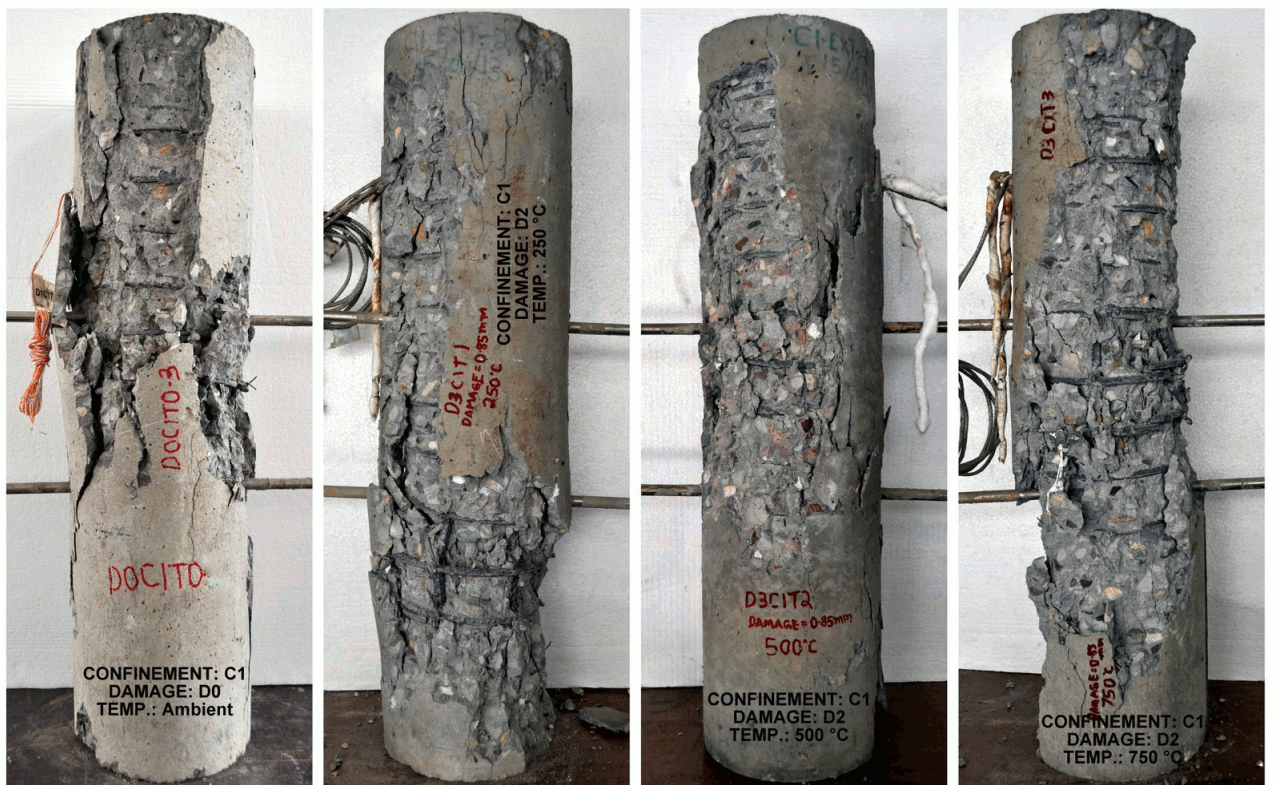
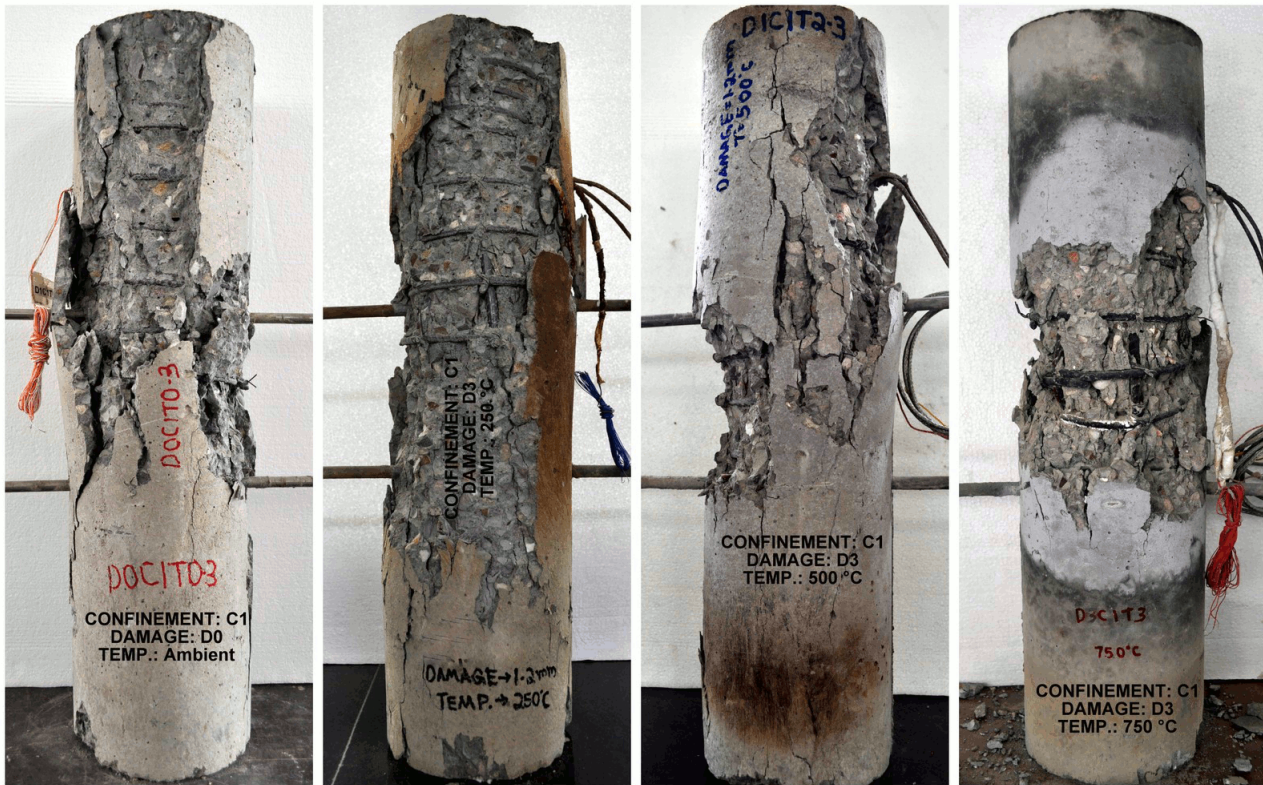
Fig. 3.22: Failure of specimens with confinement C1 under damage category D1

Fig. 3.23: Failure of specimens with confinement C1 under damage category D2

Fig. 3.24: Failure of specimens with confinement C1 under damage category D3

In specimens with confinement C1, one of the longitudinal bars was seen buckling under compression. This behaviour shows that a well-distributed confinement action was achieved. Whereas, in specimens with confinement C2, 2-3 or in some cases, all the longitudinal bars buckled before failing in compression. Failure due to buckling of longitudinal bars governed over failure due to opening of lateral ties. Figure 3.22 to Figure 3.27 shows the failure of specimens at different damage levels and elevated temperatures. Figure 3.22, 3.23 and 3.24 shows the failure of specimens with confinement C1 under damage categories

It is evident from the pictures that the failure generally occurred in the middle-third of the specimens. It is also observed that the thermal gradients were pronounced more severe at very high temperatures (750 °C). Explosive failure of concrete under high temperatures (500 °C and 750 °C) was observed. When a temperature of 750 °C was maintained inside the furnace for a long duration in order to achieve the steady state, the steel reinforcement, being a very good conductor of heat, reaches its austenitizing temperature which is beyond 900 °C resulting in excessive softening. When tested at 750 °C, confined concrete specimen completely loses its confinement action. When compression force is applied on the specimen, the reinforcement expands along with the concrete till it fails. Surface cracks start appearing on steel at a temperature of 500 °C. Figure 3.28 shows the expanded transverse reinforcement and surface cracks generated after exposure to 750 °C. Opening of ties was not observed in the specimens exposed to 750 °C.

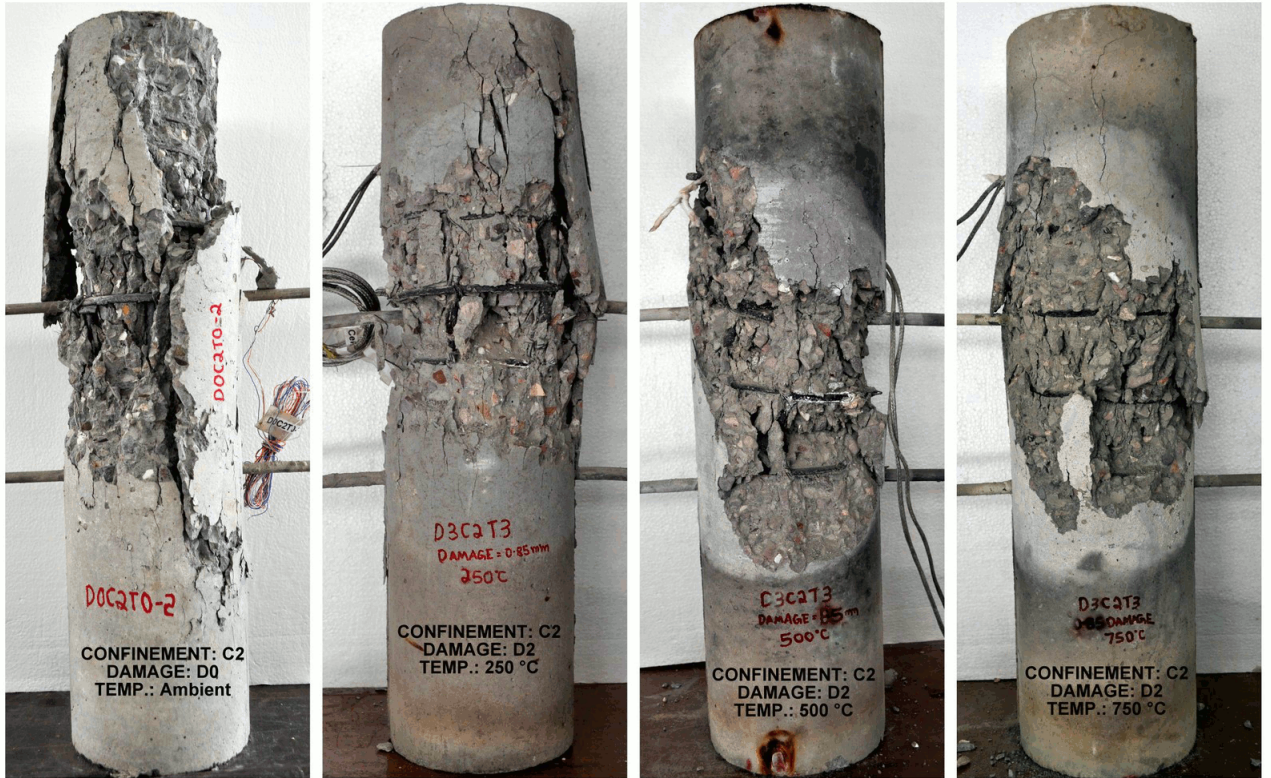
Fig. 3.25: Failure of specimens with confinement C2 under damage category D1

Fig. 3.26: Failure of specimens with confinement C2 under damage category D2

Fig. 3.27: Failure of specimens with confinement C2 under damage category D3

D1, D2 and D3 at ambient temperature, 250 °C, 500 °C and 750 °C. Figure 3.25, 3.26 and 3.27 shows the failure of specimens with confinement C2 under damage categories D1, D2 and D3 at ambient temperature, 250 °C, 500 °C and 750 °C.

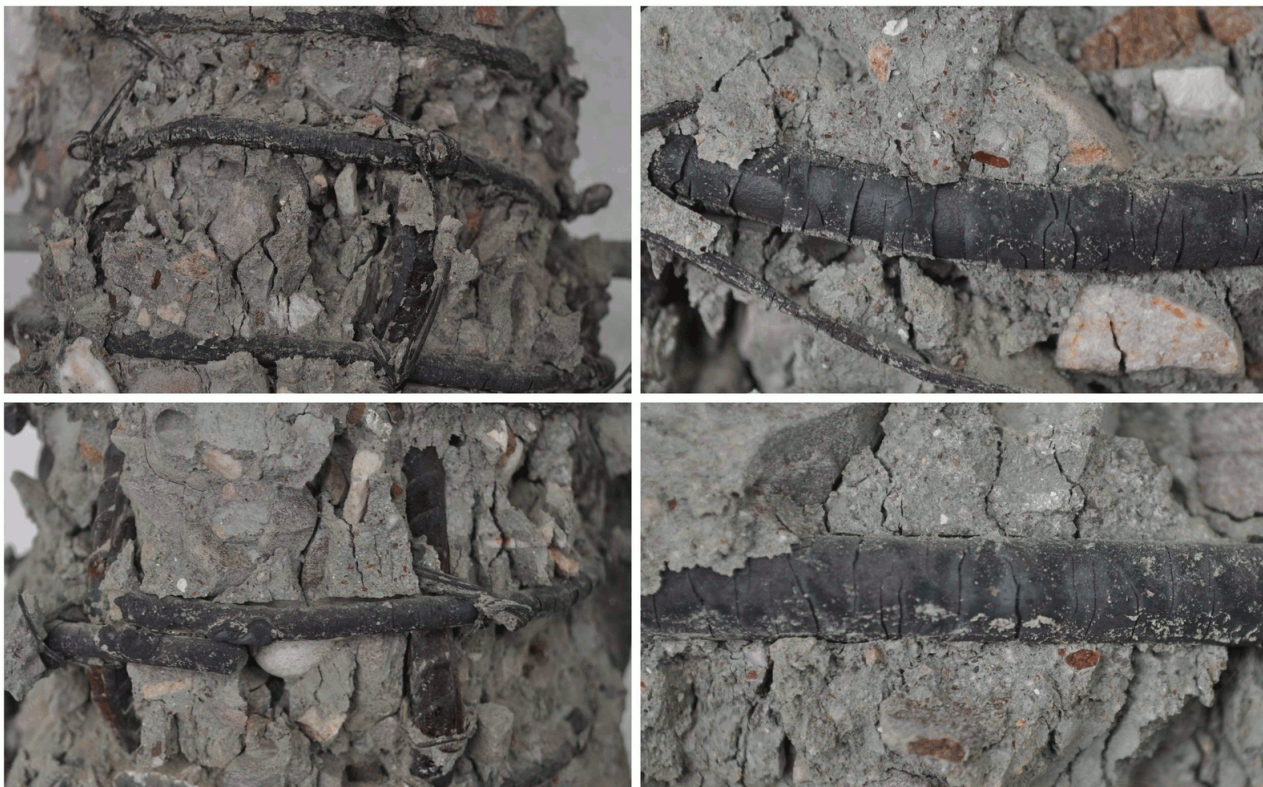
Fig. 3.28: Confinement failure at 750 °C

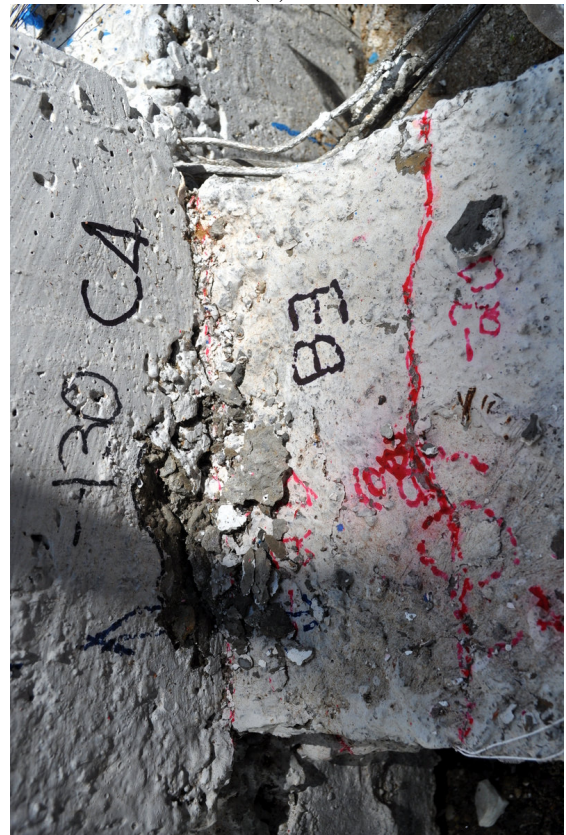
Fig. 4.10: Damage induced at floor beam column joints

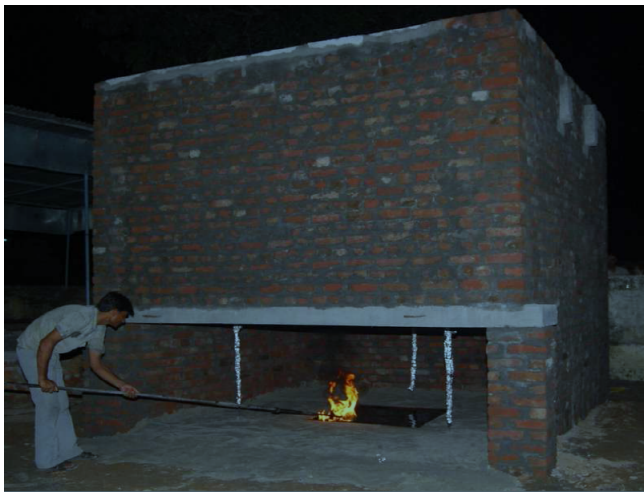
(a)

first mock fire test, a conduit diameter of 1.27 cm was used for supplying fuel to the burner. However, the target temperature of $1000\text{ }^{\circ}\text{C}$ was not achieved in less than 5 minutes as expected. This can be attributed to the dampness of brick walls following an overnight precipitation. The damp walls were suspected of absorbing the radiant heat from the fire. In the second mock fire test, the size of the conduit supplying the fuel was increased to 2.54 cm and the brick masonry walls were plastered with a cement mortar having a cement-sand ratio of $1 : 3$. A peak burning rate of $0.117\text{ kg/m}^2\text{ s}$ and a peak fuel flow rate of $1.43 \times 10^{-4}\text{ m/s}$ was maintained. The target temperature of $1000\text{ }^{\circ}\text{C}$ was achieved within 5 minutes as indicated from temperature-time curve for the compartment shown in Figure 4.31 (b).

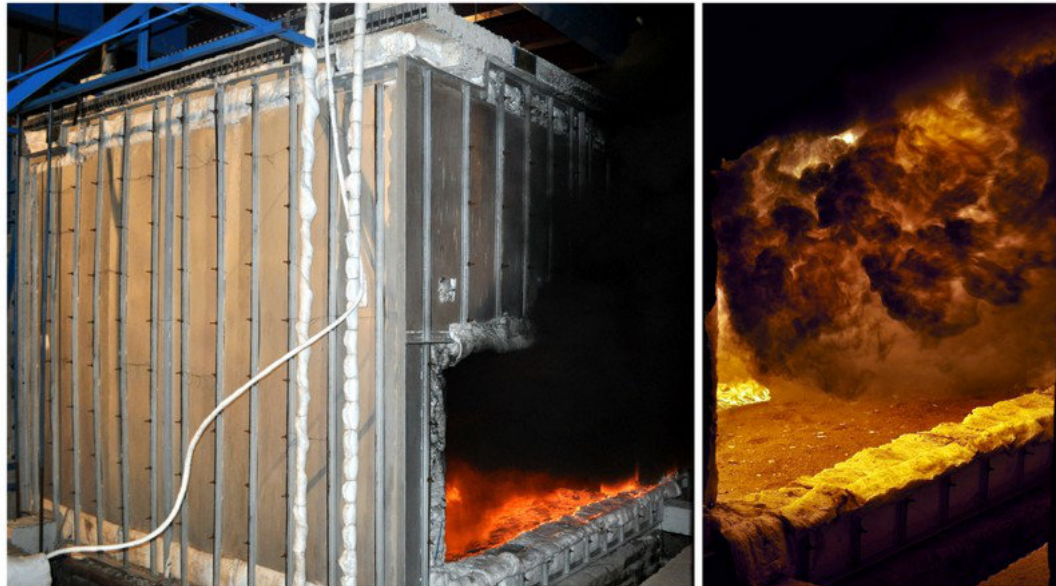
Fig. 4.32: Flashover

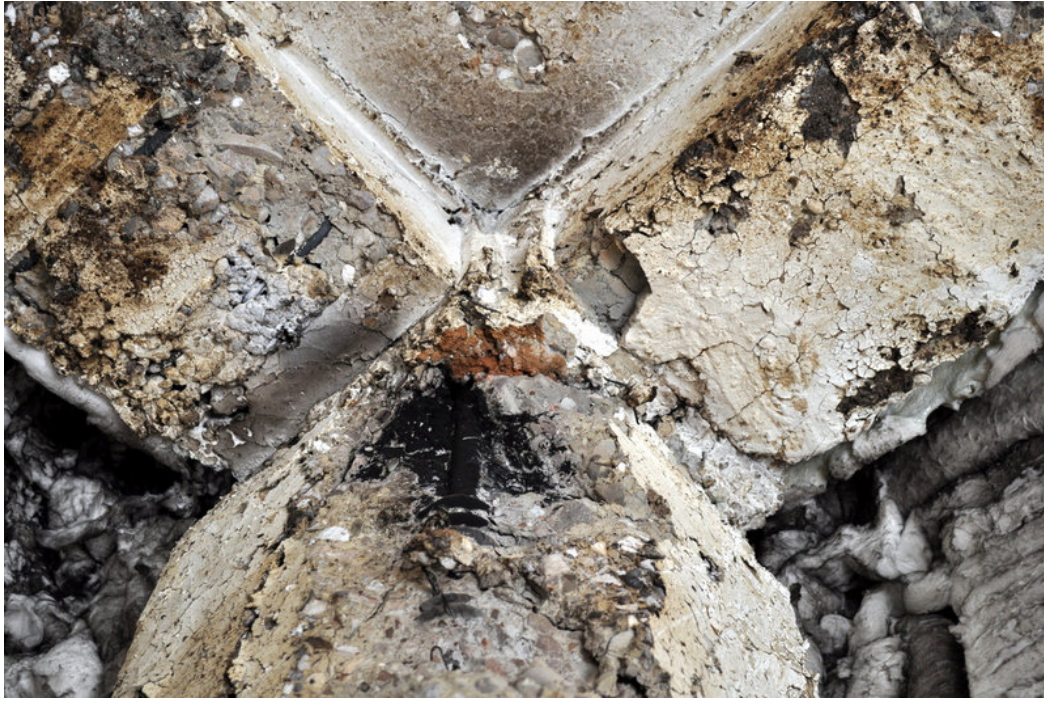
Fig. 4.51: Concrete spalling (a) Beam-column joints (b) Corners of the column

Figures 4.50 (a), (b), (c) and (d) illustrate the extent of damage in the frame after fire test. Figure 4.50 (a) shows a typical spalling of corner concrete 40 minutes after the fire ignition. Cracks started developing on the exposed face, which propagated along the sharp corners and eventually led to spalling. Similar trends were observed in all the four columns. Figure 4.50 (b) shows the micro-cracks developed on the column surface due to an accelerated cooling of cover concrete. Figure 4.50 (c) shows one of the corners that experienced wide cracks as a result of spalling during the cooling stage. All four columns experienced a loss of corner cover exposing the main reinforcement. From Figure 4.50 (d), a loss of bond between the rebar surface and concrete can be distinctly observed. Beams B7, B8 and B9 showed a significant spalling on the exposed edge making visible the reinforcing bars. The slab remained intact with very less or negligible spalling. Figure 4.51 (a) and Figure 4.51 (b) show the fire damaged beam-column intersection and column C2 respectively. Cracking / spalling of cover concrete was more pronounced in region where cracking due to simulated earthquake loading was significant.

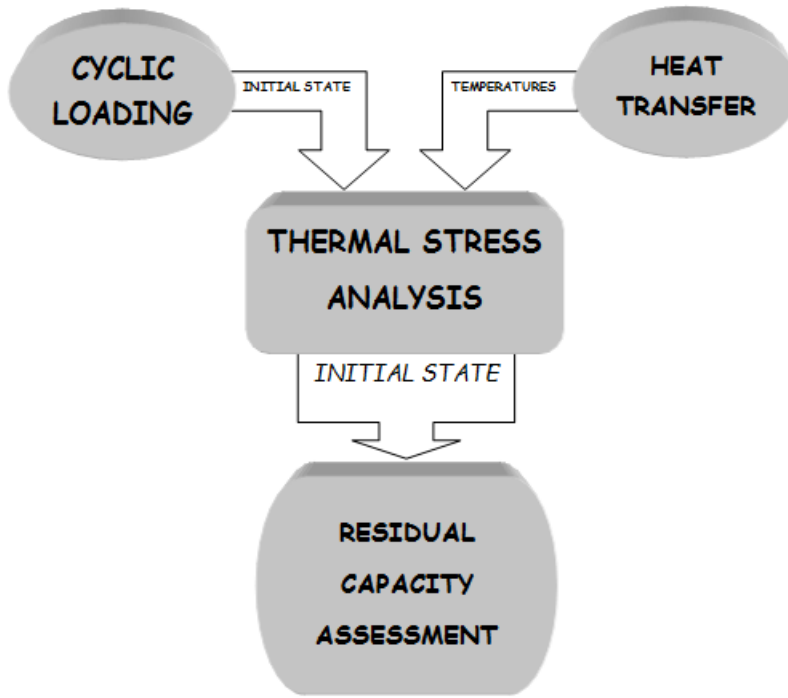
Fig. 5.1: Sequence of analysis
