# **STRENGTHENING OF HEAT DAMAGED REINFORCED CONCRETE ELEMENTS**

**Ph.D. THESIS**

**DEPARTMENT OF CIVIL ENGINEERING  
INDIAN INSTITUTE OF TECHNOLOGY ROORKEE  
ROORKEE – 247 667 (INDIA)  
DECEMBER, 2014**

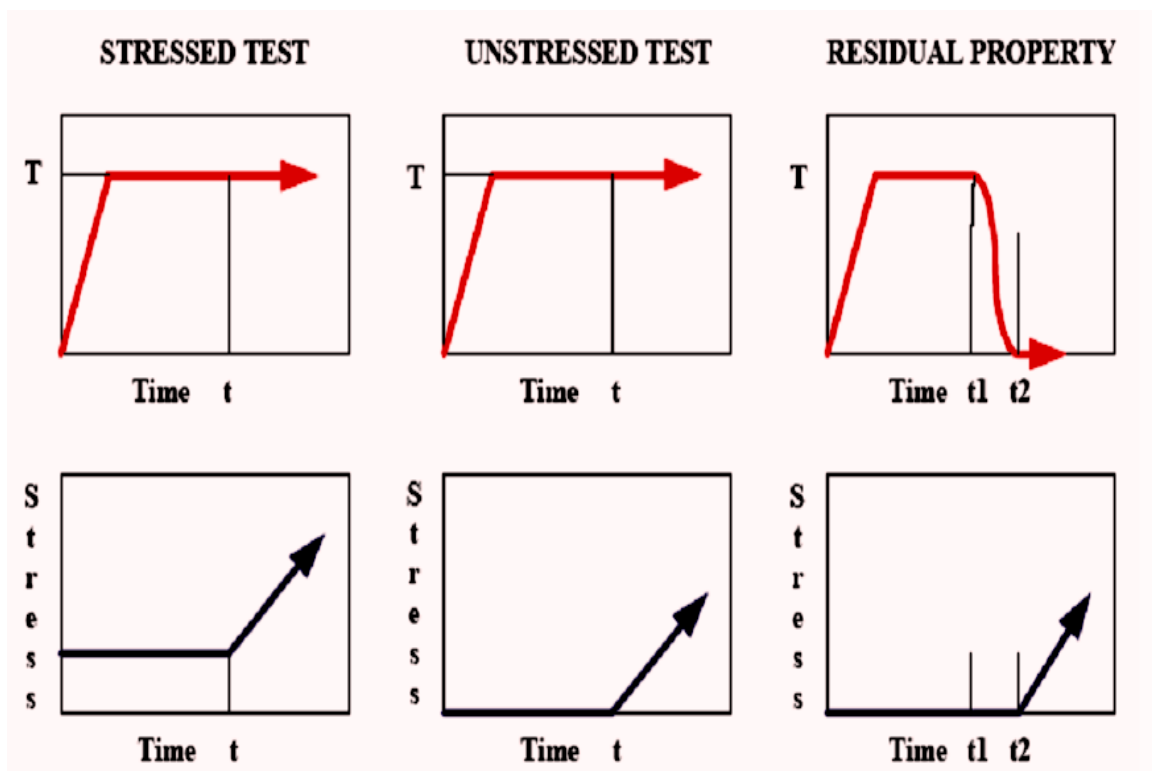
Fig.1. 1: Schematic of temperature and load histories for different test methods

compression. In a stressed test condition, a preload, generally in the range of 20 to 40 percent of the ultimate compressive strength at room temperature is applied to the concrete specimen subsequent to heating, and the load is maintained during the heating period. The specimen is heated continuously at a recommended rate until a definite temperature is reached, and the temperature is kept constant until a thermal steady state is achieved (Phan et al. 1996). After achieving uniform temperature, the load is then increased at a recommended rate until the specimen fails. In the un-stressed test method, the specimen is heated, without any loading, at a recommended rate to the specified temperature, and is maintained constant until a thermal steady state is reached within the specimen. After attaining the target temperature, the specimen is loaded at a recommended rate until failure occurs. The stressed and un-stressed test methods are performed to assess the properties of concrete at elevated temperature (Phan et al. 1996). In the un-stressed residual strength test, the specimen is heated without any load at a recommended heating degree. After attaining the target temperature, the temperature is kept constant until a thermal steady state is reached within the specimen. After heating, the specimen is then allowed to cool down to room temperature and loaded at room temperature up to the failure. This method is most suitable for assessing the post-fire or residual properties of concrete (Phan et al. 1996) for retrofitting purpose.

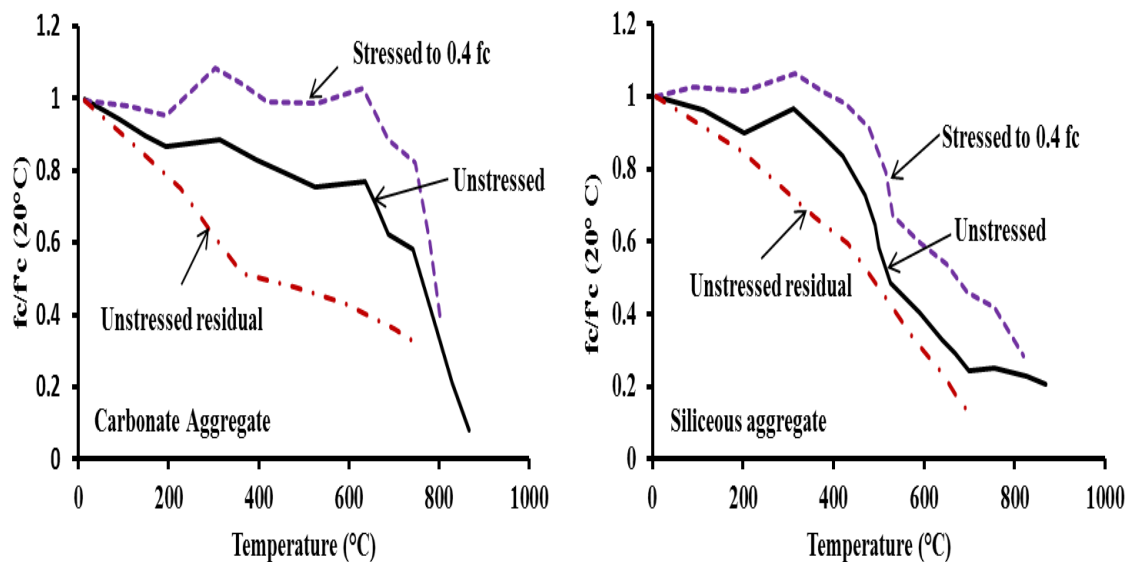
Fig.1. 2: Effect of temperature on compressive strength of carbonate aggregate concrete and siliceous aggregate concrete (Abrams 1971)

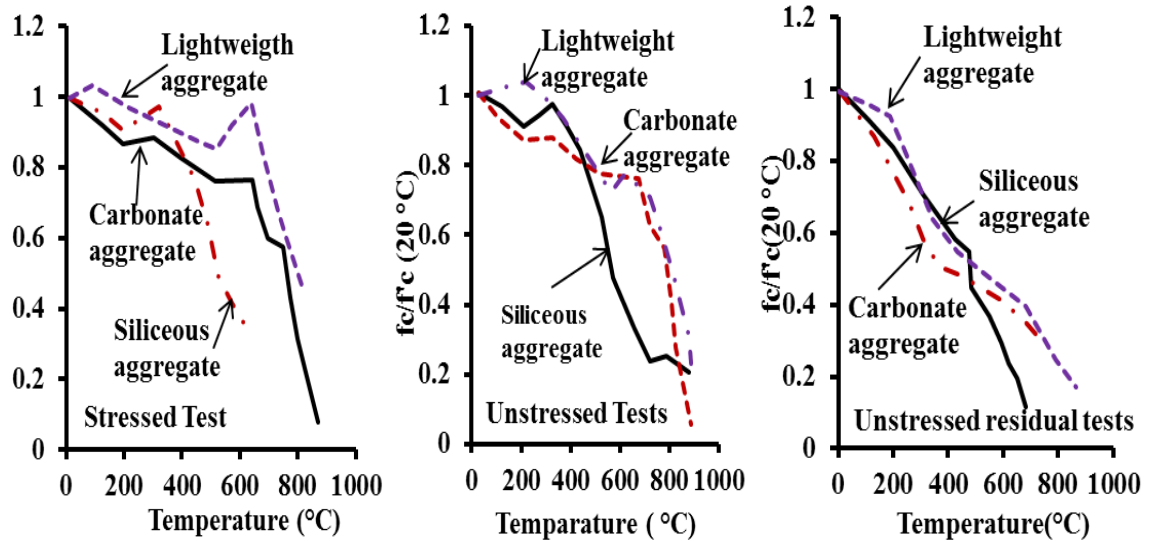
Fig.1. 3: The stressed, unstressed and residual properties test data of high temperatures (Abrams 1971)

reduction in compressive strength at 500°C for stressed and, unstressed specimens was about 35% and 60% of the un-heated value respectively. The residual strength of unstressed specimens heated at 500°C and tested after cooling was reported to have reduced by up to about 80% of its initial strength. It was also found that the reduction in compressive strength for concrete made with an aggregate-cement mix ratio of 4.5:1 and water-cement ratio of 0.65 was larger than that of concrete made with an aggregate-cement mix ratio 6:1 and water-cement ratio of 0.5. It was reported that the residual strength of the heated and cooled concrete was less than the strength in heated condition and was approximately 20% less than the corresponding hot strength in the temperature range of 200°C to 450°C. Abrams (Abrams 1977) reported the results of compressive strength of cylindrical specimens heated to temperatures of 93-871°C. The results confirmed that the unstressed residual strength obtained after cooling showed the greater losses compared to unstressed and stressed strength tested at elevated temperature. The results of siliceous and expanded shale aggregate concretes showed that the specimens stressed during heating had smaller reductions in strength at high temperatures than unstressed specimens tested hot (Fig. 1.2). This may be due to the reduction of crack formation owing to the imposed stress. The siliceous aggregate concrete exhibited about 75% of the original strength at 450°C in unstressed conditions (Fig. 1.3)

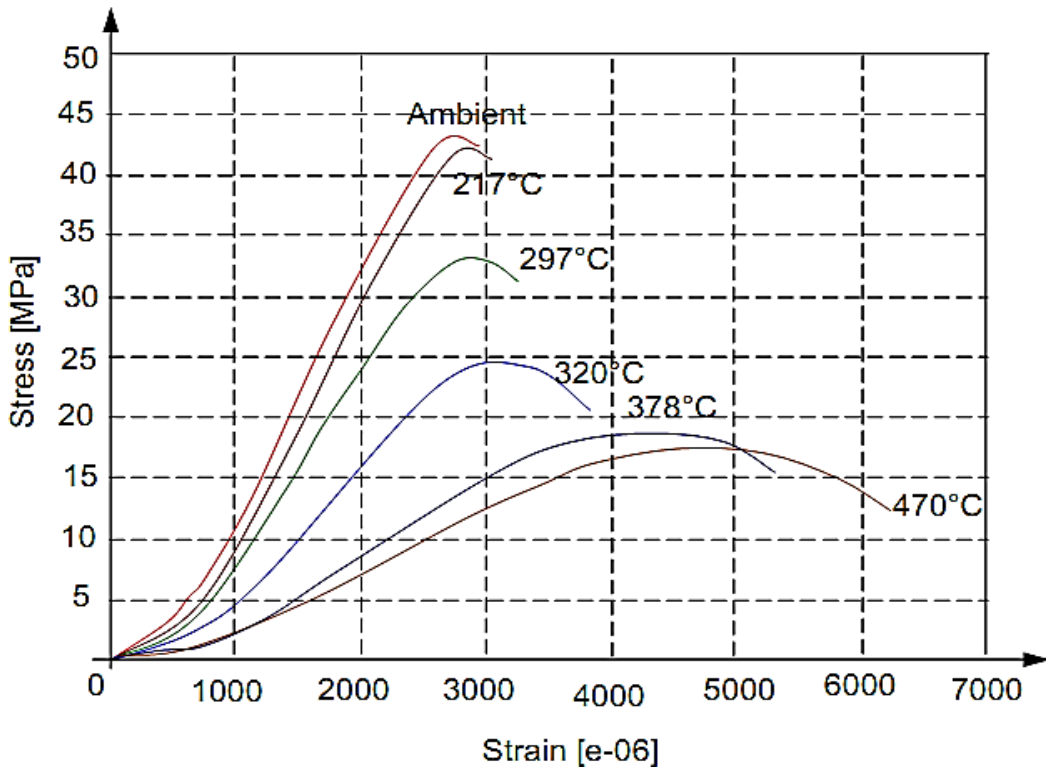
Fig.1. 4: stress-strain relationship of water quenched fire-damaged river gravel concrete (Nassif 2006).

Many researchers examined the stress-strain relationships of concrete during and after heating to high temperatures. Nassif (Nassif 2006) tested concrete cores to examine the stress-strain relationships of river gravel concrete and limestone concrete. The test results demonstrated that river gravel heated concrete after cooling with water exhibited a brittle failure mode below 320°C and exhibited gradual failure above 320°C due to increasing the internal plasticity, as shown in Fig. 1.4. On the other hand, in limestone concrete the brittle failure was observed only in un-heated cores while heated limestone concrete after cooling with water showed a gradual kind of failure as shown in Fig. 1.5. The effect of elevated temperatures on concrete strength and load-deformation behaviour of high strength concrete (HSC) and normal strength concrete (NSC) have also been investigated by many other researchers (Castillo and Durani 1990, Furumura et al. 1995, Freskakis 1979, Kodur et al. 1998, Kodur et al. 2008, Ali et al. 2010, Zaidi et al.2011, Ozawa et al. 2010, 2011). Harada et al. (Harada 1972) tested concrete cylinders heated in an electric furnace at a rate of 1.5°C/min and allowed to cool down gradually. The results confirmed that the gradient of the curves becomes gradual with rise in temperature. The curve is convex in the upward direction up to 400°C and becomes concave at 500°C, as shown in Fig. 1.6. The residual strain increases with increasing temperature. At 500°C, the residual strain is more than 50% of the total strain.

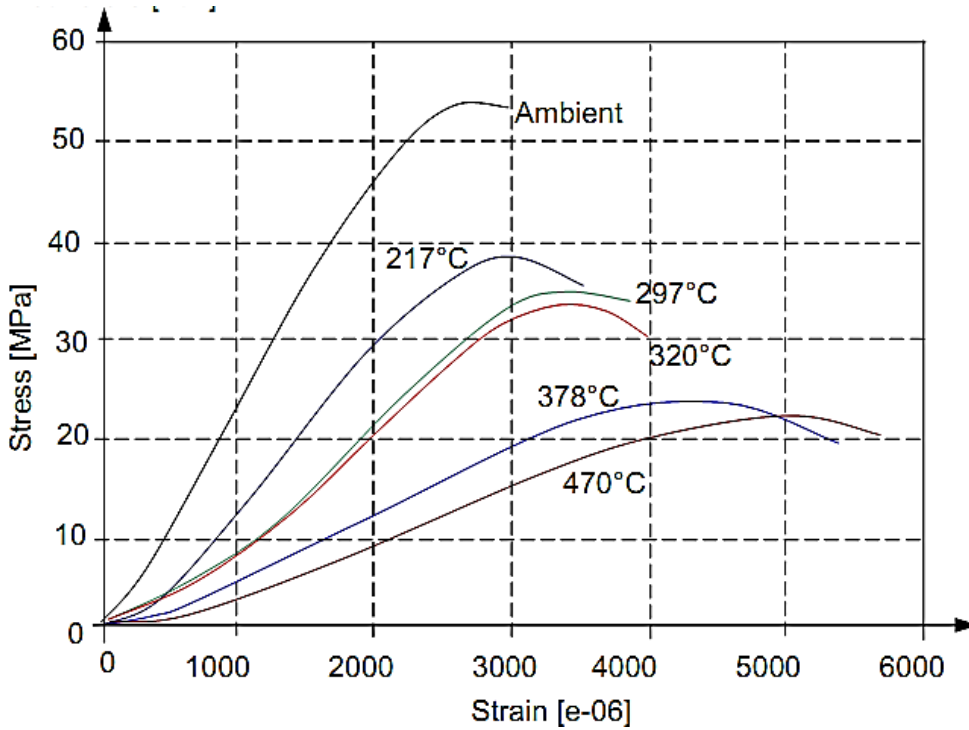
Fig.1. 5: stress-strain relationship of water quenched fire-damaged limestone concrete (Nassif 2006).

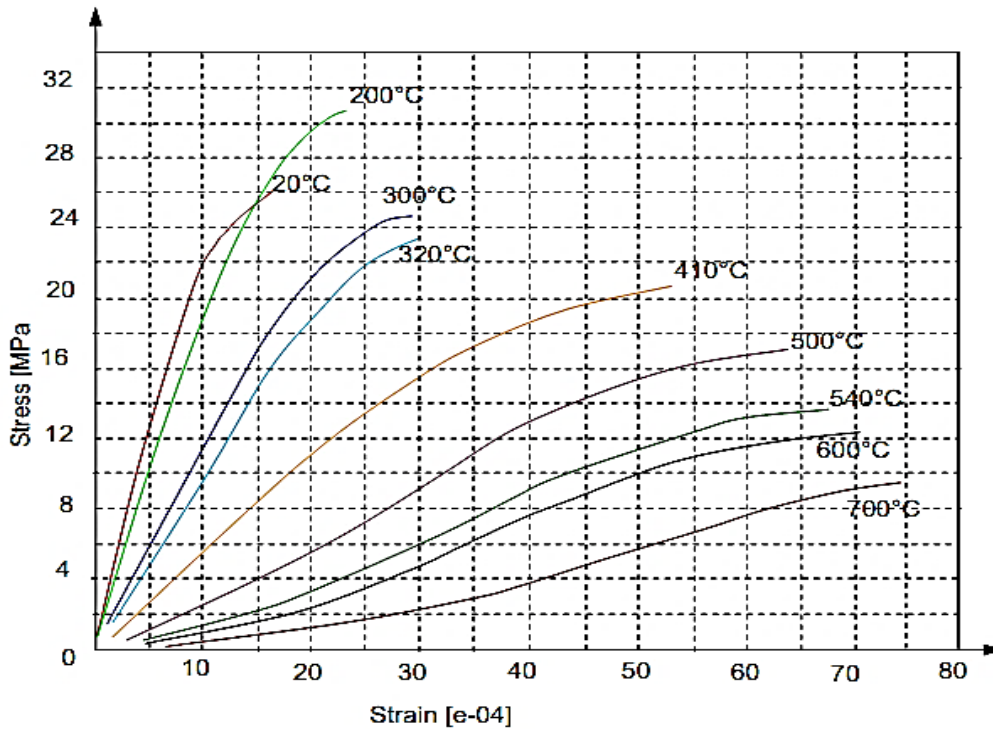
Fig.1. 6: Stress-strain curves of sand stone aggregate concrete (Harada et al. 1972)

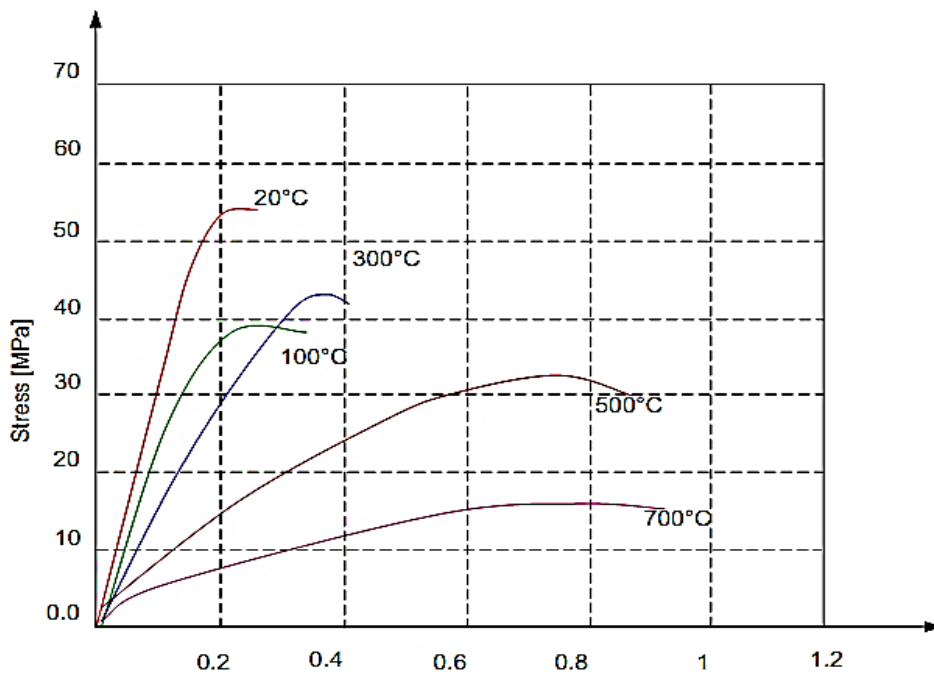
Fig.1. 10: Stress-strain relationships for NSC at different temperatures (Furumura et al. 1995)

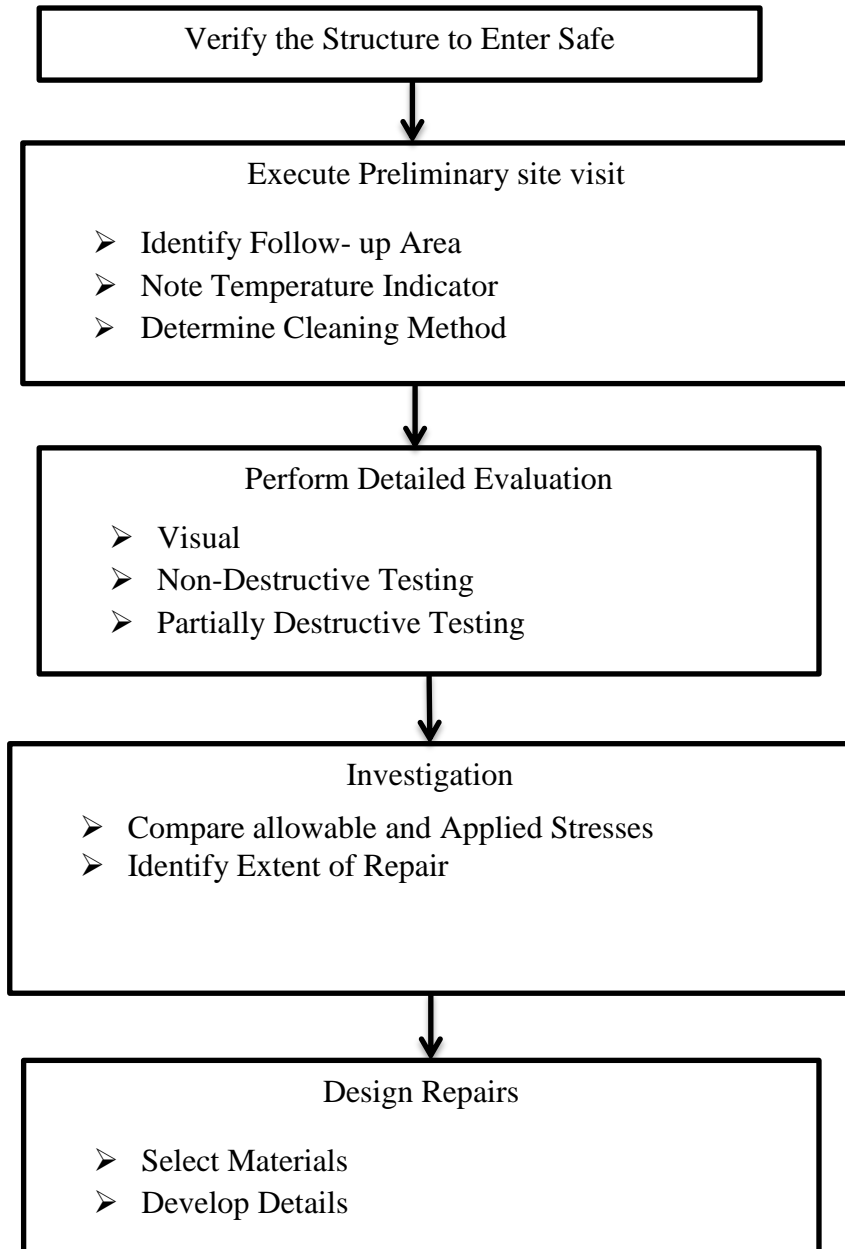
Fig.1. 11: Stages in the assessment and repair process (Narendra et al. 2008)

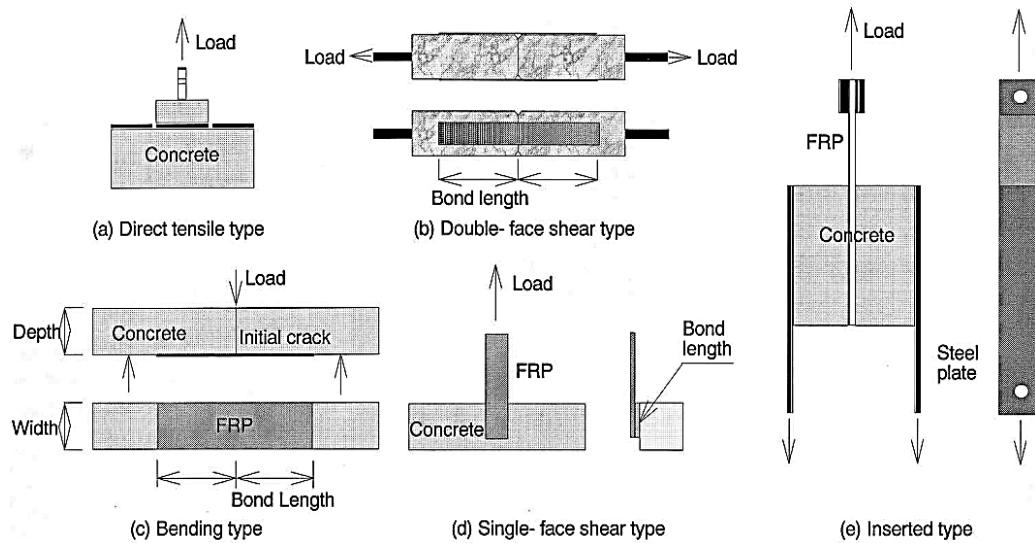
Fig.1. 13: Bond test techniques (Nakaba et al. 2001)

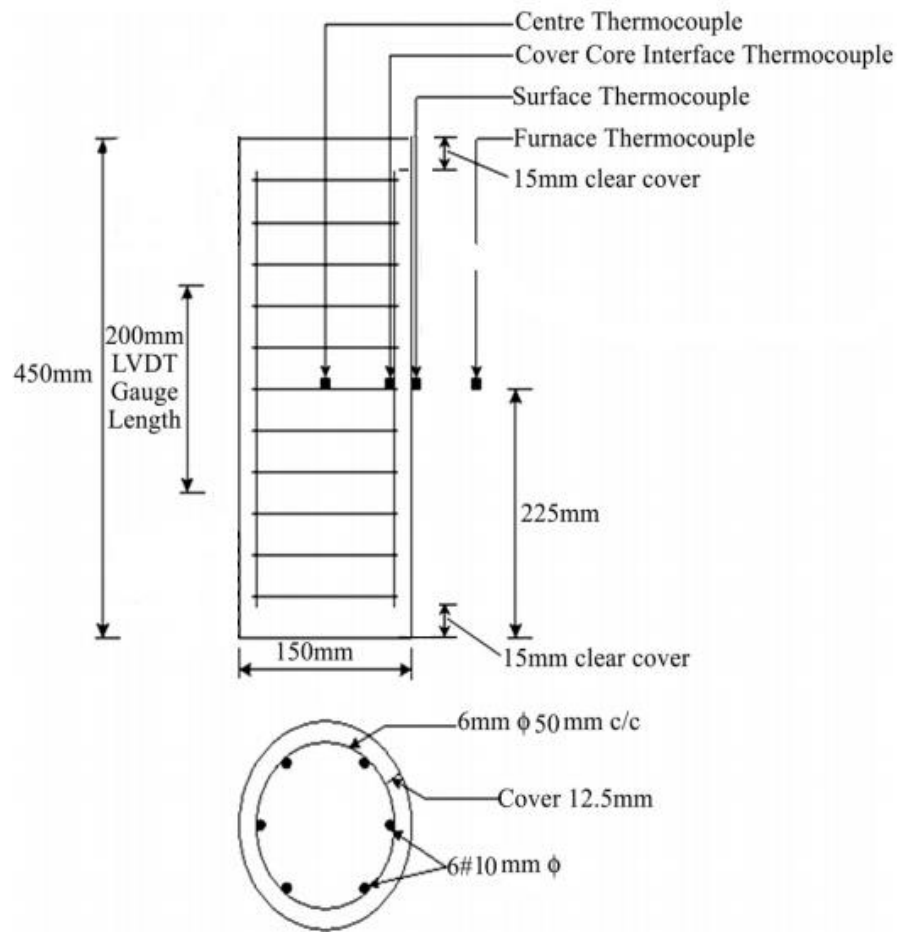
Fig. 2. 1: Size of specimens, reinforcement details and position of thermocouples

are illustrated in Table 2.1 and Fig. 2.1. Experimental variables included temperature of exposure, type of strengthening, monotonic/ cyclic heating and type of cooling. All the concrete specimens were cast in twenty three different series as shown in Table 2.1. The first two letters (CC) in the abbreviation denote circular column, the numeral (3, 6 and 9) indicates the temperature i.e. 300<sup>0</sup>C, 600<sup>0</sup>C & 900<sup>0</sup>C, CY indicates cyclic heating, NA refers to Natural Cooling and WQ for Water quenching specimens. The geometry and other details of the reinforced concrete specimens are shown in Fig. 2.1. A clear concrete cover of 12.5 mm was provided between the confining tie and outer concrete surface of the specimens. A clear concrete cover of 15 mm was provided between the ends of the longitudinal reinforcement and the top and bottom surface of the specimens to prevent direct loading on the rebar during the compression testing. The hoop spacing was approximately one third to half of the core dimension of the specimen. Sufficient number of companion standard plain concrete cylinders (150 mm x 300 mm) and 150 mm cubes were also cast along with each series of main specimens. They were tested to get the average 28 days cylinder compressive strength of plain concrete ( $f'_c$ ).

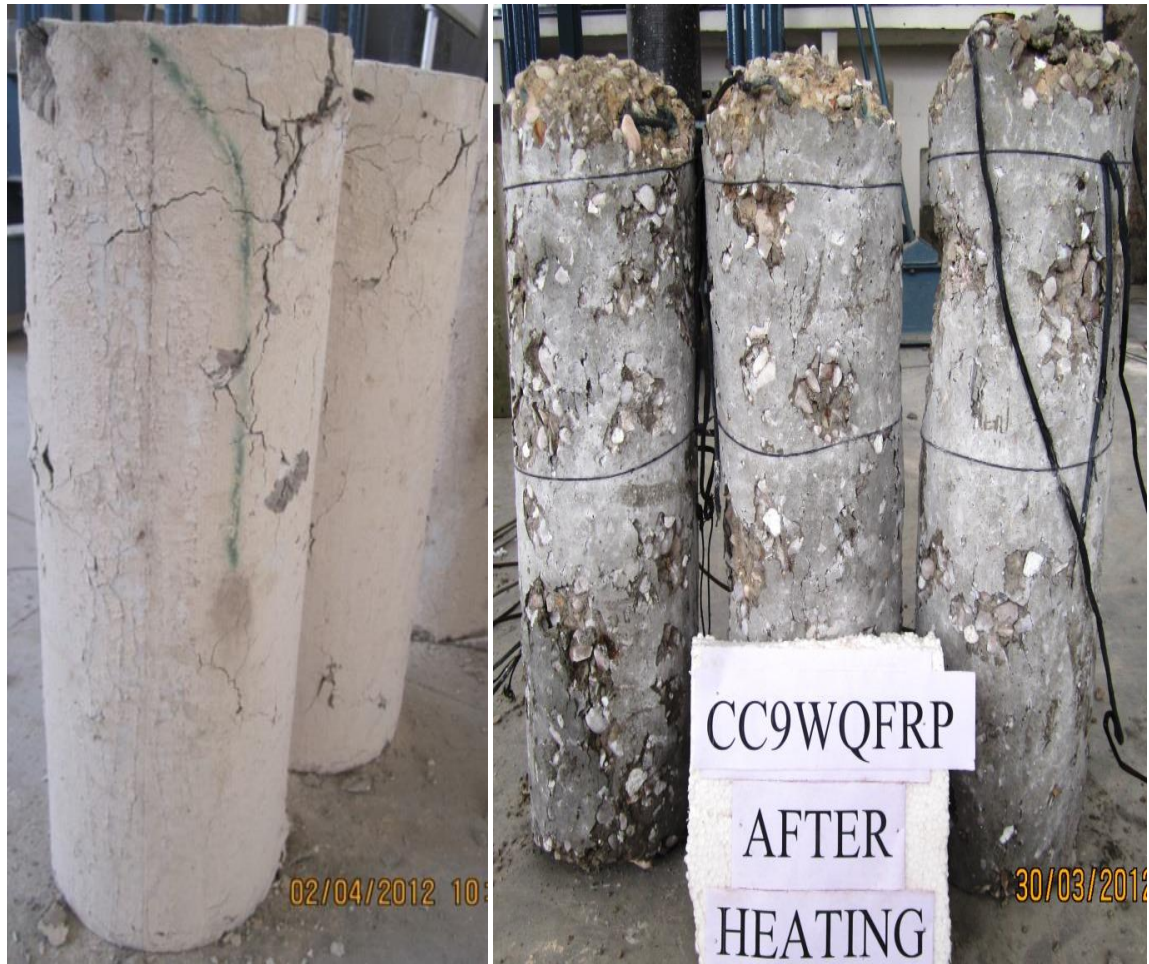
Fig. 2. 8: Surface cracking and spalling observed in test specimens exposed to 900 °C and cooled naturally and water quenched

Heat induced damages in concrete specimens can be roughly detected by observing the concrete's surface. An assessment of fire damaged concrete usually starts with visual observation of colour change, cracking and spalling of concrete surface. In this study the colour of concrete changed to pink when the specimens were exposed to 300°C temperature and became light greyish at 600°C. However, the colour of specimens changed to ash white when exposed to 900°C. There was no visible cracking on the surface of the specimens heated up to 300°C. However some hairline cracks were observed at 600°C. The number of cracks became relatively pronounced at 900°C. The structure of the cement mortar after temperature exposure was observed to have become loose because of the pore expansion owing to the vaporization of the absorbed water. No spalling was noted in any of the heated and naturally cooled specimens. However in case of water quenched specimens spalling was observed (Fig. 2.8). During the cooling, the ionized CaO decomposed from Ca (OH)<sub>2</sub> absorbed water and then became Ca (OH)<sub>2</sub> again, which resulted in the expansion of the concrete volume (Zaidi et al. 2012 and Mehmet 2013).

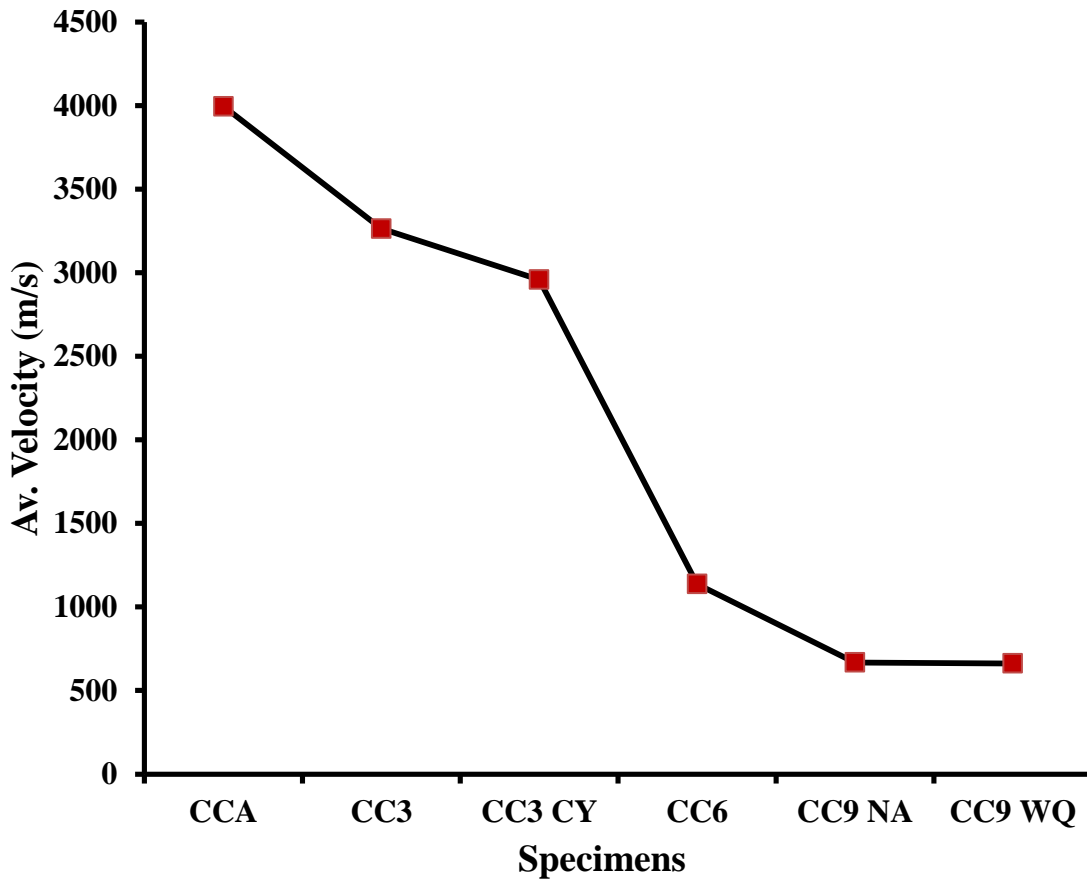
Fig. 2. 9: Ultrasonic pulse velocity v/s temperature

Ultrasonic pulse velocity (UPV) testing was conducted on each group of specimens before heating and seven days after heating. The transmitting and receiving transducers were placed on the opposite faces of the concrete columns and transducers were pressed firmly against the column surfaces until an unchanging reading was observed. The distance between the transducers was divided by the transit time to obtain the pulse velocity through the concrete. Three readings were taken in each column. Ultrasound values were then recorded by hand. The ultrasonic pulse velocity test results for all the specimens are shown in Fig. 2.9. This indicates that up to 400°C, the residual unstressed strength reduced rather gradually and above this temperature, it dropped sharply. This is due to the fact that above 500°C, the calcium silicates commence to decompose into quick lime and silica. This process is irreversible and there is a progressive loss of strength.

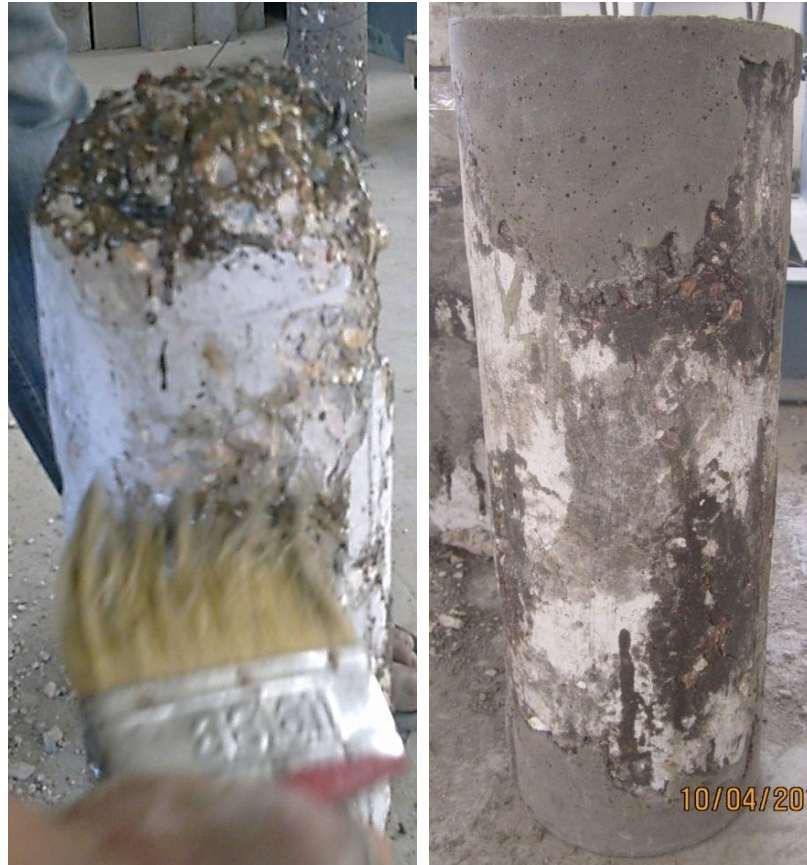
Fig. 2. 10: Application of bonding agent and application of micro concrete

After heating and cooling the heat damaged specimens were inspected for damage and restoration. The specimens, which got spalled, were repaired with micro concrete before going ahead with the chosen strengthening schemes. These were the specimens heated to 900 °C temperature as other specimens heated at lower temperatures did not require section restoration. They were first repaired and their section was restored before wrapping. The porous concrete was removed using steel wire brush, chisels and hammer. The surfaces of specimen were cleaned thoroughly to ensure no dust. A bonding agent was applied on the surface of the specimen to achieve good bond between old concrete and new repair material i.e. micro concrete. The micro concrete was applied above the bonding agent with the help of a steel trowel, as shown in Fig. 2.10. The repaired reinforced concrete columns were cured for fourteen days in the laboratory atmosphere until strengthening.

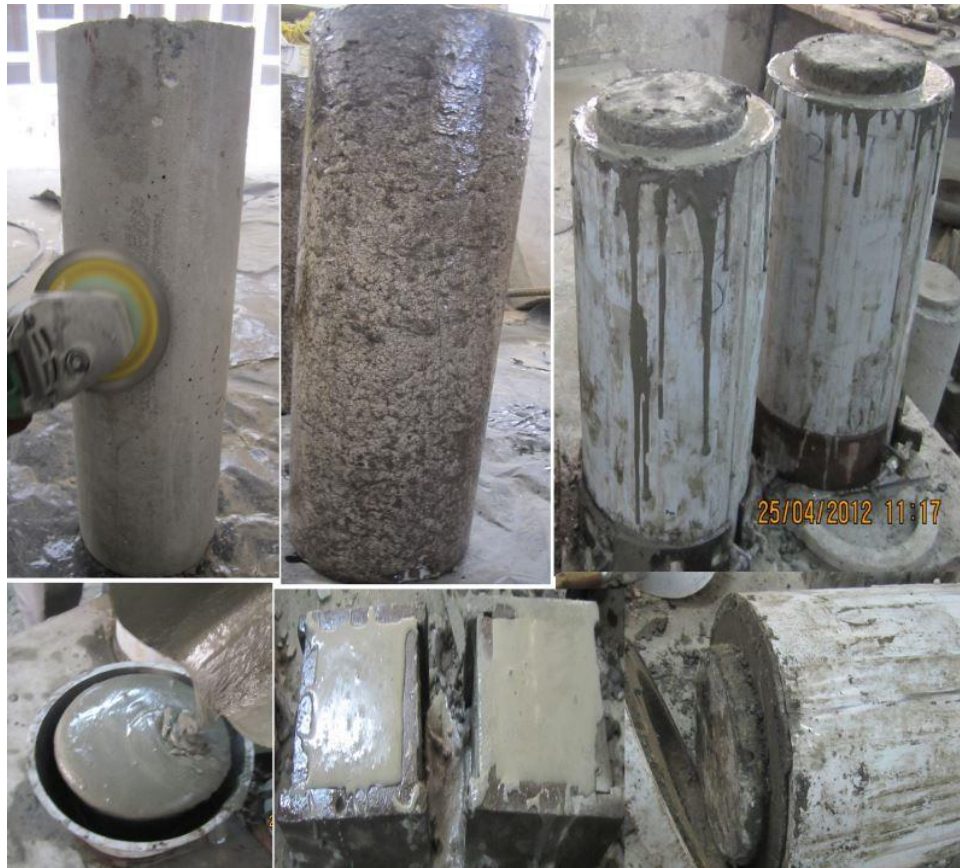
Fig. 2.11: Stages of HSFRC jacketing

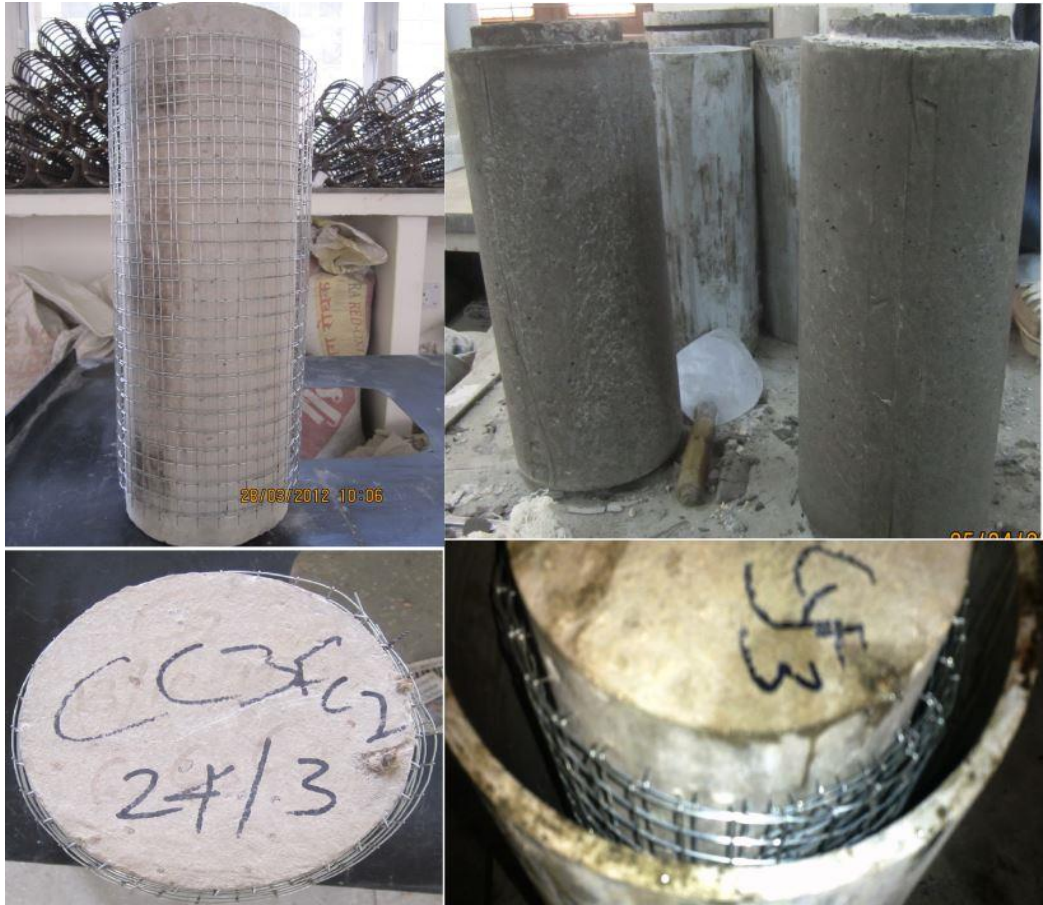
Fig. 2.12: Stages of FC jacketing

provided between the Ferro cement jacket and the ends of the column (Fig.2.12) to avoid direct axial loading on the jacket during testing.

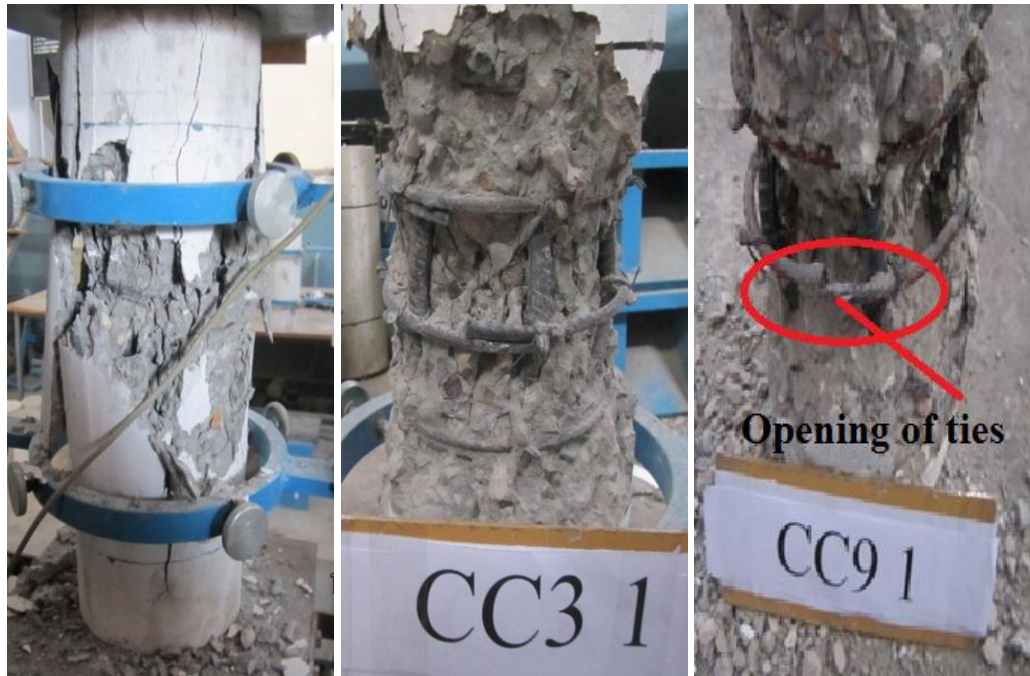
Fig. 2.15: Buckling of rebars, opening if ties and crushing failure of control and heat damaged specimens

failure was observed in all control and heat damaged columns (Fig. 2.15), at the ends due to the effect of stress concentration in these regions (Kumutha et al. 2007). The failure was particularly brittle, sudden and explosive, in nature in case of control specimens. But in case of heat damaged specimens the failure was gradual and exhibited ductile behavior with the increase in load (Yaqub 2011 and 2013). In case of specimens heated to 900° C, as the lateral ties got exposed to heat due to spalling of cover concrete, a crushing failure and opening of ties was noted.

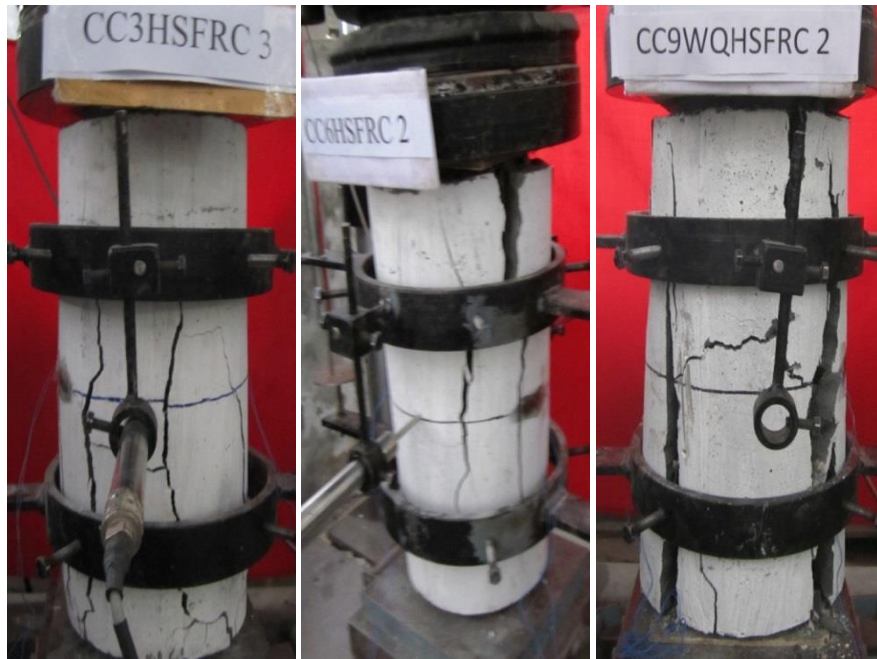
Fig. 2.16: Failure pattern of heat damaged reinforced concrete columns strengthened by HSFRC jacket

direction bulged, whereas those in horizontal direction got broken in full length of the specimens, resulting in crack propagation throughout the length of the specimen in vertical direction. In this case the failure and separation between the core and FC laminates was observed. The FC jacketed specimen's failure mode is shown in Fig. 2.17.

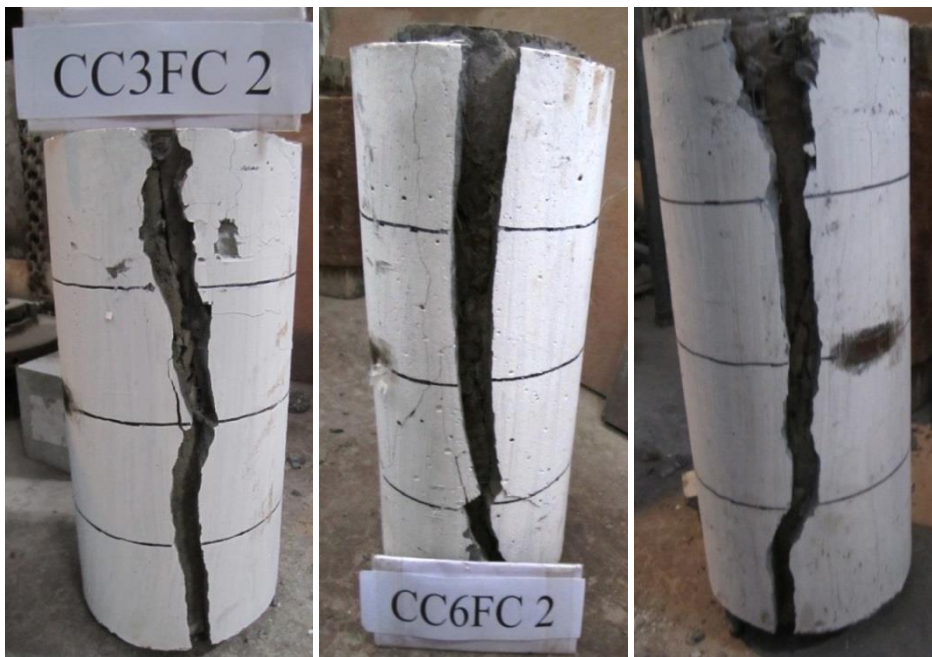
Fig. 2.17: Failure pattern of heat damaged reinforced concrete columns strengthened by FC jackets

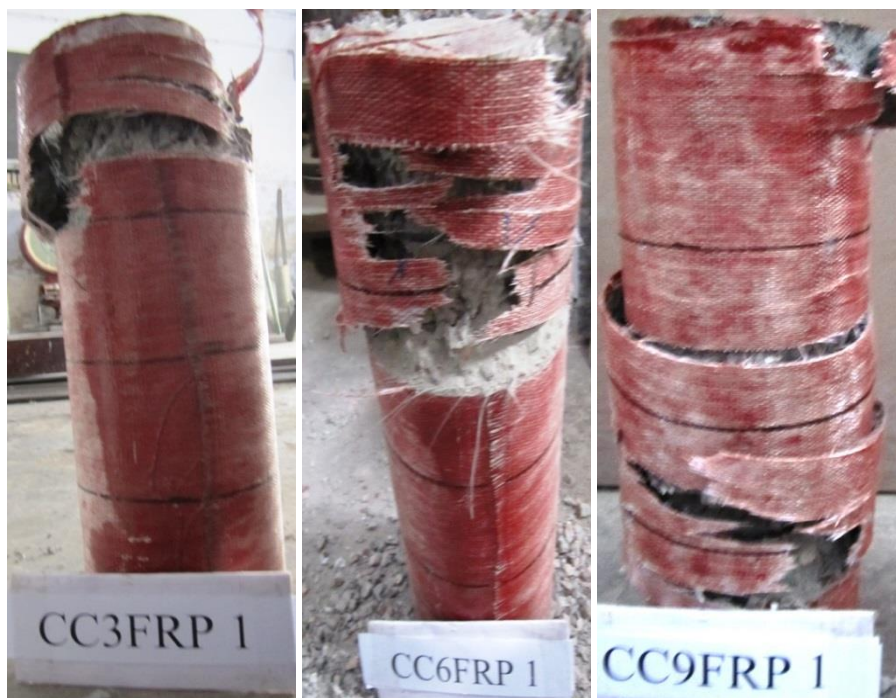
Fig. 2. 18: Failure pattern of heat damaged reinforced concrete columns strengthened by GFRP jacket

The GFRP jacketed columns experienced a gradual failure in the initial stage, and ended with a sudden and explosive noise. It was observed that for the GFRP wrapped specimens, the jackets ruptured outside the overlap position at both the ends (Fig. 2.18). This is due to maximum stress concentration at these regions. In the specimen repaired with GFRP, prior to failure, a cracking noise was heard, indicating significant activation of the GFRP jackets. At the time of failure, loud noise was heard. The sudden and explosive failure indicates release of enormous amount of energy. The visual inspection of tested columns showed good bond between the jacket and the concrete representing no de-bonding at any stage of tests.

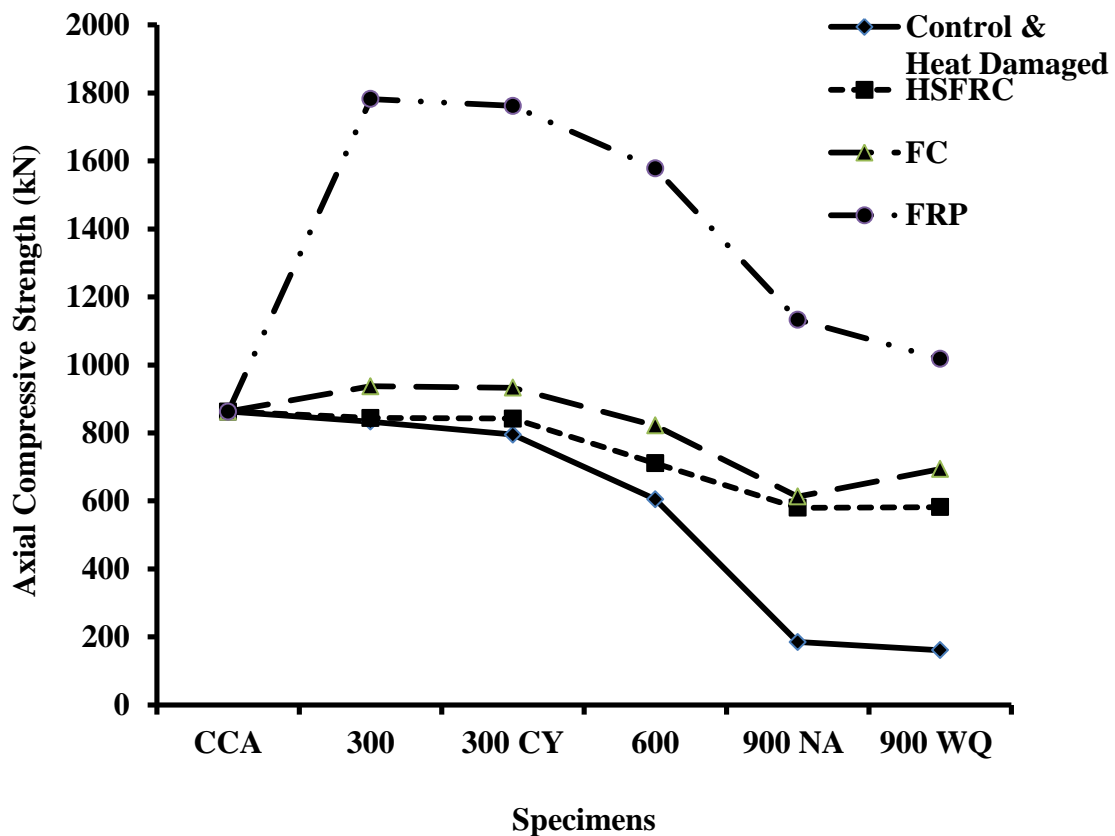
Fig. 2. 19: Axial compressive strength of Specimens

unstrengthen heat damaged specimens, but remained less than the control specimens except for 300°C heat damaged specimens, Fig. 2.19. The strength of GFRP jacketed specimen was considerably higher than both the heat damaged unstrengthen specimens and the control specimens. Since GFRP wrapping becomes active after core concrete fails due to the compressive forces, expansion of the concrete core in the radial direction makes the GFRP more and more active in resisting the axial compressive force. The average strength of heat damaged specimens strengthened with two layer of GFRP jackets was observed to have increased by 106%, 104%, 83%, 31% and 18% compared to that of control unheated specimens and 114%, 121%, 160%, 540% and 532% compared to that of the heat damaged specimens. It was observed that in control and heat damaged specimens the lateral ties opened at the overlap position (Fig. 2.15). The same behaviour was observed in specimen strengthened with GFRP; however the failure load was greater and was defined by failure of GFRP. This shows that the lateral steel tie confinement becomes insignificant when the columns are confined by both steel ties and FRP jackets.

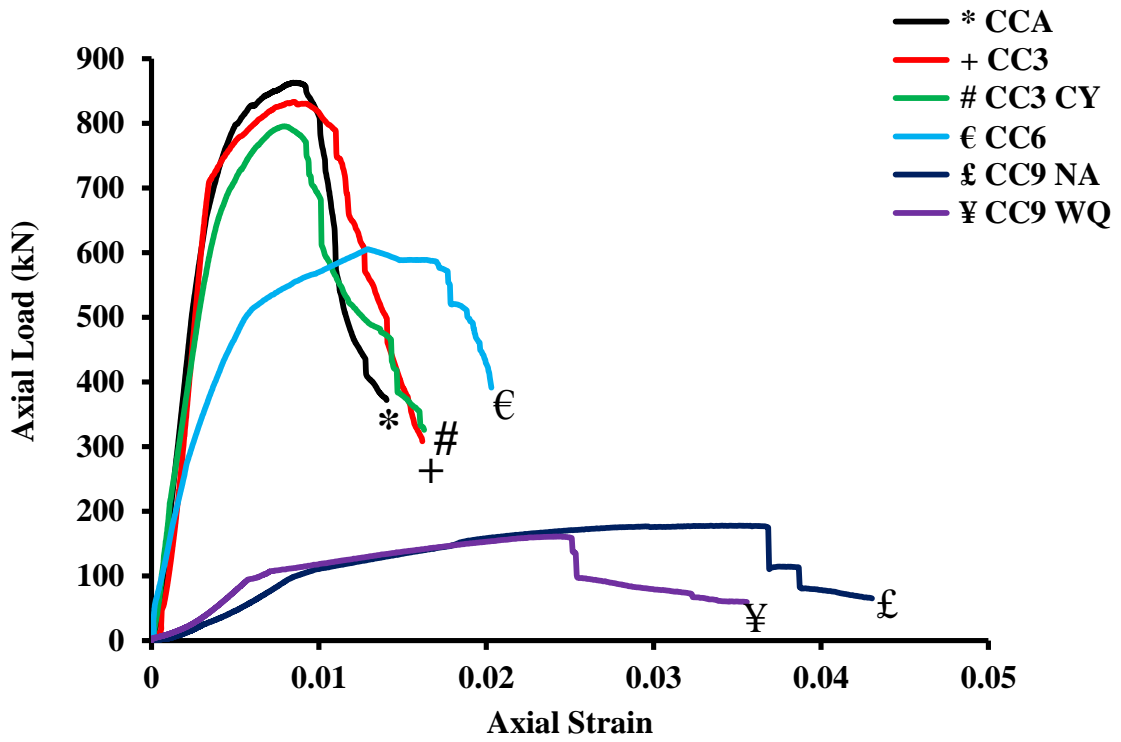
Fig. 2. 20: Load – axial strain comparison of control specimens and all heat damaged specimens

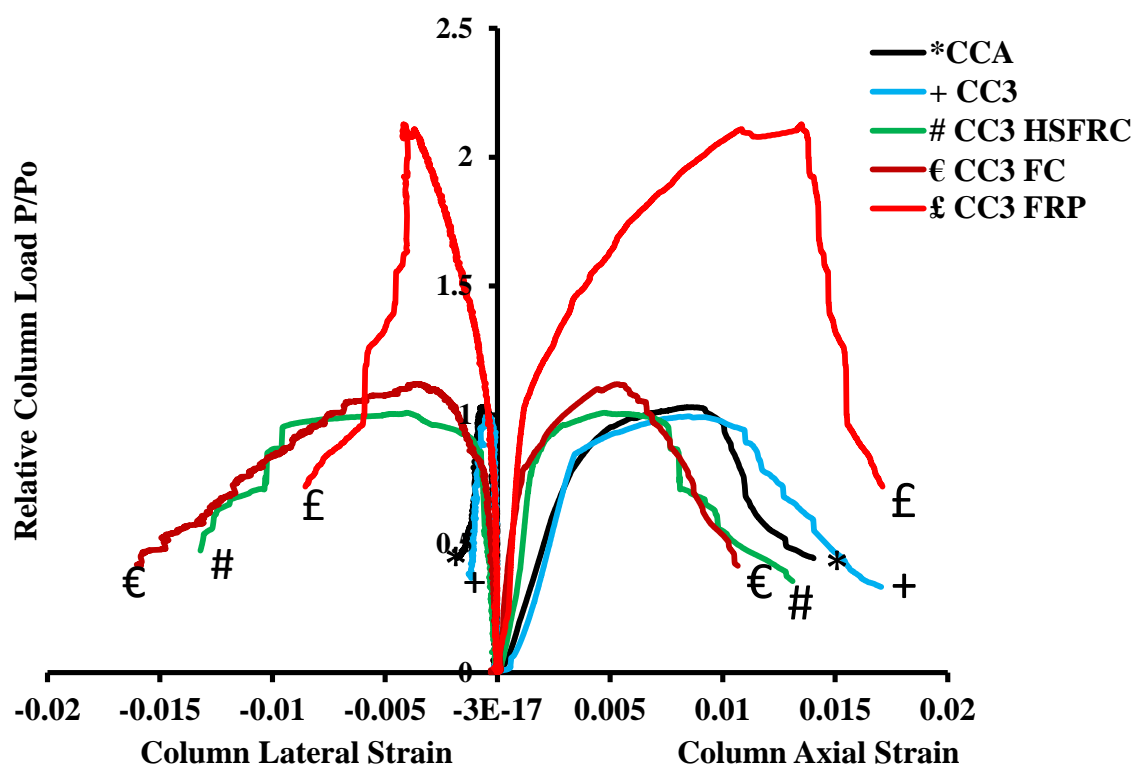
Fig. 2. 21: Load –axial & lateral strain comparison of strengthened specimens heated at 300°C

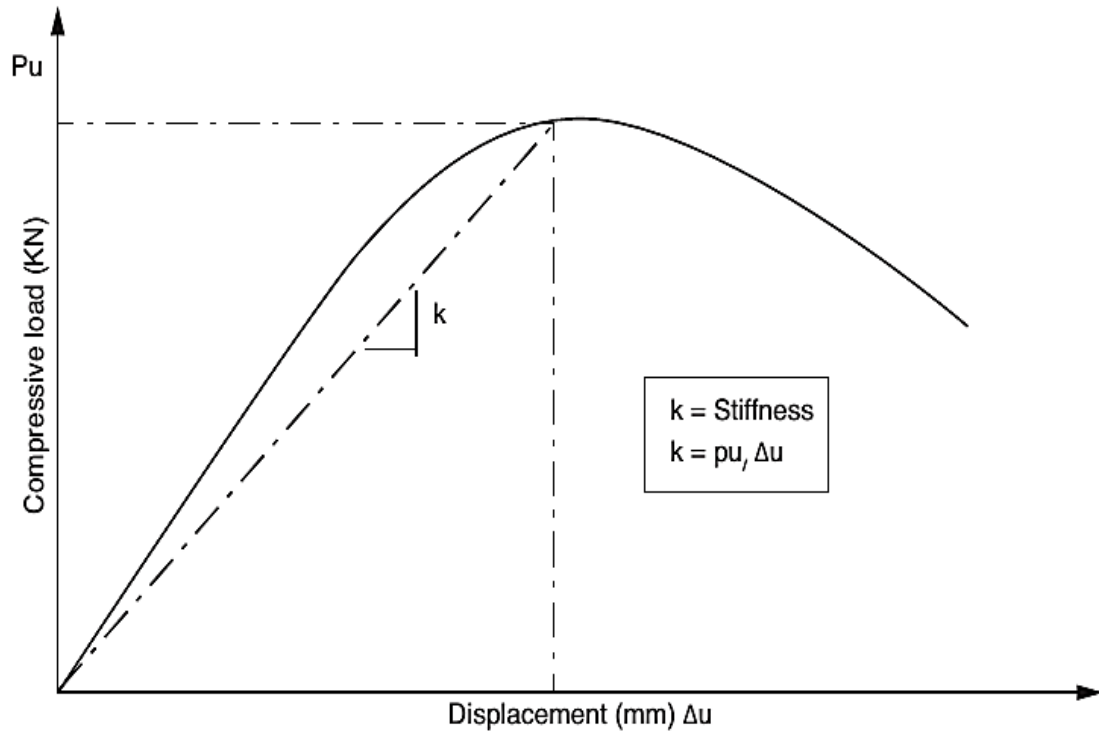
Fig. 2.26: Secant stiffness

The restoration of stiffness of the heat damaged columns depends upon the confining action of HSFRC, FC and GFRP jackets. The confining effect is related to the load at which these systems begin to act. The confining effect of GFRP jacket takes place when the heated concrete specimen approaches its ultimate unconfined compressive strength. This means that before approaching the ultimate unconfined compressive strength, the GFRP jacket does not contribute in the structural response because it plays no part in the elastic range of the axially loaded heated specimen (Yaqub et al. 2011, 2013). Stiffness was observed to have increased in the case of HSFRC and FC jacketed columns, which may be due to the increase in cross sectional area offered by these techniques. On the contrary, the use of GFRP jacketing increases the compressive strength of heat damaged columns massively, but could not restore the stiffness property.
