# **STRENGTHENING OF HEAT DAMAGED REINFORCED CONCRETE ELEMENTS**

**Ph.D. THESIS**

**DEPARTMENT OF CIVIL ENGINEERING  
INDIAN INSTITUTE OF TECHNOLOGY ROORKEE  
ROORKEE – 247 667 (INDIA)  
DECEMBER, 2014**

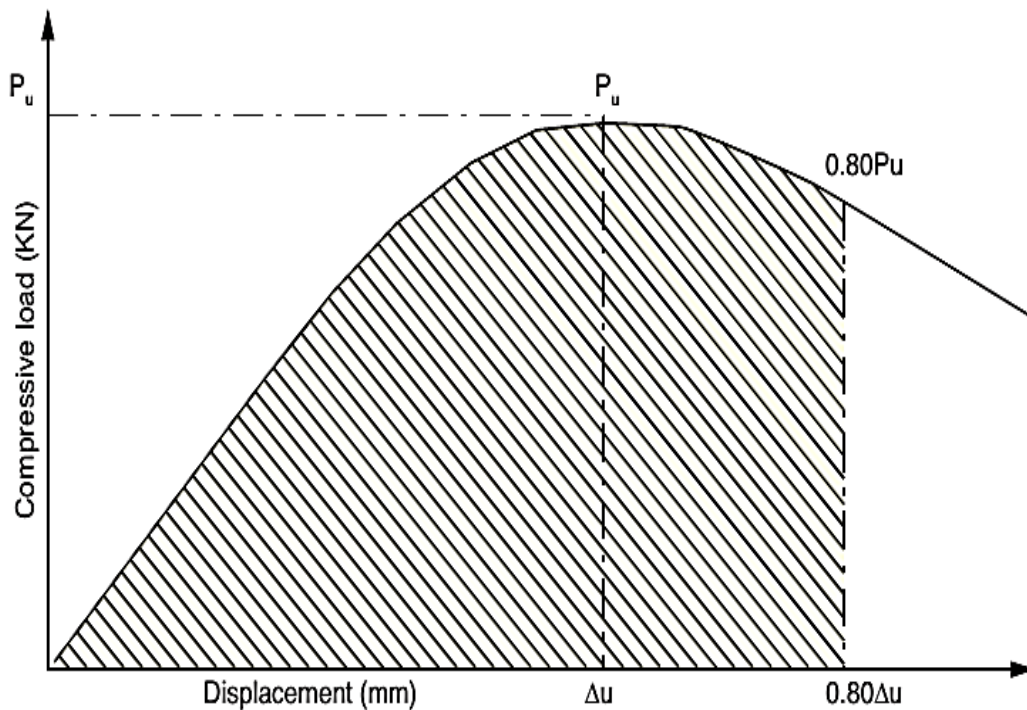
Fig. 2. 28: Energy dissipation calculation

The energy dissipation is defined as the area under the concrete stress-strain curve. The energy absorption capacity values were calculated up to the 80% of  $P_{u_{max}}$  on the descending portion of the curve (Fig. 2.28). Table 2.24 shows the energy dissipation capacity values of all the specimens. It was observed that the specimens strengthened with GFRP dissipated more energy compared to HSFRC and FC jacketed specimens. This was due to the fact that GFRP jacketed specimens achieved higher strength and strains compared to other two strengthening techniques. GFRP strengthened specimens dissipated 129 to 360 % more energy compared to the control specimens, which was quite higher than the HSFRC and FC jacketed specimens. It was due to the fact that the HSFRC and FC strengthened specimens were stiffer and less ductile than the GFRP strengthened specimens. Further it can be noted from Figs. 2.24 and 2.25 that the specimens which were cooled naturally dissipated more energy compared to that in water quenched specimen.

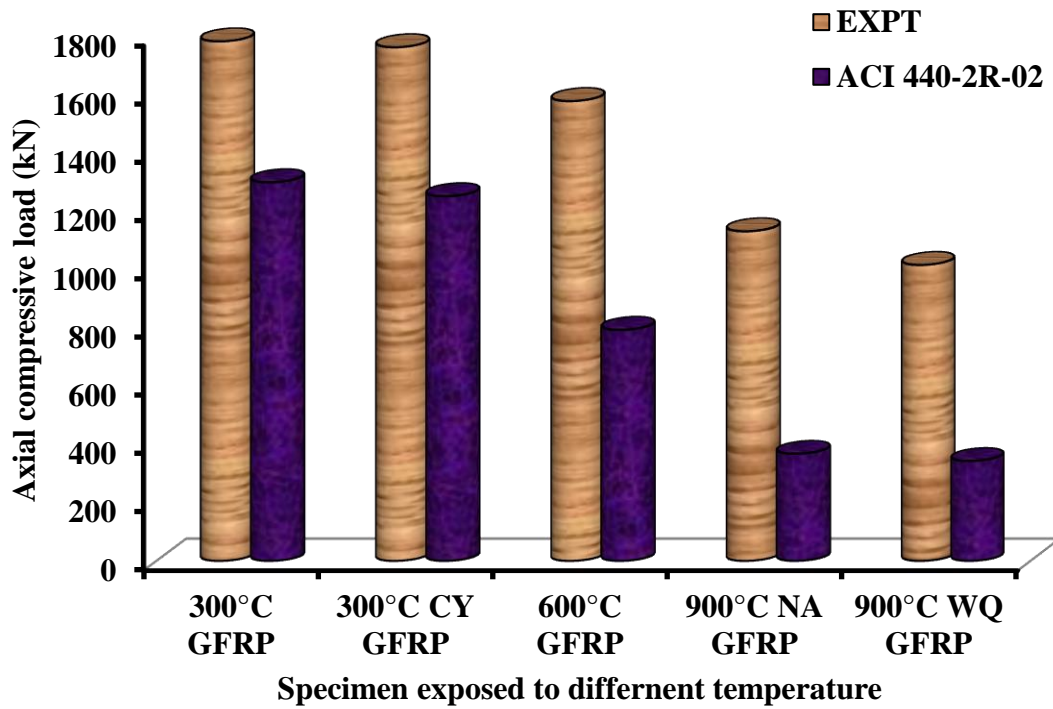
Fig. 2. 29: GFRP strengthened heat damaged columns

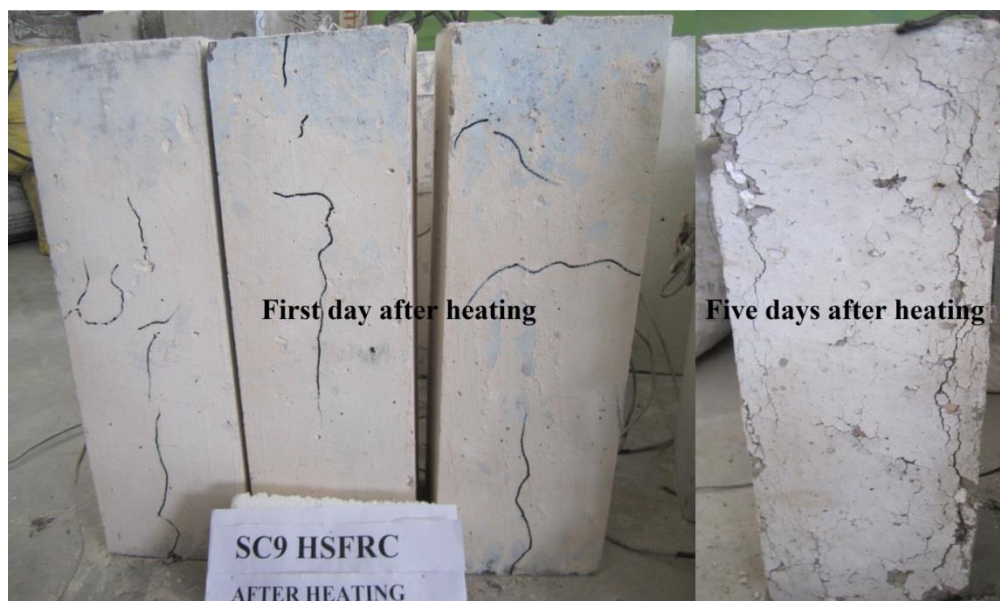
Fig. 3.5: Surface cracking observed in test specimens exposed to 900 °C

There were no visible cracks on the surface of the specimens heated up to 300°C. However, some hairline cracks were observed at 600° C. The number of cracks became relatively pronounced at 900° C along with disintegration of concrete as shown in Fig. 3.5. However, no serious spalling was observed in concrete specimens at any exposure temperature. The damage accumulated during the cooling process further reduces the residual strength which leads to further expansion of crack day by day (Fig. 3.5).

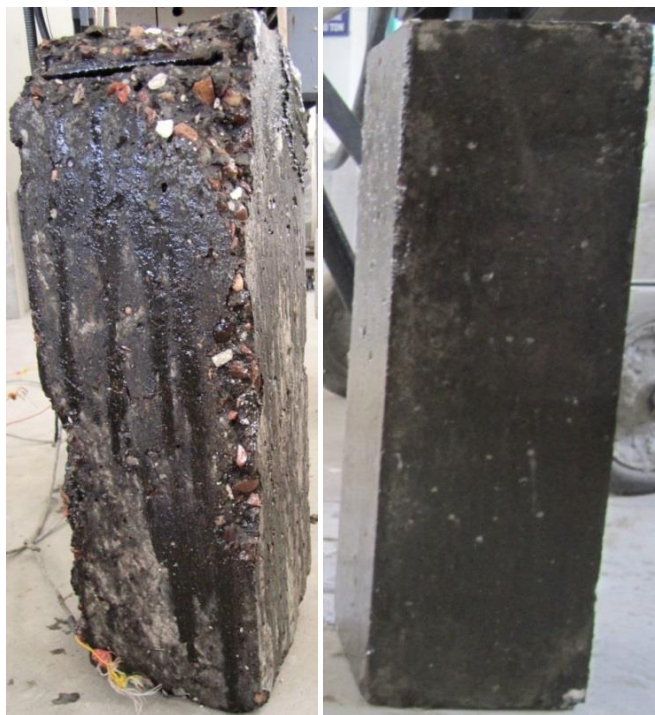
Fig. 3.6: View of a typical specimen before repair and after application of micro concrete

After heat exposure, the heat damaged square columns, which got cracked and spalled, were repaired before further strengthening. The spalled sections were restored using micro-concrete. The loose concrete was removed using steel wire brush, chisel and hammer. The surface of specimen was cleaned thoroughly to ensure no dust. A bonding agent was applied on the spalled surfaces of the specimen to achieve good bonding between the old concrete and new repair material i.e. micro concrete as shown in Fig. 3.6. Once the bond coat became tacky, the micro concrete was applied to the specimens. The micro concrete repaired specimens were covered with damped gunny bags for 7 days and kept in laboratory conditions until strengthening. The specimens, which did not undergo any spalling, were directly strengthened by the appropriate technique. The corners of the heat damaged square columns were also ground before strengthening to reduce stress concentration at the corners.

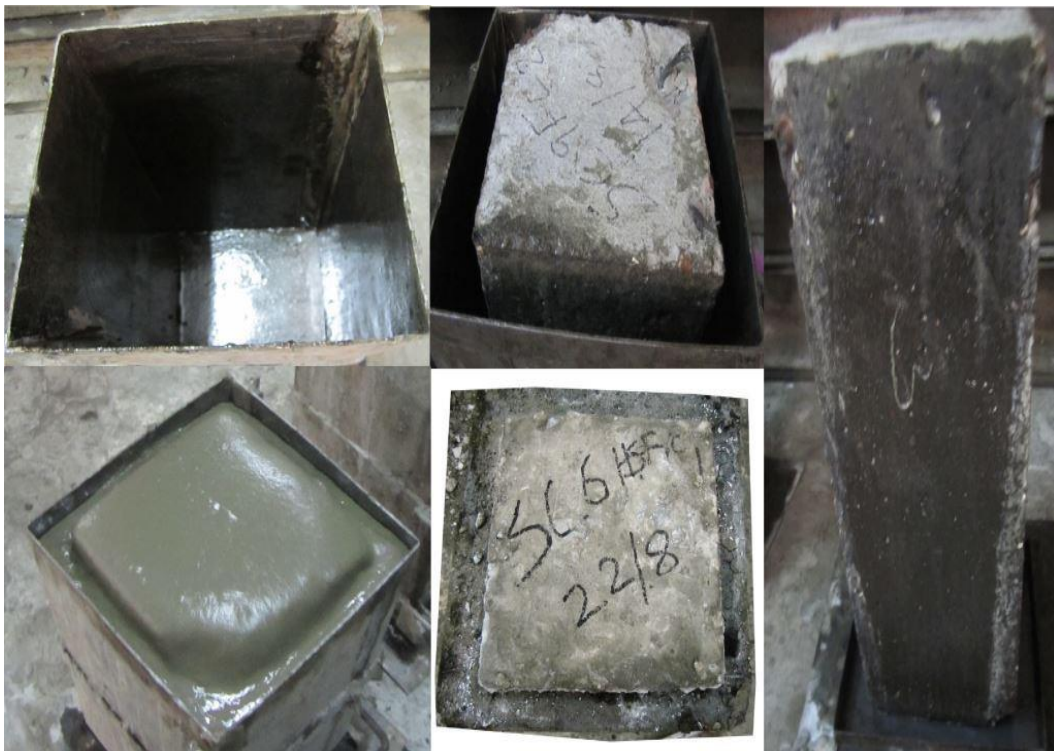
Fig. 3.7: Strengthening process of HSFRC jacketing

The heat damaged short columns, which were to be strengthened with HSFRC jacketing, were cleaned thoroughly to ensure no dust. A layer of Epoxy was applied on the surface of square columns to fill micro-cracks if any, and to provide good connection between the heat damaged concrete and the HSFRC jacketing. HSFRC slurry reinforced with hooked steel at a volume fraction of 2% with average compressive strength of 74.07 MPa was poured into the mould to form a 25 mm thick jacket as shown in Fig. 3.7. After 24 hrs, the strengthened specimens were demoulded and cured using damped gunny bags for another 14 days. After fourteen days, the test specimens and the companion cubes were air cured under laboratory environment conditions until testing.

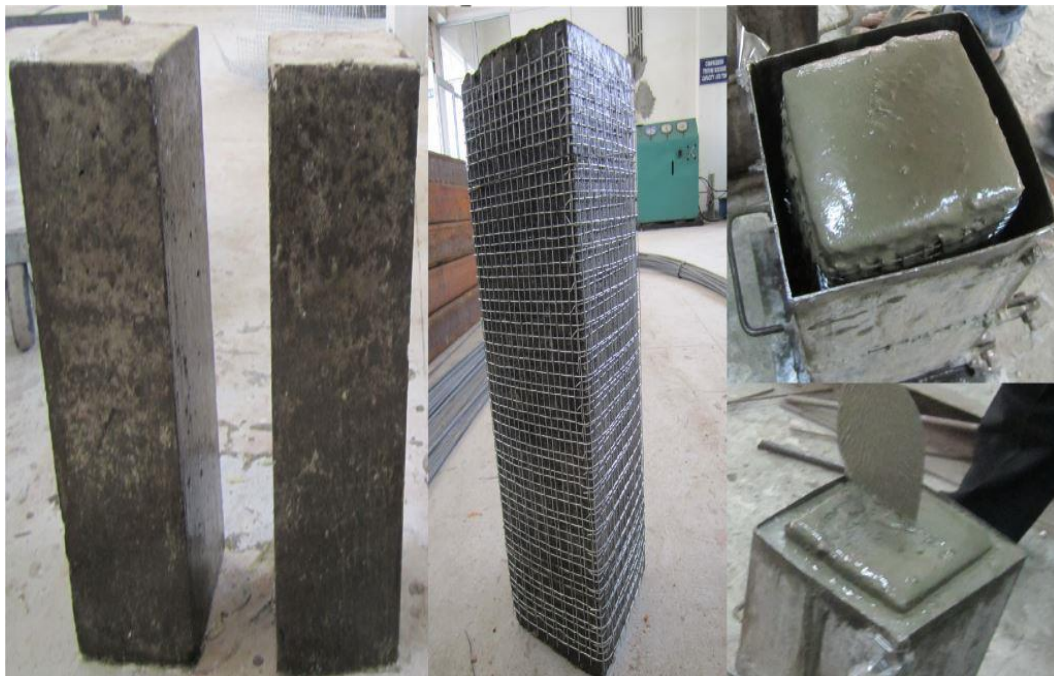
Fig. 3.8: Strengthening process of FC jacketing

Slurry with high compressive strength of 68.06 MPa was poured into the mould to form 25mm thick FC jacket around the heated specimen. Spacing of about 20 mm was provided between the Ferro cement jacket and the ends of the column to prevent the jacket from direct axial loading during test. The strengthened square columns were covered with damped gunny bags for 14 days after demoulding. After fourteen days, the column and companion cubes were air cured in laboratory atmosphere until testing.

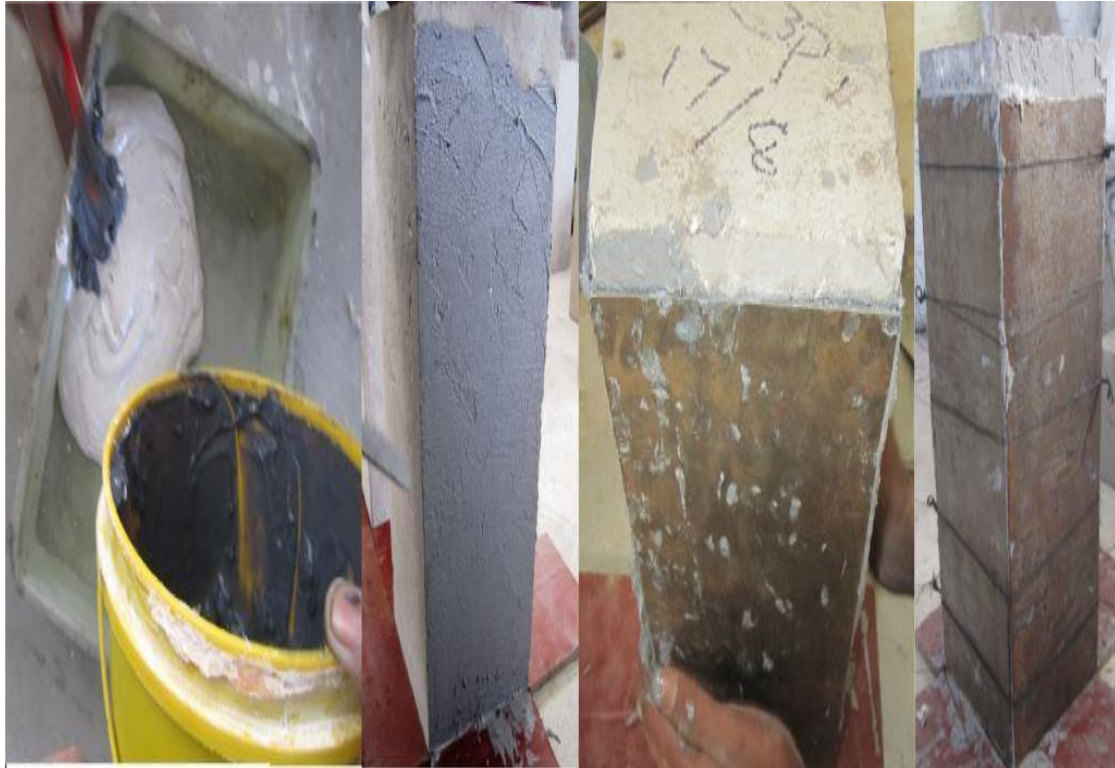
Fig. 3.10: Strengthening process of SP Jacketing

epoxy adhesive on the external surfaces of the concrete to fill air voids and to provide good bond strength. Secondly, a thin layer of the adhesive is applied on the steel plate. The gap were filled with adhesive, the plates were tightened with binding wire. The strengthened prisms were cured at laboratory environment for at least 28 days before testing (Fig. 3.10).

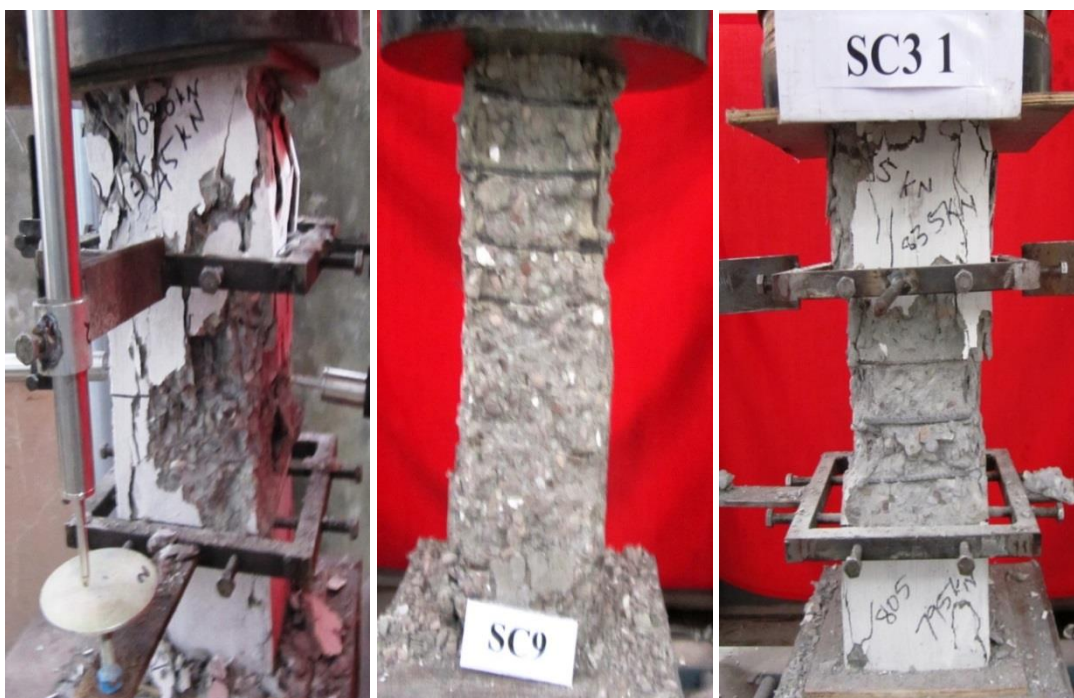
Fig. 3.12: Typical crushing failure of control and heat damaged square short columns

The specimens were tested under monotonic compression up to failure. Different failure modes were observed in the various control unheated and heat damaged specimens. The failure was particularly brittle, sudden and explosive in nature in case of control unheated specimens. But in case of heat damaged specimens the failure was gradual and exhibited ductile behavior with the increase in the axial load. The exposure of concrete to high temperatures results in softening of material due to deterioration in chemical and physical make up of concrete. It is believed that these changes along with the cracking of concrete at high temperatures make it ductile. In case of specimen heated to 900°C, it was noticed that the lateral ties were exposed due to spalling of cover concrete resulting in crushing failure as shown in Fig. 3.12. At 900°C, the heat induced disintegration and damage is very severe due to the loss in bond between aggregate surface and cement paste, which results in loss of integrity in aggregate-cement paste matrix. This is believed to be the reason of considerable damage noticed in the specimens exposed to 900°C tested under axial loads, especially in the cover concrete, which is unconfined and has maximum exposure to heat. This results in separation of unconfined cover concrete from the confined core concrete resulting into premature failure of cover concrete under loads. In the control and heat damaged specimens the vertical cracks started at the top followed by crushing of the concrete.

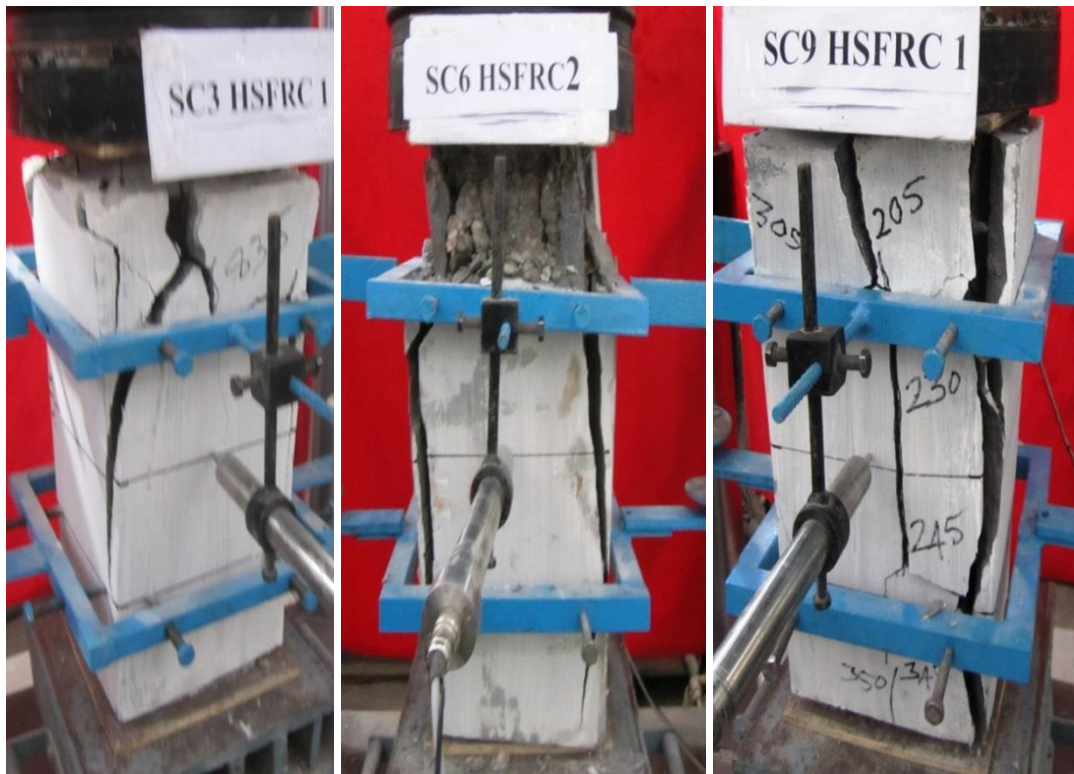
Fig. 3.13: Typical failure pattern of HSFRC strengthened square column specimens

For strengthened HSFRC short square columns, the failure got initiated at top and bottom of the specimen due to stress concentration during loading. Diagonal and vertical cracks were observed in these specimens. Propagation and widening of vertical cracks was observed with increase in loading condition after the specimen had reached its ultimate loading capacity. At this point; increase in load created noise due to breaking of steel fibers there by indicating the stress transfer from the dilated concrete to the jacket. Bonding between the HSFRC jacket and concrete remained good enough as the de-bonding was never observed throughout the process (Fig. 3.13).

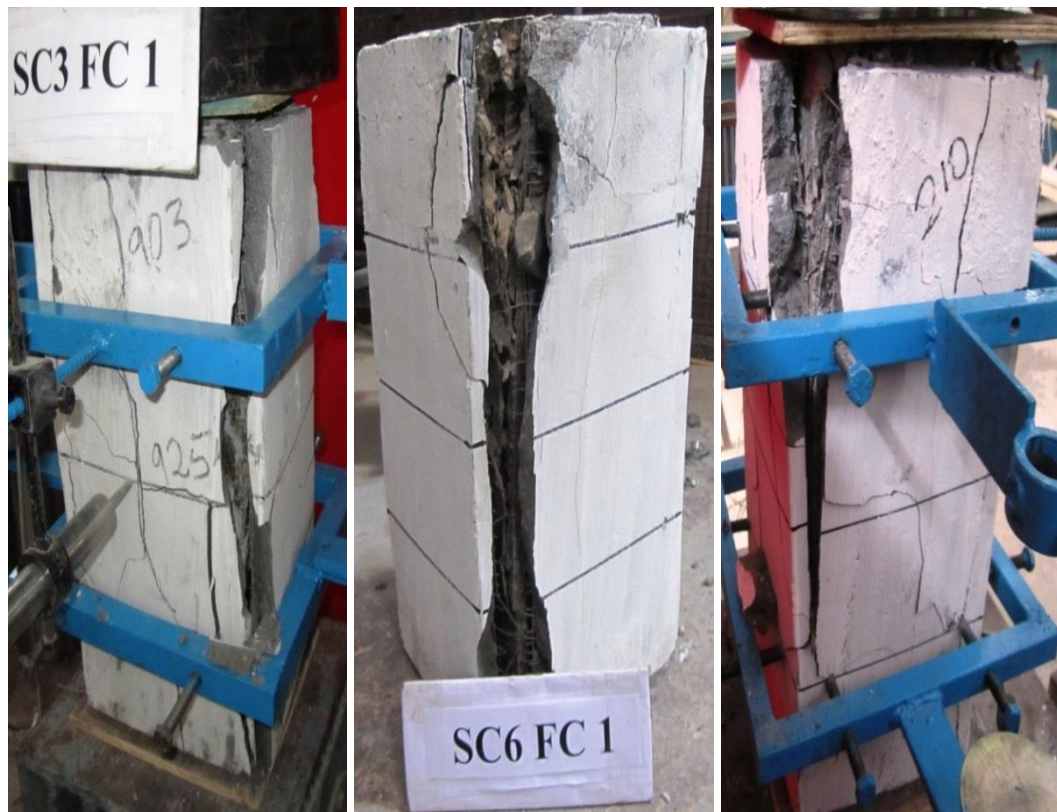
Fig. 3.14: Typical failure pattern of FC strengthened square column

specimens showed that no de-bonding took place between the concrete and FC jackets. The failure pattern clearly shows that the wires of the weld mesh in the horizontal direction got broken, while wires in the vertical direction got buckled and broken at the corner (Fig. 3.14). Under axial compression, the stress in the square column tends to be concentrated in the lateral direction at the corners. The failure initiated with the development of vertical cracks followed by the yielding of the horizontal wires due to transverse tension at the corner of specimens.

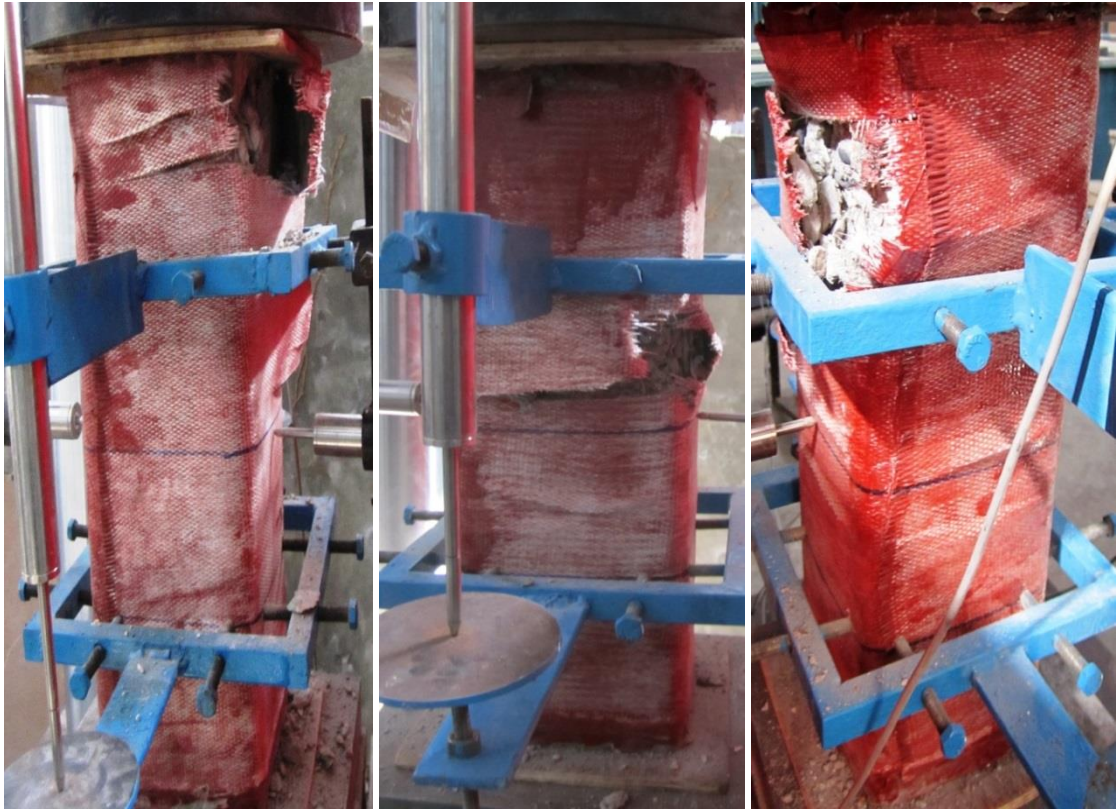
Fig. 3.15: Typical failure pattern of GFRP strengthened square column

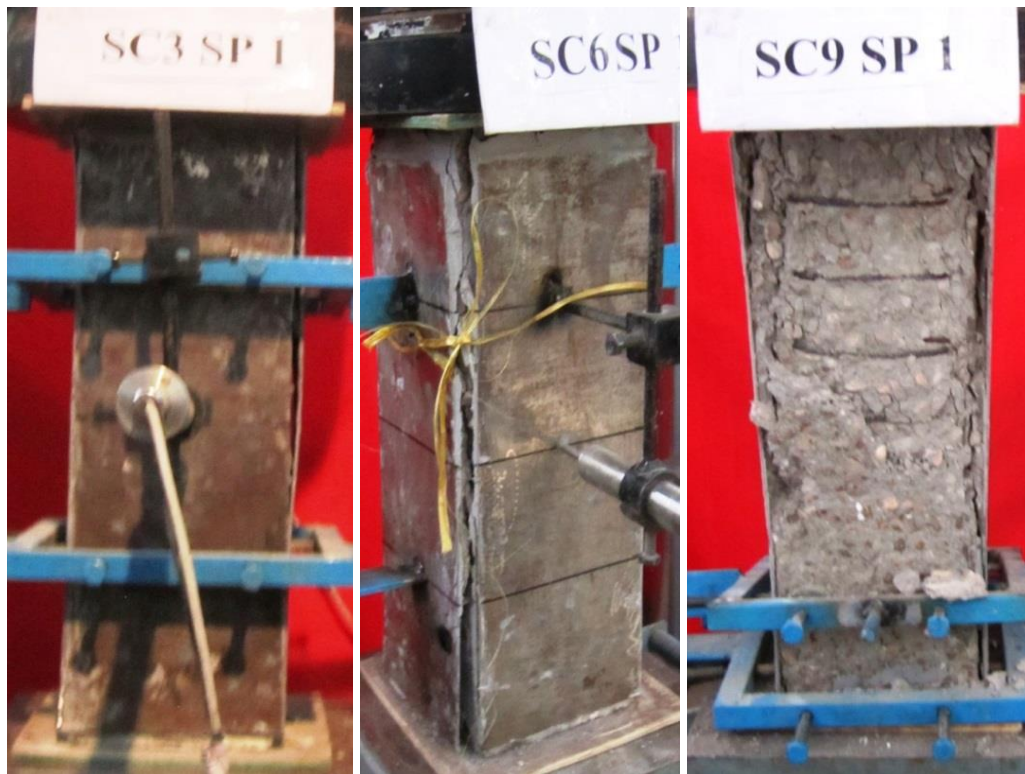
Fig. 3. 16: Typical failure pattern of SP strengthened square column

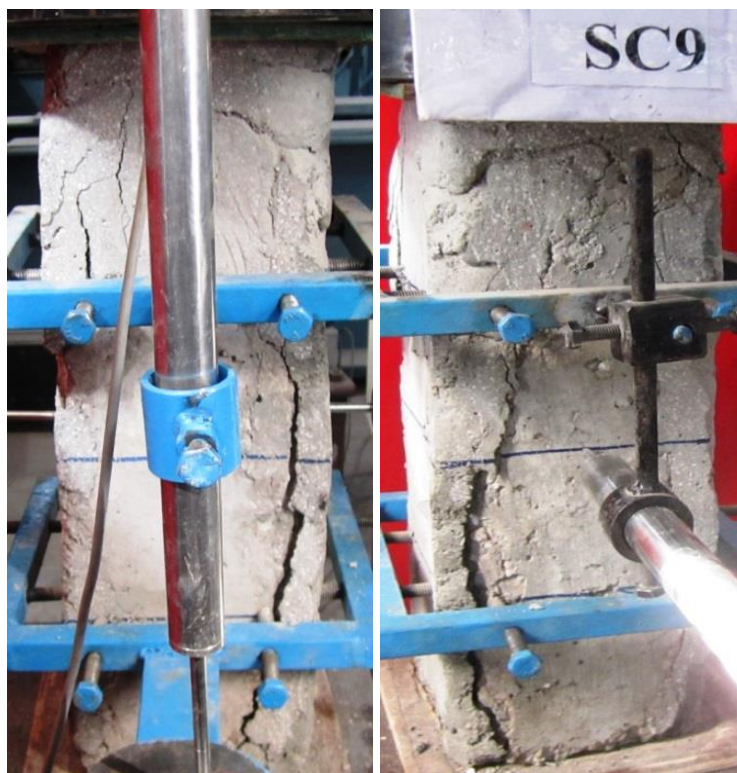
Fig. 3. 17: Typical failure pattern of micro concrete repaired specimens

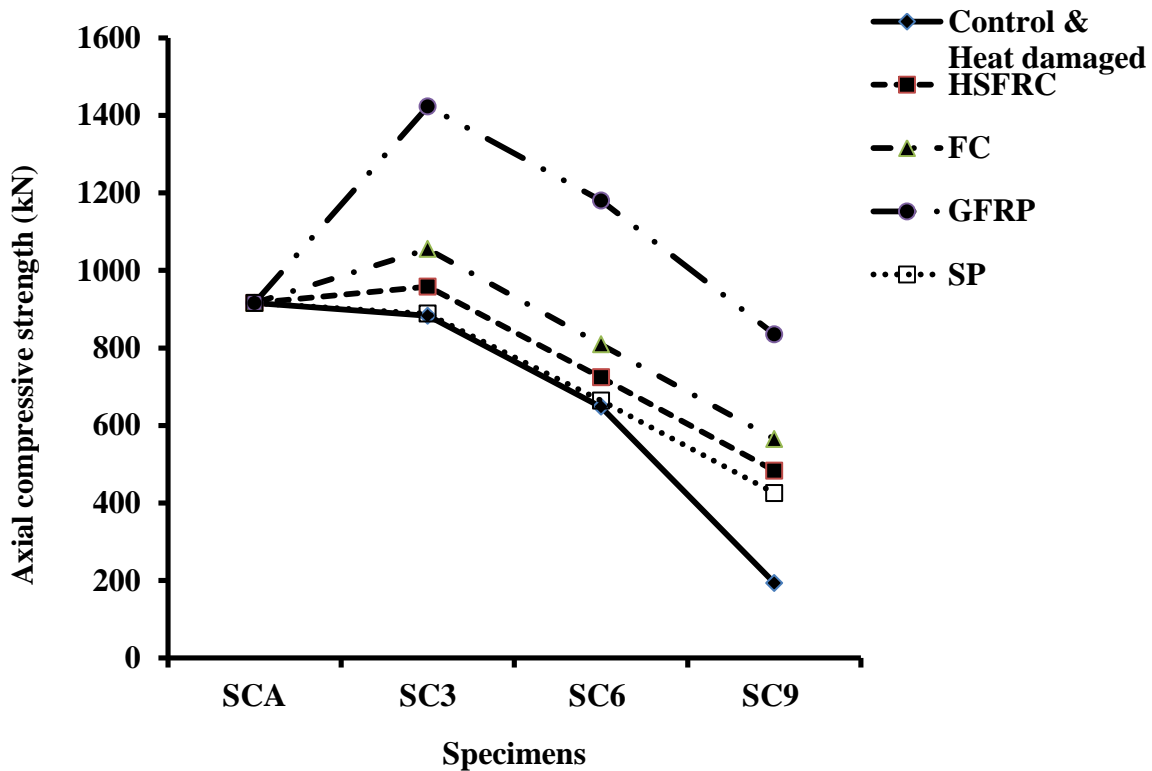
Fig. 3. 18: Axial compressive strength of square columns

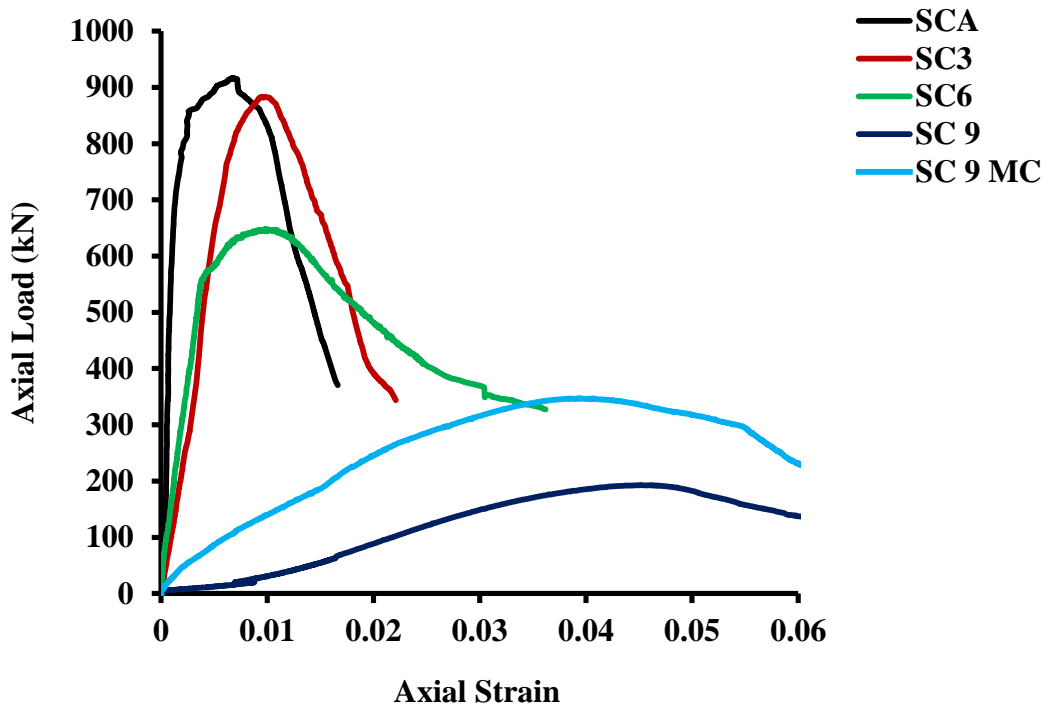
Fig. 3.19: Loads – axial strain Curves of control unheated columns and heat damaged columns

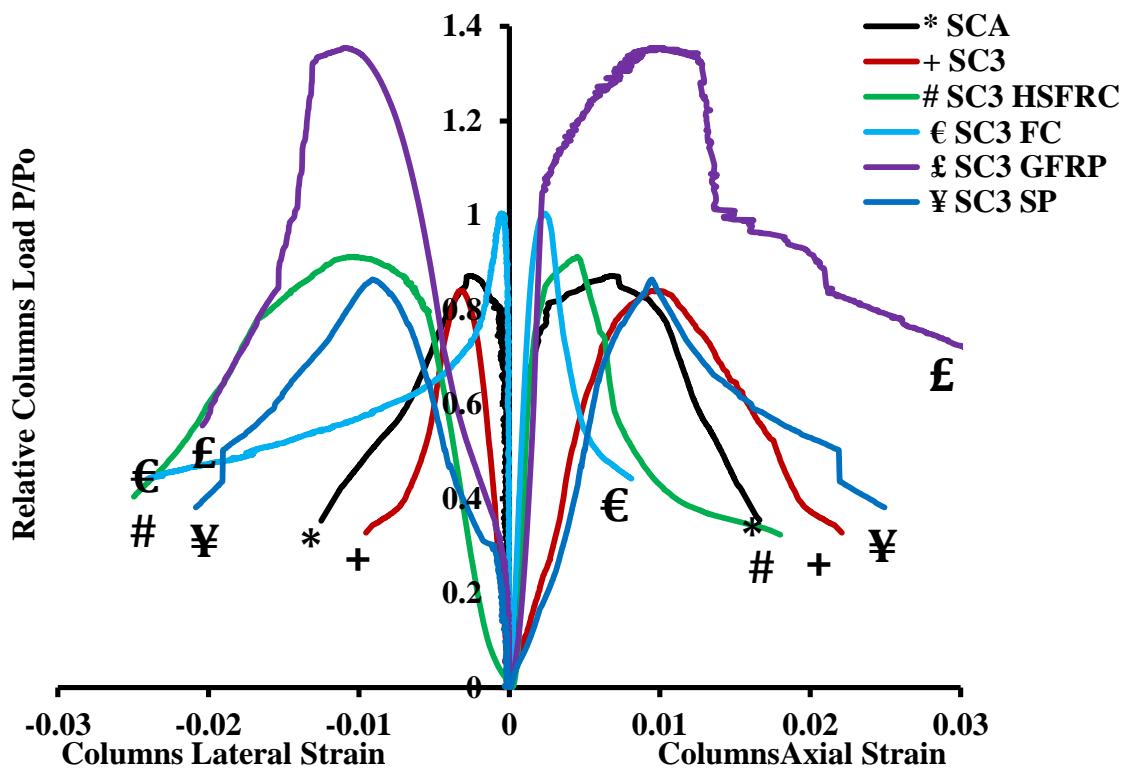
Fig. 3. 20: Load – axial & lateral strain curves of specimens heated at 300°C and strengthened with various techniques

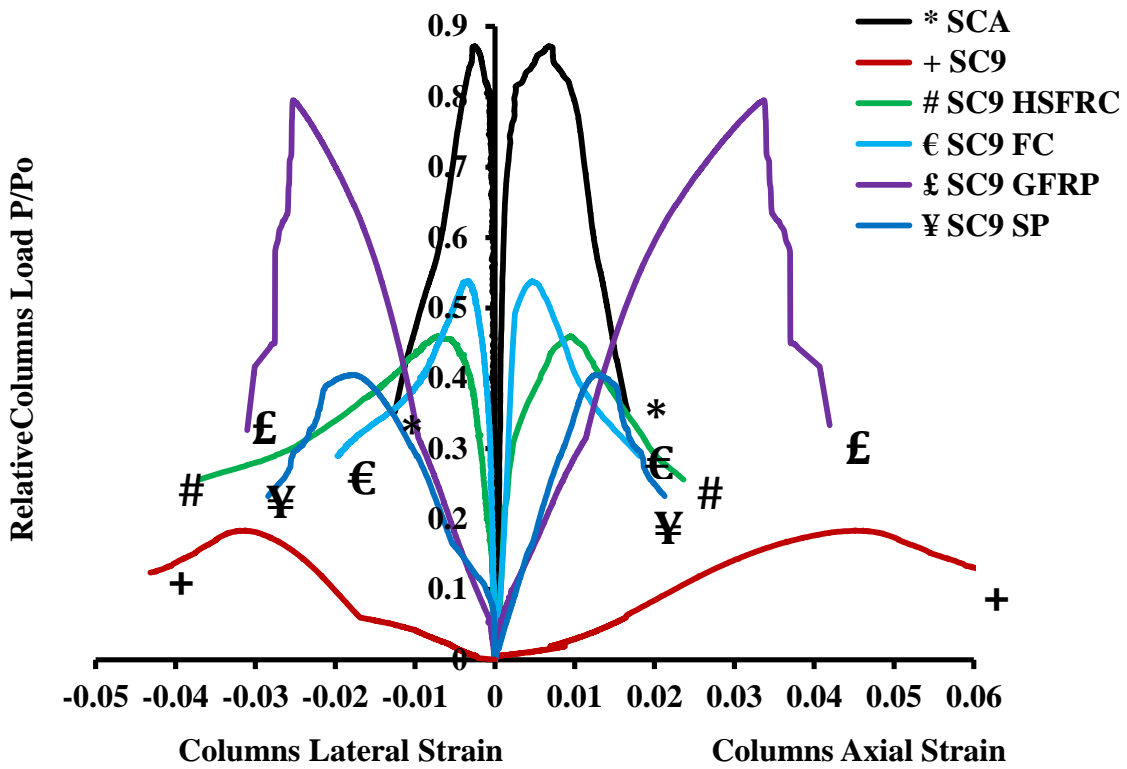
Fig. 3. 22: Load – axial & lateral strain curves of specimens heated at 900°C and strengthened with various techniques

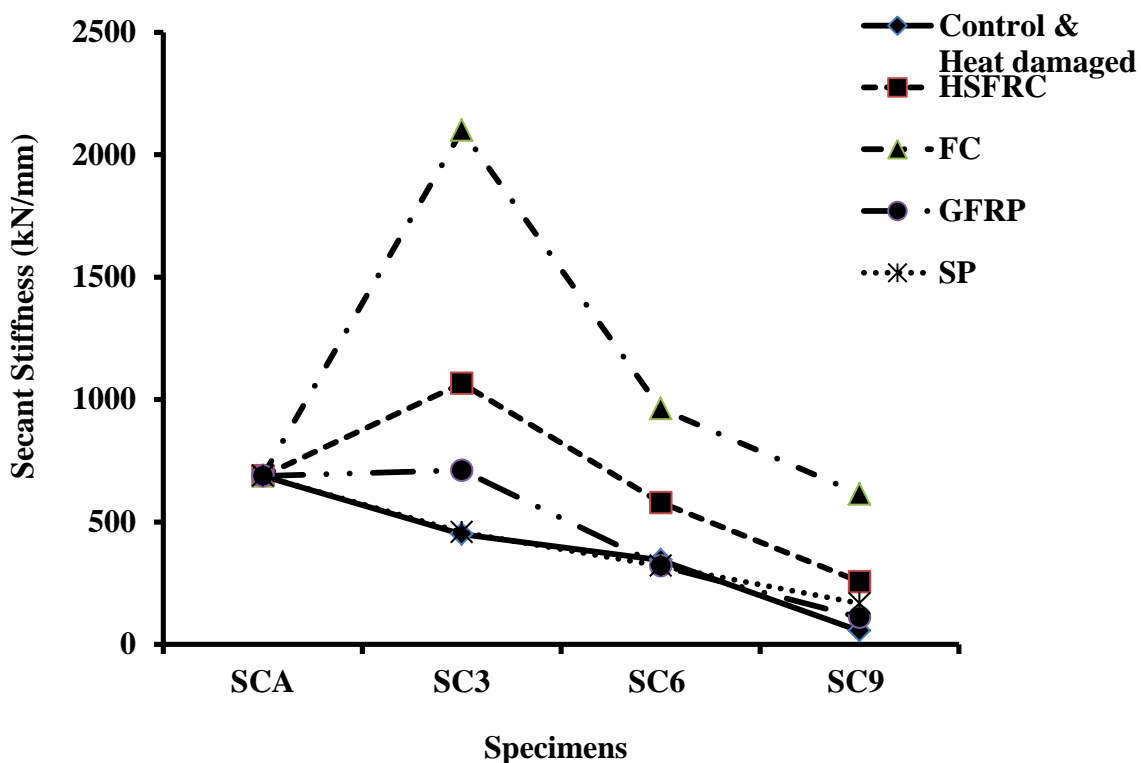
Fig. 3. 23: Comparison of secant stiffness of square columns

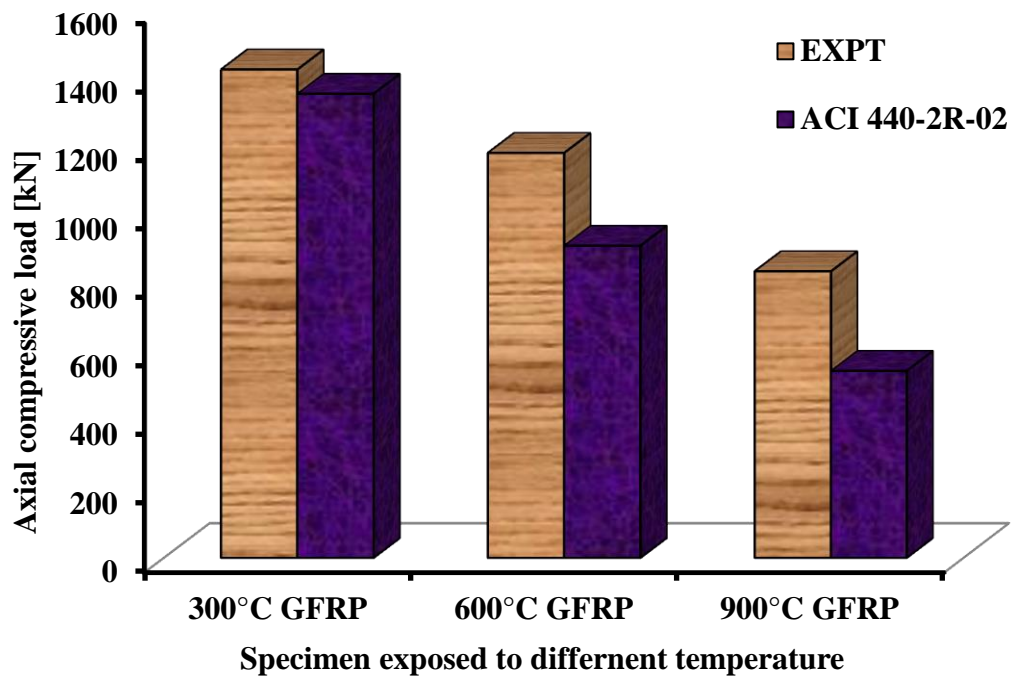
Fig. 3. 24: GFRP strengthen heat damaged square column specimens

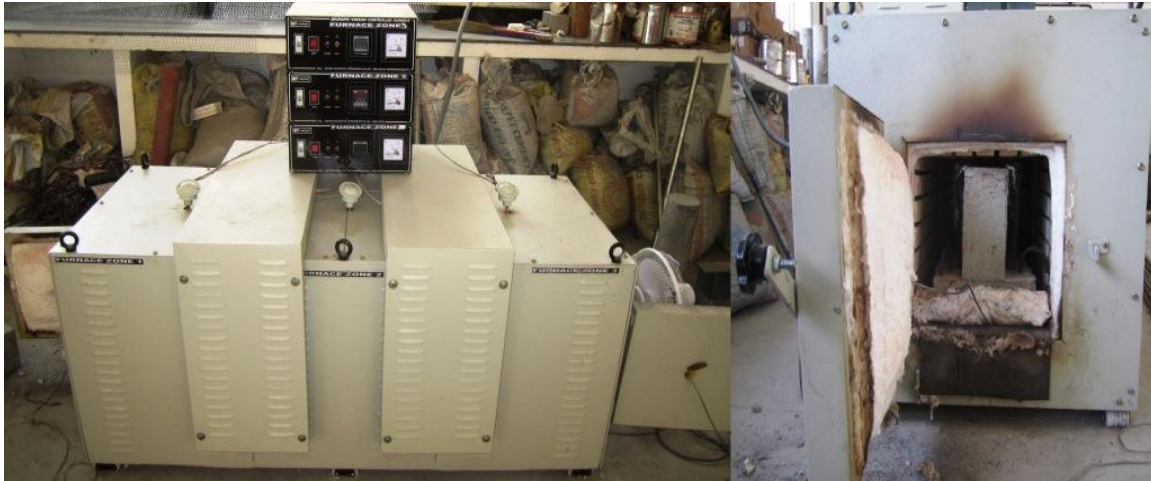
Fig. 4.4: A view of furnace and beam specimen

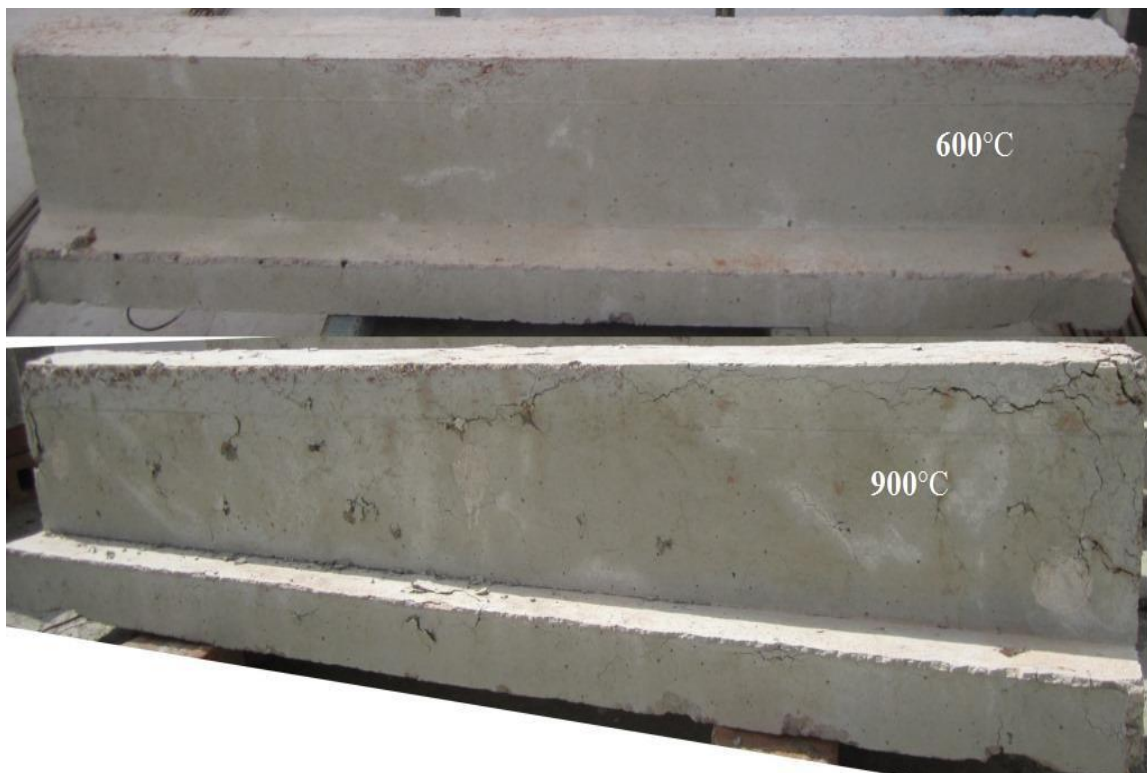
Fig. 4.6: Surface cracking observed in test specimens exposed to 600°C and 900 °C

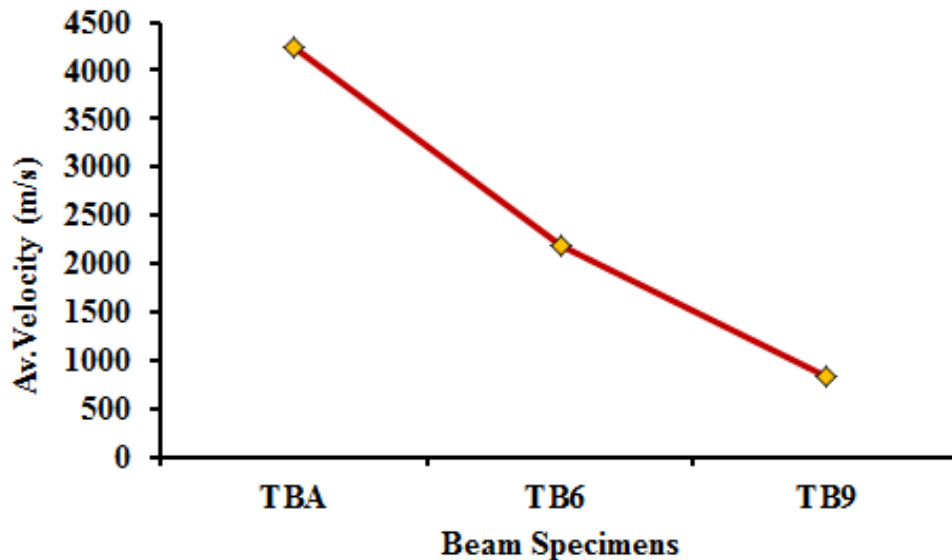
Fig. 4. 5: Average Ultrasonic pulse velocity in specimens before and after high temperature

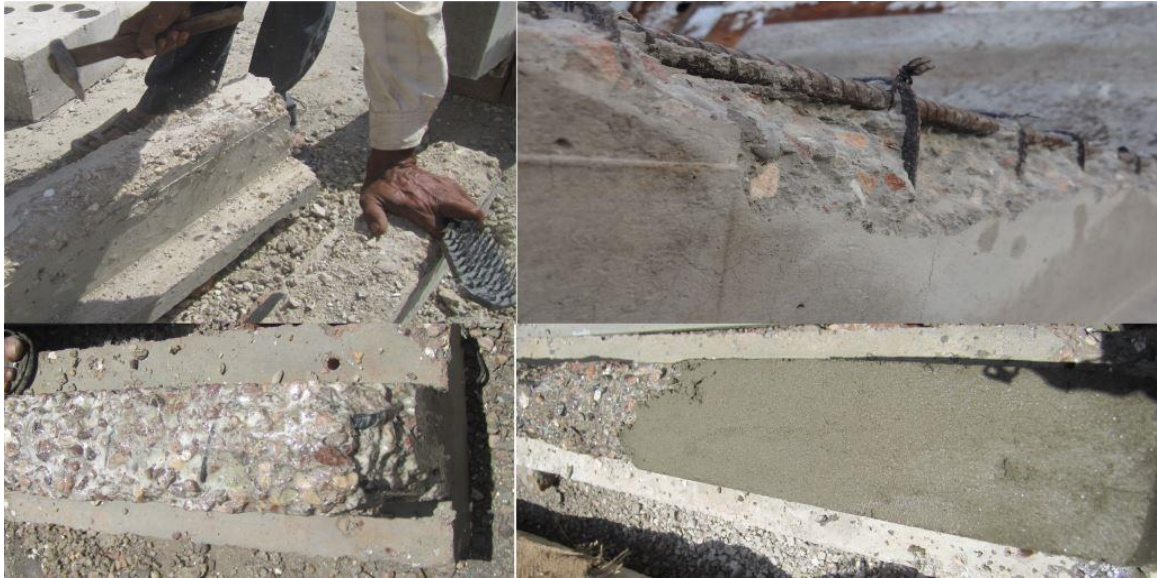
Fig. 4.6: Restoration process of beam elements

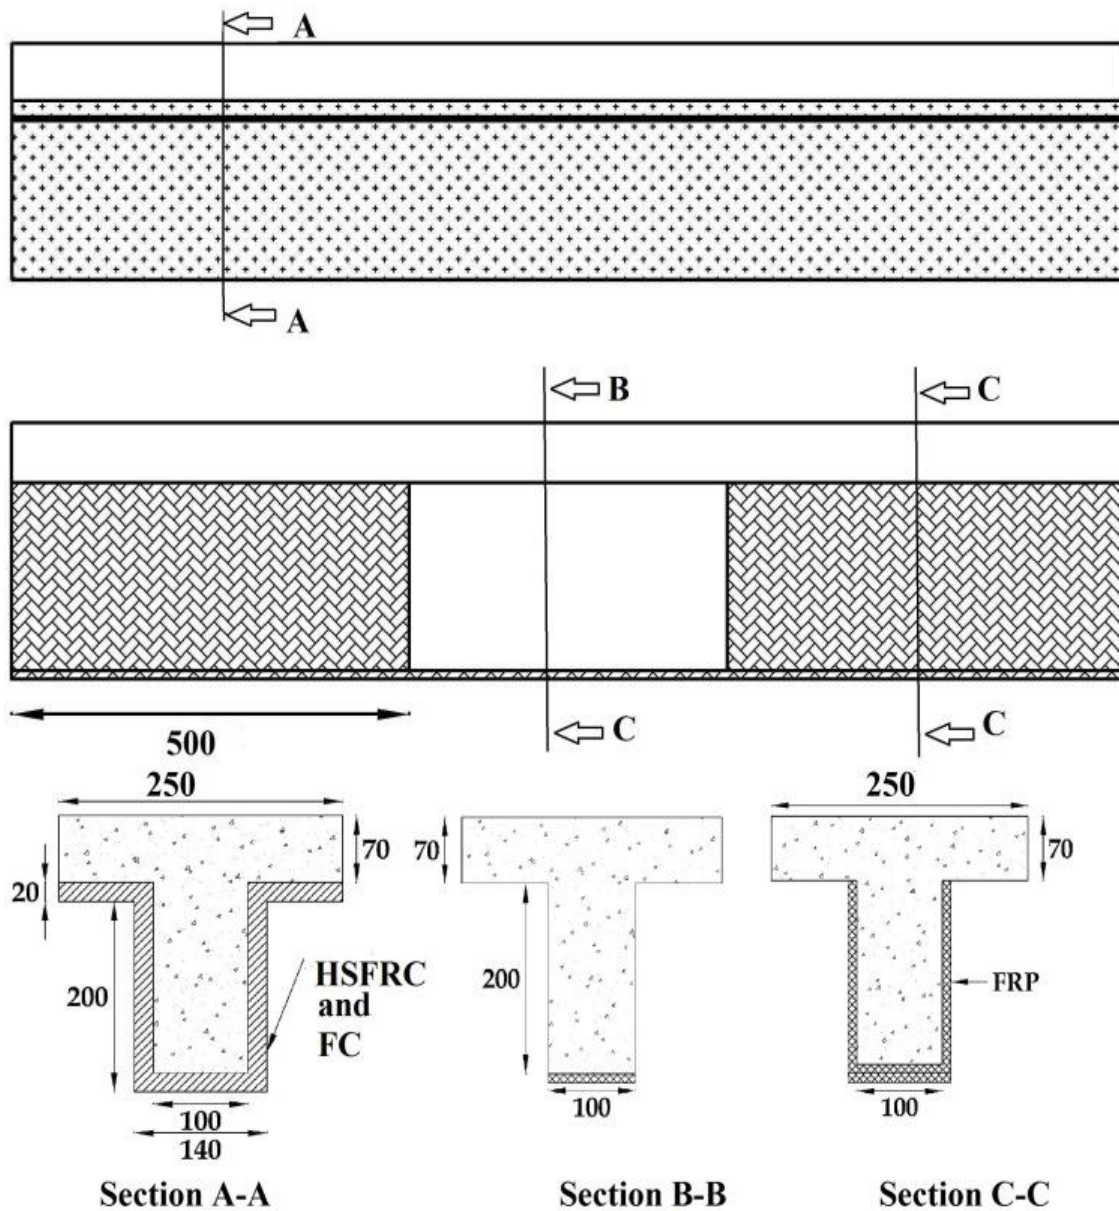
Fig. 4. 8: Strengthening schemes

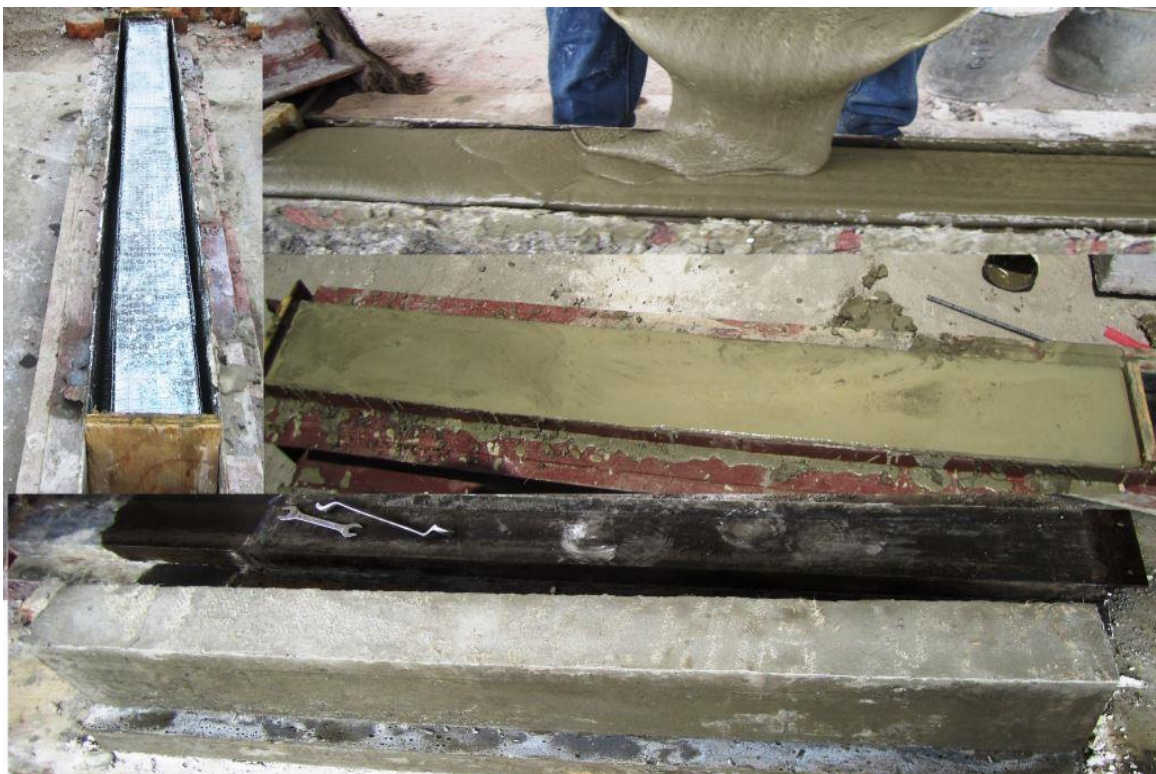
Fig. 4.9: HSFRC jacketing in progress

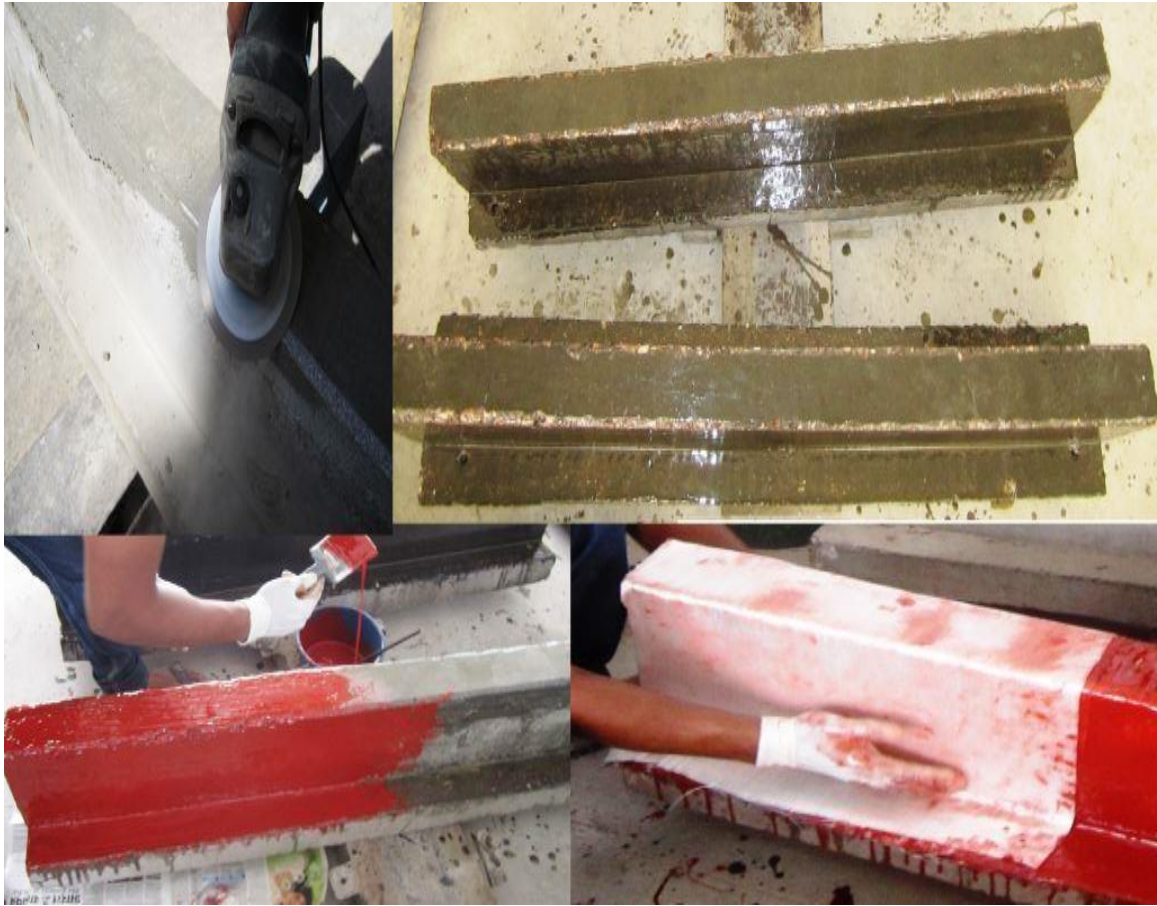
Fig. 4. 11: GFRP jacketing
