# **STRENGTHENING OF HEAT DAMAGED REINFORCED CONCRETE ELEMENTS**

**Ph.D. THESIS**

**DEPARTMENT OF CIVIL ENGINEERING  
INDIAN INSTITUTE OF TECHNOLOGY ROORKEE  
ROORKEE – 247 667 (INDIA)  
DECEMBER, 2014**

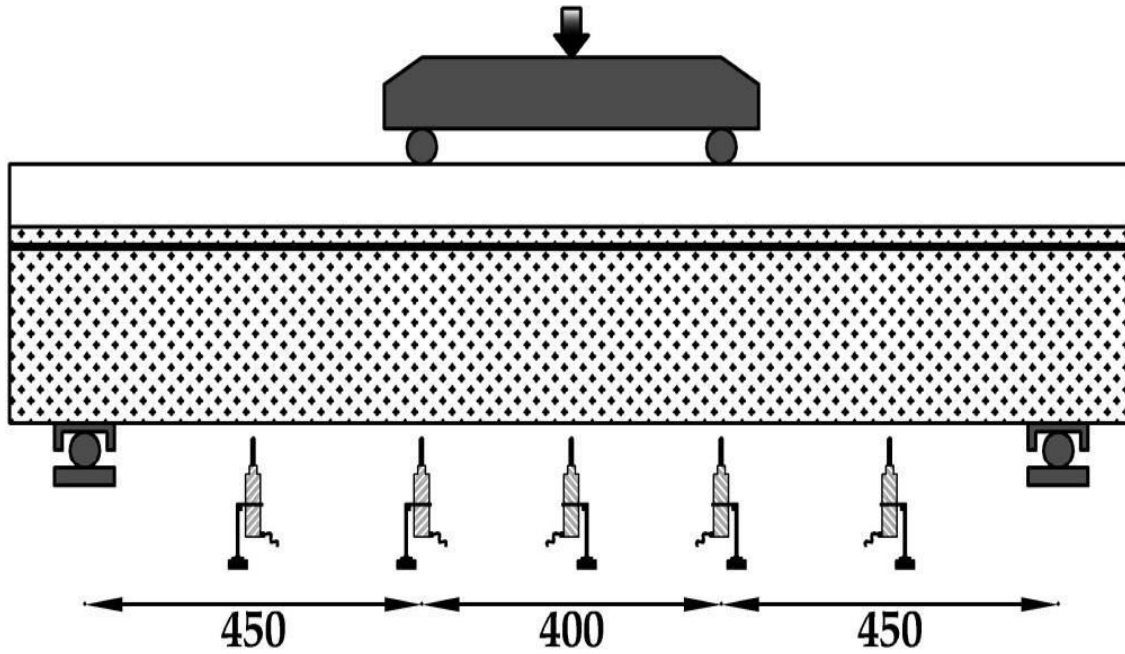
Fig. 4.12: Test setup

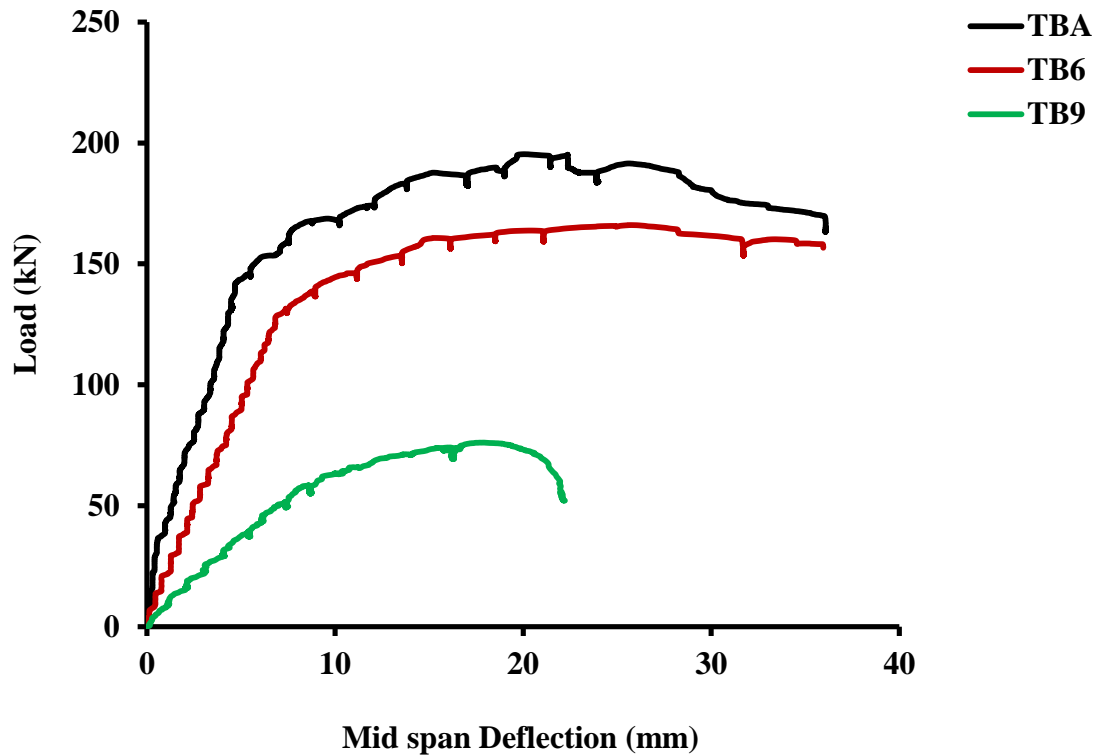
Fig. 4.13: Load–deflection relationships of control and heat-damaged specimens

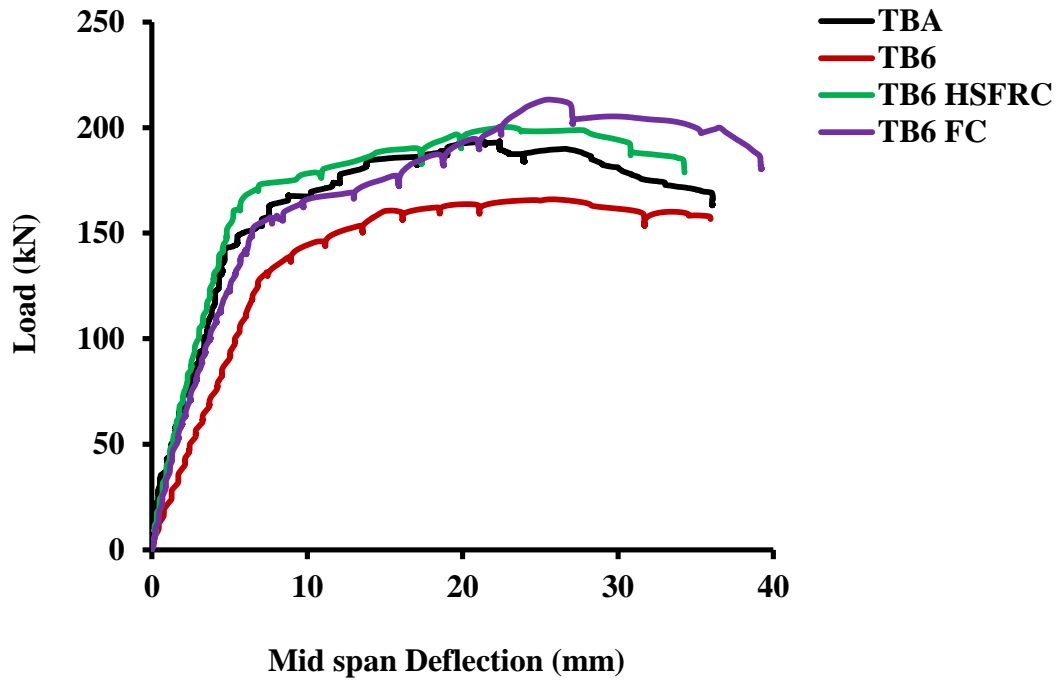
Fig. 4.14: Load–deflection relationships of un-strengthened and strengthened beams (FC and HSFRC) heated at 600° C temperature

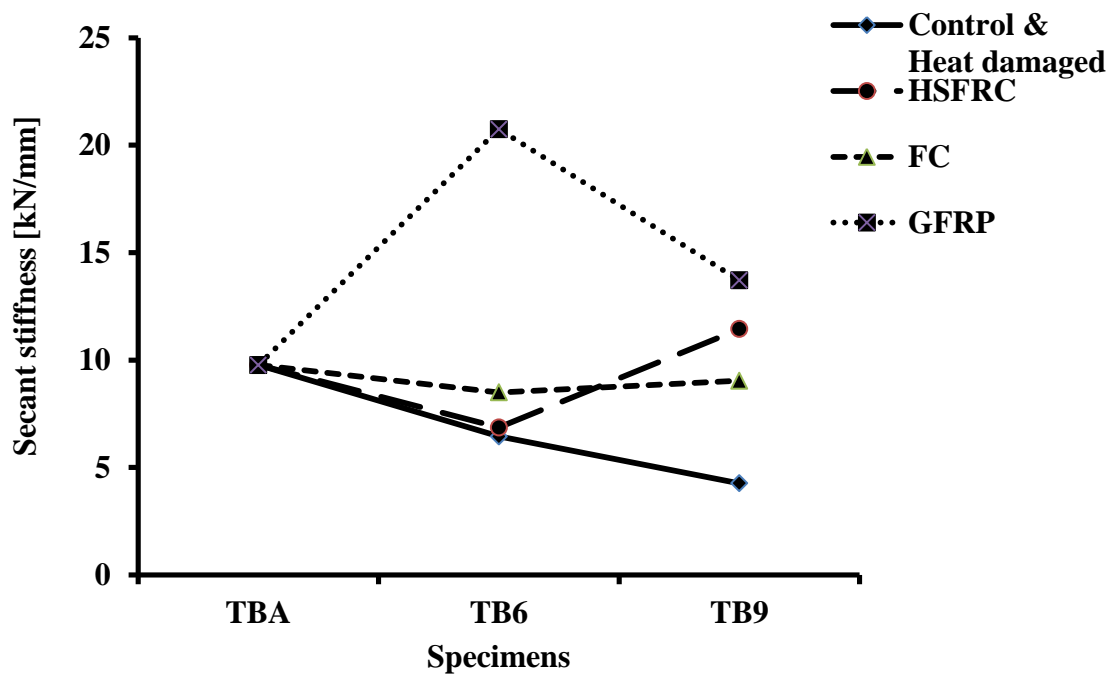
Fig. 4.18: Stiffness of beams

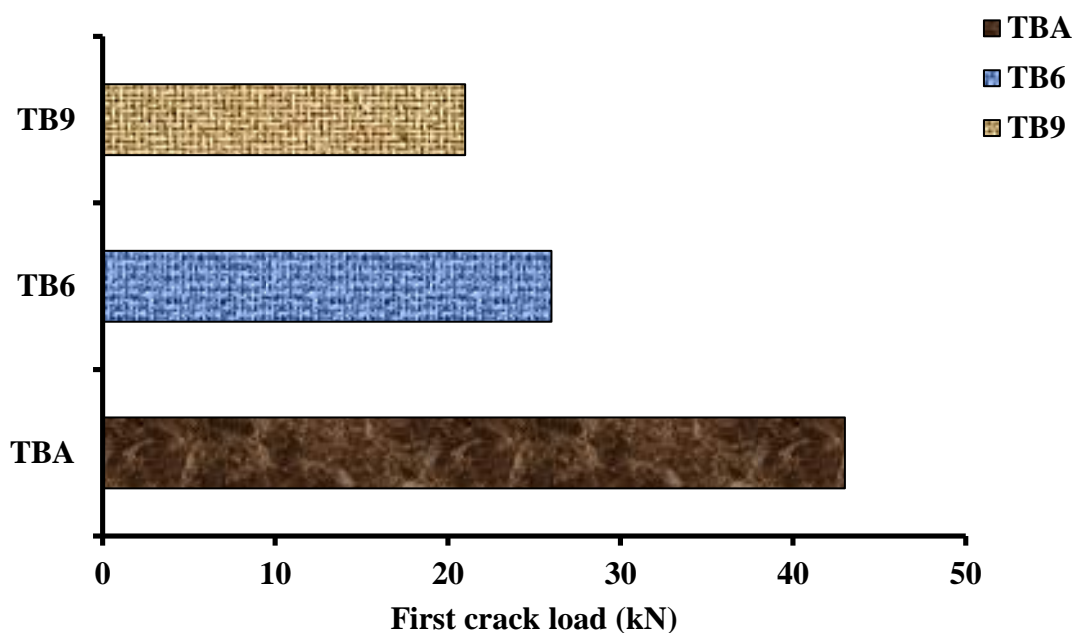
(a) Beams exposed to different temperatures

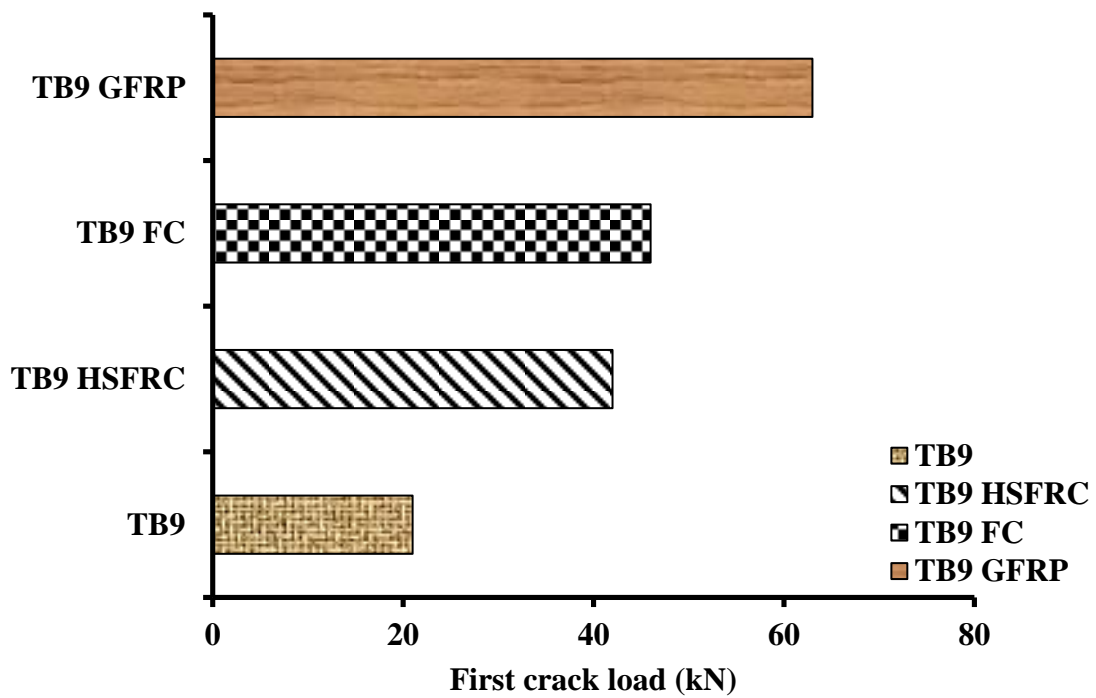
(c) Beams exposed to 900° C and then strengthened

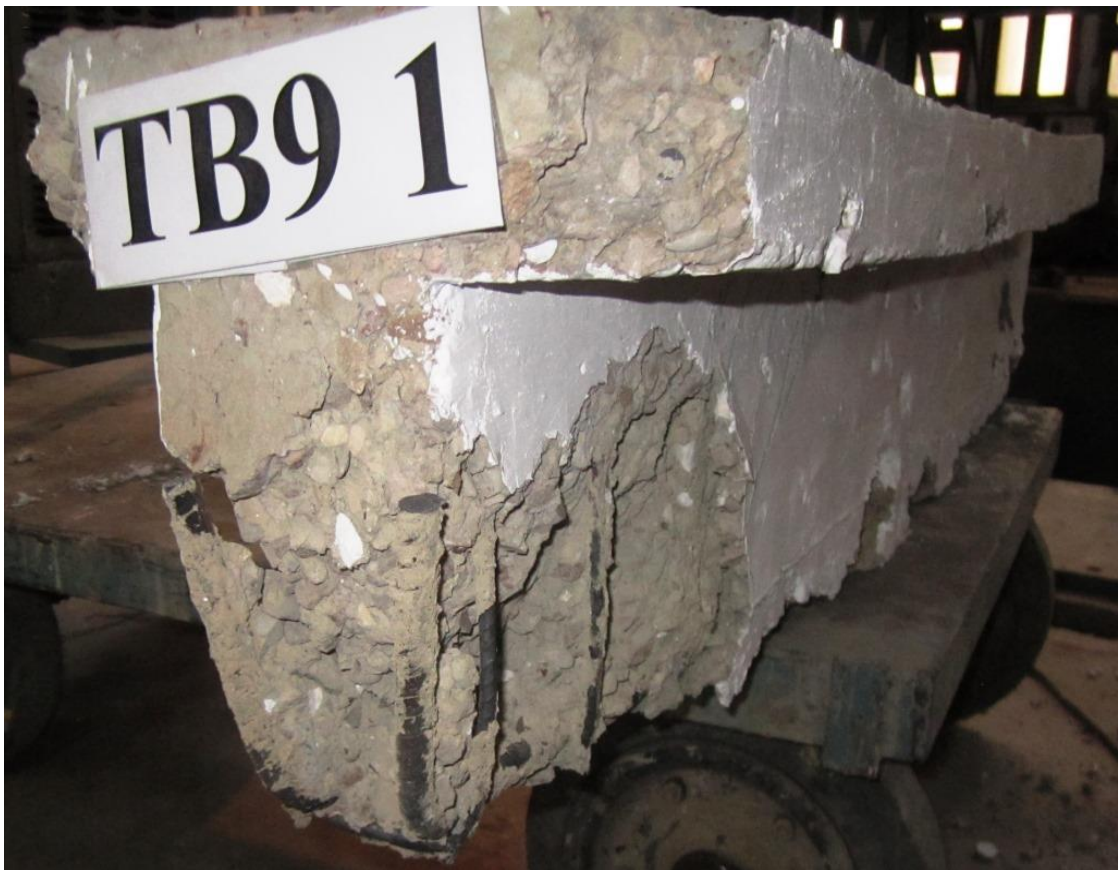
Fig. 4.22: Failure pattern of 900° C heat damaged beams

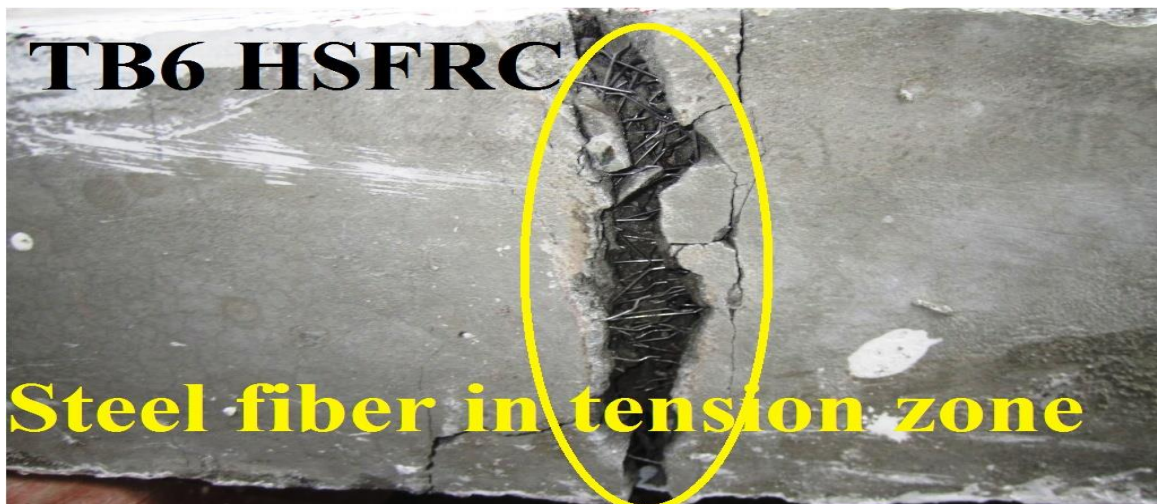
Fig. 4. 23: Failure pattern of 600° C and 900° C heat damaged beams strengthened with HSFRC

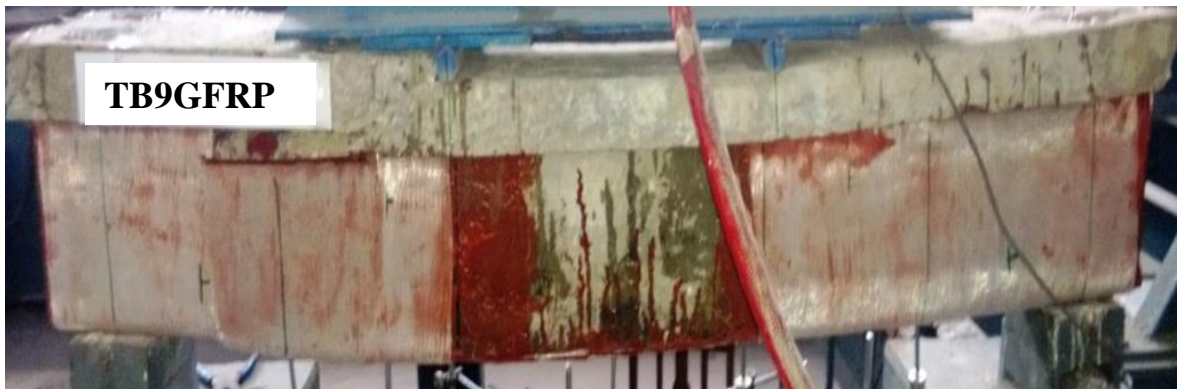
Fig. 4. 25: Failure pattern of 600° C and 900° C heat damaged beams strengthened with GFRP

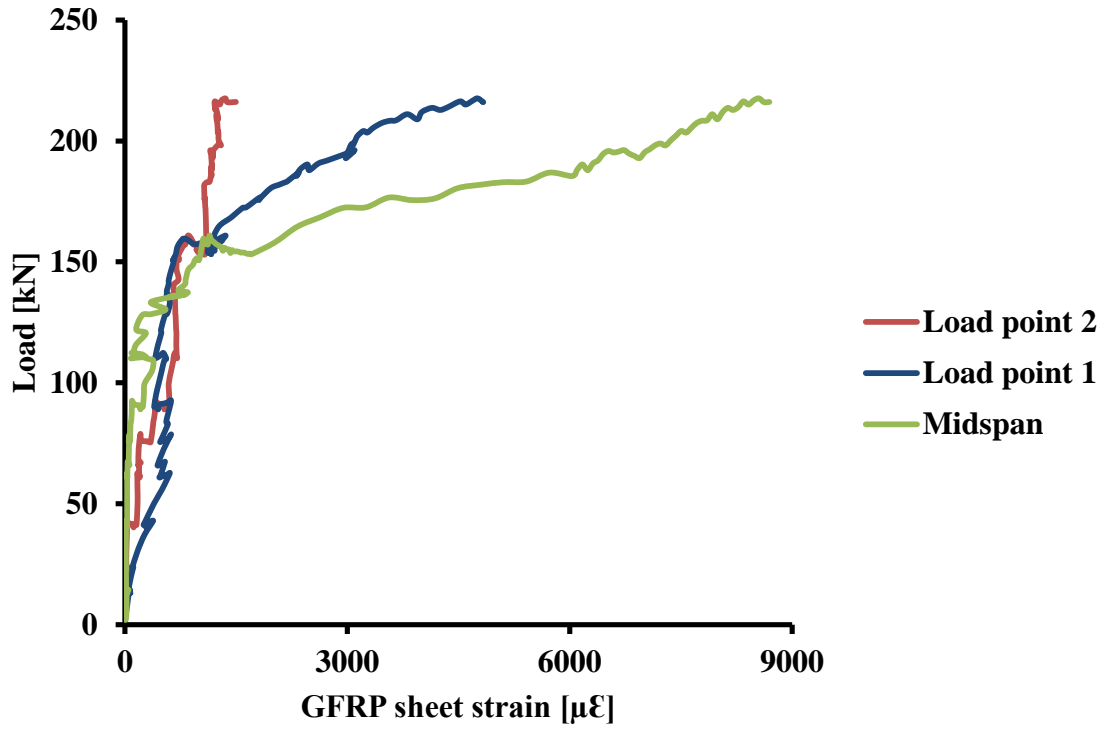
(a) Beams exposed to 600° C and strengthened with GFRP

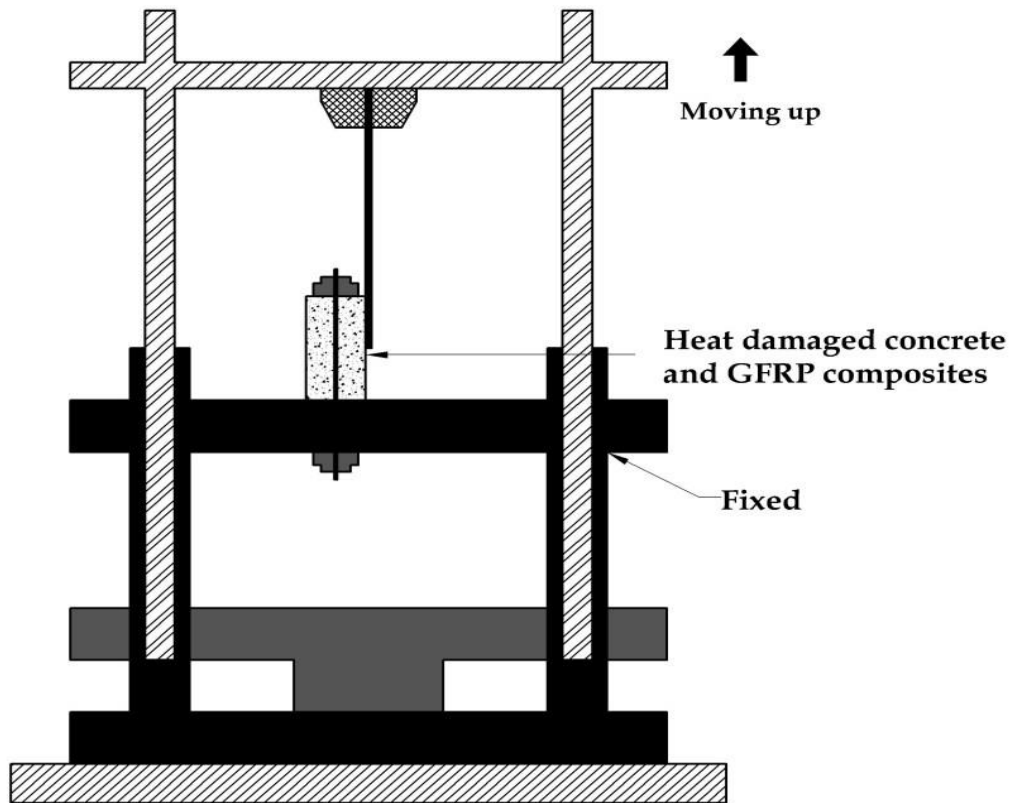
Fig. 5.1: Single shear test setup

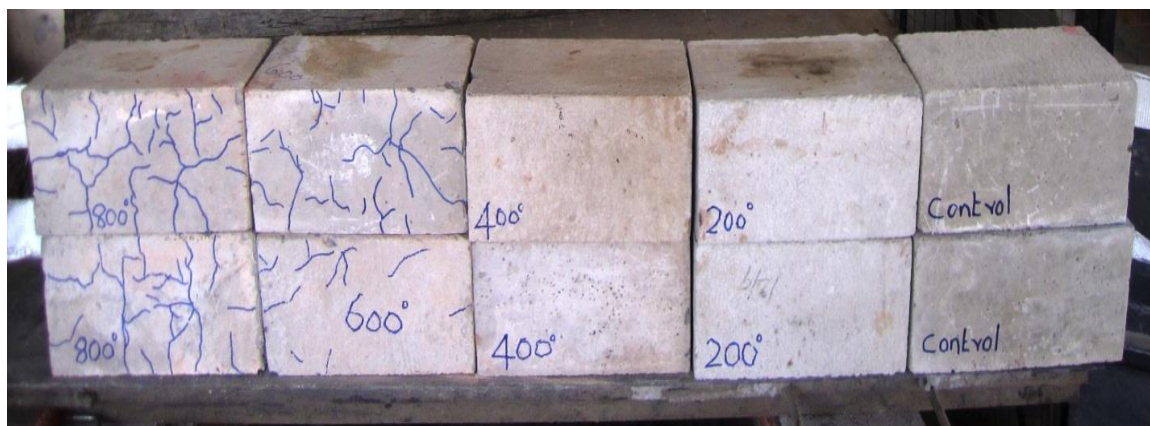
Fig. 5.3: Crack pattern in heated specimens

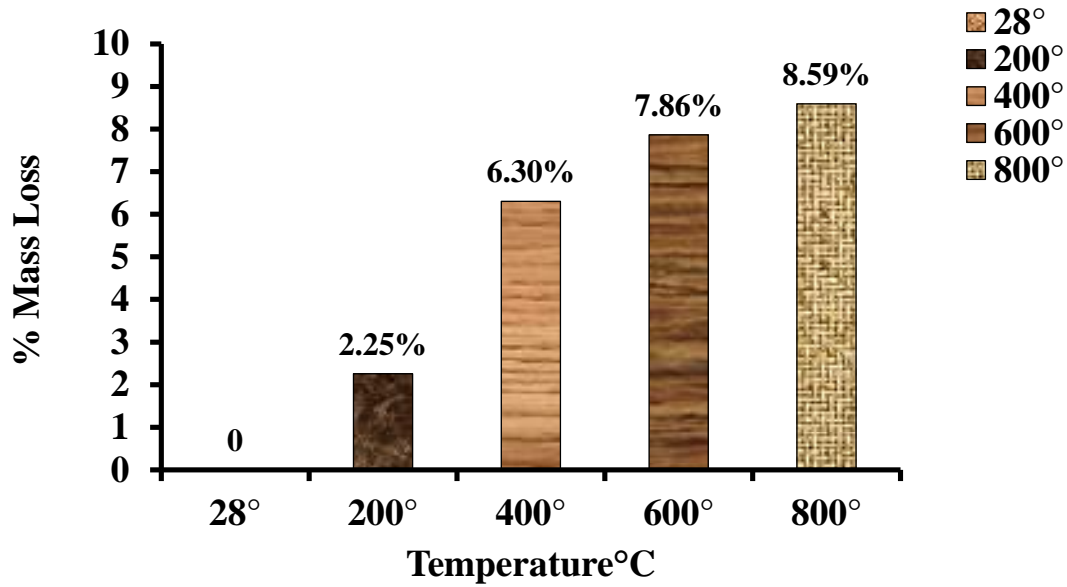
Fig. 5.3: Mass loss after high temperature exposure

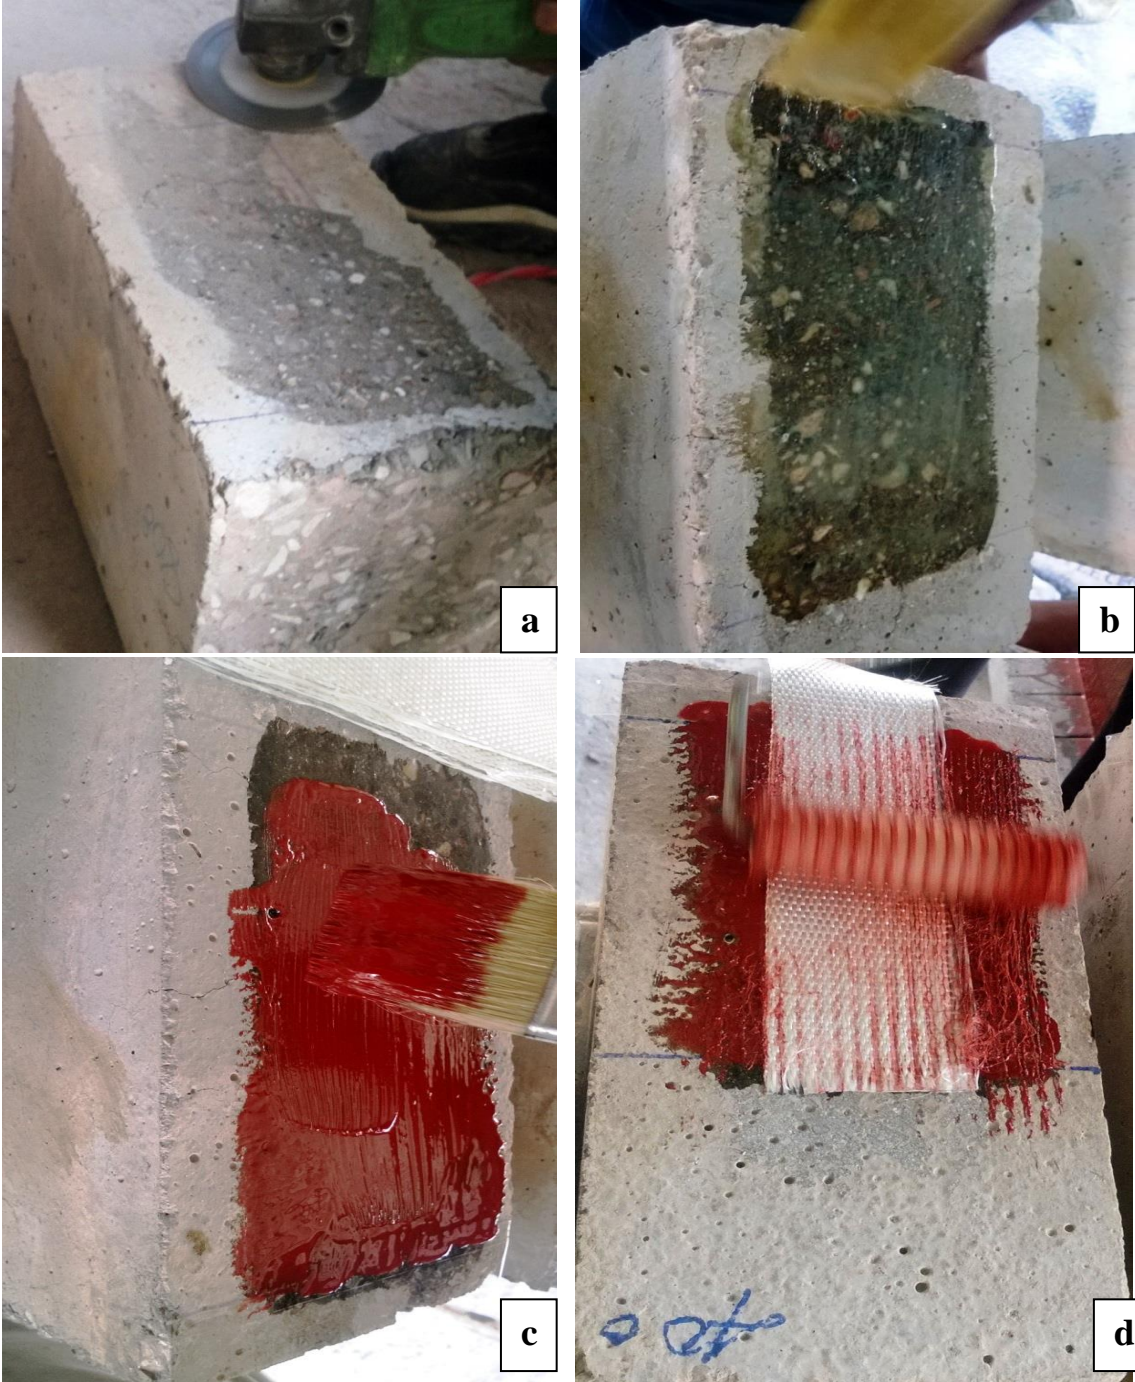
Fig. 5. 5(a-d): Process of bonding GFRP sheet to SST Specimens

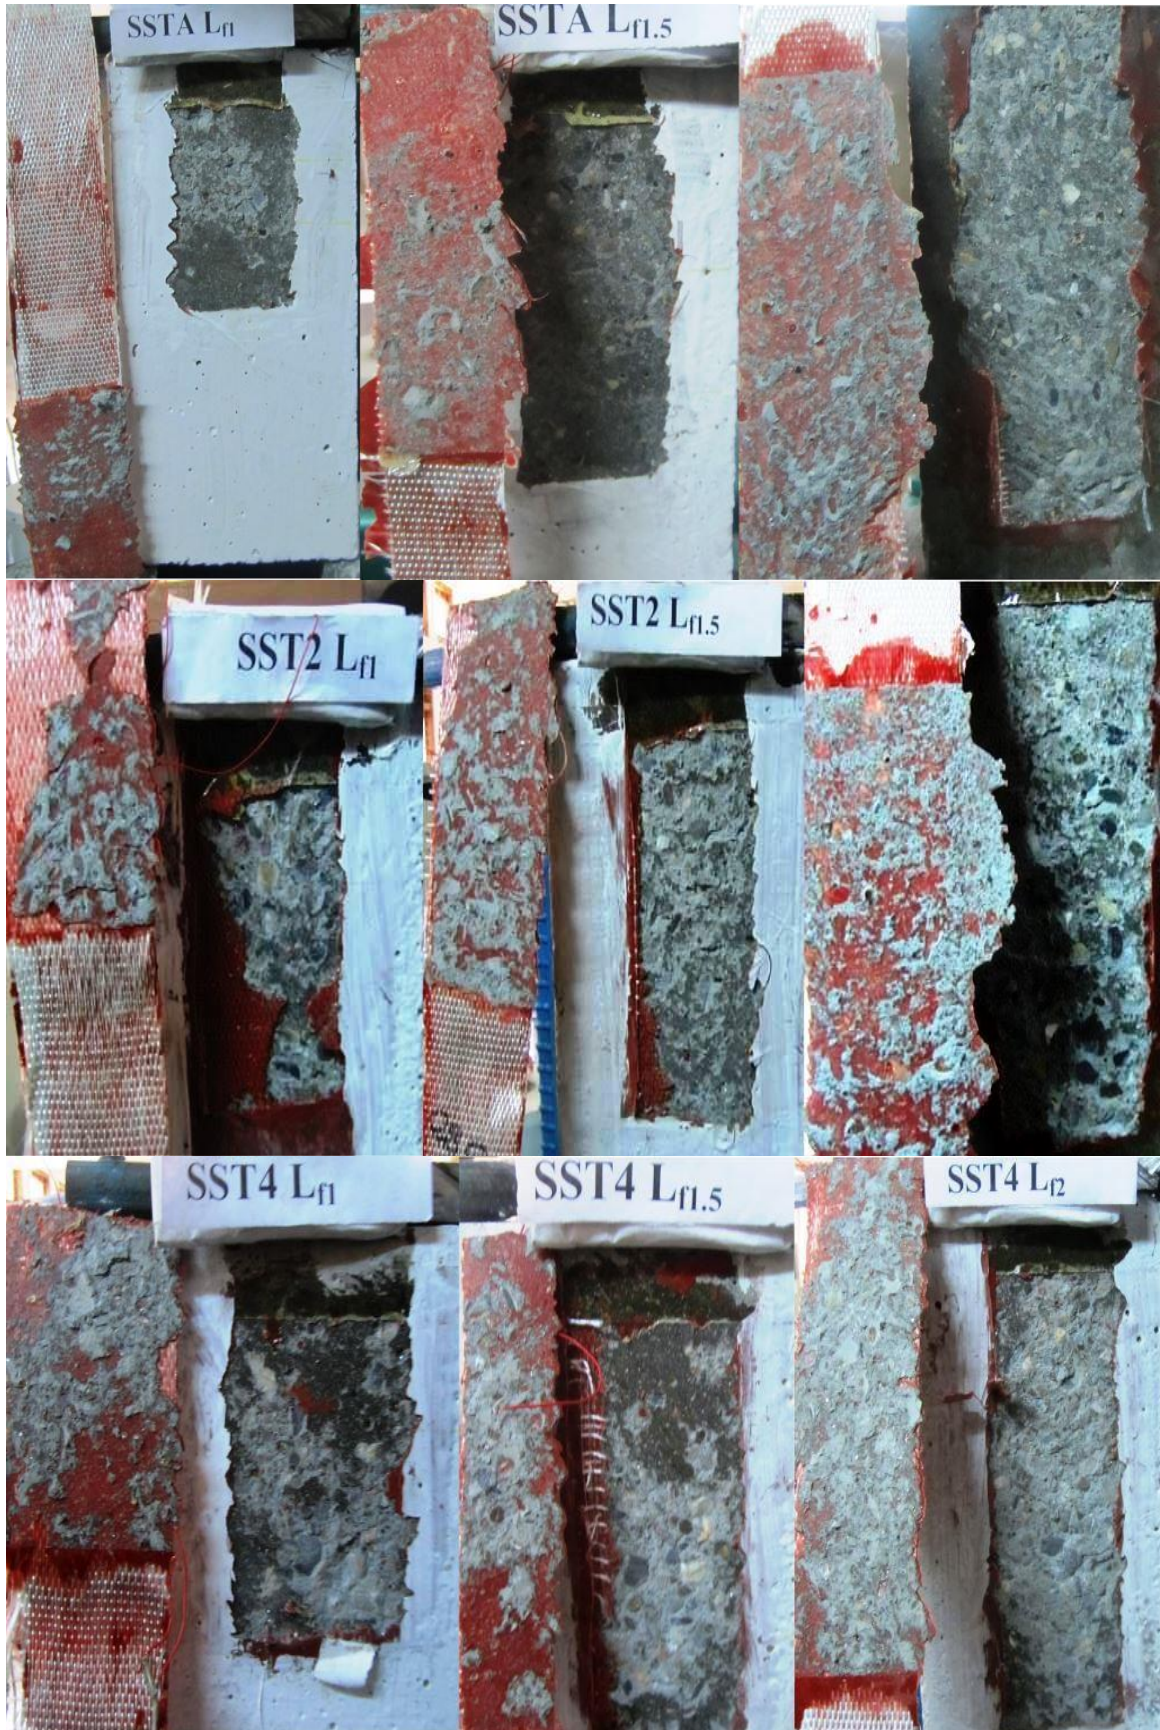
Fig. 5.10: Typical mode of failure of specimens with different bonded area/length (Cont)

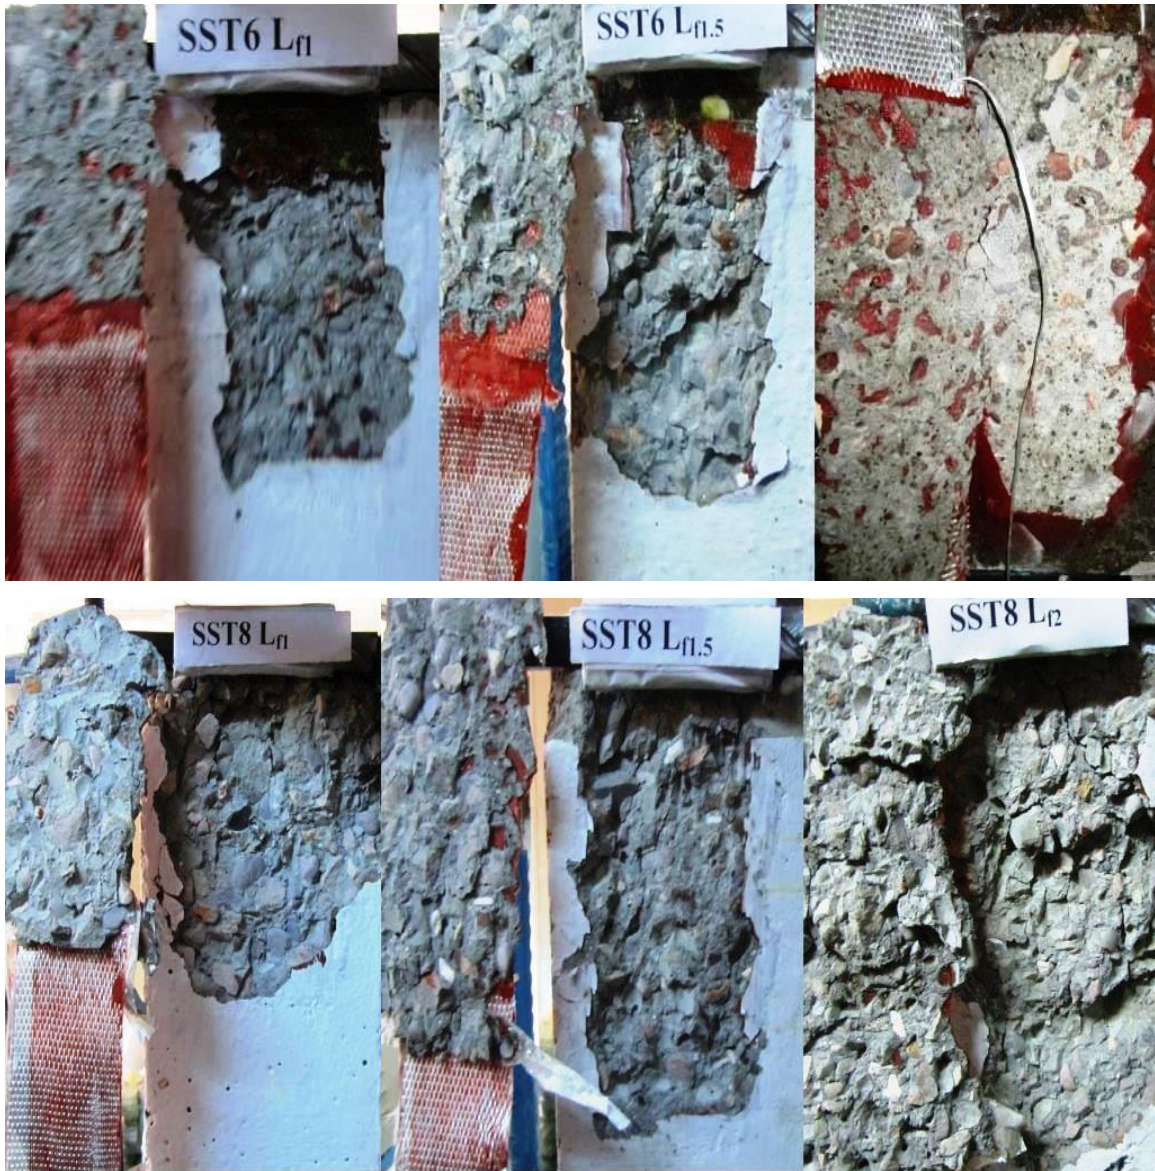
Fig. 5. 9: Typical mode of failure of specimens with different bonded area/ length

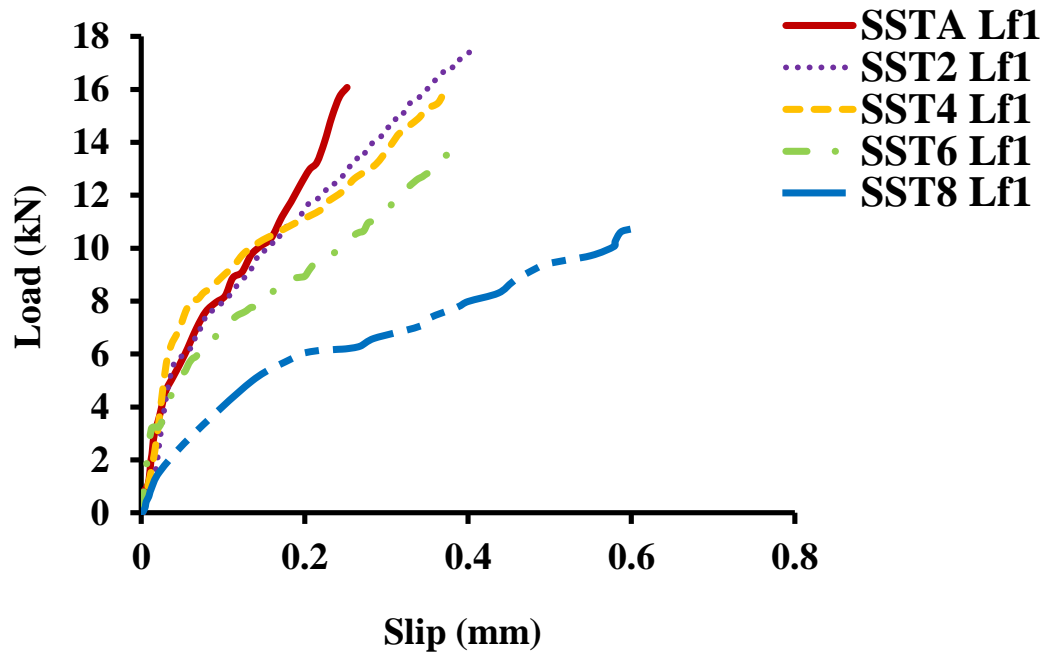
(a) Specimens exposed to different temperatures with  $L_f$  100mm

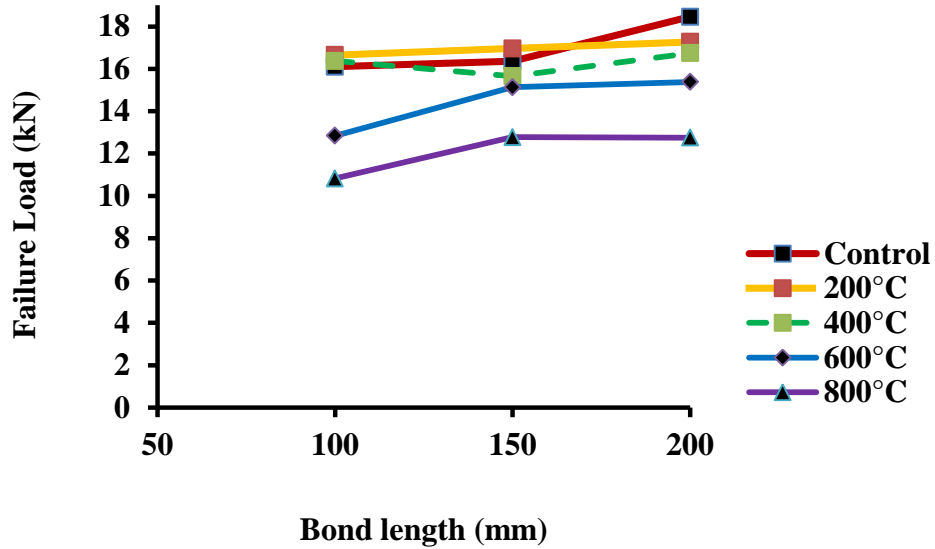
Fig. 5. 14: Effect of bond length
