AN EXPERIMENTAL INVESTIGATION OF FIRE PERFORMANCE OF EARTHQUAKE DAMAGED STRUCTURES

Ph.D. THESIS

**DEPARTMENT OF CIVIL ENGINEERING
INDIAN INSTITUTE OF TECHNOLOGY ROORKEE
ROORKEE-247667, UTTARAKHAND, INDIA**

SEPTEMBER, 2015

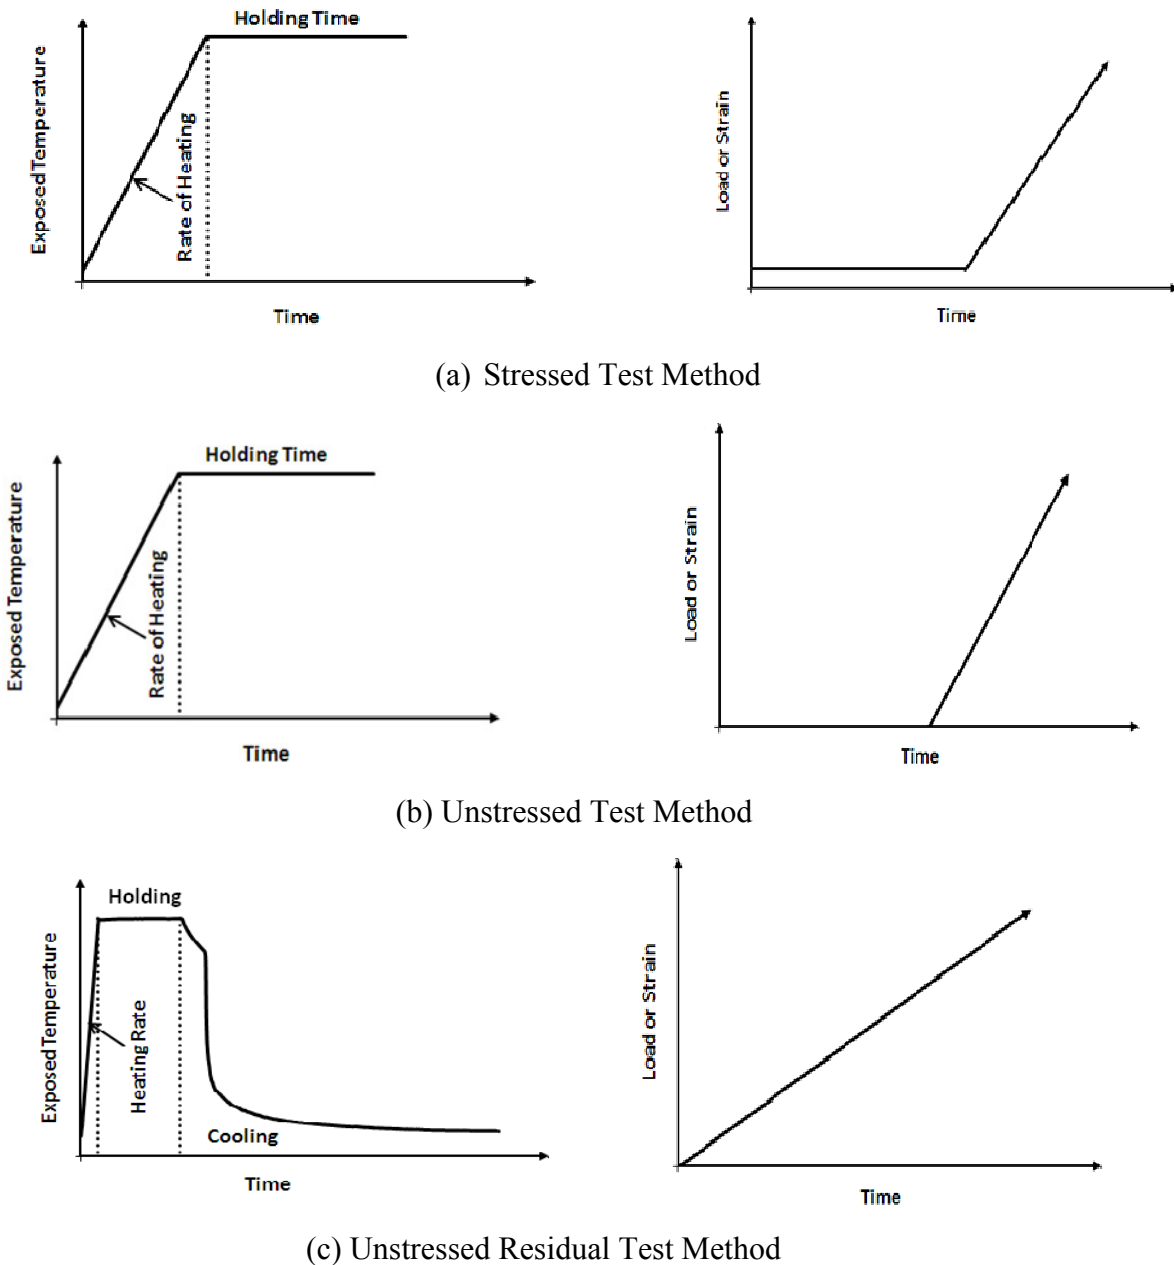
Fig. 1.2 - Schematic of temperature and loading histories for the test methods in uni-axial compression (Phan 1996)

The test methods mentioned by Phan (1996) may be used to determine the compressive strength (the maximum stress), the modulus of elasticity and the strain at the maximum stress as function of temperatures. The test results of Abrams (1971) indicate that compressive strengths of specimens with preload (stressed tests) were generally 5 percent to 25 percent higher than those without preload (unstressed tests), with the reasoning that the preload helps to close existing cracks in concrete. Abrams (1971) has also reported that the unstressed residual specimens had the lowest strength compared to the stressed and unstressed specimens tested after exposure to elevated temperature. This is because the cooling of concrete actually generates very significant damage in

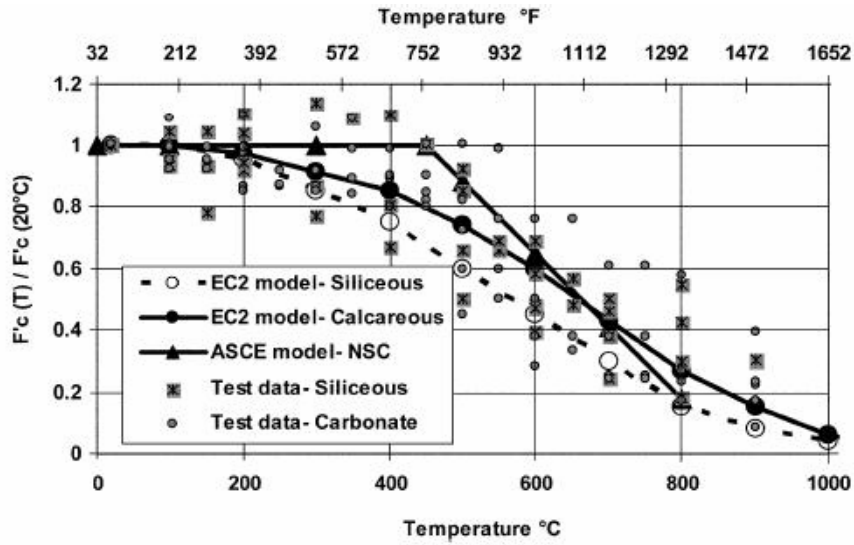
Fig. 1.3 - High temperature models for NSC concrete (Kodur et al. 2008)

concrete as shown recently by Lee et al. (2008). Figs. 1.3 and 1.4 compare test data on NSC and HSC tested under hot conditions with the predictions of Eurocode EC 2 (ENV 1992-1-2 1995) for siliceous and carbonate concretes whereas, there is no degradation of the compressive strength up to 100 °C in the case of normal strength concrete. Fig. 1.4 shows an early reduction of compressive strength to 75 % when high strength concrete was tested at 100 °C. Morita et al. (1992) showed that high strength concrete has higher rate of reduction in residual compressive strength.

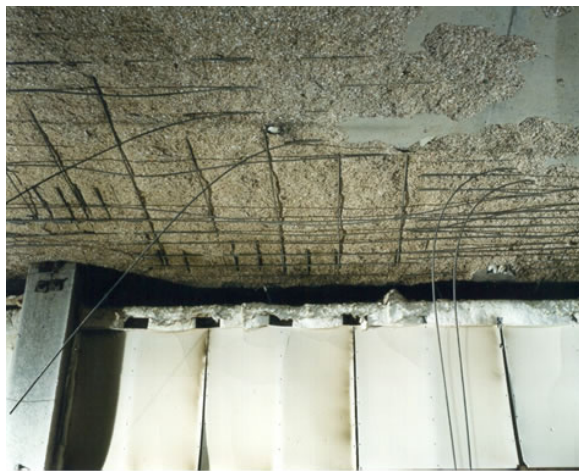
Fig. 1.9 - Picture showing extent of spalling of roof slab (Bailey 2002)

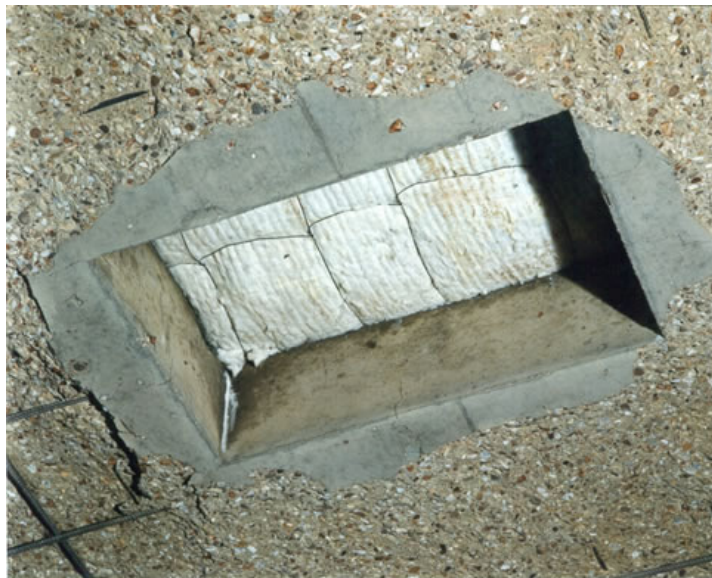
Fig. 1.10 - Picture showing spalling around service hole (Bailey 2002)

since no spalling occurred where the compressive stresses got reduced along the edges of the hole. Although concrete spalling considerably reduced the flexural strength of the slab, collapse did not take place. This could be attributed to the behavior of slab in compressive membrane action. This test also presented significant lateral displacement of external columns because of thermal expansion of the heated slab as illustrated in Fig. 1.11. The results obtained in this Cardington test were used to provide input data for a finite element model which made large number of assumptions regarding the performance of concrete in fire (viz. the effects of spalling were neglected) (Canisius et al. 2003). Further study of the effects of fire on full-scale buildings is highly desirable and will yield valuable data which can be used for the calibration of numerical models.

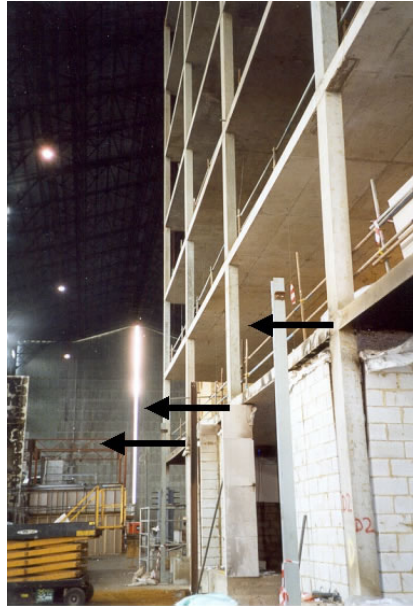
Fig. 1.11 - Picture showing lateral displacement of external columns (Bailey 2002)

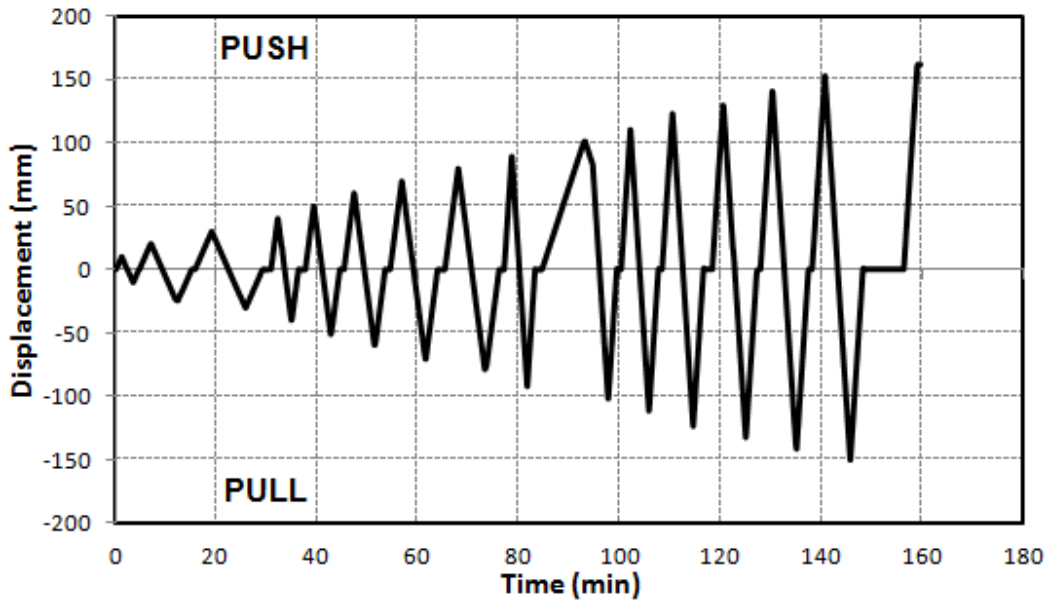
Fig.2.14: Displacement- time history of the frame

Fig. 2.14 shows the load time history of the test frame while Fig. 2.15 shows the displacement time history. After achieving the target displacement in each cycle, the load was maintained and the distress mapping was carried out by marking the crack orientation, crack growth and the crack widths on the different elements of the test frame.

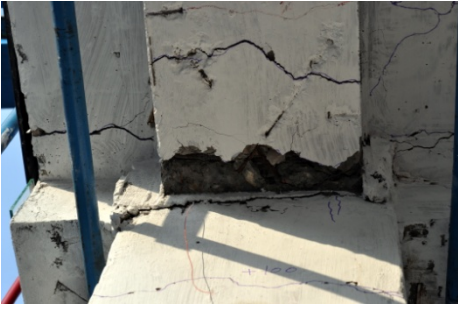
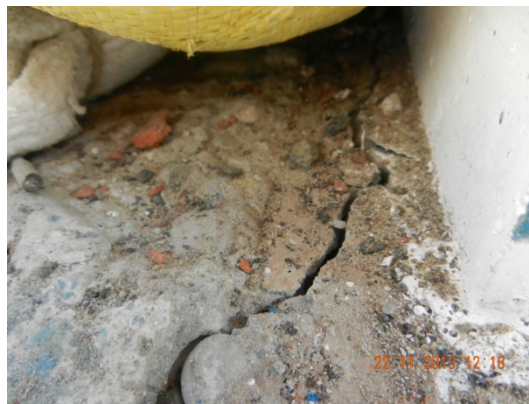
After the seismic loading a detailed distress mapping was carried in all the structural elements of the RC test frame assemblage. Figure 2.17 shows the damage induced in the members of the frame. It was observed that the beams, (plinth as well as the roof) B2, B4, B6 and B8, perpendicular to the loading were not damaged as expected. However, the columns, slab and the beams parallel to the seismic loading direction were observed to have undergone extensive damage in terms of cracks and the concrete cover spalling. The roof beam B5 near column C1 had undergone extensive spalling with a spalled chunk of 230 mm × 60 mm × 16 mm being registered resulting in the exposure of the underlying reinforcing rebars (Figure 2.17 a). A 3 mm wide crack was measured throughout the cross section of the beam at 160 mm from the face of the column C1, which made its influence into the slab span also. A shear crack was observed with a width of 3.6-4 mm which traversed through the span of the slab at a distance of 60 mm from the face of beam B8 and converged with the shear cracks of the beam B7 which was symmetrically opposite to the beam B8. Another crack 1.5 mm wide was measured which started as an offshoot of shear crack of beam B5 and traversed the span of the slab at a distance of 300 mm from the face of beam B8 and terminated by joining the shear crack of the beam B7.

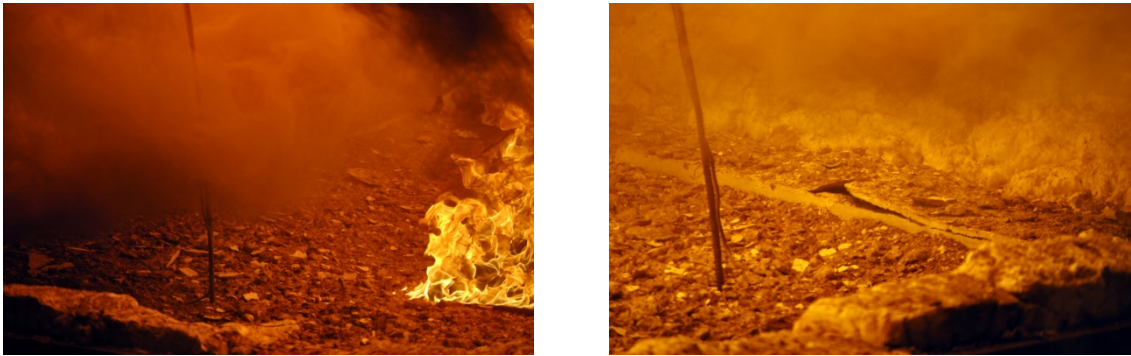
Fig.2.39: Spalled concrete from the elements of the frame during fire

The different elements of the RC frame assemblage began to spall within 3 minutes of the fire test. The slab experienced spalling accompanied with intense bullet shot sound heard at 5 minutes. The spalling was quite intense at 6 minutes which corresponded to the compartment temperature of about 1100 °C. Spalling occurred throughout the first 30 minutes of the fire with clear marked sound of spalling being heard at 6, 8, 12, 14 and 16 minutes after the ignition. The floor of the compartment got filled with the spalled concrete pieces during the fire as shown in Fig.2.39. It was also observed during the fire that the gravity loads on columns C1 and C2, which was applied through the hydraulic jacks kept atop the columns, increased from 10 ton to a maximum of 13 ton at 7 minutes after ignition.

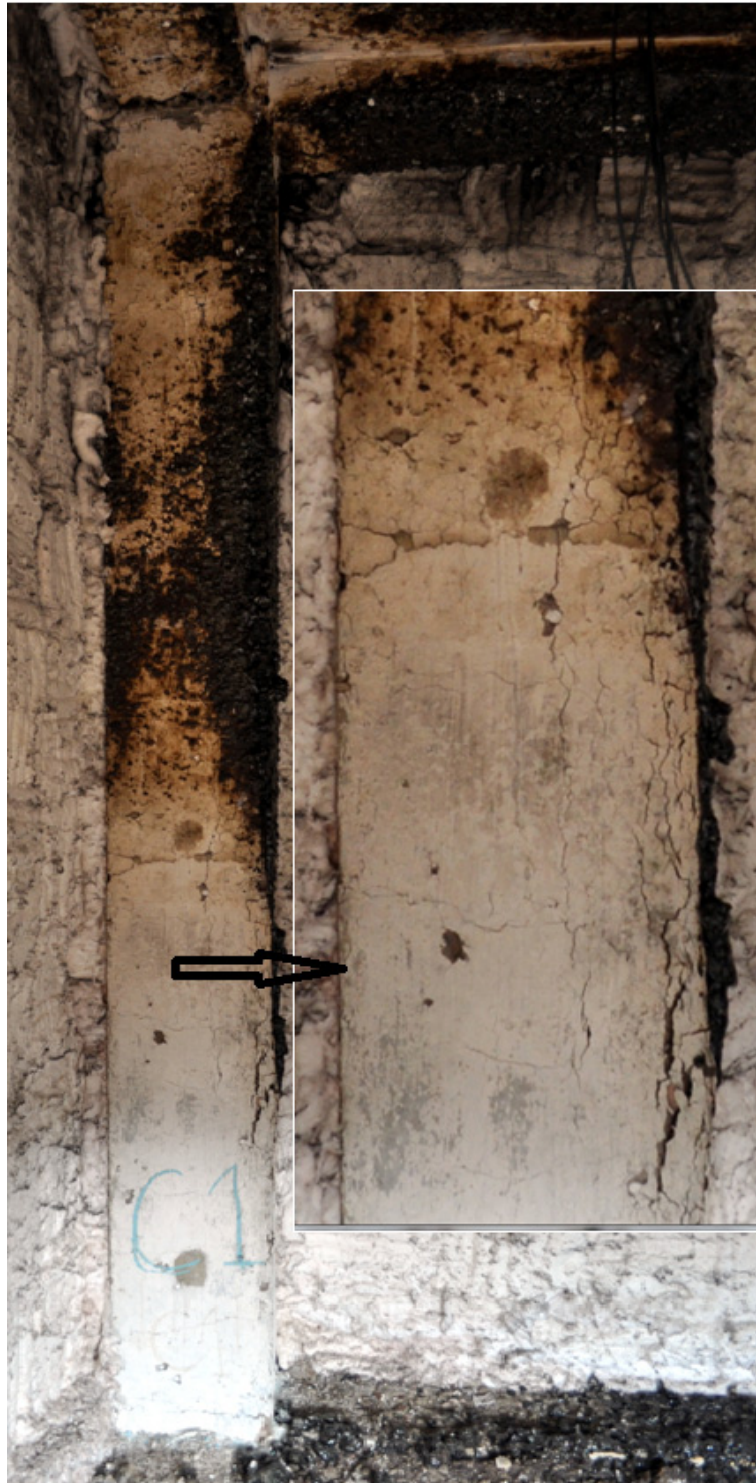
Fig. 2.40: Fire damage in Column C1

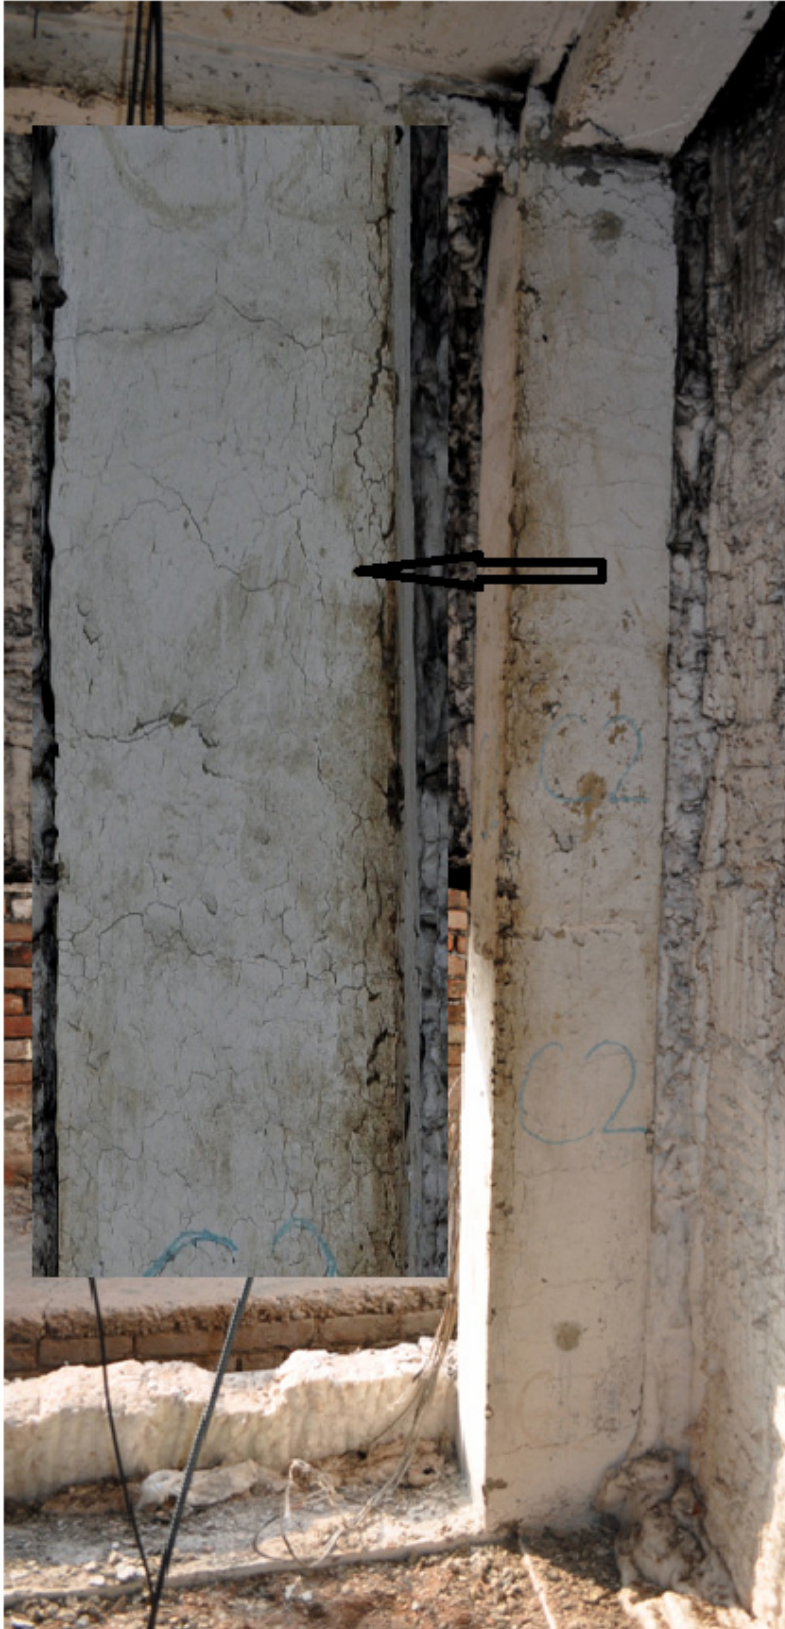
Fig. 2.41: Fire damage in Column C2

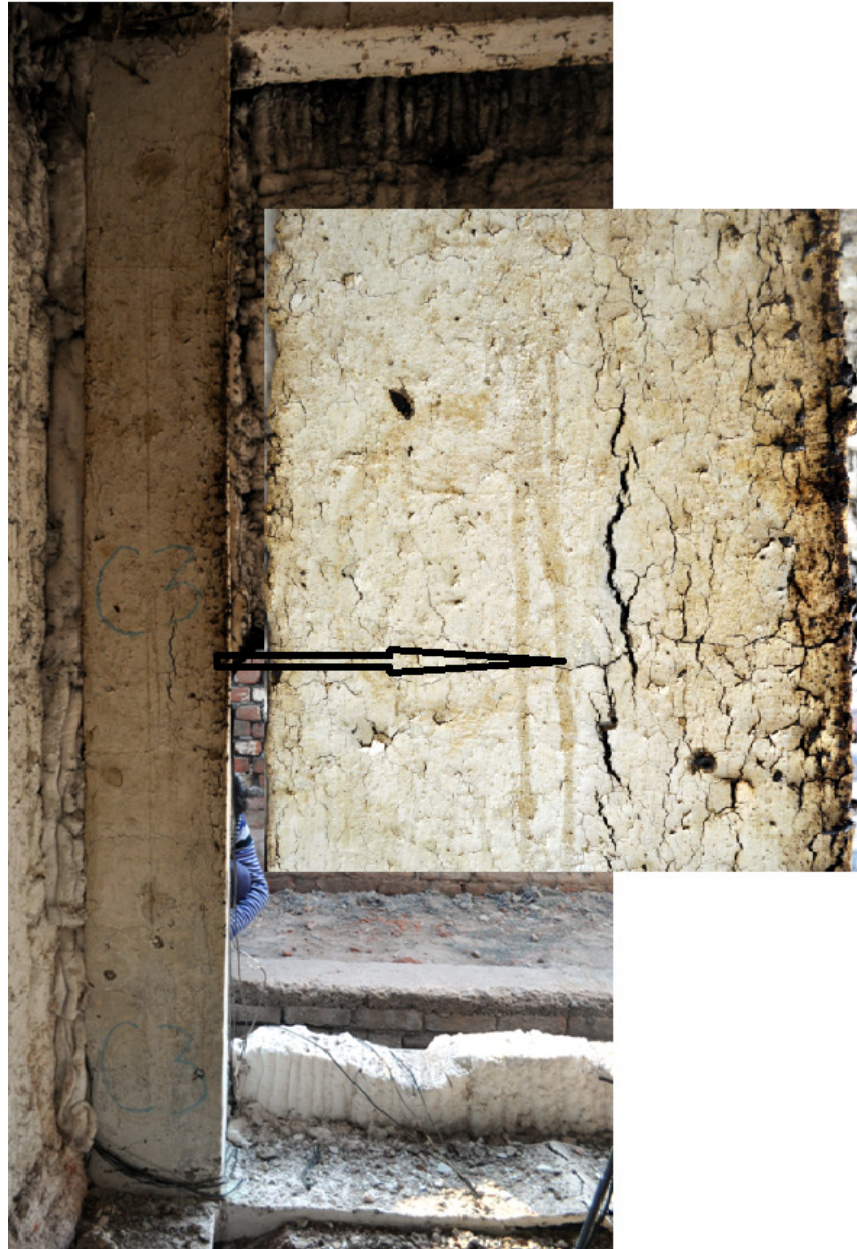
Fig.2.42: Fire damage in Column C3

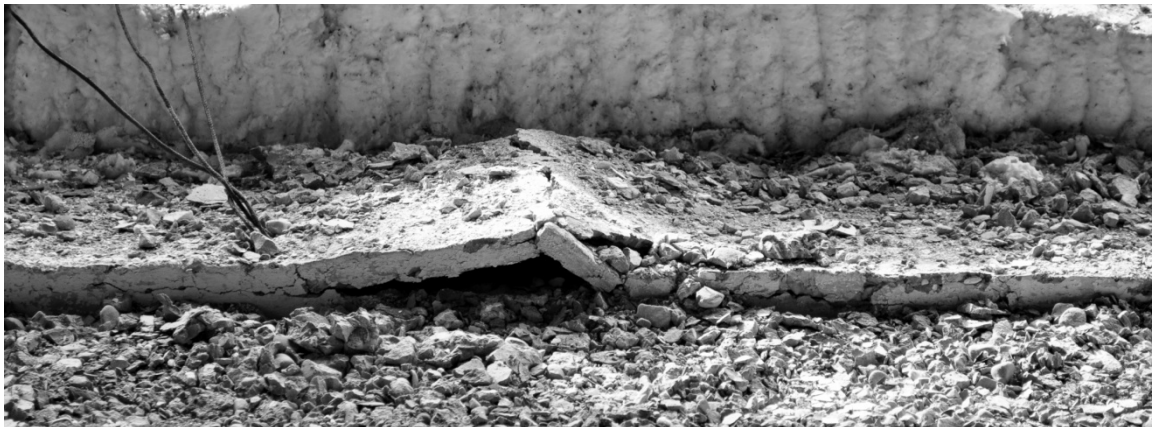
Fig.2.43: Delamination of concrete cover in beam B2

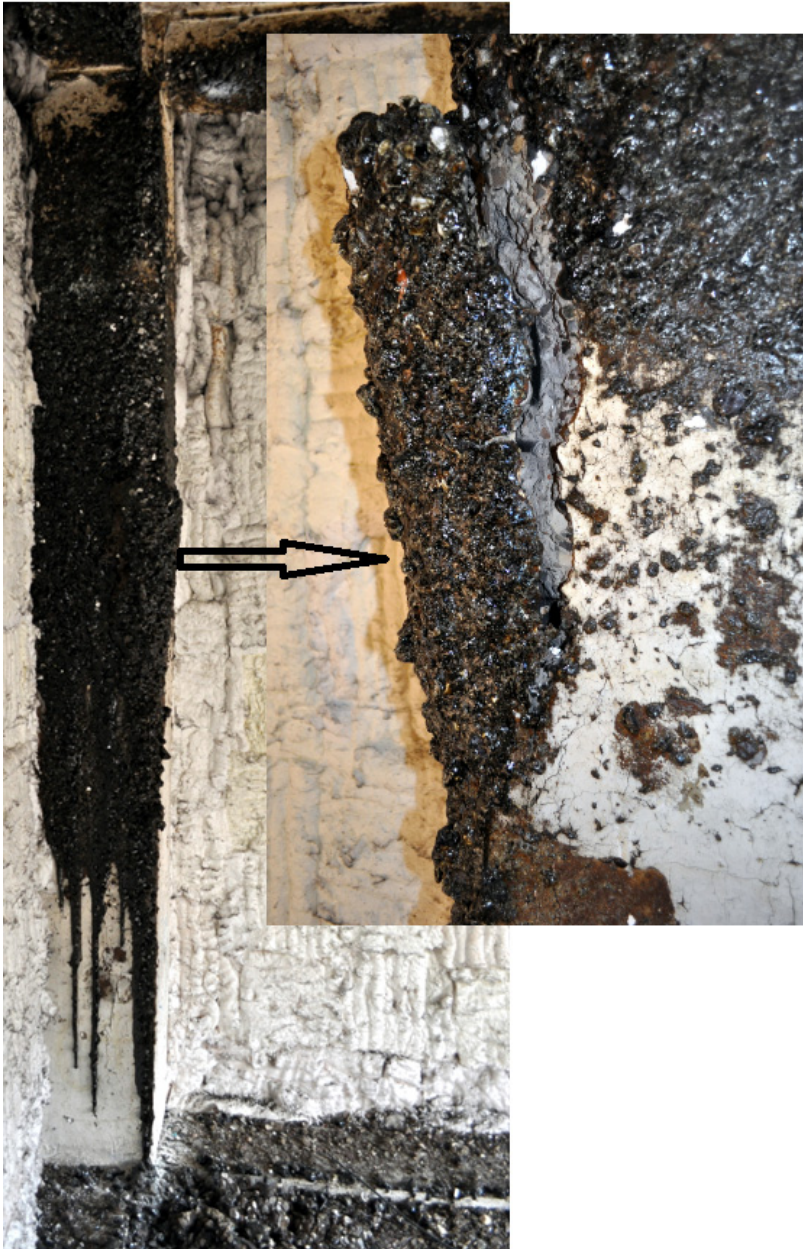
Fig.2.44: Fire damage in Column C4

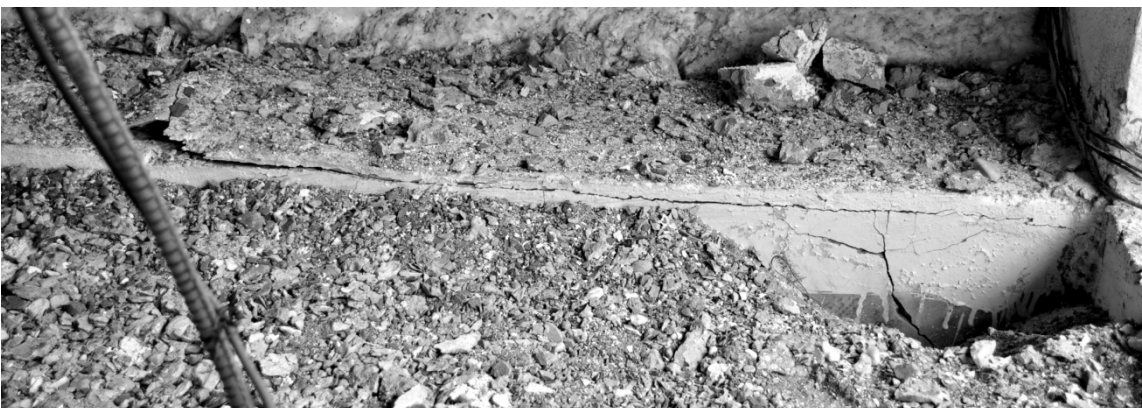
Fig.2.45: The delamination of the cover concrete in Beam B3

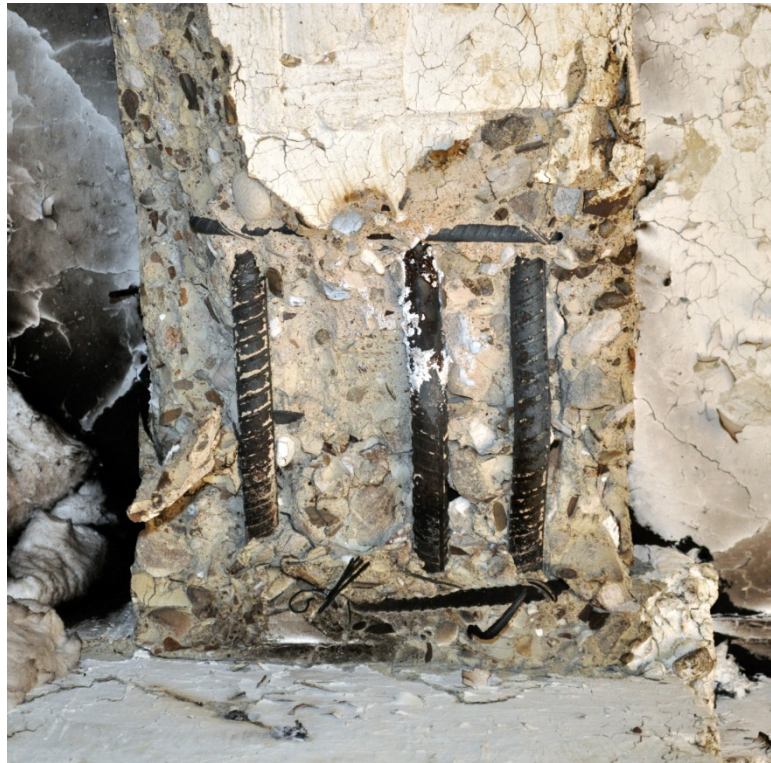
Fig. 2.47: Buckled reinforcement bars (Beam B7) exposed to direct flame

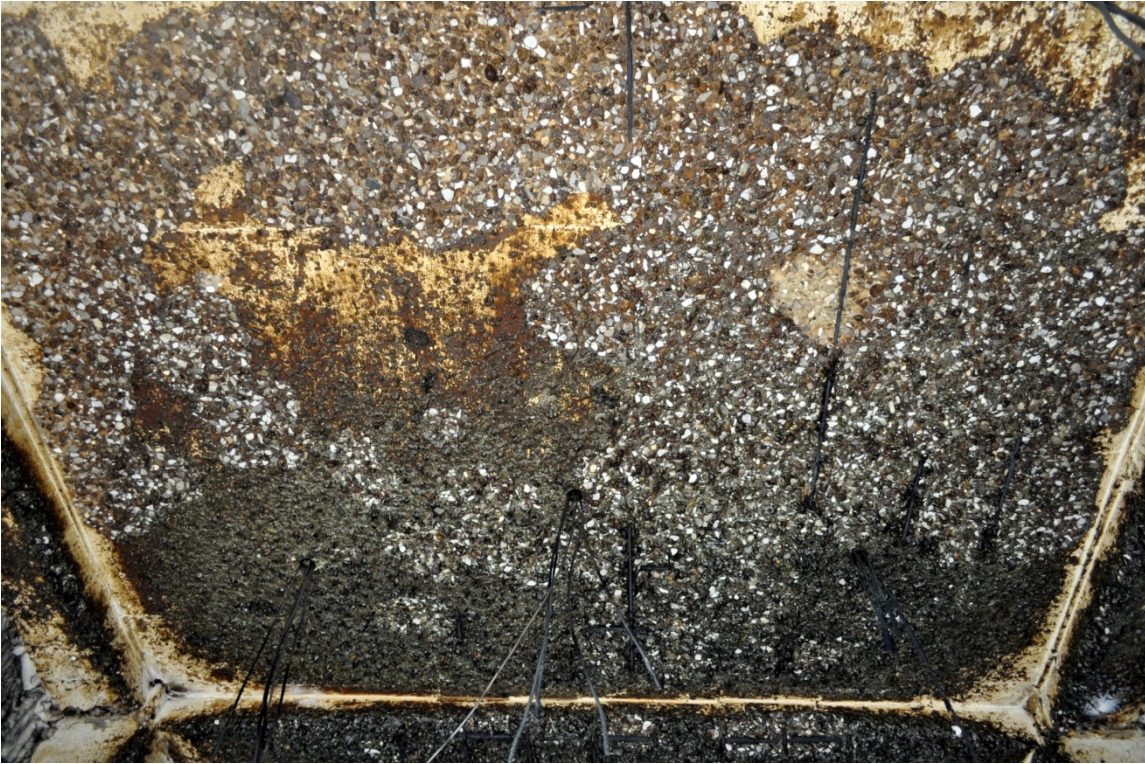
Fig.2.49: Spalling in slab

As evident in Fig.2.49, the roof slab spalled extensively with most of the cover concrete lost exposing the reinforcement. This may be attributed to high temperature gradients across the slab cross section. At some places in the slab, as shown in the Fig. 2.50, the steel reinforcement was observed to have undergone loss in the cross section due to the melting of the steel. The reinforcement being directly exposed to the high temperatures as high as 1370 °C caused the reduction in the strength of the steel. This phenomenon is important from the safety point of view as this would cause considerable loss in the tensile capacity of the steel and thus the flexural capacity of the slab element. While drawing the attention towards addressing the issues of fire following earthquakes, the melting of reinforcement after spalling of thin elements like slab and shells needs to be considered in design codes. Spalling of depths ranging from 9 mm to 45 mm was observed in the slab. The slab also witnessed the formation of cracks other than those formed due to the mechanical loads. These cracks were mostly with the lines at which the reinforcement in the upper part of the slab was curtailed. The spalling contour of the slab is shown in the Fig. 2.51. The spalling depths in slab were manually measured with the help of a steel scale ruler. The slab was divided into a number of points and the loss of concrete at each point was measured with the help of the steel scale ruler. The loss of concrete was plotted across the slab area and same is reproduced in Fig. 2.51.

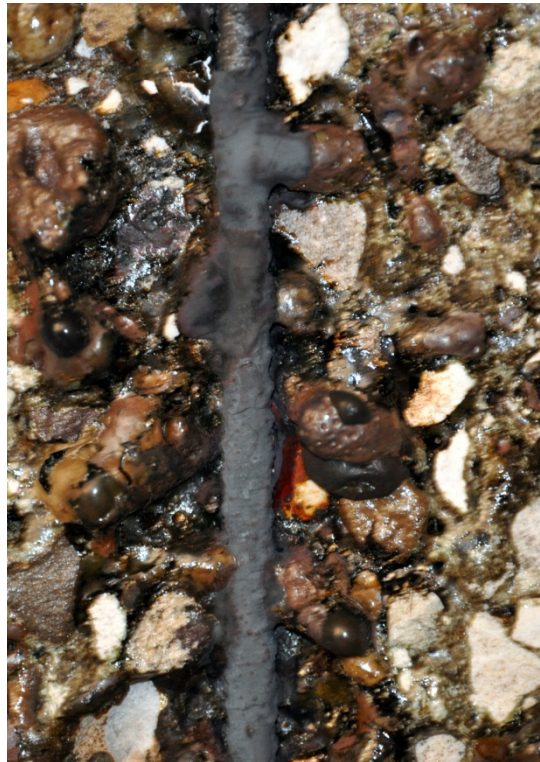
Fig. 2.50: Reduced cross section of the reinforcement of slab due to fire exposure.

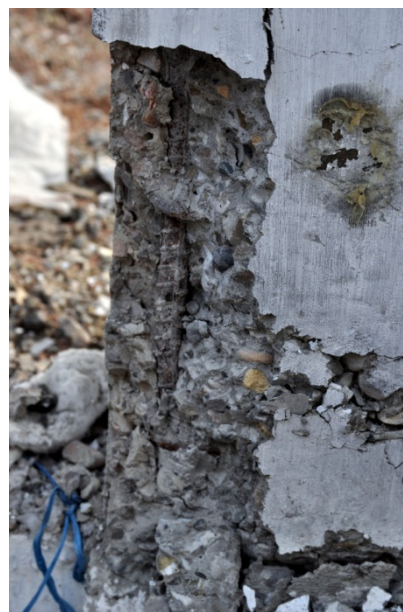
Fig. 2.65: (a) Damaged core concrete in Beam B7 (b) failed shear stirrup in beam B7 (c) view of a column

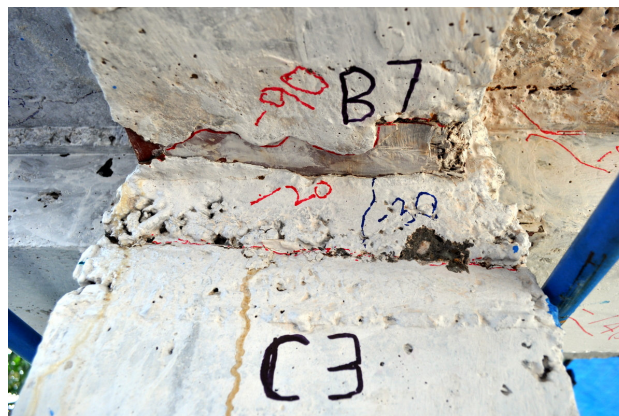
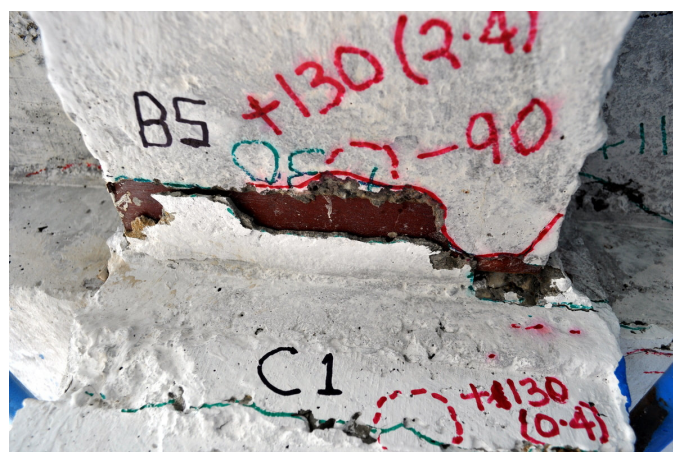
Fig.2.68: (a) & (b) Fine cracks in the elements of frame with ductile detailing tested by Kamath (2014)

In the frame with ductile detailing as tested and reported by Kamath (2014), the nucleation and propagation of cracks did not initiate up to 20 mm displacement cycles. Cracks on columns and beams initiated during 20 mm and 30 mm push cycles respectively. Mostly the cracks got initiated in the planes perpendicular to the loading direction and these cracks further propagated in the subsequent cycles.

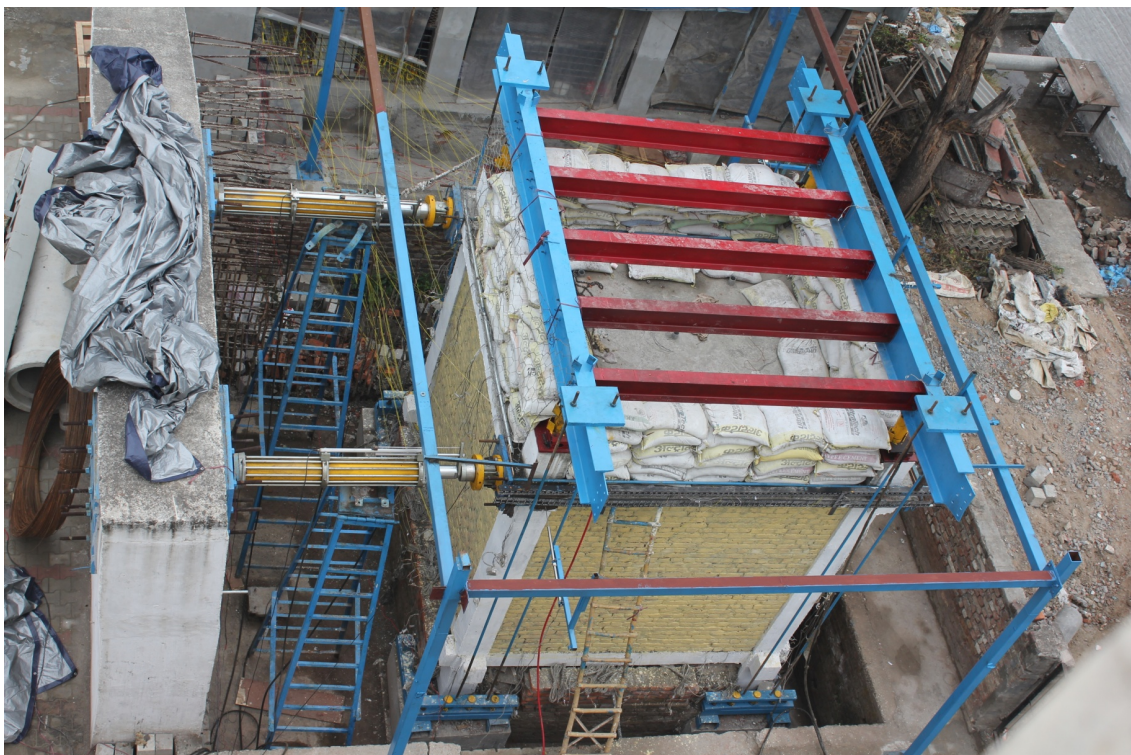
Fig. 3.1 RC test frame before the test

Test procedure adopted in this study was same as in the previous study on bare RC frame for comparison purposes. A three phase test procedure was adopted and followed in testing the RC frame. The test procedure consisted of subjecting the frame to a simulated cyclic lateral load in a quasi-static fashion followed by a one hour compartment fire and after which the frame was subjected to a residual load test. The simulated cyclic lateral load was applied onto the RC frame using two displacement controlled double acting hydraulic actuators acting in tandem with each other against a strong reaction wall. Fig. 3.1 shows the RC frame before the simulated earthquake load test.

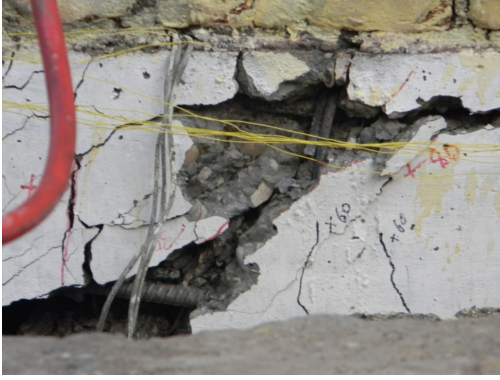
Fig.3.5: Shear failure in beam B1 with buckled reinforcement

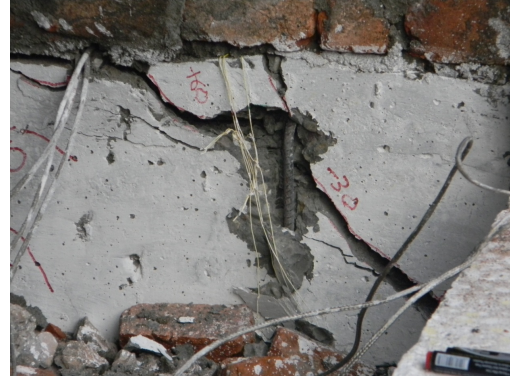
Fig 3.6: Shear failure in beam B3.

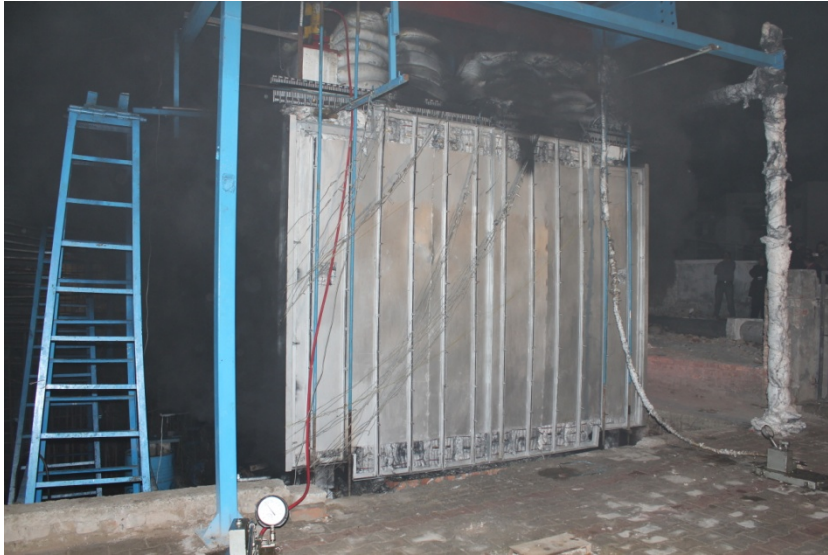
Fig. 3.8: RC frame with fire enclosure.

After inducing the damage corresponding to a drift of 4%, the test frame was subjected to a one hour designed compartment fire. The design parameters of the fire and the compartment size were kept same as in the previous test on the bare RC frame. Fig 3.8 shows the test setup before the fire test.

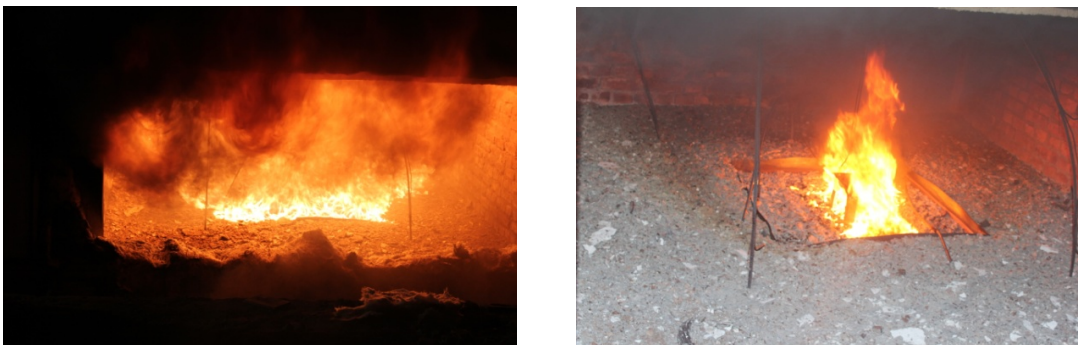
Fig. 3.10: Spalled concrete from the slab of the RC frame: (left) before flashover; (right) at the end of the test

The slab began to spall within 4-5 minutes of the test. The spalling aggravated at about 8-9 minutes after ignition that was just before the flashover. As in case of bare frame intense bullet shot sound was heard around this time. The spalling aggravated at 11 minutes which corresponded to the compartment temperature of about 1250 °C. The spalled concrete from slab can be seen lying on the floor in Fig. 3.10.

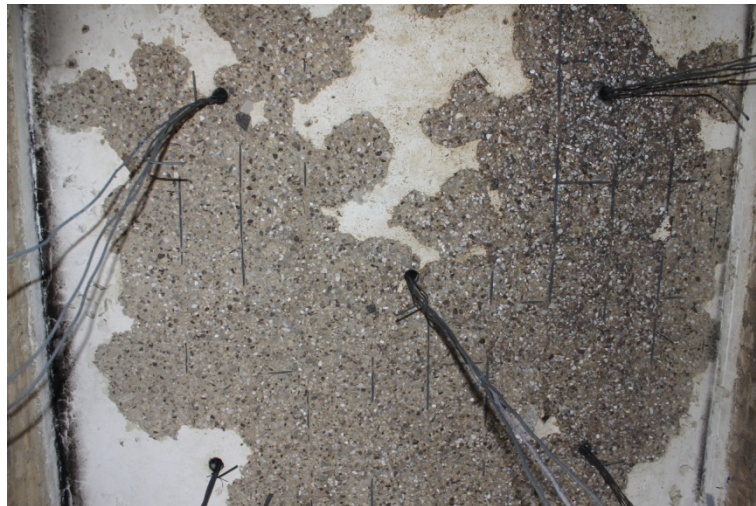
Fig. 3.11 Spalled soffit of the slab.

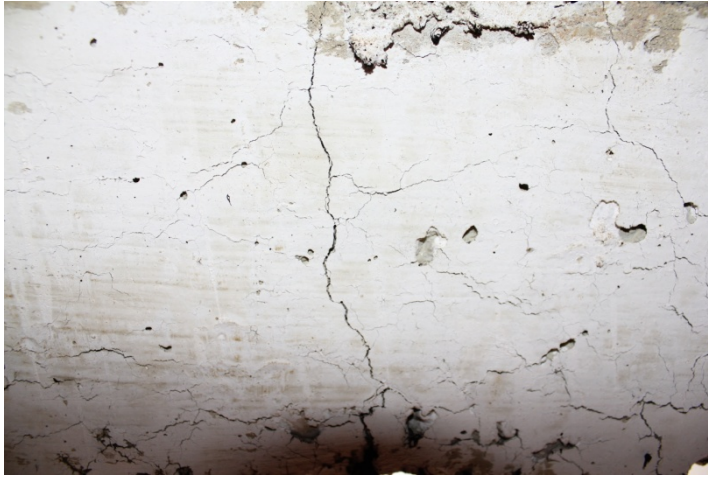
Fig.3.12. Thermal cracking in slab soffit

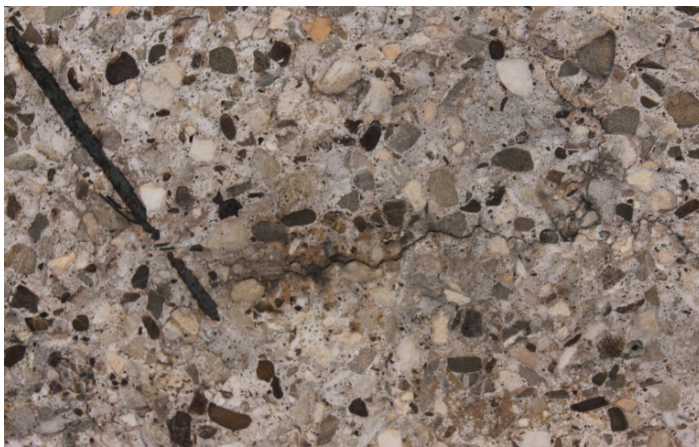
Fig.3.13: Exposed reinforcement in slab and the flexural cracks.

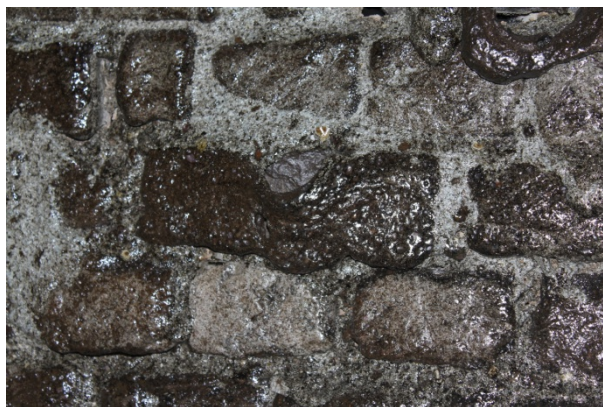
Fig. 3.14: Solidified molten mass from masonry walls

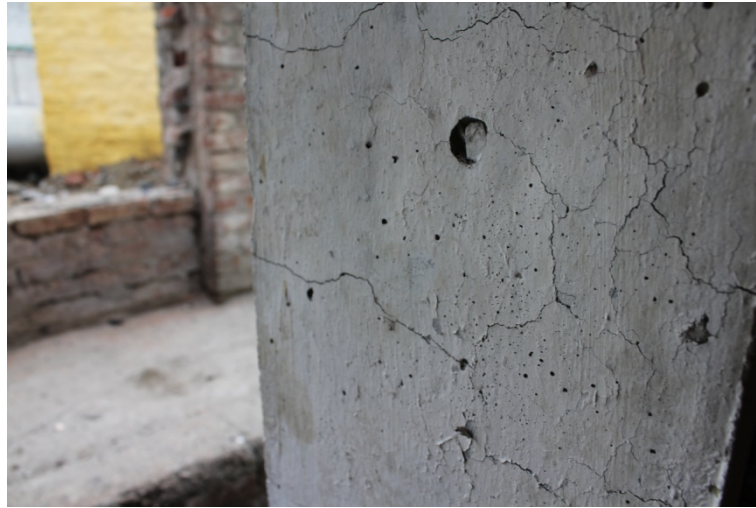
Fig.3.15: Thermal cracking in Column C2

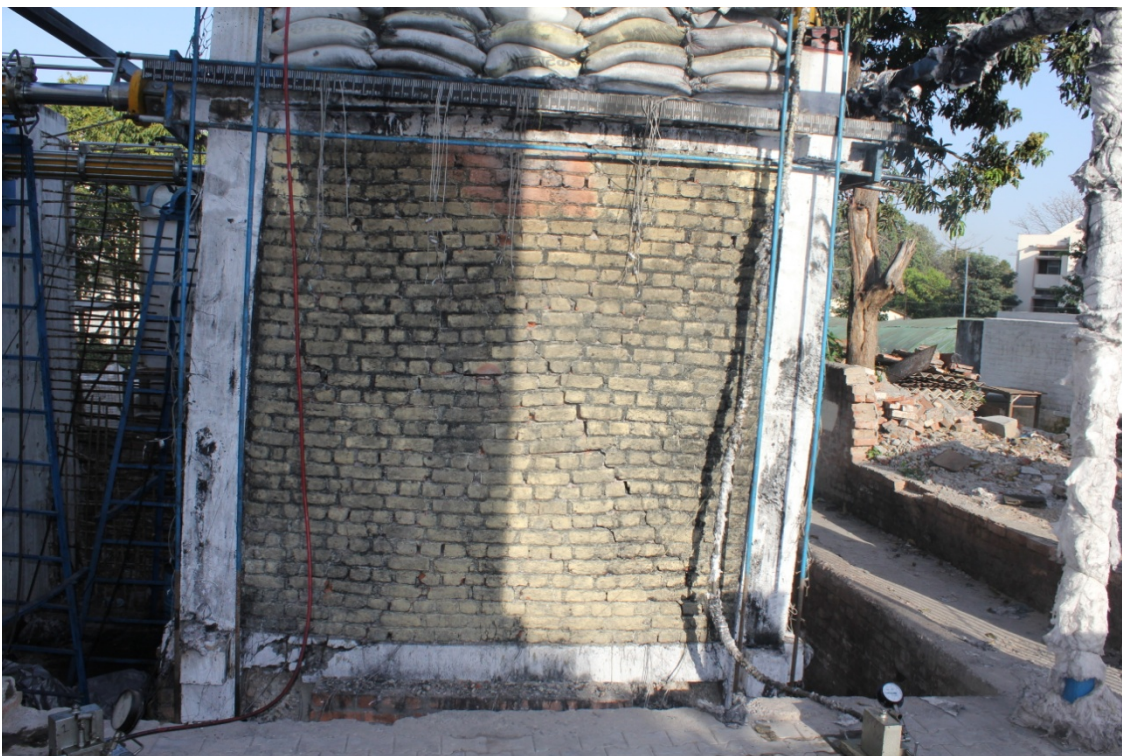
Fig. 3.25: The test frame during the residual load test.

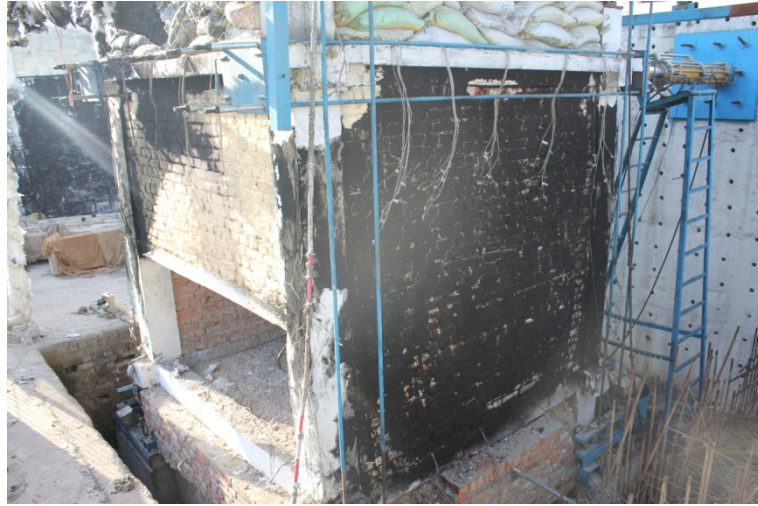
Fig.3.26: A view of the frame after residual test

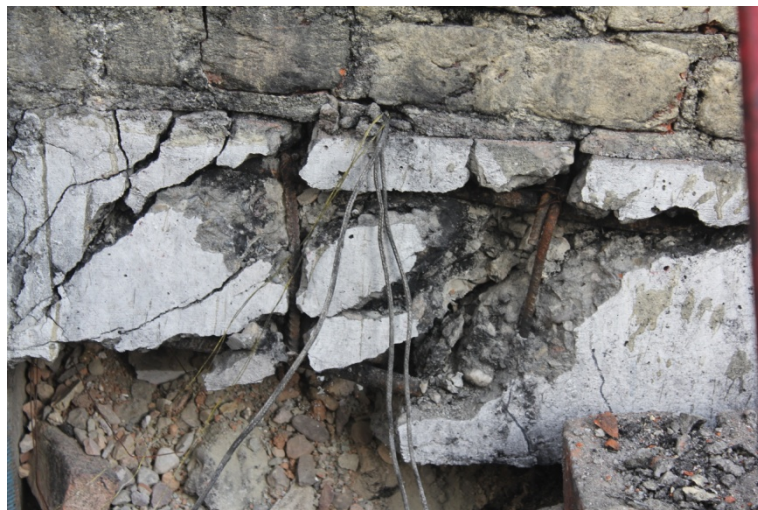
Fig 3.28: A closer view of the beam B1 showing damaged portion

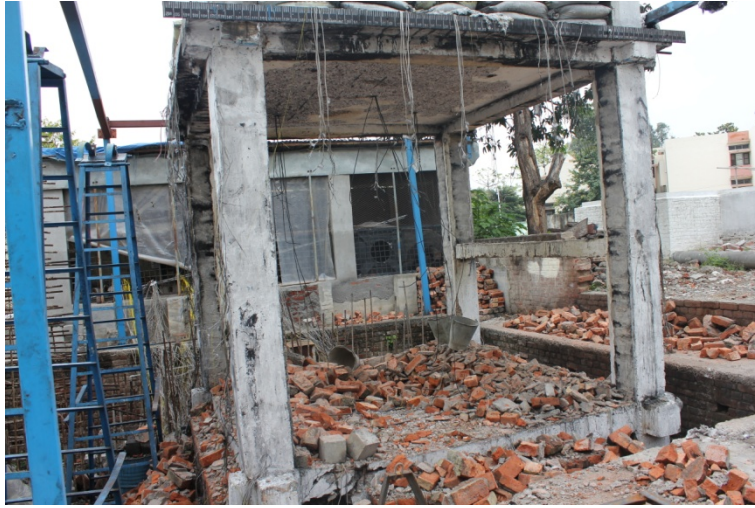
Fig. 3.29: A view of the frame after removal of infill walls

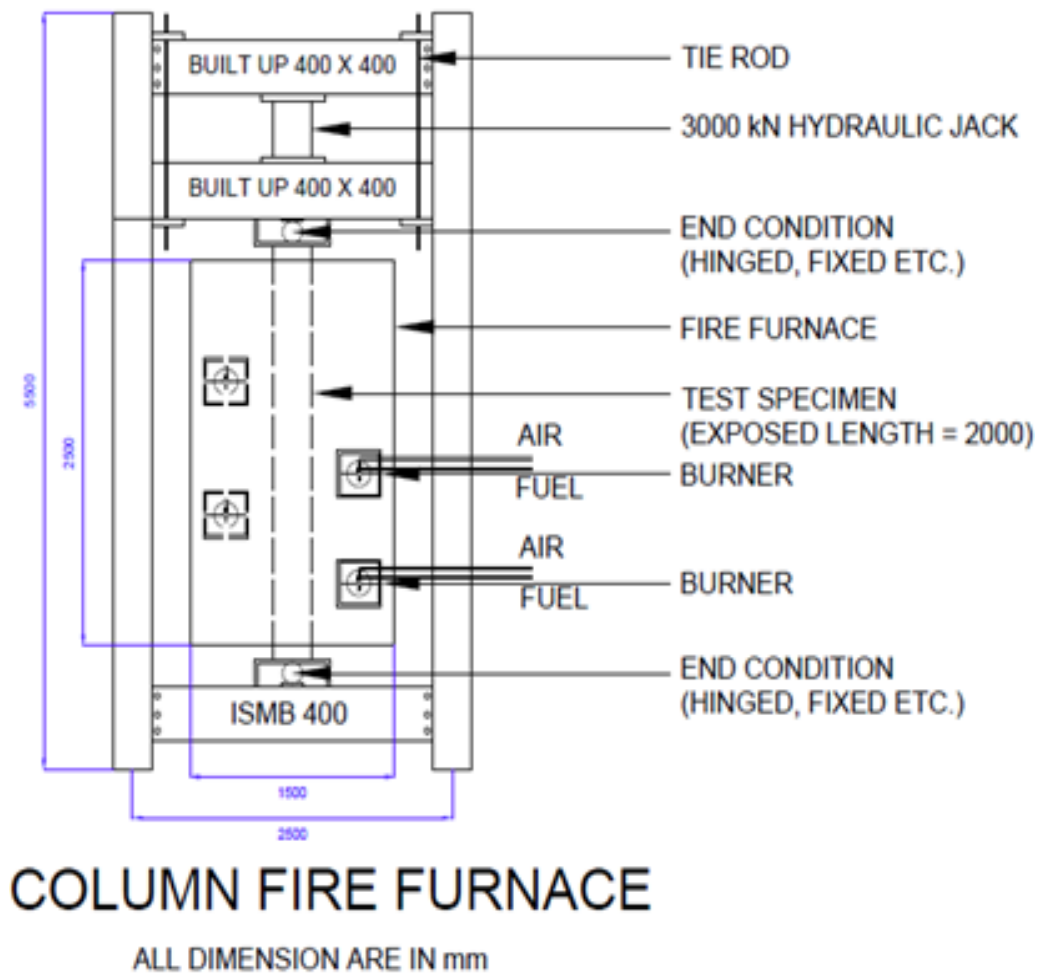
Figure 4.5: Furnace elevation

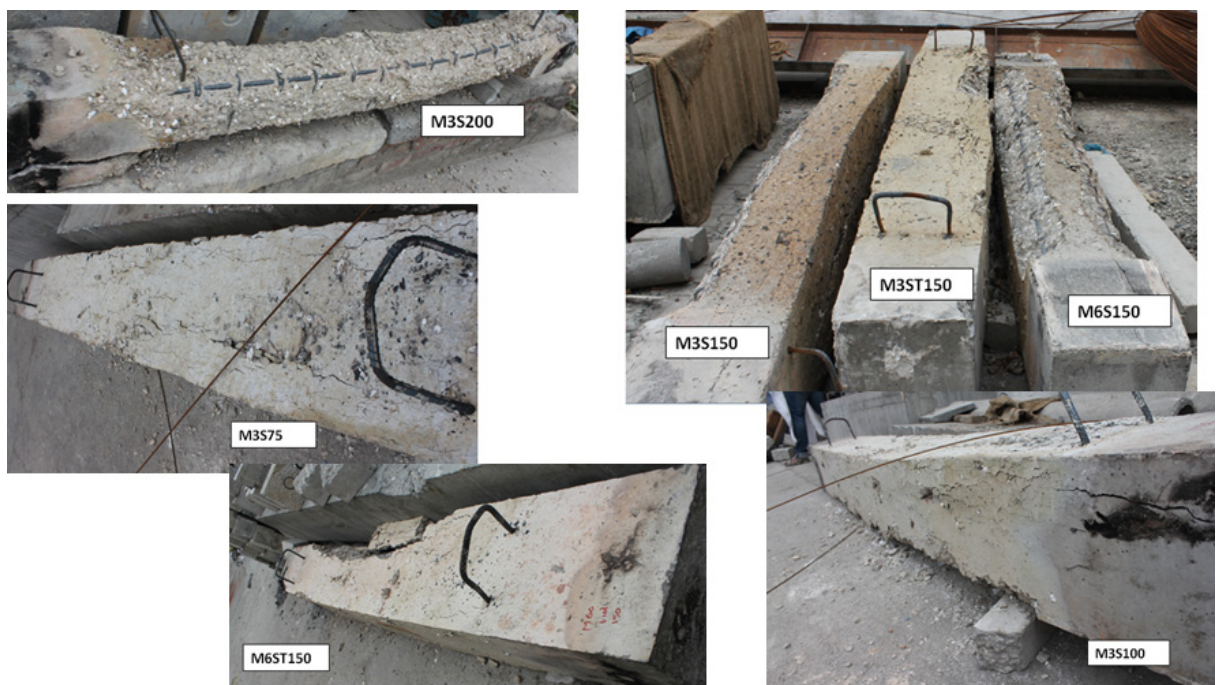
Fig. 4.17: RC columns after the fire exposure
