STUDIES ON HOT CORROSION BEHAVIOUR OF CONVENTIONAL AND NANOSTRUCTURED COATINGS

Ph.D. THESIS

**DEPARTMENT OF METALLURGICAL AND MATERIALS ENGINEERING
INDIAN INSTITUTE OF TECHNOLOGY ROORKEE
ROORKEE – 247667, INDIA**

DECEMBER, 2013

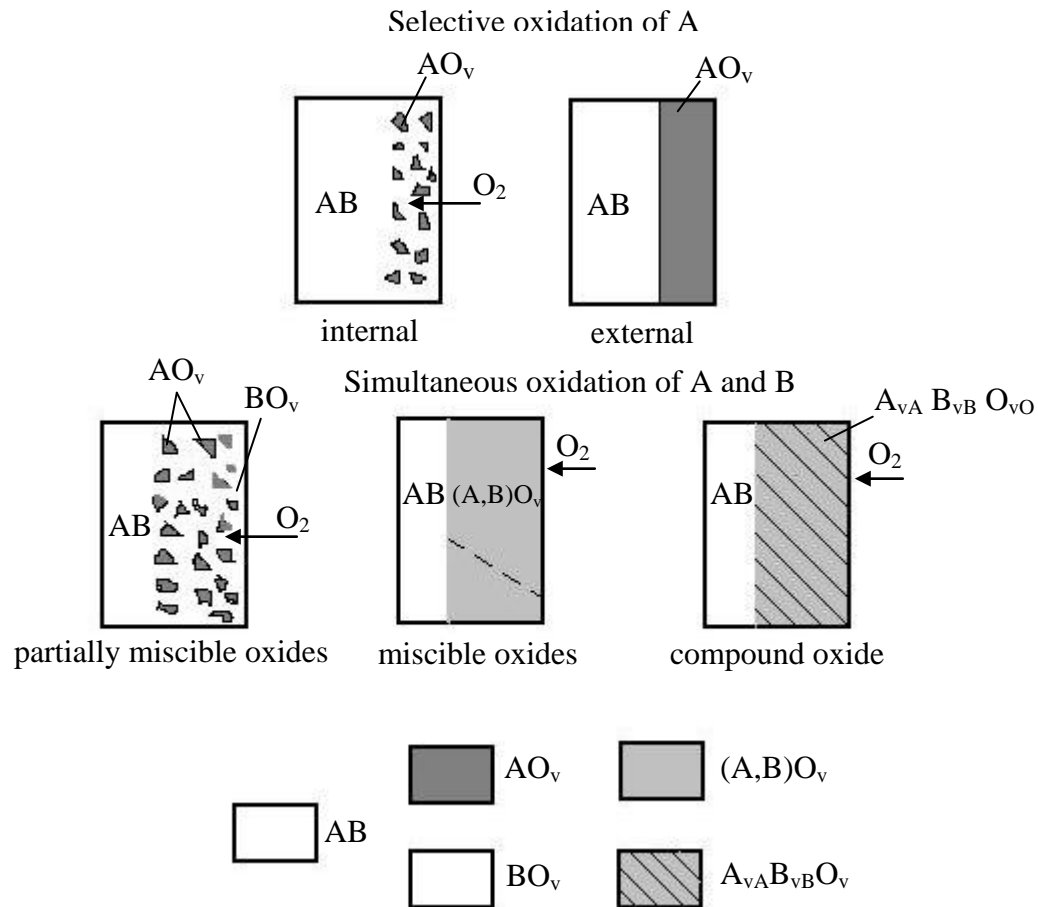
Fig. 2.3 Alloy oxidation mechanisms, with the corresponding morphologies of the oxide layers (Dieter, 2007).

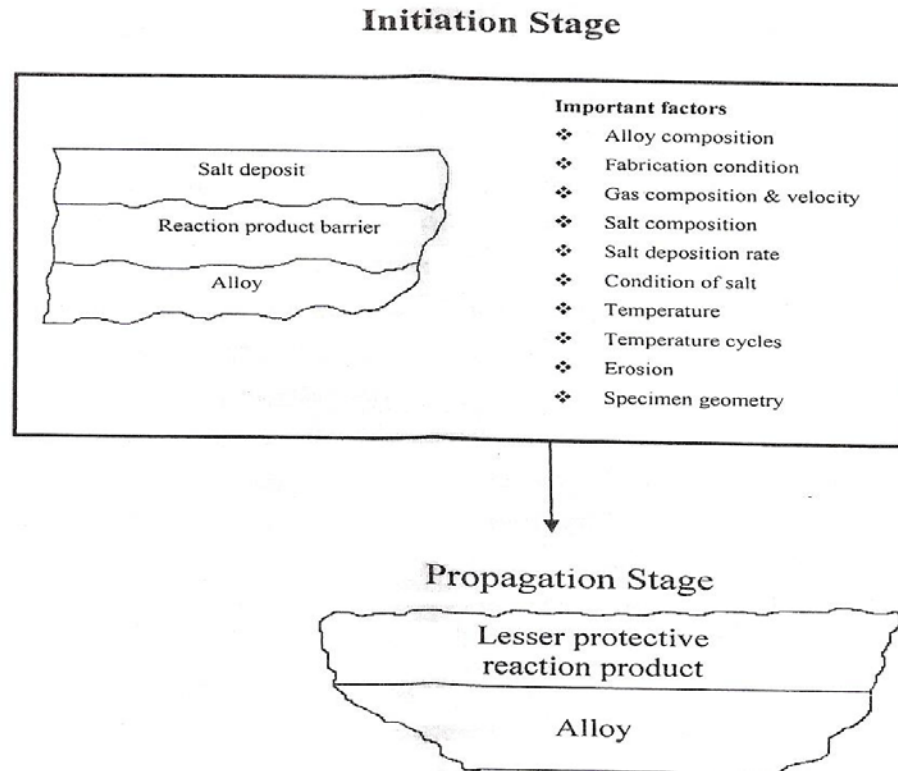
Fig. 2.5 Schematic diagram showing the conditions that develop during hot corrosion attack. (Pettit and Meier, 1985).

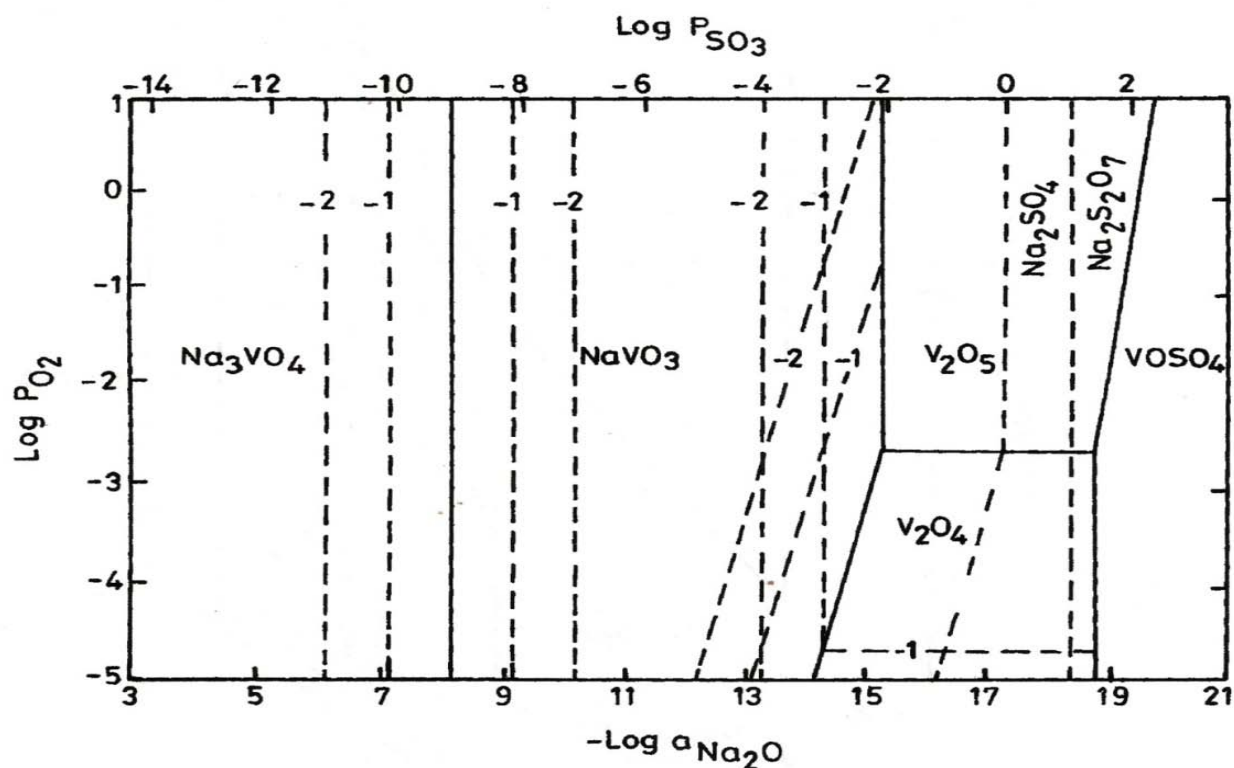
Fig. 2.7 Phase stability diagram for Na-V-S-O phase diagram at 900°C (Hwang and Rapp, 1989)

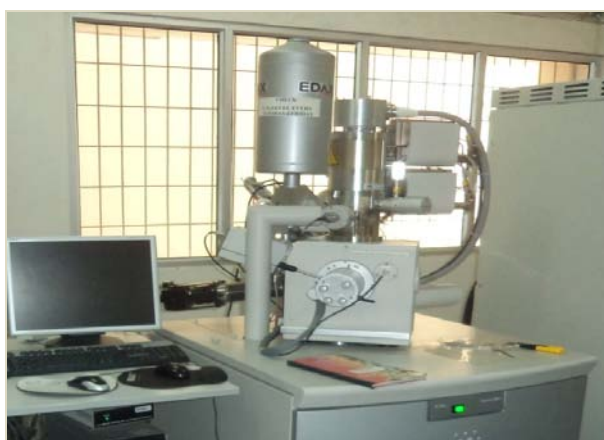
Fig. 3.2: A photograph of FEI Quanta 200F scanning electron microscope used in the present study.

The surface morphologies of the feedstock materials and as-coated coupons were studied using FE-SEM fitted with EDAX Genesis software attachment (Fig. 3.2); with an aim to understand the morphology of the coating powders and to identify inclusions, un-melted, partially melted particles and pores in the as sprayed coatings. FE-SEM/EDS analysis of the as coated specimens is reported in Chapter 4, 5 and 6 of the present study.

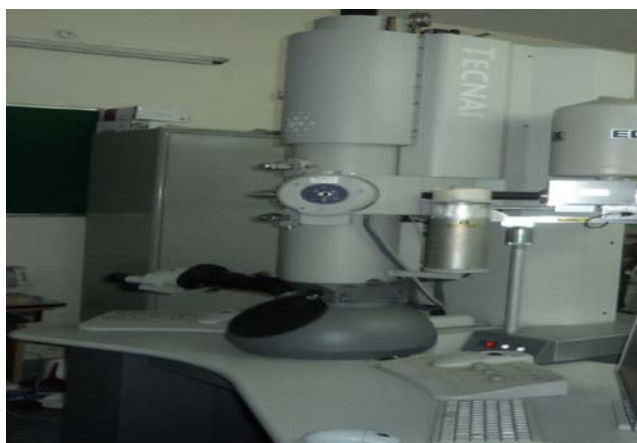
Fig. 3.3: A photograph of TECNAI G2 transmission electron microscope used in the present study.

TEM images and SAED patterns of the feedstock material (140MXC) as well as nanostructured alloy coating (NC) were recorded on FEI TECNAI G2 (Fig. 3.3) electron microscopes. TEM analysis of the feedstock material (140MXC) as well as nanostructured alloy coating (NC) is reported in Chapter 6 of the present study.
