# TRIBOLOGICAL BEHAVIOUR OF SiC-WC COMPOSITES

Ph.D. THESIS

DEPARTMENT OF METALLURGICAL AND MATERIALS ENGINEERING  
INDIAN INSTITUTE OF TECHNOLOGY ROORKEE  
ROORKEE – 247667, INDIA  
JULY, 2017

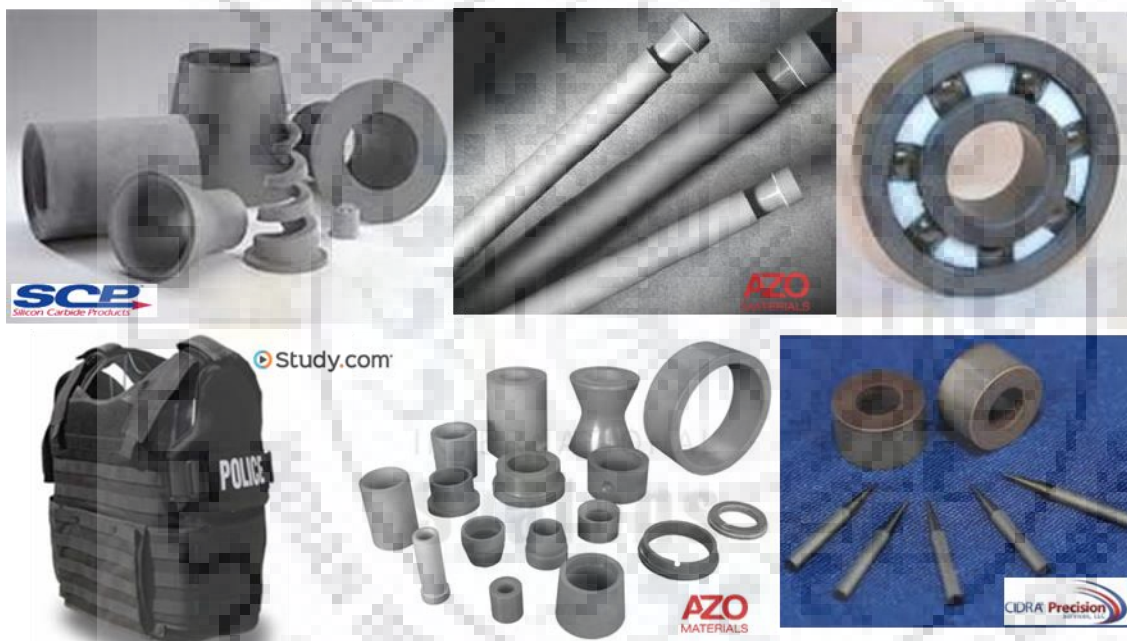
**Figure 1.1.** Typical structural applications of SiC based ceramics

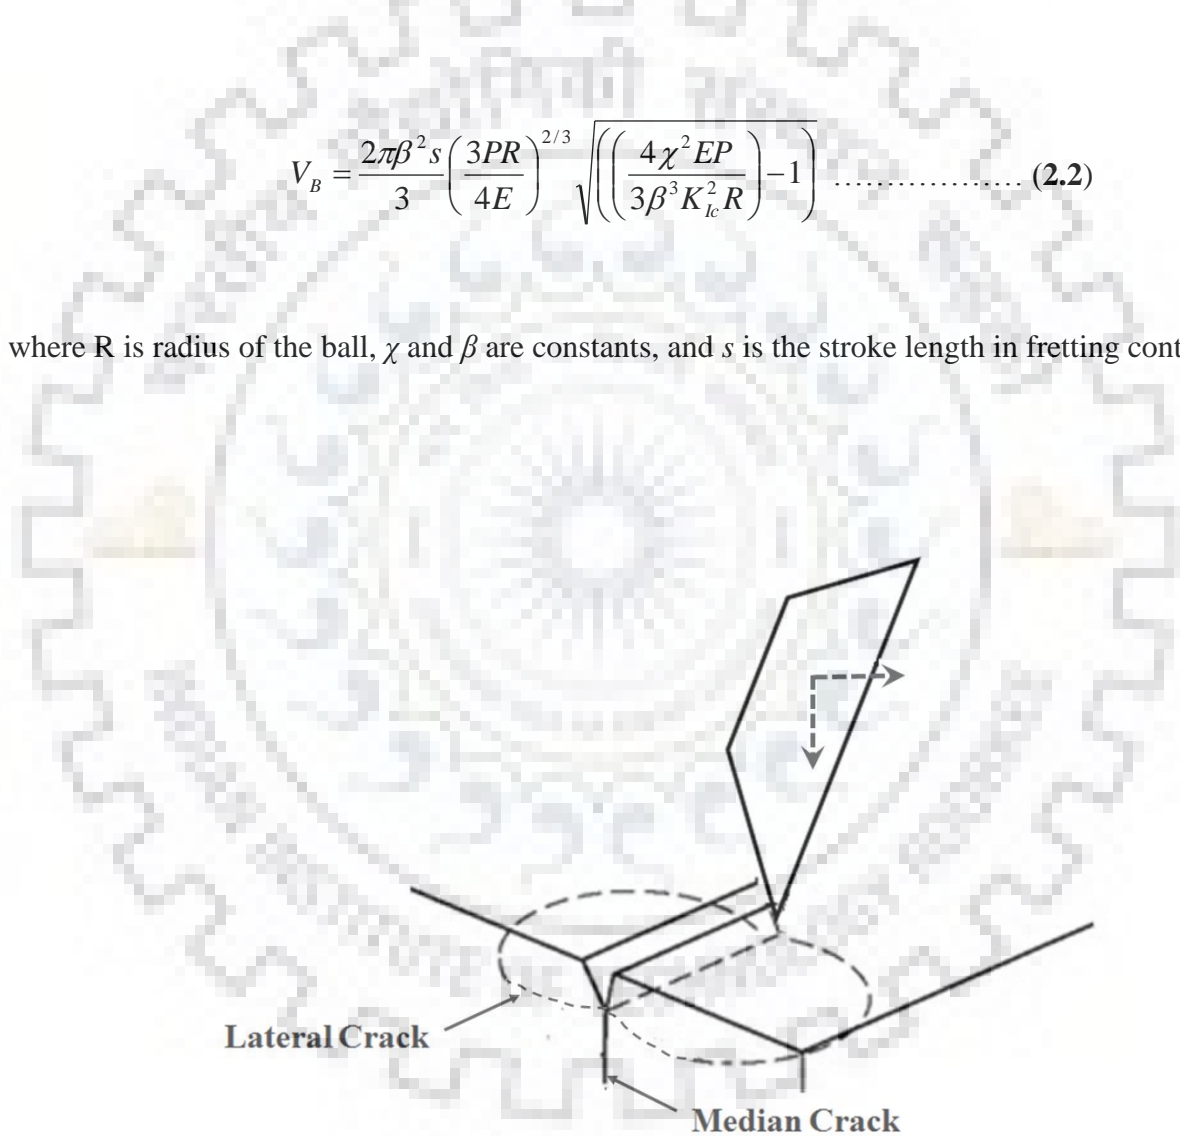
**Figure 2.5.** Wear mechanism of brittle material dominated by lateral and median crack [Marshall 1982].

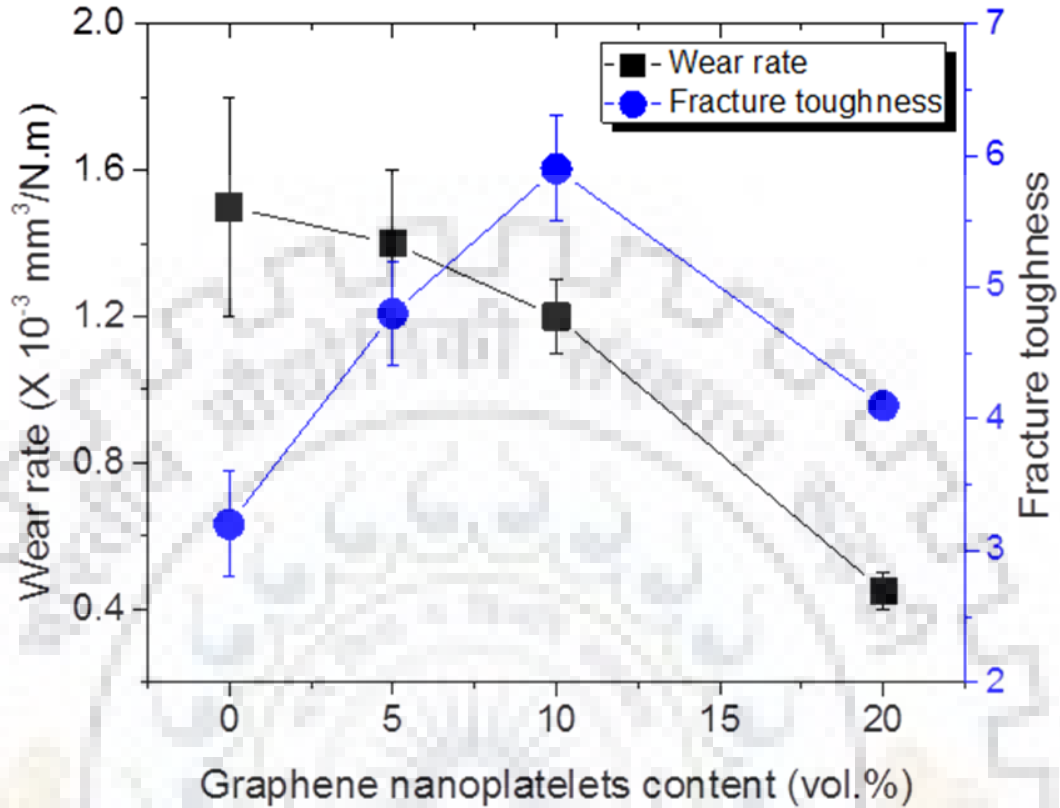
**Figure 2.6.** The wear rate and fracture toughness of SiC- graphene nanoplatelets composites as function of content of graphene nanoplatelets [Llorente 2016].

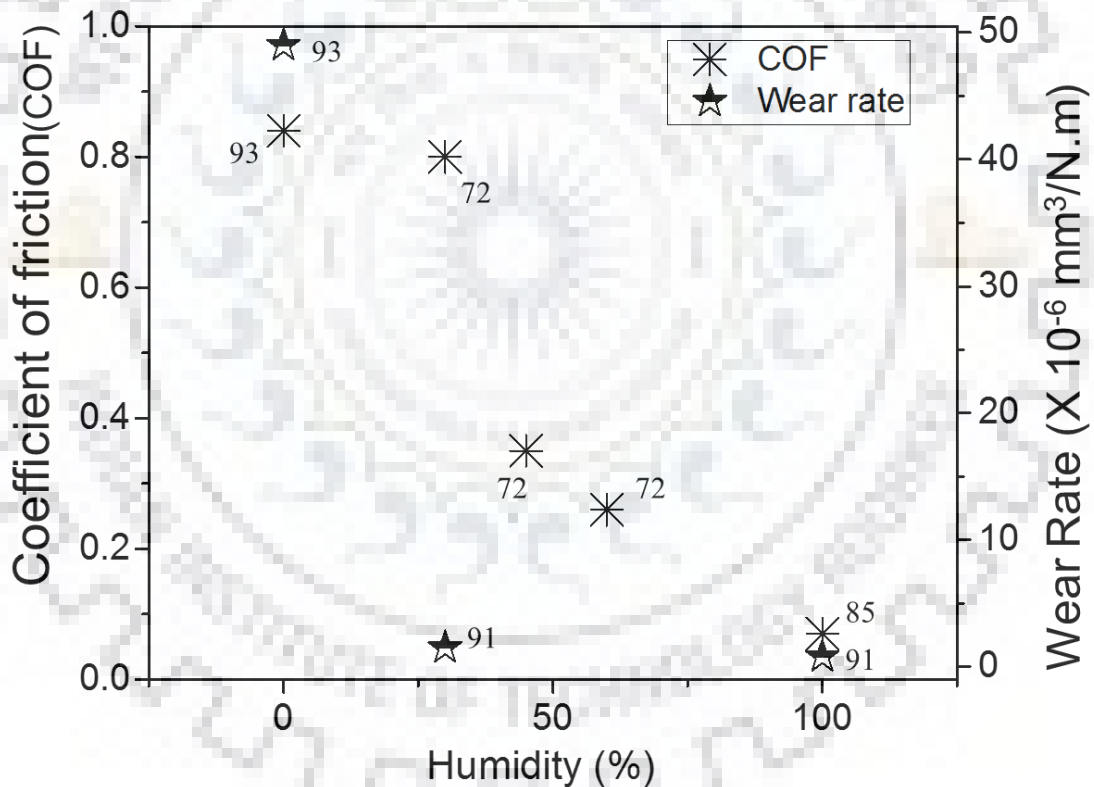
**Figure 2.10.** Average steady state coefficient of friction and wear rate of SiC ceramic with respect to humidity against SiC counterbody [Murthy 2004; Li 1998; Wasche 2004; Hotta 1988].

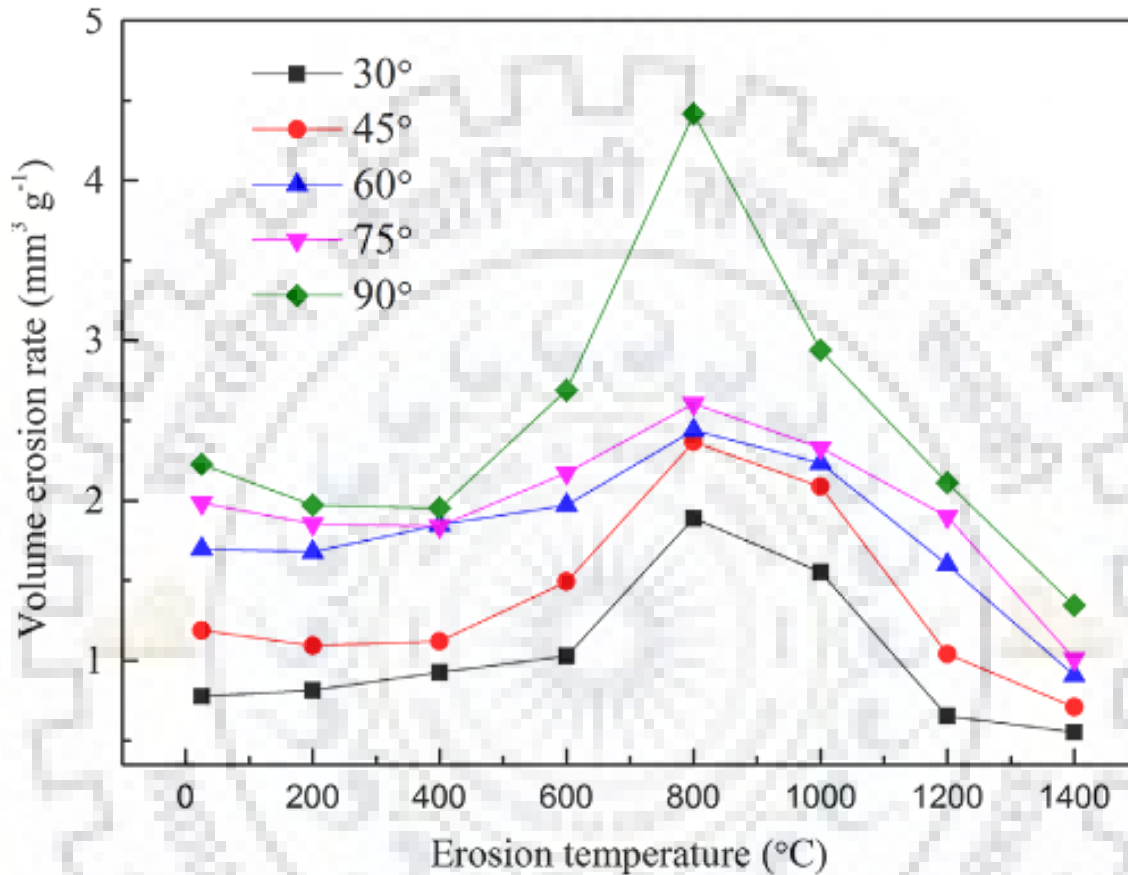
**Figure 2.12.** Change in the volume erosion rates with respect to the erosion temperature at different impingement angles for SiC-Si<sub>3</sub>N<sub>4</sub> composite [Li 2014].

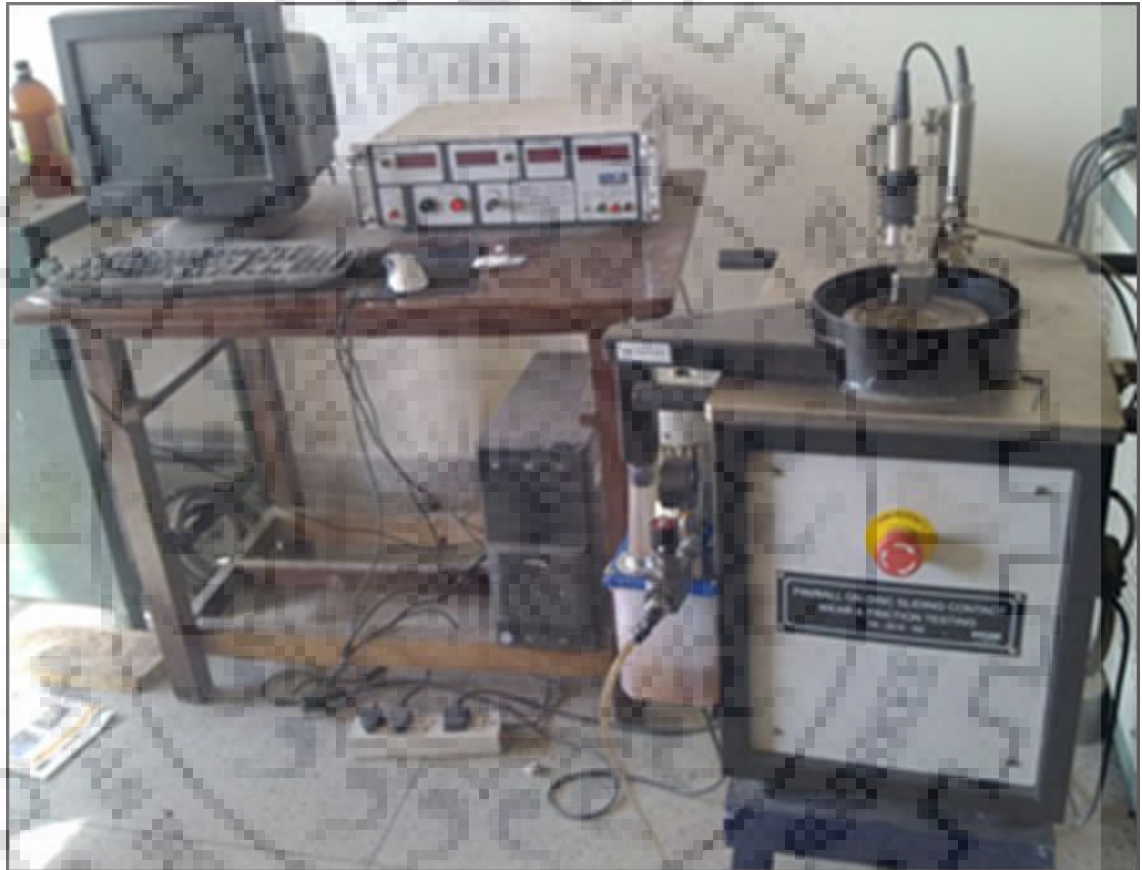
**Figure 3.4.** Ball-on-disk tribometer used to perform continuous sliding wear test.

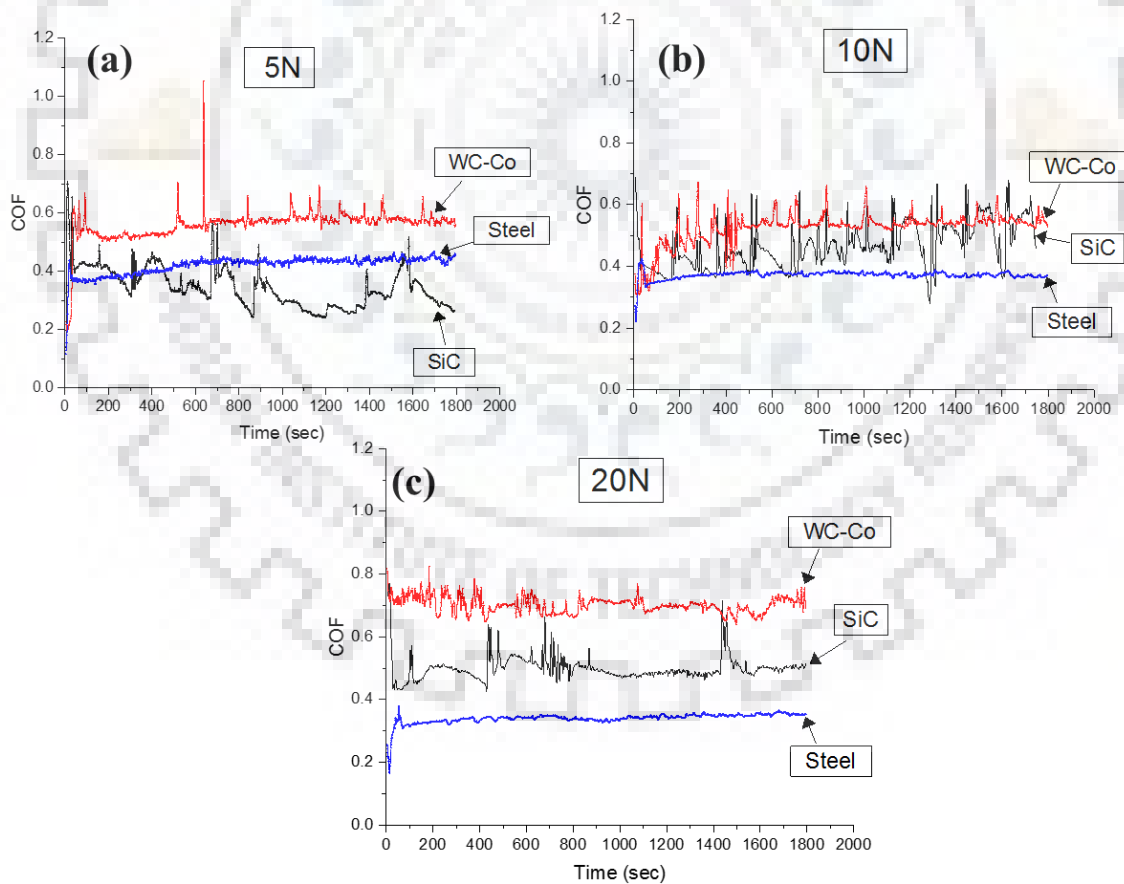
**Figure 4.1.** Evolution of coefficient of friction for monolithic SiC ceramics at (a) 5 N, (b) 10 N and (c) 20 N, against SiC, WC-Co and steel counterbodies.

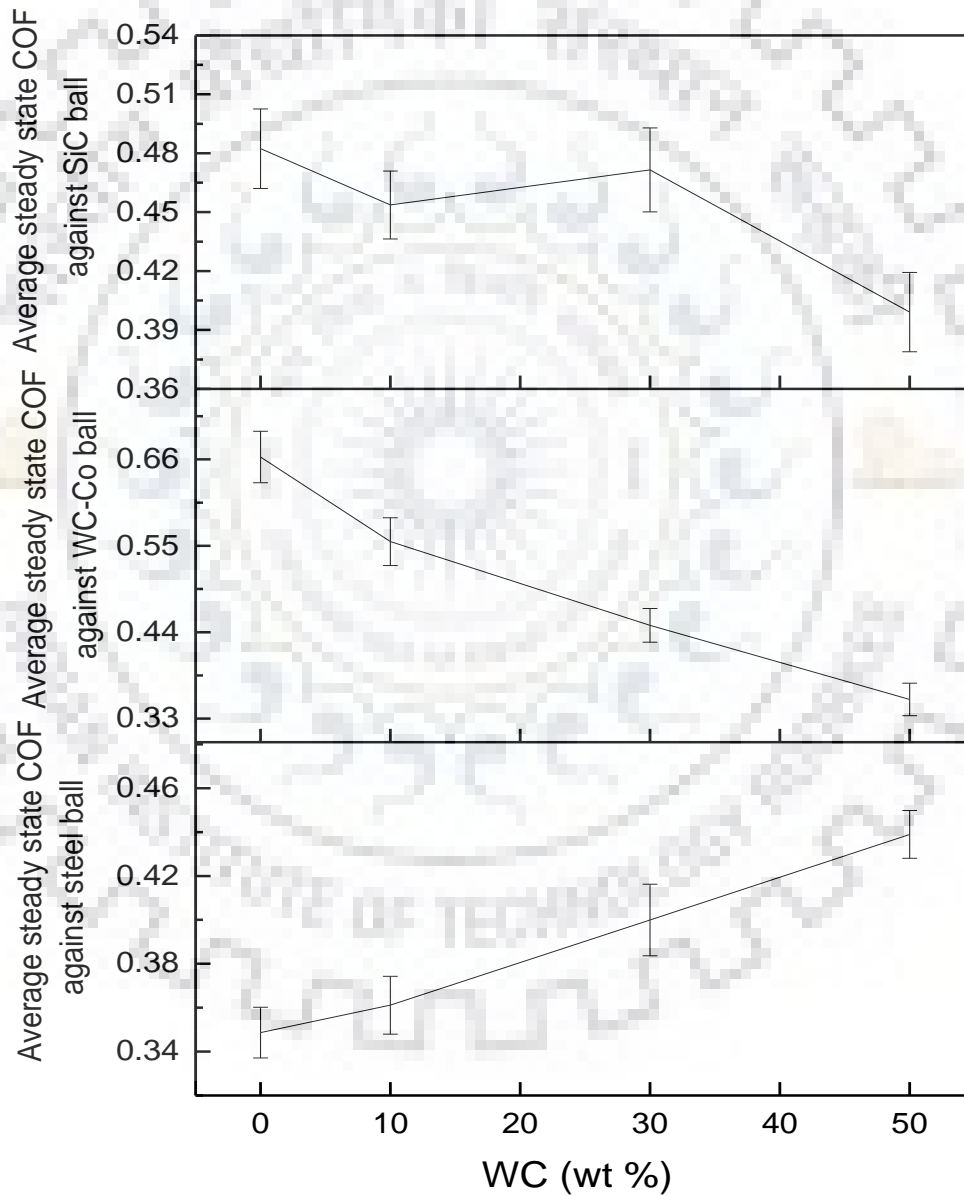
**Figure 4.2.** Average steady state coefficient of friction of SiC-WC composites against SiC, WC-Co and steel counterbodies at 20 N load.

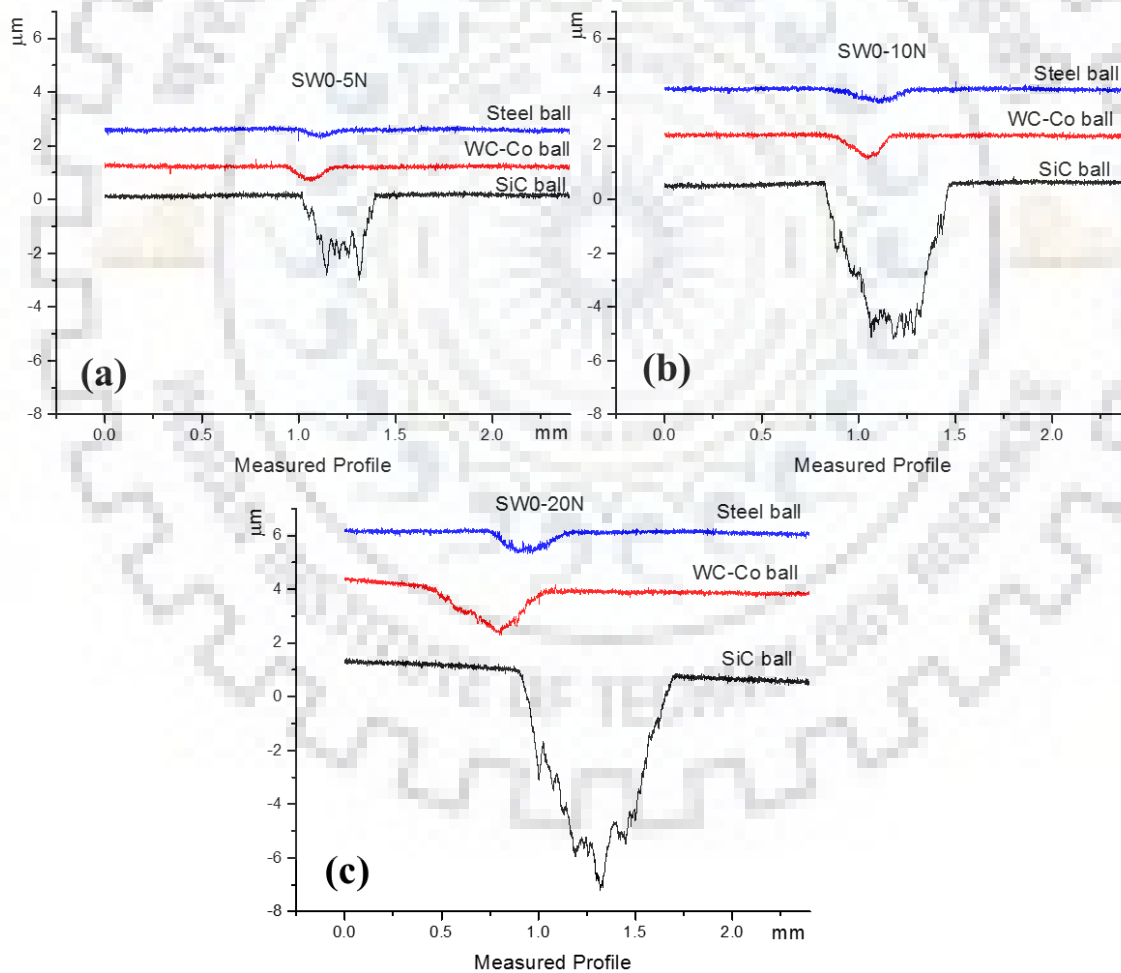
**Figure 4.3.** Typical surface profile of wear scar on monolithic SiC ceramics at (a) 5 N, (b) 10 N and (c) 20 N, against SiC, WC-Co and steel counterbodies.

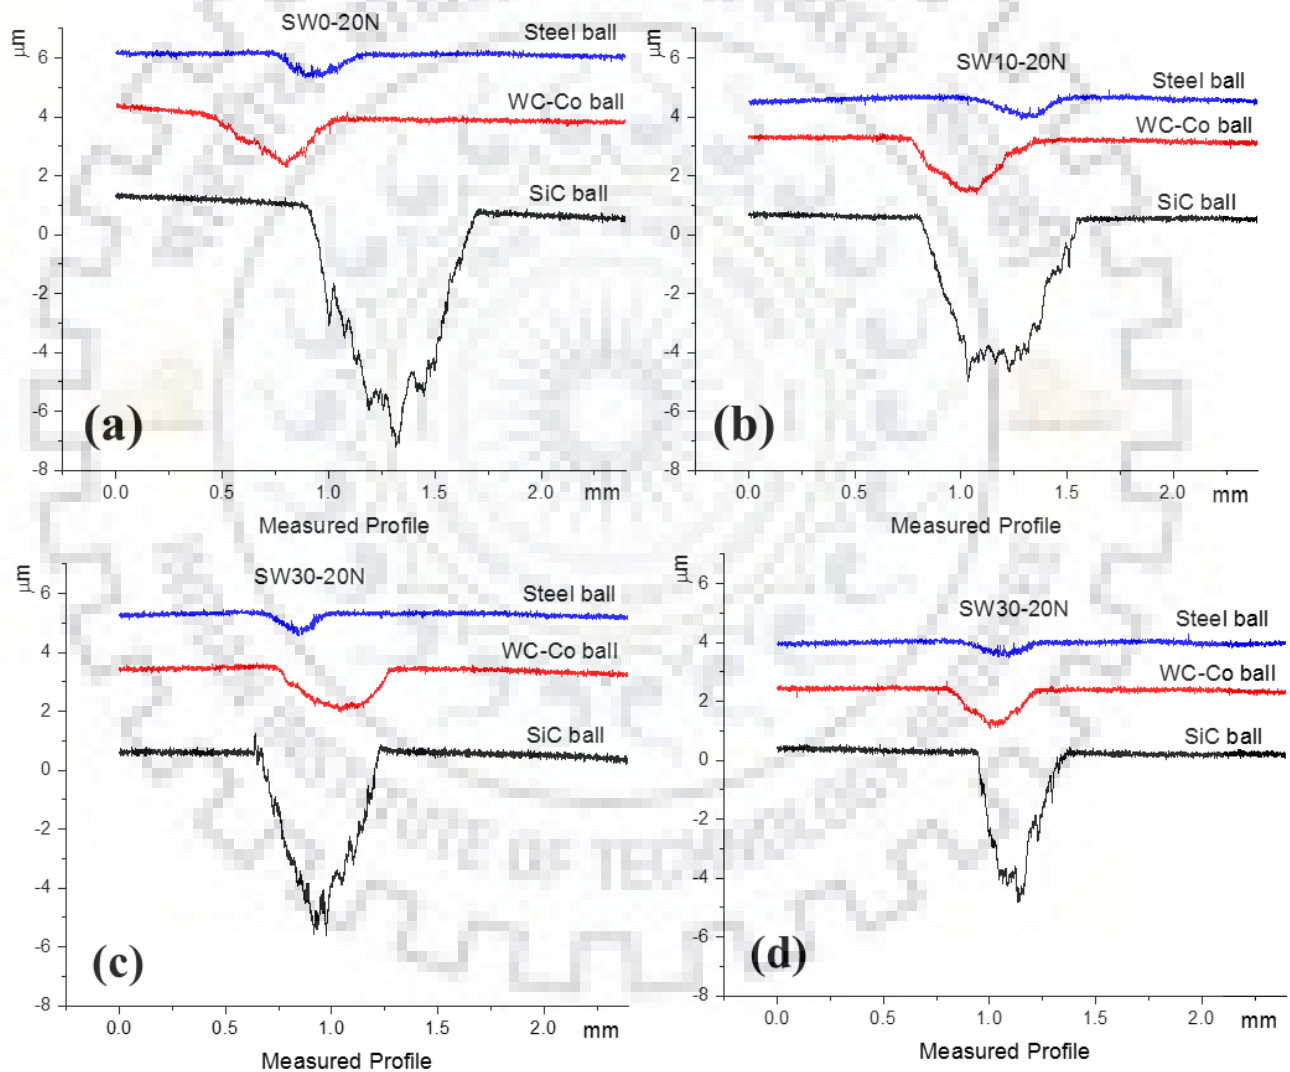
**Figure 4.4.** Typical surfaces profiles of wear scars against SiC, WC-Co and steel counterbodies at 20 N for SiC ceramics sintered with (a) 0, (b) 10, (c) 30 and (d) 50 wt% WC.

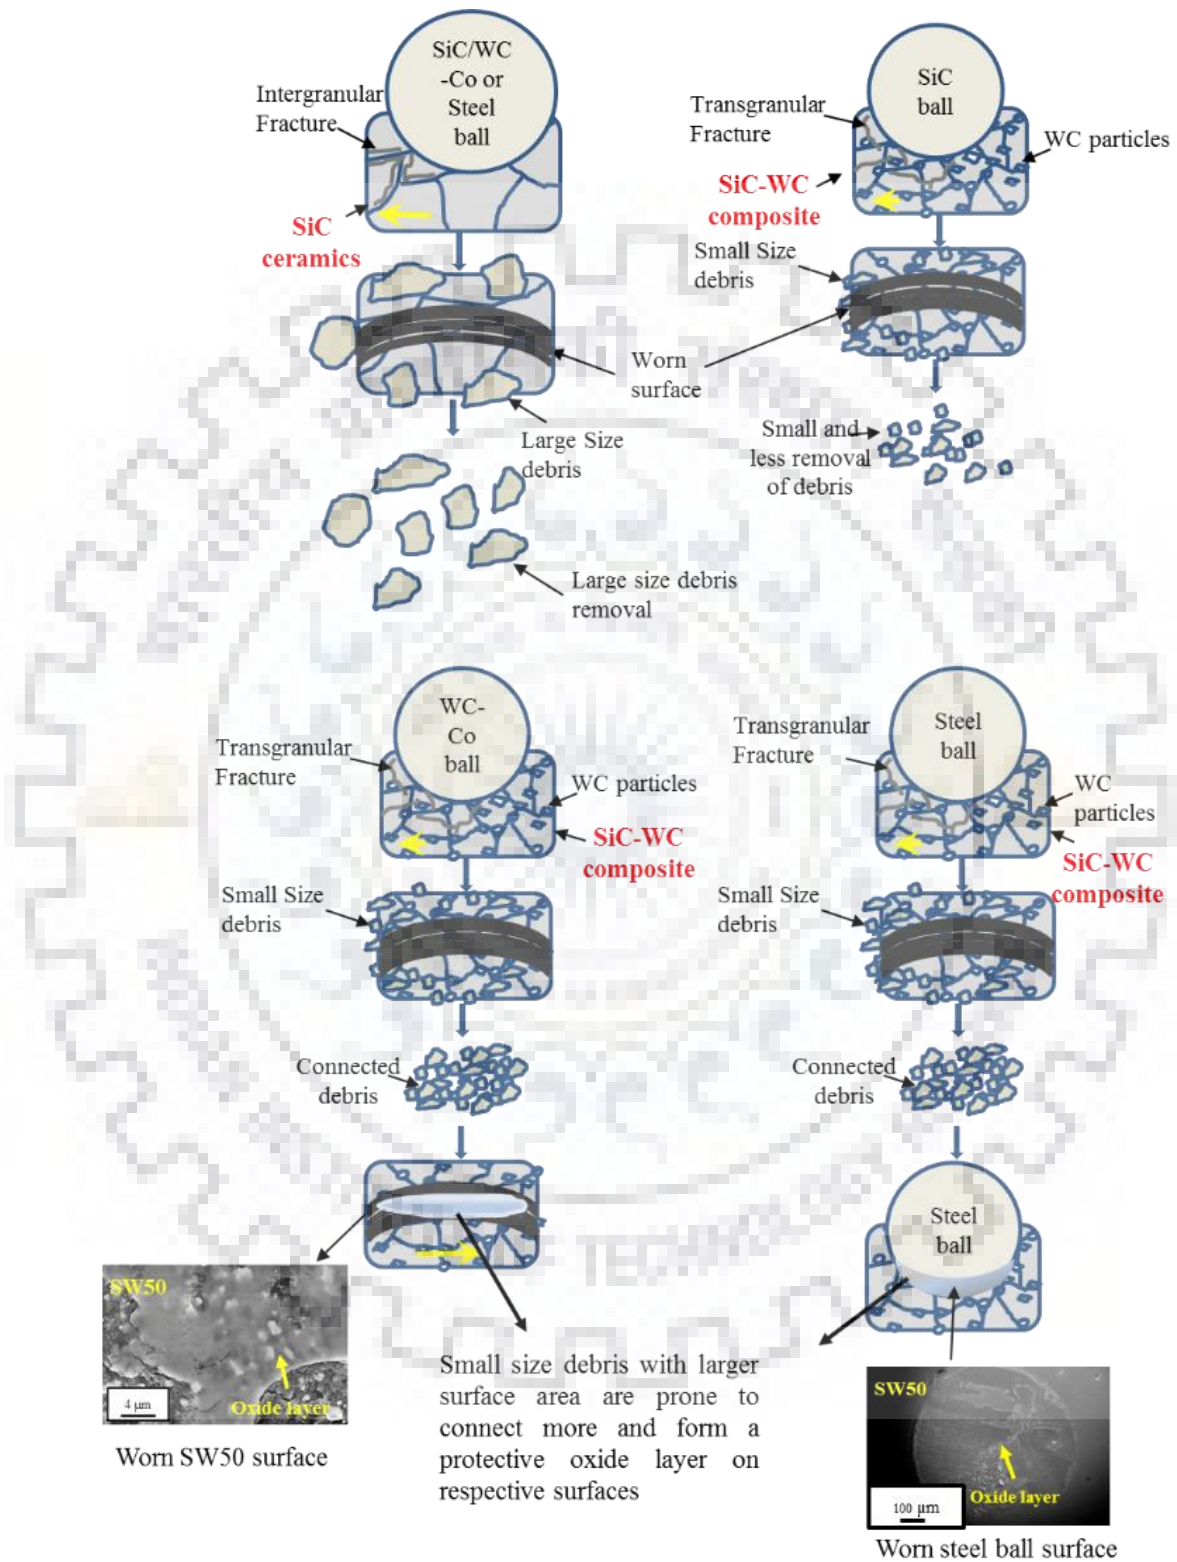
**Figure 4.12.** Schematic illustration of dominant wear mechanisms for SiC ceramics and SiC-WC ceramics when slid against SiC, WC-Co or steel ball.

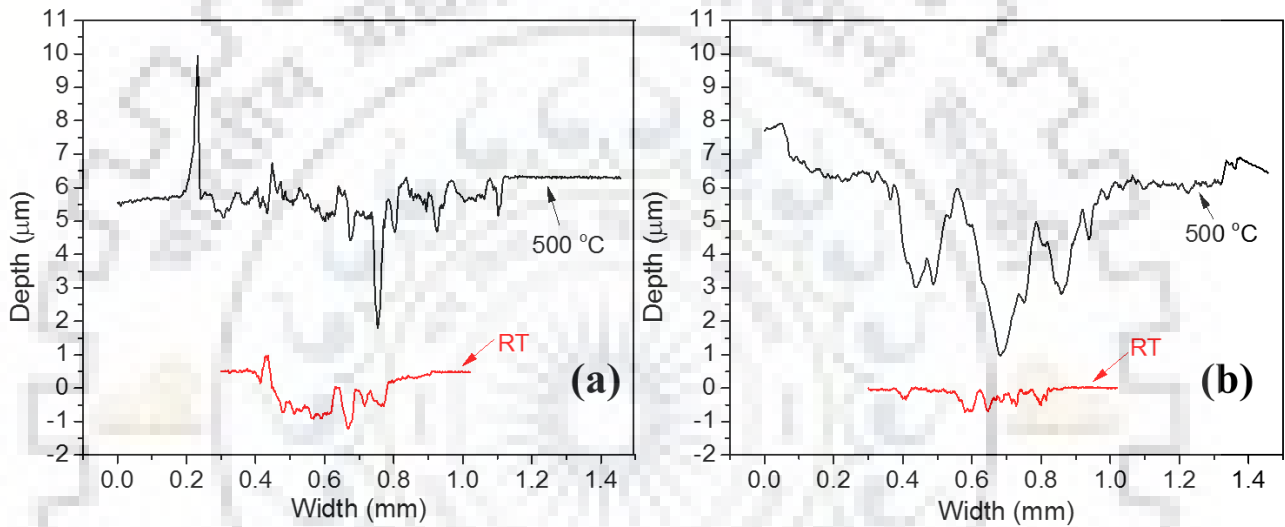
**Figure 5.4.** Scar profiles of (a) SiC ceramics and (b) SiC-50 wt% WC composites worn at 19 N load and ambient (RT) or 500°C.

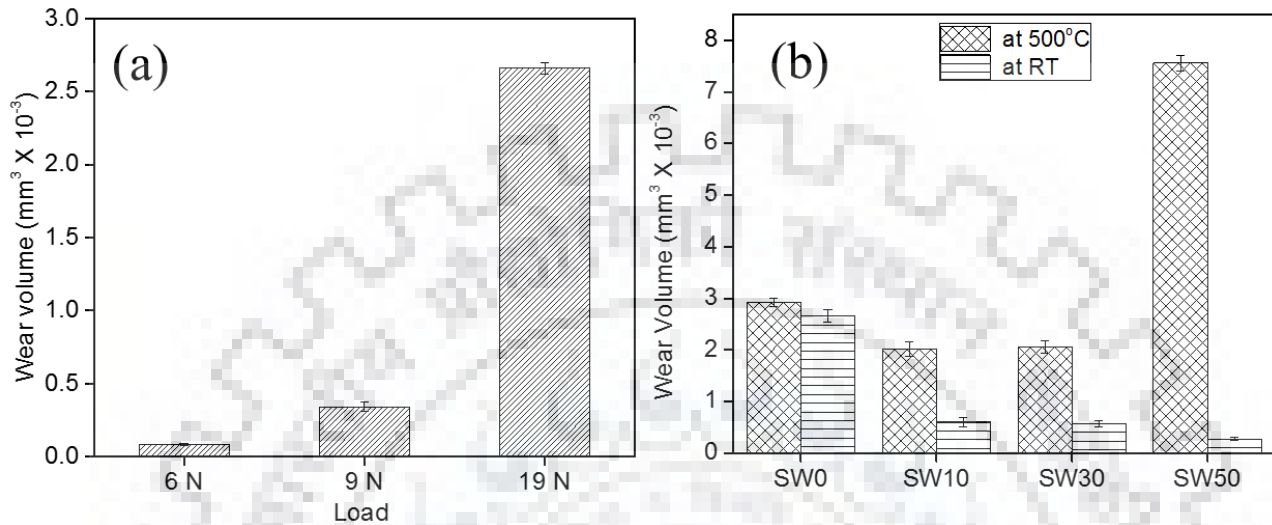
**Figure 5.5.** Wear volume of (a) SiC ceramics at different sliding loads at ambient temperature (RT) and (b) SiC-WC composites at 19 N load at RT or 500°C.

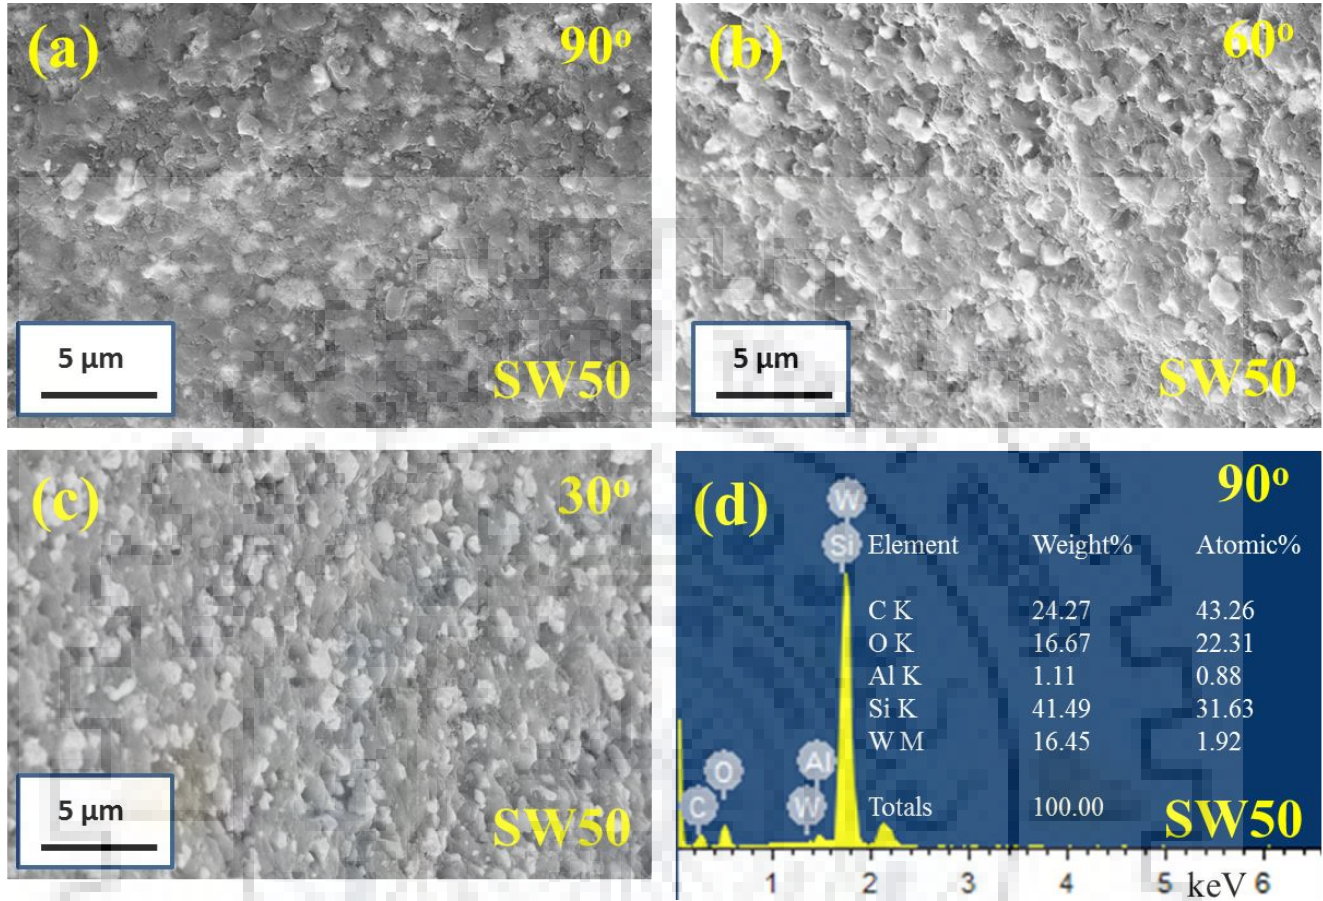
**Figure 6.5.** SEM images of SiC-50 wt% WC composite worn at 800°C with an impingement angle of (a) 90°, (b) 60° and (c) 30°. (d) EDS results of the surface eroded at 90°.

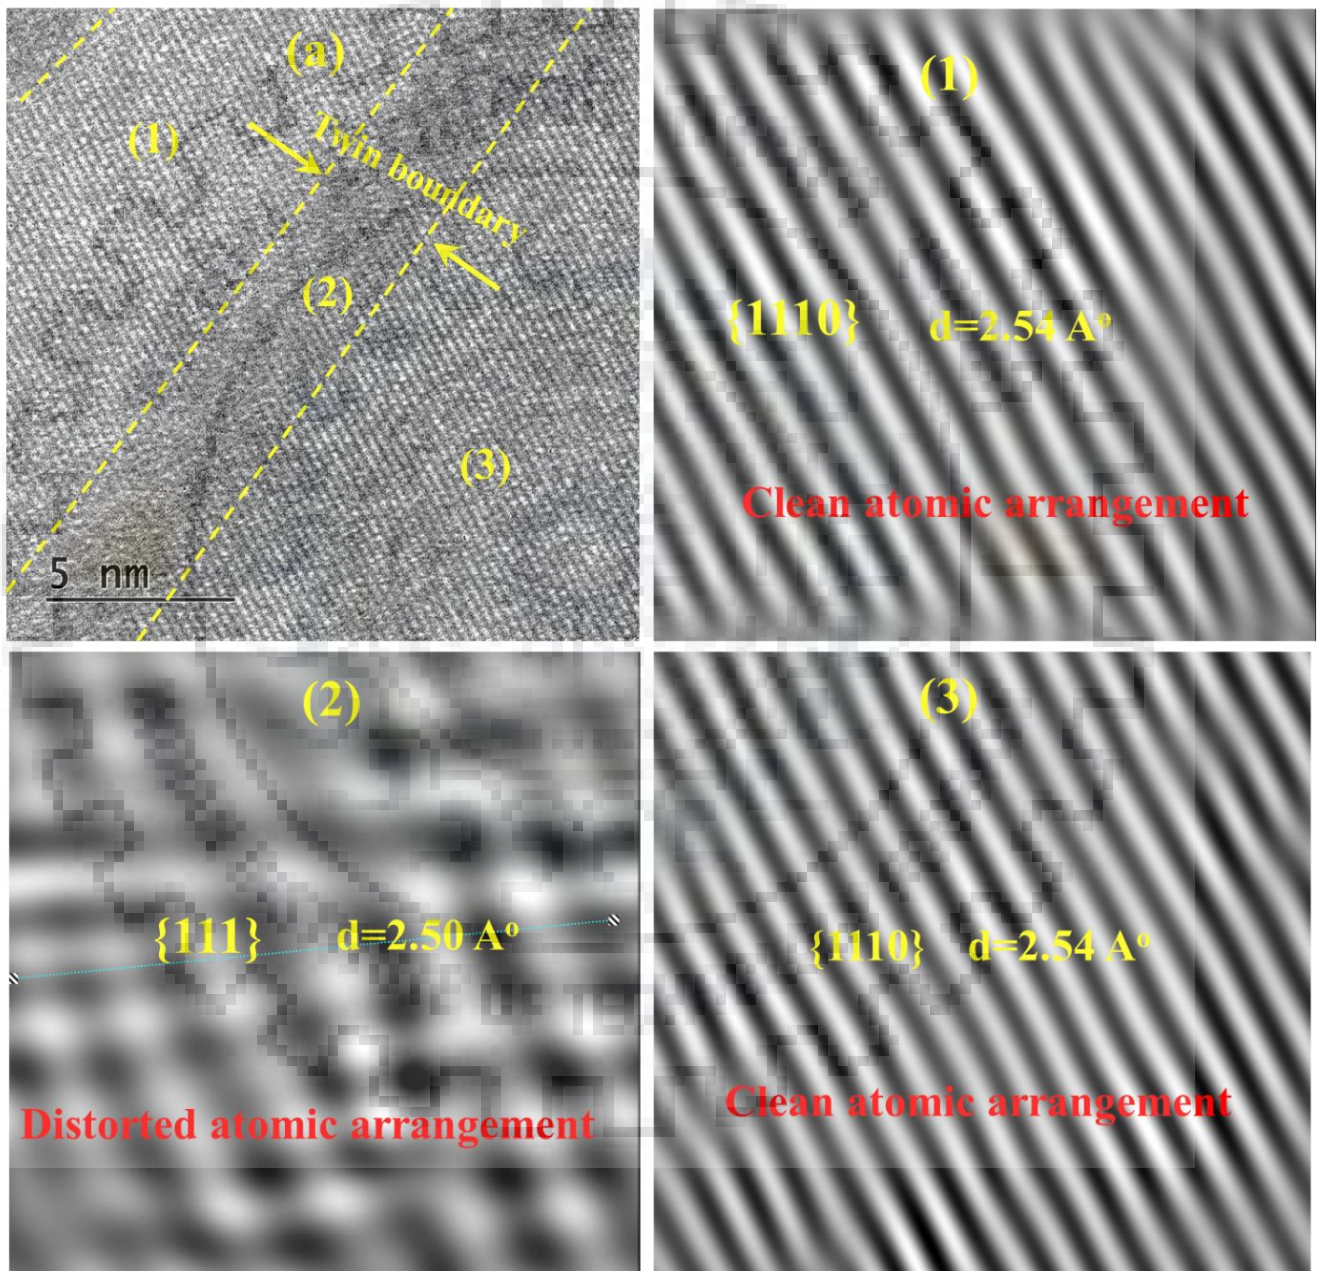
**Figure 7.10.** (a) HR-TEM image of twin, (b, c and d) IFT image of zone 1, 2 and 3 respectively.
