INFLUENCE OF ARCHITECTURAL CONFIGURATION ON BUILDING SEISMIC PERFORMANCE

A DISSERTATION

of
MASTER OF TECHNOLOGY
in
DISASTER MITIGATION AND MANAGEMENT

INDIAN INSTITUTE OF TECHNOLOGY ROORKEE

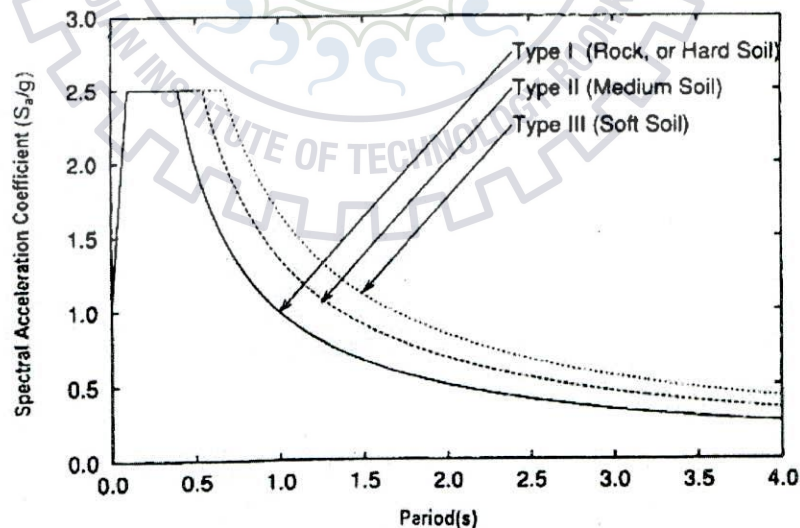
Figure 2.3: Site response spectra

Additional factors to be known are different types of ground and their respective periods (**Figure 2.3**). Structures undergo severe damage in soft ground sites because they amplify forces by lowering the frequency and producing longer periods. But hard grounds such as rock having

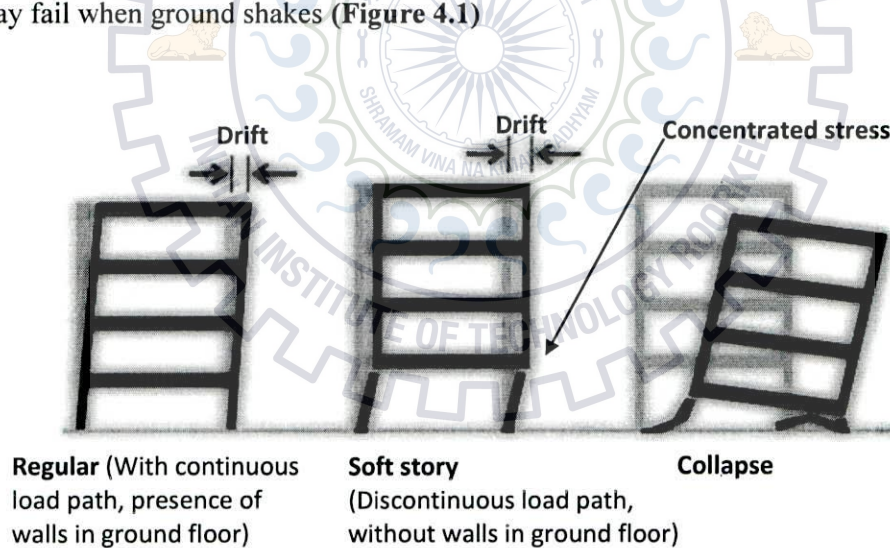
Figure 4.1: Soft story failure mechanism

Generally if there is existence of a building floor that possess a significantly lower stiffness than the others is an irregularity called soft story. As per ASCE 7-10, “the irregularity of soft story said to be existed, if there is a story with the lateral stiffness less than 70% of that in the story above or less than 80% of the average stiffness of the three stories above. We can find soft **first story** as the most common type of soft story irregularities. It is mostly present in modern RC frame buildings when a large number of nonstructural rigid components, such as masonry walls, are attached to the columns of the upper floors of a RC frame structure while the first story is left empty of walls or with a reduced number of walls in comparison to the upper floors for parking and other architectural requirements. The rigid nonstructural components in upper floors can limit deformation of the columns to some extent, modifying the structural performance of the building to horizontal forces. In a regular building, the earthquake shear forces increase towards the first story. So in soft story buildings, the first story columns which have to take axial and shear load also, may fail when ground shakes (**Figure 4.1**)

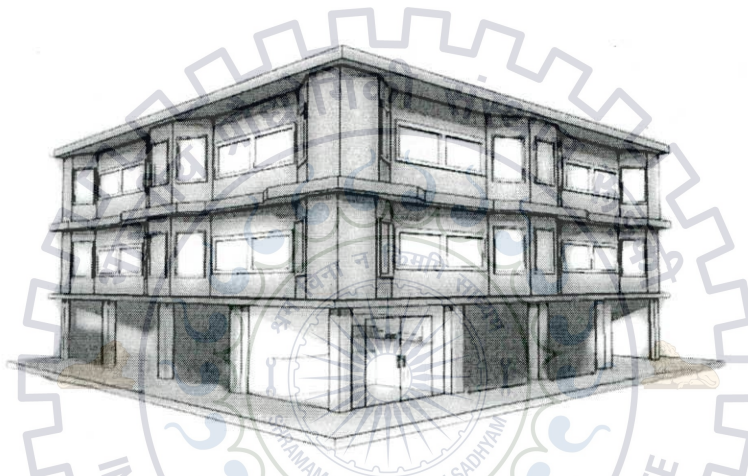
Figure 4.6: Building without walls in the ground floor

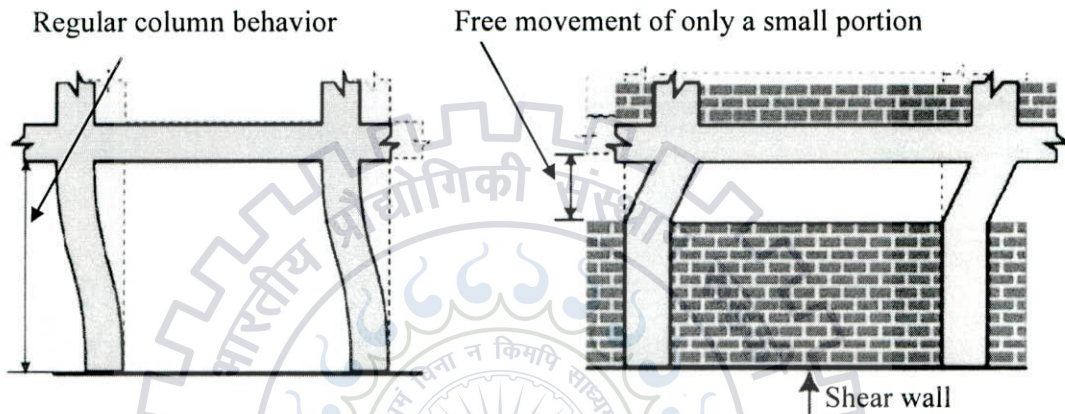
Figure 4.19 Restriction of lateral drift of column leading to captive effect

The captive column or a short column (**Figure 4.19**) comes in picture in a structure when there is a need to provide openings with large horizontal windows for light and air circulation at more than eye level height. Presence of nonstructural elements, which confine partially leading to a **captive column by restricting its freedom to deform laterally** may happen intentionally or sometimes accidental modification to the original structural configuration.
