SEISMIC RETROFITTING OF DAMAGED TWO STOREY RC FRAMED SCHOOL BUILDINGS

A DISSERTATION

MASTER OF TECHNOLOGY

CENTER OF EXCELLENCE IN DISASTER MITIGATION AND MANAGEMENT
INDIAN INSTITUTE OF TECHNOLOGY ROORKEE

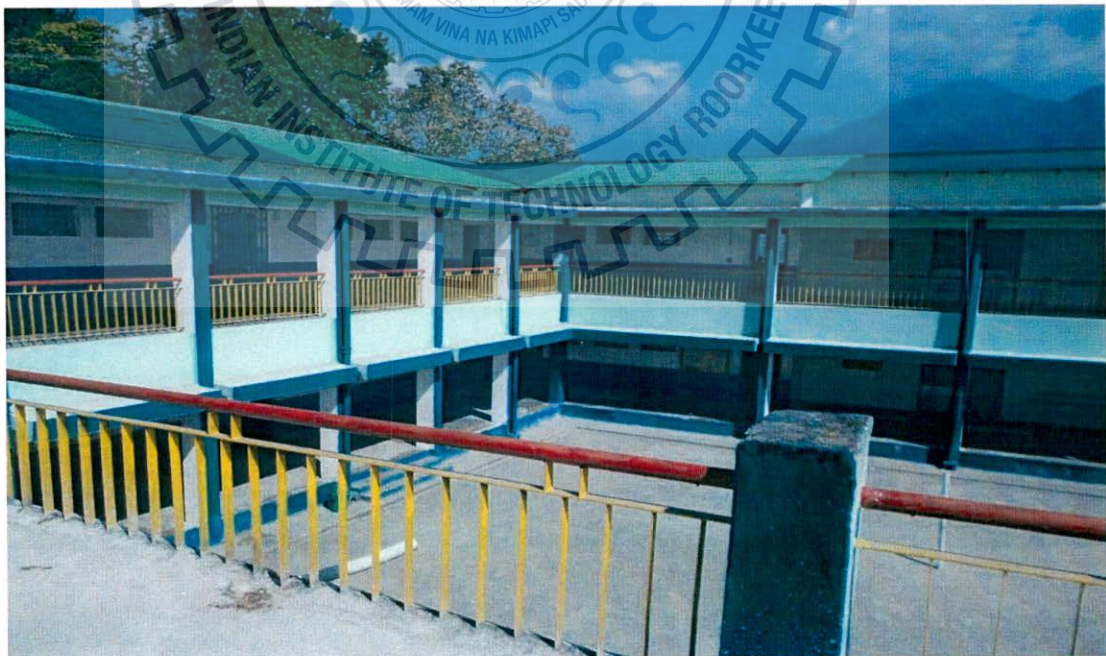
Fig 3.2: Isometric view of Block III (Primary School): 3-sides covered with roof trusses and 1-side open terrace

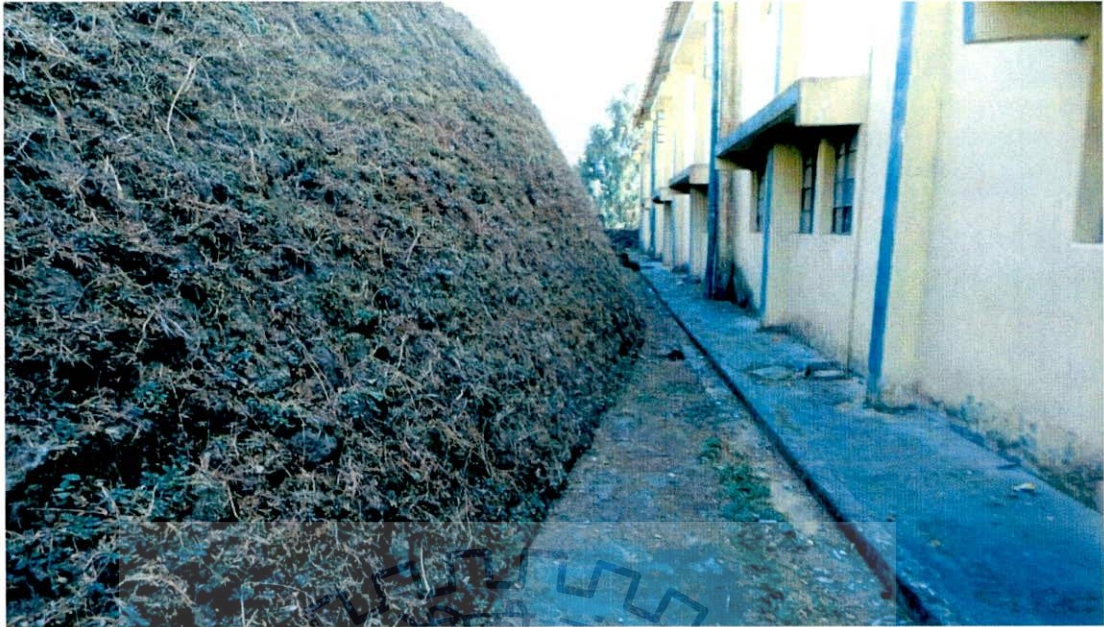
Fig 3.3: Back view of Block II showing soil retained by high retaining wall

while front side has 1-storey with open terrace (Fig 3.3). Tables 3.1 and 3.2 give the details of columns sizes and reinforcement. Building blocks are located on hill slope and having natural aesthetic appearance. Typical layout of Block II, III and IV are shown in figs 3.10 to 3.12.

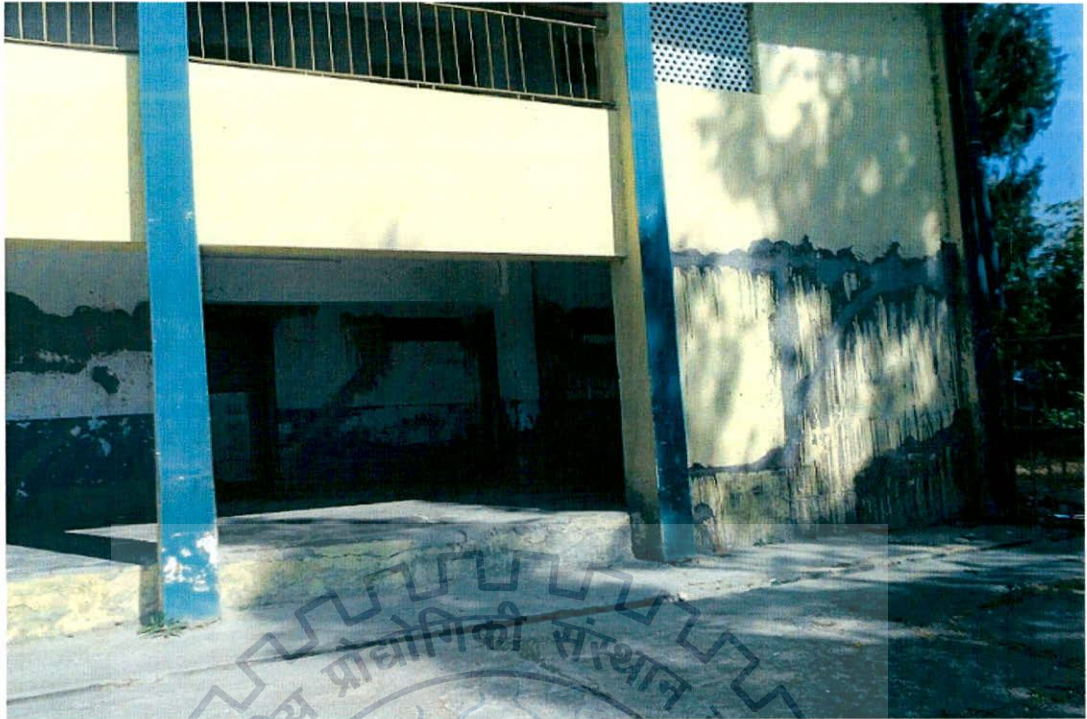
Fig 3.4: Damage in masonry infill panel of classrooms and exterior wall

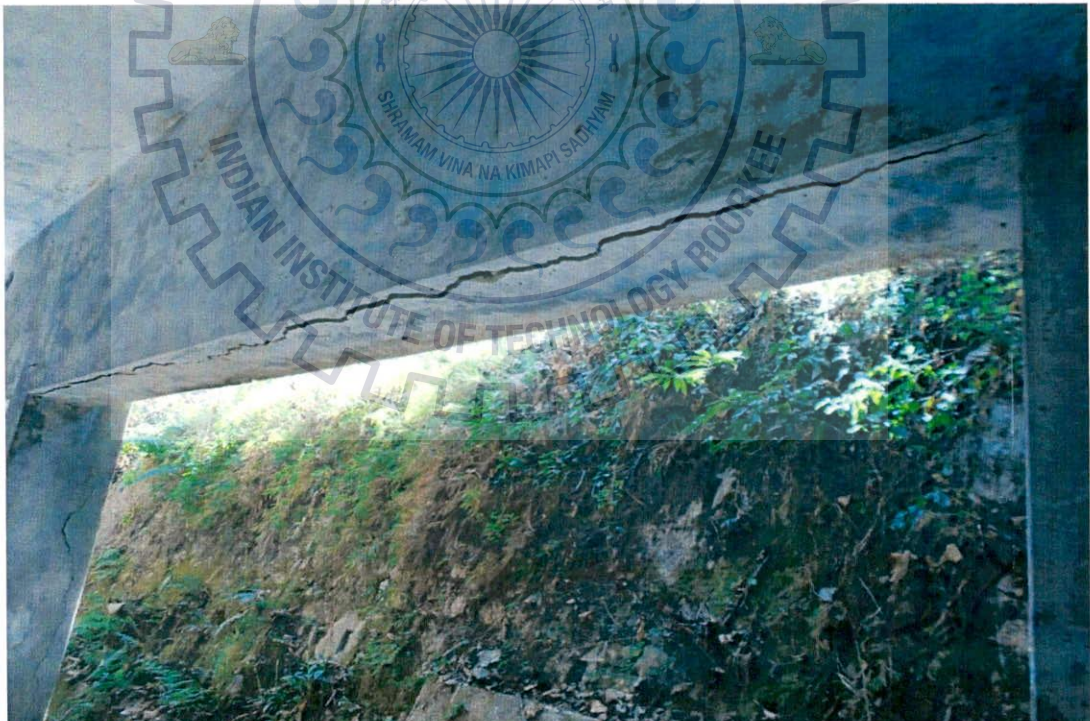
Fig 3.5: Crack in Beam due to corrosion of reinforcement

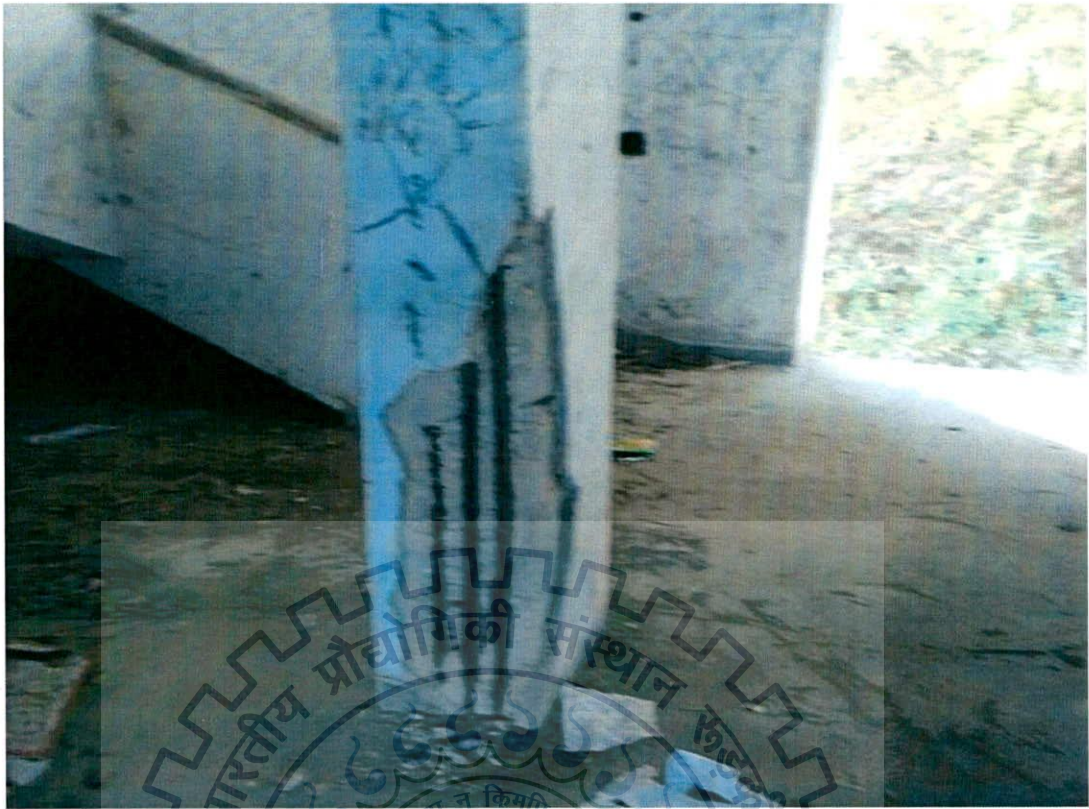
Fig 3.6: Spalling of concrete cover showing missing stirrups

Damages occurred in the blocks may be due to high stresses caused by earthquake forces. Distresses are mostly in the form of cracks in columns and masonry walls (Figs 3.6 & 3.7). Damages are observed in masonry wall of classrooms and exterior wall (Fig 3.4). Bathroom and Toilet portion of the blocks are damaged caused due to dampness (Fig 3.8). Spalling of concrete from column, beam and roof slab has also been observed at several locations. Reason of distress in columns and beams may also be due to spreading of retaining wall (Figs 3.5 & 3.9). After spalling of concrete from column it has also been seen that transverse reinforcement are not provided.

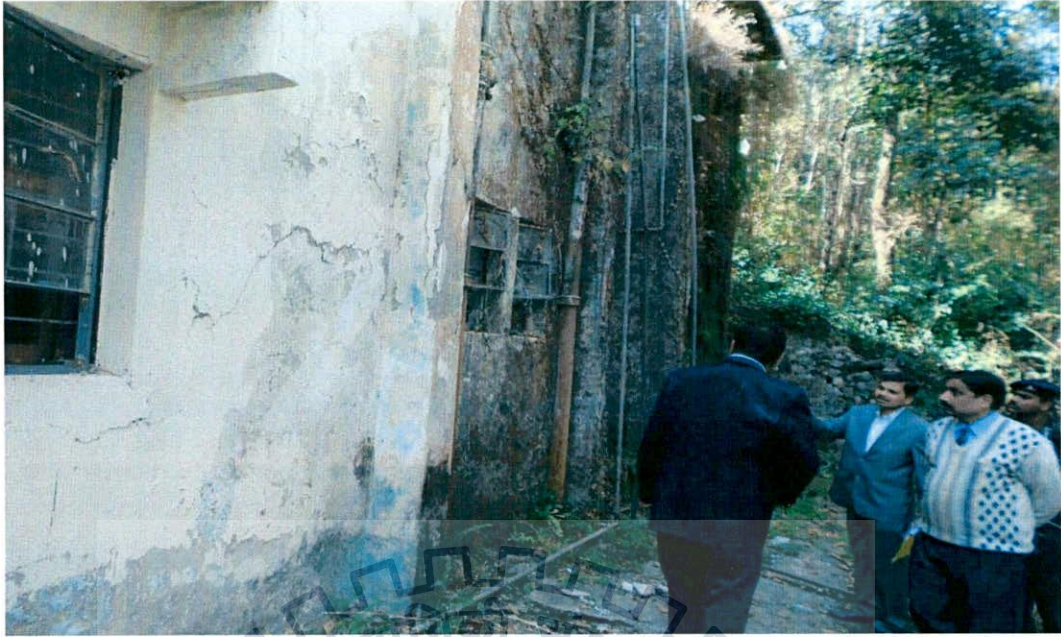
Fig 3.8: Damages due to dampness and appearance of cracks in column

Under DBE demand almost all ground floor infill panel have yielded beyond the IO level limit (Fig 5.13). Columns around the staircase also yield but remains within IO level. Under MCE level ground floor masonry panels have shown to undergo to collapse state which can also be seen in photographs of damages in chapter-3 (Fig 3.4). Columns of corridor and bathroom area yielded beyond IO level which corresponds to damages in the building (Fig 3.8).

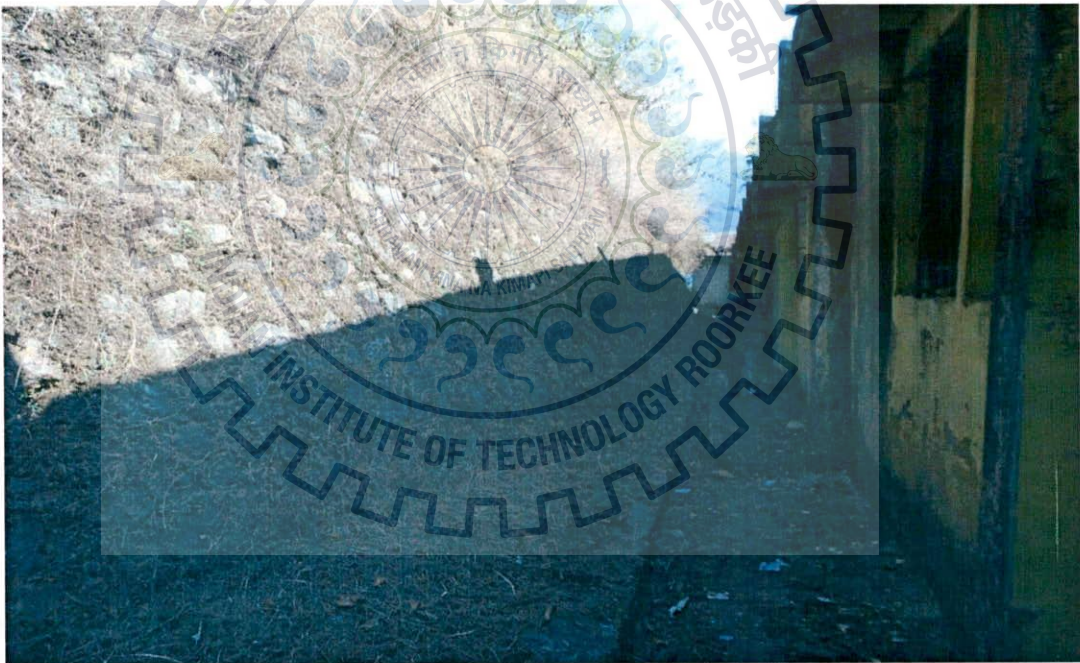
Fig 3.9: Damages in column due to movement of retaining wall

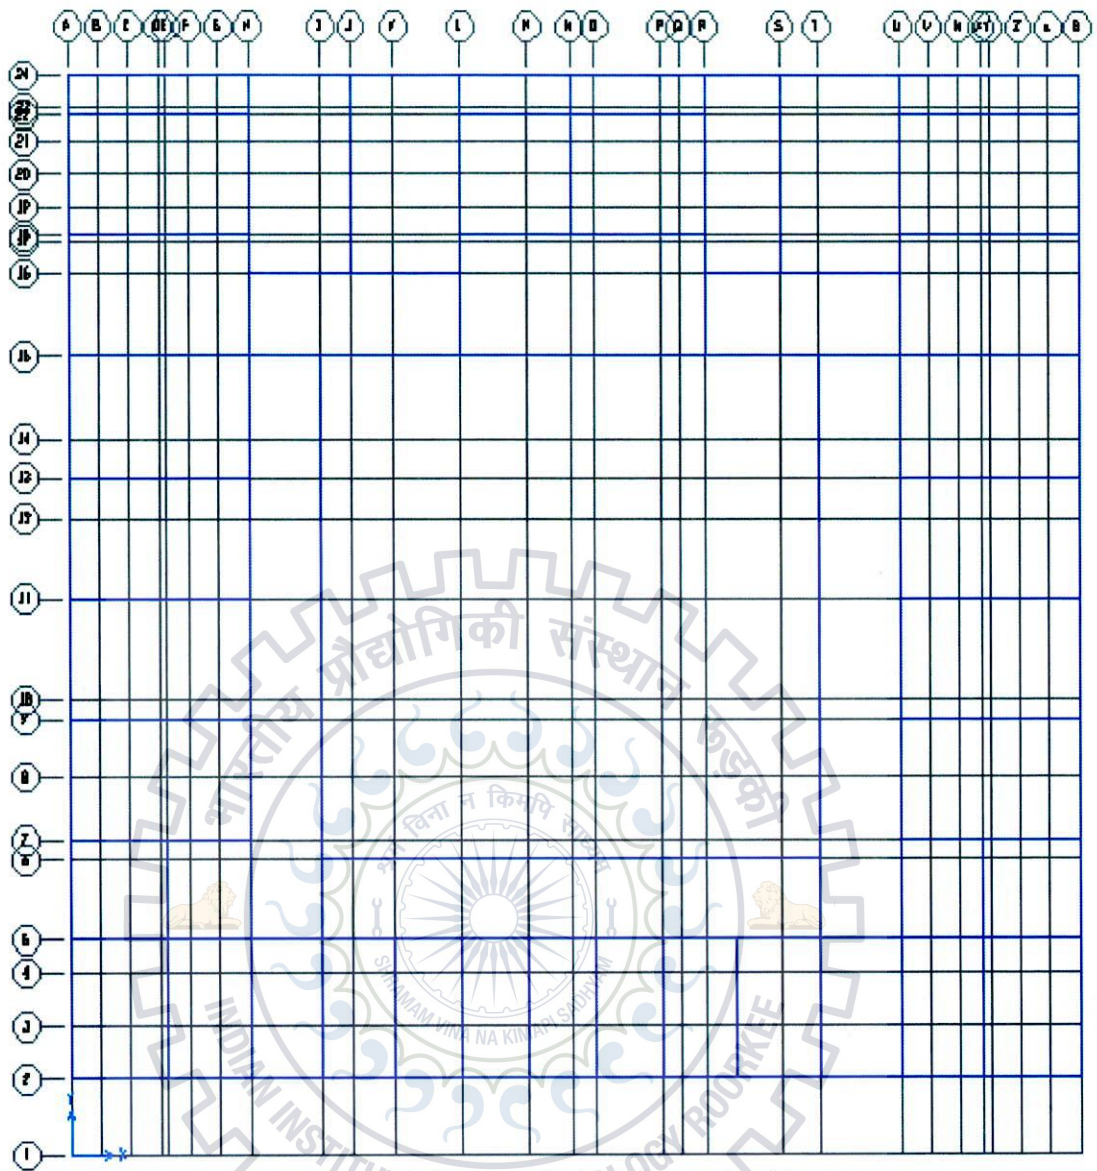
Fig 3.12: Typical layout of Block III and grid pattern

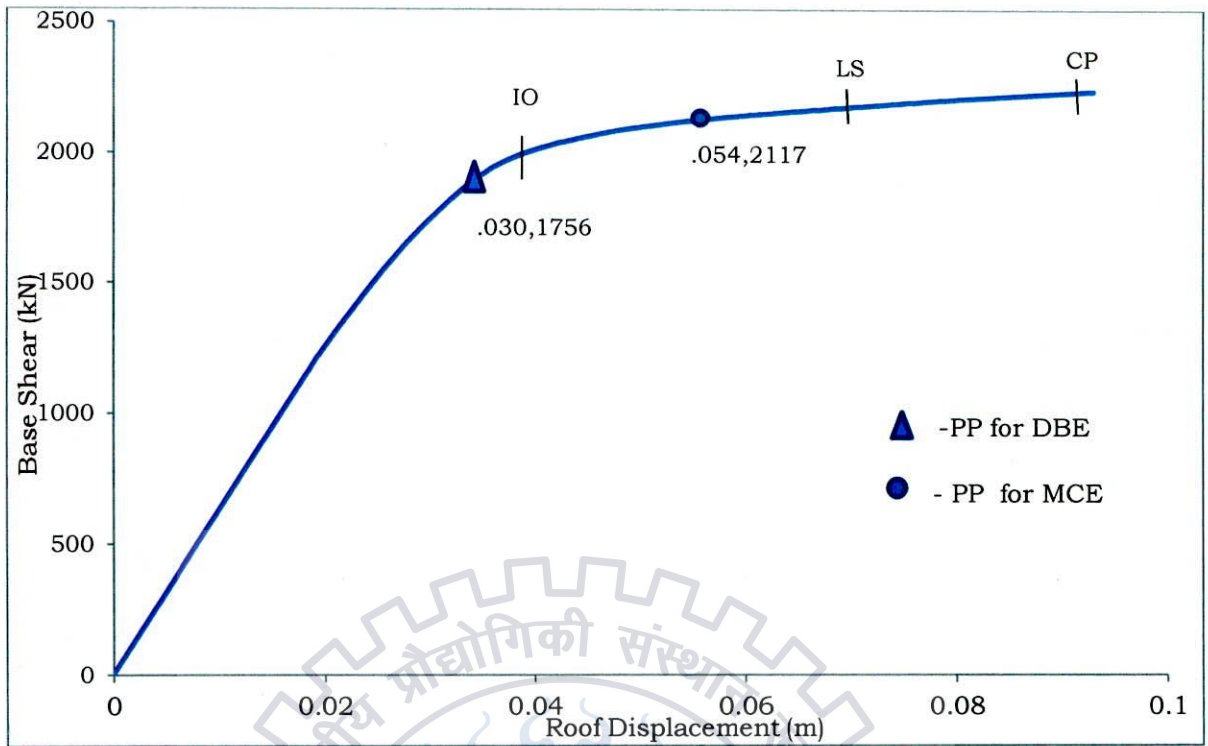
Fig 5.1: Nonlinear Pushover curve of Block II (bare frame) along X (longitudinal)-direction

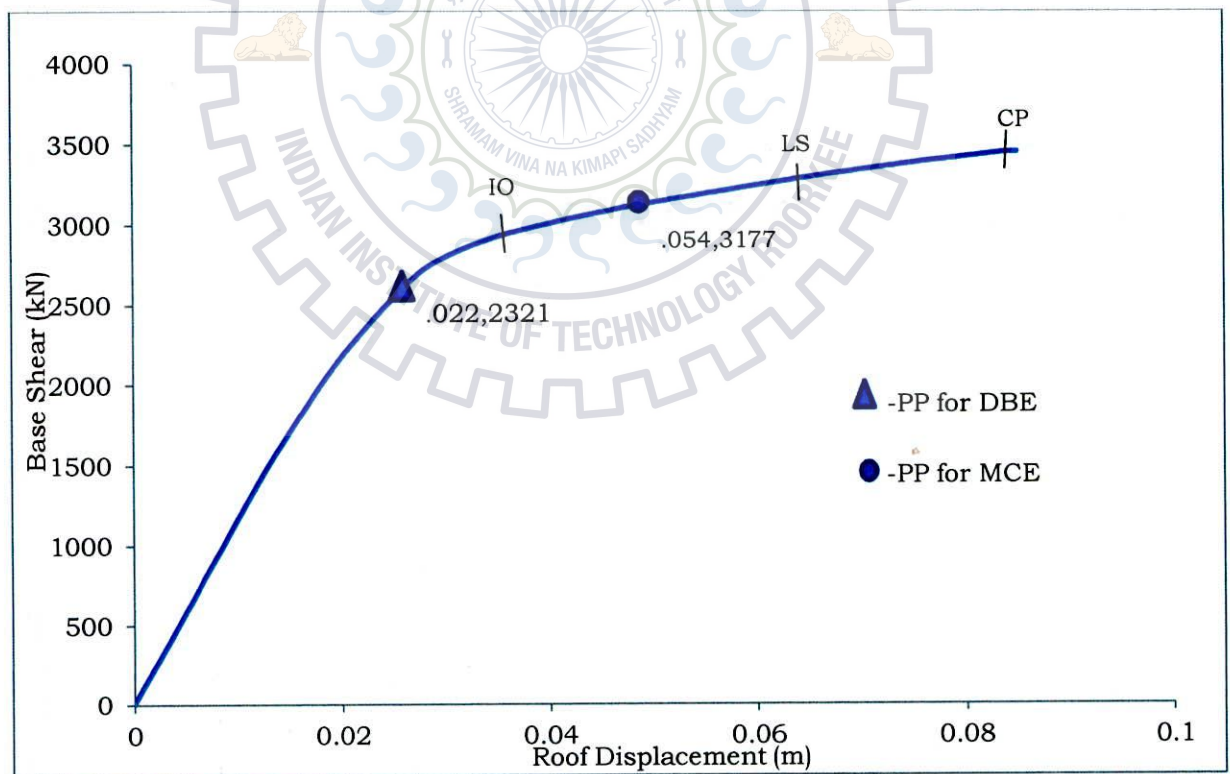
Fig 5.2: Nonlinear Pushover curve of Block II (bare frame) along Y (transverse)-direction

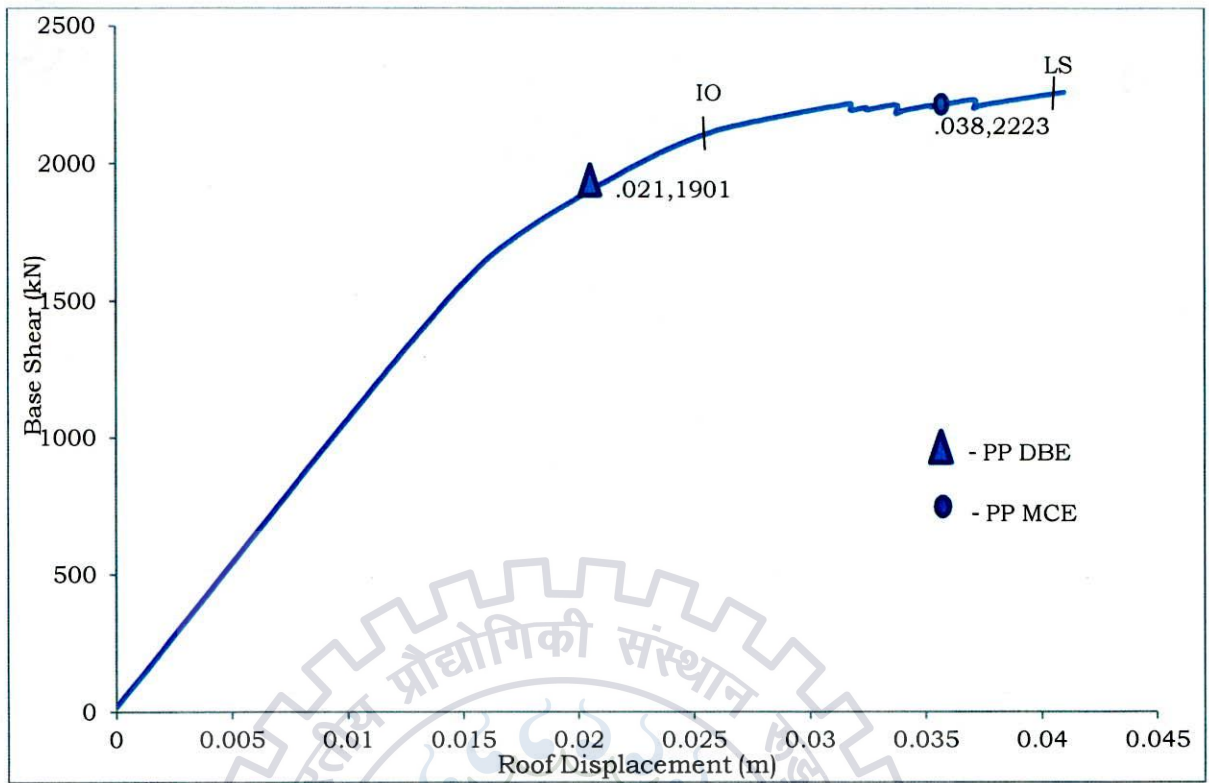
Fig 5.3: Nonlinear Pushover curve of Block II (Infilled frame) along X (longitudinal) direction

Figures 5.3, 5.4, 5.7, 5.8 and 5.12 show saw-tooth curves which represent sudden drop in lateral force caused by failure of infill panels. And in these curves lateral force again quickly increases with displacement due to stiffness of infill.

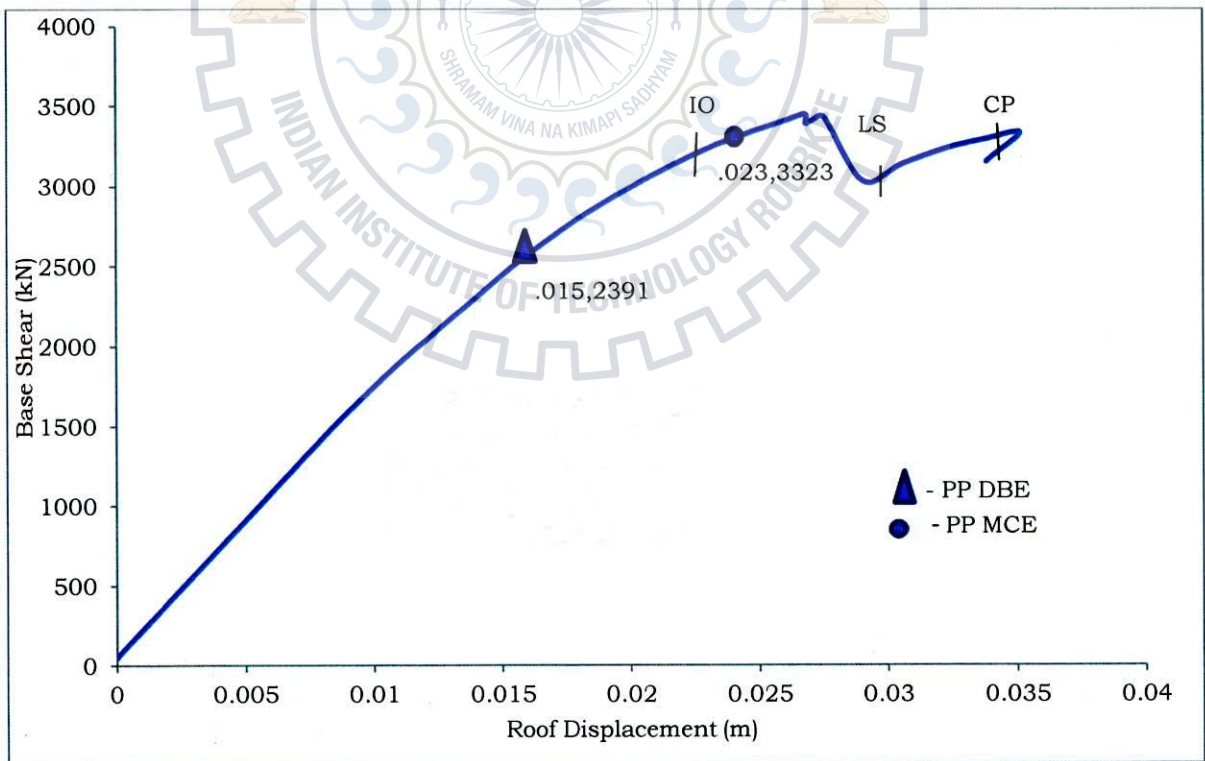
Fig 5.4: Nonlinear Pushover curve of Block II (Infilled frame) along Y (transverse) direction

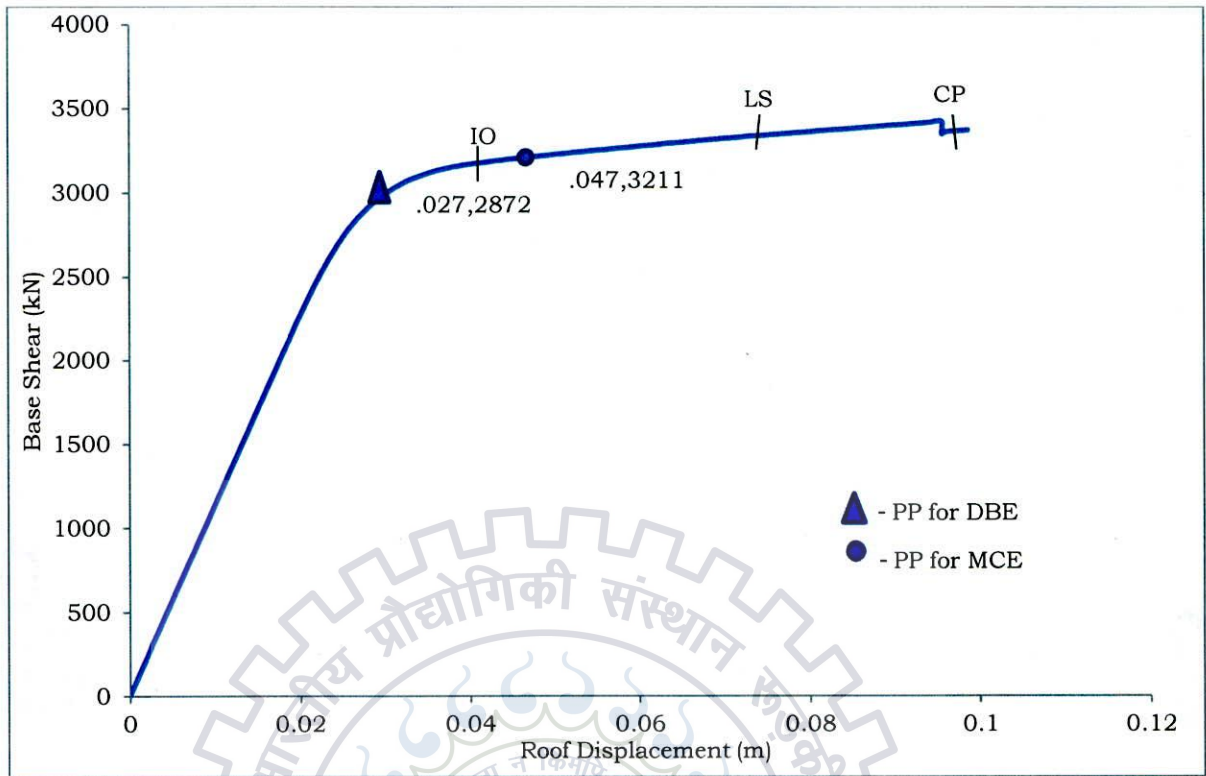
Fig 5.5: Nonlinear Pushover curve of Block III (bare Frame) along X (longitudinal)-direction

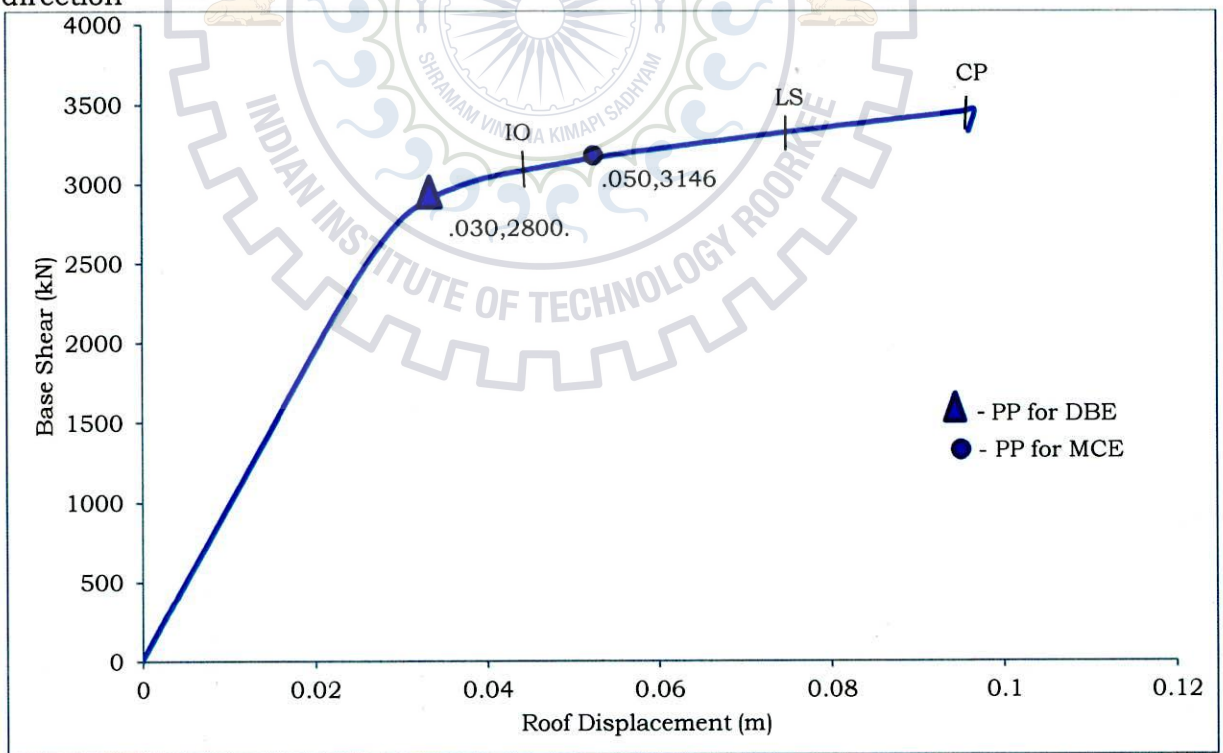
Fig 5.6: Nonlinear Pushover curve of Block III (bare Frame) along Y (transverse)-direction

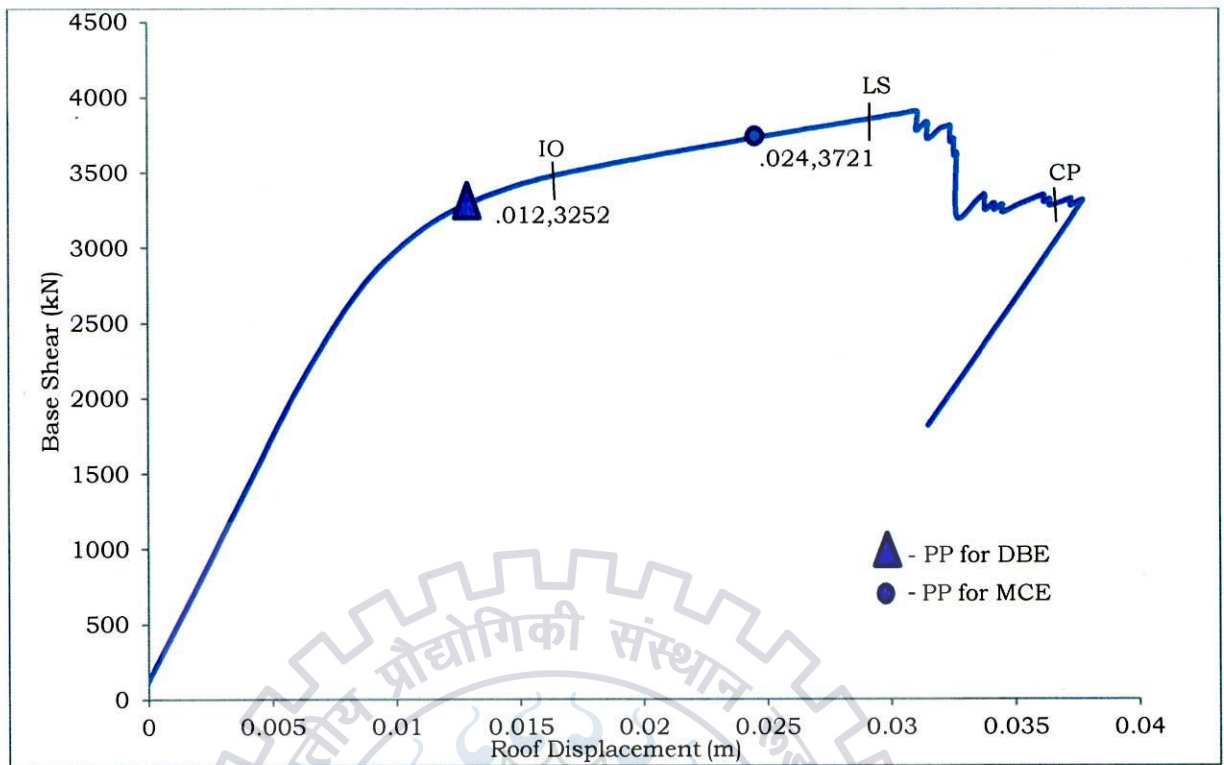
Fig 5.7: Nonlinear Pushover curve for Block III (Infilled Frame) along X (longitudinal)-direction

point has also been evaluated in terms of number of hinges for DBE and MCE level of earthquakes (Table 5.4 to 5.6). It has been observed that blocks are found to be safe for DBE. But at performance point, plastic hinges are formed in columns at MCE level demand. The performance point reaches beyond Immediate Occupancy (IO) level (Figs 5.7 to 5.12).

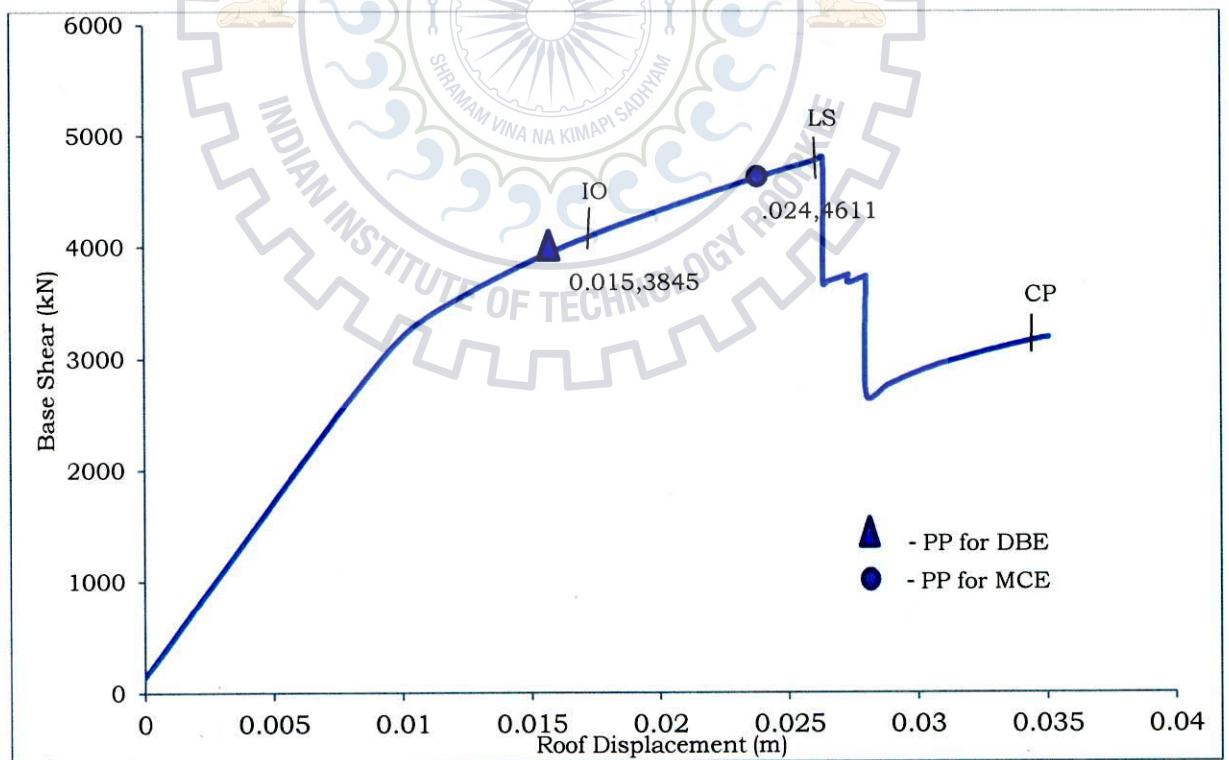
Fig 5.8: Nonlinear Pushover curve of Block III (Infilled Frame) along Y (transverse)-direction

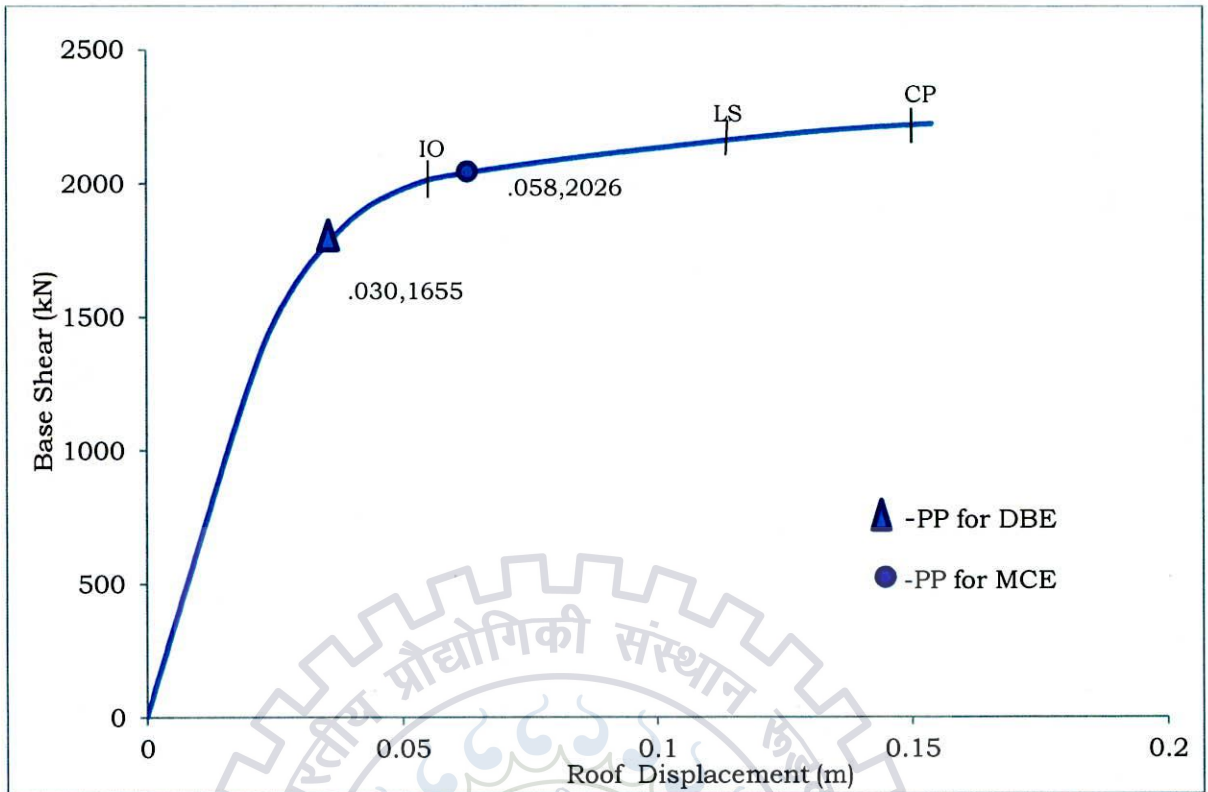
Fig 5.9: Nonlinear Pushover curve of Block IV (Bare Frame) along X (longitudinal)-direction

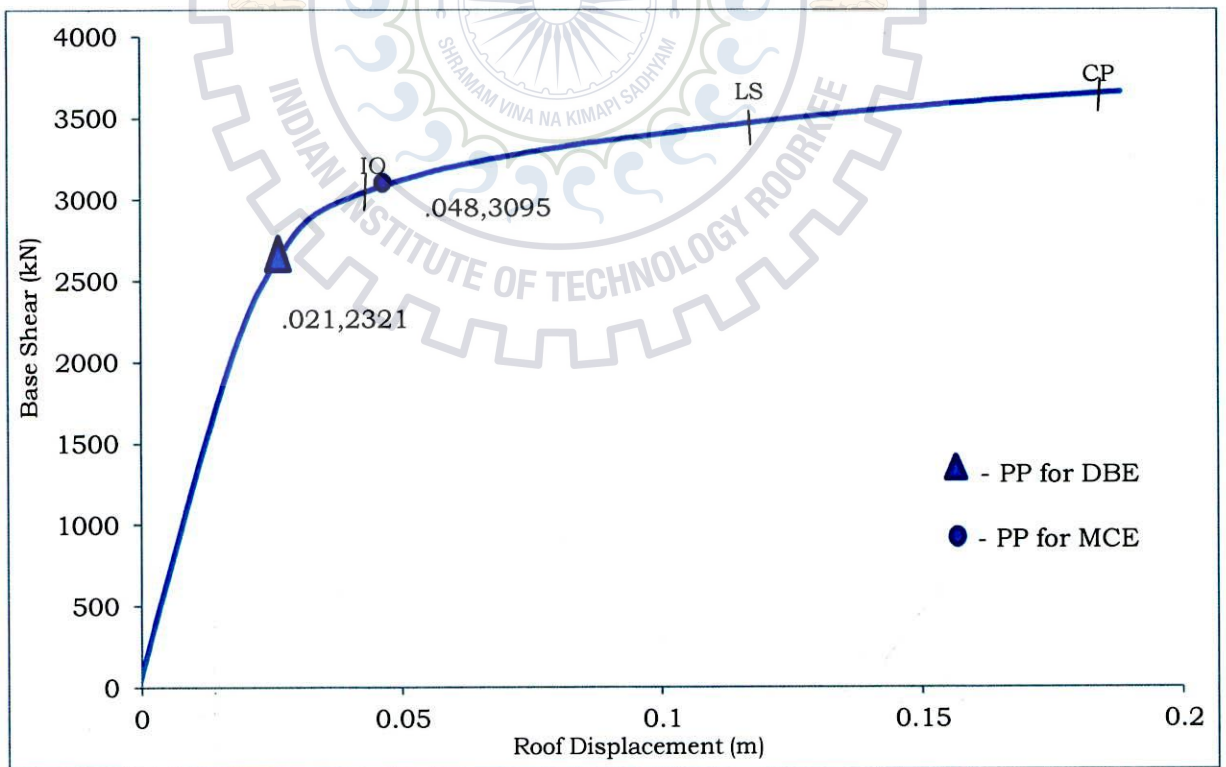
Fig 5.10: Nonlinear Pushover curve of Block IV (Bare Frame) along Y (transverse)-direction

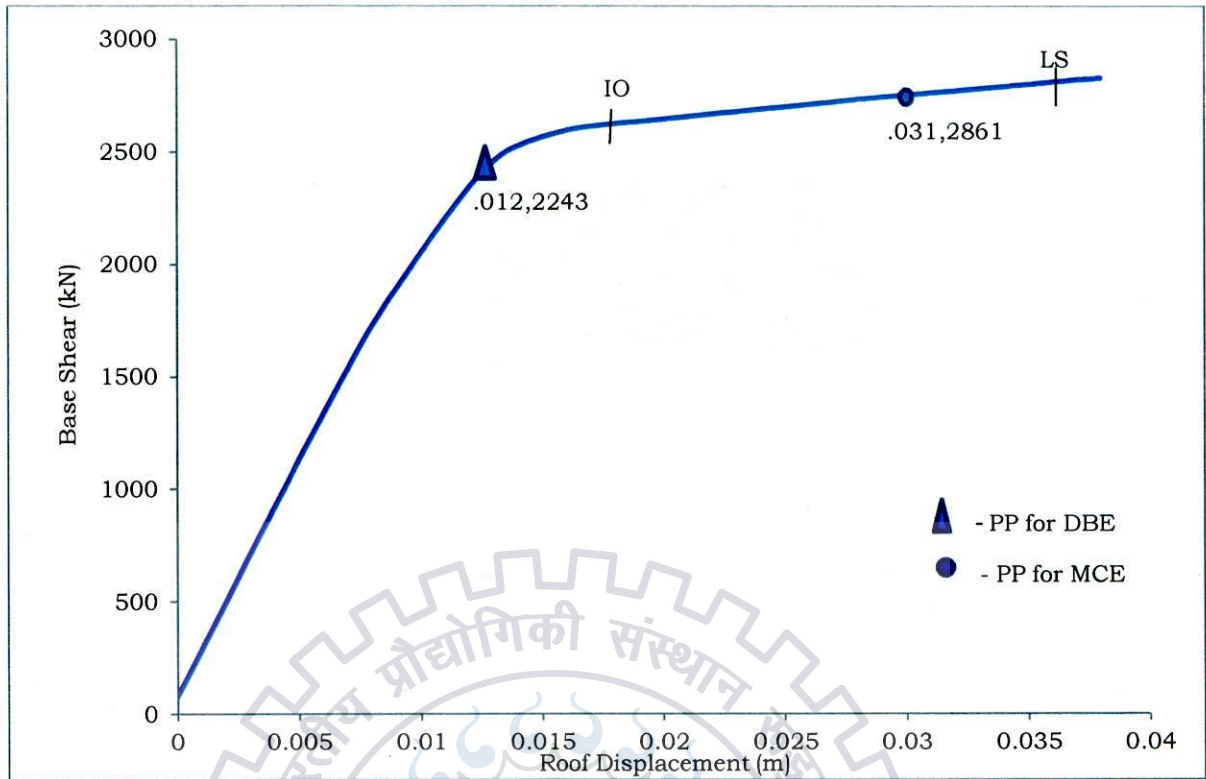
Fig 5.11: Nonlinear Pushover curve of Block IV (Infilled Frame) along X (longitudinal)-direction

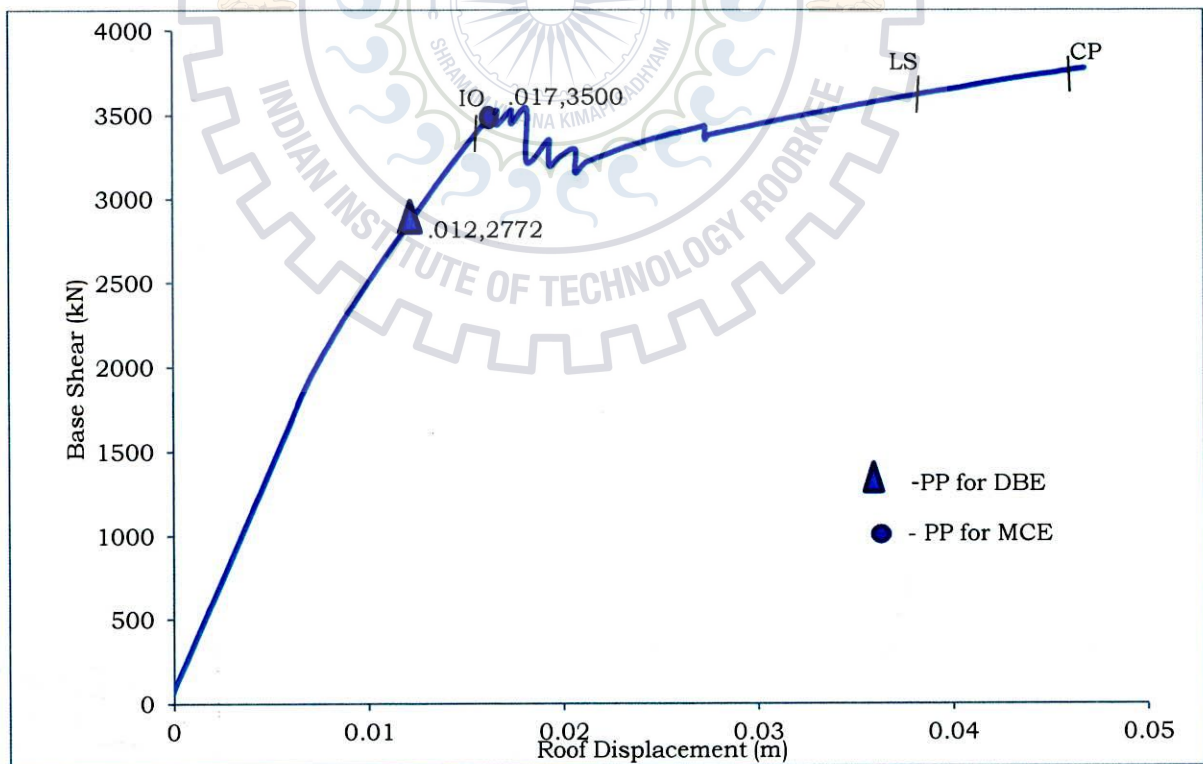
Fig 5.12: Nonlinear Pushover curve of Block IV (Infilled Frame) along Y (transverse)-direction

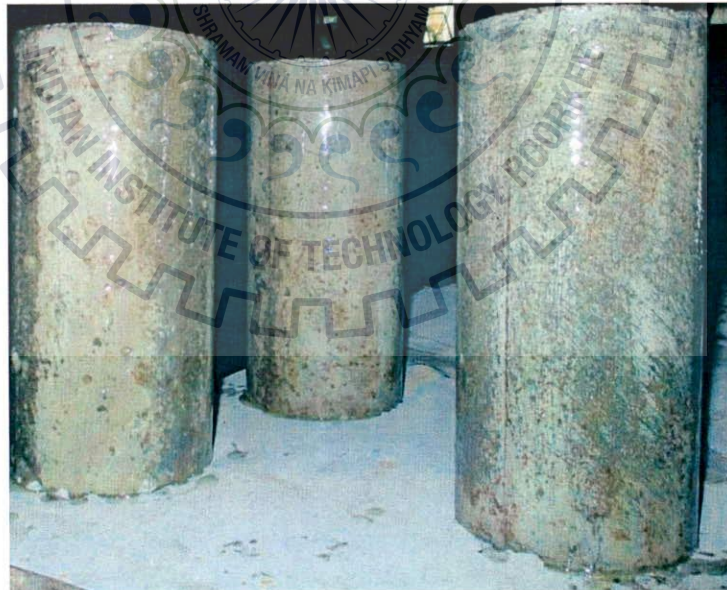
Fig 6.2: Primer coated column before wrapping of FRP

For better confinement and effectiveness of FRP jacket, edges of rectangular column should be made rounded to give elliptical shape [32]. Before wrapping of FRP jacket, primer epoxy should be applied on column to make surface smooth. Primer Epoxy coating also filled of honeycomb gaps of column surface (Fig 6.2). After one day of primer epoxy coating, FRP are wrapped on column and saturated with epoxy resin so that effective bond between concrete and FRP layer (Fig 6.3) can be achieved. FRP jacket should be wrapped at distance of 1 inch from joint to avoid joint failure. The length of hinge region is same as plastic hinge length (L_p) which can be found out by eqn 6.6 [27] or typically taken as 0.5 times of section depth (Fig 6.1).

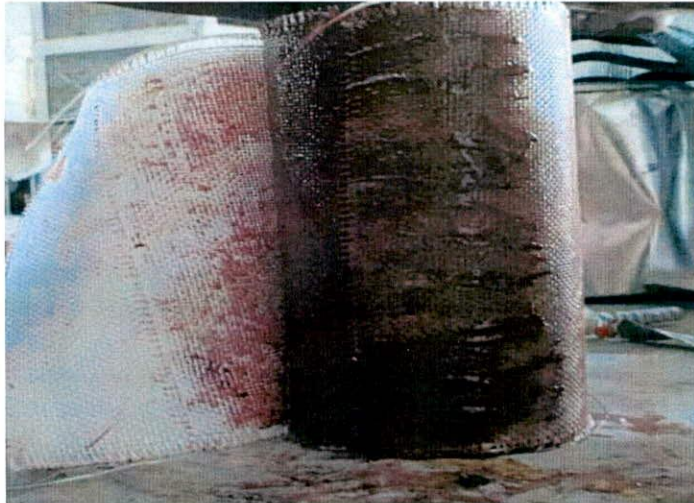
Fig 6.3: wrapping of FRP and saturating with epoxy resin

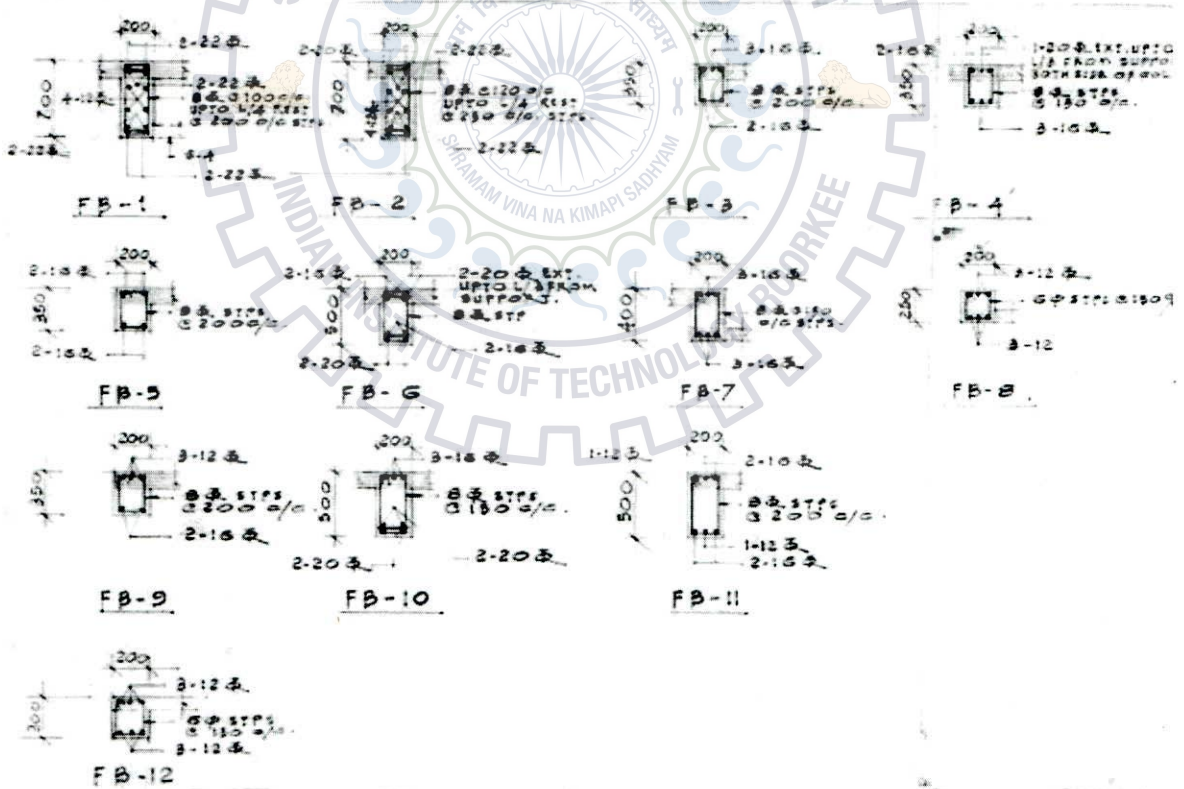
Fig B-6: Detailing of beams for Block II and IV
