# RESILIENCE OF VERNACULAR STRUCTURES TOWARDS EARTHQUAKE

## A DISSERTATION

*of*  
MASTER OF TECHNOLOGY  
*in*  
DISASTER MITIGATION AND MANAGEMENT

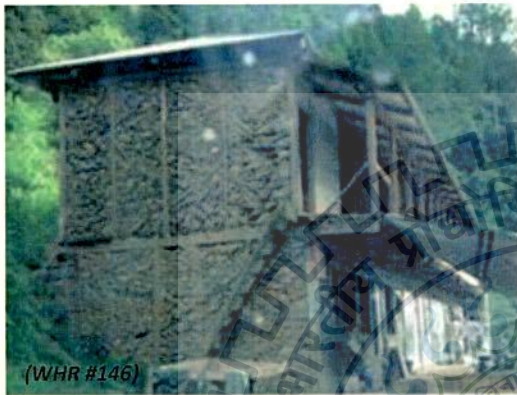
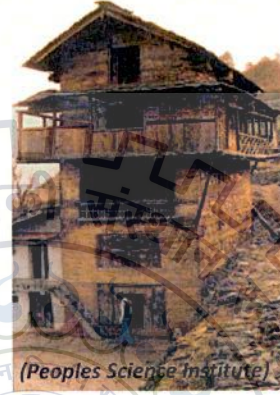
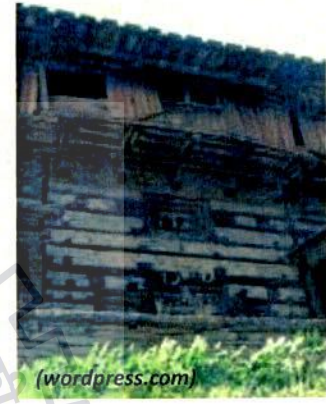
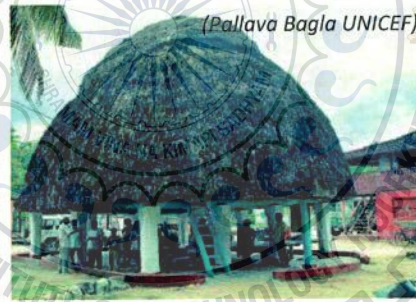
*Dhajji dewari- Kashmir*

*Pherols- Uttarkashi*

*Kat ki kunni- Himachal*

*Nicobarese hut- Nicobar*

Fig.1.3. Various earthquake resistant vernacular structures located at different high seismic zone areas

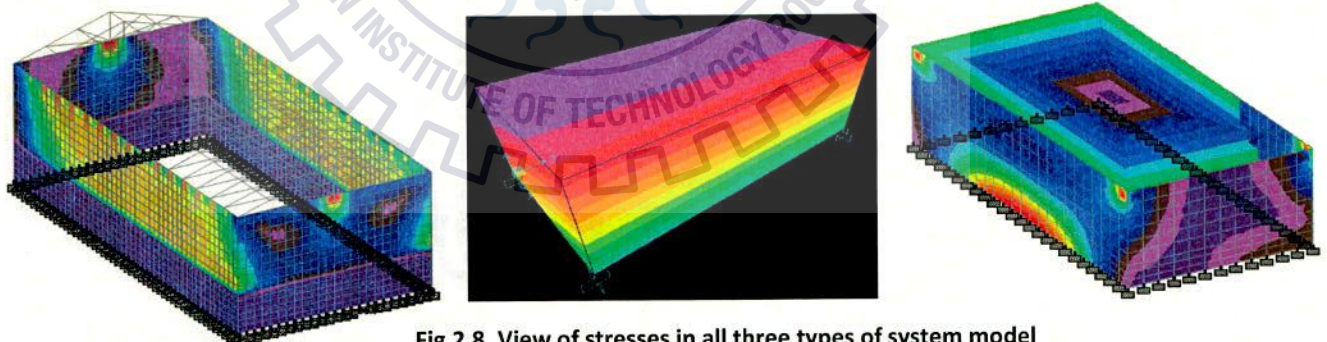
- Through surface generation in software, stress concentration is studied in all three systems

Fig.2.8. View of stresses in all three types of system model

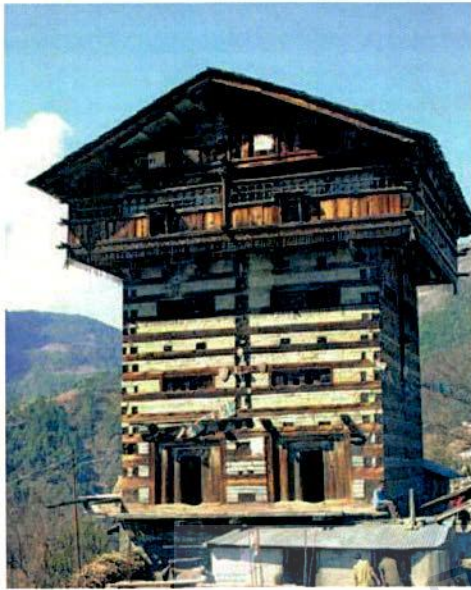
Fig.2.10. Five storied structure in Koti Banal village constructed  $880 \pm 90$  yrs BP  
(Source: Rautela P.)

In a research paper "*Earthquake-safe Koti Banal architecture of Uttarakhand, India.*" by Piyooosh Rautela and Girish Chandra Joshi, equivalent lateral force analysis of a five storied koti banal structure (as shown in Fig. 2.10) is done. Lateral forces on a structure are generated due to its mass during an earthquake.

For this analysis, the methodology is adopted as per IS1893 (Part 1):2002. To transfer the seismic forces to the ground, a building should have continuous load path. In case of Koti banal structures the earthquake forces generated in all the building elements are delivered through transverse walls which get bent between the floors. From the transverse walls, lateral loads move to the side shear walls by horizontal floor and roof diaphragm. From diaphragms forces are distributed to vertical resisting components which transfer these forces to the foundation.

Floors of Koti Banal structure are made of 20–22 mm thick wooden planks are expected to have high degree of flexibility and all the walls are 45 cm dry dressed stone that are highly rigid. These factors adequately fulfil the flexible diaphragm conditions.

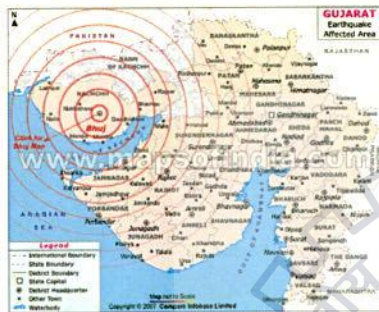
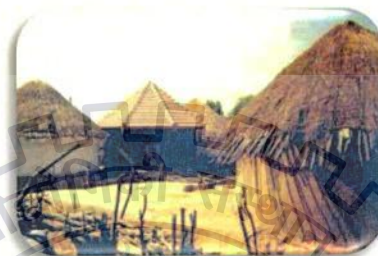
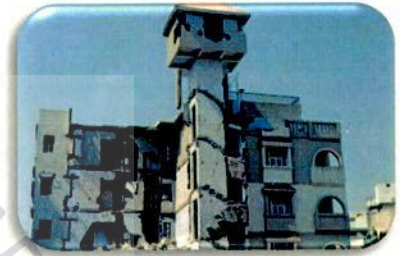
A) Map showing bhuj earthquake, 2001

B) Traditional Bhunga that survived in Ludia village (≈70 km N of epicentre) Modern construction that collapsed in Ahemdabad (250 km E of epicentre)

Fig.3.2. A) Map showing bhuj earthquake of 2001

A study on the earthquake affected structures in the Ludiya village shows the commendable performance of the bhunga houses over other type of houses. Maximum numbers of bhunga houses were in liveable condition as compared to other type of houses.

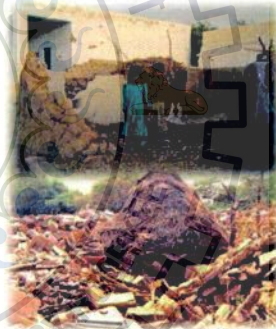
(Choudhary et. Al 2002)  
Fig.3.8. Collapse of adobe wall Bhunga houses

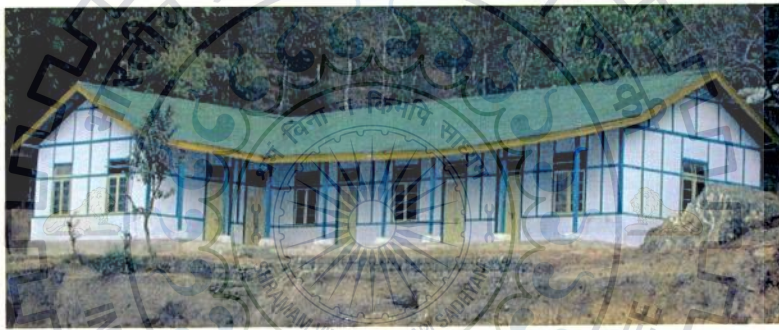
Fig.3.9. A school building in Assam made in Assam/Ikara style  
(Source: World Housing Report #154)

The Assam type construction style was started by Britishers and houses of this style were built in Assam and few neighbouring states during British rule. The old built structures can still be seen in urban areas which mainly consist of government and public buildings. Though this construction is now mainly practiced in rural areas. This construction style is also known as Ikra houses because of the use of reed in the construction. This reed has some special properties because of which it found its use in construction like: Grows in river plains and lake and is thus easily available, Less susceptible to insect attack: made of starch and cellulose, Bonds well with mortar, has Hollow inner core that provides good thermal insulation and does not shrink or flatten while drying.

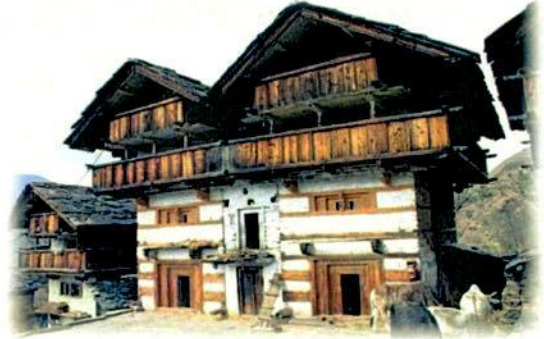
Fig.3.14. Traditional house in Koti- banal village (Source: Rautela P.)

These structures have survived major earthquakes like: 1803 Garhwal ( $M 8.0$ ), 1905 Kangra ( $M 7.8$ ), 1991 Garhwal ( $M 6.8$ ), and 1999 Chamoli ( $M 6.8$ ).

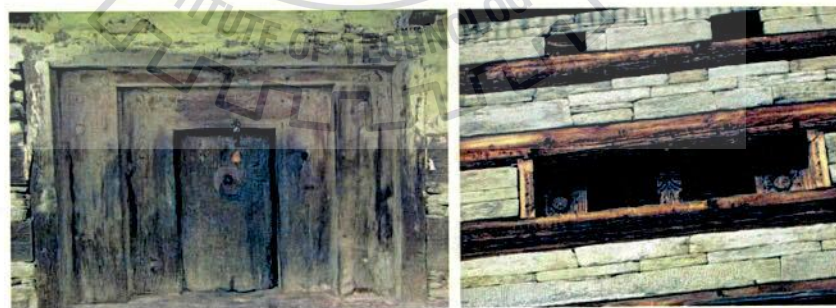
Fig.3.18. Small openings (Source: World Housing Report #150)

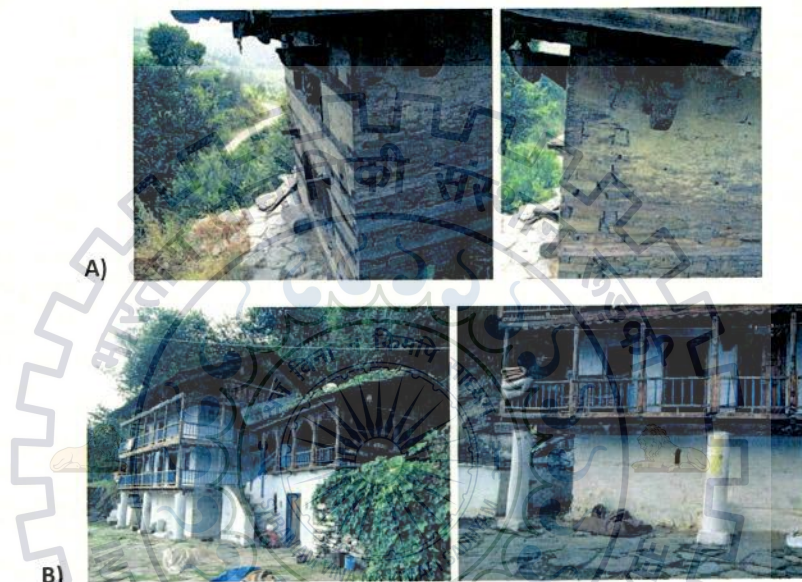
Fig.3.19. A) Increase in distance between timber logs

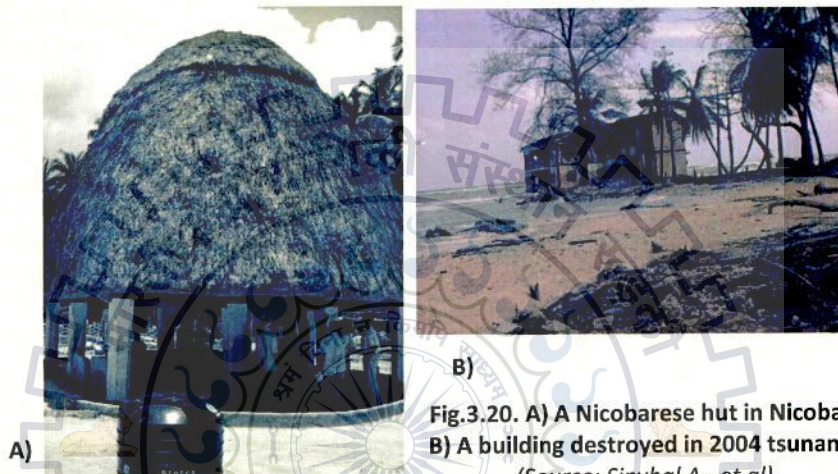
Fig.3.20. A) A Nicobarese hut in Nicobar  
B) A building destroyed in 2004 tsunami  
(Source: Sinvhal A., et al)

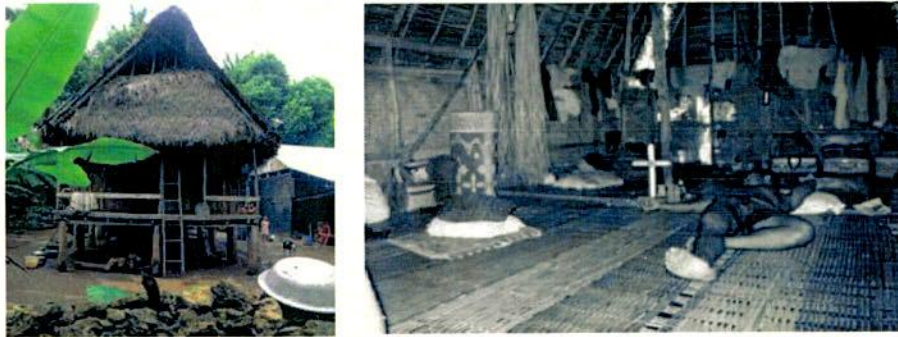
- The huts are circular in plan and made entirely of timber and natural materials.
- Usually there is a single room with one tall post at the centre to support the dome shaped roof.
- The hut is made on stilts i.e. supported on vertical timber posts (height 6' to 8')
- Floor of the hut rests on the horizontal timber members and consists of stiff wooden mat with perforation (for good ventilation in humid climate) on split bamboo floor.
- Wall is a timber (split cane) skeleton also covered with mat.
- The roof dome is made of local thin stems of wood covered over by thick dry bushes.
- Coconut tree stem are used for horizontal and inclined supporting member.
- All connections are tied by rope. No nails are used.
- Ladder is used for access to the hut.
- Comfortable (ventilated properly), eco friendly and earthquake resistant.

Fig.3.21. A) A Nicobarese hut on timber stilts and ladder for access (Source: Rawal.V, et.al)  
 B) Interior of the hut showing perforated mat (Source: Sinvhal A., et al)

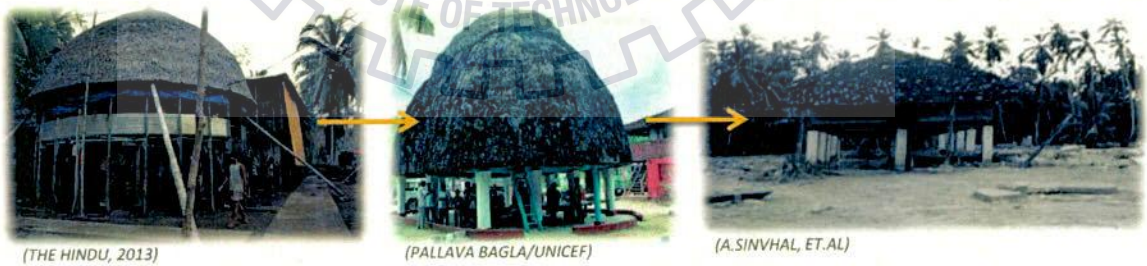
- Change in plan from circular to rectangular or square.
- Timber stilts replaced by plain concrete stilts.
- Use of concrete moreover with poor quality concrete mix consisting of sea gravel, sand and cement in the ratio 4:6-10:1.
- Water mixed without any measurement, to make the concrete workable. No steel used.
- Construction of masonry walls instead of wooden mat. (or walls made of same mix as that of concrete column)
- Sometimes, there is no connection between the concrete stilts and the horizontal wooden floor members.
- Dome shaped roof modified to hipped roof with sloping GI sheets.
- Stilts got shorter and gradually disappeared.

Fig.3.22. Evolution in design of Nicobarese huts

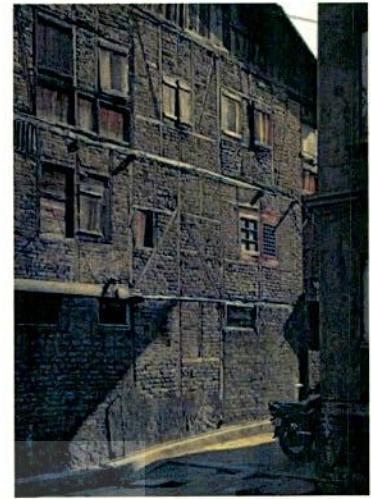
Fig.3.23. Dhajji dewari structure in Kashmir

This traditional style found mainly in western Himalayas, is a style developed by people to survive in adverse seismic conditions. These structures performed reasonably well than other types of construction during 8<sup>th</sup> Oct 2005 earthquake (M 7.6) in which 86,000 people were killed. An example of survival of 3 storied dhajji dewari house was seen, within the epicentral distance of 30 km, in the Baramulla district post-earthquake. Though the house was damaged but all its occupants were saved.

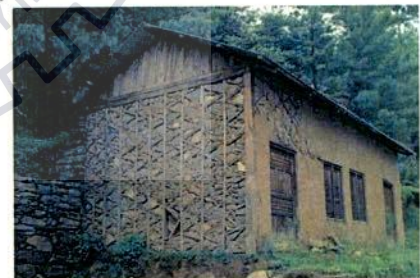
Fig.3.25. Dhajji dewari house showing bracing, masonry and mud plaster (Source: World Housing Report #146)

- Construction is generally square or rectangle in plan.
- Houses are typically 1-4 storeys tall.
- Superstructure consists of elaborate braced timber framework.
- Spaces between bracing and frame filled with stone or brick masonry which is laid in mud mortar.
- Timber framing and bracing is erected first, so that the masonry does not directly carry vertical load.
- Finished walls are plastered in mud mortar.
- Roof is either flat timber and mud roof or pitched roof of GI sheets.
- Roof is generally laid first to stabilise the timber

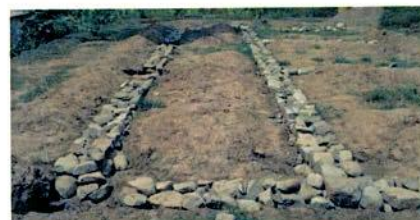
Fig.3.26. Shallow foundation of rubble stones (Source: World Housing Report #146)

- Floors of the house are made with timber beams that span between opposite walls.
- Timber floor boards are overlain by layer of mud.
- Structure is made on shallow foundation of rubble stone masonry.

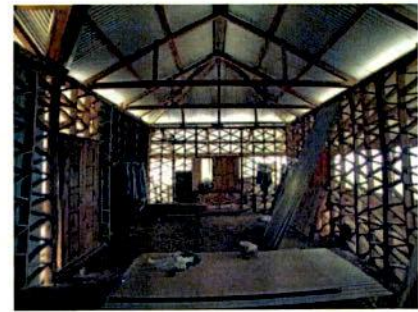
**Fig.3.27. Timber framework and bracing with pitched roof** (Source: WHR#146)

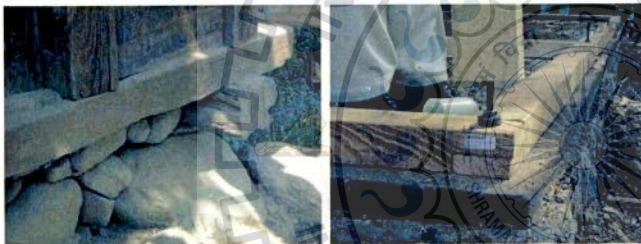
- Addition of new space, to the old existing construction, by building upward or horizontally.
- Anchoring of timber plinth beam to the foundation instead of directly keeping it on plinth.
- Raising plinth beam above the ground to avoid rotting of timber instead of building frame directly on the ground.

**Fig.3.28. Evolution in connection of plinth to the foundation** (Source: World Housing Report #146)

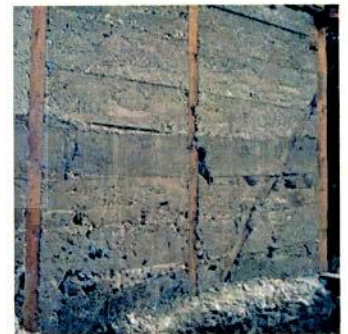
**Fig.3.30. Various bracing patterns and masonry laid in concrete** (Source: World Housing Report #146)

- Providing nailed and strap connections instead of just wooden joints.
- Evolution of various types of extensive bracing patterns.
- Sometimes, timber and stones are laid in concrete. Holds risk of entire panel fall out as rigid object.

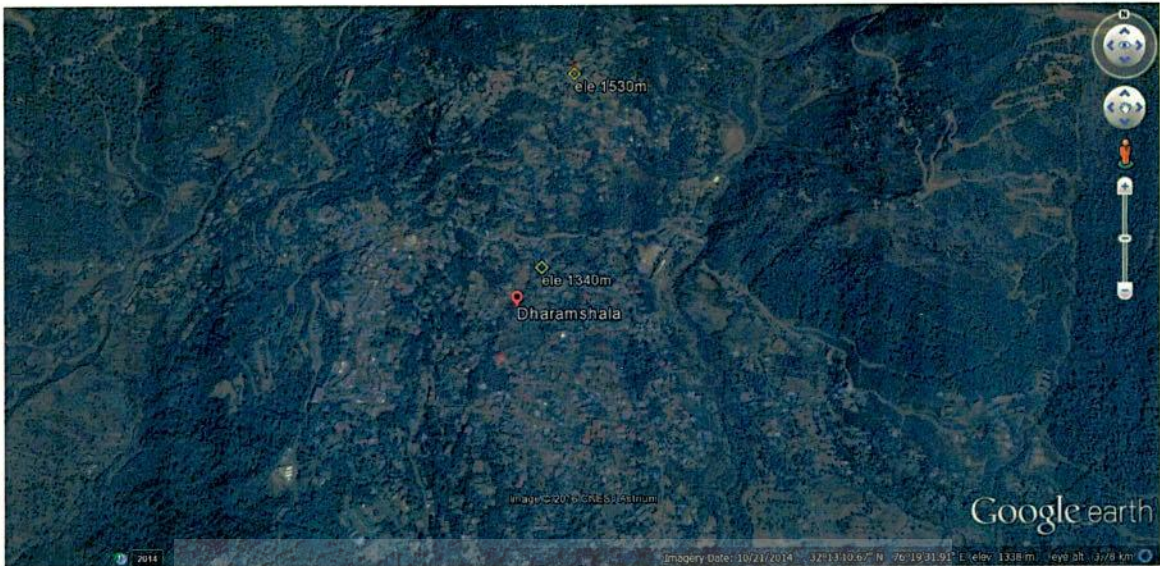
Fig.4.3 A) Dharamshala in Kangra district

Dharamshala, lying on the spur of Dhauladhar range, is the district headquarters of the Kangra district. It is a growing city with lot of modern development coming up on its hilly terrain. Reason behind this development is that Dharamshala is a place of tourist interest. McLeodganj in its upper reaches is home to Dalai lama. During the 1905 earthquake, Dharamshala and McLeodganj were most affected areas. But still the lesson is not learnt. Modern construction, irrespective of proper planning and hazards, is happening with the availability of area for construction. Satellite image shows the settlements that have covered the hill from ridge to valley.

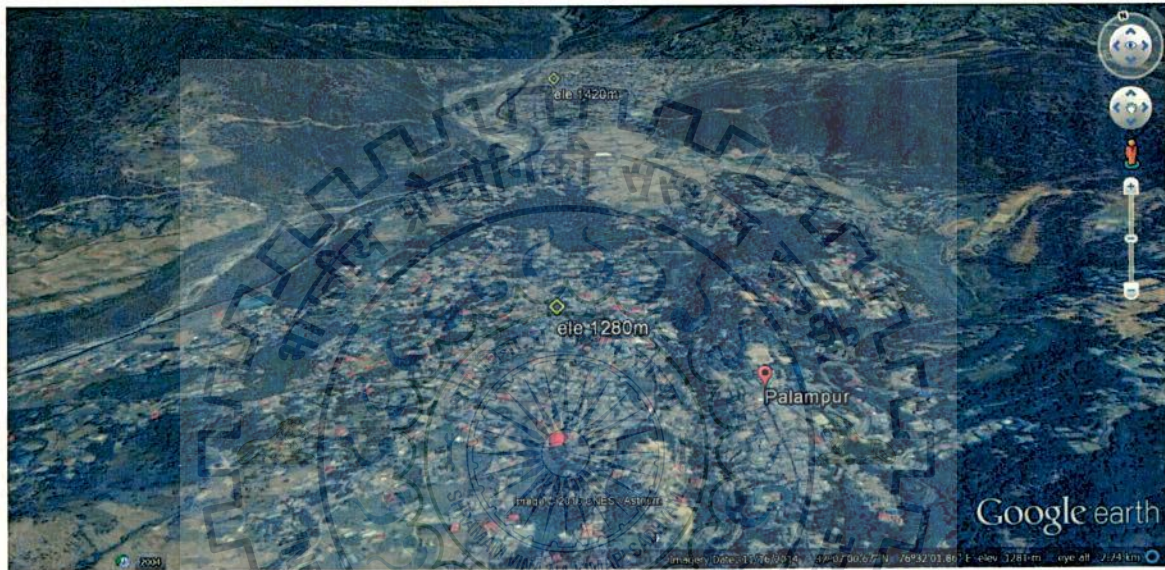
Fig.4.3 C) Palampur in Kangra district

**P**alampur is a town located at the junction of plains and the hills. Numerous streams from the snow peaks of Dhauladhar range spread in the plains. Streams may remain dry during the winter season but get water during the summers. The settlements located in the plain area may suffer liquefaction damage, because of abundance of water, during earthquake. And those at the gradually rising elevation can be prone to mudslides.

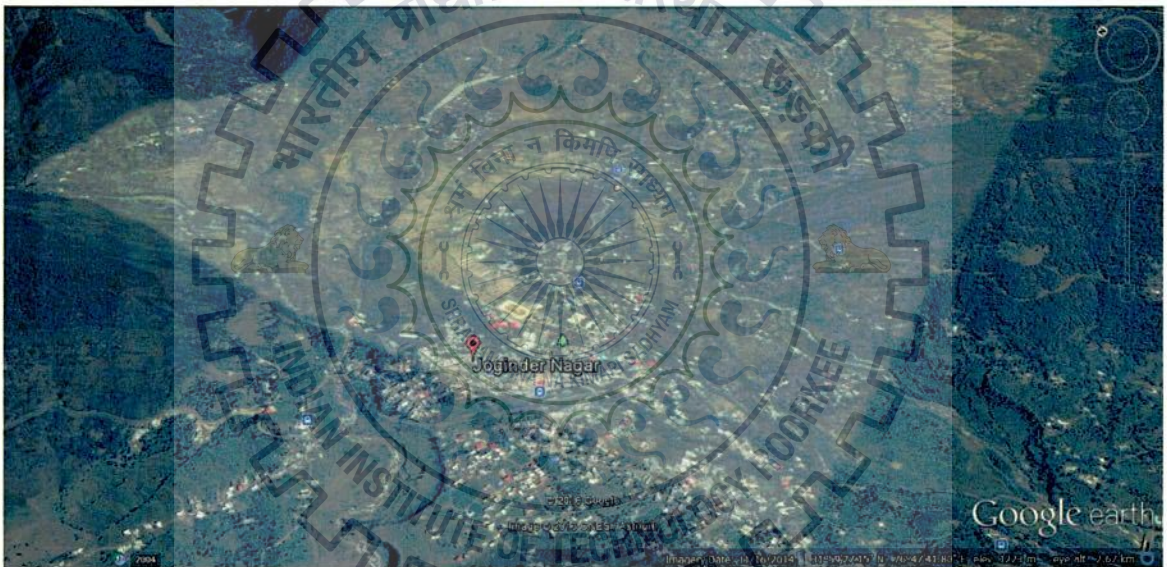
Fig.4.3 E) Jogindernagar in Mandi district

Jogindernagar is a town located in the valley, surrounded by hills on all sides, in Mandi district. Various streams from the surrounding hills pass through the region on gentle slope. Flash floods can be initiated in this area if landslides happen on the upper reaches due to earthquake. Also there are few hydro-electricity power station that can affect the settlements, if get damaged due to high intensity earthquake.

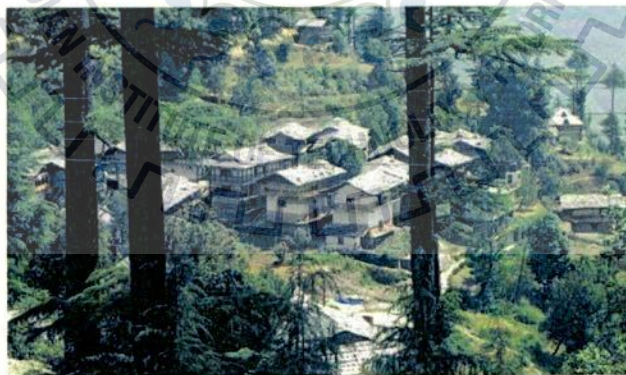
Fig.5.1. Image showing vernacular settlement in the Himalayan region  
(Source: Kumar, A.et al. 2013)

- The vernacular structures have survived for years in difficult terrains by following simple construction techniques. The development of traditional settlements are carried out with careful consideration of the context i.e. the surrounding physiographic features. The structures are generally constructed along the contours so as to reduce the site development work which involves cutting and filling of slopes. Usually the firm ground is used for construction. Vernacular structures merge well with the surrounding environment and have minimum impact on environment.

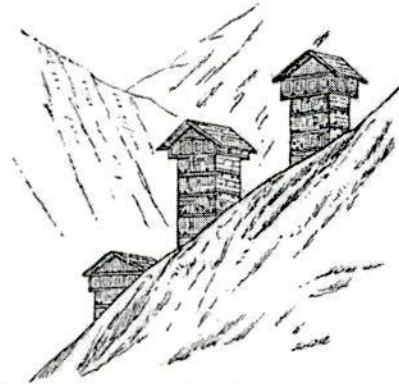
Fig.5.2. Sketch showing Koti banal houses in Kangra valley (Source: Middlemiss 1910)

- In vernacular construction, the structures are planned such that they are separated from each other. And also they are clustered around an open space. During the dormant period, such planning is helpful in making the houses climate responsive (E.g. More exposure to the sun in cold hilly climate and avoiding mutual shading). The open spaces become the gathering area for the community, for different purposes.

But during the earthquake, every structure has a proper earthquake gap as no other structure comes in its immediate vicinity.

Thus the shaking of one structure during earthquake does not affect the other and structures are safe. The open spaces at such time become the escape zones where people can collect safely.

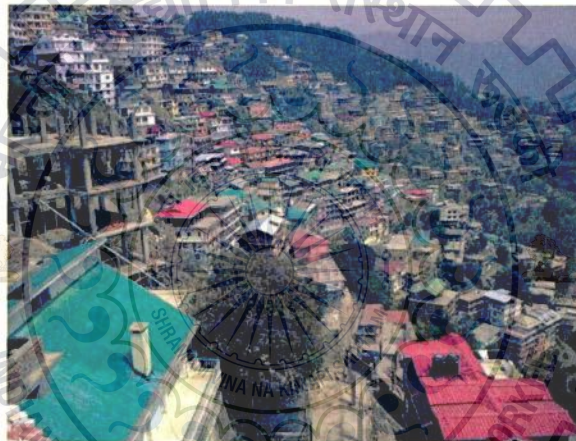
Fig.5.3. Image showing multi storey modern construction on the hills  
(Source: Kumar, A.et al. 2013)

- The state of Himachal Pradesh has a hilly terrain. Also the MBT passes through districts of Chamba, Kangra, Mandi, Bilaspur, Solan in the Kangra source zone, thus increasing the hazard level. The nature of landforms in such areas becomes unpredictable in case of earthquakes. Modern construction is rushing on the hills, weakening the slope stability due to heavy concentrated construction. Development on hilly terrains should be in a controlled manner and site development work i.e. mainly cut and fill method should be as minimum as possible. Following the vernacular approach, construction should be along the contour so as to have minimum impact on the slope and environment as well.

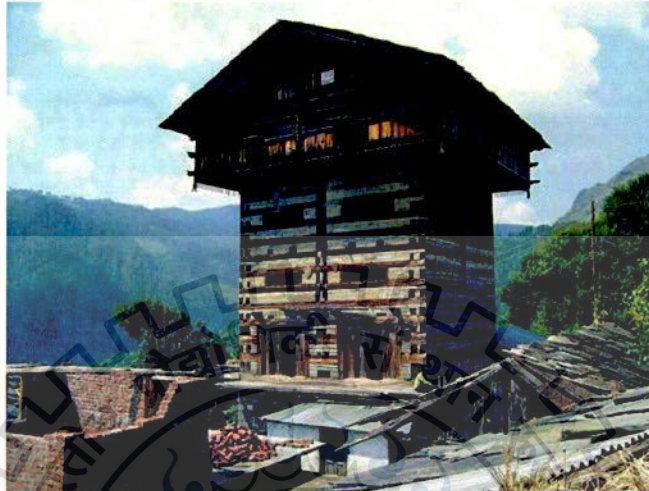
Fig.5.4. Unplanned construction around a traditional house in Koti Banal village  
(Source: World Housing Report #150)

- For the new construction in the hilly terrain, the buildings should be planned in a way such that they are separated from each other and every building should have open space around them. During earthquake, this separation will act as earthquake gap as no building will lie in the immediate vicinity of the other building. Since the number of storeys will differ in every building, their behaviour (natural period) will be different during ground shaking. To avoid pounding between buildings this gap is required. Also the open spaces at such times become the escape zones where people can collect safely.
- The modern unplanned construction is also intruding the few existing traditional settlements. The figure below shows the old Koti Banal structure, in the Koti banal village, encroached by new construction. This practice needs to be stopped. Also

these old structures are partly demolished so as to use their material in new buildings. This practice affects the dynamic behaviour of these traditional structures during earthquake shaking. Also the adverse effects are enhanced due to the lack of maintenance of these age old structures as they deteriorate structurally. Preservation of these structures is required so as they stand as examples for more years to come.
