**SEISMIC RISK ASSESSMENT DUE TO SCENARIO
EARTHQUAKE: A CASE-STUDY FOR BIHAR-NEPAL
EARTHQUAKE-1934**

A DISSERTATION

of
MASTER OF TECHNOLOGY
in
DISASTER MITIGATION AND MANAGEMENT

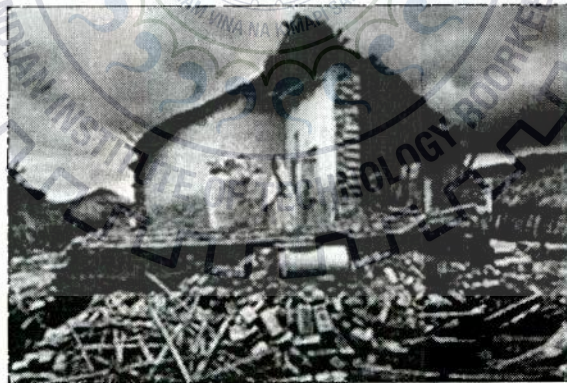
Figure 4: A damaged house in Munger district during Earthquake 1988

The number of deaths was surprisingly low in view of the fact that 149334 houses were damaged in Bihar. Number of Pucca private houses collapsed: 11335, major damage: 19141, minor damage 34142, Kutchha houses: Collapsed 13758, major damage 27258 and minor damage 43700. Mostly the damaged houses were built in Unburnt or burnt brick masonry.

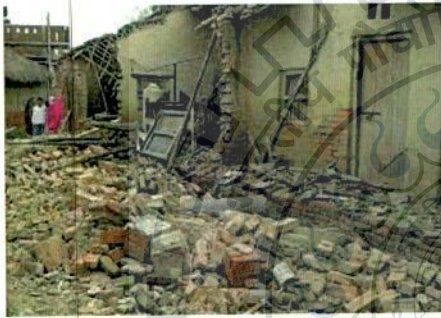
Figure 6: Damaged masonry house in Madhubani, Bihar

The earthquake left devastating impact on buildings and infrastructure. 489500 buildings were completely and 262600 partially destroyed in Nepal. A large part of northern India (UP, Bihar and Bangladesh) was affected by the earthquake; especially the districts of Bihar adjoining Nepal border were severely affected. Bihar witnessed the shaking intensity of VII on MMI scale.

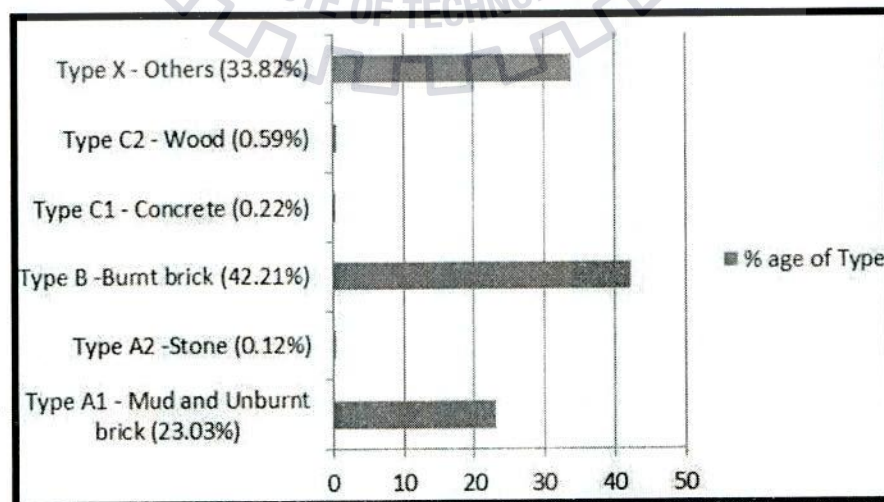
Figure 13: Percentage number of houses based on wall materials in Bihar

The state carries 23% of Type 'A' houses, 42% of Type 'B' houses, 0.8% of Type 'C' houses and 33% of Type 'X' houses. Also, houses with R1, R2 and R3 Type of roofing accounts for 39%, 34% and 26% respectively. As per this, houses made of lightweight materials are the largest in number; they are not considered while studying damage scenario though (they do not cause any threat to life even if they fail during earthquake). The data clearly shows that besides Type 'X' and 'R1', Type 'B' with 'R3' type of roofing in houses is prominent in the state(See Figure: 13 and 14).

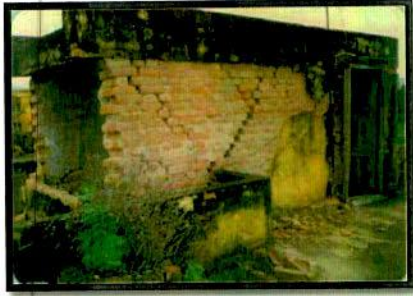
Figure 23: Damaged building at Munger during 1988 Bihar-Nepal Earthquake

Reason behind this peculiar behaviour of Munger district: The district Munger has an interesting geological condition. It is bordered by Ganges from North side and stands both on **Alluvium soil** and peninsula of **Archean rock** (See Figure: 23 and 25). Therefore, there is a discontinuity of geological set up throughout the district. Whenever an earthquake hits the region, the seismic waves get affected by this geological setup and eventually amplify the ground motion greatly. Consequently, the whole region experiences severe ground acceleration and this eventually led to large scale destruction throughout the district.
