ASSESSMENT OF A TYPICAL LANDSLIDE IN UTTARAKHAND AND MITIGATION SOLUTIONS

A Dissertation

DISASTER MITIGATION AND MANAGEMENT

INDIAN INSTITUTE OF TECHNOLOGY ROORKEE, ROORKEE-247667 (INDIA)

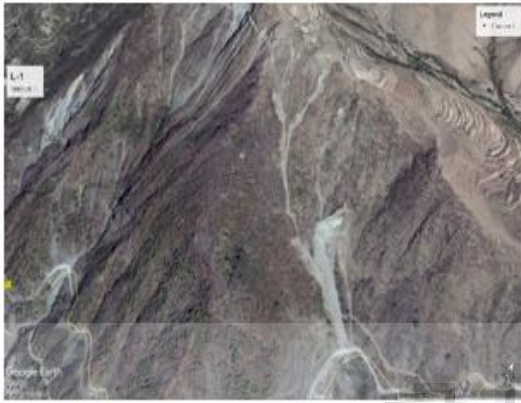
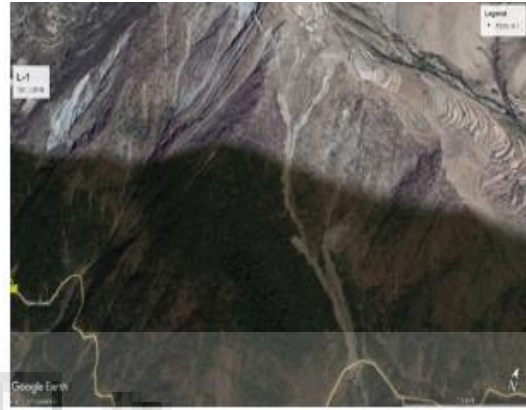
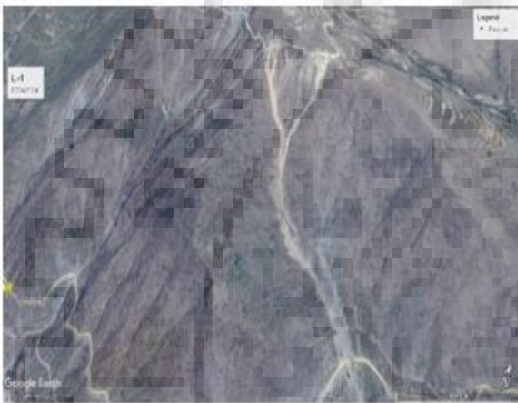
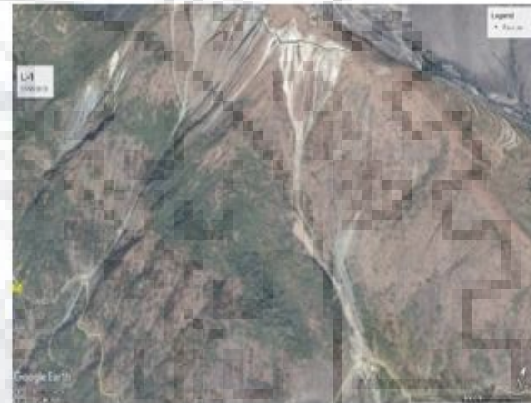
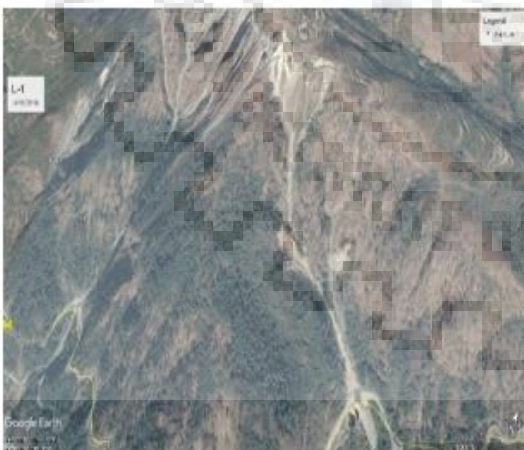
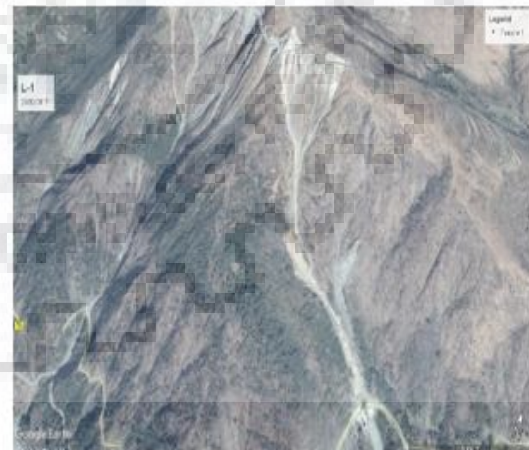
Fig.1.1(a): Landslide affected area in 2004

Fig.1.1(b): Landslide affected area in 2010

Fig.1.1(c): Landslide affected area in 2011

Fig.1.1(d): Landslide affected area in 2013

Fig.1.1(e): Landslide affected area in 2016

Fig.1.1(f): Landslide affected area in 2017

Figure 1.1: Landslide affected area of Lakhwar Dam Top Landslide at various stages. (from Google Earth)

According to the google images, the landslide started since 2004, however local findings states that it was started in 1999 when the first rock fall detached and fall down nearer to the existing natural water outlet source. After interpreting the various years google images Figure 1.1(a) to Figure 1.1(f) showing different year images of landslide and it was observed that landslide area is increasing and widening year by year. On this basis, it can be used to investigate the reason of extended affected areas of landslide. It was observed and identified that material at the site

is colluvial and rocks are phyllite and sandstone. In the year 2002, landslide had a very small area that was affected but later the affected area has increased due to ignorance of landslide mitigation. Earlier the problem started from middle of the landslide but later the source of the landslide was changed and now it is from the head of the landslide. The reason behind this was the construction of a new road in year 2011 where all slope cutting material were dumped at the head of the landslide and it eroded the head of the landslide as well as got accumulated between the catchment. When a catchment gets heavy rainfall, water and all accumulated colluvial material start sliding down rapidly as the slope is very steep. In the year 2010, due to heavy rainfall landslide became severe and came to attention of public work department of Uttarakhand and they applied some mitigation measures to control the landslide. Due to lack of complete understanding about the existing hydrology, geography and the root cause of the affected area, some retaining structure such as concrete block and gabion wall at the toe of landslide was constructed. As a result, the retaining structure got destroyed and became debris as show in Figure 1.2. During the monsoon season with rainfall as the landslide had a very high velocity due to steep slope.

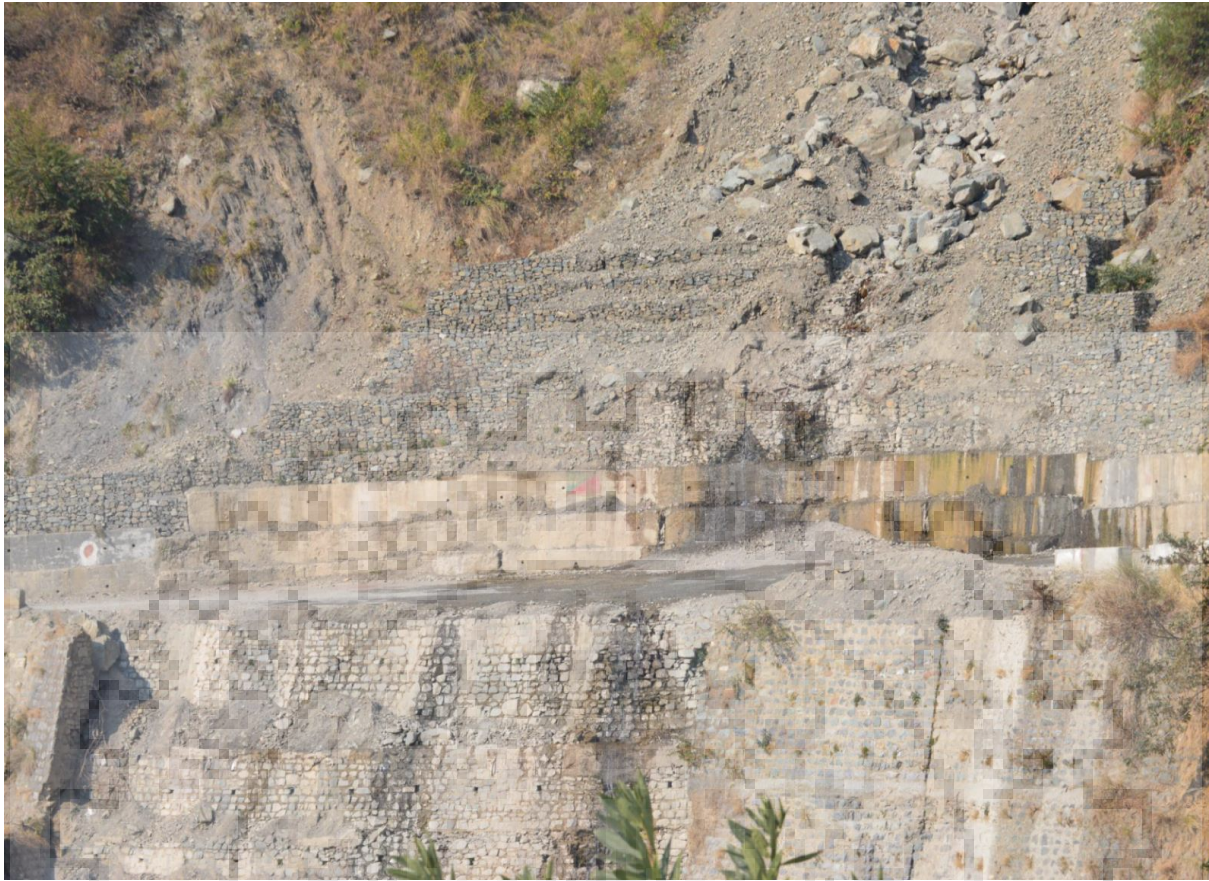
Figure 1.2: Destroyed retaining structure at the toe of the Lakhwar Dam Top Landslide
(Photo taken on 14th January,2018)

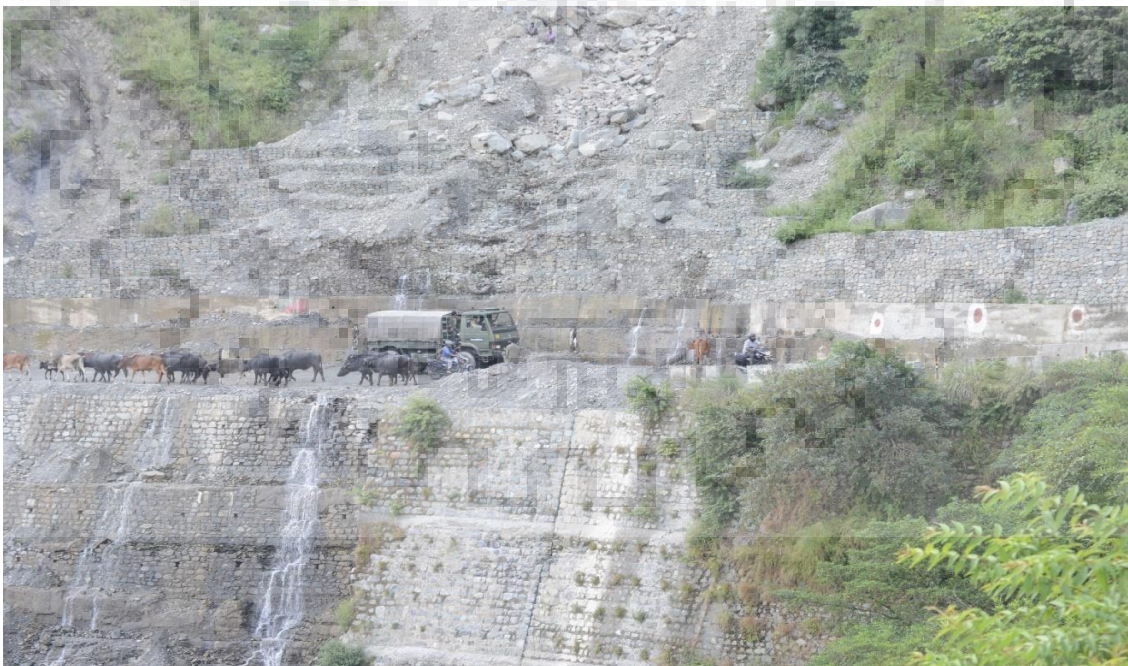
Figure 1.4: Drainage above the road in 2017 (Photo taken on 25th September, 2017)

The patch where the landslide occurred was earlier free from any water source but after mass sliding from the hill it came out and water started flowing on the surface of landslide as well as on the national highway. Figure 1.3 and 1.4 showing the water source before 2004 and after the 2010 respectively.

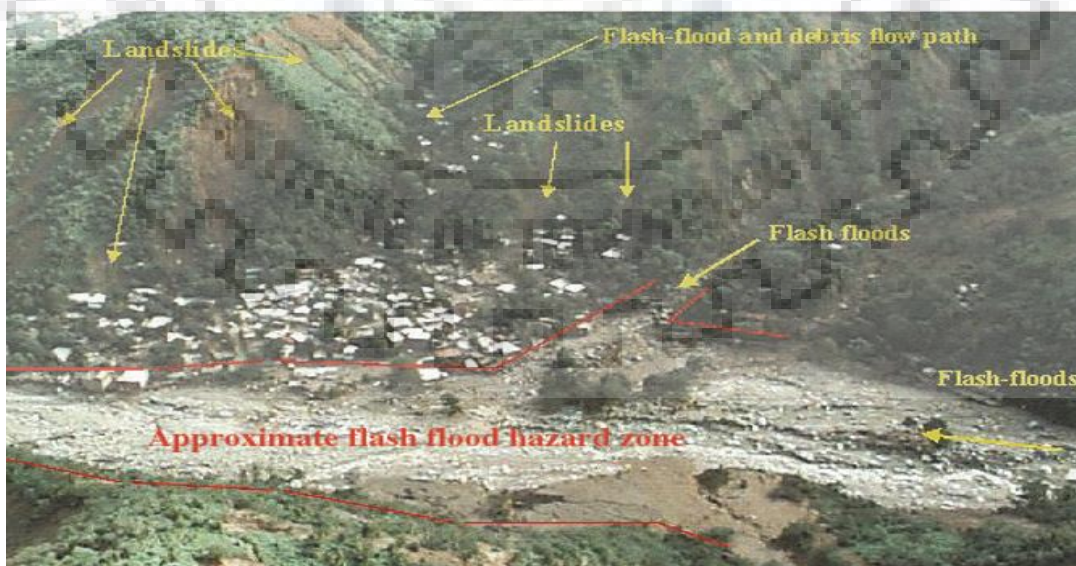
Figure 2.1: The 1999 multi-hazard event in Tanaguarena, America. (After Matthew, 2008)

- 1) Volcanic eruption induced earthquake or induced landslide that block the river, due to which the water is backed up behind the mass and floods in the upstream area.
- 2) An earthquake induced landslide can case a fatal tsunami if enough landslide material falls down into the water body in reservoir to remove large amount of water. Figure 2.2 shows multi-hazard event involving landside.

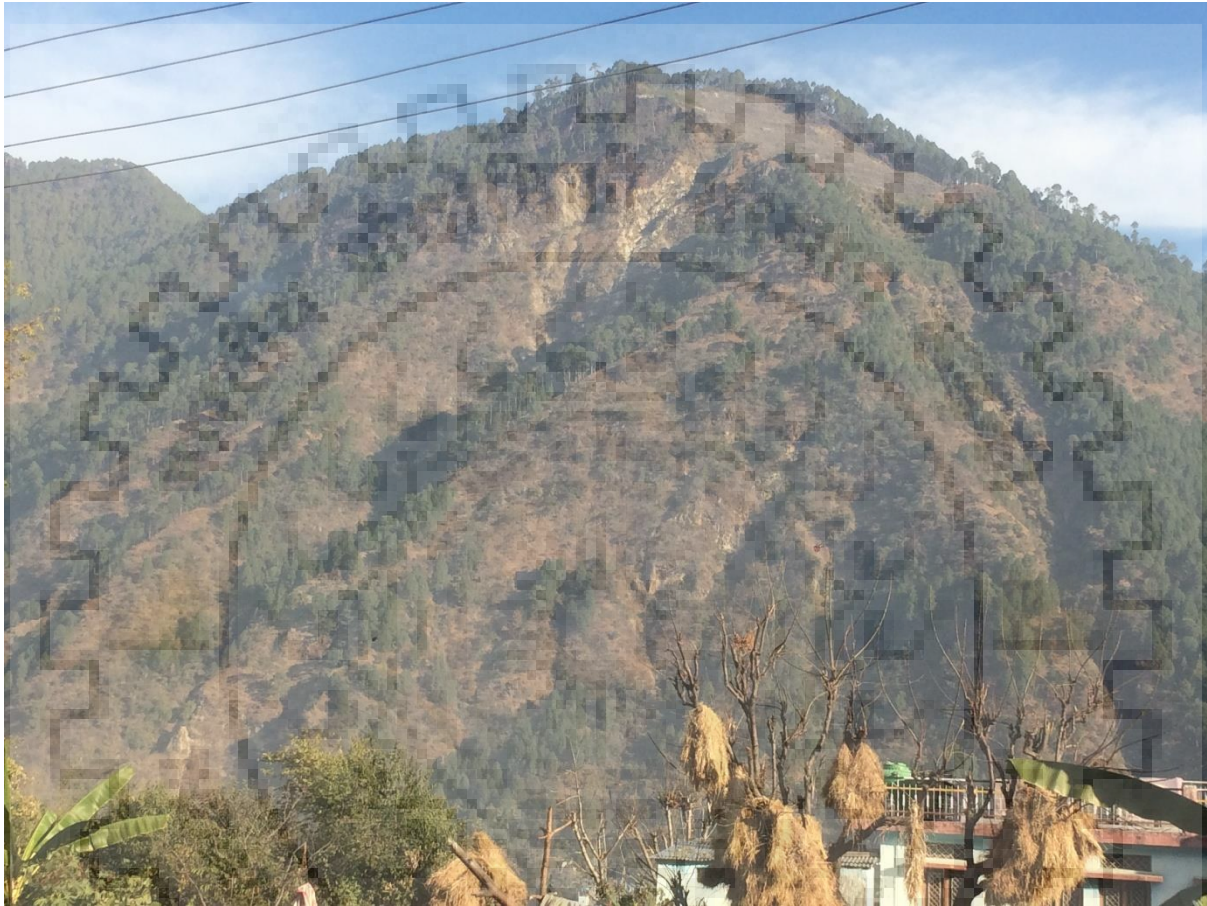
Figure 2.4: Present scenario after implementation of control measures at Varunavat Landslide (Photo taken on 31st December, 2017)

The Geological Survey of India recommended control measures to arrest the sliding activity. These are mainly slope grading, shotcreting, surface drainage and rock anchoring. To implement these measures a vehicular track was made to reach the uphill slope. The accumulated debris resting on the middle of the slope and at the road level was removed and disposed of in an adjacent valley and covered with biodegradable jute mesh to avoid erosion and debris flow. The control measures were implemented during 2008–2009. The slope has been modified and shotcreting has been applied with wire mesh reinforcement on the entire slope. Rock anchoring and rock bolting has been implemented to strengthen the weak jointed and fractured rocks. After covering the main landslide scarp at the crown portion with geogrid, bio-measures have been adopted to protect the slope from erosion. Special grass has been

planted to stabilize the slope through root reinforcement. Subsurface horizontal drains have been installed at various levels to drain groundwater. Surface drainage has also been constructed at various levels to drain surface runoff from the slope. At the toe, a retaining wall was constructed to provide support to the slope. At present Figure 2.4, the slide appears to be stabilized and no activity was reported after the implementation of the above control measures.

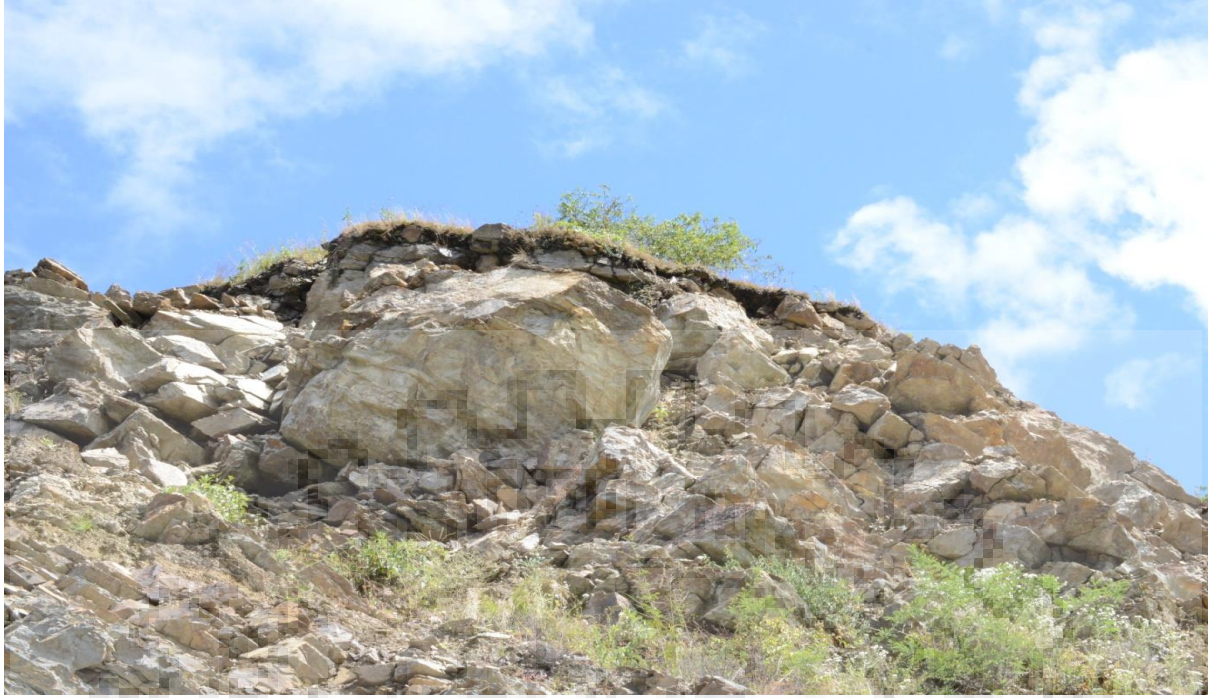
Figure 3.4: Detachment of rocks on site at the top of the landslide

The site was visited during and after the monsoon and it was observed that the landslide is more active during monsoon time, however, the risk of sliding of loose material pronounced throughout the year. It was also observed that after the monsoon, the detachment of rocks was there as shown in Figure 3.4.

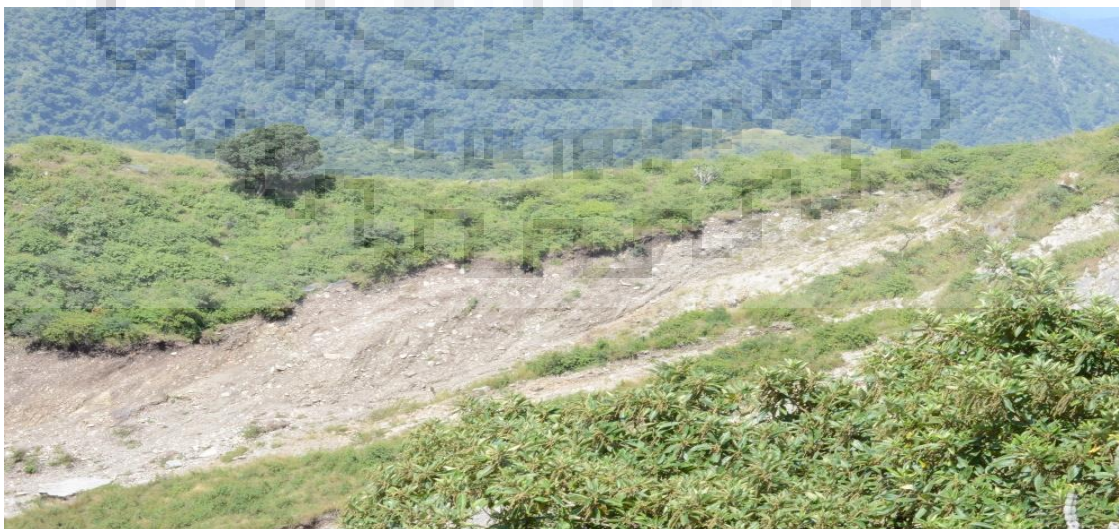
The vegetation grown in the site was of varying nature in the monsoon season. After monsoon, it was observed that in the upper portion of the landslide, there was a scarce vegetation and it varies from top to bottom when compared during monsoon. It was also seen that the right flank has more vegetation than left as there is no layer of soil present and the rock is almost exposed, because of which the left flank is more stable than the right flank. The top to bottom view of right flank shows that it is lightly dense which consists largely of shrubs and small trees or it can be said that the right flank has mixed forests as shown in Figure 3.5.

Figure 3.5: Showing mix vegetation on the right flank

In Figure 3.5 showing loose material, there are loose soil and rocks at the site. For stabilization of the slope first, it is required to remove that loose material from top to the bottom of the slide because the slope of the landslide is very steep. During removal of cracked and fractured rock mass should be chiseled and gradient of the slope should be maintained to standard slope gradient.

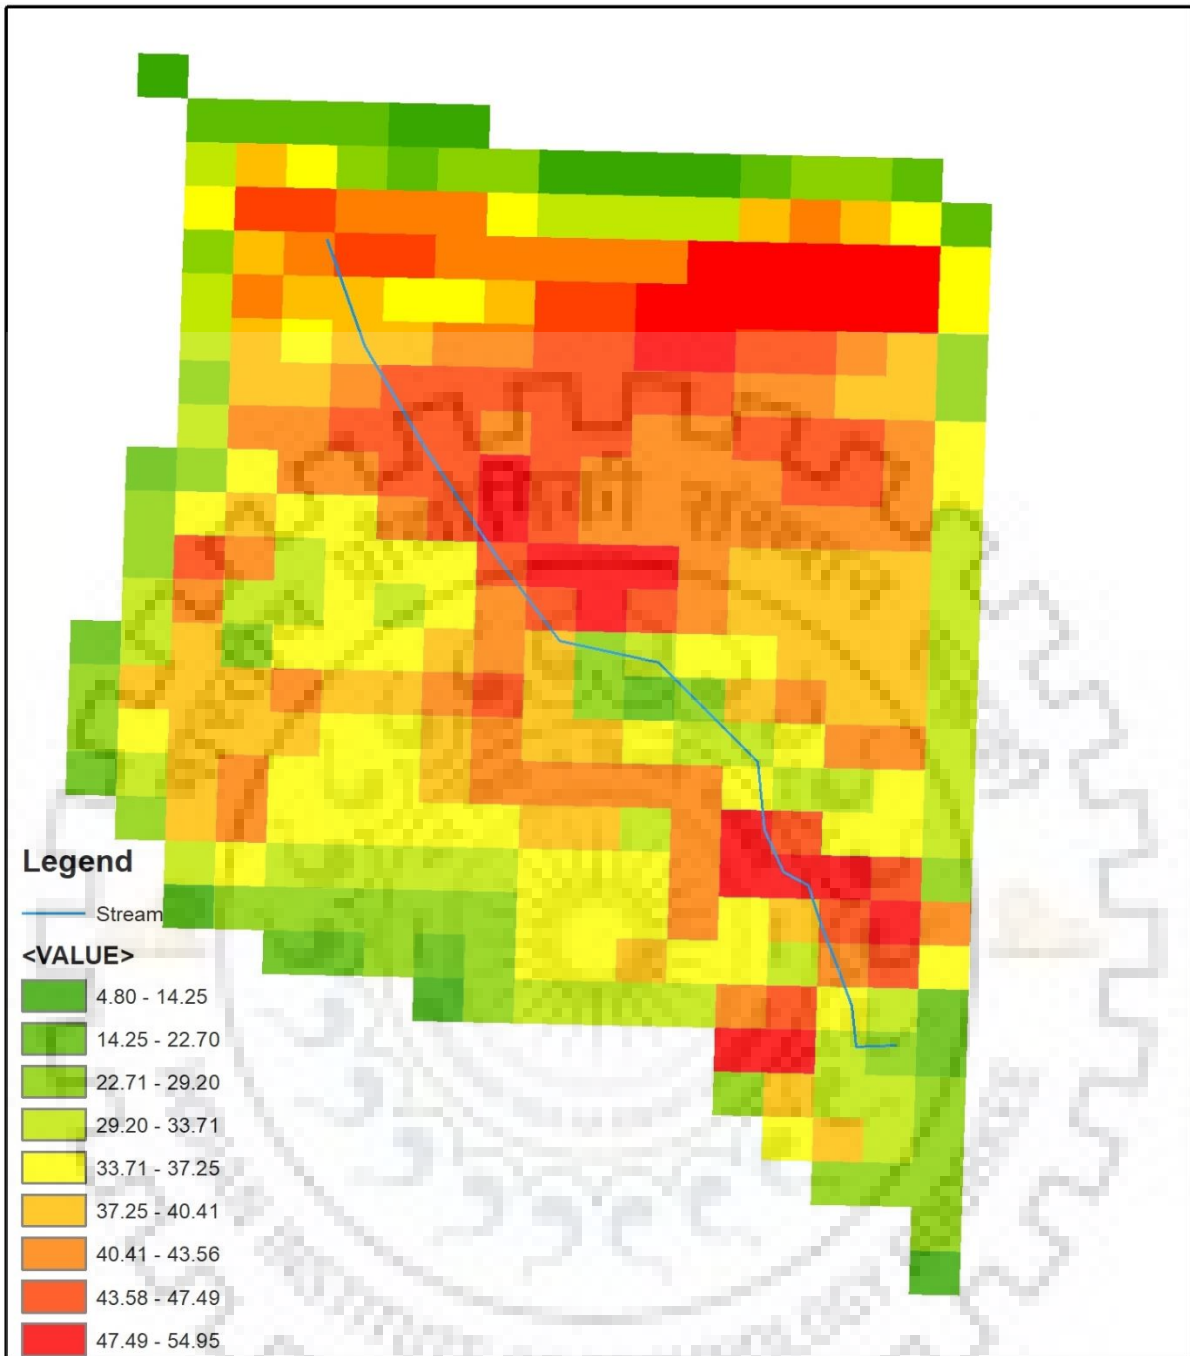
Figure 3.6: Slope map produced by ArcGIS, 2012

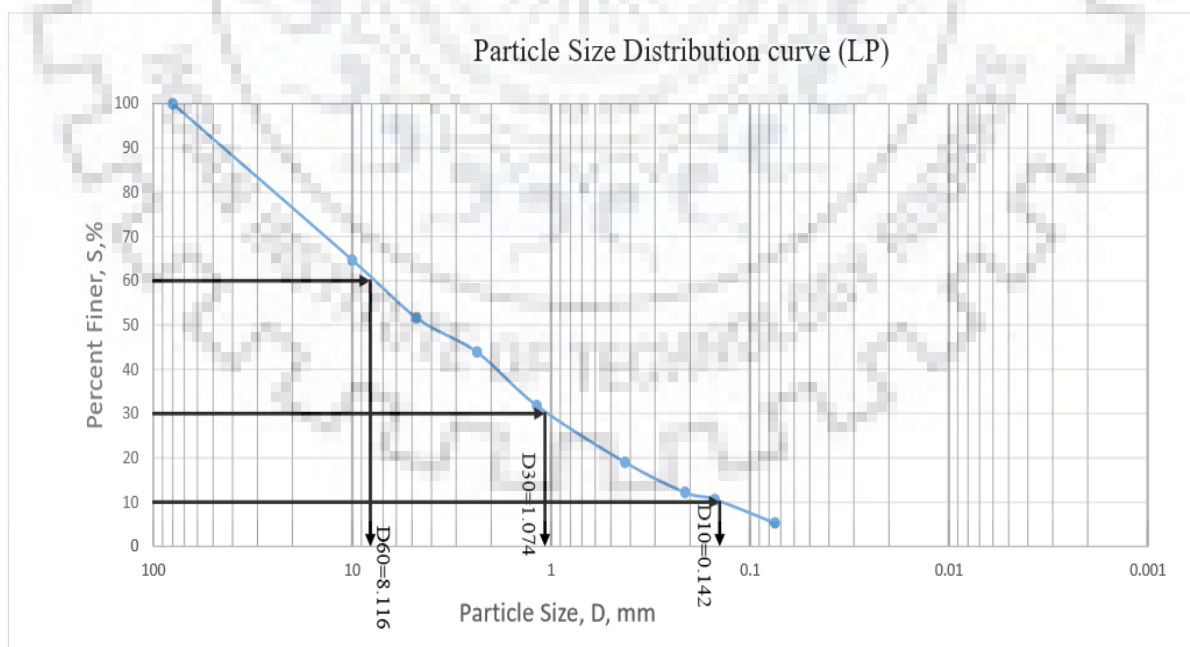
Figure 3.7: Particle size distribution curve of left flank soil sample

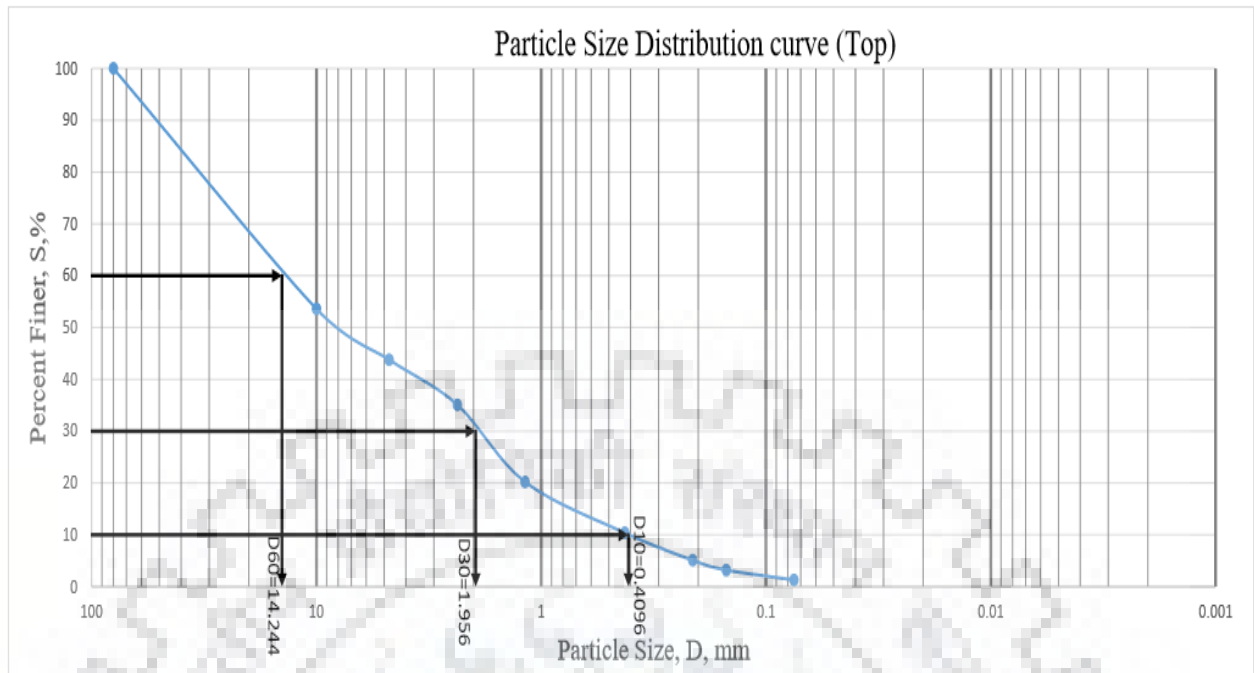
Figure 3.8: Particle size distribution curve of top of the landslide soil sample

After the analysis of soil sample coefficient of curvature (C_c) and coefficient of uniformity (C_u) were calculated from the graph. Putting the value of (C_c) and (C_u) in the equation (3.a) and (3.b) (C_c) and (C_u) values are 0.65576 and 34.7753 respectively. According to ISSCS soil fall in the group of coarse-grained soil along with more than half of coarse fraction is greater than 4.75 mm IS Sieve size and the percentage finer from 75 microns is less than 5% so it is classified as **poorly graded gravel**.

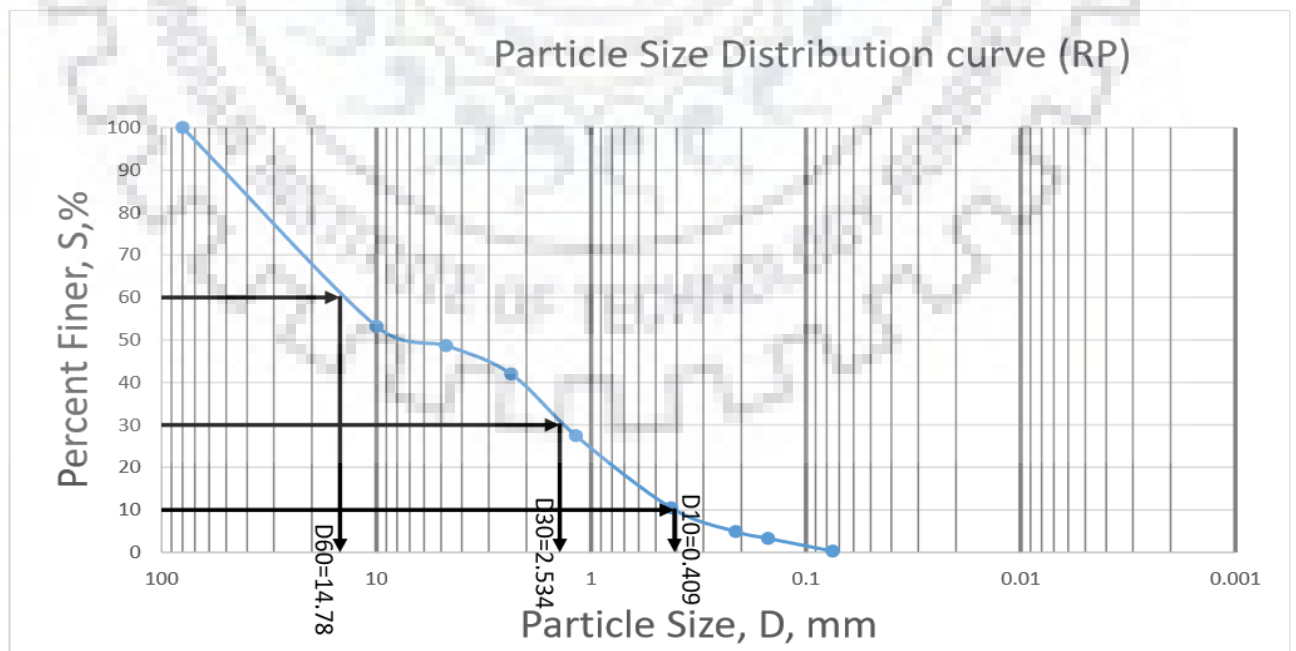
Figure 3.9: Particle size distribution curve of right flank soil sample

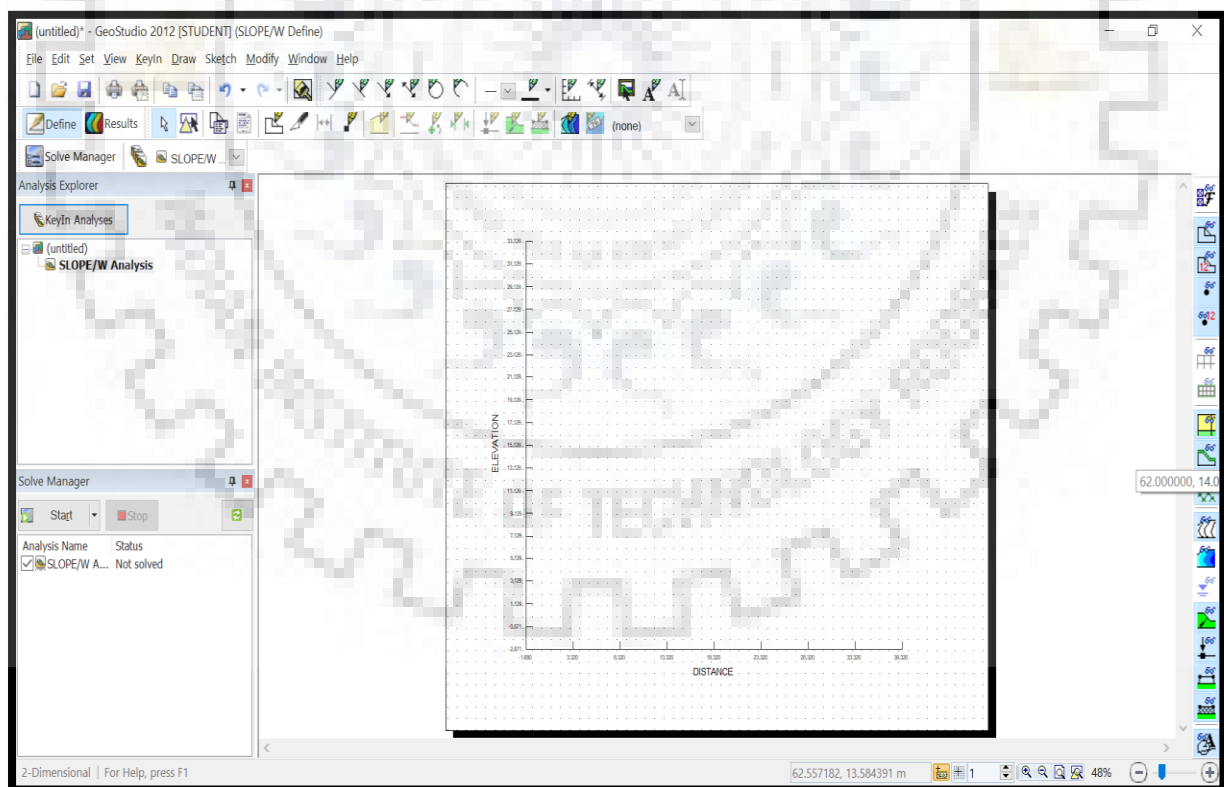
Figure 5.1: Showing interface of the Geo Slope

So as far as stability analysis of slope is a concern, check slope stability in GEO SLOPE, 2012. This is a software which is used for the analysis of slope according to different site condition.

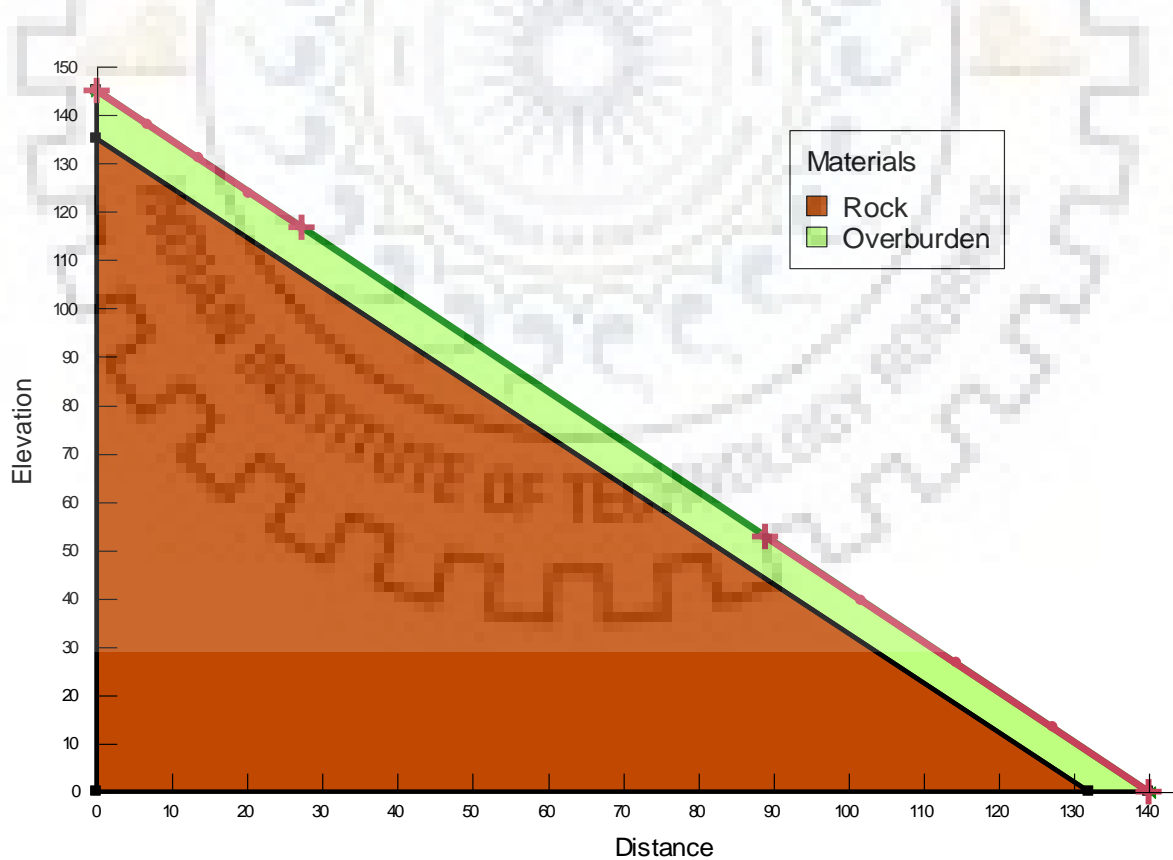
Figure 5.4(b): Lower slope profile before slope stability analysis

As the results come out in Figure 5.4(b), 5.4(c), and 5.4(d) lower slope FOS is less than 1. After applying mitigation measures on the slope stability was checked again and the factor of safety increase and now it is more than 1 (Figure 6.9), therefore slope is stable and our purpose to increase slope stability get fulfilled.

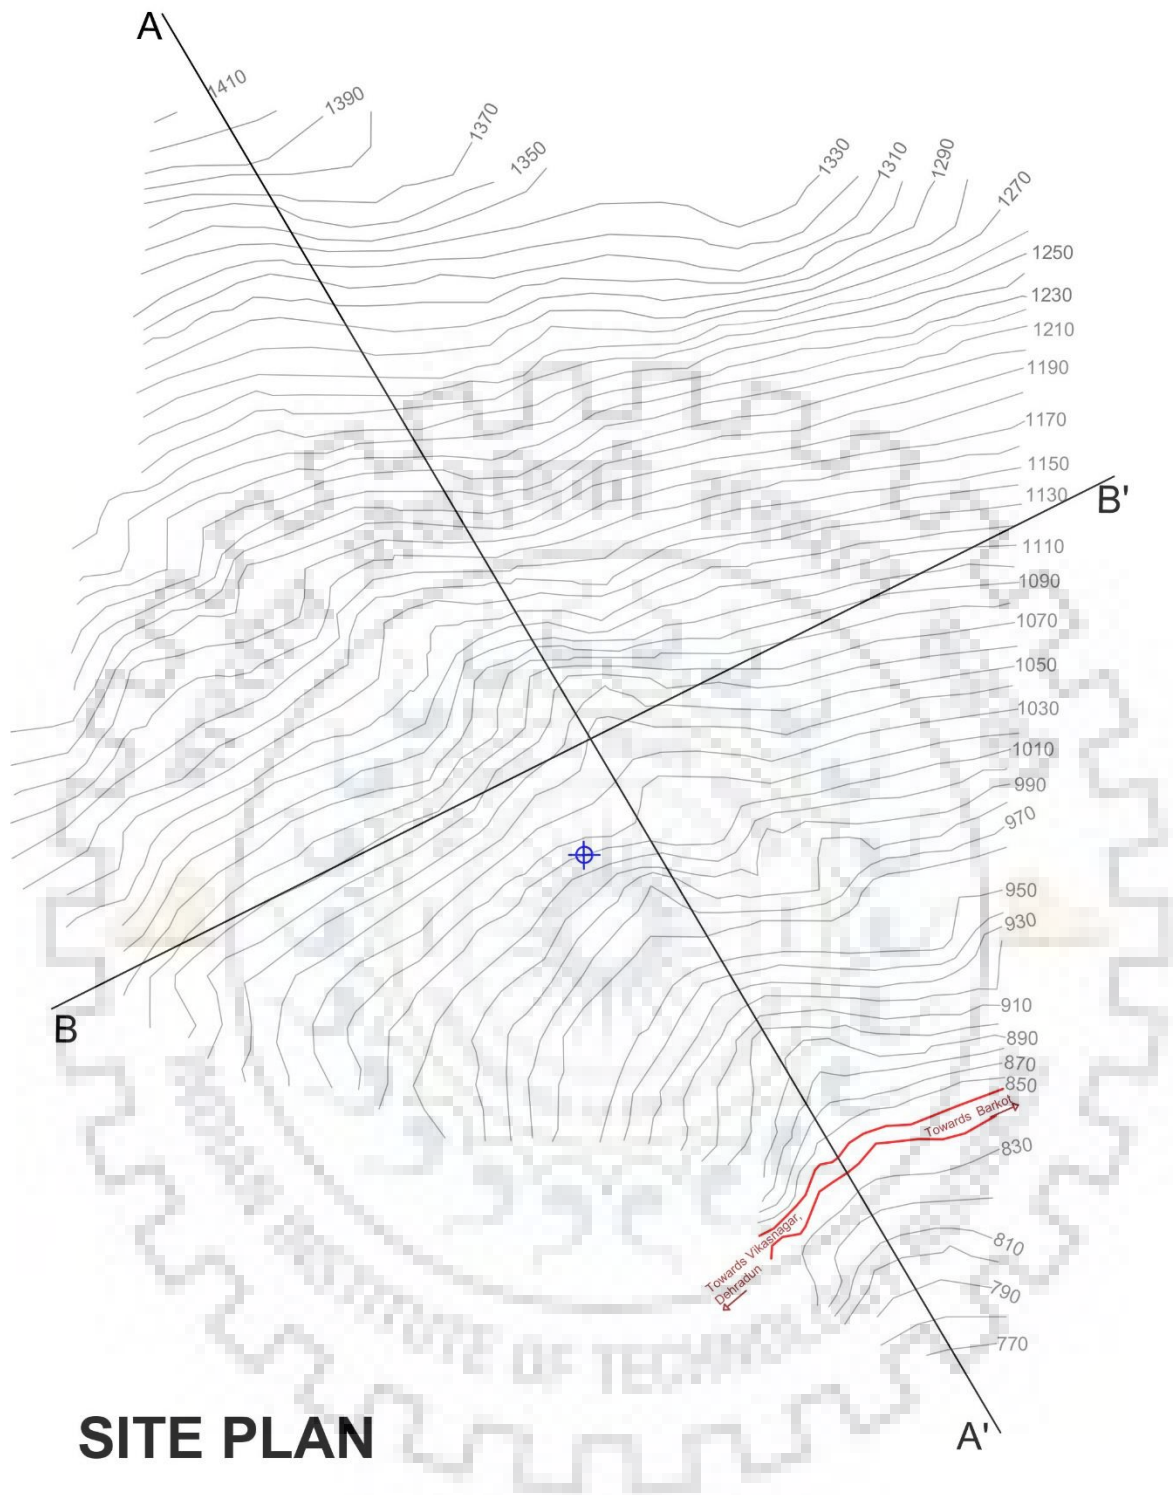
Figure 6.1: Showing contour map with cross section AA' and BB'.

By regulating surface runoff, preventing soil erosion and providing slope stability measures, landslide can be effectively controlled. In this section, the main focus of remedial measures is to restore the affected slope of the landslide (Panigrahi et al. 2011). All remedial measures should be provided separately for all slopes and in the vicinity of landslide affected area. For better understanding contour map created at the 10-meter interval as well as cross-section of landslide were developed as shown in Figure 6.1.

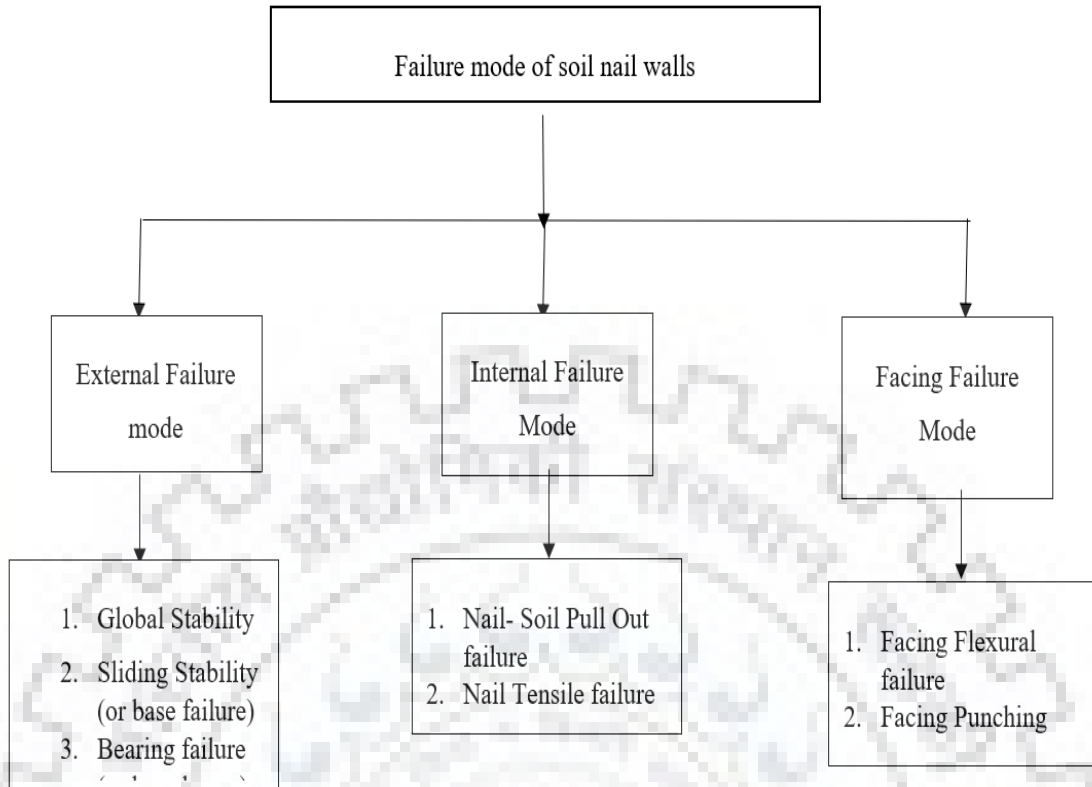
Figure 6.5: Principal failure mode of soil nail wall (FHWA,2012)

So, for designing a soil nail wall, it is important to first understand what the failure modes are, which can occur during or after construction.

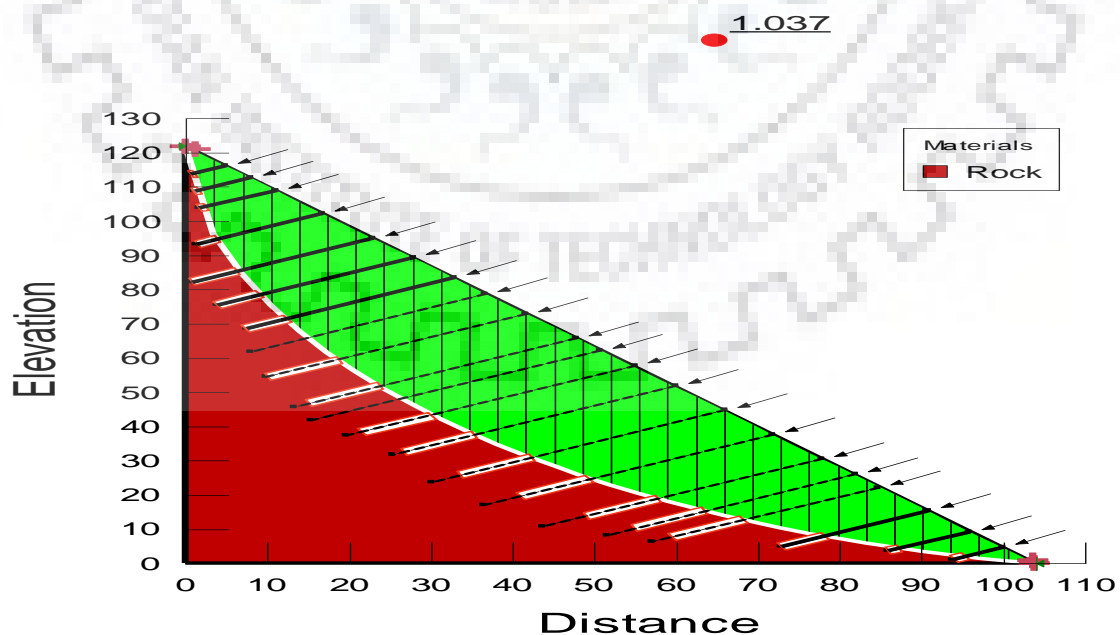
As the results come out in Figure 5.2(b) and 5.2(c), upper slope FOS is less than 1. After applying mitigation measures on the slope stability was checked again and the factor of safety increase and now it is more than 1 (Figure 6.7), therefore slope is stable and our purpose to increase slope stability get fulfilled.

Figure 6.7: Upper slope slip surface after application of soil nailing

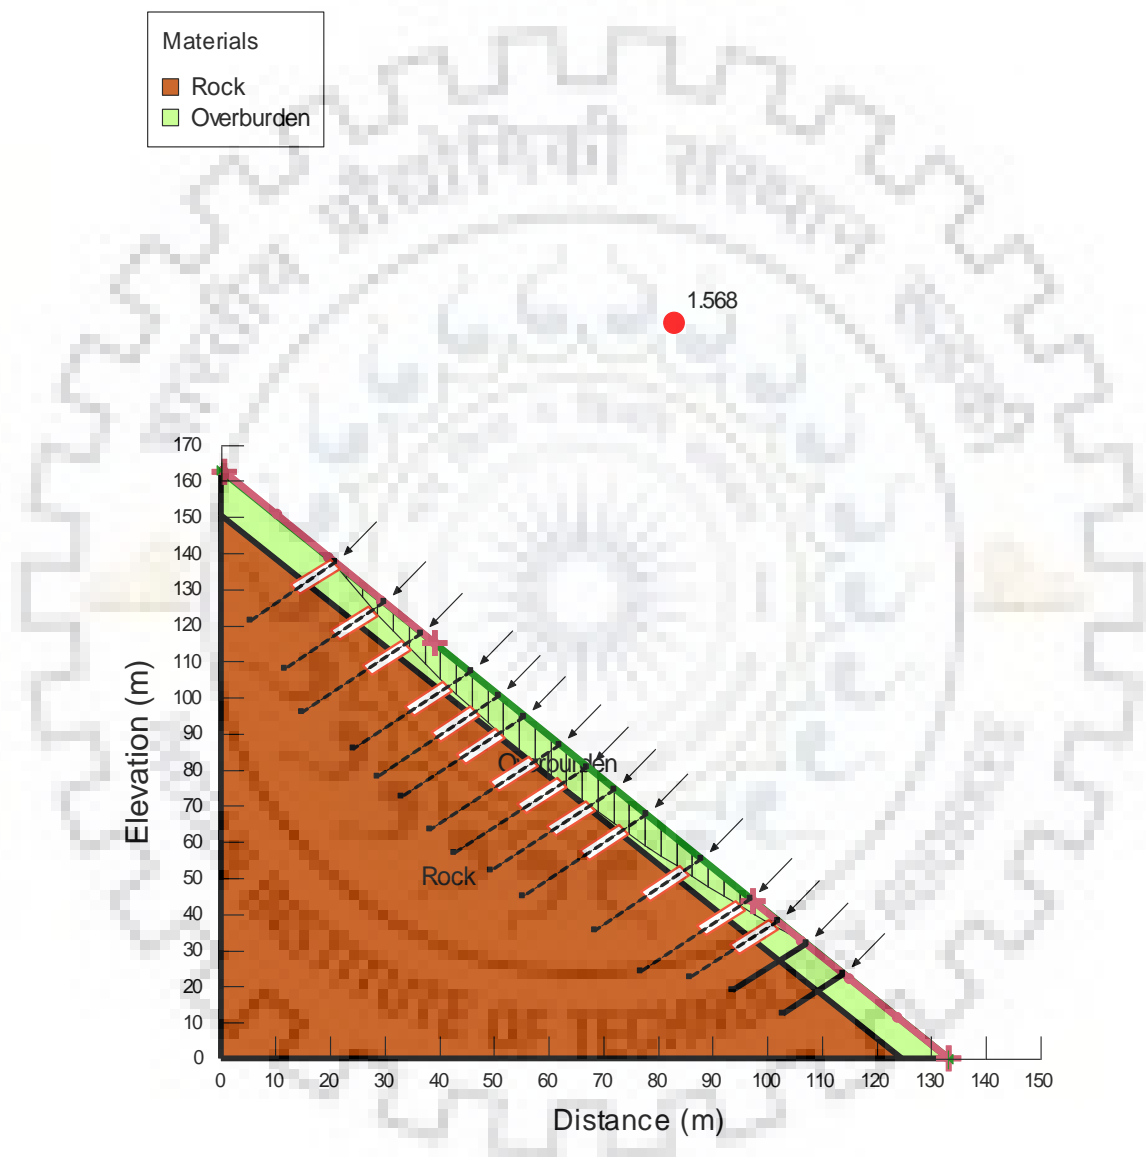
As the results come out in Figure 5.3(b) and 5.3(c), middle slope FOS is less than 1. After applying mitigation measures on the slope stability was checked again and the factor of safety increase and now it is more than 1 (Figure 6.8), therefore slope is stable and our purpose to increase slope stability get fulfilled.

Figure 6.8: Middle slope slip surface after application of retaining structure
