SLOPE STABILITY INVESTIGATIONS OF ROAD CUT SLOPES: NH-58, RISHIKESH TO DEVPRAYAG

Ph.D. THESIS

DEPARTMENT OF EARTH SCIENCES INDIAN INSTITUTE OF TECHNOLOGY ROORKEE ROORKEE – 247 667 (INDIA) JANUARY, 2019

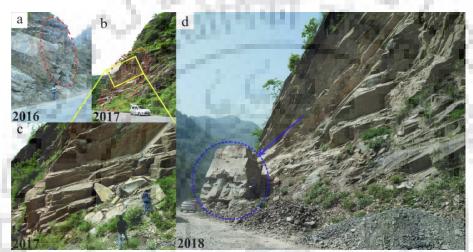
Figure 3.1: Field photographs depicting recurrent failure at slope S13 near Kaudiyala (a) Prefailure condition of slope with encircled probable zone observed in during initial field surveys and measurement in the year 2016 (b) Structurally controlled mass failure observed during successive field survey in 2017 (c) Inset view showing the massive failed blocks (d) Much larger failure occurred in 2018

Recurrent nature of structurally controlled failure in the form of a wedge and planar failure was observed at slope S13 (figure 3). Pre and post-failure conditions at slope S13 have been depicted in figures 3.1(a), 3.1(b) and 3.1(d) in the year 2016, 2017 and 2018 respectively. A massive failed block of 5-6 feet is shown in the inset view (figure 3c) and even much larger block (~15 feet) has been witnessed in successive failure (figure 3d). Interestingly, S13 lies near to the township Kaudiyala, the zone which is proximal to thrust fault and slope S13 was evaluated as unstable by numerical simulation. Such correlation among existing field conditions and predicted stability dictate the soundness of the outcomes obtained by numerical simulation.

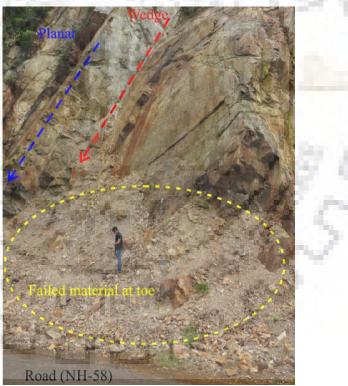
Figure 3.4: Extremely persistent discontinuities forming a wedge and planar failure, failed material (encircled) at the toe region of the slope at S2

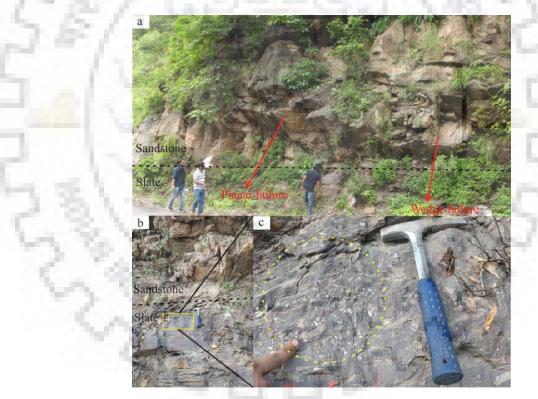
Figure 3.6: Field photograph depicting the condition of rock mass at slope S4 (a) Showing the joints forming a wedge and planar sliding (b) Lithological contact between Slate and Sandstone (c) Inset image showing clast at lithological contact

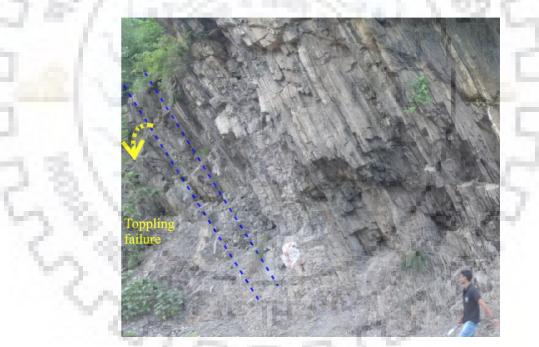
Figure 3.8: Steeply dipping discontinuities in Slate forming toppling failure at slope S6

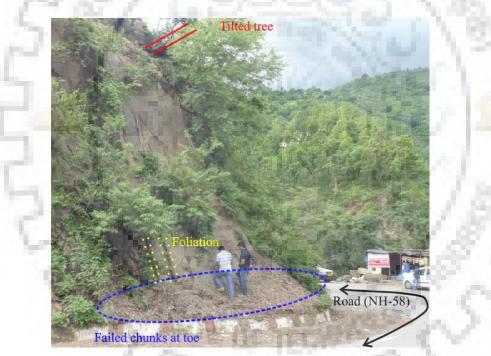
Figure 3.9: Weathered and soft rock causing failure of small chunks and tilted trees indicating deformation within rock mass at slope S7

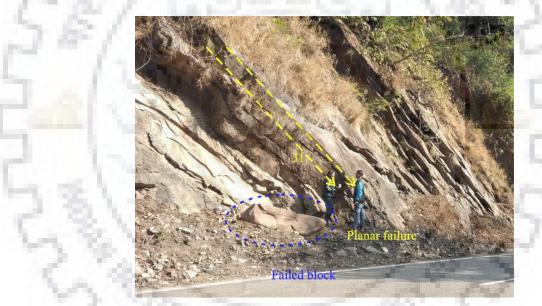
Figure 3.10: Daylighting conditions offering a planar mode of failure due to joint set J1 at slope S8 and failed blocks at the toe portion of the slope

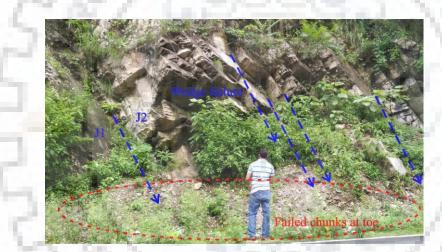
Figure 3.11: Unfavourably oriented jointed induced wedge sliding at slope S9 and failed chunks at bottom of the slope 2ª

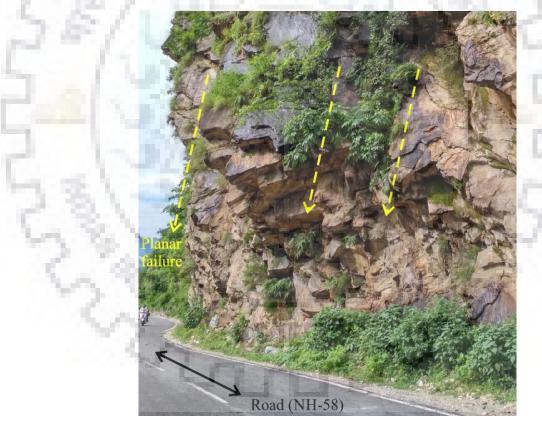
Figure 3.12: Rock mass having persistent joints offering planar failure followed by rockfall at slope S10

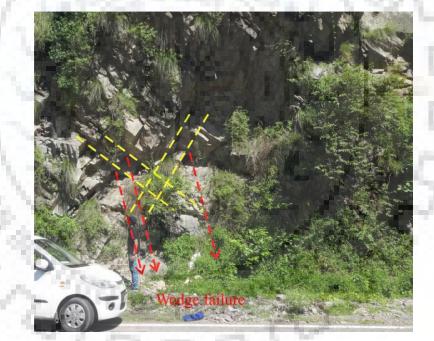
Figure 3.14: Discontinuities forming wedge failure at slope S12

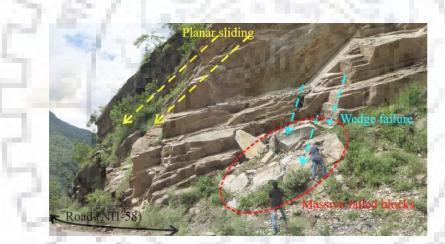
Figure 3.15: Field photograph depicting massive failed blocks and a potential site for planar and wedge sliding at slope S13 35

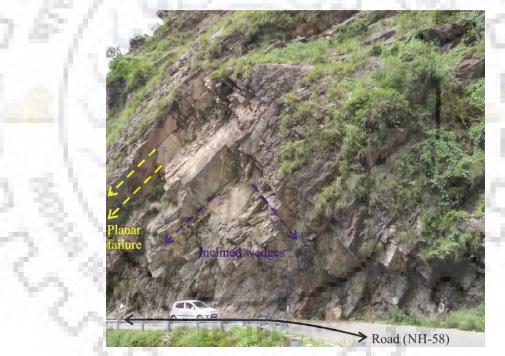
Figure 3.16: Wedge and planar failure conditions at slope S14

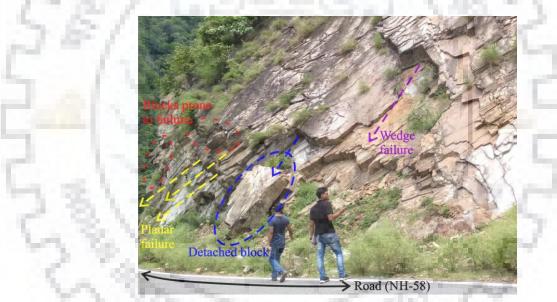
Figure 3.18: Failed blocks and potential rockslide for different modes of structurally controlled failures at slope S16

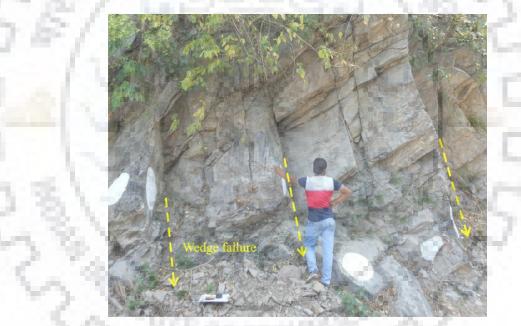
Figure 3.22: Blocky rock mass favoring wedge failure at slope S20

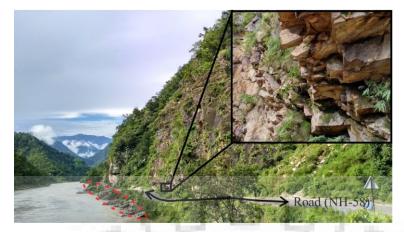
Figure 3.23: A panoramic view at slope S10 along NH-58 during monsoon season showing the level of water in the Ganga River, causing toe cutting and seepage through joints and Inset view is depicting jointed & blocky rock mass conditions at slope S10

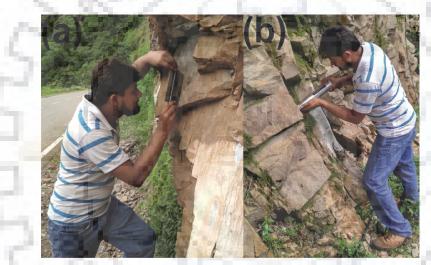
Figure 3.24: Measurement of geotechnical parameters during field survey (a) Roughness profile of joint wall by using Barton comb (b) Schmidt hammer hardness of jointed surface

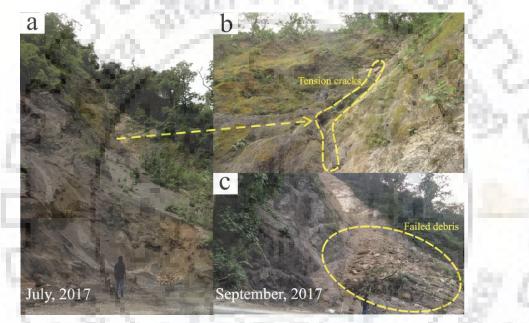
Figure 3.25: Road cut debris slope at location L1 near Shivpuri township along NH-58 (a) Without installing retaining wall, debris were excavated from toe portion of slope contributing towards disequilibrium in the stability of slope (b) Tension cracks at crown portion are indicating possible zone of initiation of failure and formation of algae is addressing moist condition which may also act as lubricant during failure (c) Post-failure photograph showing massive landslide along cut slope near Shivpuri township

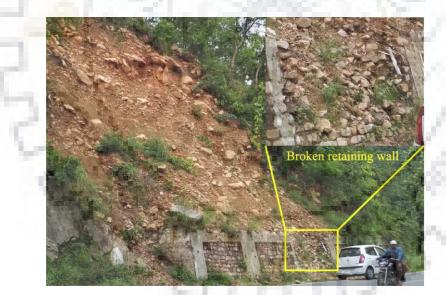
Figure 3.29: Debris material with mixed clast size at location L5 and inset image showing damaged retaining wall

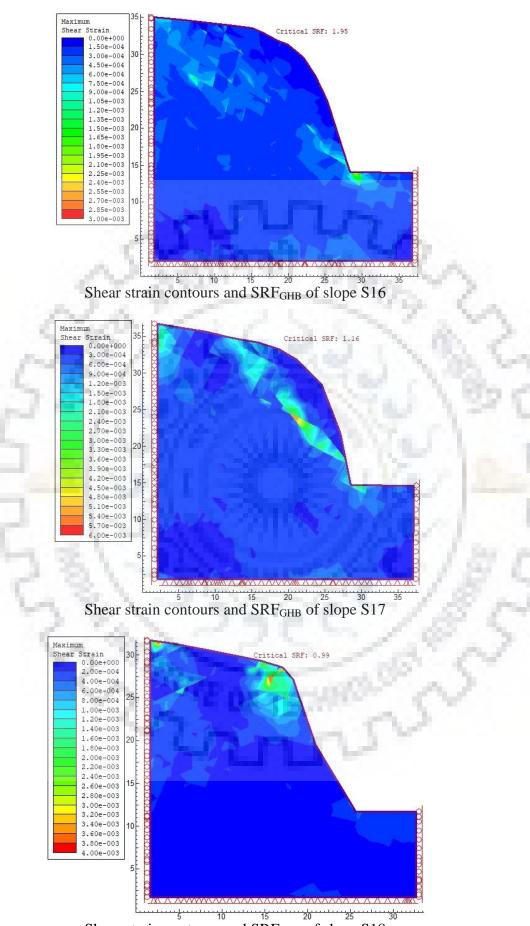
Shear strain contours and SRF_{GHB} of slope S18
