**SEDIMENT ABRASIVE EROSION ON HYDROPOWER  
PLANTS IN NEPAL**

**A DISSERTATION**

**MASTER OF TECHNOLOGY**

**ALTERNATE HYDRO ENERGY SYSTEMS**

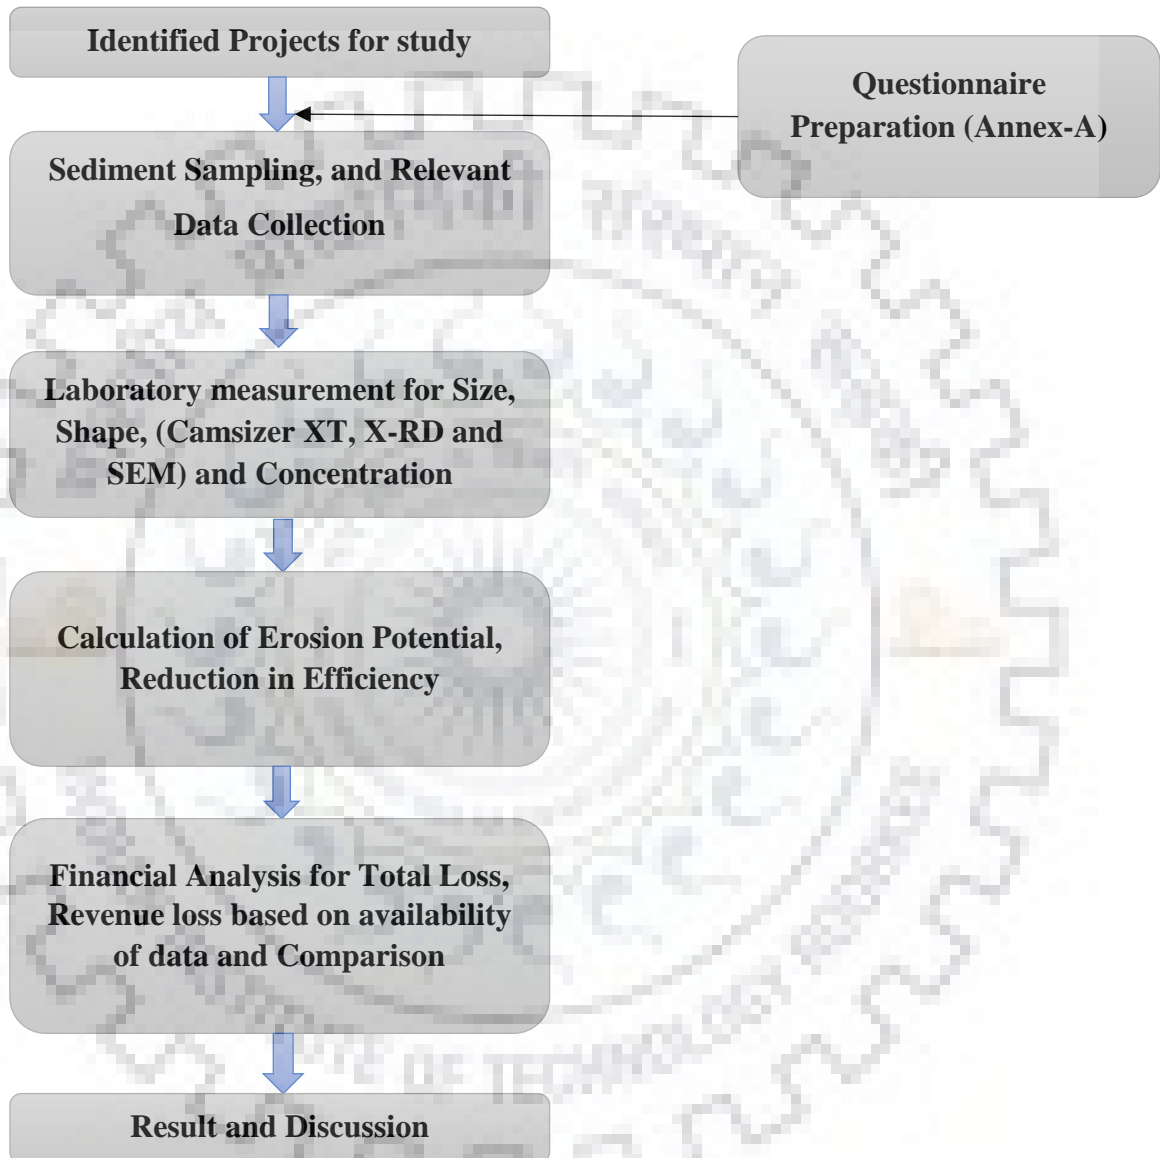
The methodology followed for study is shown as per Flowchart in Figure 3.1.

Figure 3.1 Methodology Flow diagram for dissertation work

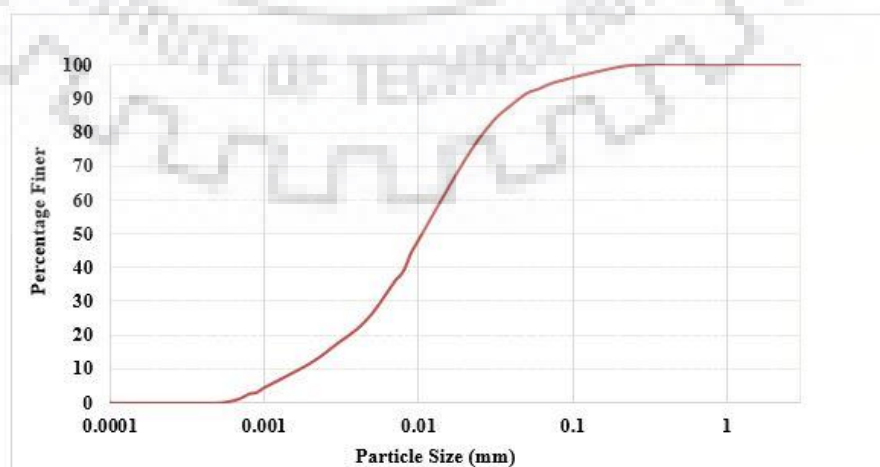
**Figure 4.1 PSD at Tailrace of Marsyangdi HPP [NEA, 2018]**

Medium diameter of particle size passing through turbine is 0.0108mm. 89.58 % of sediment load passing through turbine falls in the range of 0.001 mm to 0.07 mm.

The representative sample are taken each day before settling basin and at tail race each by the hydropower. Sample is processed in the R&D lab at hydropower. Annual average sediment load passing through turbine is 1.83 million tons [Chaudhary, C.S., 1999]. The sample PSD at tailrace is shown in Figure 4.1.

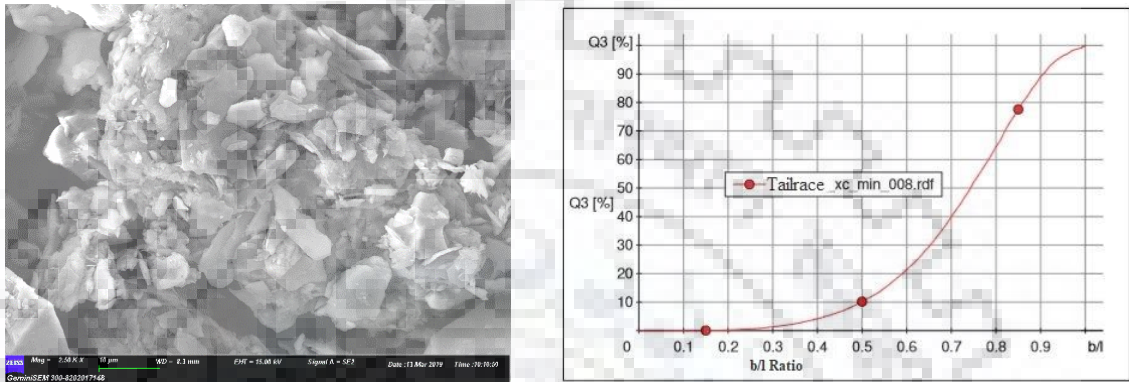
The shape of the sediment particle is measured in relation to b/l ratio. Figure 4.2 (a) and (b) shows SEM image (2.5k magnification) and Camsizer XT measurements were employed for the shape factor calculation.

**Figure 4.2(a) SEM Image for sediment and 4.2(b): CamsizerXT plot for b/l ratio Vs percentage finer.**

The recommended value of shape factor (Kshape), as per IEC-62364 (2013) for round, sub-angular and angular particles for hydro-abrasive erosion to be 1, 1.5 or 2 respectively. In this case, the Kshape value will be (2.000 - 0.72) i.e., 1.28 as sub-angular by nature, is the precise estimate than just a qualitative prediction. [Rai et.al, 2017].

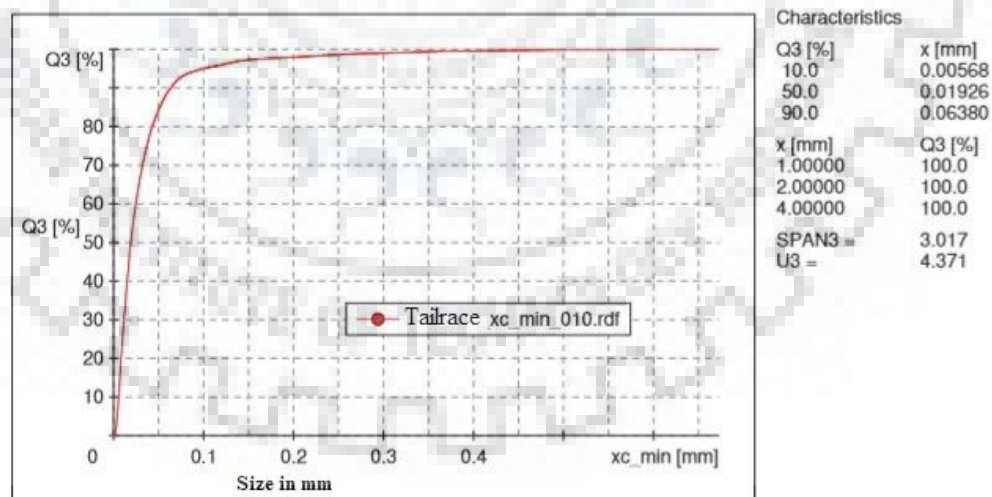
The processed representative sample, taken from tail race by the hydropower. The sample PSD at tailrace is shown in Figure 4.4. Median size of particle passing through turbine is 0.019mm. 90 % of sediment load passing through turbine falls in the range of 0.0056 mm to 0.063 mm.

**Figure 4.4 PSD at Tailrace of Middle Marsyangdi HPP**

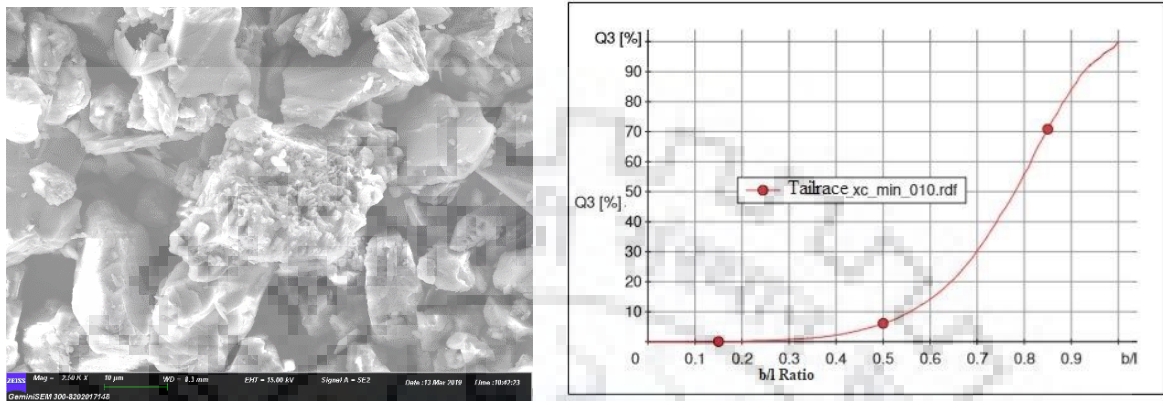
The shape of the sediment particle is measured in relation to b/l ratio. Figure 4.5 (a) and (b) shows SEM image in 2.5k magnification and Camsizer XT measurements were employed for the shape factor calculation.

**Figure 4.5 (a) SEM Image for sediment and 4.5 (b) CamsizerXT plot for b/l ratio Vs percentage finer.**

The recommended value of shape factor ( $K_{shape}$ ), as per IEC-62364 (2013) for round, sub-angular and angular particles for hydro-abrasive erosion to be 1, 1.5 or 2 respectively. In this case, the  $K_{shape}$  value will be  $(2.0 - 0.78)$  i.e., 1.22 as sub-angular by nature, is the precise estimate than just a qualitative prediction. [Rai et.al, 2017].

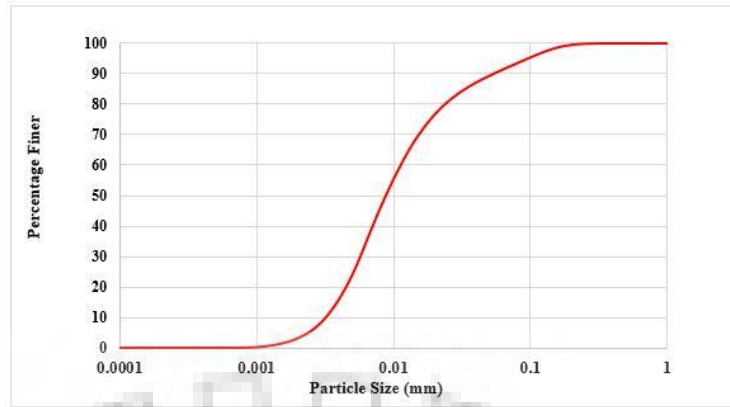
Form figure it is obtained that the medium diameter of particle size passing through turbine is 0.00884. 81.12 % of sediment load passing through turbine falls in the range of 0.002976 mm to 0.029907 mm.

**Figure 4.7 PSD at tailrace of Upper Marsyangdi A HPP [Jha, B., 2017].**

The representative sample are taken each day before settling basin and at tail race each by the hydropower. Representative sample and corresponding discharge for each week from June 2017 to October 2017. [Jha, B., 2017]. The sample PSD at tailrace is shown in Figure 4.7.

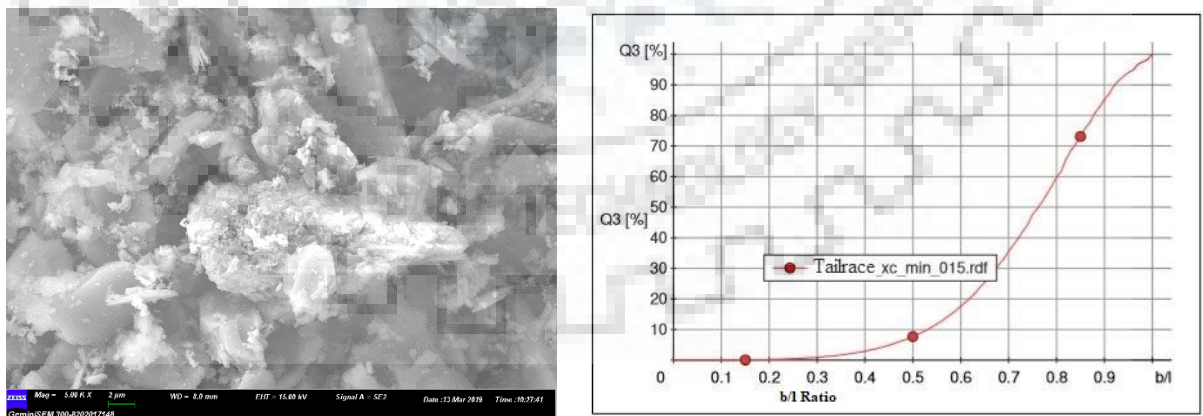
Shape of the sediment particle is measured in relation to b/l ratio. Figure 4.9 (a), and (b) shows the SEM image in 2.5k magnification and Camsizer XT measurements were employed for the shape factor calculation.

Figure 4.9 (a) SEM Image for sediment and (b) Camsizer XT plot for b/l ratio Vs percentage finer (Q3%)

The recommended value of shape factor (Kshape) as per IEC-62364 (2013) for round, sub-angular and angular particles for hydro-abrasive erosion to be 1, 1.5 or 2 respectively. In this

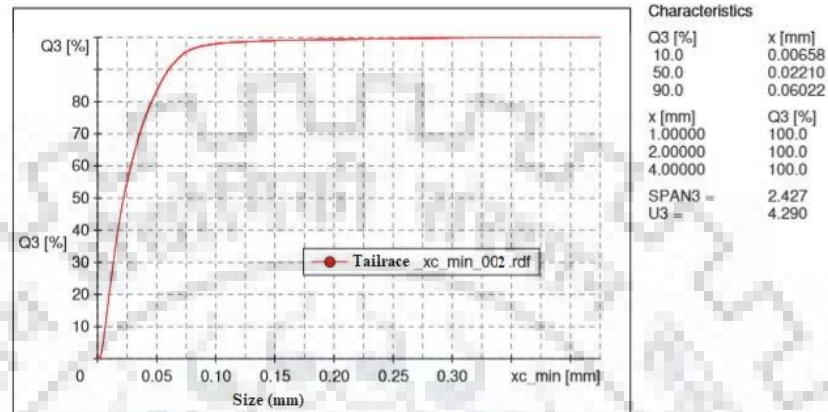
The representative sample taken from tailrace by the hydropower. The particle size distribution of sample at tailrace is shown in Figure 4.11. Medium diameter of particle size passing through turbine is 0.022 mm. 90 % of sediment load passing through turbine falls in the range of 0.0065 mm to 0.060 mm.

Figure 4.11 PSD at Tailrace of Trishuli HPP

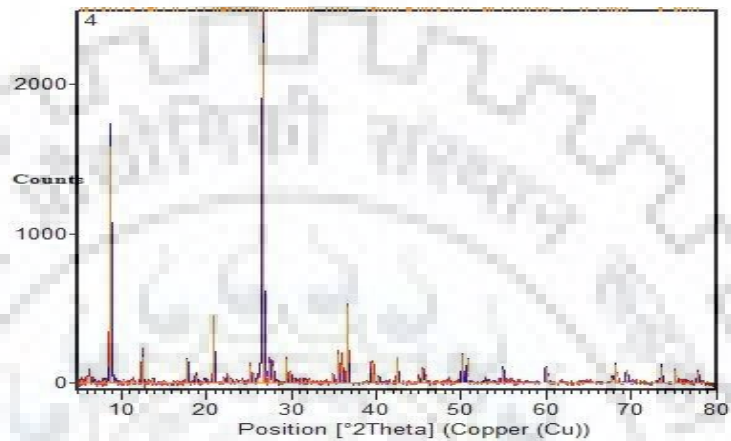
For the mineral constituents of the sediment, X-ray diffraction measurement is carried out. Mineral content for the sample taken at Trishuli HPP is found to be Quartz 67.5%, Feldspar 2.0%. Metamorphosed rock fragment 5.6%, Igneous rock fragment 0.5%, Mica 22.5% and few other constituents. [DoED, 2018] Figure 4.13 shows the riveted head graph from X-ray diffraction measurement.

**Figure 4.13 XRD plot for riveted head Vs particle counts for Trishuli HPP**

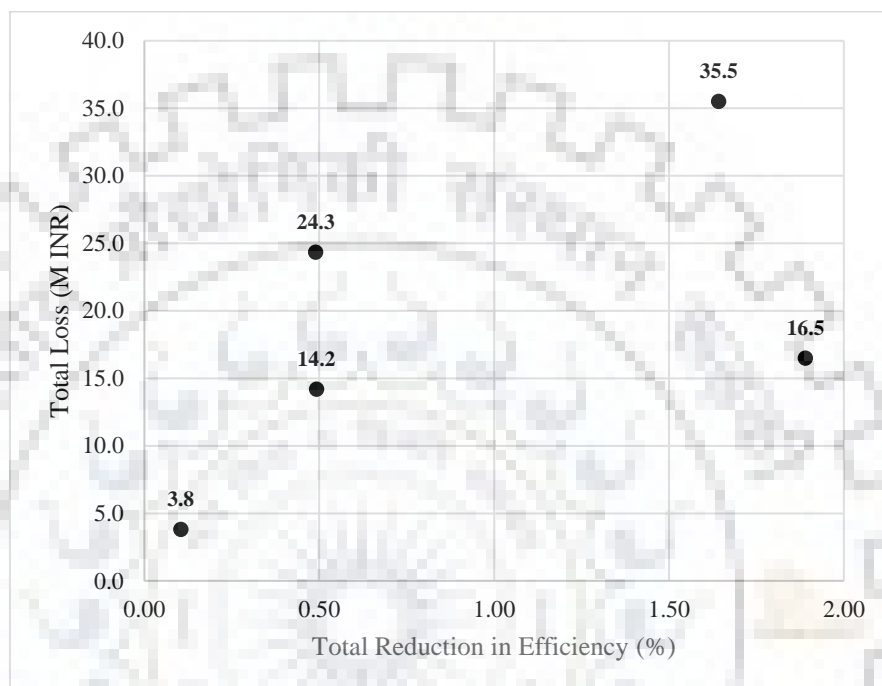
Total loss in amount has increased with increased in reduction of turbine efficiency due to abrasive erosion in relation with energy loss. Among all five HPP, the Middle Marsyangdi HPP has found higher total loss in amount with 35.5M INR with higher value of energy reduction of 1.64% per year likewise the Upper Marsyangdi A HPP has least value of total reduction on efficiency 0.10mm/yr resulting total loss 3.8 M INR per year.

**Figure 4.14 Total reduction in efficiency due to abrasive erosion and total loss for HPPs**  
Energy loss and revenue loss each year due to the reduction of turbine efficiency by abrasive erosion for all five case is listed in table 5.28 and illustrated in Figure 4.15.

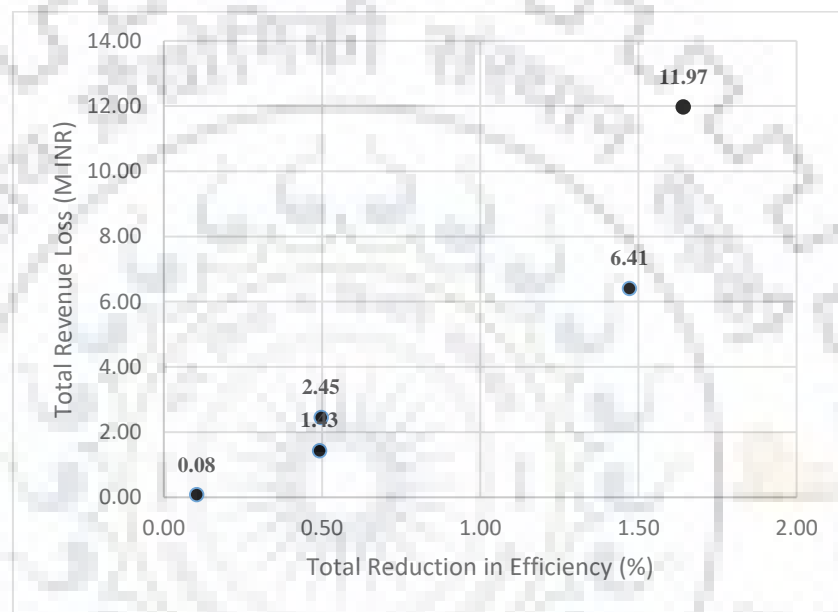
Total revenue loss each year due to the reduction of turbine efficiency by abrasive erosion of turbine has increased with increased in their total energy loss among all five HPP, the Kaligandaki A HPP has found to be higher revenue loss as in Figure 4.15.

**Figure 4.15 Total Reduction in efficiency due to abrasive erosion and total revenue loss for HPPs**

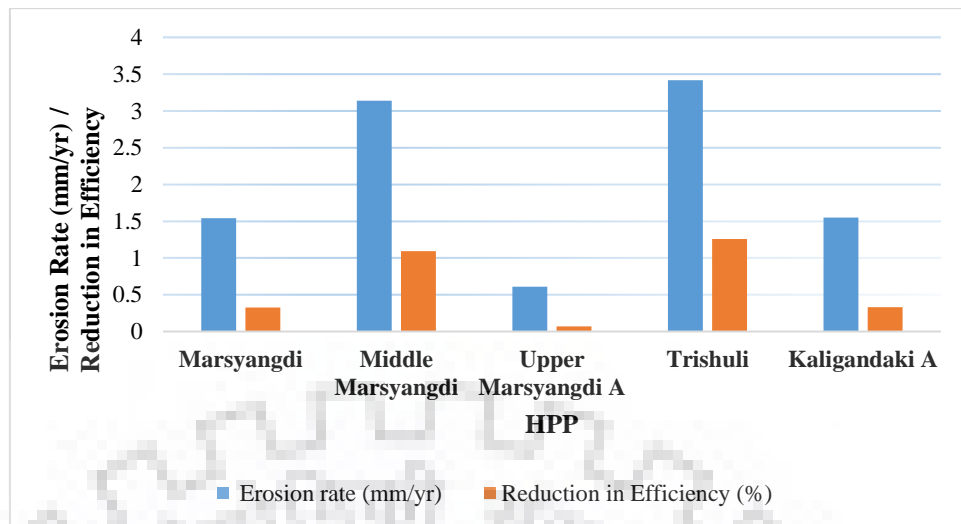
SN	Name of HPP	Erosion rate (mm/yr)	Reduction in Efficiency (%)
1	Marsyangdi	1.54	0.328
2	Middle Marsyangdi	3.14	1.095
3	Upper Marsyangdi A	0.61	0.069
4	Trishuli	3.42	1.265
5	Kaligandaki A	1.55	0.331

**Figure 4.16 Erosion rate and total reduction in efficiency due to abrasive erosion for five HPPs**

- I. Although three hydropower are in same Marsyangdi river basin, rate of abrasive erosion in Middle Marsyangdi Hydropower Plant is found to be more than Marsyangdi and Upper Marsyangdi ‘A’ Hydropower Plant. This is due to higher particle size of sediment concentration at Middle Marsyangdi HPP. Likewise, remaining two Kaligandaki A HPP and Trishuli HPP have also the higher value of abrasive erosion because of difference in catchment characteristics, concentration of sediment passing through turbine, particle shape, particle size, and mineral content.
