# Surface coating of materials for Hydroturbine applications

**M.Tech. Project Thesis | 16<sup>th</sup> May, 2018**

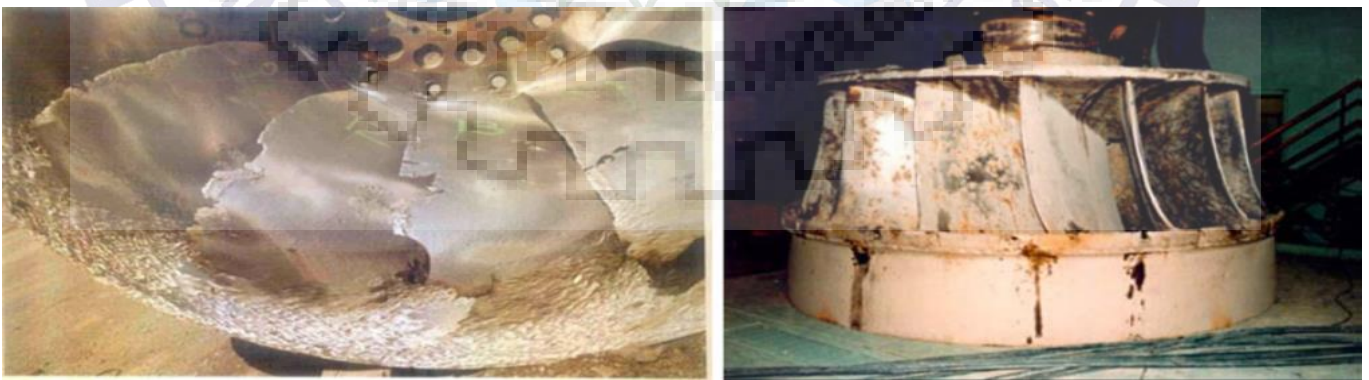
*Fig. (1) Runner blades showing cavitation erosive failure [1]*

Hydro Turbine segments, let's say, guide vane, runner blade, labyrinth, pivot ring, pump compressor, and so forth are known to be influenced by cavitation or blend of cavitation, silt erosion, and corrosion, as represented in Fig.1. Cavitation led erosion/pitting may surpass 40-mm depth beyond which a Hydroturbine runner is viewed as disastrous for operation and is for the most part taken out for the maintenance [1]. The cavitation penetration rate of basic parts, for example, impellor, turbine blades, and casing. A large amount of metal loss plainly demonstrates cavitation erosion as a serious issue One of the significant reasons for this is the presence of huge amount of quartz (90% or 5000-20,000 ppm) in the silt ( $\text{SiO}_2$ ,  $\text{Al}_2\text{O}_3$ ,  $\text{Fe}_2\text{O}_3$ ,  $\text{MgO}$ ,  $\text{CaO}$ , and so forth.), especially amid rainstorm season. Quartz which is known to have a high hardness Erosive wear of the turbine blades is a complex phenomenon that relies upon eroding particles, their size, shape, hardness and concentration, substrates chemistry, elastic properties, surface hardness and surface morphology and Operating conditions, speed and impingement angle  $\theta$ .

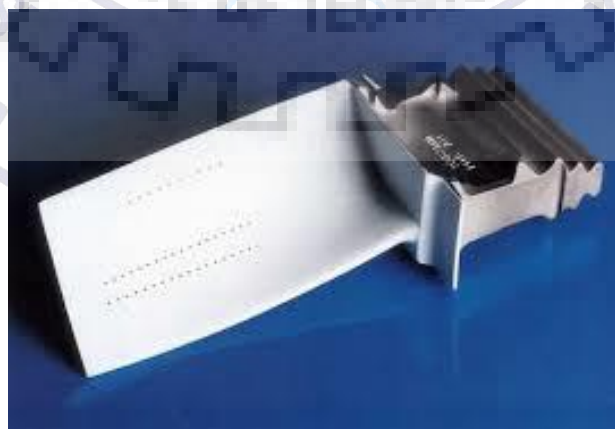
*Fig (2) Turbine blade profile*

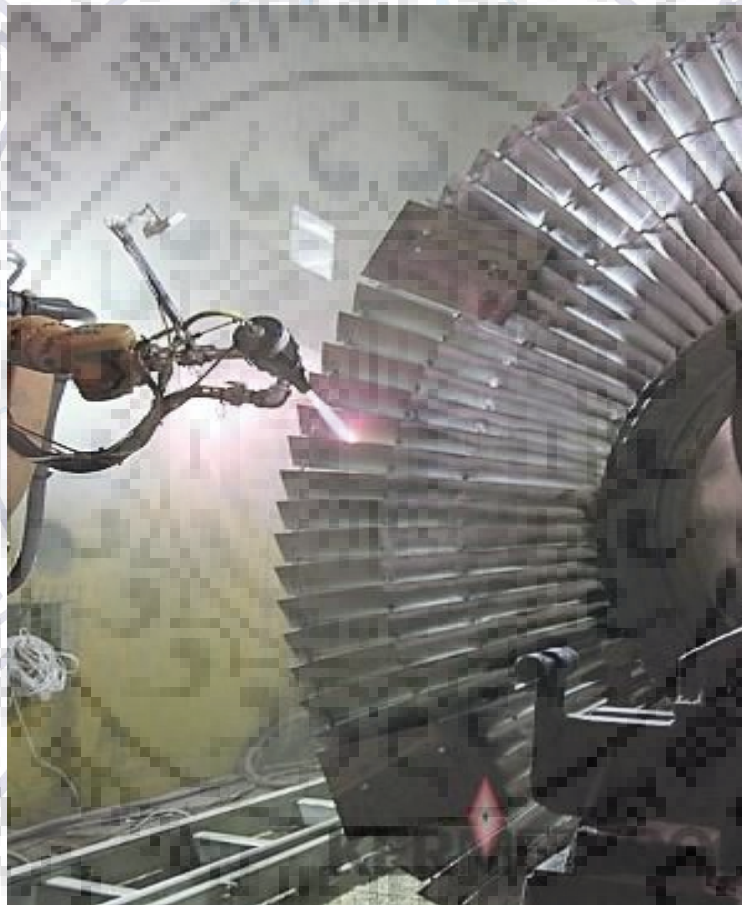
*Fig (3) Turbine undergoing HVOF coating*

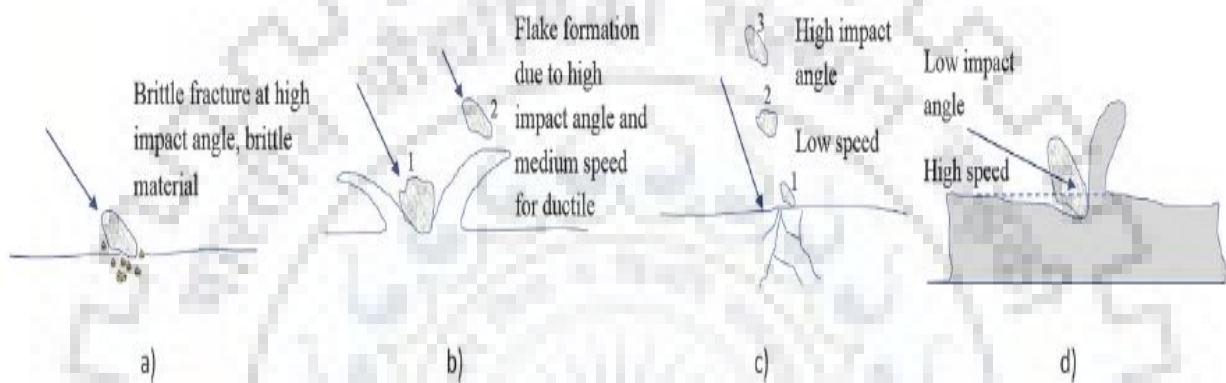
Fig (4 )Various forms of Erosive wear mechanisms a) Brittle fracture b) Plastic deformation c) Fatigue erosion d) Abrasive/cutting erosion [2]

Hydraulic devices functioning in the range of high Reynolds's number amid  $10^6$  and  $10^{10}$  in the sediment carrying fluid experience erosion. In the case of Francis turbines, enlightens that the erosion occurs in the guide vanes due to the secondary flows from the spiral casing causing non-uniform flow angles at the inlet with high absolute velocities. The guide vane system is highly affected by the silt erosion. Wear mechanisms and its relationship with the particle material, angle of impingement, impact velocity and particle size. For ductile material, they have found that the maximum erosion occurs at impingement angle of  $30^\circ$ , whereas in brittle material, it occurs at  $80^\circ$  to  $90^\circ$  degree shown in fig (4).

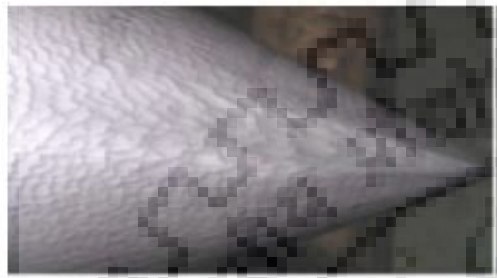
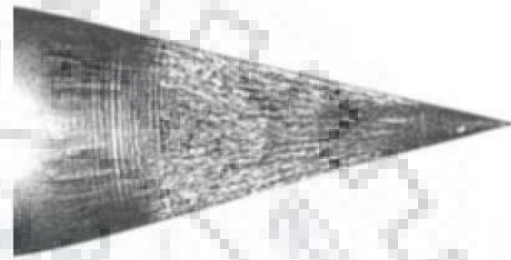
Pure sand erosion (wavy pattern)

Combination of cavitation and sand erosion

*Fig (5) Damage in Pelton turbine needle due to pure sand and combined effect of sand and cavitation erosion [3]*

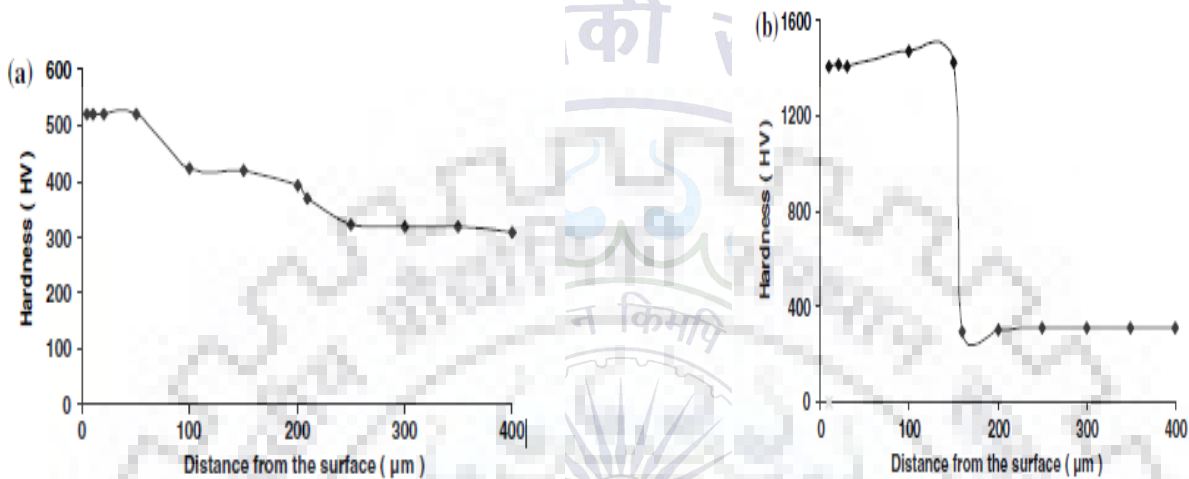
Fig (6) Cross-sectional hardness distribution of (a) laser-hardened 13Cr-4Ni steels (b) pulsed-plasma nitrided 13Cr-4Ni steels [11]

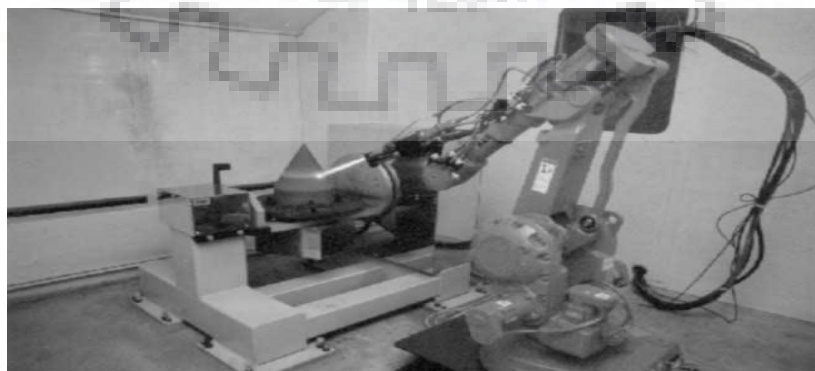
Fig (7) The HVOF coating process being adopted on a spear of a Pelton turbine [12]

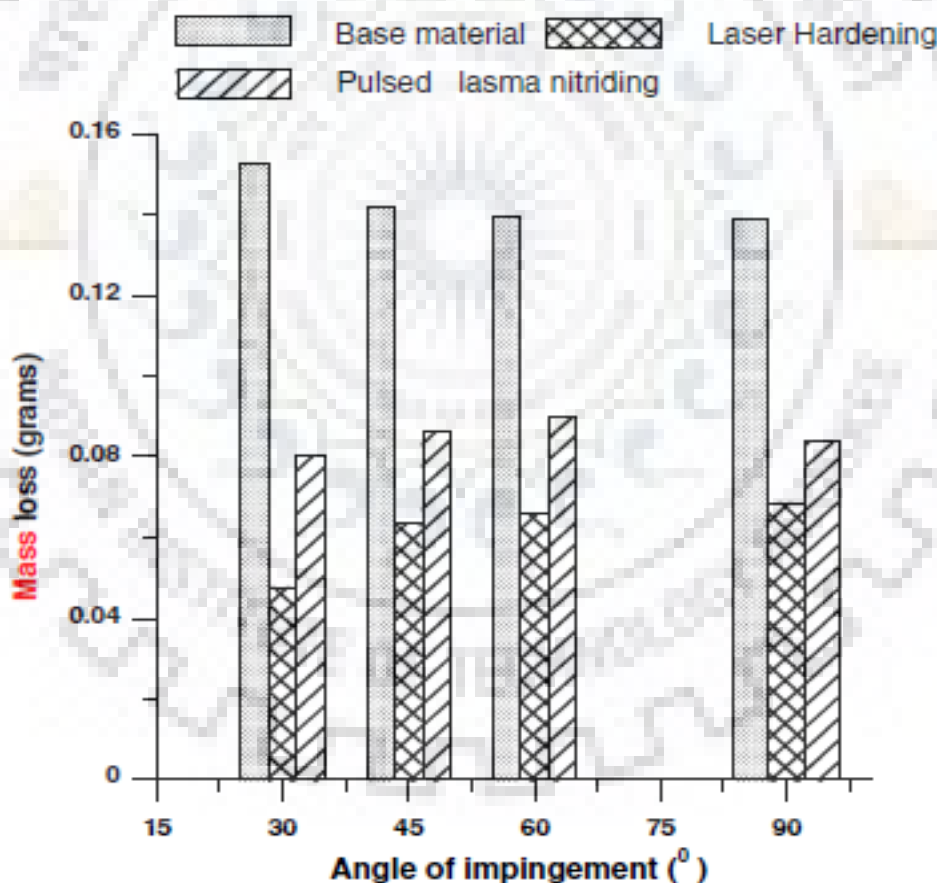
Fig (8) Erosion loss for modified steels and as received material at various angles of impingement [11]

Erosion of a material is also depends upon the angle at which the erodent particles i.e. quartz strikes at the surface. It has been found that maximum erosion rate for a ductile material is at impingement angle of approximately 20 to 30 degree and, it decreases as angles goes on higher side. This phenomena contrasts with brittle materials where the loss of material due to erosion rises steadily with angle, reaching a peak at 90 degree. Hence, coatings, which displays good performance, close to or at near normal incidence angles may not exhibit the same performance at low-incidence angles. Thus, the effect of angle of impingement has comes as an important parameter, since the silt entrained in water impinges at various incidence angles over the surface of the components in actual turbine atmosphere. Figure (8) shows the amount of erosion in terms of mass loss after 1 h of testing at various angles of impingement. It can be observed that the laser-hardened 13Cr-4Ni steel exhibited better results than the pulse plasma nitrided 13Cr-4Ni steels particularly, at low angles of impinge

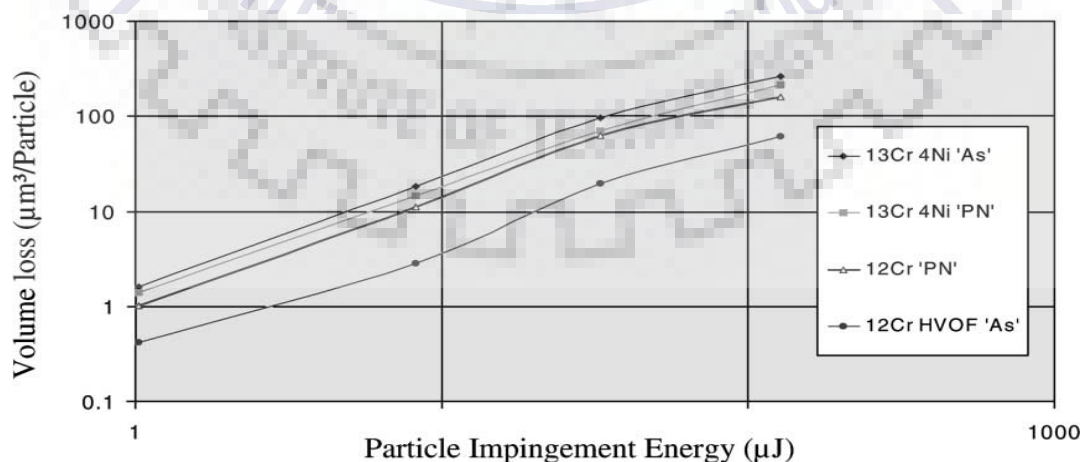
Fig (9) Relationship between erosion rate and particle impingement energy. [11]

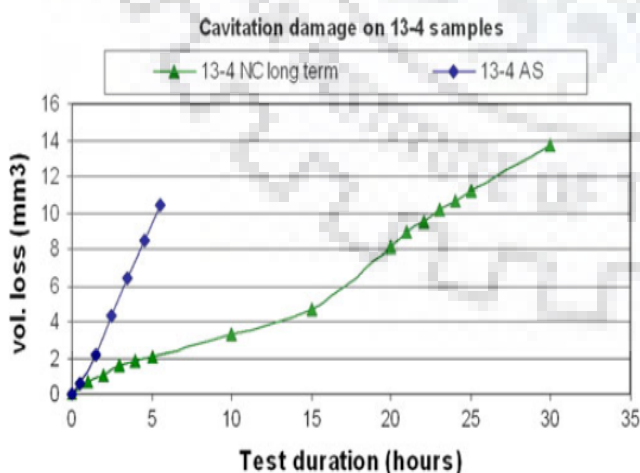
Fig (10) Volume loss by cavitation erosion after removal of nitro carburized

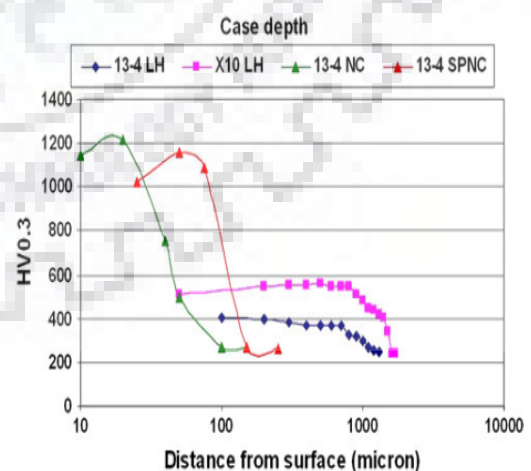
Fig (11) Vickers hardness as a function of depth below surface

The Vickers micro-macro-hardness tester was used to carry out micro-hardness as well as case depth measurements of the samples. Vickers hardness as a function of depth below surface as shown in fig (11). The advantages of the Vickers hardness test are that extremely accurate readings can be taken and just one type of indenter is used for all types of metals.

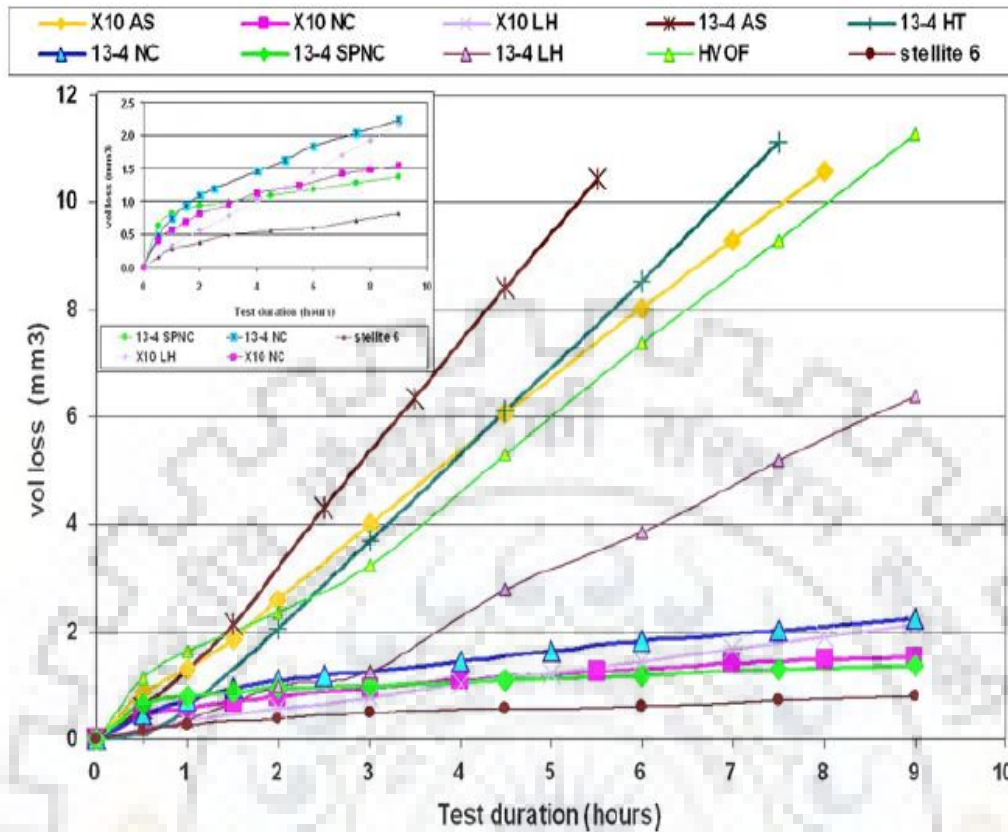
Fig. (12) Volume loss due to cavitation as a function of test duration [12]

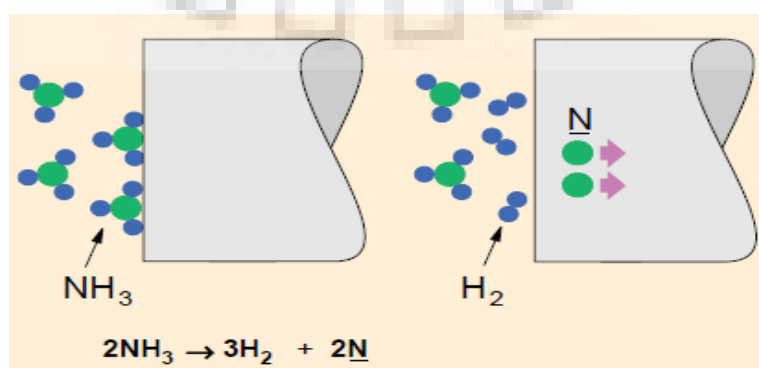
Fig (13) Schematic diagram showing Nitriding process

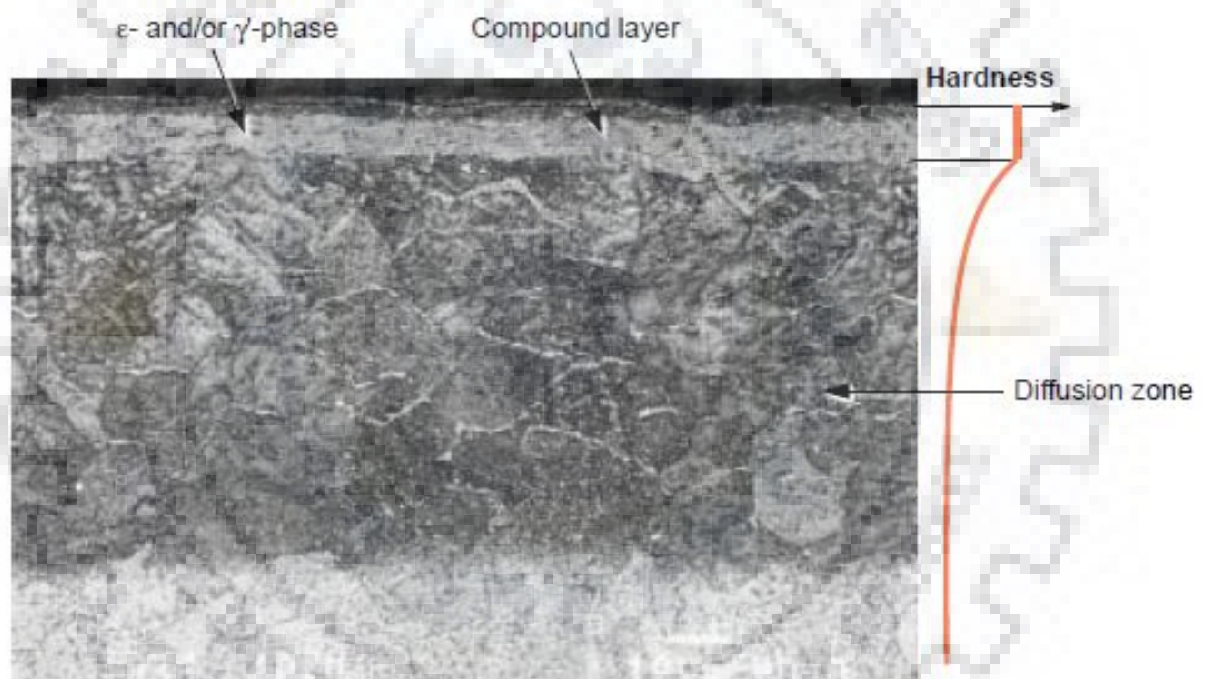
Fig (14) Micrograph shows both the compound layer and the underlying diffusion zone

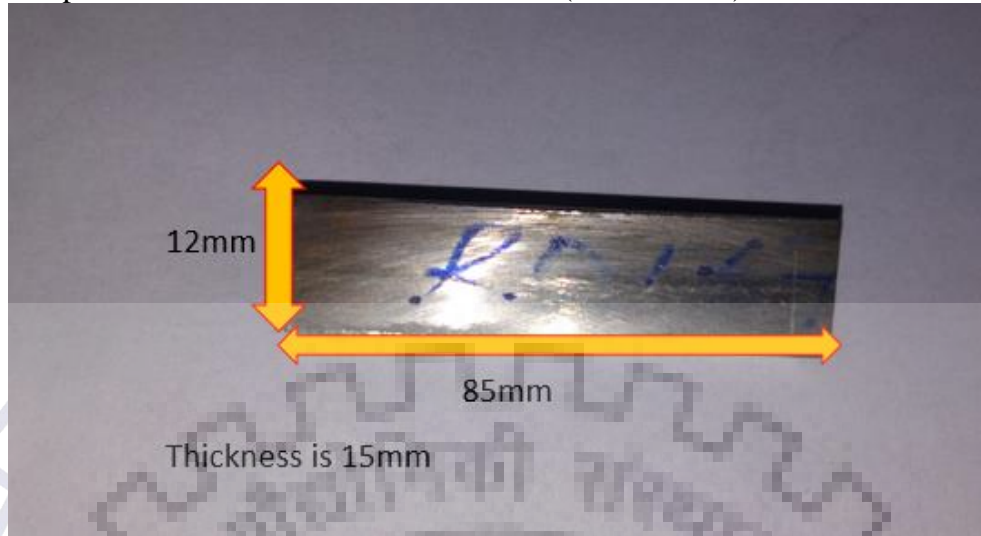
As received sample of martensite stainless steel size of ( 85 x12 x15 )mm

Fig (16) Dimensions of as received sample

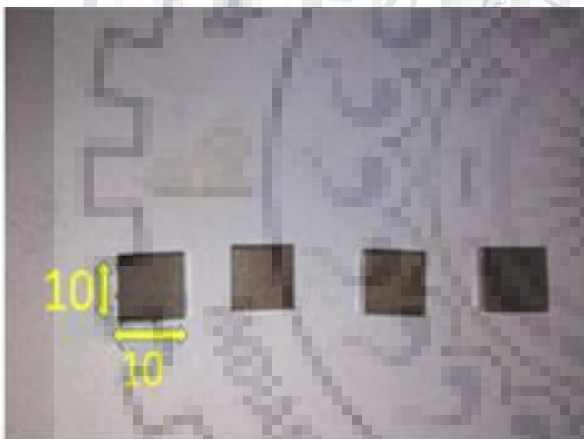
To study of silt erosion in martensitic stainless steel sample is used of dimension (10 x 10 x 3 mm).

Fig (17) samples obtained after wire cut EDM

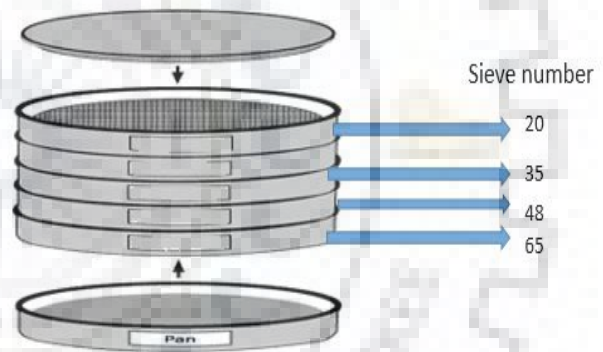
Fig (18) Sand sieving pans

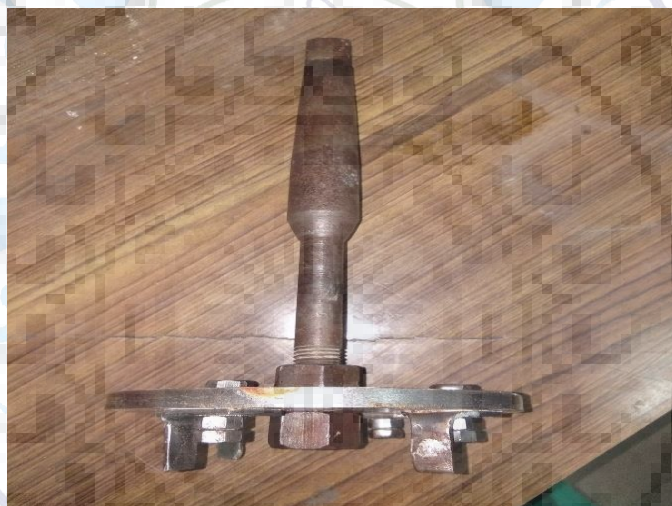
*Fig (19) sample holder of slurry testing machine*

The slurry erosion tests were carried out, in which the specimens were submitted to wear conditions similar to those of the liners of Francis hydraulic turbines. Fig.14 shows the configuration of the testing machine, which is composed of a sample holder connected to an electrical motor. Test is performed at room temperature. The samples were pasted at the sample holder at different angle of inclination to ensure grazing incidence of the particles (see Fig.13). The slurry was composed of normal tap water and quartz particles i.e. regular sand with a mean diameter is in between 212 and 300  $\mu\text{m}$  (AFS 50/70) and the solids content i.e. slurry concentration was 18 wt%. The erosion resistance was determined from the mass loss results. Mass losses were measured every 4hrs by using a scale with 0.01 mg resolution. The total duration of each test was 16 hrs, and after that period both the sample and the slurry were replaced

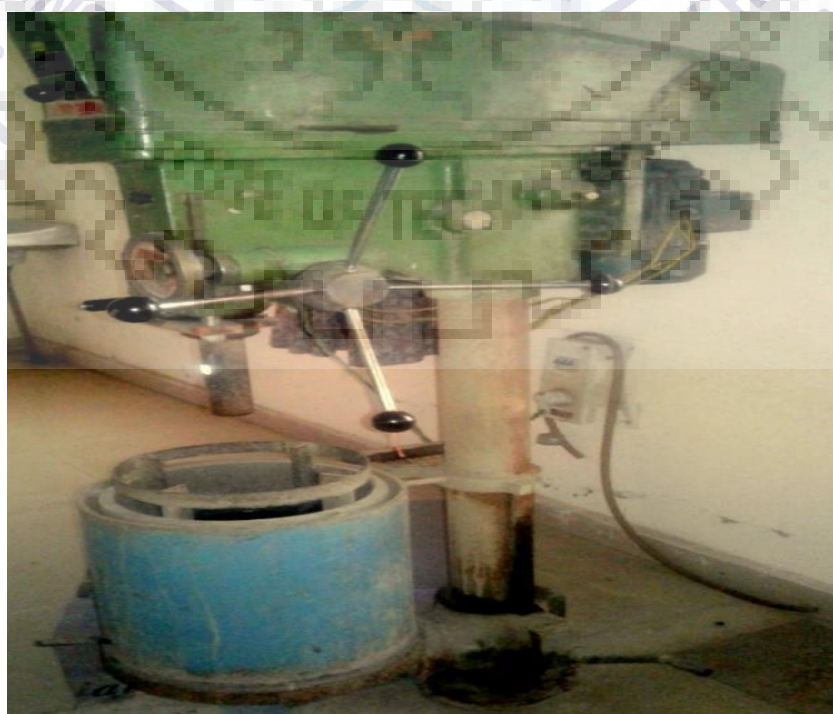
*Fig (20) Slurry Erosion Testing Machine*

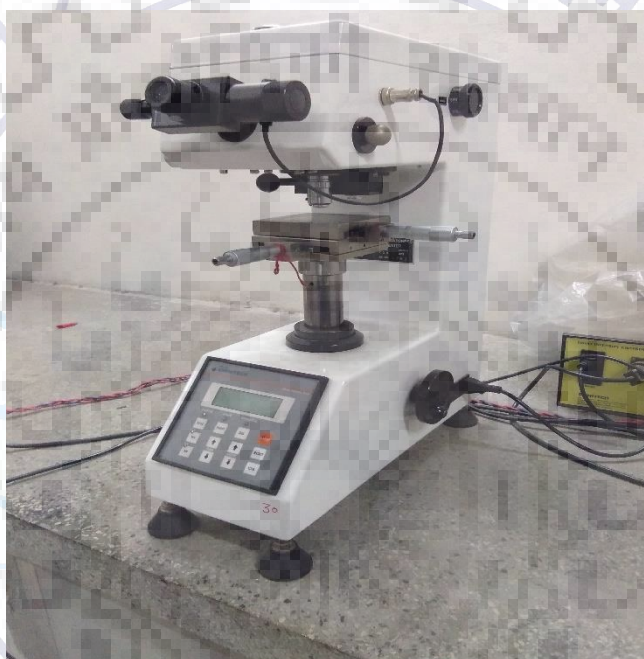
*Fig (21) Microhardness Testing Machine*

During microhardness testing, a diamond indenter is pressed into the material's surface with a penetrator and a light load of up to 1000 grams. The result of applying the load with a penetrator is an indent or permanent deformation of the material surface caused by the shape of the indenter.

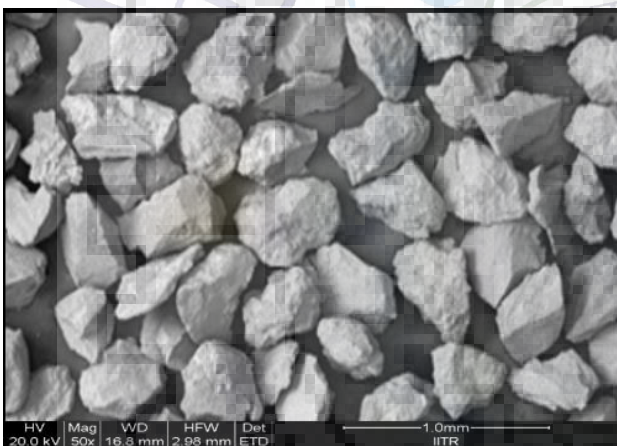
Fig (22 a) SEM image of abrasive particles before test

- Silt used in experiment is a regular sand found abundant in nature.
- Largest particle size used in study were up to 300  $\mu\text{m}$ .
- Sand particle range from very fine to fine sand in size.
- Shape of particles ranges from semi round to sub angular.
- SEM image of abrasive particles before slurry erosion test.
- Change in size distribution shown in fig (22)
- Edges are sharp and pointed.
- Note that after the tests the distribution is shifted to smaller grain sizes.

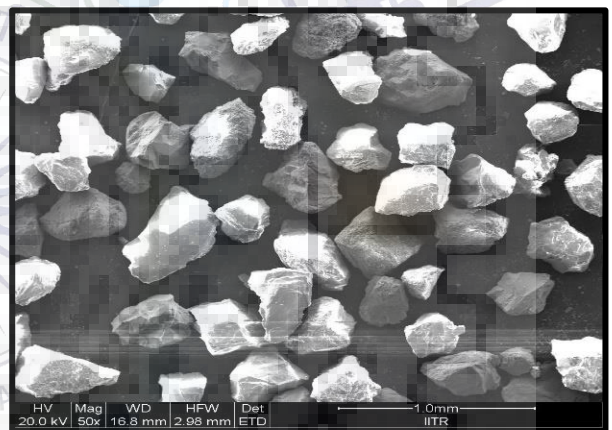
Fig (22 b) SEM image of abrasive particles after test

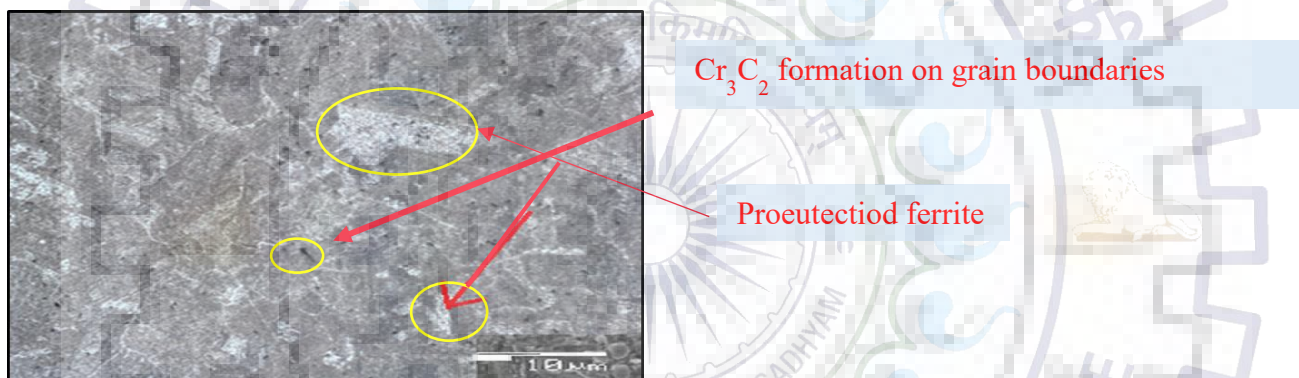
So corrosion resistance is highly reduced in neighbor regions. In this case after etching, the regions are seen dark which is an evidence of chromium carbides presence shown in fig (23)

Fig (23a) optical image of 16- 5 MSS depicting pro-eutectoid ferrite and chromium carbide

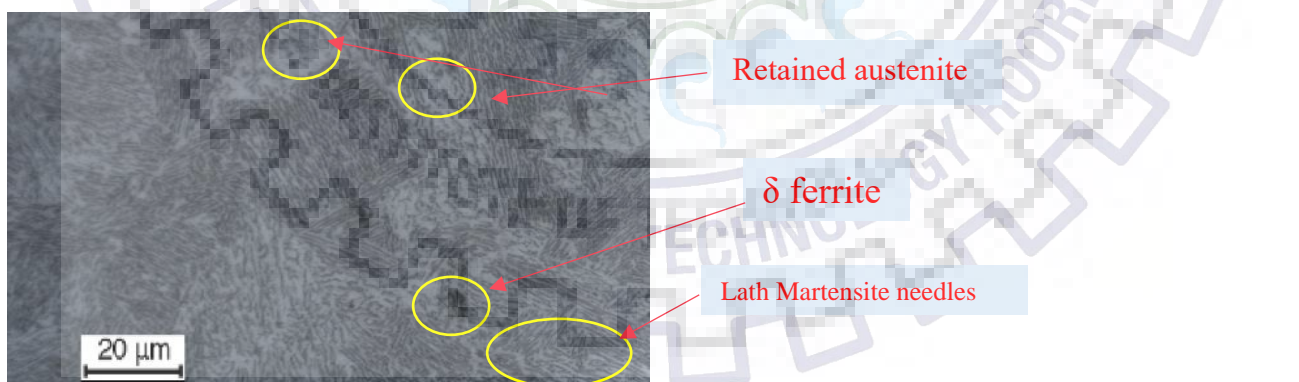
- The microstructure composed of tempered martensite along with retained austenite and delta ferrite in it.
- The prior austenite grains were subdivided into packets of thin laths (needles) of martensite.
- Due to high chromium atom mobility, chromium carbide formation will be very prominent when the temperatures reaches above 425 °C
- Formation of chromium carbide leads to depletion of chromium in the adjacent areas.
- Although MSS has a very low carbon concentration, intergranular stress corrosion cracking (IGSCC) had been observed due to formation of Cr depleted zones due to precipitation of Cr carbide.

Fig (23b) optical image of 16-5 MSS AISI 431 depicting lath needles and retained austenite

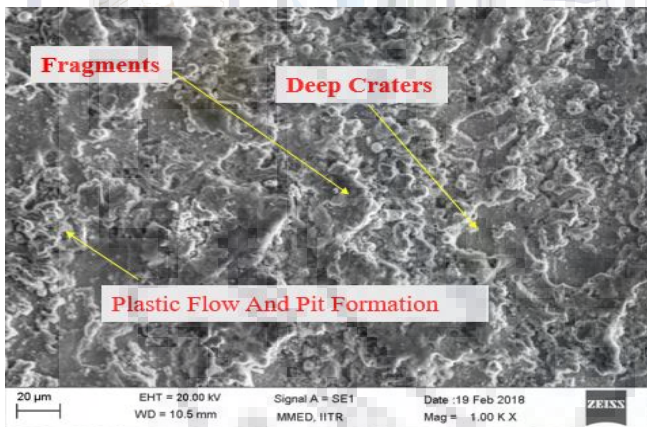
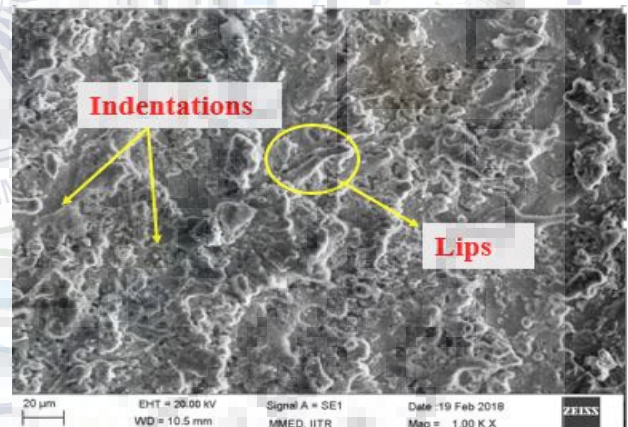
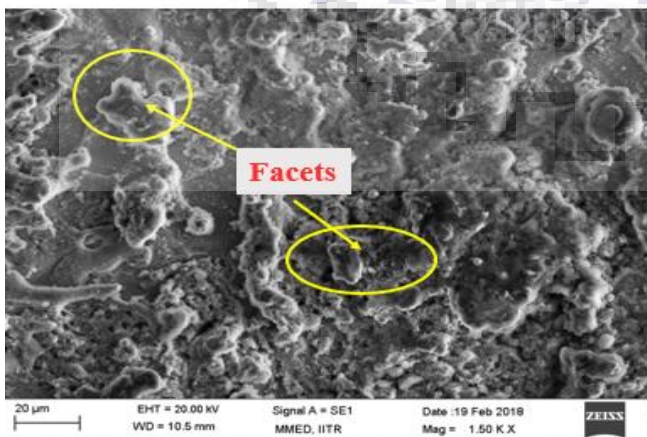
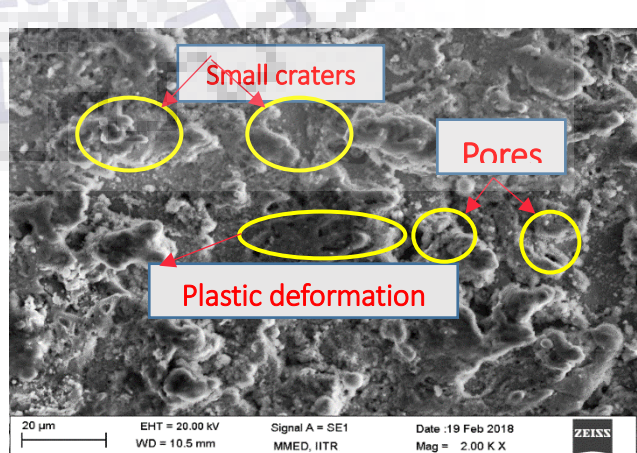
Fig (24a) SEM of nitrided eroded specimen after test at 60 °

Fig (24b) SEM of nitrided eroded specimen after test at 60 °

Fig (24c) SEM of nitrided eroded specimen after test at 30 °

Fig (24d) SEM of nitrided eroded specimen after test at 30 °

The mechanism of material removal in erosion mainly depends on material properties as well as the angle at which the erodent strikes at the surface of the target. Commonly there are two mechanisms reflected to be connected with the removal of material. There are repetitive plastic deformation and cutting. Ductile materials will undergoes mass loss by the process of straight micro cutting or plastic deformation, followed by cutting. While in brittle materials, here energy transfer is associated with repeated particle impacts resulting in a fatigue process. Appearance of specimen, formation of small pits and grooves, which indicates that the material is submitted to plastic deformation. The erosion damage as well as removal of material initiated from its prior austenite grain boundaries and martensite laths. It was observed that there is increase in Ra value as well. The roughness parameters keeps on increasing due to the formation of craters on it with strained material surrounding around them. The worn surface loses the detached particles, eventually micro-cracks grows and joins each other shown in fig (24). After 16 hrs of testing several deep craters, tiny pores fragments had been appeared inside some grains. Bare mss shows ductile to brittle behavior, exhibiting two different modes of material detachment. The first mode was characterized by a great degree of plastic deformation, fatigue and ductile fracture. The second failure mode will be brittle fracture by cleavage mechanisms.

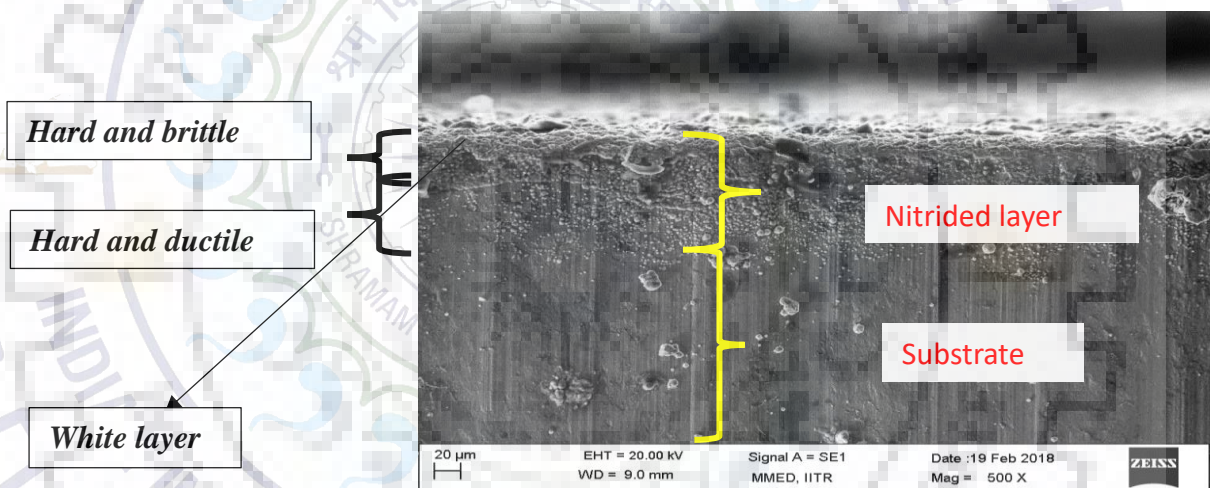
Fig (25 a) SEM of nitrided layer

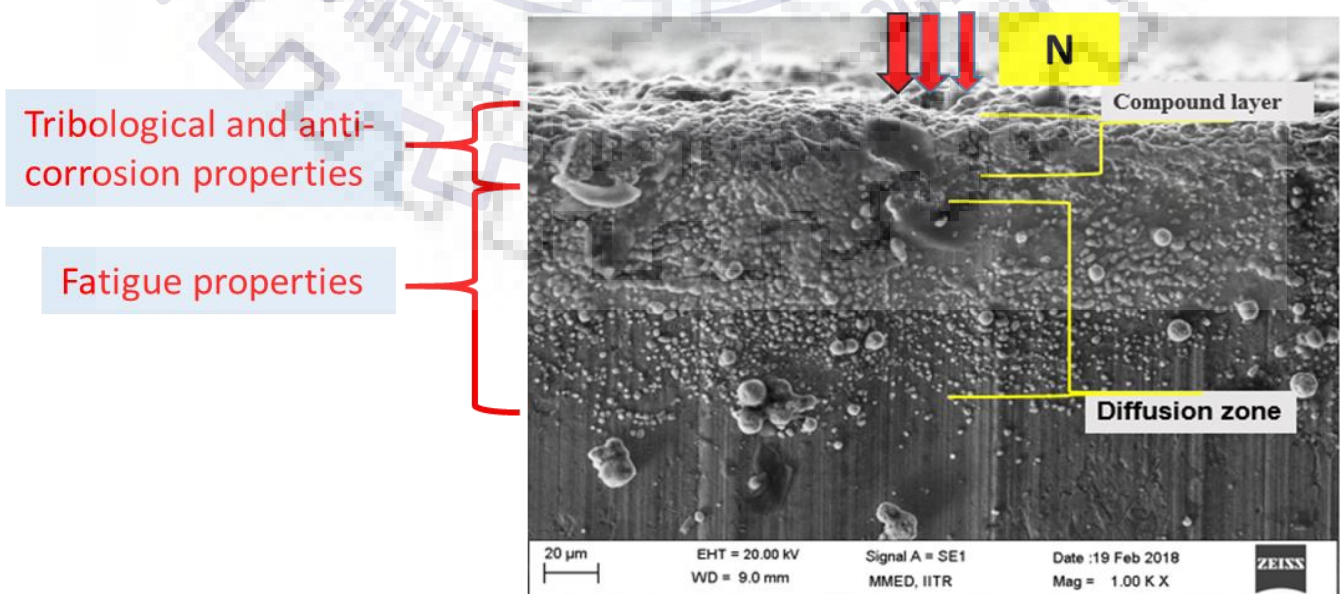
Fig (25 b) SEM of nitrided layer depicting both zones

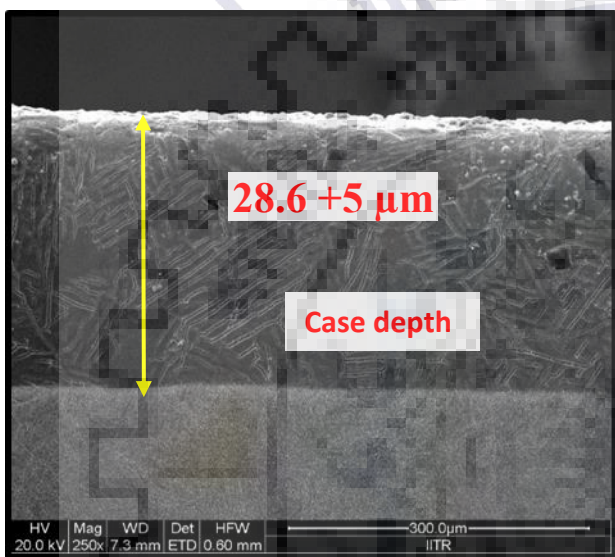
In fig 26 (a) shows Total case depth of coating of Compound layer is of  $5\mu\text{m}$  (very hard and brittle) Diffusion layer is of  $28.6\mu\text{m}$  (hard and ductile in nature) the white layer was identified as a multiphase compound layer of  $\epsilon$  and  $\gamma'$  phases. In fig 26 (b) shows Diffused layer consist of expanded martensite and  $\epsilon$  iron nitride and rest is martensite. Fig 26 (c) At elevated temperature, chromium gets mobile enough to diffuse through the material, form a chemical bond with nitrogen and precipitate in  $\text{Cr}_2\text{N}$  crystallites. one can conclude that the  $\text{Cr}_2\text{N}$  precipitates reduce the corrosion resistance by intergranular sensitization high fluence nitrogen ion implantation in martensite in the temperature up to  $540^\circ\text{C}$  leads to formation of expanded martensite. In fig 26 (d) an anisotropic lattice expansion is also observed.

Fig. (26a) Total case depth obtained

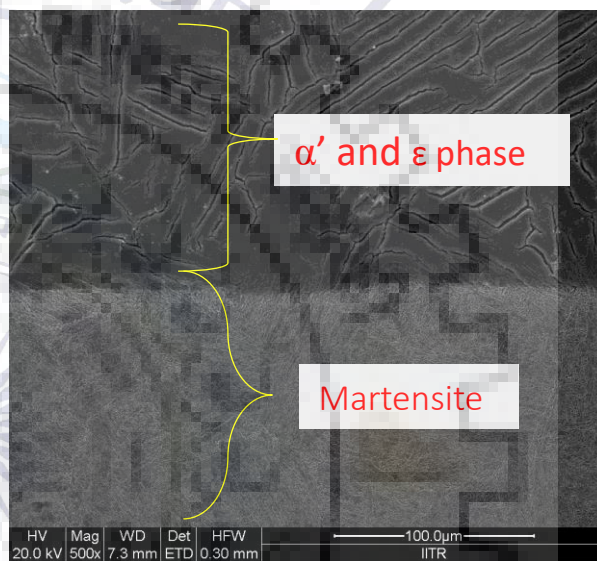
Fig. (26b) SEM depicting diffusion zone and rest MSS

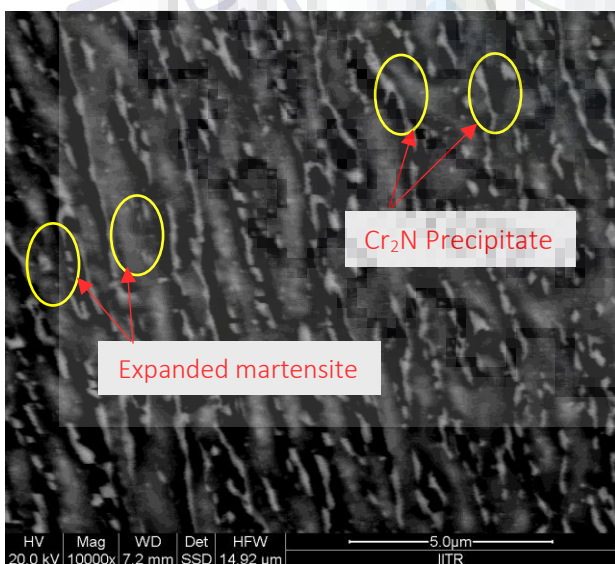
Fig. (26c) Chromium nitrides at grain boundaries

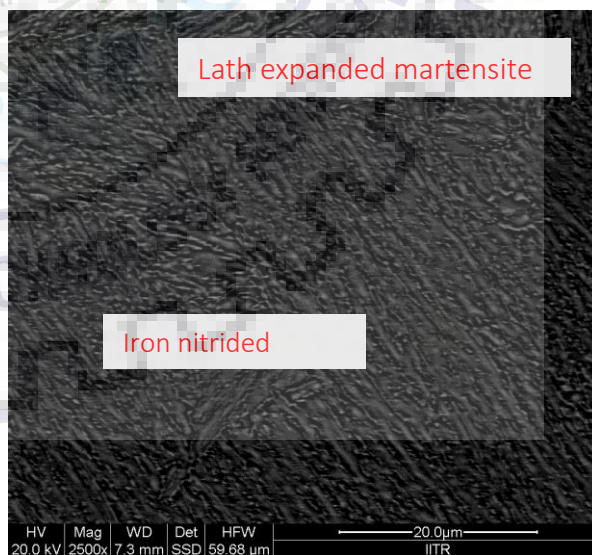
Fig. (26d) Back scattered image of expanded MSS

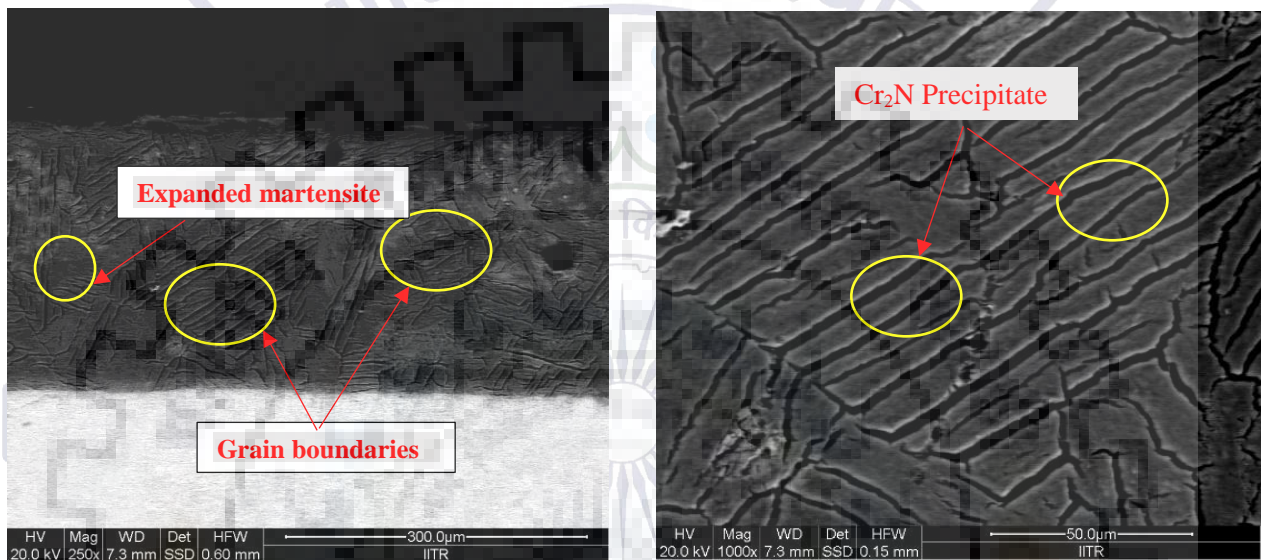
Fig (27a) back scatter image showing Grain boundary

Precipitates in low carbon martensitic stainless steel during tempering are mainly  $M_{23}C_6$ , where M represents Cr, Mo and Fe. It is reported that the addition of nitrogen delays carbide precipitation and results in disappearance of carbide phase in high nitrogen martensitic stainless steel. Severe precipitation of  $Cr_2N$  along martensitic inter-lath boundaries and within matrix shown in fig (27). Precipitation of rod-like  $Cr_2N$  along martensite lath boundaries and within laths of MSS with N after tempering above  $550^\circ C$  contributes to slight increase in strength and much decrease in toughness compared to the steel without nitrogen actually, the precipitation of  $Cr_2N$  in this

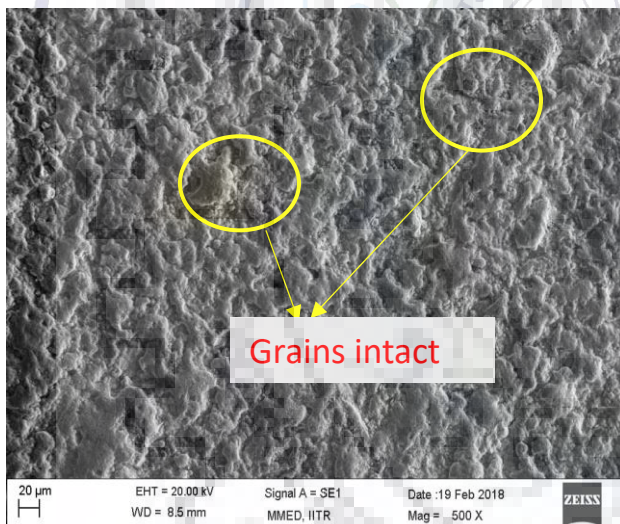
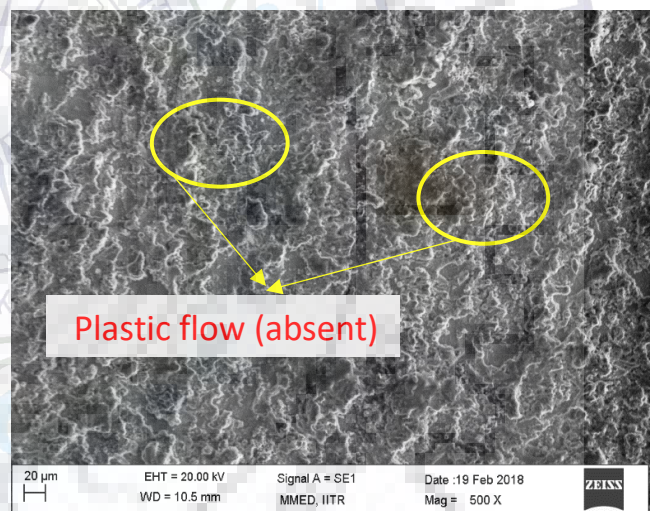
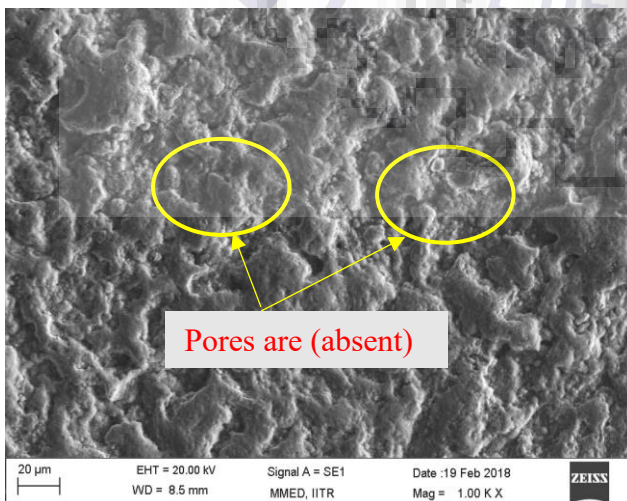
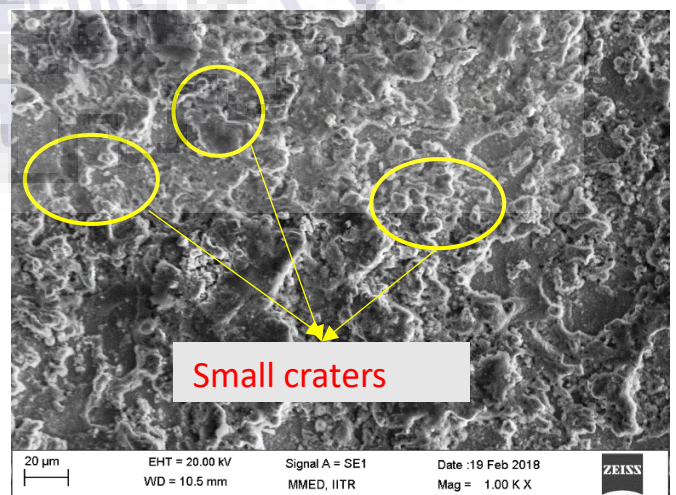
The nitrided specimen surface before and after 4 hrs of testing. During the first 60 min of testing, some tiny pores (1) appeared inside some grains; but, generally speaking, the nitrided specimen surface did not show any significant change and most of the grains remained intact, supporting the fact that the expanded martensite elastically absorbed the shock-waves impact, without plastic deforming. After 105 min, the number of pores inside the grains increased (2) and new pores were nucleated, not only in other grains (3) but also at grain boundaries (4), as can be seen in Fig. 12. Furthermore, it can be seen in Fig. 12 that the damage inside the grain was nucleated at the martensite lath boundaries. The pores nucleation process, along the surface within grains and at grain boundaries, increased with the exposure time, wear particles were detached from the surface, as can be seen for 180 and 300 min of testing time in Figs. 13 and 14, respectively. Moreover, some former pores increased their size and depth, becoming craters (5), particularly those located at martensite laths. It can be inferred that the material removal is due to brittle fracture without plastic deformation. Pores nucleation and growth proceeded and spread over the entire surface till around 600 min of testing, as shown in Fig. 28.

Fig (28a) SEM of nitrided eroded specimen after test at 60°

Fig (28b) SEM of nitrided eroded specimen after test at 30°

Fig (28c) SEM of nitrided eroded specimen after test at 60°

Fig (28d) SEM of nitrided eroded specimen after test at 30°

The original surface was completely removed, but grain Surface did not show any significant change. The grains remained intact, The expanded martensite elastically absorbed the shock-waves impact, without plastic deforming. After 16hrs pores inside the grains are absent not only in other grains but also at grain boundaries. The erosion penetration depth into the nitrided specimen was very low. The wear mechanism remained unchanged. Pores nucleation process, increased with the exposure time, wear particles were detached from the surface former pores increased their size and depth, becoming craters, particularly those located at martensite laths. The material removal is due to brittle fracture without plastic deformation.

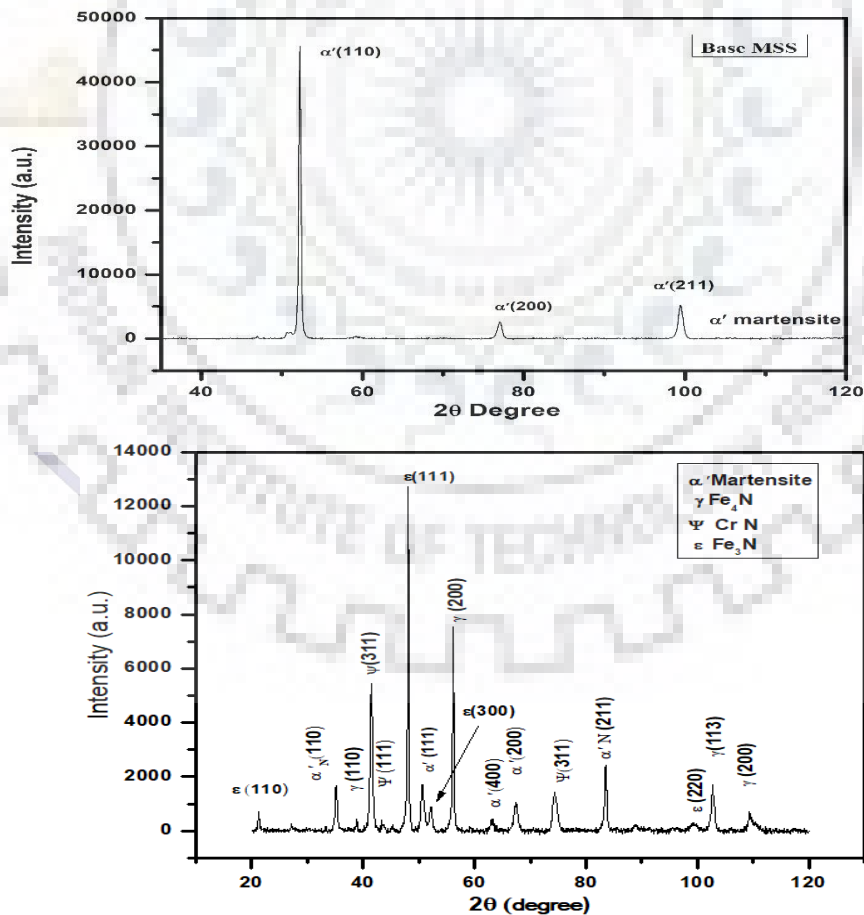
X-ray diffraction patterns for both specimens. As can be seen in Fig. (29 a), the non-nitrided specimen shows typical BCC martensite peaks located at  $2\theta$  angles of 47.81, 78.06 and 99.33. On the other hand, in the nitrided specimen those 3 martensite peaks were broadened and shifted to the left due to the nitrogen gradient along the nitrided case, which produced a different lattice parameter (interplanar spacing) as a consequence of the different nitrogen amounts dissolved at the interstitial sites of the crystal structure. It should be noted that part of the expansion is due to development of compressive stresses in the nitrided case [23]. The peaks located at  $2\theta$  angles of 43.12, 68.11 and 81.60 correspond to a nitrogen supersaturated phase, known as expanded martensite. The  $\alpha'$   $\alpha'$  N (110) expanded martensite region of the X-ray pattern lies between 43.121 and 44.661, as shown in Fig. (29b), indicating a nitrogen gradient inside the nitrided case. In addition to the expanded martensite peaks, the nitrided specimen diffraction pattern shows hexagonal  $\epsilon$ -Fe<sub>24</sub>N<sub>10</sub> iron nitrides peaks structurally similar to  $\epsilon$  Fe<sub>3</sub>N.

Fig (29b) X-ray diffraction patterns for nitrided specimens.

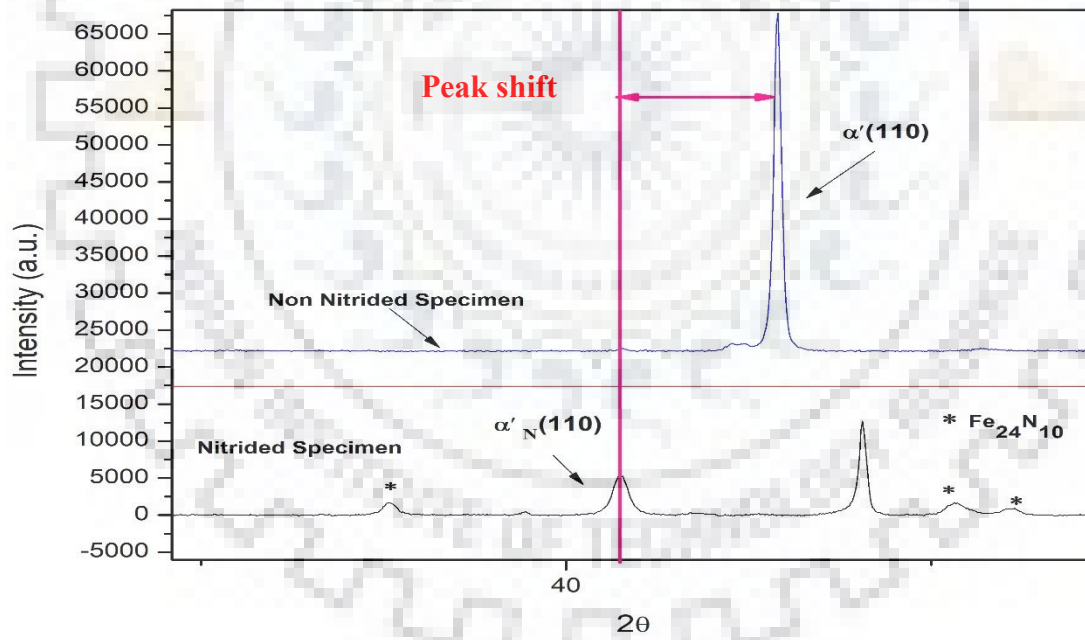
Fig (30 b) X-ray diffraction patterns showing peak shift b/w two specimens.
