# Surface coating of materials for Hydroturbine applications

**M.Tech. Project Thesis | 16<sup>th</sup> May, 2018**

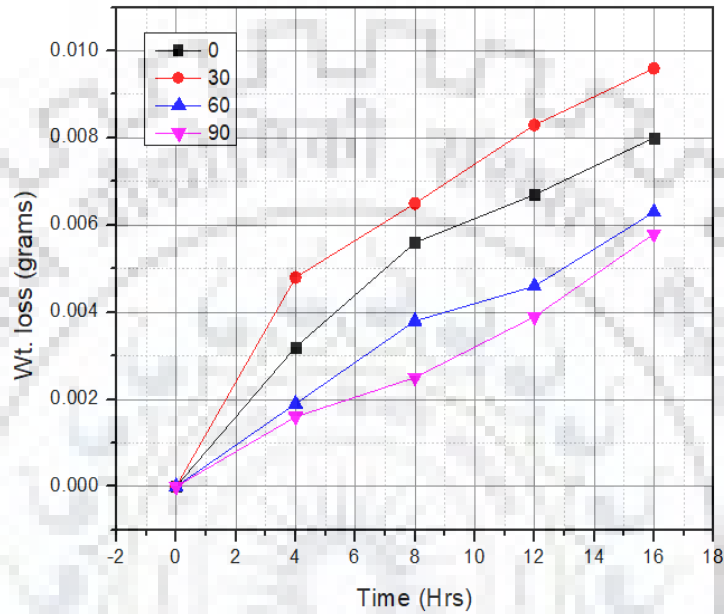
At the initial stage of cavitation, with a high erosion rate (1.2 mg/h), the AISI 410N Rq roughness values remain almost constant (2.5  $\mu\text{m}$ ) from the fourth hour of testing on, implying that the removed mass comes mainly from a maximum depth of 5  $\mu\text{m}$  when this initial nitride containing layer is removed from the sample, only expanded martensite is exposed to the shock-waves produced by cavitation and the erosion rate drops to a lower value of 0.36mg/h shown in fig (31).

Fig (31a) Wt. loss plot for non nitrided specimen

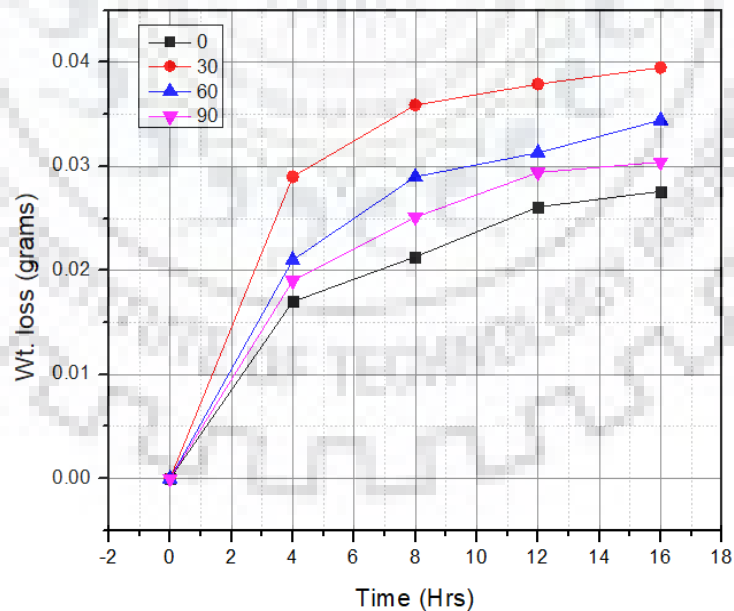
Fig (31b) Wt. loss plot for nitrided specimen

**The erosion rates** were calculated from the slope of the straight line plotted from the 4th hour on accordingly, the erosion rates are 6.9 mg/h and 1.7 mg/h for nitrided and non-nitrided specimens.

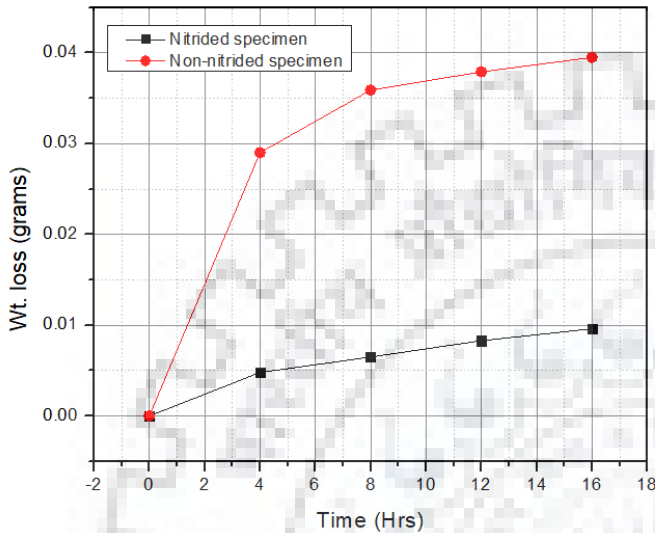
Fig (32a) wt. loss vs exposure time plot

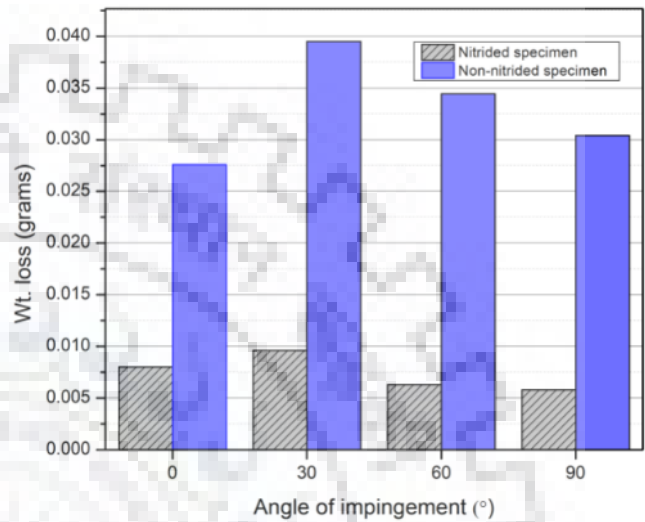
Fig (32b) wt. loss vs angle of impingement

Erosion of a material is dependent upon the angle at which the erodent particles strike the surface of the target. It has been found that maximum erosion rate for a ductile material is at impingement angle of approximately 20–30 and, it decreases at higher angle. Nitrided specimen i.e. AISI431 steel exhibited better performance than the bare AISI 431 steels especially, at angles of impingement of instance, at 90°. This is quite interesting, because the coated layer has very high hardness so, it had shown excellent performance at low angles as well as on high angle of impingement shown in fig 32 (b). This might be due to the transformability of expanded martensite which undergoes repetitive plastic deformation at all angles of impingement.

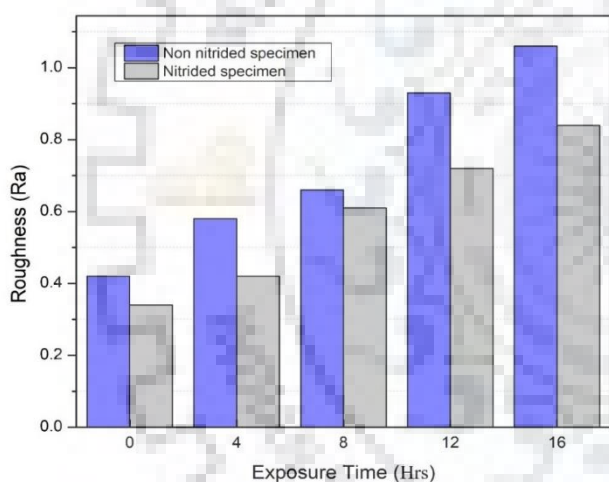
Fig (33a) Surface Roughness Profile

It shows the microhardness variation as a function of depth for the nitrided the maximum hardness of 1021 HVN measured on the surface continuously decreases as a consequence of the reduction of nitrogen content with depth, till the hardness of the substrate is achieved shown in fig (33b). The microhardness gradient is very gentle throughout the nitrided case, formation of nitrogen expanded martensite increased the hardness almost 3 times, from for the tempered martensite. While Ra value for nitrided specimen is much lesser than the non nitrided specimen. After 16 hrs of testing results in case of bare MSS is  $1.78\mu\text{m}$  while in nitrided specimen it has reached to the value of  $0.81\mu\text{m}$  shown in fig (33a). This happens because of the wear mechanism take place in the bare MSS. Pores nucleation process, increased with the exposure time, wear particles were detached from the surface, former pores increased their size and depth, becoming craters, particularly those located at martensite laths and thereby the surface roughness parameter goes on increasing.

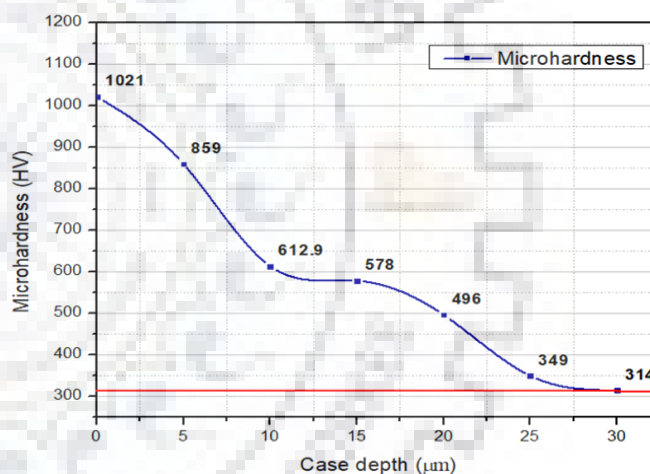
Fig (33b) Case Hardness Profile
