**A STUDY OF LANDSLIDES
BETWEEN
PIPALKOTI - BADRINATH
AND
JOSHIMATH - BHAPKUND
DISTRICT CHAMOLI, UTTAR PRADESH**

DISSERTATION
IN PART FULFILMENT OF THE REQUIREMENTS
FOR THE AWARD OF
M.Sc. Tech. DEGREE IN APPLIED GEOLOGY

**DEPARTMENT OF GEOLOGY & GEOPHYSICS
UNIVERSITY OF ROORKEE
ROORKEE (U.P.)**

1967

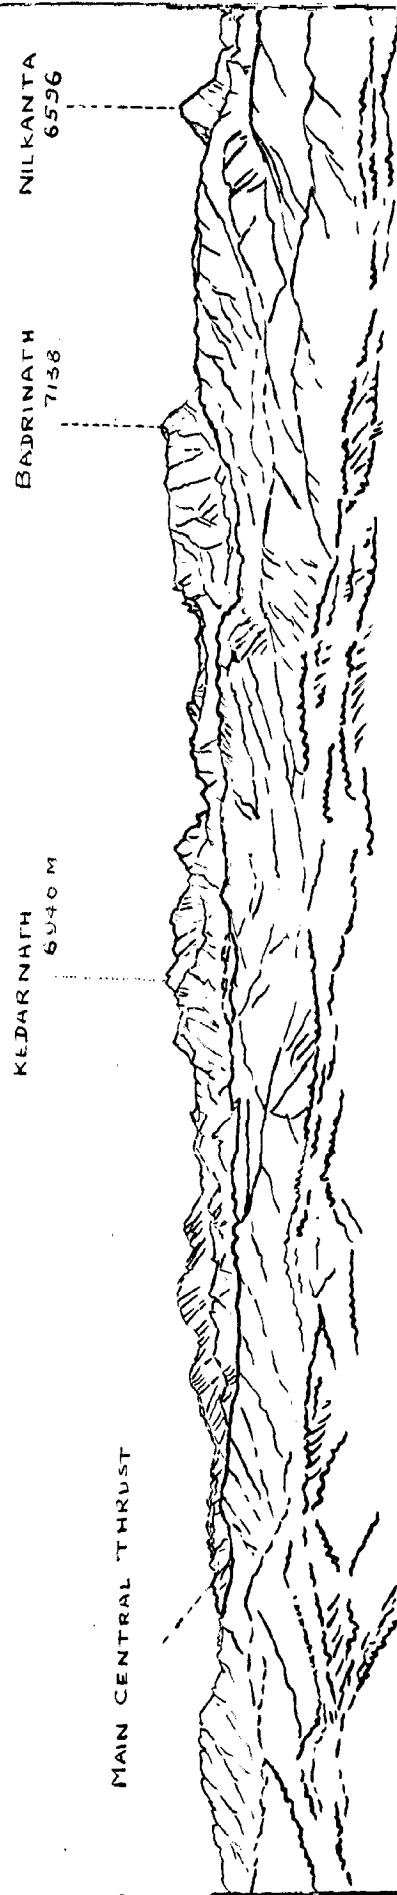
FIGURE NO. 1.1

PANORAMA OF EASTERN KUMAON HIMALAYAS

CLEAR DIVISION BETWEEN CENTRAL HIMALAYAS & LOWER HIMALAYAS

THRUST PLANE CLEARLY MARKS CHANGE OF TOPOGRAPHY.

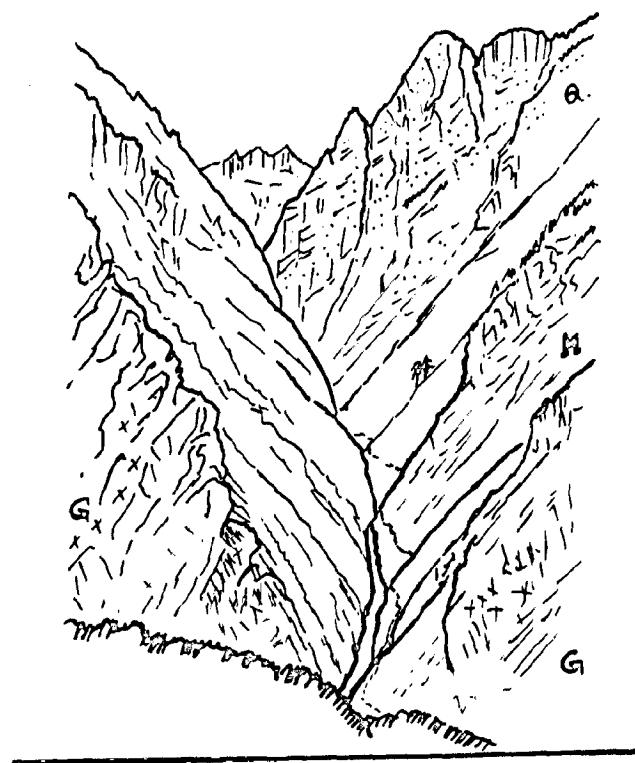
THE GORGE OF THE ALAKNANDA R.

ABOVE VISHNU PRAYAG VIEW TOWARDS N.

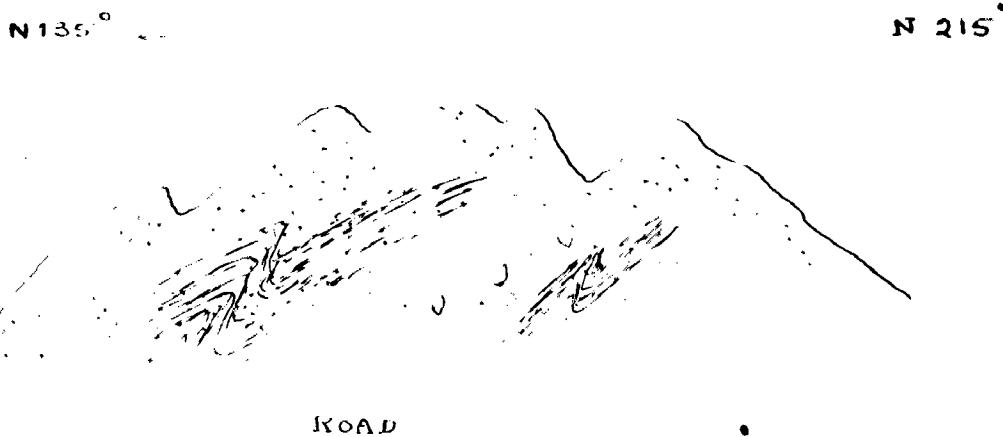
FIG NO 3.5 INSITU ALTERATION OF CHLORITE SCHIST
IN BOULDER CLAY - ACTION OF GW
NEAR 11/2 MILE

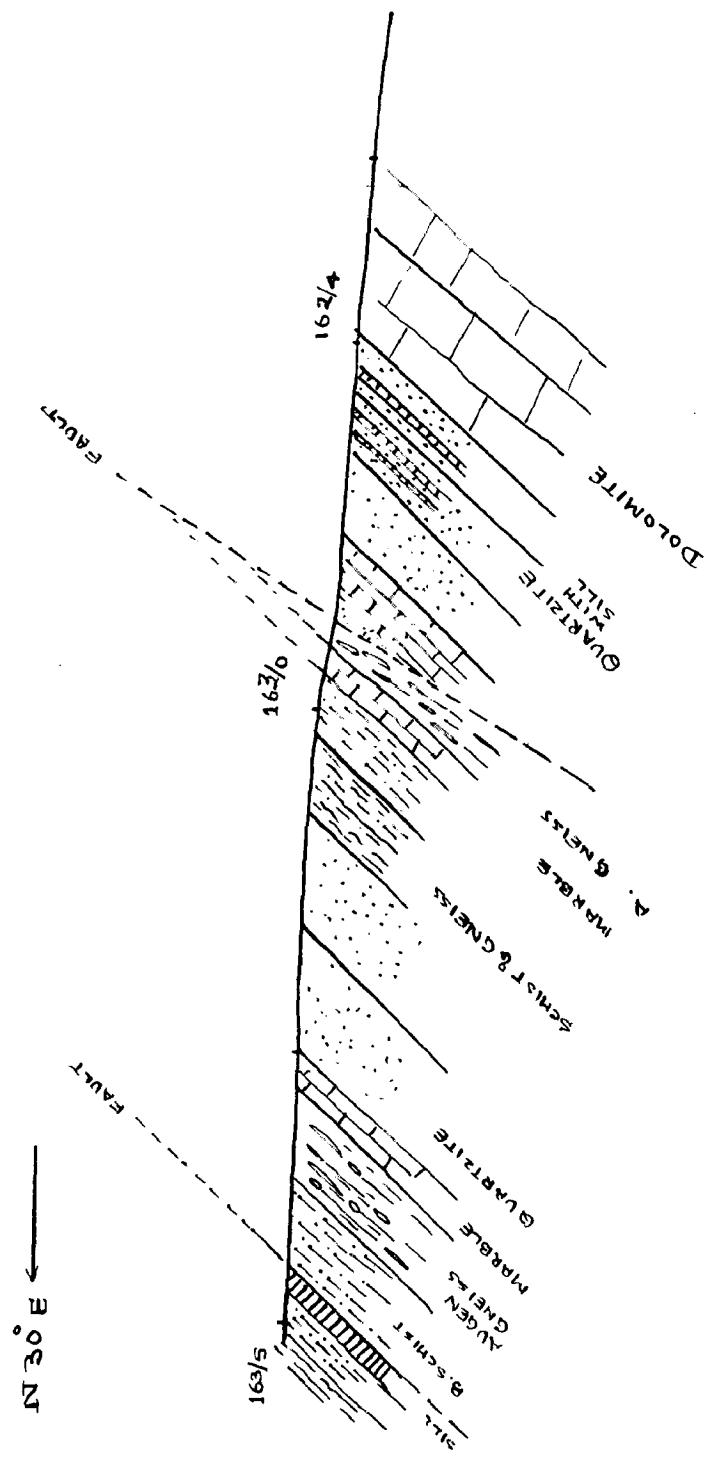
FIG. NO. 3.6

A SECTION ALONG ROAD BETWEEN
HE LONG AND 16 3/4 MILE STONE.

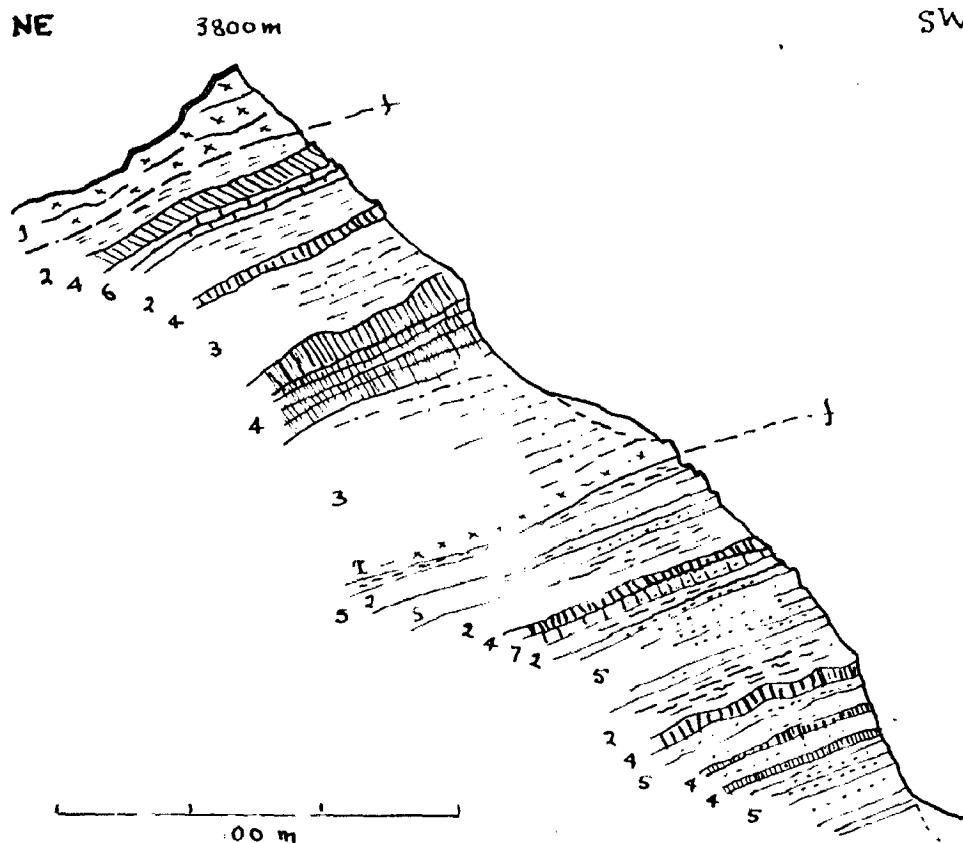
THE INCREASE IN METAMORPHISM TOWARD MAIN CENTRAL THRUST

IN THE SECTION NEAR KAURI PASS "HEIMBGN.
(1931)

The idea of the two thrust planes is however, not completely new. Heim and Gansser (1939) have shown two thrust planes to exist the gneisses at the Kauri Pass Section, which is very similar to the present area. A geological section of the Kauri Pass area and that of the present area has been given in Fig. Nos. 36, 37 and these sections show the resemblance.

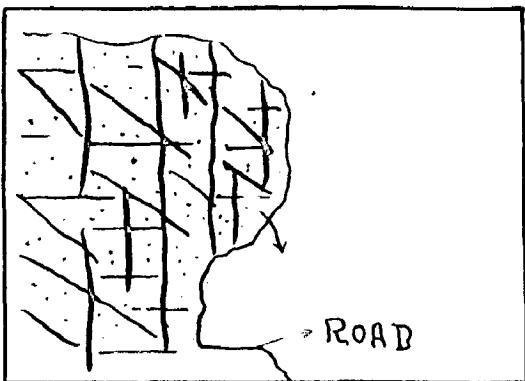
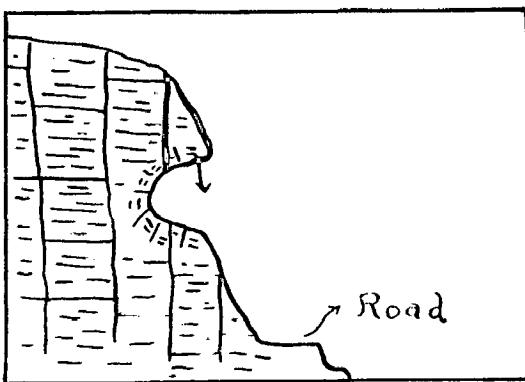
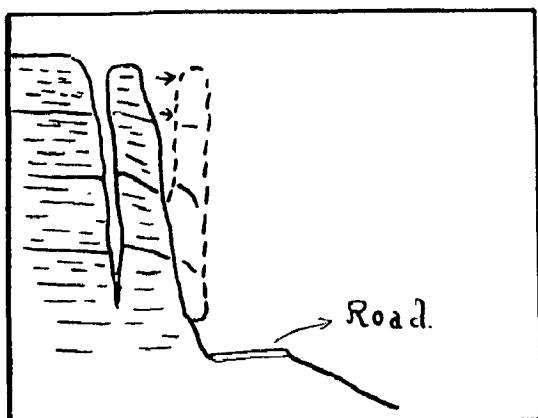
Fig - 5.1

DIFFERENT TYPE OF ROCK FALL

vertical joints -
Homogeneous - non homogeneous
Jointed Rock - overhang

overbreakage and
blast fracturing .

Frost wedging in jointed
homogeneous Rock.

- I. Fall - The moving mass may be rock or soil and it falls due to action of gravity. The rock is loosened by different agencies and in the end this loose rock falls. The Fig. No. 5.1 shows falls due to action of different agencies.
- II. Slide - In true slide the movement results from shear failure along one or several surfaces which are either visible or may be reasonably inferred. There are two sub groups based on the quality of material.
 - (a) Slump
 - (b) Block slide.
 (a) Slump - In the case of slump the moving material is not deformed and the slide is of rotational shear type. In this case the dimension of unit is greater than the displacement. Movement is controlled by surfaces of weakness such as faults, joints, foliation plane. The movement in slump takes place along internal slip surface. The surface of rupture is a

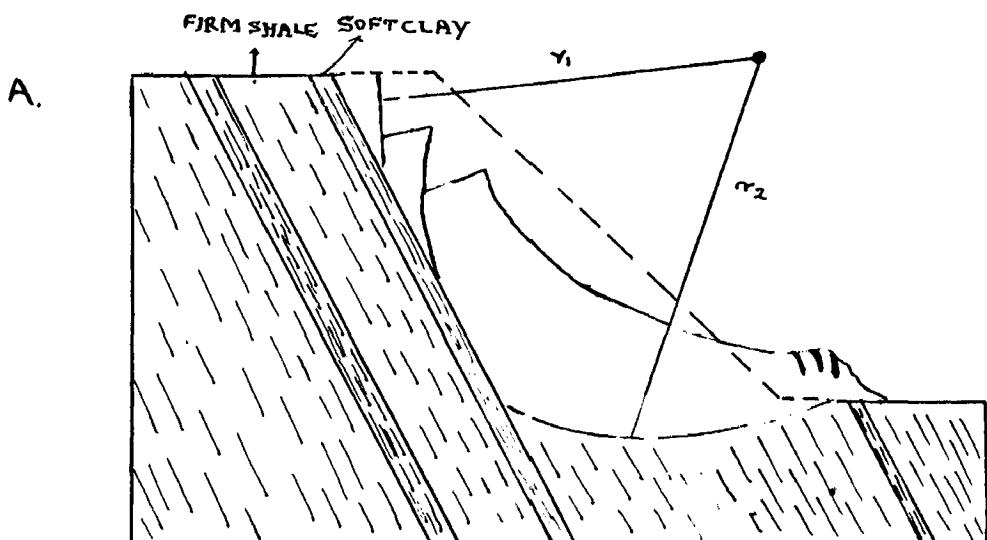
FIGURE NO 5.2

SLOPE FAILURE IN NON HOMOGENEOUS
MATERIAL. SURFACE RUPTURE FOLLOWS
DIPPING WEAK BED.

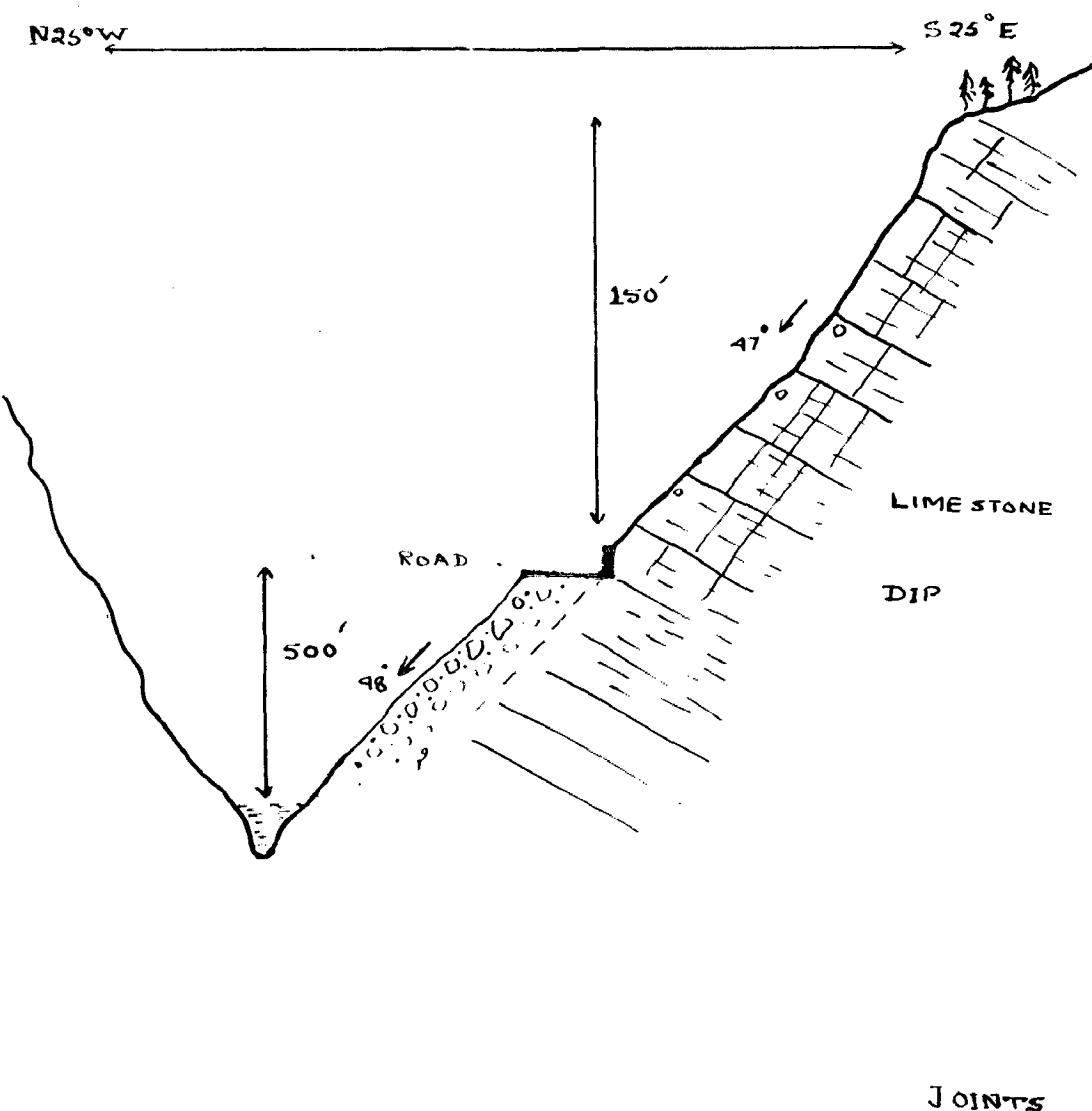
FIG. No. 6.1

SECTION ACROSS RALAKNANDA

AT 157/7 MILESTONE

ROCK - LIME STONE DIP 45° N 140°

40° due to 40° F, due to the action of water. The slope of valley side is about 48° and is itself in unstable condition. A section across the river Fig. No. 61 shows the geological and structural condition of the area.

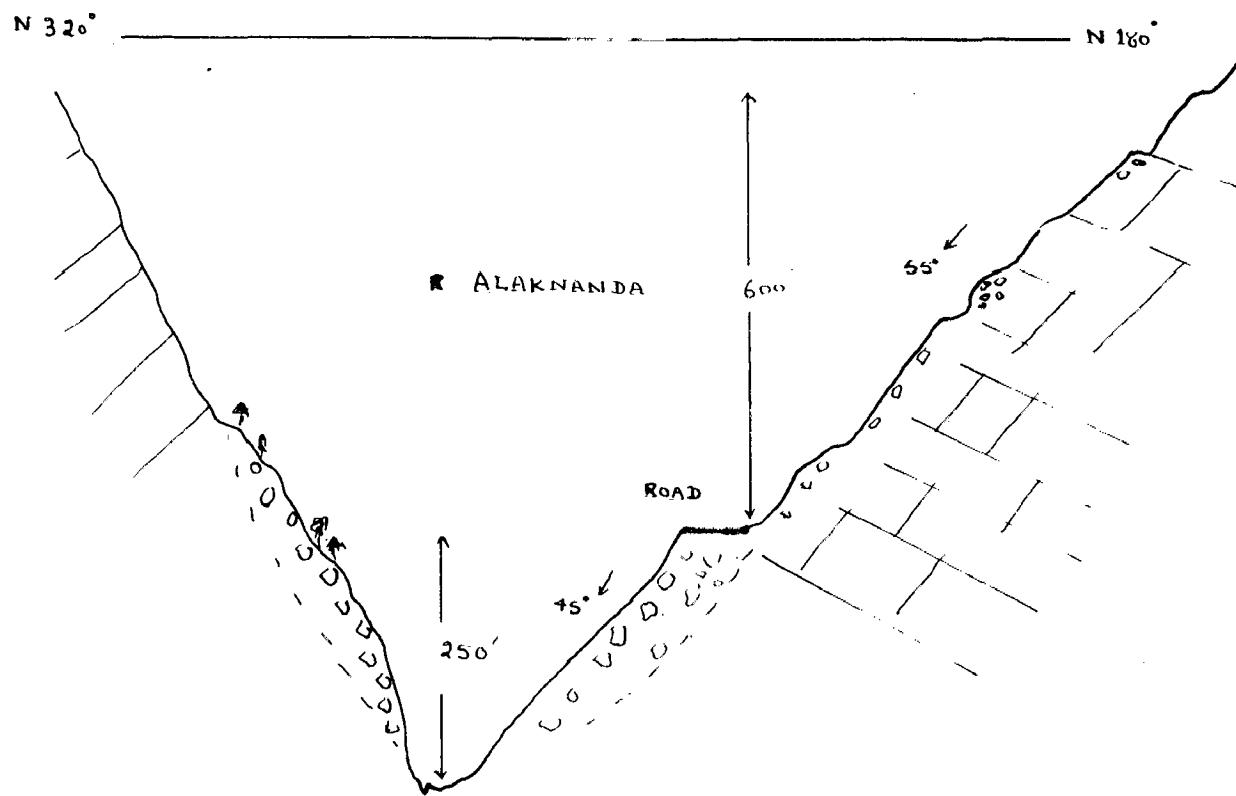
Fig. No 6.2

SECTION AT 158 $\frac{1}{2}$ MILE STONE

ROCK - LIME STONE DIP 45° N 15°

The road direction at this place is N 80° E - S 80° W. Thus the dip is away from the road but the joint 62° due N 15° W is main cause of slip along this plane. The photograph No. 17 Plate No. 10 and a section (fig. No. 62) drawn across the river Alaknanda will show the true nature of the slip zone.

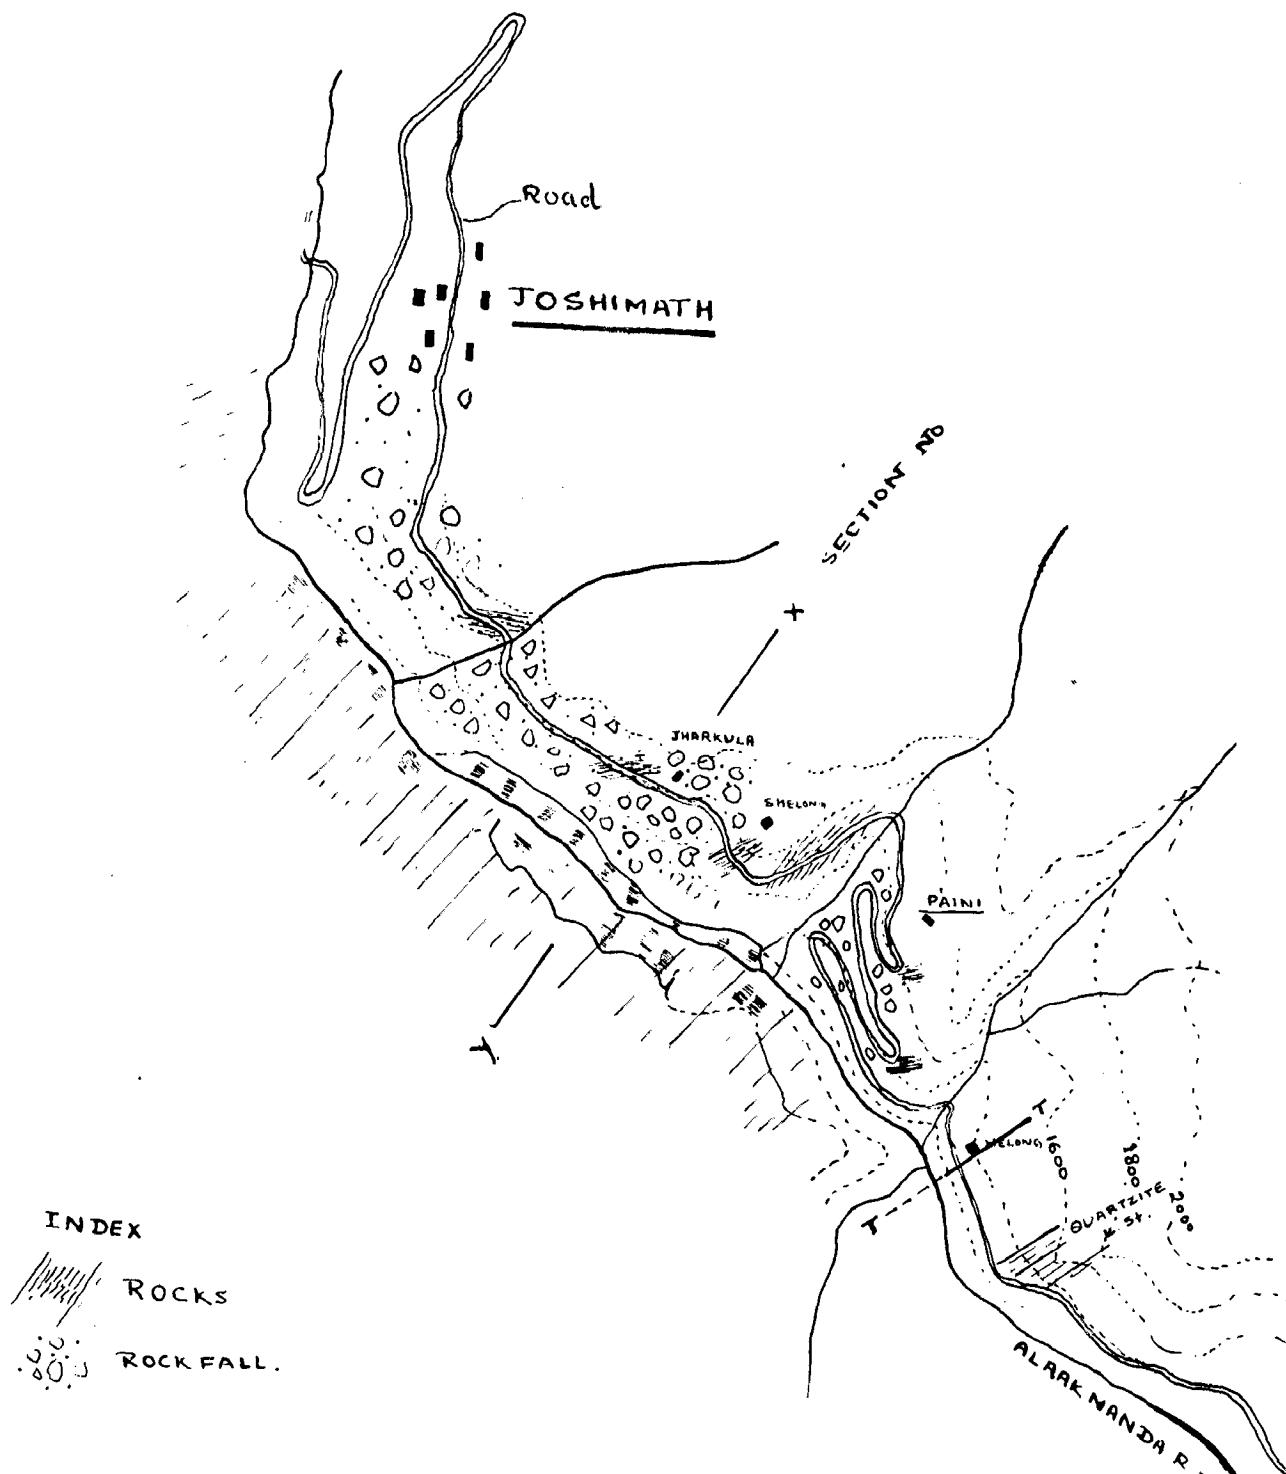
GEOLOGICAL PLAN OF AREA
JOSHIMATH - PAINI - HELONG

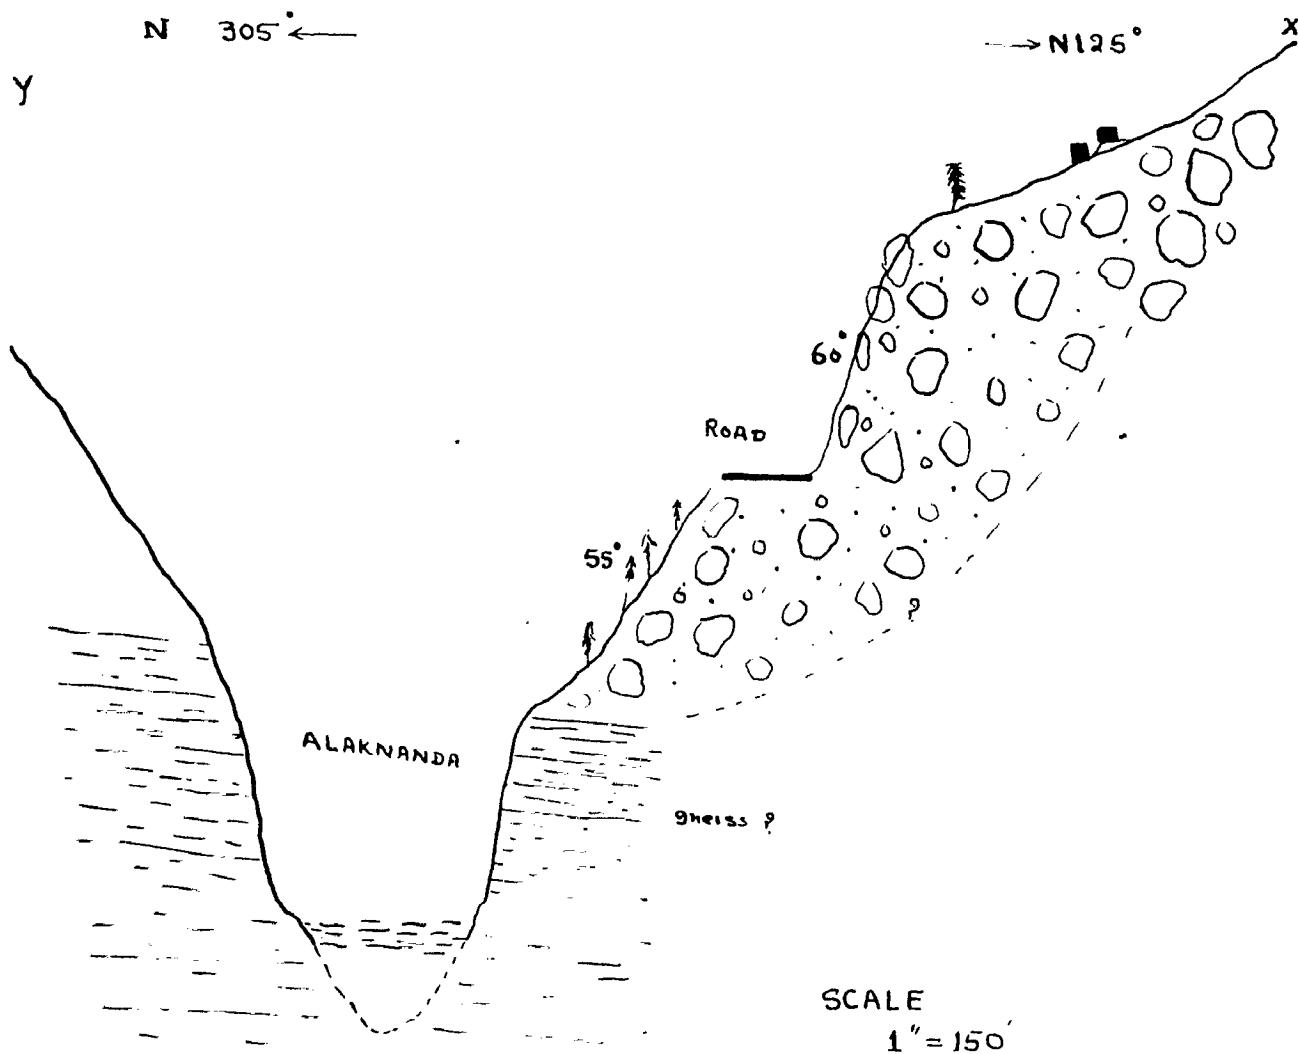
FIG. NO 6.5

SECTION ALONG LINE XY NEAR JHARKULA CHATTI
AS SHOWN IN PLAN

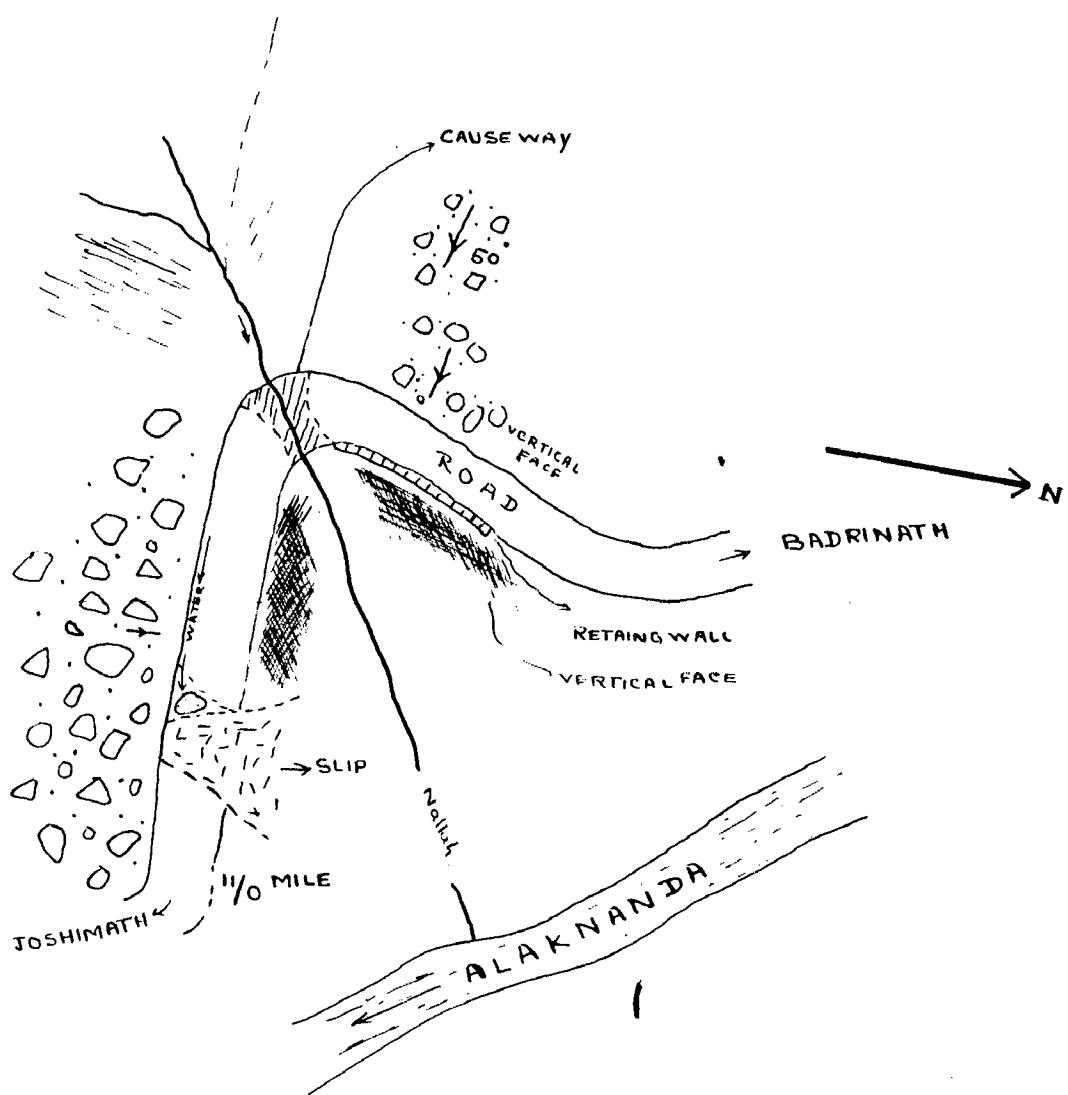
FIG. NO 67

GEOLOGICAL PLAN
OF
HANUMANCHATTI

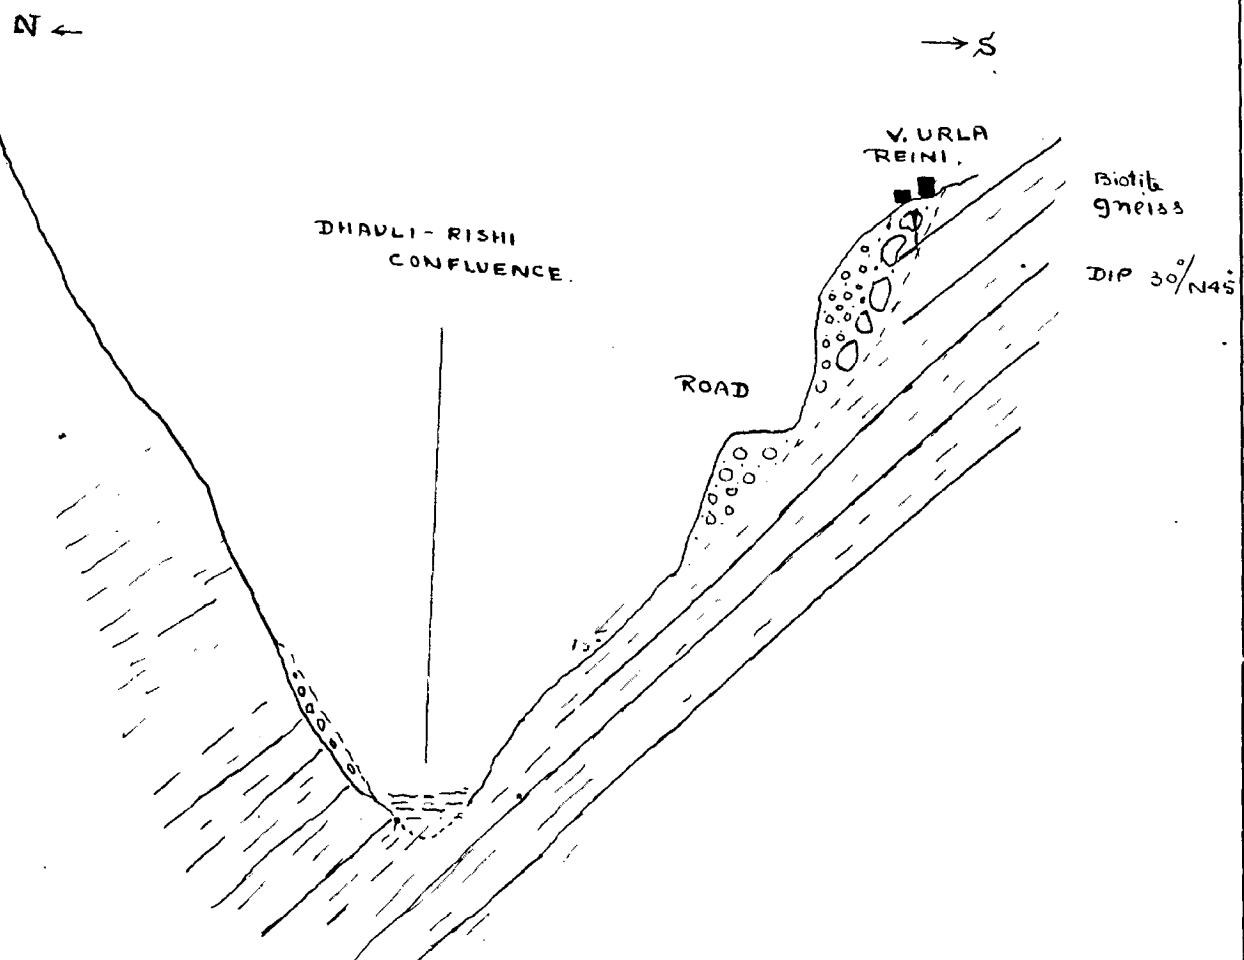
SECTION ALONG XY LINE NEAR RE NI VILLAGE.

MILE 13/7 FROM JOSHIMATH

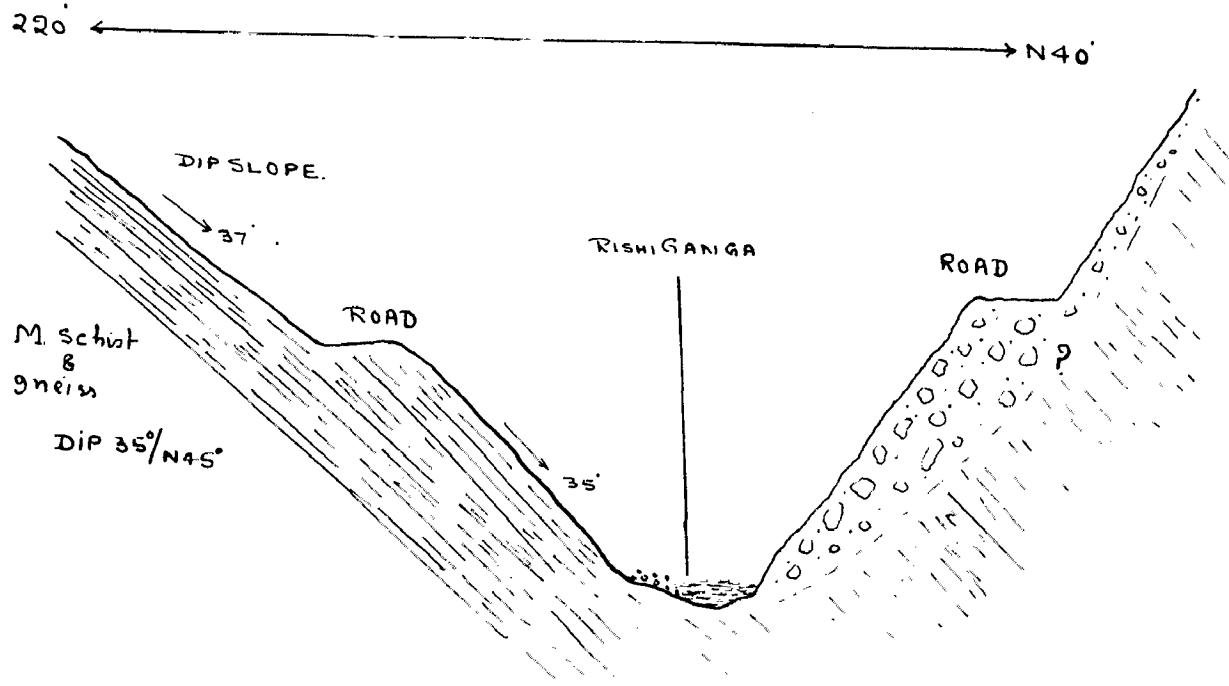
FIG. NO. 6.12

SECTION ALONG XY NEAR $14\frac{1}{2}$ M. STONE FROM TOSHIMATH

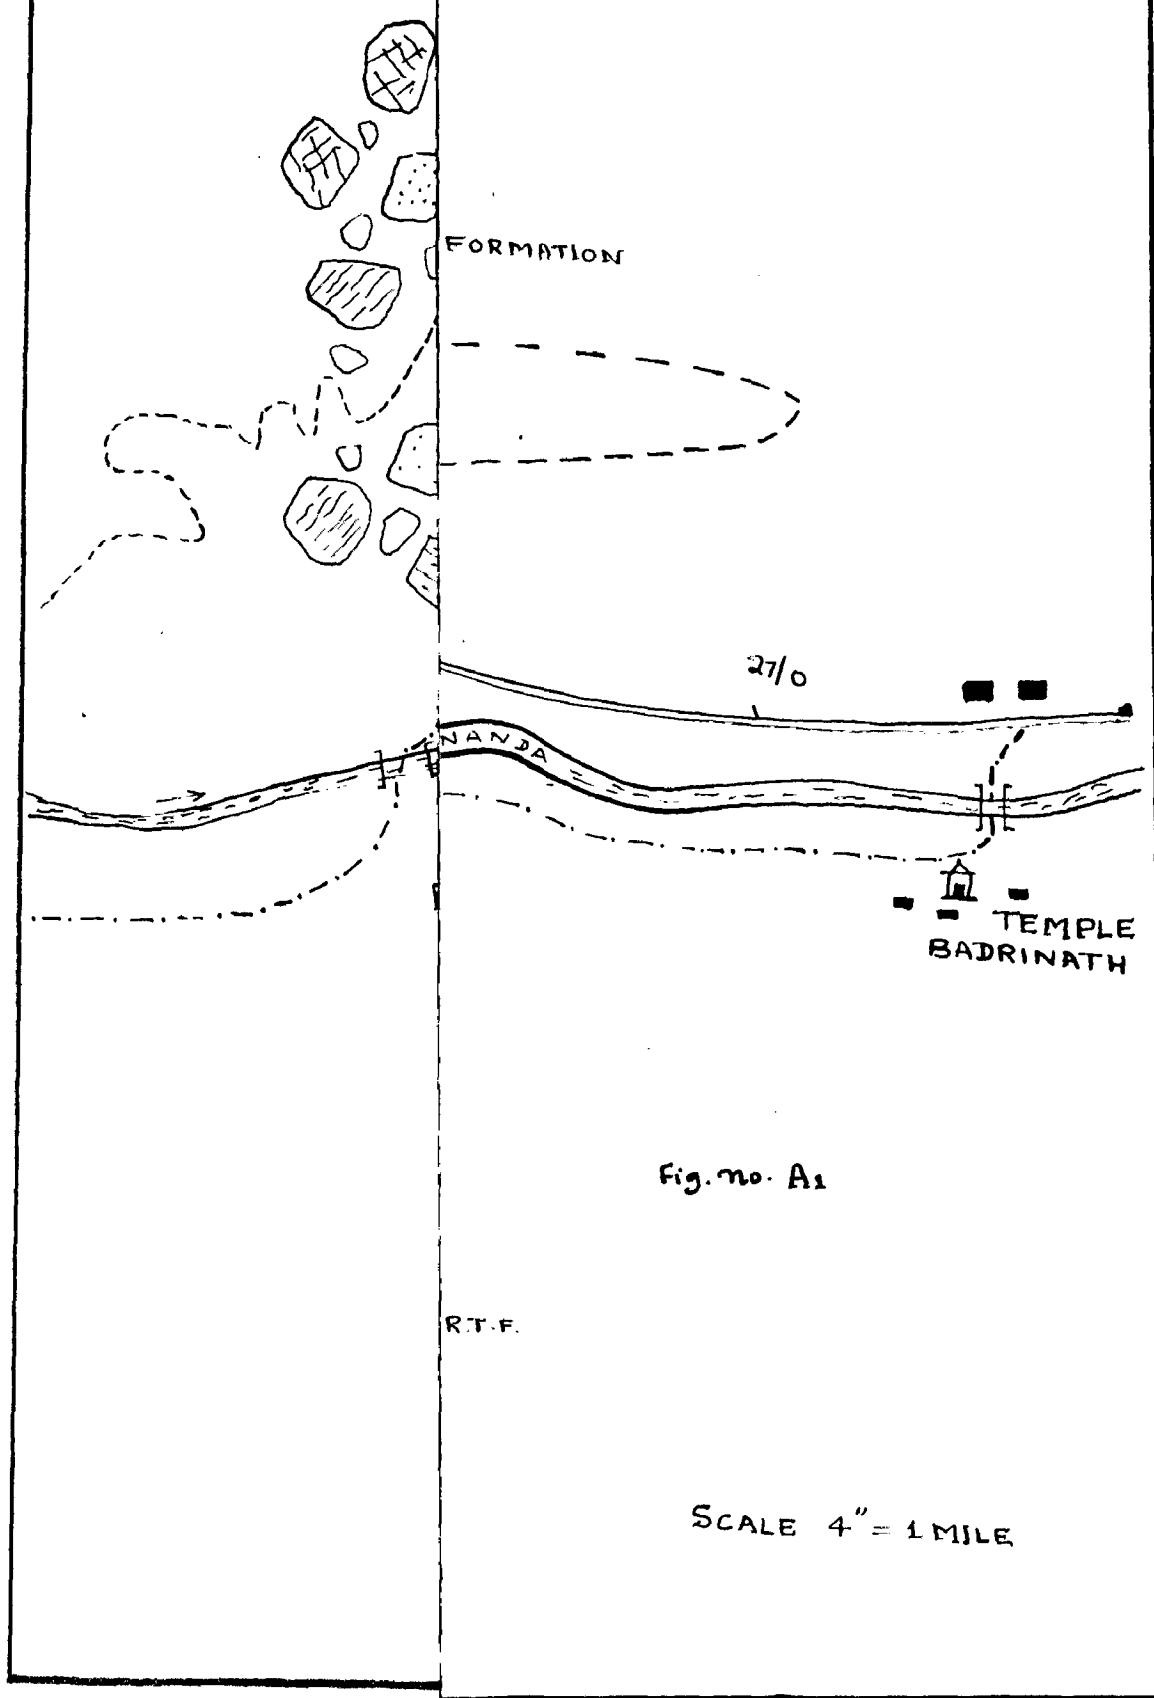
Fig. no. A1

ROAD PLAN BETWEEN BADRINATH & MANA ONWARD

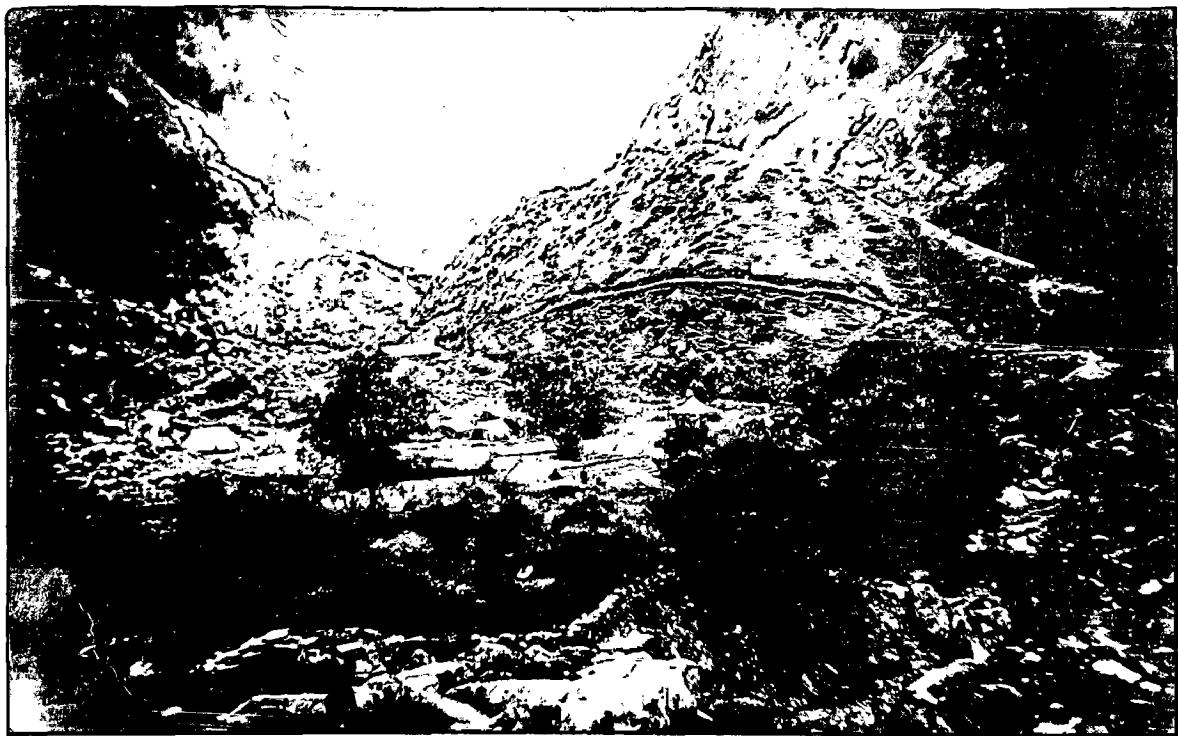
PHOTO NO 2

Photograph No.2 : River terraces of Alaknanda near
Pipalkoti: The terraces are clearly
seen and R-Alaknanda is flowing deep
in the gorge. Photo taken from Pipal
koti towards down stream direction.

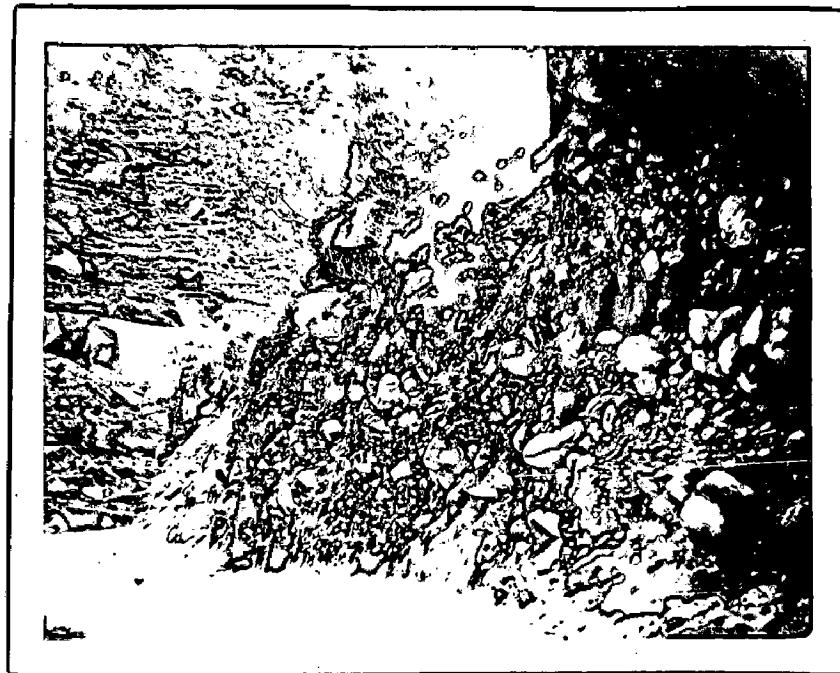
**Photograph No. 4 : River gravels on the road side
at Reni village 14/o mile stone
on Joshimath - Malari Road.**

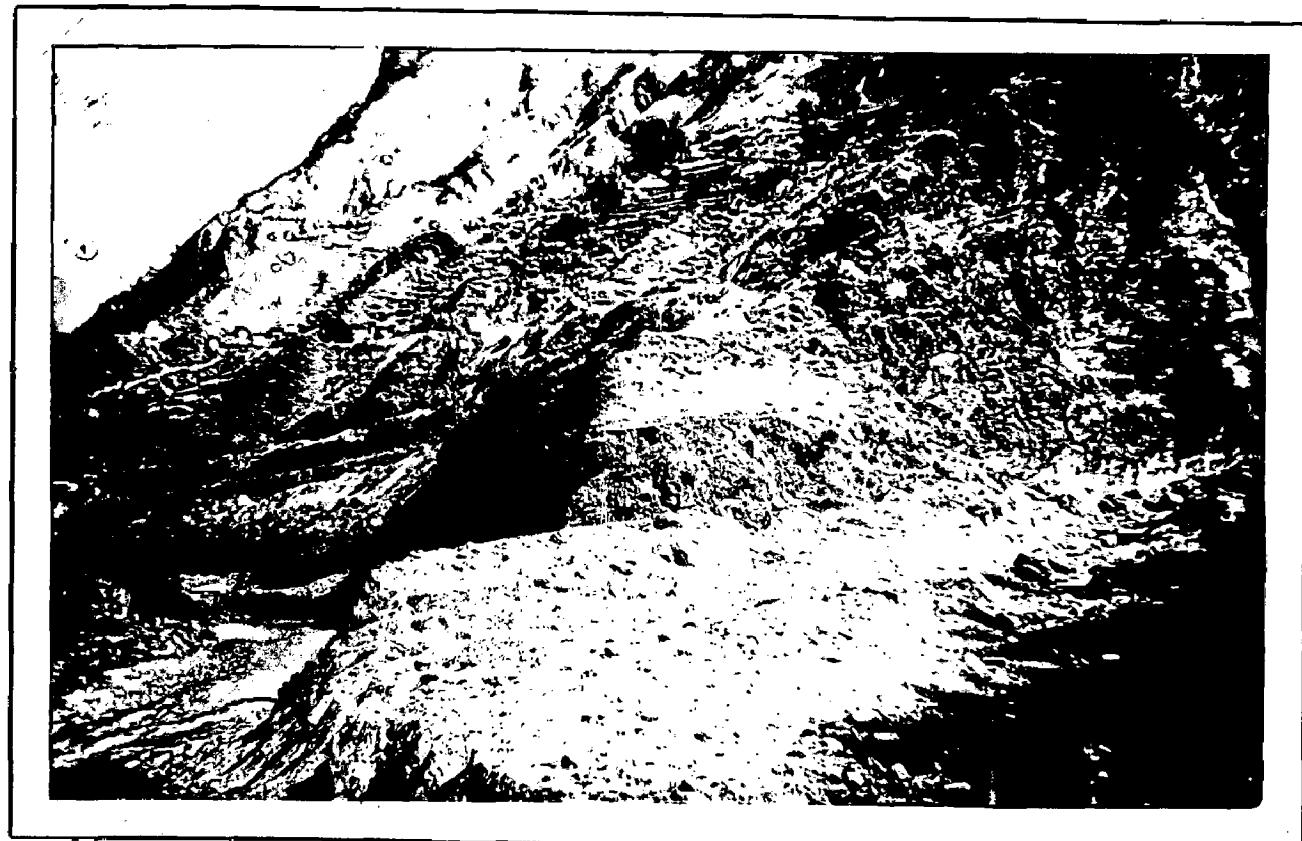
Photograph No. 20 : showing the old landslide material at about 1 mile from Belakuchi towards Joshimath; R. Patal ganga flows towards right and R. Alaknanda towards the left in the photograph; Two stages of P.Patalganga are clearly visible

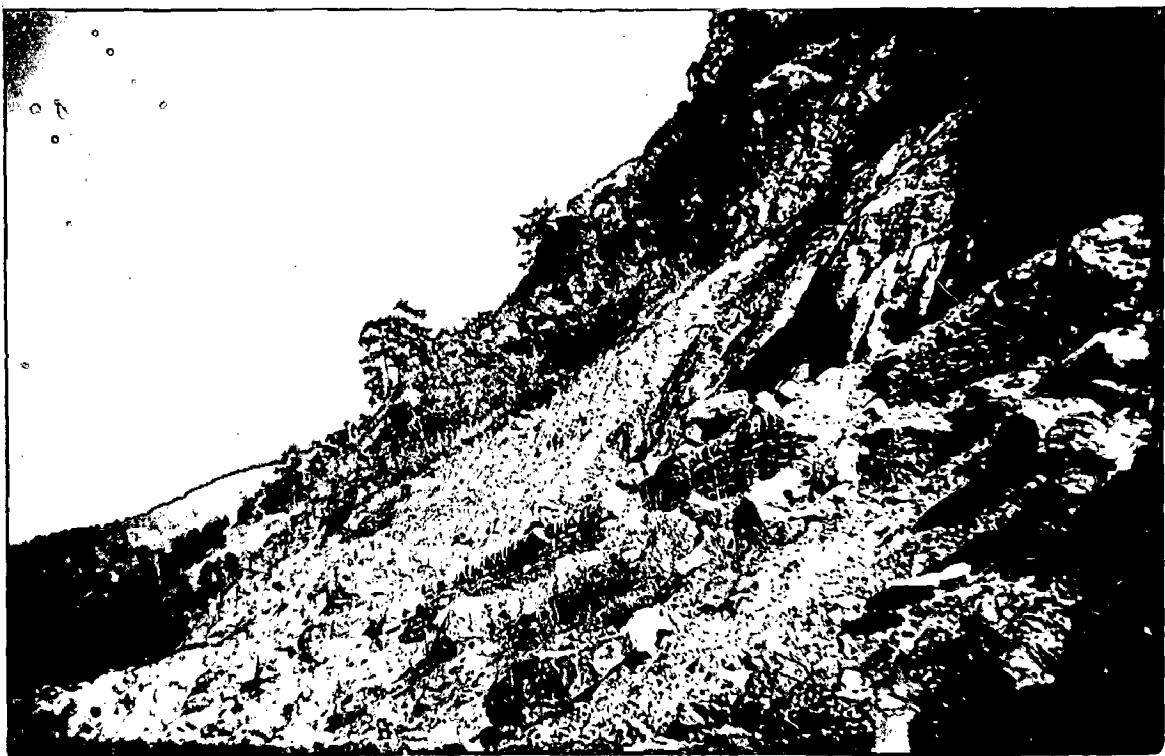
Photograph No. 18 : Slide zone at 158/1 milestone

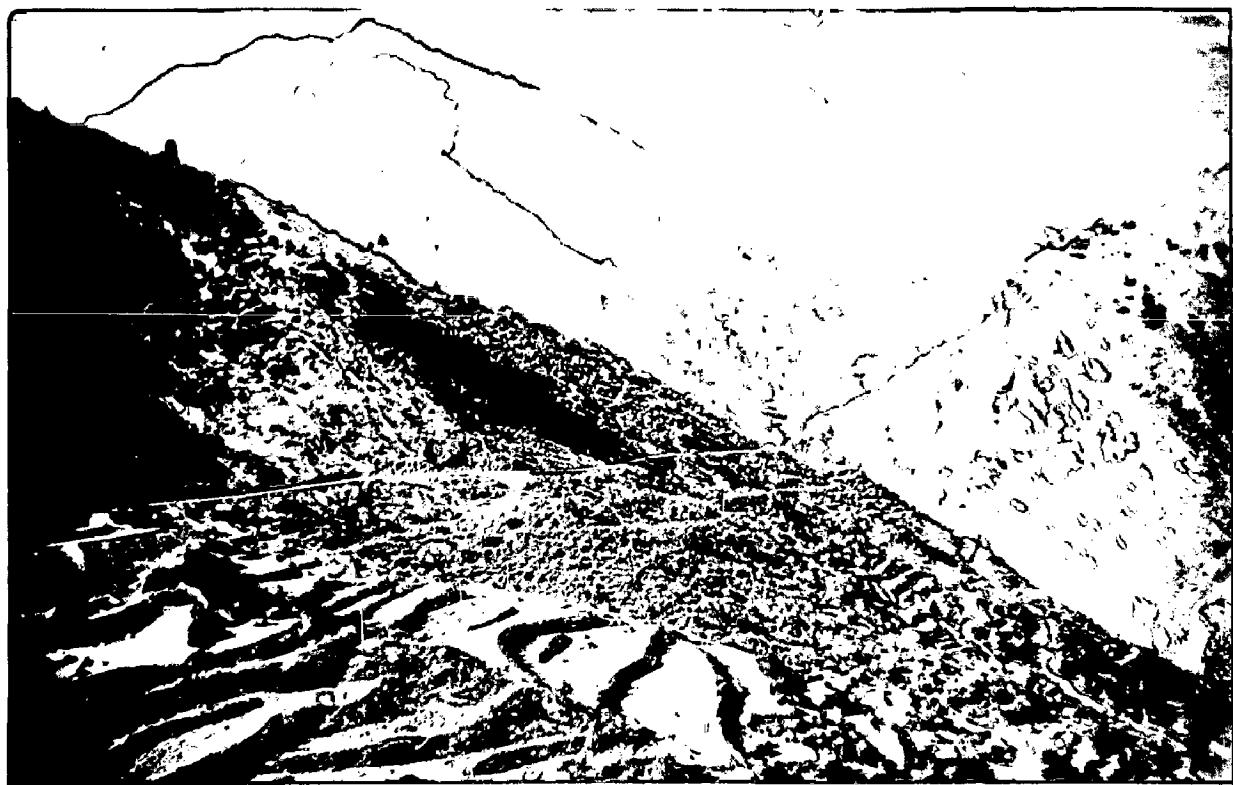
Photograph No. 23 : Photograph showing the 1st and
2nd leg of road near Paitnit
In the back ground norther dipslopes
are seen covered with vegetation
where as the steeper southern
slopes are devoid of any vegeta-
tion.

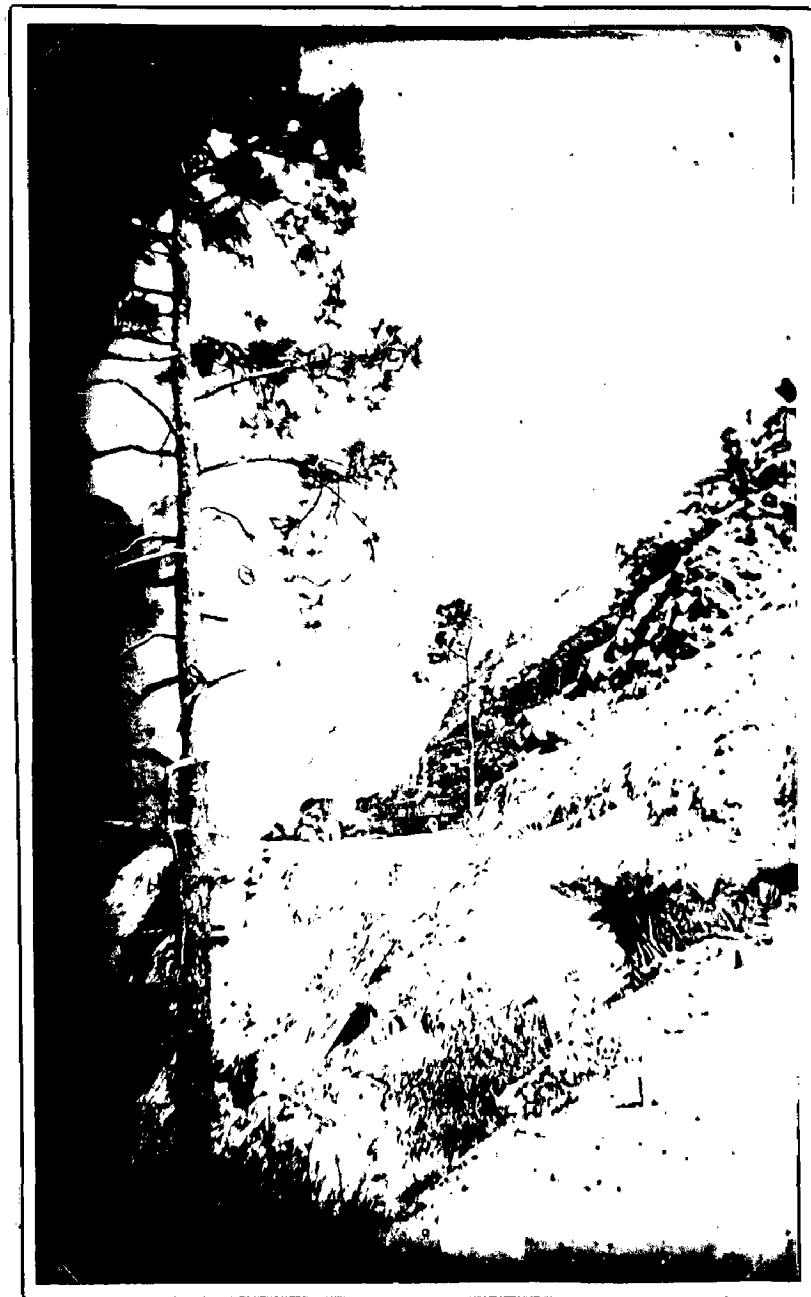
Photograph No. 24 : Rock fall zone of Jharkula,
the landslides are very frequent
here due to the sliding of well
jointed quartzites. The slip takes
place along the joint planes. A
road roller damaged due to a slide
can be seen. The slope below the
road is also steep.

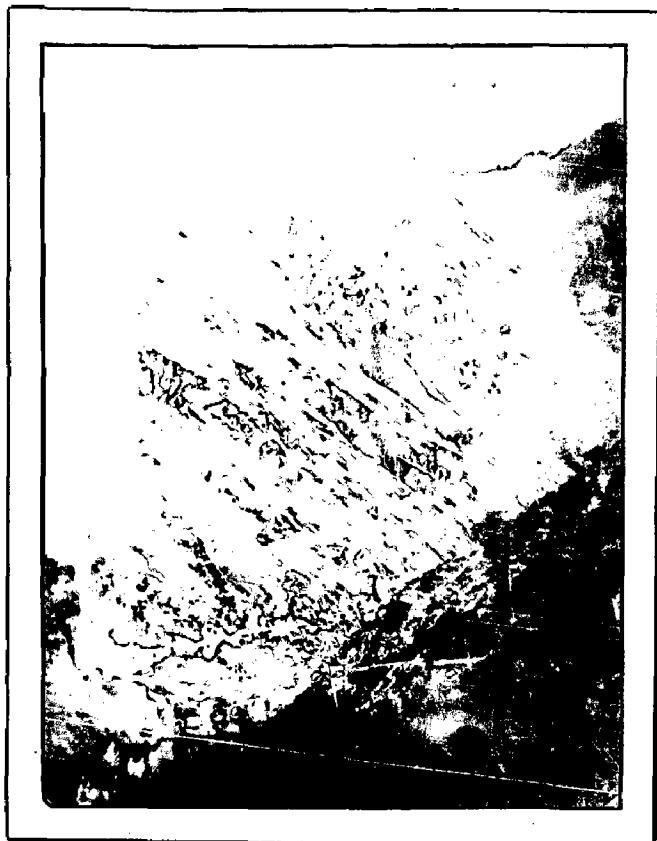
Photograph No. 26 : Stable slope of Joshimath two
legs of road on the left side
of R. Alaknanda are visible. In
the background the road on the
right side of R. Alaknanda is
visible.

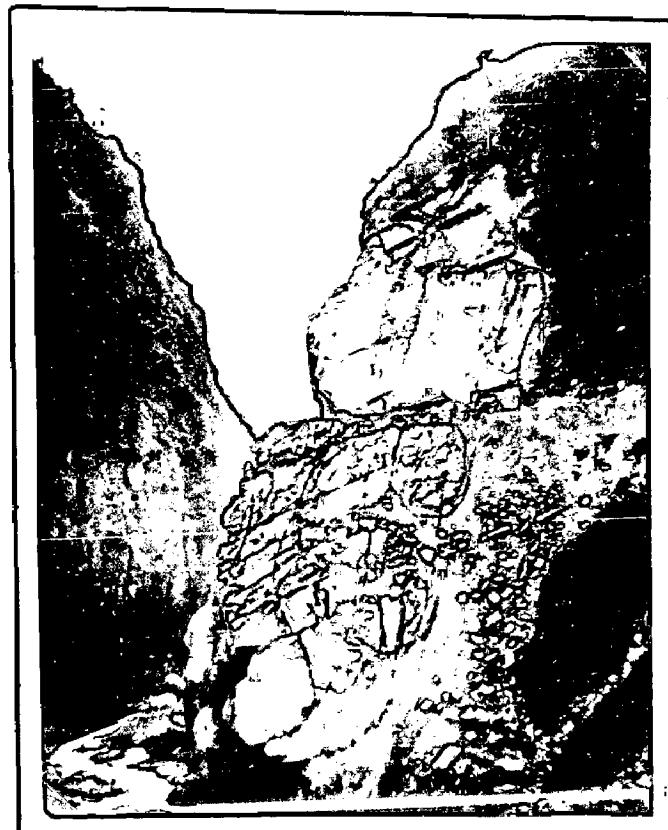
Photograph No. 27 A : A close up of the above spot . Hanging blocks of rocks are clearly visible. The road is parallel to the strike of the formation,
