**A STUDY OF LANDSLIDES
BETWEEN
PIPALKOTI - BADRINATH
AND
JOSHIMATH - BHAPKUND
DISTRICT CHAMOLI, UTTAR PRADESH**

DISSERTATION
IN PART FULFILMENT OF THE REQUIREMENTS
FOR THE AWARD OF
M.Sc. Tech. DEGREE IN APPLIED GEOLOGY

**DEPARTMENT OF GEOLOGY & GEOPHYSICS
UNIVERSITY OF ROORKEE
ROORKEE (U.P.)**

1967

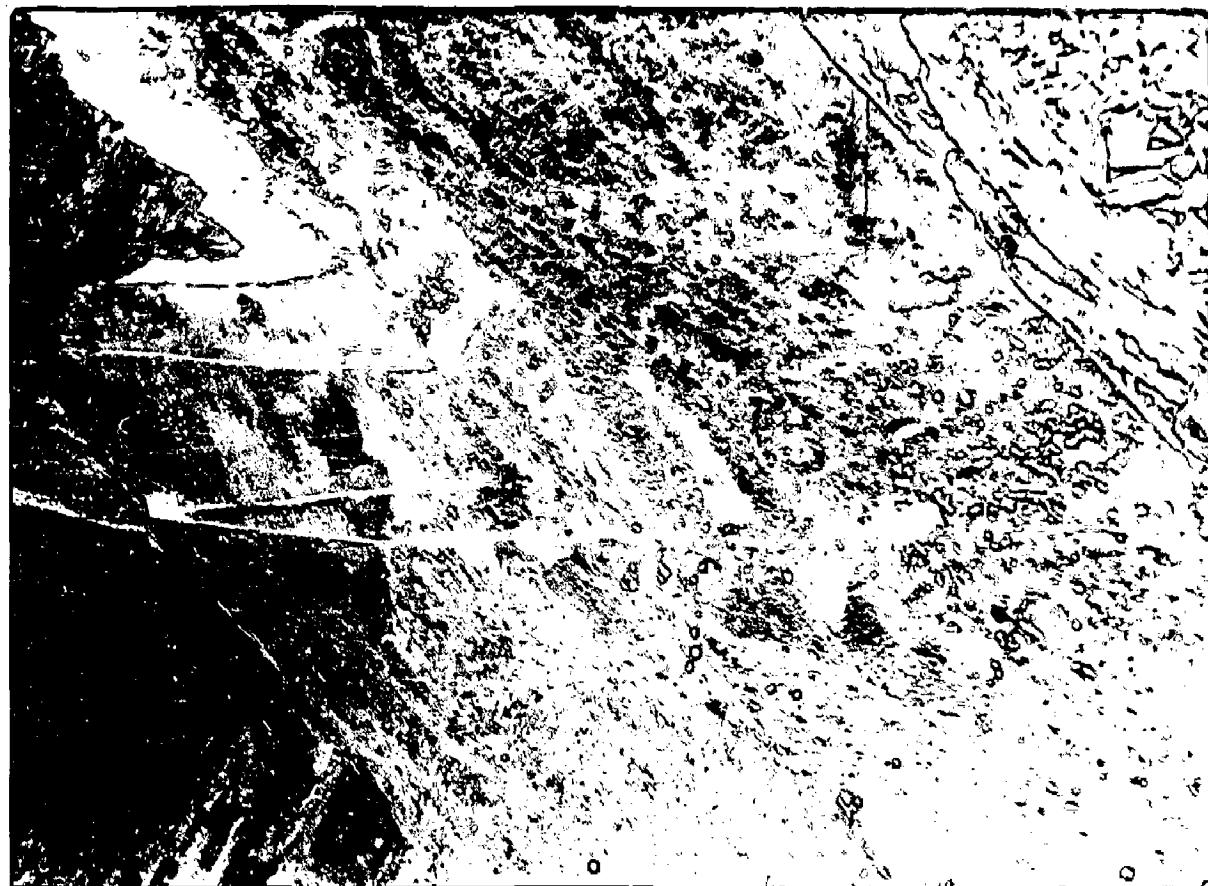
Photograph No. 28 : A general view of the Hanuman chotti
landslide zone: showing all the three
legs and extent of slide zone, River
bank can be noticed.

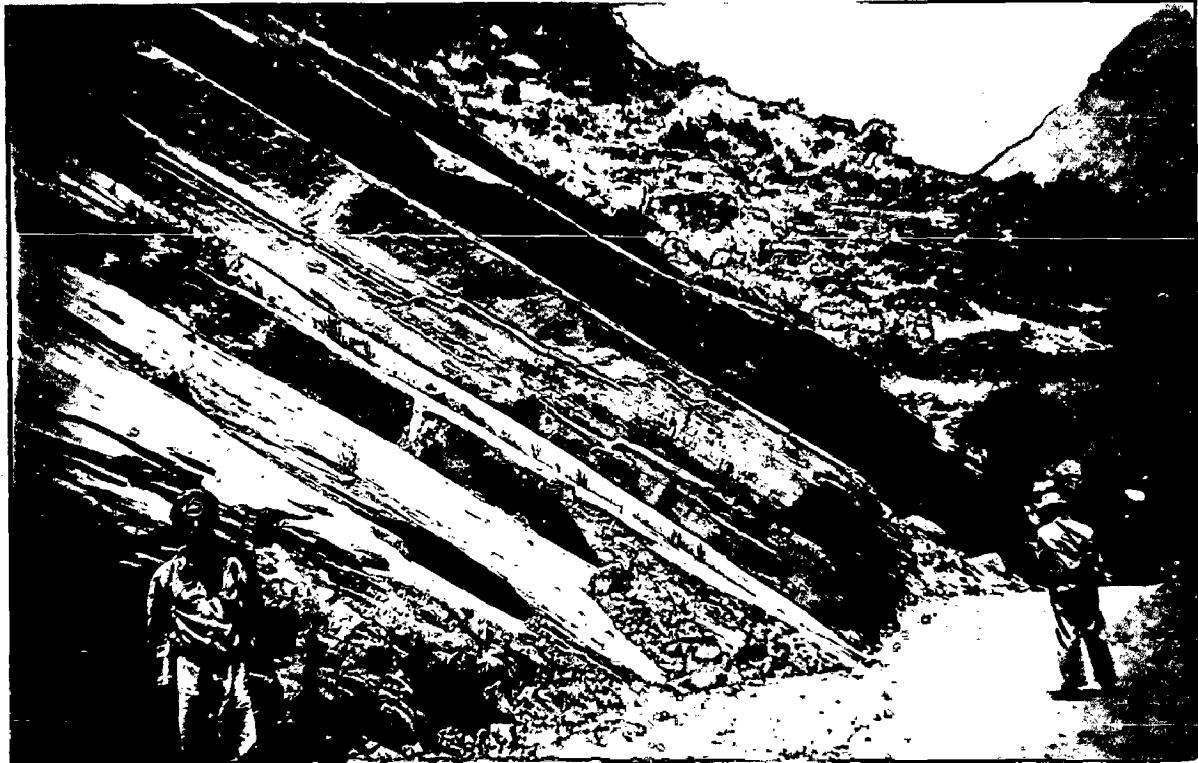
Photograph No. 36 : Dib slope in augen gneiss at
14/2 milestone near Benit
The slipping takes place along
the foliation plane:

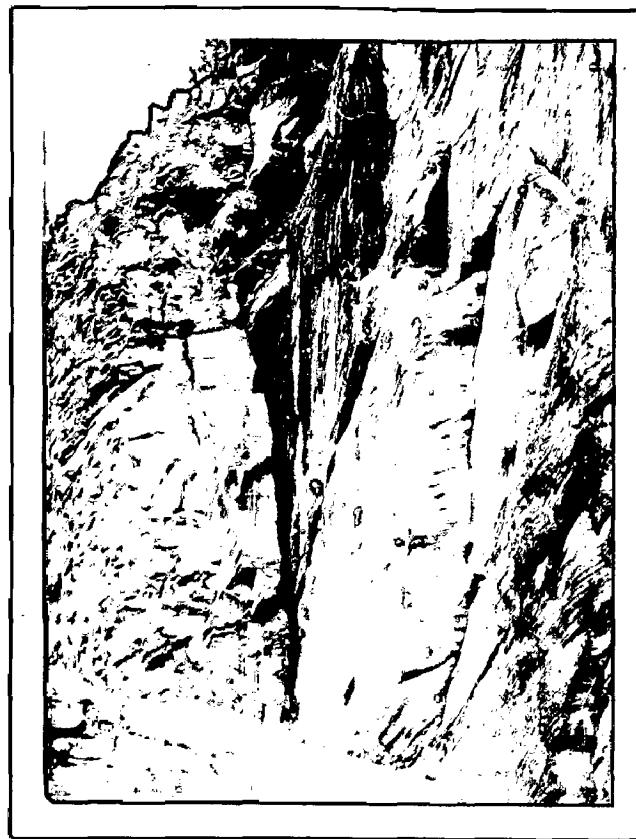
Photograph No. 37 : Photograph showing the vertical
joints wide gaps have developed due
to blasting: This is the zone of fre-
quent landslide and rock fall:
Location - 16/7 milestone on
Joshimath Malari Road.

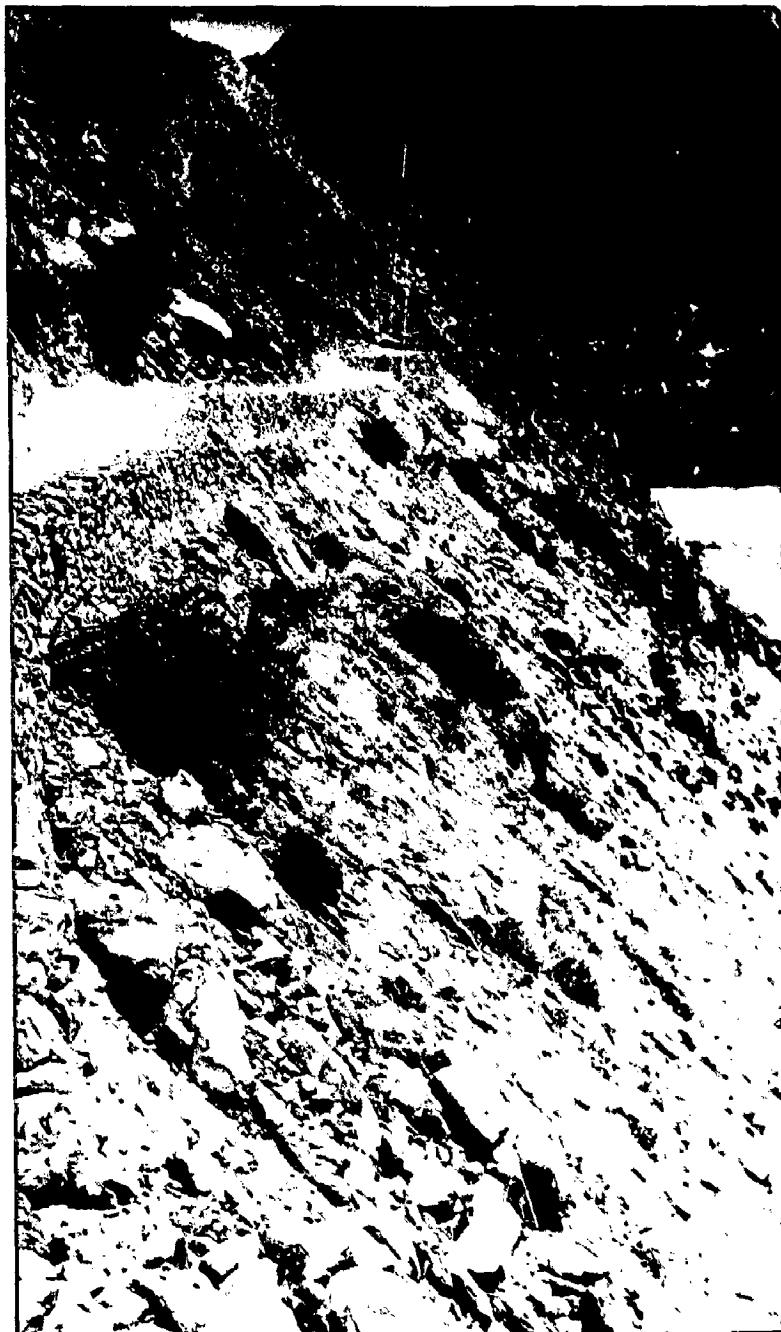
Photograph No. 38 : showing road in slided material,
photograph taken from 28/7 towards
East: natural angle of repose can
be seen in the portion through which
the road does not pass. The effect
of disturbing this angle for road
construction can be visualised.

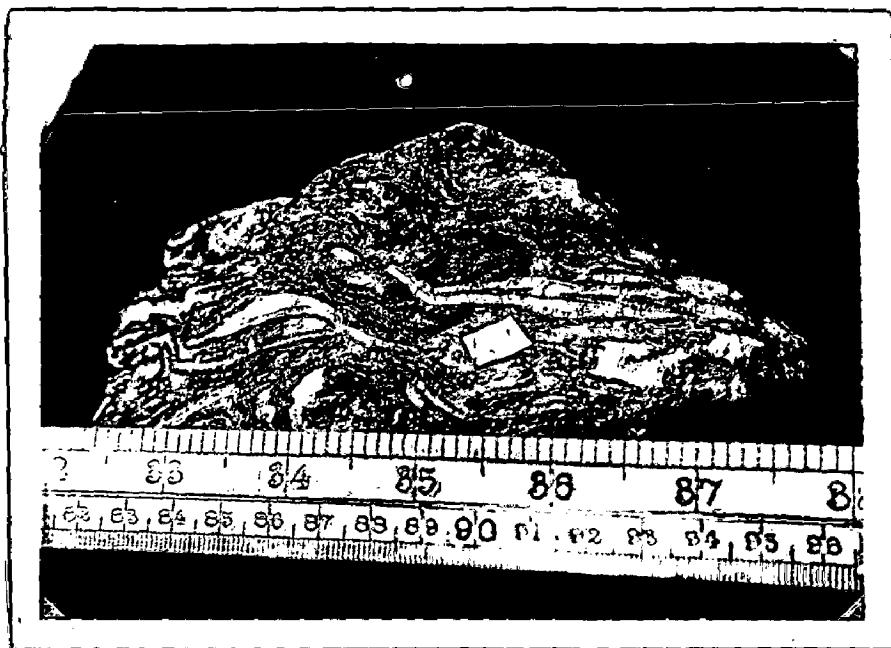
Photograph No. 41 : The specimen of chlorite schist showing quartz veins. The quartz veins show pinching and swelling texture.

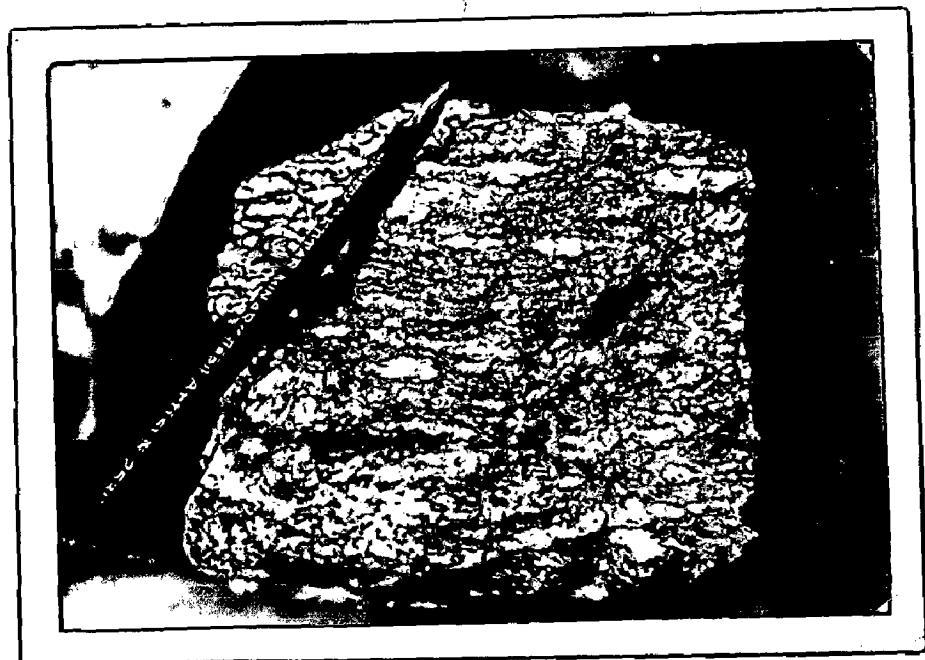
Photograph No. 42 : The Augen gneiss showing augens of quartz and felspar of variable width.
