STUDIES OF SOME PHYSICO-CHEMICAL & BIOLOGICAL ASPECTS OF BUILDING STONE DETERIORATION & PRESERVATION

THESIS

Submitted to University of Roorkee
for the award of the degree
of
DOCTOR OF PHILOSOPHY
in
BIOSCIENCES

DEPARTMENT OF BIOSCIENCES AND BIOTECHNOLOGY
UNIVERSITY OF ROORKEE
ROORKEE-247 667 (INDIA)
January, 1988

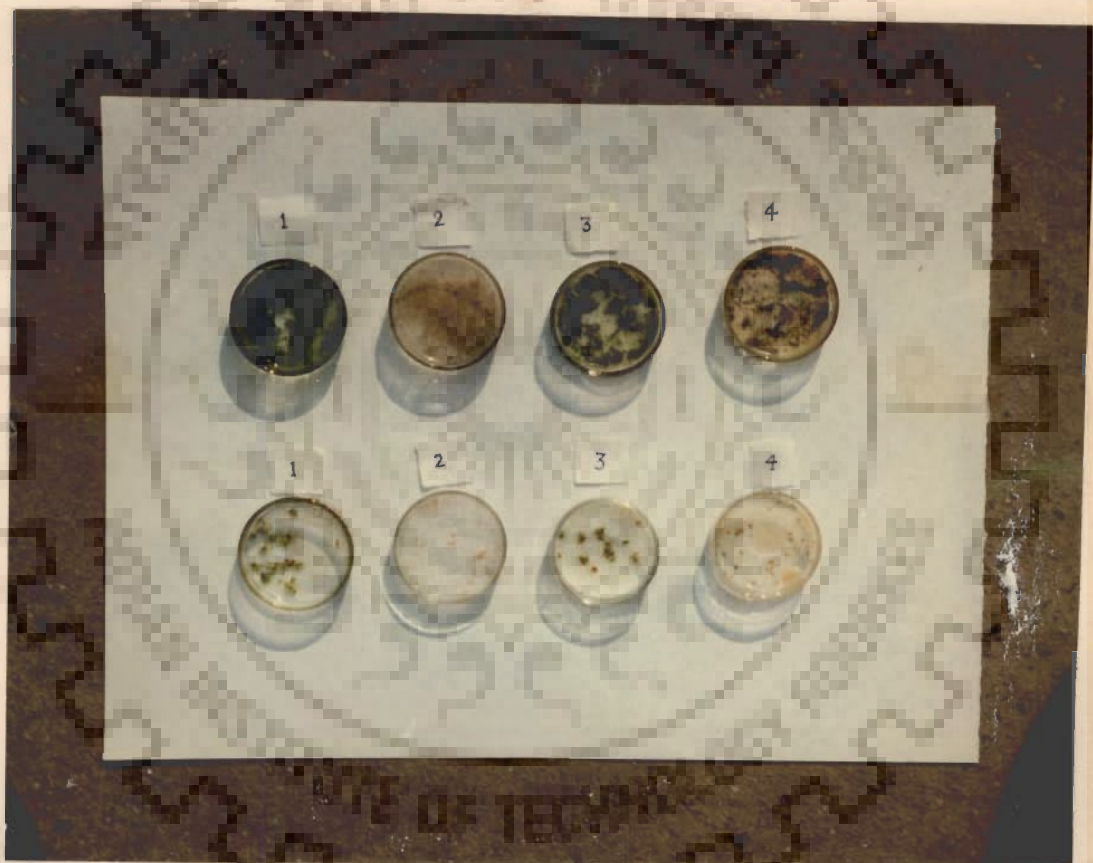
Plate 3.5 :
Growth of Micro-Organisms in Culture Medium
with and without Preservatives

The preservatives barium hydroxide solution, PMMA and silicone resin found suitable to enhance durability characteristics of the stones have also been found to retard the biological growth over the stones.

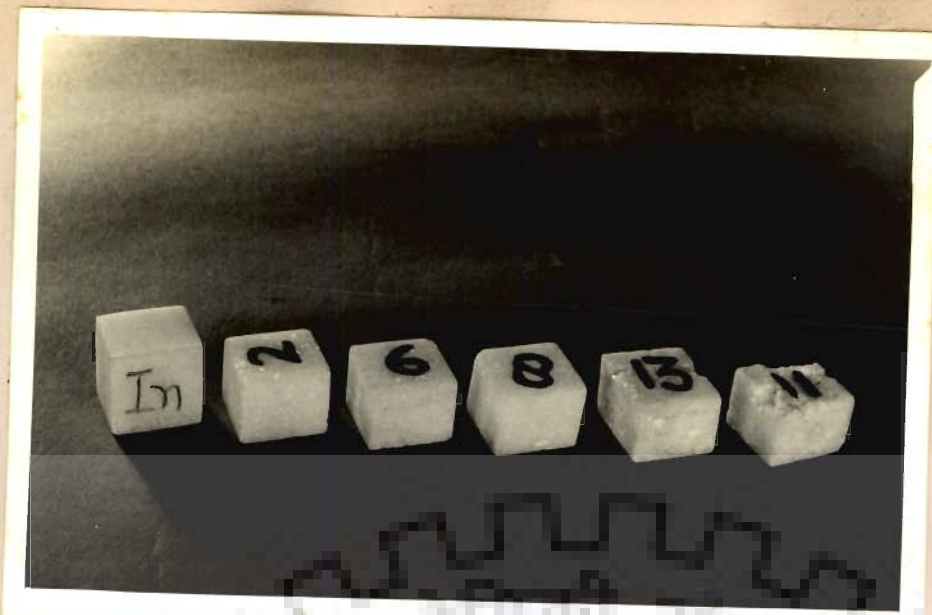
Plate 4.4: Durability Behaviour of Marble Under Test Condition (1)

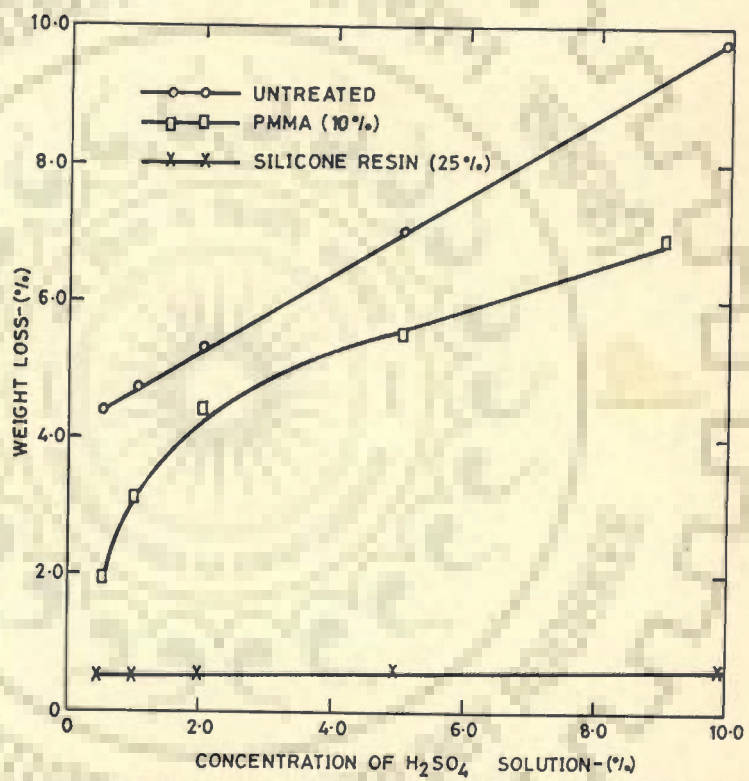
FIG. 4.13. VARIATION OF WEIGHT LOSS OF MARBLE WITH CONCENTRATION OF SULPHURIC ACID SOLUTION

The weight loss was reduced considerably after the treatment with PMMA and silicone resin (Table 4.9). In the case of samples treated with PMMA, calcium sulphate was deposited beneath the coating film. In 0.5 per cent acid solution the samples were not uniformly attacked while in 1.0 per cent solution CaSO_4 was deposited on all surfaces of the samples with the loosening of PMMA film. The thickness of CaSO_4 deposition increased with the concentration of acid solution and in 10 per cent solution the samples showed the pits on the surfaces due to leaching of CaSO_4 formed. After the test the samples showed different weight loss values before and after the washings confirming the deposition and dissolution of CaSO_4 . In 0.5 to 5.0 per cent solution weight loss is reduced,

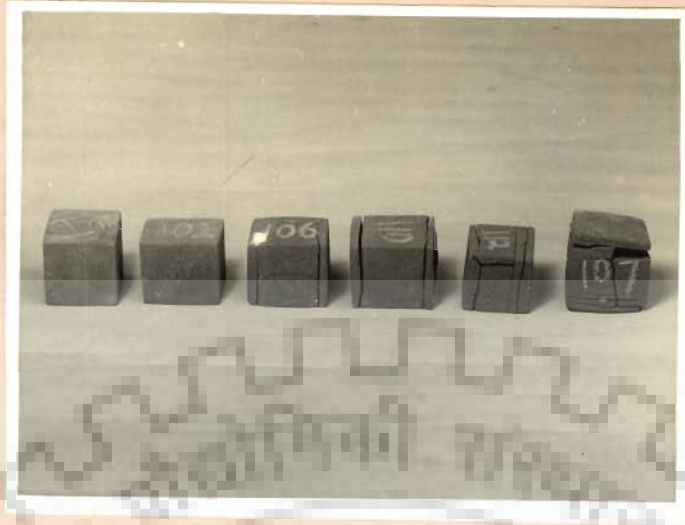
Plate 5.5 : Durability behaviour under test condition (1)

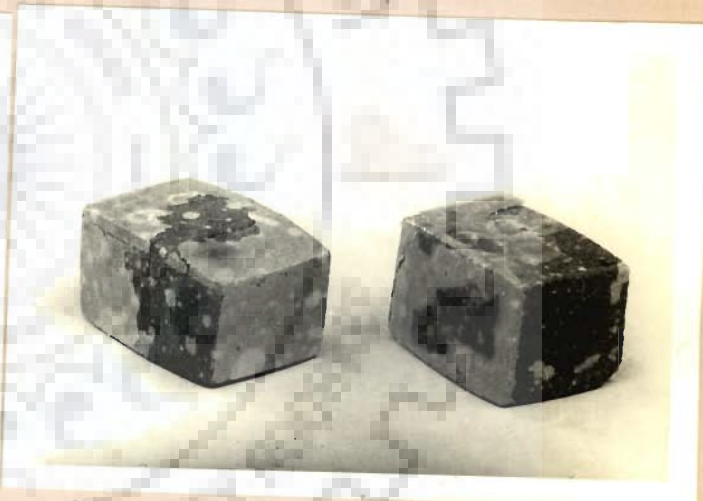
Plate 5.14: Development of cracks after 70 cycles

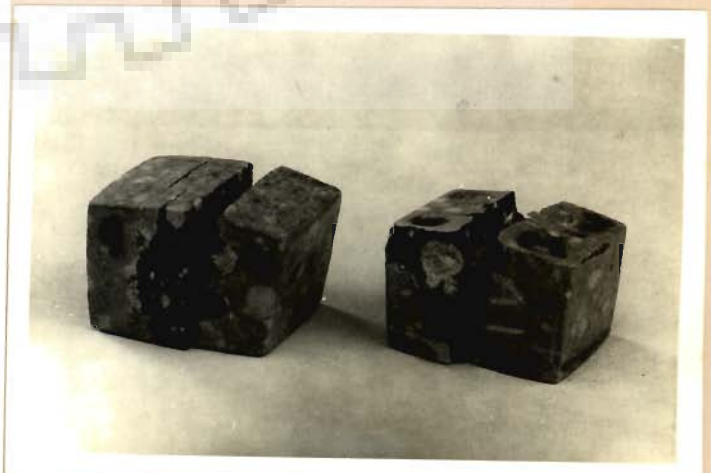
Plate 5.16: Highly disintegrated after 90 cycles

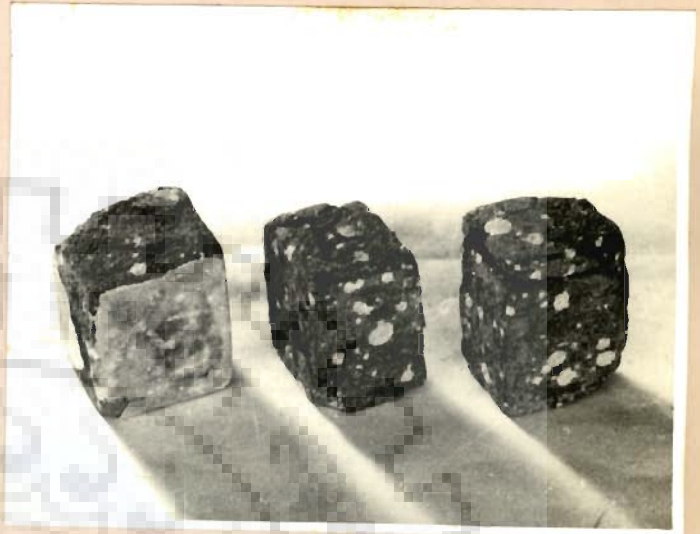
Plate 5.22: Failure of PMMA treated samples after 20 cycles

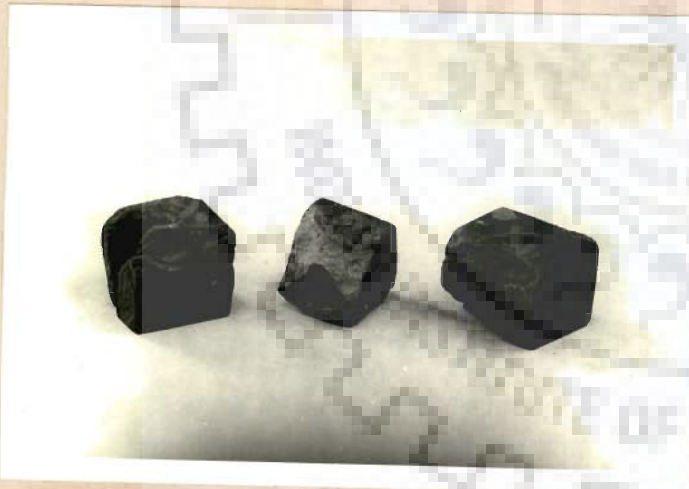
Plate 5.23: Failure of Silicone Resin treated samples after 40 cycles

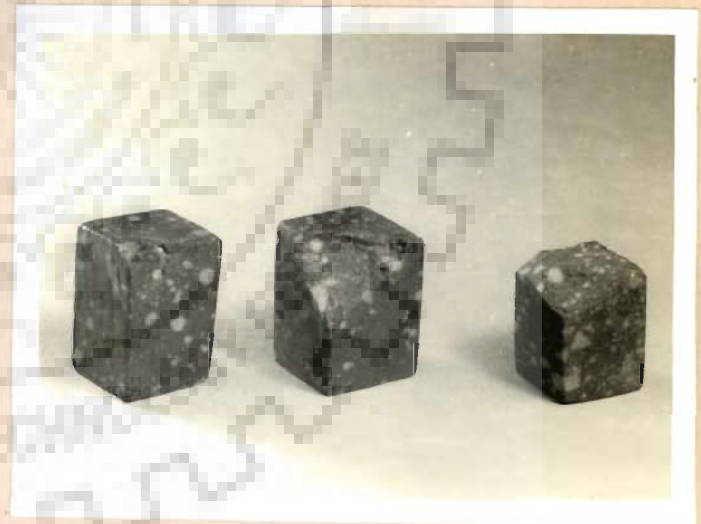
Plate 5.24: Failure of Silicone Resin treated samples after 40 cycles

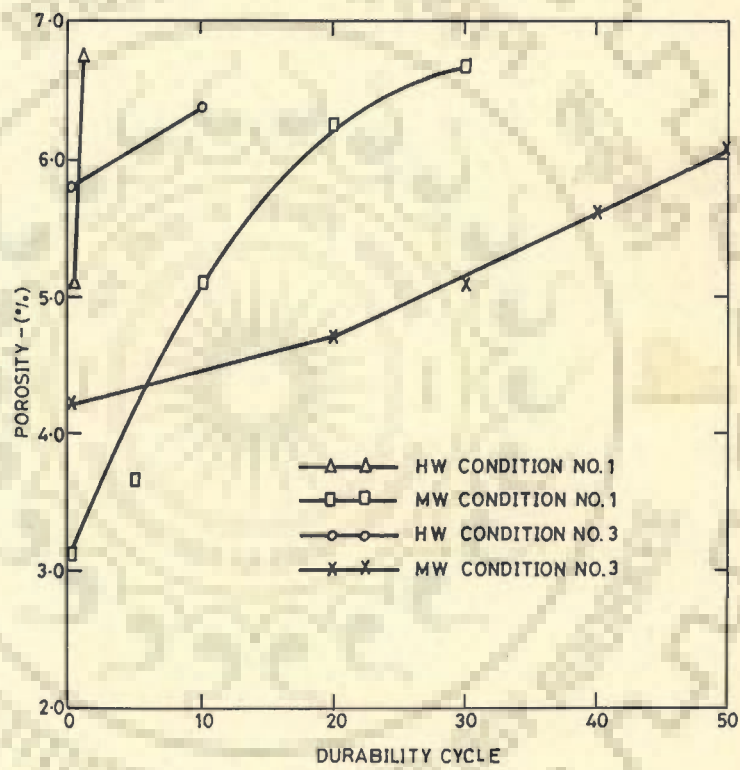
FIG.6.1. VARIATION OF POROSITY OF UNTREATED BASALT WITH DURABILITY CYCLES UNDER DIFFERENT TEST CONDITIONS

The study has clearly shown that the disintegration of basalt samples under weathering, durability and sea-water tests starts with the leaching of material filled in the pores (amygdals) of the stone forming grooves and pits over the surface of stone along with the appearance of brown ferruginous material. The degree of disintegration of the stone can be assessed with the presence of brownish material over the surface which could be the weathered product released from the

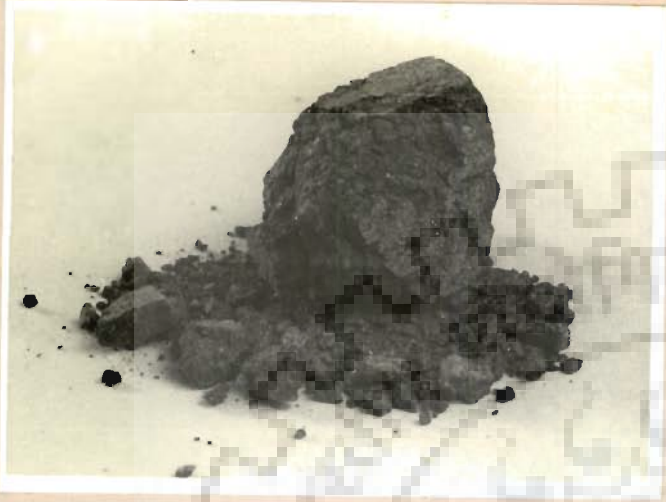
Plate 6.4: Highly weathered Basalt after 1 cycle

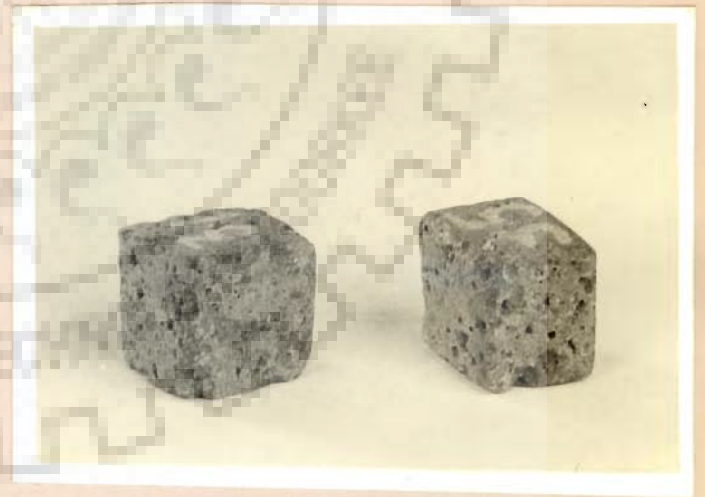
Plate 6.7: Moderately Weathered Basalt treated with Styrene after 70 cycles

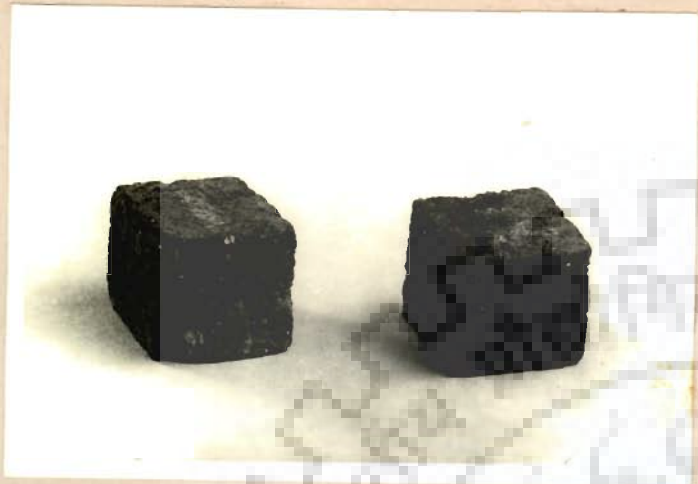
Plate 7.5: Untreated Scoria
after 10 cycles of Durability
test

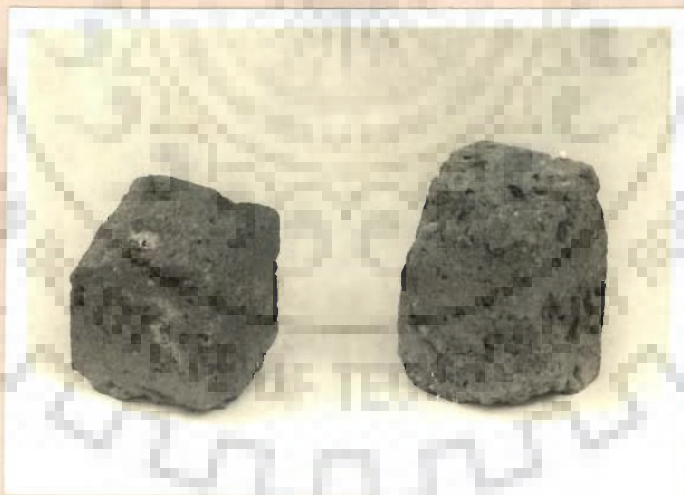
Plate 7.7: Untreated
Scoria after ³⁰cycles
of Durability Test

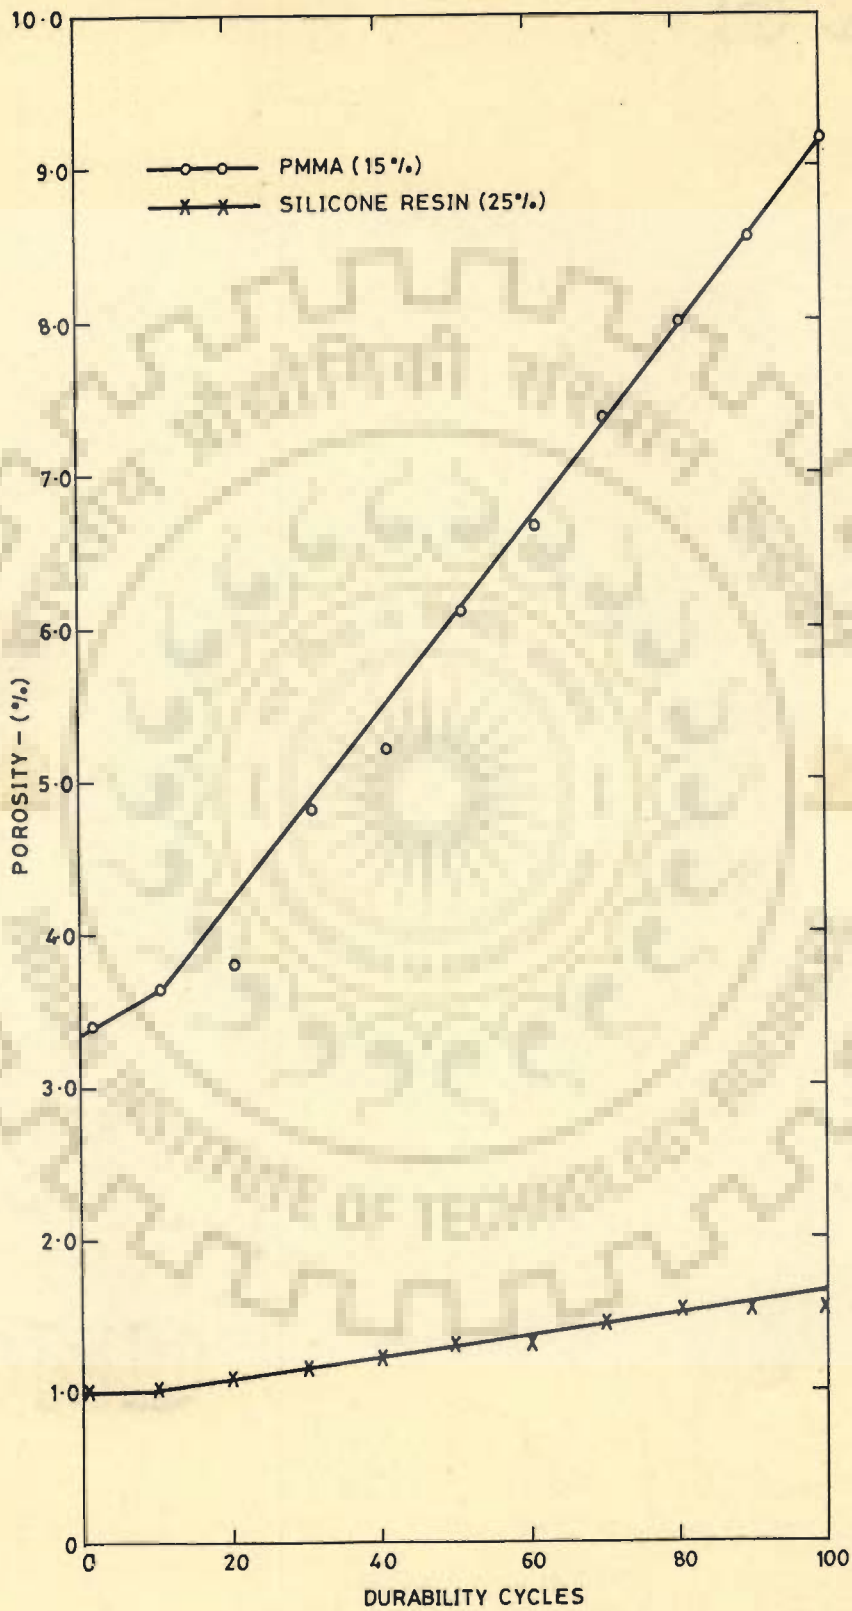
FIG.7.3. VARIATION OF POROSITY OF TREATED SCORIA WITH DURABILITY CYCLES
