PROVISION OF CUTOFF IN TENUGHAT DAM AND ITS PERFORMANCE

A DISSERTATION
submitted in partial fulfilment of the
requirements for the award of the Degree
of
MASTER OF ENGINEERING
in
WATER RESOURCES DEVELOPMENT

By
AYODHYA PRASAD

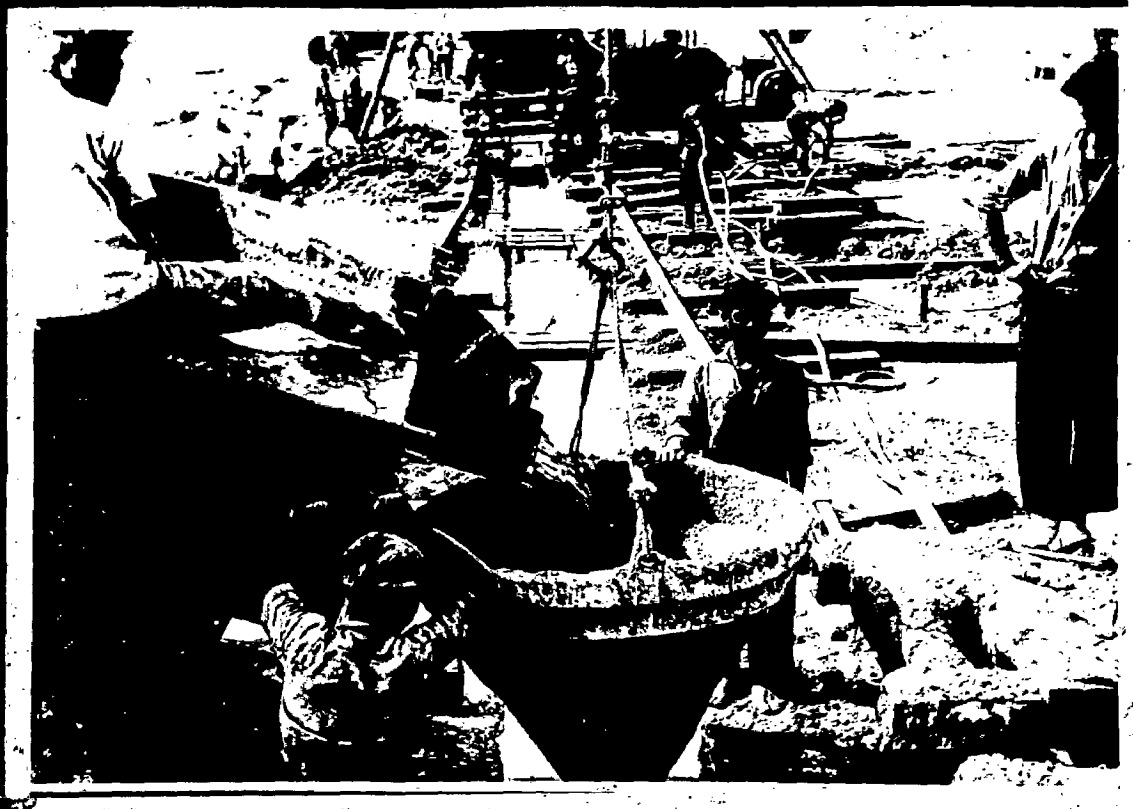
Concreting by Tremie
