# DEVELOPMENT OF EROSION RESISTANT NITRONIC STEEL

## A THESIS

DOCTOR OF PHILOSOPHY

METALLURGICAL AND MATERIALS ENGINEERING

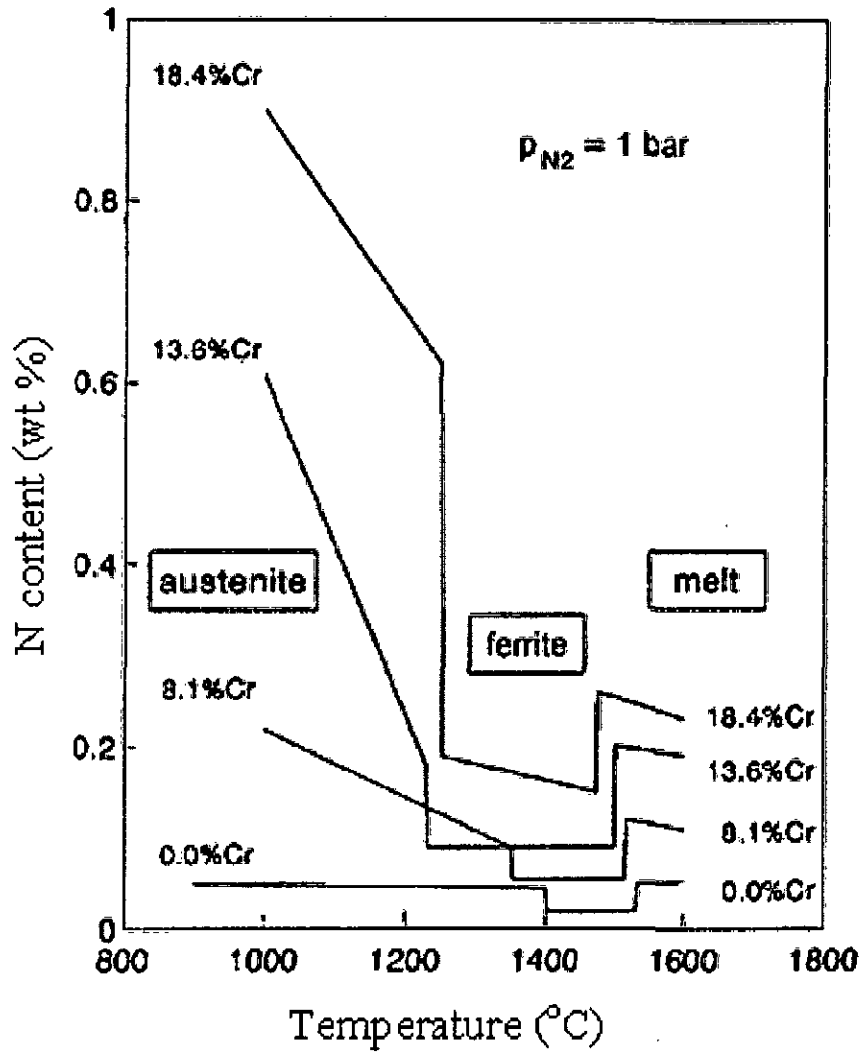
Fig. 1.1. Nitrogen solubility in steel as a function of temperature and Cr content [76]

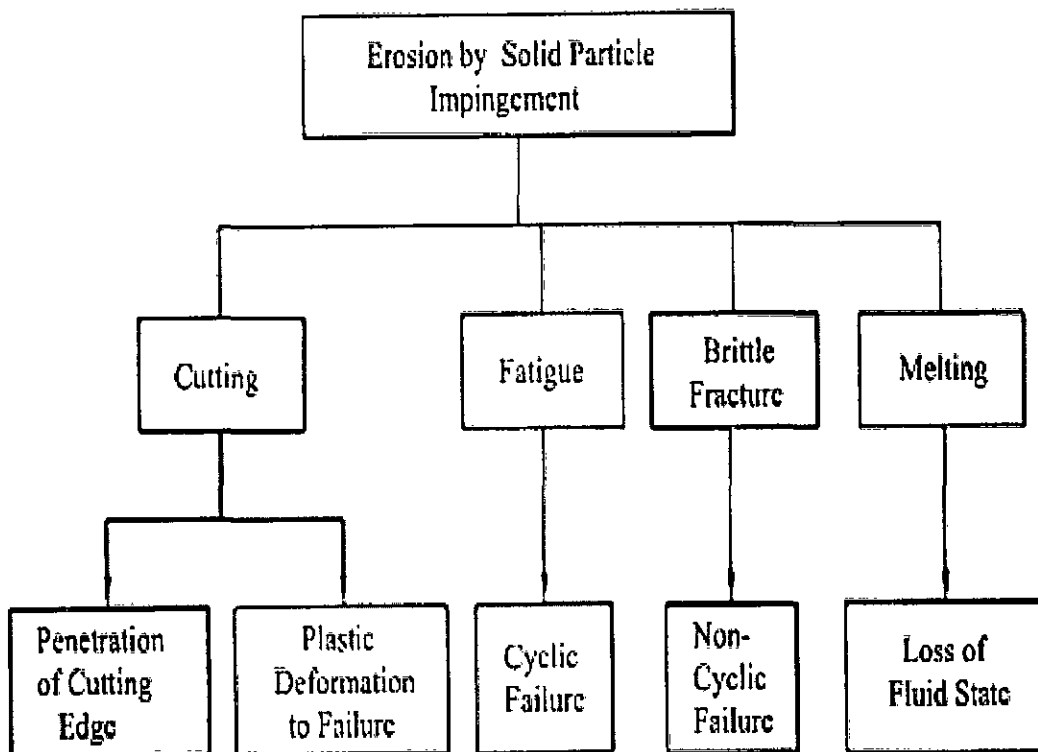
Fig. 1.2. Mechanisms of material-removal by solid-particle erosion [83]

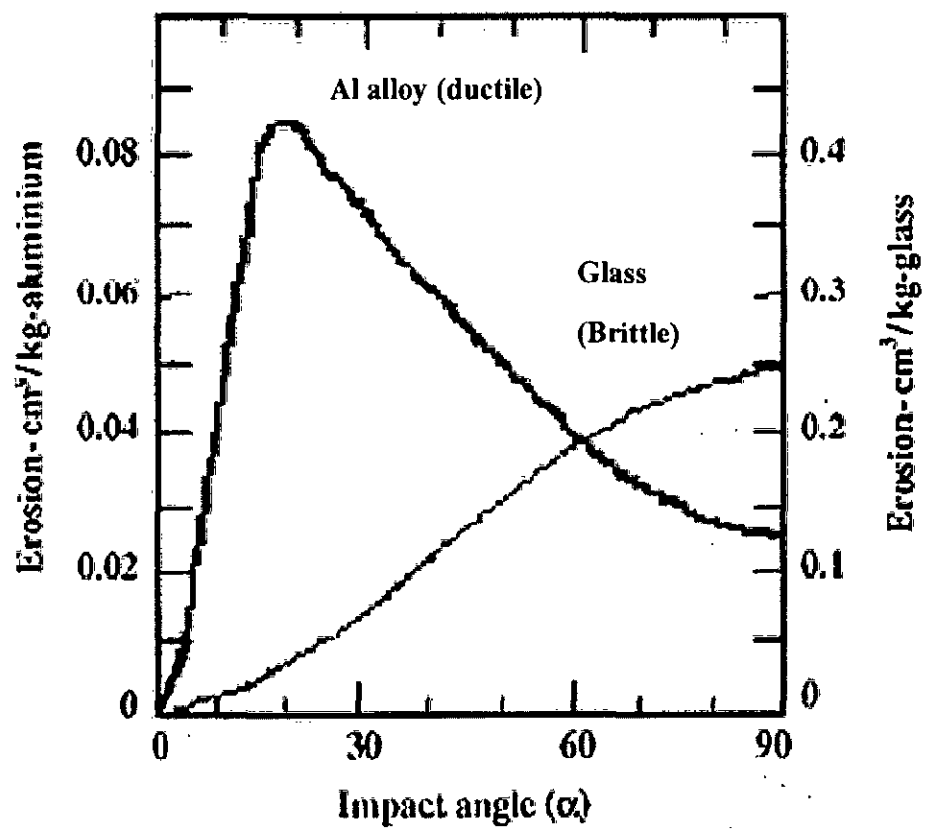
Fig. 1.4. Erosion behavior of brittle and ductile materials [50]

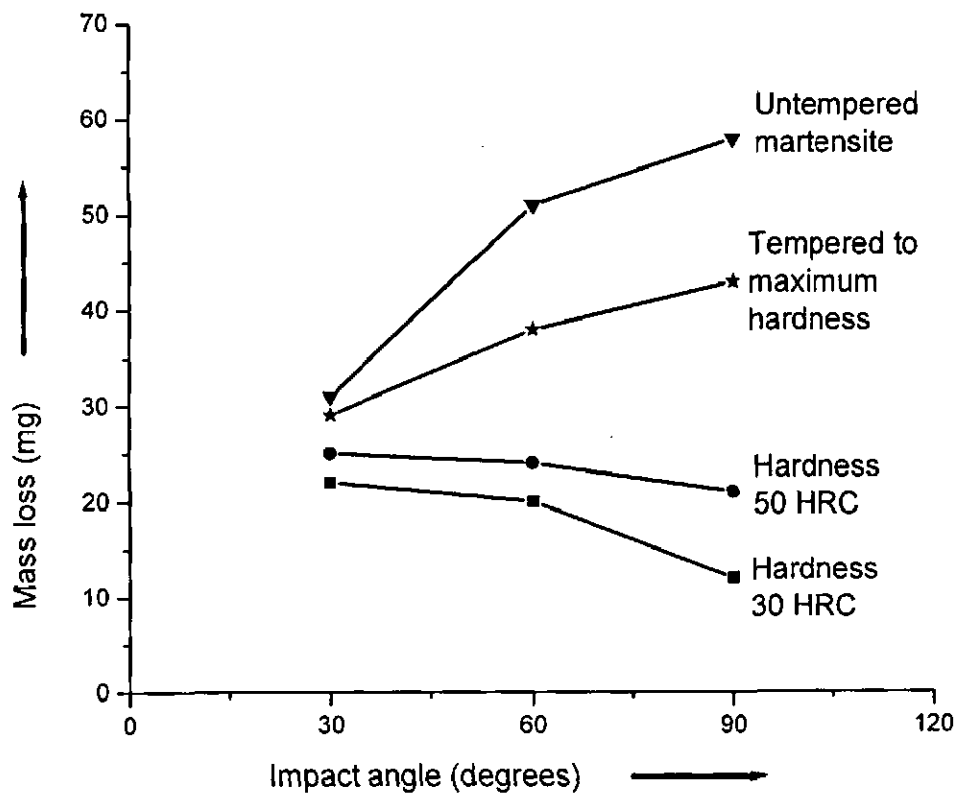
**Fig. 1.9.** Erosion rate of AISI 52100 steel samples (1%C, 1.5%Cr) with different microstructures as a function of impact angle. Silica particles were used at  $153 \text{ ms}^{-1}$  [104]

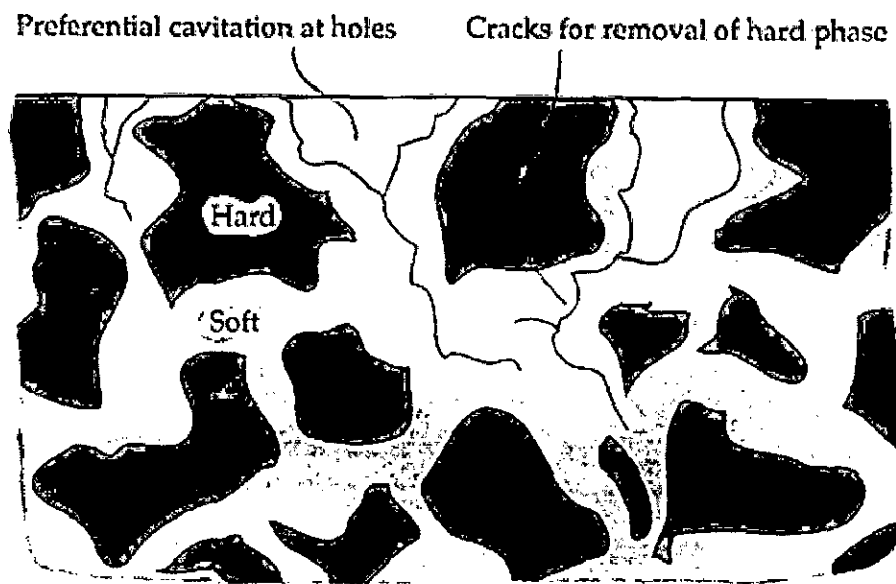
Fig. 1.14. Preferential attack by cavitation of the weaker phase in a microstructure [84]

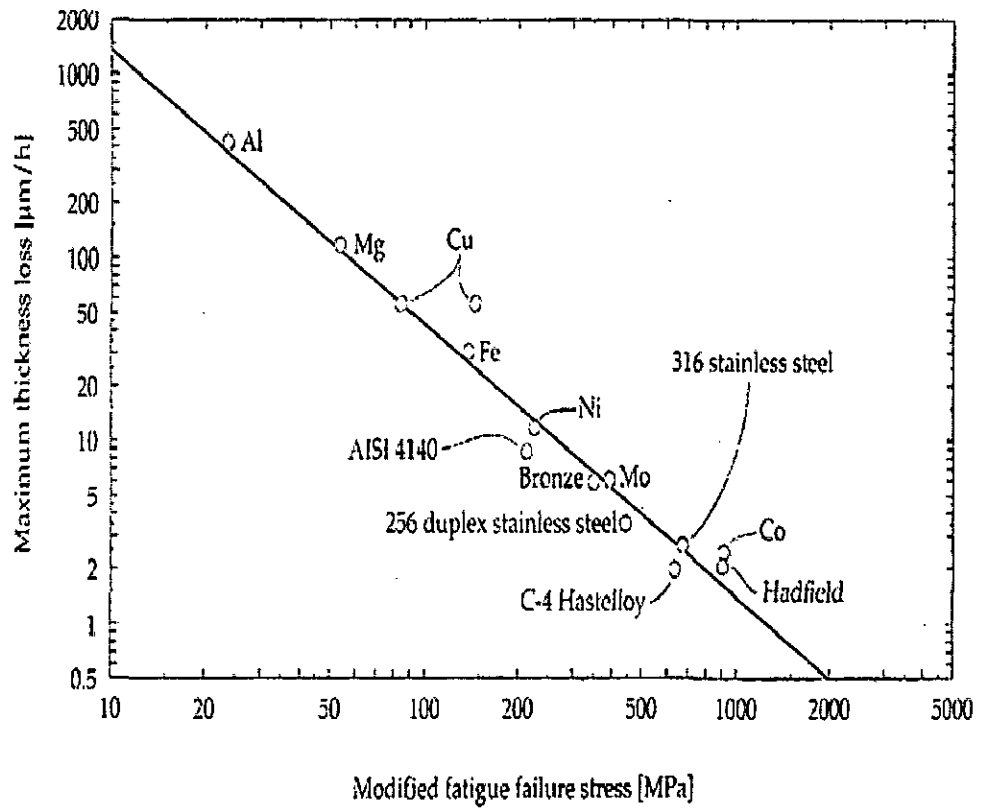
**Fig. 1.15. Relationship between the cavitation wear resistances expressed in terms of maximum thickness loss and modified fatigue failure stress [125]**

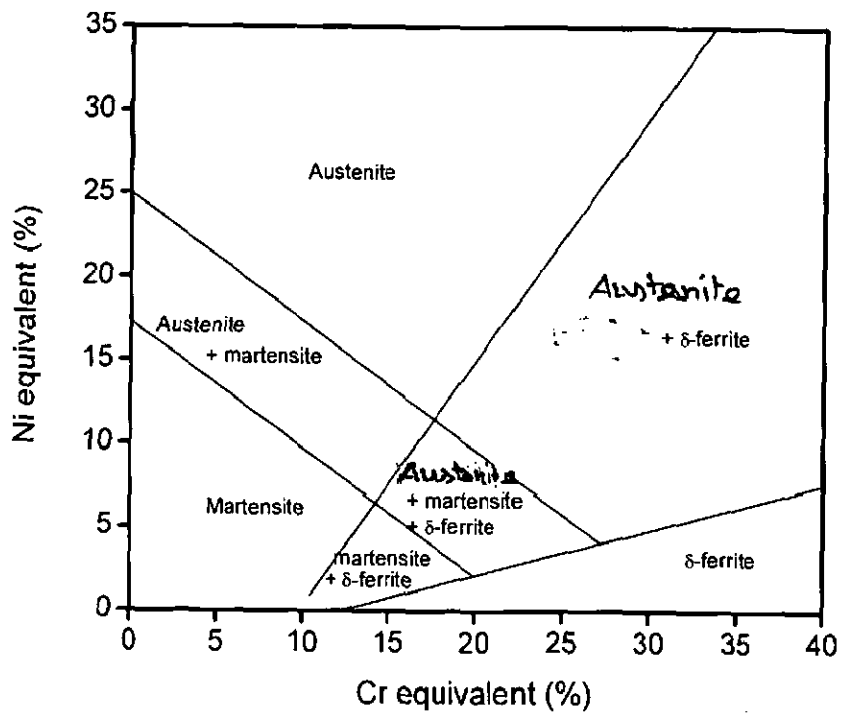
Fig. 4.3. Schaffler diagram [177]
