ENGINEERING GEOLOGICAL APPRAISAL OF KISHAU DAM PROJECT, GARHWAL HIMALAYA

A THESIS

*submitted in fulfilment of the
requirements for the award of the degree
of*
DOCTOR OF PHILOSOPHY
in
EARTH SCIENCES

DEPARTMENT OF EARTH SCIENCES
UNIVERSITY OF ROORKEE
ROORKEE-247 667 (INDIA)

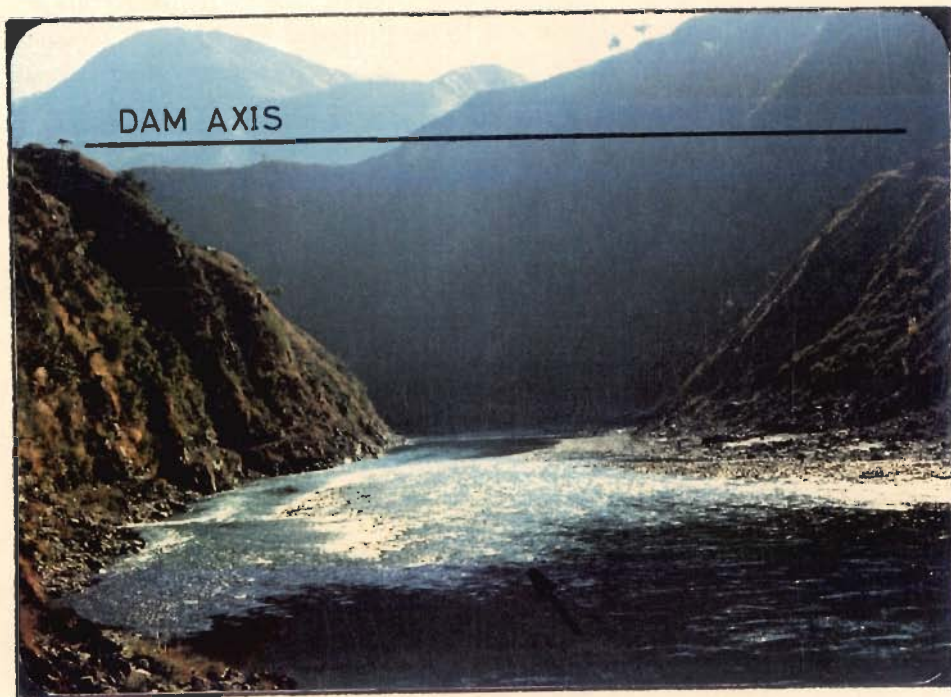
PLATE 1.1 DOWNSTREAM VIEW OF DAM SITE

The Kishau dam is being planned across the Tons river, near Samberkhera village (Plate 1) defined by the coordinates ($30^{\circ} 39' 39'' : 77^{\circ} 46' 55''$), about 45 km upstream of Dakhpathar in Dehradun District of Uttar Pradesh (Plate 1.1).

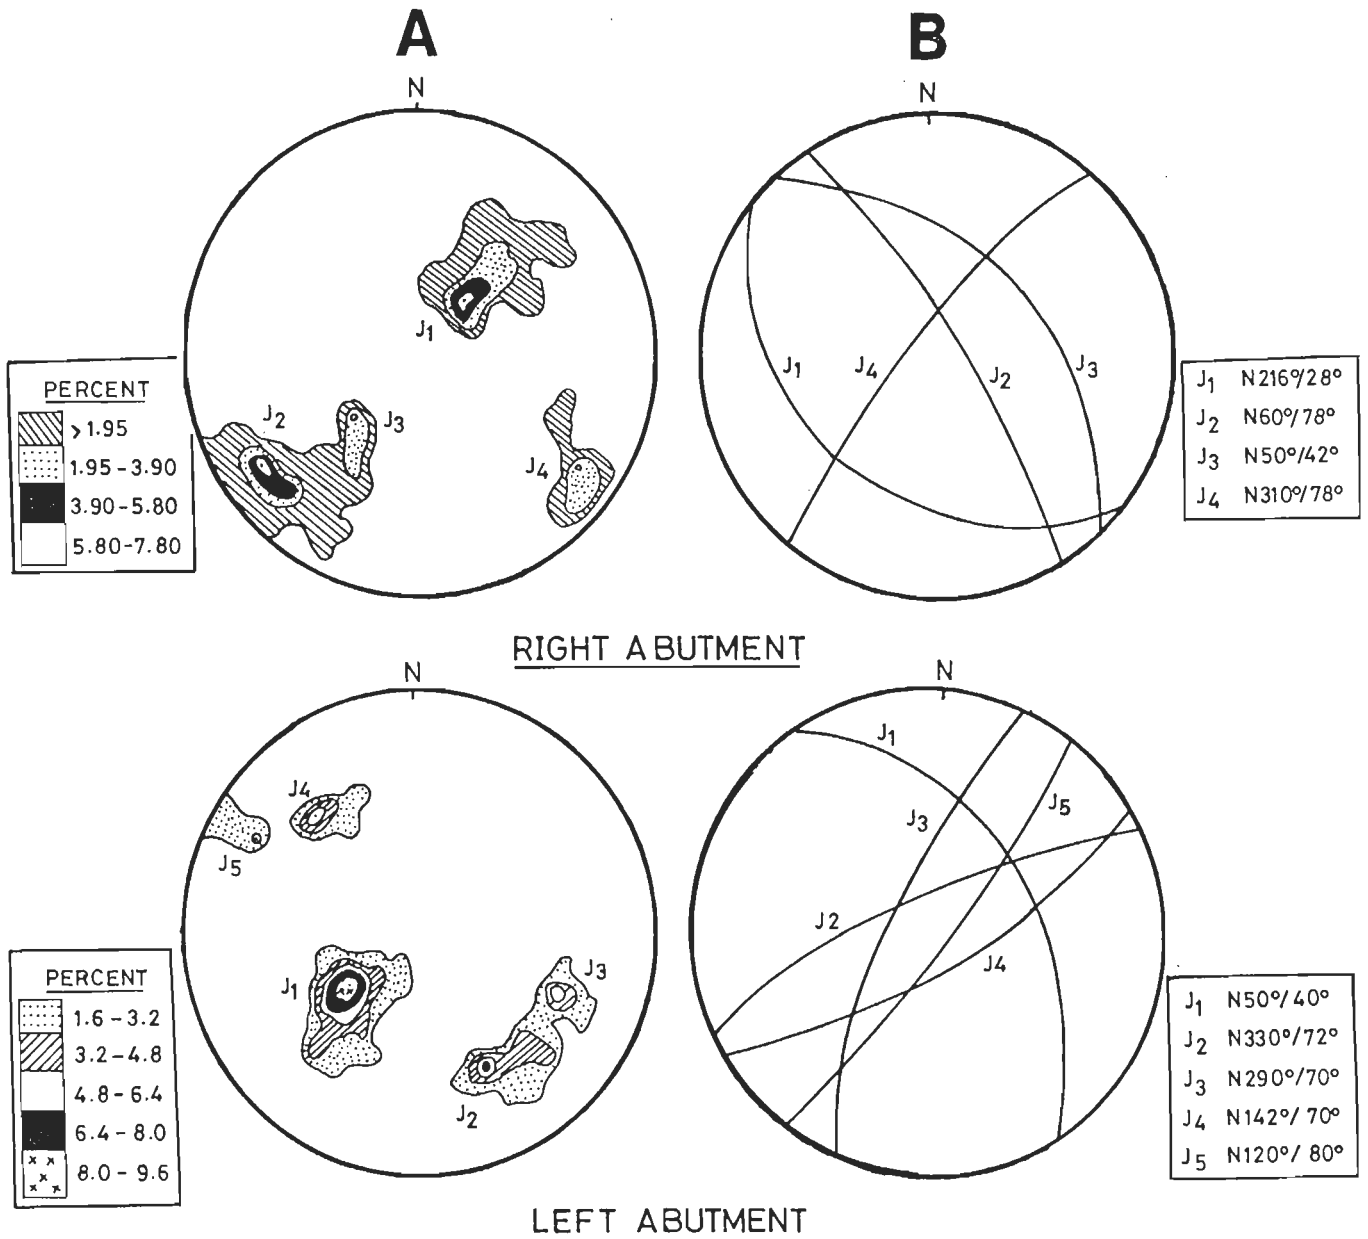
FIG. 2.6 A - DENSITY PLOT OF JOINT POLES ON LEFT AND RIGHT ABUTMENT.
 B - ATTITUDE OF STRUCTURAL DISCONTINUITIES ON LEFT AND RIGHT ABUTMENT

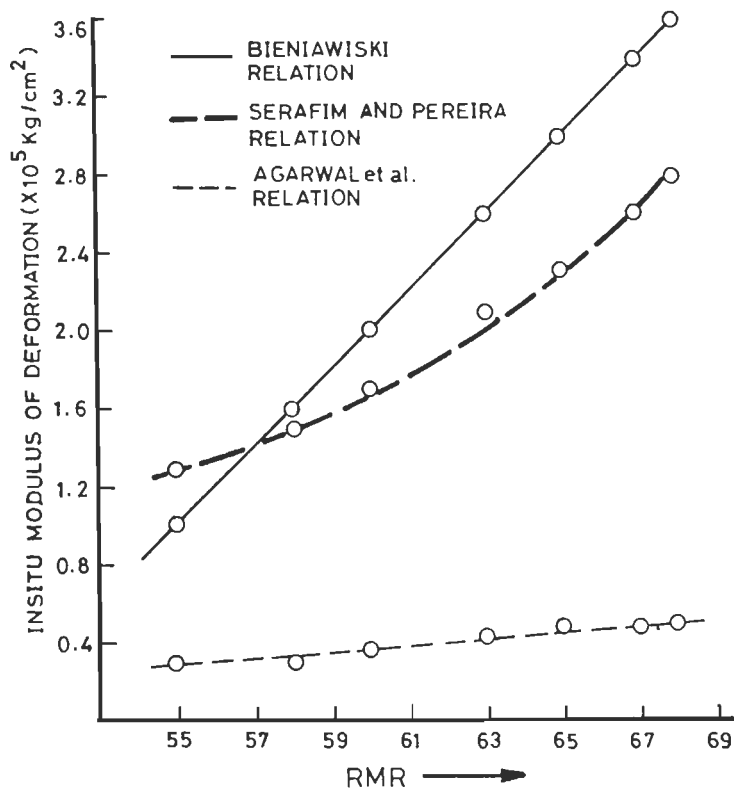
FIG. 3.7 COMPARISON OF IN-SITU MODULUS OF DEFORMATION OF FOUNDATION ROCKS OBTAINED BY EMPIRICAL APPROACHES.

A perusal of Table 3.11 indicates that the values of in-situ modulus of deformation obtained by empirical approaches of Bieniawski and Serafim & Pereira are much higher than the in-situ

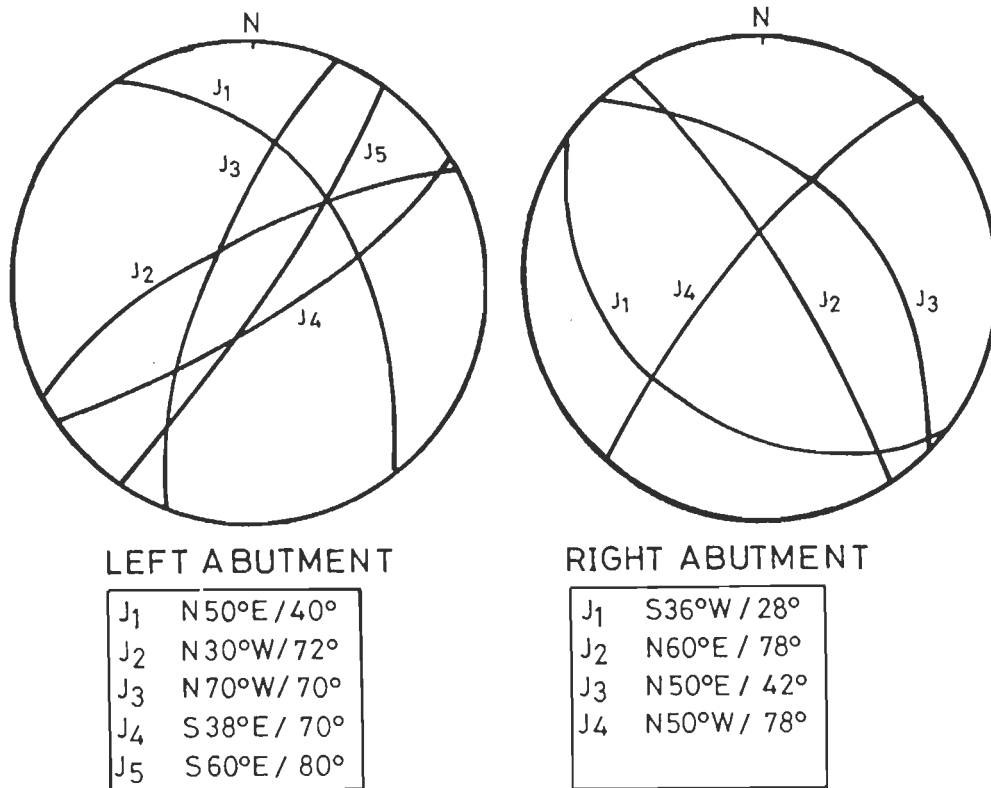
FIG. 3.9 ATTITUDE OF STRUCTURAL DISCONTINUITIES ON LEFT AND RIGHT ABUTMENT

Data pertaining to structural discontinuities, mainly joints has been collected from both left and right abutments (300 nos. each). The poles of the attitude of joints, as observed in the field have been plotted on the stereonet for both the abutments separately. These poles have been contoured and the predominant clusters have been identified. The attitude of maxima of the structural discontinuities, thus obtained are presented in Fig.3.9.

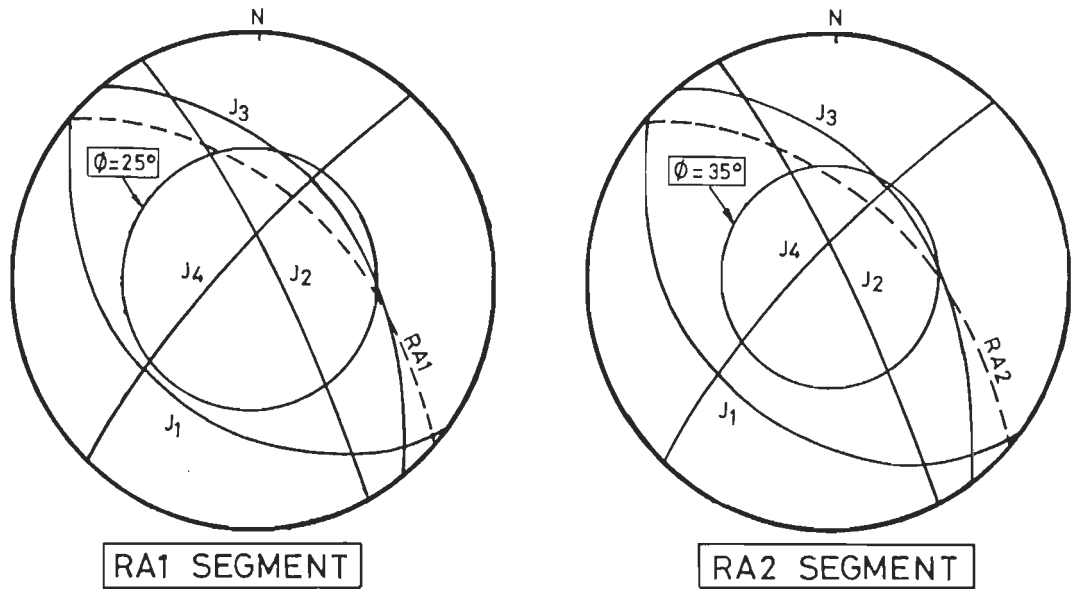
FIG. 3.13 KINEMATIC CHECK FOR RIGHT ABUTMENT SLOPE.

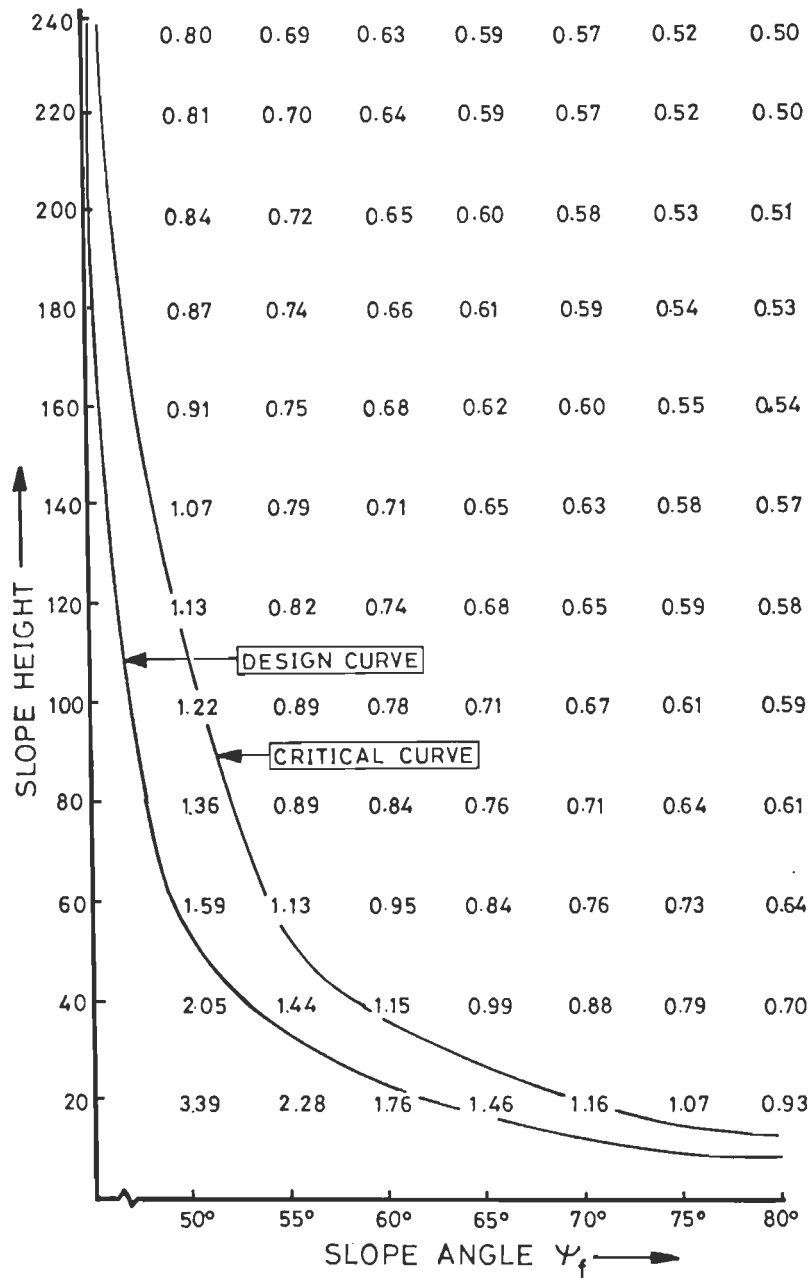
FIG. 3.20 DESIGN CURVE FOR RIGHT ABUTMENT SLOPE.

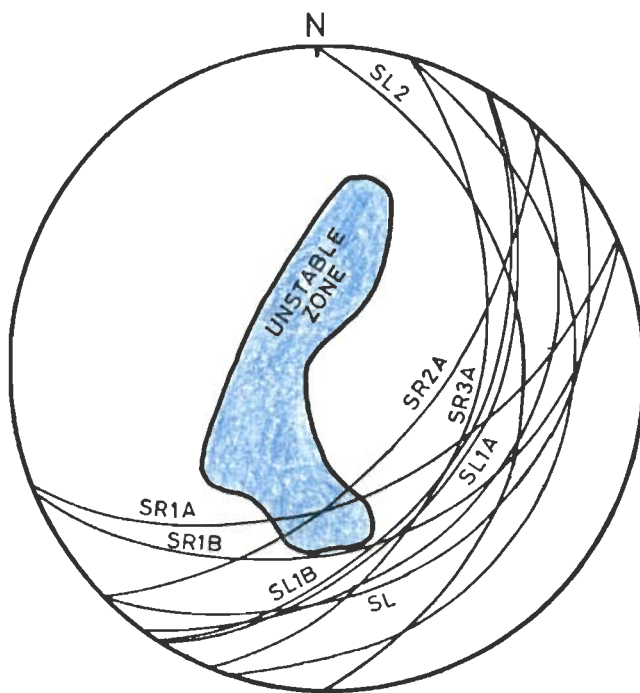
FIG. 4.6 STEREO PLOT SHOWING STABILITY CONDITION OF DIFFERENT SLOPES AT POWER HOUSE SITE.

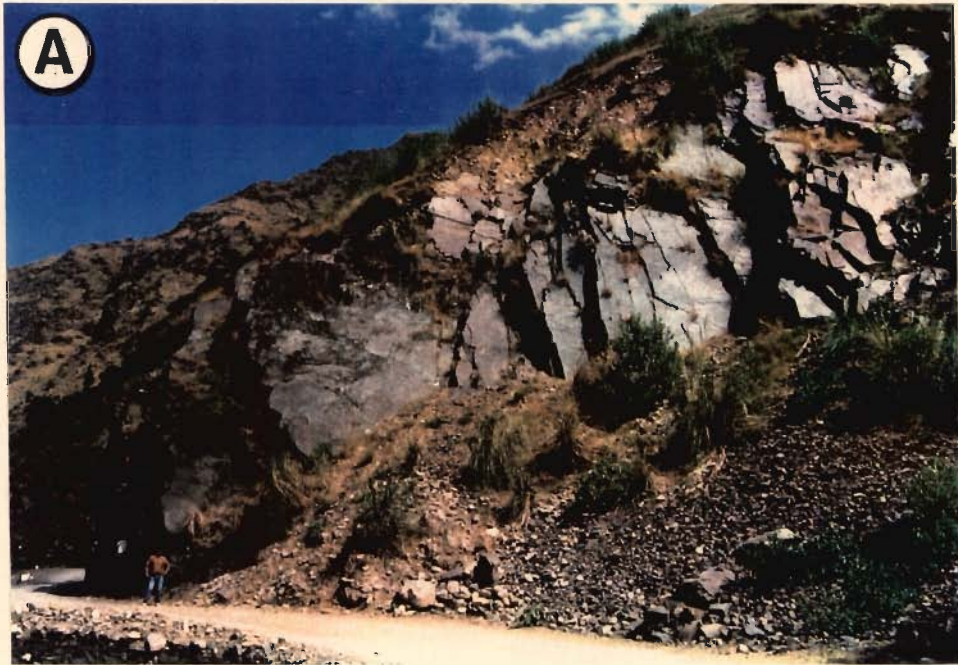
PLATE 5.1 A - PART OF SLOPE SECTION KL13A
FAILED ALONG KWANU MINAS ROAD
AT 14 KM MILESTONE
B - SKETCH OF KL13A SLOPE SECTION

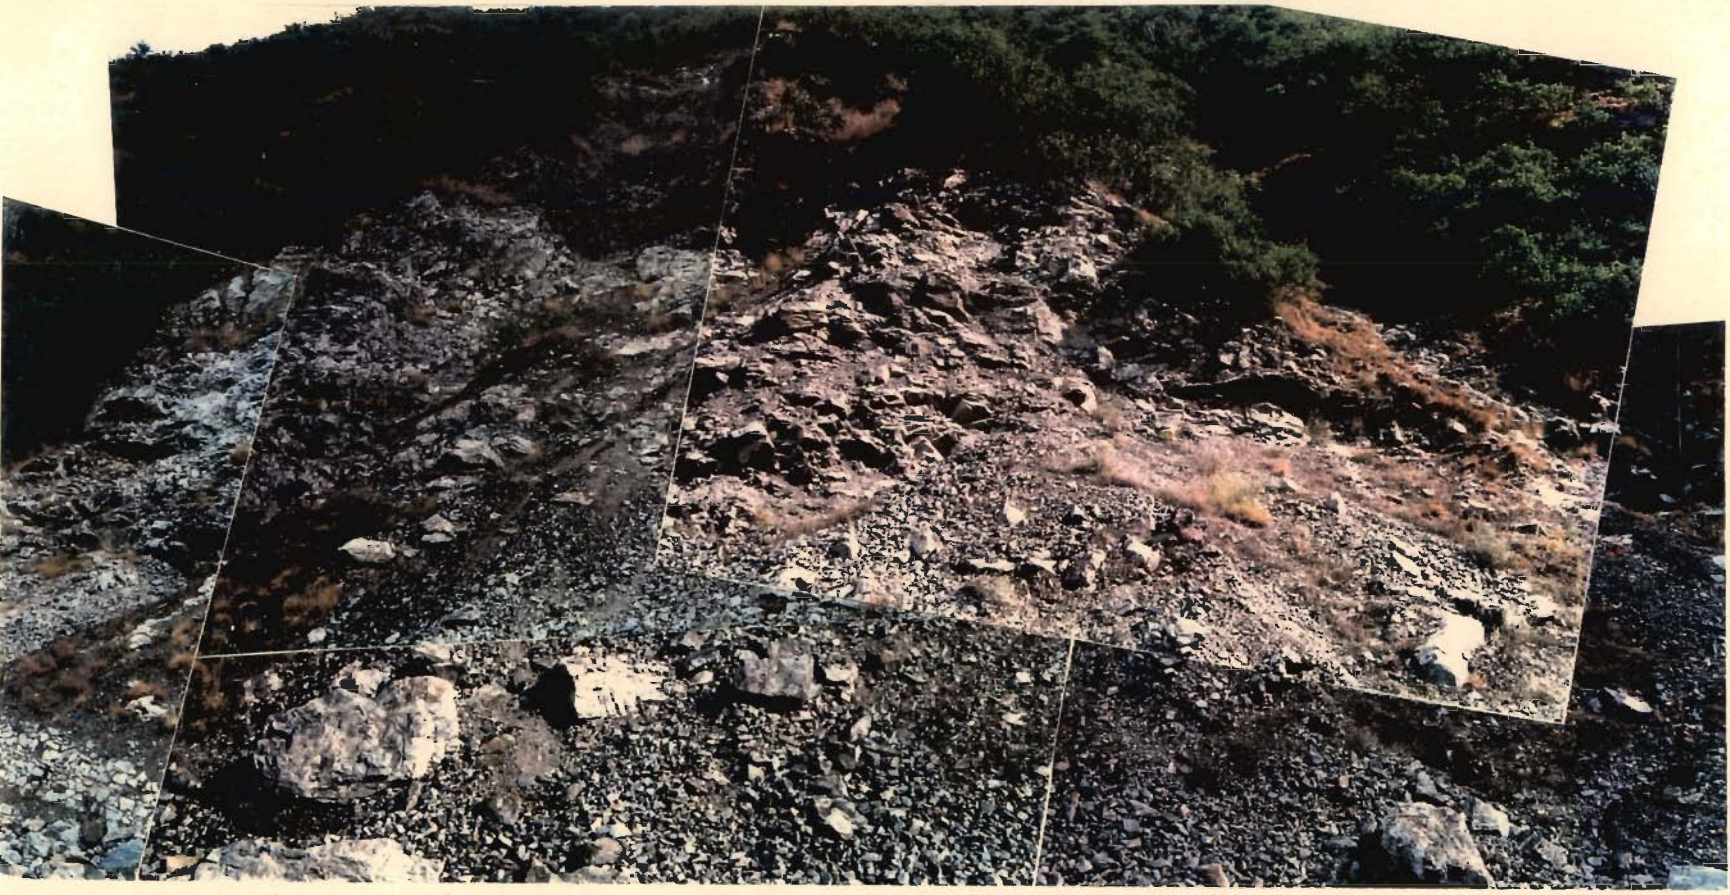
PLATE 5.3 A PART OF KR30A SLOPE SECTION
FAILED ALONG ATAL TIUNI ROAD

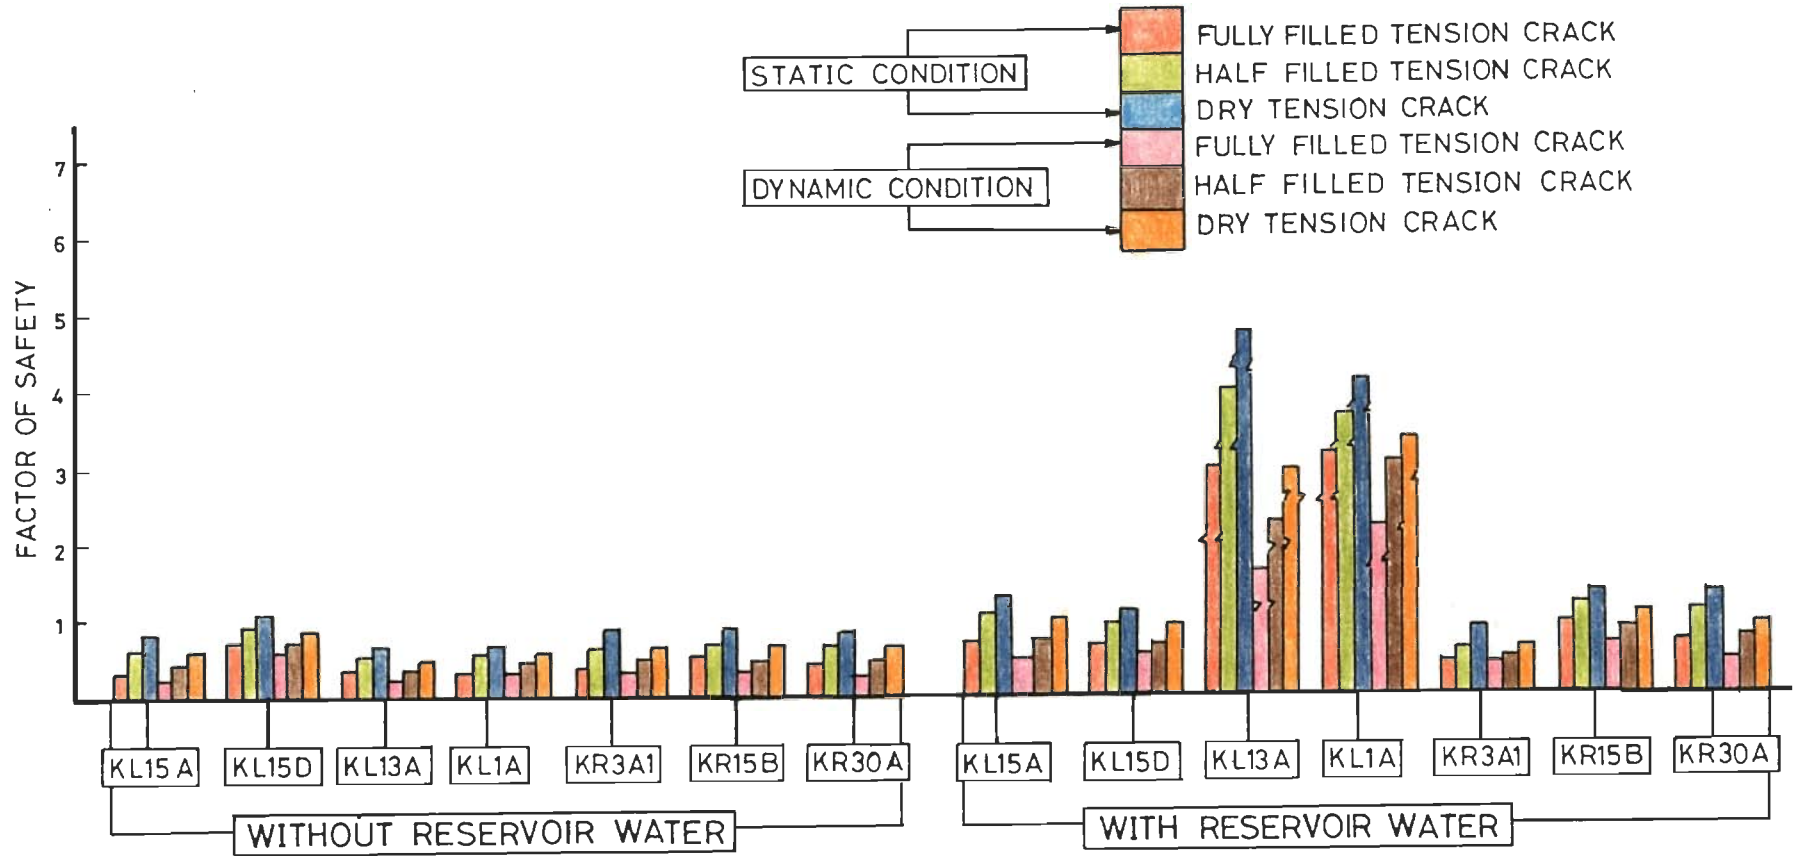
FIG. 5.10 'FACTOR OF SAFETY' OF SLOPES HAVING PLANE MODE OF FAILURE IN THE RESERVOIR AREA.

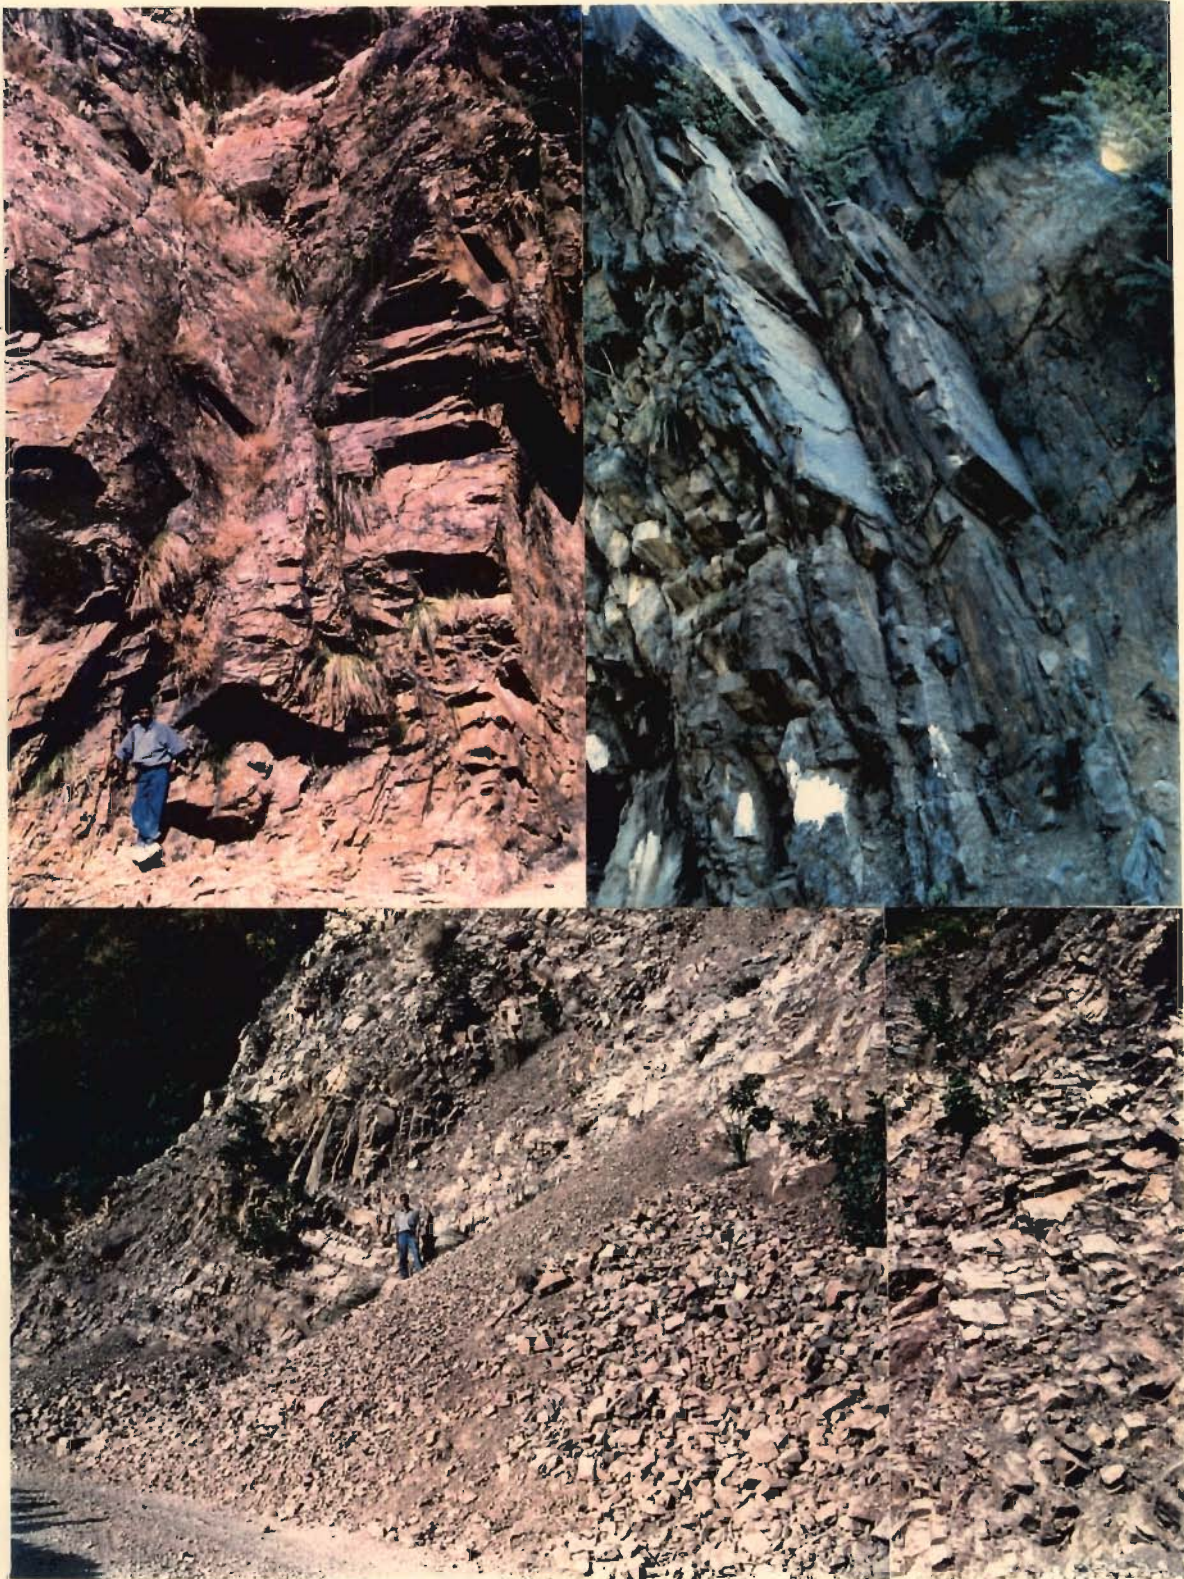
PLATE 5.4 WEDGE MODE OF FAILURES IN RESERVOIR AREA
