DEVELOPMENT OF BRICK BUILDING SYSTEMS  
FOR  
IMPROVED EARTHQUAKE PERFORMANCE

A THESIS  
*Submitted in fulfilment*  
*of the requirements for the award of the degree*  
*of*  
DOCTOR OF PHILOSOPHY  
*in*  
EARTHQUAKE ENGINEERING

DEPARTMENT OF EARTHQUAKE ENGINEERING  
UNIVERSITY OF ROORKEE  
ROORKEE (INDIA)

September 1978

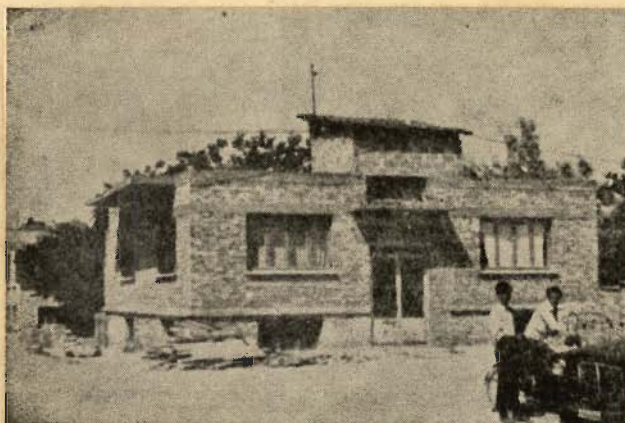
Photo 1.1 BRICK BUILDING WITH R.C. BANDS SHOWING EFFECTIVENESS OF THE BAND IN KEEPING THE BUILDING SAFE IN AREA OF MOST SEVERE SHAKING IN EARTHQUAKE OF MAY 1971 (TURKEY)

Some strengthening methods for brick buildings have been suggested by earlier investigators (Krishna and Chandra, 1965; Arya, 1967; Arya, 1969 and Krishna and Chandra, 1969) for improving their lateral strength with a small increase in the overall cost of their construction, and these have been incorporated in IS: 4326-1976 'Recommendations for Earthquake Resistant Building Construction'. But these have not been tested experimentally for actual or simulated ground motion inputs. Though, effectiveness of only R.C. bands in brick building (Photo 1.1) has been proved in keeping the building

safe from collapse in area of most severe shaking in Burdur (Turkey) earthquake of May 1971 (Arya, Chandra and Thakkar, 1977), worth of overall strengthened brick buildings has yet to be seen in future earthquakes and still awaits the test of time. Therefore, more extensive investigations are required for evolving suitable aseismic brick building system, rational methods of seismic analysis and design and construction practices for such structure.

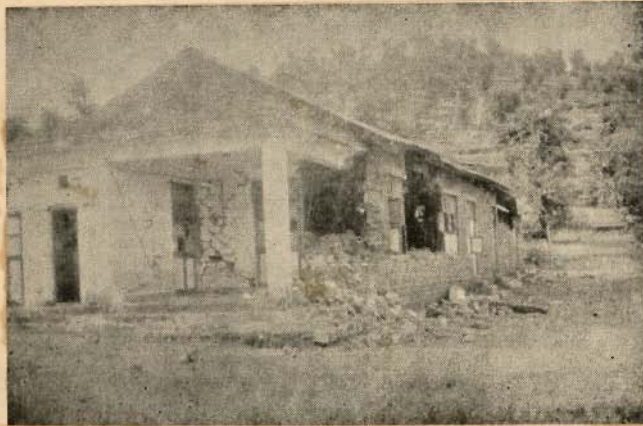
PHOTO 2.1\_ DAMAGE TO SCHOOL IN KOYNA EARTHQUAKE, INDIA ( STAR CRACK PATTERN IN BRICK WALL )

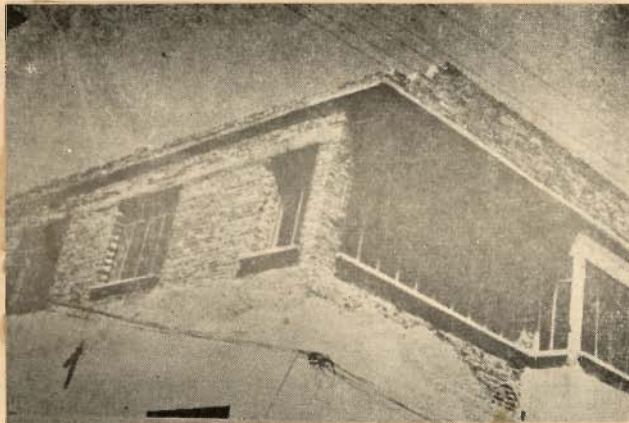
PHOTO 2.2\_ EARTHQUAKE DAMAGE TO UNREINFORCED BRICK PARAPET

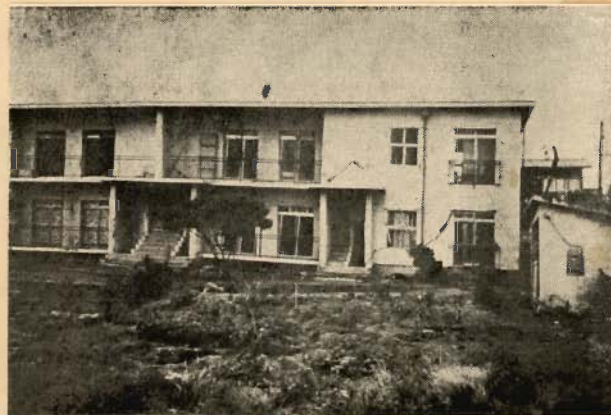
PHOTO 2.3\_ DIAGONAL CRACKING OF WALLS NEAR WINDOW OPENING (GEDIZ EARTHQUAKE OF 1970 TURKEY )

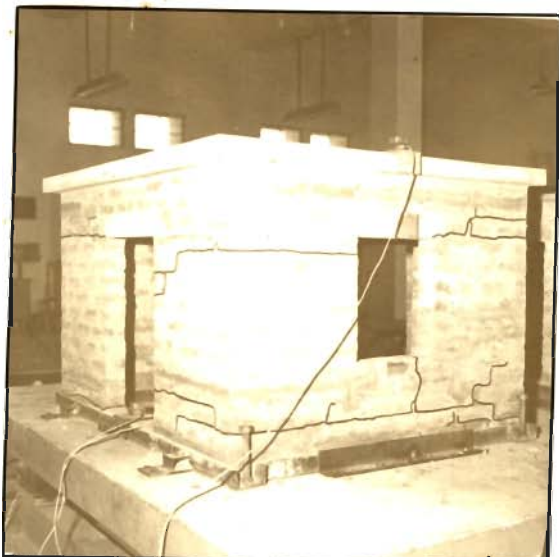
PHOTO 4.4 - NORTH AND WEST WALLS OF MODEL NO. 1 DAMAGED WITH FIXED BASE

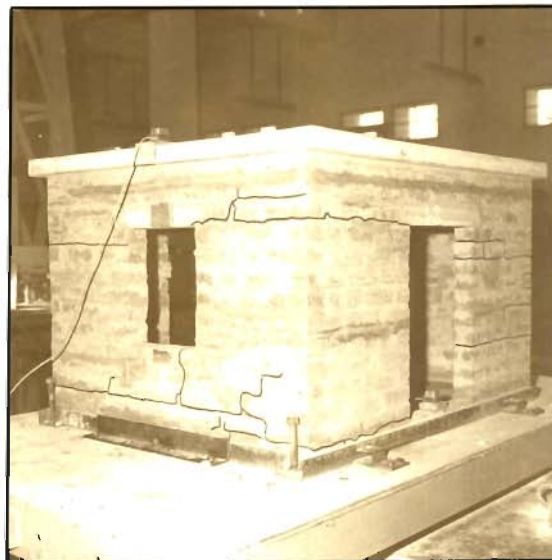
PHOTO 4.5 - DAMAGE TO SOUTH AND WEST WALLS OF MODEL NO. 1 WITH FIXED BASE

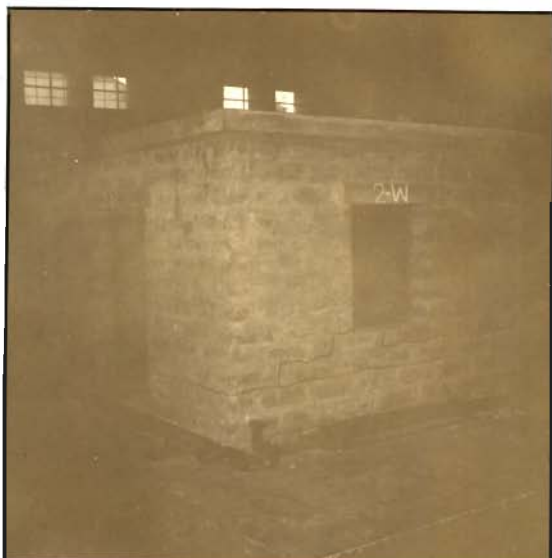
PHOTO 4.6 - NORTH AND WEST WALLS OF MODEL NO. 2 WITH FIXED BASE CRACKED

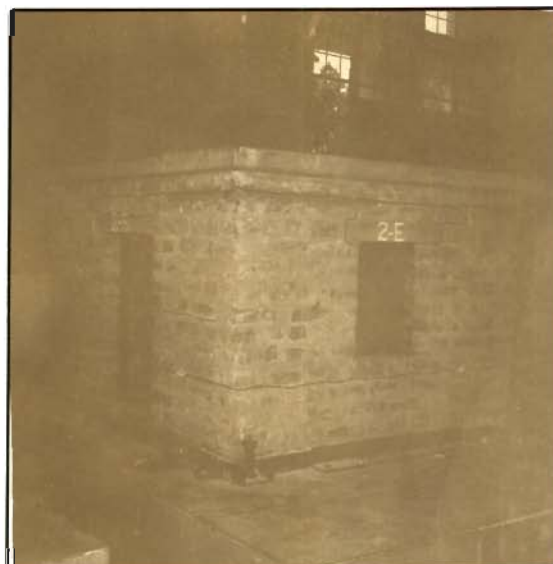
PHOTO 4.7 - SOUTH AND EAST WALLS OF MODEL NO. 2 DAMAGED WITH FIXED BASE

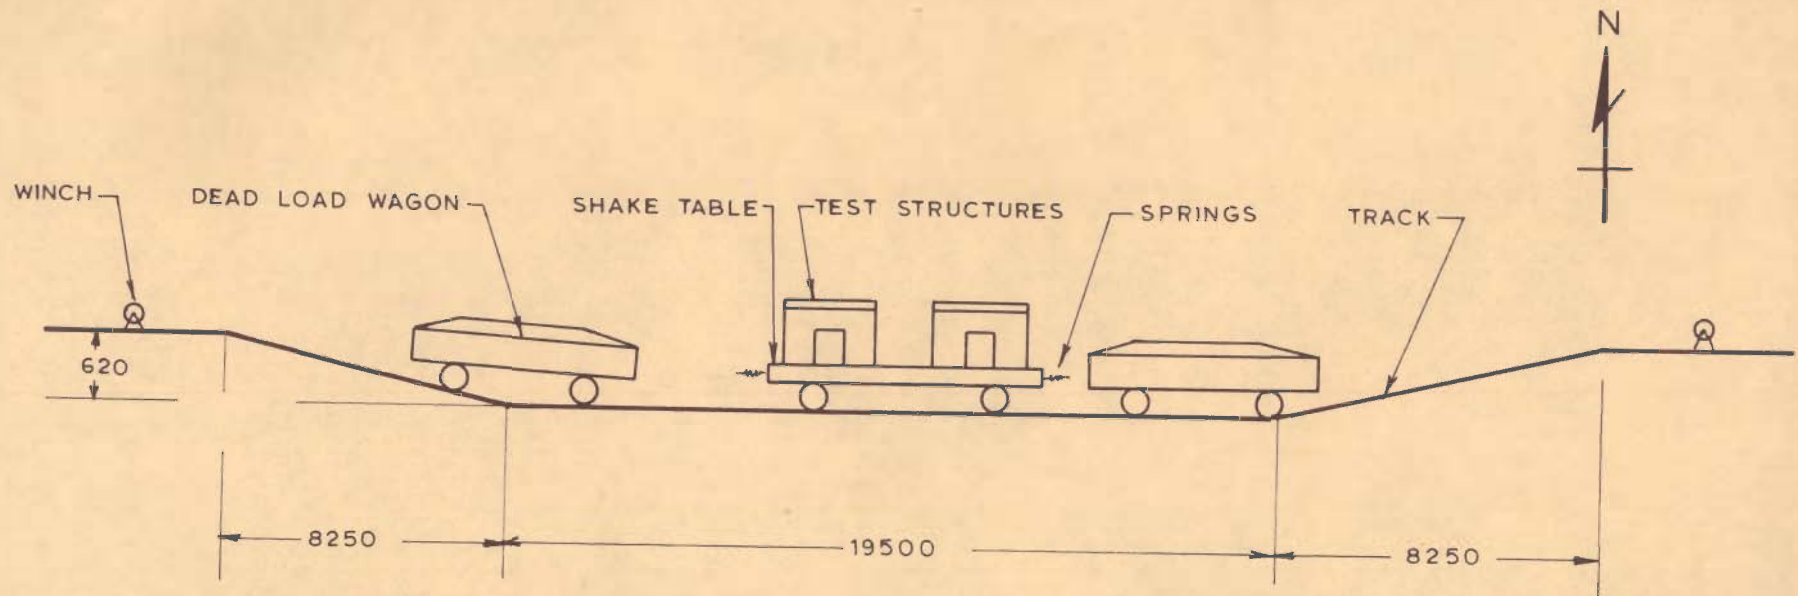
ALL DIMENSIONS IN mm

FIG. 5.1 - SCHEMATIC VIEW OF RAILWAY WAGON SHAKE TABLE TEST FACILITY

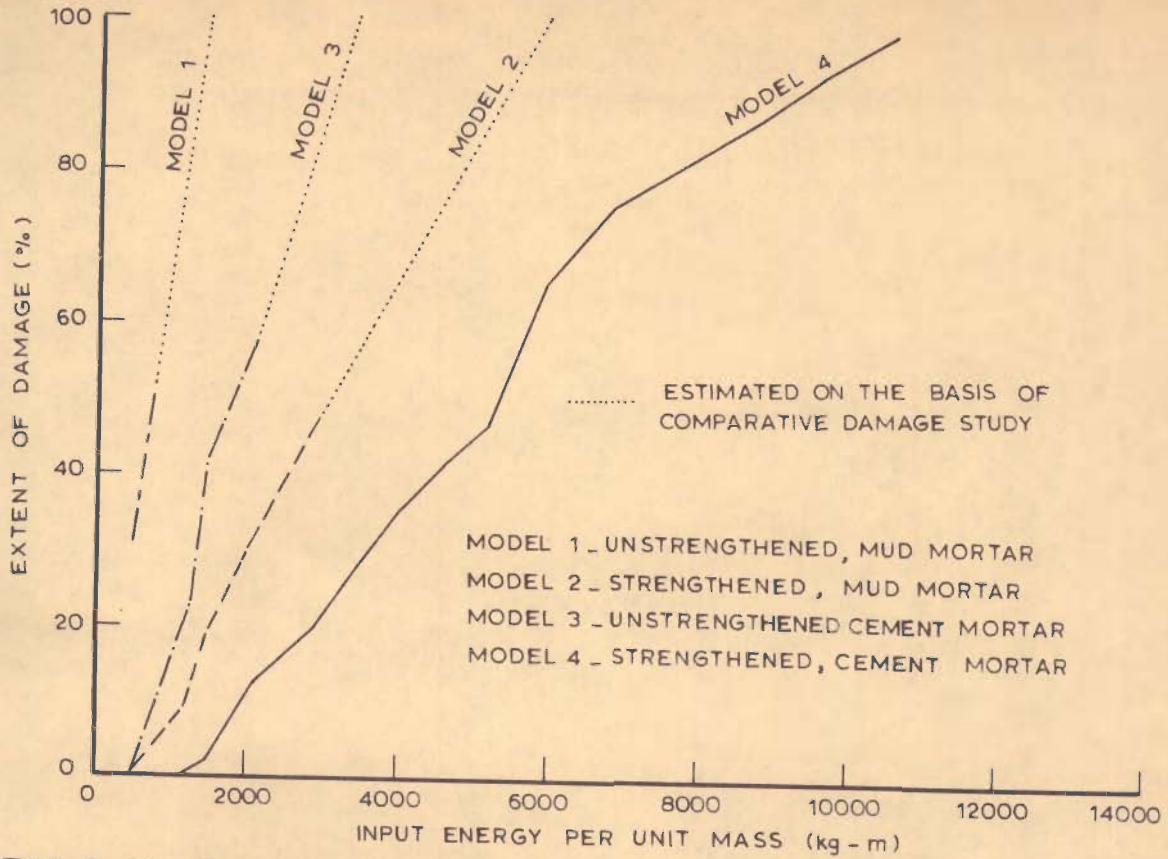
FIG. 5.10 - PROGRESSIVE DAMAGE & RELATIVE COMPETENCE OF FIRST SET OF BRICK TEST STRUCTURES SUBJECTED TO SHOCK LOADS

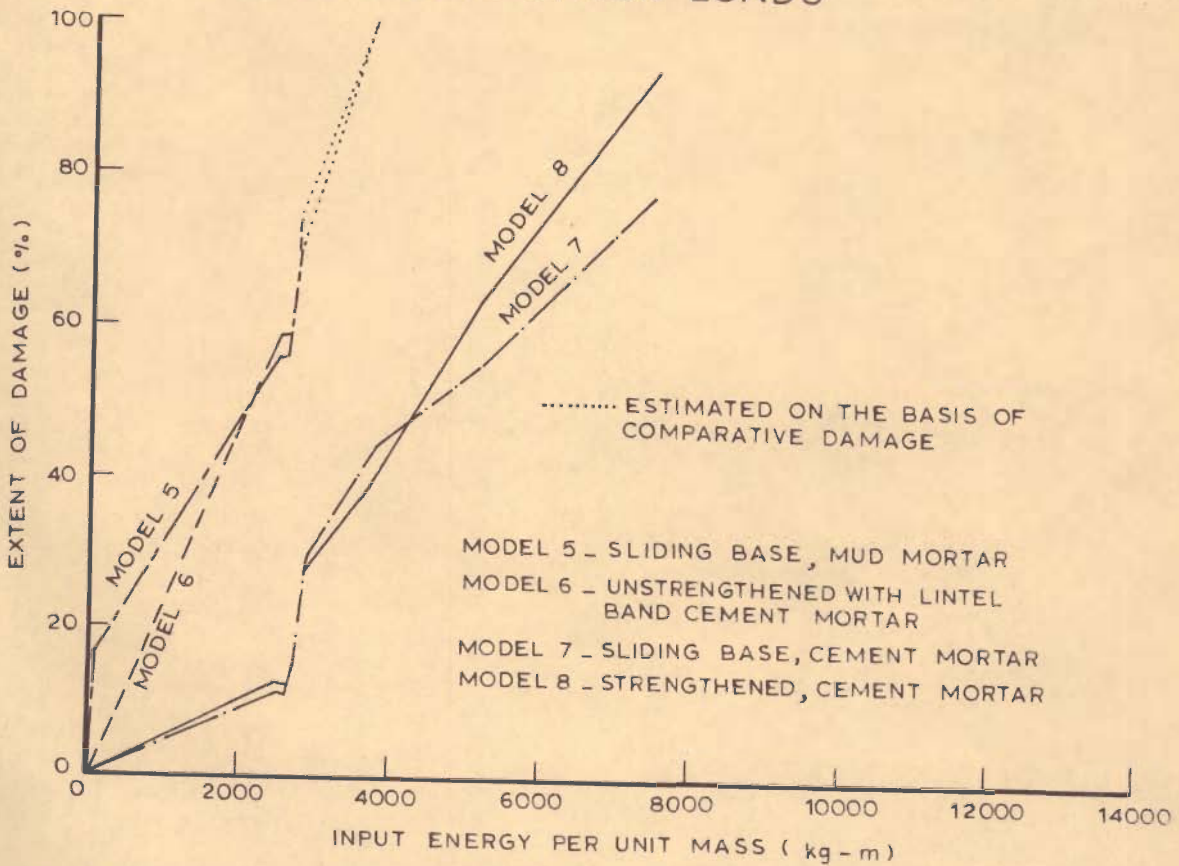
FIG. 5.11 - PROGRESSIVE DAMAGE AND RELATIVE COMPETENCE OF SECOND SET OF BRICK TEST STRUCTURES SUBJECTED TO SHOCK LOADS

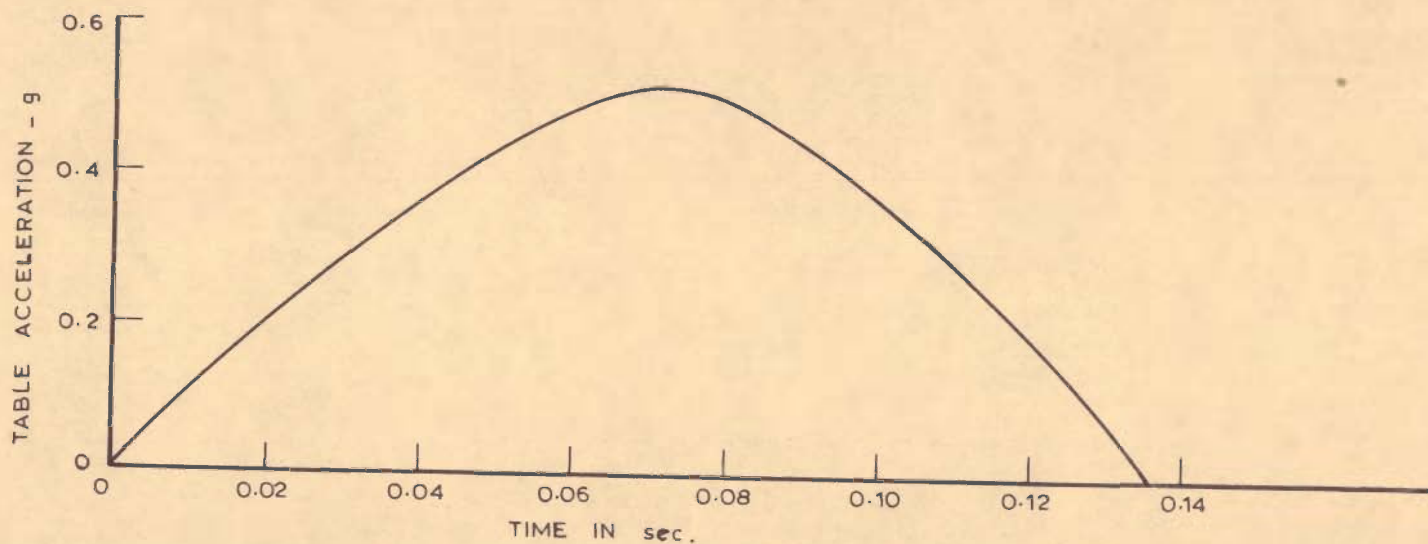
FIG. 5.12 - DIGITIZED PLOT OF THE SHAKE TABLE ACCELERATION PULSE (FOR SHOCK NO. 1 OF SECOND SERIES OF TESTING)
