**SLOPE STABILITY EVALUATION IN AND AROUND
KODAIKANAL TOWN, TAMILNADU**

Ph.D THESIS

**DEPARTMENT OF EARTH SCIENCES
INDIAN INSTITUTE OF TECHNOLOGY ROORKEE
ROORKEE- 247667, INDIA
MARCH, 2018**

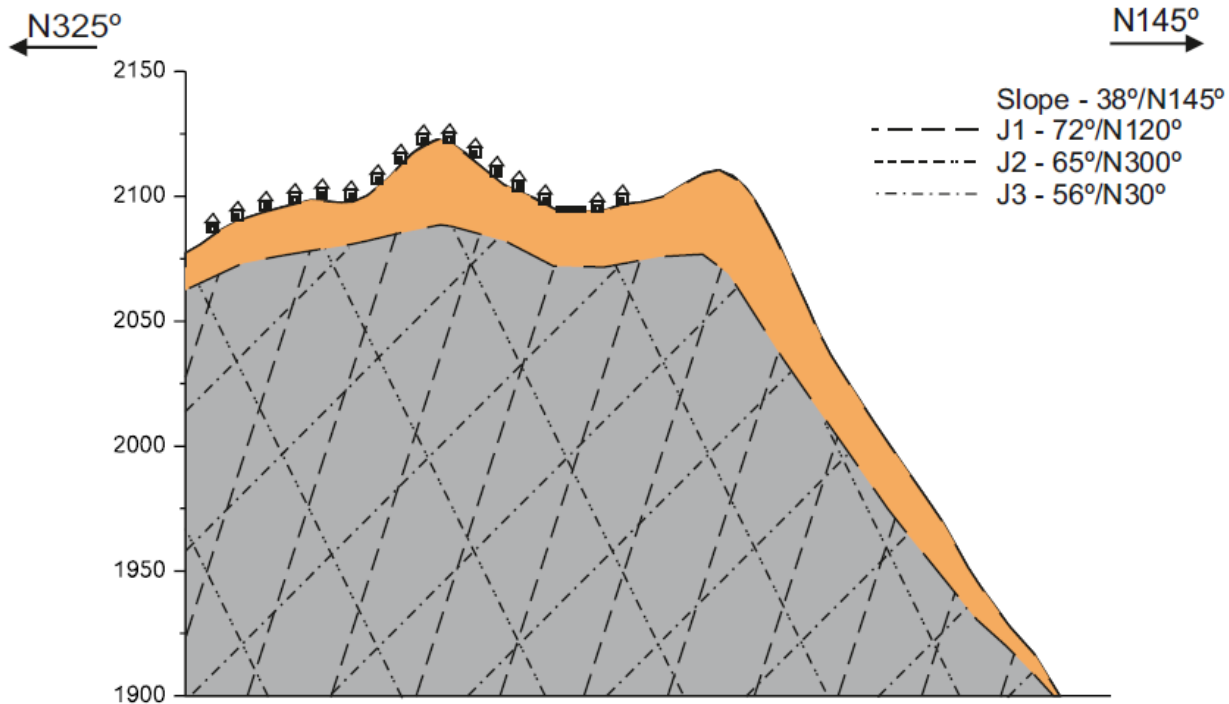
debris materials are being used for terraced cultivation. The thickness of the debris varies from a minimum of 5m to more than 20m (Fig 2.4). The thick debris is seen particularly in the lower reaches. The slopes in the area varies from gentle to steep ($<20^{\circ}$ to 45°). The slopes in the upper reaches are gentle to moderate supporting terraced cultivation and high urbanization can be seen in this reach. The lower reaches of Kurinji Nagar are particularly steeper with slope angles of 45° or more. The geological discontinuities observed in the area are plotted in a stereonet (Fig 2.3).

The Palar River flowing at the toe has been mainly responsible for the instabilities of the slope in the lower reaches. The river flows eastwards and further down, the Silver Cascade Falls can be seen close to the border of the Gandhipuram Block. Charnockite rock exposures are seen on the steep valley slope just adjoining the Palar River. Since the area has good vegetation cover including trees, shrubs and grass, the surface retains moisture to produce damp condition in most parts of the area and only a small part of the area is found to be in dry condition. The fairly thick overburden cover with steep slopes in the Kurinji Nagar area is prone to circular failure. The following are the readings of the structural discontinuities observed in the area:

Fig 2.4 Cross Section along the Kurinji block

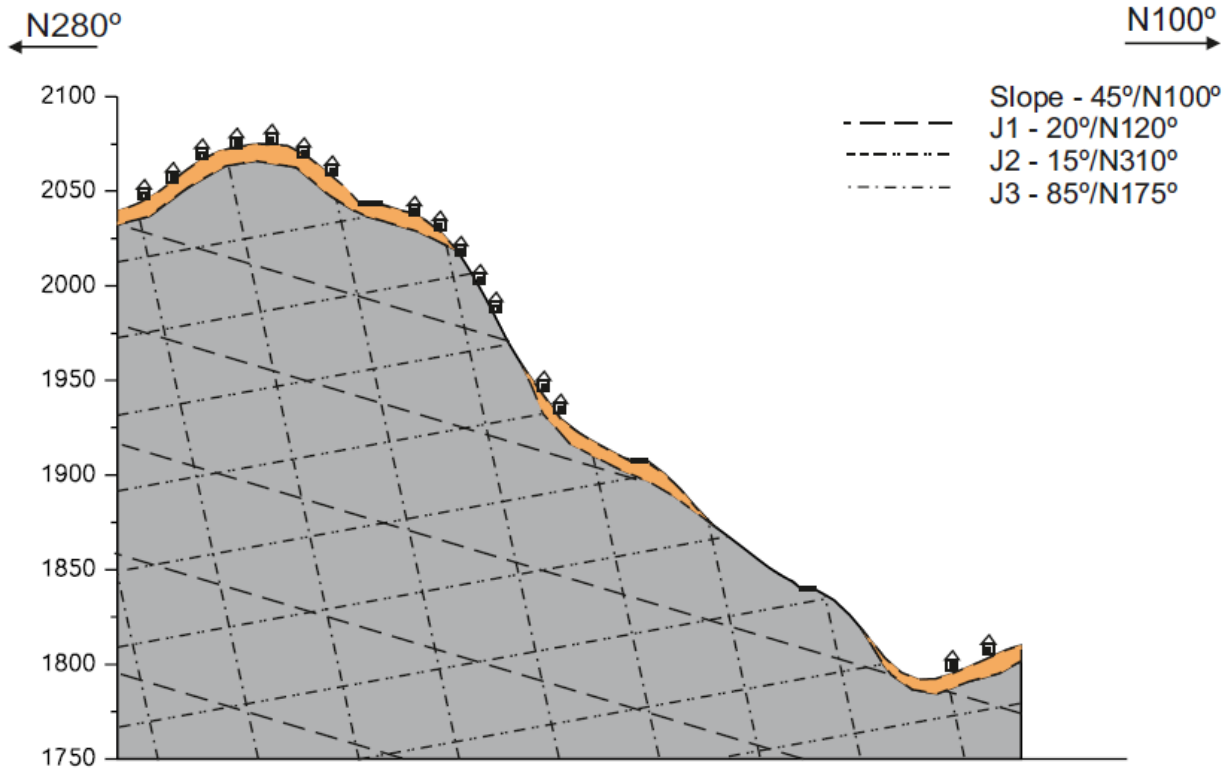
The domestic waste water is drained out directly at many places on the slope rather than through a proper drainage network. This causes wet patches at many places on the slope. Cracks in civil structures are commonly seen at many buildings indicating signs of instability in the area (Fig 2.9). The Palar River borders the upper reaches, taking a 90° turn from the eastern side and towards a roughly north-east direction. The State Highway road, SH156 connects Kodaikanal to Dindigul and Vattalagundu, cuts across this block thrice. Steep cut slopes are made for the construction of this highway making it all the more vulnerable to landslides. The midslope is steeper in comparison to the ridge top and lower portion where the slope is gentler. In spite of the steepness of the slope, it is packed with civil structures.

Fig 2.8 Cross Section along the Gandhipuram block

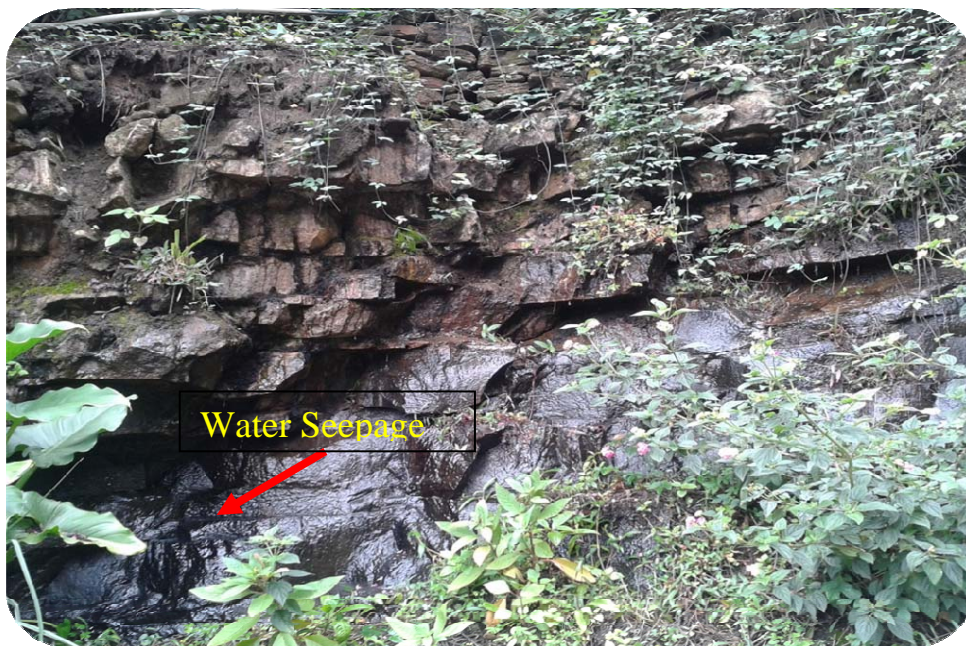
observed (Fig 2.12). It is noted that the slopes in this area are generally gentle to moderate. There is a mixed pattern of land used that is observed. A major portion is covered by agricultural lands with urbanization intermittently. Occurrences of landslides have been reported in the past in this area (Fig 2.15). Along with it, moderate and dense vegetation is also seen towards the west. In the lower reaches, it is bordered by the Levinge stream which flows towards the southeast direction and joins the Kodaikanal Reservoir. The Fairy Falls is also situated in this block. In some of the rock outcrops water seepage is observed to such extent that it is dripping or wet constantly.

Fig 2.14 Highly dissected rock exposure seen along the Observatory Road showing water seepage along the joints

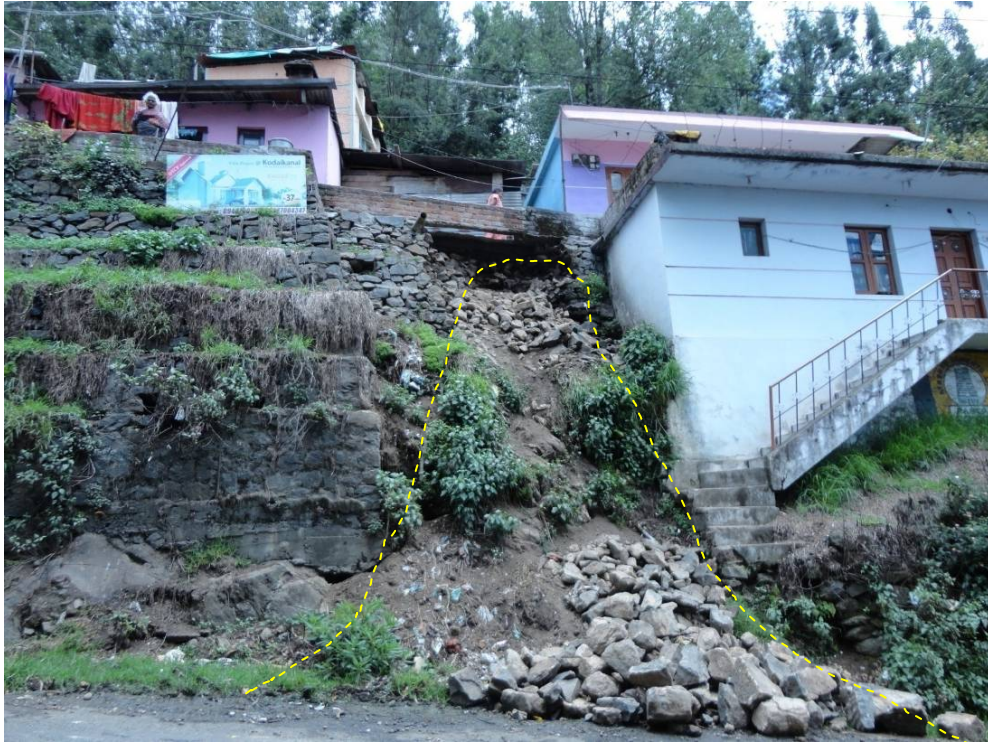
Fig 2.15 A slide along the Observatory road, below the houses

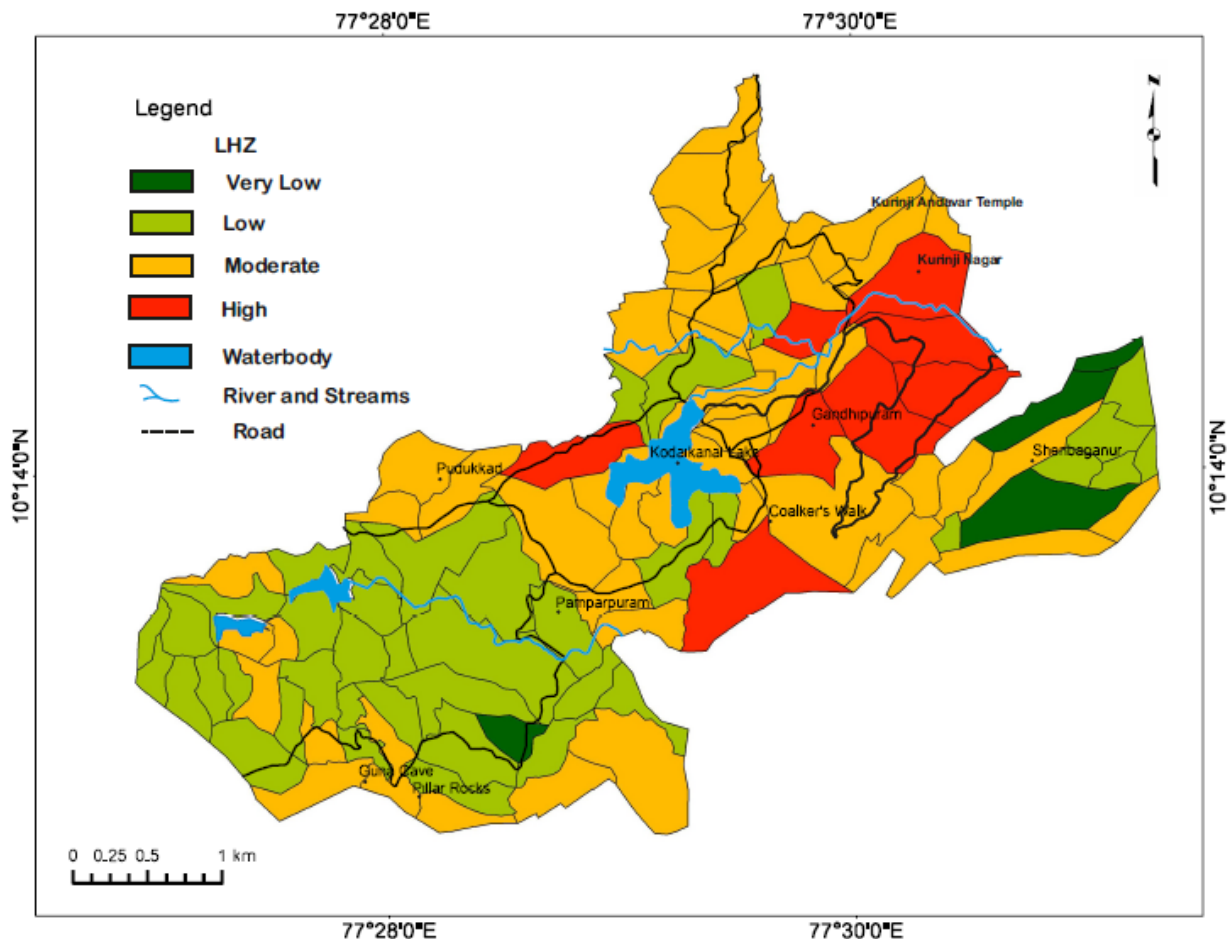
Fig 4.9. Landslide hazard zonation map of Kodaikanal area

A Landslide Hazard Zonation (LHZ) map (Fig 4.9) divides the land surface into zones of varying degrees of stability, based on the estimated significance of causative factors in inducing instability. The map shows that about 50% of the areas fall under very low and low hazard zones, which are dominantly seen in areas of Vattaparai, Fairy fall area and Shenbaganur area. It is noted that the slopes falling under the low hazard and very low hazard zones have dominant land use patterns such as dense vegetation and cultivated land. The Pamparpuram, Kurinji Nagar, Fern hill and Vilpatti areas fall under the moderate hazard zone

category. The Ananthagiri and Coalker's walk areas, which fall under high hazard zone are the highly urbanized parts of the Kodaikanal Township. From the Landslide Hazard Zonation (LHZ) map, out of the total 96 facets, 8 slopes were found to be in HH zone.

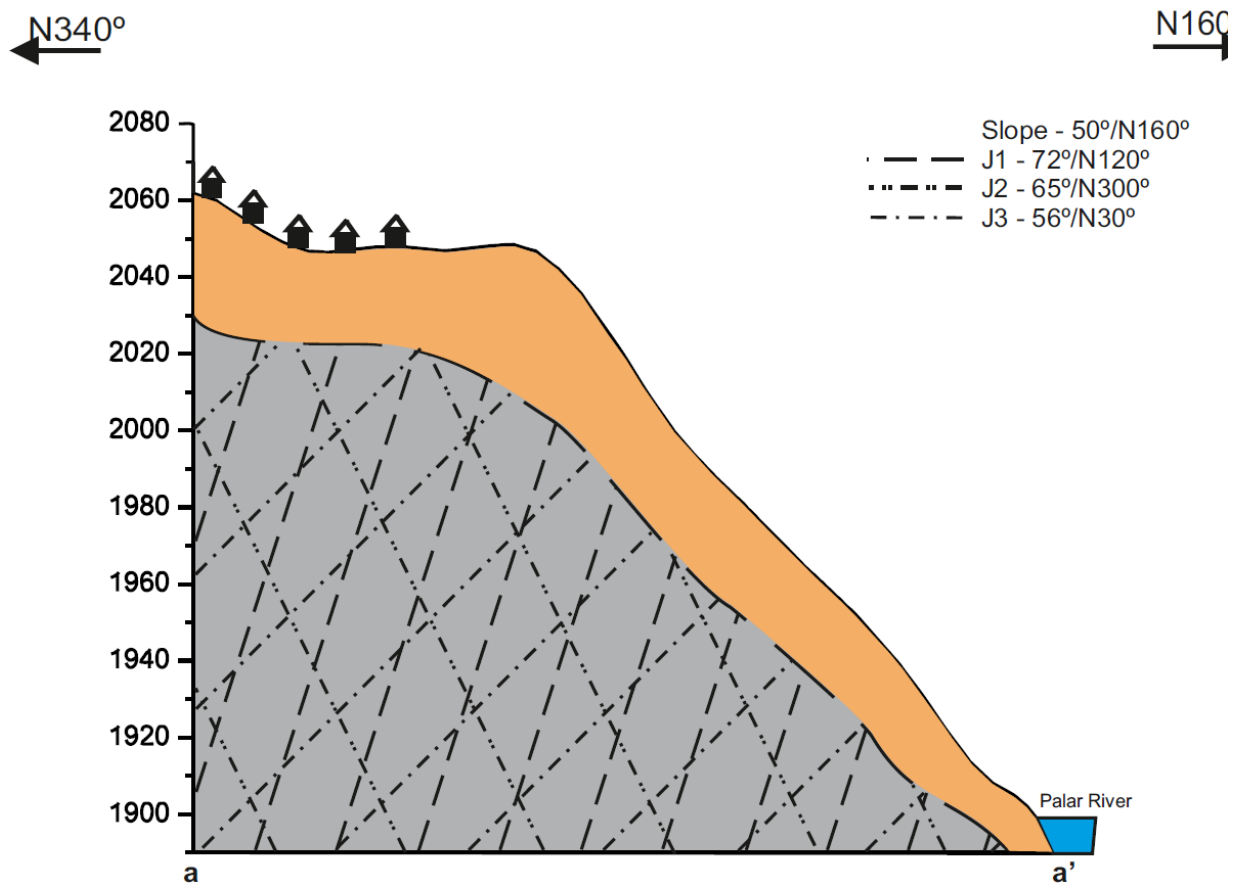
Fig 5.3 Geological cross section (a-a') along the Kurinji slope

A single profile (a-a') was taken in the Kurinji Nagar slope facet. The middle and lower parts of the slope have slope angles varying from 40° - 45° towards $N160^\circ$, while the upper slope is very gentle. The section covers the entire width of the facet from the ridge to the stream at the toe. The slope gradient is steep (45°) close to the stream. The agricultural terraces are located in the lower and middle reaches above the stream course. In this segment, on the basis of site observations, it is inferred that the thickness of debris cover may be approximately 15m or even more in the upper reaches and the thickness gradually gets reduced downwards. The thickness is of the order of about 5m just above the stream. Taking into consideration the thickness of debris and slope inclination, it is inferred that rotational failure may be the dominant mode of failure.

Rotational type of failure is the probable failure mode to occur in this slope. Since the slope has sufficiently thick debris cover of more than 15m and extending up to 25m in addition to having a fairly steep slope, the probability of a circular failure is very high. In view of this, the circular failure analysis was carried out using Circular chart method and later a more accurate analysis using Slide 2D software was done for the potentially unstable Kurinji Nagar slope facet.

The Kurinji Nagar slope is stable under dry condition. During saturated condition, the FOS gets reduced. The analysis clearly indicates that subsurface seepage is the major reason for the slope instability. Since domestic water is major contributor. A well planned network of pipes to collect all the domestic waste water will help in a big way to reduce water charging of the slope. Moreover, open RCC surface drains at different levels will help to collect storm water efficiently. These measures will help the slope against the forces of destabilization.

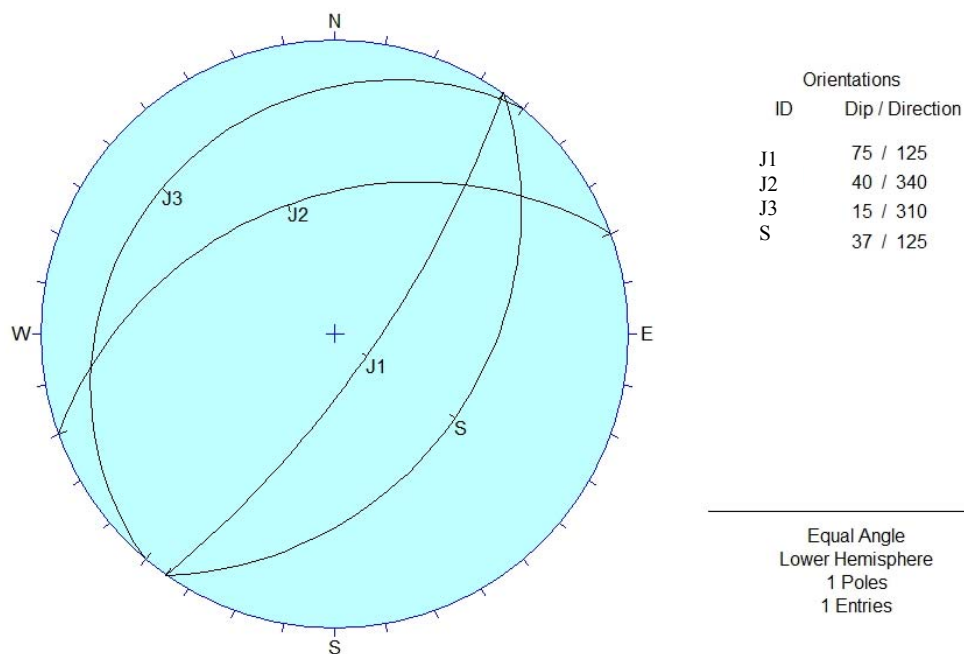
Fig 5.5 Stereoplot of geological discontinuities observed in the Srinivasapuram Slope of Gandhipuram Block

Most parts of the slope are covered by debris, which are seen in thin layers over the in-situ rocks. However, the in-situ rocks are seen in the middle part of the slope and hence, stability analysis of the rocks has been taken up for possible rock failure analysis. For that purpose, the geological discontinuities observed on the slope were plotted in a stereonet and the representative joint directions were obtained in addition to the slope direction (Fig 5.5).

A perusal of the attitude of the joint planes indicates that the joint J1 only dips in the same direction as that of the slope but at a steep angle and hence, it does not satisfy the Markland test condition ($\psi_f > \psi_p > \phi$) for plane failure. Similar conditions were obtained for wedge failure also. Hence, both plane mode of failure and wedge mode of failure are eliminated as the possible modes of failure.

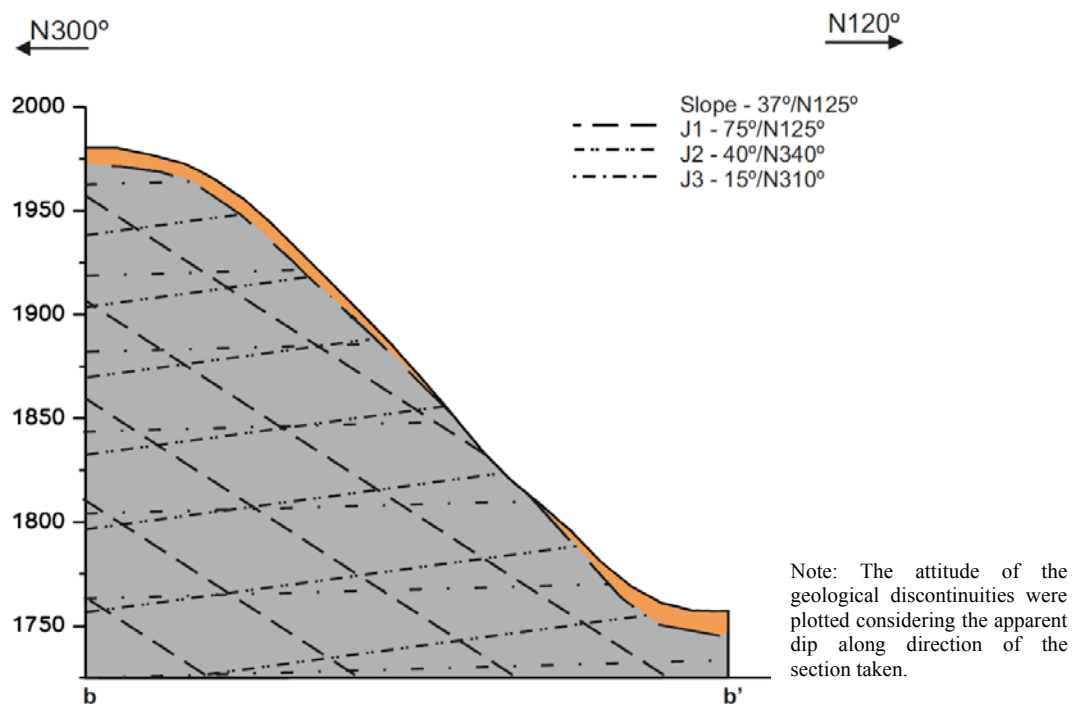
Fig 5.6 Geological cross section along (b-b') the Srinivasapuram Slope

The Srinivasapuram slope falling in facet no. 16 of Gandhipuram block is located close to its eastern margin. The slope is inclined towards N125°, with a fairly steep slope angle of 37° (Fig. 5.6). Charnockite rock that is observed to be exposed with thin overburden of less than 1m in the mid slope is fairly fresh to moderately weathered in nature.

The thickness of the debris observed in the upper slope on slope surface ranges from 2m to 4m, but generally more than 3m. Hence, the slope has been analyzed for a potential talus failure. The slope inclination varies from 30° to 35. Taking into consideration the geology and overall site condition, a cohesion (c) value of 5.2kPa and friction angle (Φ) = 35° were judiciously selected from the direct shear test (Table 5.7). These values were applied for stability analysis for a potential talus failure.

From the stability analysis, it is observed that the FOS of the talus slopes of the Srinivasapuram slope is 1.14, indicating that the debris slope is marginally stable under dry condition. The FOS of the slope becomes close to 1.0 under normal saturation during rains. However, during heavy rains when the saturation increases drastically the slope may become unstable. This observation corroborates with the site condition in the form of cracks seen in the buildings which were created during heavy rains.

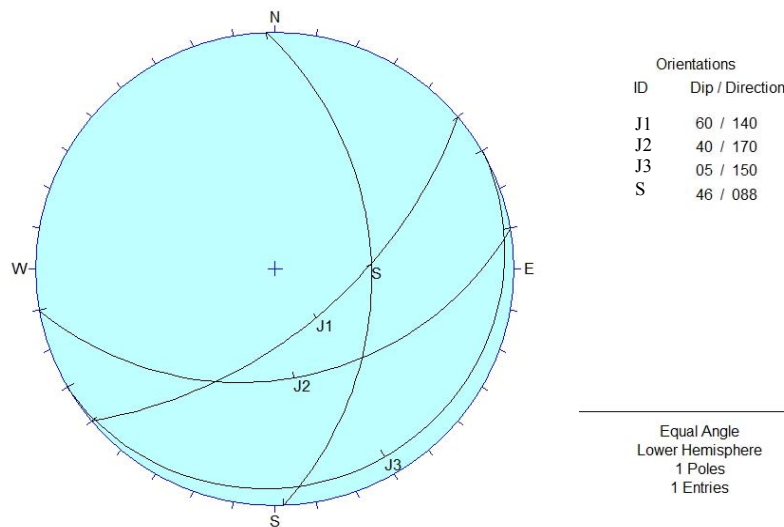
Fig 5.7 Stereoplot of geological discontinuities observed in the Annanagar Slope of Gandhipuram Block

The slope is mostly covered by debris in the upper and lower reaches except for the middle region where in-situ rocks are exposed. The rock slope has been taken up for possible rock failure analysis. For that purpose, the geological discontinuities observed on the slope were plotted in a stereonet along with the attitudes of the slope (Fig 5.7). From the kinematic

analysis of the attitude of the joint planes, it is observed that none of the joints J1, J2 or J3, satisfy the condition of parallelism between the slope and the discontinuity and hence, it does not satisfy the Markland test condition ($\psi_f > \psi_p > \phi$) for plane failure. Similar conditions were obtained for wedge failure also. Hence, both plane mode of failure and wedge mode of failure are eliminated as the possible modes of failure.

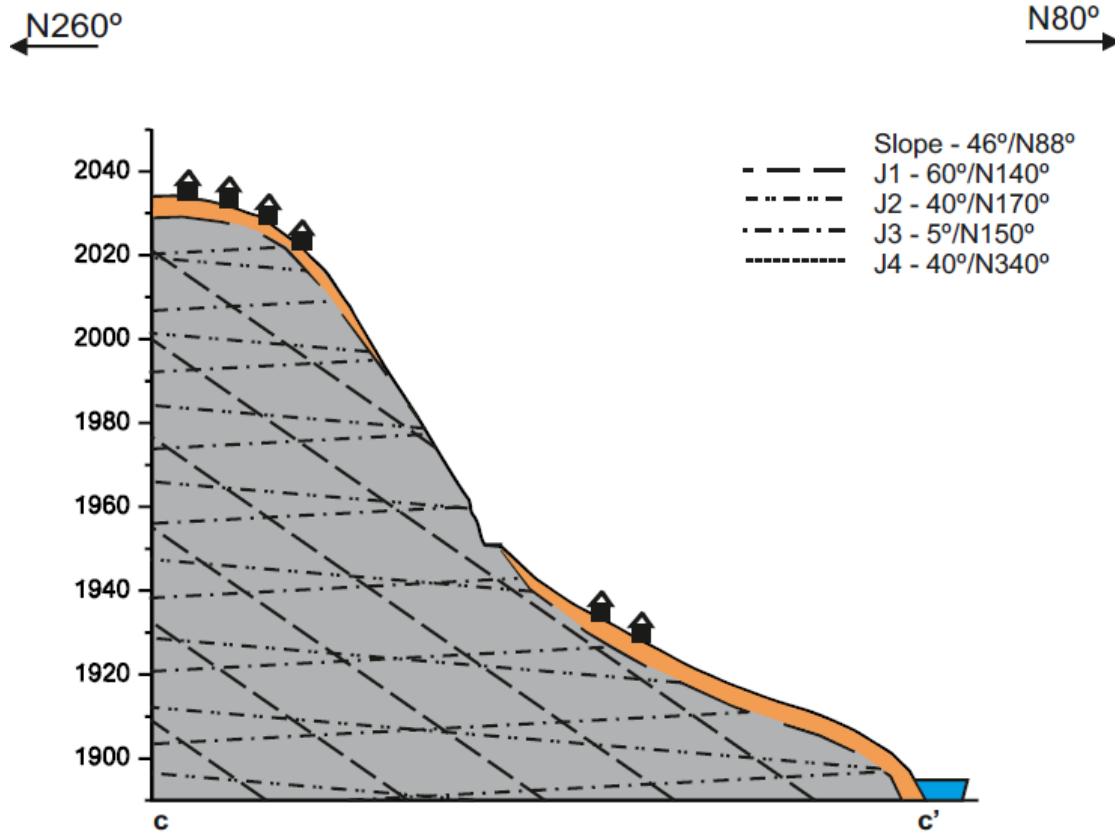
Fig 5.8 Geological cross section along (c-c') the Annanagar Slope

The thickness of the debris seen on the upper slope above the slope surface ranges from 1m to 4m, but generally more than 3m. As the slope inclination of the upper slope ranges between 30° to 35°, the upper slope has been analyzed for a potential talus failure. Taking into consideration the geology and overall site condition where, the debris are associated with big angular boulders, a cohesion (c) value of 4 kPa and friction angle (Φ) = 34° were judiciously

selected on the basis of direct shear test (Table 5.8). These values were applied for stability analysis for a potential talus failure.

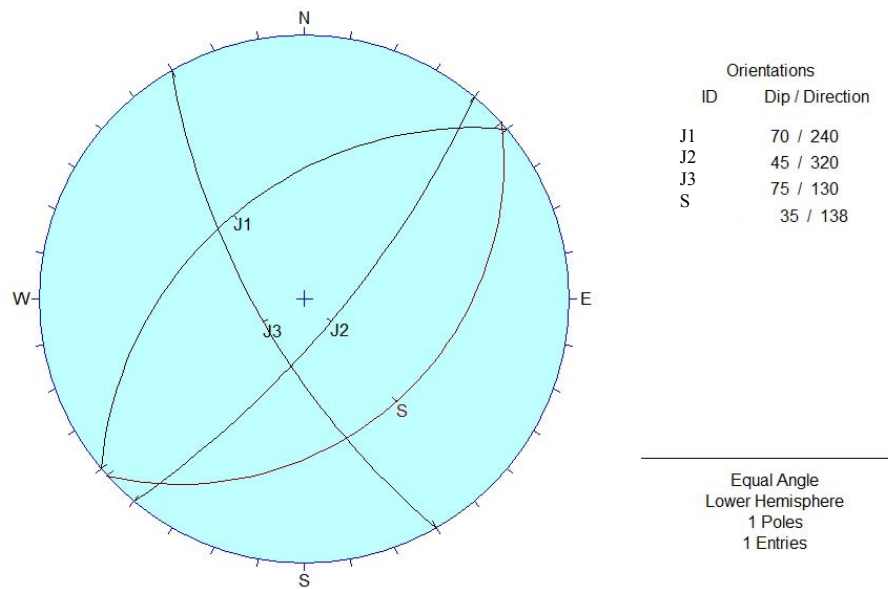
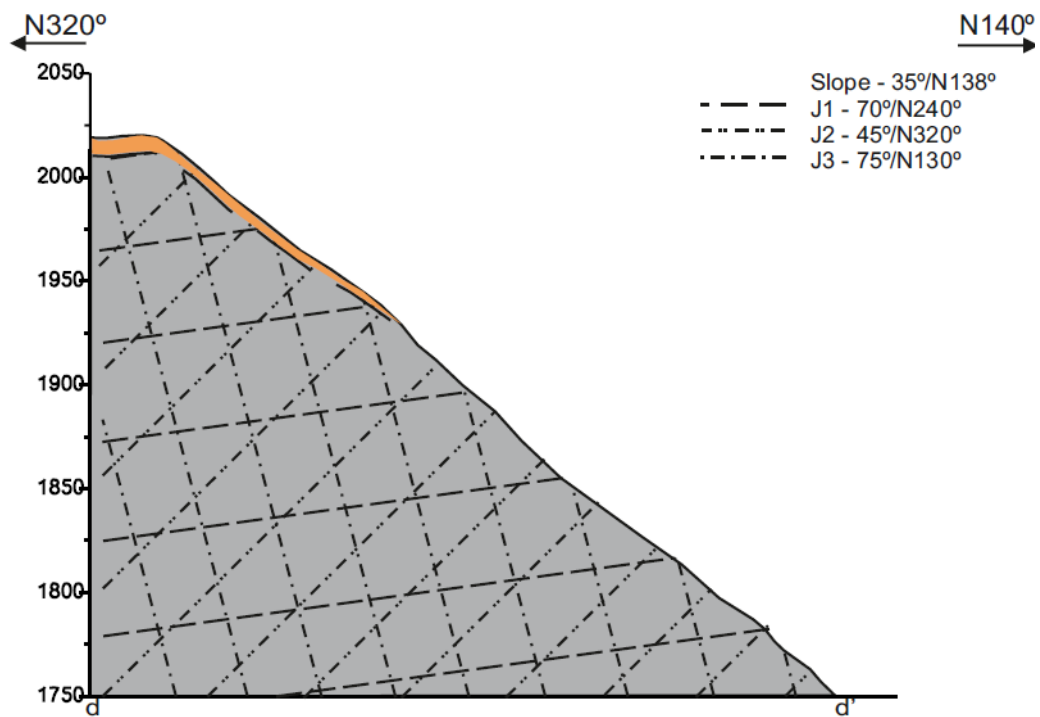
The Ananthagiri slope (Facet no. 32) is located west of Srinivasapuram and Annanagar slopes. The slope has an average angle of 35° trending towards N138° with a small stream flowing in the middle of the slope along the southeastern direction. The slope is constituted of thin overburden cover in the top reaches over fairly fresh to moderately weathered charnockite rock. The thickness of the soil varies from 3 to 4m. The state highway cuts across the entire slope a total of 3 times at different levels. Apart from the state highway, various parallel running streets with residential and trade buildings in either side are also observed. The top reaches of this slope is crammed with urbanization. The Ananthagiri slope is one of the heavily urbanized slopes of the Gandhipuram block (Fig 5.11 and Fig 5.13). A break in slope is observed along the road located close to Kodai FM station. Above the road, the slope is moderate with angle of 30° but below the road the slope becomes steep up to an angle of 45°. The buildings are located on the slope particularly below the church shows minor settlement cracks. No major ground cracks are observed in this area. It was also observed that like the rest

For sections 1 and 2, two profile were taken along the Ananthagiri slope (Fig 5.10 and Fig 5.15). The rock slopes present along sections 1 and 2 were taken up for the stability analysis. For that purpose, the geological discontinuities observed on the slope were plotted in a stereonet along with the slope direction (Fig 5.9 and Fig 5.12). A perusal of the attitudes of the joint planes indicates that the joint J3 dips in the same direction as that of the slope but at a steep angle and hence, it does not satisfy the Markland test condition ($\psi_f > \psi_p > \phi$) for plane failure. Similar conditions were obtained for wedge failure also. Hence, both plane mode of failure and wedge mode of failure are eliminated as the possible modes of failure.

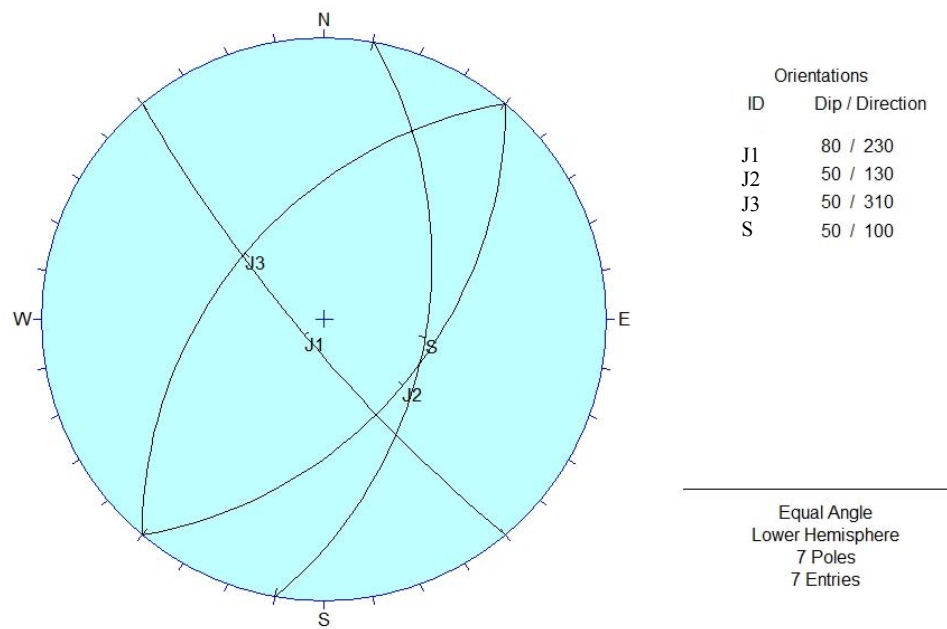
Fig 5.18 Stereoplot of geological discontinuities observed in the Gandhipuram Slope

to highly weathered in nature (Fig 5.17). The joints observed have been plotted in a stereonet (Fig 5.18). The entire slope is packed with civil structures like residential buildings, shops and even a school (Fig 5.16). These buildings are very closely spaced. The houses are mostly of masonry type and without suitable column and beam supports. The residential buildings sometimes are even of two storeys level. The school is located at the ridge top of this slope and is a three storeys building. The state highway, SH156, borders the upper boundary of the Gandhipuram slope. Even though the areas between the buildings are very small, it is observed that even in these congested spaces agriculture is practiced. Vegetation/grass/banana tree/other bushes support the entire cut slope wherever possible.

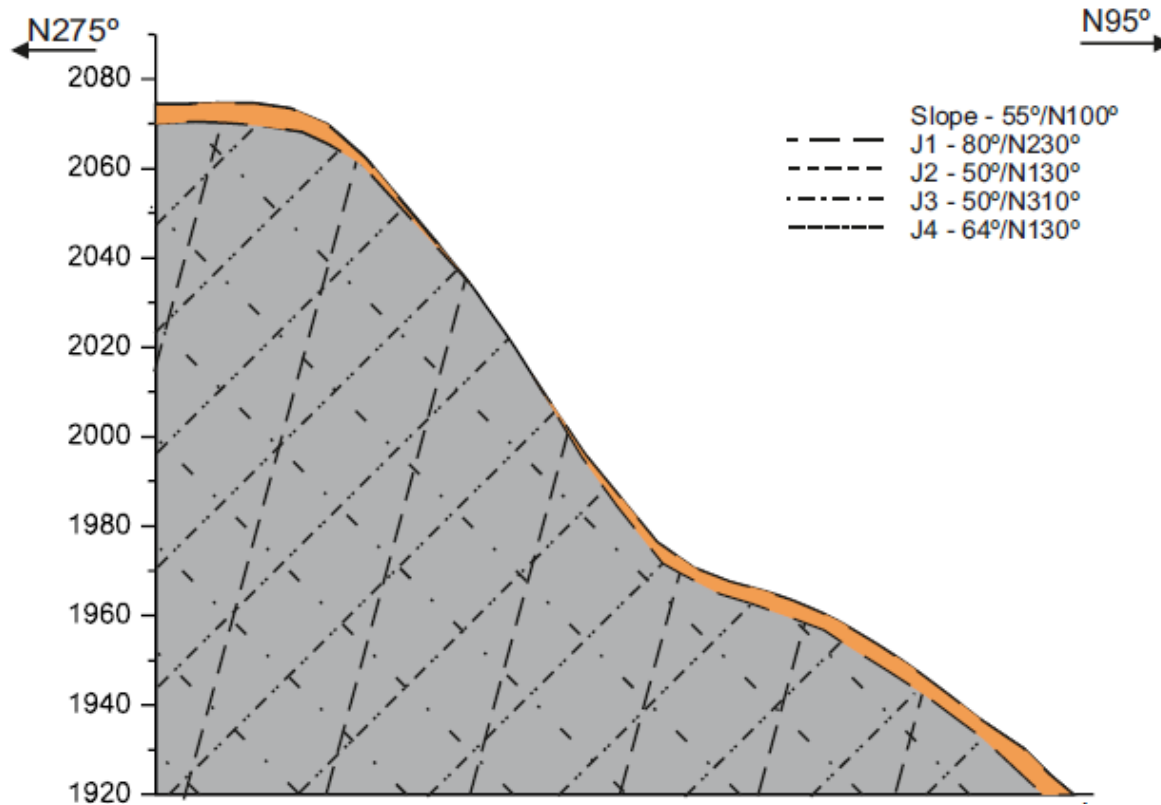
Fig 5.19 Geological cross section along (f-f') the Gandhipuram Slope

The Gandhipuram Slope (Facet No. 34) is located to the west of the Kodaikanal Lake. The slope is nearly concave with average slope angle being greater than 40° towards N100°. The upper slope is very steep, with a slope angle of 50° and exposes charnockite rock with varying thickness of overburden cover (Fig 5.19). The thickness of the debris in the upper slope is of the order of about 10m with very gentle to nearly flat slopes. Similar thickness of debris is seen at lower levels having gentle slopes. The charnockite rocks are well exposed in most parts of the inclined slope. The charnockite rocks below the overburden soil are moderate

The values of cohesion, c , and friction angle, ϕ , satisfies the Markland test condition ($\psi_f > \psi_p > \phi$) for plane failure. The stability analysis was carried out using the SASP program by Bhawani Singh and the value of factor of safety was obtained as 2.42. This F value (Table 5.10) did not corroborate with the visible ground observations, regarding slope instability.

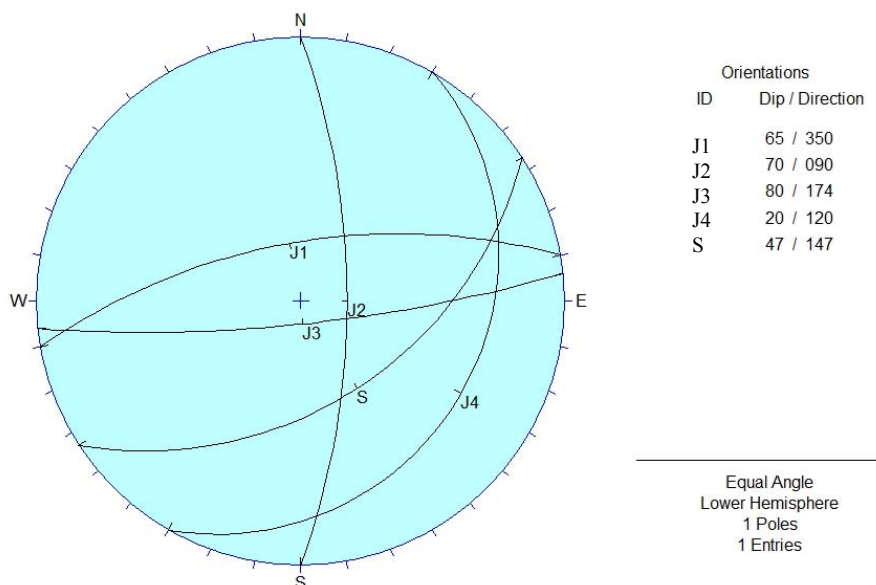
Fig 5.20 Stereoplot of geological discontinuities observed in the Coalker's Walk Slope

The entire slope mostly consists of rock outcrop except at the toe region and a small portion in the upper portion where slope break is observed. The geological discontinuities were plotted in a stereonet along with the slope direction. From the kinematic analysis, it is observed that the joint, J4, satisfies the parallelism condition with the slope. The values of cohesion, c , and friction angle, ϕ , satisfies the Markland test condition ($\psi_f > \psi_p > \phi$) for plane failure. The stability analysis was carried out using the SASP program by Singh and Goel, 130, and the value of factor of safety (Table 5.11) was obtained as 1.59 suggesting that the slope is considerably stable.

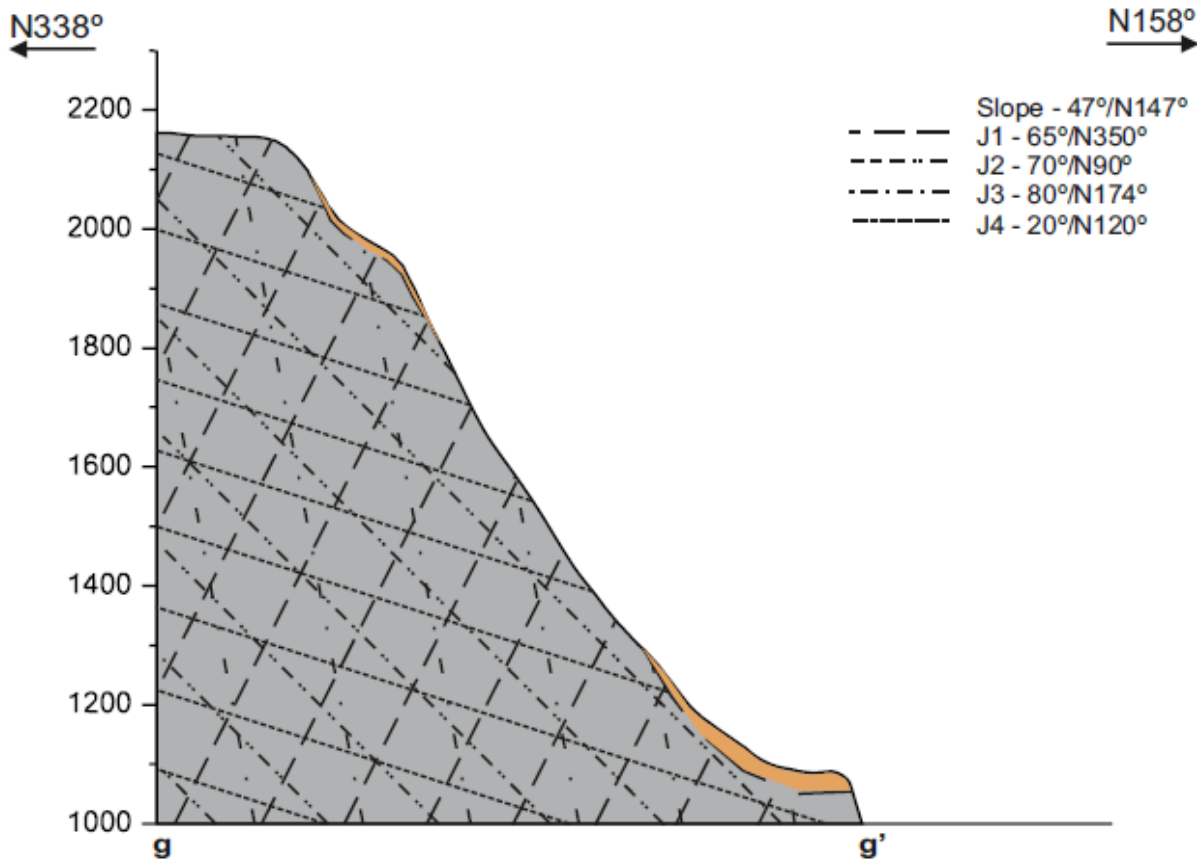
Fig 5.21 Geological cross section along (g-g') the Coalkers Walk Slope

The Coalkers Walk, Facet no. 34, slope is located directly to the south of the Kodaikanal Lake. The slope is nearly concave with an average slope angle greater than 45° towards $N147^\circ$ (Fig 5.21). The Coalkers Walk slope is a rock cliff slope that makes a part of the southern boundary of the study area. The slope is constituted of charnockite rocks with thin overburden on the top. Fairly thick deposit of debris material is seen at the toe area. The Coalkers Walk is one of the major tourist attraction spot in Kodaikanal. The 1 km paved pedestrian path was constructed by Lt. Coalker in 1872, is running along the edge of steep rock slope. It provides a stunning panoramic view of the plains on the south. The slope has a total height of 1200m with continuous steep slope for a height 850m, on a clear day one can view as far as Dolphin's Nose in the south, the valley of the Pambar River in the southeast, Periyakulam town and even the city of Madurai. The steepness of the slope makes it impossible to access the lower reaches. A small cluster of urbanization is observed in the western part of the slope facet along with moderate vegetation. The slope also hosts one of the major hospitals in the township. The district road passes through the facet at the crest of the slope.

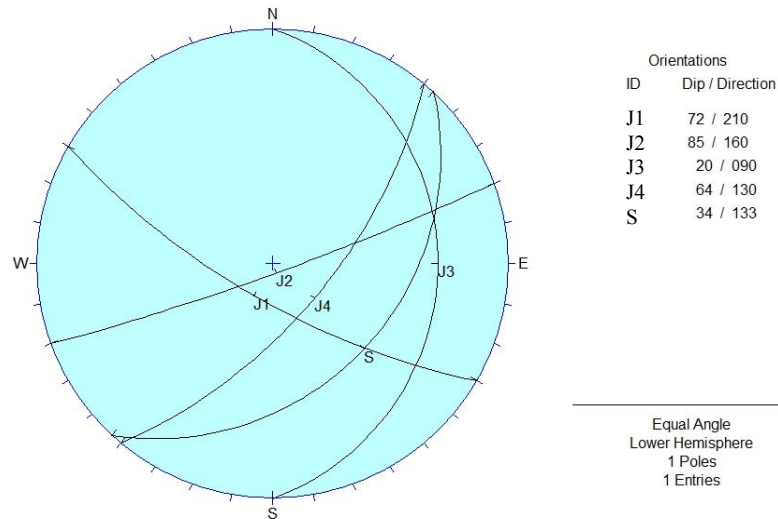
Fig 5.23 Stereonet of geological discontinuities observed in the M. M Street Slope

The inclination of rock slope is about 35° in higher levels and attains an angle of 55° at lower levels, which has been taken up for stability analysis. From the kinematic analysis of the stereoplot (Fig 5.23), it is observed that the joint, J4, dips along the same direction of that of the slope but dips at an angle steeper than the slope inclination. Hence, it does not satisfy the daylighting condition of the joints of the Markland's test condition for plane failure. Similar conditions were obtained for the wedge failure also. Consequently, both the plane failure and wedge failure are eliminated from the possible modes of failure.

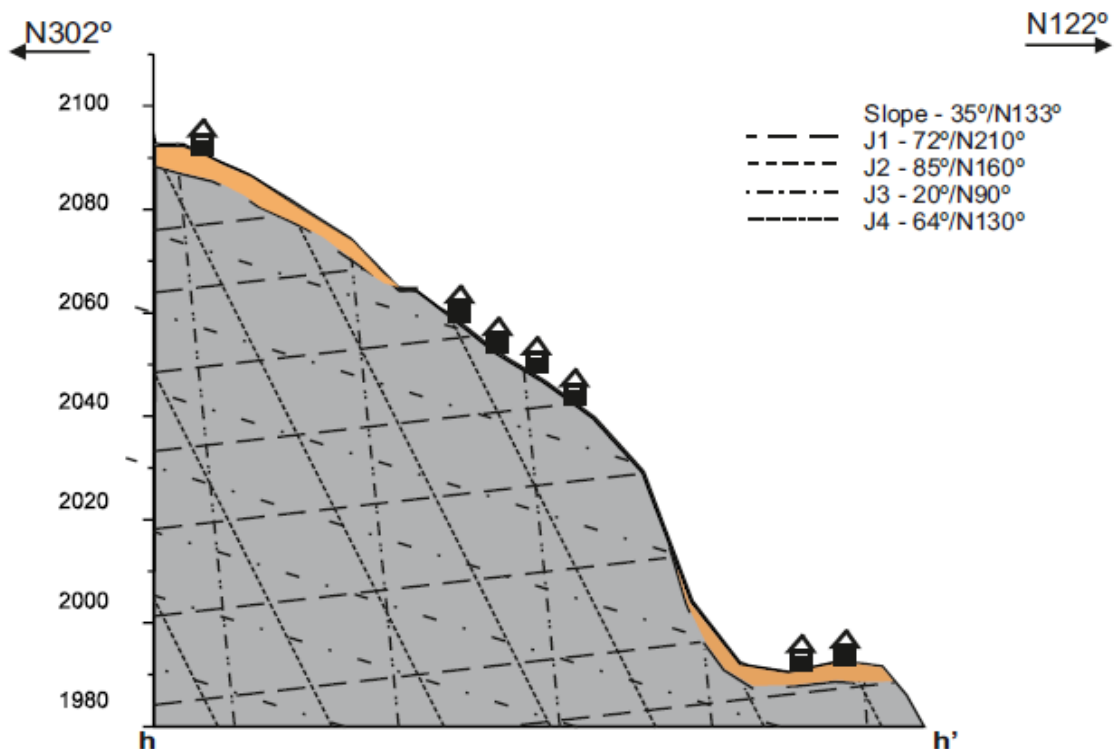
Fig 5.24 Geological cross section along (h-h') the M. M Street Slope

The M.M. Street slope is located at the western periphery of the Naidupuram Block. The slope has an average angle of 35° towards $N133^{\circ}$ (Fig 5.24). It is constituted of charnockite rock with thin debris cover. The debris materials of 3-4m thickness are seen

The overburden debris materials seen over the rocks in the upper reach of the slope have an average thickness of about 3m. The slope has an average inclination of around 35° . Cohesion, c , value of 3.5kPa and friction angle, ϕ , of 35° was selected judiciously taking into consideration the site conditions.

The stability analysis (Table 5.12) of the talus slope of the M. M. Street indicates that the slope section is marginally stable under both normal and saturated condition with a FOS of 1.13 and 1.04 respectively. However, during heavy precipitation, the slopes may show conditions of instability.

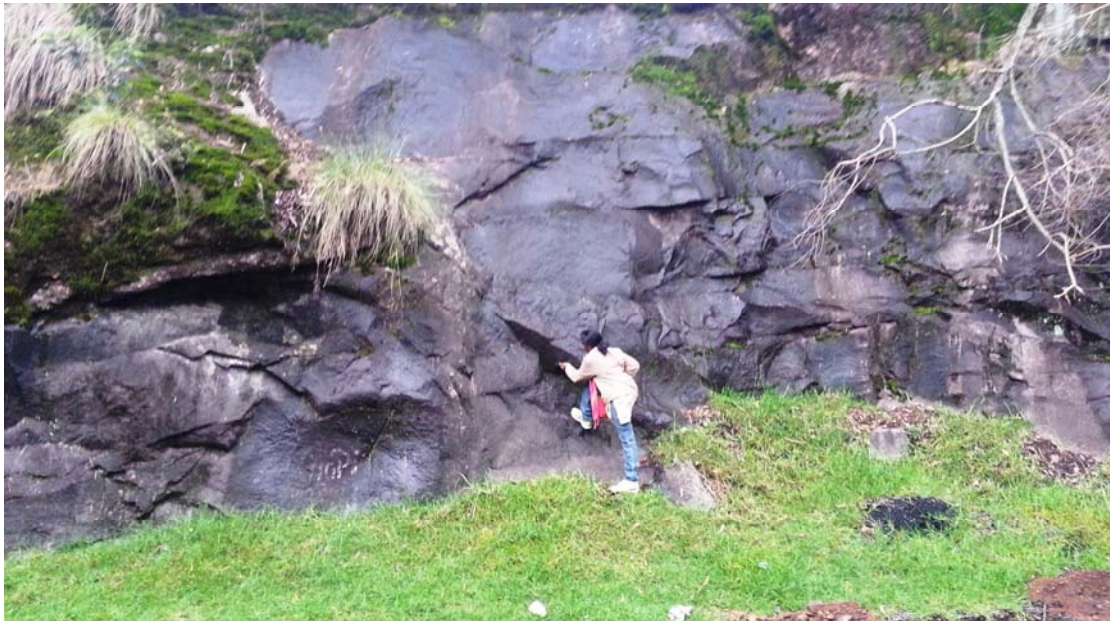
Fig 5.27 Massive charnockite rock exposure along the Observatory Road in Pudukkad Slope

The Pudukkad slope facet (Facet No. 96) is located north of the Kodaikanal Lake. It has a fairly steep slope of 35° towards $N108^\circ$ facing the Kodaikanal Lake (Fig 5.29). Charnockite rock exposure is observed in the top reaches of this facet (Fig 5.27). Overburden debris of the order of 2-3m is seen at the lower and middle reach. The rock is heavily jointed with a minimum of 5 sets of joints (Fig 5.28). The frequency of these joints varies from few centimeters to up to 1m (Fig 5.26).

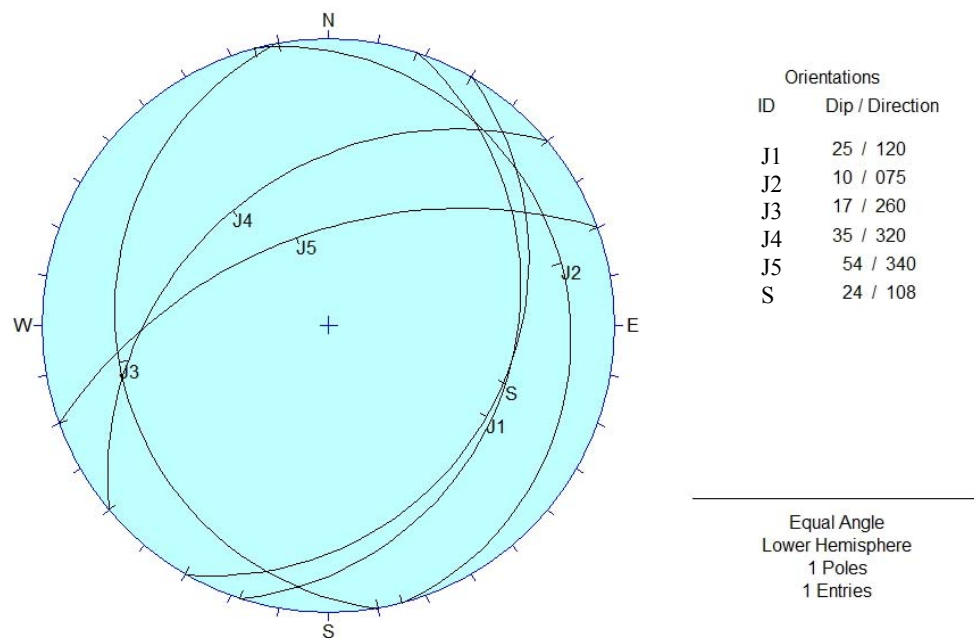
Fig 5.28 Stereoplot of geological discontinuities observed in the Pudukkad Slope

The inclination of rock slope of about 40° in the top reaches and have been taken up for stability analysis. From the kinematic analysis of the stereoplot (Fig 5.28), it is observed that the joint, J1 and J2, dips roughly along the same direction of that of the slope but does not satisfy the daylighting condition. Hence, it does not comply with the Markland's test condition

for plane failure. Similar conditions were obtained for the wedge failure also. Consequently, both the plane failure and wedge failure are eliminated from the possible modes of failure.

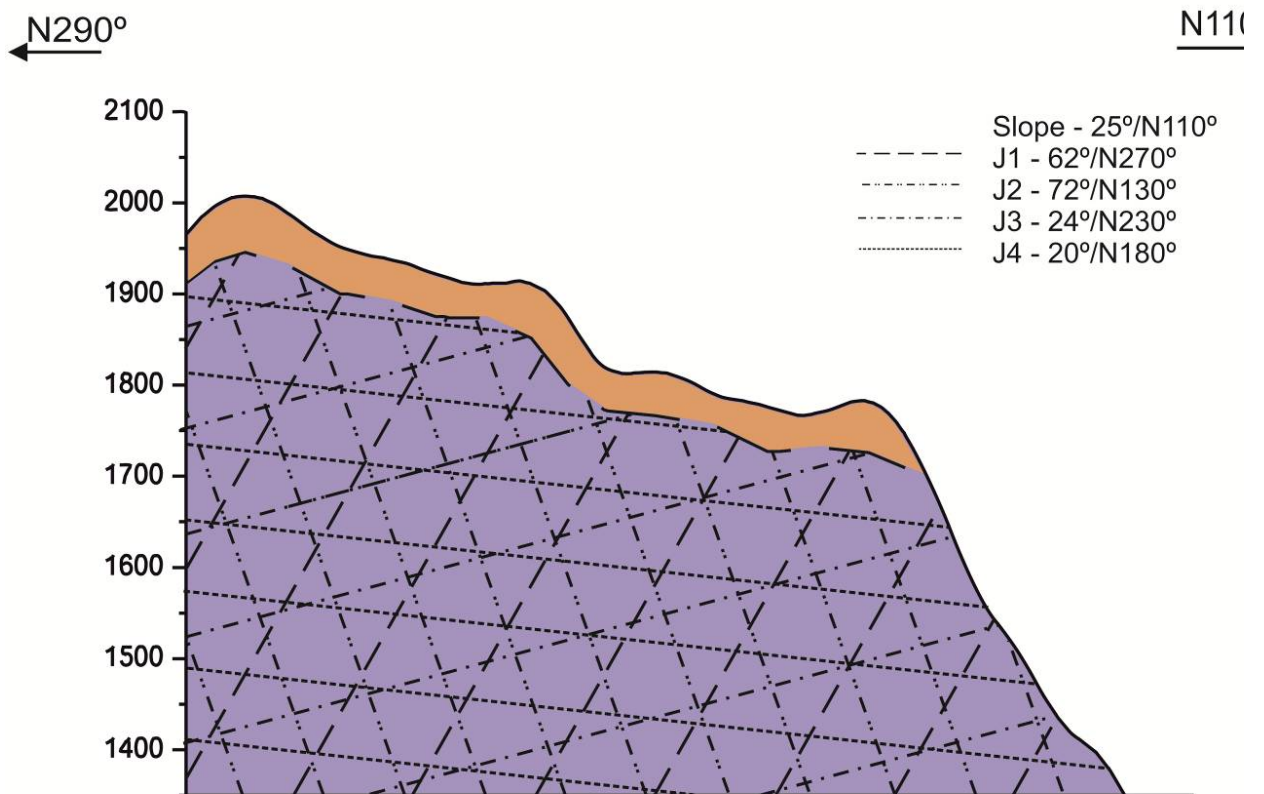
Fig 6.5 Geological cross section along the Vilpatti Slope

The Vilpatti area is located to the north of the Kurinji Block. Like the Shenbaganur area, the terrain has gentle to very gentle slope close to ridge top with slight undulations. The maximum of the thickness of the debris materials is of the order of 20m close to the ridge top. Charnockite rocks are exposed on the steep slope of the eastern boundary. The charnockite rock exposed in this area is fairly fresh to moderately weathered. The gentle ground to the west of rock cliff is mainly utilized for agricultural purpose with little spots of urbanization seen within intermittently. The urbanization is seen in small clusters within the slope. The dampness of the slope can be accounted to the incessant agricultural practices and also to some extent to the pleasant climatic condition that is present throughout the year. Plotting (Fig 6.4) of the observed joint discontinuities in a stereonet indicates the presence of four sets of well developed joints. The cross section has been prepared taking these discontinuities into consideration (Fig 6.5). The joints are tight with no fillings between them.
