**SLOPE STABILITY EVALUATION IN AND AROUND
KODAIKANAL TOWN, TAMILNADU**

Ph.D THESIS

**DEPARTMENT OF EARTH SCIENCES
INDIAN INSTITUTE OF TECHNOLOGY ROORKEE
ROORKEE- 247667, INDIA
MARCH, 2018**

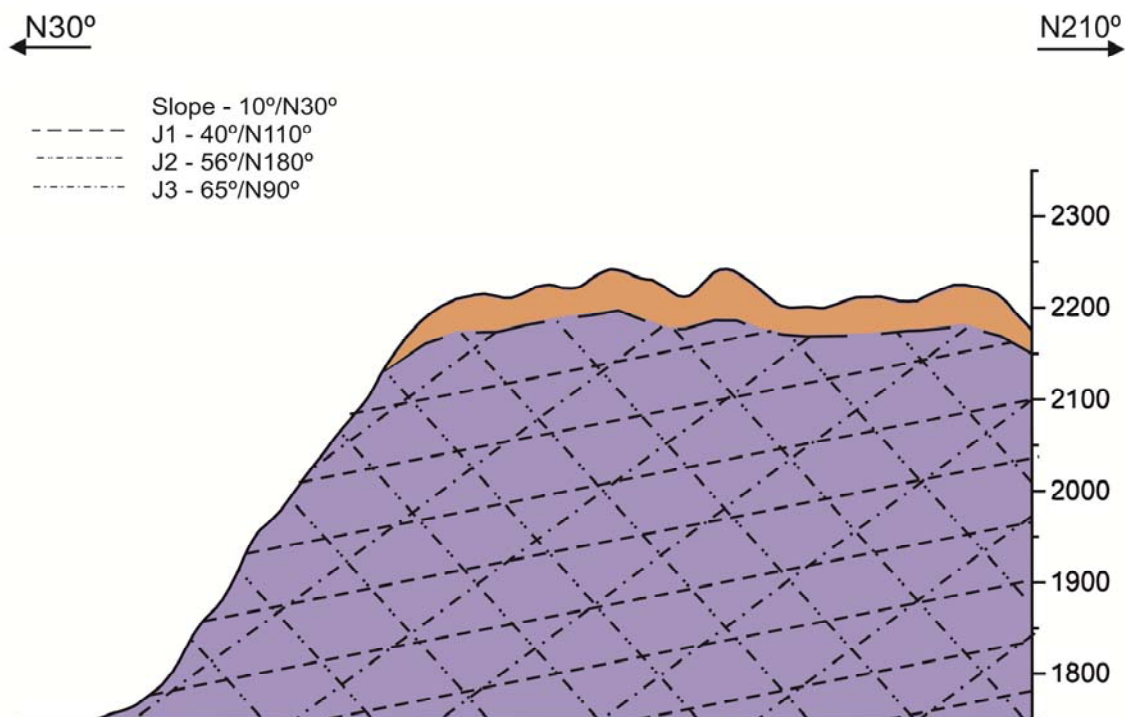
Fig 6.7 Geological cross section along the Perumpallam Slope

The Perumpallam area is located to the west of the Kodaikanal Lake. Similar to the Shenbaganur and Vilpatti area, it also has gentle to very gentle slope close to the ridge top with slight undulations of the terrain. The maximum of the thickness of the debris materials is of the order of 20m close to the ridge top. Fairly fresh charnockite rock exposures are observed on the steep slope of the western boundary. The joints are tight with no fillings between them. The gentle flats are mainly utilized for agricultural purpose. Urbanization is seen in small clusters within the slope. Though the northern portion of this area is explored to some extent, the southern half of this area, is barely touched by any sort of human interaction. Vegetation covers the southern half portion. Plotting (Fig 6.6) of the observed joint discontinuities in a stereonet indicates the presence of three sets of well developed joints. The cross section has been prepared taking these discontinuities into consideration (Fig 6.7).
