ANALYSIS OF FAILURE AND RENOVATION OF PANSHET DAM

A Dissertation
submitted in partial fulfilment
of the requirements for the degree
of
MASTER OF ENGINEERING
in
WATER RESOURCES DEVELOPMENT

by
N.P. DUSE

WATER RESOURCES DEVELOPMENT TRAINING CENTRE
UNIVERSITY OF ROORKEE
ROORKEE
September 1971

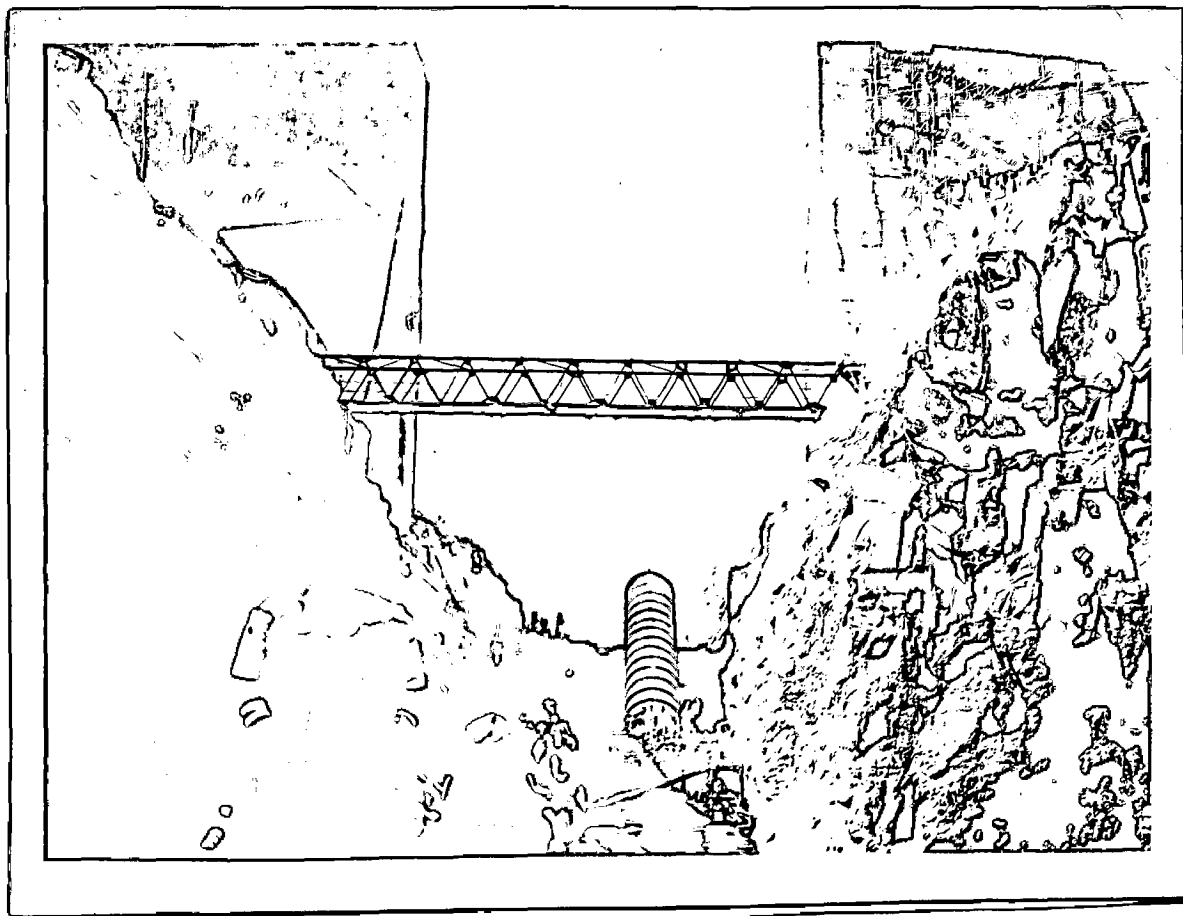
Photograph No.10 - Work of Installation of 10' dia penstock in

The work of installation of penstock was taken up and completed partly. Photographs No. 9 & 10 show the penstock work in progress. The penstock fabrication and erection work was entrusted to the Indian Hemp Pipe Company.

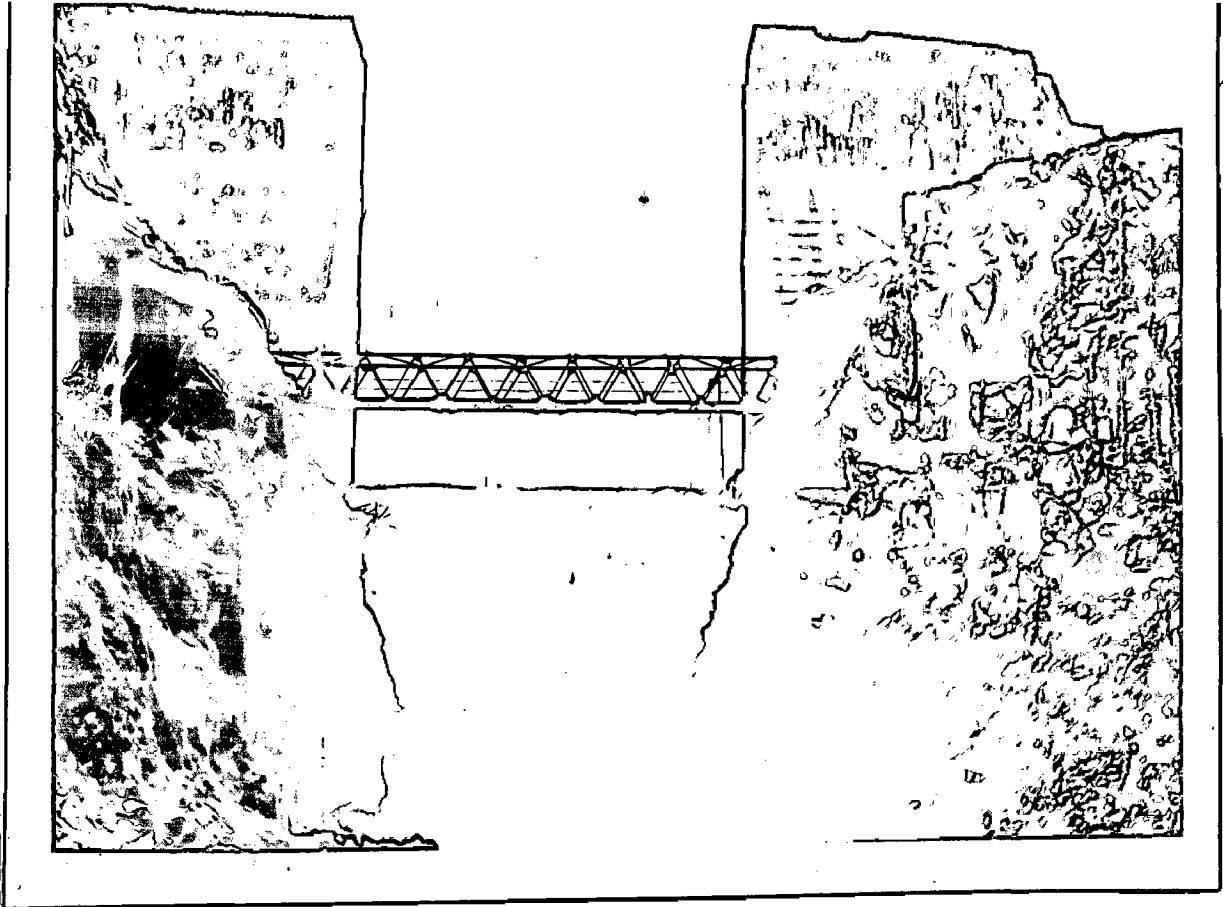
Photograph No.11 - Spilling Arrangements at the end of 1968-69 Season
as on 16-7-69
