**CRITICAL STUDY OF DESIGN OF CORE FOR  
EMBANKMENT DAMS WITH SPECIAL REFERENCE  
TO TEHRI DAM**

**A DISSERTATION**

submitted in partial fulfillment of the  
requirements for the award of the degree  
of  
**MASTER OF TECHNOLOGY**  
in  
**WATER RESOURCES DEVELOPMENT**

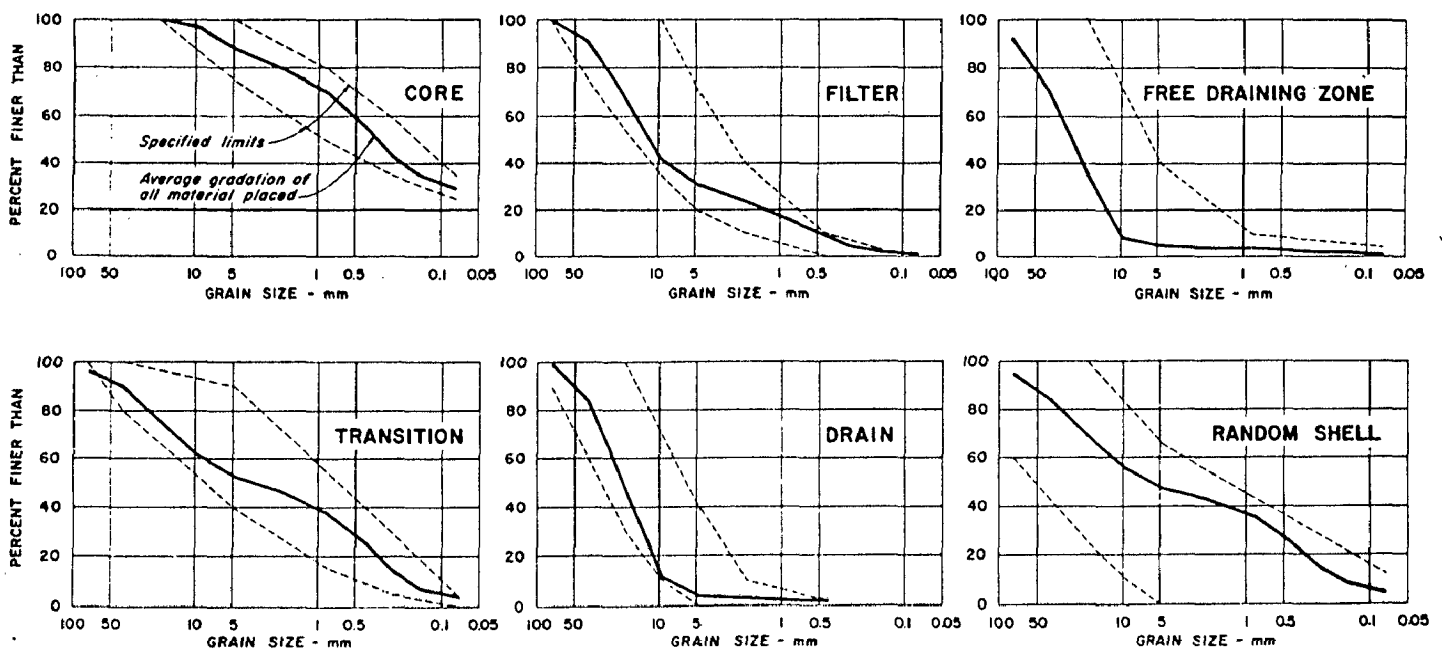
**Fig.3.54.** Gradation Curves of Core Material & other zones, of the W.A.C. Bennett Dam, Canada

The properties of the core material and its gradation curves together with other zones are shown in Table 3.5 and Fig.3.54 respectively.

This core material was placed in layers of maximum thickness of 25 cm and compacted with 4 coverages (8 passes) of a 90 ton pneumatic tire roller. Permeability of the core material is about  $1 \times 10^{-7}$  cm/sec., and cohesion between  $0 - 3.5$  kg/cm<sup>2</sup>.
