# **A STUDY OF FOUNDATION TREATMENT OF CONCRETE GRAVITY DAMS - A CASE STUDY OF LAKHWAR DAM USING FINITE ELEMENT METHOD**

**A DISSERTATION**

**MASTER OF TECHNOLOGY**

**WATER RESOURCES DEVELOPMENT**

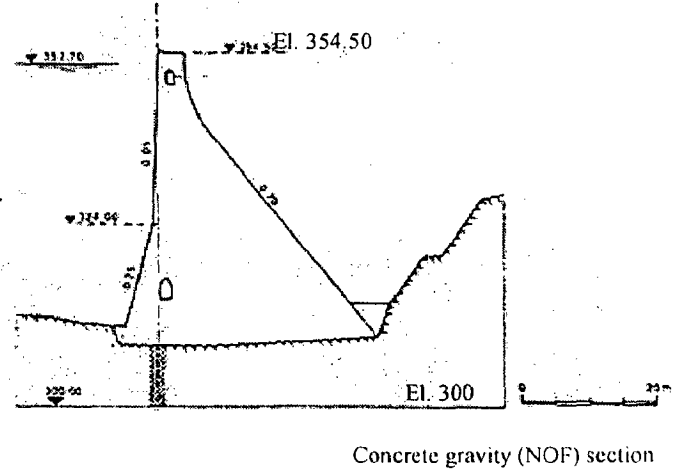
Fig. 3.3.2: Ravasanella Dam.  
Cross section of Concrete Block and  
Concrete Gravity Dams

Briefly, the structure of a concrete block dam comprises columns of concrete blocks. The columns are contact-poured so as to form the real buttress, which are made independent by lubricated joints (filled with gravel of a single grain size) and therefore, able to absorb any differential settlement of the foundation. A steel membrane on the upstream face ensures waterproofing of the dam.
