# **STUDIES ON THE ROLE OF HVOF COATINGS IN IMPROVING RESISTANCE TO HOT CORROSION AND EROSION**

## **A THESIS**

**DOCTOR OF PHILOSOPHY**

**METALLURGICAL AND MATERIALS ENGINEERING**

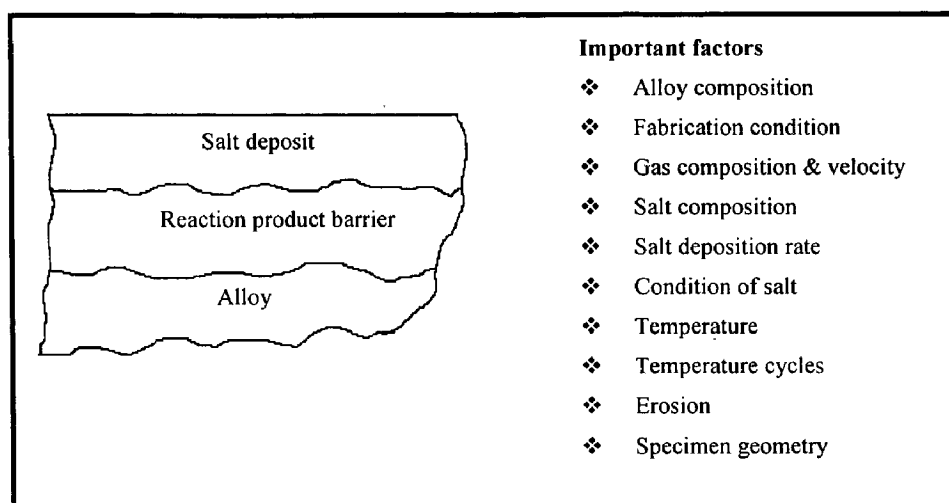
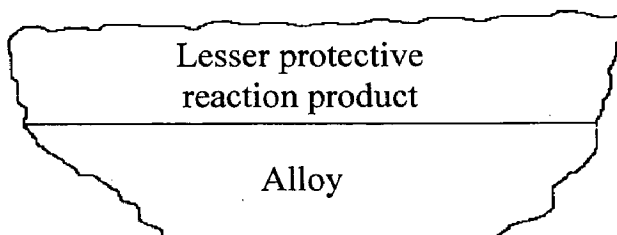
**Fig. 2.1** Schematic diagram to illustrate the conditions that develop during the initiation and the propagation of hot corrosion attack, and to identify the factors that determine the time at which the transition from the initiation to the propagation stage occurs (Pettit and Meier, 1985).

In some cases of hot corrosion an increasing amount of sulphide particles become evident in the alloy beneath the protective reaction product barrier. In other small holes become evident in the protective reaction product barrier where the molten deposit begins to penetrate it. Eventually the protective barrier formed via selective oxidation is rendered ineffective, and the hot corrosion process enters into the propagation stage. Obviously in attempting to develop resistance to hot corrosion one should strive to have the superalloys remain in the initiation stage as long as possible. Initiation stage is important to the life of the alloy. Numerous factors affect the time at which the hot corrosion process moves from the initiation stage into the propagation stage as shown in Fig. 2.1. These factors also play the dominant role in determining the type of reaction product that is formed in the propagation stage. (Pettit and Meier, 1985).

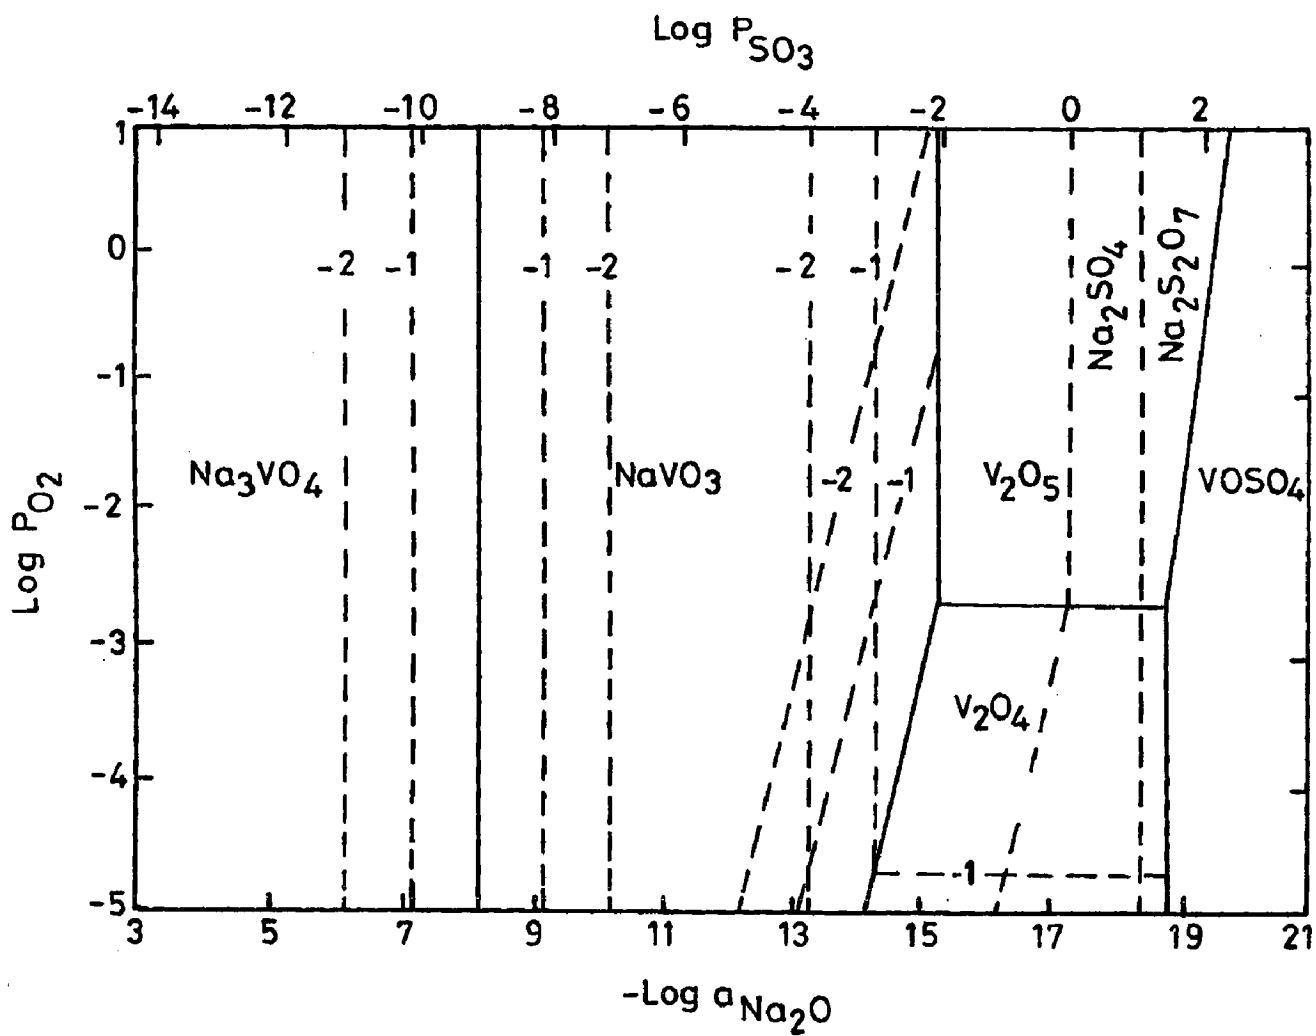
**Fig. 2.2** Phase stability diagram for Na-V-S-O system at 900 °C (Hwang and Rapp, 1989).

According to Otero et al (1987)  $Na_2SO_4$ -60% $V_2O_5$  deposit was detected on a number of components in actual service which were operated at high temperature and were in contact with high-temperature gases from combustion of dirty fuels, containing certain amounts of impurities, i.e. Na, V, and S etc. The presence of sulphur and its oxidised compounds were reported to favour the formation of isolated lobes with radial morphology having great permeability to facilitate the access of oxygen which further led to reduction in the protector character of scale. The presence of vanadium and its oxidised products was observed to generate compounds with aciculate morphology, identified to look like alkaline vanadate complexes. These aciculate shapes further contribute to reduce the protective character of the scale. The equilibrium diagram for varying composition of

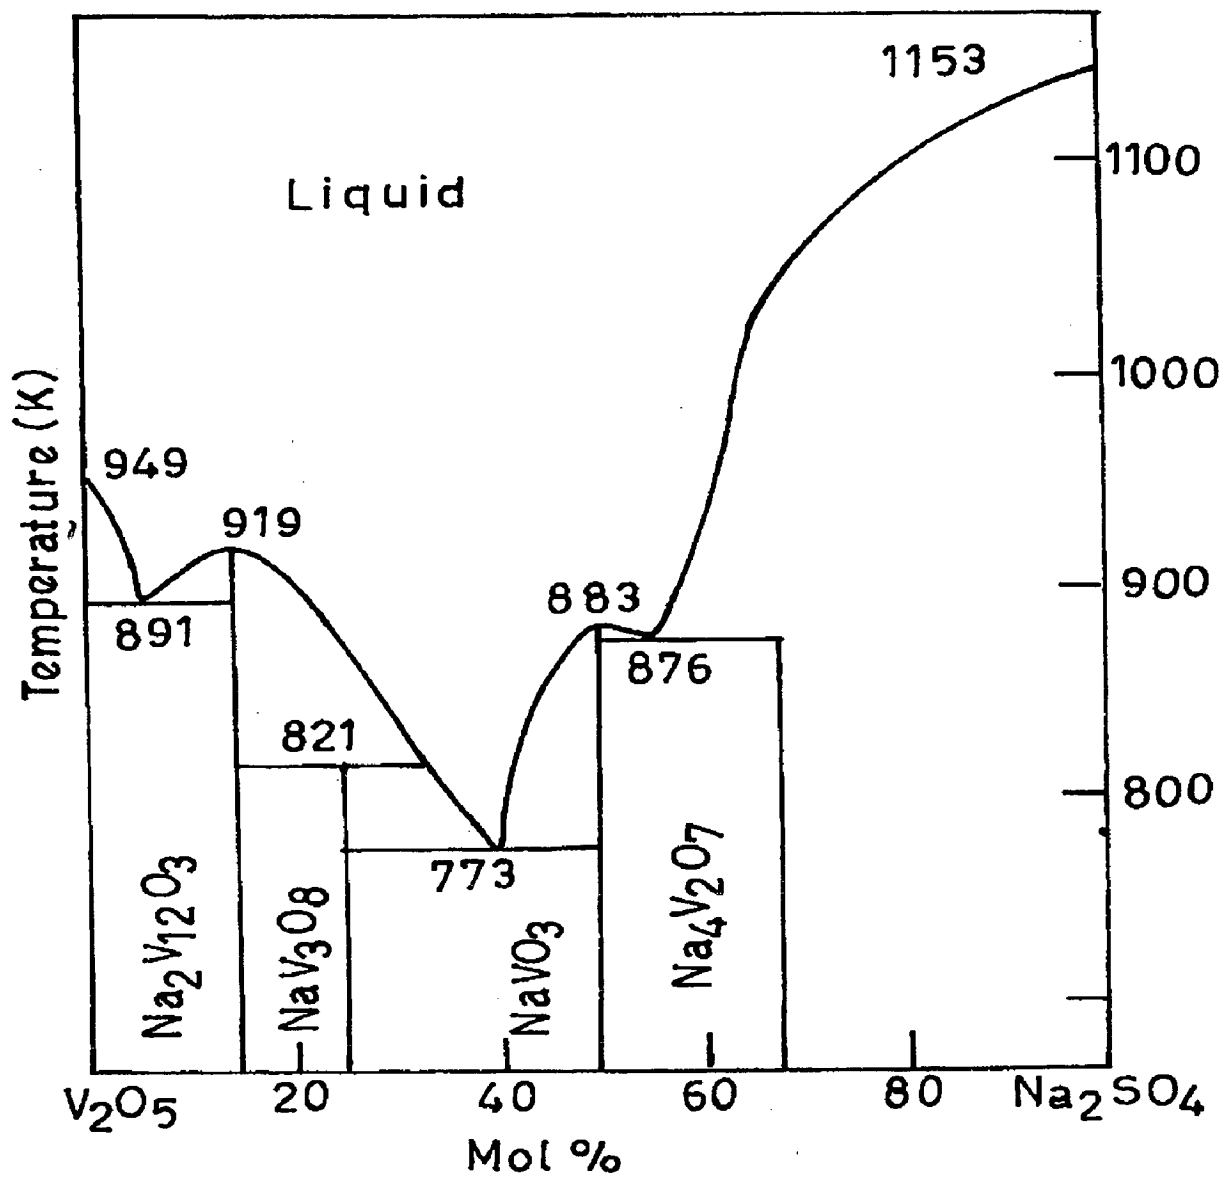
Fig. 2.3 Phase Diagram for Na<sub>2</sub>SO<sub>4</sub>-V<sub>2</sub>O<sub>5</sub> System (Otero et al, 1987).

$\text{Na}_2\text{SO}_4$  is shown in Fig. 2.3 and the mixture of  $\text{Na}_2\text{SO}_4$ -60% $\text{V}_2\text{O}_5$  is seen to be the lowest eutectic temperature.

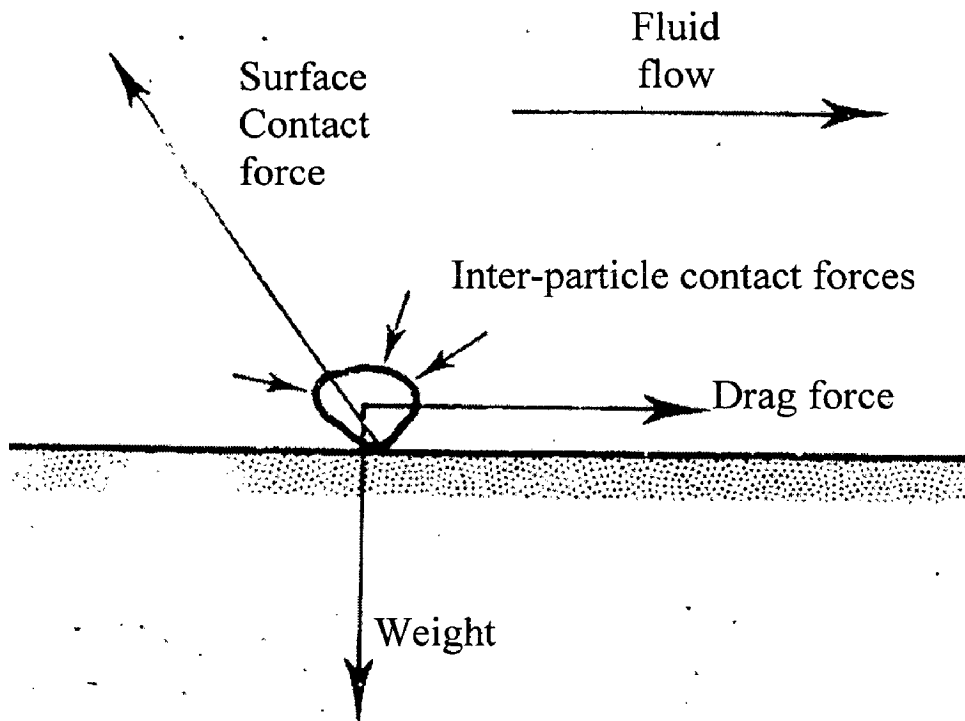
**Fig. 2.4** Diagram showing the forces which can act on a particle in contact with a solid surface (Hutchings 1992)

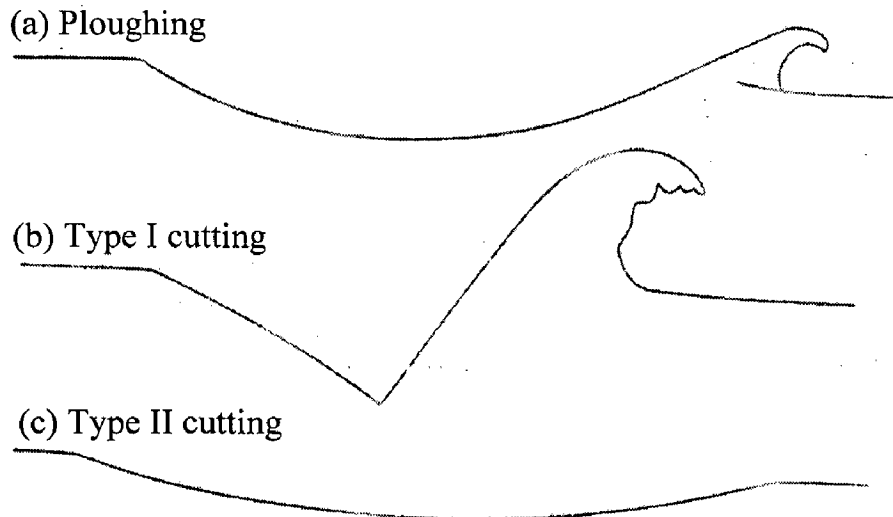
**Fig. 2.5** Section through impact sites formed by hard particles on a ductile metal, showing typical shapes. (a) Ploughing deformation by a sphere (b) type I cutting by an angular particle, rotating forwards during impact: (c) type II cutting by an angular particle, rotating backwards during impact (Hutchings, 1979).

Hutchings (1974 and 1979) have identified the two different regimes of deformation, referred to as ploughing and cutting. Studies of the impact of single particles on to metals at  $30^\circ$  impact angle show three type of impact damage, as illustrated in Fig 2.5. According to them rounded particles deform the surface by ploughing, displacing material to the side and

in front of the particle. Further impacts on neighbouring areas lead to the detachment of heavily-strained material from the rim of the crater or from the terminal lip. The deformation caused by an angular particle depends on the orientation of the particles as it strikes the surface, and on whether the particle rolls forwards or backwards during contact. He proposed that in the mode which has been termed type I cutting, the particle rolls forward, indenting the surface and raising material into a prominent lip, which is vulnerable to removal by subsequent nearby impacts. If the particle rolls backward, a true machining action can occur, in which the sharp corner of the abrasive grain cuts a chip from the surface. The type II cutting occurs over only in a narrow range of particles geometries and impact orientations. Ploughing tends to occur at large negative rake angles; i.e. when the angle between the surface and the leading edge of the particle is small. Whereas at large positive rake angle cutting deformation occurs.

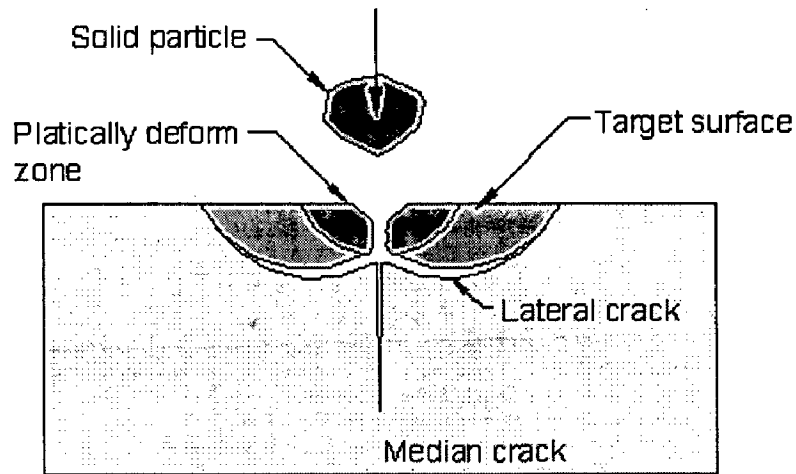
**Fig. 2.6** Simplified schematic drawing of crack formation from a single particle impact.(Wensink and Elwenspoek, 2002)

Wensink and Elwenspoek (2002) reported that the brittle erosion deals with material removal due to crack formation as illustrated in Fig. 2.6. When a brittle material is impacted by a hard sharp particle, the contact area is plastically deformed due to the high compressive and shear stresses and a radial crack is formed. After the impact, the plastic deformation leads to large tensile stresses that result in lateral cracks causing the material removal.

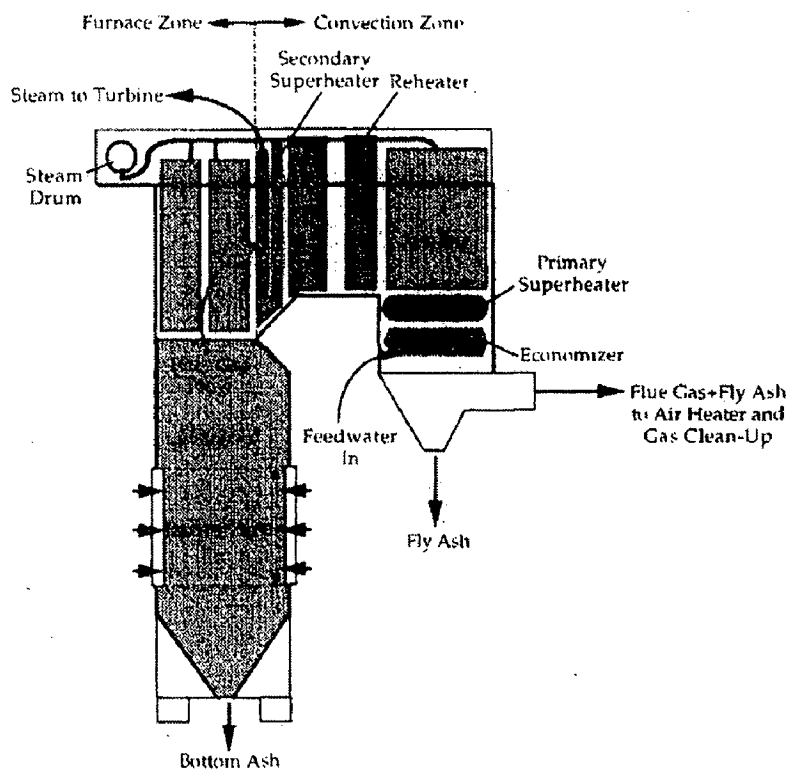
**Fig. 2.7** Layout of a typical pulverized coal-fired boiler (Stringer John, 1995)

Superheaters are a series of tubes placed with in the flue gas path of the boiler, whose purpose is to heat the boiler steam beyond saturated conditions. The supersaturated steam is then delivered to a turbine for electric power generation in thermal power plants, to run plant and machineries in a process and manufacturing industry. Figure 2.7 illustrates a typical boiler

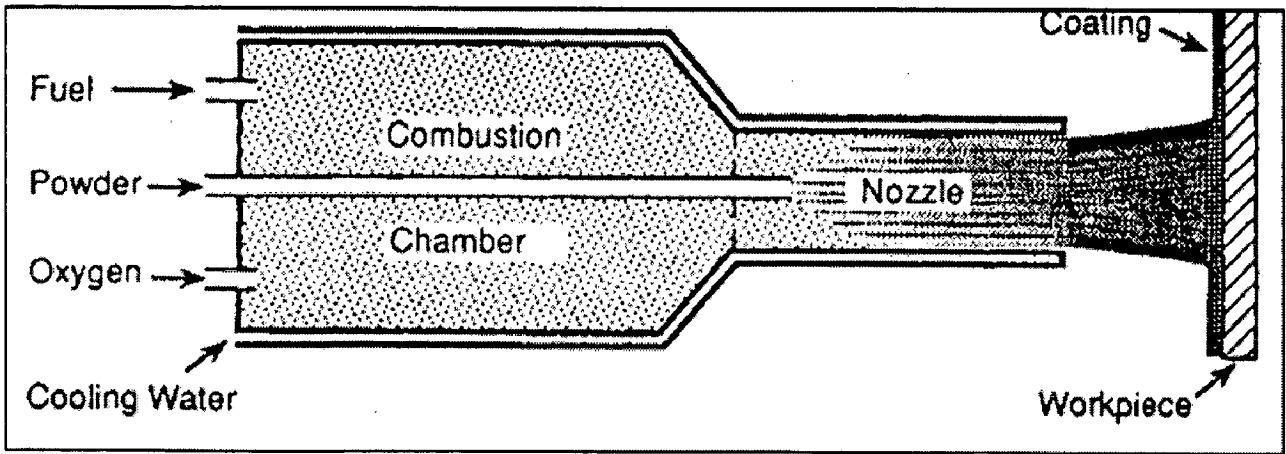
**Fig.2.8** Schematic representation of high velocity oxy fuel spray process (Bunshah 1994)

This process has been shown to produce coatings with better density, coating cohesive strength and bond strength than any thermal spray processes. Although a variety of high velocity combustion spray devices have been developed, most have in common a combustion chamber with ports leading to a nozzle, shown schematically in Fig. 2.8. The HVOF deposition process involves the combustion of oxygen and a fuel gas such as propylene, hydrogen or kerosene, under high pressure within a cooled confined combustion chamber. The products of combustion are then discharged through a cooled nozzle at high velocities. Powders to be deposited are fed into the combustion area by a carrier gas, where they are heated and carried by the gases exiting from the nozzle. Molten or partially molten droplets arrive at the substrate, flatten and solidify on impact. Coating thicknesses are normally in the range of 100 to 300  $\mu\text{m}$ . Depending upon the injection pressures of the fuel gases, jet velocities exiting the nozzles are in the order of  $1700 \text{ m s}^{-1}$ , i.e. supersonic. High velocity combustion spray is a line-of-sight process hence it should be expected that the properties of the coatings will vary with the angle of deposition. In addition, stand-off may be an important parameter, a distance which is too short allows too little time for heating and acceleration of the powder particles or overheating of the substrate, while a stand-off which is too long may allow the powder particle velocities to diminish and their temperature to drop too far. The actual powder temperature and velocity distributions are strongly a function of the design of the high velocity combustion spray device as well as the operating parameters, morphology, and composition. (Mohanty et al. 1996 and Bunshah 1994).

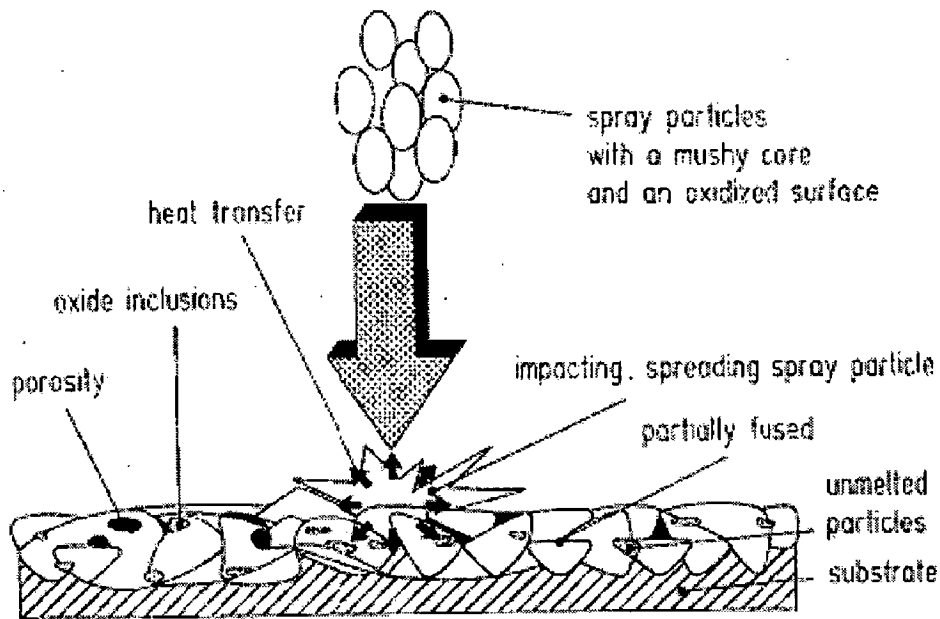
**Fig.2.9** Schematic of a typical structure of sprayed coating (Bunshah 2001).

The state of the particle as it exits the combustion zone has an effect on the final microstructure of the coating. The kinetics of droplet flattening depends upon the droplet size and the impact velocity. Initially, just after impact, inertial effects dominate, the viscous flow effect becomes more important as the droplet spreads, and the influence of the surface energy could become a significant factor towards the end of the spreading process (Pawlowski 1995 and Sobolev 2004). During the rapid solidification of the spray particles there is a close contact between particles and the substrate surface. This leads to bonding effects due to mechanical interlocking, adhesion, diffusion, chemical reactions, and sometimes partial fusion of the contact surfaces. These bonding effects permit the formation of a continuous coating layer as illustrated in Fig. 2.9. Mechanical interlocking

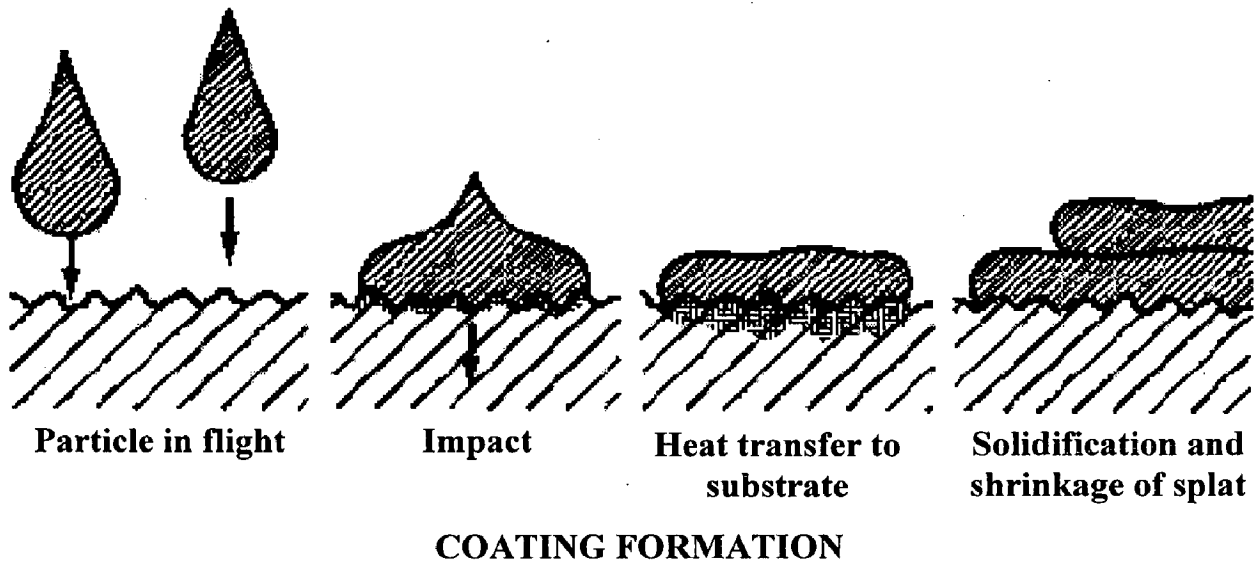
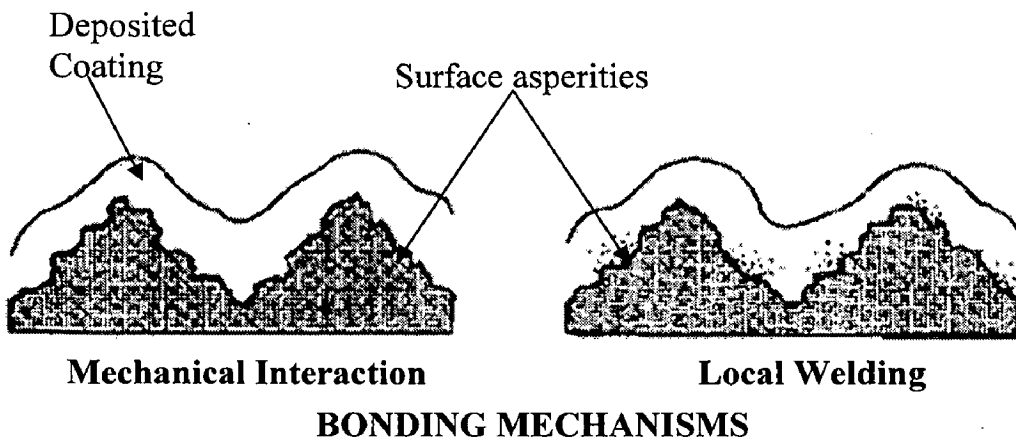
**Fig.2.10** Bonding interactions within a spray coating (Bunshah 2001).

The quenching stresses within the spray particles increase the interlocking effects. In Fig. 2.10, the possible bonding interactions are illustrated. The adhesive bonding mechanisms are effective at microcontact areas between particles and/or substrate. These forces correspond to the atomic attractive forces within crystalline solid matter, since the particles approach one another as close as atomic levels. Depending on the type of atomic bonding, on the one hand Vander Waals forces (physisorption) and on the other hand an exchange of valence electrons (chemisorption) may take place.

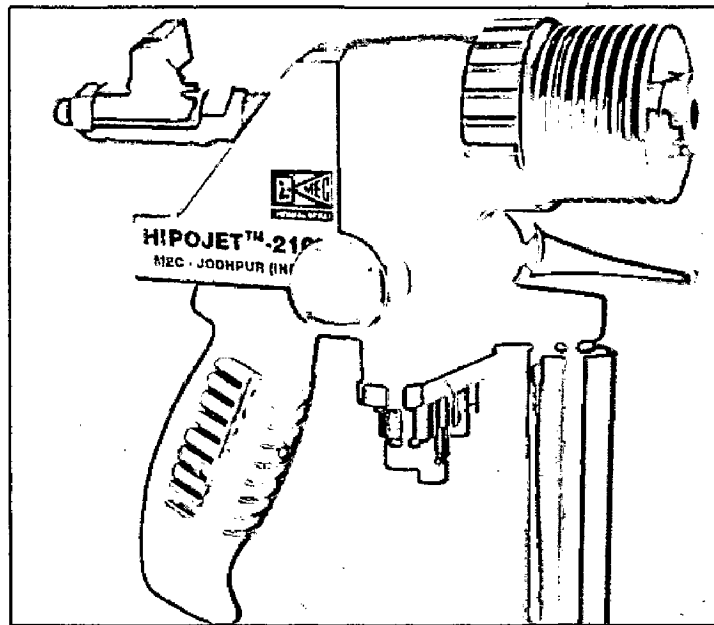
**Fig.3.1** HVOF system hipojet 2100 used in the current research

HVOF spraying has been carried out using a HIPOJET 2100 equipment (M/S Metallizing Equipment Co.Pvt.Ltd, Jodhpur, India), which utilises the supersonic jet generated by the combustion of liquid petroleum gas and oxygen mixture. The complex formulations containing Ni, Al, Cr, Si, Mo, WC, Co and boron have been used to develop combined corrosion and erosion resistant coatings. Four types of commercially available feed stock powders namely NiCrAl, NiAlCrFeMo, NiCrFeSiB and WC-Co/NiCrFeSiB were HVOF sprayed on three kinds of boiler tube steels designated as ASTM-SA210-Grade A1, ASTM-SA213-T11 and ASTM-SA213-T22. Differences in chemical compositions of coatings and substrate alloys can lead to inter-diffusion across the coating substrate interface, which can modify the oxidation and hot corrosion resistance of the coatings. Under the given spray parameters, seemingly dense laminar structured coating with thickness in the desired range of 260-295  $\mu\text{m}$  and porosity less than 2 % has been achieved. All the coatings have retained the phases observed in starting powder, containing nickel rich FCC structure as a principal phase and has not undergone significant phase transformation. Oxidation, decomposition and decarburization of the coating powder are not serious due to higher particle speed and chosen parameters during HVOF spraying.

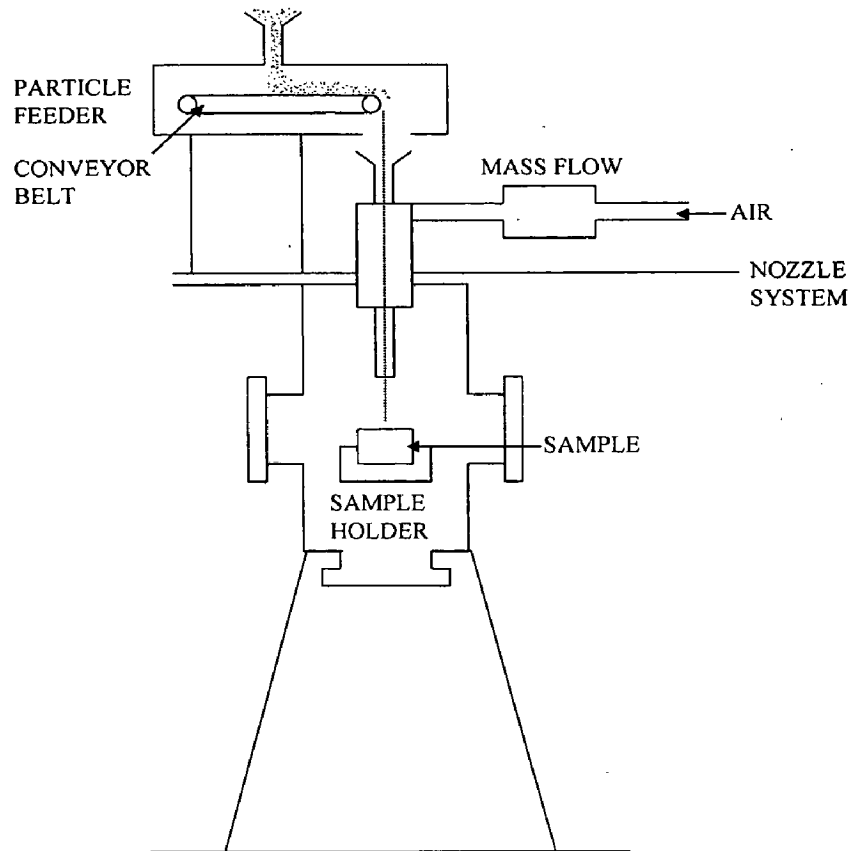
**Fig. 3.3** Schematic view of an Air Jet Erosion Test Rig

Room temperature erosion test was carried out using air jet erosion test rig (Fig3.3) as per ASTM G76-02 standard at the Defence Metallurgical Research Laboratory, Hyderabad, India. The rig consisted, of an air compressor, and particle feeder, an air particle mixing and accelerating chambers. Dry compressed air was mixed with the particles, which were fed at a constant rate from a conveyor belt type feeder in the mixing chamber and then accelerated by passing the mixture through a tungsten carbide converging nozzle of 4.5mm diameter. These accelerated particles impacted the specimen, which could be held at various angles with respect to the impacting particles using an adjustable sample holder. The feed rate of the particles could be controlled by monitoring the distance between the particle feeding hopper and the belt drive carrying the particles to the mixing chamber. The impact velocities of the particles could be varied by varying the pressure of the compressed air. The velocity of the eroding particles was determined using a well known rotating double-disc method as described by Ruff and Ives (1975).

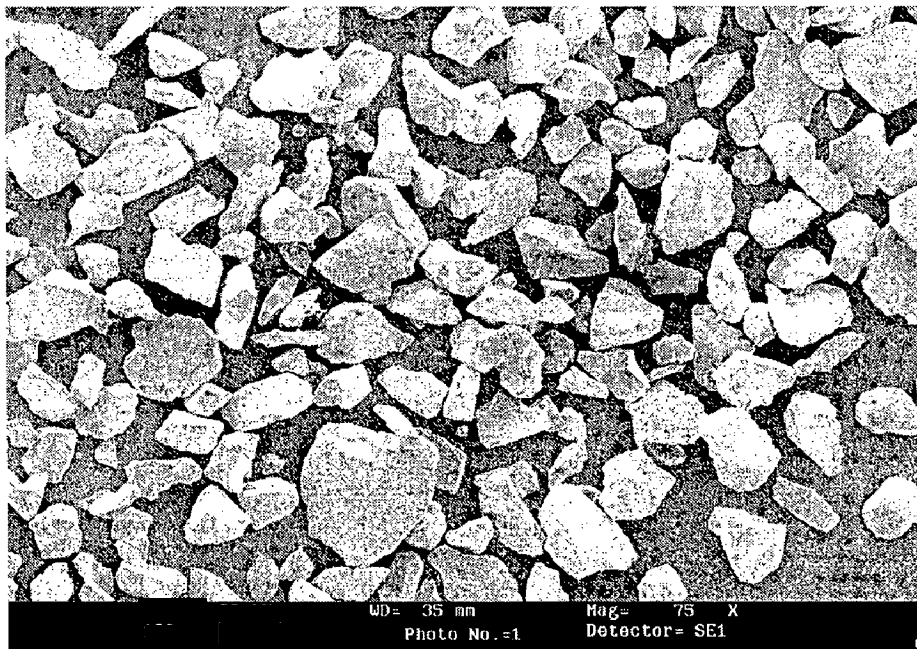
**Fig. 3.4** Scanning electron micrograph of the silica sand particles

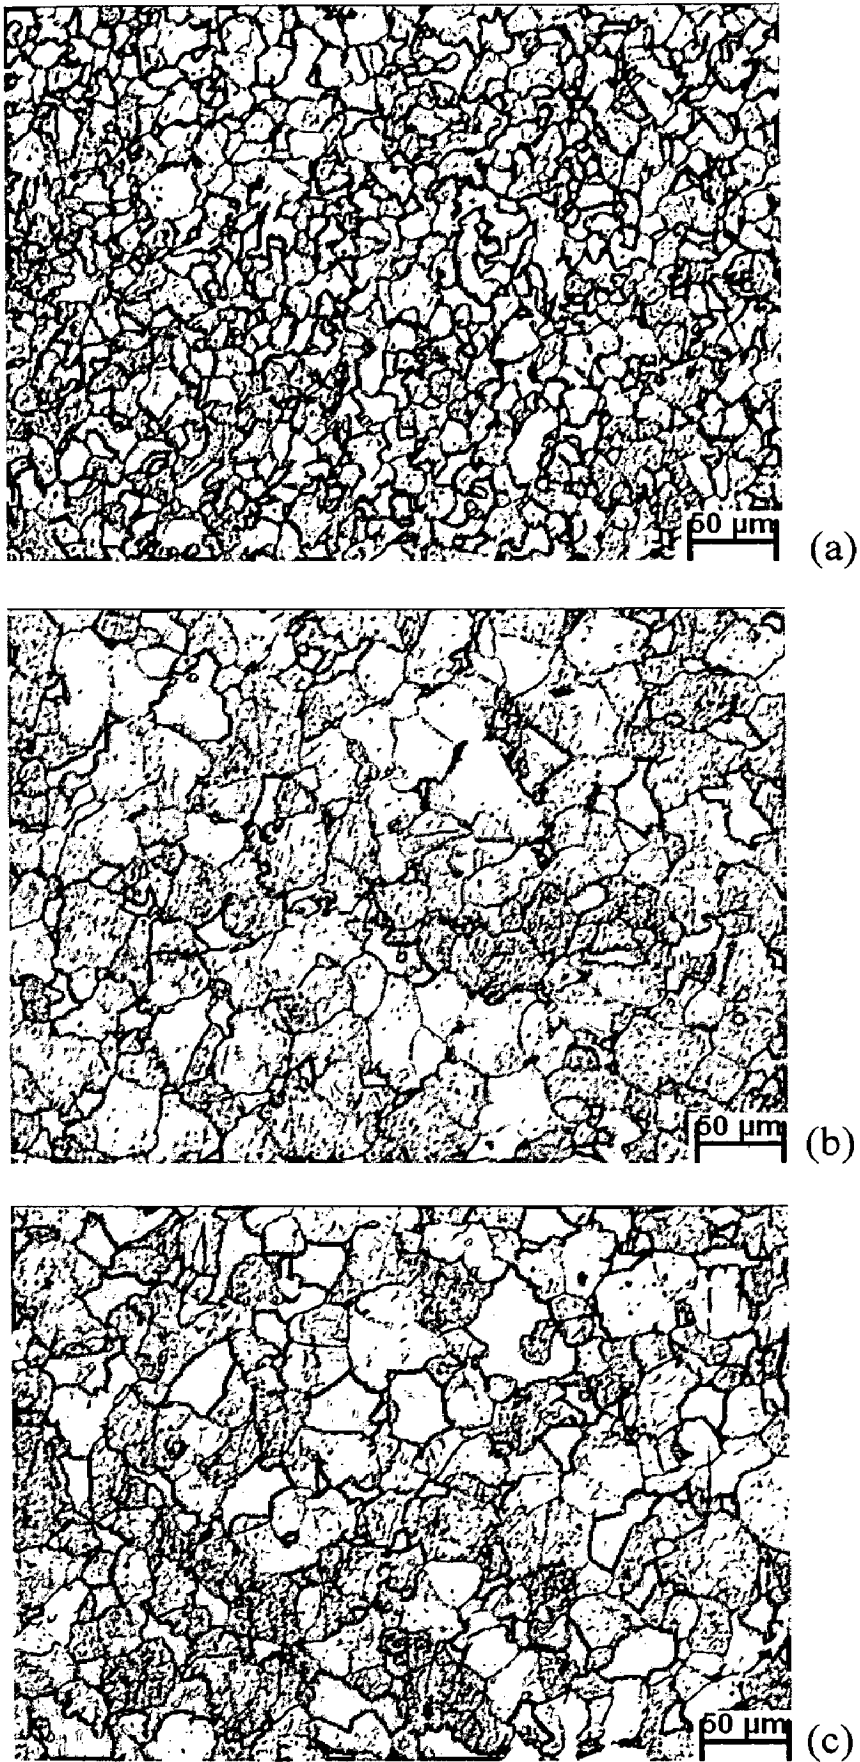
**Fig. 4.1** Optical micrograph of substrate steels at 320X magnification  
(a) ASTM-SA210-Grade A1 (b) ASTM-SA213-T11 (c) ASTM-SA213-T22

The optical microstructures of the substrate steels are shown in Fig. 4.1. The microstructures for Grade A1 steel (Fig 4.1.a) are found as ferrite and pearlite. The ferrite appears white in colour, and the boundaries between the ferrite grains of different orientations appear as dark lines. The pearlite appears uniformly black as the interlamellar spacing of the pearlite is too fine to be resolved by a light microscope. The microstructures of the T11 and T22 steels (Figs. 4.1b and 4.1c) consist of polygonal ferrite (white constituent) and bainite (dark constituent).

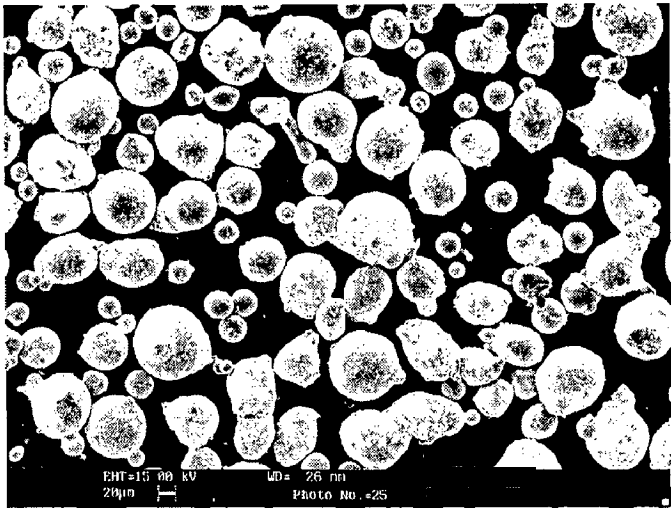
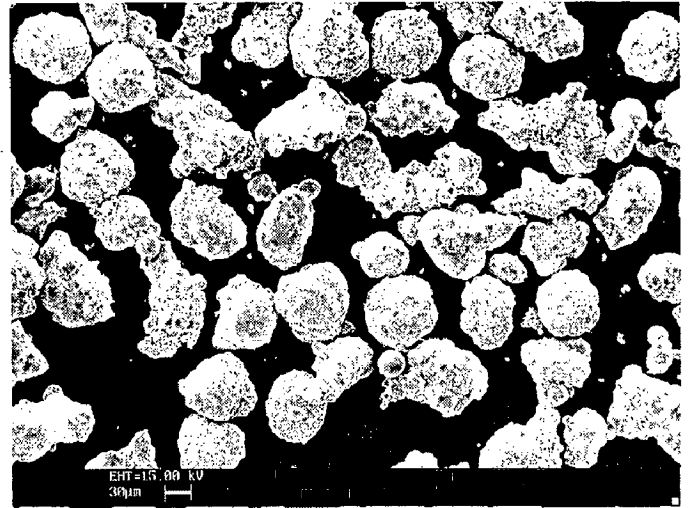
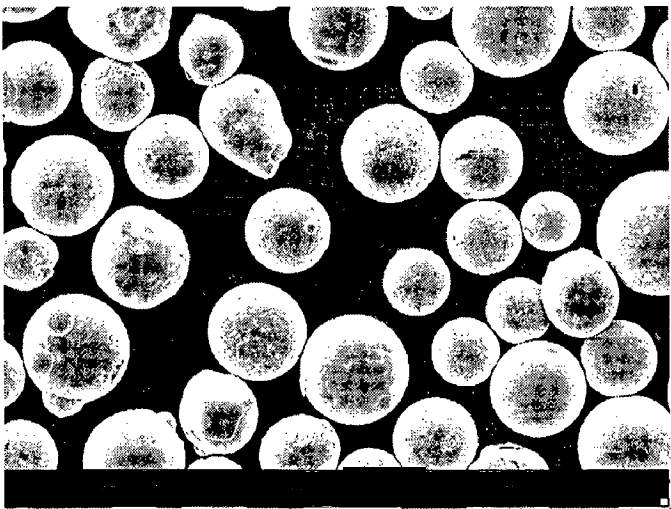
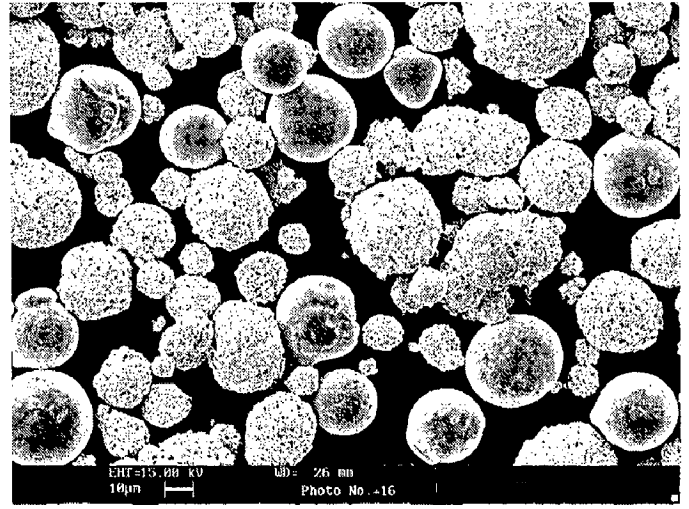
**Fig. 4.2** Scanning electron micrograph of different coating powders:  
(a) NiCrAl powder                      (b) NiAlCrFeMo powder  
(c) NiCrFeSiB powder                (d) WC-Co/NiCrFeSiB powder

The morphology of the coating powders have been evaluated using the scanning electron microscopy which is shown in Fig.4.2. It is found from this figure that the NiAlCrFeMo powder particles have irregular shapes, whereas the NiCrAl, NiCrFeSiB, and WC-Co/NiCrFeSiB powder particles have spherical morphology. The particle size distribution of the powder as determined by the image analysis of the secondary electron micrographs are found to be consistent with the nominal size distribution as provided by the manufacturer.

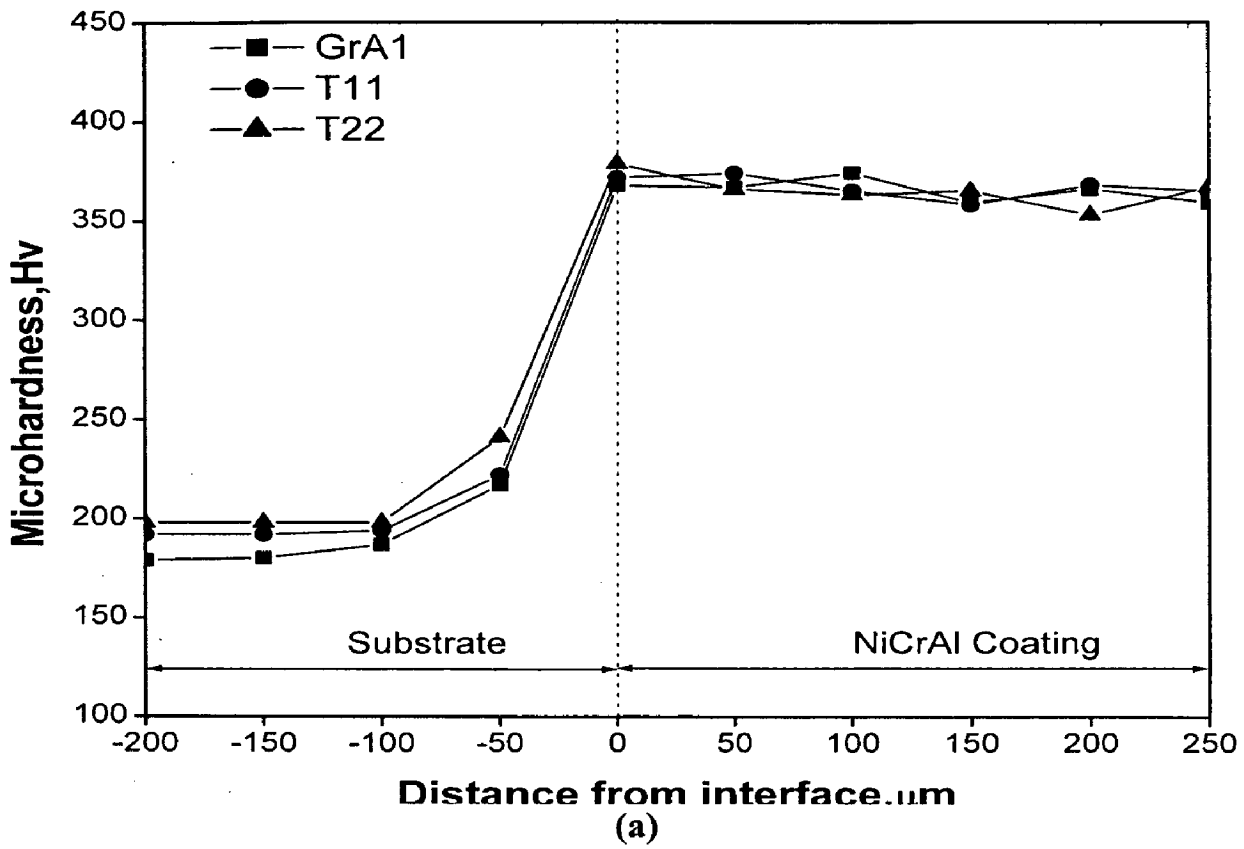
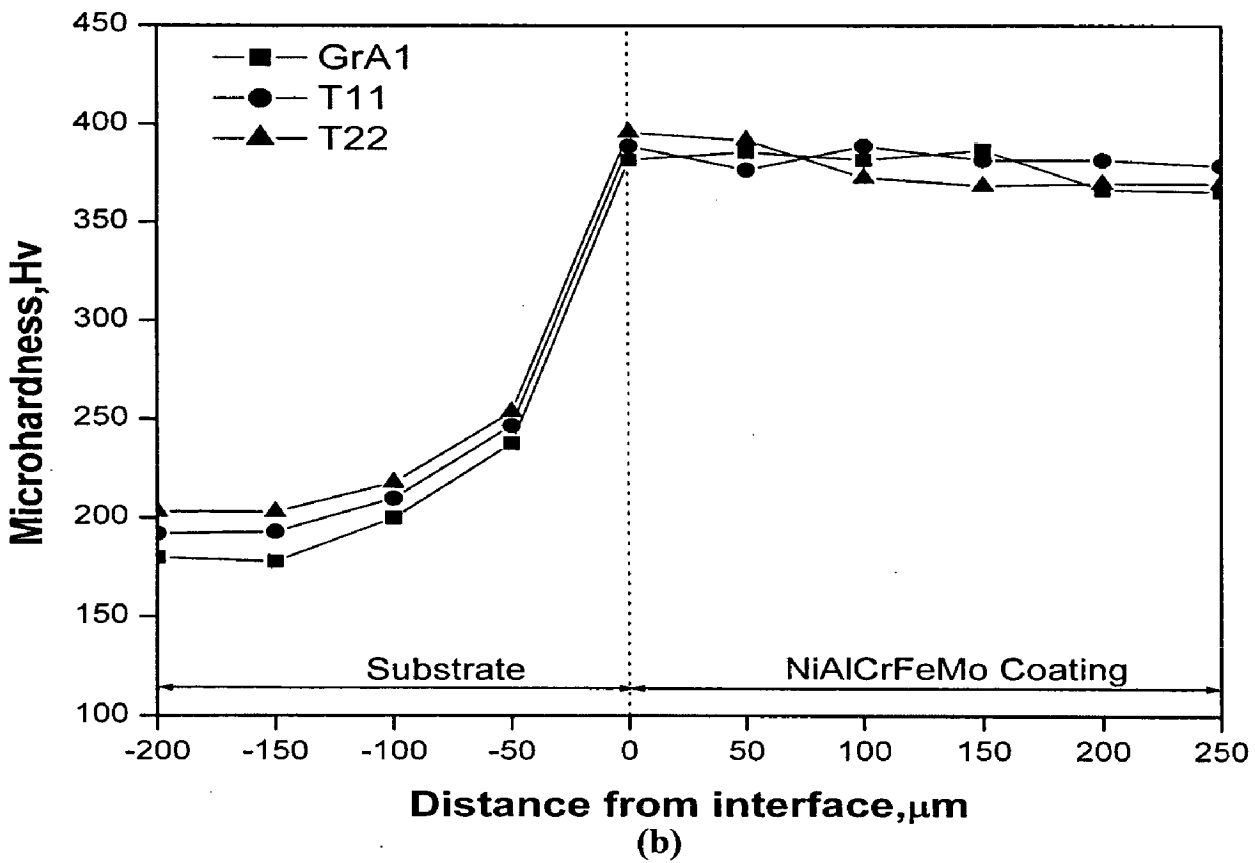
**Fig. 4.4** Microhardness profiles of HVOF sprayed coatings for different substrate steels along the cross-section:  
 (a) NiCrAl coating (b) NiAlCrFeMo coating

The micro-hardness values are the measures across the coating-substrate interface. The micro-hardness profile of all the coatings as a function of distance from the coating-substrate interface is shown in Figs. 4.4 and 4.5. As indicated by the microhardness profiles, the WC-Co/NiCrFeSiB coatings recorded higher hardness value of 1223 Hv with a standard deviation of 46. The average values of microhardness for the NiCrAl, NiAlCrFeMo, and

NiCrFeSiB coatings are found as 366 Hv, 380 Hv and 972 Hv, respectively with a standard deviation of less than 15 for all these coatings. The microhardness of the coatings is found to vary along the cross-section and, further, considerable increase in microhardness values are measured on the substrate region closer to the coating-substrate interface.

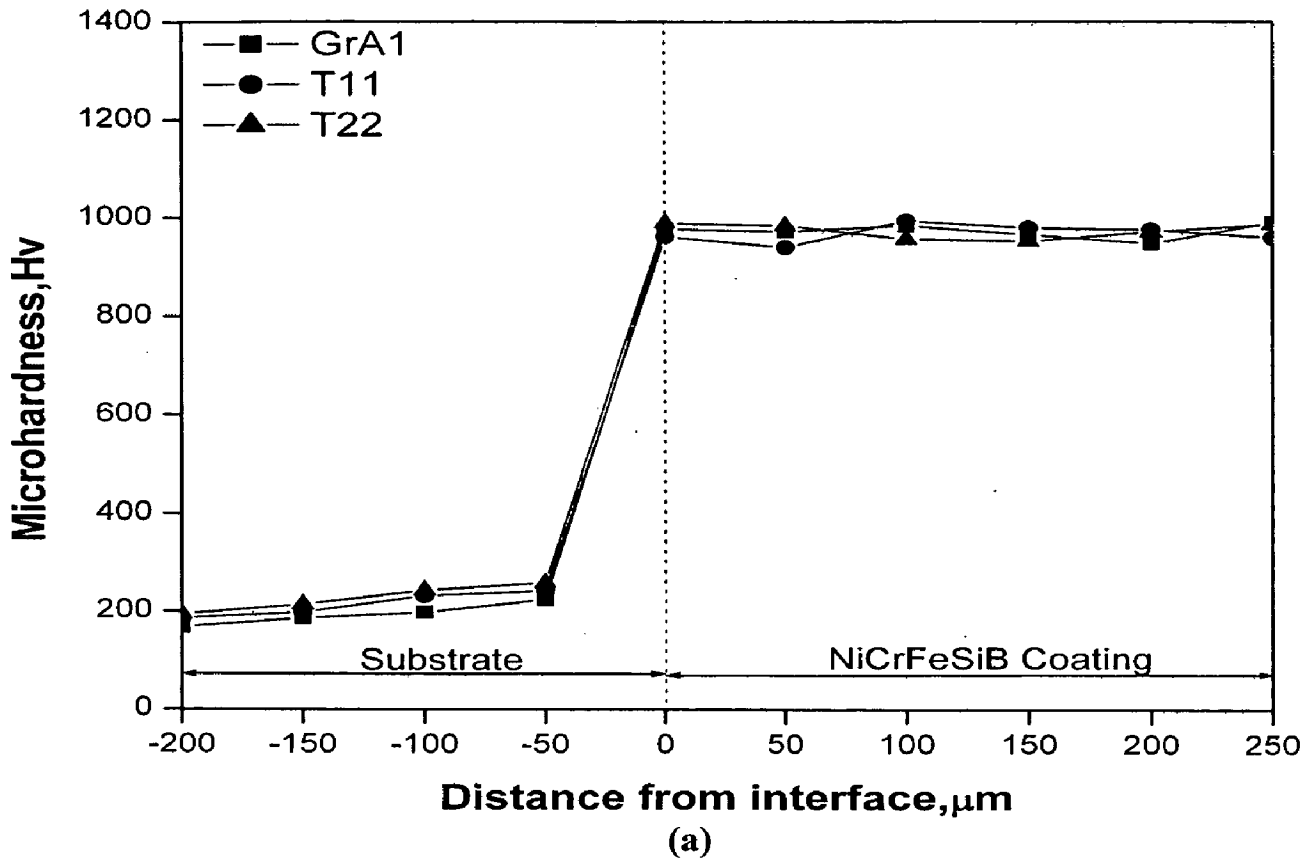
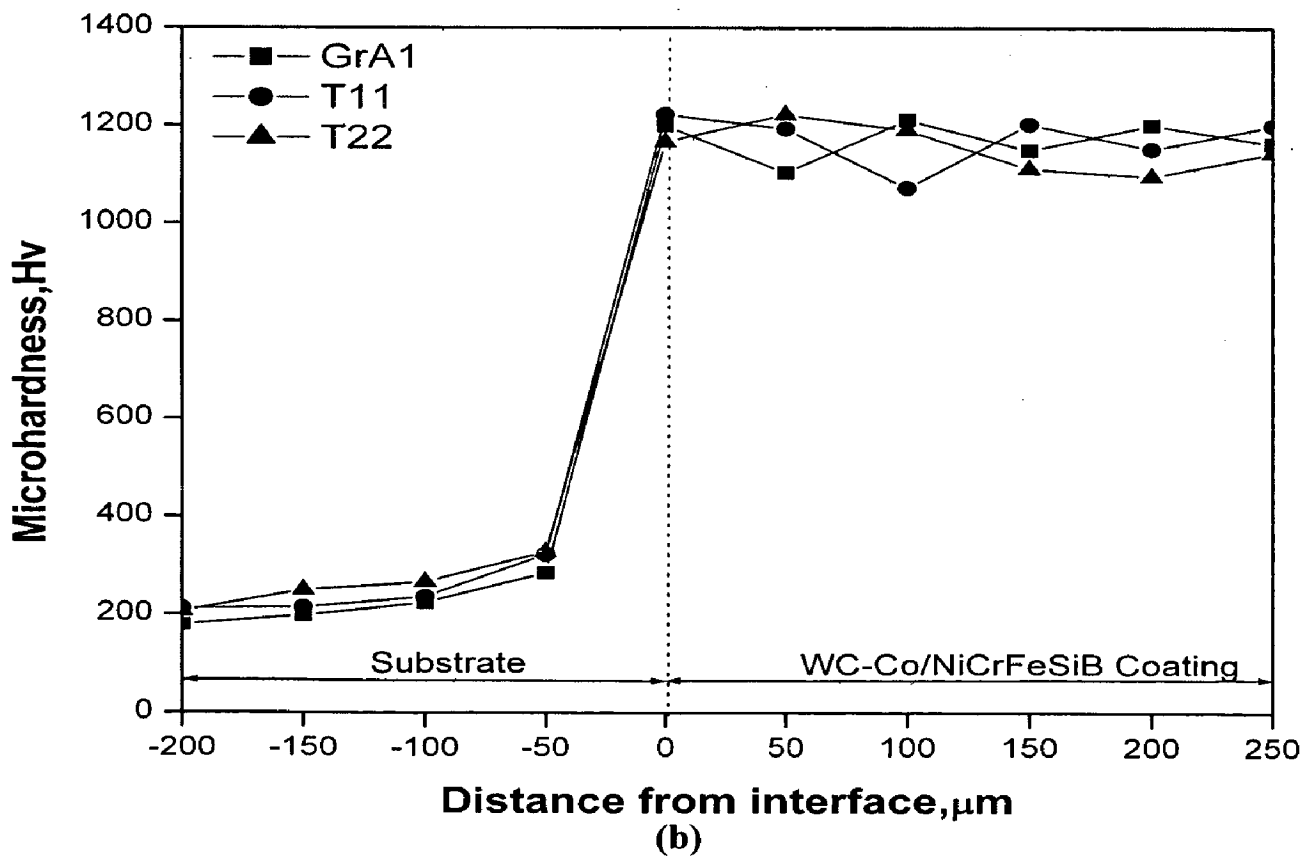
**Fig. 4.5** Micro hardness profiles of HVOF sprayed coatings for different substrate steels along the cross-section:  
 (a) NiCrFeSiB coating (b) WC-Co/NiCrFeSiB coating
