# **STUDIES ON THE ROLE OF HVOF COATINGS IN IMPROVING RESISTANCE TO HOT CORROSION AND EROSION**

## **A THESIS**

**DOCTOR OF PHILOSOPHY**

**METALLURGICAL AND MATERIALS ENGINEERING**

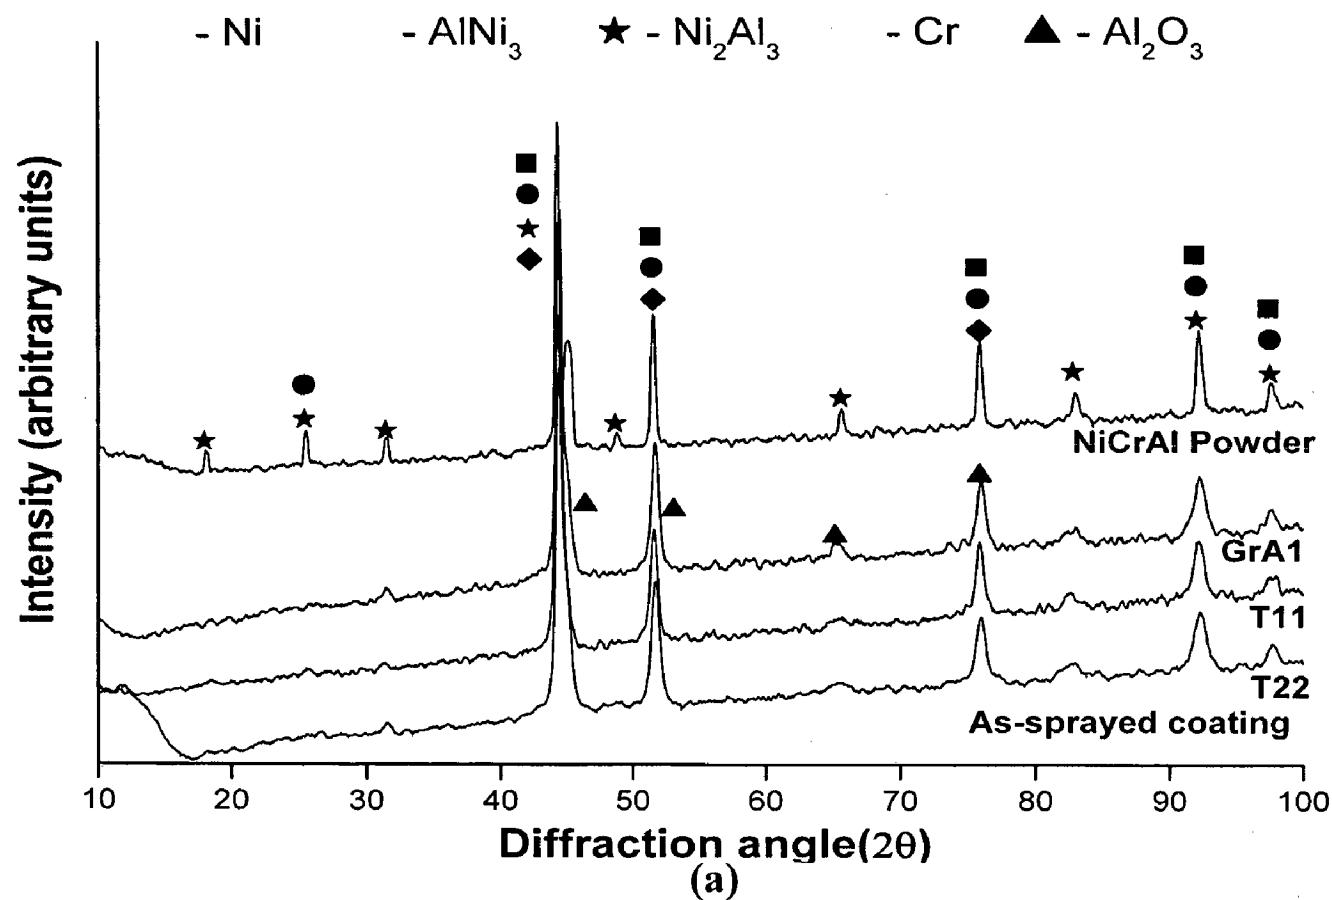
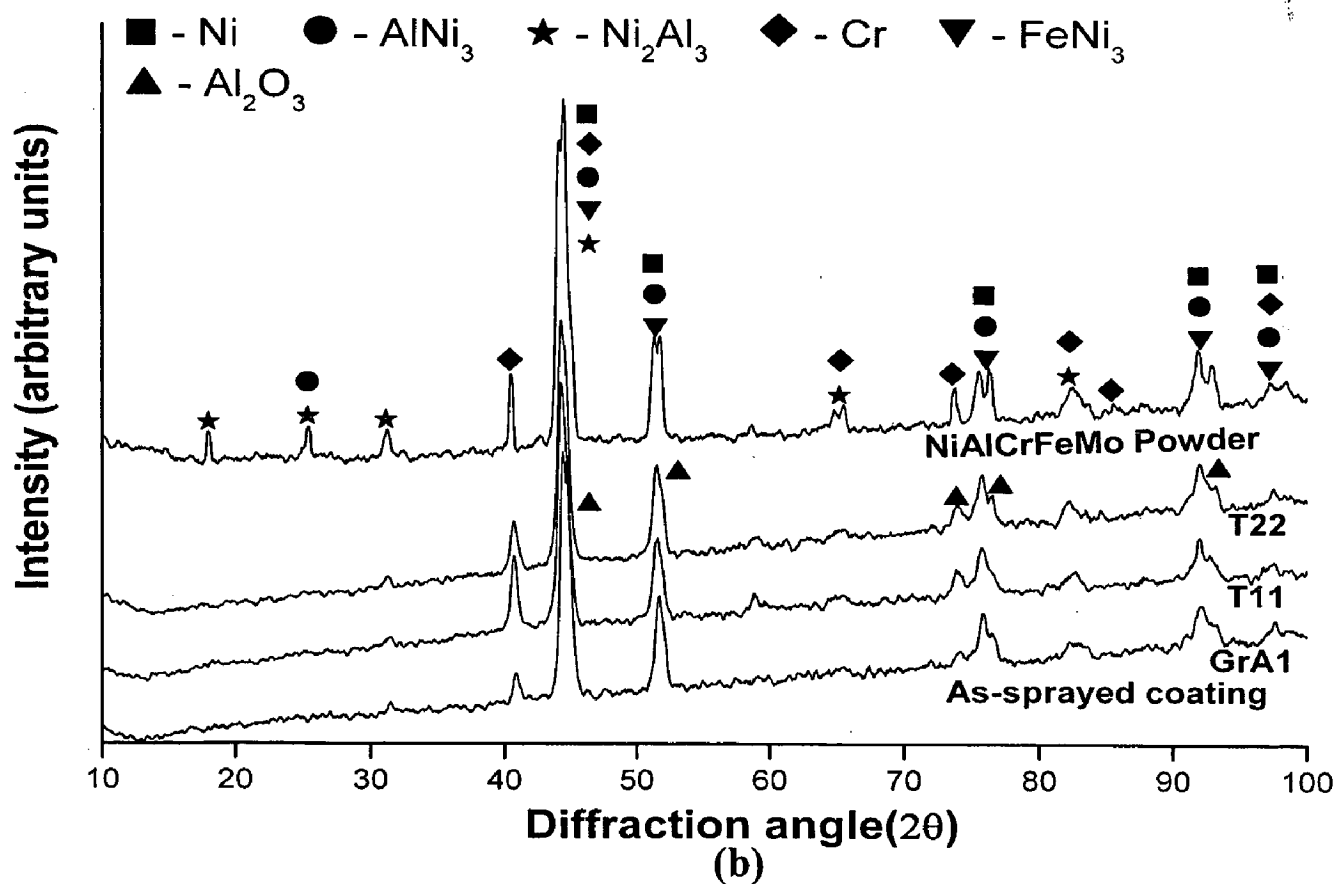
Fig. 4.6 X-ray diffraction patterns for powder and as-sprayed coatings  
 (a) NiCrAl coating (b) NiAlCrFeMo coating

The coatings obtained by the HVOF did not undergo significant phase transformations. It may be due to the supersonic speeds of the sprayed particles, which limits exposure of the particles to an oxidizing environment and to the fact that they are exposed to moderate heating. Hence, the XRD peaks for the coatings are almost similar to that of the powder.

The XRD analysis of the NiCrAl coating envisages the presence of nickel-rich FCC structure as the principal phase along with the minor phases of AlNi<sub>3</sub>, Ni<sub>2</sub>Al<sub>3</sub>, Cr, and Al<sub>2</sub>O<sub>3</sub>. The strong peaks appearing in the pattern of the as-sprayed coating (Fig. 4.6a) shows an almost crystallized structure. Further, the EDAX analysis of the melted region in the microstructure of the coating (Figs. 4.8a and 4.11a) shows increased content of Al. This confirms the formation of Ni-Al intermetallic compounds like AlNi<sub>3</sub> and Ni<sub>2</sub>Al<sub>3</sub>. The presence of weak intensity peaks indexed to Al<sub>2</sub>O<sub>3</sub> indicate that a small amount of oxidation has occurred during spraying. The oxide formation during the HVOF spraying has also been observed by Dent et al. (2001) and Sundararajan et al. (2003). The XRD patterns for the NiAlCrFeMo coating also shows the formation of  $\gamma$ -Ni solid solution as a principal phase along with the peaks of the AlNi<sub>3</sub>, Ni<sub>2</sub>Al<sub>3</sub>, Cr, and FeNi<sub>3</sub>. The presence of low intensity peaks of Al<sub>2</sub>O<sub>3</sub> indicates that a small amount of oxidation occurred during spraying.

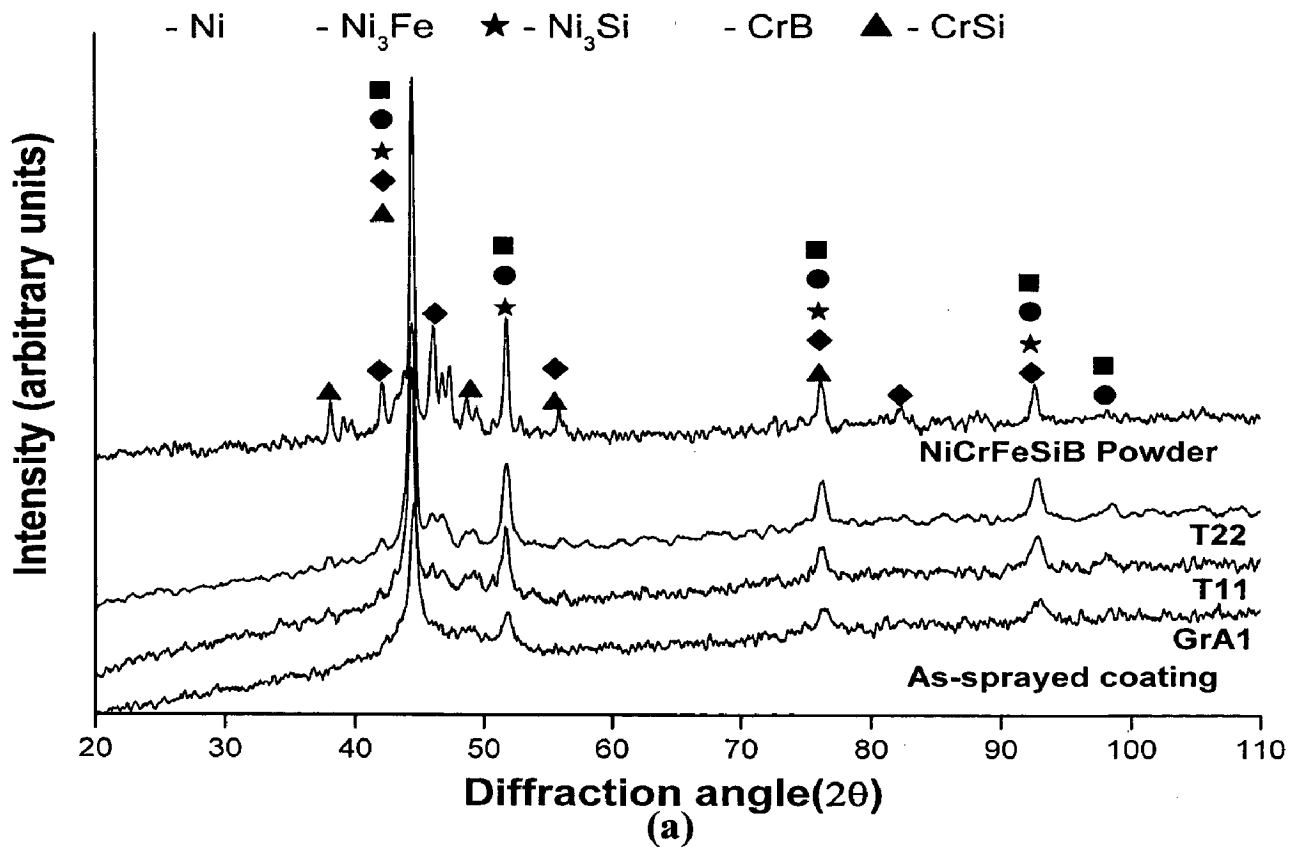
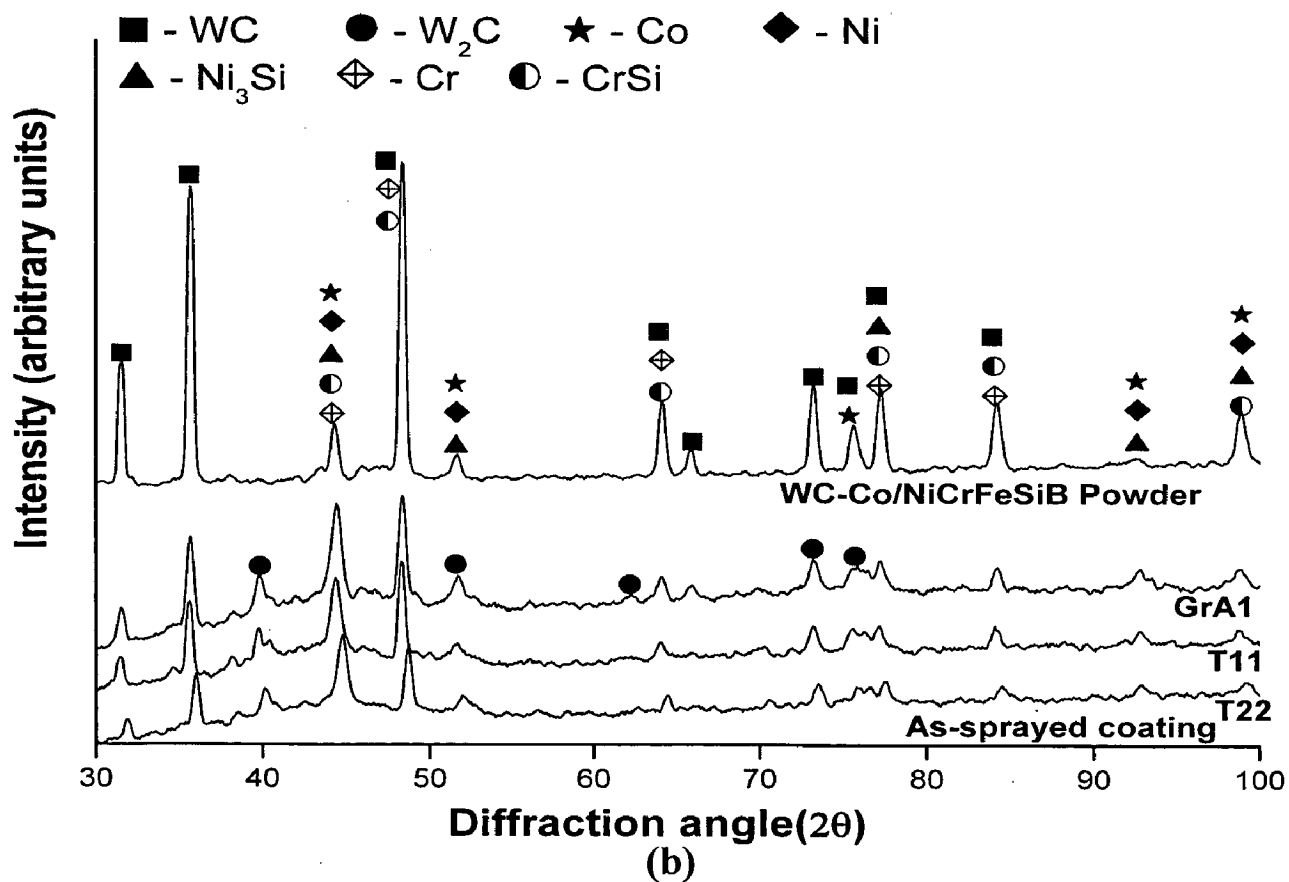
Fig 4.7 X-ray diffraction patterns for powder and as-sprayed coatings  
 (a) NiCrFeSiB coating (b) WC-Co/NiCrFeSiB coating

The X-ray pattern for the as-sprayed NiCrFeSiB coatings and powder (Fig. 4.7a) reveals that the Ni-rich FCC structure has a strong peak. The presence of CrSi and CrB phases indicate the melting of powder during spraying to the extent of dissolution of the borides and silicides in the liquid phase. The dissolution of B and Si makes the crystallization process impossible. Evidently, a very broad peak accompanied by reduction in peak intensity at  $2\theta$  of about 44.5° can be observed for the as-sprayed coating in comparison to the XRD pattern for the initial powder. This difference reveals the formation of amorphous matrix. The EDAX composition analysis across the coating cross-section (Fig. 4.12 a) shows the homogeneous elemental concentration, which indicates complete melting of the coating powder. Similar observations are reported by Eigena et al. (2005), Sundararajan et al. (2004), Planche et al. (2005), Sidhu (2006E) and Li et al. (2004).

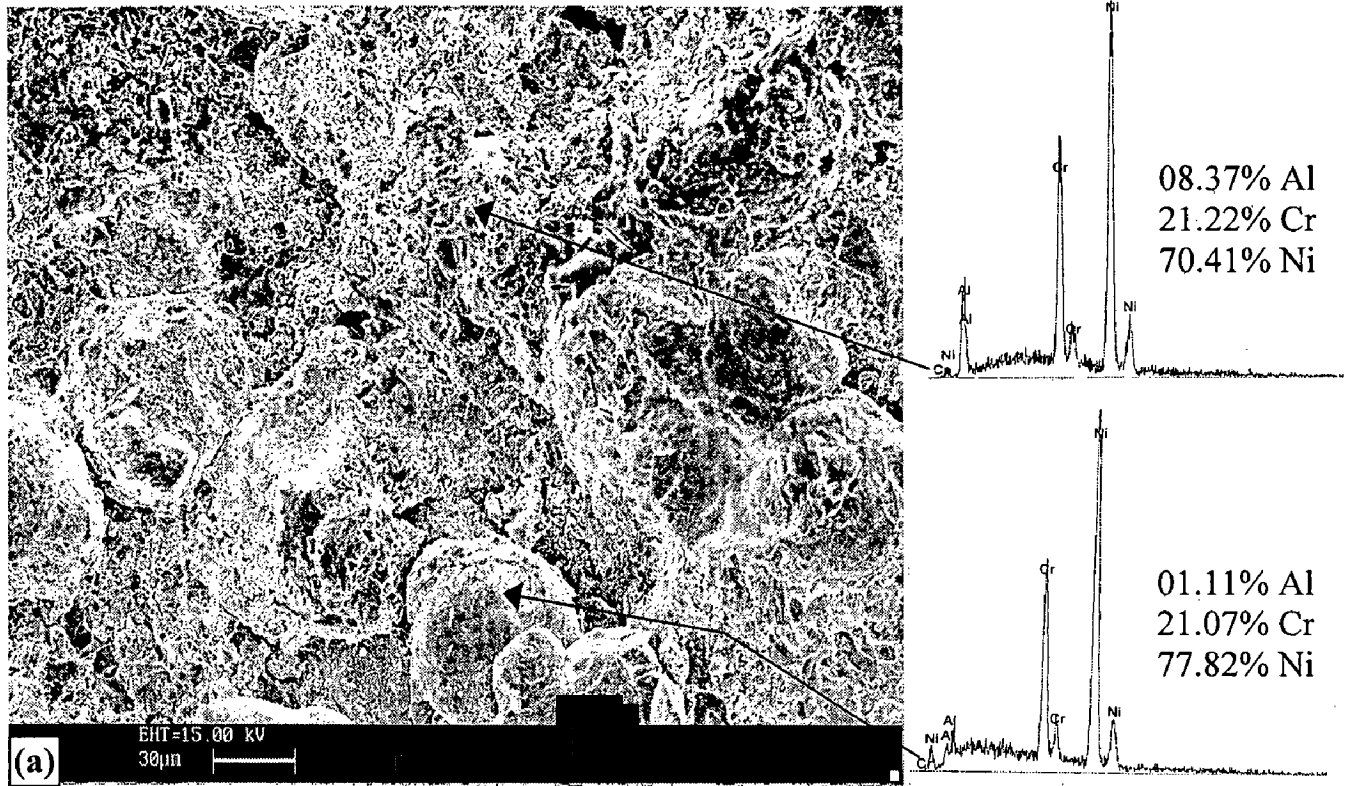
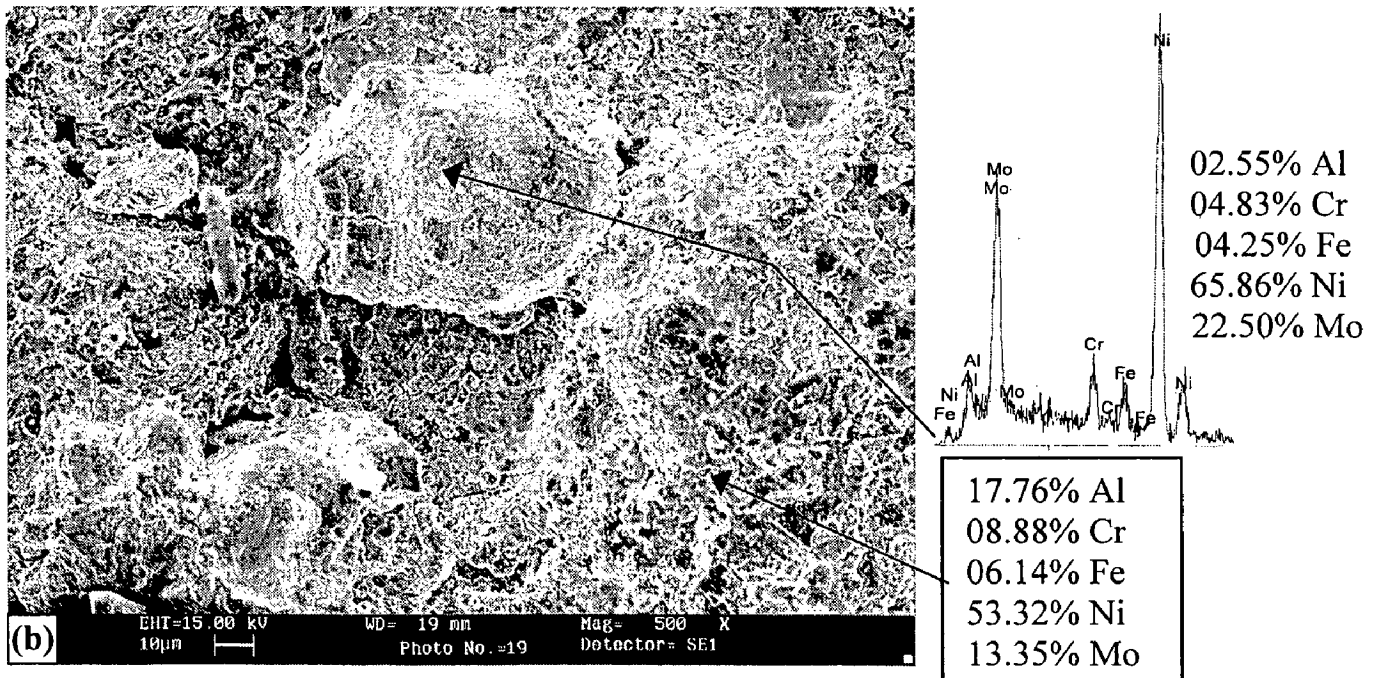
**Fig. 4.8** SEM/EDAX analysis on surface of as-sprayed coating showing elemental composition (wt %) and spectra at selected points:  
(a) NiCrAl coating (b) NiAlCrFeMo coatings

The scanning electron micrographs showing surface morphologies along with the EDAX composition analysis, at the selected points, on the surface of the as-sprayed HVOF coatings are shown in Figs. 4.8 and 4.9. The surface of the NiCrAl and NiAlCrFeMo coatings consists of melted matrix distributed with globules of partially melted particles, which reflects overlapping of the individual splats. The partially melted particles are found to be rich in nickel and have similar size and shape as that of the powder. The compositional analysis of the light grey phases of the WC-Co/NiCrFeSiB coatings (Fig. 4.9b) show higher amount of tungsten and cobalt, which represents the distribution of carbides in the coating.

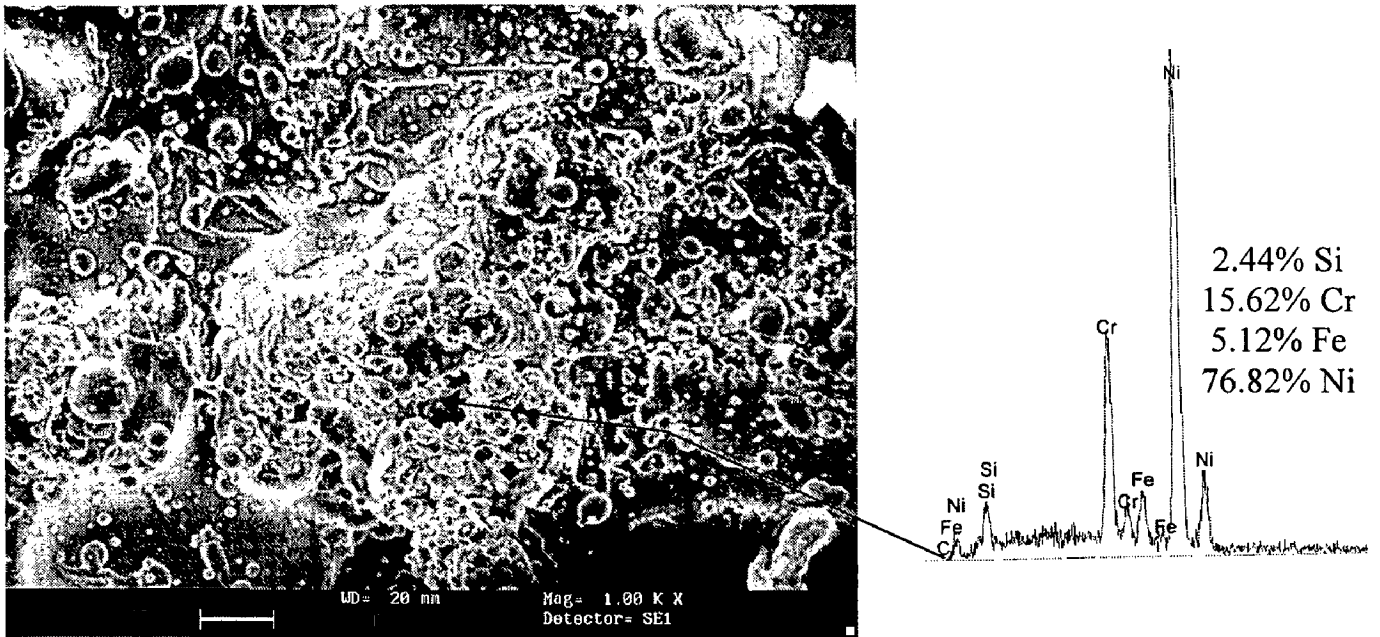
**Fig. 4.9** SEM/EDAX analysis on surface of as-sprayed coating showing elemental Composition (wt %) and spectra at selected points:  
(a) NiCrFeSiB coatings (b) WC-Co/NiCrFeSiB coatings

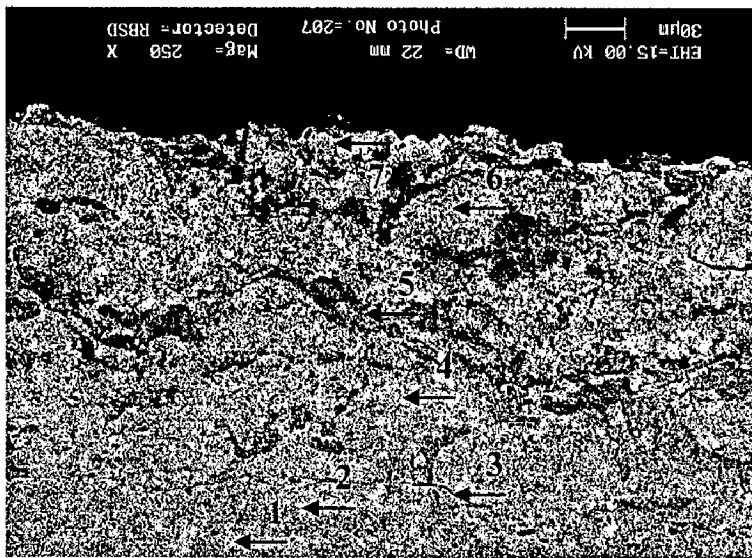
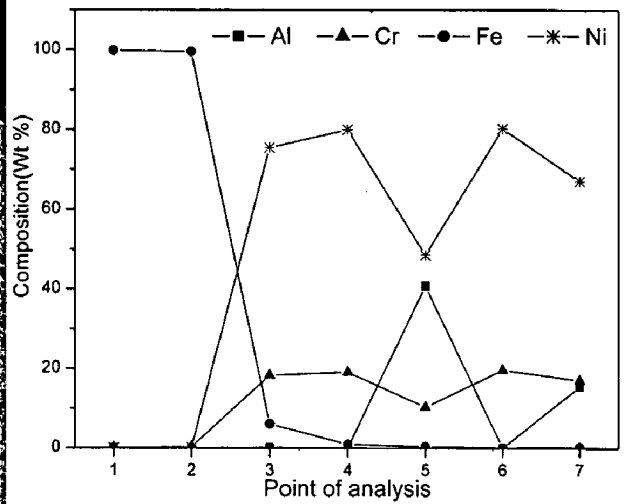
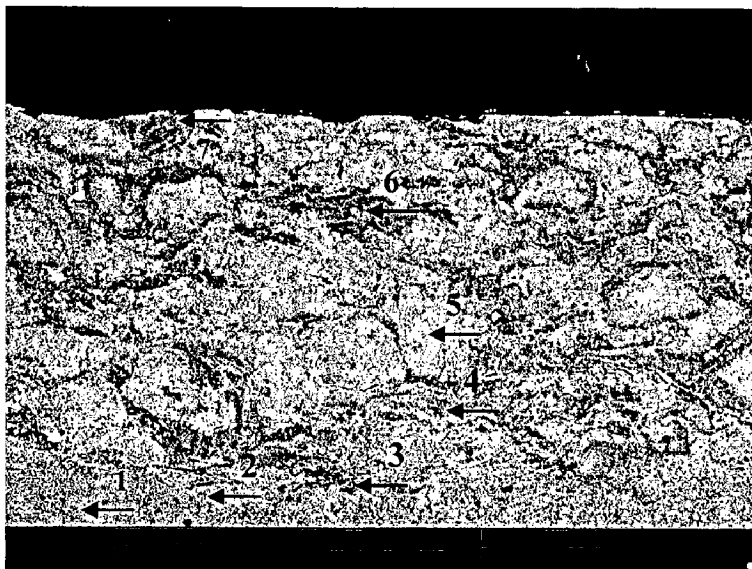
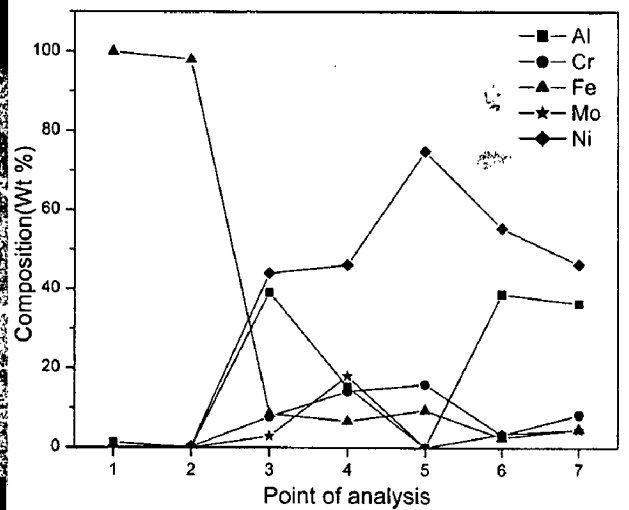
**Fig. 4.11** Back scattered electron image and EDAX point analysis (wt %) across the cross-section of the as-sprayed coating deposited on T22 steels:  
 (a) NiCrAl coatings      (b) NiAlCrFeMo coatings

The BSE images were obtained at the cross-section of the coatings and the EDAX compositional analyses at different points along the cross-section of the as-sprayed coatings are shown in Figs. 4.11 and 4.12. The EDAX analysis at Point 4 of the NiCrAl coatings

(Fig. 4.11a) and point 5 of the NiAlCrFeMo coatings (Fig. 4.11b) are found to be rich in nickel content which are identified as the partially melted splats. The chemical composition profile of the NiCrFeSiB coating (Fig. 4.12a) indicates homogeneous elemental concentration throughout the thickness of the coating. Further, the microstructure of the WC-Co/NiCrFeSiB coating (Fig. 4.12b) is characterized by WC+Co aggregates (Points 4 and 6) enveloped by the nickel alloy particles (point 5).

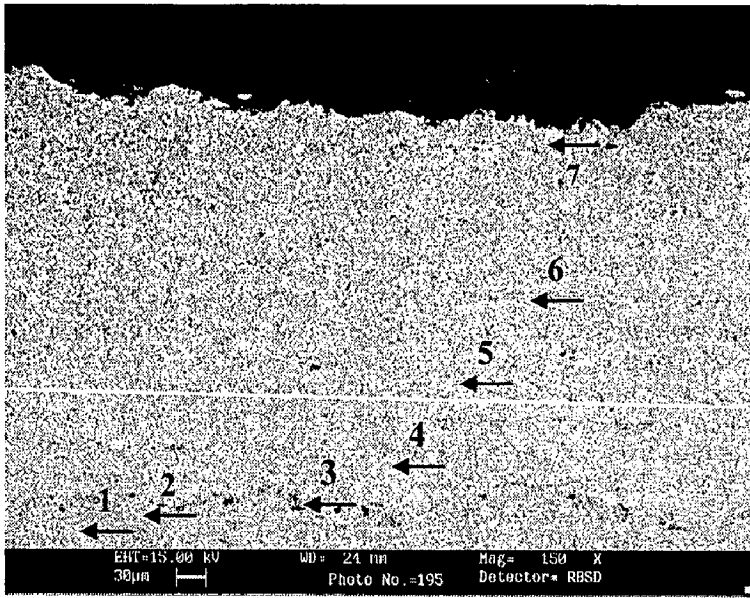
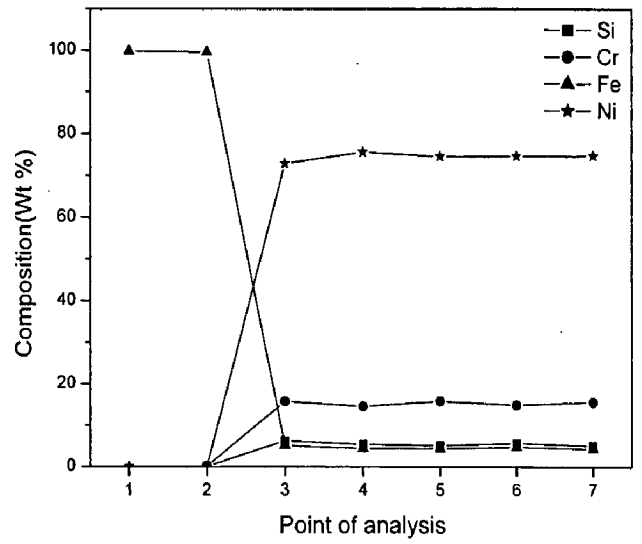
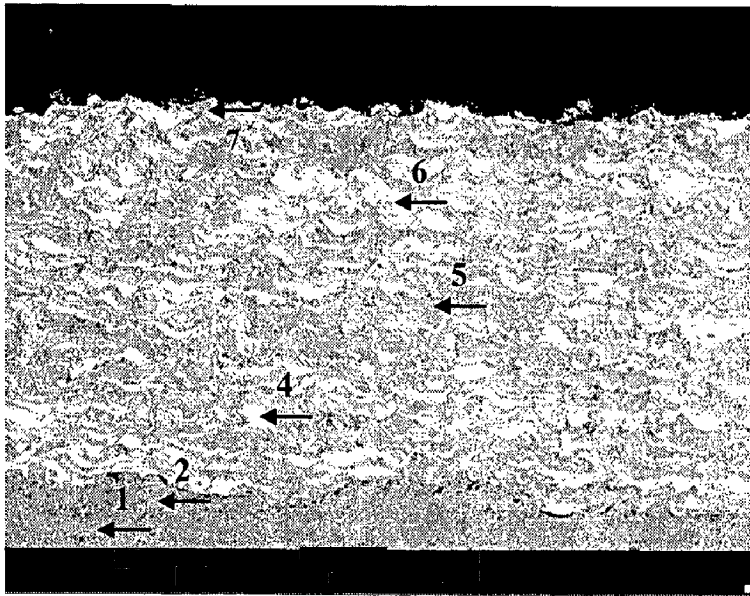
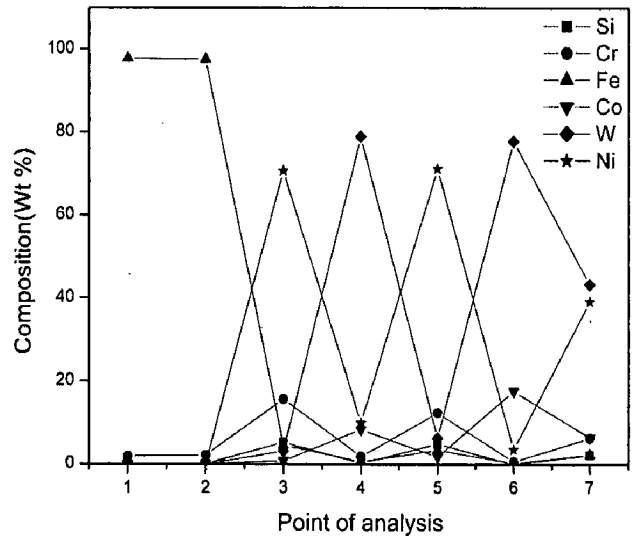
**Fig. 4.12** Back scattered electron image and EDAX point analysis (wt %) across the cross-section of the as-sprayed coatings deposited on T11 steels:  
 (a) NiCrFeSiB coatings (b) WC-Co/NiCrFeSiB coatings

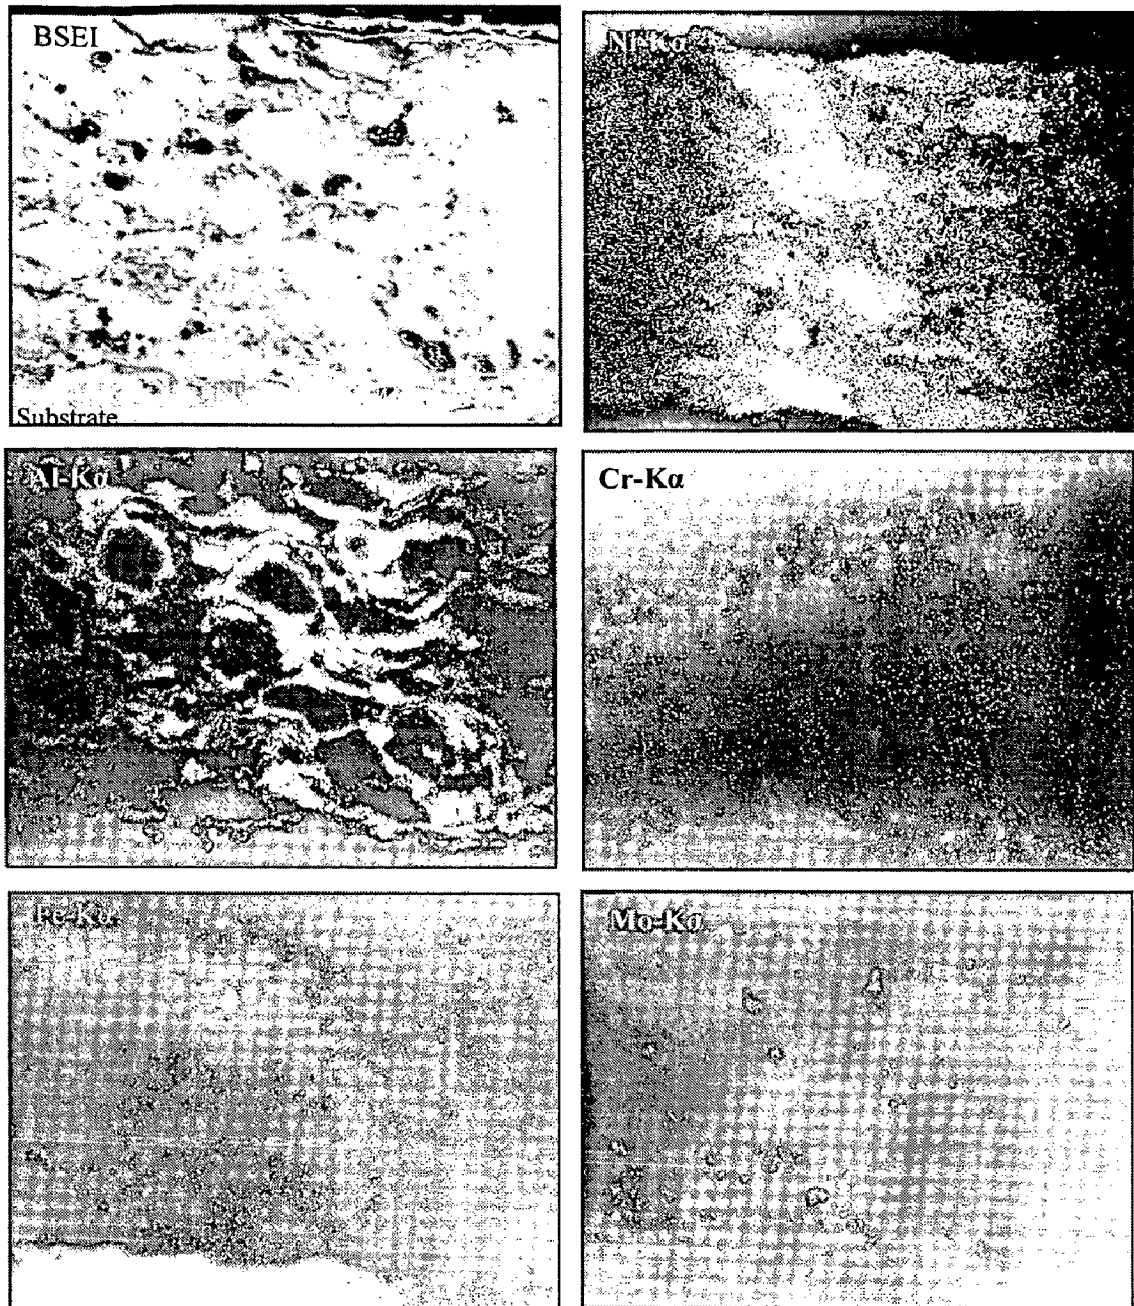
**Fig. 4.14** BSEI and elemental X-ray mapping at the cross-section of the as-sprayed NiAlCrFeMo coating on T22 steel.

The elemental mapping for the NiAlCrFeMo coating (Fig. 4.14) shows higher intensity for nickel. The Aluminum shows a tendency to distribute mainly along the splat boundaries in the form of ridges. The clusters of molybdenum are also present at the splat boundaries. A uniform distribution is observed for chromium and iron along the splat boundary. It is evident from the observation across the coating-substrate interface that a minor amount of nickel and aluminum are diffused from the coating into the substrate steel.

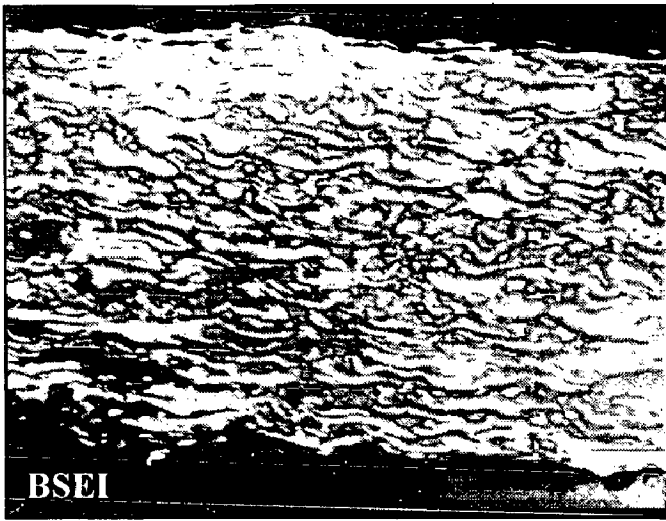
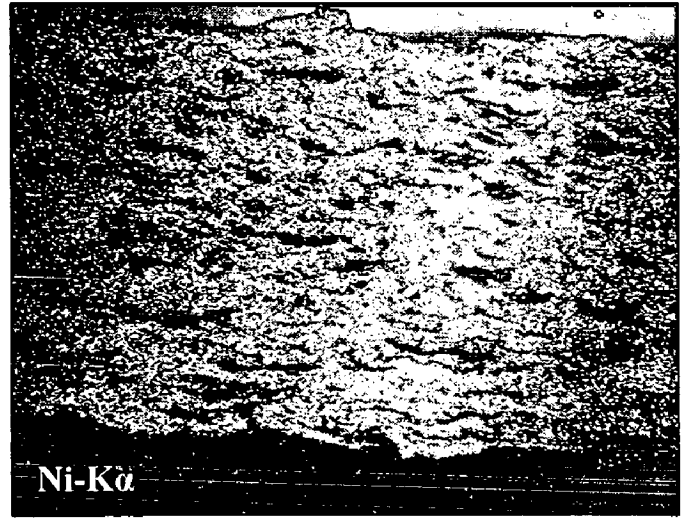
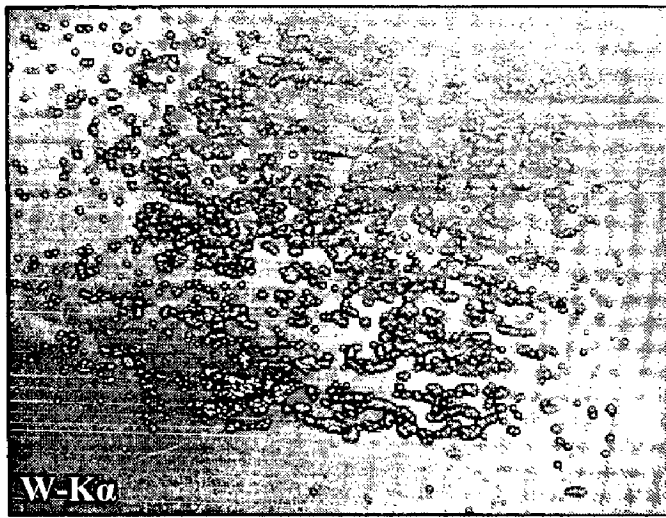
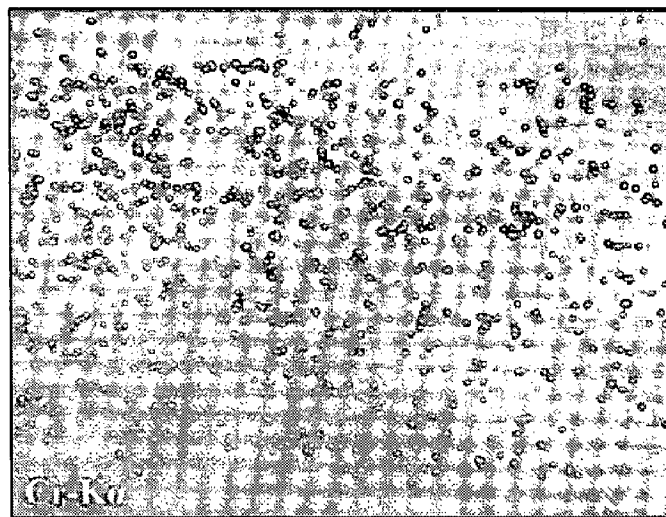
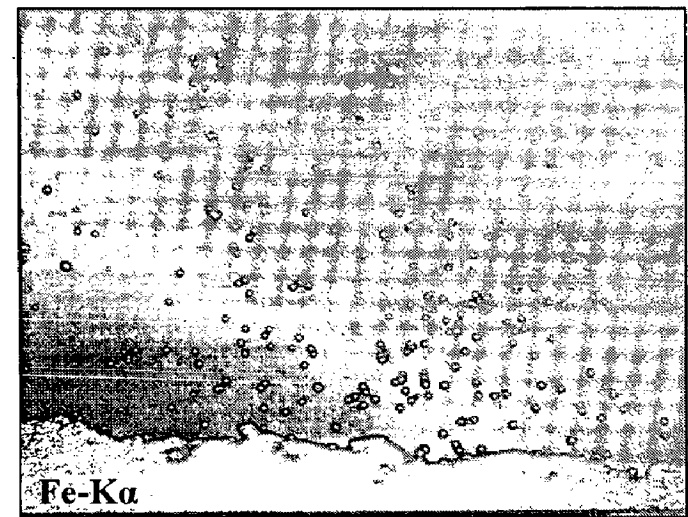
**Fig. 4.16** BSEI and elemental X-ray mapping at the cross-section of the as-sprayed WC-Co/NiCrFeSiB coating on GrA1 steel.

The qualitative X-ray mapping images for the as-sprayed coatings, which indicate the distribution chemistry of the various elements in the scanned area, are shown in Figs. 4.13 to 4.16. The intensity of the images gives an idea about the relative concentration of the element in a particular phase.

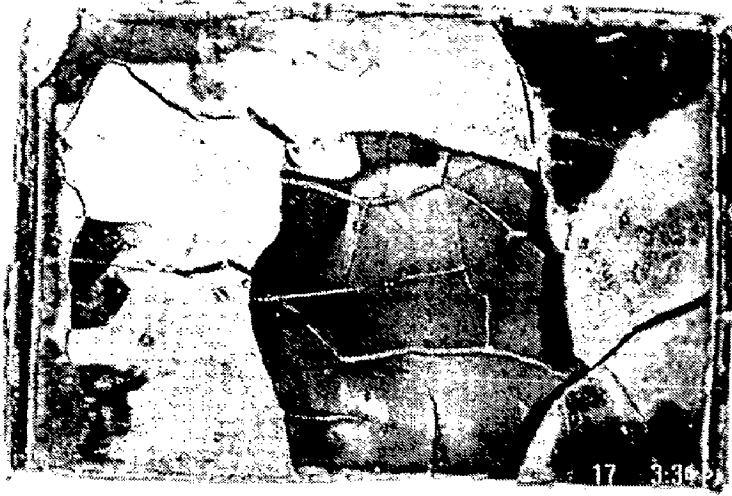
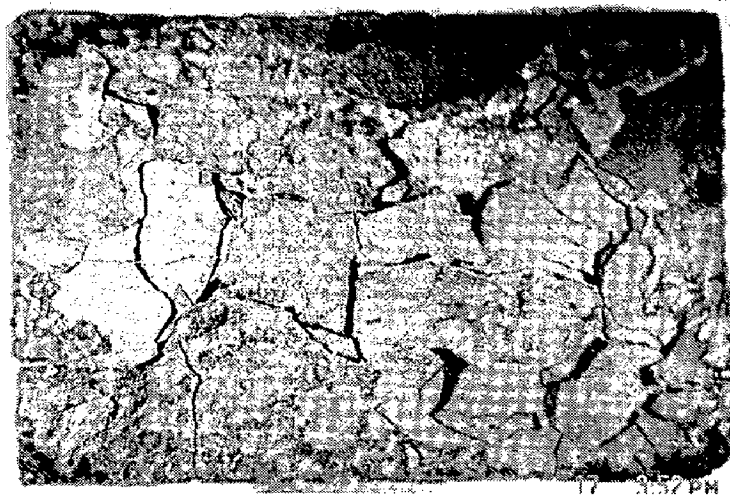
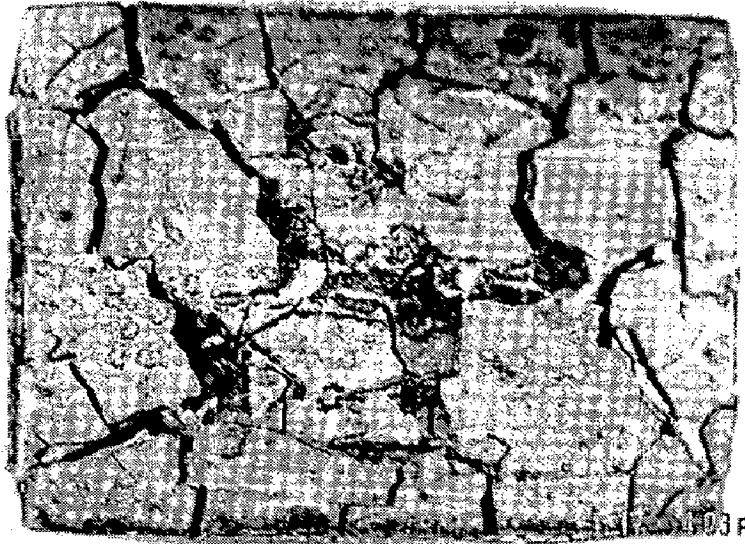
**Fig. 5.1**

Macrographs of bare boiler steels subjected to cyclic oxidation in air at 900°C for 50 cycles:

(a) GrA1 steels (b) T11 steels (c) T22 steels

The macrographs of the GrA1, T11 and T22 steel specimens subjected to cyclic oxidation for 50 cycles at 900°C are shown in Fig. 5.1. All the steels developed a dark grey colored oxide scale. During the cyclic oxidation, the minimum spallation of scale was observed for the T11 steels as compared to the other steels. The scale formed on the T22 steel, found to be fragile and cracked from centre of the sample.

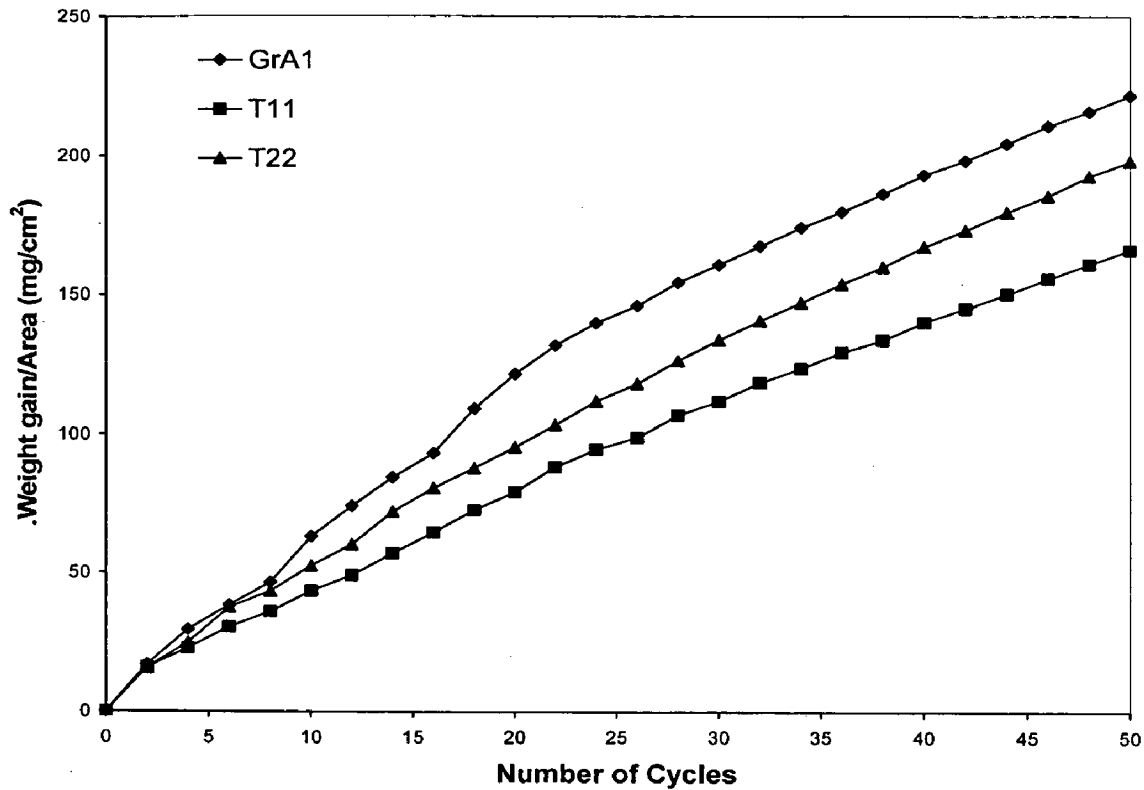
**Fig. 5.2** Weight gain vs. number of cycles plot for uncoated steels subjected to cyclic oxidation for 50 cycles in air at 900°C

The plots of cumulative weight gain ( $\text{mg}/\text{cm}^2$ ) as a function of time expressed in number of cycles are shown in Fig. 5.2. The weight gain for the GrA1, T11 and T22 steels at the end of 50 cycles are found to be 221.5, 165.9 and 197.7  $\text{mg}/\text{cm}^2$ , respectively. Evidently, the GrA1 steel shows the maximum weight gain during the course of the study. Further, the weight gain square ( $\text{mg}^2/\text{cm}^4$ ) data has been plotted as a function of time, as shown in Fig. 5.3, to establish law governing the corrosion. This plot shows the observable deviation from the parabolic rate law for all types of steel, which indicate that the oxide films were weakly protective at 900°C. The parabolic rate constant  $K_p$  was calculated by a linear least-square algorithm function in the form of  $(\Delta W/A)^2 = K_p \times t$ , where  $\Delta W/A$  is the weight gain per unit area, and  $t$  is the oxidation time in seconds. The values of  $K_p$  for the

GrA1, T11 and T22 are found to be  $29.14 \times 10^{-8}$ ,  $15.87 \times 10^{-8}$  and  $22.54 \times 10^{-8} \text{ g}^2 \text{ cm}^4 \text{ s}^{-1}$  respectively.

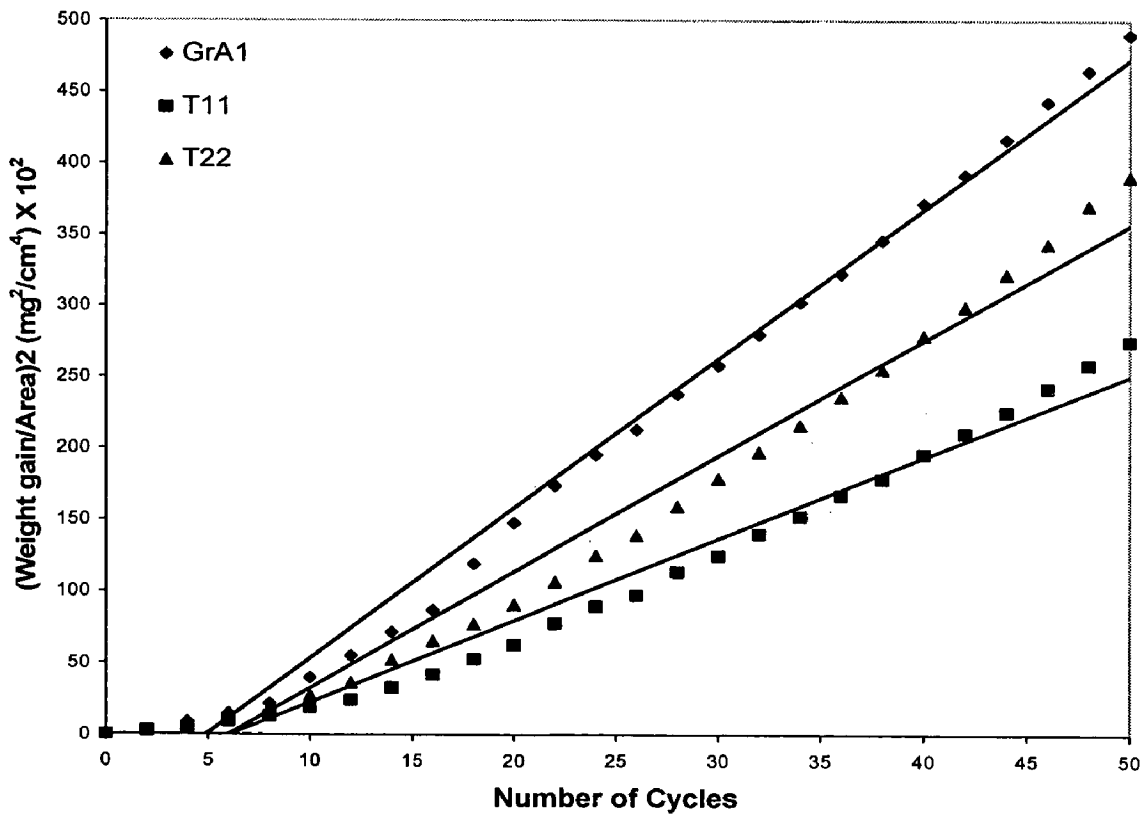
**Fig. 5.3**  $(\text{Weight gain/area})^2$  vs. number of cycles plot for uncoated steels subjected to cyclic oxidation for 50 cycles in air at 900°C

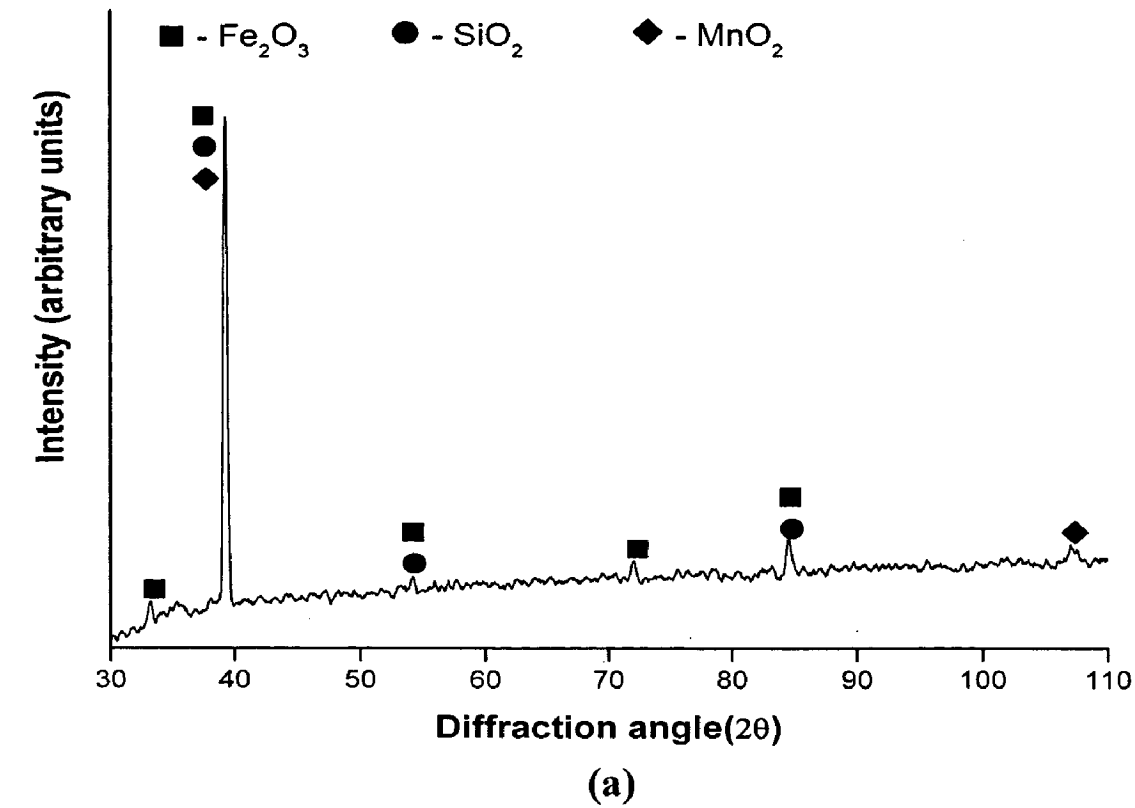
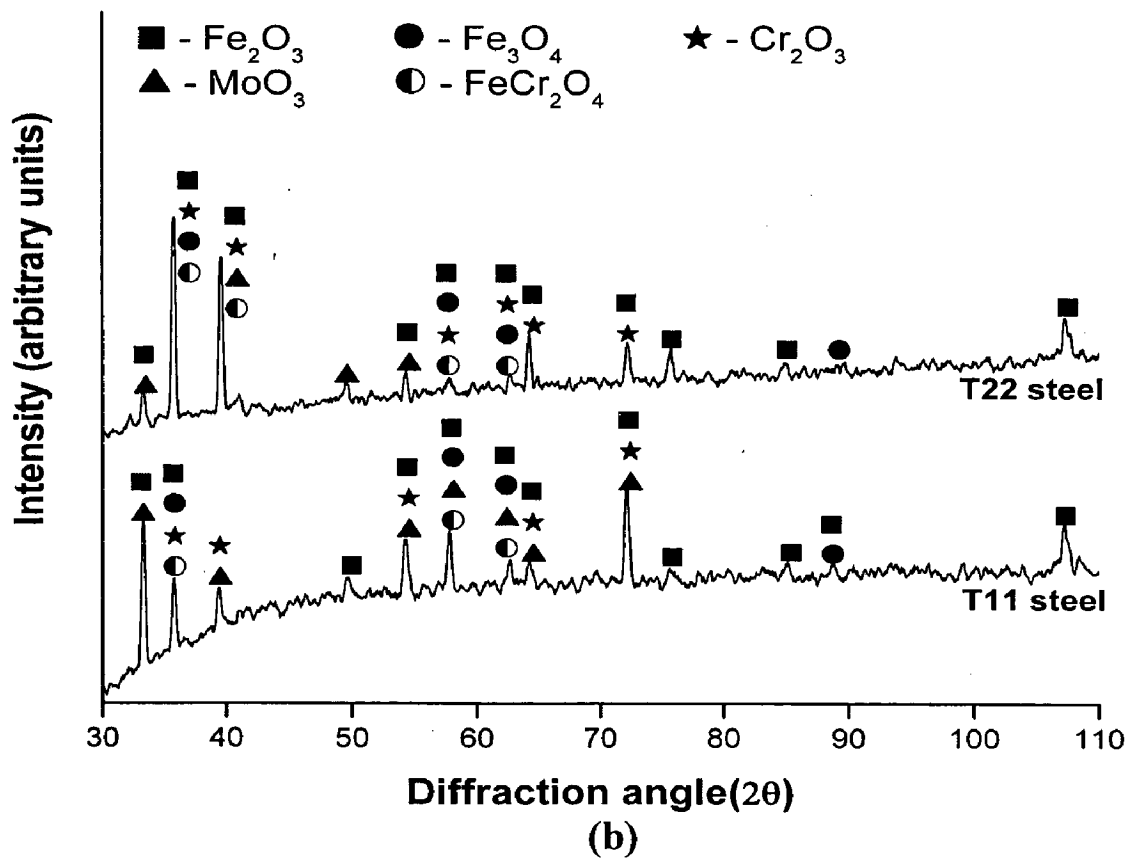
**Fig.5.4** X-ray diffraction patterns for the uncoated steels subjected to cyclic oxidation for 50 cycles in air at  $900^\circ\text{C}$ :  
 (a) GrA1 Steel (b) T11 and T22 steels

The X-ray diffraction pattern for the steels, after exposure to air at  $900^\circ\text{C}$  for 50 cycles is compiled in Fig. 5.4. As obvious from the composition, all the steels show  $\text{Fe}_2\text{O}_3$  as the major peak, whereas the minor peaks of  $\text{Fe}_3\text{O}_4$ ,  $\text{Cr}_2\text{O}_3$  and  $\text{MoO}_3$  are found in the oxide scale of T11 and T22 steels. Further, the “d” values matched well with the rhombohedral mixed oxide of Fe and Cr, viz.  $\text{FeCr}_2\text{O}_4$ .

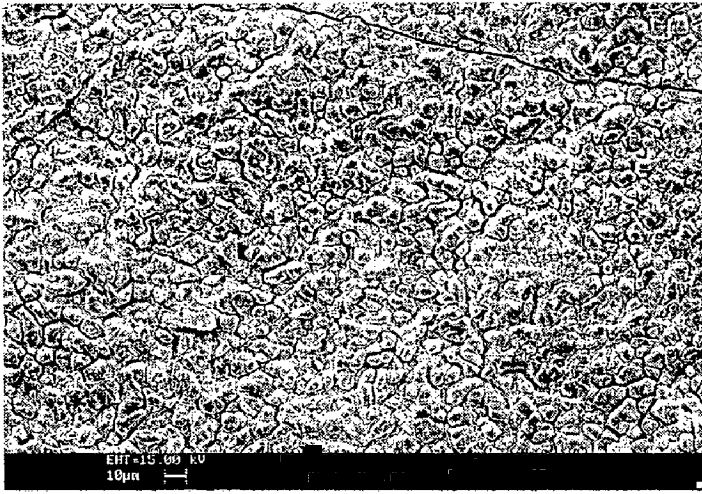
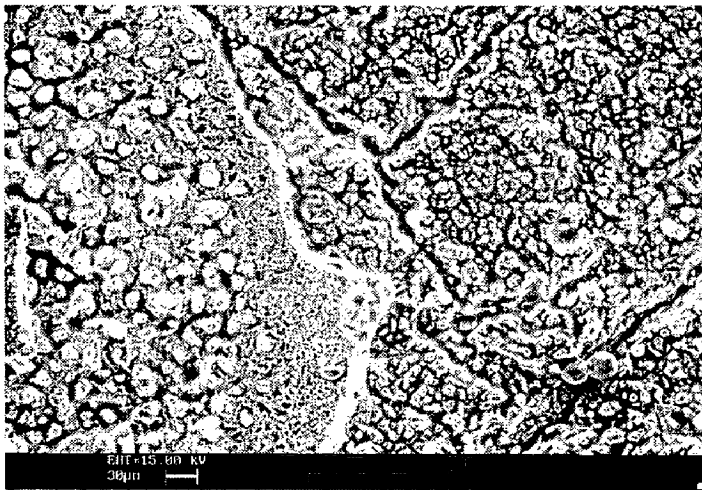
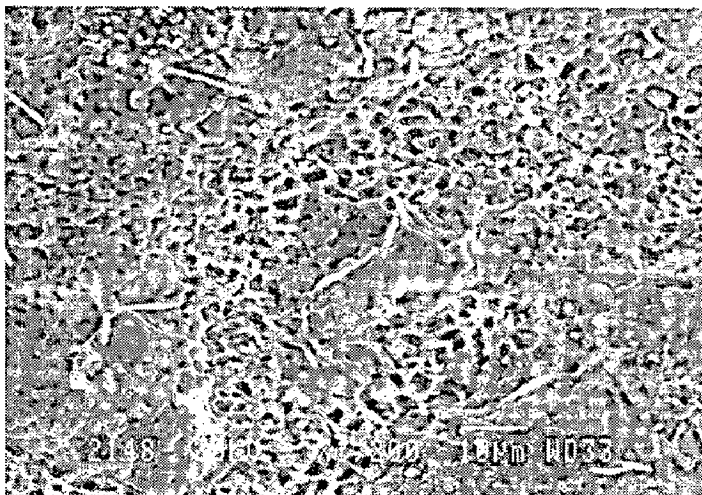
99.31% Fe<sub>2</sub>O<sub>3</sub>

97.51% Fe<sub>2</sub>O<sub>3</sub>  
2.04% MnO

94.65% Fe<sub>2</sub>O<sub>3</sub>  
2.96% Cr<sub>2</sub>O<sub>3</sub>  
2.03% MnO

**Fig. 5.5** Surface scale morphology and EDAX area analysis for the uncoated steels subjected to cyclic oxidation in air at 900°C for 50 cycles:  
(a) GrA1 Steel                      (b) T11 Steel                      (c) T22 Steel

The SEM micrograph showing the scale morphology along with the EDAX analysis is shown in Fig. 5.5. The iron oxide is the main constituent of the scale in case of all the steels. All other minor elements and chromium had depleted considerably. The surface scale, in case of the GrA1 and T11 steels show intergranular cracking. Figure 5.6 shows the BSEI taken along the cross section of the oxidized samples. Deep pits are seen along the metal-scale interface, which grows laterally, meets one another and leads to the formation of cracks. This crack allows the oxygen to reach the metal surface, and increased oxidation eventually ends in spalling of scale. The multi-laminations, as seen in the cross section of oxide scale, weaken its protection against oxidation. The EDAX point analysis (Fig. 5.6c) along the cross section confirms iron oxide as the major phase.
