# **STUDIES ON THE ROLE OF HVOF COATINGS IN IMPROVING RESISTANCE TO HOT CORROSION AND EROSION**

## **A THESIS**

**DOCTOR OF PHILOSOPHY**

**METALLURGICAL AND MATERIALS ENGINEERING**

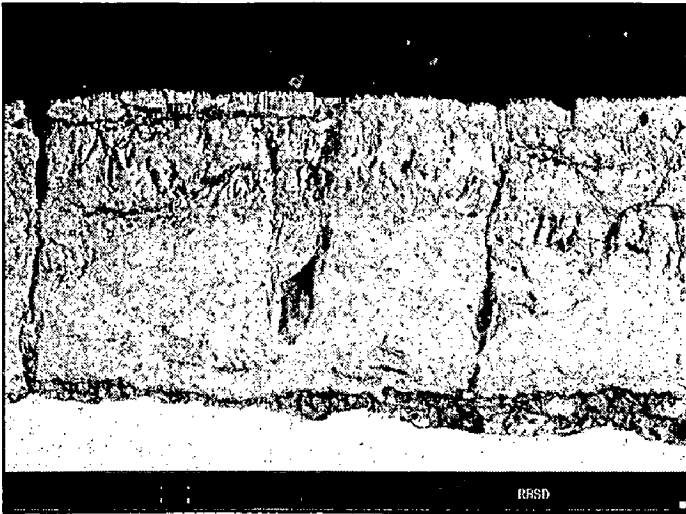
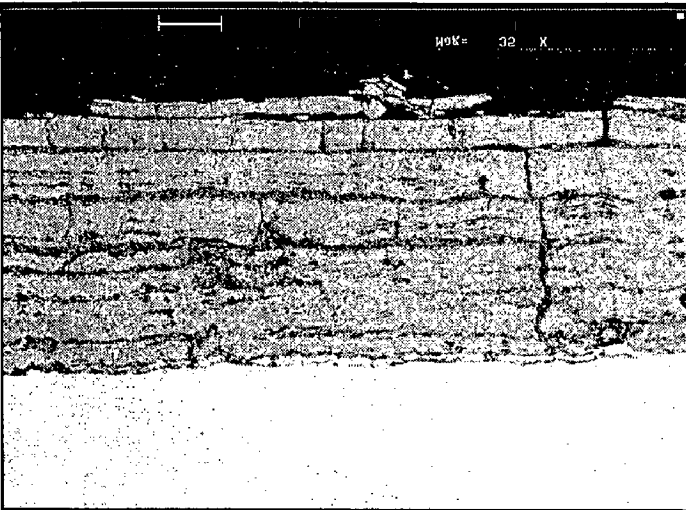
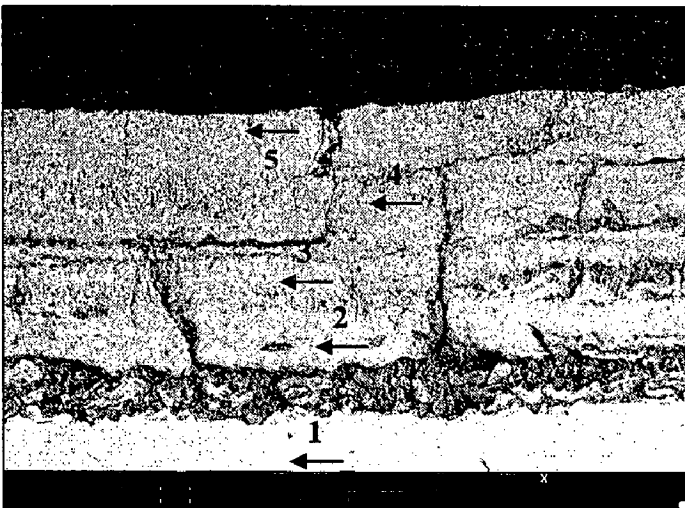
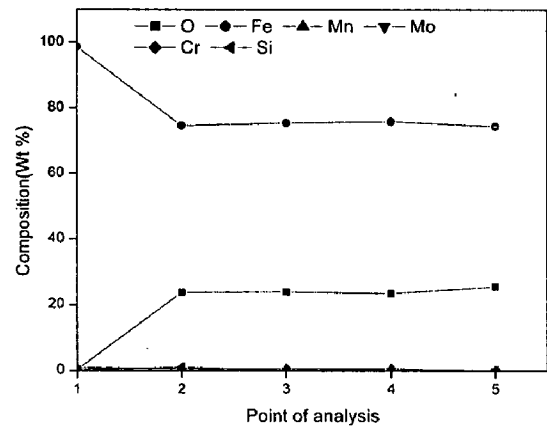
**Fig.5.6** Back scattered images for the uncoated steels after cyclic oxidation in air at 900°C for 50 cycles  
 (a) GrA1 Steel (b) T11 Steel (c) T22 Steel  
 (d) EDAX point analysis along the cross-section of T22 steel

The SEM micrograph showing the scale morphology along with the EDAX analysis is shown in Fig. 5.5. The iron oxide is the main constituent of the scale in case of all the steels. All other minor elements and chromium had depleted considerably. The surface scale, in case of the GrA1 and T11 steels show intergranular cracking. Figure 5.6 shows the BSEI taken along the cross section of the oxidized samples. Deep pits are seen along the metal-scale interface, which grows laterally, meets one another and leads to the formation of cracks. This crack allows the oxygen to reach the metal surface, and increased oxidation eventually ends in spalling of scale. The multi-laminations, as seen in the cross section of oxide scale, weaken its protection against oxidation. The EDAX point analysis (Fig. 5.6c) along the cross section confirms iron oxide as the major phase.

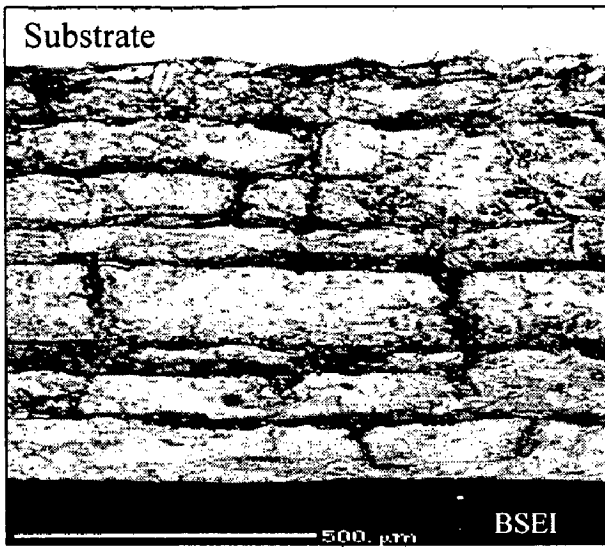
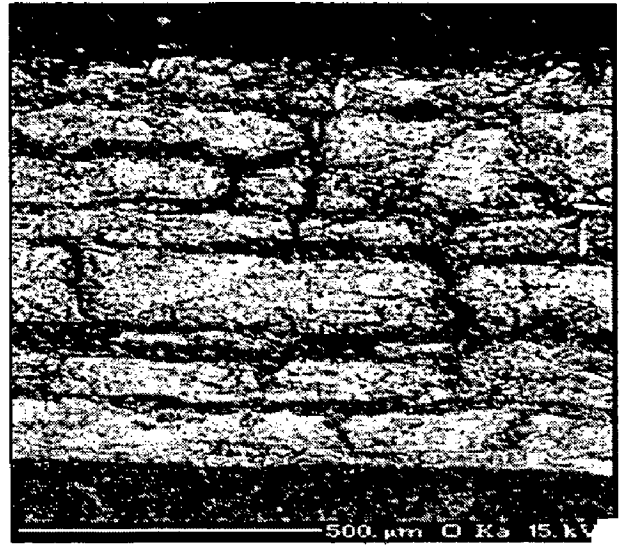
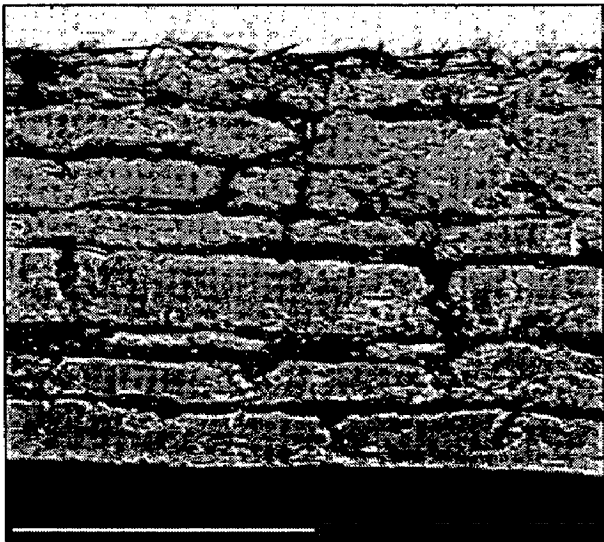
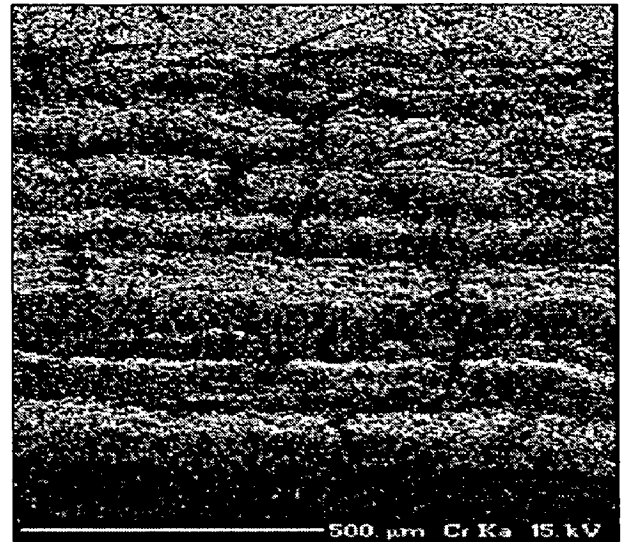
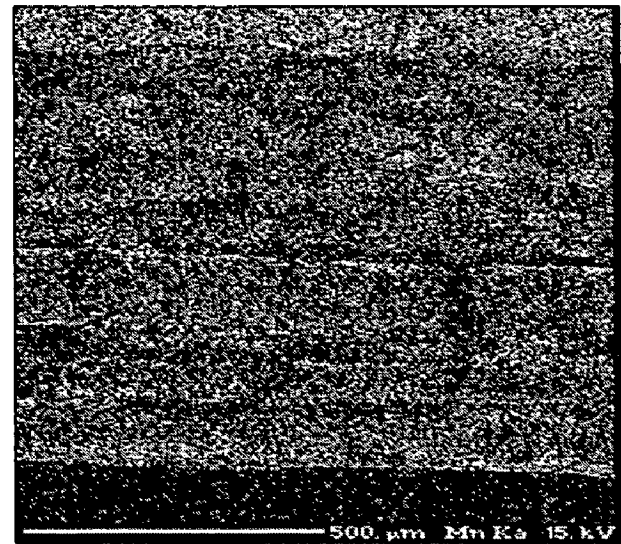
**Fig.5.7** BSEI and X-ray mapping of the cross-section of T22 boiler steel subjected to cyclic oxidation for 50 cycles in air at 900°C

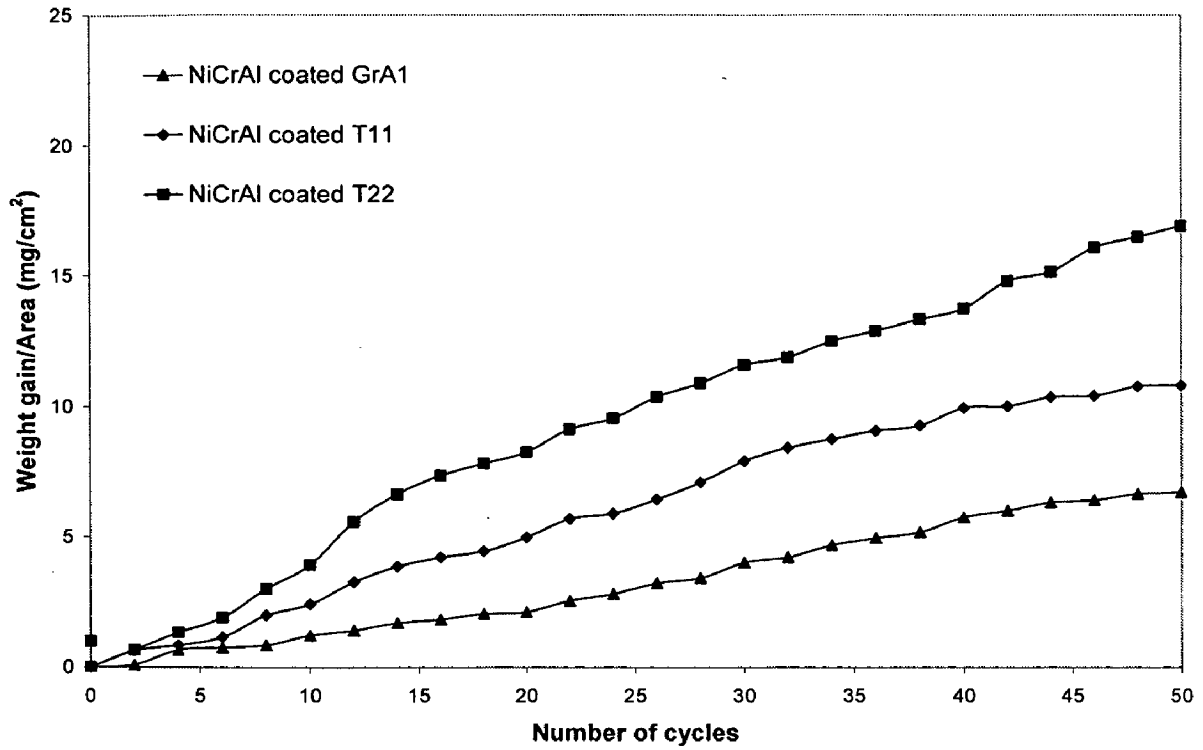
**Fig.5.9** Weight gain vs. number of cycles plot for NiCrAl coated steels subjected to oxidation for 50 cycles in air at 900°C

The plots of cumulative weight gain ( $\text{mg}/\text{cm}^2$ ) as a function of time expressed in number of cycles are illustrated in Fig. 5.9. The NiCrAl coated T22 steels showed a maximum weight gain in comparison to the coated GrAl and T11 steels. Extents of weight gain in all the coated steels are similar up to the 12<sup>th</sup> cycle and, thereafter, the coated T22 showed a higher weight gain in comparison to the other coated steels. The weight gain for the coated GrAl, T11 and T22 steels at the end of 50 cycles of cyclic oxidation is found to be 6.7, 10.8 and 16.91  $\text{mg}/\text{cm}^2$ , respectively.

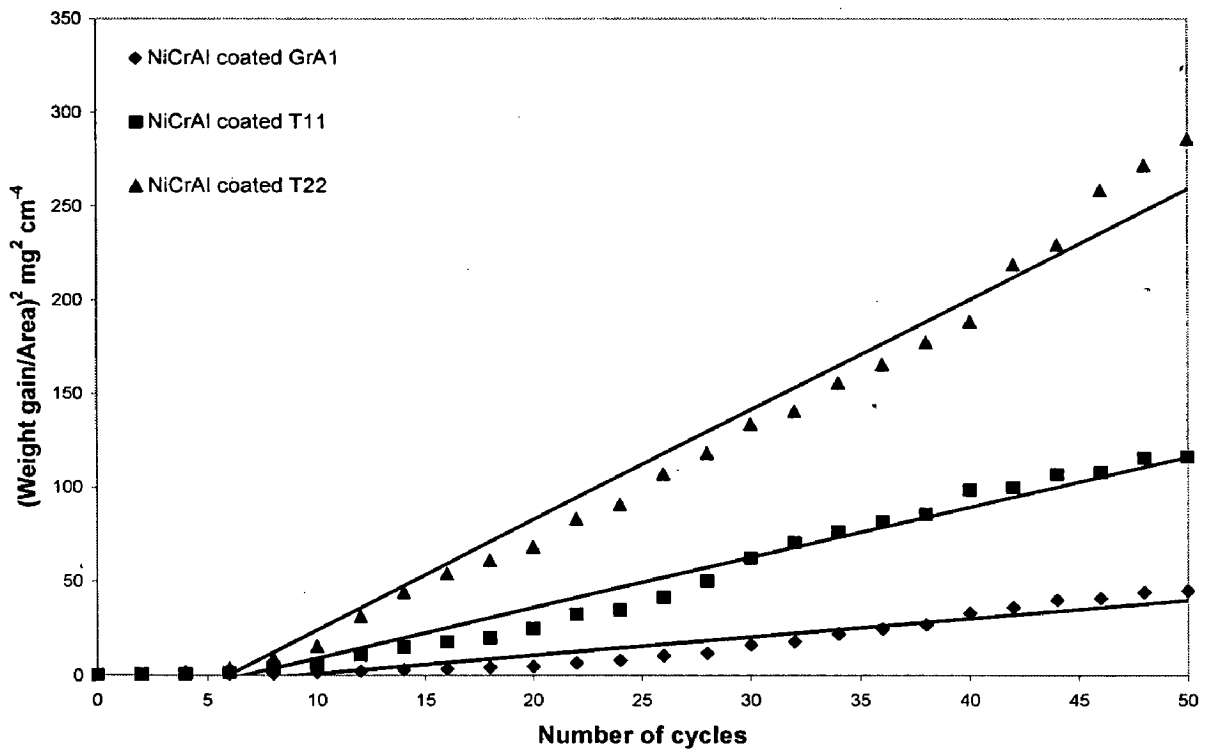
**Fig.5.10** (Weight gain/area)² vs. number of cycles plot for NiCrAl coated steels subjected to oxidation for 50 cycles in air at 900°C

Further, the weight gain square ( $\text{mg}^2/\text{cm}^4$ ) data were plotted as a function of time, as shown in Fig. 5.10, to establish the rate law for oxidation. From Fig. 5.10, it can be envisaged that the oxidation behavior of the coated GrAl and T11 steels is parabolic in nature up to 50 cycles. The plot for the coated T22 steels showed a perceptible deviation from the parabolic rate law. The parabolic rate constant  $K_p$ , as calculated from the slope of the linear regression fitted line for the NiCrAl coated GrAl, T11 and T22 steels is  $0.027 \times 10^{-8}$ ,  $0.075 \times 10^{-8}$  and  $0.164 \times 10^{-8} \text{ g}^2 \text{ cm}^4 \text{ s}^{-1}$ , respectively.

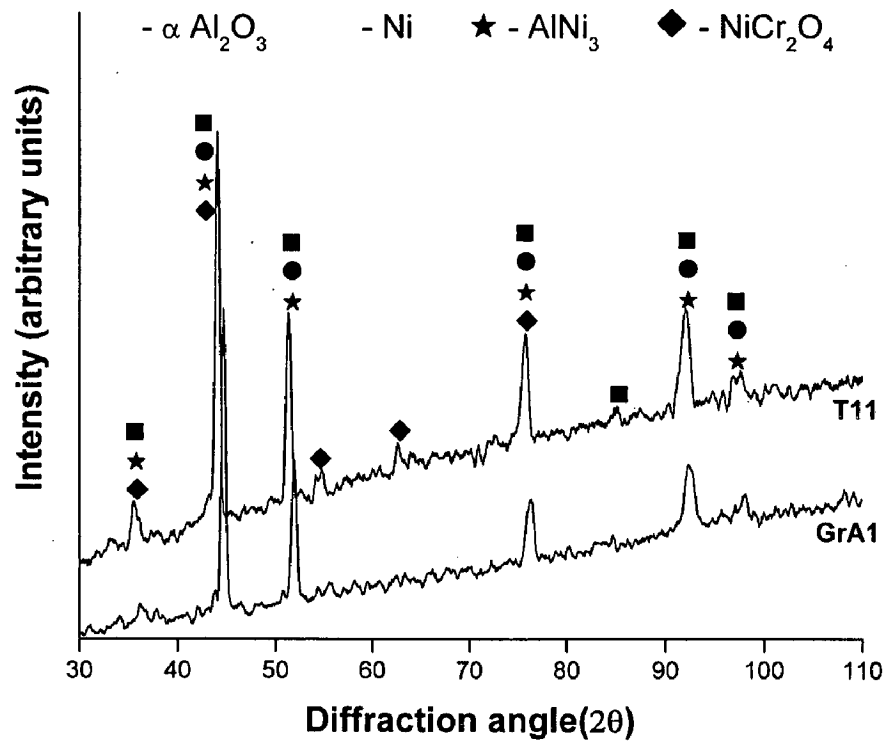
**Fig.5.11** X-ray diffraction patterns for NiCrAl coated GrA1 and T11 steels subjected to cyclic oxidation in air for 50 cycles at 900°C

The X-ray diffraction patterns for the NiCrAl coated GrAl and T11 steels are shown in Fig. 5.11 which revealed the phases of  $\alpha\text{-Al}_2\text{O}_3$ , Ni,  $\text{AlNi}_3$  and mixed spinel-type oxide,  $\text{NiCr}_2\text{O}_4$ . The XRD plot for the NiCrAl coated T22 steel is shown in Fig. 5.12. The presence of  $\text{Fe}_2\text{O}_3$  has been revealed along with the phases of  $\alpha\text{-Al}_2\text{O}_3$ ,  $\text{Cr}_2\text{O}_3$ , and  $\text{NiCr}_2\text{O}_4$ .

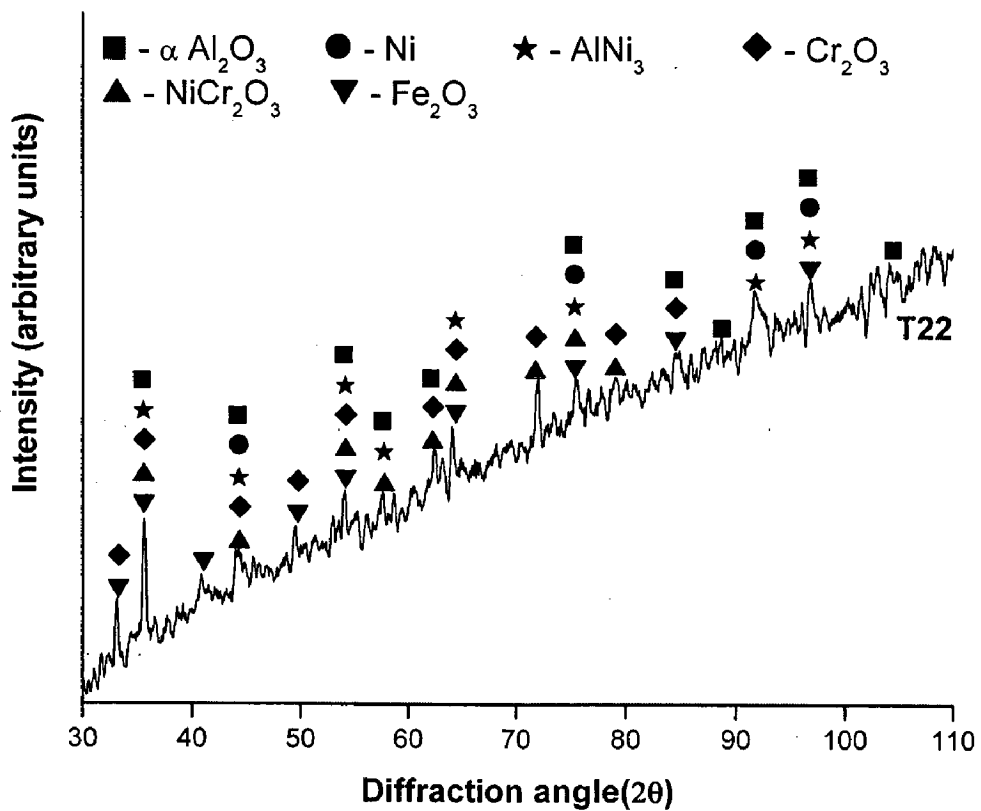
**Fig.5.12** X-ray diffraction patterns for NiCrAl coated T22 steels subjected to cyclic oxidation in air for 50 cycles at 900°C

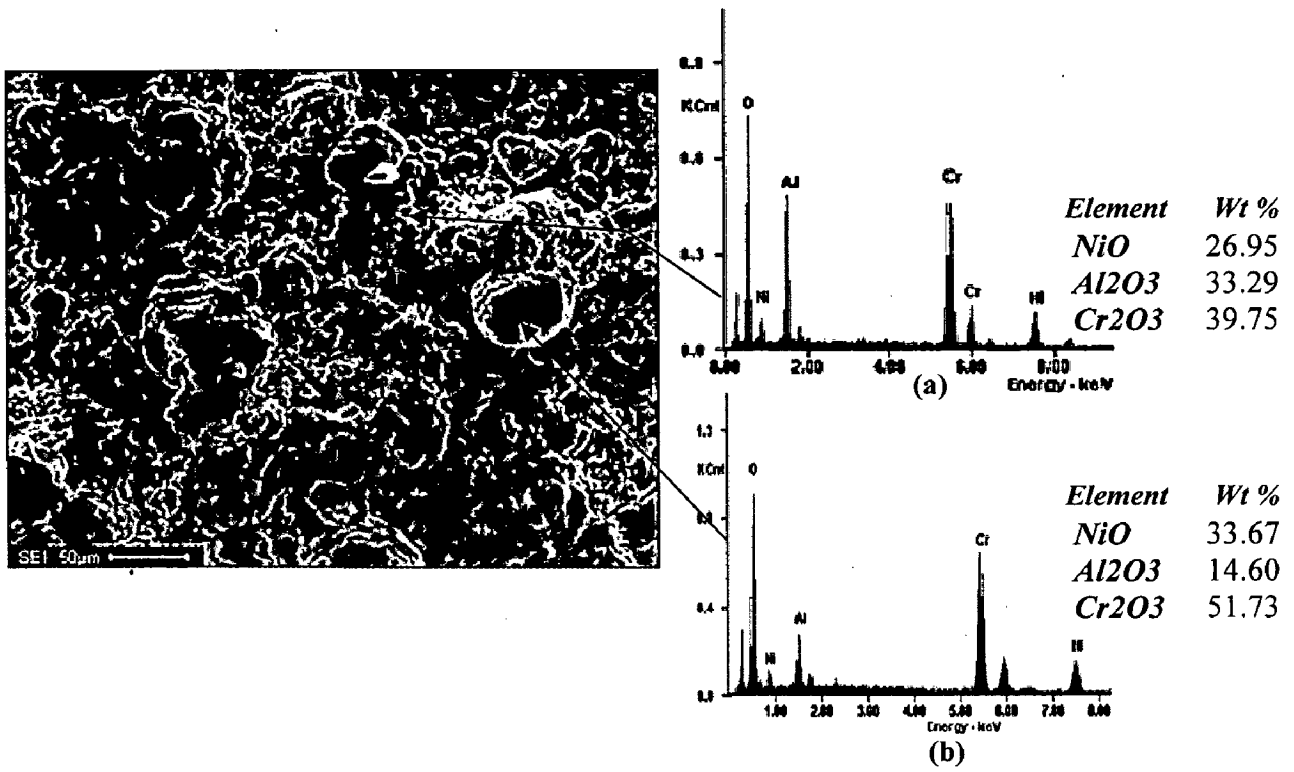
**Fig.5.13** SEM and EDAX point analysis for NiCrAl coatings on GrAl steel subjected to oxidation for 50 cycles in air at 900°C

The SEM micrograph showing the scale morphology along with the EDAX analysis is demonstrated in Figs. 5.13–5.15. The surface of the oxide scale shows different morphologies of its constituents. The EDAX analysis on nearly spherical globule (Fig. 5.13b) on the surface corresponds to a higher amount of Ni and Cr oxides, while the

matrix (Fig. 5.13a) indicates an increased content of  $\text{Al}_2\text{O}_3$ . The EDAX area analysis on the surface of NiCrAl coated T11 steels (Fig. 5.14) also shows the protective oxides of Ni and Cr. The surface morphology of the coated T22 steels (Fig. 5.15) shows oxide protrusion, and the EDAX analysis on this protrusion confirmed that it is  $\text{Fe}_2\text{O}_3$ , which might have oozed out from the substrate.

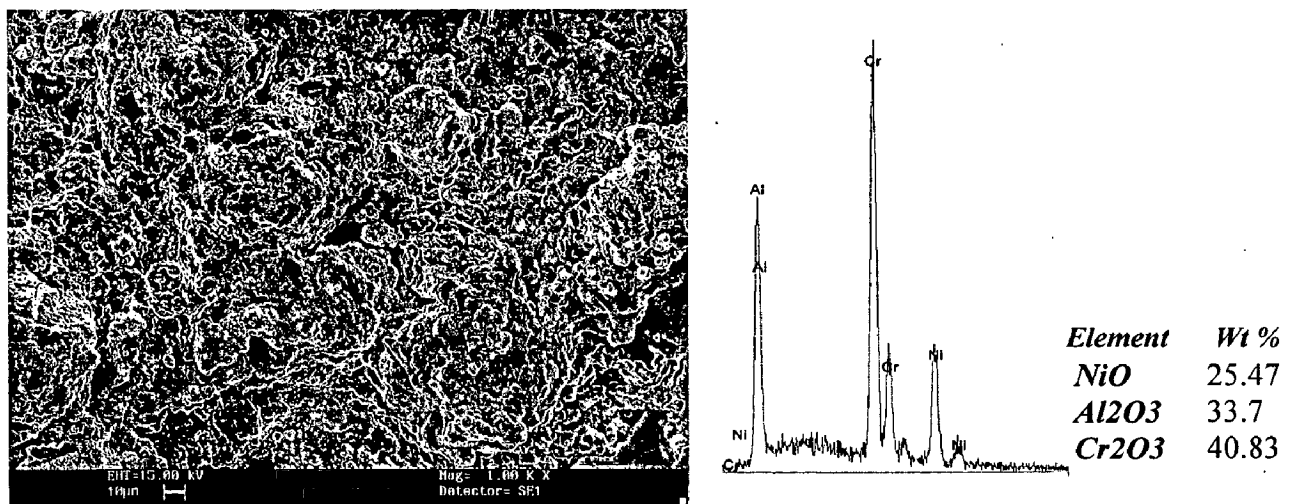
**Fig.5.14** SEM and EDAX area analysis for NiCrAl coatings on T11 substrate steel subjected to oxidation for 50 cycles in air at 900°C

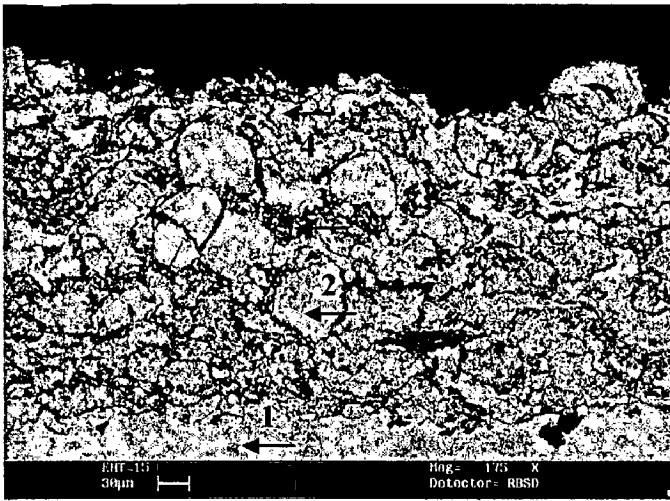
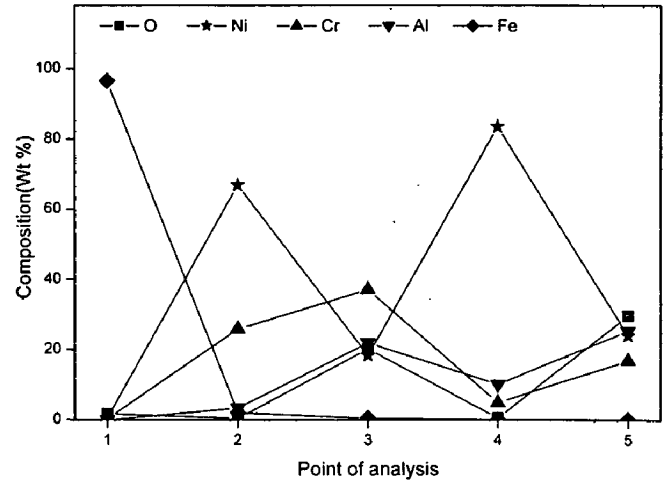
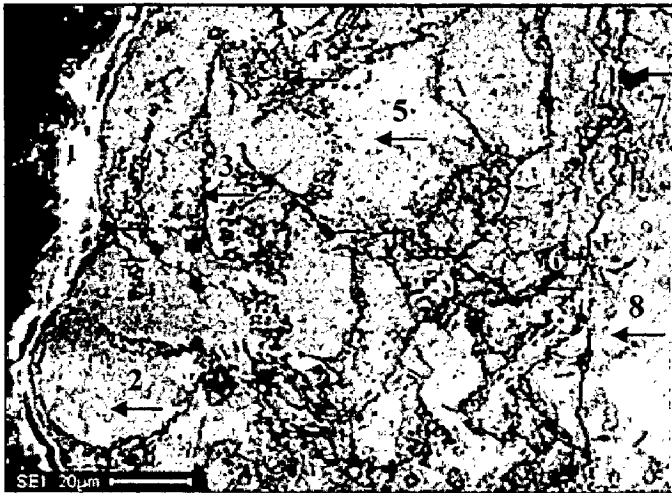
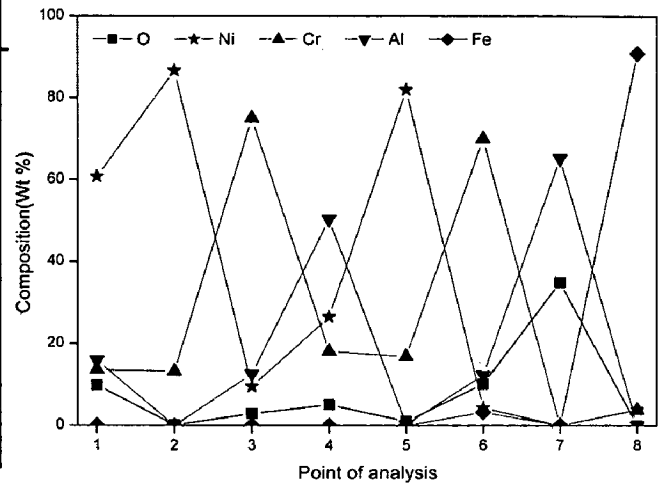
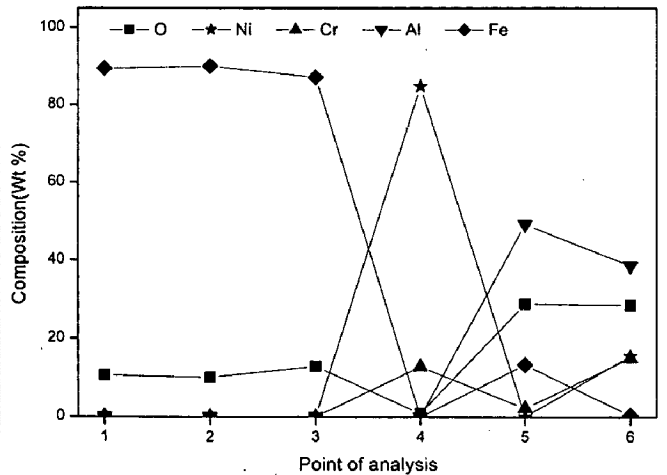
**Fig. 5.16** Back scattered electron image and EDAX point analysis (wt %) across the cross-section of the NiCrAl coated steels subjected to cyclic oxidation for 50 cycles in air at 900°C : (a) GrA1 steel (b) T11 steel (c) T22 steel

Similarly, Fig. 5.16 shows the BSEI taken along the cross section of the oxidized NiCrAl coated steels and the EDAX composition analysis at the point of interest. Figure 5.16a shows the point analysis along the cross section of the oxidized NiCrAl coated GrAl steel. The EDAX analysis at point 5 shows the presence of  $\text{Al}_2\text{O}_3$  and the oxides of Ni and Cr. The presence of oxygen at point 3 indicates that the coating might have got oxidized along the splat boundaries, whereas the absence of oxygen at point 2 shows that the Ni-rich splat has not got oxidized.

The analysis for the oxidized NiCrAl coated T11 steels, as illustrated in Fig. 5.15b, shows that the outermost layer of the scale mainly consists of the oxides of Ni, Al, and Cr. The points 2 and 5 indicate Ni and Cr-rich splat in an unoxidised state, as oxygen is absent at this point. At points 3 and 5, the concentration of Cr, Al and O is high; which reveals about the internal oxidation along the splat boundary. The black phase present at the coating substrate interface (point 7) is found to be rich in elements Al and O and, therefore, it is an inclusion of the alumina particles as already discussed in Chapter 5.

Figure 5.16c shows the BSEI/EDAX analysis along the cross-section of the oxidized NiCrAl coated T22 steel. The EDAX analysis at the points 1, 2 and 3 revealed the presence of only Fe and O. This implies that iron oxide has oozed out from the substrate on to the surface of the coatings along the crack formed during the oxidation studies. The crack has followed the path along the splat boundary via the open porosity. Similarly, the point 5 shows the presence of  $\text{Al}_2\text{O}_3$  and  $\text{Cr}_2\text{O}_3$  along with a minor amount of  $\text{Fe}_2\text{O}_3$ . It is also observed that the corrosion of substrate occurred to a large extent near the area where the coating is cracked.

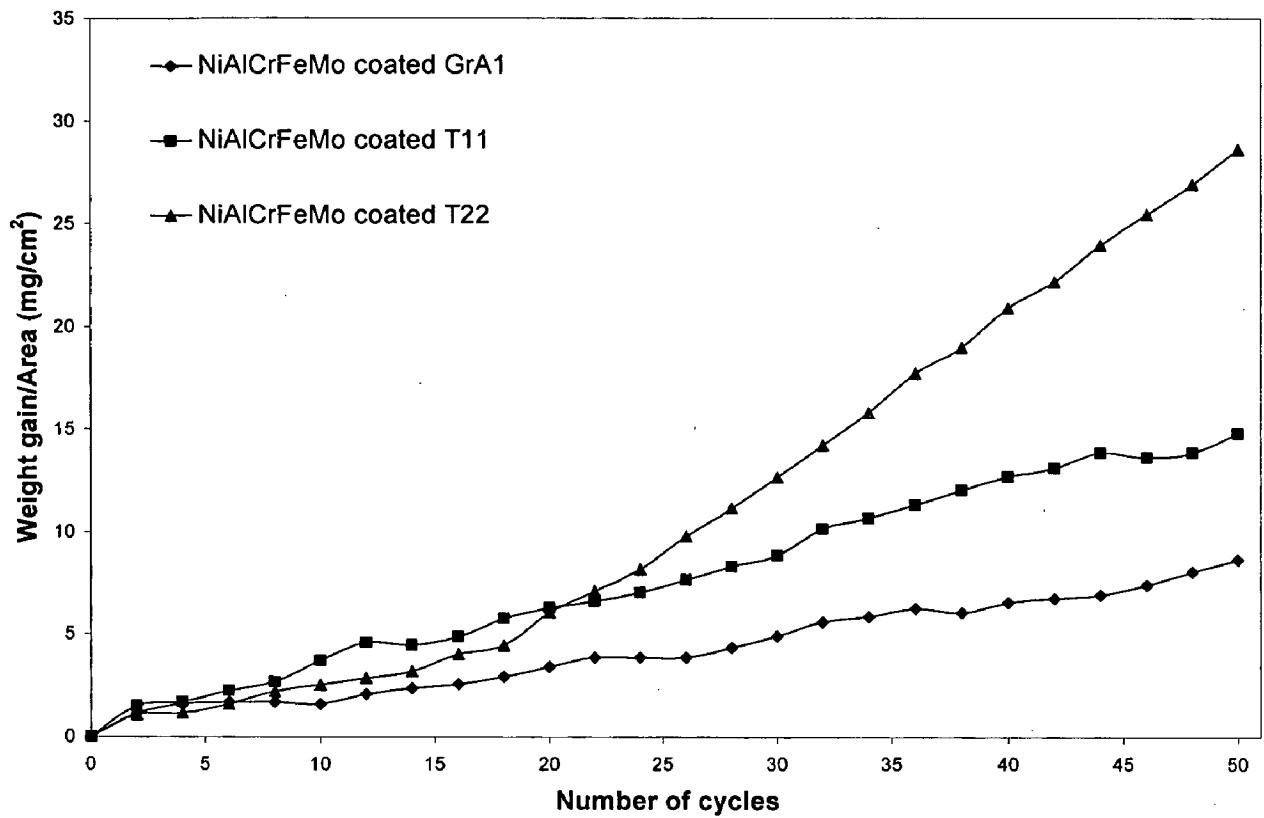
**Fig.5.20** Weight gain vs. number of cycles plot for NiAlCrFeMo coated steels subjected to oxidation for 50 cycles in air at 900°C

The plots of cumulative weight gain as a function of time are shown in Fig.5.20. NiAlCrFeMo coated T22 steel show higher weight gain in comparison to other coated steels. The weight gain for coated GrA1, T11 and T22 steels at the end of 50 cycles of oxidation found to be 8.6, 14.79 and 28.63  $\text{mg}/\text{cm}^2$  respectively. Further the weight gain square ( $\text{mg}^2/\text{cm}^4$ ) data were plotted as a function of time, as shown in Fig 5.21. The kinetics of oxidation of coated GrA1 and T11 steels are almost parabolic in nature. The parabolic rate constant  $K_p$ , as calculated from slope of the linear regression fitted line for coated GrA1 and T11 steels are found to be  $0.372 \times 10^{-8}$  and  $1.26 \times 10^{-8} \text{ g}^2 \text{ cm}^{-4} \text{ s}^{-1}$  respectively. The T22 Steel followed linear behaviour from 18<sup>th</sup> cycle of oxidation study.

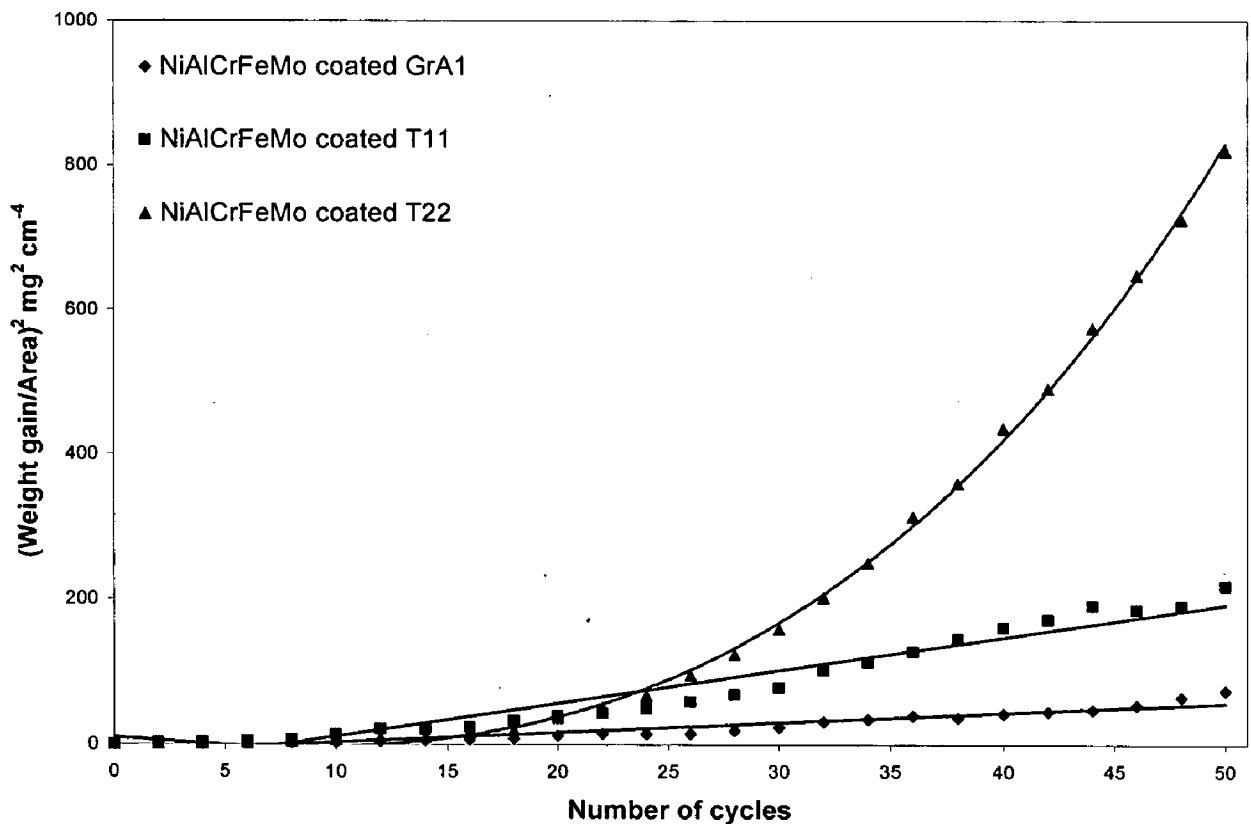
**Fig.5.21** (Weight gain/area)² vs. number of cycles plot for NiAlCrFeMo coated steels subjected to oxidation for 50 cycles in air at 900°C

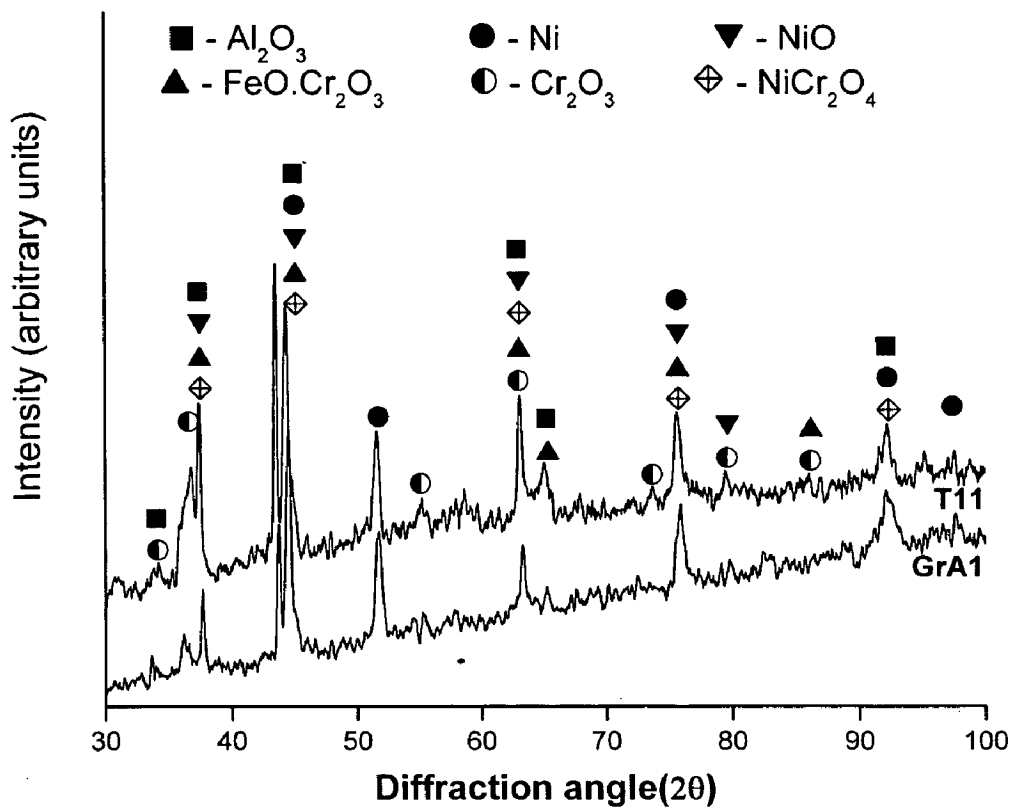
**Fig.5.22** X-ray diffraction patterns for NiAlCrFeMo coated GrA1 and T11 steels subjected to cyclic oxidation in air for 50 cycles at 900°C

The X-ray diffraction pattern for NiAlCrFeMo coated GrA1 and T11 steels (Fig.5.22) shows the phases of Ni, Al<sub>2</sub>O<sub>3</sub>, Cr<sub>2</sub>O<sub>3</sub>, NiO, NiCr<sub>2</sub>O<sub>4</sub> and FeO.Cr<sub>2</sub>O<sub>3</sub>. The oxide scale formed on the NiAlCrFeMo coated T22 steel (Fig.5.23) mainly consisted of Al<sub>2</sub>O<sub>3</sub>, Cr<sub>2</sub>O<sub>3</sub>, NiO, Fe<sub>2</sub>O<sub>3</sub>, NiCr<sub>2</sub>O<sub>4</sub> and NiMoO<sub>4</sub>.

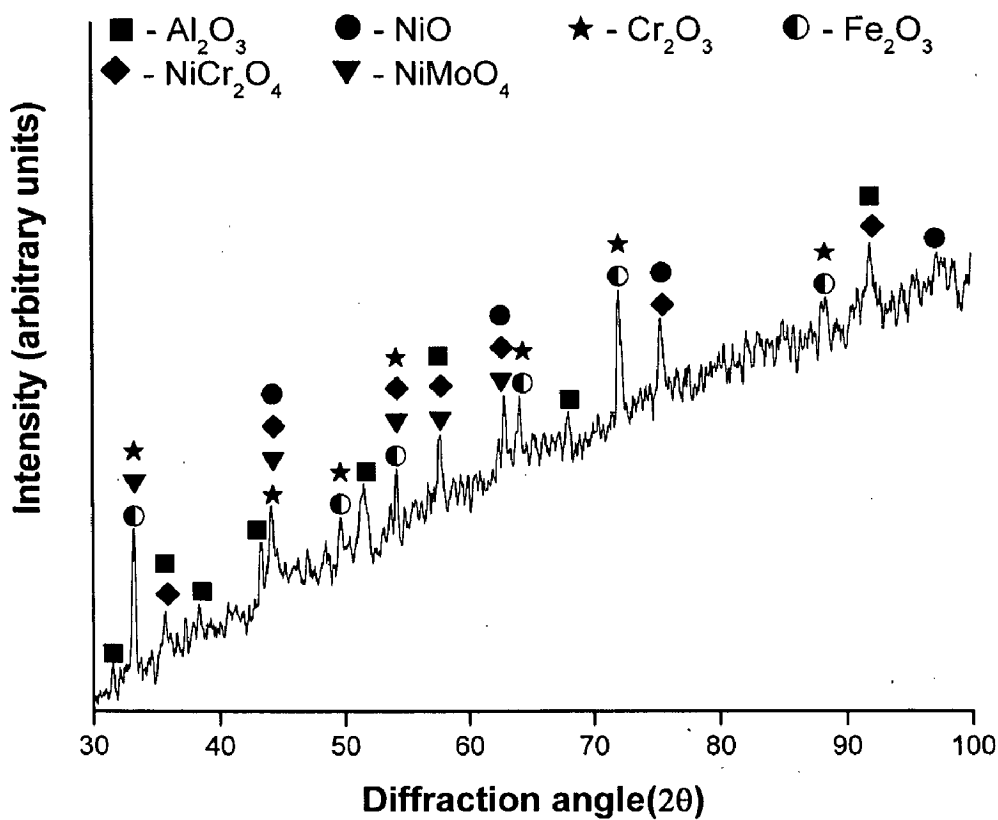
**Fig.5.23** X-ray diffraction patterns for NiAlCrFeMo coated T22 steels subjected to cyclic oxidation in air for 50 cycles at 900°C

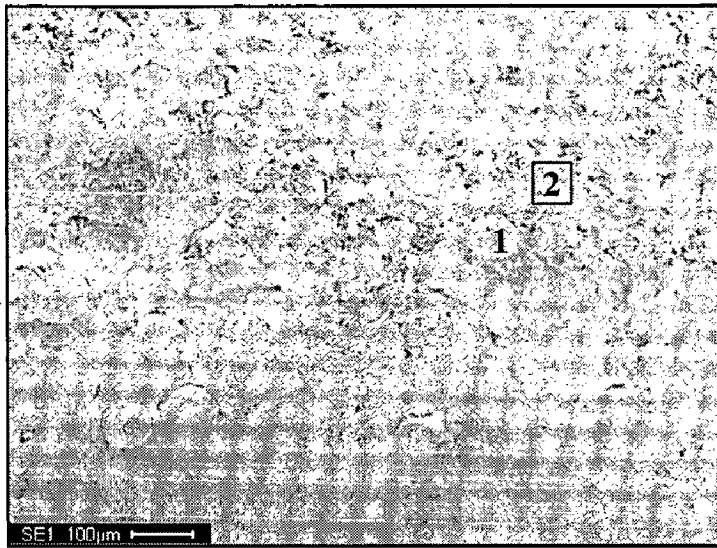
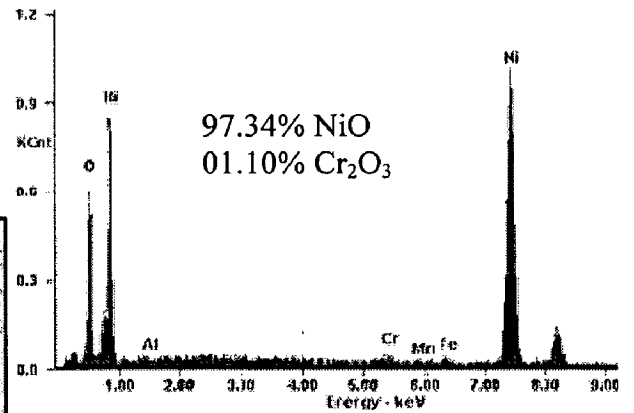
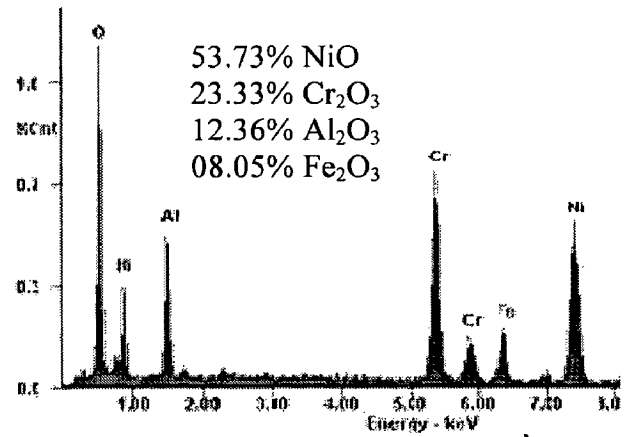
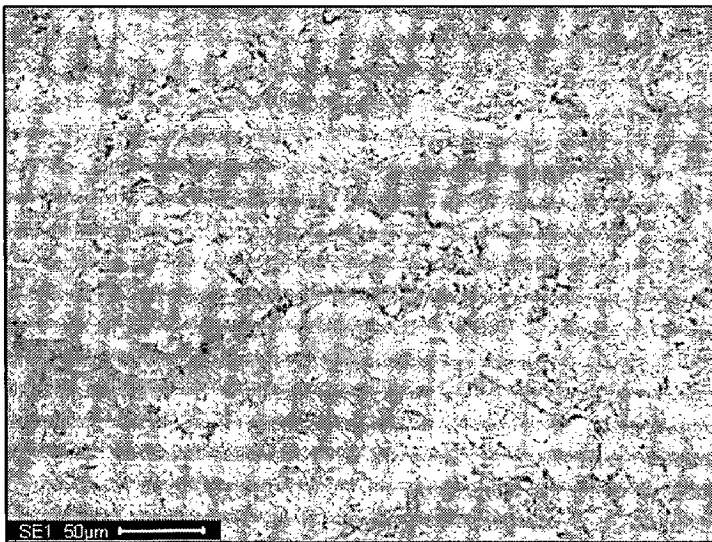
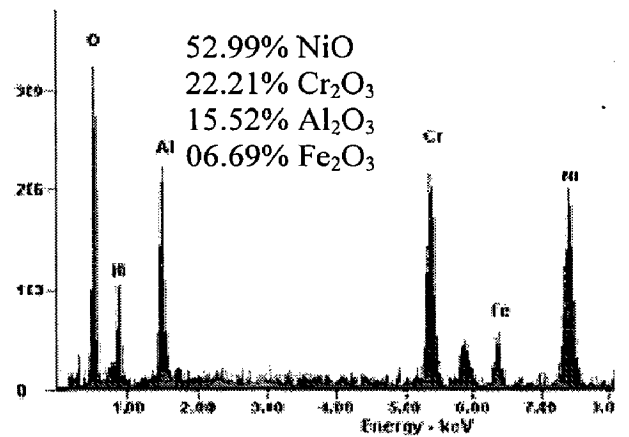
**Fig.5.24** Surface scale morphology and EDAX analysis for NiAlCrFeMo coated GrA1 and T11 steels subjected to oxidation for 50 cycles in air at 900°C  
 (a) GrA1 steel      (b) T11 steel

Fig.5.24a shows the surface morphology of oxide scale formed on the oxidized NiAlCrFeMo coated GrA1 steel. Oxide scale consists of spherical globules dispersed in the non uniform matrix. The EDAX analysis revealed spherical globules as nickel rich splats (97.3% NiO) and the matrix composed of NiO (53.7%), Cr<sub>2</sub>O<sub>3</sub> (23.3%), Al<sub>2</sub>O<sub>3</sub> (12.36%) and Fe<sub>2</sub>O<sub>3</sub> (8.05%). Corresponding analysis on the surface of coated T11 steel (Fig.5.24b) mainly consist of nickel oxide along with the oxides of Cr, Al and Fe. Protrusions formed on the surface of coated T22 steel is as shown in Fig.5.25a. The blown-up area on the protrusion (Fig.5.25b) clearly shows the growth oriented outwards on the surface. Iron rich area has been detected by EDAX analysis (Point 2) on the protrusions. EDAX analysis on the matrix (Point 1) shows the oxide layer consist of oxides of Ni, Cr, Al and Fe.

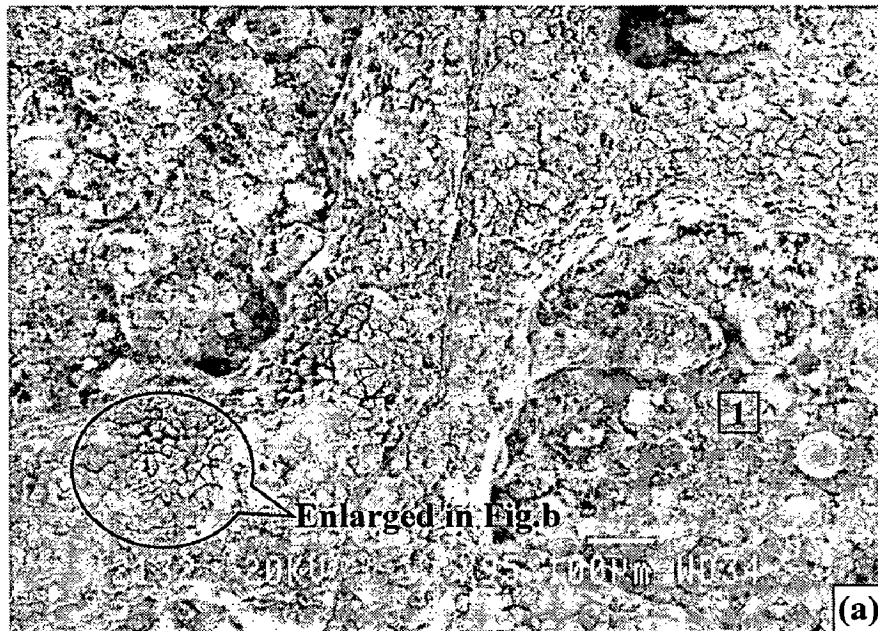
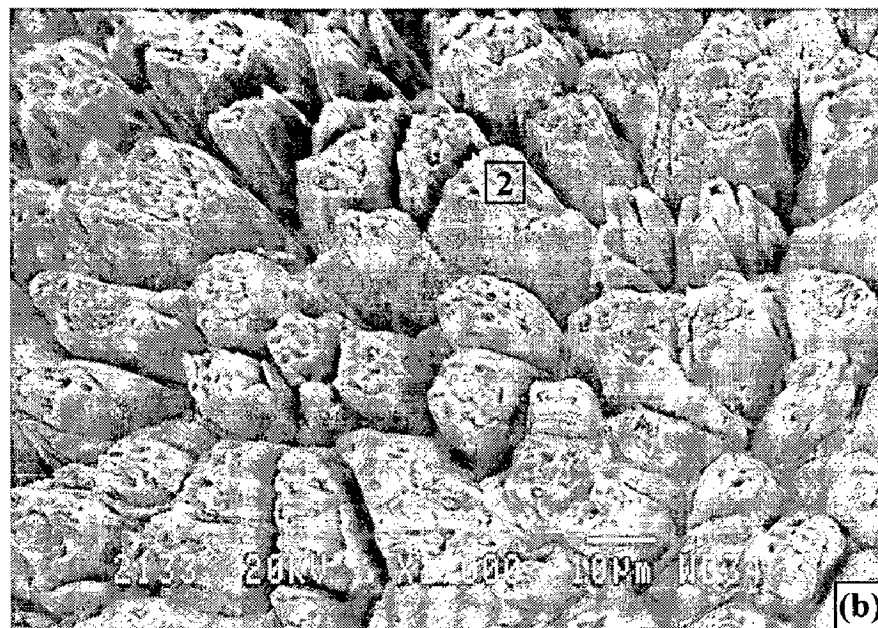
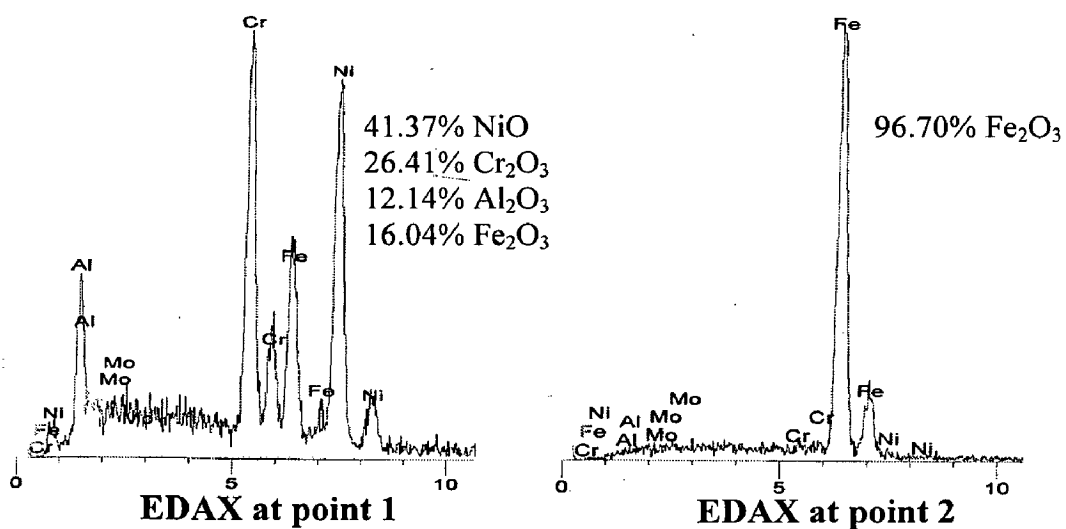
**Fig.5.25** Surface scale morphology and EDAX point analysis for NiAlCrFeMo coated T22 steel subjected to oxidation for 50 cycles in air at 900°C  
 (a) Protrusion on coating surface (b) Enlarged image of marked region in Fig (a)

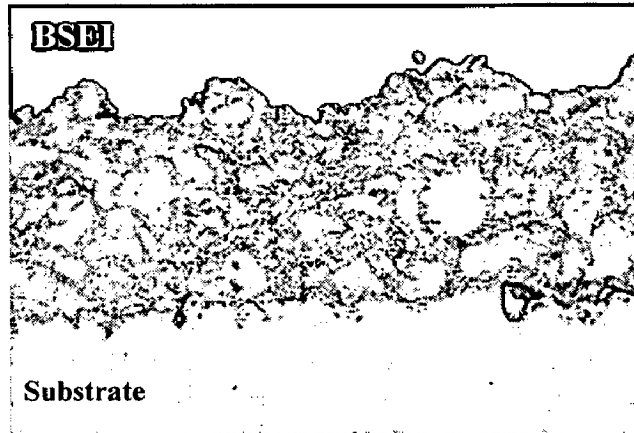
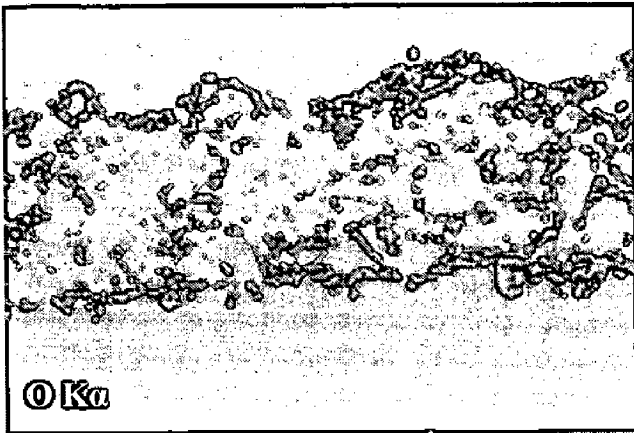
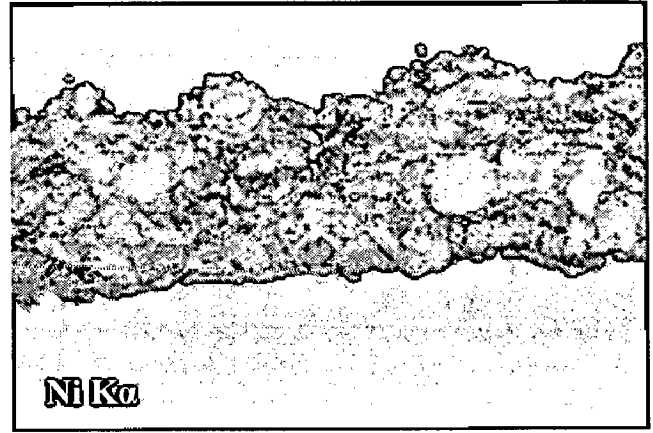
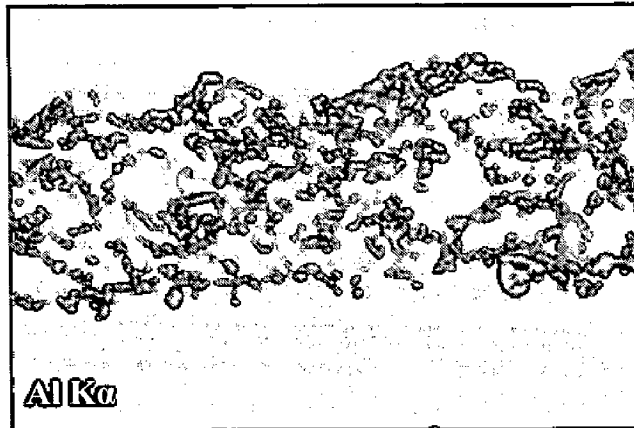
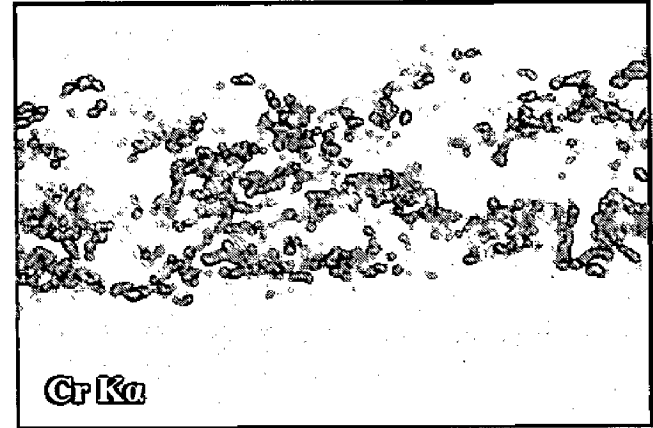
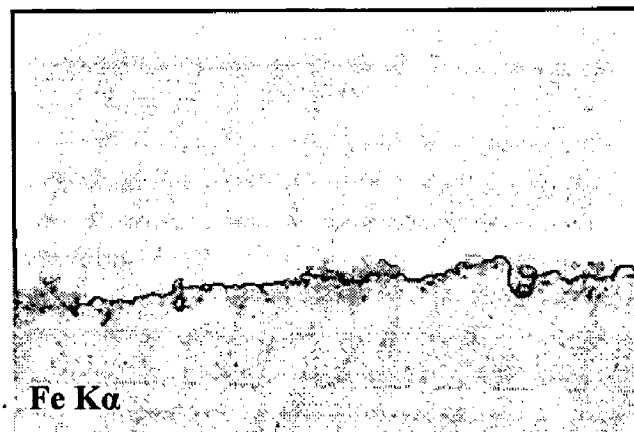
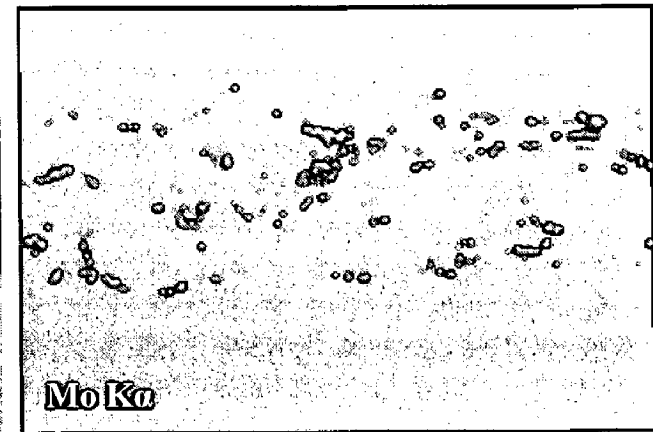
**Fig.5.27** BSEI and elemental X-ray mapping at the cross-section of the NiAlCrFeMo coated GrAl steels subjected to cyclic oxidation in air at 900°C

Elemental X-ray maps for the NiAlCrFeMo coated GrA1 steel subjected to cyclic oxidation for 50 cycles at 900°C are shown in Fig.5.27. The mapping for oxygen indicates that the complete cross-section of coating has been oxidized along the splat boundary. The selective oxidation of aluminum, chromium and molybdenum along the splat boundary has been observed. Also during the early stage of oxidation, oxidising atmosphere penetrates into the coatings through open porosity (mostly located at splat boundary) until all the accessible internal surfaces have been oxidized. Subsequently the oxidation phenomenon takes place only on the outer surface of the coating due to formation of protective oxide layer. Elemental maps for O, Ni, Al and Cr, show a thin distinct oxide layer formed on the outer surface and mainly consists of oxides of Ni, Al and Cr. It is apparent from the mapping for oxygen and nickel that nickel rich splats remain unoxidised up to the end of 50 cycles of oxidation studies. Minor diffusion of nickel from the coating into the substrate can also be observed along the coating-substrate interface. Similar observations have been noticed for the oxide scale formed on NiAlCrFeMo coated T11 steel as shown in Fig.5.28. The top layer of the oxide scale mainly consisted of oxides of Ni, Al and Cr. The nickel rich splats remain unoxidised and the splat boundaries consist of oxides of Al, Cr and Mo.
