# **STUDIES ON THE ROLE OF HVOF COATINGS IN IMPROVING RESISTANCE TO HOT CORROSION AND EROSION**

## **A THESIS**

**DOCTOR OF PHILOSOPHY**

**METALLURGICAL AND MATERIALS ENGINEERING**

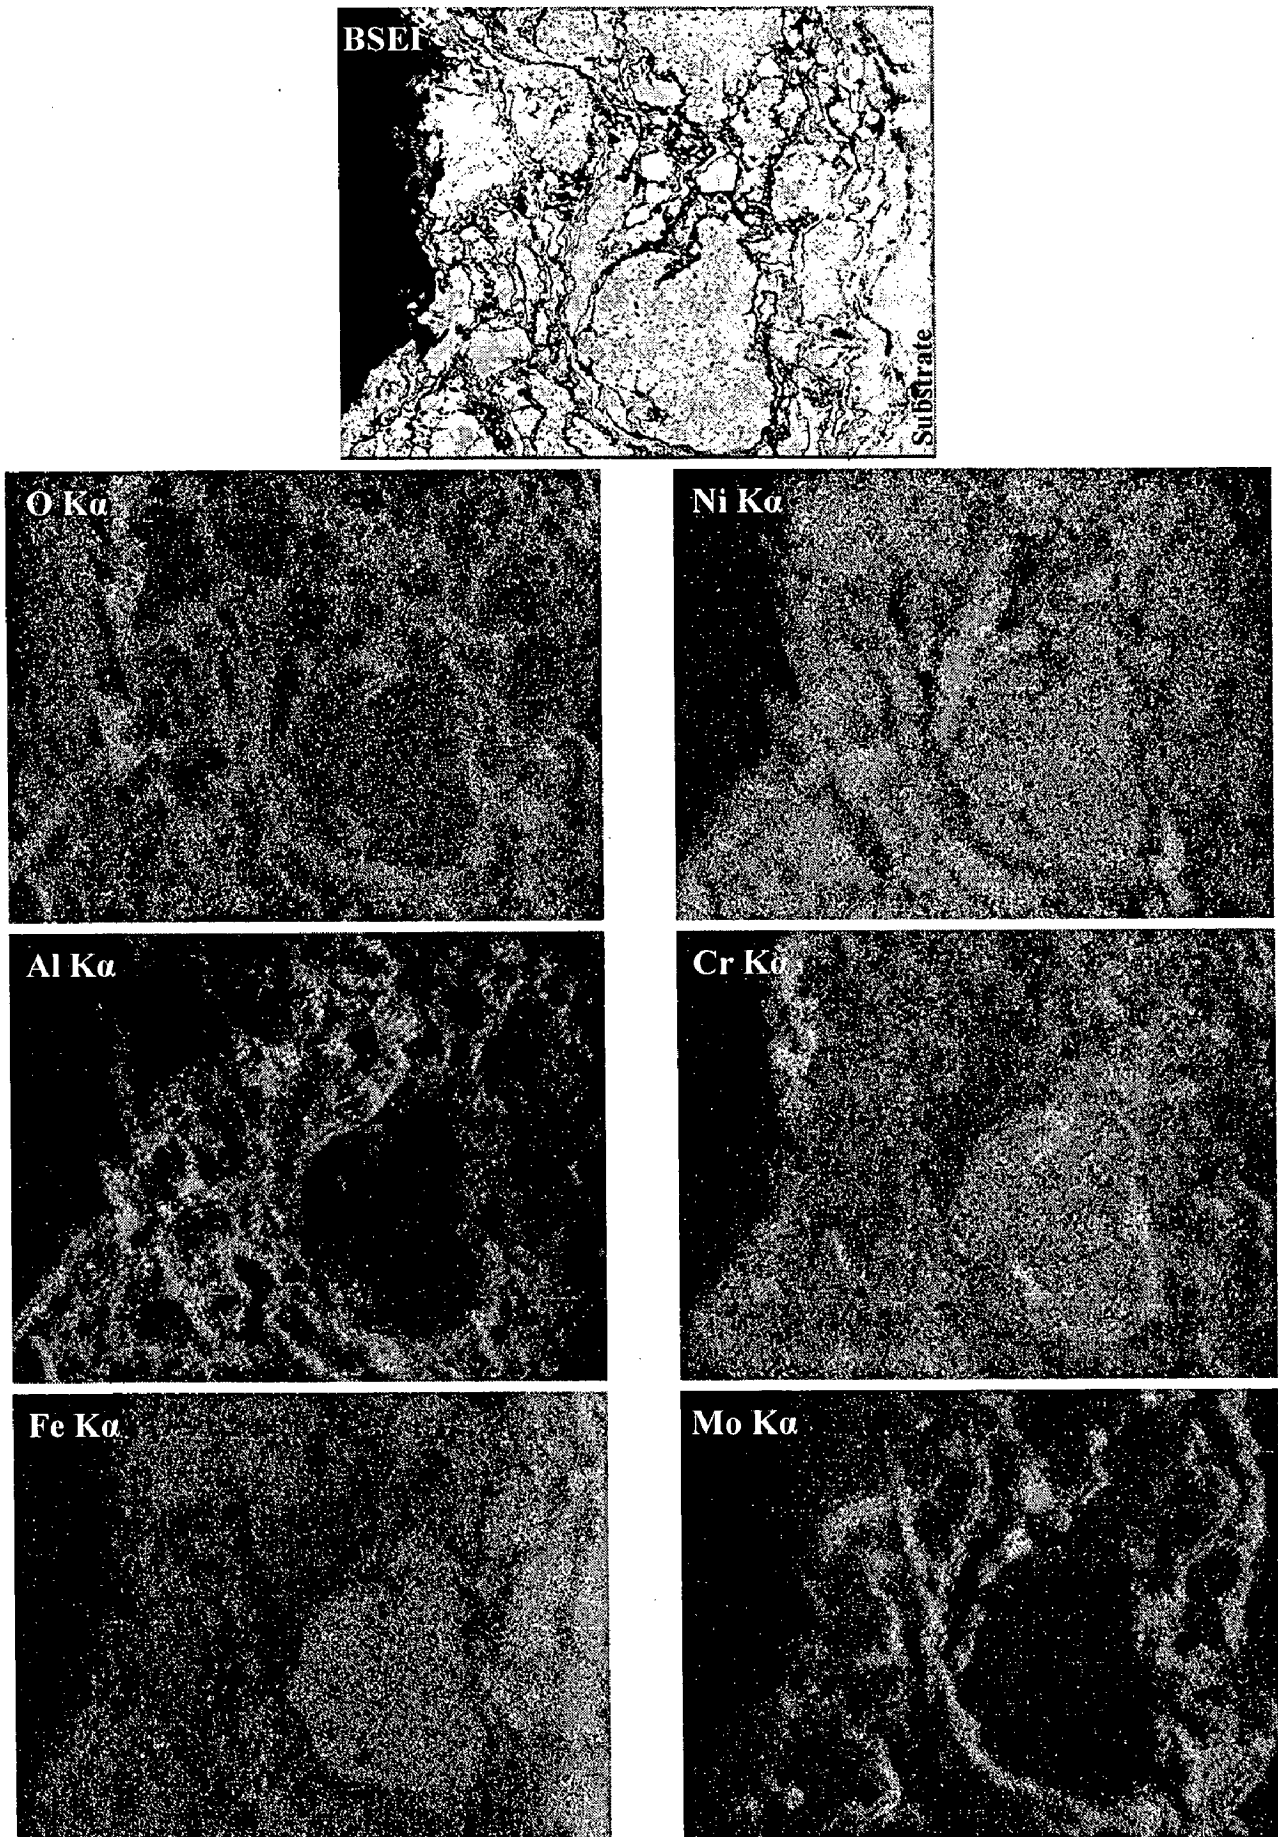
**Fig.5.28** BSEI and elemental X-ray mapping at the cross-section of the NiAlCrFeMo coated T11 steels subjected to cyclic oxidation in air at 900°C

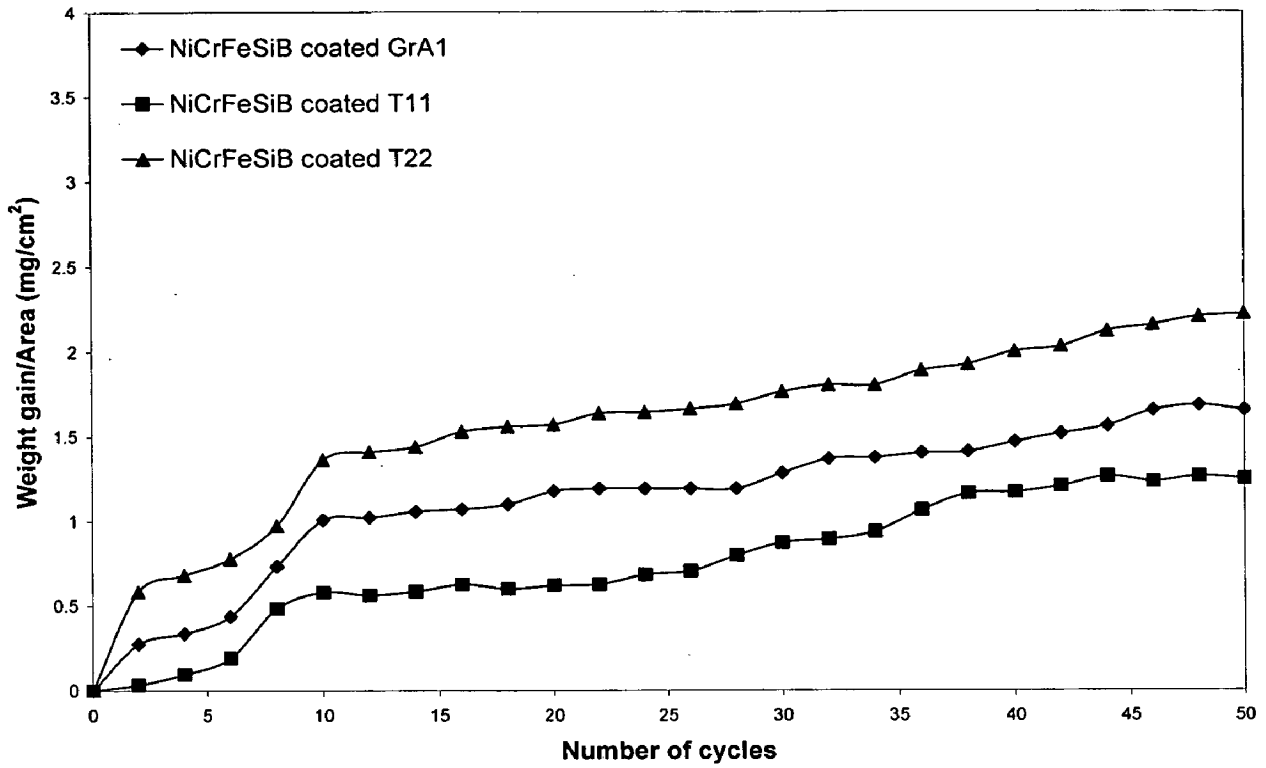
**Fig.5.31** Weight gain vs. number of cycles plot for NiCrFeSiB coated steels subjected to oxidation for 50 cycles in air at 900°C

The plots of cumulative weight gain ( $\text{mg}/\text{cm}^2$ ) as a function of time, expressed in number of cycles, are shown in Fig.5.31. The rapid weight gain of the coating has been observed in the initial oxidation period up to 10 cycles of study, thereafter, exhibits a gradual decrease in oxidation rate with exposure time. The total weight gain at the end of 50 cycles for the NiCrFeSiB coated GrA1, T11 and T22 steels are found as 1.65, 1.25 and  $2.22 \text{ mg}/\text{cm}^2$ , respectively.

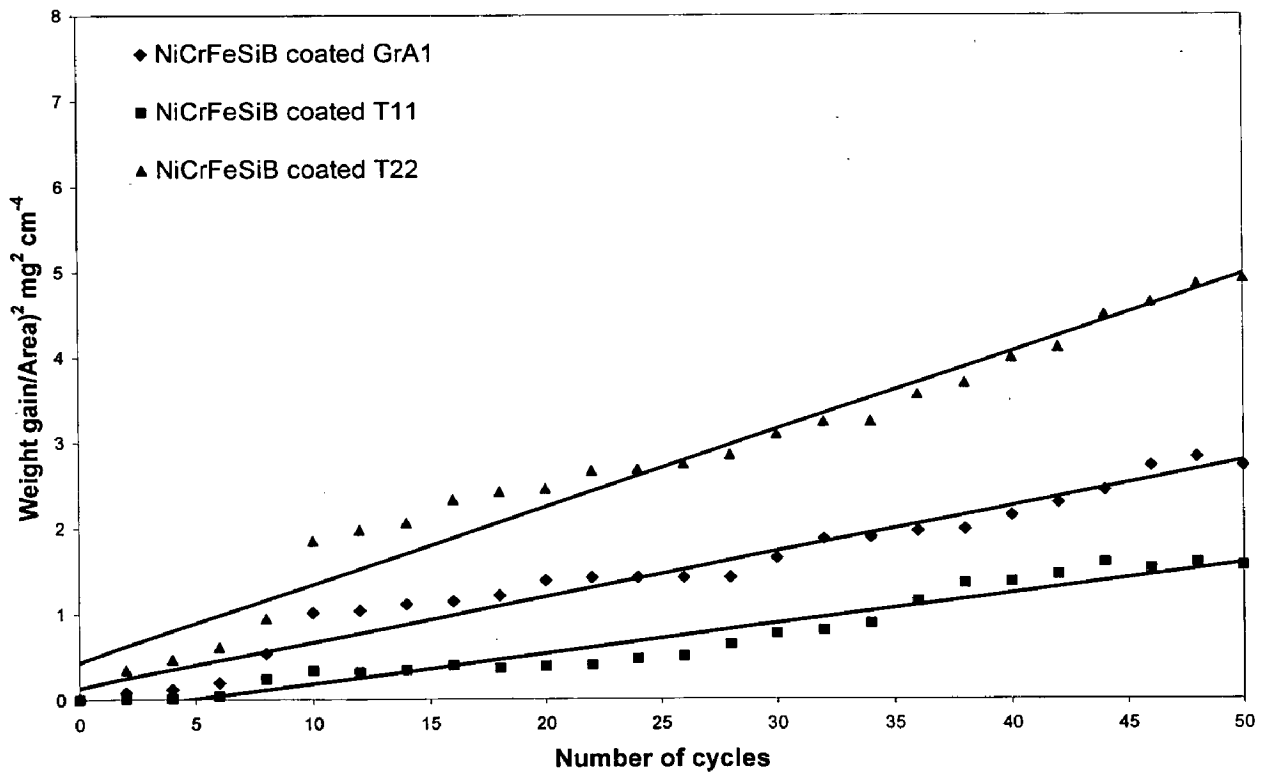
**Fig.5.32** (Weight gain/area)² vs. number of cycles plot for NiCrFeSiB coated steels subjected to oxidation for 50 cycles in air at 900°C

Further, the weight gain square ( $\text{mg}^2/\text{cm}^4$ ) versus the number of cycles are plotted in Fig. 5.32. The oxidation behavior of the coated GrA1, T11 and T22 steels were parabolic in nature up to 50 cycles. The parabolic rate constant  $K_p$ , as calculated from the slope of the linear regression fitted line for the NiCrFeSiB coated GrA1, T11 and T22 steels, were found to be  $0.147 \times 10^{-10}$ ,  $0.097 \times 10^{-10}$  and  $0.25 \times 10^{-10} \text{ g}^2 \text{ cm}^{-4} \text{ s}^{-1}$ , respectively.

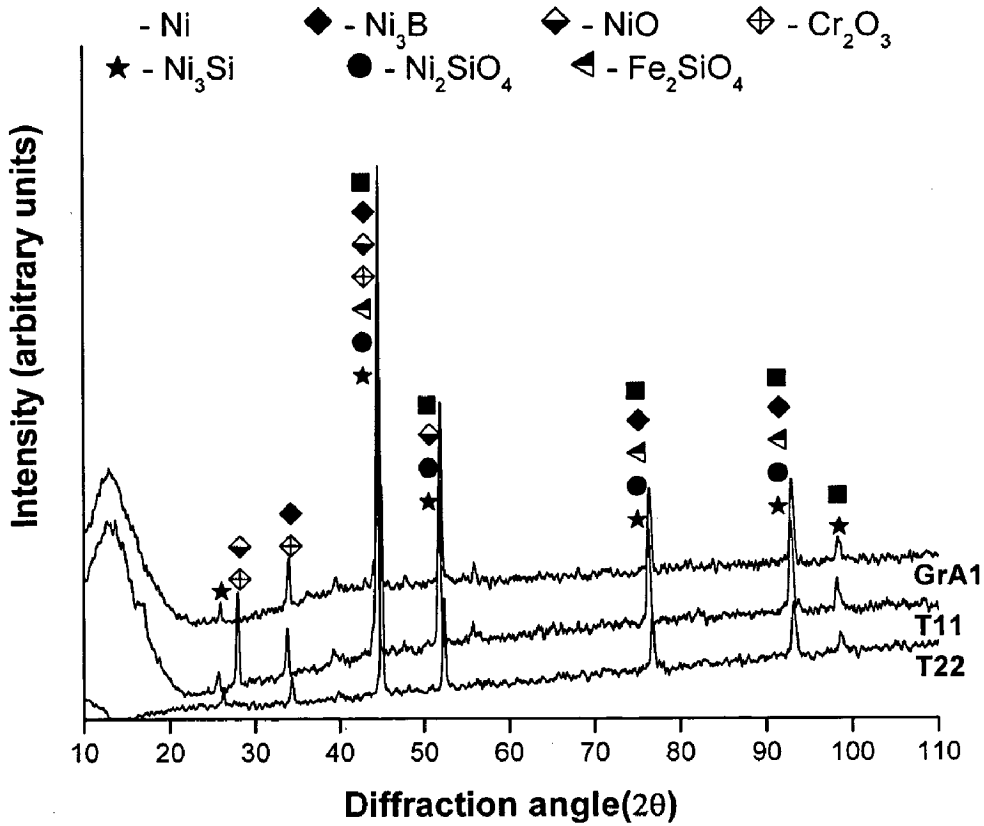
**Fig.5.33** X-ray diffraction patterns for NiCrFeSiB coated GrA1, T11 and T22 steels subjected to cyclic oxidation in air for 50 cycles at 900°C

The diffraction patterns for the NiCrFeSiB coated steels are shown in Fig. 5.33. The XRD results reveal the presence of the phases of NiO,  $\text{Cr}_2\text{O}_3$ , Ni,  $\text{Ni}_3\text{B}$ ,  $\text{Ni}_3\text{Si}$ ,  $\text{Ni}_2\text{SiO}_4$ , and  $\text{Fe}_2\text{SiO}_4$ . All the three coated steels have been found to have identical oxides on the surface. No peaks for  $\text{SiO}_2$  are present.

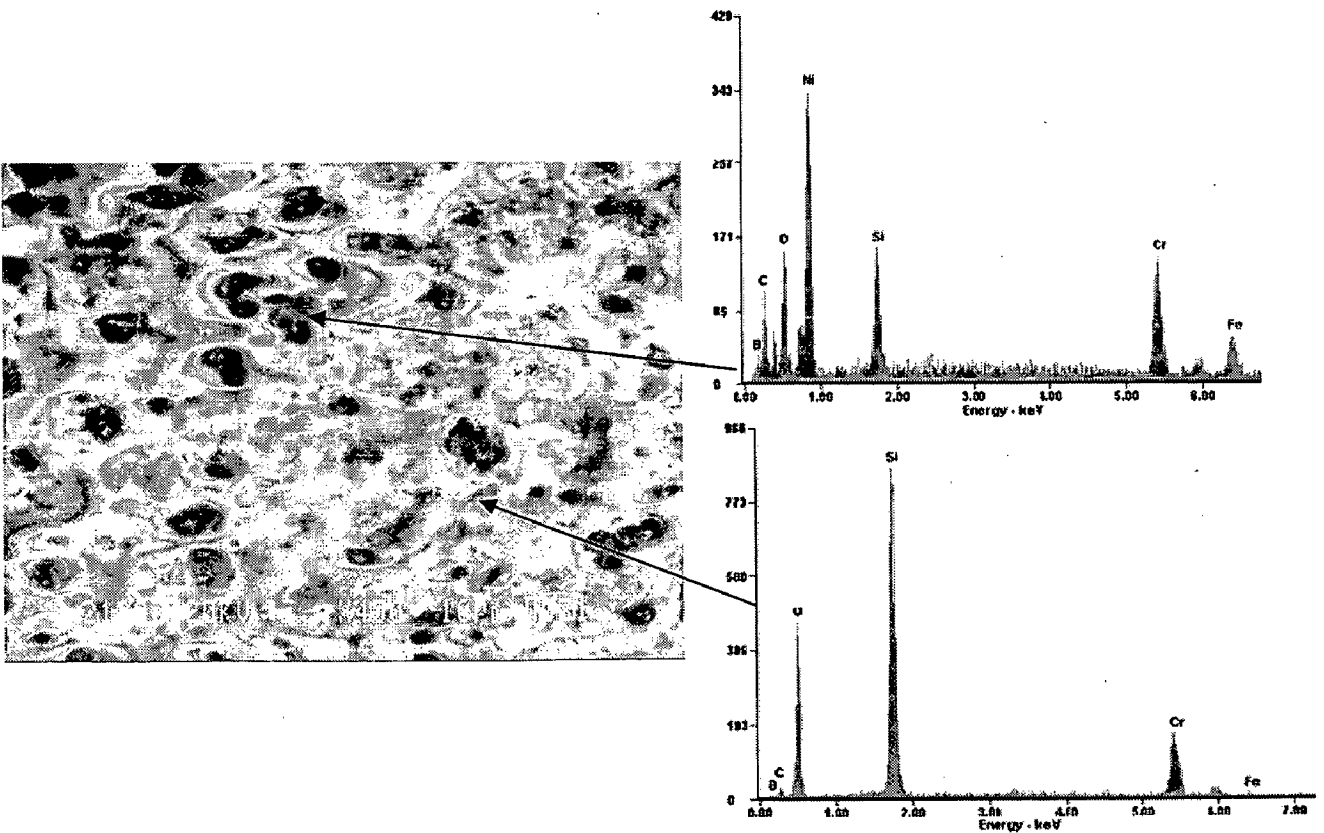
**Fig.5.34** Surface scale morphology and EDAX point analysis for NiCrFeSiB coated GrA1 steel subjected to oxidation for 50 cycles in air at 900°C

The SEM micrographs showing the scale morphology along with the EDAX spectra at the point of interest are shown in Figs. 5.34 and 5.35. It can be observed in Fig. 5.34 that the oxide scale has a glassy matrix with some coarse nodules dispersed uniformly. The EDAX compositional analysis of the glassy scale shows the dominant presence of Si and O peaks along with the minor peaks of Cr and B. This can be attributed to the formation of a  $\text{SiO}_2$  glass scale. The results of the EDAX analysis of the dark nodules reveal that these are mainly rich in Ni and Cr and oxygen with some Fe. The most interesting point is that the O and Si contents in these dark nodules are low, while the Ni contents were rather high. This implies that the metallic Ni rich globules exist within the

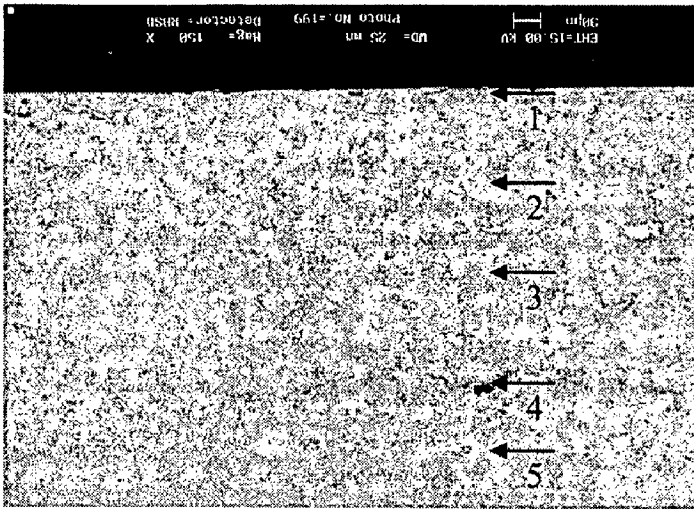
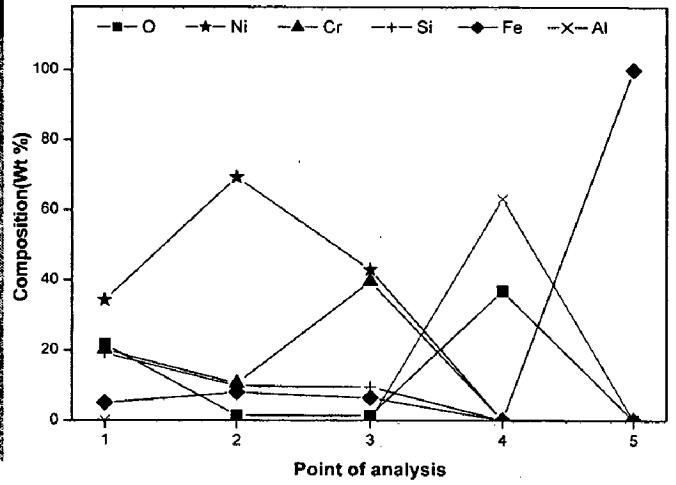
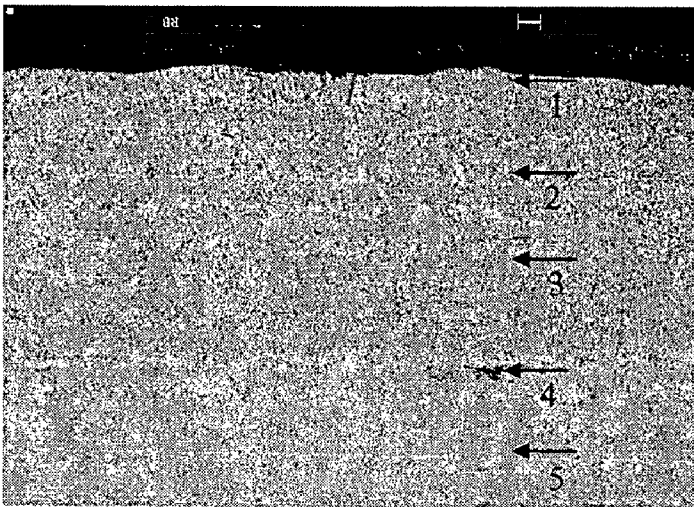
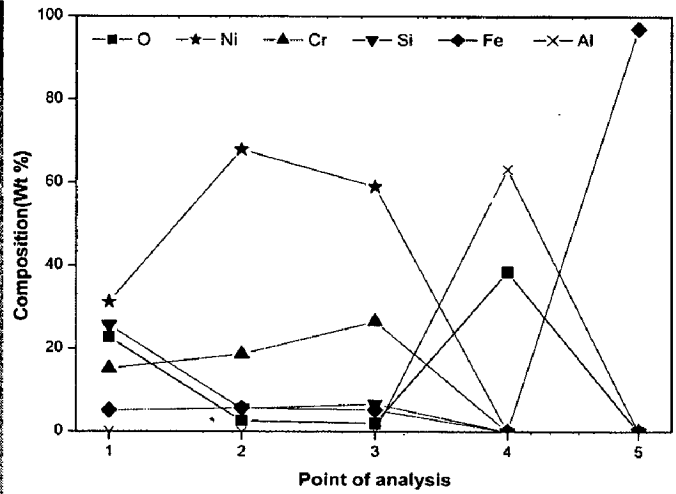
**Fig.5.36** Back scattered electron image and EDAX point analysis (wt %) across the cross-section of the NiCrFeSiB coated steels subjected to cyclic oxidation for 50 cycles in air at 900°C: (a) GrA1 steel (b) T22 steel

Figure 5.36 depicts the BSE image along the cross section of the oxidized NiCrFeSiB coated GrA1 and T22 steels and the elemental composition at the point of interest are represented in the form of a graph. The oxide scale formed is compact and the structure of the oxidized coating appears similar to the as-sprayed coating. The EDAX analysis at point 1 (Figs. 5.36a and 5.36b) shows that the oxide scale formed on the surface is mainly composed of the oxides of Si, Ni and Cr. Points 2 and 3 represent the Ni-rich splats with a minor content of Cr, Si, and Fe. The absence of oxygen at these points indicates that oxidation has been restricted to the upper most layer, and the protective oxides of Si, Cr, and Ni formed on the surface acts as a barrier to the oxygen transport to the inside of coating. The dark region along the coating-substrate interface is found to be rich in Al and O which may be an inclusion of aluminum oxide during the surface preparation prior to the HVOF spraying since aluminum is neither present in composition of coating nor in the substrate.

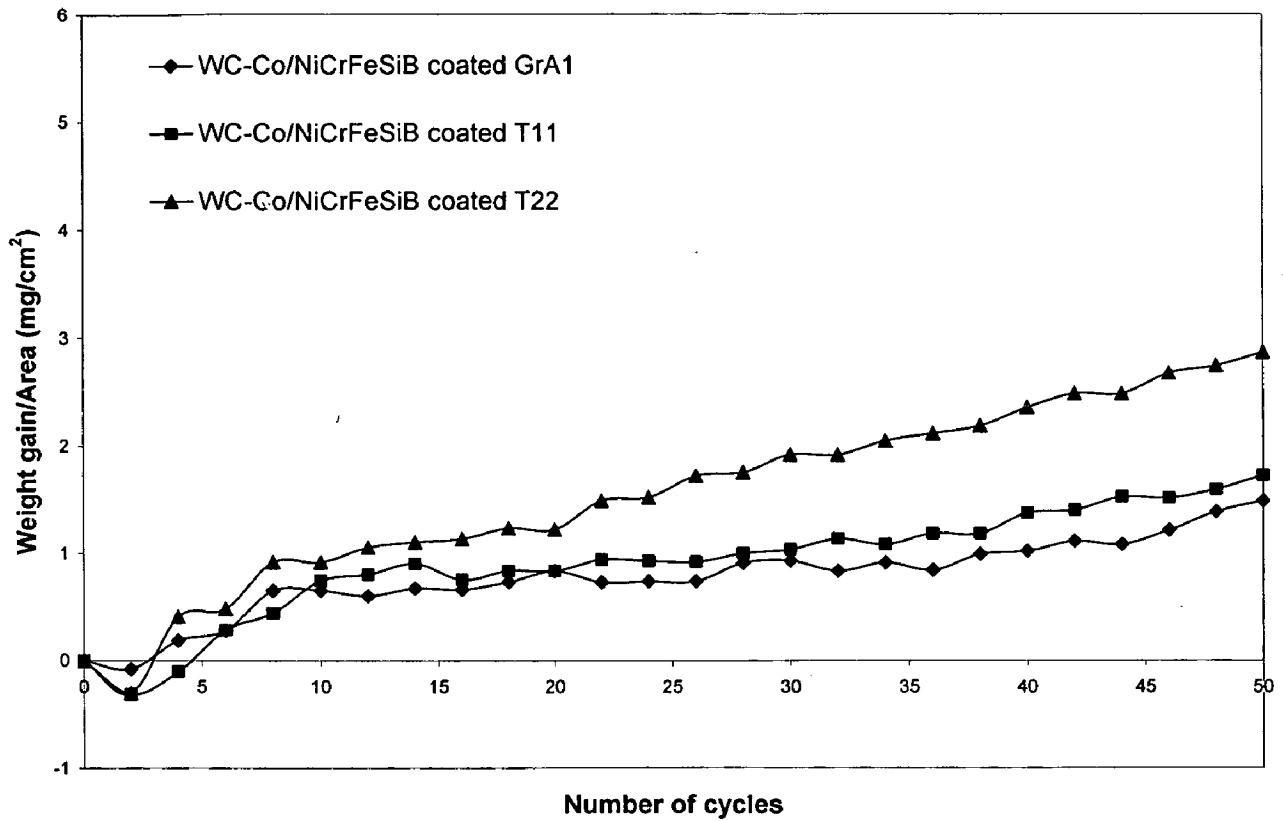
**Fig.5.40** Weight gain versus number of cycles plot for WC-Co/NiCrFeSiB coated steels subjected to oxidation for 50 cycles in air at 900°C

Figure 5.40 shows the weight change per unit area (mg/cm<sup>2</sup>) for the oxidation of the coated steels in air at 900°C. During the initial cycles of study, all the three coated steels showed weight loss (up to 4<sup>th</sup> cycle), probably due to evaporation of W-oxides (WO<sub>3</sub>) from the surface. The growth of protective oxides from the active elements of the coating stabilize the formation of volatile tungsten oxides, would result in the weight gain with subsequent oxidation cycles. After 8 cycles, gradual decrease in oxidation rate has been observed in case of coated GrA1 and T11 steels. Coated T22 steel showed a increased weight gain after 26<sup>th</sup> cycles of oxidation. Cumulative weight gain at the end of 50 cycles for WC-Co/NiCrFeSiB coated GrA1, T11 and T22 steels are 1.48, 1.72 and 2.86 mg/cm<sup>2</sup> respectively which is marginal. Coated T22 showed a higher weight gain where as weight gain values are not very different in case of coated GrA1 and T11 steels. So far, as the kinetics of the oxidation is concerned, it can be approximated by the parabolic rate law in all the cases, (Fig. 5.41). The calculated values of parabolic rate constant (K<sub>p</sub>) for WC-

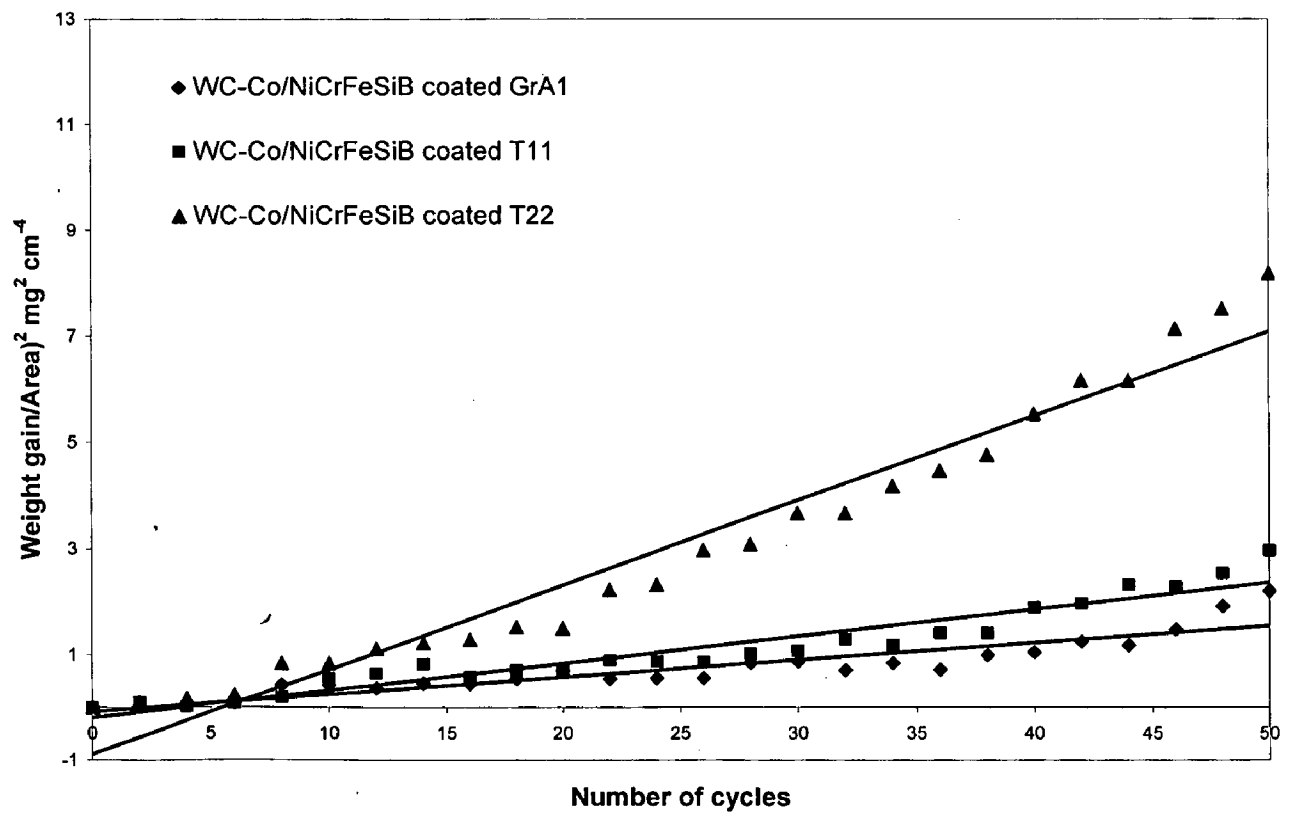
**Fig.5.41** (Weight gain/area)<sup>2</sup> versus number of cycles plot for WC-Co/NiCrFeSiB coated steels subjected to oxidation for 50 cycles in air at 900°C

Co/NiCrFeSiB coated GrA1, T11 and T22 steels are  $0.09 \times 10^{-10}$ ,  $0.14 \times 10^{-10}$  and  $0.44 \times 10^{-10} \text{ g}^2 \text{ cm}^{-4} \text{ s}^{-1}$  respectively.

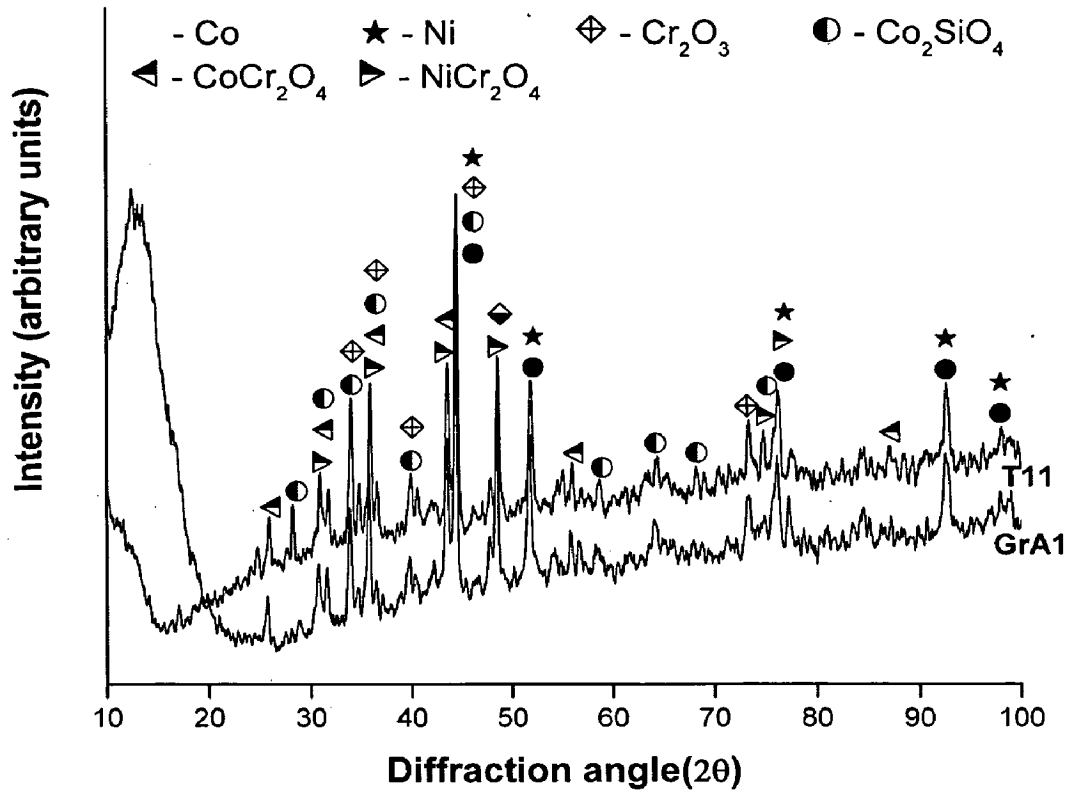
**Fig.5.42** X-ray diffraction patterns for WC-Co/NiCrFeSiB coated GrA1 and T11 steels subjected to cyclic oxidation in air for 50 cycles at 900°C

X-ray diffraction patterns of the oxide scale formed on the surface of oxidized WC-Co/NiCrFeSiB coated steels after cyclic oxidation in air at 900°C have been compiled in Fig. 5.42 and 5.43. The main XRD phases identified for the coated GrA1 and T11 steels are Co, Ni,  $\text{Cr}_2\text{O}_3$ ,  $\text{CoCr}_2\text{O}_4$ ,  $\text{Co}_2\text{SiO}_4$  and  $\text{NiCr}_2\text{O}_4$ . In case of coated T22 steel, additional phases of  $\text{Fe}_2\text{O}_3$  and  $\text{Fe}_2\text{SiO}_4$  has been observed along with the phases mentioned above. No peaks for  $\text{SiO}_2$  could be identified.

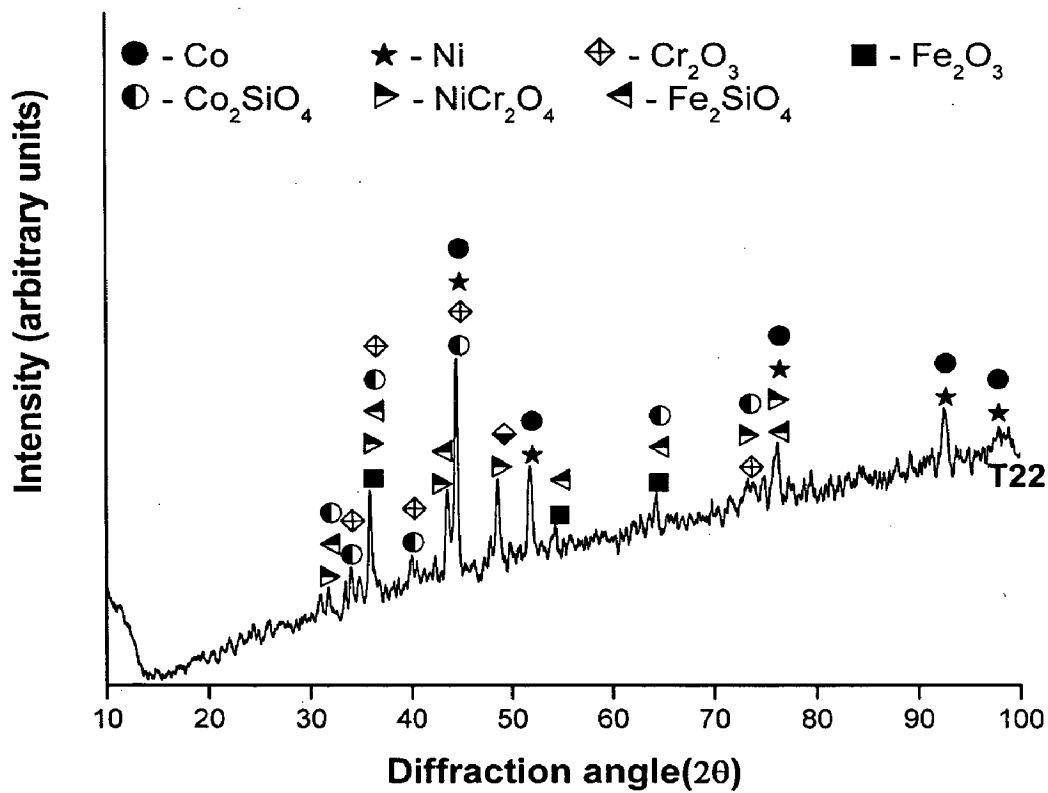
**Fig.5.43** X-ray diffraction patterns for WC-Co/NiCrFeSiB coated T22 steels subjected to cyclic oxidation in air for 50 cycles at 900°C

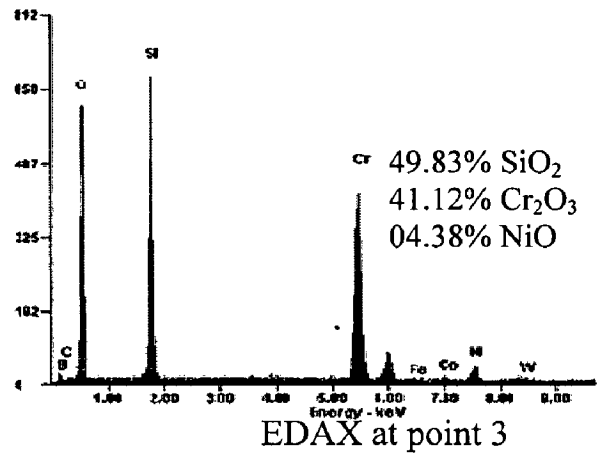
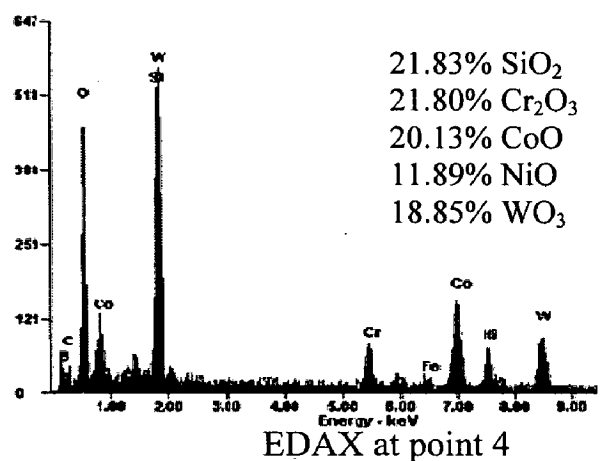
Fig.5.44 Surface scale morphology and EDAX analysis for WC-Co/NiCrFeSiB coated steels subjected to oxidation for 50 cycles in air at 900°C  
 (a) GrA1 steel (b) T11 steel

Thin oxide layer on the external surface of the oxidized coating, mainly composed of protective oxides of Si, Cr and Co has been identified with the help of EPMA analysis (Fig.5.47 and 5.48) and compositional EDAX analysis (Fig.5.44 to 5.46). Further XRD analysis on the outer surface confirms the presence of chromium oxide and not showed peaks corresponds to SiO<sub>2</sub>. However EDAX and EPMA analysis confirm the existence of Si-related oxide phase, which should be present as amorphous SiO<sub>2</sub> on the surface of oxidized coating. Yu et al., (2007), Douglass et al., (1987), Wu et al., (2005) have

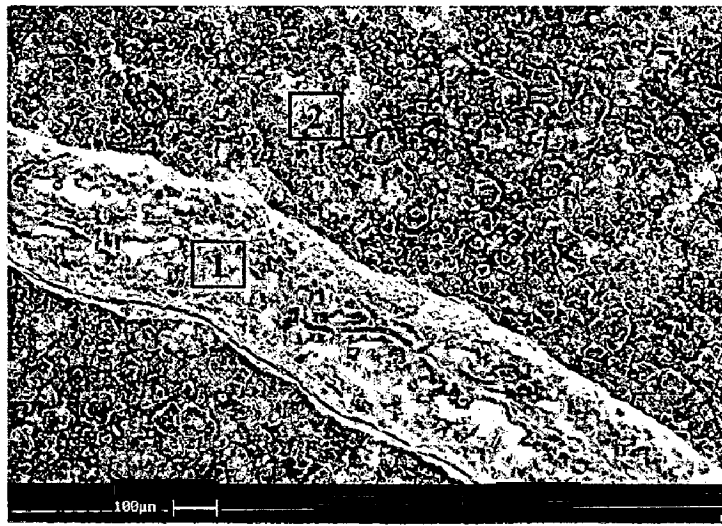
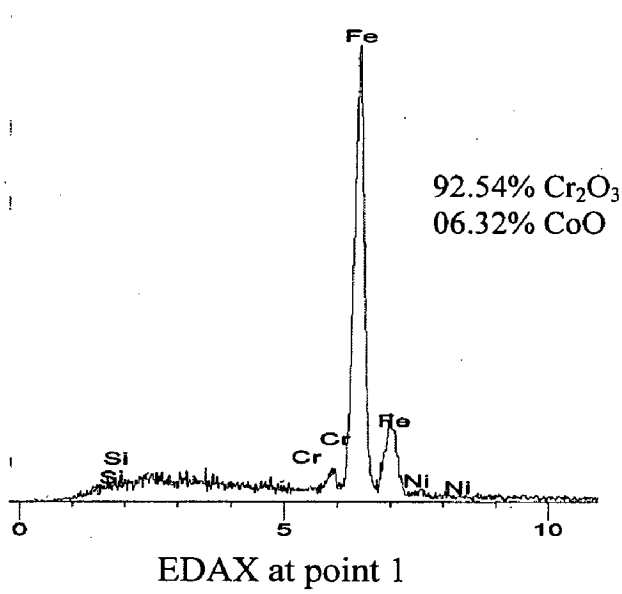
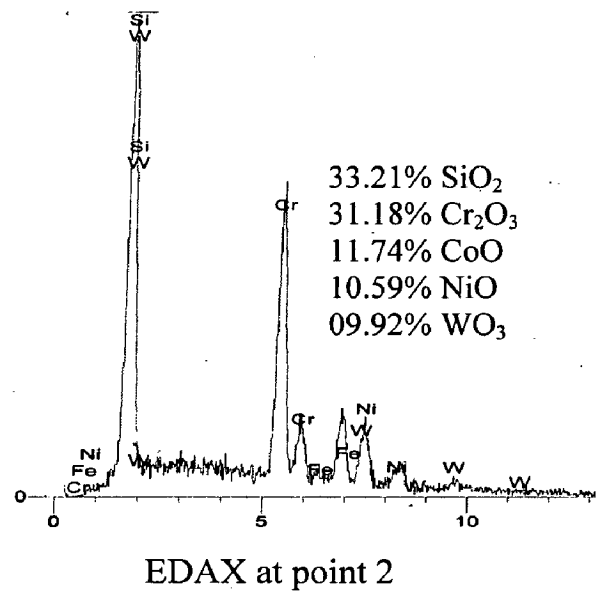
**Fig.5.45** Surface scale morphology and EDAX analysis for WC-Co/NiCrFeSiB coated T22 steel subjected to oxidation for 50 cycles in air at 900°C

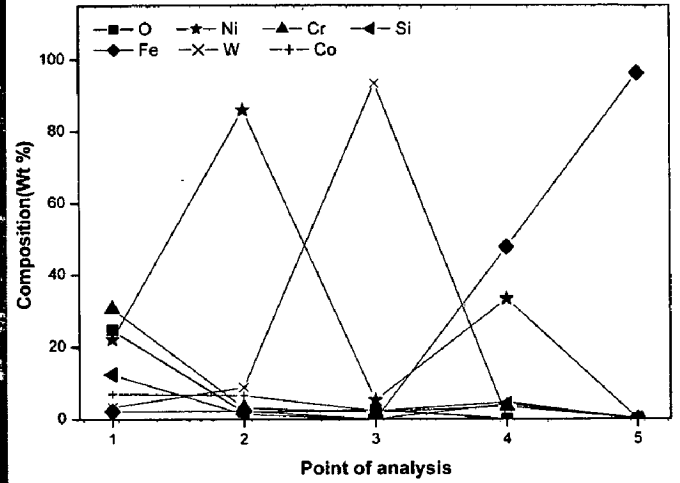
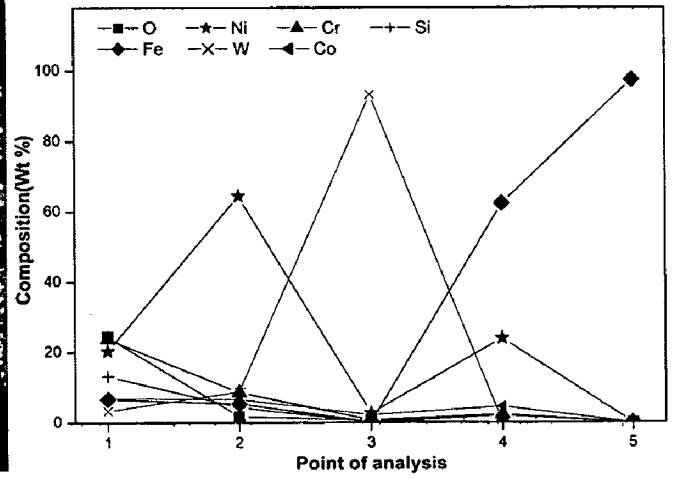
**Fig.5.46** Back scattered electron image and EDAX point analysis (wt %) across the cross-section of the WC-Co/NiCrFeSiB coated steels subjected to cyclic oxidation for 50 cycles in air at 900°C: (a) T11 steel (b) T22 steel

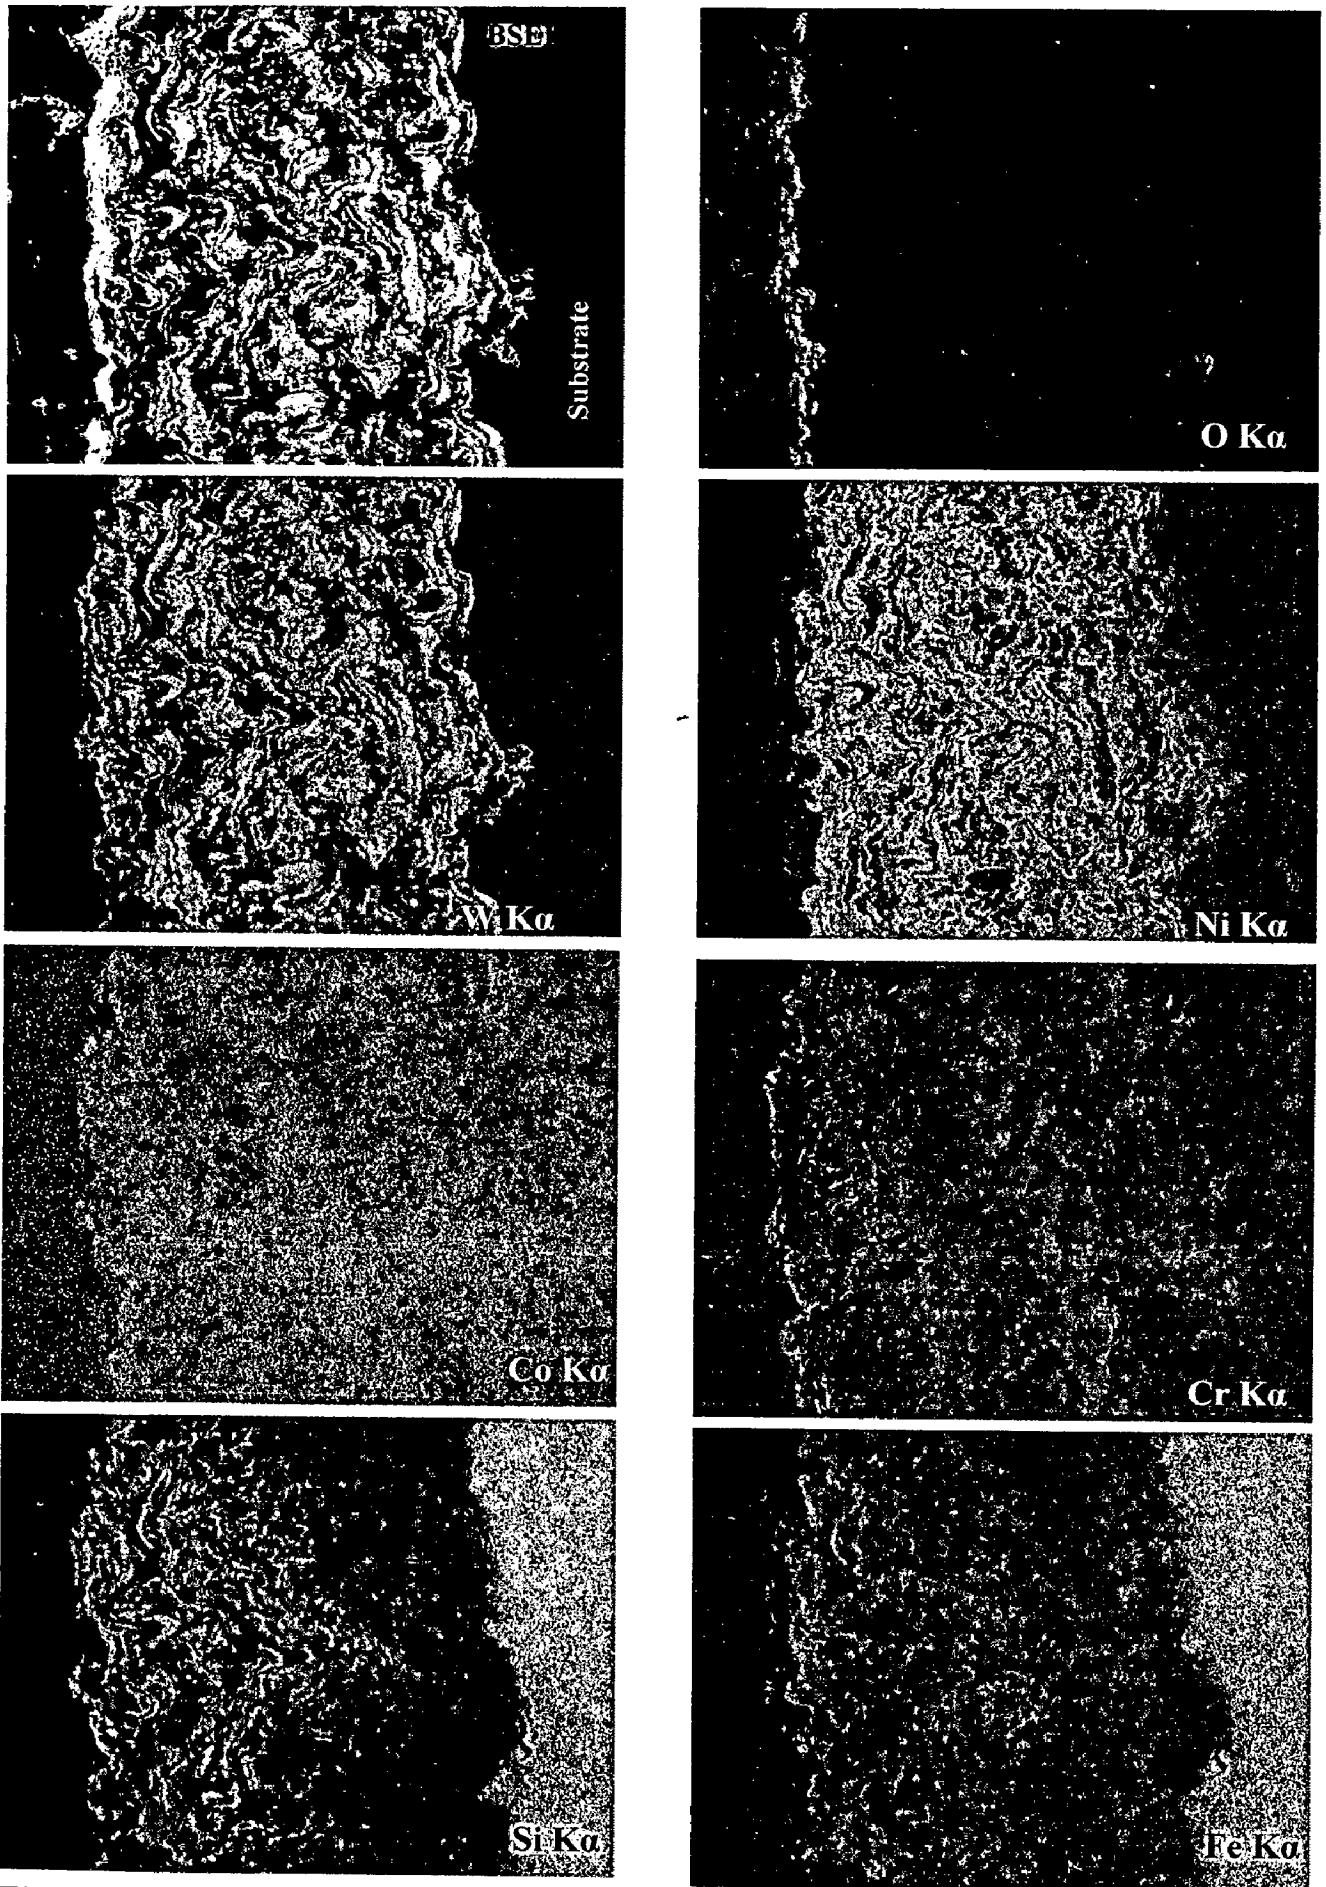
**Fig.5.48** BSEI and WDS X-ray mapping at the cross-section of the WC-Co/NiCrFeSiB coated T22 steel subjected to cyclic oxidation in air at 900°C

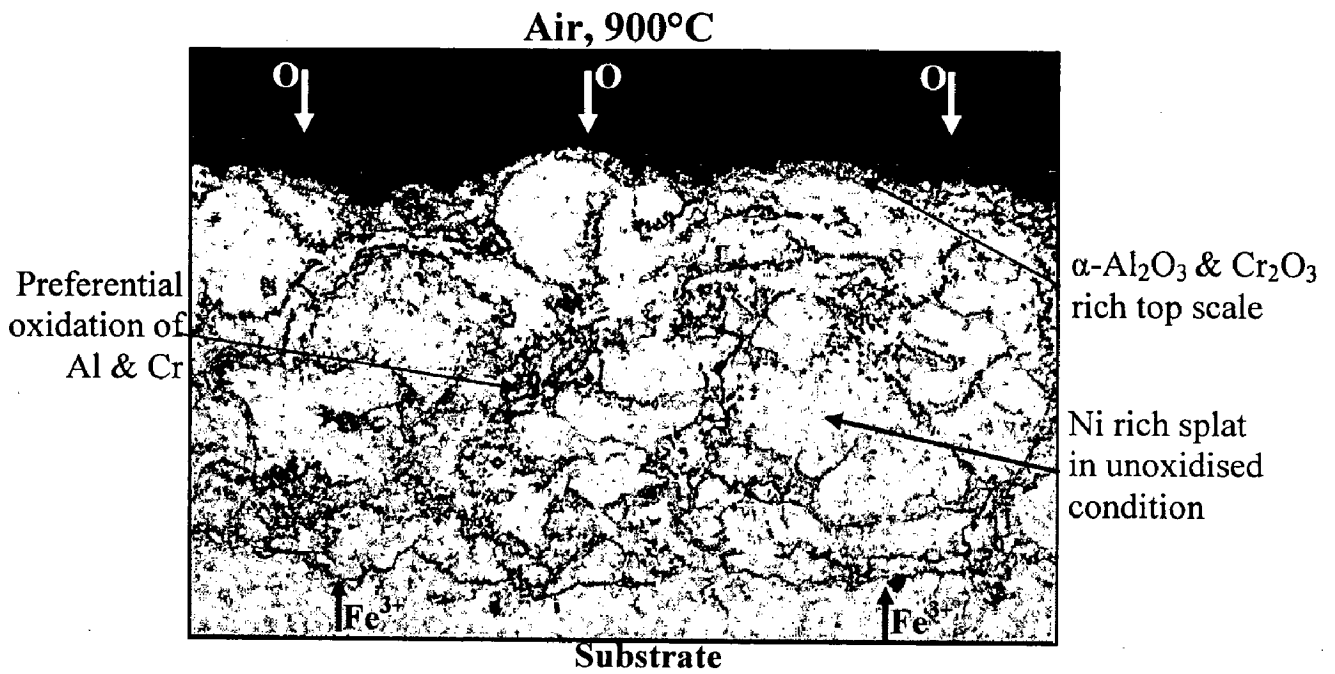
**Fig.5.49** General oxidation mode of NiCrAl coated steels exposed to air for 50 cycles at 900°C

(2003A), where they observed a similar oxidation behavior of NiCrAlY coated T22 steels. The minor diffusion of substrate iron through the open pores along the splat boundary into the coating is indicated by an arrow mark in Fig. 5.17. Fe has a faster diffusion rate in the Ni system as suggested by Sundarajan et al. (2003). Fig.5.49 shows the general oxidation mode based on the present study.

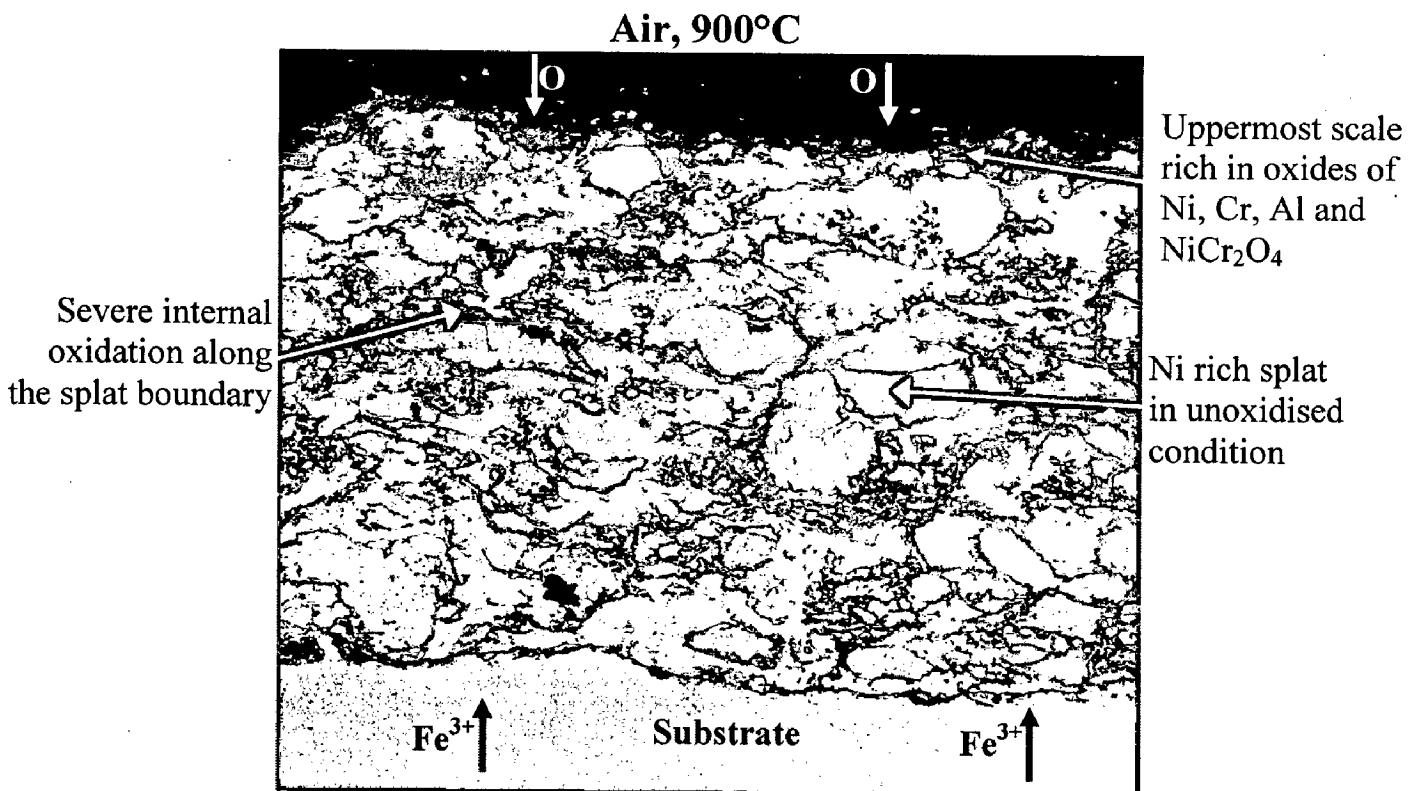
**Fig.5.50** General oxidation mode of NiAlCrFeMo coated steels exposed to air for 50 cycles at 900°C

Analysis across the cross section of coated steels (Figs.5.26, 5.27 and 5.28) shows the outermost thin oxide layer mainly composed of oxides of nickel, chromium and aluminum. Further the XRD analysis on the surface confirms the protection of the substrate steel by the oxides of nickel, chromium and aluminum and mixed spinel oxide NiCr<sub>2</sub>O<sub>4</sub>. Internal oxidation along the splat boundary has been observed along the entire thickness of the coating. EDAX and elemental mapping revealed the oxidation of aluminum, chromium, iron and molybdenum along the splat boundary whereas nickel rich splats remain unoxidized at the end of 50 cycles of oxidation studies. During the early stage of oxidation, oxidant atmosphere penetrates into the coatings through open porosity (mostly located at splat boundary) until all the accessible internal surfaces have been oxidized. Subsequently the oxidation phenomenon takes place only on the outer surface of the coating due to formation of protective oxide layer (Belzunce et al. 2001). Uusitalo et al. 2003, also observed the internal oxidation occurred at the splat boundaries of HVOF sprayed Ni21Cr9MoFe coatings. Minor diffusion of nickel from the coating into the substrate can also be observed along the coating-substrate interface which perhaps provided good adherence of coating with substrate. Based upon the results, the general oxidation mode for NiAlCrFeMo coatings at 900°C is shown in Fig.5.50.

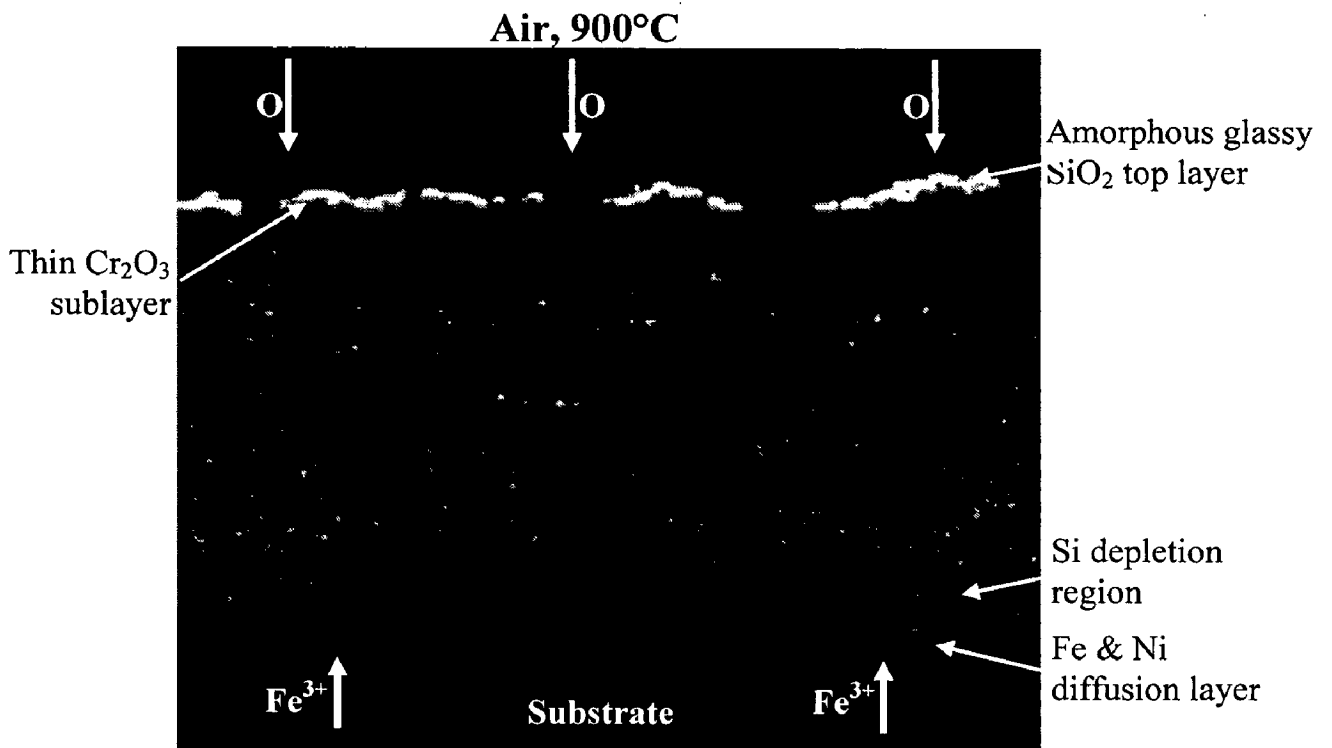
**Fig. 5.51** General oxidation mode of NiCrFeSiB coated steels exposed to air for 50 cycles at 900°C

From the thermogravimetry data, the weight gain of NiCrFeSiB coated GrA1, T11 and T22 steels are much lower than that of the respective uncoated steels as reported in Section 5.1.1.1. Furthermore, the coated steels follow the parabolic rate law of oxidation up to 50 cycles and the parabolic rate constant ( $K_p$ ) values are lower in comparison to the uncoated steels. Hence, it can be inferred that NiCrFeSiB coatings are successful in protecting the steels from the accelerated oxidation to a considerable extent. Kerr (1975) has reported that a significant drop in the parabolic oxidation rate was found with Ni-Cr alloys when silicon was added at low chromium concentrations. Si and B, which are distributed at the grain boundary, hinder the diffusion of Fe and Mo from the substrate into the coating along the grain boundary. A thick diffusion band has been observed at the substrate-coating interface (Figs. 5.37 and 5.38) which may be attributed to restricted inter-diffusion of Ni and Fe between coating and substrate, thereby resulting in better bonding of coating and substrate. Fig 5.51 shows the general oxidation mode for NiCrFeSiB coatings subjected to oxidation in static air for 50 cycles at 900°C.
