# **STUDIES ON THE ROLE OF HVOF COATINGS IN IMPROVING RESISTANCE TO HOT CORROSION AND EROSION**

## **A THESIS**

**DOCTOR OF PHILOSOPHY**

**METALLURGICAL AND MATERIALS ENGINEERING**

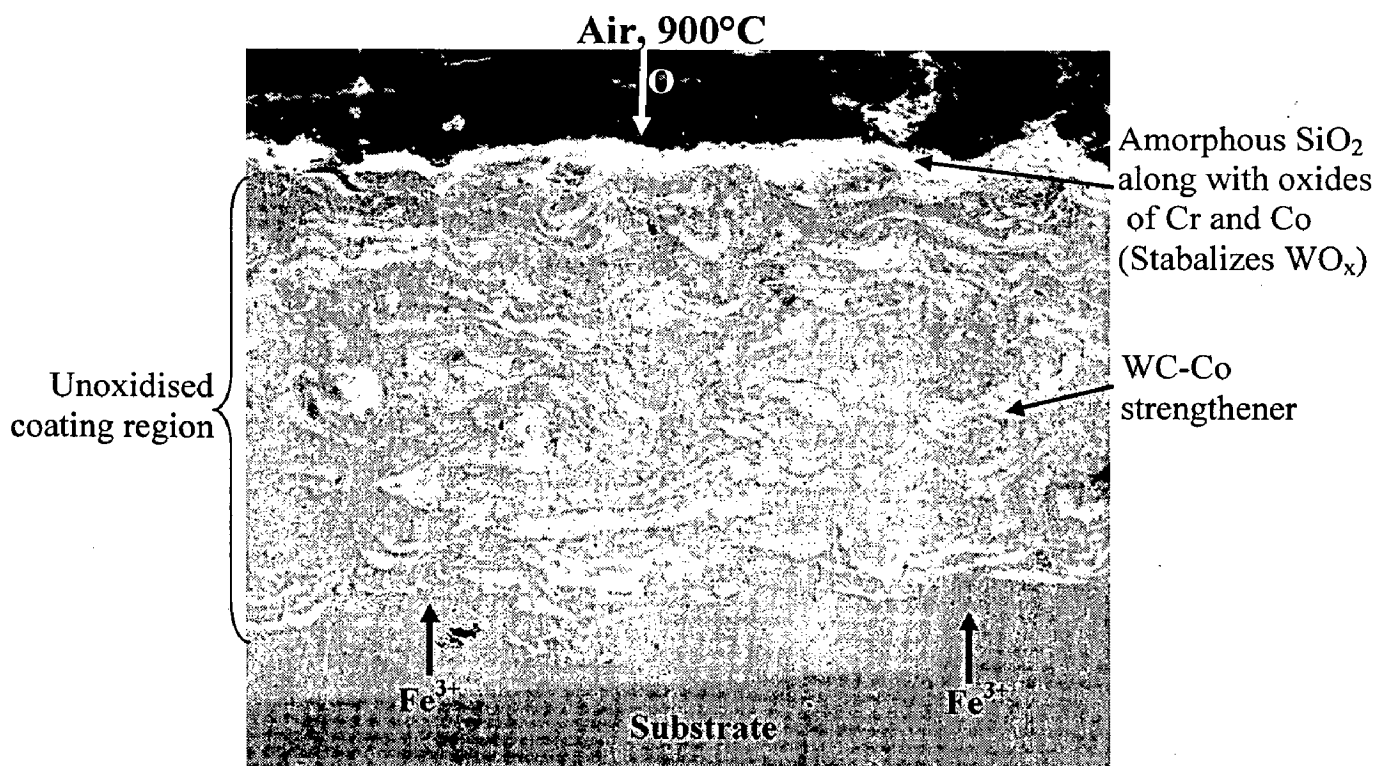
**Fig. 5.52** General oxidation mode of WC-Co/NiCrFeSiB coated steels exposed to air for 50 cycles at 900°C

HVOF sprayed WC-Co/NiCrFeSiB coated steels shows much lower weight gain in comparison to uncoated steels as reported in section 5.1.1.1. Weight gain at the end of 50 cycles of oxidation studies for WC-Co/NiCrFeSiB coated GrA1, T11 and T22 Steels are only 0.66%, 1.04% and 1.45% respectively than that of similar uncoated steels. Further oxidation kinetics of all the coated steel can be approximated to by parabolic rate law, which signifies necessary protection has been provided by the WC-Co/NiCrFeSiB coatings to the substrate steel. Fig.5.52 shows the overall view of oxidation mode for WC-Co/NiCrFeSiB coatings exposed to air at  $900^\circ\text{C}$  for 50 cycles.

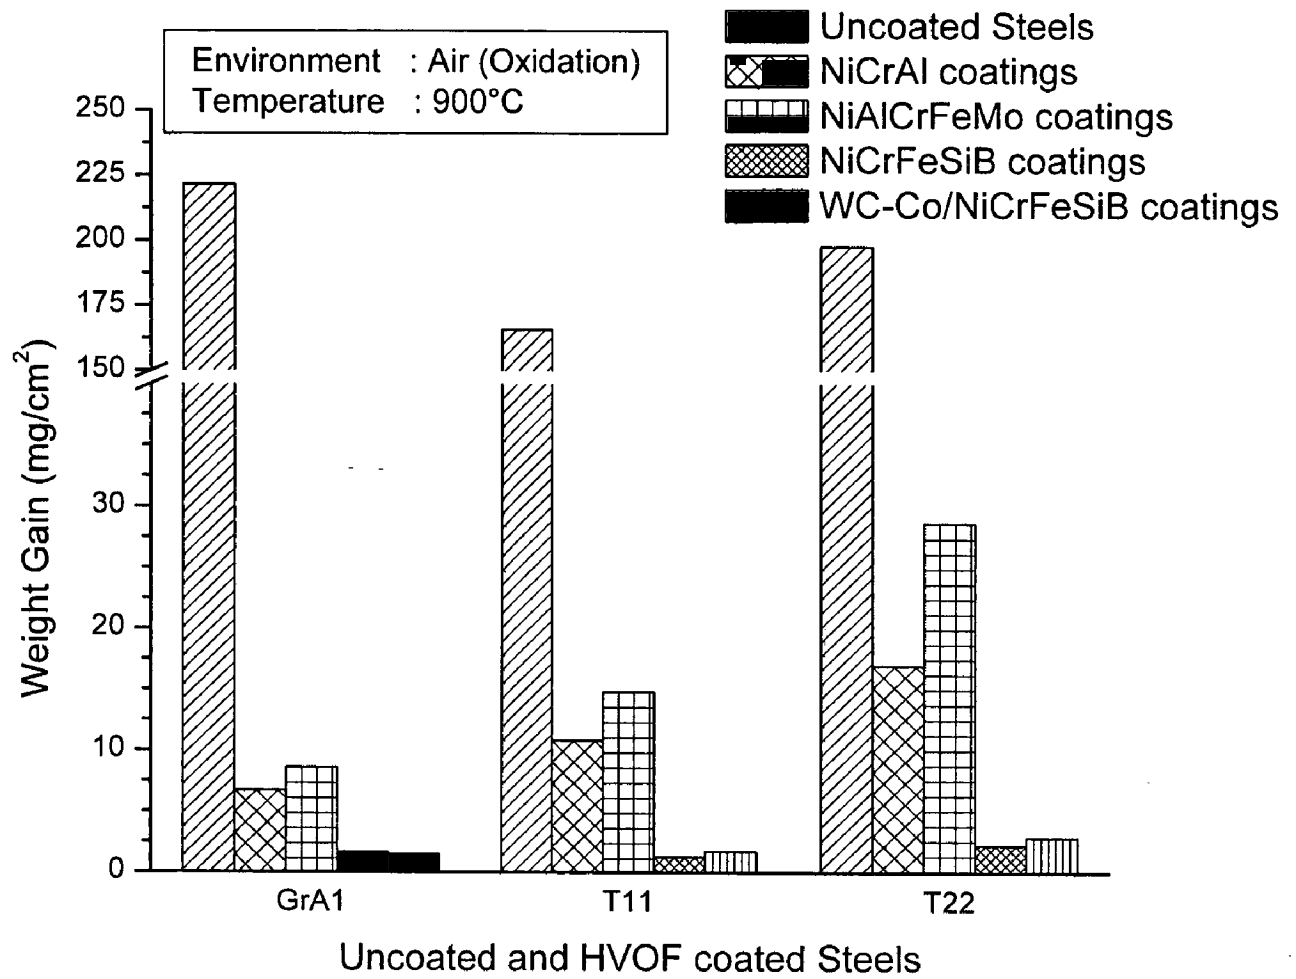
**Fig.5.53** Bar chart showing cumulative weight gain ( $\text{mg}/\text{cm}^2$ ) for uncoated and HVOF coated steels subjected to cyclic oxidation in air for 50 cycles at 900°C

The cumulative weight gain ( $\text{mg}/\text{cm}^2$ ) for uncoated and HVOF coated steels subjected to cyclic oxidation in air for 50 cycles at  $900^\circ\text{C}$  is shown in Fig.5.53. In general, it is evident from the bar chart that the weight gains for all the HVOF coated steels are considerably lower than that of uncoated steels. All the uncoated steels suffered intense spalling of oxide scale. The massive oxide scale formed on all the bare steels mainly consisted of iron oxide. The stresses developed due to higher volume of oxide scale leads to cracks, further these cracks help in internal oxidation and spalling of scale. Based on the thermogravimetric data, the relative oxidation resistance of the various coating under study can be arranged in the following sequence:

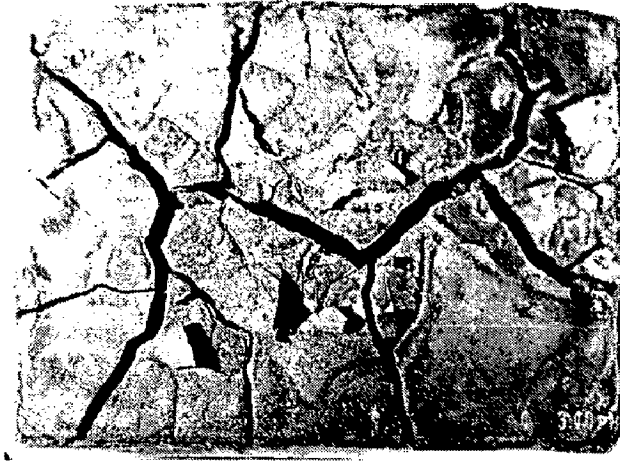
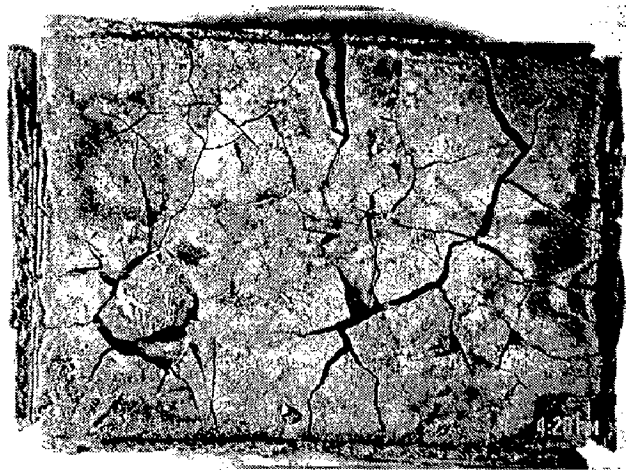
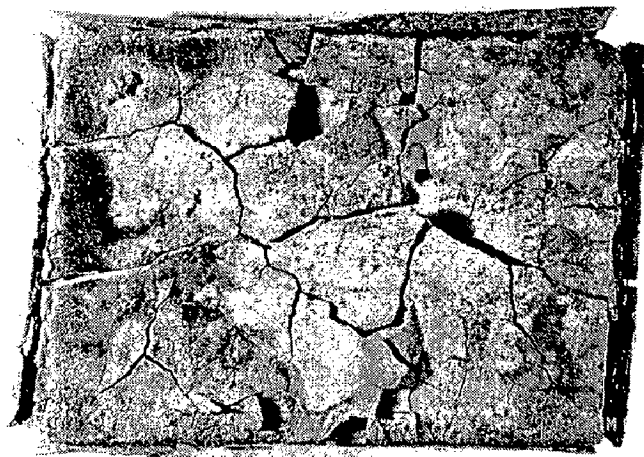
**Fig.6.1** Macrograph of uncoated steel subjected to hot corrosion in  $\text{Na}_2\text{SO}_4$ - $60\%\text{V}_2\text{O}_5$  at  $900^\circ\text{C}$  for 50 cycles:  
(a) GrA1 steel      (b) T11 steel      (c) T22 steel

The macrographs of GrA1, T11 and T22 steels subjected to hot corrosion in  $\text{Na}_2\text{SO}_4\text{-60}\%\text{V}_2\text{O}_5$  molten salt for 50 cycles at  $900^\circ\text{C}$  are shown in Fig. 6.1. It can be observed in Fig. 6.1 that there is an intense spalling of oxide scale for the T22 steel and after eighth cycle the scale starts separating from the substrate. For the GrA1 steel, the exfoliation of the oxide scale was observed from the 35<sup>th</sup> cycle onwards.

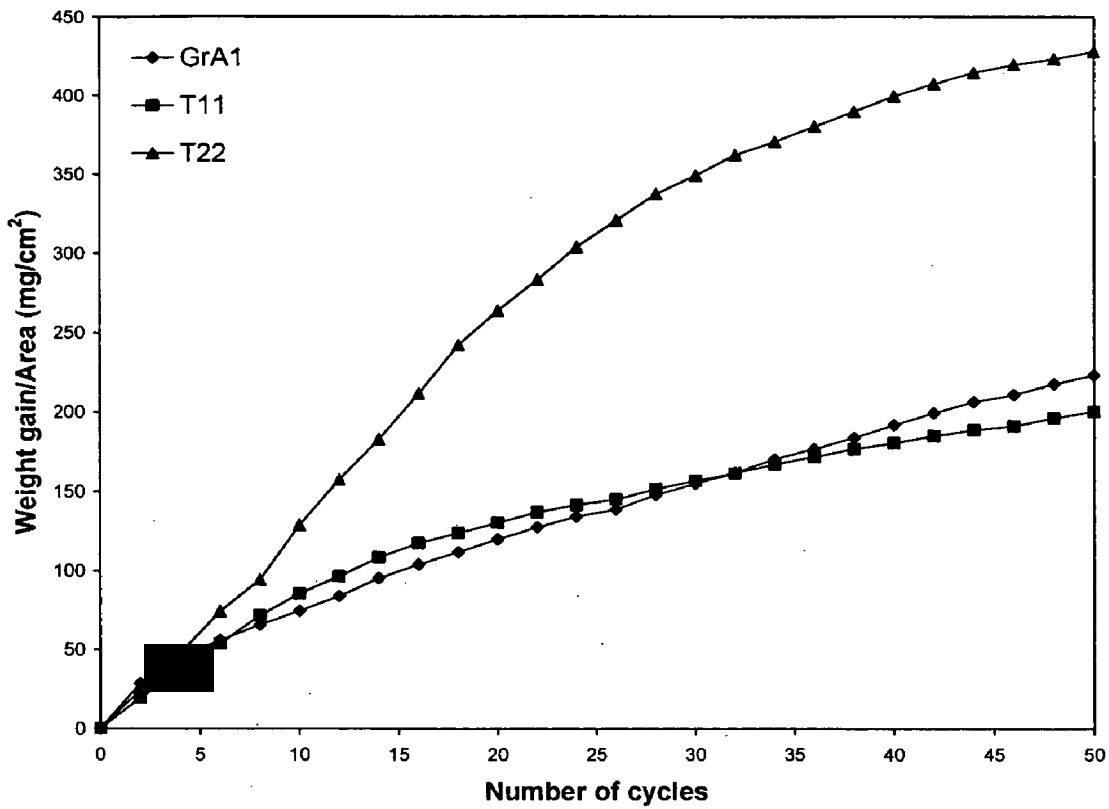
**Fig.6.2** Weight change versus. number of cycles plot for uncoated steels subjected to hot corrosion for 50 cycles in  $\text{Na}_2\text{SO}_4$ -60%  $\text{V}_2\text{O}_5$  environment at  $900^\circ\text{C}$

The plots of cumulative weight gain ( $\text{mg}/\text{cm}^2$ ) as a function of time expressed in number of cycles are shown in Fig. 6.2. The weight gain for the GrA1, T11 and T22 steels at the end of 50 cycles are found to be 223.79, 200.91, and 428.12, respectively. Evidently, the T22 steel showed a maximum weight gain during the hot corrosion studies in molten salt environment as compared to the GrA1 and T11 steels, which is more than double the weight gain value for T22 subjected to oxidation in air at the same temperature (as reported in Chapter 5). Further, the weight gain square ( $\text{mg}^2/\text{cm}^4$ ) data is plotted as a function of time in Fig. 6.3. The plot shows an observable deviation from the parabolic rate law for the T22 steel, which indicates that the oxide scale is not very protective in molten salt environment. It is evident from the plot that the GrA1 and T11

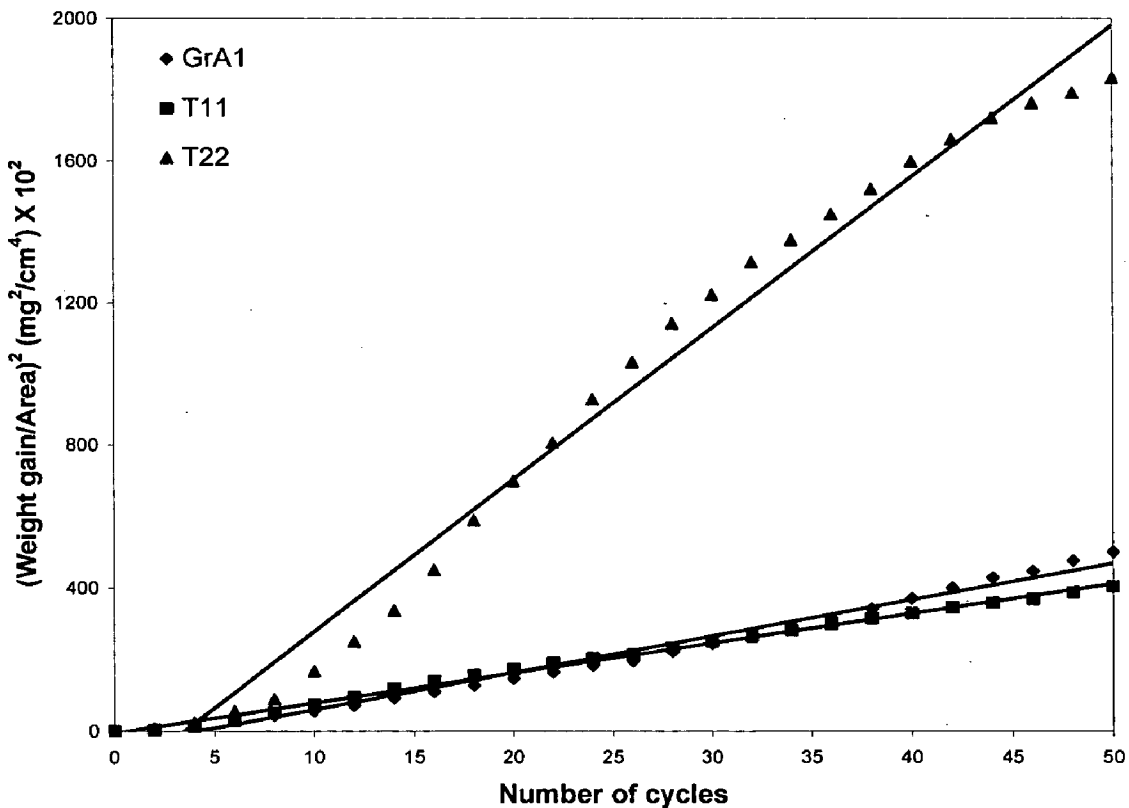
**Fig.6.3**  $(\text{Weight change/area})^2$  vs. number of cycles plot for uncoated steels subjected to hot corrosion for 50 cycles in  $\text{Na}_2\text{SO}_4$ -60%  $\text{V}_2\text{O}_5$  environment at  $900^\circ\text{C}$

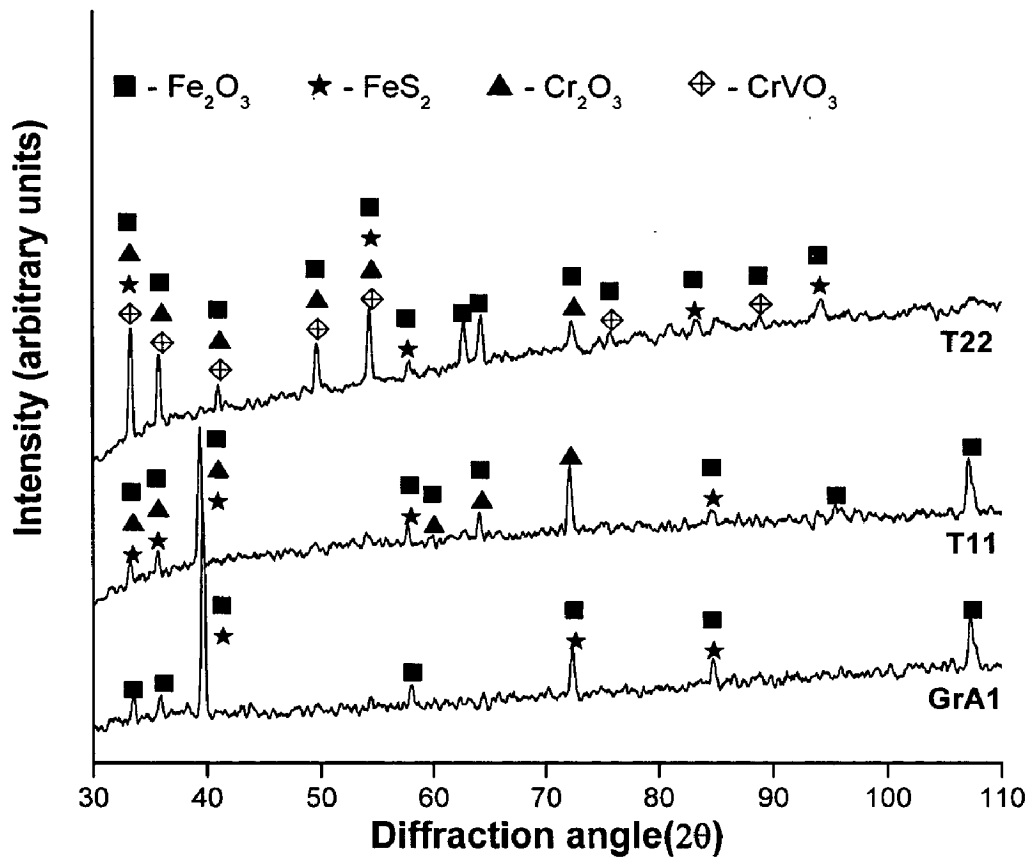
**Fig. 6.4**

X-ray diffraction patterns for the boiler steels subjected to hot corrosion for 50 cycles in  $\text{Na}_2\text{SO}_4$ -60% $\text{V}_2\text{O}_5$  environment at  $900^\circ\text{C}$

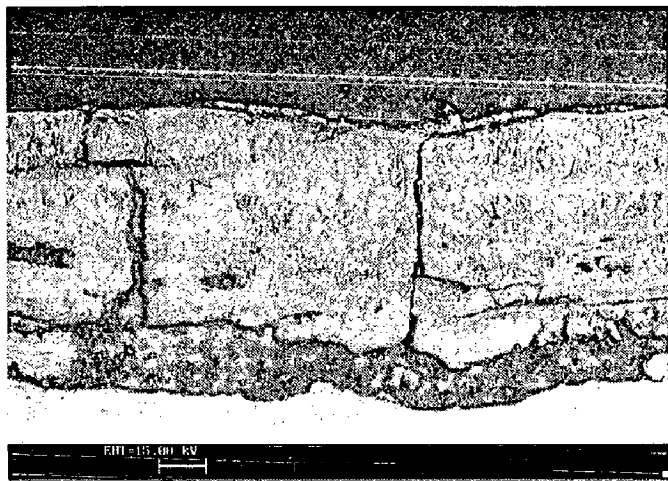
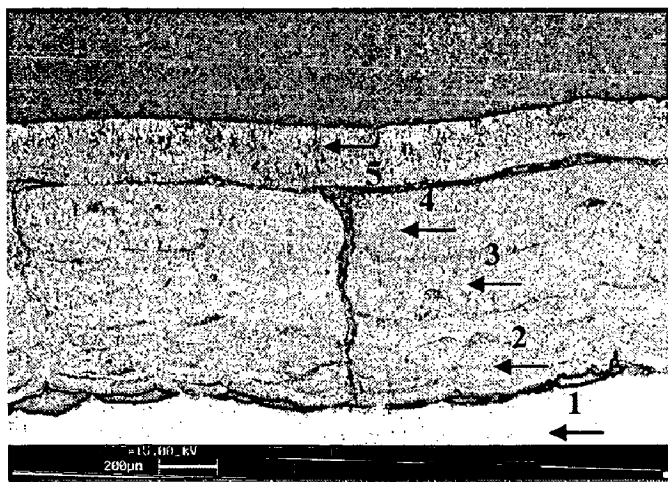
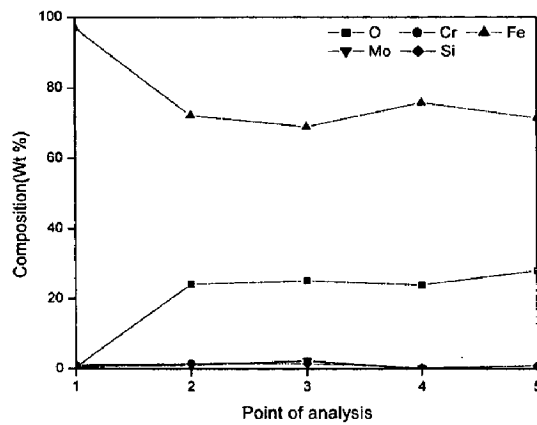
**Fig.6.6**

Back scattered images for the uncoated steels subjected to hot corrosion in  $\text{Na}_2\text{SO}_4$ -60% $\text{V}_2\text{O}_5$  environment at 900°C for 50 cycles  
 (a) GrA1 Steel (b) T11 Steel (c) T22 Steel  
 (d) EDAX point analysis along the cross-section of T22 steel

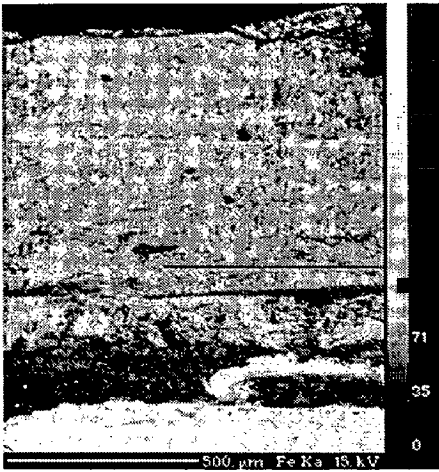
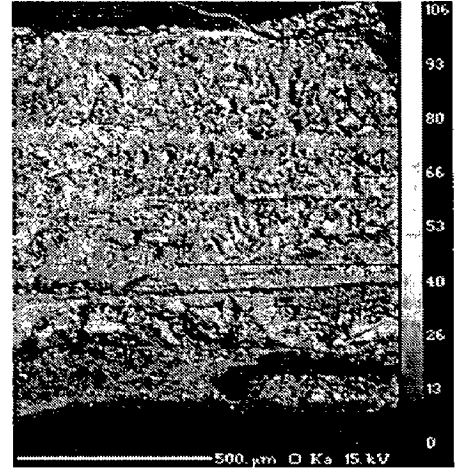
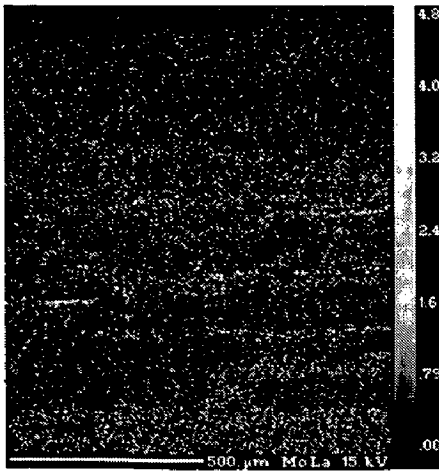
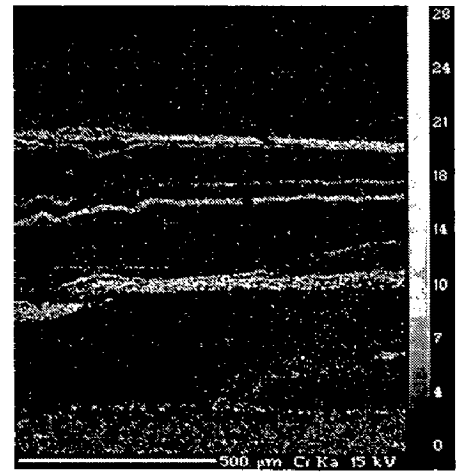
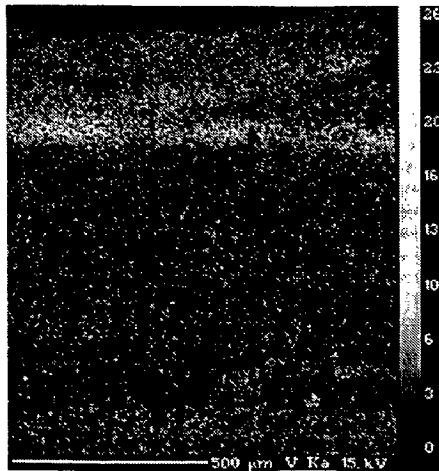
**Fig.6.7** WDS X-ray mapping across the cross-section of the T22 steel subjected to hot corrosion in  $\text{Na}_2\text{SO}_4\text{-60}\%\text{V}_2\text{O}_5$  environment at  $900^\circ\text{C}$  for 50 cycles

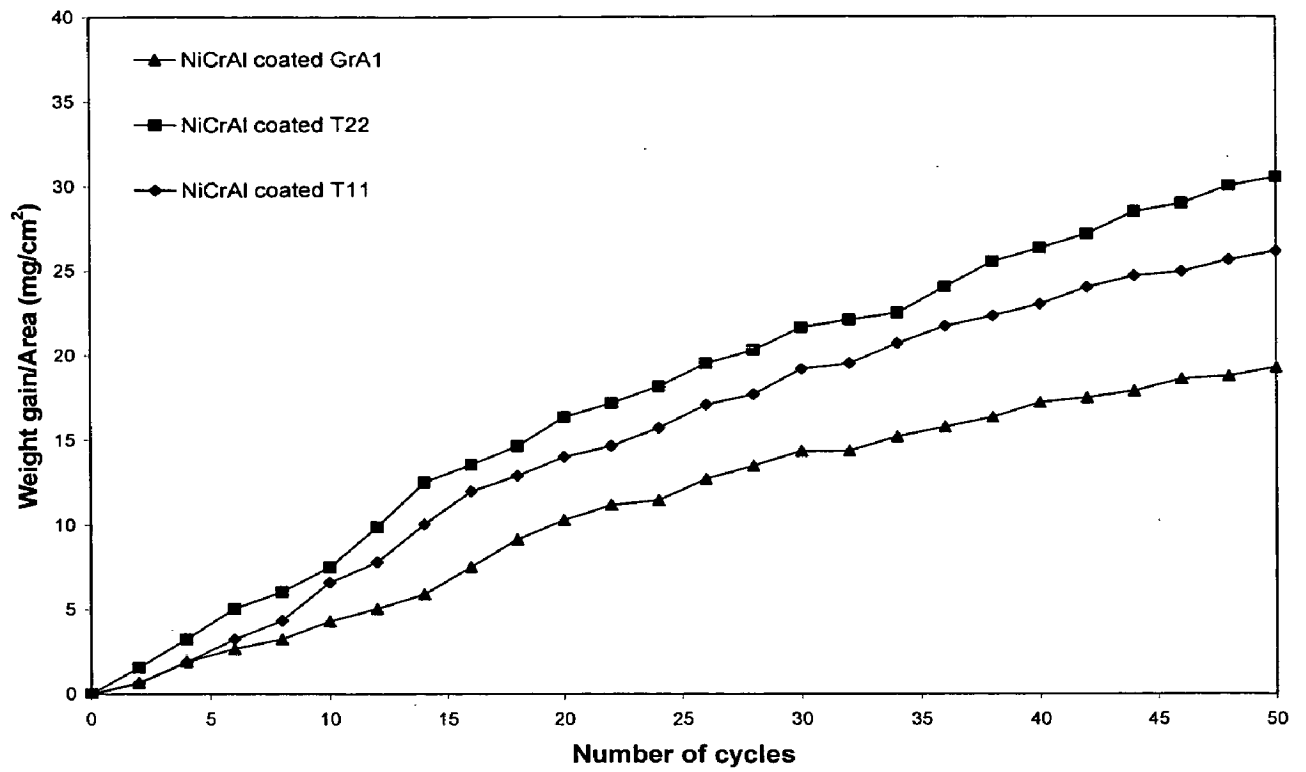
**Fig.6.9** Weight gain versus number of cycles plot for NiCrAl coated steels subjected to hot Corrosion for 50 cycles in  $\text{Na}_2\text{SO}_4\text{-60\%V}_2\text{O}_5$  at  $900^\circ\text{C}$

The plots of cumulative weight gain ( $\text{mg}/\text{cm}^2$ ) as a function of time expressed in number of cycles are shown in Fig. 6.9. The values of overall weight gain after 50 cycles of hot corrosion for the NiCrAl coated GrA1, T11 and T22 steels are found to be 19.28, 26.14 and 30.52  $\text{mg}/\text{cm}^2$ , respectively. Evidently, the coated T22 steel showed a maximum weight gain. The coated GrA1 and T11 steels followed nearly the parabolic behavior up to 50 cycles as can be inferred from the weight gain square ( $\text{mg}^2/\text{cm}^4$ ) data plotted as a function of time, as shown in Fig. 6.10, whereas the coated T22 steel shows a perceptible deviation from the parabolic rate law. The parabolic rate constants ( $K_p$  in  $10^{-8} \text{ g}^2 \text{ cm}^{-4} \text{ s}^{-1}$ ) for the NiCrAl coated GrA1, T11 and T22 steels are 0.229, 0.419 and 0.549, respectively.

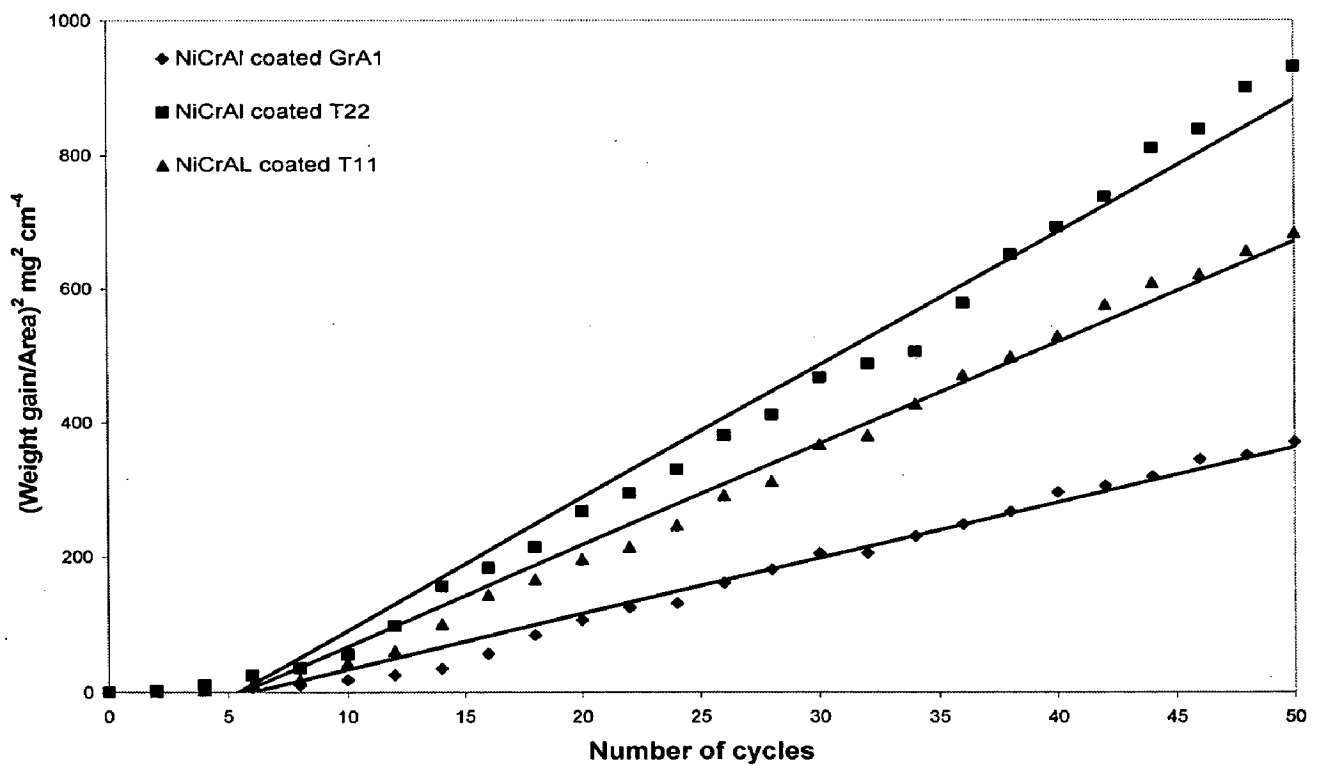
**Fig.6.10**  $(\text{Weight gain/area})^2$  versus number of cycles plot for NiCrAl coated steels subjected to hot corrosion for 50 cycles in  $\text{Na}_2\text{SO}_4\text{-60\%V}_2\text{O}_5$  at  $900^\circ\text{C}$

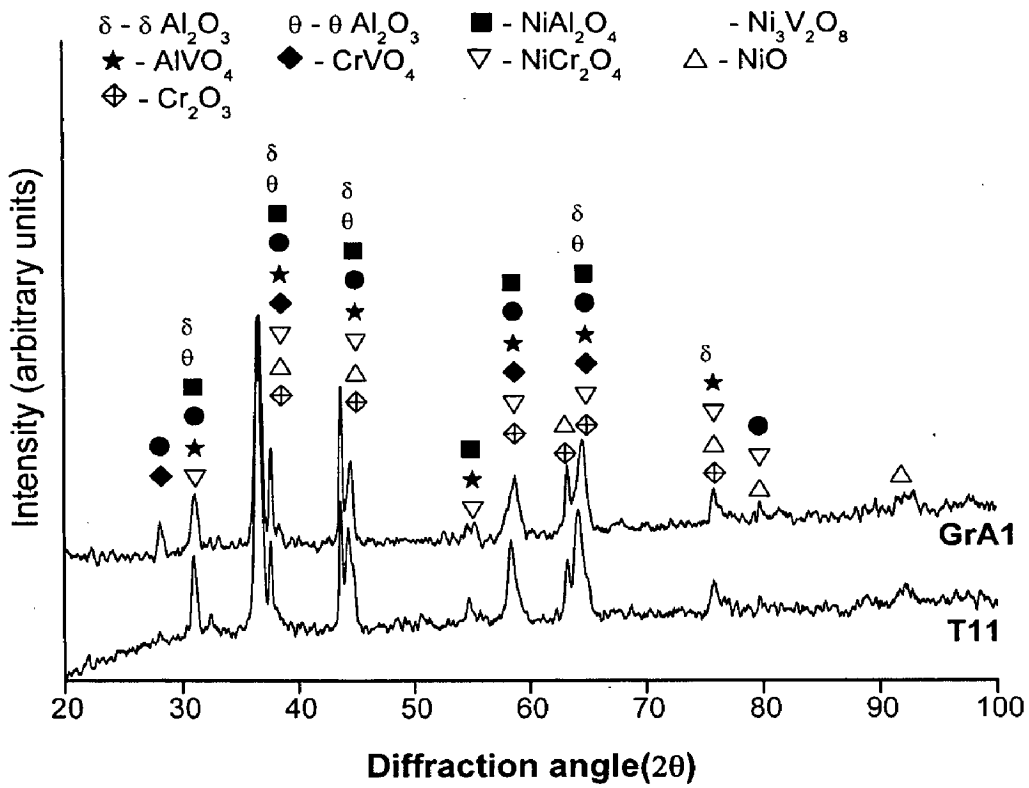
**Fig.6.11** X-ray diffraction patterns for NiCrAl coated GrA1 and T11 steels subjected to hot corrosion in  $\text{Na}_2\text{SO}_4$ -60% $\text{V}_2\text{O}_5$  for 50 cycles at 900°C

The X-ray diffraction pattern for NiCrAl coated steels after exposure to molten salt environment for 50 cycles is as shown in Figs. 6.11 and 6.12. The XRD results reveal  $\delta\text{-Al}_2\text{O}_3$ ,  $\theta\text{-Al}_2\text{O}_3$ , NiO,  $\text{Cr}_2\text{O}_3$ ,  $\text{NiCr}_2\text{O}_4$  and  $\text{NiAl}_2\text{O}_4$  as major phases along with minor phases of  $\text{Ni}_3\text{V}_2\text{O}_8$ ,  $\text{AlVO}_4$  and  $\text{CrVO}_4$ . In case of coated T22 steel additional phase of  $\text{Fe}_2\text{O}_3$  have been revealed.

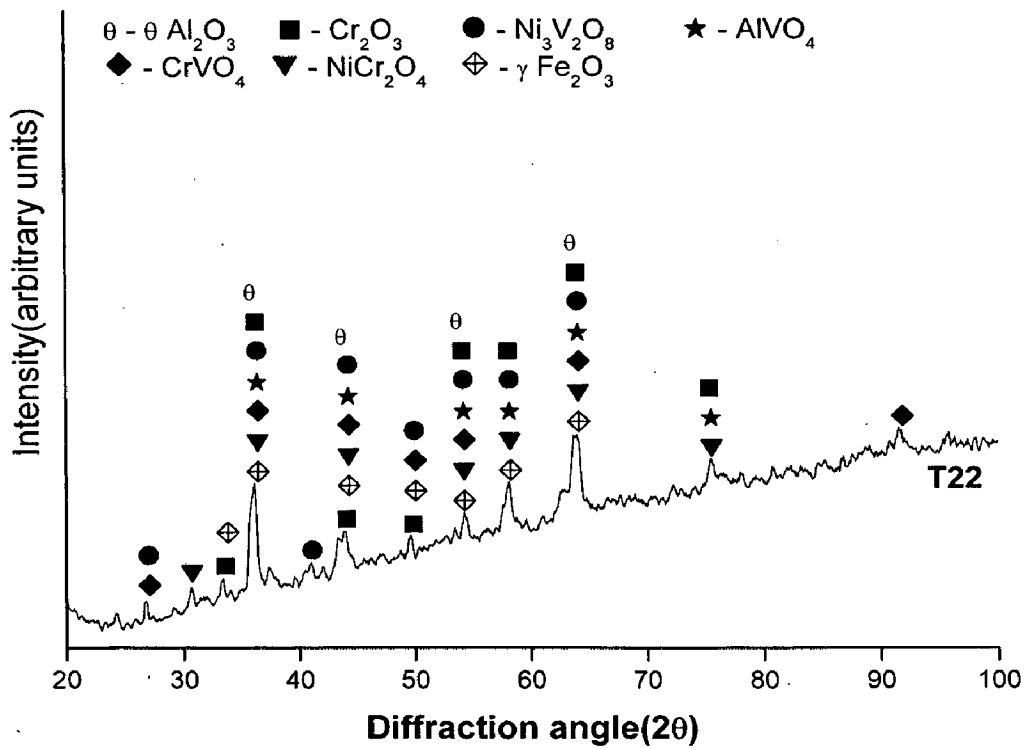
**Fig.6.12** X-ray diffraction patterns for NiCrAl coated T22 steels subjected to hot corrosion in  $\text{Na}_2\text{SO}_4$ -60% $\text{V}_2\text{O}_5$  for 50 cycles at 900°C

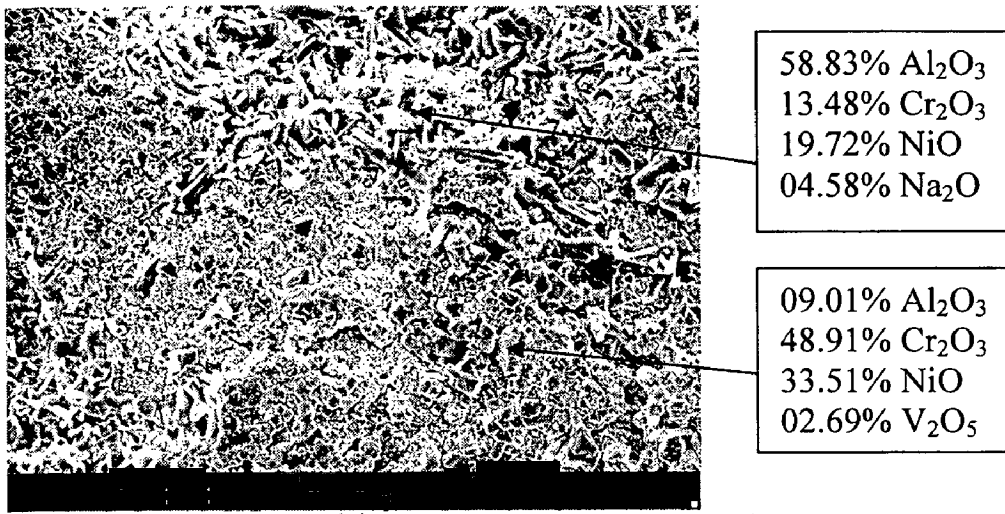
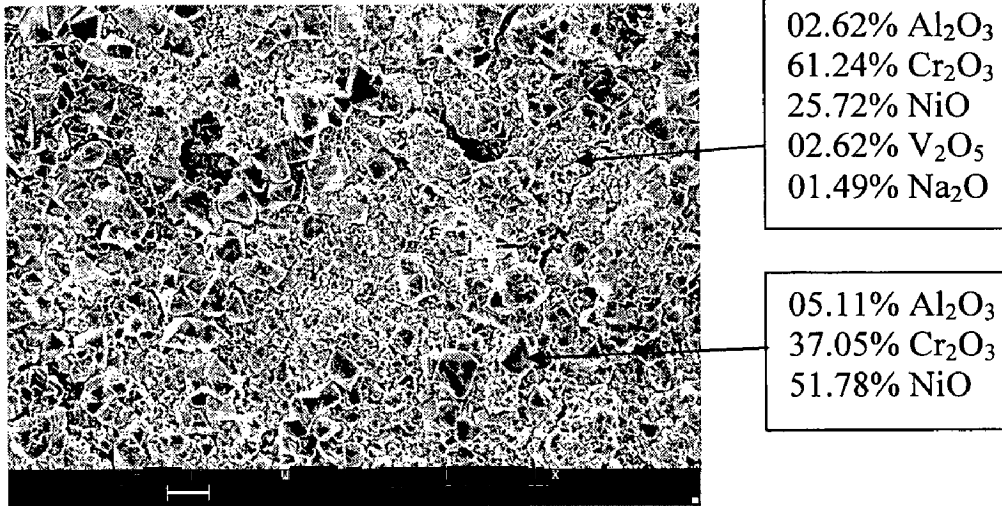
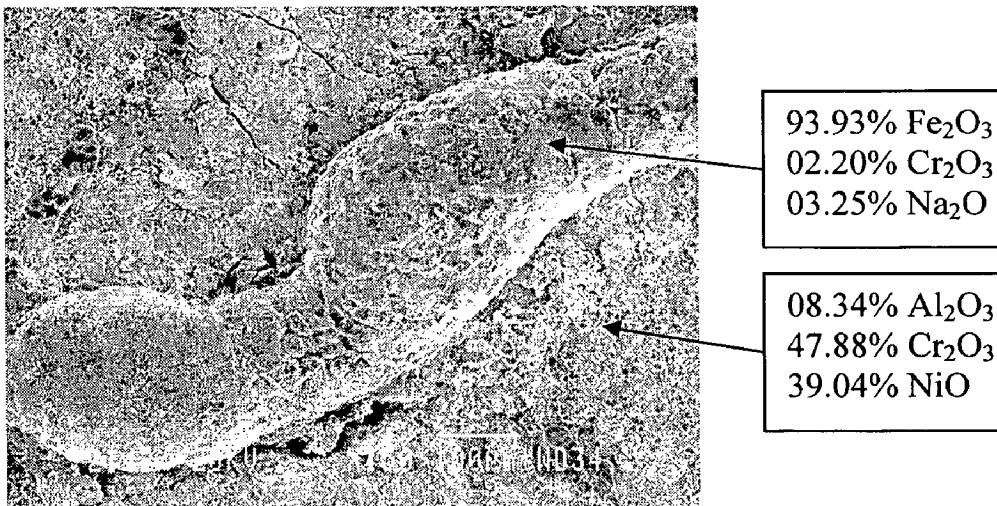
**Fig.6.13** Surface scale morphology and EDAX point analysis for NiCrAl coated steels subjected to hot corrosion for 50 cycles in Na<sub>2</sub>SO<sub>4</sub>-60%V<sub>2</sub>O<sub>5</sub> at 900°C:

(b) T11 steel

(c) T22 steel

The surface morphology of the coated T22 steels (Fig. 6.13c) shows worm-like protrusion which is oriented parallel to the edges of the coating. The EDAX analysis on this protrusion shows higher amount of  $\text{Fe}_2\text{O}_3$ , which might have oozed out from the substrate through the cracks developed during the hot corrosion studies.

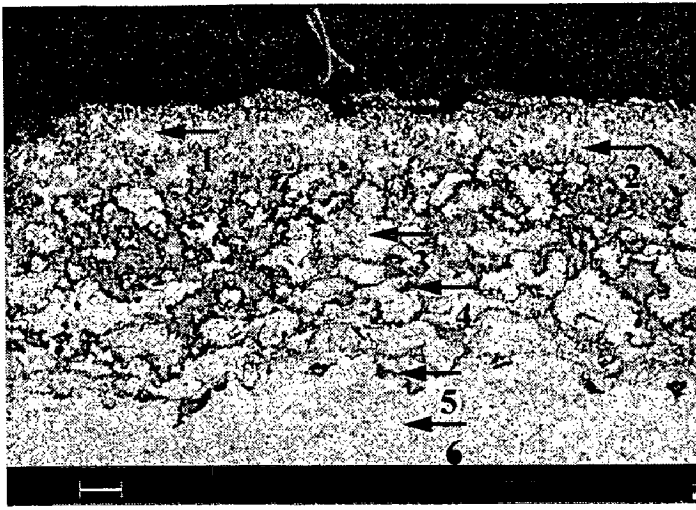
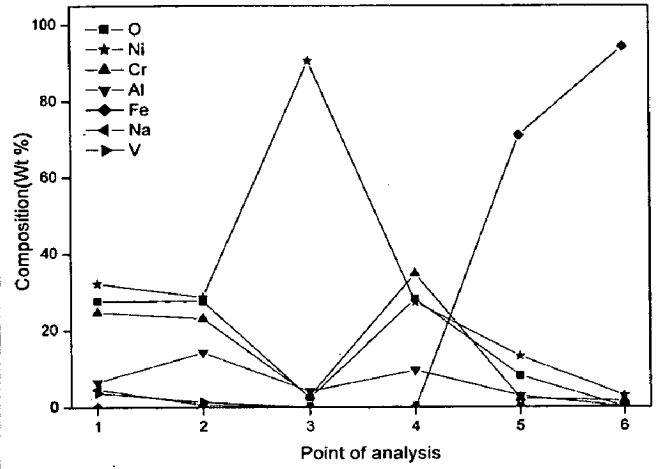
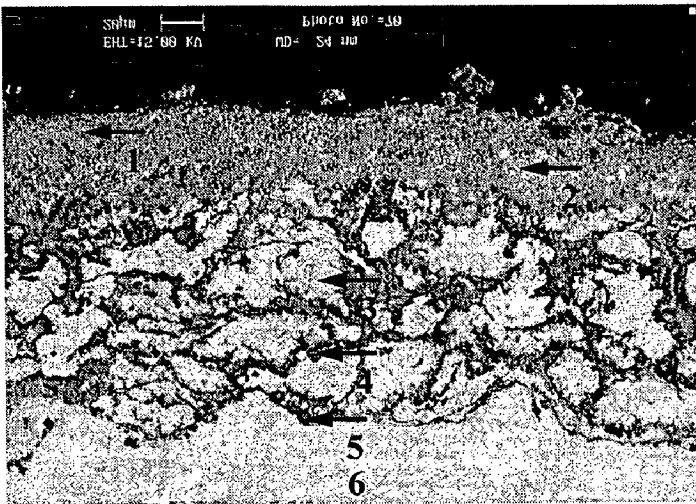
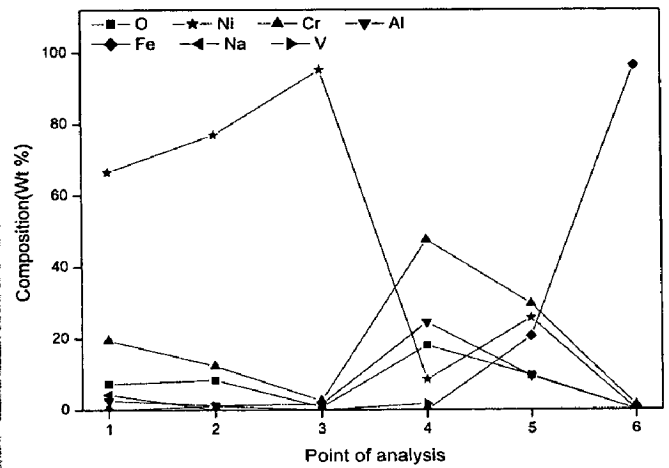
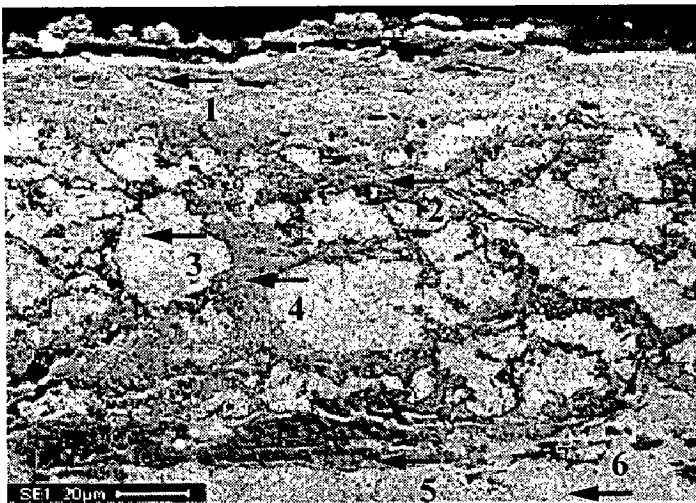
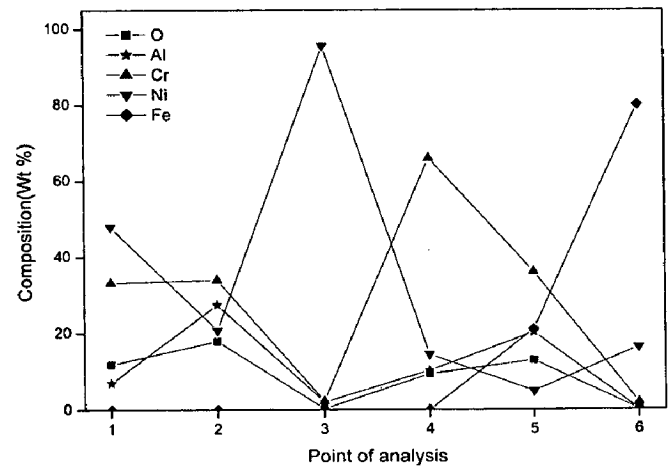
Fig.6.14

Back scattered electron image and EDAX point analysis (wt %) across the cross-section of the NiCrAl coated steels subjected to hot corrosion in  $\text{Na}_2\text{SO}_4$ -60% $\text{V}_2\text{O}_5$  environment for 50 cycles at 900°C :

(a) GrAl steel (b) T11 steel (c) T22 steel

Figure 6.14 shows the BSEI taken along the cross section of the corroded NiCrAl coated steels and the EDAX composition analysis at the site of interest. A continuous and adherent thick layer of scale has been observed on the top of the corroded coating. The thickness of this outermost oxide layer as measured from the BSEI image is in the range of 25-50  $\mu\text{m}$  after 50 cycles of hot corrosion studies. The EDAX analysis across this oxide layer indicates mainly the presence of NiO and  $\text{Cr}_2\text{O}_3$  along with a lower percent of  $\text{Al}_2\text{O}_3$  (Points 1 and 2 in Figs. 6.14a and 6.14b; and point 1 in Fig. 6.14c). The white grains (Point 3 in Figs. 6.14a–6.14c) underneath the uppermost oxide layer in the microstructure of all the coated steels corresponds to the nickel-rich splats in an unoxidized state, as oxygen is absent at this point. The EDAX analysis shows the light grey phases formed at the boundaries of these splats (point 4) consisted of mainly Cr, Al, Ni and O, which reveals that internal oxidation has occurred along the splat boundary. The presence of minor amount of iron at the coating substrate interface (point 5) explains the diffusion of Fe into the coating.

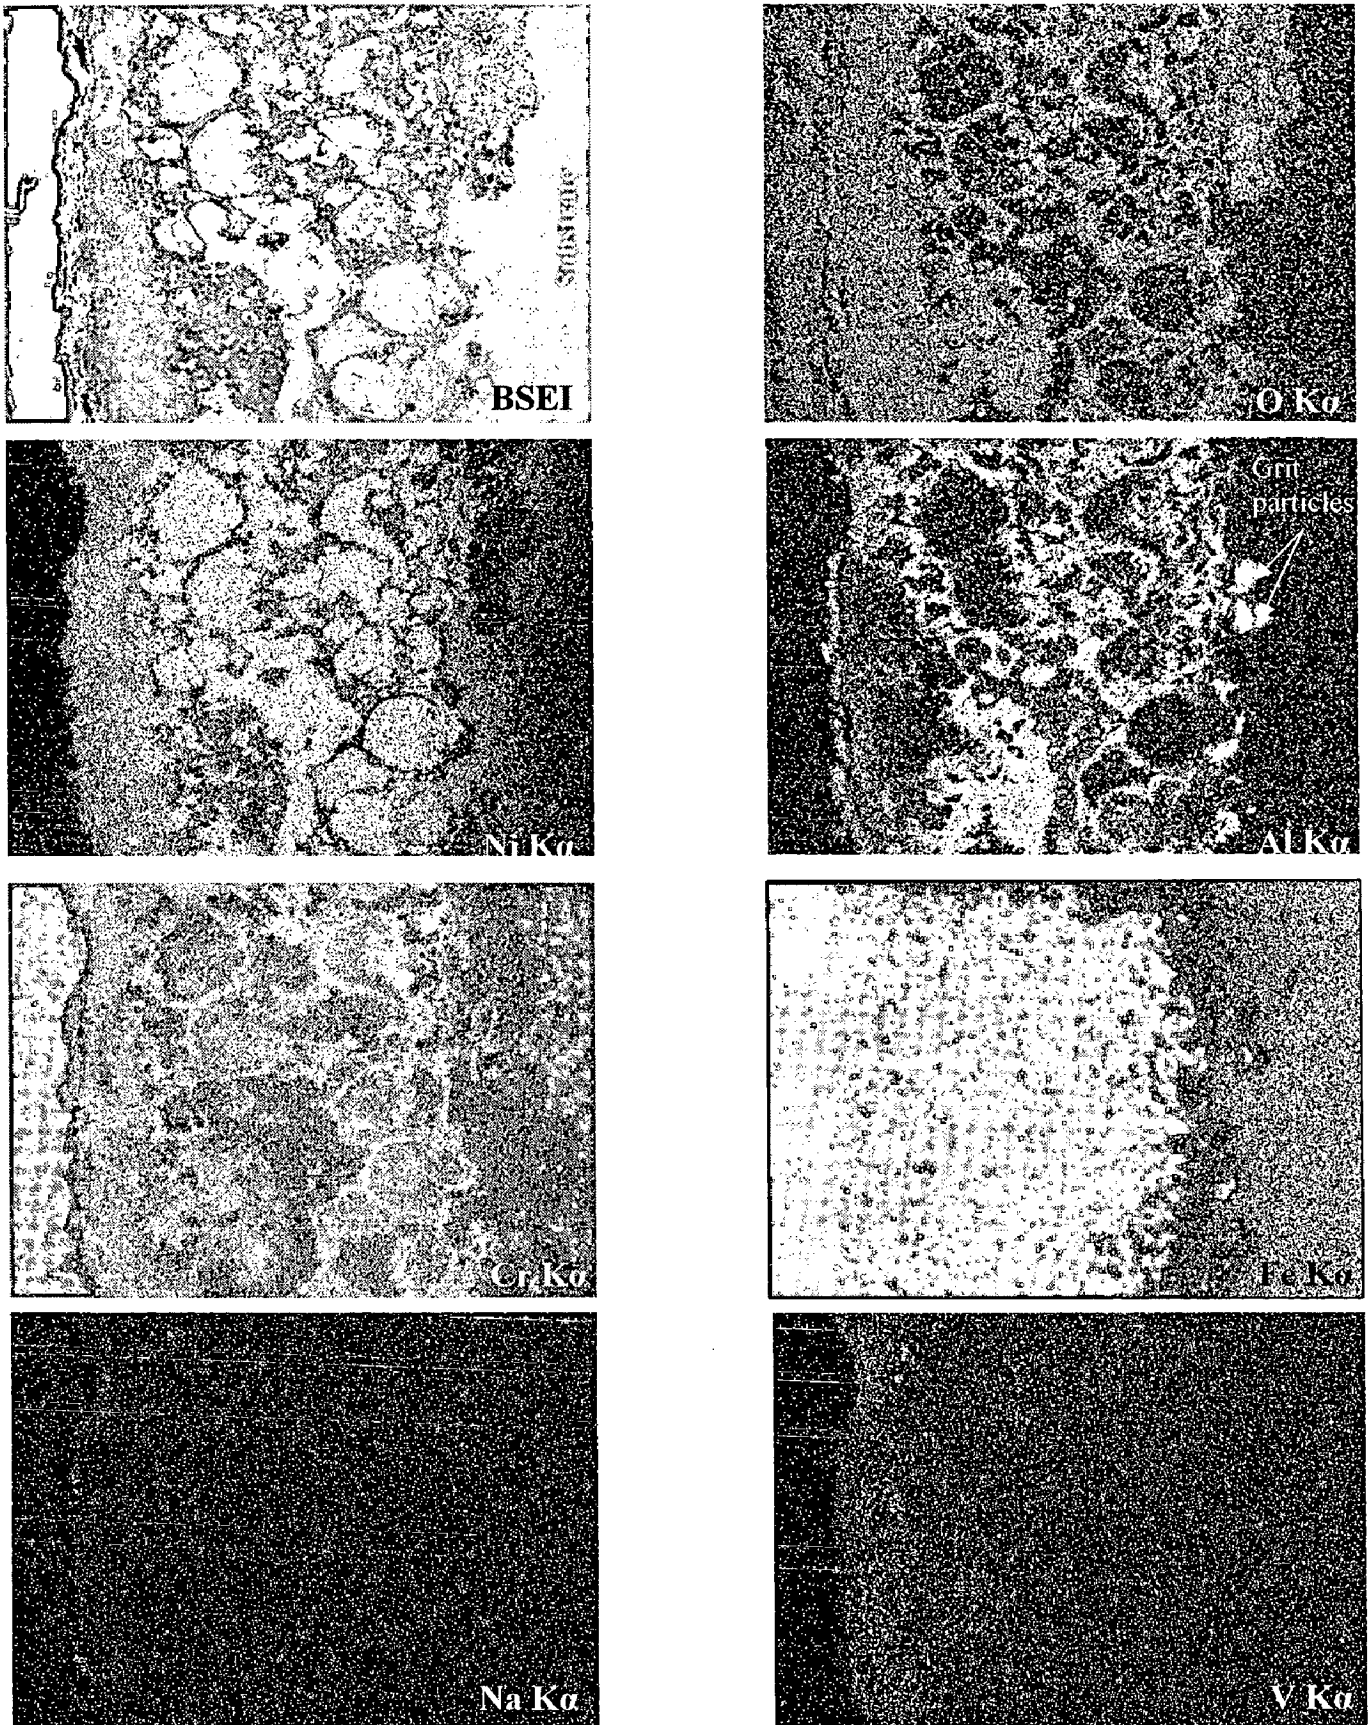
**Fig.6.15** BSEI and elemental X-ray mapping along the cross-section of the NiCrAl coated GrA1 steels subjected to hot corrosion for 50 cycles in  $\text{Na}_2\text{SO}_4$ -60% $\text{V}_2\text{O}_5$  environment at 900°C

The BSEI and X-ray maps for the NiCrAl coated steels after exposure to  $\text{Na}_2\text{SO}_4$ -60% $\text{V}_2\text{O}_5$  environment for 50 cycles at 900°C are shown in Figs. 6.15 to 6.17. The corroded NiCrAl coated GrAl steel (Fig. 6.15) illustrates the formation of a thick uppermost oxide layer which mainly consisted of Ni and Cr oxides. The combined mapping for Al and O reveals thin stringers of aluminum oxide on top of the oxide scale. Moreover, the presence of a minor amount of V and Na in the uppermost oxide layer confirms the formation of corrosion products. The mapping for the elements Al, Cr, and O clearly shows the selective oxidation of Al and Cr along the splat boundary. The nickel rich splats are in unoxidised condition. The observation into the coating-substrate interface reveals the diffusion of iron into the coating along with the diffusion of coating elements Ni, Cr, and Al into the substrate which helps in better bonding. The presence of

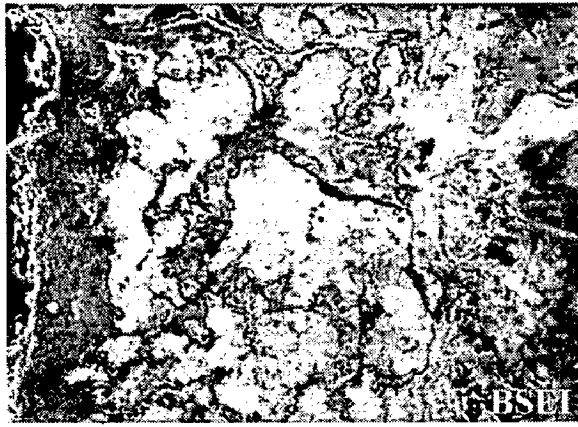
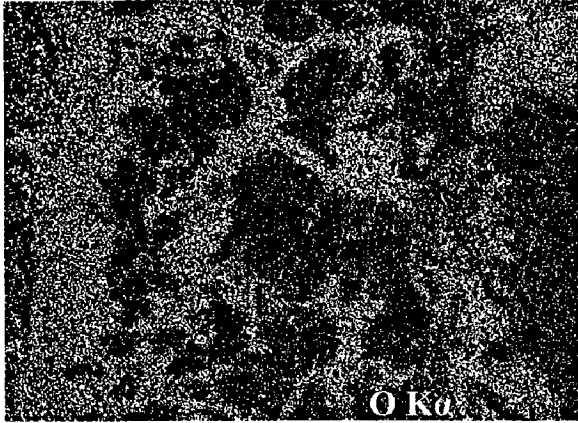
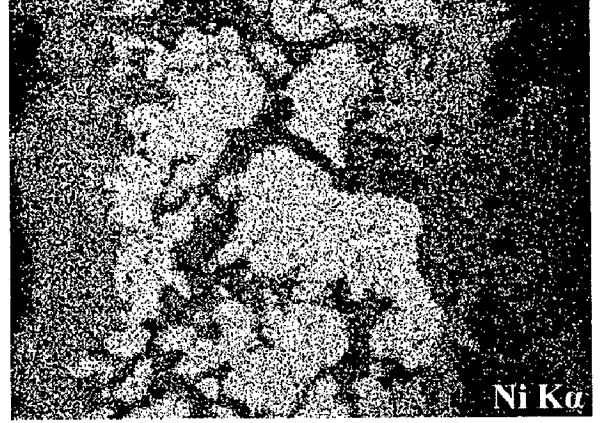
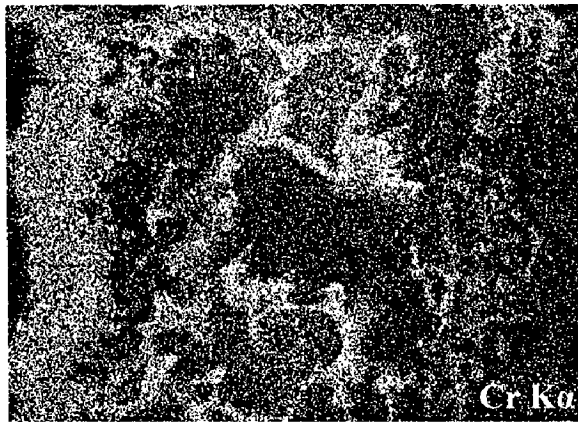
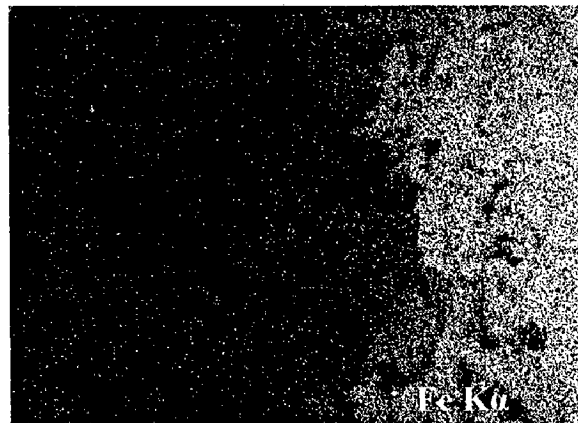
**Fig.6.17** BSEI and elemental X-ray mapping along the cross-section of the NiCrAl coated T22 steels subjected to hot corrosion for 50 cycles in  $\text{Na}_2\text{SO}_4$ -60% $\text{V}_2\text{O}_5$  environment at 900°C

The X-ray mappings for NiCrAl coated T22 Steel (Fig. 6.17) shows a broader coating-substrate interface. Further, a higher diffusion of Ni, Cr, and Al into the substrate as well as the diffusion of iron into the coating has been observed after 50 cycles of exposure. The oxygen penetrates deeper inside and oxidized the substrate to a certain extent in case of the coated T22 steel.

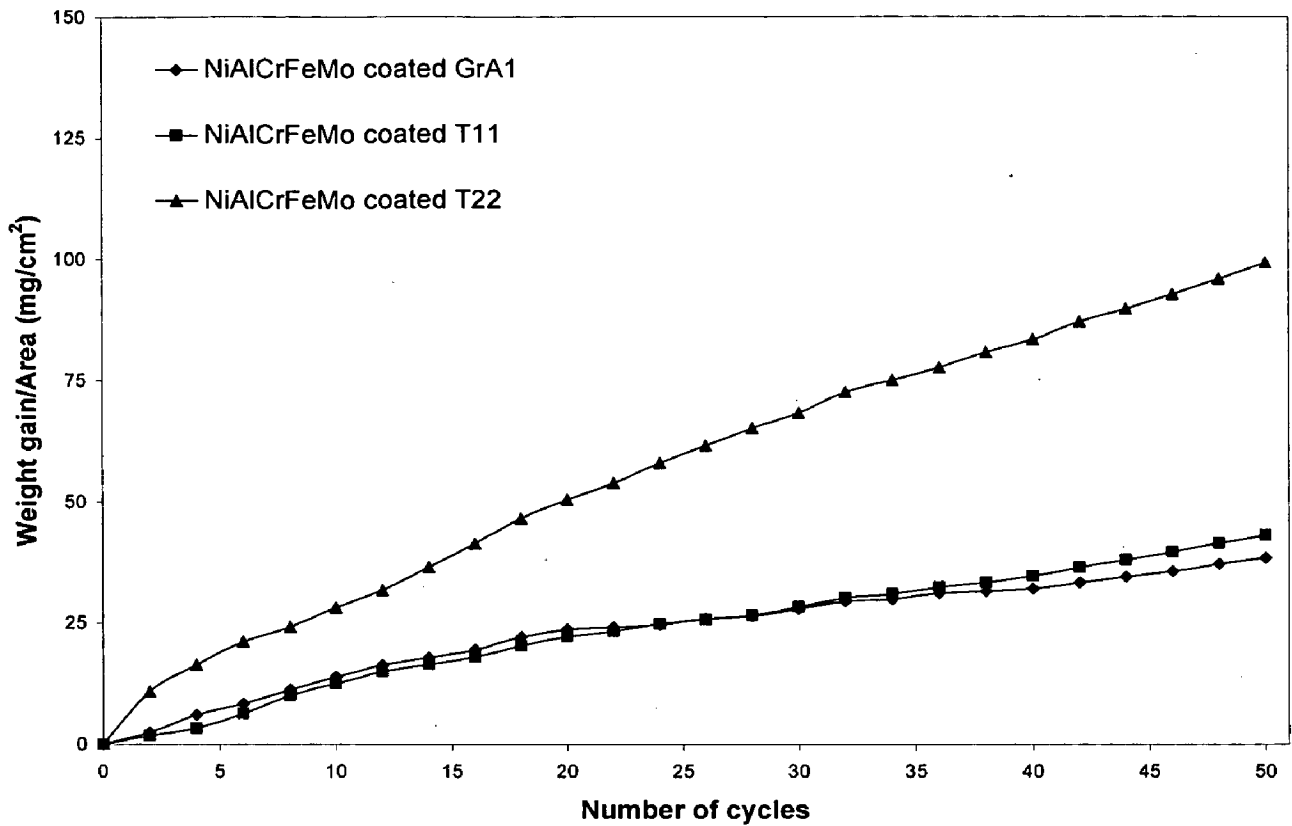
**Fig.6.19** Weight gain versus number of cycles plot for NiAlCrFeMo coated steels subjected to hot Corrosion for 50 cycles in  $\text{Na}_2\text{SO}_4$ -60% $\text{V}_2\text{O}_5$  at  $900^\circ\text{C}$

The plots of cumulative weight gain ( $\text{mg}/\text{cm}^2$ ) as a function of time are shown in Fig.6.19. It can be inferred from the thermogravimetric data that the necessary protection against hot corrosion has been provided by the NiAlCrFeMo coating, as the weight gain values for the coated steels are smaller than those for respective uncoated steels as reported in section 6.1.1.1. The total weight gain values for the coated GrA1, T11 and T22 steels at the end of 50 cycles of hot corrosion studies are found to be 38.49, 43.16
