# **STUDIES ON THE ROLE OF HVOF COATINGS IN IMPROVING RESISTANCE TO HOT CORROSION AND EROSION**

## **A THESIS**

**DOCTOR OF PHILOSOPHY**

**METALLURGICAL AND MATERIALS ENGINEERING**

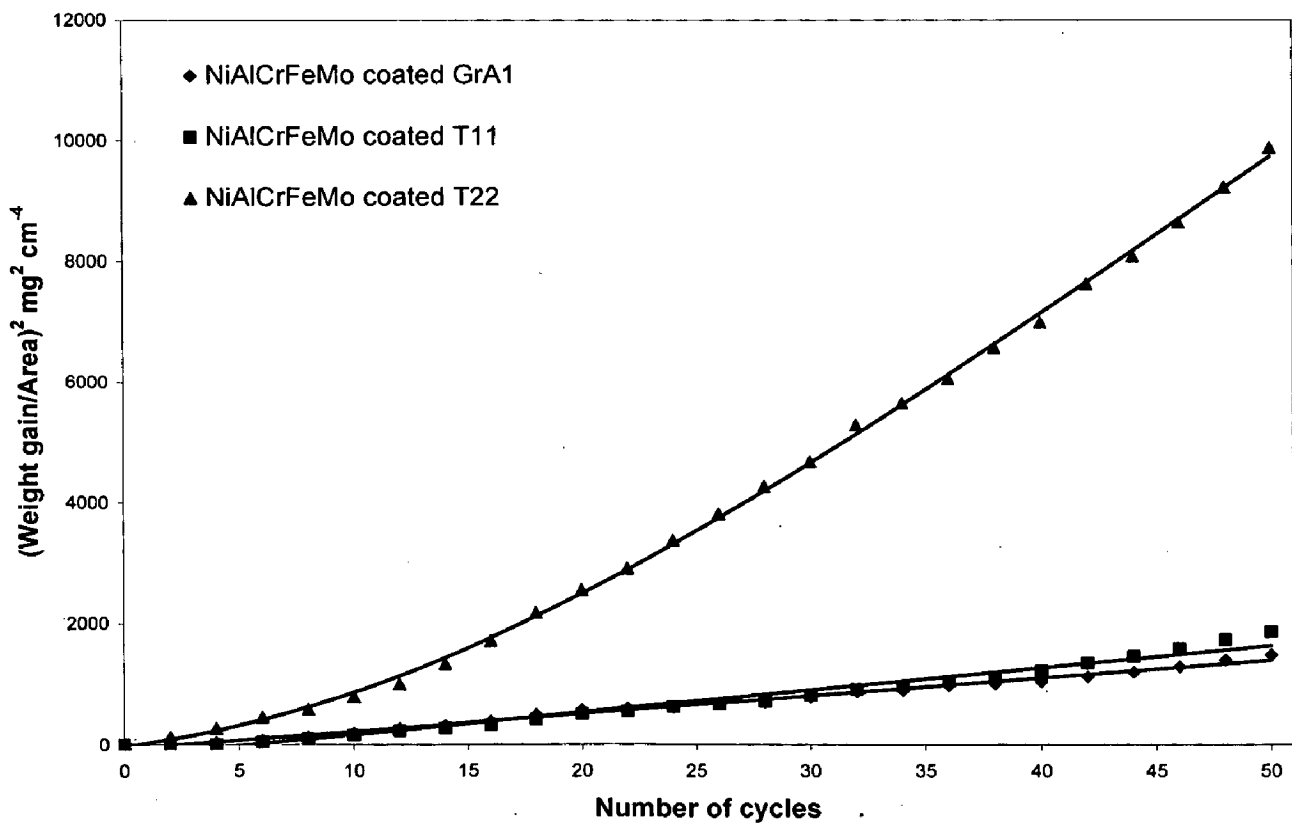
**Fig.6.20**  $(\text{Weight gain/area})^2$  versus number of cycles plot for NiAlCrFeMo coated steels subjected to hot corrosion for 50 cycles in  $\text{Na}_2\text{SO}_4$ -60% $\text{V}_2\text{O}_5$  at  $900^\circ\text{C}$

and  $99.35 \text{ mg/cm}^2$  respectively. Further the weight gain square ( $\text{mg}^2/\text{cm}^4$ ) data were plotted as a function of time, shown in Fig.6.20. The GrA1 and T11 steels followed the parabolic behaviour and the parabolic rate constants calculated are  $8.15 \times 10^{-9}$  and  $10.19 \times 10^{-9} \text{ g}^2 \text{ cm}^{-4} \text{ s}^{-1}$  respectively. The coated T22 steel followed linear behaviour.

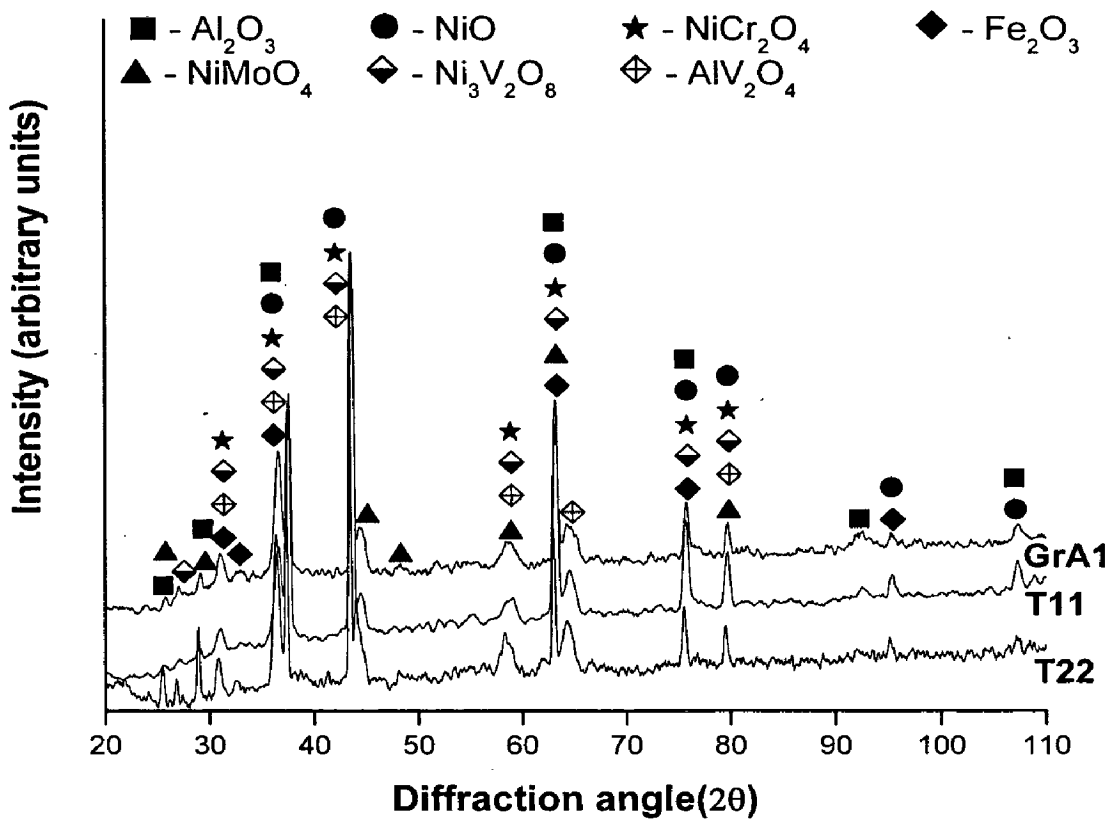
**Fig.6.21**

X-ray diffraction patterns for NiAlCrFeMo coated GrA1, T11 and T22 steels subjected to hot corrosion in  $\text{Na}_2\text{SO}_4$ -60% $\text{V}_2\text{O}_5$  for 50 cycles at 900°C

X-ray diffractograms for the corroded surfaces of NiAlCrFeMo coated steels after cyclic studies in molten salt are shown in Fig.6.21. All the coated GrA1, T11 and T22 steels indicated the formation of similar phases. The main phases revealed by XRD analysis are NiO, NiCr<sub>2</sub>O<sub>4</sub>, Ni<sub>3</sub>V<sub>2</sub>O<sub>8</sub>, AlV<sub>2</sub>O<sub>4</sub>, Al<sub>2</sub>O<sub>3</sub>, Fe<sub>2</sub>O<sub>3</sub> and NiMoO<sub>4</sub>.

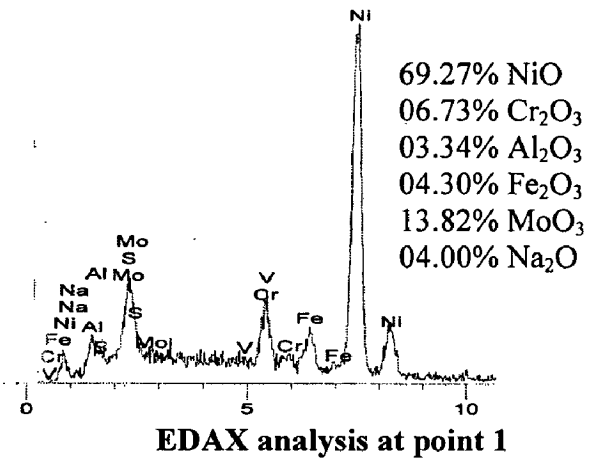
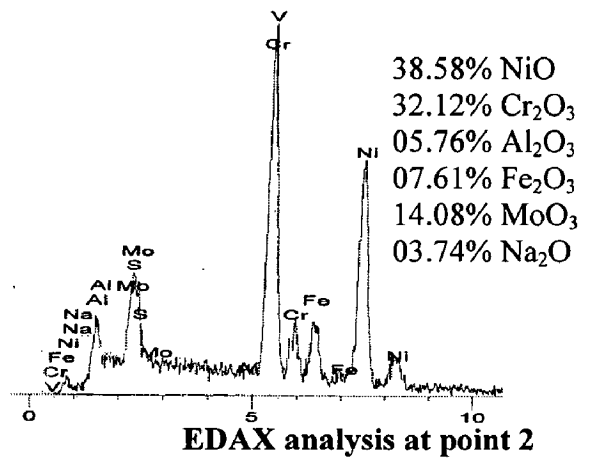
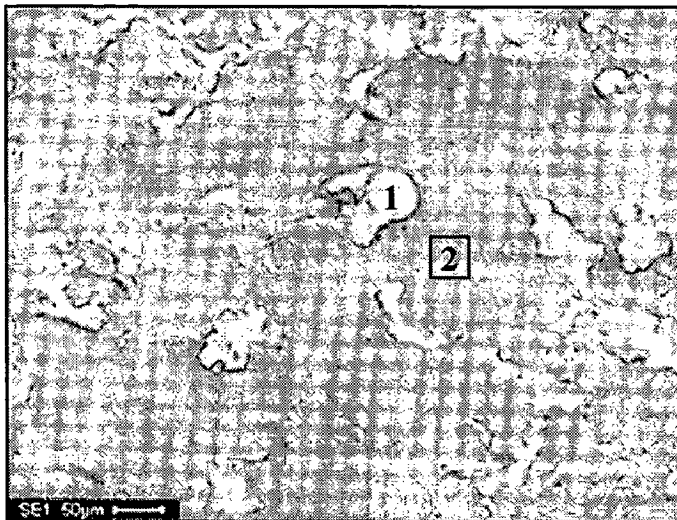
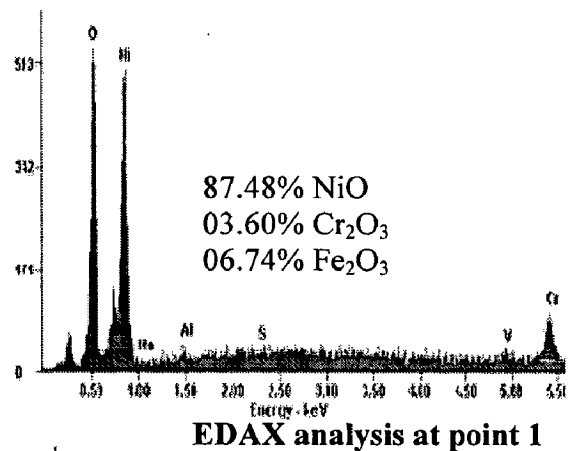
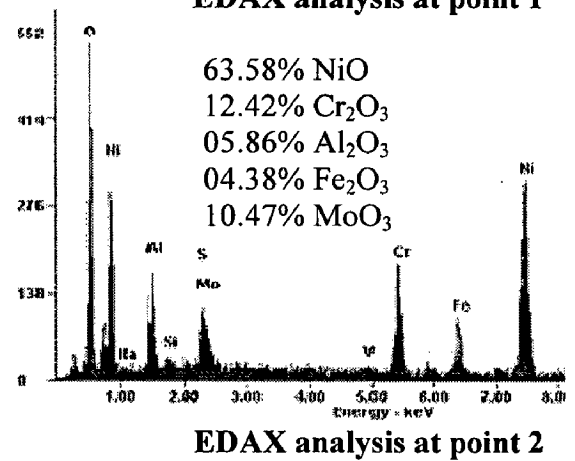
**Fig.6.22**

Surface scale morphology and EDAX analysis for NiAlCrFeMo coated GrA1 and T11 steels subjected to hot corrosion for 50 cycles in Na<sub>2</sub>SO<sub>4</sub>-60%V<sub>2</sub>O<sub>5</sub> at 900°C:

(a) Coated GrA1 steel

(b) Coated T11 steel

The surface morphologies of the corroded NiAlCrFeMo coated steels along with EDAX analysis at some points of interest are shown in Figs.6.22 and 6.23. Oxide scales formed on the surface seem to be porous and cracks are observed at some region. Grey colored phases (Fig.6.22a) dispersed on the dark matrix has been identified to be nickel rich splats. While the matrix has relative higher concentration of oxides of Cr, Al, Fe and Mo. The exact sulphur content of the oxide scale could not be quantified with EDAX analysis, since the EDS peaks of Mo (L-peak) and S (K-peak) overlap at  $\sim 2.35 \text{ KeV}$  makes accurate quantification difficult and hence the peak corresponds to the presence of both S and Mo. Similarly presence of both V (K-peak) and Cr (K-peak) at  $\sim 5.5 \text{ KeV}$  can be expected even though the accurate quantification is difficult with EDAX analysis. Similar observations have been noticed for the oxide scale formed on NiAlCrFeMo coated T11 and T22 steels as shown in Fig.6.22b and Fig.6.23.

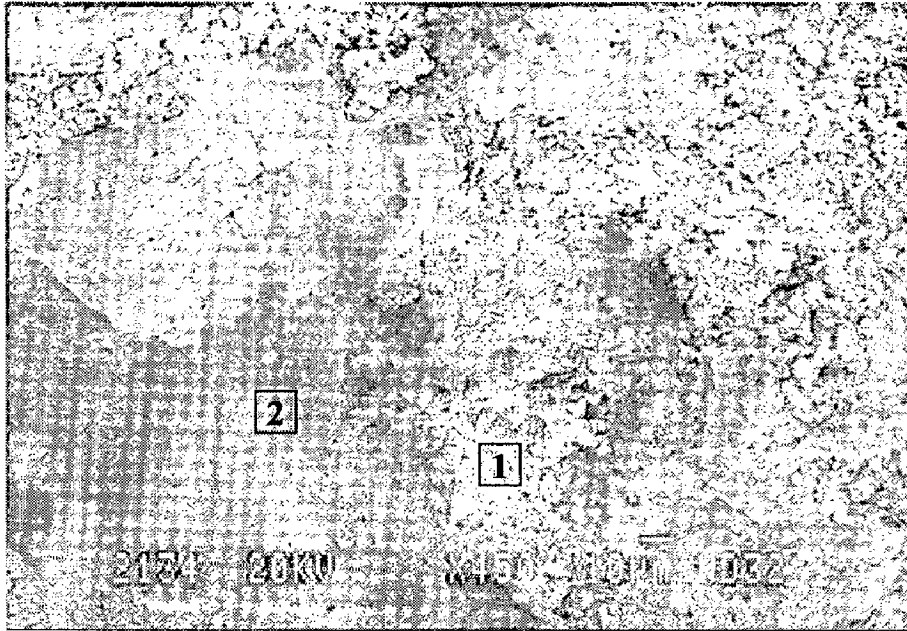
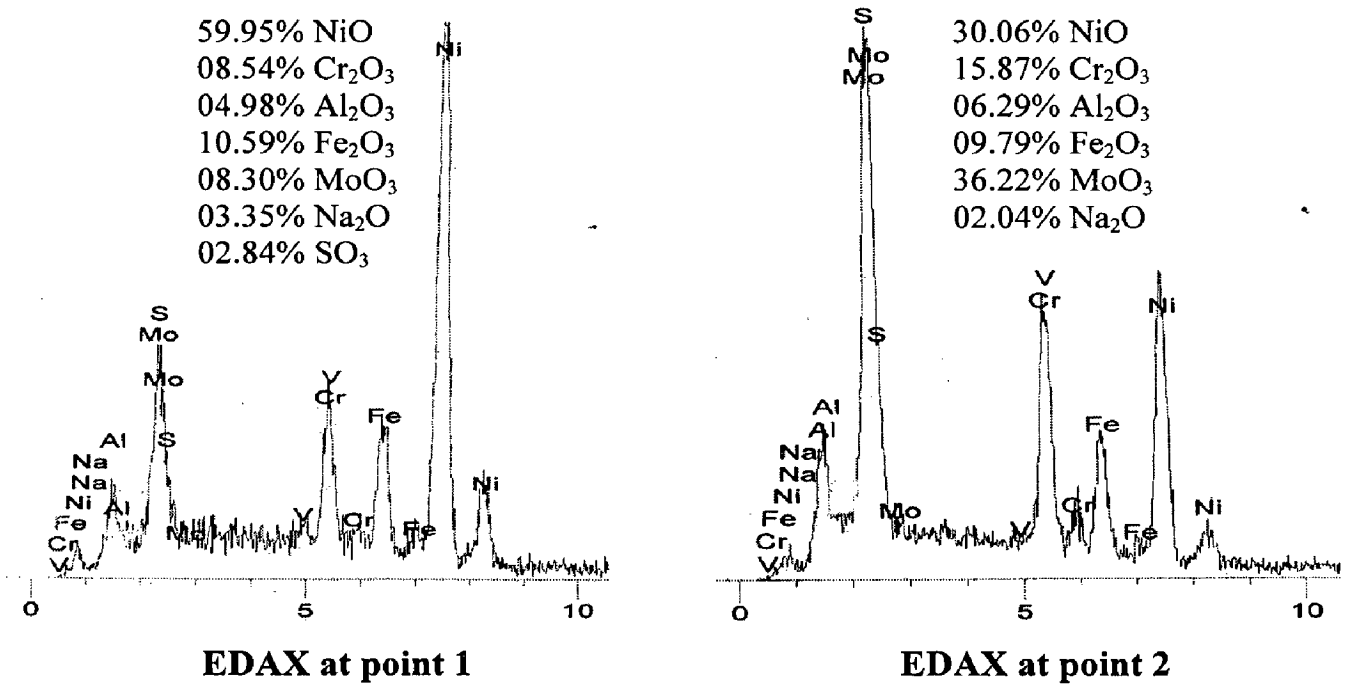
**Fig.6.23**

Surface scale morphology and EDAX point analysis for NiAlCrFeMo coated T22 steel subjected to hot corrosion for 50 cycles in Na<sub>2</sub>SO<sub>4</sub>-60%V<sub>2</sub>O<sub>5</sub> at 900°C

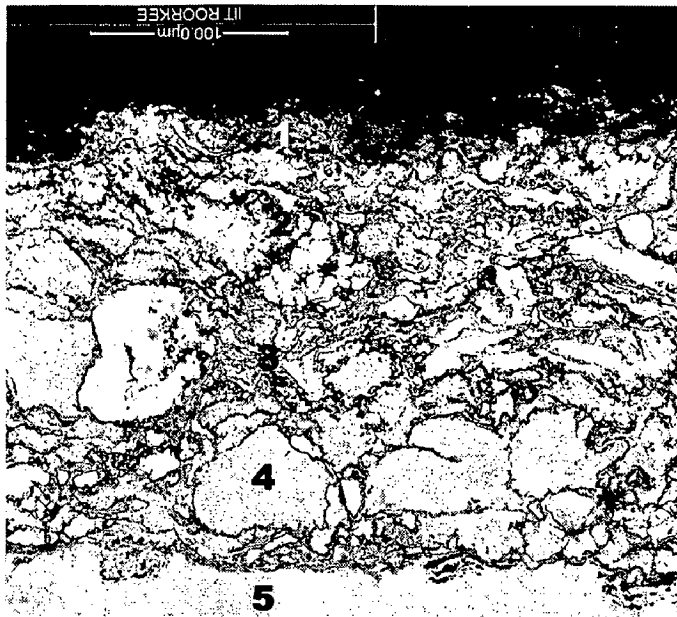
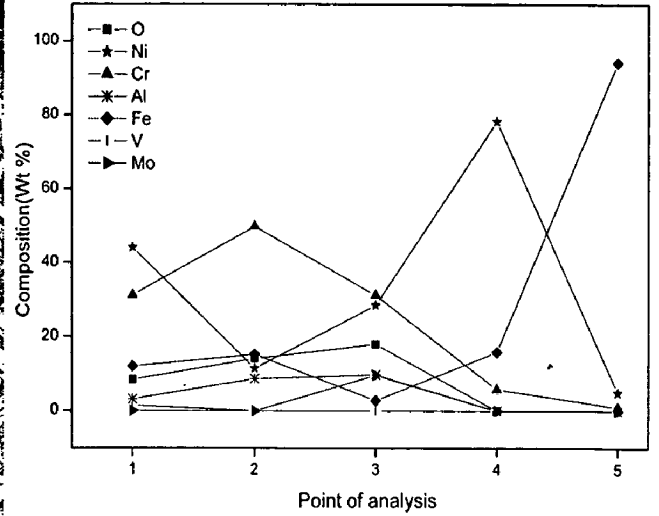
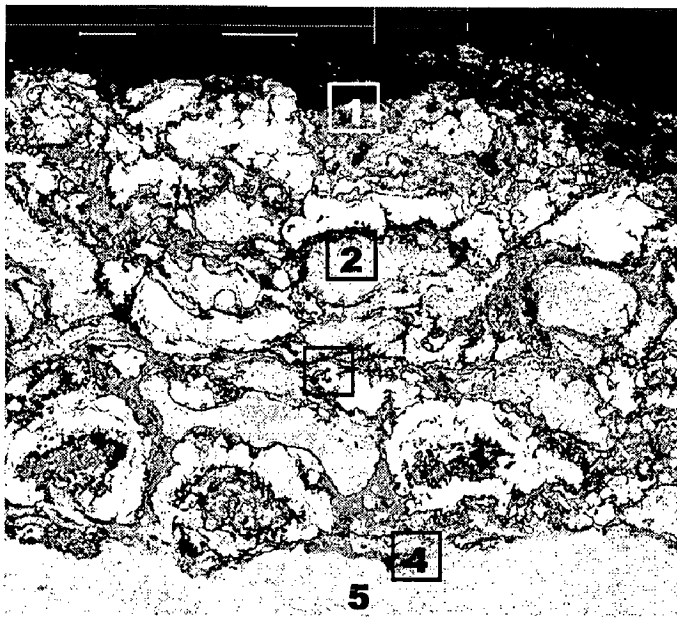
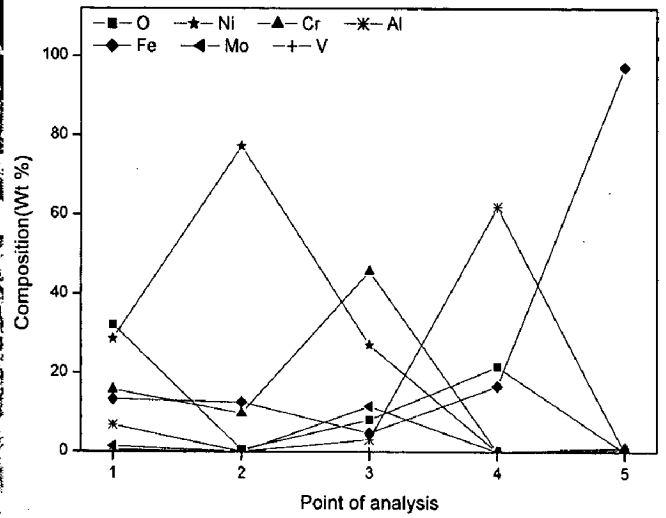
**Fig.6.24** Back scattered electron image and EDAX point analysis (wt %) across the cross-section of the NiAlCrFeMo coated steels subjected to hot corrosion in  $\text{Na}_2\text{SO}_4\text{-60}\%\text{V}_2\text{O}_5$  environment for 50 cycles at  $900^\circ\text{C}$  :  
 (a) Coated GrA1 steel (b) Coated T11 steel

The back scattered electron image along the cross section of coated GrA1 steel (Fig.6.24a) subjected to hot corrosion in molten salt environment, shows a discontinuous and fragmented oxide scale formed on the uppermost surface and EDAX analysis on this scale (Point1) revealed oxides of Ni and Cr as the main constituent. Analysis at point 2 and 3 shows that the oxidation occurred at the splat boundary and oxides rich in Cr, Al and Fe were detected. The absence of oxygen at point 4 shows nickel rich splat in an unoxidised state. Presence of minor quantity of Ni and Cr at point 5 shows the diffusion

of these elements from the coating into substrate. Similar results have been noticed for the corroded NiAlCrFeMo coating on T11 steel, as shown in Fig.6.24b.

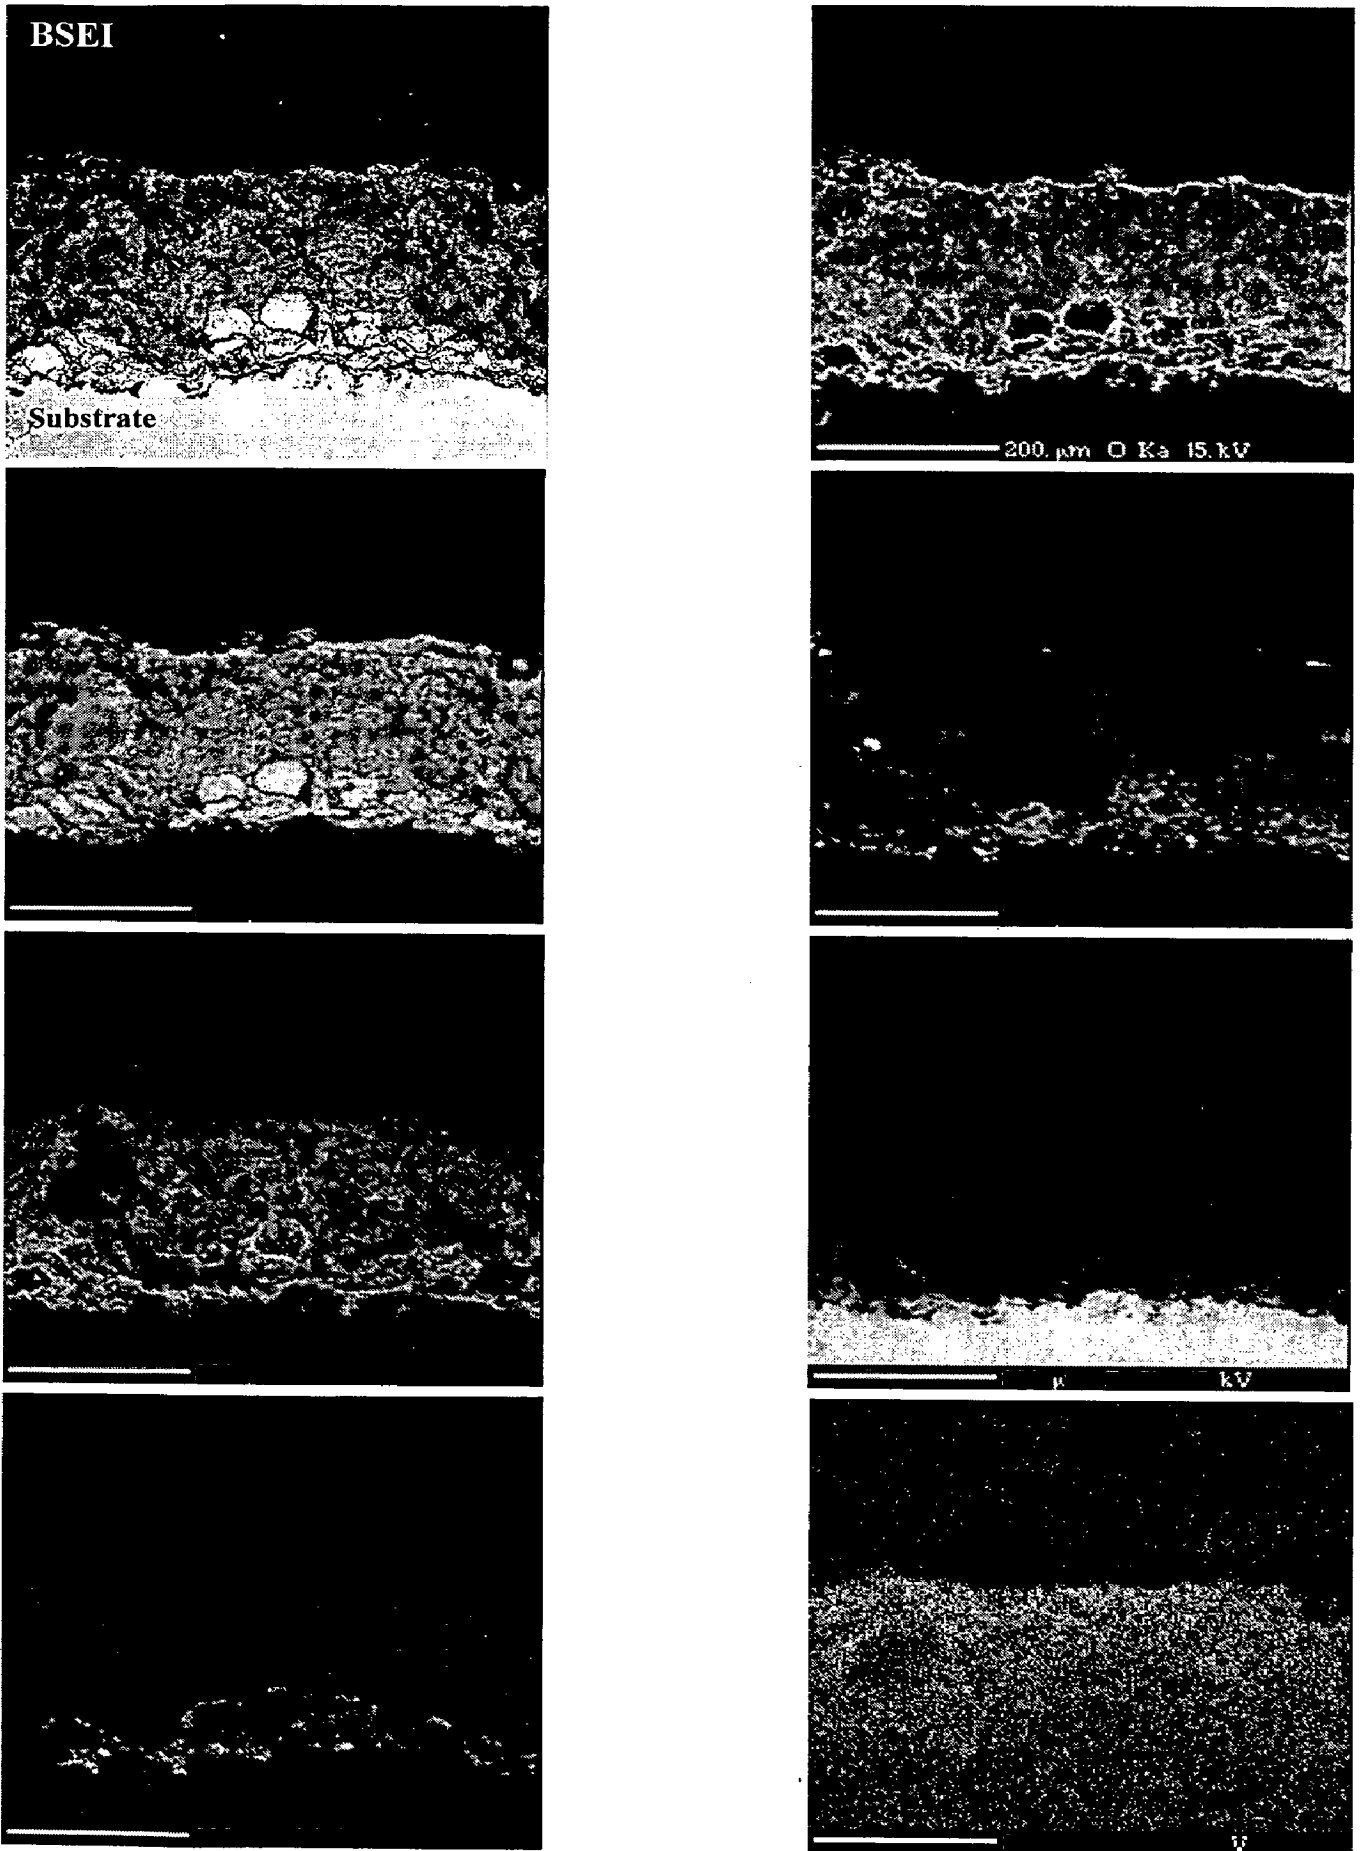
**Fig.6.25** BSEI and elemental X-ray mapping along the cross-section of the NiAlCrFeMo coated T22 steels subjected to hot corrosion for 50 cycles in  $\text{Na}_2\text{SO}_4\text{-60\%V}_2\text{O}_5$  environment at  $900^\circ\text{C}$

Elemental X-ray maps for the NiAlCrFeMo coated T22 steel after exposure to oxidation in  $\text{Na}_2\text{SO}_4$ -60% $\text{V}_2\text{O}_5$  environment for 50 cycles at 900°C has been compiled in Fig. 6.25. As can be noticed from the mapping for oxygen, the entire cross-section of the coating has been oxidized. The outermost surface of the corroded coating mainly shows the presence of oxides of Ni and Cr and perhaps their spinels. Aluminum and iron have been oxidized around the nickel rich splat boundary. Penetration of vanadium into the coating is observed from the X-ray map for vanadium. Higher concentration of the vanadium distributed at the uppermost surface of the corroded coating, substantiate the formation of spinel oxides with Ni, Cr and Al. Presence of higher concentration of Mo at the bottom portion of the coating suggest that the Mo has been consumed at the surface in the formation of volatile oxides. X-ray maps for Ni and O show nickel rich splats in unoxidised form, distributed at some region of coating.

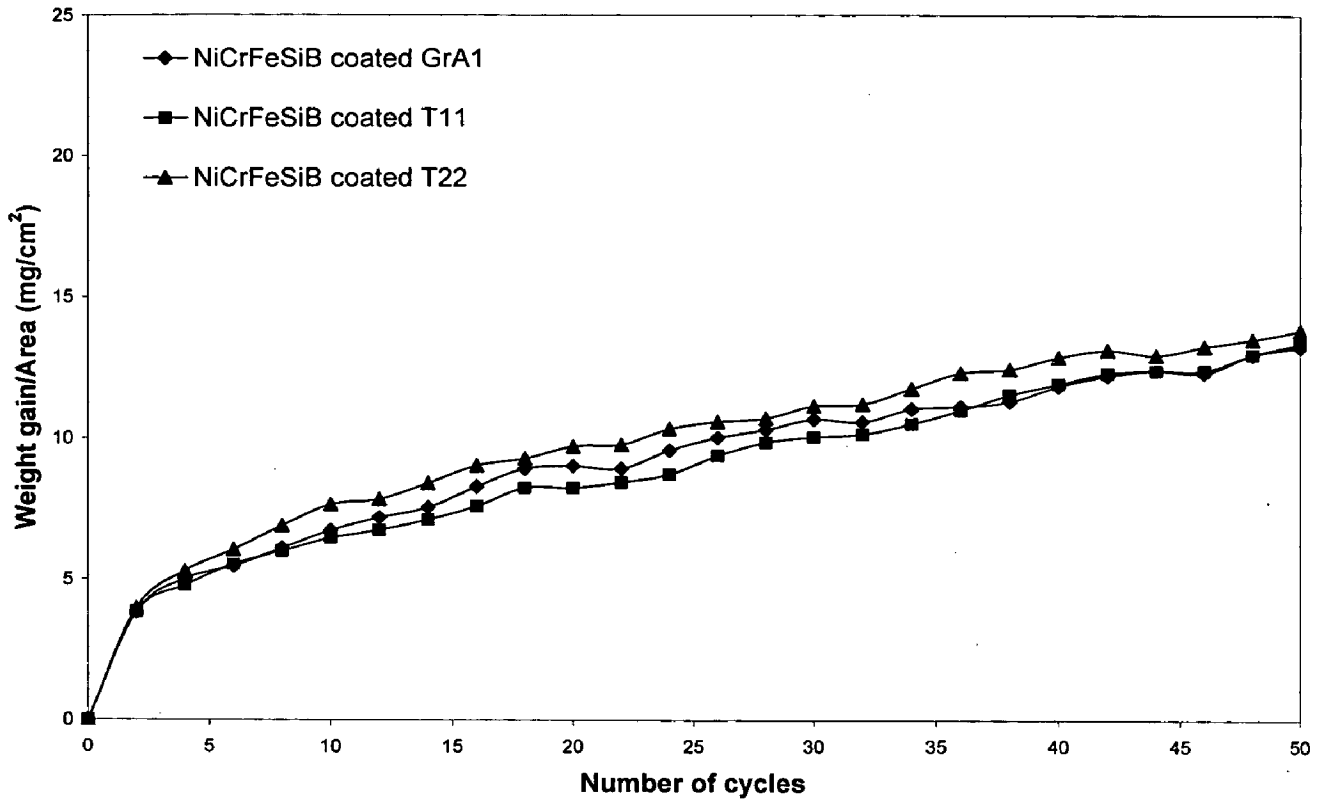
**Fig.6.27** Weight gain vs. number of cycles plot for NiCrFeSiB coated steels subjected to hot Corrosion for 50 cycles in  $\text{Na}_2\text{SO}_4$ -60% $\text{V}_2\text{O}_5$  at  $900^\circ\text{C}$

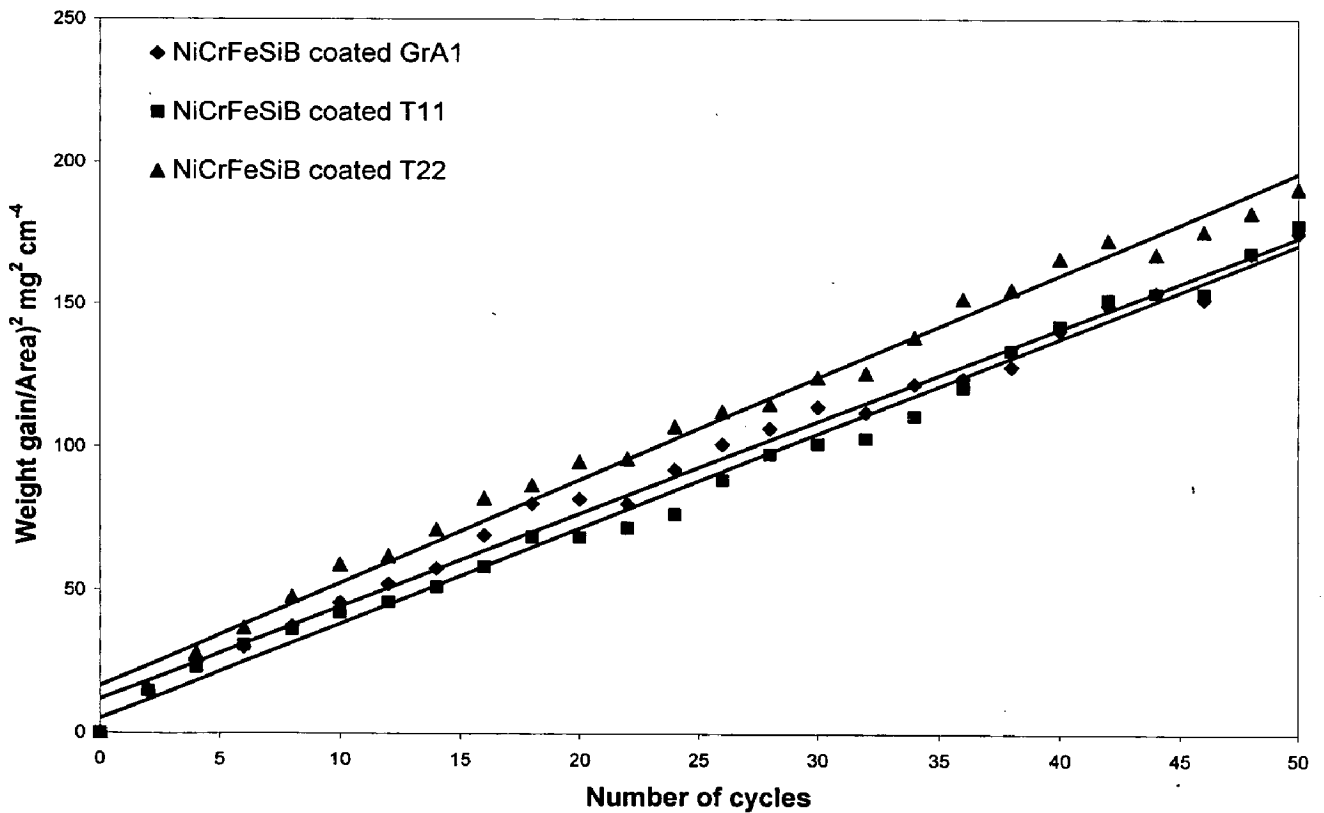
**Fig.6.28**  $(\text{Weight gain/area})^2$  vs. number of cycles plot for NiCrFeSiB coated steels subjected to hot corrosion for 50 cycles in  $\text{Na}_2\text{SO}_4$ -60% $\text{V}_2\text{O}_5$  at  $900^\circ\text{C}$

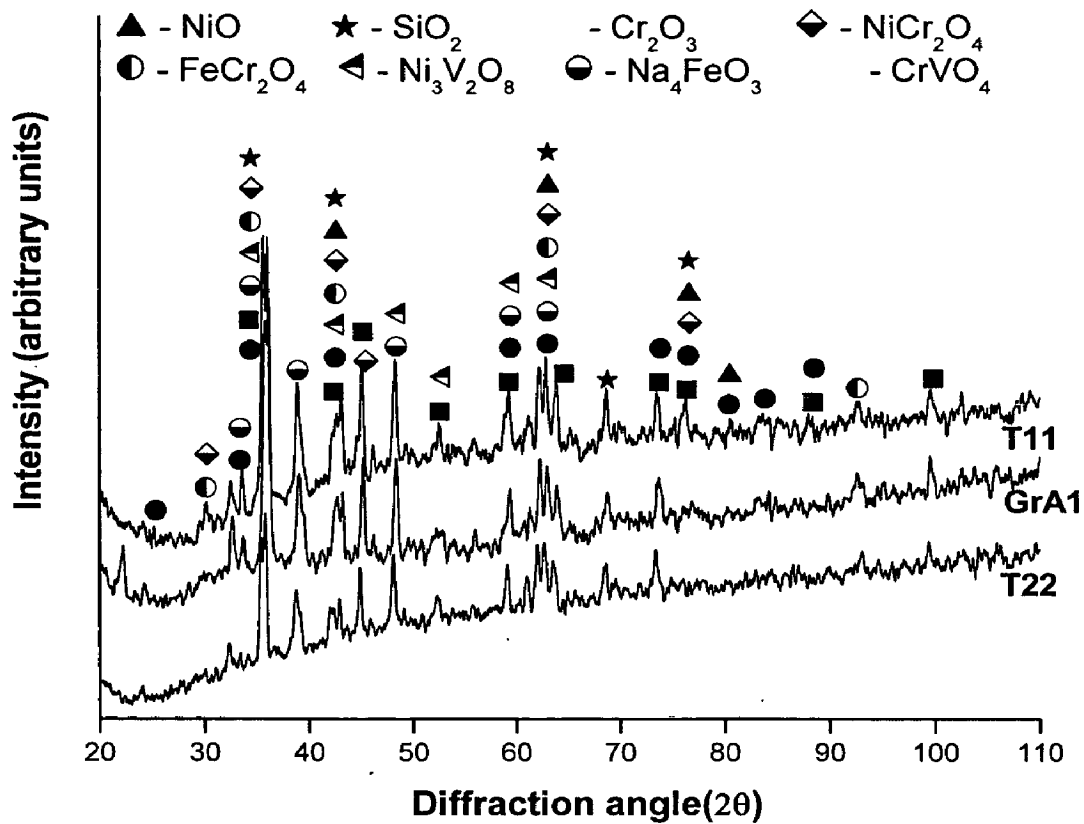
**Fig.6.29** X-ray diffraction patterns for NiCrFeSiB coated GrA1, T11 and T22 steels subjected to hot corrosion in  $\text{Na}_2\text{SO}_4\text{-60\%V}_2\text{O}_5$  for 50 cycles at  $900^\circ\text{C}$

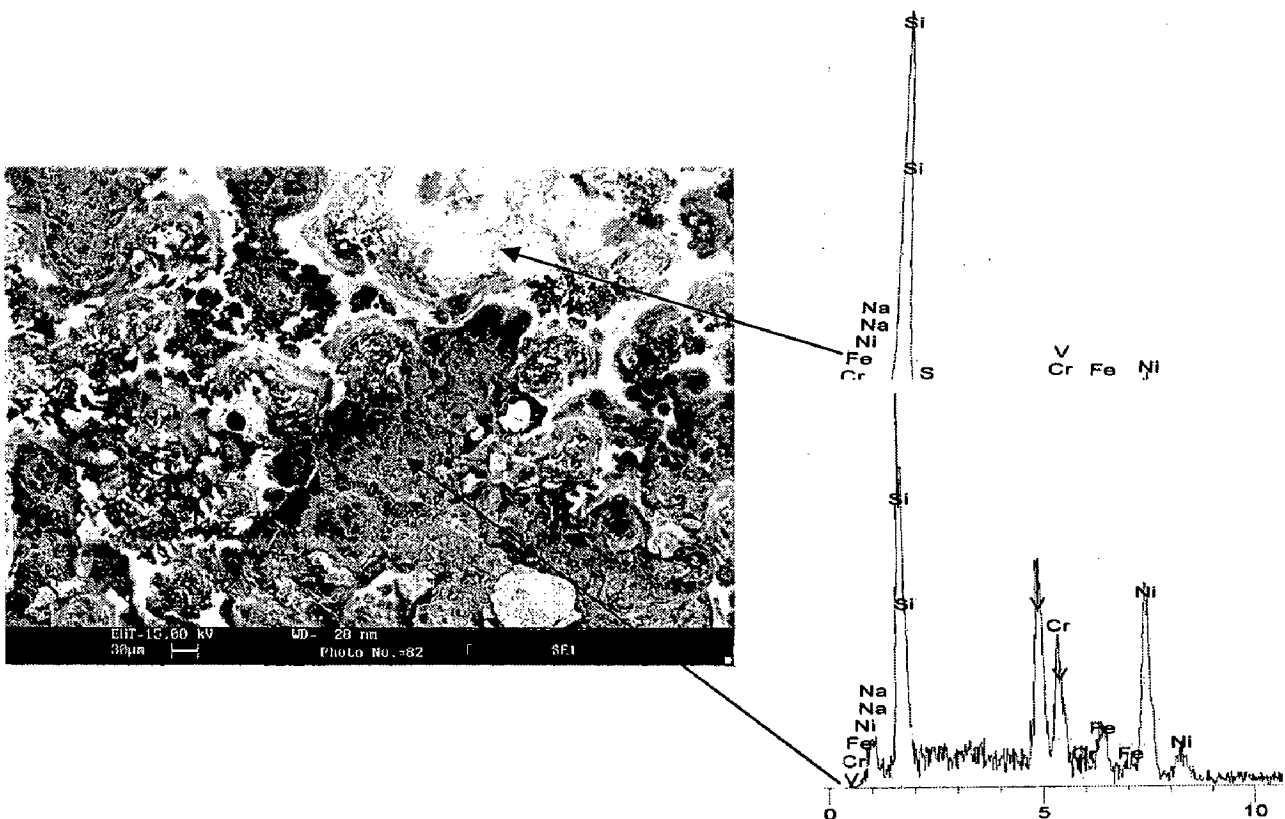
**Fig.6.30** Surface scale morphology and EDAX area analysis for NiCrFeSiB coated GrA1 steel subjected to hot corrosion for 50 cycles in  $\text{Na}_2\text{SO}_4\text{-60\%V}_2\text{O}_5$  at  $900^\circ\text{C}$

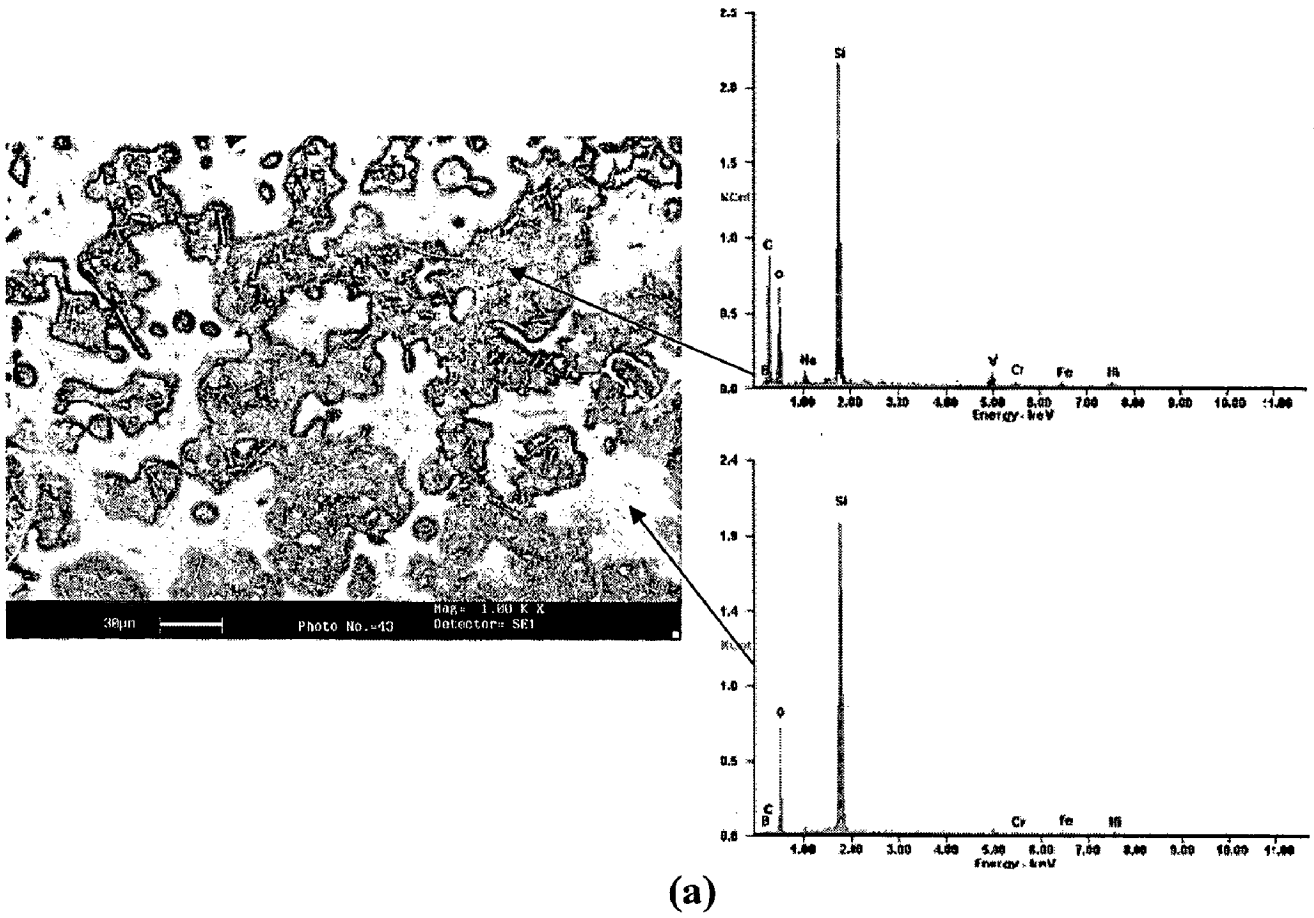
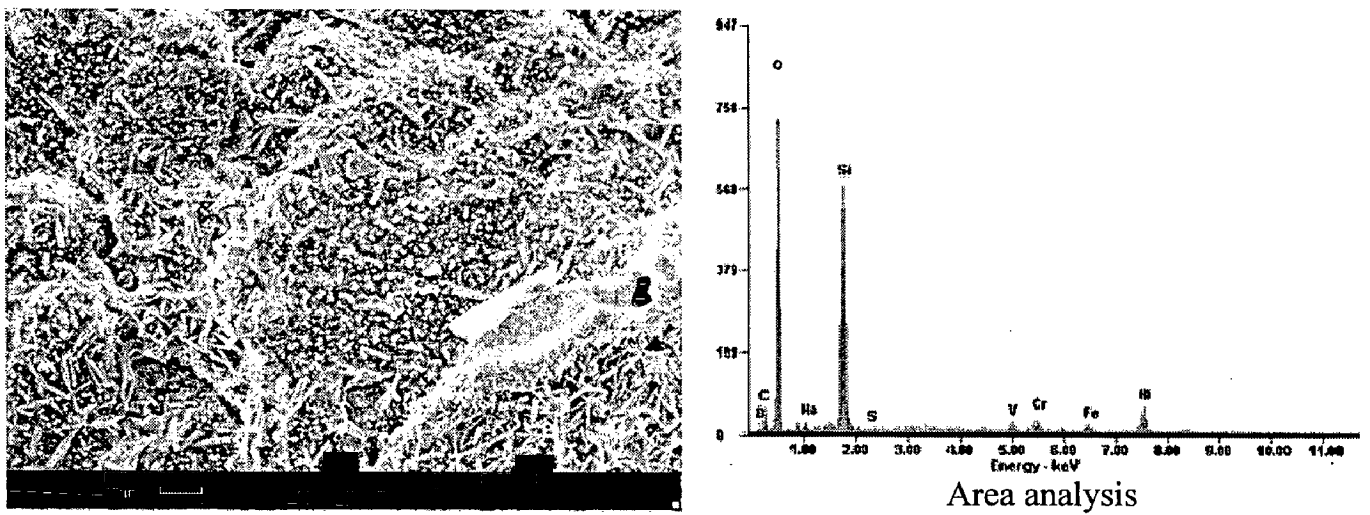
**Fig.6.31** Surface scale morphology and EDAX analysis for NiCrFeSiB coated steels subjected to hot corrosion for 50 cycles in  $\text{Na}_2\text{SO}_4\text{-60\%V}_2\text{O}_5$  at  $900^\circ\text{C}$ : (a) T11 steel (b) T22 steel

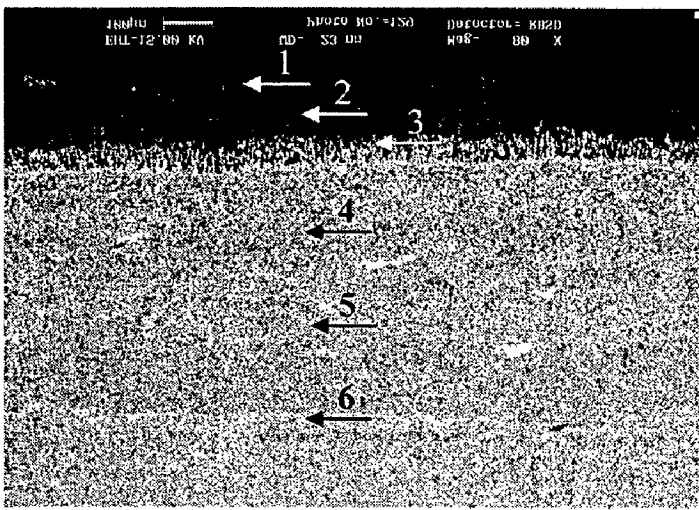
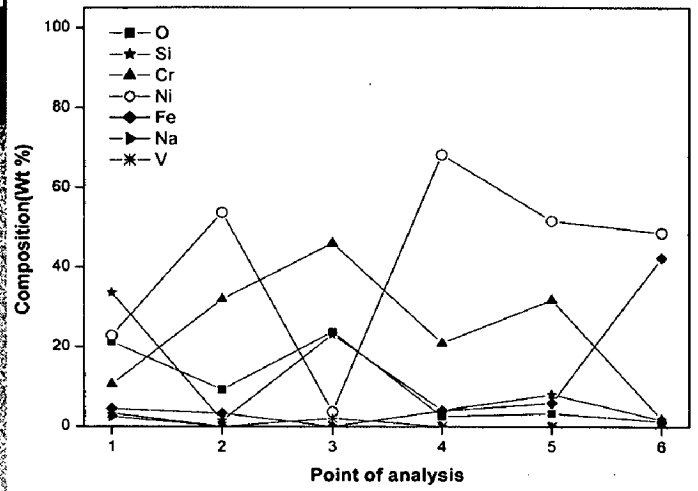
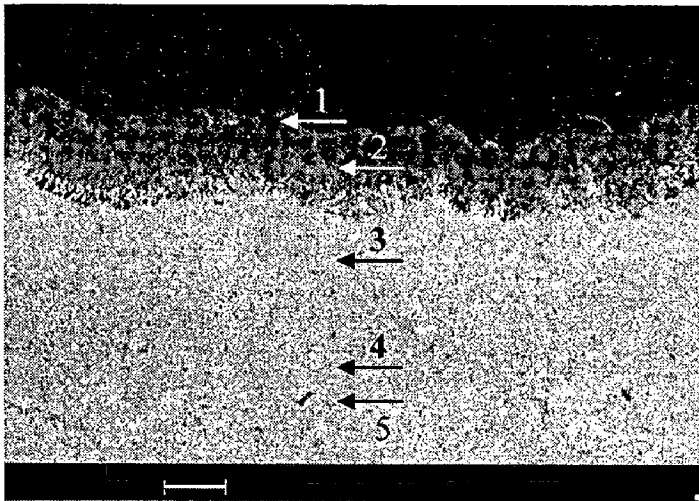
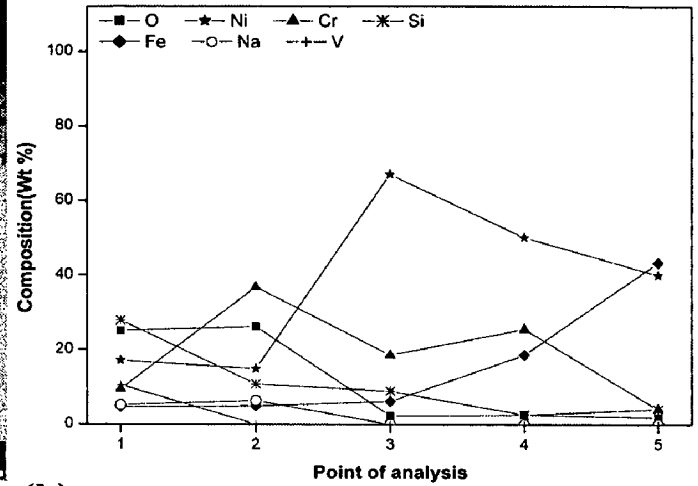
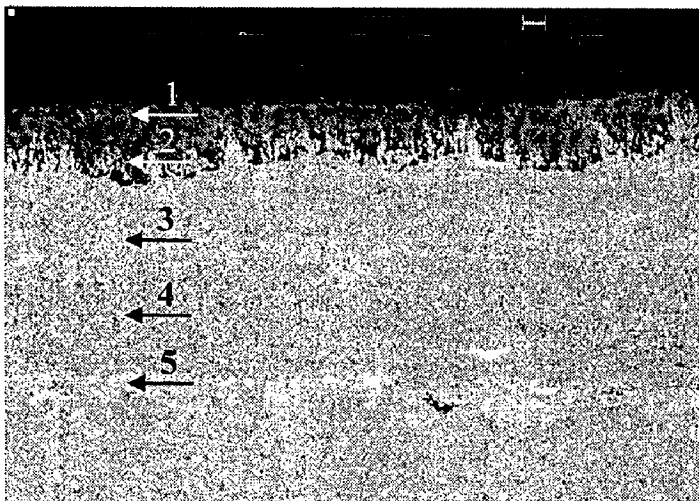
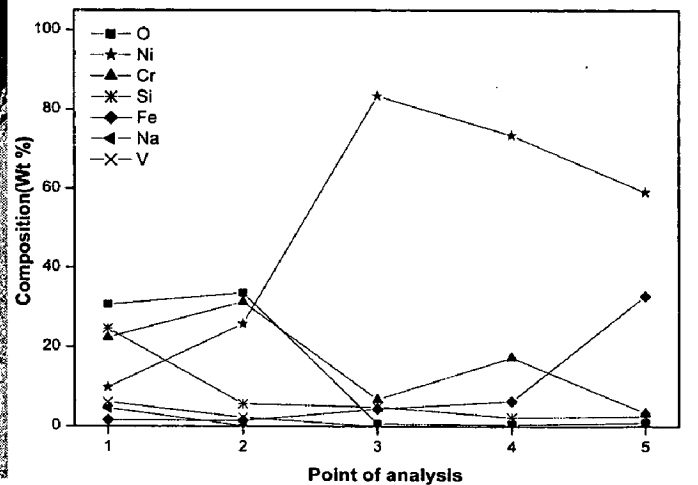
**Fig.6.32** Back scattered electron image and EDAX point analysis (wt %) across the cross-section of the NiCrFeSiB coated steels subjected to hot corrosion in  $\text{Na}_2\text{SO}_4\text{-60\%V}_2\text{O}_5$  environment for 50 cycles at  $900^\circ\text{C}$  :  
 (a) GrA1 steel    (b) T11 steel    (c) T22 steel

The salt induced high temperature corrosion of NiCrFeSiB coatings yield a bulky oxide scale of about 110 μm to 140 μm, measured from the BSE image (Fig. 6.32) acquired along the cross section of the corroded coatings. The EDAX composition analyses at the points along the cross-section are represented in the form of a graph. Figure 6.31a depicts the BSEI image of the coated GrA1 steel. The EDAX analyses on

the topmost layer of the oxide scale (Point 1) reveal that there is a higher content of  $\text{SiO}_2$  along with a small amount of oxides of Cr and Ni. The presence of V and Na has also been indicated in this outermost layer. The Point 2 just below the topmost layer has been dominated by the oxides of Ni and Cr. The Point 3 at the bottom of the oxide scale shows the presence of a higher amount of oxides of Cr and Si. The coating region below the oxide scale (Points 4 and 5) shows a negligible amount of oxygen which infers that this region remained unoxidised. The oxide scale formed on the surface acts as a barrier to the inward diffusion of oxygen and other corrosive species which is proved to be protective. The thick band along the coating-substrate interface (Point 6) shows the presence of Fe and Ni, which signifies the interdiffusion of these elements along the interface. Similar results have been observed in case of the NiCrFeSiB coated T11 and T22 shown in Figs.6.32b and 6.32c.

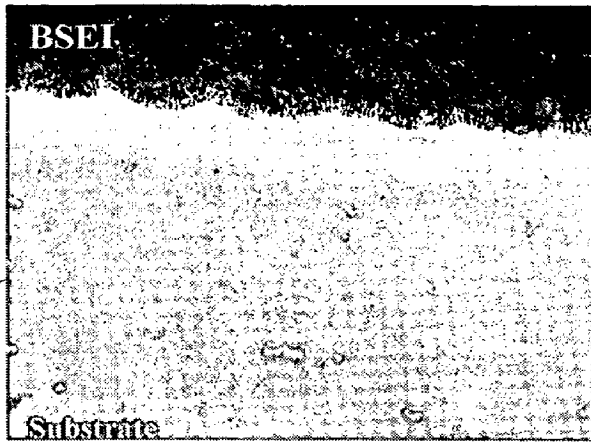
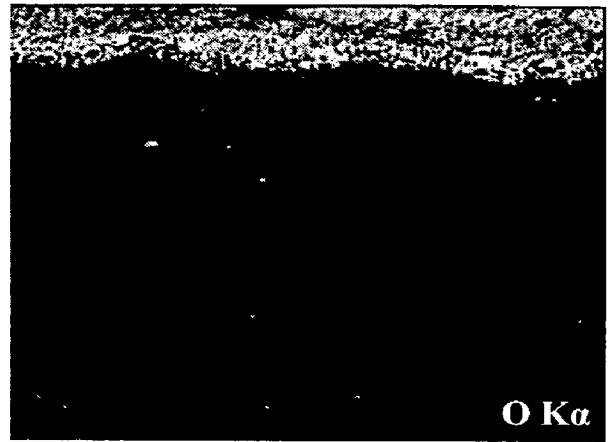
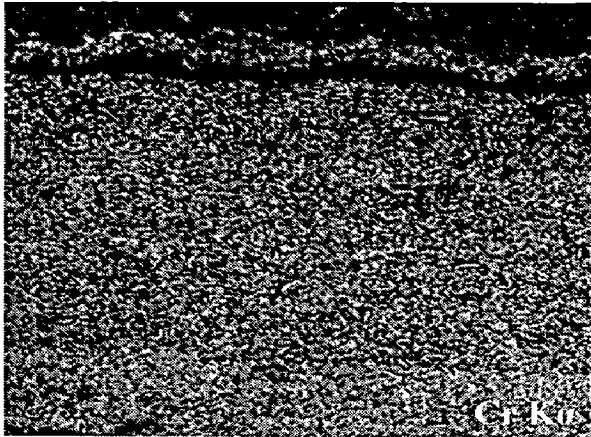
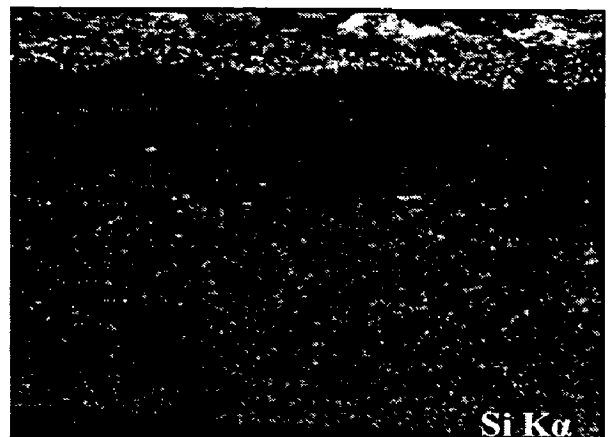
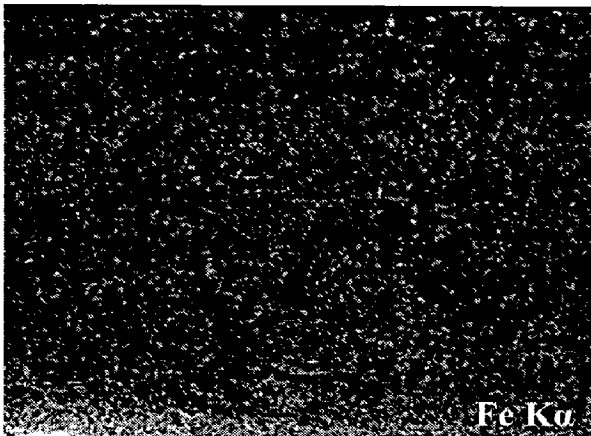
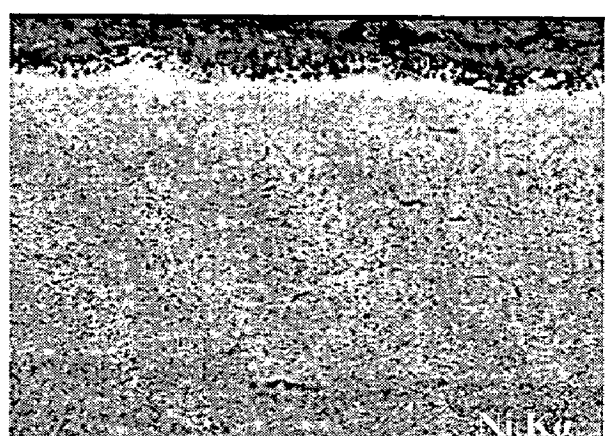
**Fig.6.34** BSEI and elemental X-ray mapping along the cross-section of the NiCrAl coated T22 steels subjected to hot corrosion for 50 cycles in  $\text{Na}_2\text{SO}_4$ - $60\%\text{V}_2\text{O}_5$  environment at  $900^\circ\text{C}$

Figure 6.33 shows the elemental X-ray maps for the NiCrFeSiB coated GrAl steel after its exposure to the  $\text{Na}_2\text{SO}_4$ -60% $\text{V}_2\text{O}_5$  environment for 50 cycles at 900°C. It is apparent from the BSE image that the thick oxide scale is formed on the corroded coating which consists of three distinct regions based on the oxides developed. The topmost region mainly consists of  $\text{SiO}_2$ , as silicon and oxygen co-exist in their respective X-ray maps. The presence of V and Na in this region also indicate the possibility of formation of corrosion products with Ni, Cr, and Fe. The intermediate region is dominated with the presence of  $\text{Cr}_2\text{O}_3$  along with the uniform distribution of oxides of Ni and Fe. The formation of  $\text{FeCr}_2\text{O}_4$  and  $\text{NiCr}_2\text{O}_4$  spinel phase can also be expected. The underlying region just below this consists of unoxidised nickel-rich splats surrounded by oxides of mainly chromium and silicon. As can be observed from the X-ray mapping for oxygen, the coating is oxidized partially which is restricted to few microns on the surface at the end of 50 cycles of hot corrosion studies in the molten salt environment. The interdiffusion of Fe from the substrate into the coating, as well as, Ni from the coating into the substrate can be observed along the coating-substrate interface which forms a thick band that is rich in nickel and iron. Similar oxide scales has also been observed for the NiCrFeSiB coated T22 steels which is illustrated in Fig. 6.34. It can be observed from

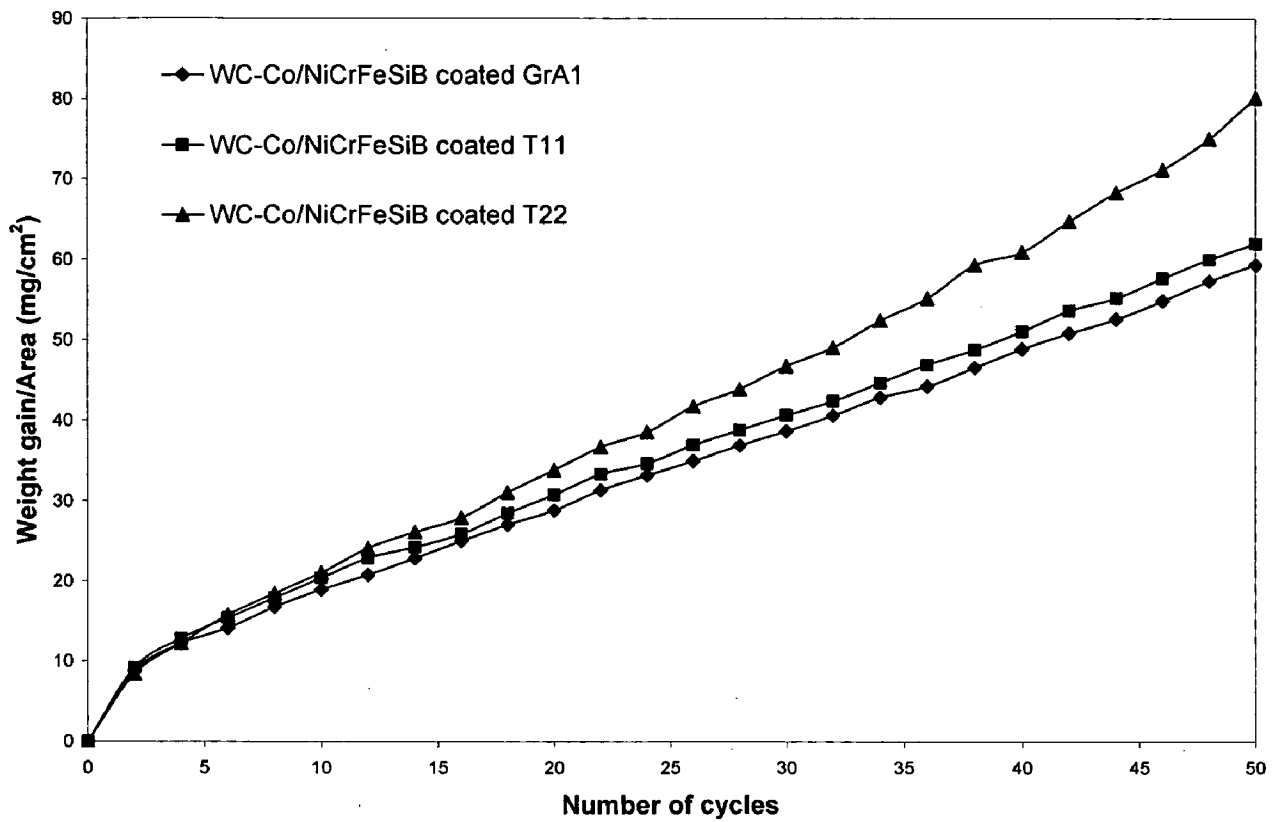
**Fig.6.36** Weight gain versus number of cycles plot for WC-Co/NiCrFeSiB coated steels subjected to hot Corrosion for 50 cycles in  $\text{Na}_2\text{SO}_4\text{-60\%V}_2\text{O}_5$  at  $900^\circ\text{C}$

Weight change of the WC-Co/NiCrFeSiB coated steels ( $\text{mg}/\text{cm}^2$ ) plotted as a function of time is as shown in Fig. 6.36. Cumulative weight gain at the end of 50 cycles of hot corrosion studies for coated GrA1, T11 and T22 steels are found to be 59.35, 61.97 and 80.18  $\text{mg}/\text{cm}^2$  respectively. Coated T22 steel shows relatively higher weight gain, where as weight gain for coated GrA1 and T11 steels are not very different. Further the weight gain square ( $\text{mg}^2/\text{cm}^4$ ) data was plotted as a function of time, shown in Fig.6.37. Coated GrA1 and T11 steels followed nearly the parabolic behavior up to 50 cycles and the parabolic rate constants calculated are  $(18.99 \text{ and } 20.81) \times 10^{-9} \text{ g}^2 \text{ cm}^{-4} \text{ s}^{-1}$  respectively. The coated T22 steel shows parabolic rate up to 28<sup>th</sup> cycle thereafter oxidation rate increased continuously with time and followed nearly linear oxidation behavior.
