# **STUDIES ON THE ROLE OF HVOF COATINGS IN IMPROVING RESISTANCE TO HOT CORROSION AND EROSION**

## **A THESIS**

**DOCTOR OF PHILOSOPHY**

**METALLURGICAL AND MATERIALS ENGINEERING**

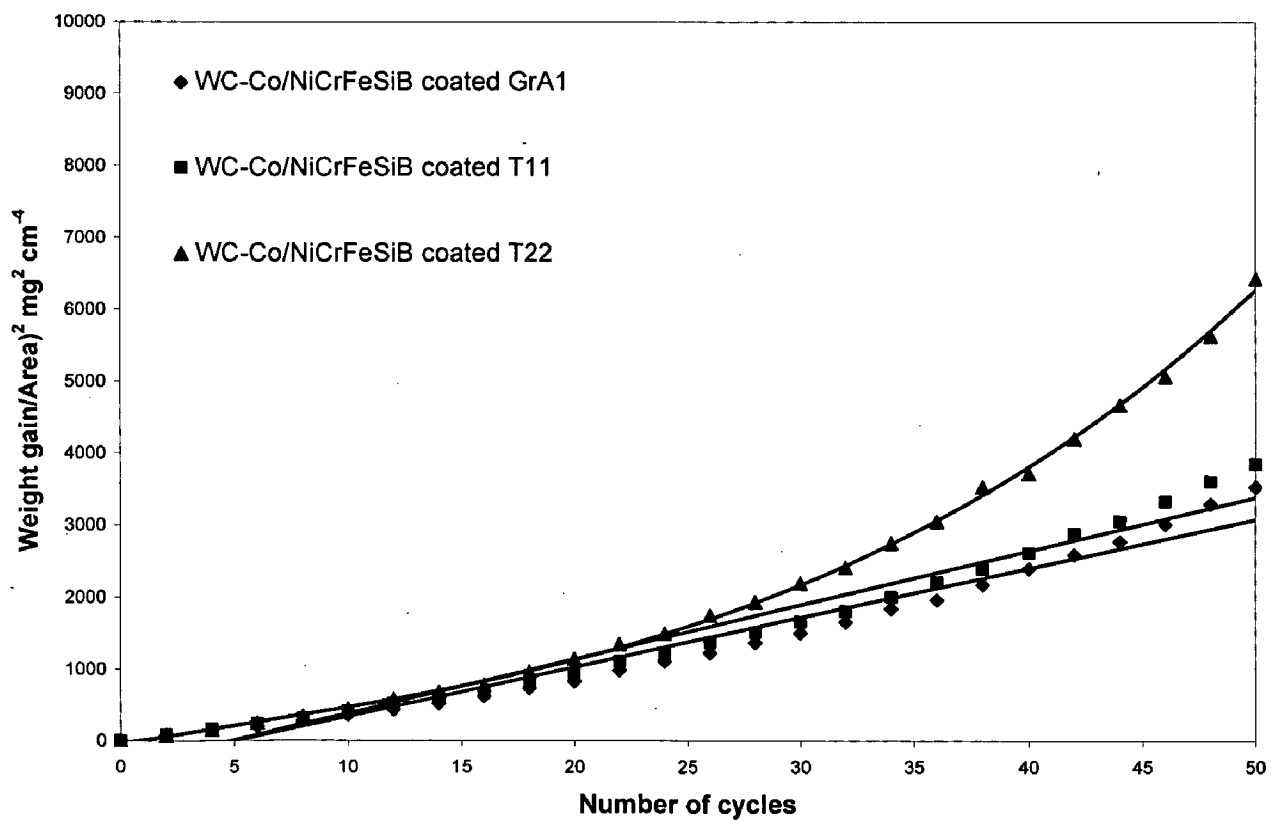
**Fig.6.37**  $(\text{Weight gain/area})^2$  versus number of cycles plot for WC-Co/NiCrFeSiB coated steels subjected to hot corrosion for 50 cycles in  $\text{Na}_2\text{SO}_4\text{-60\%V}_2\text{O}_5$  at  $900^\circ\text{C}$

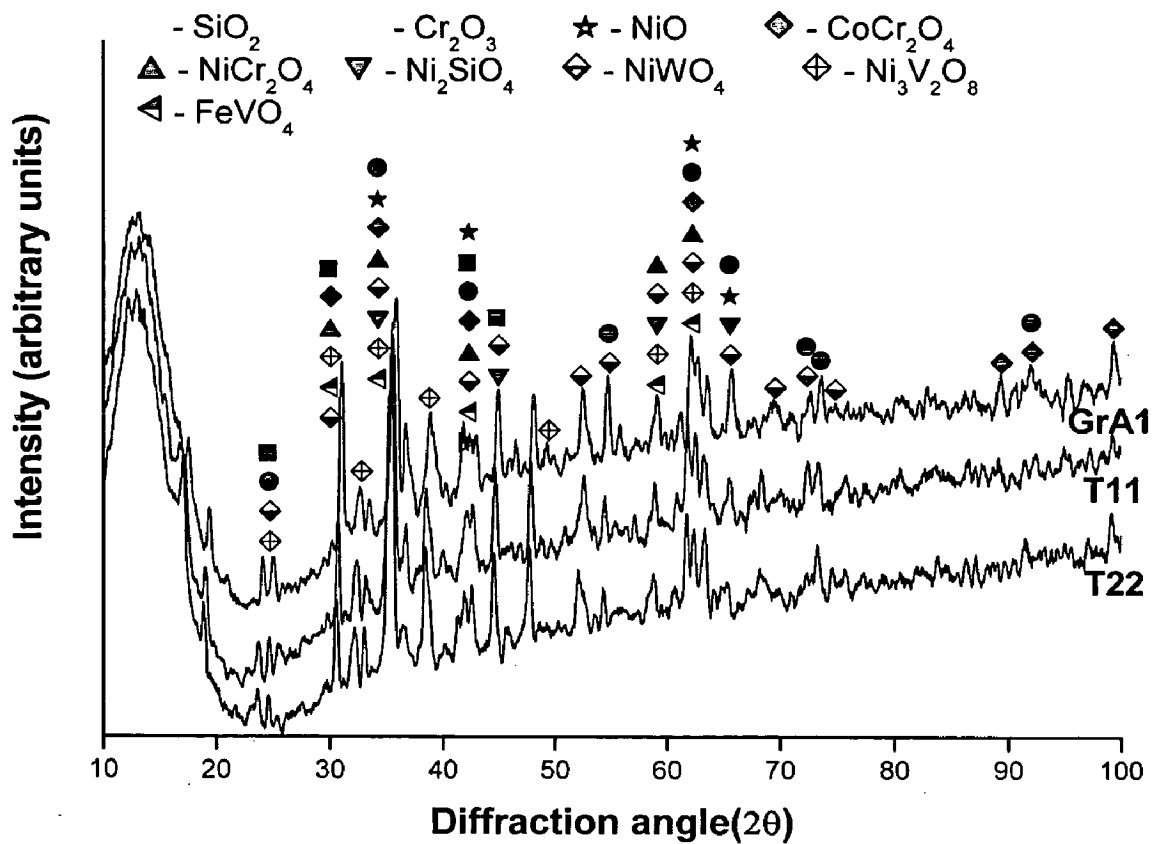
**Fig.6.38** X-ray diffraction patterns for NiCrFeSiB coated GrA1, T11 and T22 steels subjected to hot corrosion in  $\text{Na}_2\text{SO}_4$ -60% $\text{V}_2\text{O}_5$  for 50 cycles at 900°C

Figure 6.38 shows similar XRD profiles for all WC-Co/NiCrFeSiB coated steels subjected to hot corrosion in salt environment for 50 cycles at 900°C. The phases revealed by XRD analysis are  $\text{Cr}_2\text{O}_3$ , NiO,  $\text{SiO}_2$ , NiWO<sub>4</sub>,  $\text{CoCr}_2\text{O}_4$ ,  $\text{NiCr}_2\text{O}_4$ ,  $\text{Ni}_2\text{SiO}_4$ ,  $\text{Ni}_3\text{V}_2\text{O}_8$ , and  $\text{FeVO}_4$ .

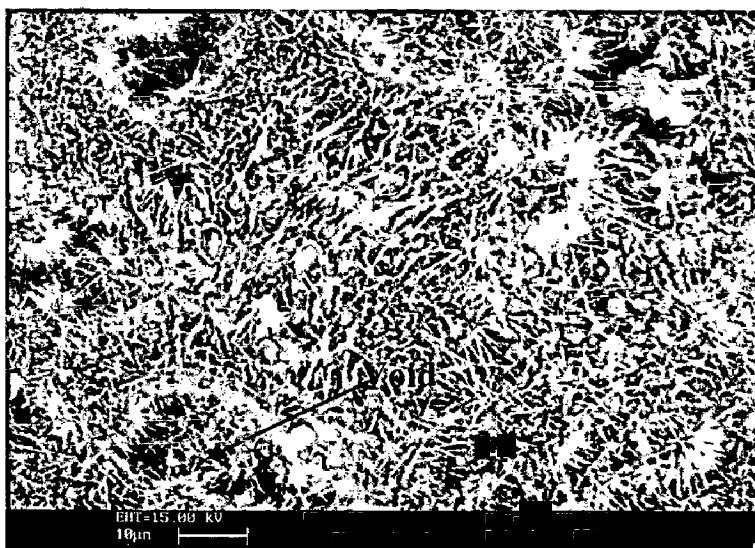
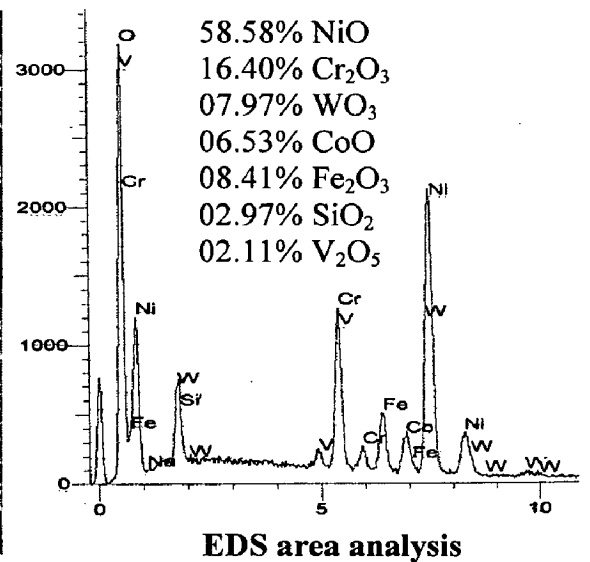
**Fig.6.39** Surface scale morphology and EDAX analysis for WC-Co/NiCrFeSiB coated GrA1 steel subjected to hot corrosion for 50 cycles in  $\text{Na}_2\text{SO}_4$ -60% $\text{V}_2\text{O}_5$  at 900°C

The surface morphology of the corroded WC-Co/NiCrFeSiB coated GrA1 steel (Fig.6.39) shows the formation of nonuniform loosely held scale consisting of voids. The loosely held microstructure illustrates the formation of porous oxide layer on the surface of the corroded coating. The compositional EDS analysis on the surface area reveals the dominating presence of nickel oxide (58.58%) along with the oxides of Cr (16.4%), W (7.97%), Co (6.53%) and Fe (8.41%). Minor amount of oxides of silicon and vanadium have also been detected.

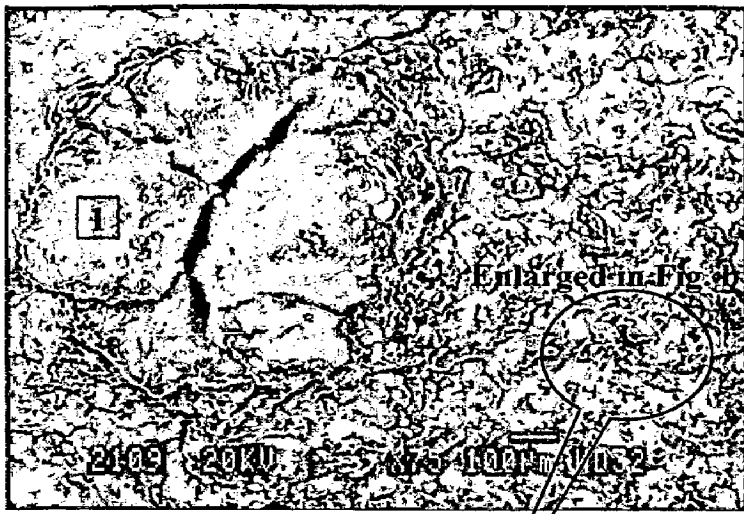
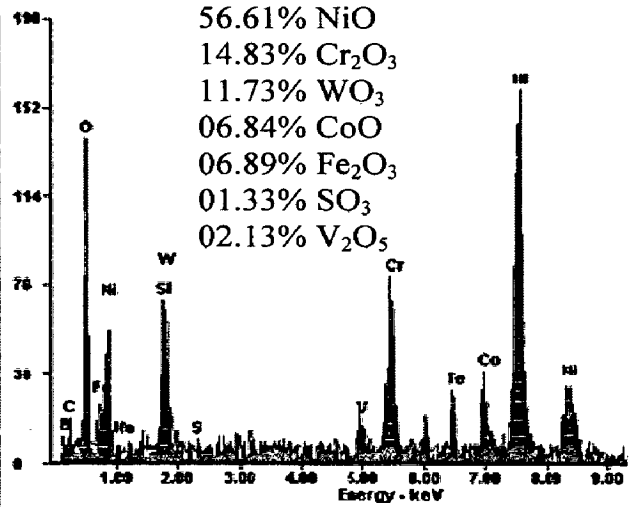
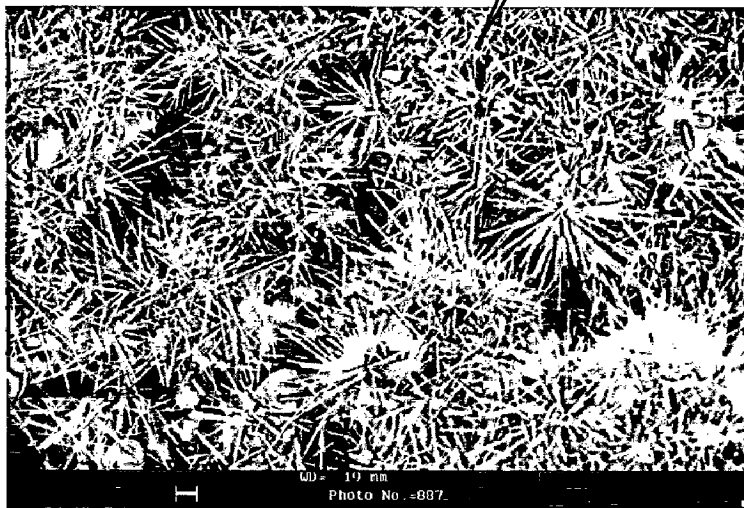
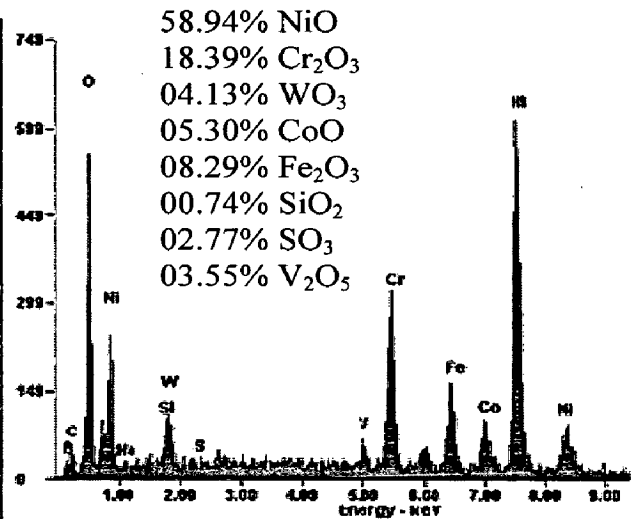
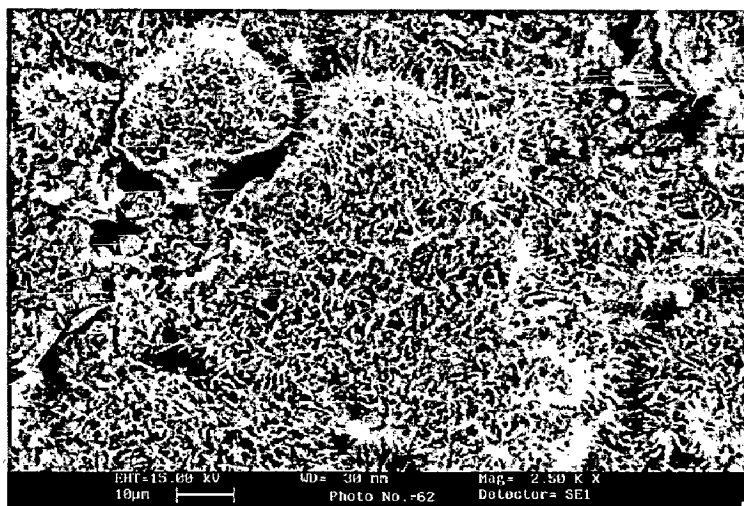
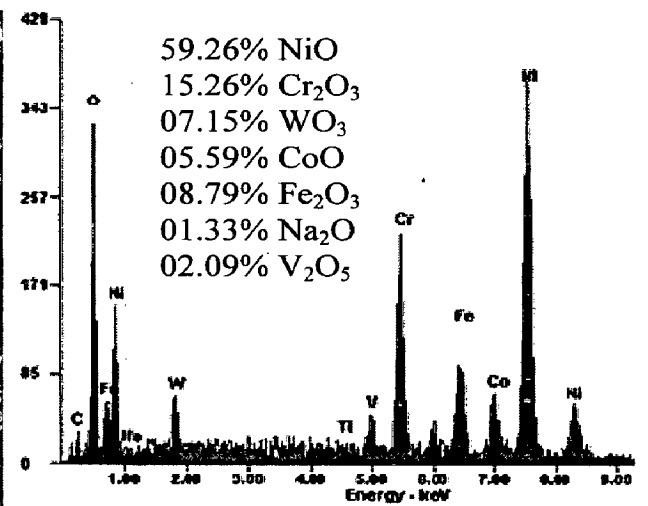
**Fig.6.40**

Surface scale morphology and EDAX analysis for WC-Co/NiCrFeSiB coated steels subjected to hot corrosion for 50 cycles in Na<sub>2</sub>SO<sub>4</sub>-60%V<sub>2</sub>O<sub>5</sub> at 900°C: (a) T11 steel (b) Enlarged area of Fig. a (c) T22 steel

The surface morphology of coated T11 steels (Fig.6.40a) shows the flakes and open bud protrusion oozed out perhaps at the region where protective oxide scale failed. Cracks can be noticed around the protrusion. Compositional analysis of the protrusion reveals the presence of oxides of Ni (56.6%), Cr (14.8%) and W (11.7%) as the main constituents. Area of the oxide scale enlarged in Fig.6.40b, shows loosely held needle structure, which might have resulted in formation of bulky oxide scale. EDAX analysis shows relatively lower amount of W (4.13%) when compared to composition of W in the protrusion. The oxide scale mainly composed of oxides of Ni, Cr, and Fe. Minor amount of sulphur and vanadium have also been detected in the surface scale. Corresponding analysis on the coated T22 steel shows non-uniform oxide scale with distinct globules, shown in Fig.6.40c.

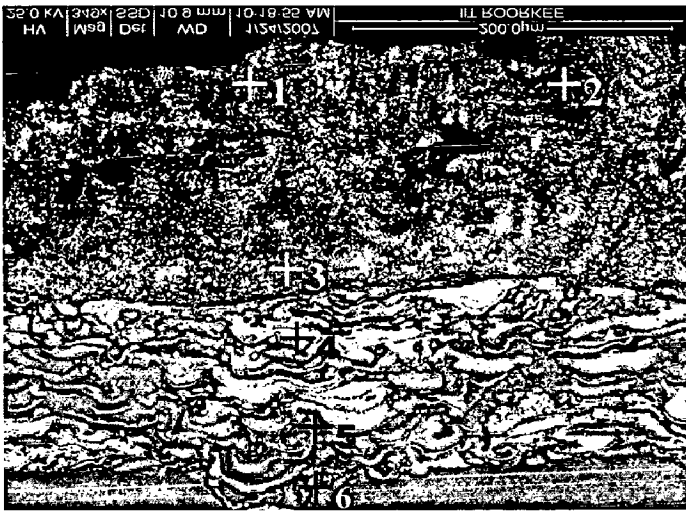
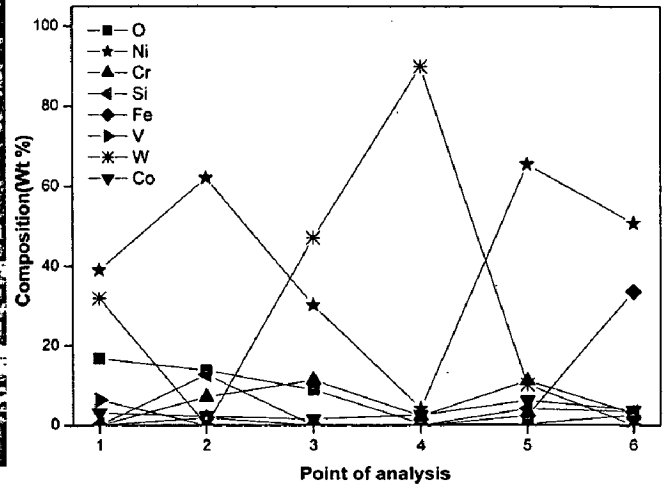
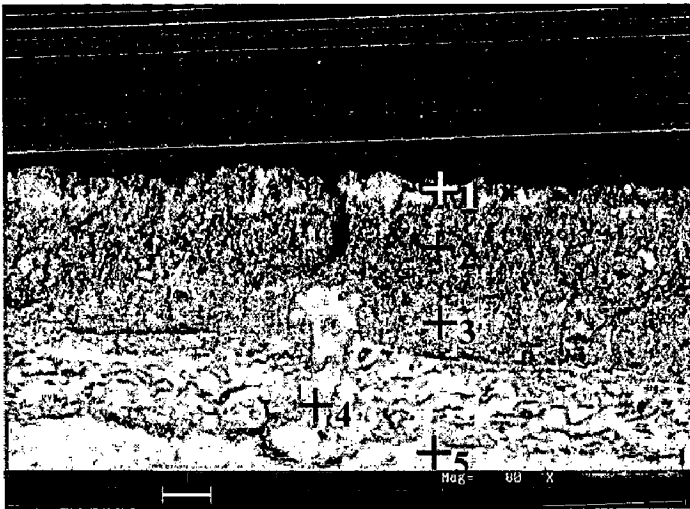
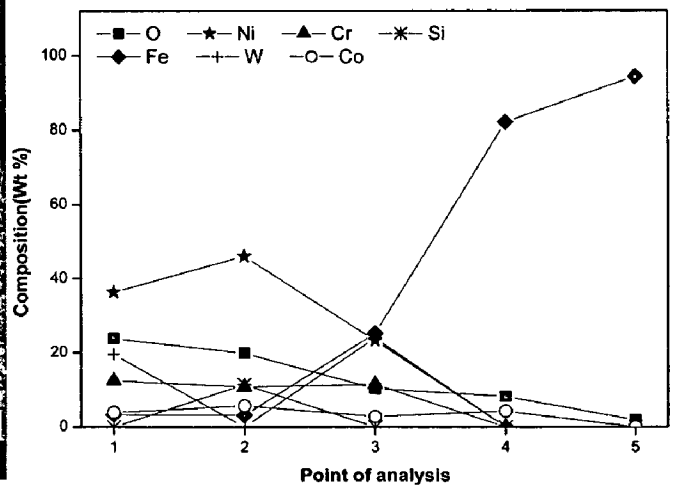
**Fig.6.41** Back scattered electron image and EDAX point analysis (wt %) across the cross-section of the WC-Co/NiCrFeSiB coated steels subjected to hot corrosion in  $\text{Na}_2\text{SO}_4$ -60% $\text{V}_2\text{O}_5$  environment for 50 cycles at 900°C :  
 (a) GrA1 steel (b) T22 steel

Salt-induced high temperature corrosion yielded a bulky oxide scale on the surface of WC-Co/NiCrFeSiB coated GrA1 steel as seen from BSE image (Fig.6.41a) acquired along the cross section of corroded coatings. EDAX analysis at point 1 shows higher amount of oxides of Ni (38.9%) and W (31.8%), suggesting the presence of  $\text{NiWO}_4$  spinel oxide. Composition at point 2 shows dominant presence of Ni oxide (62.1%) along with the oxides of Si (12.7%) and Cr (7.1%). The oxide scale at the vicinity of the coating (point 3) reveals the higher content of Ni and W. The outward diffusion of Ni from the coating resulted in enrichment of W at the subscale region and might have ended with the formation of spinel of mixed oxides of Ni and W. The contrast white elongated phases (point 4) which are oriented parallel to the substrate consist of 89.9% tungsten. Absence of oxygen at this point confirms WC particles are in an unoxidised condition. The EDAX analysis on the dark grey matrix (point 5) revealed

BSE image along the WC-Co/NiCrFeSiB coated T22 Steel (Fig.6.41b) also shows the thick oxide scale formed on the surface of the coating, mainly consisting of oxides of Ni, Cr and W (point 1 & 2). EDAX analysis at point 3 revealed the presence of significant amount of iron oxide (25.2%). Oozing out of Fe<sub>2</sub>O<sub>3</sub> (point 4) from the substrate through the coating is evident from the micrograph. Iron oxide protrusions are subsided by the bulk oxide scale and are seen at the subscale layer. A localized molten salt corrosion of the substrate at the site of protrusion can be observed.

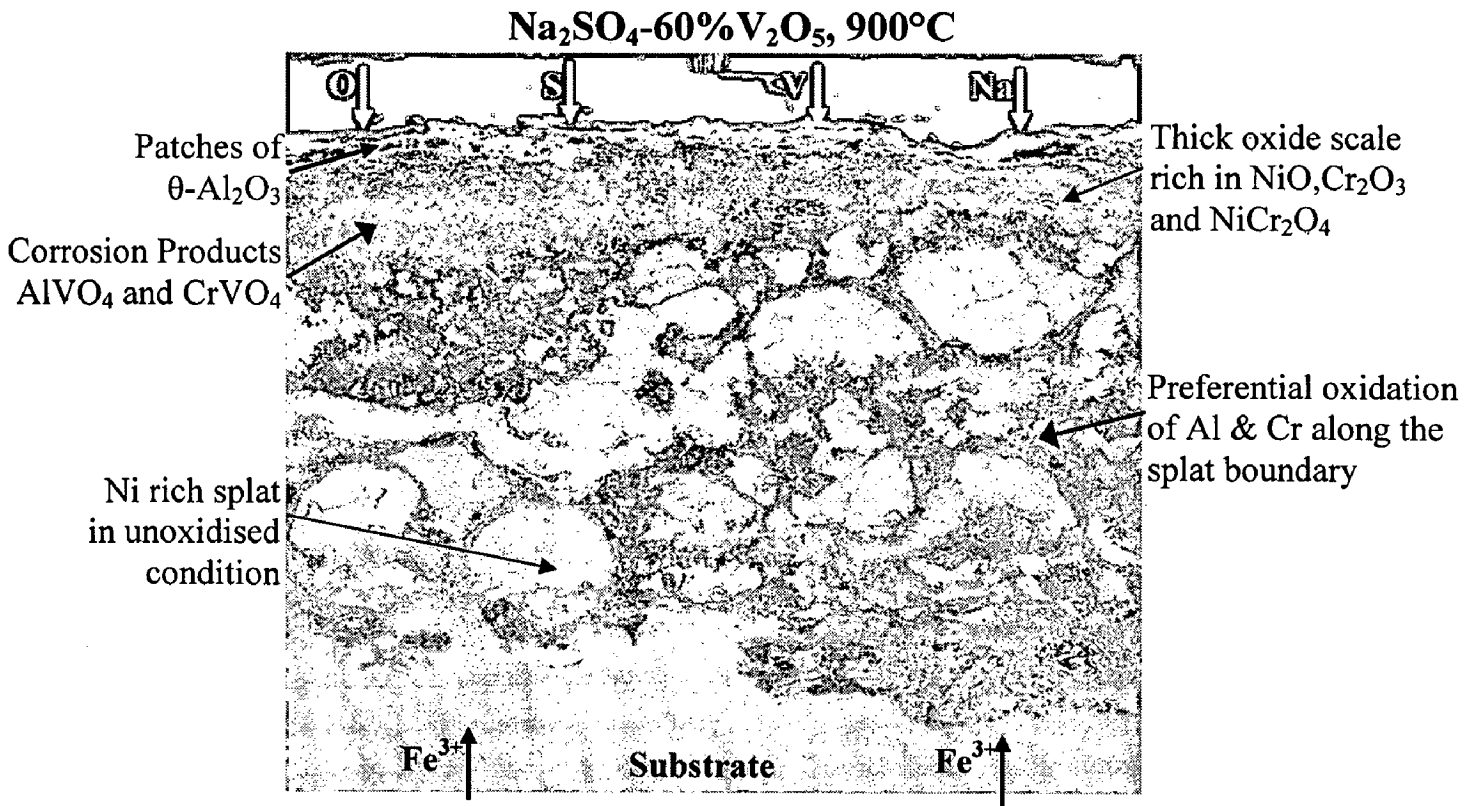
**Fig.6.44** Hot corrosion mode of NiCrAl coated steels exposed to  $\text{Na}_2\text{SO}_4\text{-}60\%\text{V}_2\text{O}_5$  environment for 50 cycles at  $900^\circ\text{C}$

The NiCrAl coated steels show lower weight gain in comparison to the uncoated steels as reported in Section 6.1.1.1., when exposed to  $\text{Na}_2\text{SO}_4$ -60% $\text{V}_2\text{O}_5$  molten salt environment. The weight gain after 50 cycles of exposure of the NiCrAl coated GrAl, T11 and T22 steels are found to be 1/11, 1/7 and 1/14, respectively, times the uncoated substrate steels of the same kind. The parabolic rate constant ( $K_p$ ) decreases for all the coated steels in comparison to the uncoated steels and, therefore, it can be inferred that the necessary protection has been provided by the HVOF-sprayed NiCrAl coatings to the substrate steels. Similar findings have also been reported by Sidhu et al.(2006A) and Singh et al. (2005B) wherein they showed a better corrosion resistance of plasma-sprayed NiCrAlY coatings in comparison to the substrate boiler steels and Fe-based super-alloy exposed to  $\text{Na}_2\text{SO}_4$ -60% $\text{V}_2\text{O}_5$  environment at 900°C.

A continuous and thick compact layer of scale is formed on the top of the corroded coating (Fig. 6.14) which measured about 25–50  $\mu\text{m}$  after 50 cycles of hot corrosion studies. The XRD analysis (Figs. 6.11 and 6.12) on the surface of the oxidized scale revealed the existence of  $\delta$ - $\text{Al}_2\text{O}_3$ ,  $\theta$ - $\text{Al}_2\text{O}_3$ , NiO,  $\text{Cr}_2\text{O}_3$ ,  $\text{NiCr}_2\text{O}_4$ ,  $\text{NiAl}_2\text{O}_4$  and traces of  $\text{Ni}_3\text{V}_2\text{O}_8$ ,  $\text{AlVO}_4$ , and  $\text{CrVO}_4$ . The SEM of oxide scale has a blade-like structure with smooth patches (Fig. 6.13a). The EDAX analysis on these patches indicates a higher percent of  $\text{Al}_2\text{O}_3$  (58.83%). The blade-like structure could correspond to  $\theta$ - $\text{Al}_2\text{O}_3$  as identified by the XRD. The  $\text{Al}_2\text{O}_3$  formed as a thin layer which is confined to the topmost portion of the oxide scale as seen in the EPMA analysis (Figs. 6.15 to 6.17). Due to the accelerated oxidation induced by the molten salt, which acts as a catalyst and oxygen carrier, it is expected that the metastable  $\text{Al}_2\text{O}_3$  has formed in the initial cycles of the studies that shows polymorphic transformation. Similar results showing the formation of metastable modifications of  $\text{Al}_2\text{O}_3$  during the oxidation of HVOF-sprayed MCrAlY coatings and sputtered NiCrAl nanocrystalline coating is also reported by Brandl et al. (1998) and Guofeng et al. (1999). The EPMA and the EDAX analysis on the surface and along the cross section of the corroded coating show that the top layer is rich in NiO,  $\text{Cr}_2\text{O}_3$ , and their spinals due to discontinuous  $\text{Al}_2\text{O}_3$  layer. Further, NiO and spinal oxides prevent the exclusive development of  $\text{Cr}_2\text{O}_3$  layer, although the Cr concentration is 17.92% in the coating. This was substantiated by the results of Singh et al.(2005A) and Longa et al. (1992), wherein they identified NiO and  $\text{NiCr}_2\text{O}_4$  along with relatively small quantities of  $\text{Cr}_2\text{O}_3$  phase for flame-sprayed NiCrAl

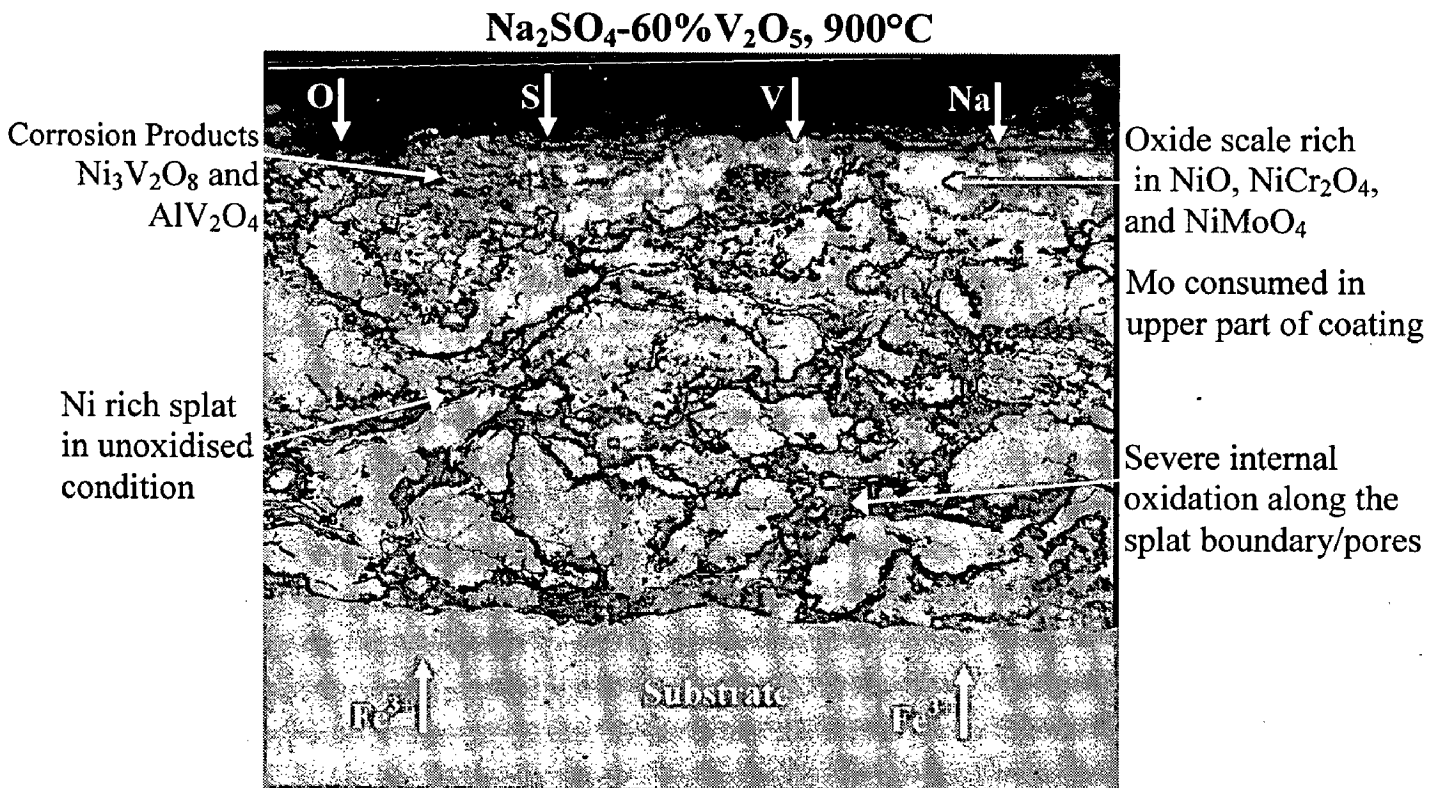
**Fig.6.45** Hot corrosion mode of NiAlCrFeMo coated steels exposed to  $\text{Na}_2\text{SO}_4\text{-}60\%\text{V}_2\text{O}_5$  environment for 50 cycles at  $900^\circ\text{C}$

Higher concentration of the vanadium distributed at the uppermost surface of the corroded coating (Fig.6.25), substantiates the formation of thick layer of corrosion products containing Ni<sub>3</sub>V<sub>2</sub>O<sub>8</sub> and AlV<sub>2</sub>O<sub>4</sub> and further confirmed by XRD analysis on the surface. Deb et al.1996, observed decrease in the corrosion rate of Ni based superalloys subjected to hot corrosion in vanadium containing salt mixture due to reprecipitation of refractory Ni<sub>3</sub>V<sub>2</sub>O<sub>8</sub>. Based on the present study, the general hot corrosion mode for NiAlCrFeMo coatings are shown in Fig.6.45.

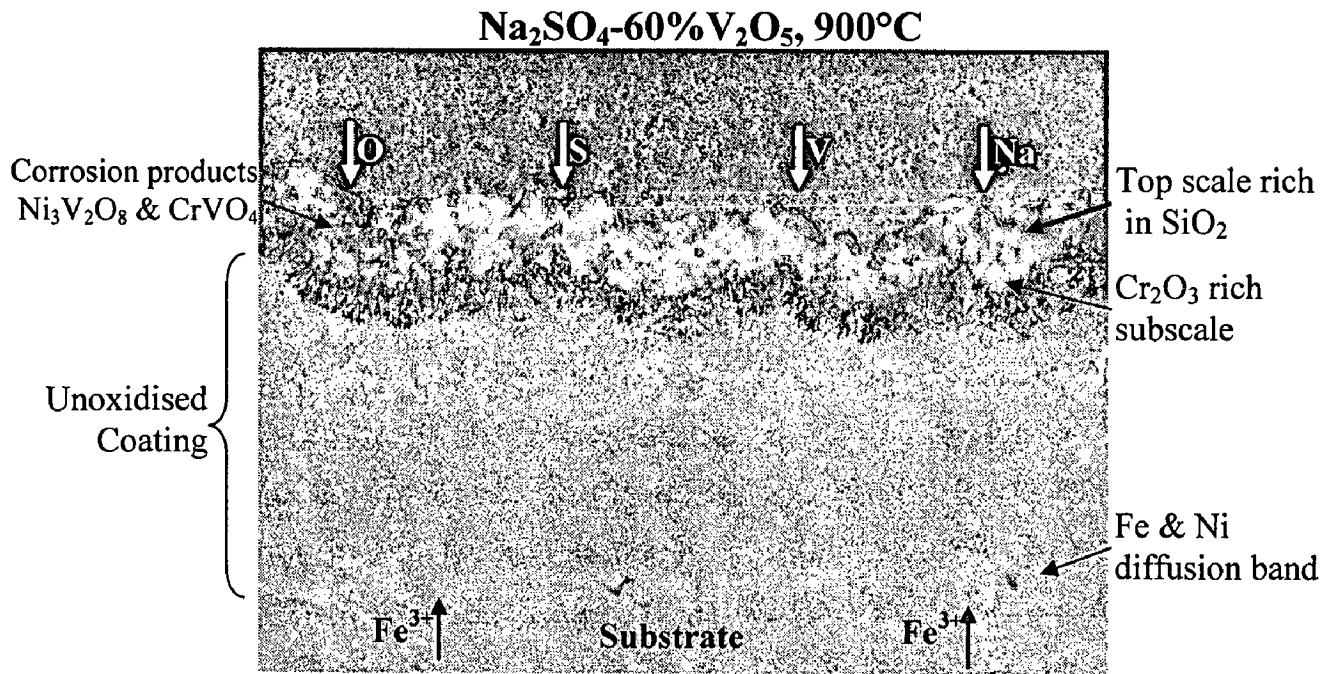
**Fig.6.46** Hot corrosion mode of NiCrFeSiB coated steels exposed to Na<sub>2</sub>SO<sub>4</sub>-60%V<sub>2</sub>O<sub>5</sub> environment for 50 cycles at 900°C

The distribution of Si and B at the splat boundary blocked the outward diffusion of Fe and Mo from the substrate into the coating, resulting in a diffusion band along the coating-substrate interface as shown in Figs. 6.33 and 6.34. These results are in agreement with the investigations reported by Wu et al. (2006). Based on the results, general hot corrosion mode for NiCrFeSiB coatings are shown in Fig.6.46.

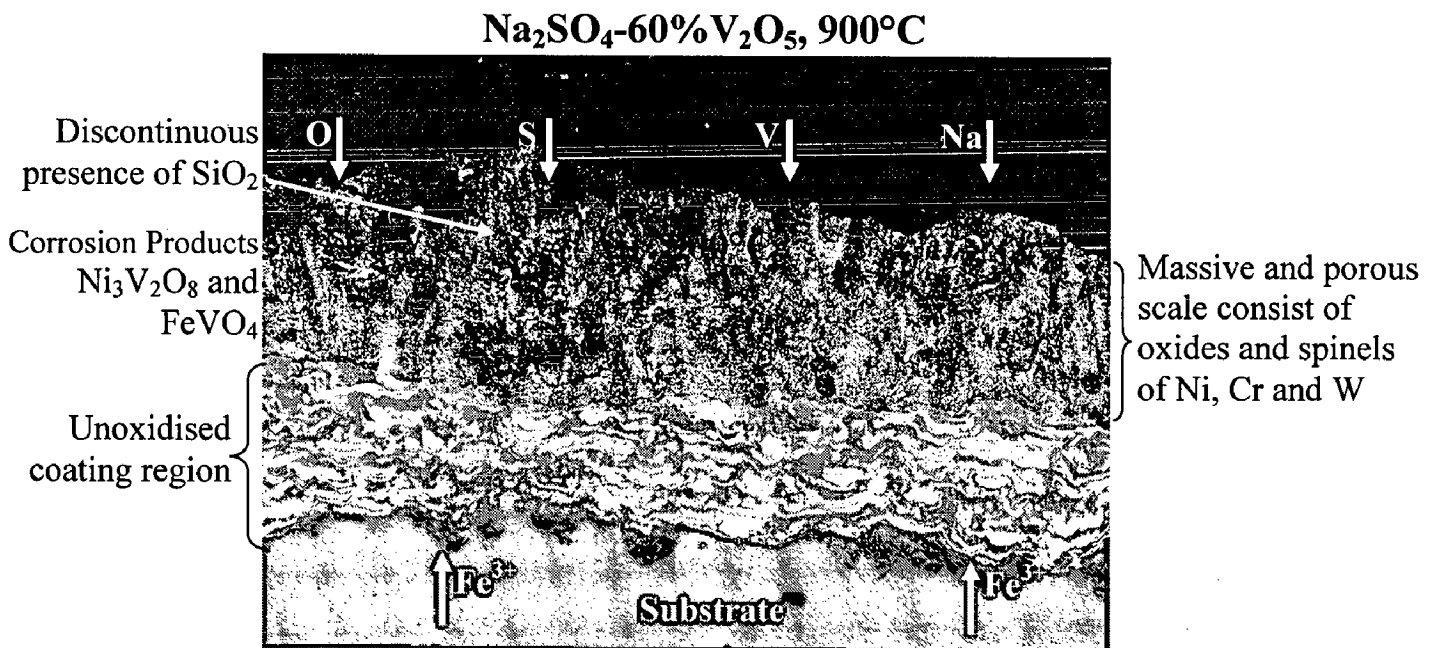
**Fig.6.47** Hot corrosion mode of WC-Co/NiCrFeSiB coated steels exposed to Na<sub>2</sub>SO<sub>4</sub>-60%V<sub>2</sub>O<sub>5</sub> environment for 50 cycles at 900°C

From the corrosion kinetics data, it can be inferred that WC-Co/NiCrFeSiB coatings show much lower weight gain in comparison to uncoated steels reported in section 6.1.1.1. The weight gain for WC-Co/NiCrFeSiB coated GrA1, T11 and T22 steels are 1/4, 1/3 and 1/5 fractions that of similar uncoated steels respectively. Hence on the basis of thermogravimetric measurements as well as by analyzing the oxide scale developed by the coating, it can be concluded that necessary protection to substrate steel, against high temperature corrosion have been provided by the coatings. Based on the present study, the general hot corrosion mode for WC-Co/NiCrFeSiB coatings exposed to Na<sub>2</sub>SO<sub>4</sub>-60%V<sub>2</sub>O<sub>5</sub> environment at 900°C is shown in Fig.6.47

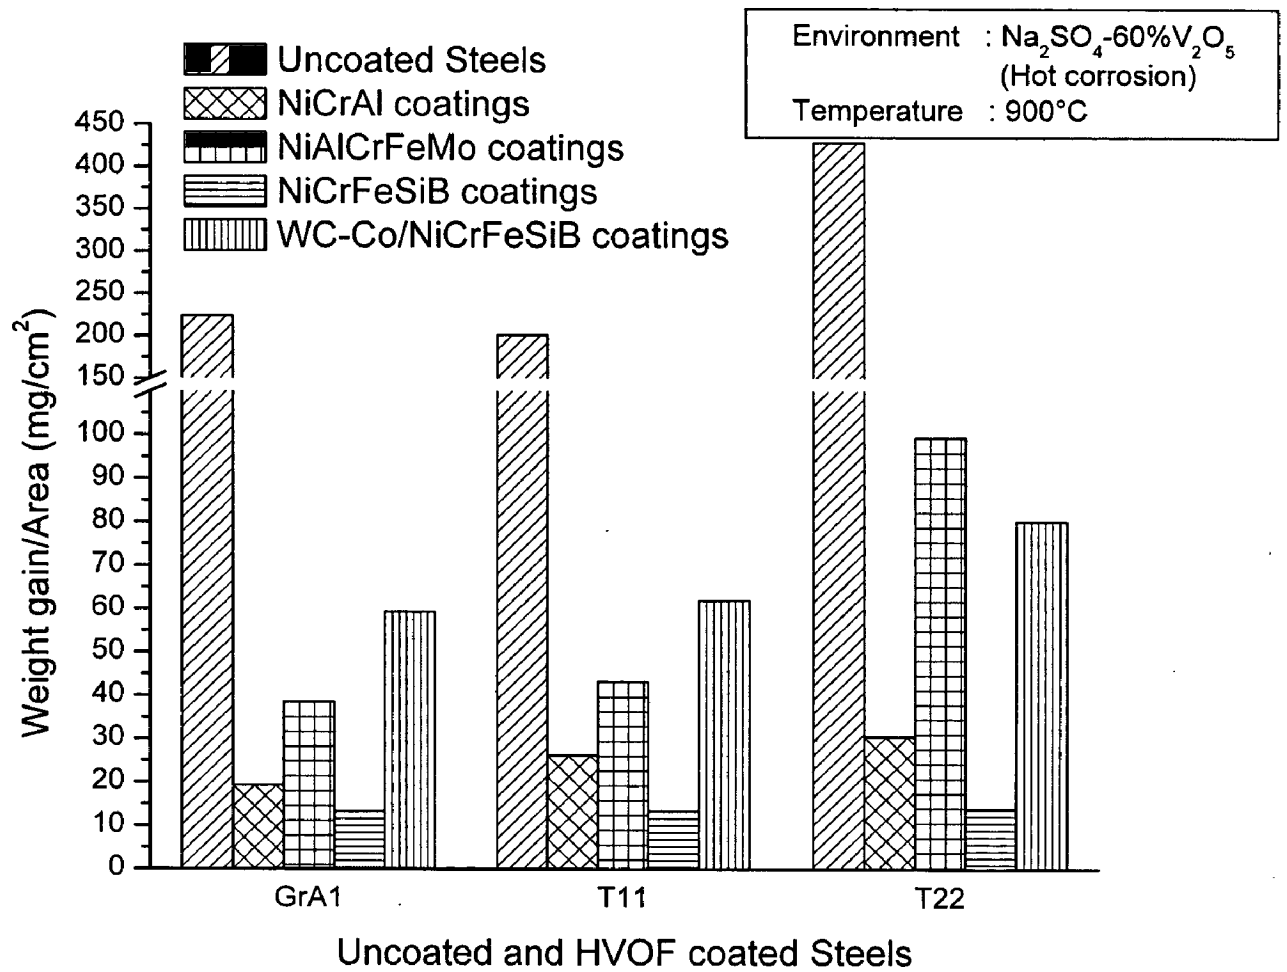
**Fig.6.48** Bar chart showing cumulative weight gain ( $\text{mg}/\text{cm}^2$ ) for uncoated and HVOF coated steels subjected to hot corrosion in  $\text{Na}_2\text{SO}_4$ -60% $\text{V}_2\text{O}_5$  salt environment for 50 cycles at 900°C

The cumulative weight gain ( $\text{mg}/\text{cm}^2$ ) for uncoated and HVOF coated GrA1, T11 and T22 steels subjected to hot corrosion in  $\text{Na}_2\text{SO}_4$ -60% $\text{V}_2\text{O}_5$  molten salt environment for 50 cycles at  $900^\circ\text{C}$  is shown in Fig.6.48. From the bar charts, it can be inferred that the weight gains for all the HVOF coated steels are significantly lower than that of uncoated steels in molten salt environment. Uncoated steels suffered a higher corrosion rate and intense spalling of oxide scale is observed. The main constituent of oxide scale formed on all the steels is iron oxide. The acidic fluxing of the oxides by the molten salt mixture has resulted in massive, porous oxide scale. The stress developed due to higher volume of the oxide scale leads to cracks, in turn resulted in spallation. Uncoated T22 steel shows higher corrosion rate in comparison to uncoated GrA1 and T11 steels. Presence of chromium vanadate indicated the dissolution of initially formed chromium oxide film on the surface of T22 steel.

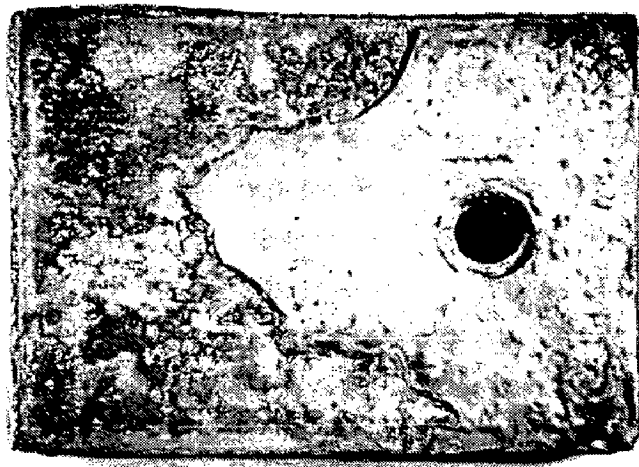
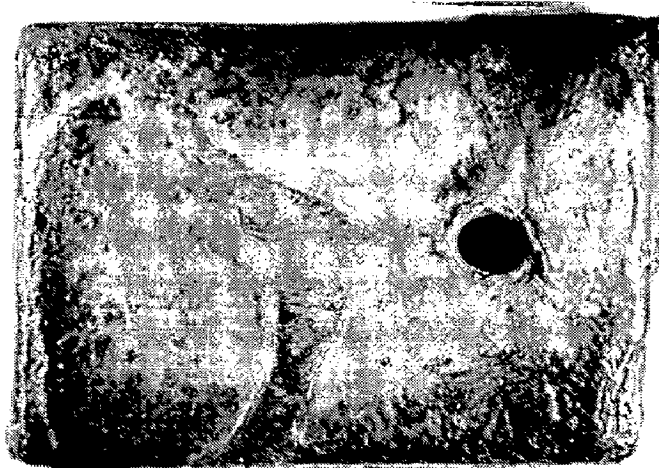
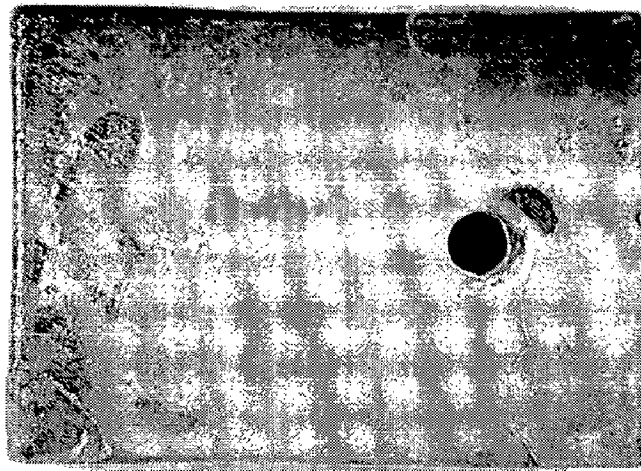
Fig.7.1

(b) T11 steel

(c) T22 steel

The macrographs of the GrA1, T11 and T22 steels after 1000 hours of exposure to the platen super heater zone of the coal-fired boiler are shown in Fig. 7.1. The scale developed on the GrA1 steel is fragile and showed intense spalling during the course of study. The GrA1 and T11 steels developed a dark grey colored scale, whereas, the light colored scale is observed in T22 steel.

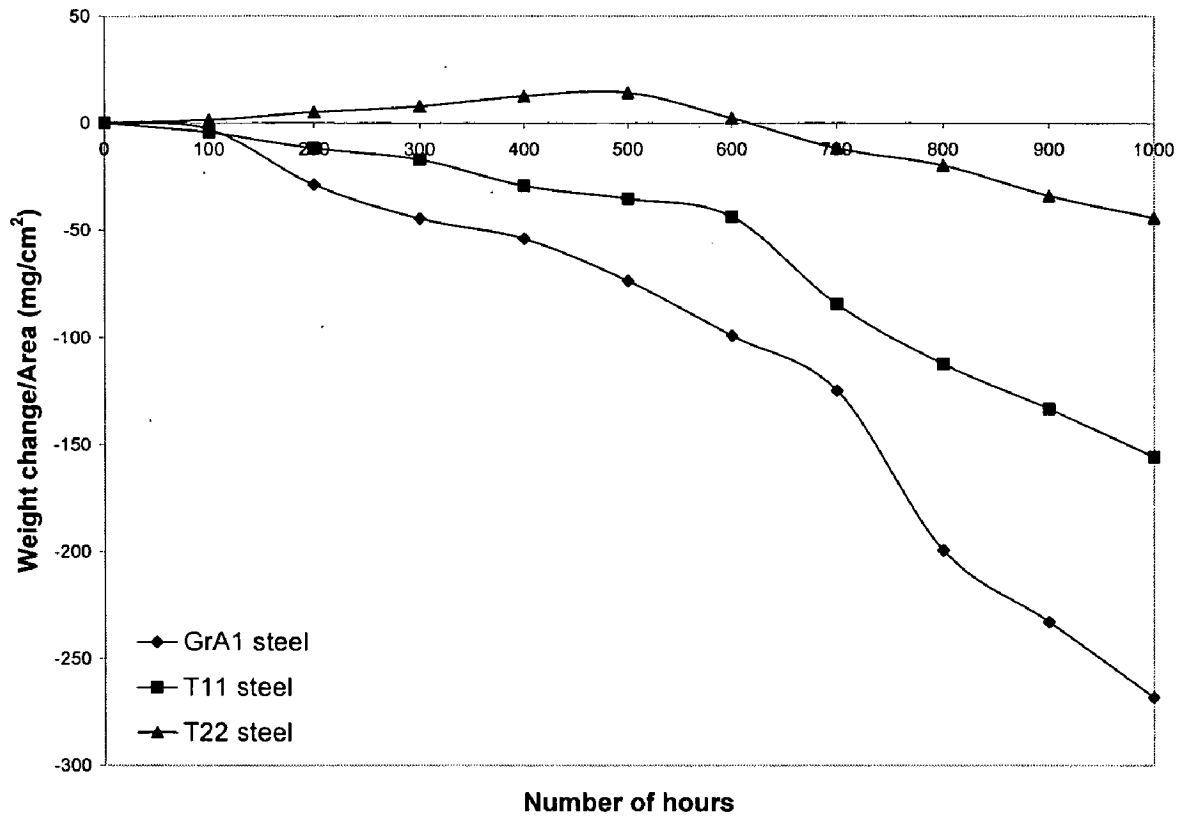
**Fig.7.2** Weight change vs. time plot for uncoated steels subjected to 1000 hours cyclic exposure to super heater zone of the coal fired boiler

The plots of weight change ( $\text{mg}/\text{cm}^2$ ) as a function of time are shown in Fig. 7.2. During the exposure to actual industrial environment, the weight gain of the sample owes to the formation of the oxide scale and the weight loss is due to the continuous impact of fly ash, results in spalling, as well as, high temperature corrosion of the oxide scale. The GrA1 and T11 steels suffered weight loss throughout the study, whereas, T22 steel showed a weight gain up to 600 hours of exposure with a minor spalling in the later cycle of study.

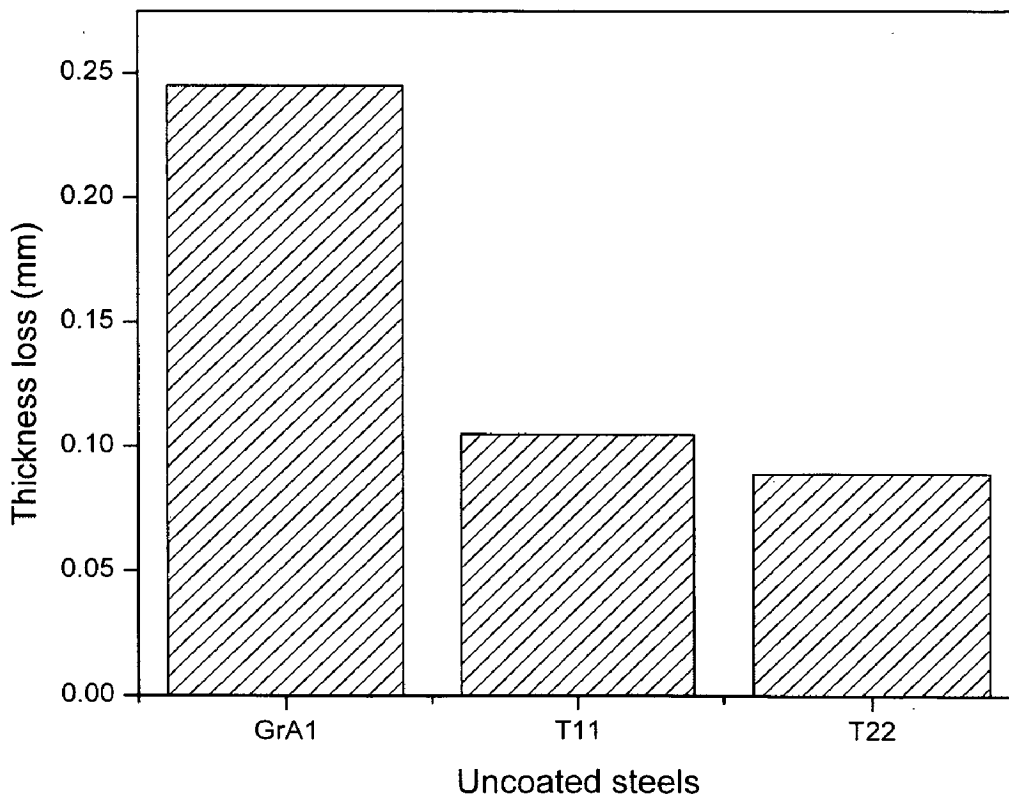
**Fig.7.3** Bar chart indicating the thickness lost in mm for the uncoated steels after 1000 hours of exposure to super heater zone of coal fired boiler.

The extent of the combined erosion-corrosion is measured in terms of metal thickness lost at the end of 1000 hours of exposure to platen super heater region. The thickness of metal lost is found to be 0.245 mm, 0.105 mm and 0.089 mm for GrA1, T11 and T22 steels respectively (Fig.7.3). The corresponding degradation rates expressed in mils per year (mpy) are found as 84.49 mpy, 36.21 mpy and 30.69 mpy respectively.

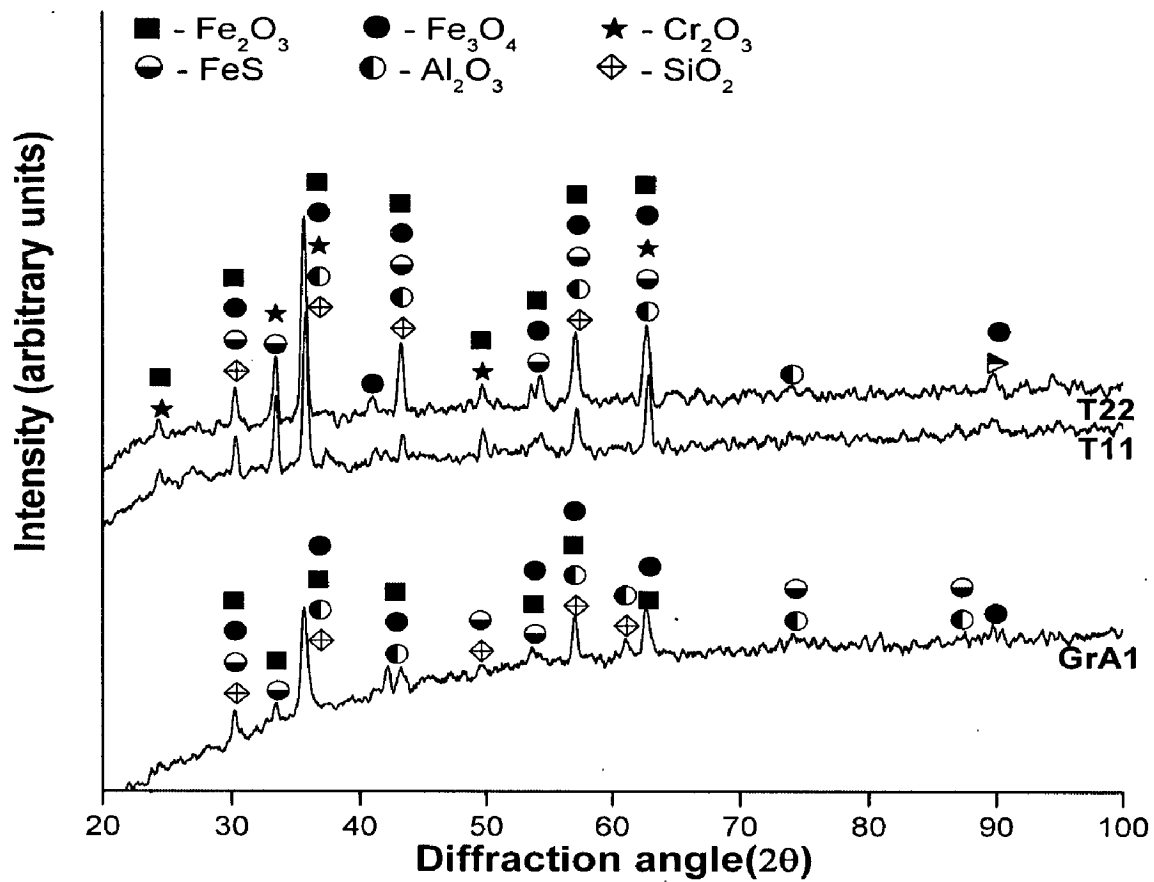
**Fig.7.4** X-ray diffraction patterns for the boiler steels after 1000 hours of exposure to super heater zone of coal fired boiler

The X-ray diffraction pattern for the steels, after exposure to boiler environment for 1000 hours, is shown in Fig. 7.4. All the steels showed  $\text{Fe}_2\text{O}_3$  and  $\text{Fe}_3\text{O}_4$  as major peaks. Sulphide deposit is also found on the scale surface. The presence of  $\text{Al}_2\text{O}_3$  and  $\text{SiO}_2$  phases indicate the deposition of fly ash on the surface of exposed steel. Presence of  $\text{Cr}_2\text{O}_3$  has been indicated in the oxide scale in case of T11 and T22 steels.

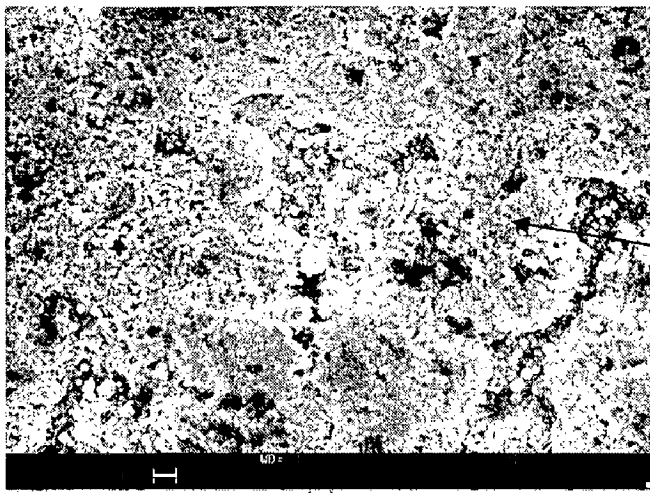
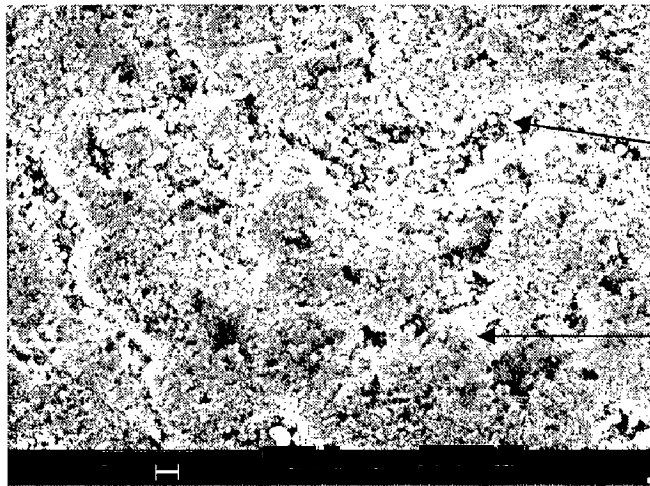
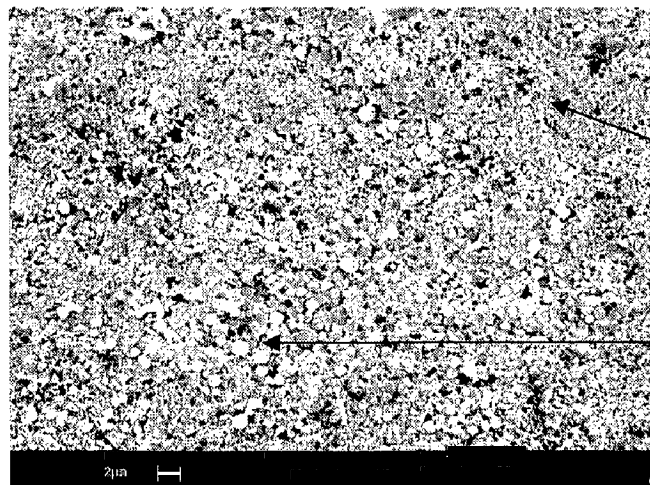
80.50% Fe<sub>2</sub>O<sub>3</sub>  
 09.92% SiO<sub>2</sub>  
 04.25% Al<sub>2</sub>O<sub>3</sub>

50.47% Fe<sub>2</sub>O<sub>3</sub>  
 25.24% SiO<sub>2</sub>  
 15.13% Al<sub>2</sub>O<sub>3</sub>  
 4.13% TiO<sub>2</sub>

89.66% Fe<sub>2</sub>O<sub>3</sub>  
 04.22% SiO<sub>2</sub>

88.37% Fe<sub>2</sub>O<sub>3</sub>  
 04.34% Cr<sub>2</sub>O<sub>3</sub>  
 04.13% SiO<sub>2</sub>

54.60% Fe<sub>2</sub>O<sub>3</sub>  
 25.24% SiO<sub>2</sub>  
 15.13% Al<sub>2</sub>O<sub>3</sub>  
 2.15% Na<sub>2</sub>O

**Fig.7.5** Surface scale morphology and EDAX analysis for boiler steels exposed to super heater of the coal fired boiler for 1000 hours:  
 (a) GrA1 steels (b) T11 steels (c) T22 steels

The surface scale morphology and the EDAX analysis for steels exposed to platen super heater region of the coal-fired boiler for 1000 hours are shown in Fig. 7.5. All the steels reveal  $\text{Fe}_2\text{O}_3$  as a main constituent of the surface scale. The white phase of the scale that appears like the spherical particles distributed along the cracks and the pits formed on the oxide scale may be attributed to the impact of fly ash. The EDAX analysis of these particles consist mainly of  $\text{SiO}_2$ ,  $\text{Al}_2\text{O}_3$ ,  $\text{Fe}_2\text{O}_3$ ,  $\text{TiO}_2$  and  $\text{Na}_2\text{O}$ , which are the constituents of fly ash and they may become a site of active corrosion later on.

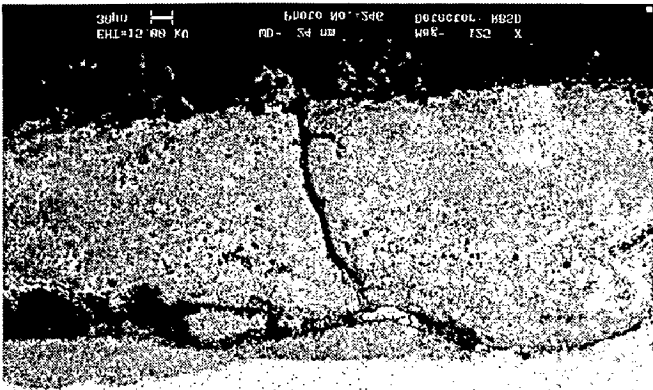
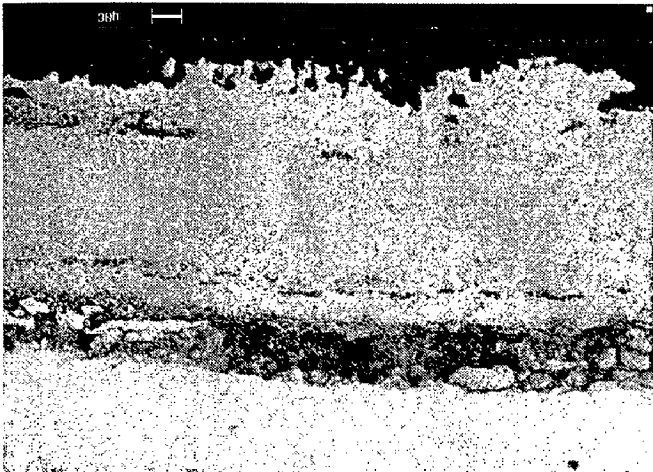
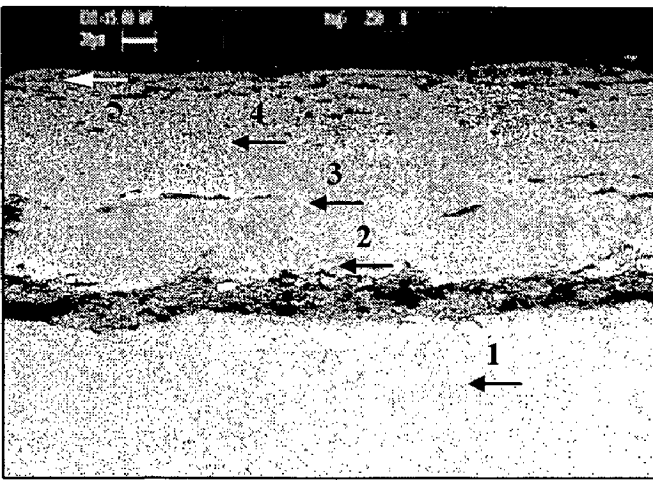
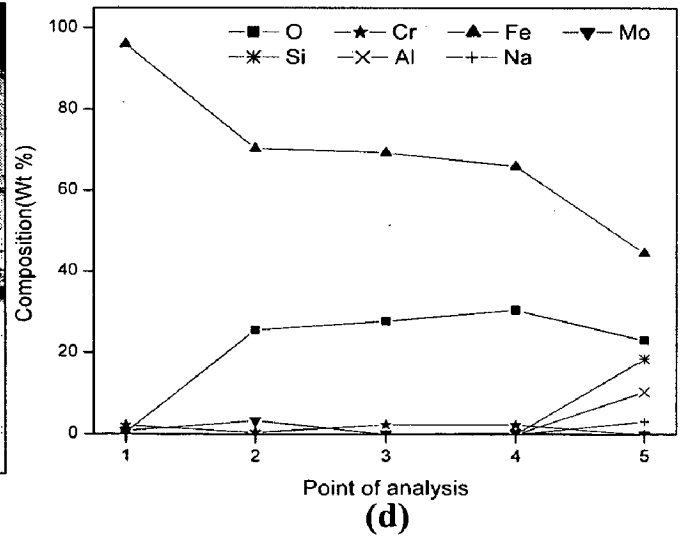
**Fig.7.6** Back scattered images for the uncoated steels after 1000 hours of cyclic exposure to superheater zone of coal fired boiler:  
 (a) GrA1 Steel (b) T11 Steel (c) T22 Steel  
 (d) EDAX point analysis along the cross-section of T11 steel

The BSE images and the EDAX analysis at some points of interest across the cross section of the exposed NiCrAl coated steels are shown in Fig. 7.6. The appearance of the scale formed on the GrA1 steel is highly porous and cracked along the scale thickness, whereas the bulk scale appears on the T11 and T22 steels. The EDAX analysis at the selected points along the scale thickness of T22 is illustrated in Fig.7.6d. The point analysis on the top of the scale shows the higher content of  $\text{SiO}_2$  and  $\text{Al}_2\text{O}_3$ . It is found that minor concentration of Cr and Mo oxides are distributed throughout the cross section.
