# **STUDIES ON THE ROLE OF HVOF COATINGS IN IMPROVING RESISTANCE TO HOT CORROSION AND EROSION**

## **A THESIS**

**DOCTOR OF PHILOSOPHY**

**METALLURGICAL AND MATERIALS ENGINEERING**

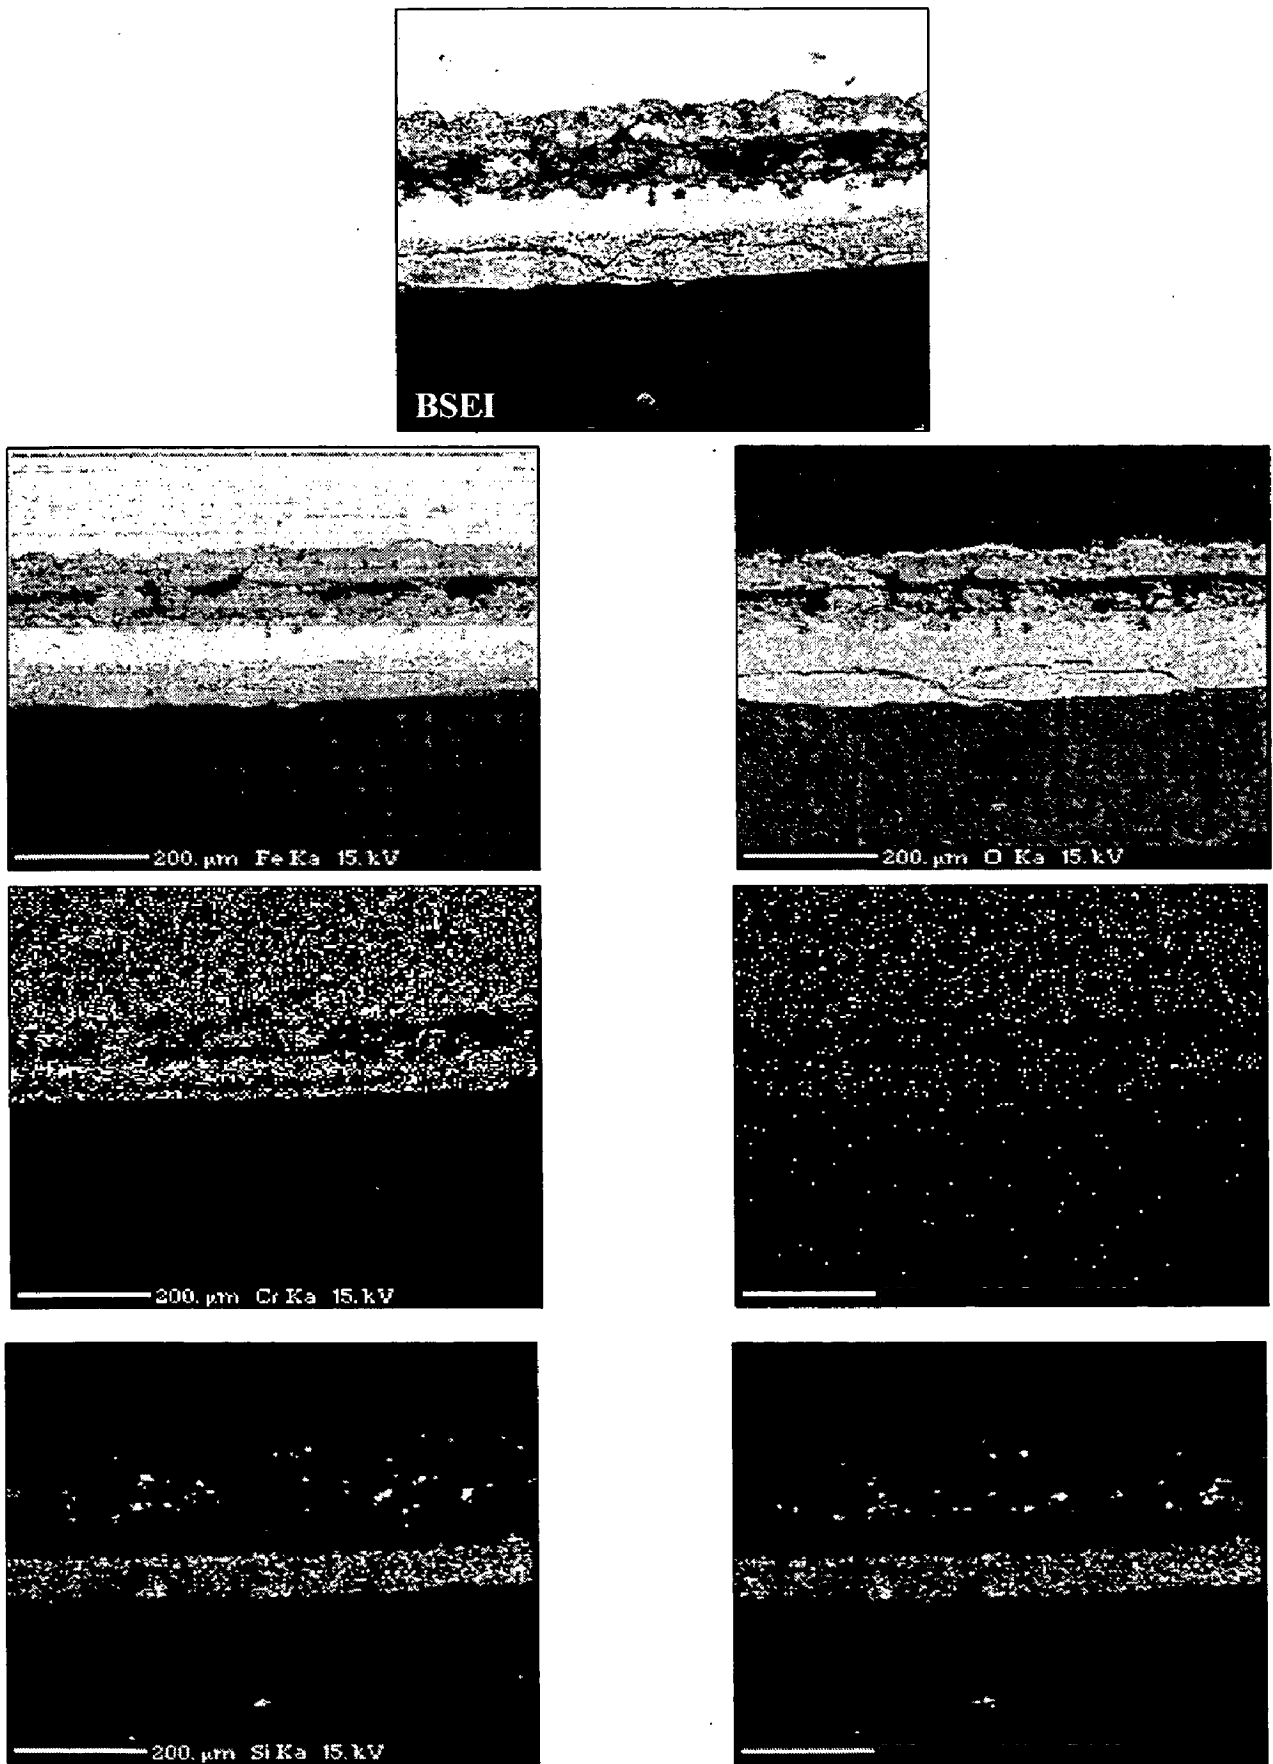
**Fig.7.7** BSEI and X-ray mapping across the cross-section of the boiler steel T22 after 1000 hours of exposure to super heater zone of the coal fired boiler

The BSEI and X-ray mappings for a part of the oxide scale of T22 steels after exposure to boiler environment is shown in Fig.7.7. The Fe mapping indicates a higher concentration of iron throughout the oxide layer. Surface oxide scale mainly consists of

oxides of Fe, Si and Al which reveals the embedment of ash particles. Further, a band of chromium oxide is clearly seen in the inner layer of the oxide scale. However, Mo seems to be homogeneous throughout the cross section.

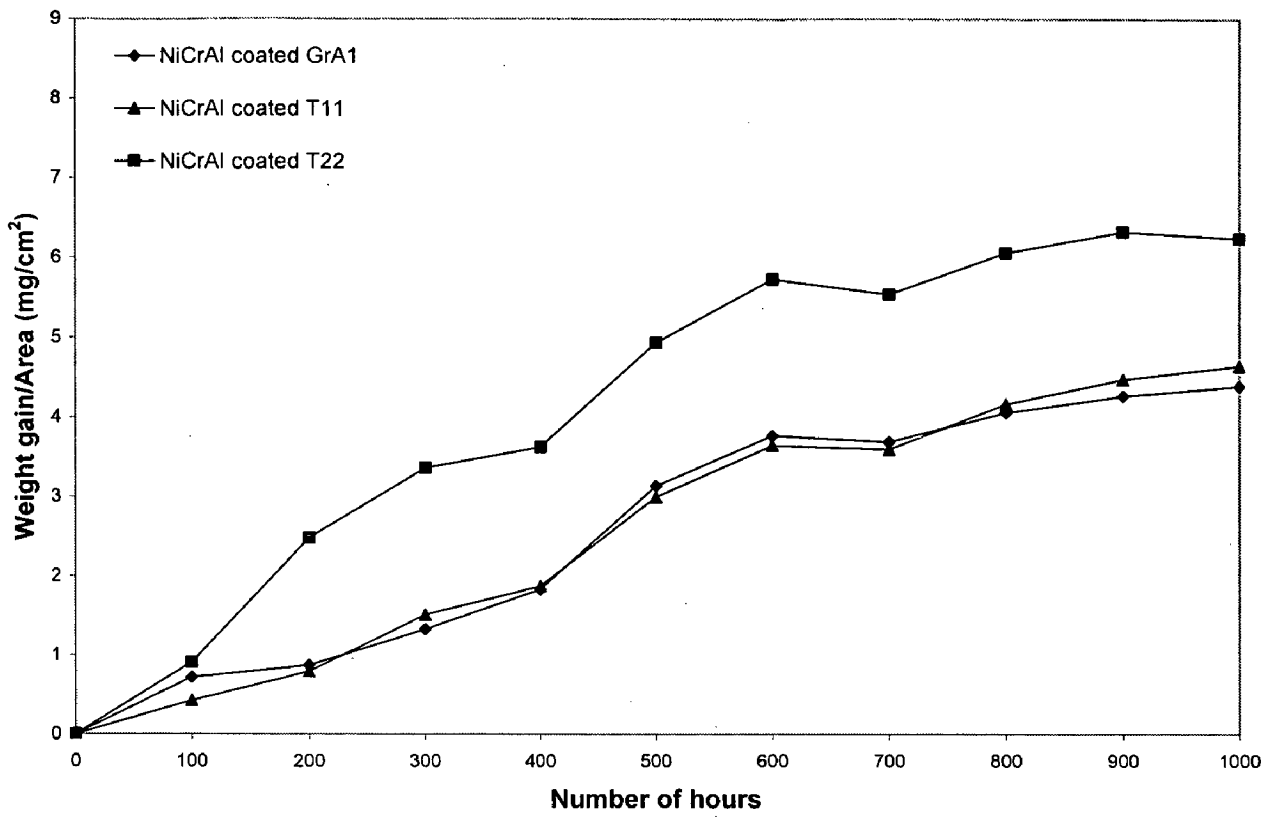
**Fig.7.9** Weight change plot for NiCrAl coated steels exposed to super heater zone of coal fired boiler for 1000 hours

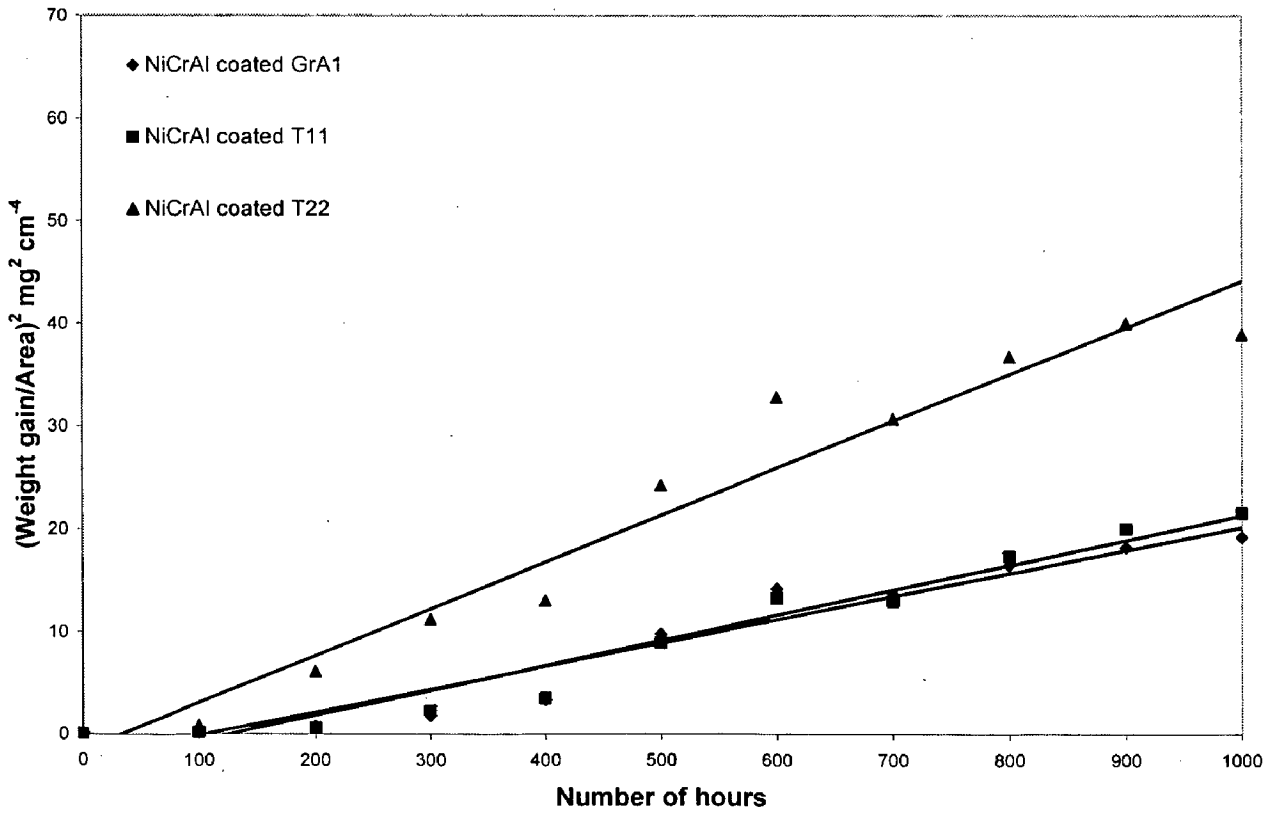
**Fig.7.10** (Weight change/area)² plot for NiCrAl coated steels exposed to super heater zone of coal fired boiler for 1000 hours

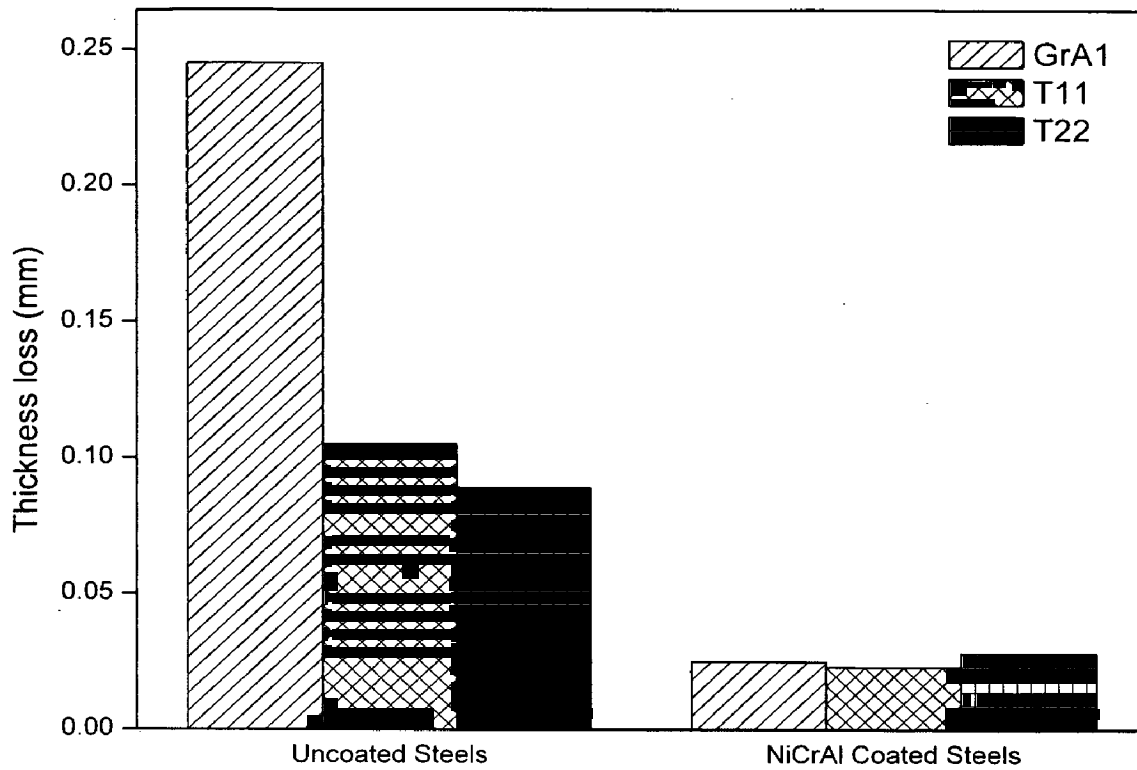
**Fig.7.11** Bar chart indicating the thickness lost in mm for the uncoated and NiCrAl coated steels after 1000 hours of exposure to super heater zone of coal fired boiler.

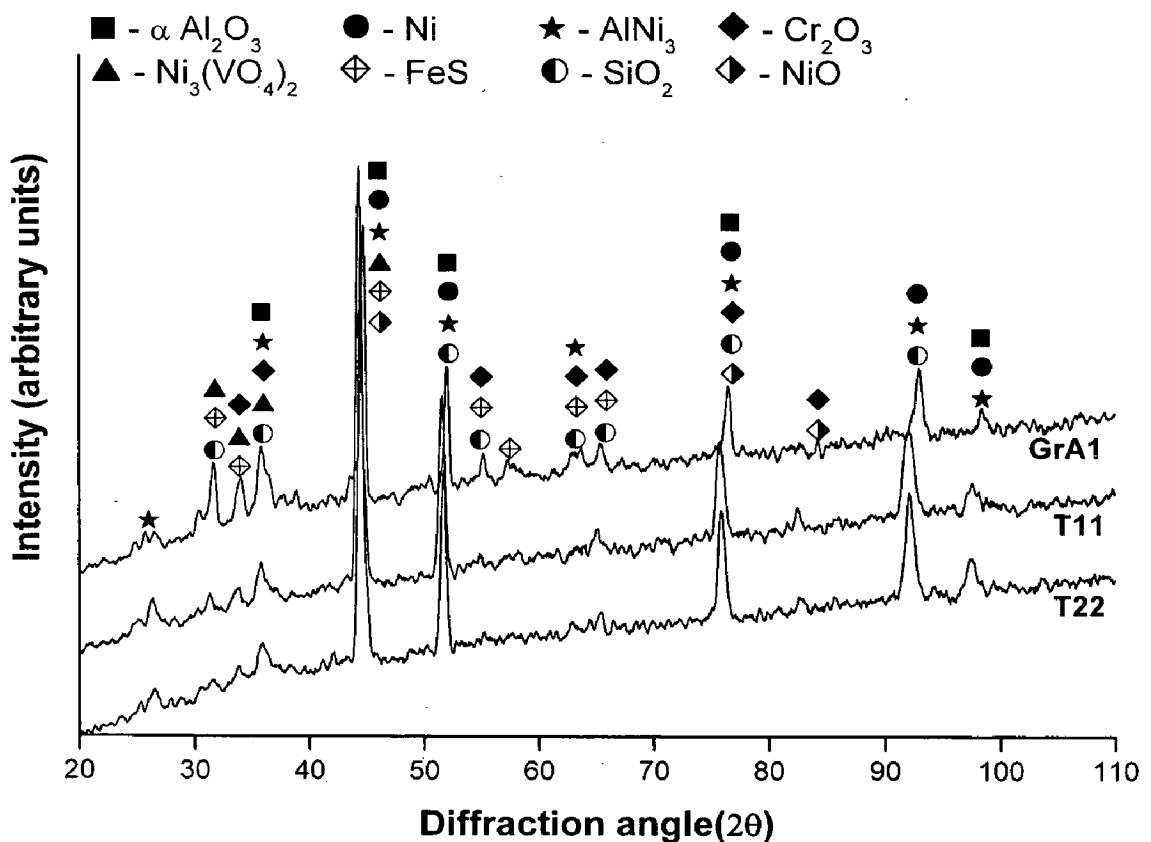
**Fig.7.12** X-ray diffraction patterns for NiCrAl coated GrA1, T11 and T22 steels Exposed to super heater zone of coal fired boiler for 1000 hours.

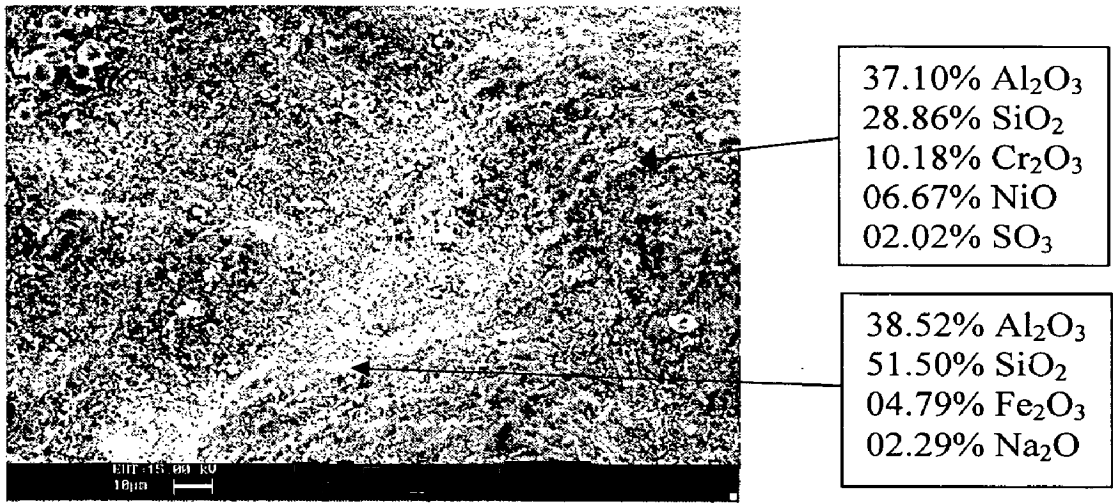
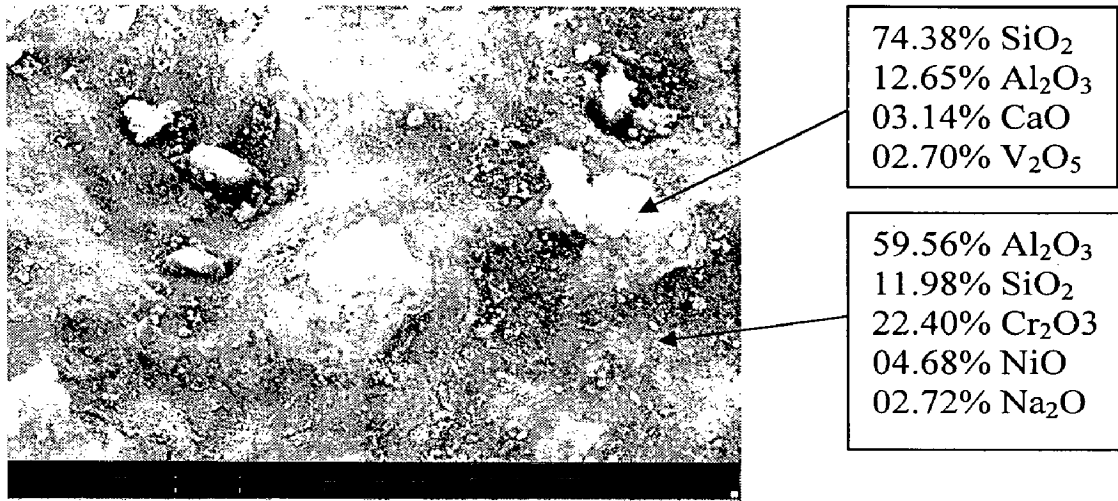
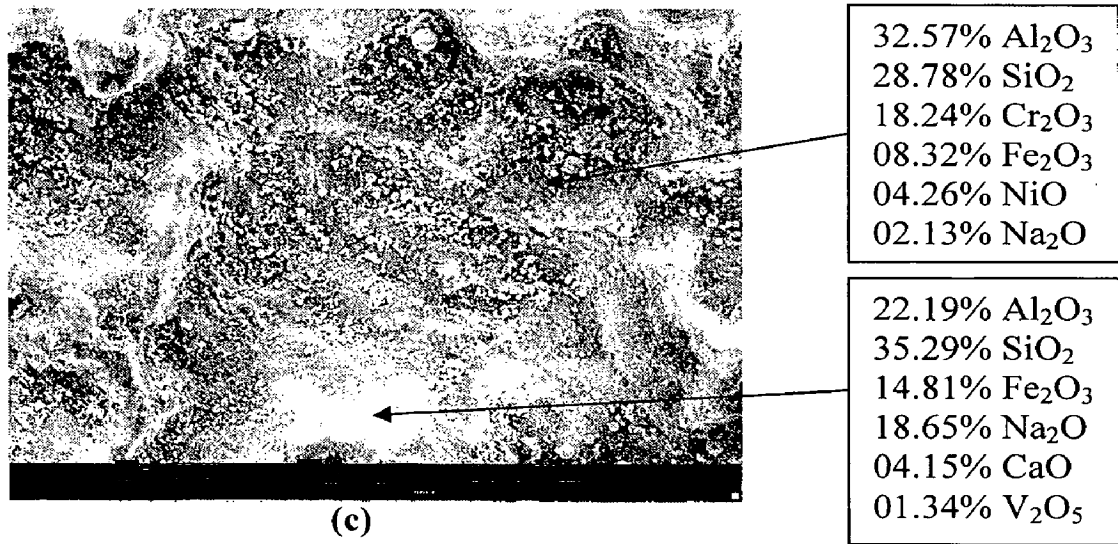
**Fig.7.13** Surface scale morphology and EDAX point analysis for NiCrAl coated steels exposed to super heater zone of coal fired boiler for 1000 hours: (a) GrA1 steel (b) T11 steel (c) T22 steel

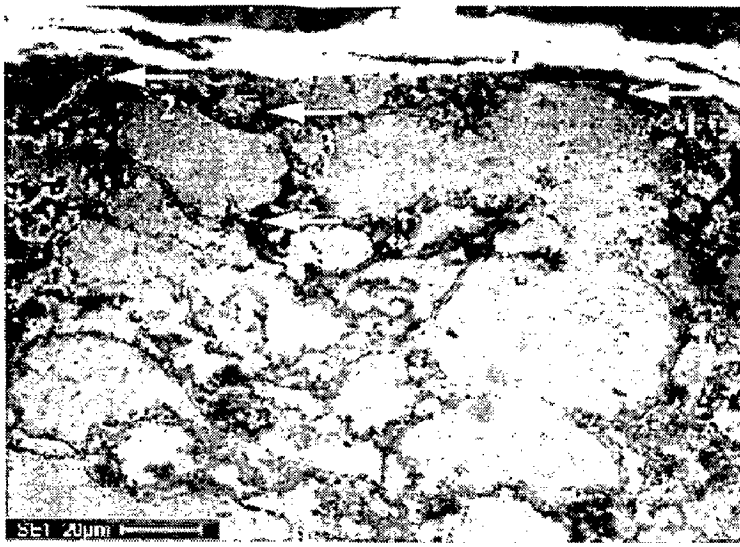
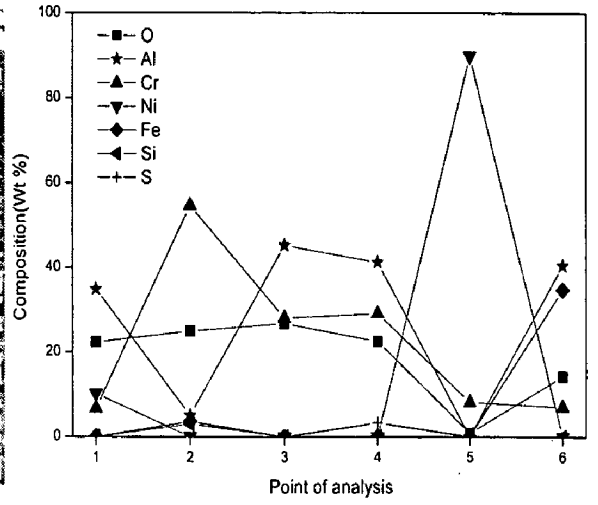
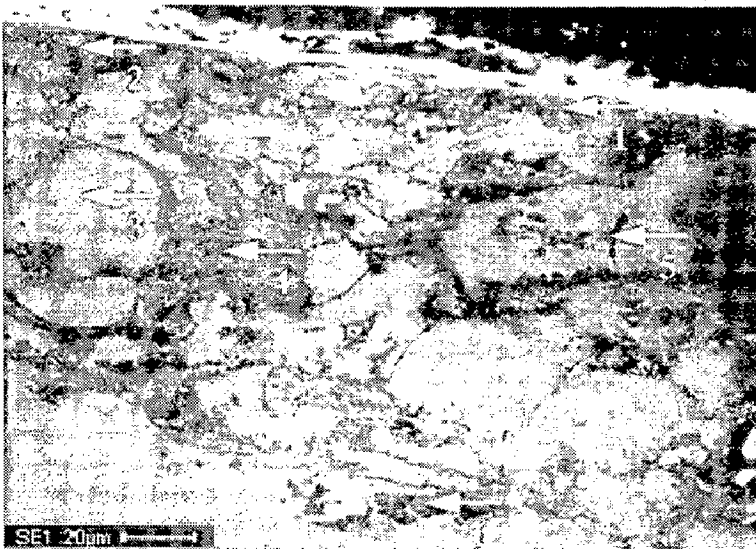
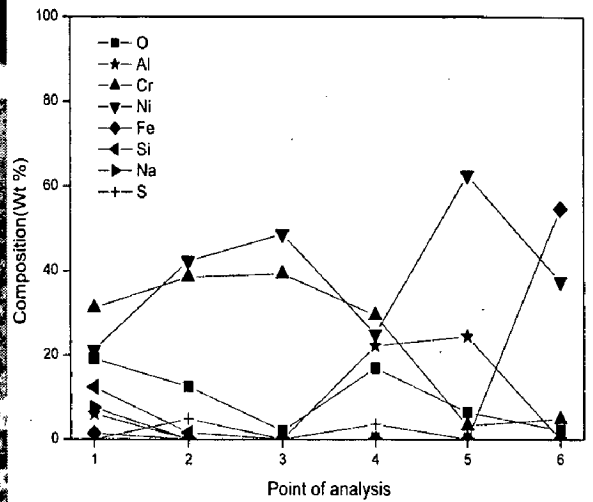
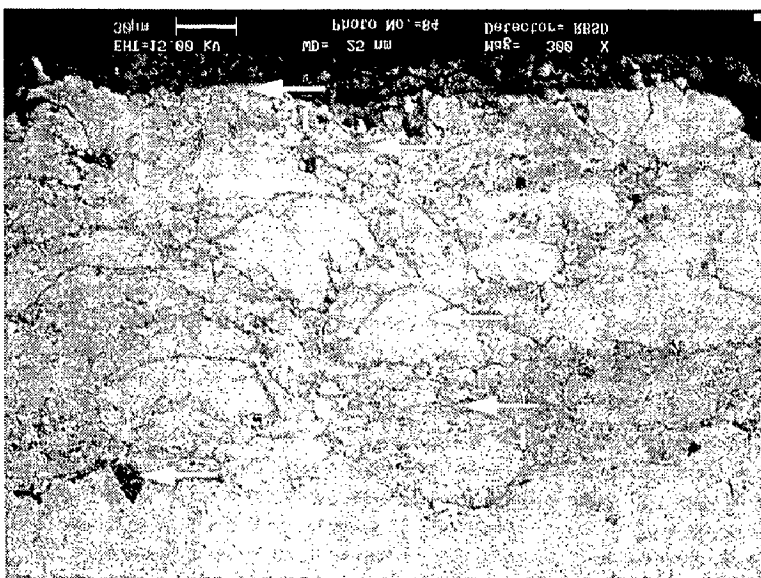
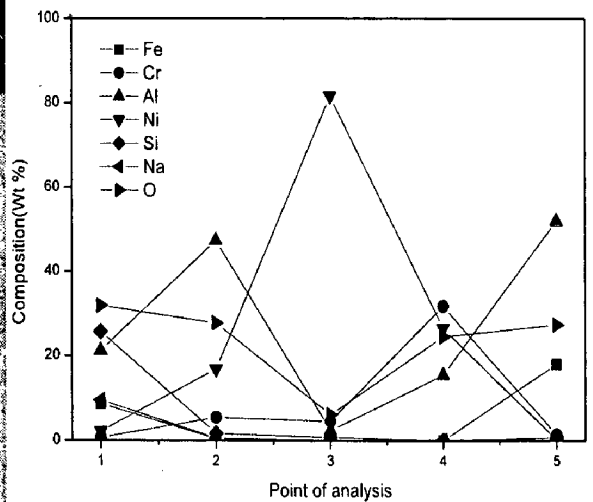
**Fig.7.14** Back scattered electron image and EDAX point analysis (wt %) across the cross-section of the NiCrAl coated steels exposed to super heater zone of coal fired boiler for 1000 hours:  
 (a) GrAl steel (b) T11 steel (c) T22 Steel

The BSE images and EDAX analysis at some selected points of interest across the cross-section of the corroded NiCrAl coated steels are shown in Fig. 7.14. A thin and adherent scale is formed without any indication of crack along the cross section at the end of 1000 hours of exposure. Figure 7.14a shows the point analysis along the cross section of corroded NiCrAl coated GrA1 steel. The EDAX analysis on the surface (Points 1 and 2) shows that, the top most layer mainly consisted of oxides of Al and Cr, along with a minor amount of Si (3.02%). The presence of sulphur is also identified along the splat boundary (Point 4). Point 5 indicates the presence of Ni rich splat and absence of oxygen at these points suggests that the Ni-rich splats are in the unoxidised state. The black contrast region along the splat boundary is rich in Al, Cr and O, which indicates the oxidation of Al and Cr along the splat boundaries. Point 6 shows that the coating substrate interface containing Al<sub>2</sub>O<sub>3</sub> grit particles.

Figure 7.14b which demonstrates the corresponding analysis for the exposed NiCrAl coated T11 steels shows that the outermost layer of the scale (Points 1 and 2) is mainly consisting of oxides of Ni, and Cr along with minor amounts of Al, Si and Na

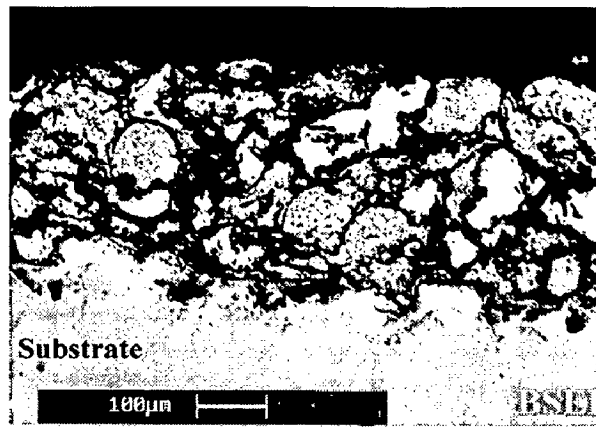
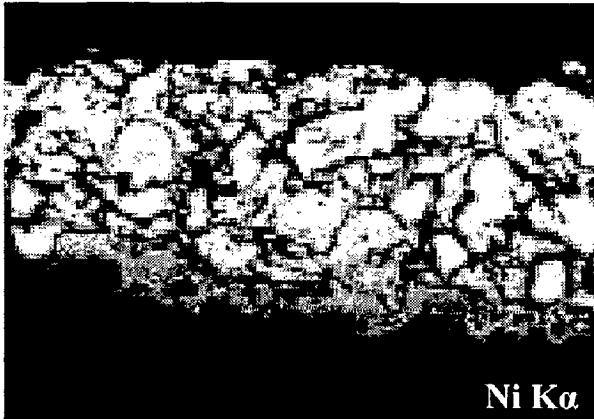
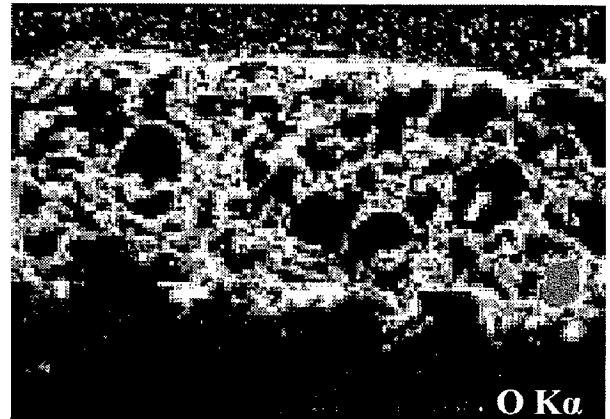
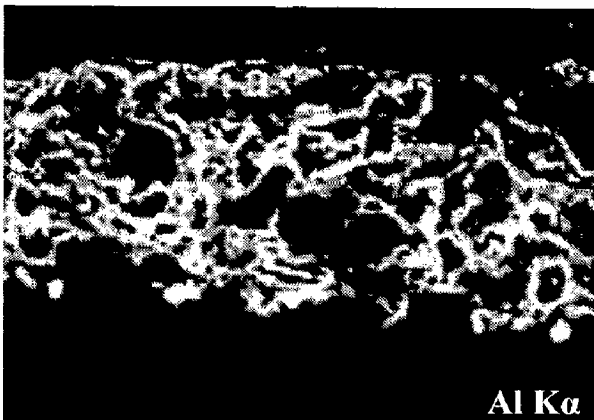
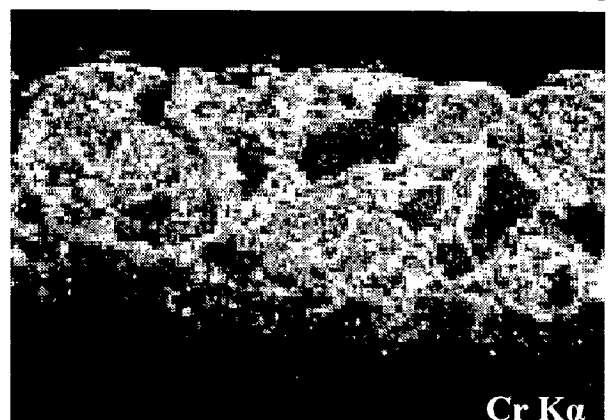
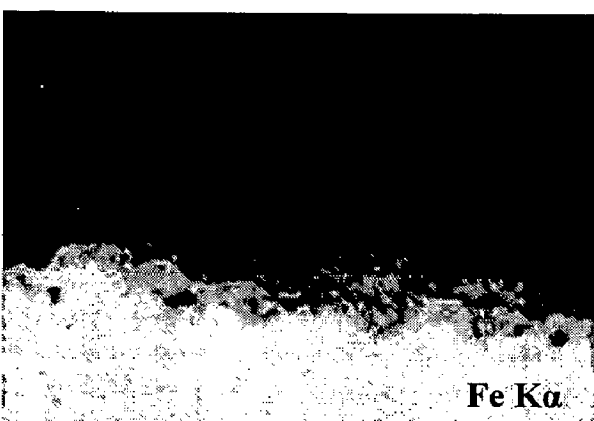
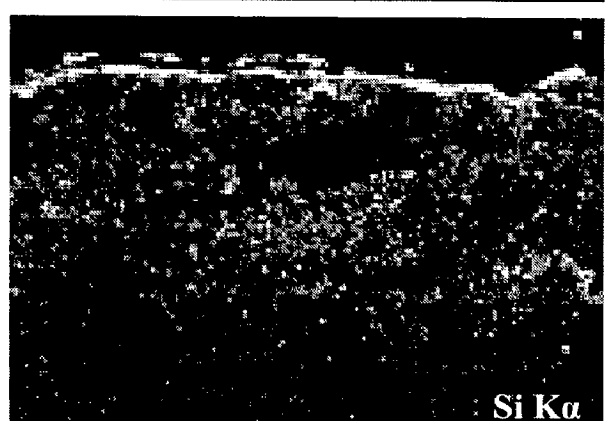
**Fig.7.15** BSEI and elemental X-ray mapping along the cross-section of the NiCrAl coated T22 steels exposed to superheater zone of coal fired boiler for 1000 hours

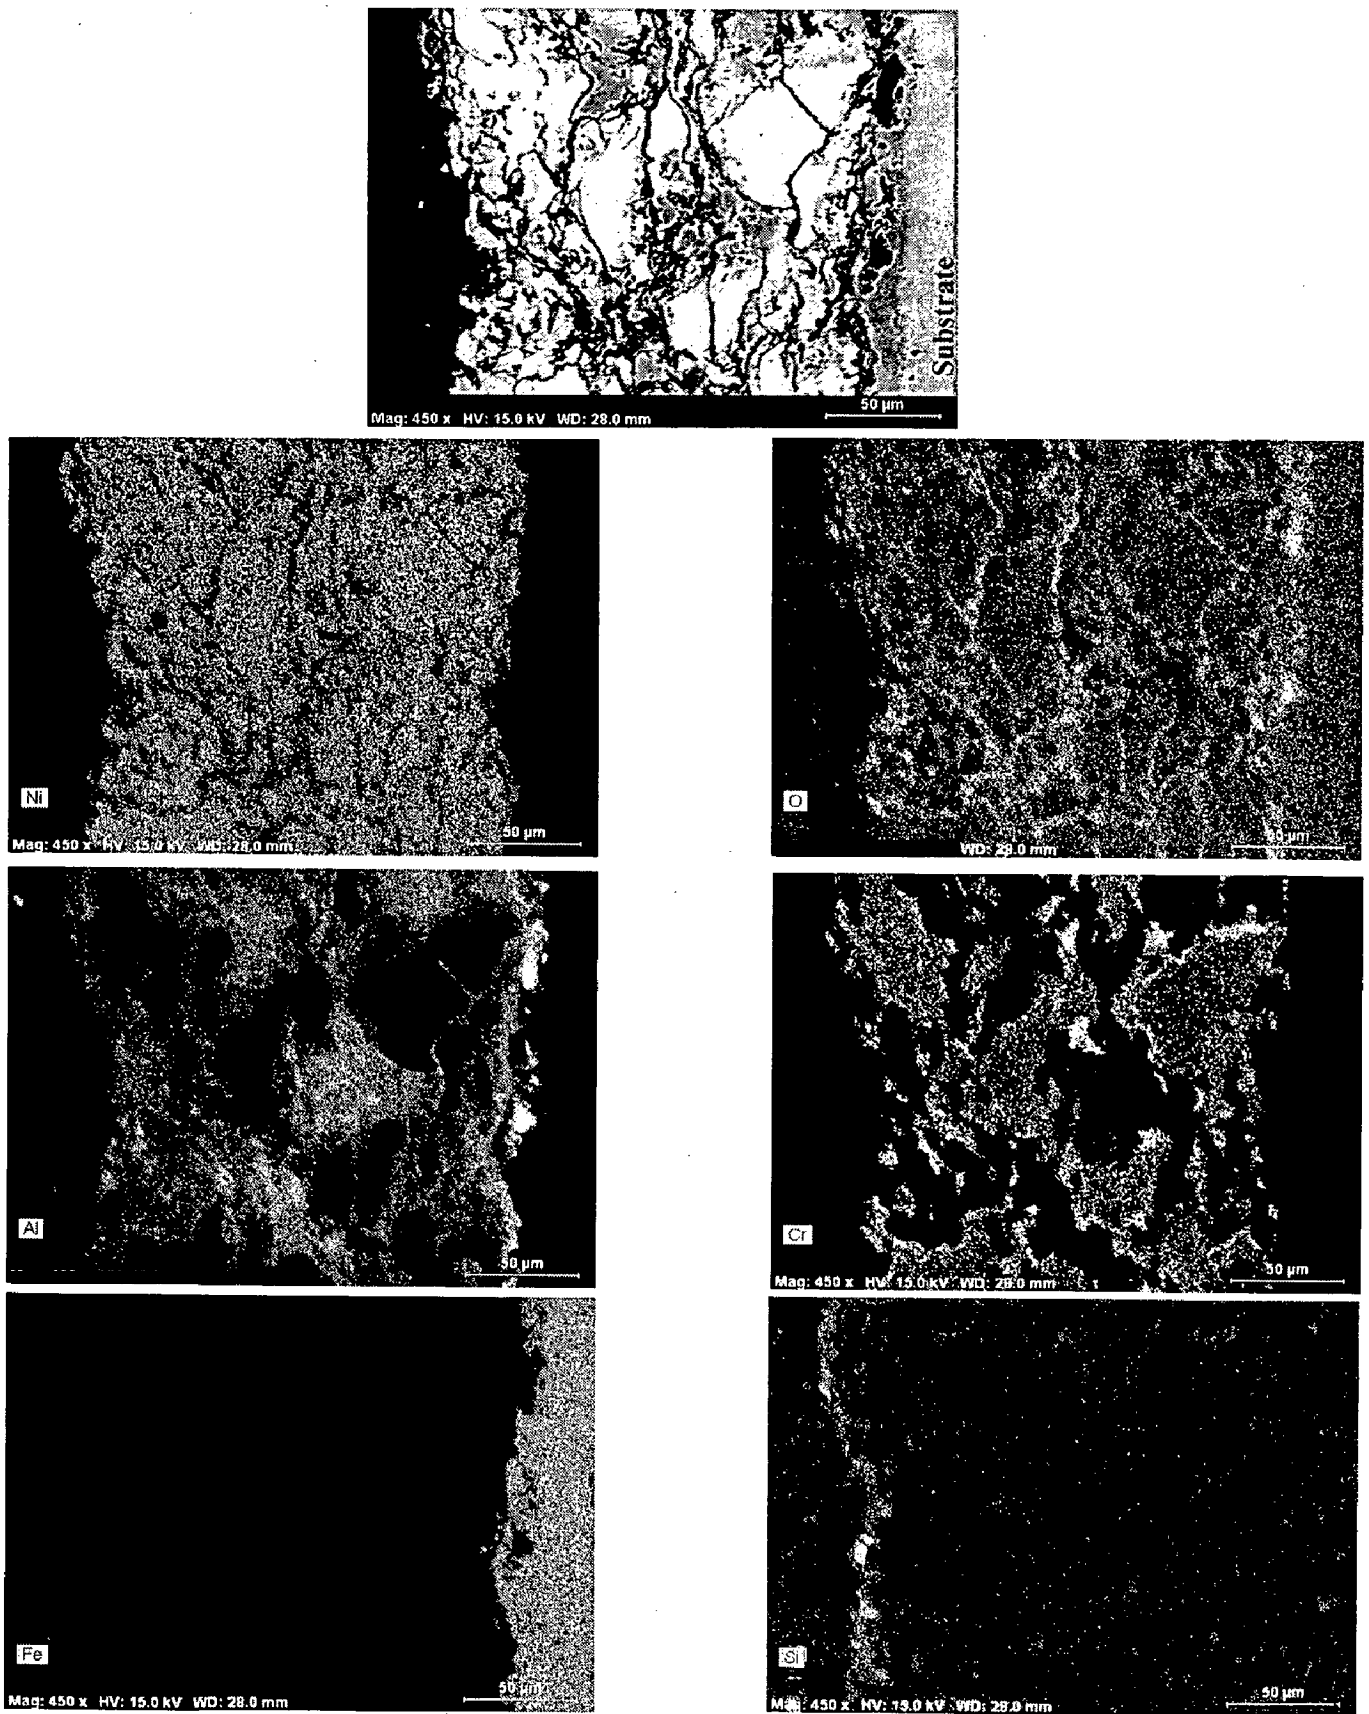
**Fig.7.16** BSEI and elemental X-ray mapping along the cross-section of the NiCrAl coated T11 steels exposed to superheater zone of coal fired boiler for 1000 hours

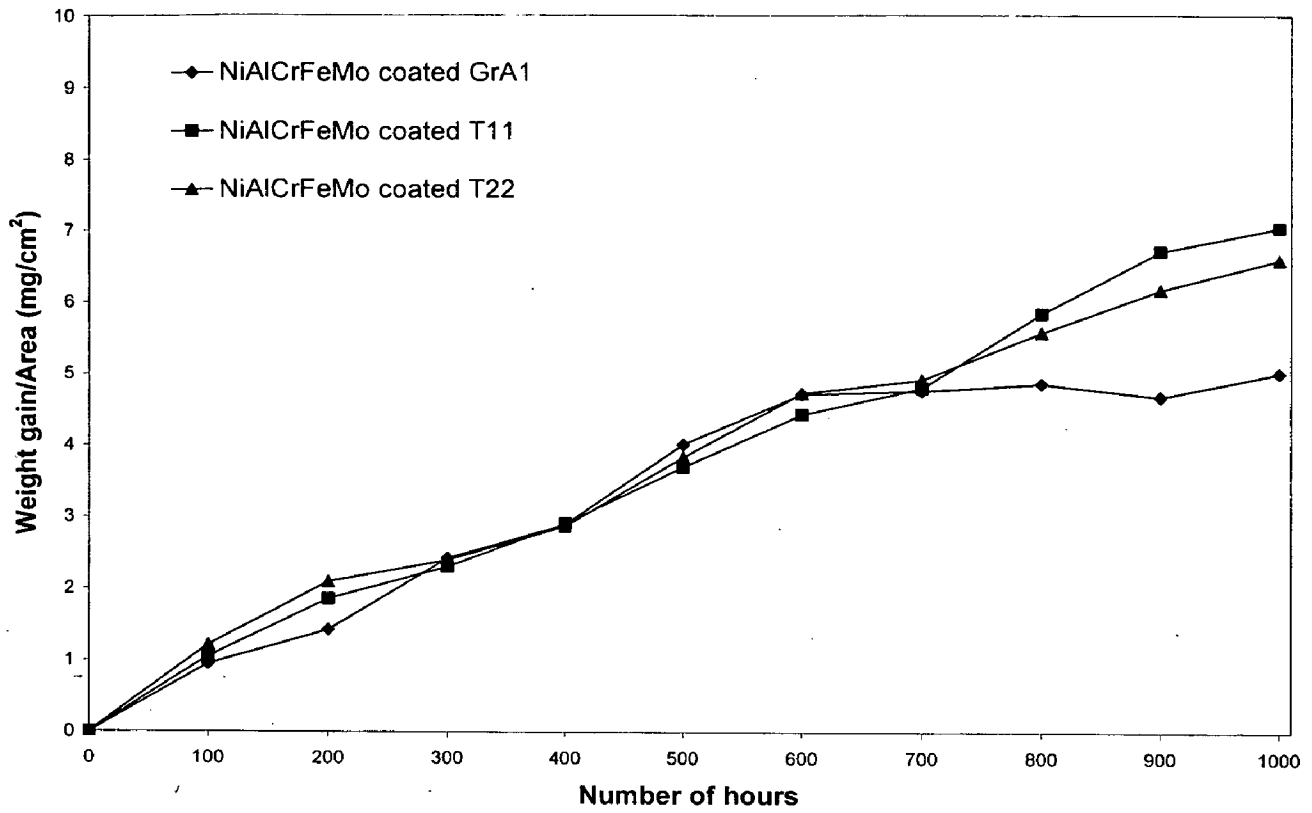
**Fig. 7.18** Weight change plot for NiAlCrFeMo coated steels exposed to super heater zone of coal fired boiler for 1000 hours

The plot of weight change per unit area as a function of exposure time is as shown in Fig.7.18. The observed fluctuations in the weight change data might be due to erosion-corrosion of the coatings accompanied with falling off and regeneration of the ash deposits on the surface of the exposed samples. The total weight gain at the end of 1000 hours of exposure for NiAlCrFeMo coated GrA1, T11 and T22 steels is 5.004, 7.04 and 6.59 mg/cm<sup>2</sup> respectively. Evidently, coated T22 steels showed a maximum weight gain, in comparison to other coated steels. All the coated steels showed noticeable deviation from the parabolic rate law, as shown in Fig.7.19. The parabolic rate constant, calculated by a linear least square algorithm function for coated GrA1, T11 and T22 steels, found to be  $0.081 \times 10^{-10}$ ,  $0.142 \times 10^{-10}$  and  $0.124 \times 10^{-10} \text{ g}^2 \text{ cm}^{-4} \text{ s}^{-1}$  respectively.

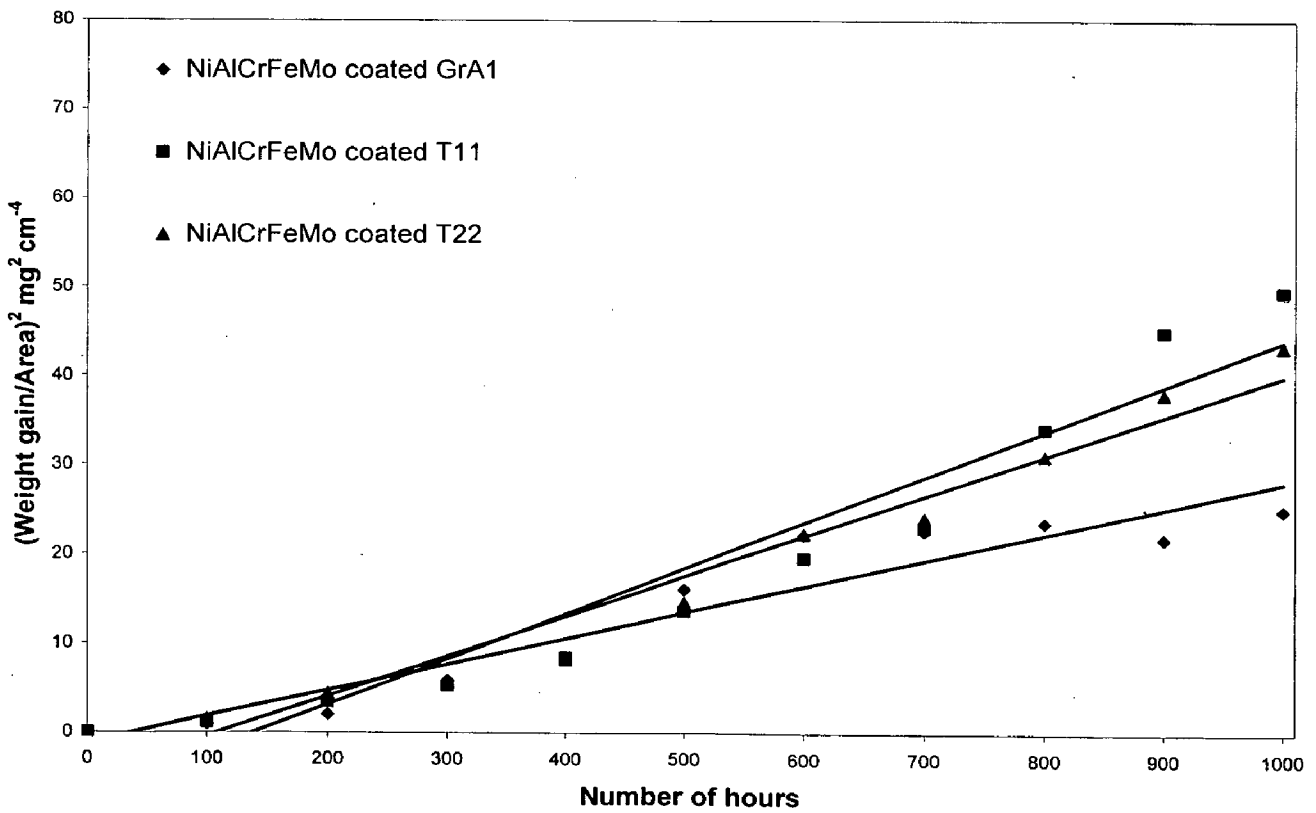
**Fig. 7.19** (Weight change/area)<sup>2</sup> plot for NiAlCrFeMo coated steels exposed to super heater zone of coal fired boiler for 1000 hours

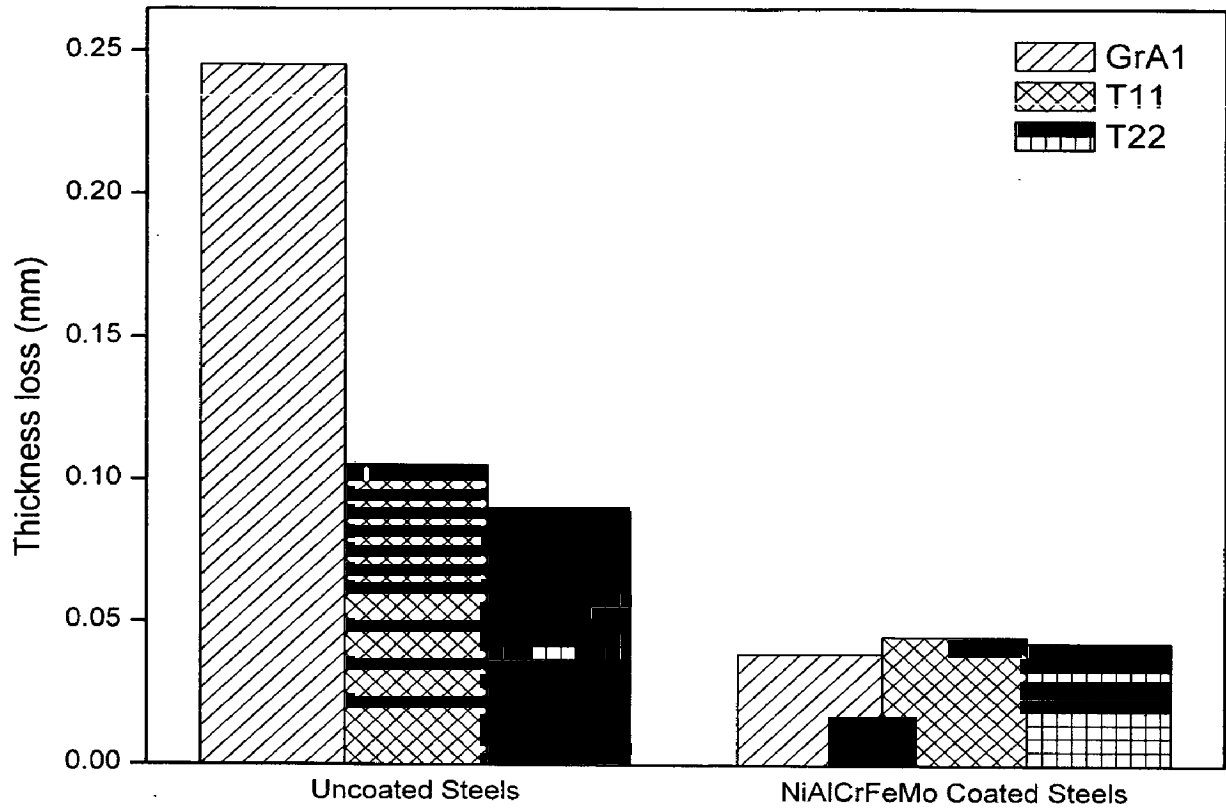
**Fig.7.20** Bar chart indicating the thickness lost in mm for the uncoated and NiAlCrFeMo coated steels after 1000 hours of exposure to super heater zone of coal fired boiler.

The histogram (Fig.7.20) indicates extent of erosion-corrosion measured in terms of thickness loss from the exposed coatings. Erosion-corrosion loss for NiAlCrFeMo coated GrA1, T11 and T22 steels are 0.039, 0.045 and 0.043 mm respectively and the corresponding degradation rate expressed in mils per year are 13.45, 15.52 and 14.82 mpy respectively.

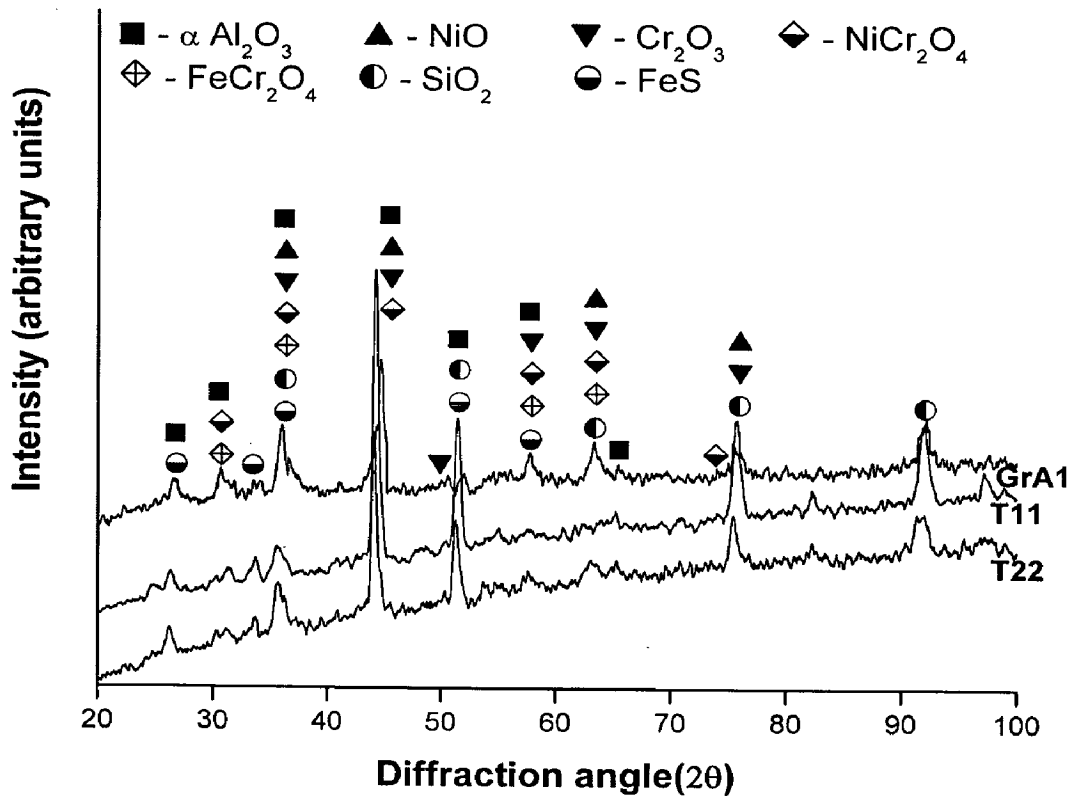
**Fig.7.21** X-ray diffraction patterns for NiAlCrFeMo coated GrA1, T11 and T22 steels exposed to super heater zone of coal fired boiler for 1000 hours.

X-ray diffraction pattern on the surface of NiAlCrFeMo coated steels exposed to environment in superheater zone of the coal fired boiler for 1000 hours are shown in Fig.7.21. The prominent phases revealed by XRD analysis are  $\alpha\text{-Al}_2\text{O}_3$ ,  $\text{Cr}_2\text{O}_3$ , NiO,  $\text{NiCr}_2\text{O}_4$  and  $\text{FeCr}_2\text{O}_4$ . The minor phases of  $\text{SiO}_2$ ,  $\text{Na}_2\text{O}_2$  and  $\text{FeS}_2$  indicated the fly ash deposit formation on the surface.

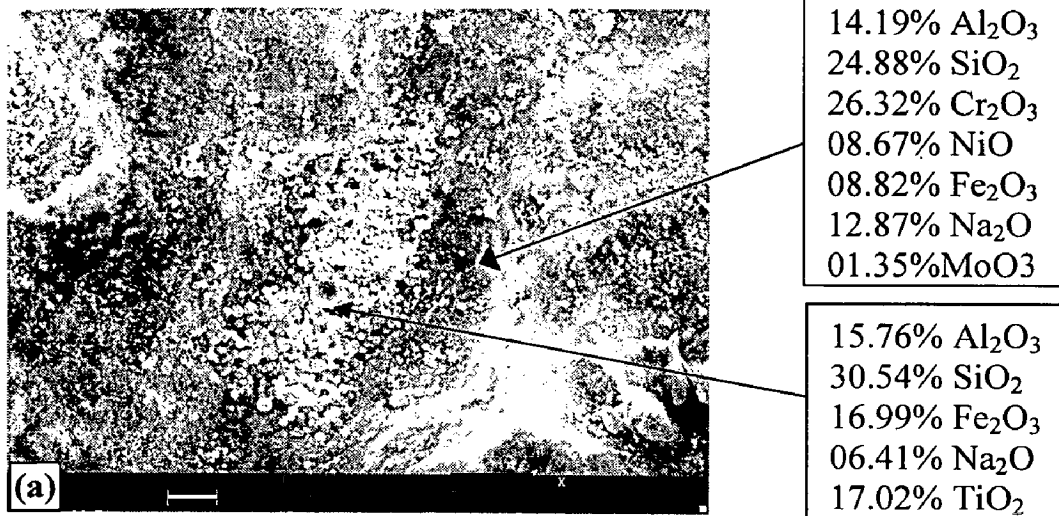
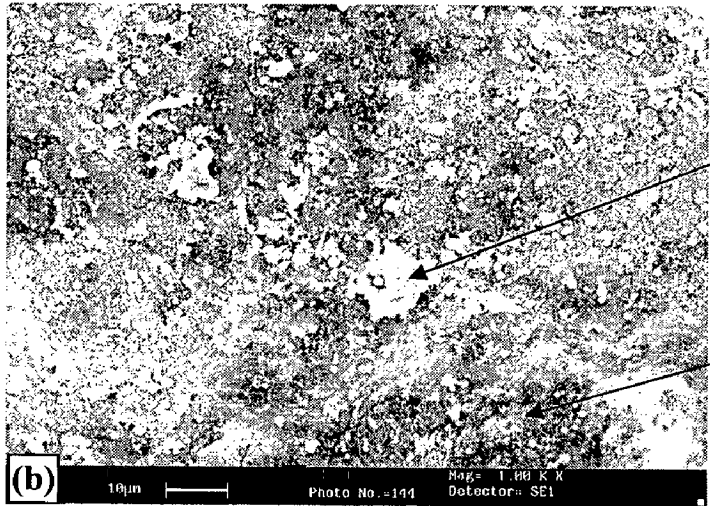
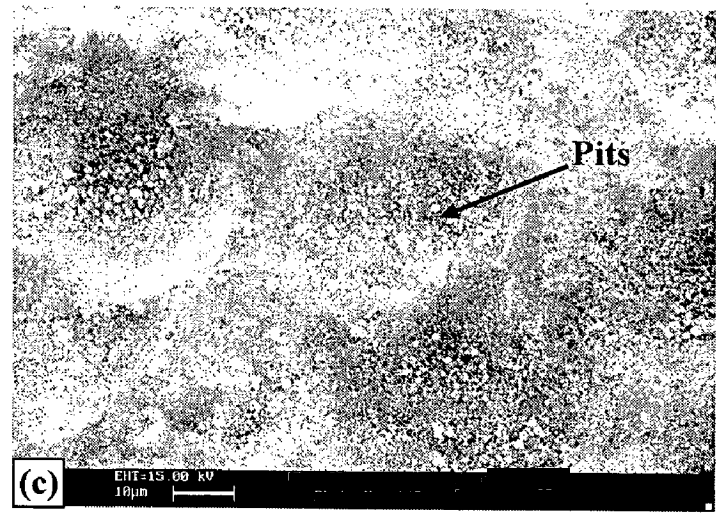
**Fig.7.22** Surface scale morphology and EDAX point analysis for NiAlCrFeMo coated steels exposed to super heater zone of coal fired boiler for 1000 hours:  
 (a) Coated T11 steel (b) Coated T22 steel (c) Coated GrA1 steel

Figure 7.22a shows the surface morphology of the NiAlCrFeMo coated T11 steel. The undulation observed on the surface might be due to erosion caused by the impacting

fly ash. The EDAX analysis on the dispersed white particles on the surface revealed the composition 15.76% Al<sub>2</sub>O<sub>3</sub>, 30.54% SiO<sub>2</sub>, 16.99% Fe<sub>2</sub>O<sub>3</sub>, 06.41% Na<sub>2</sub>O, 17.02% TiO<sub>2</sub>, 05.57% SO<sub>3</sub> and 04.22% CaO. These phases are the main constituents of flyash and show the ash embedment into the open pores of coatings and pits formed on the surface. The Na and S present in the boiler environment can form low melting point compounds such as alkali metal-trisulphates, which can cause fluxing of the protective oxide scale as discussed in section 7.3.1. The compositional analysis on the dark matrix shows mainly the protective oxides of Cr<sub>2</sub>O<sub>3</sub> (26.32%) and Al<sub>2</sub>O<sub>3</sub> (14.19%) along with relatively lesser concentrations of NiO (08.67%) and Fe<sub>2</sub>O<sub>3</sub> (08.82%) formed by the coating elements. Analogous analysis on the surface of coated T22 steel (Fig.7.22b) also shows the presence of white condensed phases of the boiler atmosphere, of which, composition is similar to flyash. The matrix shows the presence of oxides of Cr, Ni, Al and Fe. The surface morphology of coated GrA1 steel (Fig.7.22c) shows the pits formed due to impact of flyash on the surface.
