# **STUDIES ON THE ROLE OF HVOF COATINGS IN IMPROVING RESISTANCE TO HOT CORROSION AND EROSION**

## **A THESIS**

**DOCTOR OF PHILOSOPHY**

**METALLURGICAL AND MATERIALS ENGINEERING**

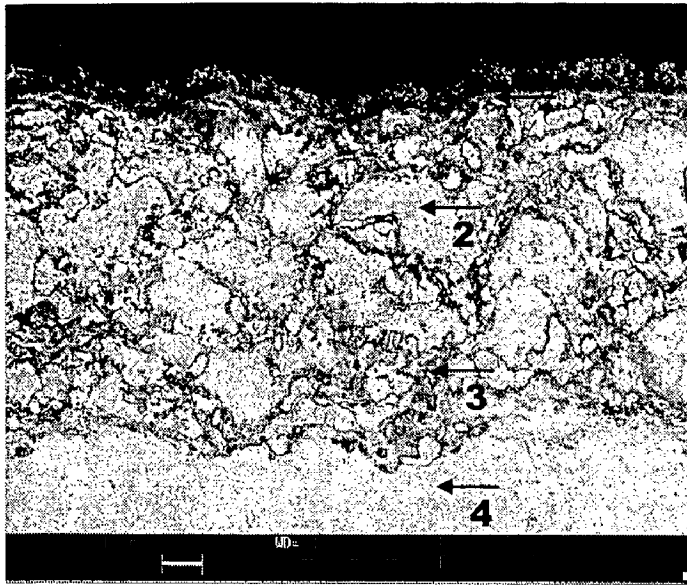
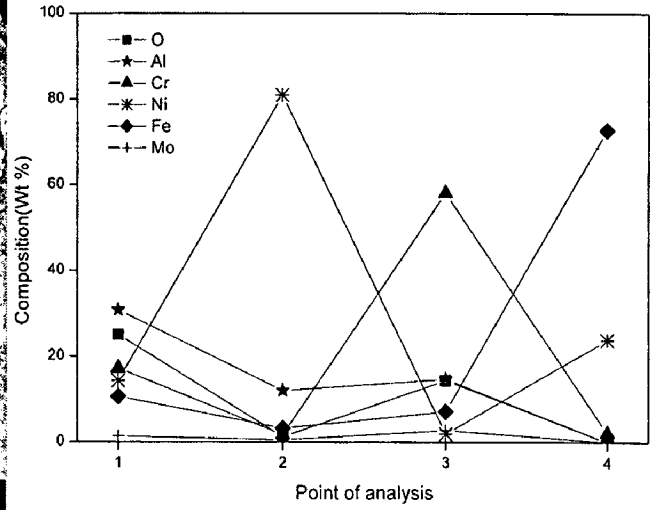
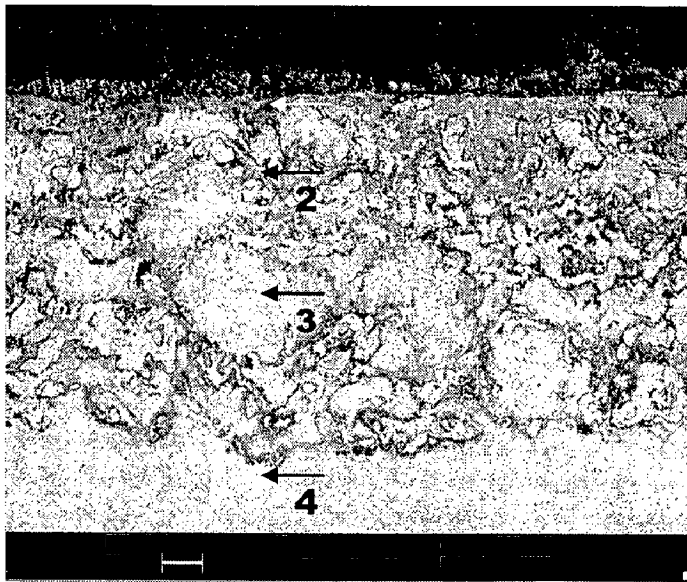
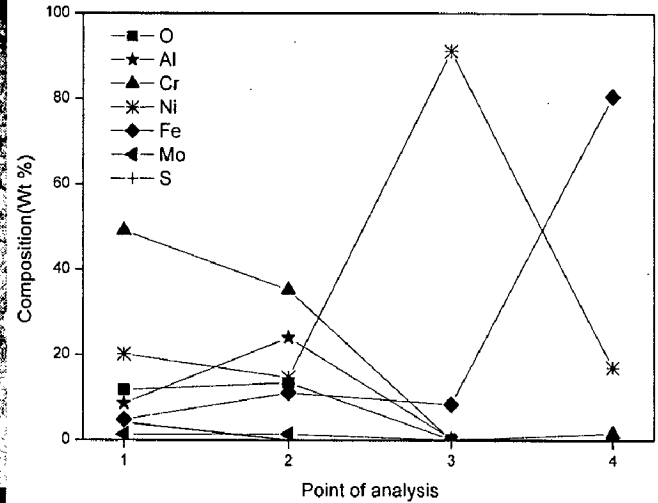
**Fig.7.23** Back scattered electron image and EDAX point analysis (wt %) across the cross-section of the NiAlCrFeMo coated steels exposed to super heater zone of coal fired boiler for 1000 hours:  
 (a) Coated GrA1 steel      (b) Coated T11 steel

The BSE images and EDAX analysis at some selected points of interest across the cross-section of the corroded NiAlCrFeMo coated GrA1 steel is shown in Fig.7.23a. Compositional analysis on the uppermost surface of the corroded coating (Point 1 and 2), mainly consist of oxides of Al and Cr along with relatively lower concentration of Ni, Fe and Mo oxides. The absence of oxygen at point 2 signifies nickel rich splats in unoxidised condition. From the EDAX analysis along the dark contrast region (point 3), it can be inferred that nickel rich splats are surrounded by the oxides of Cr, Al, Fe and Mo at their splat boundaries. Corresponding analysis along the cross-section of the NiAlCrFeMo coated T11 steel is shown in Fig.7.23b. The external surface of the corroded coating (Point 1) mainly composed of oxides of Cr, Al and Ni. Small quantity of sulphur can be found in the surface scale, indicating the possibility of chemical interaction of the corrosive boiler environment. Oxidation of the entire cross-section of the coating along the splat boundary can be observed and mainly aluminum and chromium got oxidized along the splat boundary (point2). Elongated nickel rich splats had remained unoxidised.

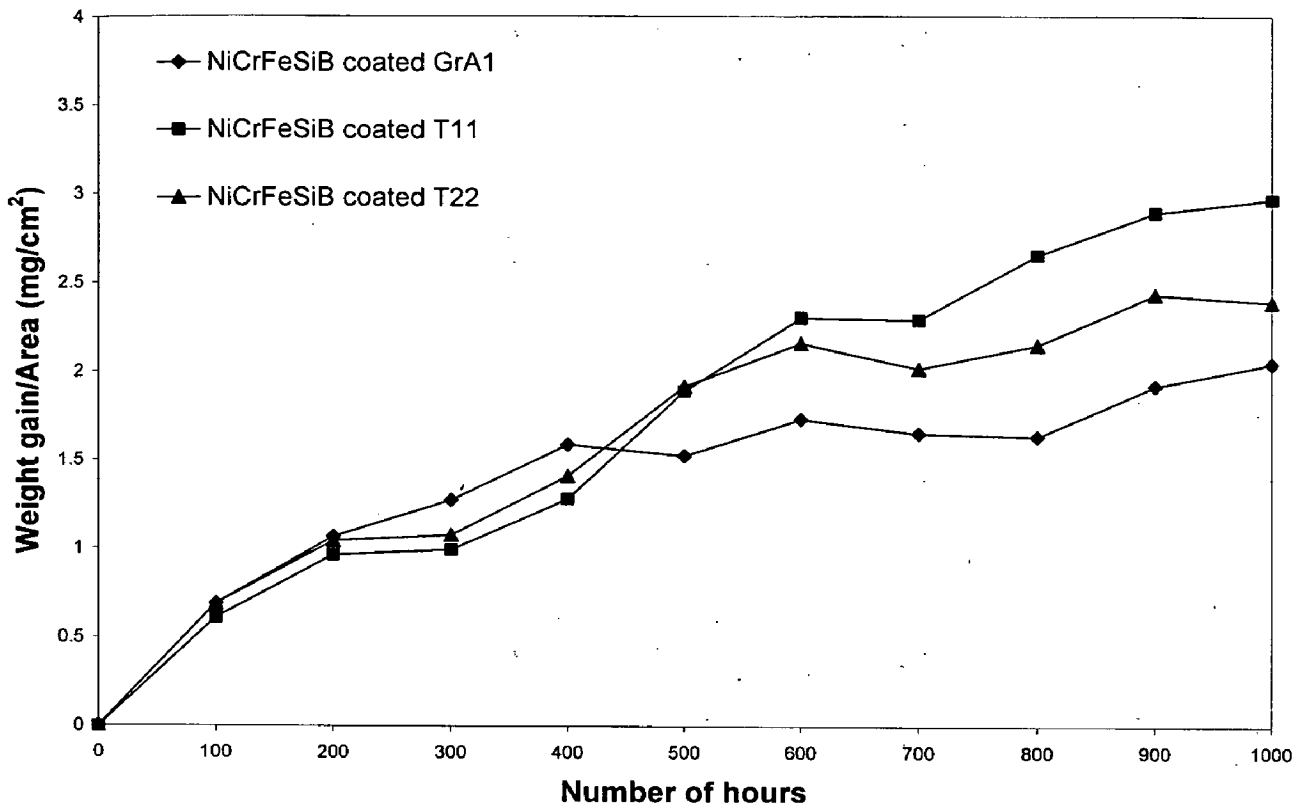
Fig.7.27 Weight change plot for NiCrFeSiB coated steels exposed to super heater zone of coal fired boiler for 1000 hours

The plot of weight change versus time is shown in Fig.7.27. The fluctuation in the weight change data as observed from the plot might be due to fly ash erosion and suspected spalling of formed oxide scale accompanied with falling off and regeneration of the ash deposits on the surface of the exposed sample. Coated T11 steel showed a maximum weight gain followed by coated T22 and GrA1 steels. Weight gain square curve (Fig.7.28) shows considerable deviations from the parabolic rate law. The parabolic rate constant  $K_p$  for NiCrFeSiB coated GrA1, T11 and T22 steels are found to be  $0.01 \times 10^{-10}$ ,  $0.027 \times 10^{-10}$  and  $0.018 \times 10^{-10} \text{ g}^2 \text{ cm}^{-4} \text{ s}^{-1}$  respectively.

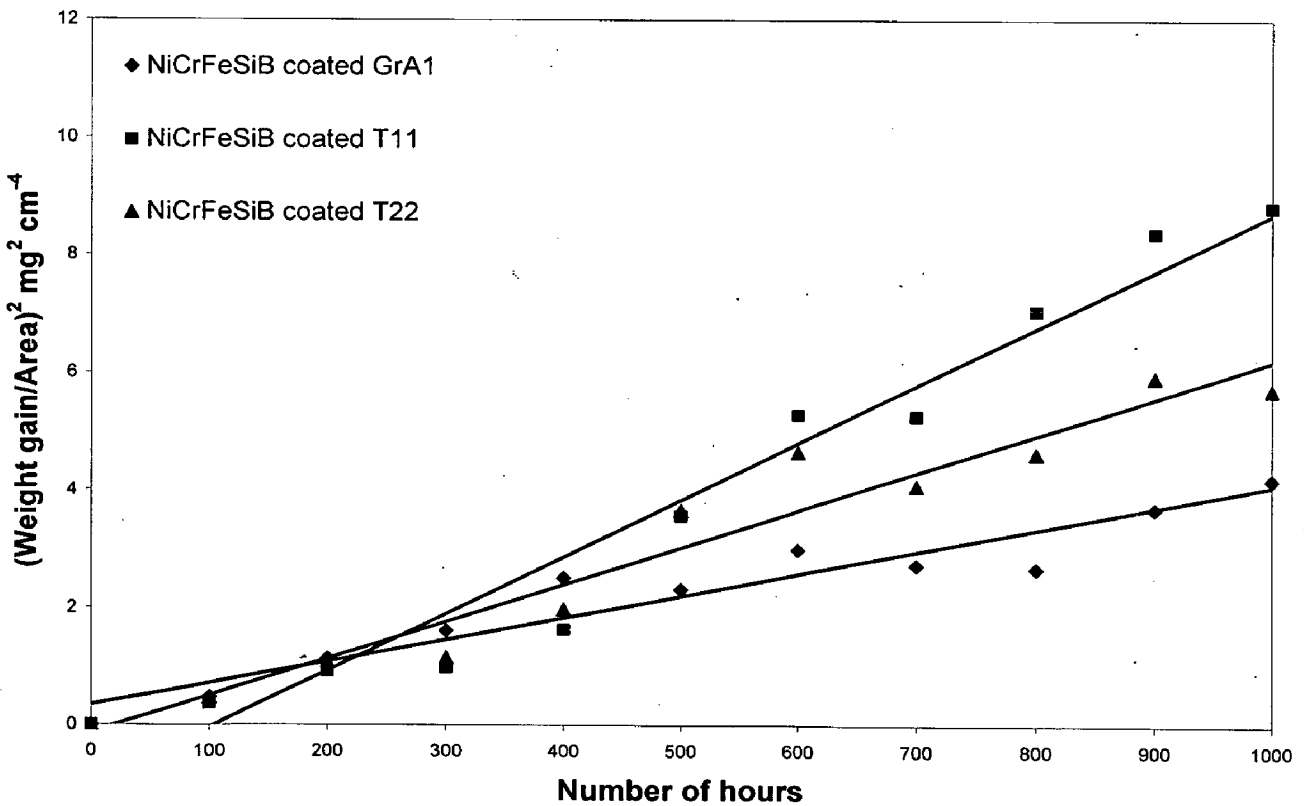
Fig.7.28 (Weight change/area)² plot for NiCrFeSiB coated steels exposed to super heater zone of coal fired boiler for 1000 hours

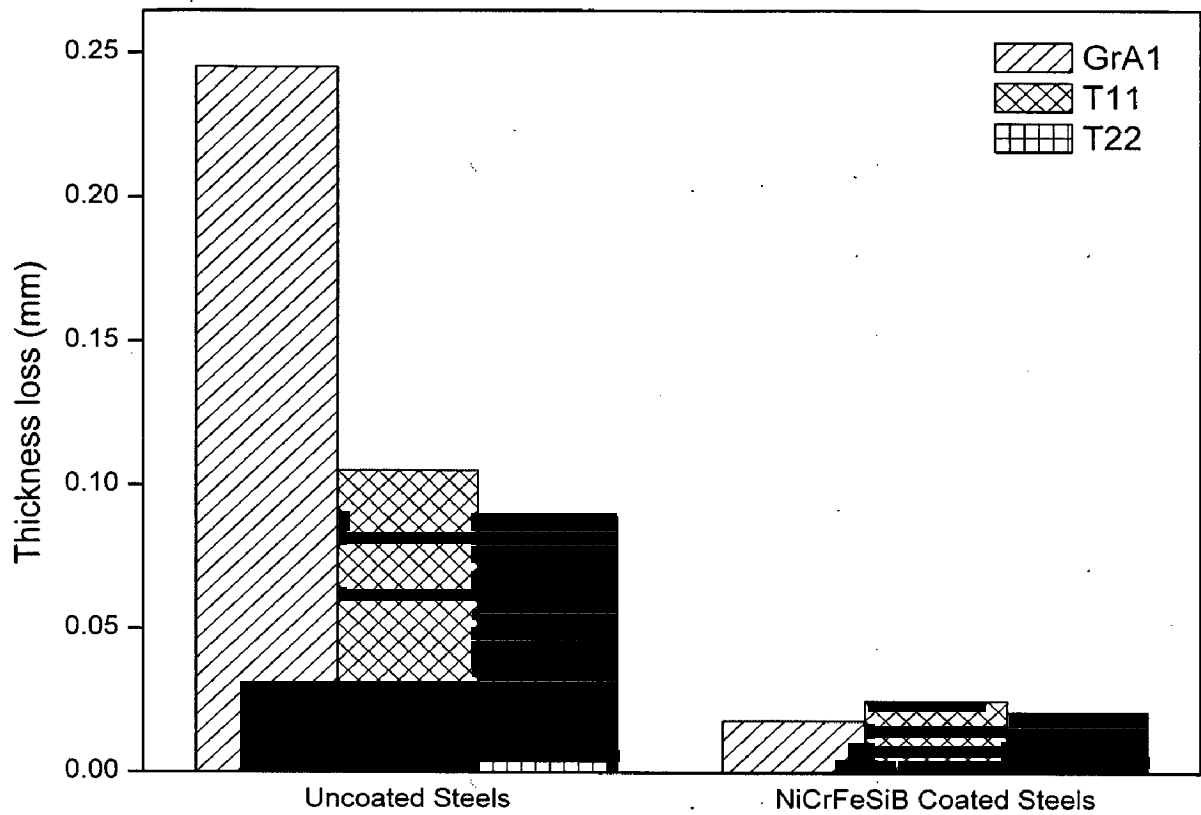
**Fig.7.29**

Bar chart indicating the thickness lost in mm for the uncoated and NiCrFeSiB coated steels after 1000 hours of exposure to super heater zone of coal fired boiler.

Erosion-corrosion in terms of thickness loss from the surface of exposed samples is represented in bar chart (Fig.7.29). Degradation rate at the end of 1000 hours of study for NiCrFeSiB coated GrA1, T11 and T22 steels are found to be 6.2, 8.62 and 7.24 mpy respectively which are very small.

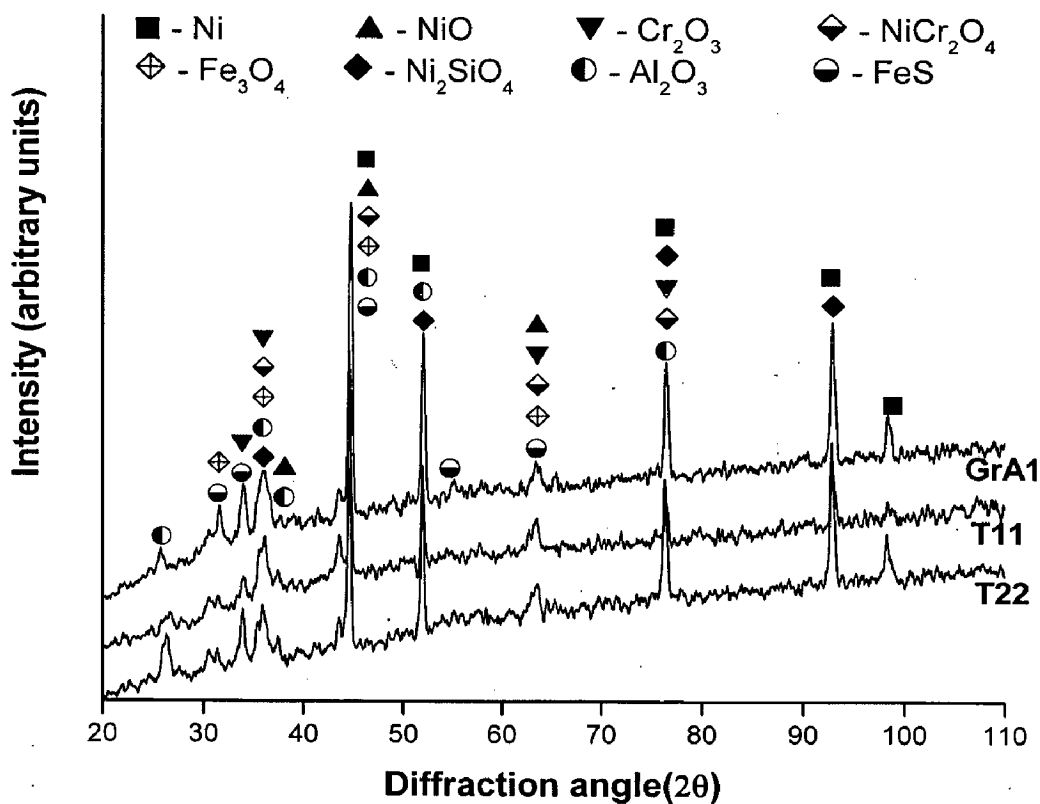
**Fig.7.30**

X-ray diffraction patterns for NiCrFeSiB coated GrA1, T11 and T22 steels Exposed to super heater zone of coal fired boiler for 1000 hours.

Fig.7.30 shows the X-ray diffraction pattern of the surface of exposed NiCrFeSiB coated steels. The main phases identified on the surface were Ni, NiO,  $\text{Cr}_2\text{O}_3$ , and  $\text{Fe}_3\text{O}_4$

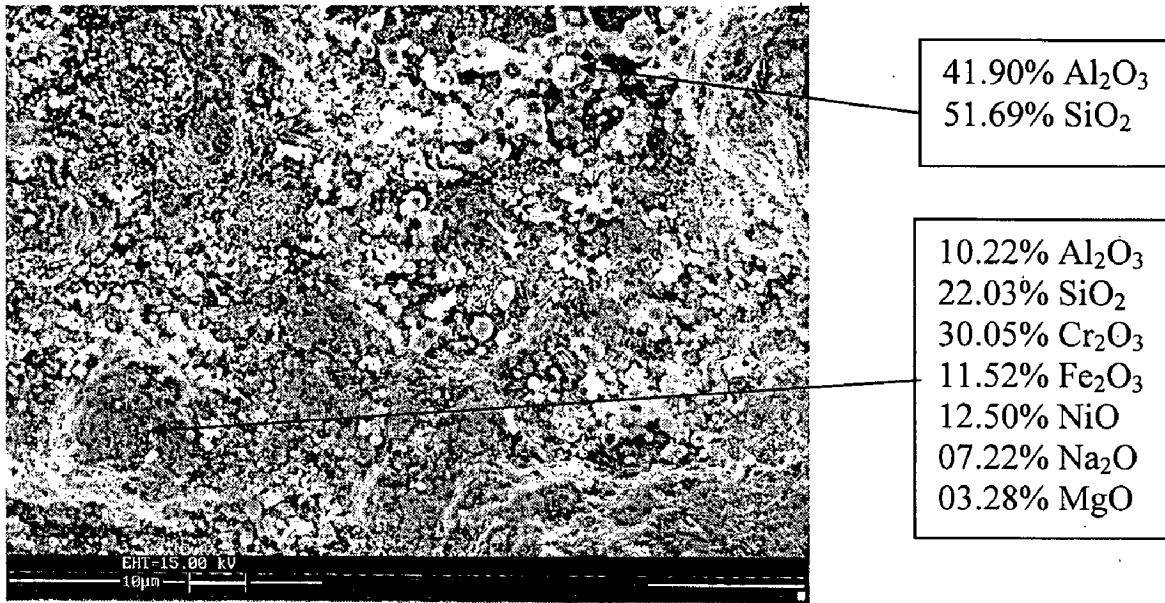
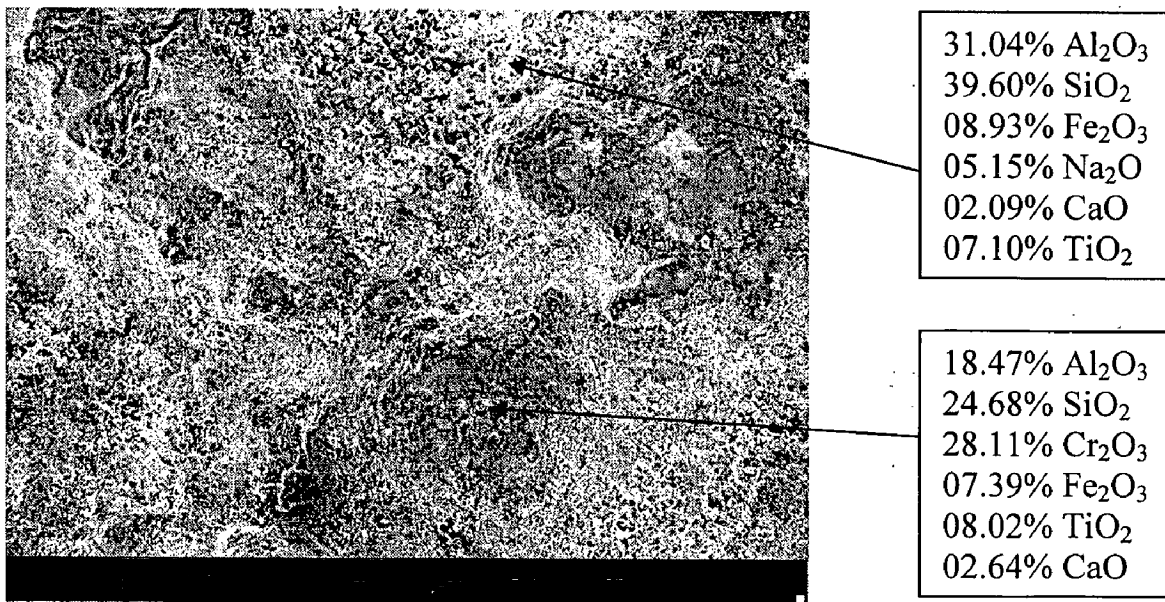
**Fig.7.31** Surface scale morphology and EDAX point analysis for NiCrFeSiB coated steels exposed to super heater zone of coal fired boiler for 1000 hours:  
(a) GrA1 steel      (b) T11 steel

SEM/EDAX analysis on the surface of the exposed NiCrFeSiB coated steels are shown in Figs.7.31 & 7.32. Pits observed on the surface (Fig. 7.31 a & b) might be due to impact of fly ash resulting in spalling of oxide scale. This is further confirmed from the EDAX analysis on the white colored deposit distributed on the oxide scale, mainly composed of  $\text{Al}_2\text{O}_3$ ,  $\text{SiO}_2$ ,  $\text{Fe}_2\text{O}_3$ ,  $\text{Na}_2\text{O}$ ,  $\text{CaO}$  and  $\text{TiO}_2$ , which is almost similar to ash composition. The EDAX analysis on the pit region shows relatively higher amount of  $\text{Cr}_2\text{O}_3$ ,  $\text{SiO}_2$  and  $\text{NiO}$ , oxides formed on oxidized coatings. Corresponding analysis on NiCrFeSiB coated T22 steels (Fig.7.32) also shows that the white patches have a composition similar to fly ash. The dark matrix mainly shows the peaks for O, Si, Cr and Ni, which confirms the oxides and their spinels, have formed during oxidation of coating elements.

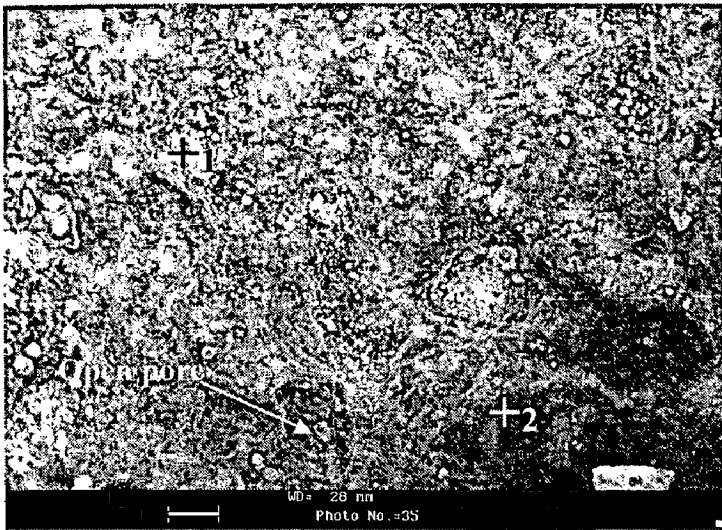
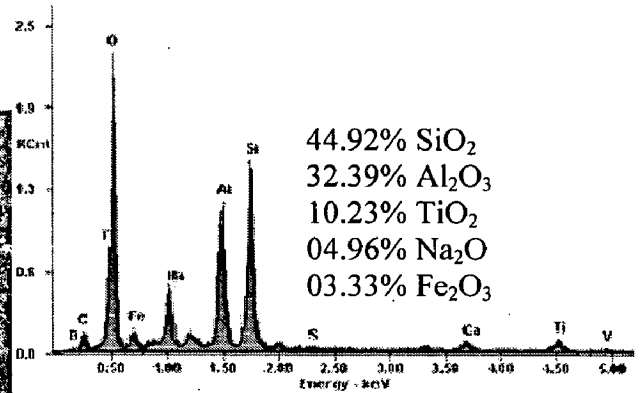
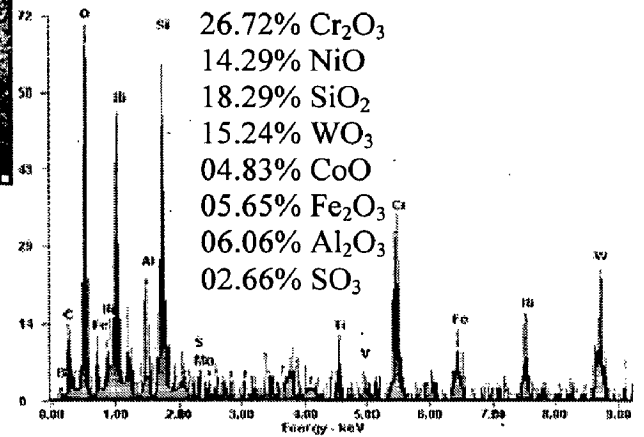
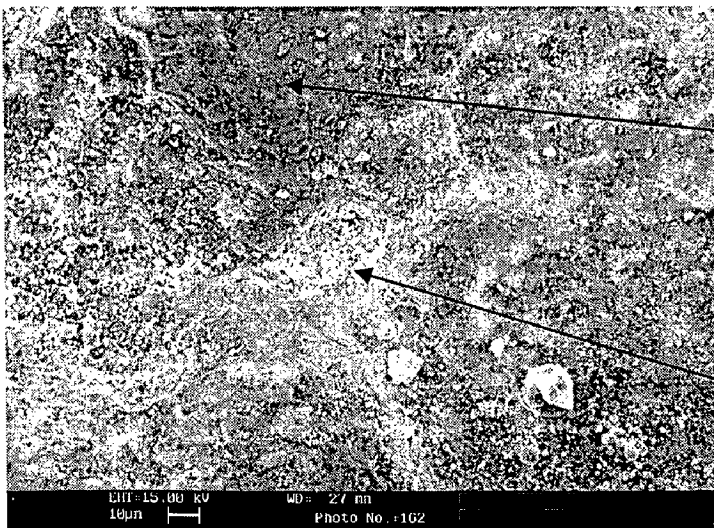
**Fig.7.41** Surface scale morphology and EDAX analysis for WC-Co/NiCrFeSiB coated steels exposed to super heater zone of coal fired boiler for 1000 hours:  
 (a) GrA1 steel      (b) T11 steel

EDS analysis at point 1

EDS analysis at point 2

18.57% Cr<sub>2</sub>O<sub>3</sub>  
 05.47% NiO  
 28.48% SiO<sub>2</sub>  
 22.70% WO<sub>3</sub>  
 02.18% CoO  
 09.33% Fe<sub>2</sub>O<sub>3</sub>  
 04.23% Na<sub>2</sub>O

66.46% SiO<sub>2</sub>  
 10.86% TiO<sub>2</sub>  
 12.44% Fe<sub>2</sub>O<sub>3</sub>  
 03.55% Na<sub>2</sub>O

SEM on the surface of WC-Co/NiCrFeSiB coated GrA1 steel (Fig.7.41a) shows irregular morphology. The EDAX analysis on the contrast white phases dispersed on the surface revealed the composition of 44.92% SiO<sub>2</sub>, 32.39% Al<sub>2</sub>O<sub>3</sub>, 10.23% TiO<sub>2</sub>, 04.96% Na<sub>2</sub>O and 03.33% Fe<sub>2</sub>O<sub>3</sub>. These phases are the main constituents of fly ash and indicated the ash embedment into the open pores of the coatings as well as fouling of exposed coatings due to condensed phases of the ash. The compositional analysis on the dark colored matrix shows the prominent oxides of Cr (26.72%), Si (18.29%), Ni (14.29%) and W (15.24%) formed from the active elements of the coating, and are protective by nature. Minor amount of sulphur has also been detected by the EDAX on the surface. Scanning electron micrograph on the surface of the coated T11 steel (Fig.7.41b) also shows the irregular morphology having hills and valleys, which indicated the likely erosion by impacting fly ash.

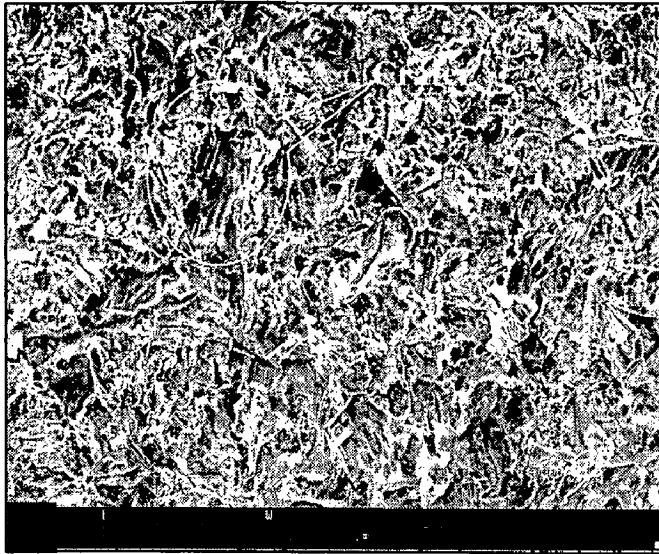
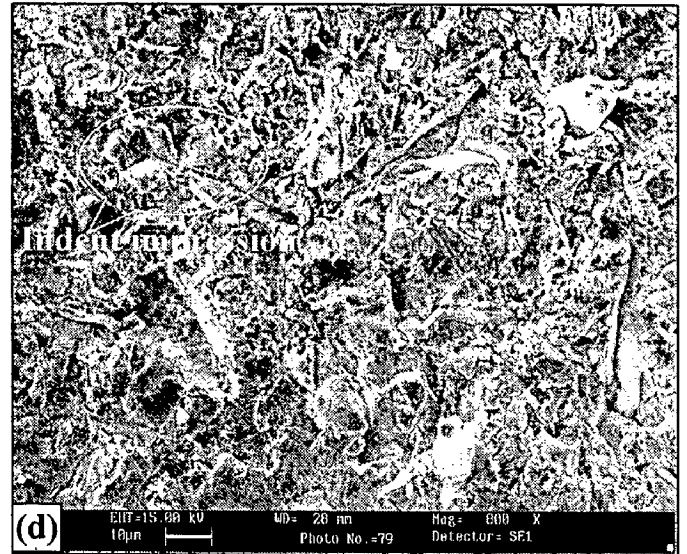
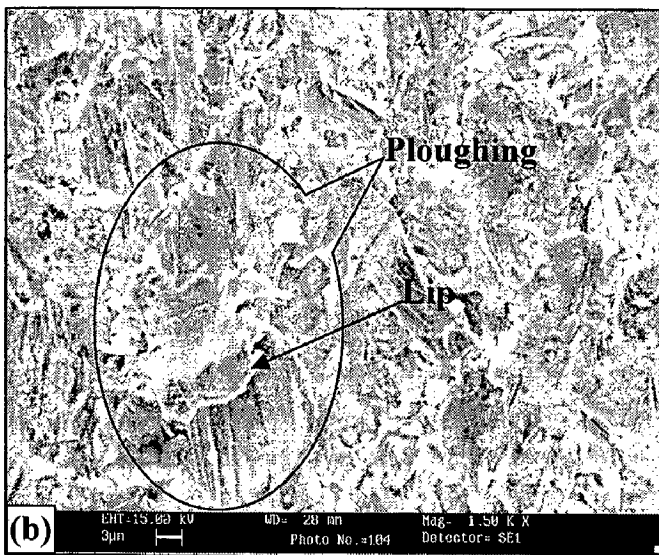
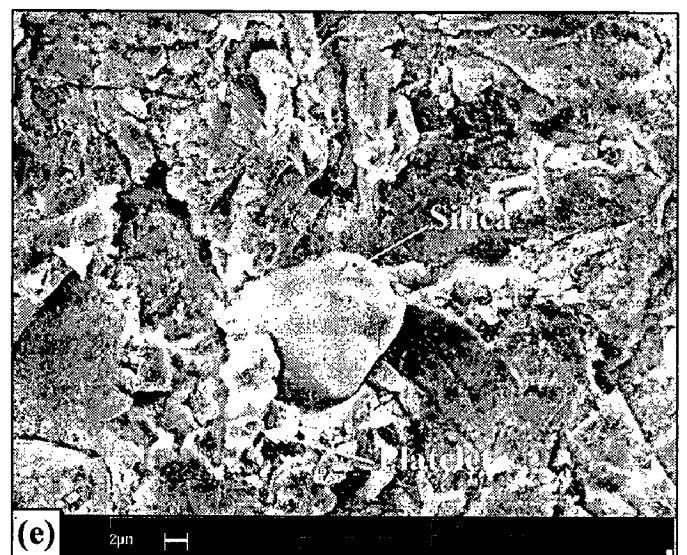
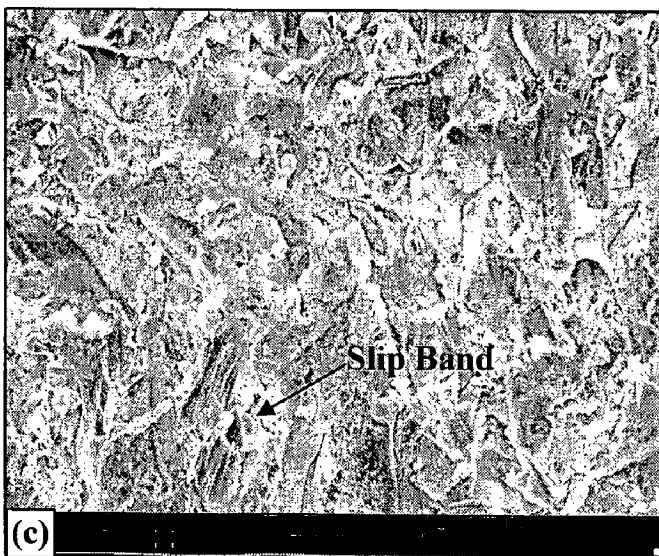
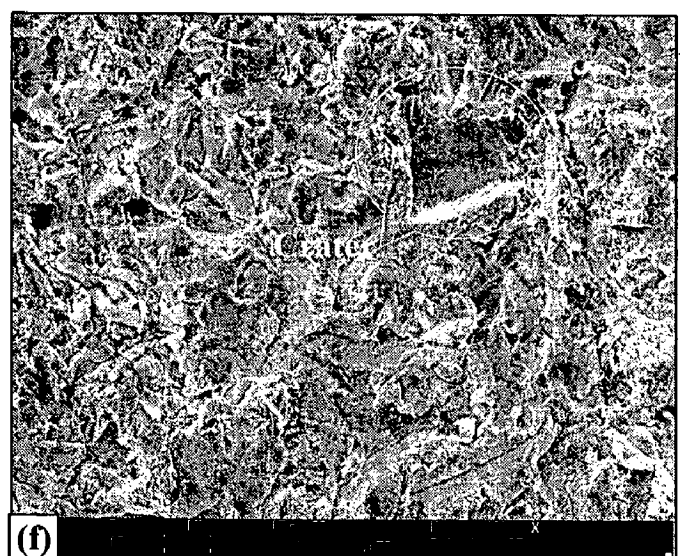
**Fig.8.6**

30° impact angle

90° impact angle

SEM micrographs showing the eroded surface morphology of GrA1 steel at different impact angle. Direction of particle impingement is from top to bottom of micrographs.

It is observed from the scanning electron micrographs (Figs. 8.6a–c) of the eroded surface at 30°C impact angle that the silica particles deform the surface by ploughing, displacing material to the side and in front of the particle in the form of lip due to severe plastic flow. With the subsequent impacts, these highly strained lips are vulnerable to be removed as micro-platelets. The crater formed by ploughing and lips at the rim of the crater are clearly visible in the micrograph. Since the erodent particles are being in contact for long time on the surface during sliding, the wear rate is much high. A careful observation of the eroded surface at the higher magnification also revealed the slip bands due to concurrence of the crater formed during repeated impacts. Similar erosion behavior of the ductile materials has also been reported by Hutchings (1992), Brown et al. (1981), Kumar et al. (2008) and Sidhu et al. (2007). Bellman (1981) has reported that these bands generally occur along the walls of the already formed craters where a fresh crater has been formed immediately adjacent to them. The particle impact cause plastic deformation of the new crater being formed on the unsupported surface of the already existing crater, resulting in slip band formation. The distance of these bands down the inclined surface of the existing crater is indicative of the depth to which the plastic deformation occurs as the result of repeated particle impact.

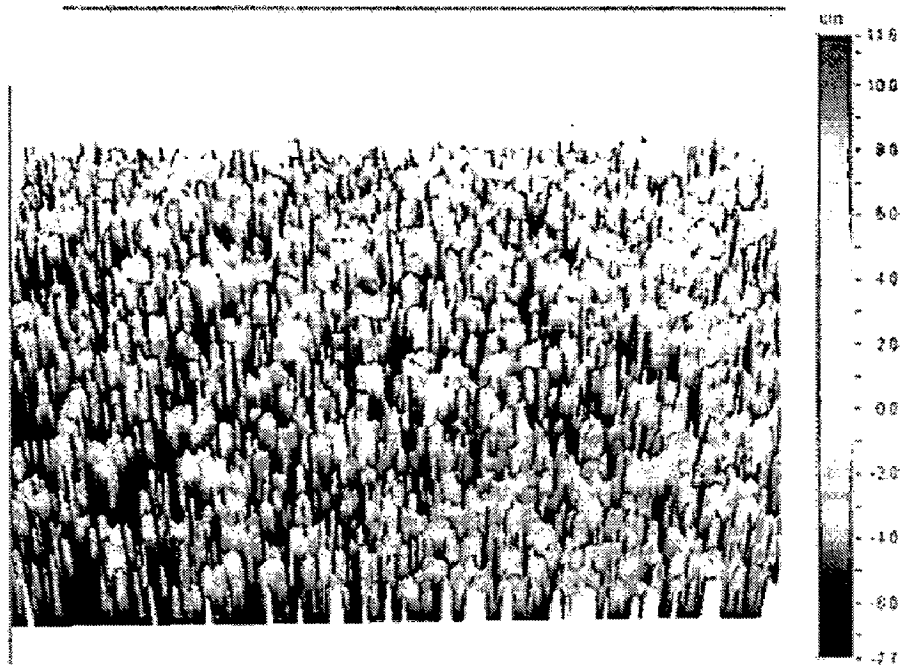
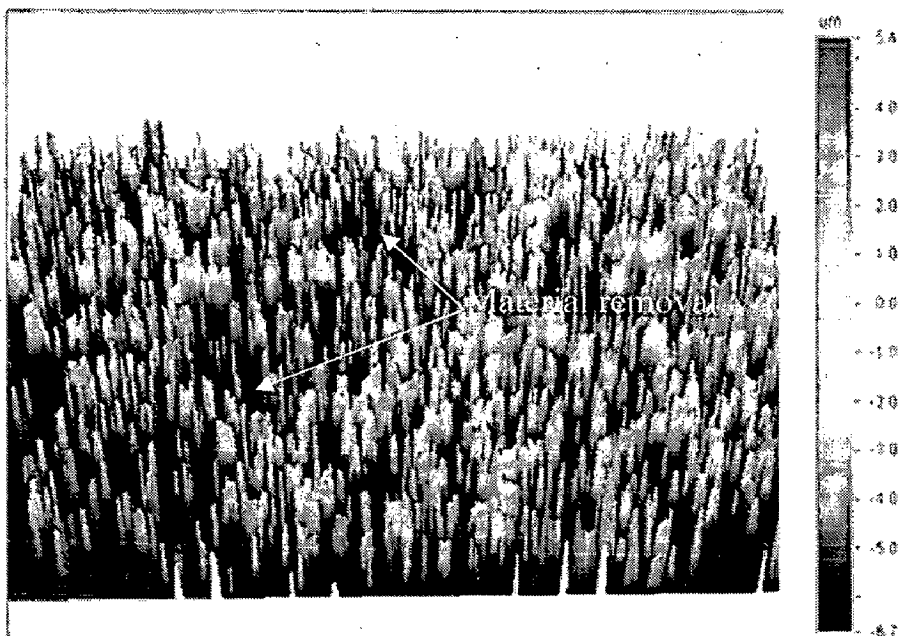
**Fig.8.8**

3D optical profile from the centre of an eroded GrA1 steel which shows depth profiles (Scanned area-591 X 449  $\mu\text{m}$ )

(a) Eroded at  $30^\circ$  impact angle; (b) Eroded at  $90^\circ$  impact angle

The 3-Dimensional topography illustrating the surface roughness profile of the eroded steels is illustrated in Fig. 8.8. The surface roughness values of the eroded surface is found to be in the range of  $1.29 \mu\text{m}$  and  $1.13 \mu\text{m}$  for  $30^\circ$  and  $90^\circ$  impact angles, respectively. The channel like region shown in this figure reveals the material removal on the surface.

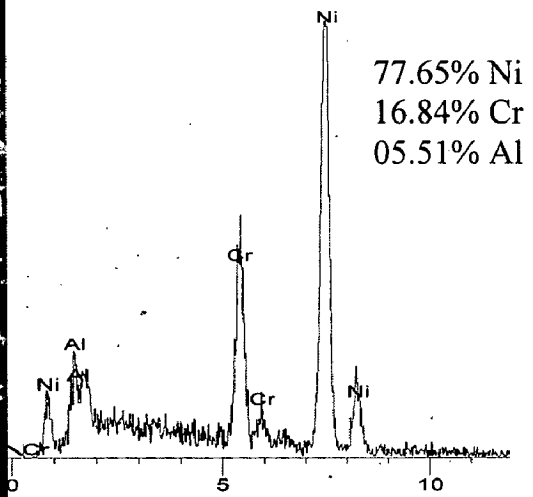
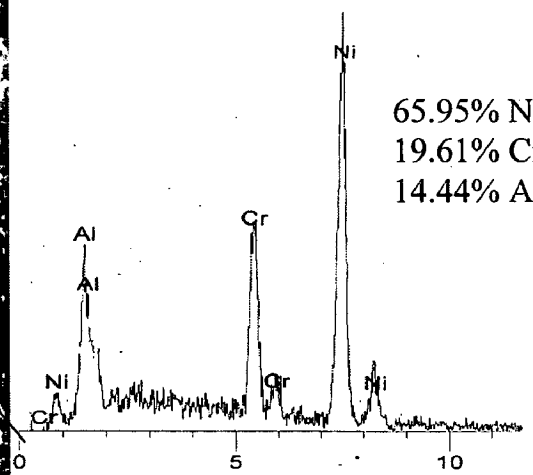
**Fig.8.11** SEM micrographs showing the surface morphology and EDAX compositional analysis at some points on NiCrAl coated steels eroded at 30° impact angle.

Figure 8.11 illustrates the surface morphology of the eroded surface at 30° impact angle. The eroded surface shows the evidence of severe plastic deformation. The smear creators are dominant on the surface due to a large horizontal component of velocity that overwhelms the particle rotational tendency at the lower angle (Bellman et al., 1981). The EDAX analysis on the spherical particle seen on the micrograph (Fig. 8.11b) revealed it as Ni-rich unmelted particles. During spraying, the particles of different sizes might have different molten states, i.e., the particles of moderate sizes may be fully melted or partially melted at the point of impact on the substrate, and the particles of either small or large sizes are usually remain unmelted as they hit the substrate. A groove is formed with a relatively softer material around these particles, resulting in undercutting, which is subsequently loosened up and the unmelted particles may get pulled out of the surface. The pull out regions surrounded by lips or ridges suggests the strain localization which is a common feature in the ductile erosion behavior (Murthy et al., 2001). Further, the cross sectional view of the eroded area in Fig. 8.13a shows that the groove formed by the ductile mode of erosion along the splat boundary and leads to unmelted particle decohesion. A number of wider grooves can be seen on the eroded surface micrograph (Fig. 8.11a) and this event may lead to loss of mass. Furthermore, it is apparent from the micrographs that the material removal occurs from the ridges or lips which are formed on the bank of the crater or on the particle exit end of the crater, undergoing repeated deformation that is, subsequently, detached in the form of platelets.

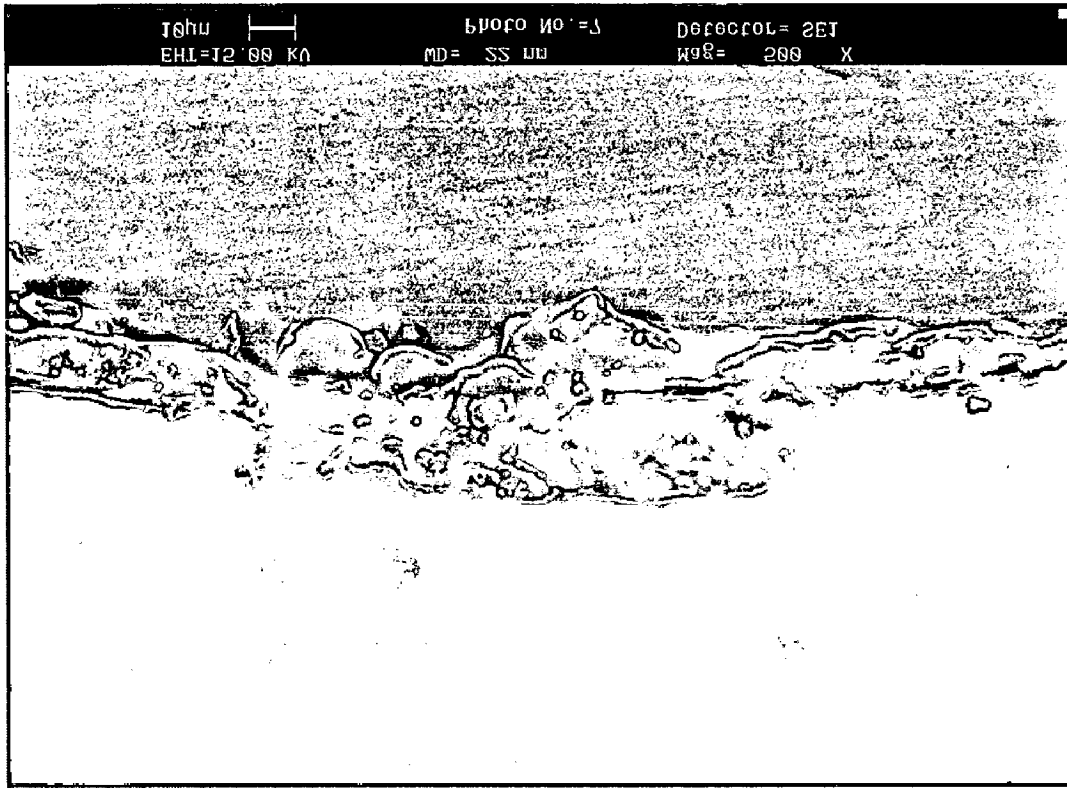
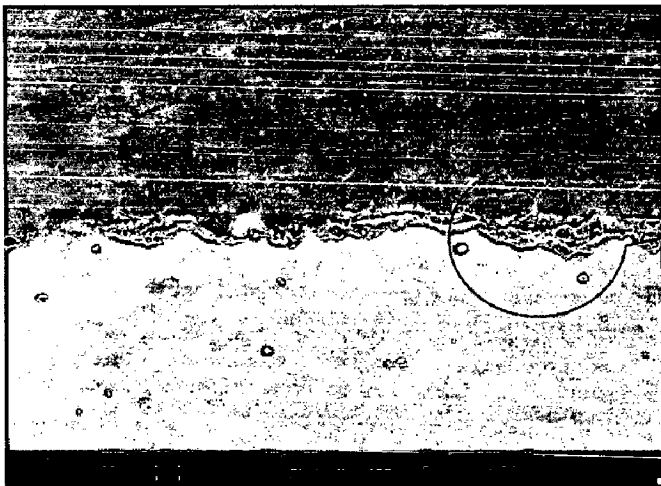
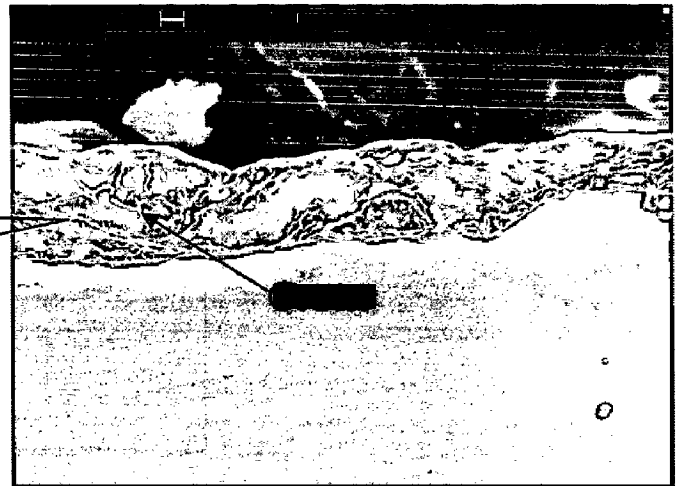
**Fig.8.13** SEM micrographs across the cross-section of the eroded region of NiCrAl coatings.

(a) Eroded at 30° impact angle;

(b) Eroded at 90° impact angle (c) Enlarged region marked in (b)

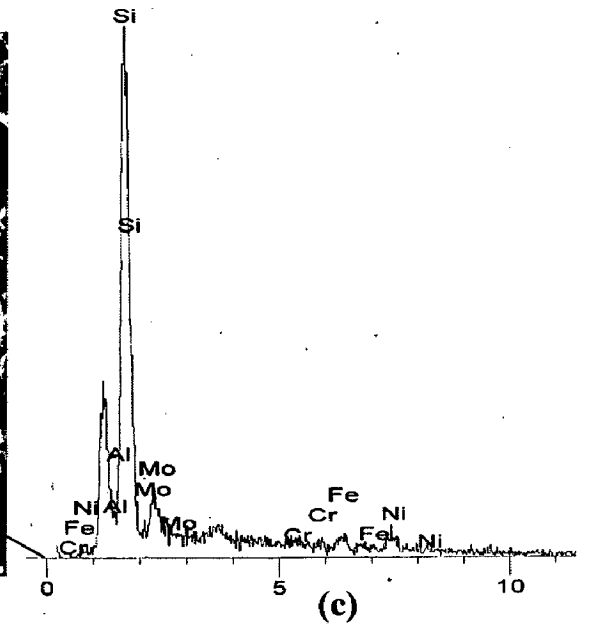
**Fig.8.18**

SEM micrographs showing the surface morphology and EDAX point analysis showing embedded sand particle on NiAlCrFeMo coated steels eroded at 90° impact angle.

Due to different impact angles of the silica particles, the eroded scars have different lengths and shapes. The surface morphologies of the eroded coatings at 30° impact angle (Fig. 8.17) show the smear craters forming lips at the exit end of the erodent, which is indicative of extensive plastic flow. Figure 8.17b clearly shows the lips formed under severe deformation which is detached from the bulk material in the form of microchips. Similar to the one observed in the previous section 8.1.2, the unmelted Ni-rich particles have pulled out by the erodent at shallow impact angle resulting in a deeper groove. It can be confirmed by the EDAX compositional analysis that the spherical particle is the unmelted splat, similar to one discussed during the characterization of the as-sprayed coatings in Chapter 4. Figure 8.18 shows the eroded surface morphology of the coatings under normal impact condition. The indentations, craters, and lips observed on the surface demonstrate the ductile type erosion behavior of the coatings. Although, each impact displaces the material from the indentations, it will often not become detached as micro platelets until it has experienced repeated plastic deformation. The lips are pancake forged and flattened by subsequent particle impact before they are finally knocked off. The embedded silica particles into open pores are clearly seen in the

micrograph (Fig 8.18b) and are further confirmed by EDAX analysis which shows a strong peak for silicon. The cross sectional view (Fig.8.19) along the eroded region shows the crater associated with subsurface cracks which propagates along splat boundary probably due to presence of porosity and oxide interface. Relatively higher porosity of NiAlCrFeMo coatings leads to higher erosion losses. 3D optical profile (Fig 8.20) at the centre of an eroded NiAlCrFeMo coating shows deep crater of 39.8  $\mu\text{m}$  for the sample eroded at 90°. Higher roughness value of 6.88 and 13.24  $\mu\text{m}$  as been observed on the surface eroded at 30° and 90° impact angle respectively.

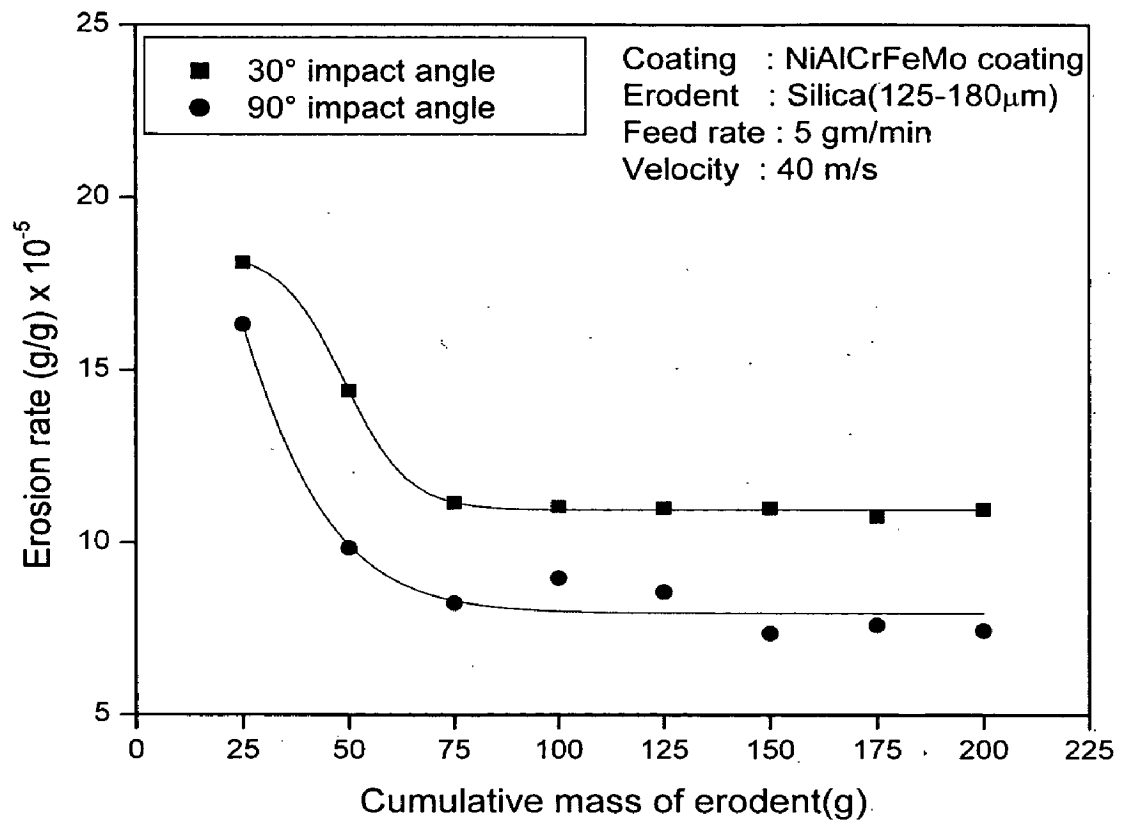
**Fig.8.15** Variation of the Incremental erosion rate with the cumulative weight of the erodent for NiAlCrFeMo coatings at 30° and 90° impact angle.

The erosion rate curves along with the bar chart indicating the volumetric steady state wear loss is shown in Figs. 8.15 and 8.16. The HVOF-sprayed NiAlCrFeMo coatings showed a higher erosion rate at 30° impact angle than that at 90°, which is the typical characteristic erosion behavior of the ductile materials. Further, the leveling of surface protrusions on the as-sprayed coating results in higher erosion rate at the earlier stage of the experiment and gradually decreases to lower steady state rate. Levy et al (1986B) also observed the ductile behavior of NiCrAlMoFe coatings eroded with SiC particles impacted at 30 m/s.

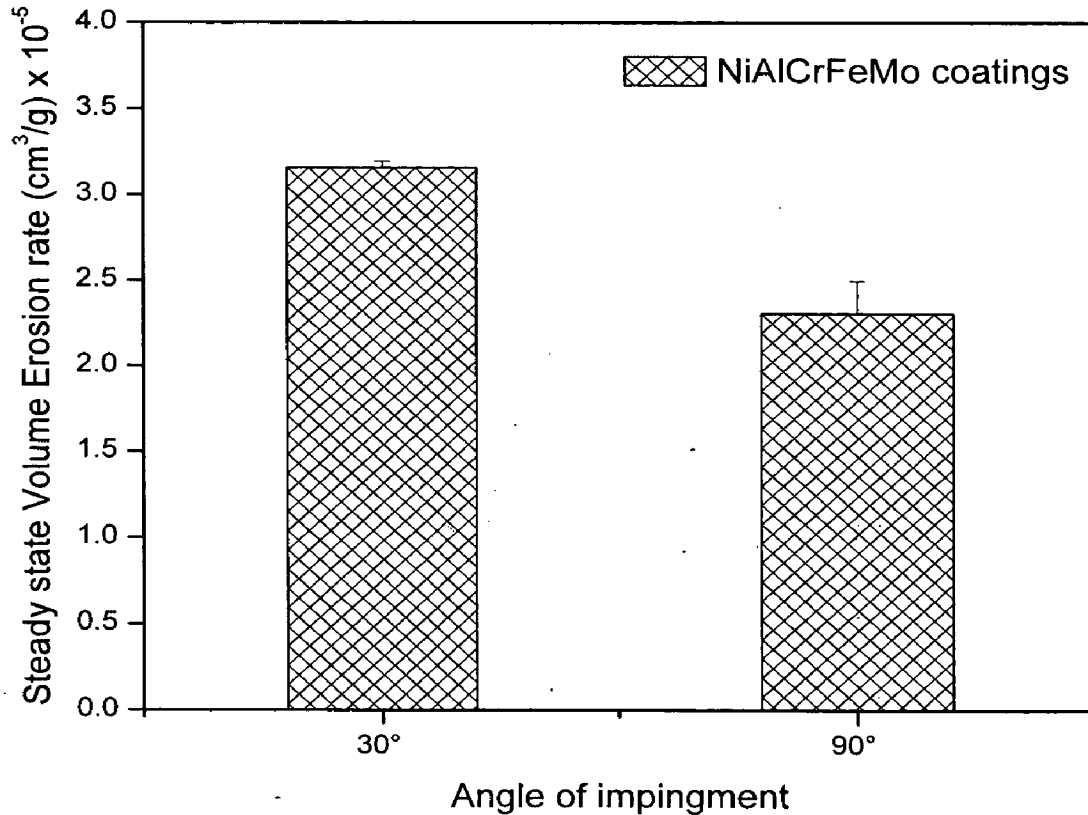
**Fig.8.16** Histogram illustrating the steady state volume erosion rate of NiAlCrFeMo coatings at different impact angles.

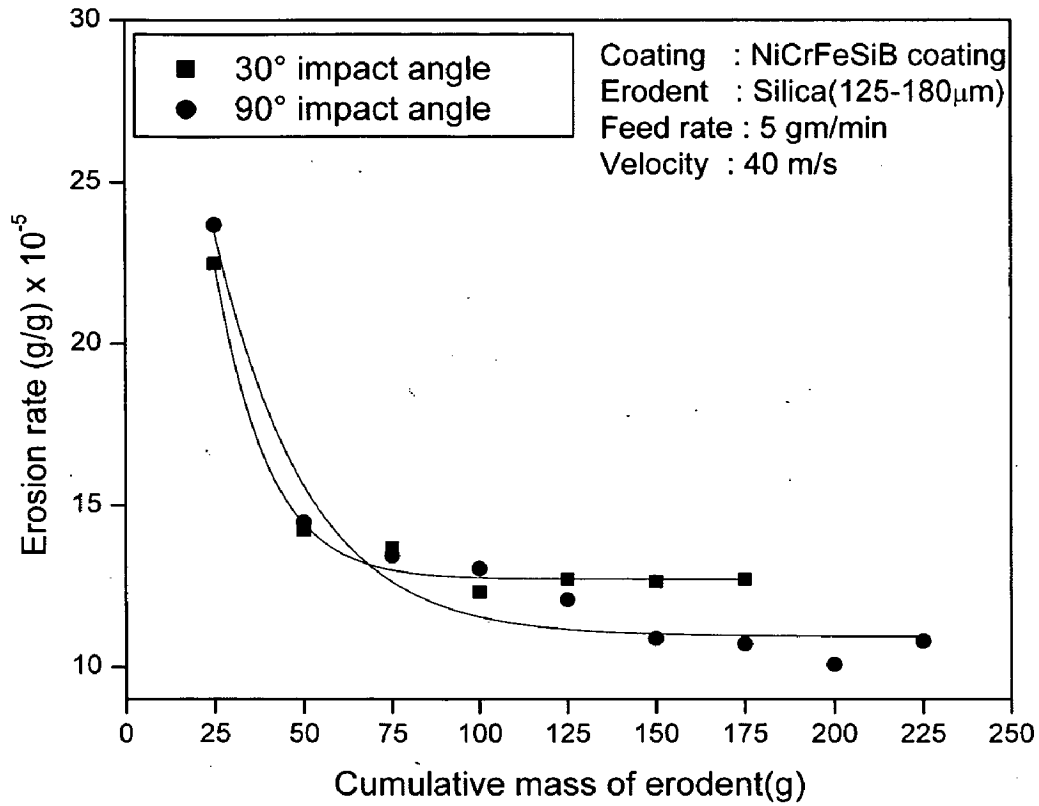
**Fig.8.21** Variation of the Incremental erosion rate with the cumulative weight of the erodent for NiCrFeSiB coatings at 30° and 90° impact angle.

Fig 8.21 and 8.22 show the ductile behavior of NiCrFeSiB coating in which steady state erosion rate at 30° is higher than that at 90°. The higher erosion rate at the initial stage is due to surface texture of the as-sprayed coating containing protrusions on them which were vulnerable to being knocked off by the eroding particles.

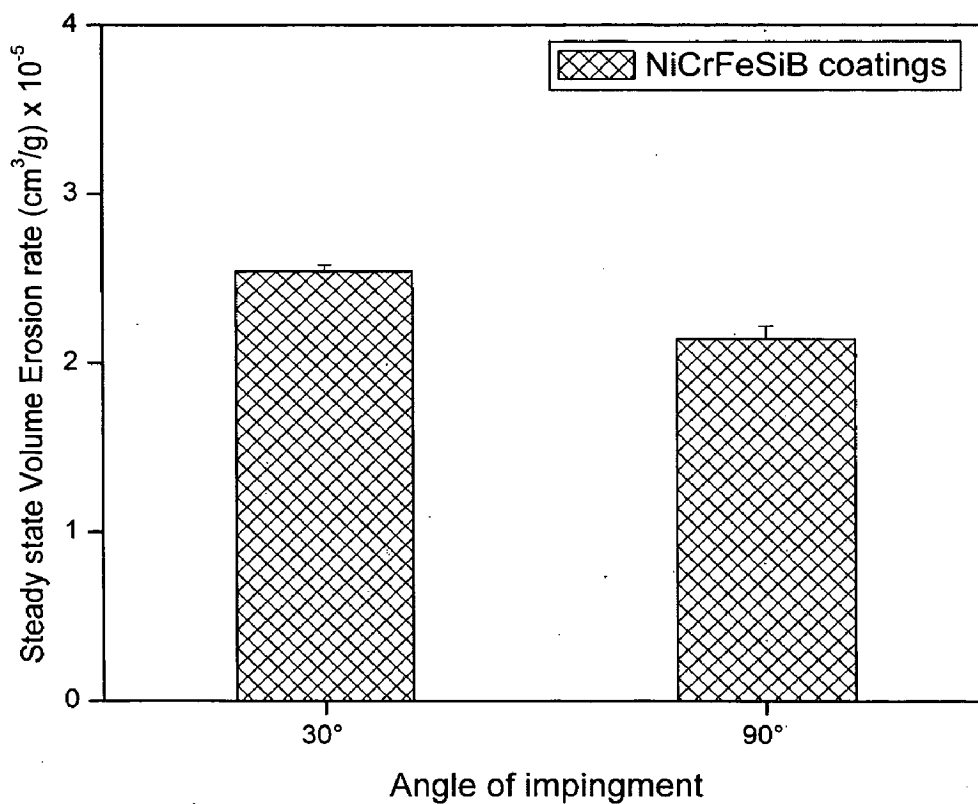
**Fig.8.22** Histogram illustrating the steady state volume erosion rate of NiCrFeSiB coatings at different impact angles.

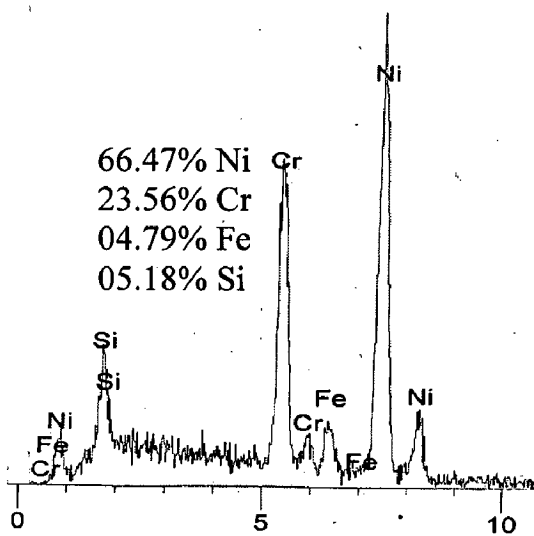
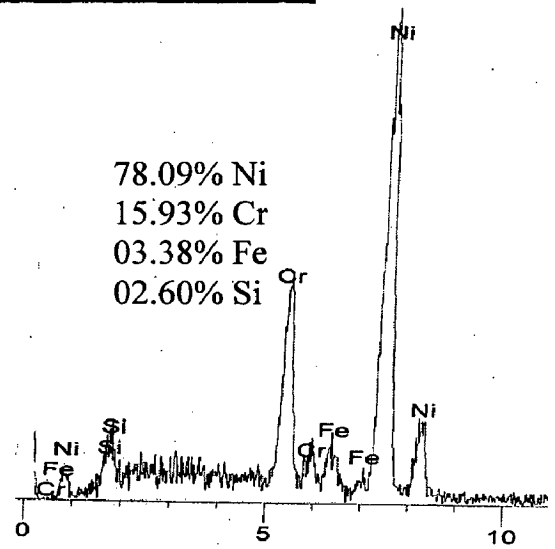
**Fig.8.23** SEM micrographs showing the surface morphology and EDAX compositional analysis at some points on NiCrFeSiB coated steels eroded at 30° impact angle.

The evidence of plastic deformation accompanied with ploughing and cutting has been observed on the eroded surface under both the test conditions, but became more pronounced at 30° impact angle. Fig 8.23 shows the scanning electron micrograph of the eroded surface at 30° oblique angle. It is apparent that plastic rupture of metal by the silica particle resulted in highly deformed platelets which are displaced by subsequent impacts. The cutting and platelet formation are clearly seen at higher magnification (Fig 8.23b). The EDAX analysis on the platelet formed shows relatively higher content of chromium and the composition on the groove are similar to that of coating. Fig 8.24 shows the micrograph of the eroded coating at 90° impact angle. Indentation-induced shallow craters along with deformed lips are observed at the impact site on the surface of coating. Fig.8.24 b shows the evidence of erosion damage localized at open pore region. It is clear from the micrograph that each impact displaces material from the impact site in to raised lips around the crater.
