# **STUDIES ON THE ROLE OF HVOF COATINGS IN IMPROVING RESISTANCE TO HOT CORROSION AND EROSION**

## **A THESIS**

**DOCTOR OF PHILOSOPHY**

**METALLURGICAL AND MATERIALS ENGINEERING**

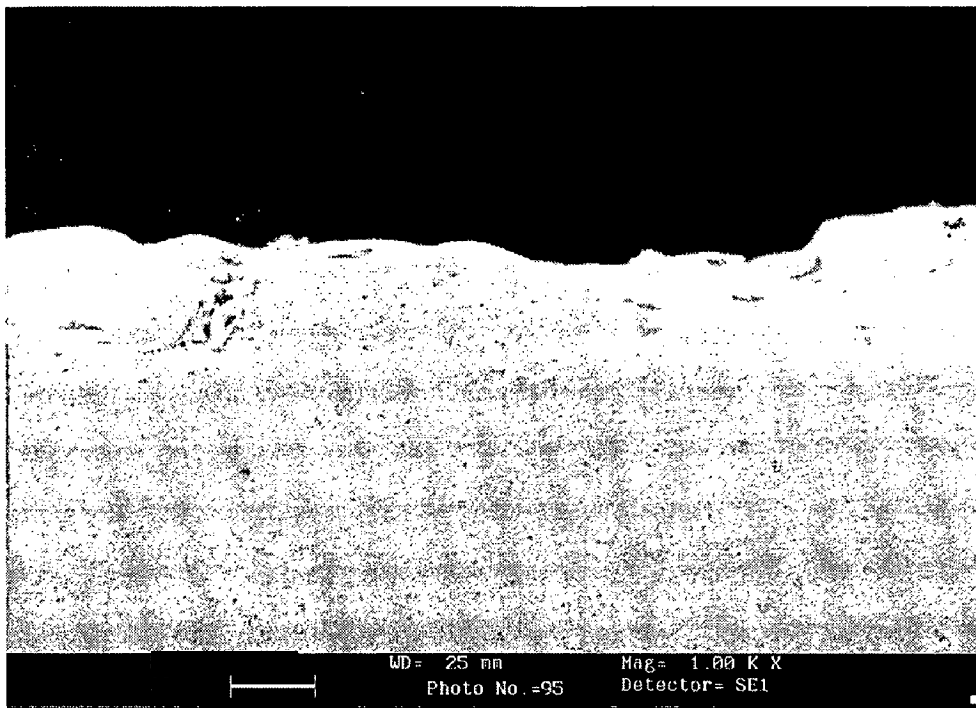
**Fig.8.25**

SEM micrographs across the cross-section of the eroded region of NiCrFeSiB coatings.

The cross sectional view at the eroded region of the coatings is shown in Fig.8.25. The coatings eroded at 30° impact angle shows crater formed from ploughing action, stretched out along its length where as those at normal impact show crater. The hillocks observed on the surface indicated the material removal by eroding silica particles. 3D optical profile (Fig.8.26) of eroded coating at shallow impact angle shows channel like regions indicating material removal from the crater and at normal impact it

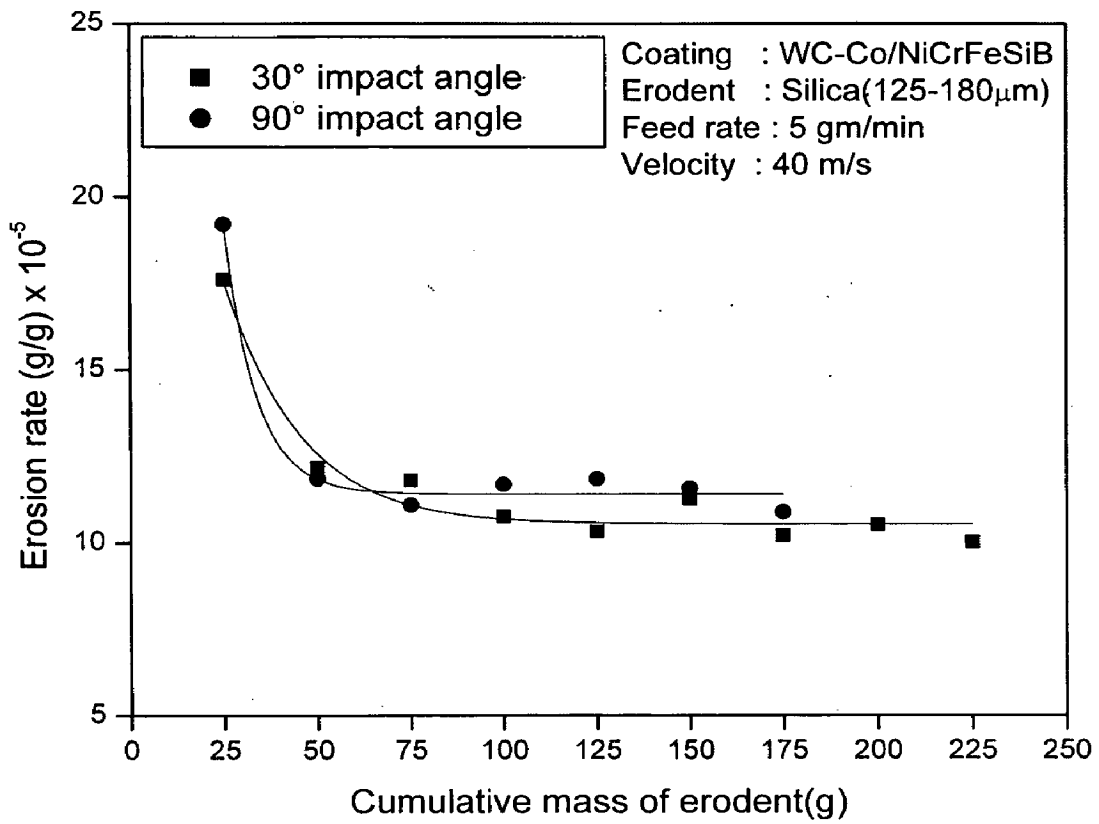
**Fig.8.27** Variation of the Incremental erosion rate with the cumulative weight of the erodent for WC-Co/NiCrFeSiB coatings at 30° and 90° impact angle.

It is known that materials that consist of both brittle and ductile constituents can behave in either a ductile or a brittle manner, as indicated by different parameters (Levy 1986A). In the present study, it is apparent from the erosion rate charts (Figs.8.27 & 8.28), WC-Co/NiCrFeSiB coatings shows brittle behavior as a function of impact angle, where it shows higher wear rate at 90° impact angle. However the difference in magnitude of steady state erosion rates at 30° and 90° impact angles are marginal and lie in a narrow range and hence it may not be conclusive in predicting the ductile or brittle nature of the coating. Hutchings (1992) and Sundararajan et al., (1997) reported that the angular dependence of erosion is not a characteristic of the material alone, but depends also on the conditions of erosion and hence suggest that the terms brittle and ductile in the context of erosion should therefore be used with caution. This leads to the further detailed microscopic analysis.

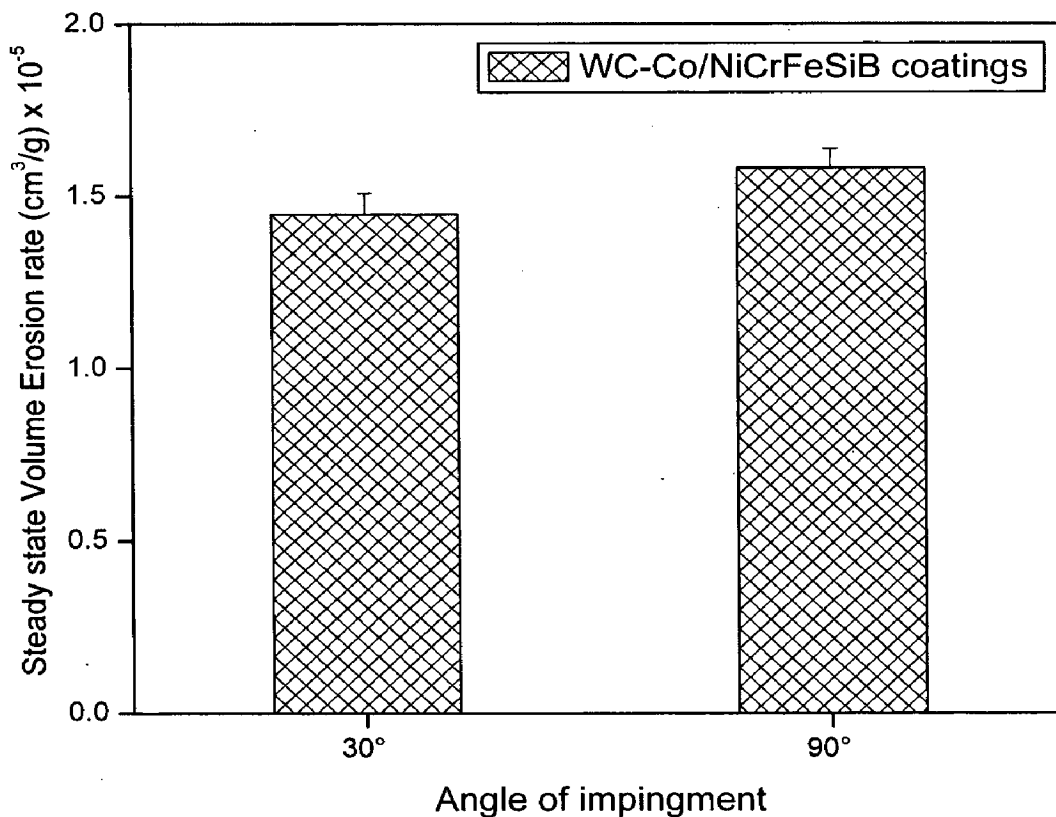
**Fig.8.28** Histogram illustrating the steady state volume erosion rate of WC-Co/NiCrFeSiB coatings at different impact angles.

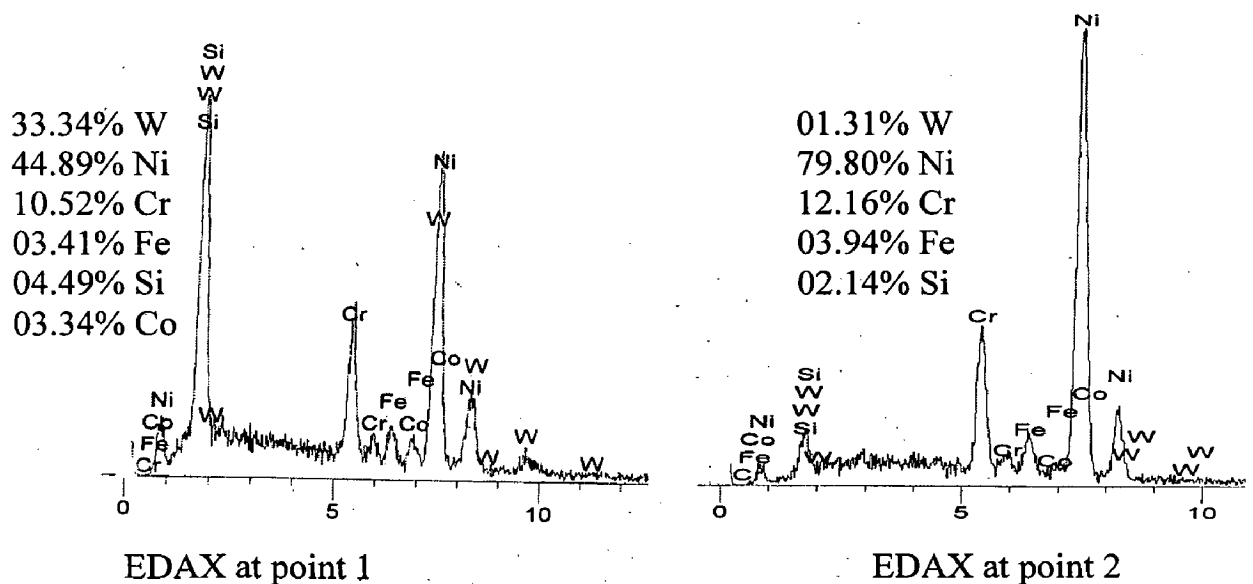
**Fig.8.29** SEM micrographs showing the surface morphology and EDAX compositional analysis at some points on WC-Co/NiCrFeSiB coated steels eroded at 30° impact angle.

The coating eroded at 30° impact angle shows a surface morphology (Fig8.29) with number of grooves and lips which indicated the material removal by ploughing and cutting mechanism. Material loss is in the form of platelets by repeated impact of erodent. It is apparent from the micrograph that groove might have formed predominantly in the softer binder region, leads to dislocation of hard WC particles. The grooves in the binder region act as failure initiating concentrators and small carbide grains crumble off uncrushed, where as the main mechanism of large grains failure is chipping (Hussainova et al., 1999). The magnified micrograph (Fig.8.29b) shows a evidence of carbide particle pull out. The EDAX analysis at point 1, confirm the particle as tungsten carbide and analysis at point 2 represent nickel rich binder matrix. Similar observations of carbide pull out from the WC-Co, WC-Co-Cr and Cr<sub>3</sub>C<sub>2</sub>-20NiCr coating surface at shallow angle of impact has been reported by Hawthorne et al., 1999, Feng et al., 1999 and Murthy et al., 2001.

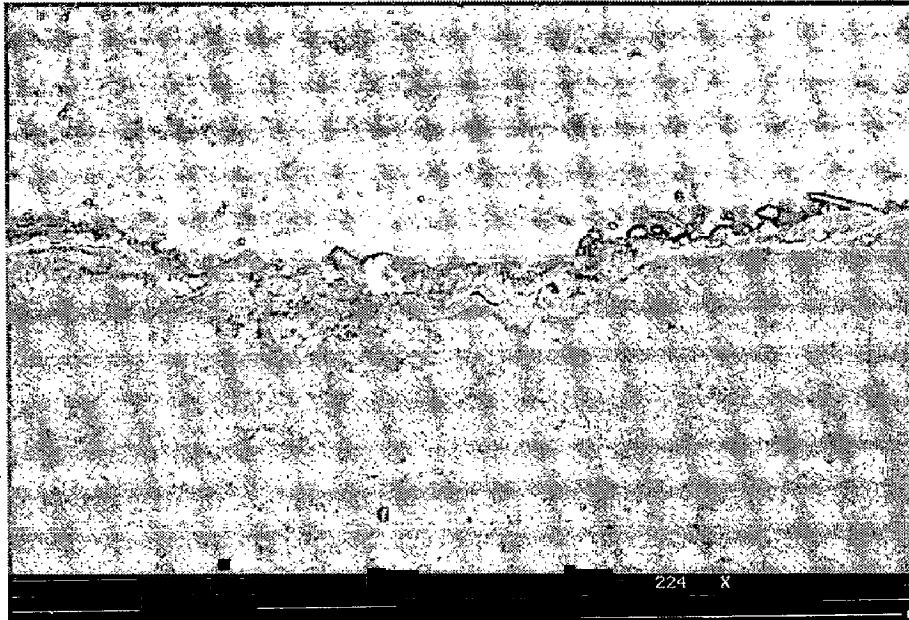
**Fig.8.31**

(a) Eroded at 30° impact angle;

(b) Eroded at 90° impact angle

There are indications of subsurface cracks in the cross-sectional view as shown in Fig.8.31. The crater and hillocks observed on the surface indicated the material removal by eroding silica particles. 3D optical profile (8.32) of eroded coating at shallow impact angle shows material removal from the binder matrix. Channel like regions observed, indicate the regions of exaggerated material removal from the surface. Wider crater of 11.3 μm deep has been observed at normal impact. The surface roughness of the coating eroded at 30° and 90° impact angle found to be 2.85 and 3.84 μm respectively.

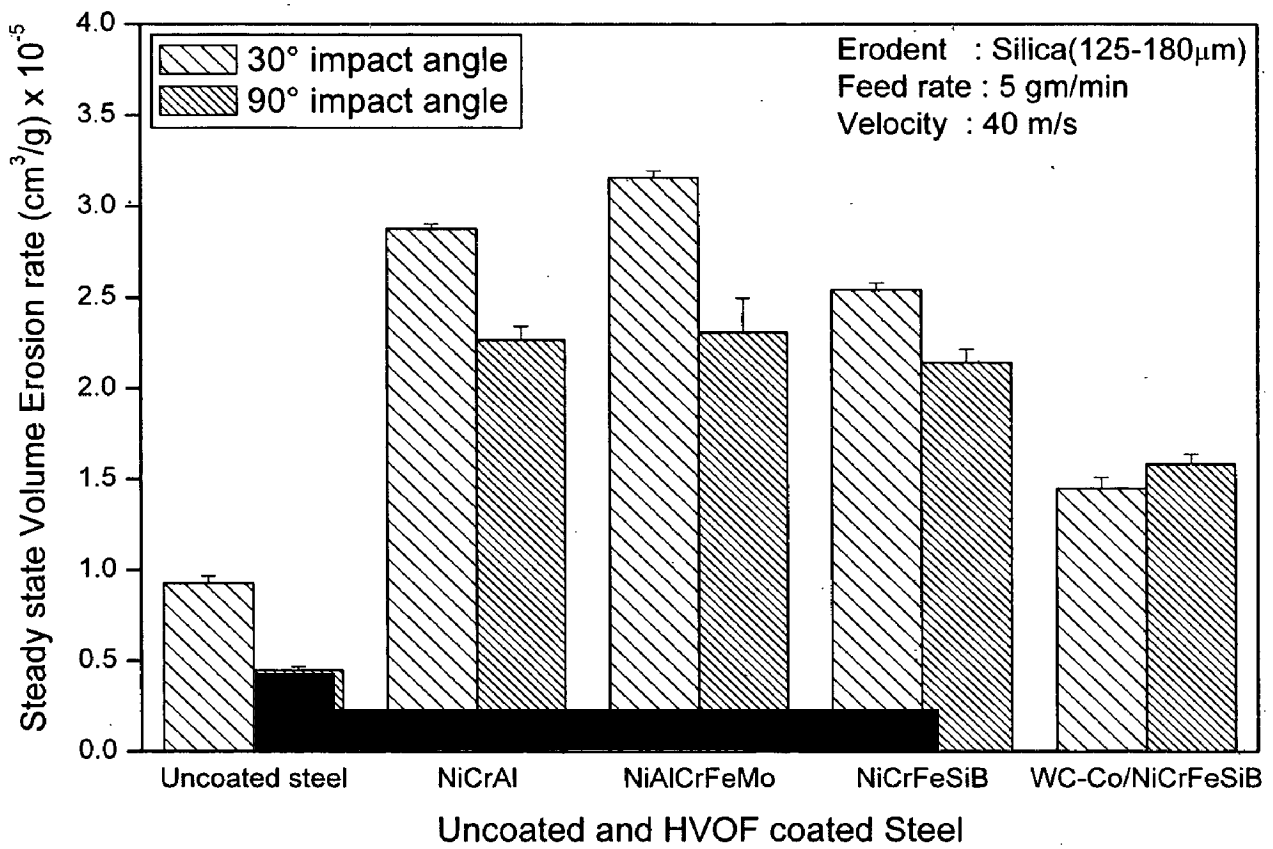
**Fig.8.33** Bar chart indicating volumetric steady state erosion rate for uncoated and HVOF coated GrA1 steels at 30° and 90° impact angle

In the present study, the GrA1 steels exhibit lower erosive loss when compared to all the HVOF coatings under similar test conditions (Fig.8.33). This may be due to the embedment of silica particles into the surface, which might bestow some shielding effect against further material loss. It is well established that the ratio of hardness of the erodent particles ( $H_p$ ) to the target hardness ( $H_t$ ), has a controlling influence in the erosion mechanisms (Lathabai et al. 1998, Hussainova et al. 1999, Shipway et al. 1996, Hearley et al. 1999). The silica particles used in the present study have an average hardness value

Bar chart indicating volumetric steady state erosion rate for uncoated and HVOF coated GrAl steels at 30° and 90° impact angle is shown in Fig.8.33. From the bar chart it can be inferred that GrAl steel exhibit lower steady state volume erosion rate in comparison to all the HVOF coatings under similar test conditions. This may be due to the embedment of silica particles in to the surface, which might bestow some shielding effect against impacting particles and leads to lower wear loss. The ratio of hardness of erodent particles ( $H_p$ ) to the target hardness ( $H_t$ ) is approximately 4.8, which cause the penetration of silica particles in to the target material. Hutchings, 1992 observed experimentally that abrasive particles of any shape will cause plastic scratching and indent the surface, if  $H_p/H_t > 1.2$ . SEM micrographs on the surface of eroded GrAl clearly show the embedment of sand particle and the wear mechanism essentially involves indentation induced severe plastic deformation. Further Mishra, (2006A) reported that relatively higher erosion loss of thermal sprayed coatings in comparison to bulk materials might be partially attributed to the presence of some porosity in the coating. GrAl steel endure severe plastic deformation in the localized region around the points of impact of each particle in the form of lip and platelets and is detached, result in mass loss.

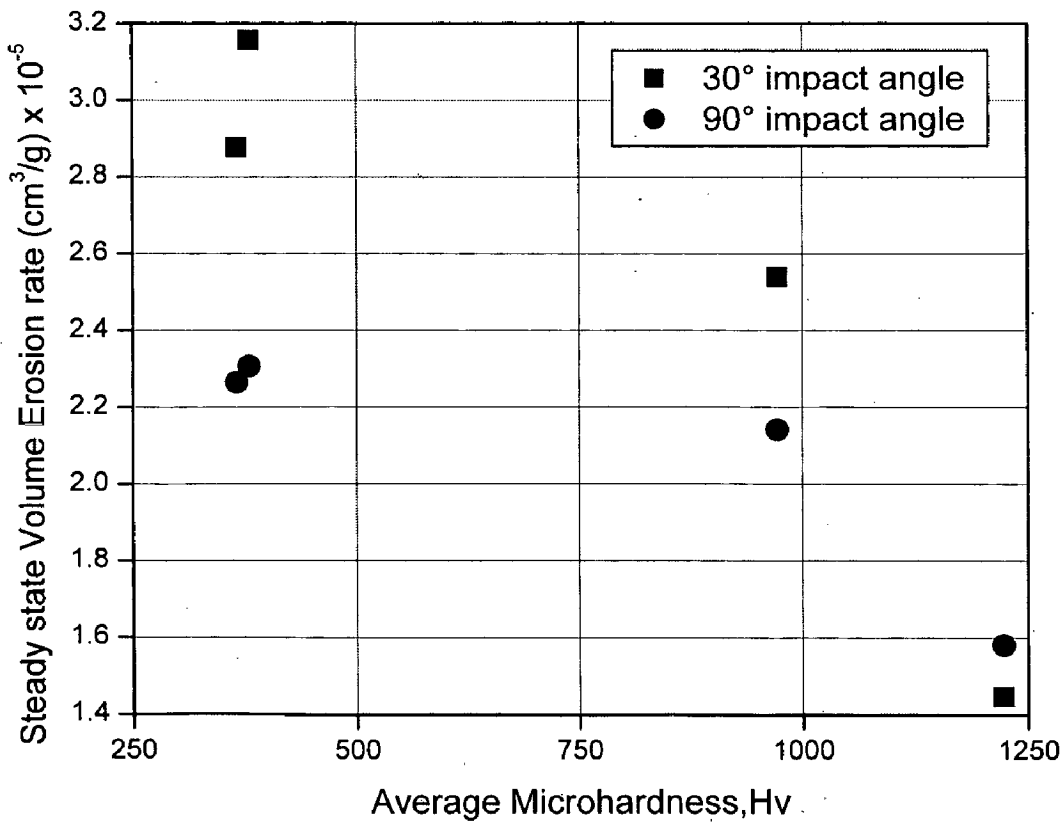
**Fig.8.34** Correlation of Volumetric steady state erosion rate with coating hardness at 30° and 90° impact angle

Fig.8.34 shows the effect of hardness on the erosion behavior of coatings. The compositions and hardness of the coatings do not relate directly with the erosion loss rates but their morphologies do (Levy 1988 and Shui et al. 1990). However at both 30° and 90° impingement, a general trend shows that the increase in hardness of HVOF coatings under study leads to an increase in their erosive wear resistance. The variation in the porosity contents of the coatings might have contributed to the variation in erosion rates of the different coatings. Relatively higher porosity with the NiAlCrFeMo coatings leads to lower erosion resistance. The porosity content of the coatings shows negative effect on the erosion resistance. Greater the porosity of the coating, the easier it is for the erodent particles to knock off pieces of exposed surface, and the greater is the removal rate (Levy 1988).
