STUDY OF DETONATION GUN COATED ALLOYS FOR RESISTANCE TO EROSION AND CORROSION

A THESIS

METALLURGICAL AND MATERIALS ENGINEERING

This thesis investigates the erosion and corrosion performance of Al_2O_3 -3 wt % TiO_2 thermal spray coatings deposited by detonation gun technique. As-sprayed coatings were characterized by using the combined techniques of optical microscopy, microhardness testing, X-ray diffractometry (XRD) and scanning electron microscopy/energy-dispersive analysis (SEM/EDX). The corrosion performance was evaluated in oxidising and molten salt environment and also in actual working conditions of boiler. The erosion performance was evaluated at room temperature conditions as well as under high temperature conditions, high erodent velocity, and actual boiler conditions. The corrosion behavior and morphological development were investigated by weight change kinetics, metallographs, depths of attack, metal thickness losses, and XRD analyses.

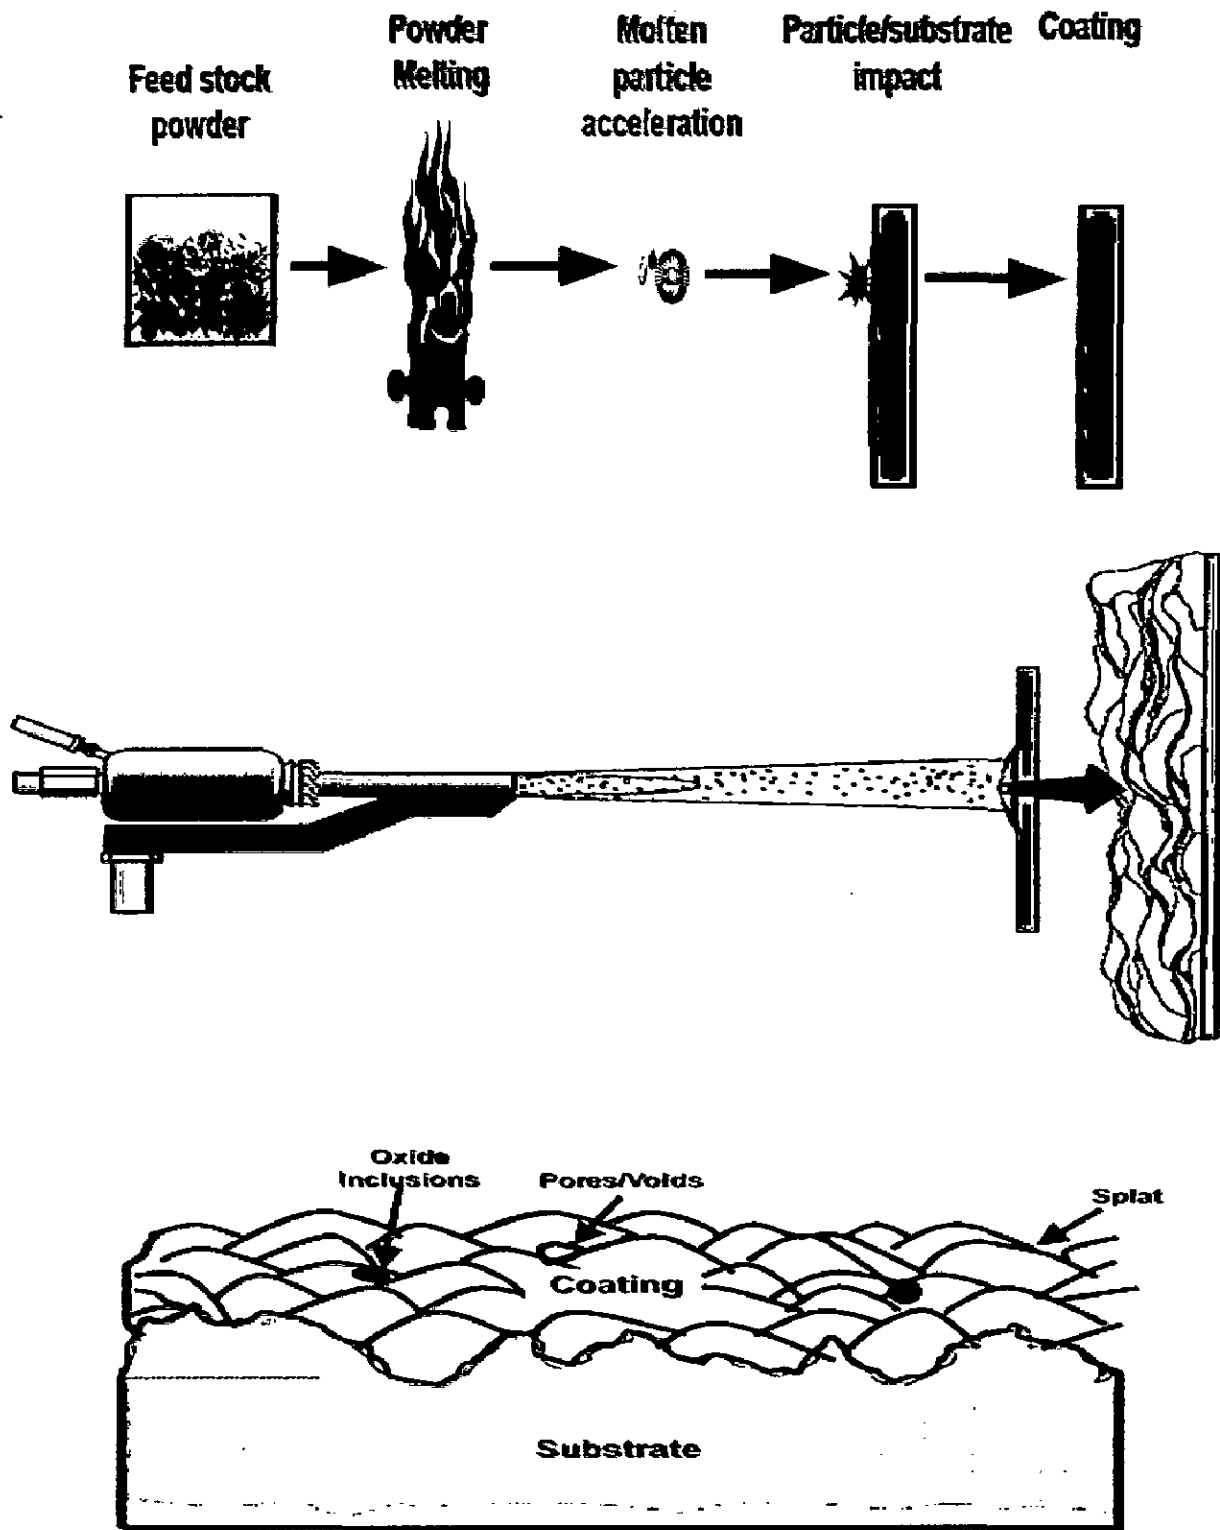
Fig. 2.1: Schematic development of the thermal spray process and mechanism of coating build-up (Engineering Manual 1110-2-3401, 1999).

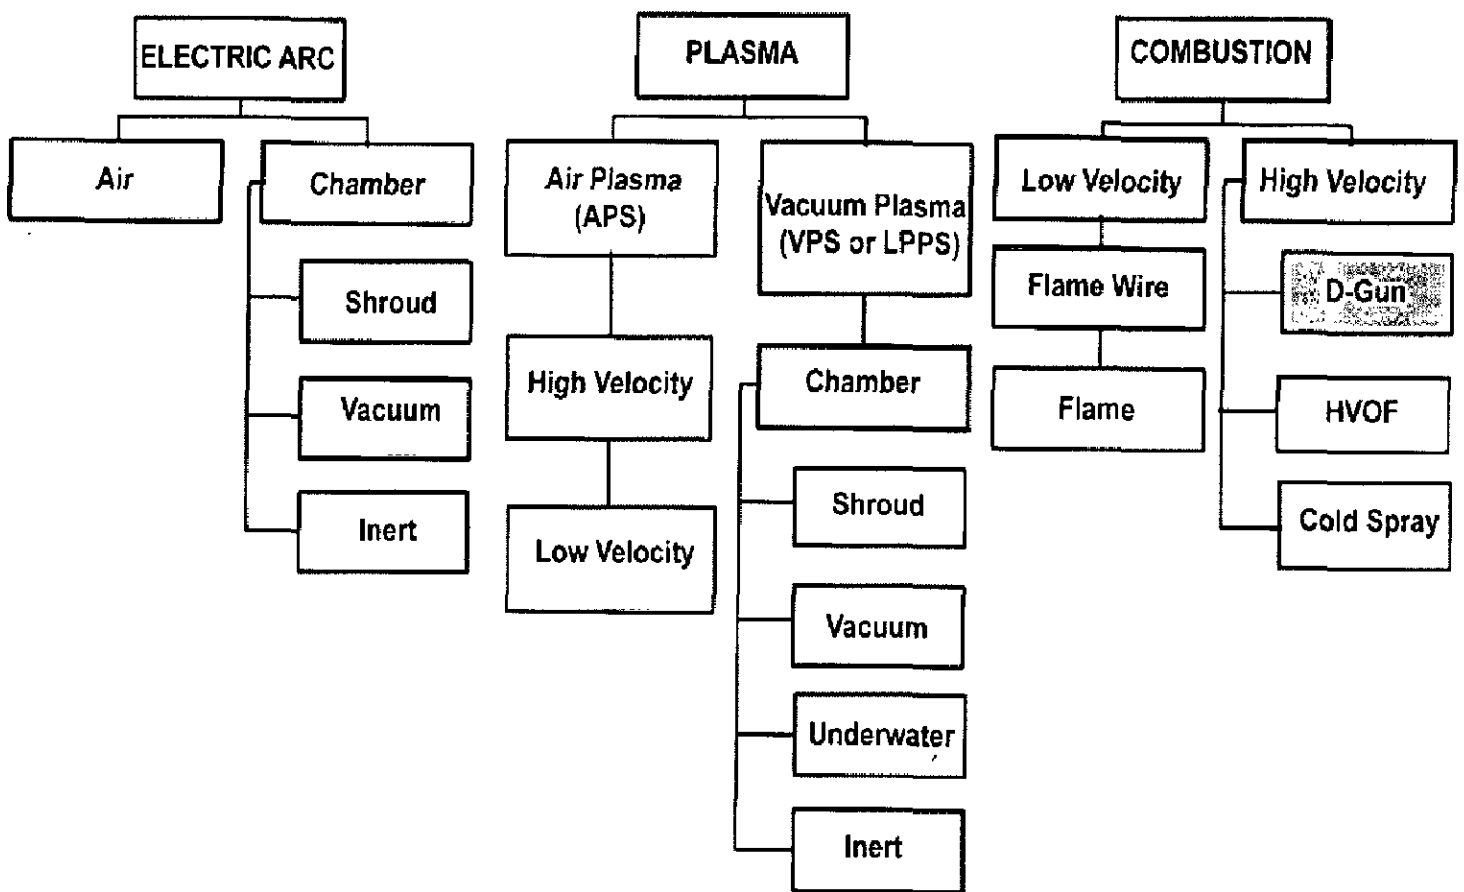
Fig. 2.2: Summary of significant thermal spray techniques (Smith, 1995).

The various thermal spray processes are broadly classified into three categories based on their method of heating - combustion, plasma, and electric arc. Each of these categories encompasses a range of different methods, Fig. 2.2

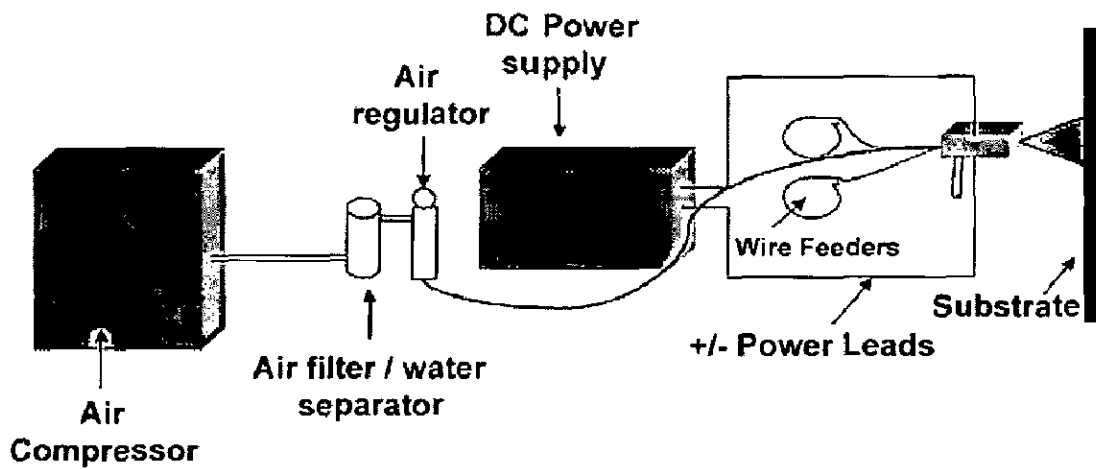
Fig. 2.3: Typical two wire arc spray system

Energy costs are lower and production rates are higher than they are with competing methods such as wire flame spray. Arc spraying may be used to apply electrically conductive materials including metals, alloys, and metal-metal oxide mixtures. Fig.2.3 shows a typical arc spray system comprised of a DC power supply, insulated power cables, a wire feed system, a compressed-air supply, controls, and an arc spray gun. Coating quality and properties can be controlled by varying the atomization pressure, air nozzle shape, power, wire feed rate, traverse speed, and standoff distance.

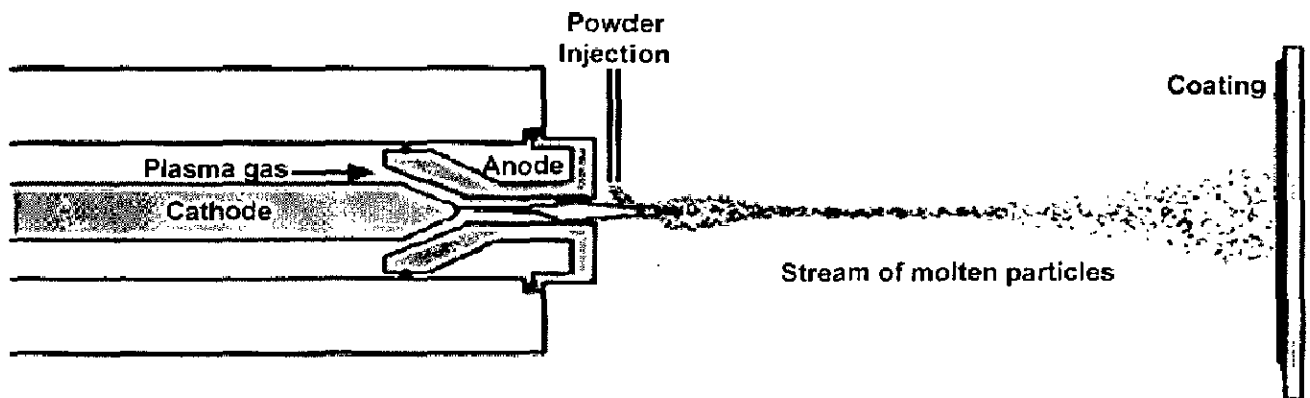
Fig. 2.4: Schematic Diagram of the Plasma spray Process

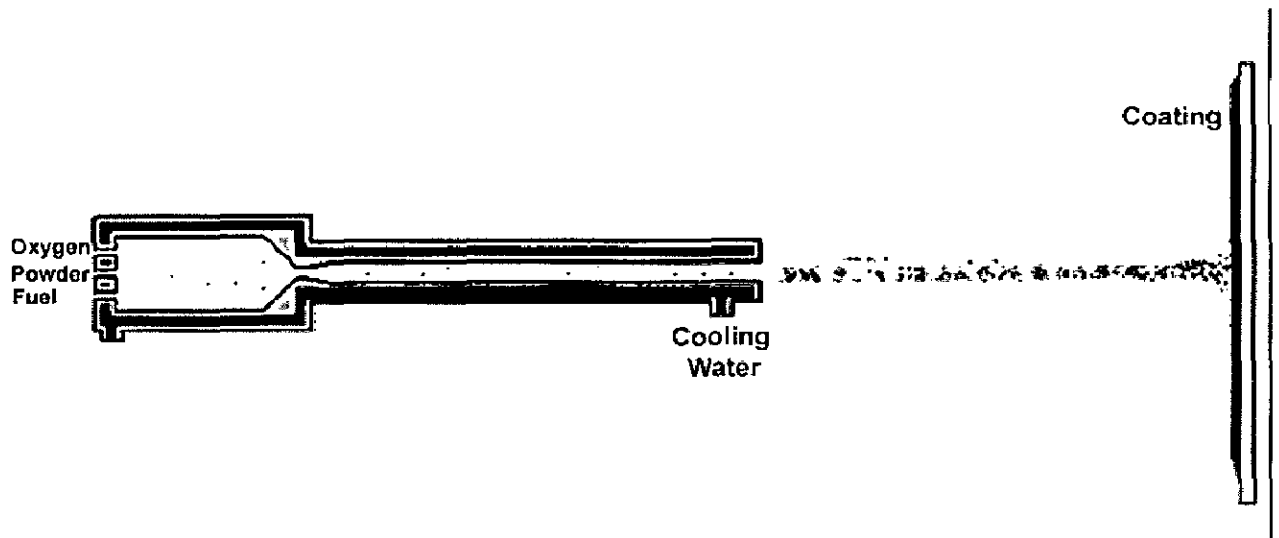
Fig. 2.5: Schematic Diagram of the HVOF Process

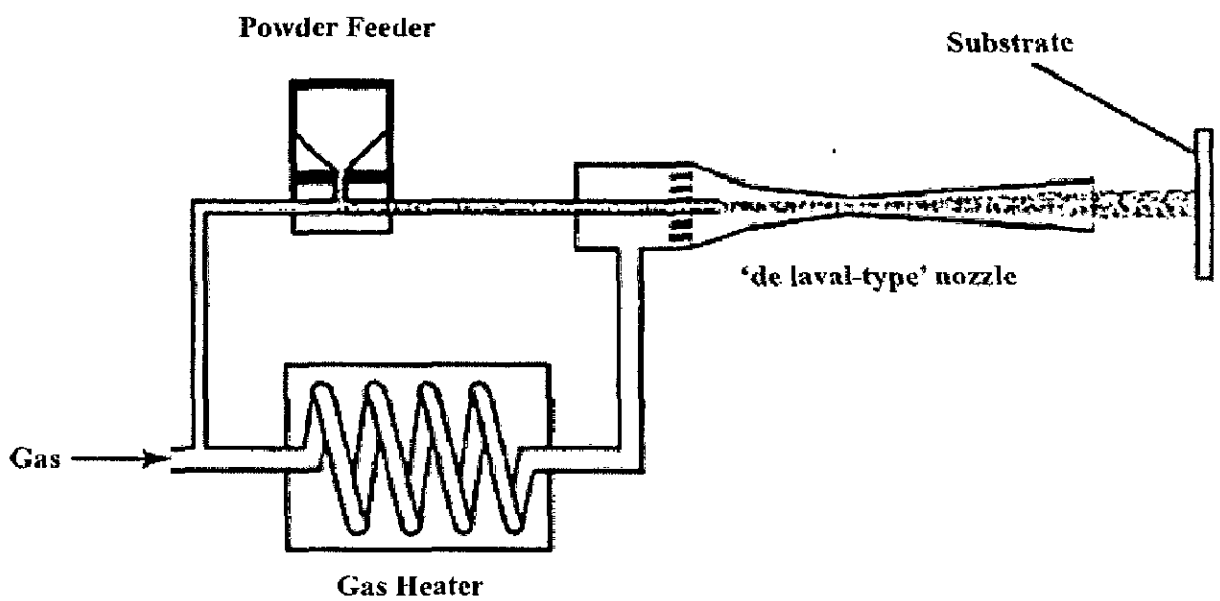
Fig. 2.6: Schematic of Cold Spraying Process (Stoltenhoff et al., 2002).

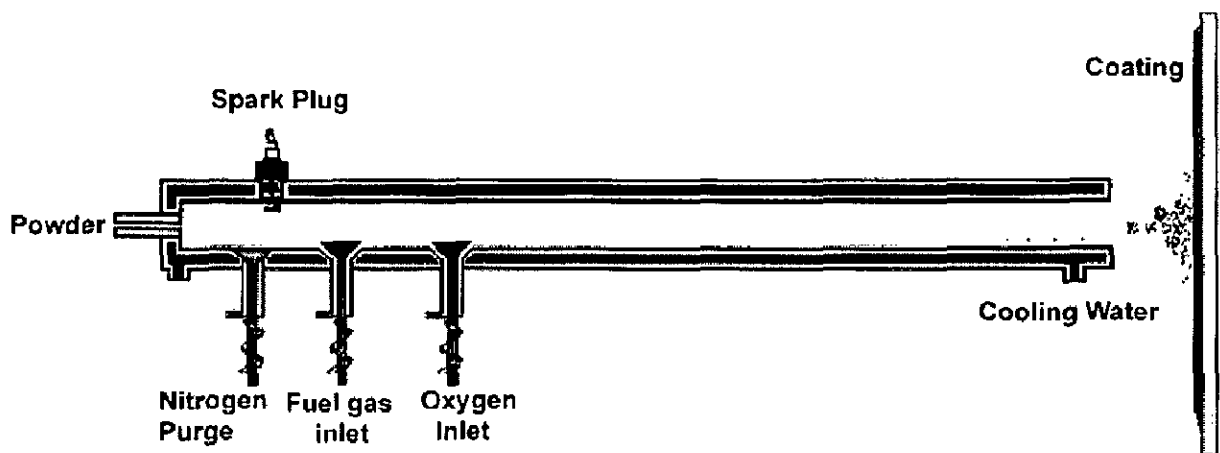
Fig. 2.7: Schematic illustration of the Detonation Gun thermal spray system.

In D-gun spraying, mixture of a fuel gas, usually H₂ or hydrocarbons, such as acetylene (C₂H₂), propane (C₃H₈) and butane (C₄H₁₀), with oxygen (O₂) is used as working gas. The composition giving the maximum temperature of 4500K corresponds to oxygen with 45 vol.% of acetylene (Tucker, 1982). The wave generated by detonation may attain a velocity of 2930 m/s (Smith, 1974) while the velocity of the particles reportedly reached 750 m/s in the D-gun™ and 1000 m/s in the ‘Super D-gun™’ (Irving et al., 1993). Kadyrov and Kadyrov, (1995) report velocities varying between 1000 and 3000 m/s. The barrel used in D-gun is circular with the length is in the range 450-1350mm and the diameter 21-25mm. The Firing rate is in the range 1-15 Hz. The Powder Particle sizes are usually in the range 5-60 µm. The Powder feed rate is in the range 16-40 g/min (Borisov et al., 1990). The Spray distance is reported to be about 100mm (Schwarz, 1980). The spray atmosphere is air in this process.

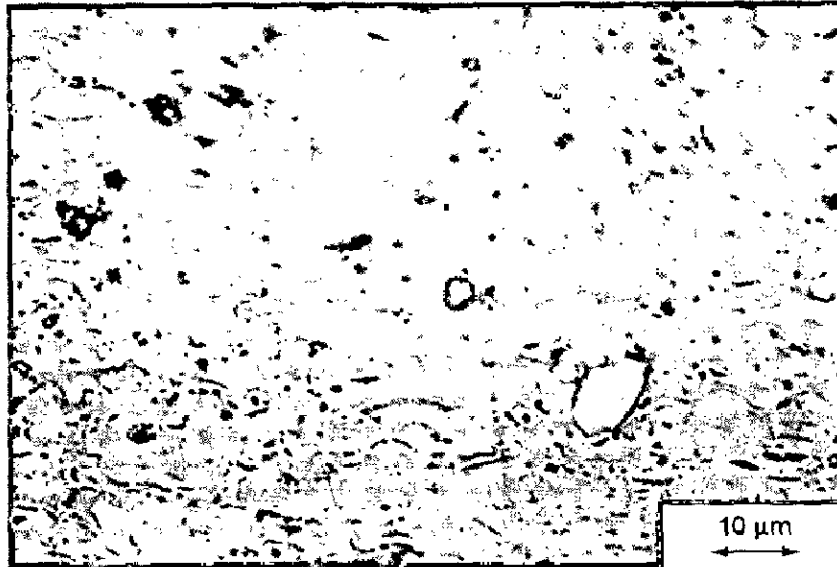
Fig. 2.8: Optical micrograph of an alumina coating used for corona rolls production, obtained by plasma-spraying (McPherson, 1973).

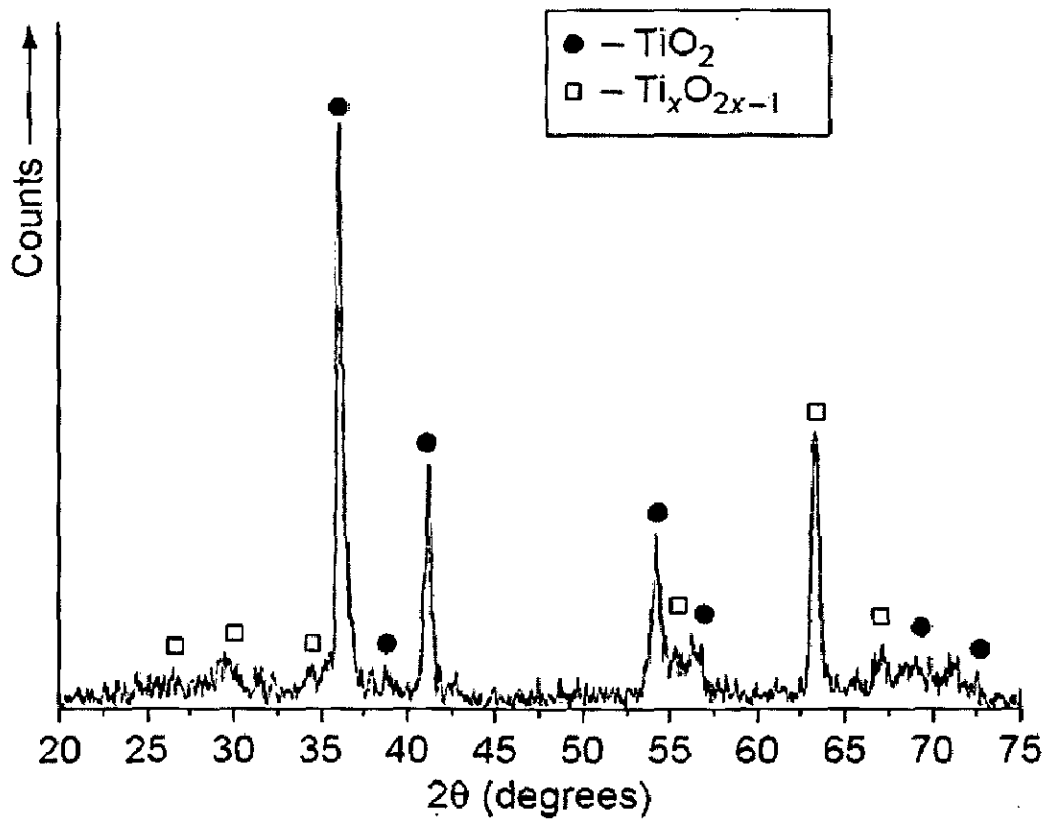
Fig. 2.9: X-ray diffraction diagrams of a coarse TiO_2 powder plasma sprayed coating (Tomaszek et al., 2006).

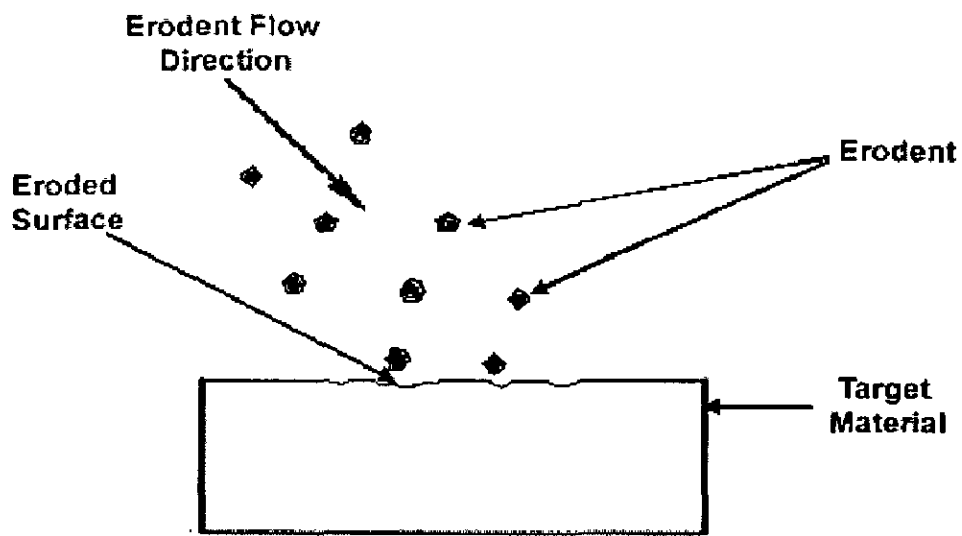
Fig. 2.10: A schematic view of solid particle erosion of material (Buckley, 1981).

velocity (greater than 1m/s). In both the cases, particles are accelerated or decelerated, and their directions of motion can be changed by the fluid, this is more significant in liquid media, and slurry erosion. A schematic view of erosion wear is shown in Fig. 2.10.

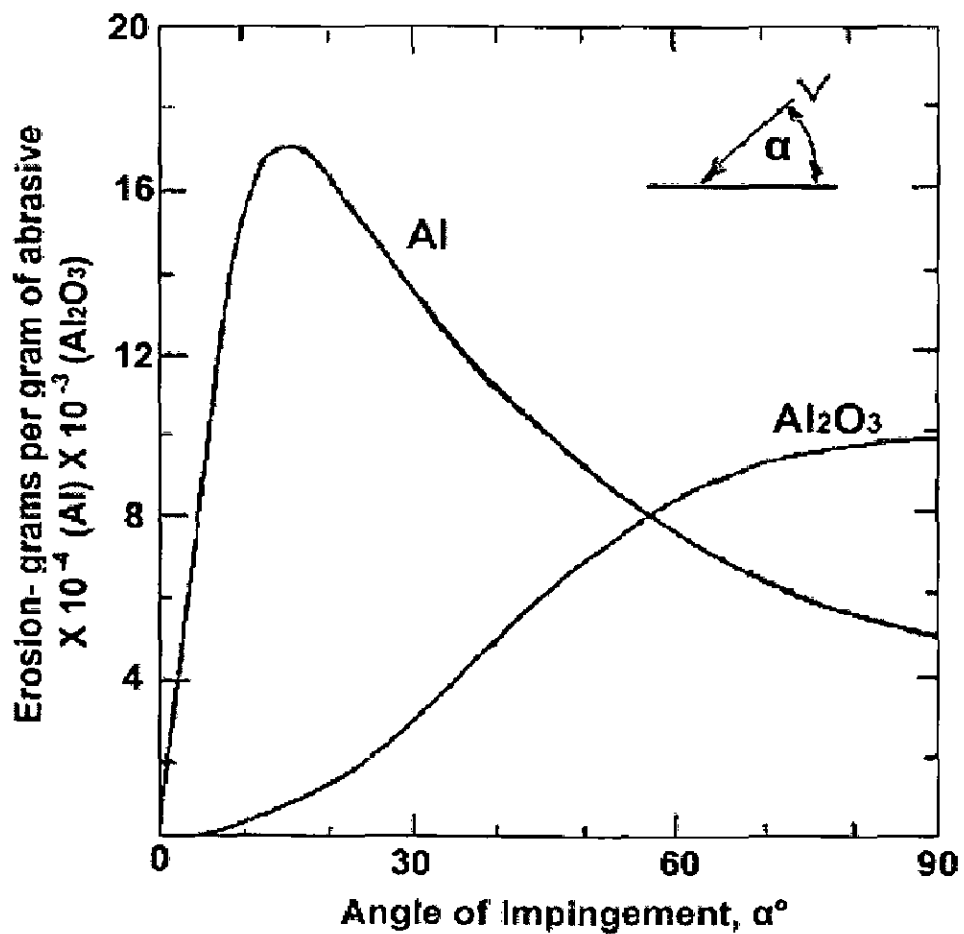
Fig. 2.11: Erosive mass losses as a function of impact angle for aluminium and Al_2O_3 substrates (Finnie, 1995)

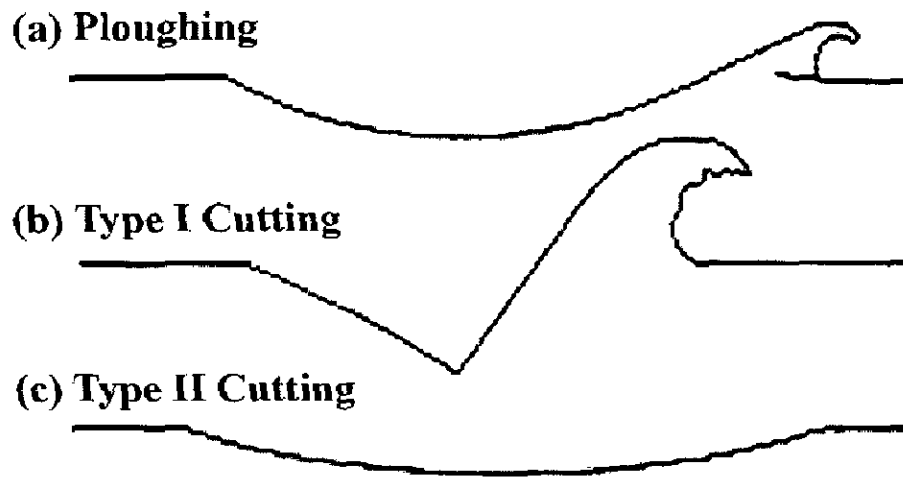
Fig. 2.12: Characteristic mechanisms of ductile erosion based on the variation in erosion conditions (Hutchings, 1992A).

finally leaves the surface. A refined model has been developed for this mechanism by Finnie and McFadden (1978) utilizing the equation of motion of the particle tip to define an amount of target material that would be removed. The classical “ductile” erosion response, exhibits the greatest magnitudes of mass loss at low impact angles ranging from 15-30°. At higher angles the erosion rate drops away, though the rate does not tend to 0 at 90°. The severity of low angle impact damage has been related to the efficiency of the generalised “machining” mechanism postulated to account for erosive mass loss in ductile materials over these angles. This generalised mechanism has been subdivided into 3 modes of response, Fig. 2.12.

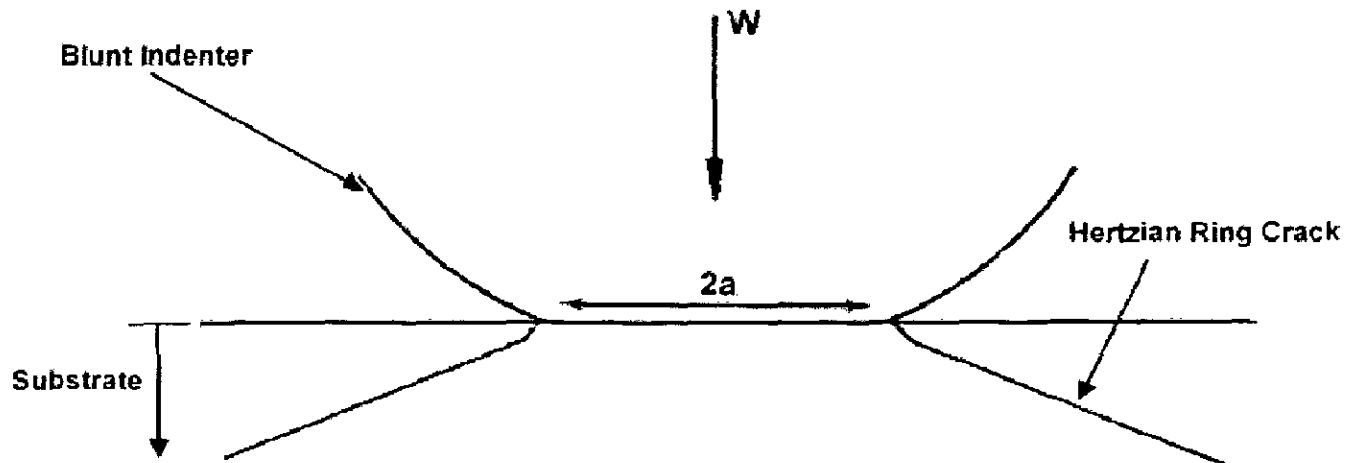
Fig. 2.13: Cross-sectional schematic of impact by a blunt indenter on to a brittle substrate, resulting in the formation of a conical Hertzian crack (Hutchings, 1992A).

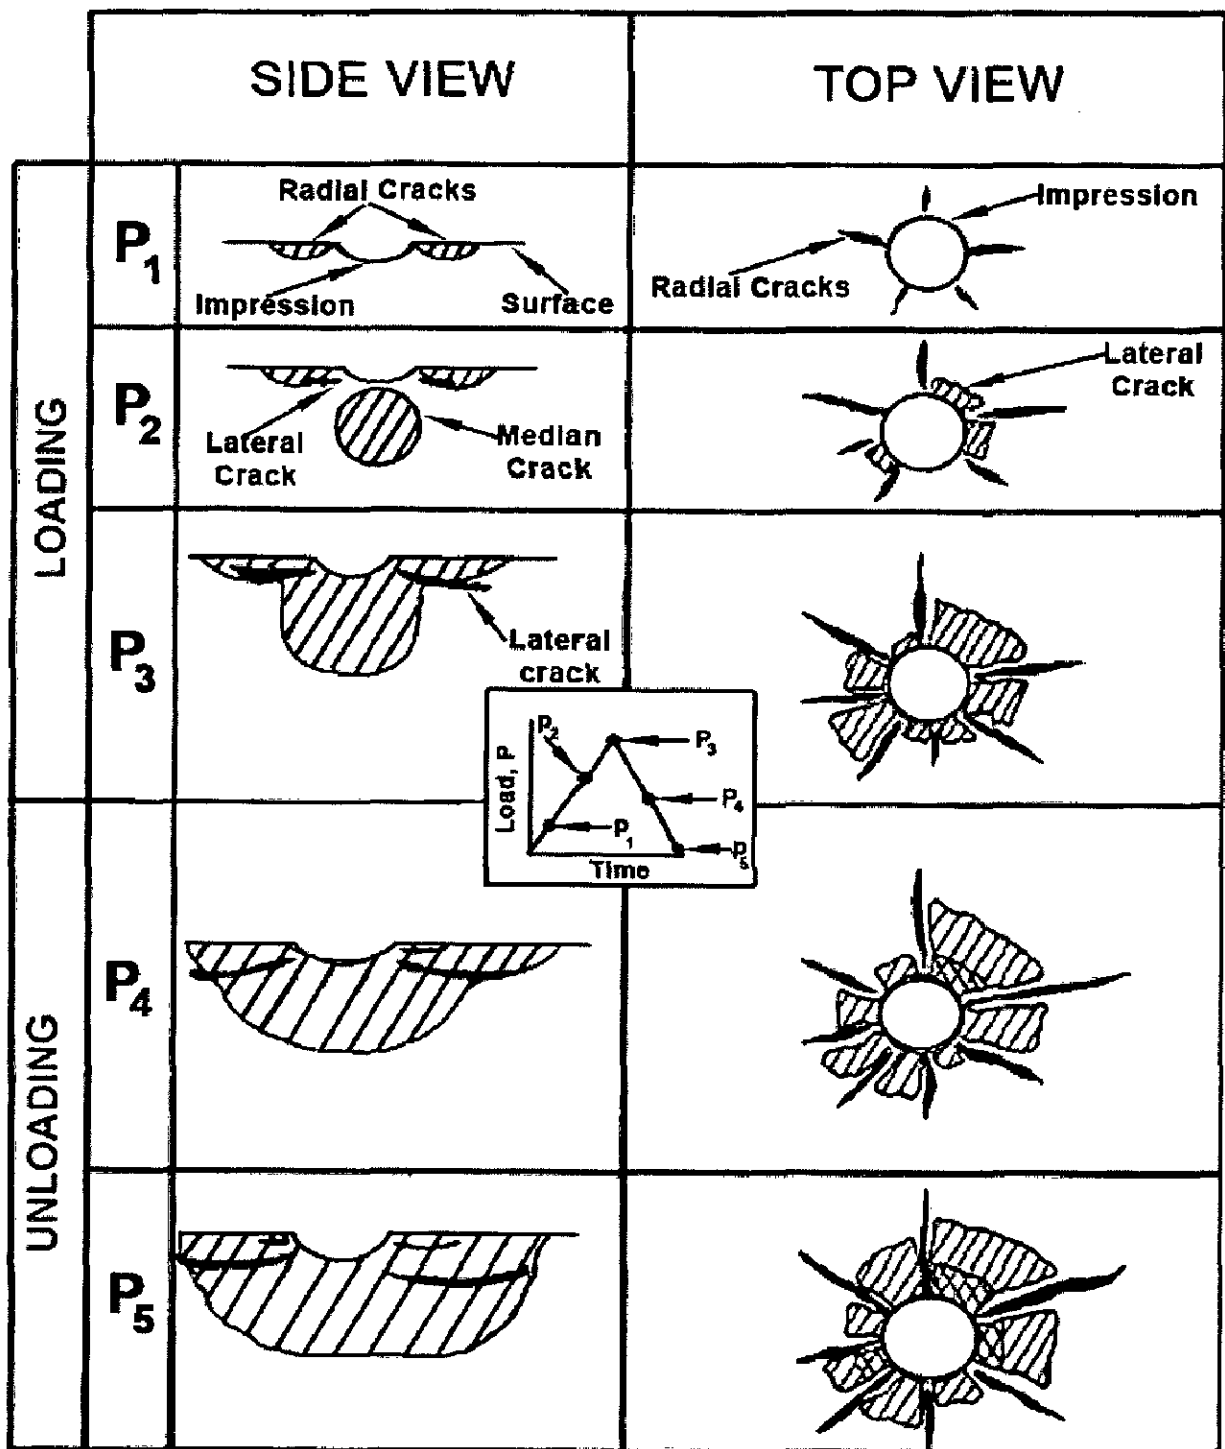
Fig. 2.14: Schematic sequence of crack formation and development as a function of indentation loading and unloading on a brittle substrate (Evans and Wilshaw, 1976).

erosive particles with sharp edges, cracking becomes more extensive. Evans and Wilshaw (1976, 1977) have characterised the mechanism as shown in Fig. 2.14. Indentation generates a zone of plastically deformed material around the indenter, the surrounding material being elastically loaded (Levy, 1995). According to this mechanism under the effect of loading, radial cracks propagate out from the indent perpendicular to the surface, while “medium vent” cracks propagate down into the material below the indenter. Upon unloading, lateral cracks form below the plastically deformed zone and propagate outwards and upwards towards the surface (Hutchings, 1992 A; Evans and Wilshaw, 1976). As a result, large chips of material may be formed in this process by the intersection of the various crack networks propagating from the indent (Finnie, 1995; Hutchings, 1992 A; Levy, 1995; Ruff and Wiederhorn, 1979; Levy, 1983, as well as by fracture of indented material generated by the combined action of the “wedging action” of the erodent with the cracks formed during impact (Ruff and Wiederhorn, 1979).

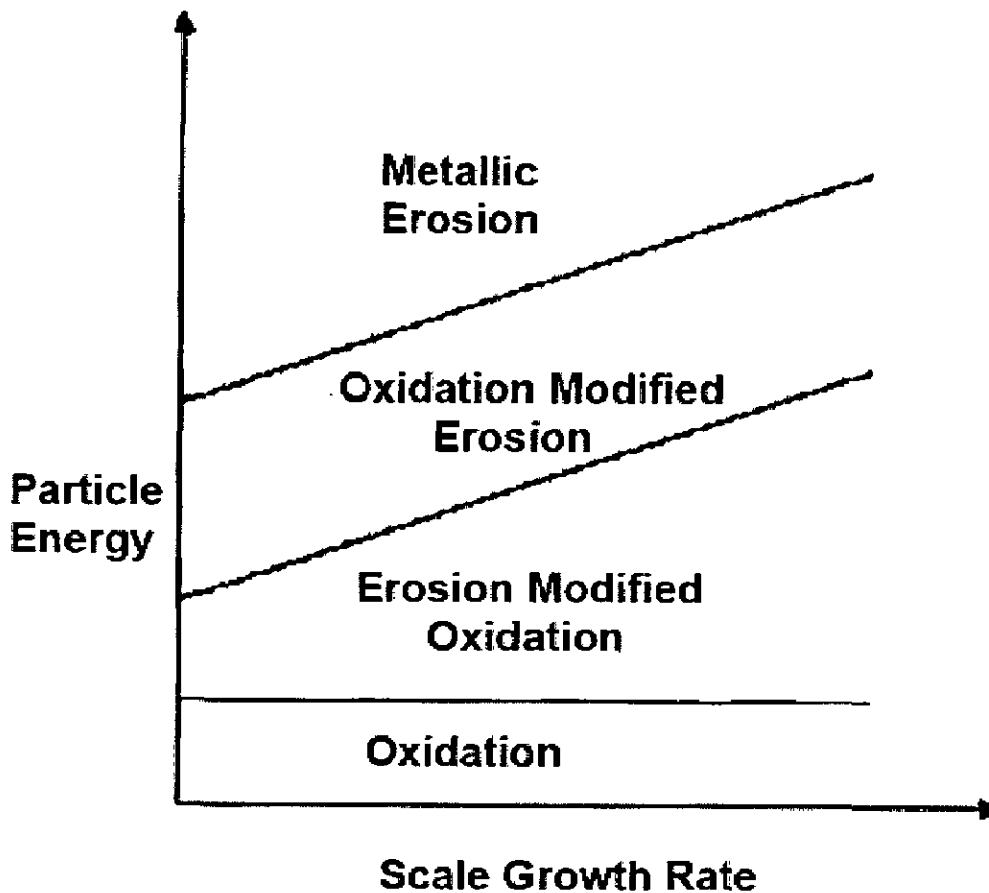
Fig. 2.16: Schematic diagram showing the types of degradation that can occur under conditions of combined oxidation-erosion (Barkalow and Pettit, 1979).

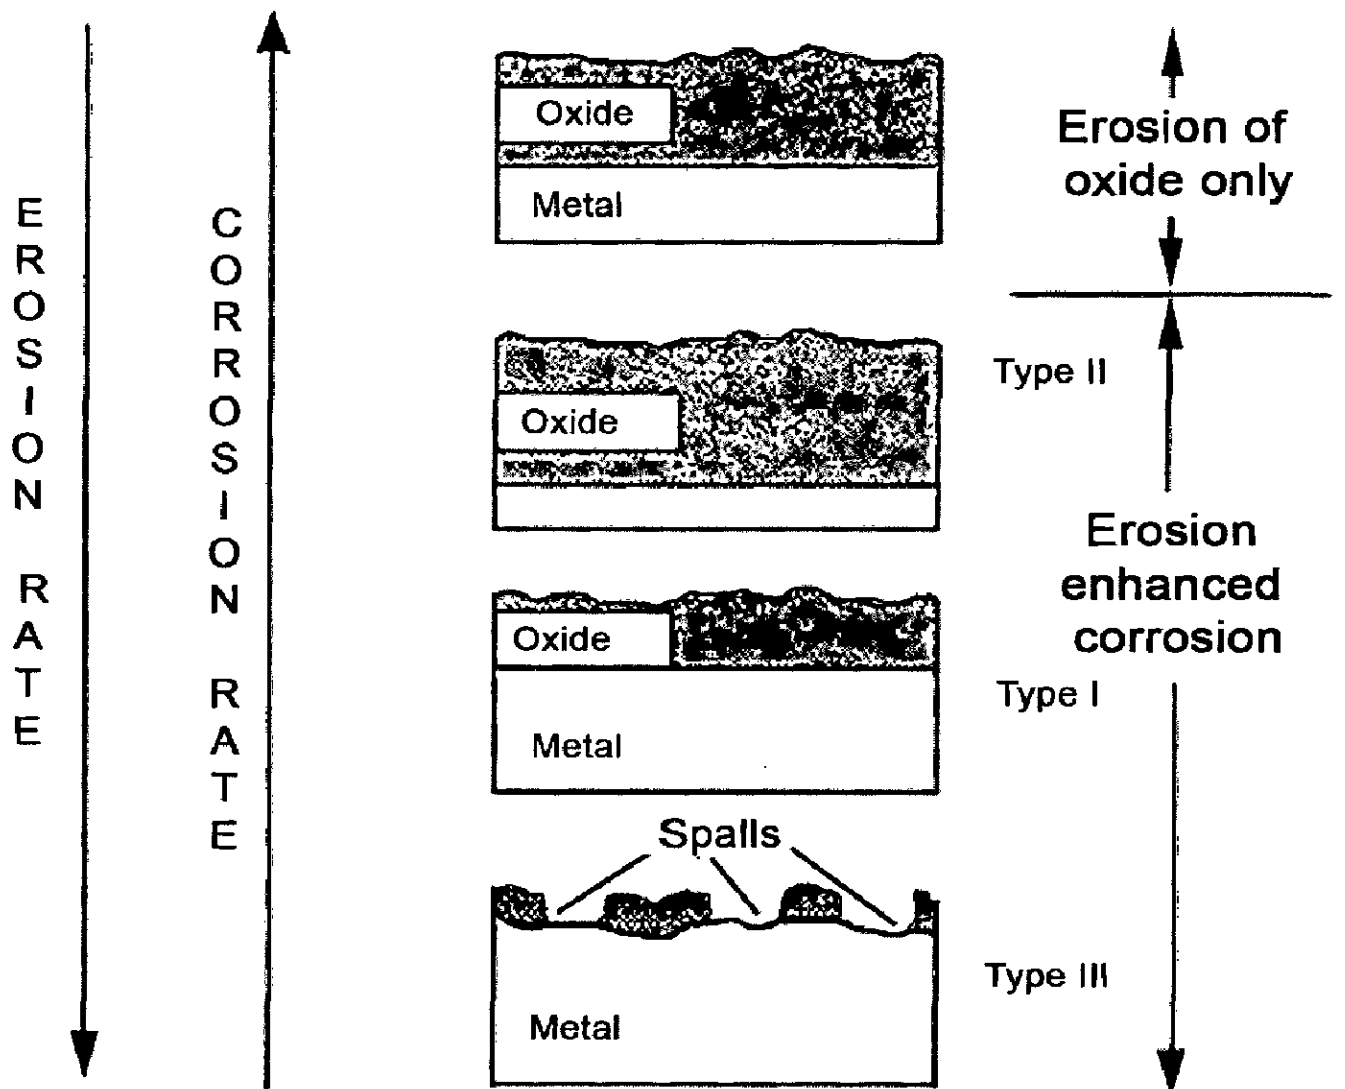
Fig. 2.18: Schematic of the different erosion-oxidation regimes (Rishel et al., 1990).

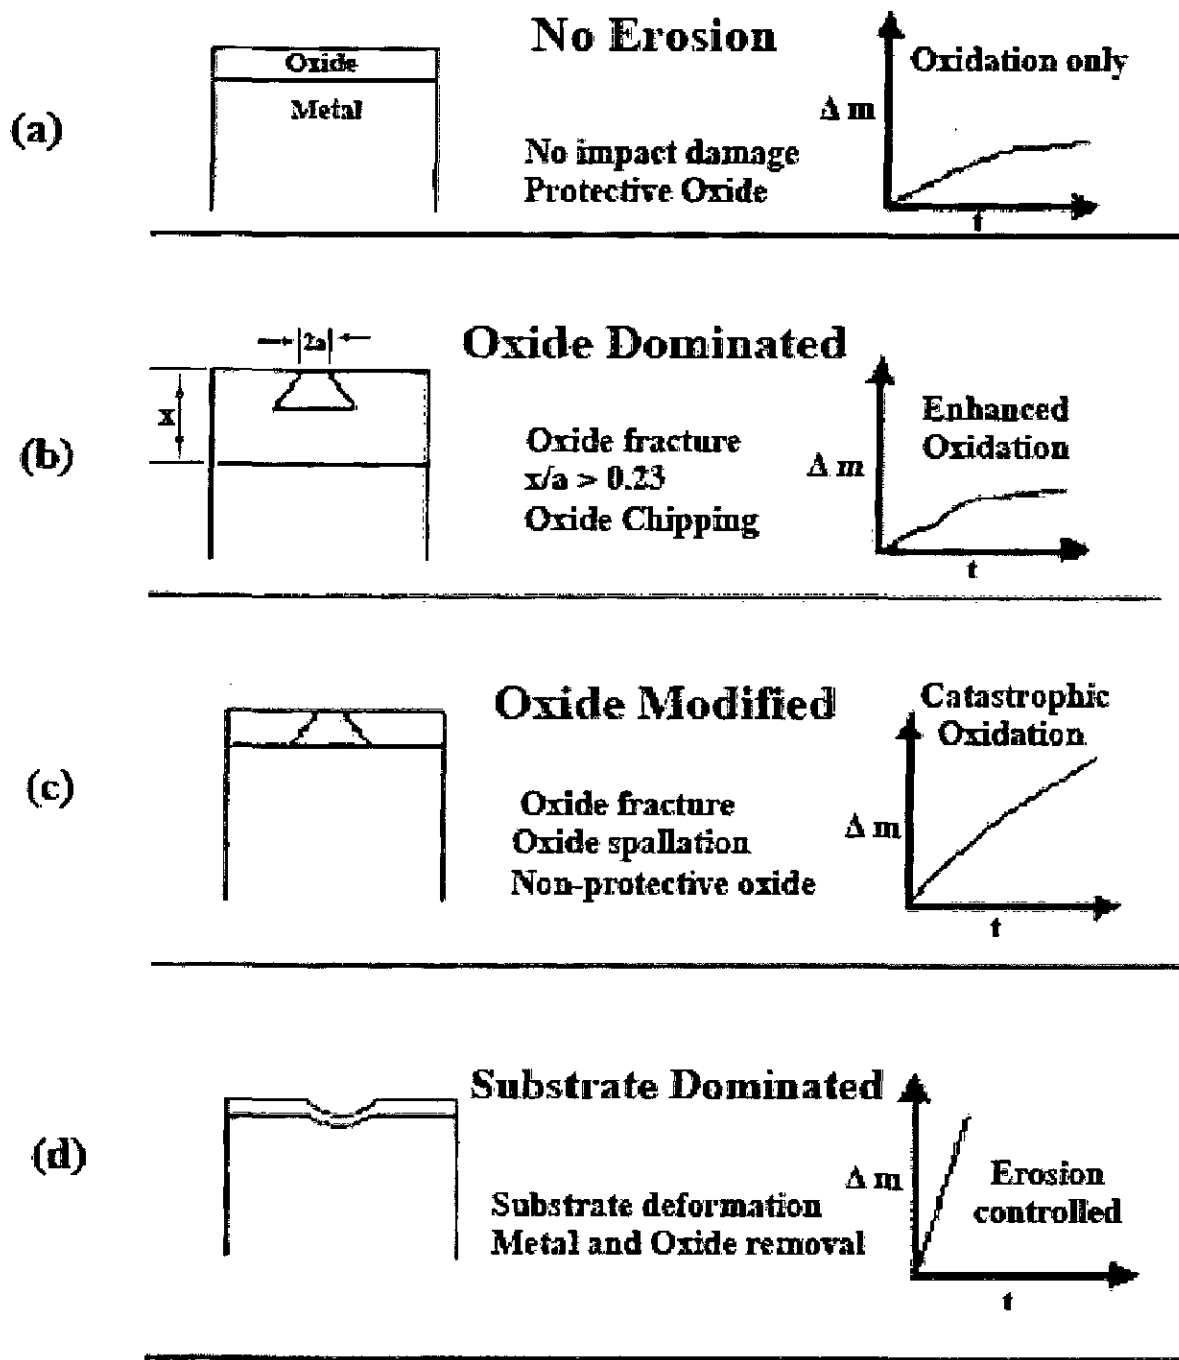
Fig. 2.19: Summary of erosion regimes observed at high temperatures (Stephenson, 1989; Stephenson and Nicholls, 1993).

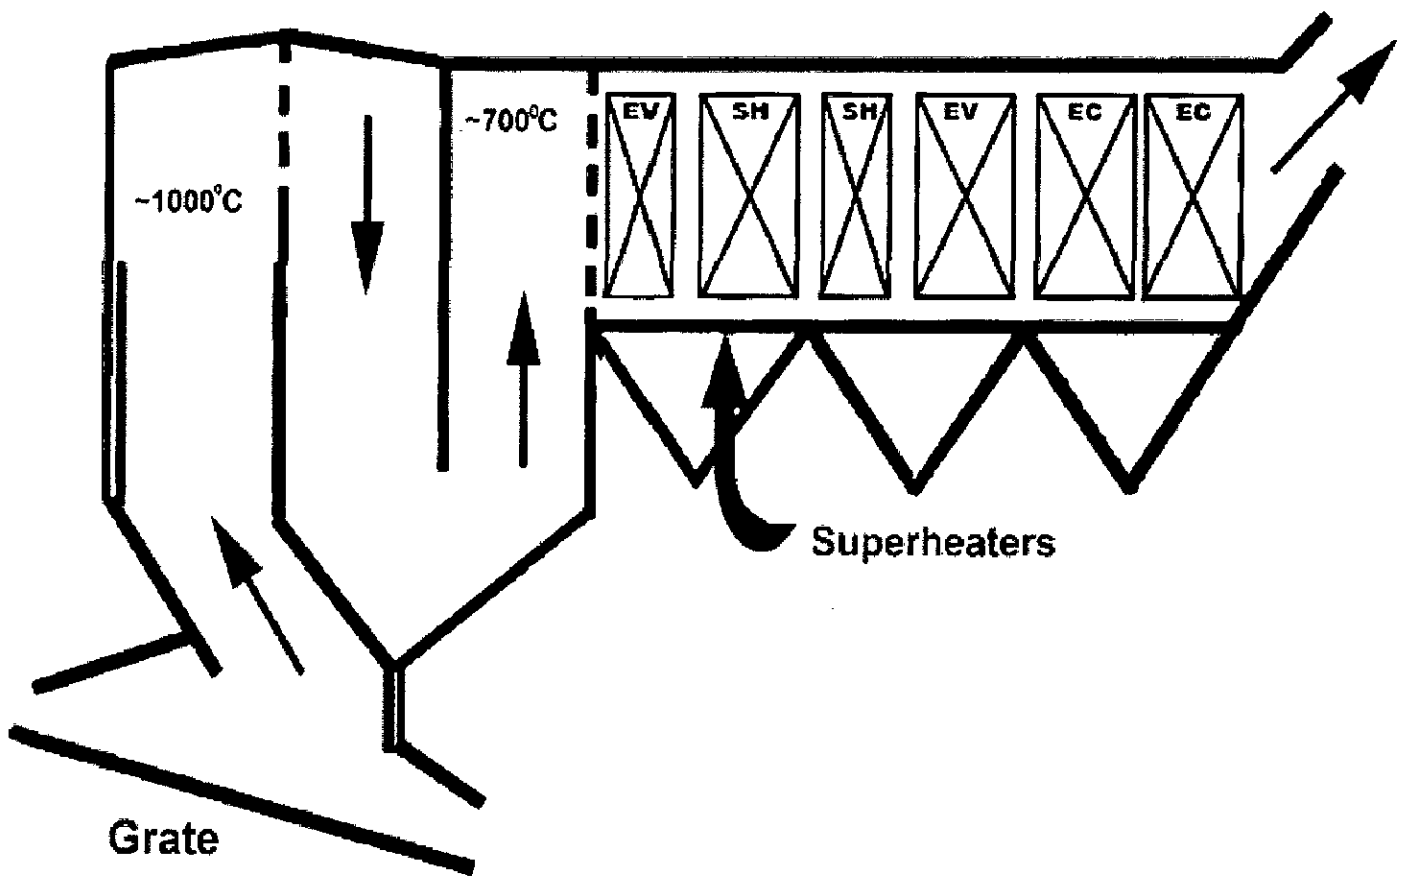
Fig. 2.20: Schematic of a typical boiler and the corresponding corrosion sensitive areas (Rademakers et al., 2002).

Due to the composition of the fuel, the flue gas environment in thermal power plants is very aggressive because of gas components such as Cl_2 , HCl , S , alkali metals, These gases when cooled down form deposits on tube walls by condensation or sublimation; soft and sticky particles can also attach to the heat transfer surfaces. These deposits contain salt of chlorides and sulfates, oxides, silicates and unburned particles. Most sensitive areas attacked by corrosion are the heat transfer surfaces like water walls, screen tubes between the passes and the superheater tube bundles. Screen tubes are installed in some boilers in front of the superheater tubes bundles to reduce the temperature and velocities of the flue gas entering into the superheater tubes. Most modern thermal power plant boilers are operated at 40 bars steam pressures and steam temperature of 400°C , while some other designs, for reasons of thermal efficiency make use of even higher steam pressures and temperature. Fig. 2.20 shows a schematic of a typical waste-to-energy boiler and the corresponding corrosion sensitive areas in the facility (Rademakers et al., 2002).

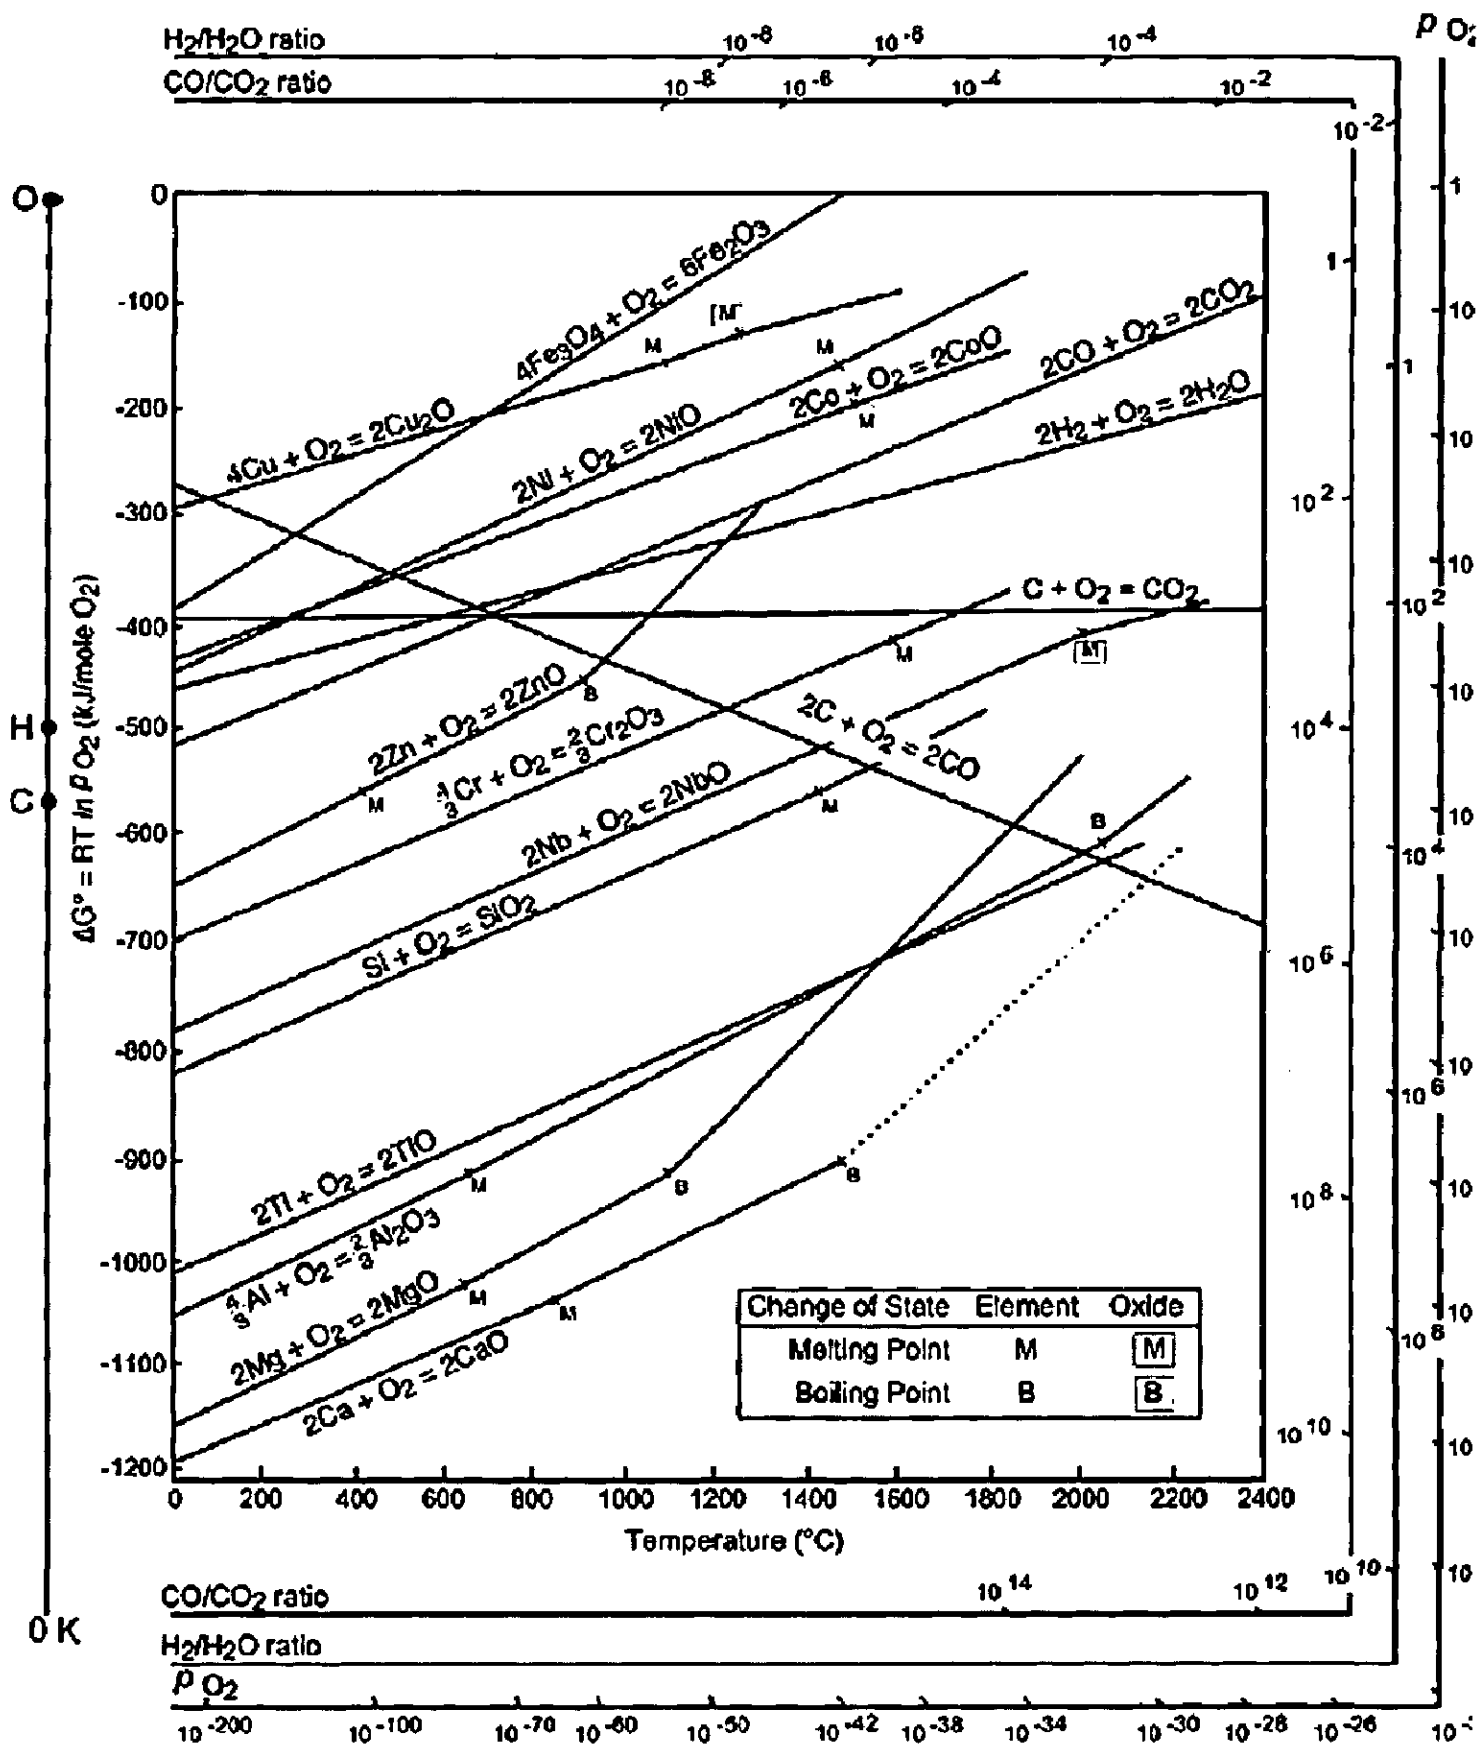
Fig. 2.21: The Ellingham diagram for metallurgically important oxides (Gaskell, 1973).

Since $\Delta G^\circ = \Delta H^\circ - T\Delta S^\circ$, a plot of ΔG° versus T approximates a straight line, which changes in slope where new phases form, i.e. at melting point or boiling point. These plots of standard free energy of reaction (ΔG°) as a function of temperature are known as the Ellingham diagram. Such a diagram can help visualize the relative stability of metals and their oxidized products. Fig. 2.21 shows an Ellingham diagram for many simple oxides (Gaskell, 1973). The values of ΔG° on in Ellingham diagram are expressed as kilojoules per mole of O_2 to normalize the scale and allow comparison of the stability of these oxides directly. The lower on the diagram a metal is found, the more negative the standard free energy of formation, and the more stable its oxide will be. For a given reaction (1), and assuming that the activities of M and MO_2 are taken as unity since activities of pure solids in the stable form are defined as unity at all temperatures and pressures, equation (5) may be used to express the oxygen partial pressure at which the metal and the oxide coexist (i.e. the dissociation pressure of the oxide).
