STUDY OF DETONATION GUN COATED ALLOYS FOR RESISTANCE TO EROSION AND CORROSION

A THESIS

METALLURGICAL AND MATERIALS ENGINEERING

This thesis investigates the erosion and corrosion performance of Al_2O_3 -3 wt % TiO_2 thermal spray coatings deposited by detonation gun technique. As-sprayed coatings were characterized by using the combined techniques of optical microscopy, microhardness testing, X-ray diffractometry (XRD) and scanning electron microscopy/energy-dispersive analysis (SEM/EDX). The corrosion performance was evaluated in oxidising and molten salt environment and also in actual working conditions of boiler. The erosion performance was evaluated at room temperature conditions as well as under high temperature conditions, high erodent velocity, and actual boiler conditions. The corrosion behavior and morphological development were investigated by weight change kinetics, metallographs, depths of attack, metal thickness losses, and XRD analyses.

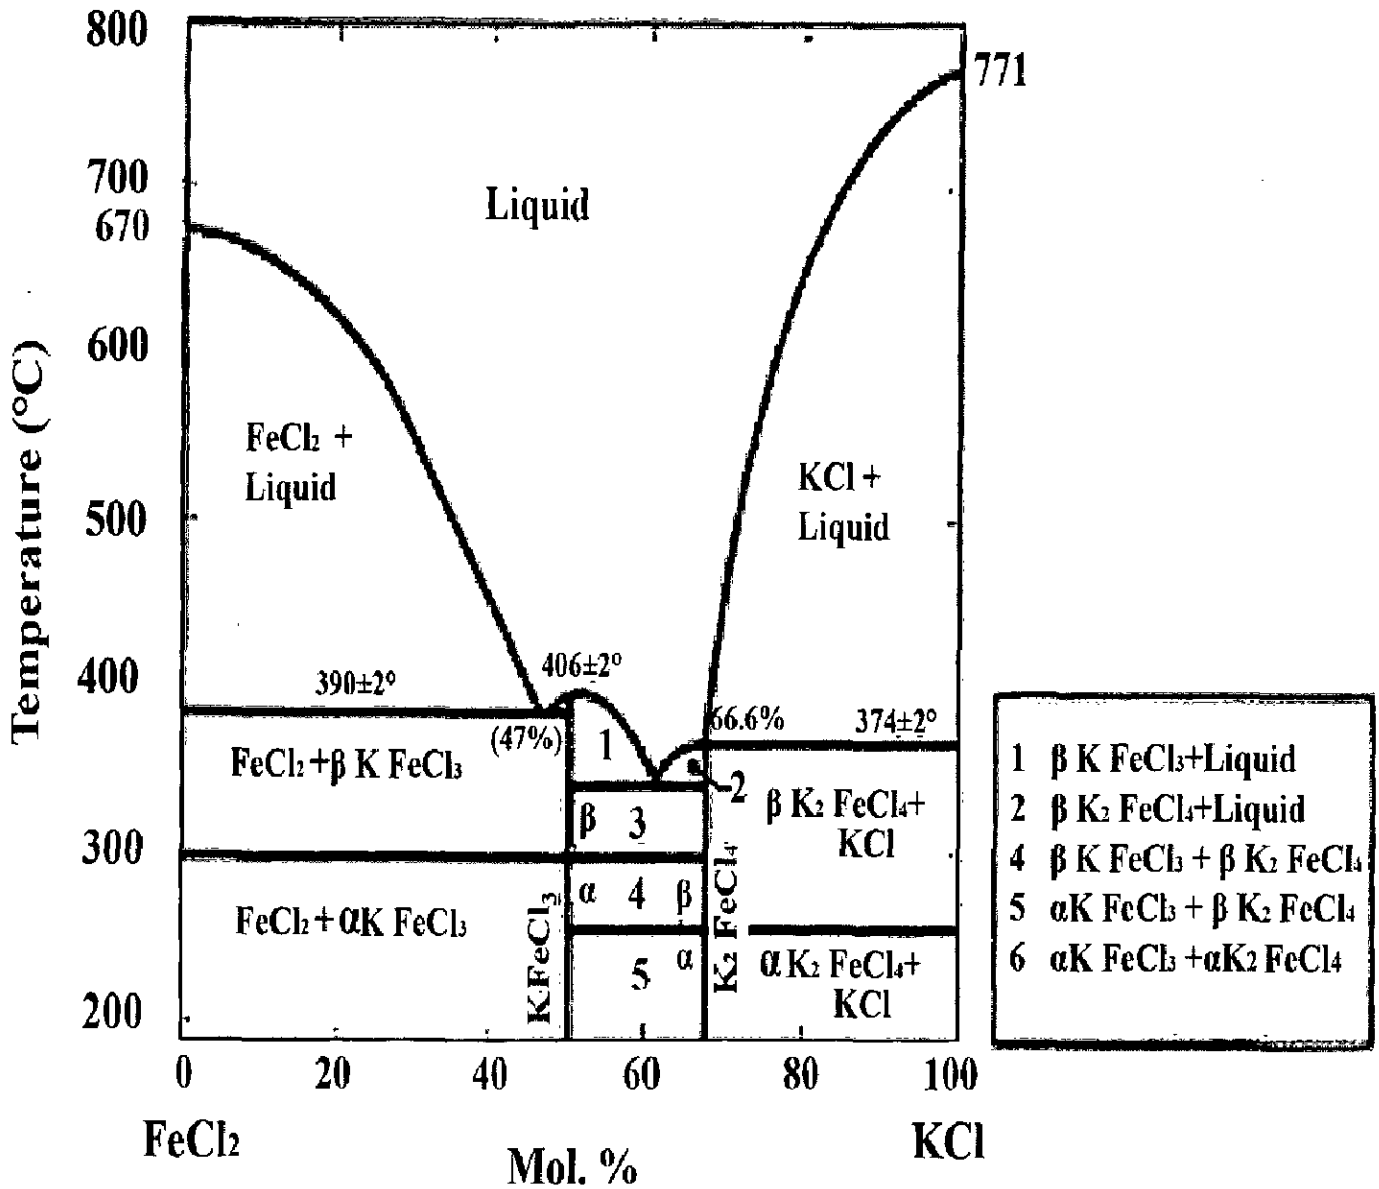
Fig. 2.22: Binary phase diagram of KCl-FeCl₂ (Neilson et al. 2000)

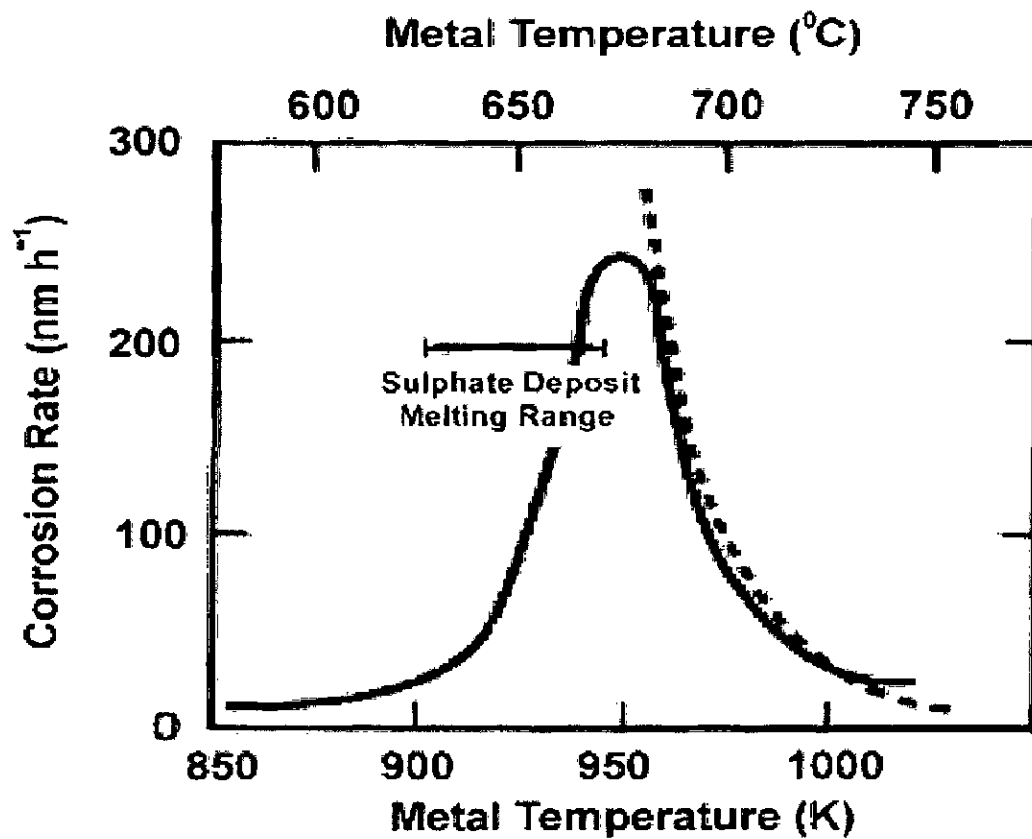
Fig. 2.23: Temperature dependence of corrosion on superheater tubes in coal fired boilers. The dotted line is a theoretical prediction (Cutler and Raask, 1981).

corrosion is observed to be a function of the metal temperature as illustrated in Fig. 2.23 (Cutler and Raask, 1981). The Fig. shows the corrosion rate of the superheater tubes of coal-fired plants at metal temperature above 550°C. The profile of the curve has something to do with the behavior of the ash deposit (which contains sulfates and chlorides (Grabke et al., 1995). At the metal temperatures at the lower end of the range for the superheater tubes, the ash deposit forms a porous layer and the normal oxidation of the metal proceeds, controlled by the growth of the protective oxide layer on the metal surface. As the metal temperatures increase (650°C), the alkali metal sulfate combustion residues form a molten layer next to the protective oxide on the surface of the metal and the corrosion rates increase rapidly over the temperature range in which the melting occurs. The reduction of corrosion rate after the peak (right side of the bell-shape curve) may be explained by the decreasing stability of the iron or chromium sulfates at higher temperatures.

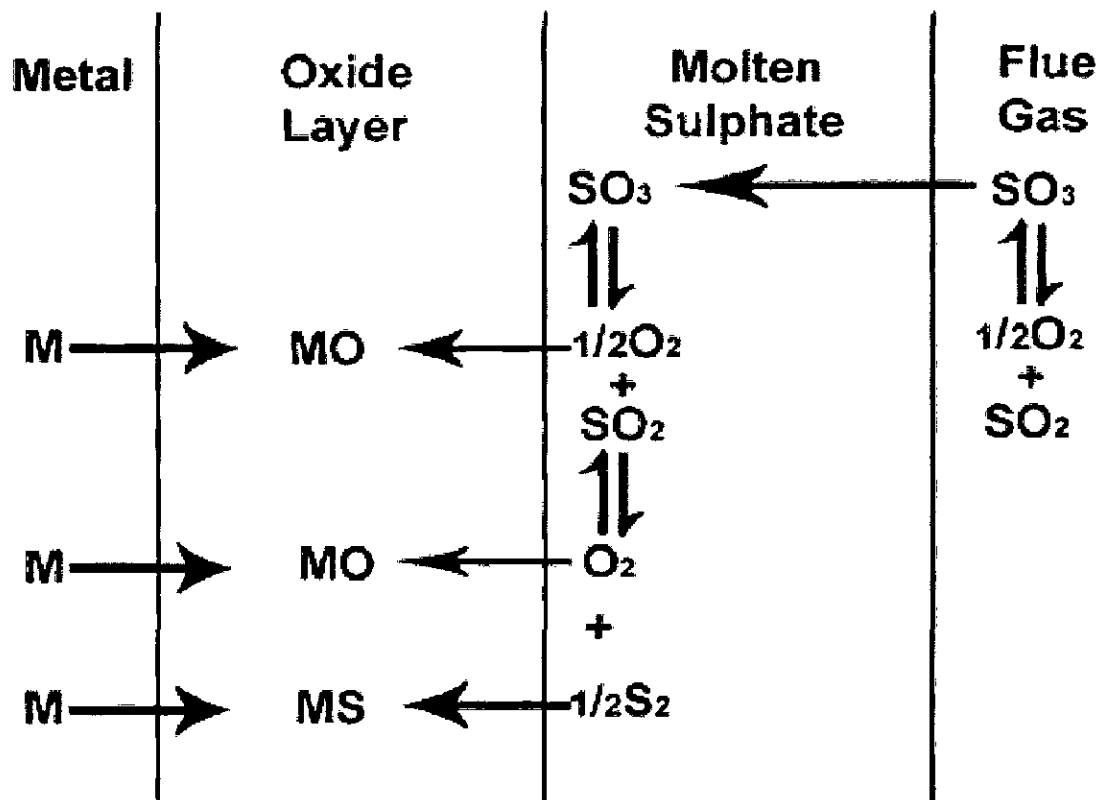
Fig. 2.24: Schematic diagram for the sulfidation mechanism and transport of oxidizing species.

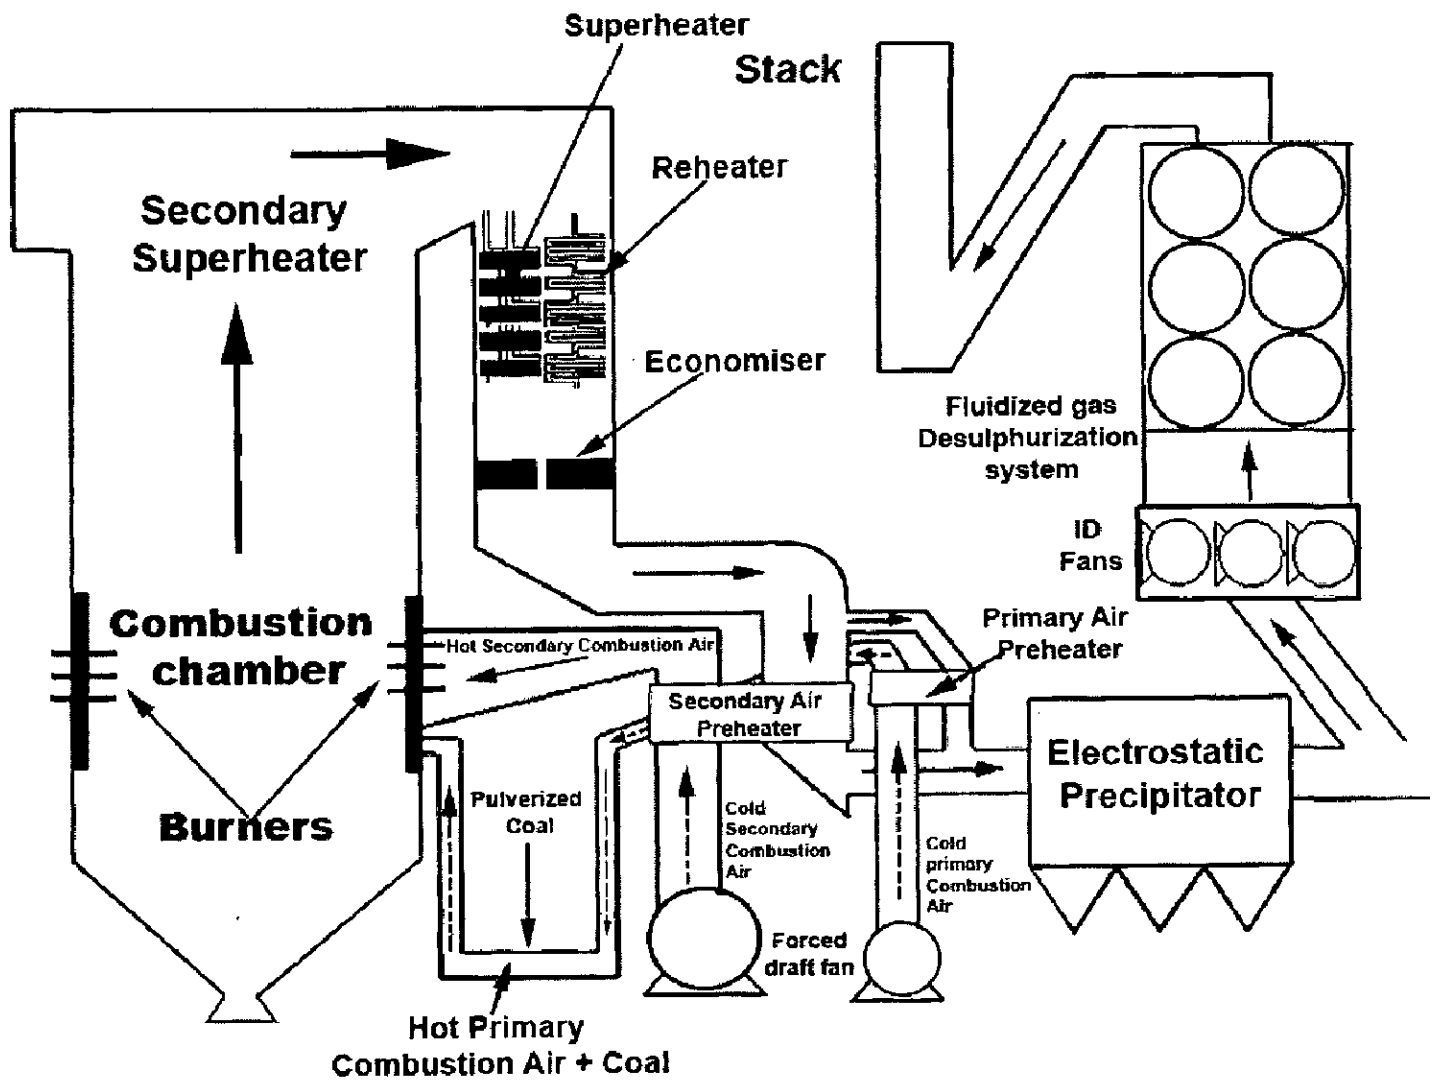
Fig. 2.25: Schematic diagram of a typical coal fired boiler (Das et al., 2006).

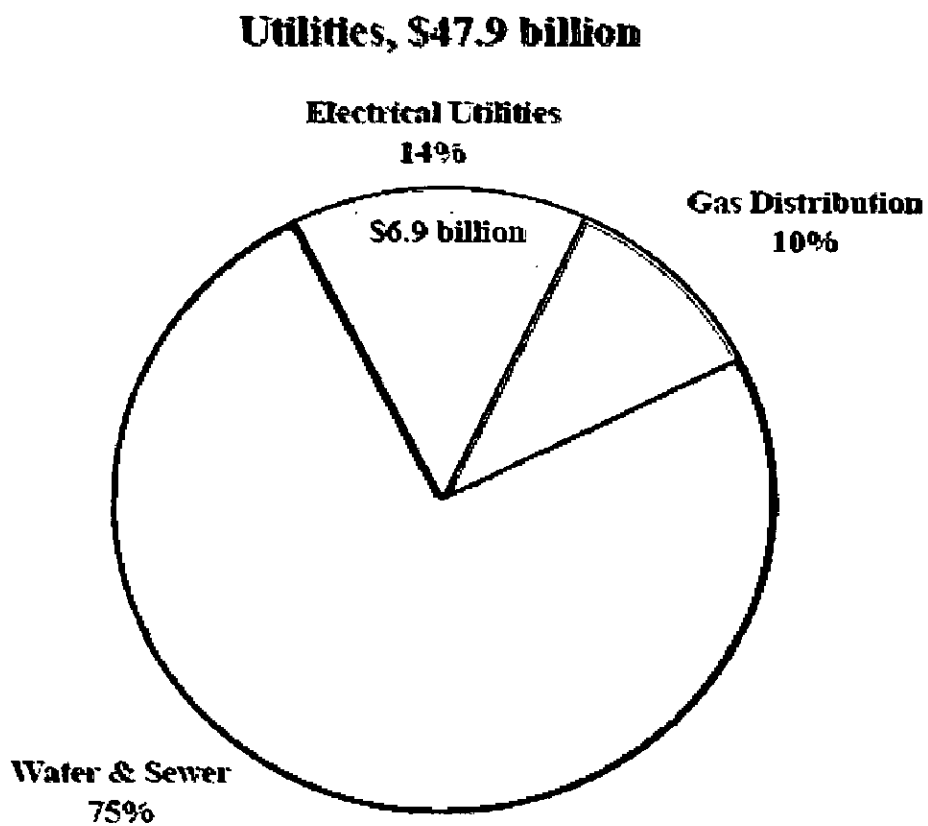
Fig. 2.26: Annual cost of corrosion in the electrical utilities industry (Koch et al., 2001).

significantly. Fig.2.26 shows that the annual cost of corrosion in the electrical utilities sector to be \$6.9 billion, which is 14 percent of the total cost of the Utilities categories.

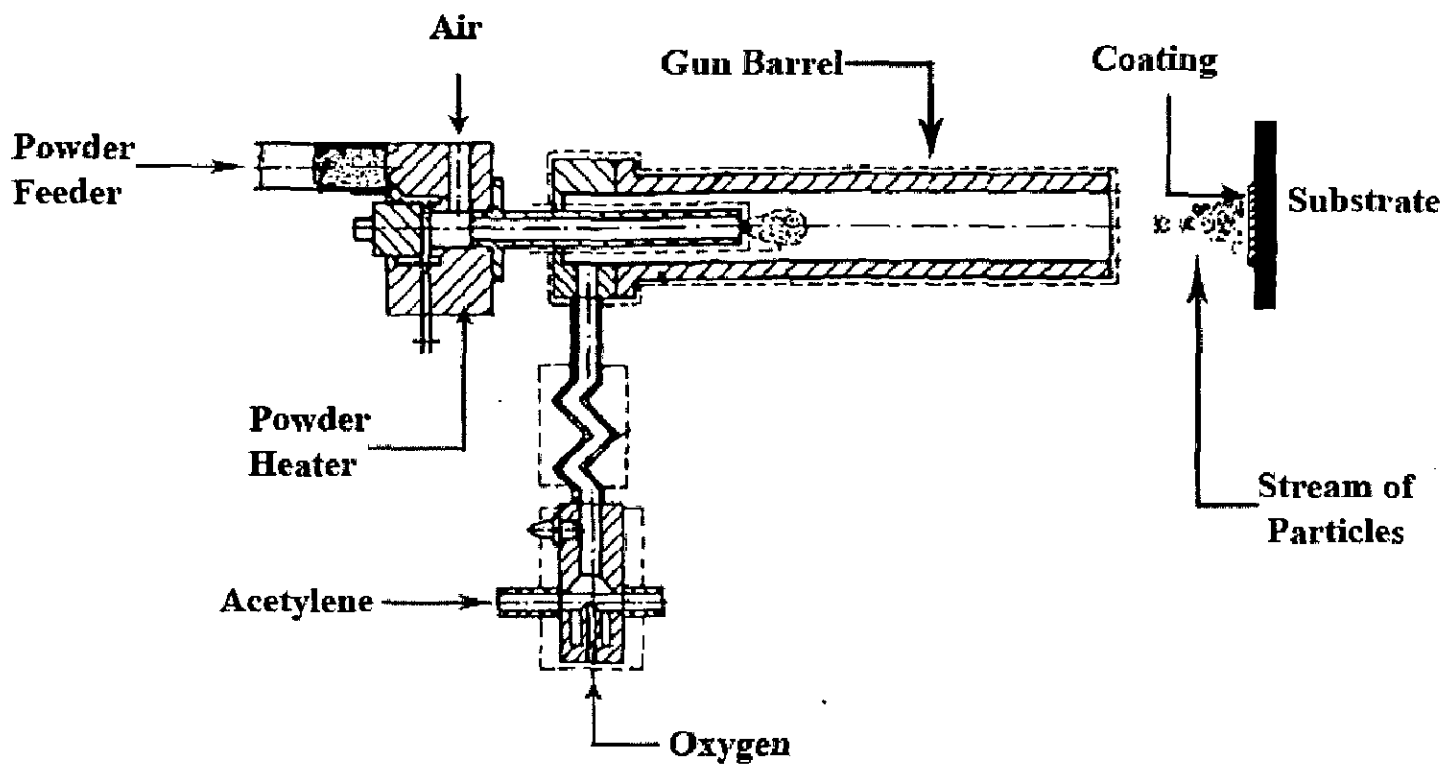
Fig. 3.2: Schematic Diagram of Detonation gun coating system (Saravanan et al., 2000)

The coatings were deposited on the substrates using D-gun spray apparatus. Before starting the coating process, the test specimens were cleaned, degreased and shot blasted. The specimens were grit blasted by alumina (Grit 60) for better adhesion before application of the coatings by detonation spray gun process. The specimens were cleaned with acetone prior to coating. The coating work was carried out by a commercial firm namely SVX Powder M Surface Engineering Private Limited, Greater Noida (India). Detonation gun was arranged in special sound-insulated chambers (cubicles) with concrete walls as shown in Fig. 3.1. The main components of D-gun spraying system involves gas supply, powder feeding system, powder heating system, mixing chamber, barrel, coating chamber as shown in Fig. 3.2.

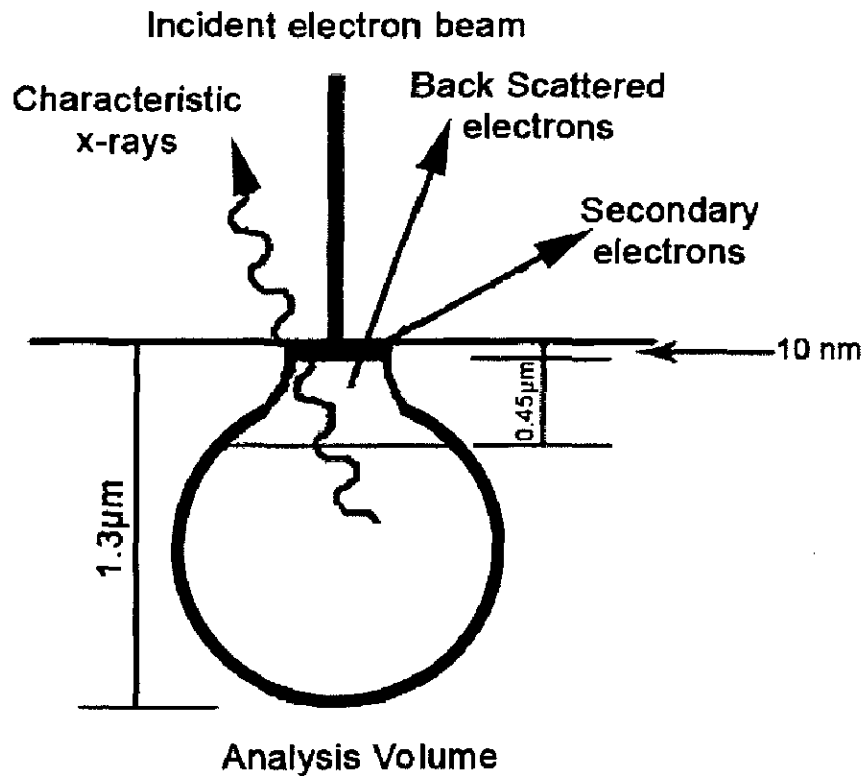
Fig. 3.3: Schematic illustrations of the relative depths from which secondary electrons, back scattered electrons and characteristic x-rays may escape the surface to be detected (Goldstein et al., 1992)

The dispersive nature of the electrons of the primary beam within the specimen, combined with the multiple interactions that each electron has, means that the signals generated from the point of the incident beam are generated over a larger “interaction volume”. The energy of the electrons or x-rays formed determines the depth from which they can escape the surface and be detected, leading to significant variation in the volume of material analysed in each technique, Fig. 3.3.

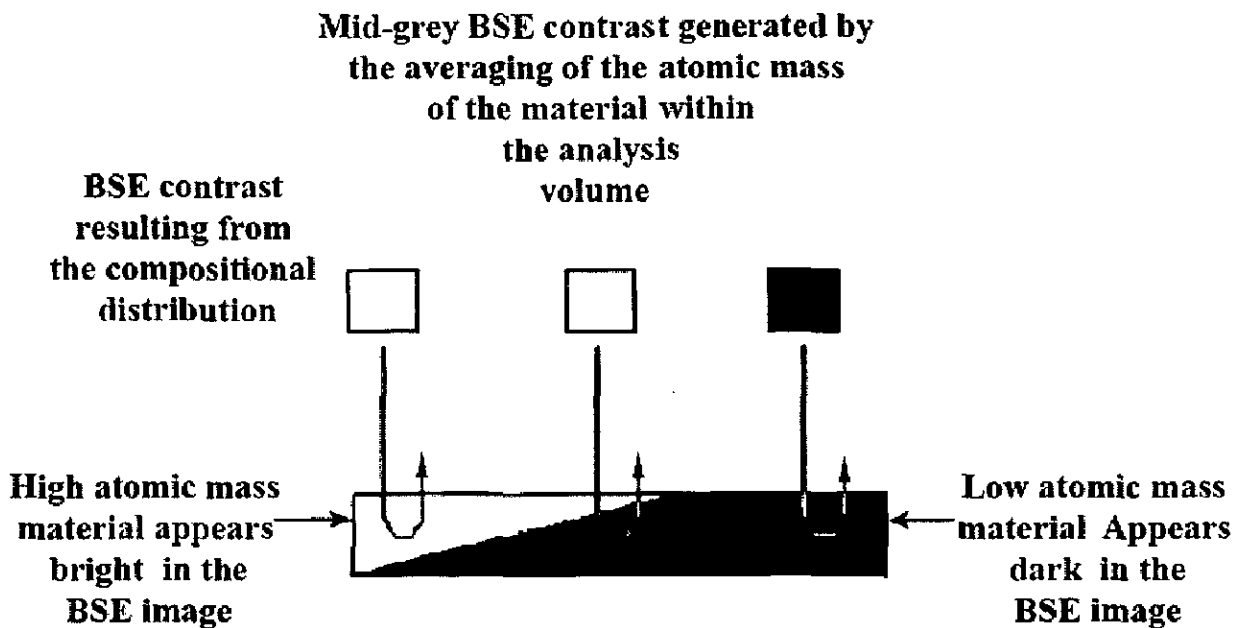
Fig. 3.4: Schematic illustration of BSE grey scale variation as a function of atomic mass distribution within the sample.

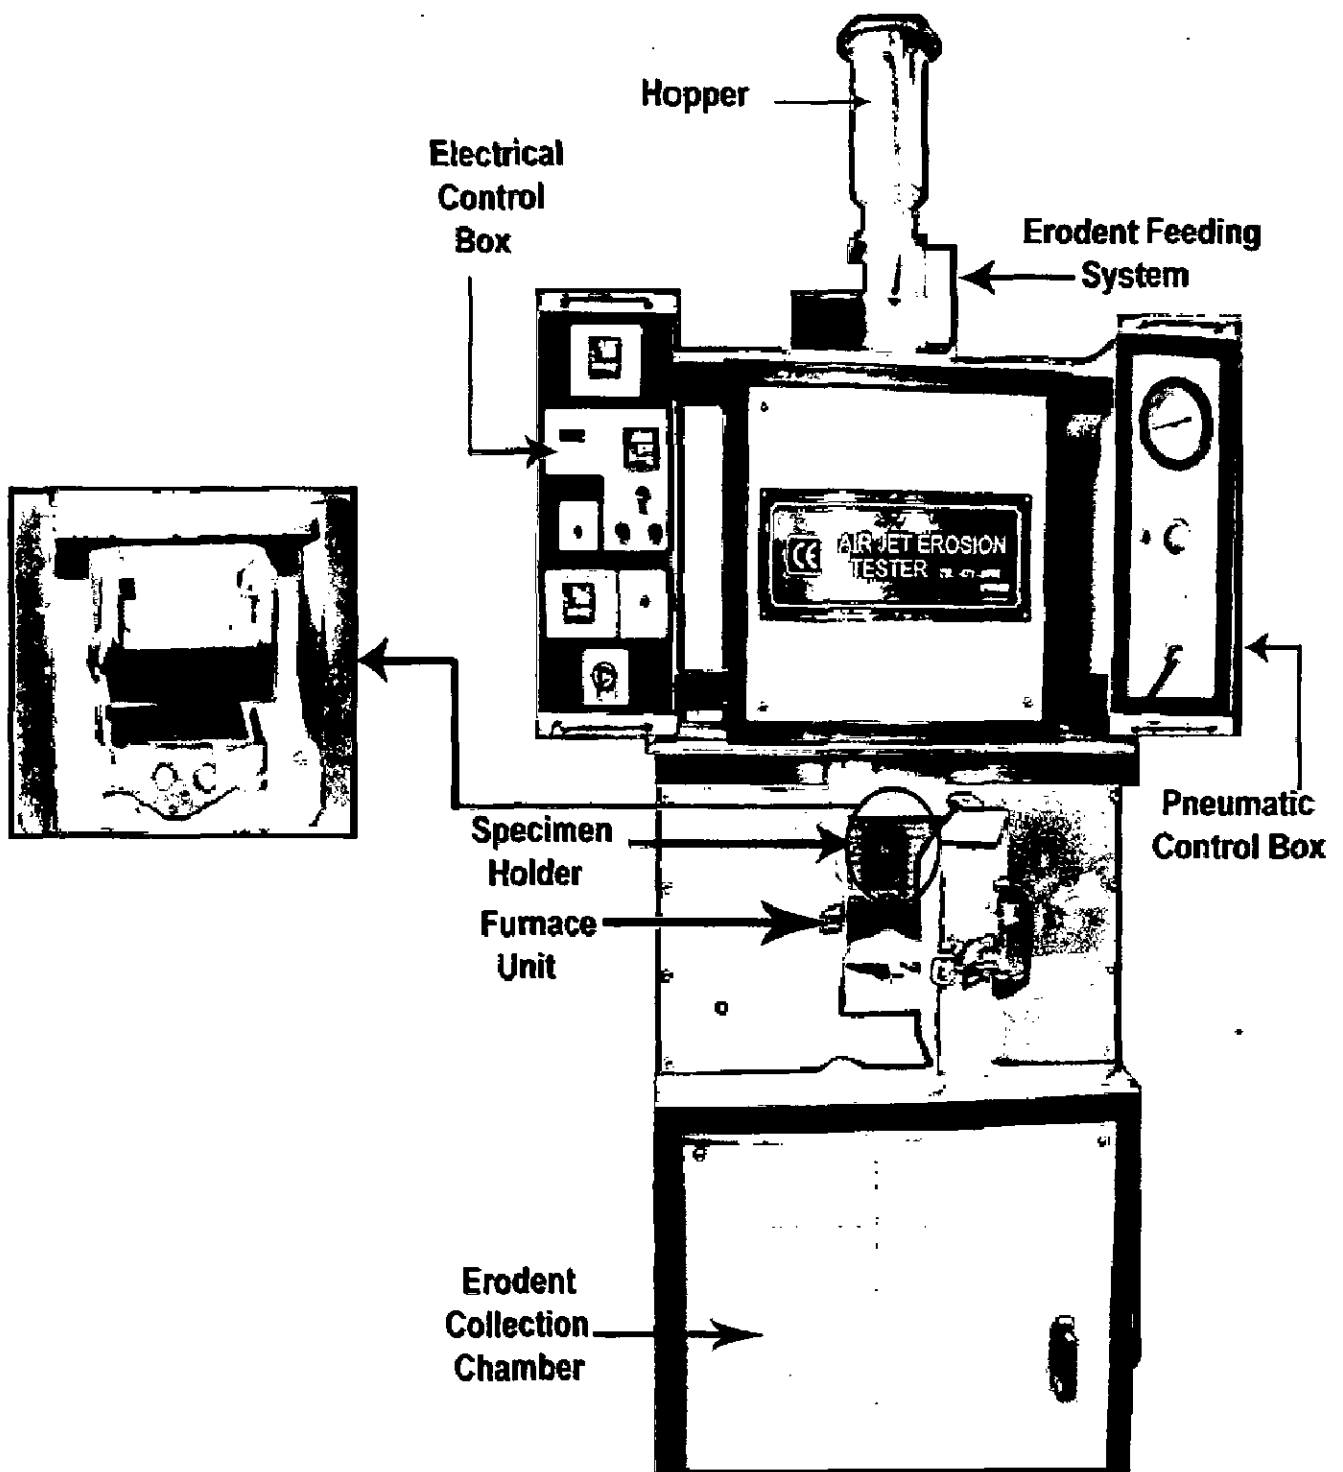
Fig. 3.5: High Temperature Air Jet Erosion Test Rig used for erosion testing.

Erosion testing was carried out using a solid particle erosion test rig TR-471-M10 Air Jet Erosion Tester (Ducom Instruments Private Limited, Bangalore, India) capable of conducting tests at room temperature as well as high temperature shown in Fig.3.5. The rig consisted of an air compressor, erodent feeding system, mixing chamber, furnace unit, specimen holder, nozzle, erodent collection chamber, pneumatic control box and electrical control box shown schematically in Fig. 3.6. The test method utilizes a repeated impact erosion approach involving a small nozzle delivering a stream of gas containing abrasive particles which impacts the surface of a test specimen.

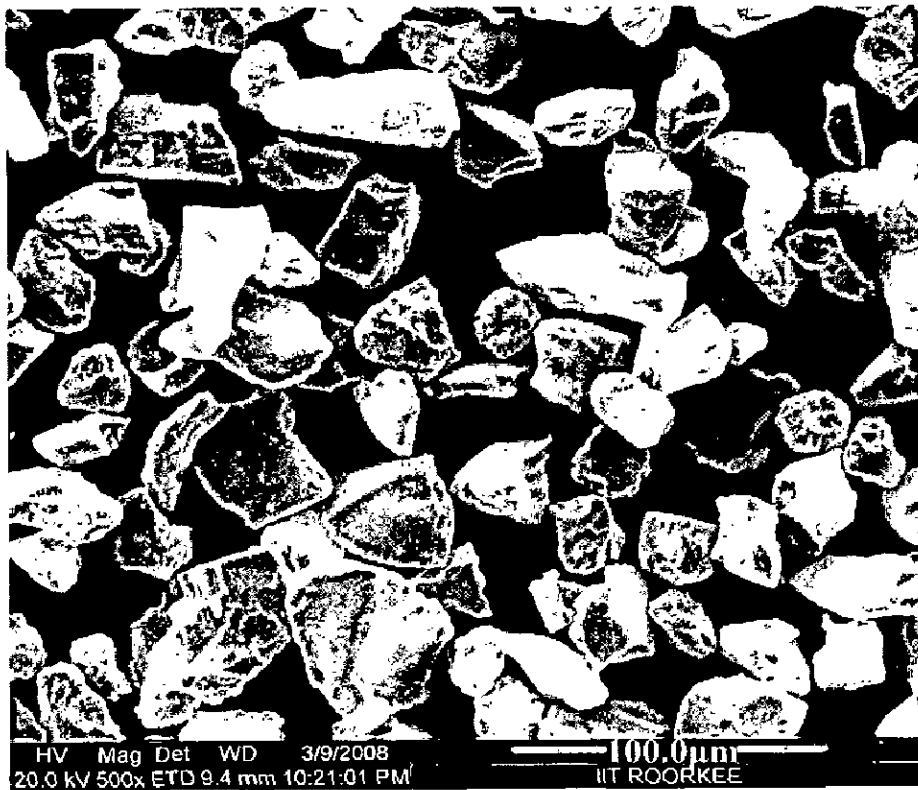
Fig. 3.7: Scanning electron micrograph of the Alumina Erodent particles.

by Ducom Instruments Private Limited, Bangalore, India) was used as erodent (Fig. 3.7). In general, Erosion resistance is measured using weight loss technique by measuring the weights before and after the test. But at high temperature, weight change measurements leads to flawed results due to oxidation of samples. In order to overcome the limitations of the weight change technique, a different technique was used for the present investigation. Erosion resistance was measured in terms of thickness loss after the erosion testing.

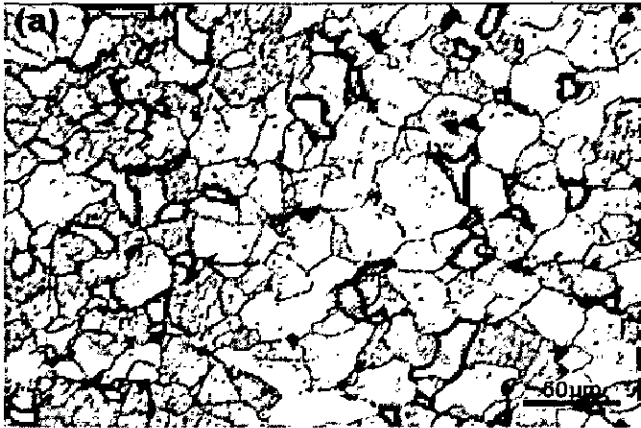
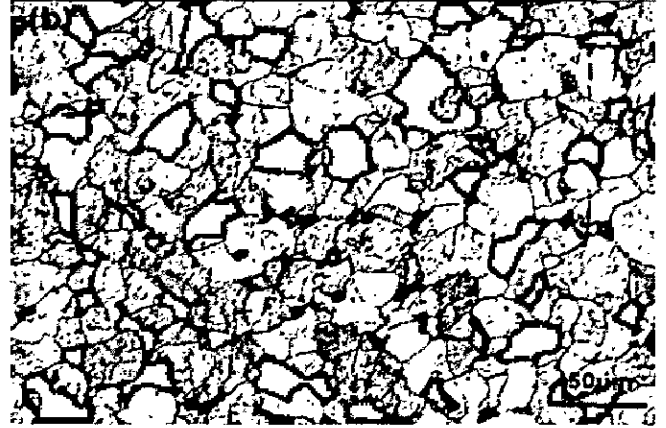
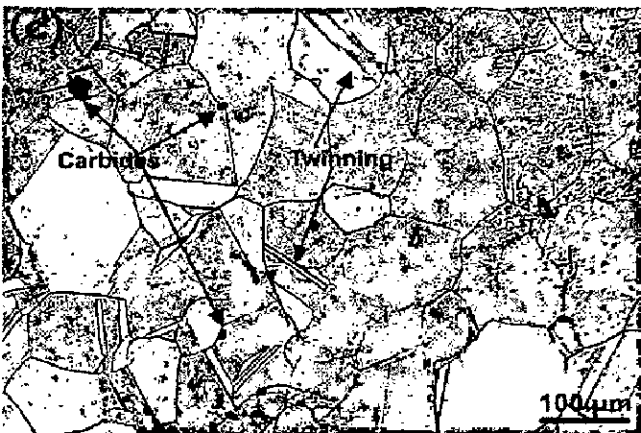
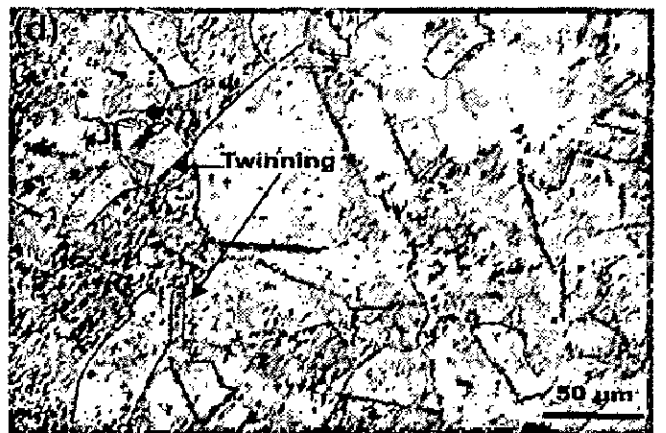
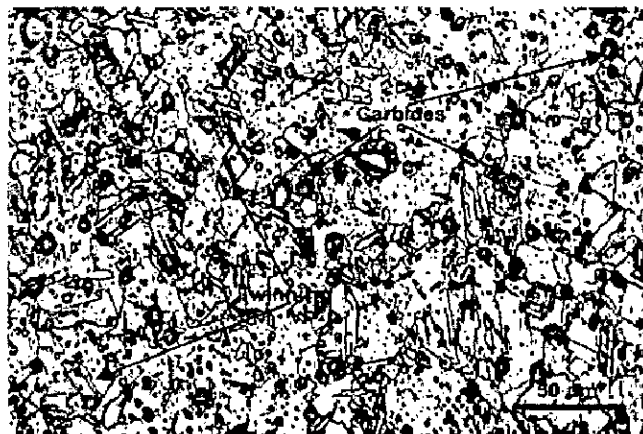
Fig. 4.1: Optical micrographs of the substrate alloys
 (a) Boiler Steel T11 (b) Boiler Steel T22 (c) Superni 600
 (d) Superni 718 (e) Superfer 800

Optical microstructures of the substrate alloys are shown in Fig. 4.1, which are explained with reference to atlas of microstructures for industrial alloys (Metals Handbook, 1972 and ASM Handbook, 1995). The microstructure of T11 and T22 steels consists of ferrite white in colour and pearlite dark in colour as shown in Fig. 4.1 (a) and (b). The microstructures of Superni 600, Superni 718 and Superfer 800, Fig. 4.1 (c), (d) and (e) respectively can be characterised by a nickel-rich γ -solid solution matrix. The microstructure of Superni 600 shows Ni-Cr-Fe solid solution containing fine as well as coarse carbides in the grains and along the grain boundaries, refer Fig. 4.1 (c). Twin boundaries are also visible in the structure of Superni 600. Whereas the microstructure of the Superfer 800 (Fig. 4.1 (e)) consists of a solid solution matrix in which some of the grains are delineated by particles of precipitated carbides at the grain boundaries and by twinning lines (Metals Handbook, 1972).

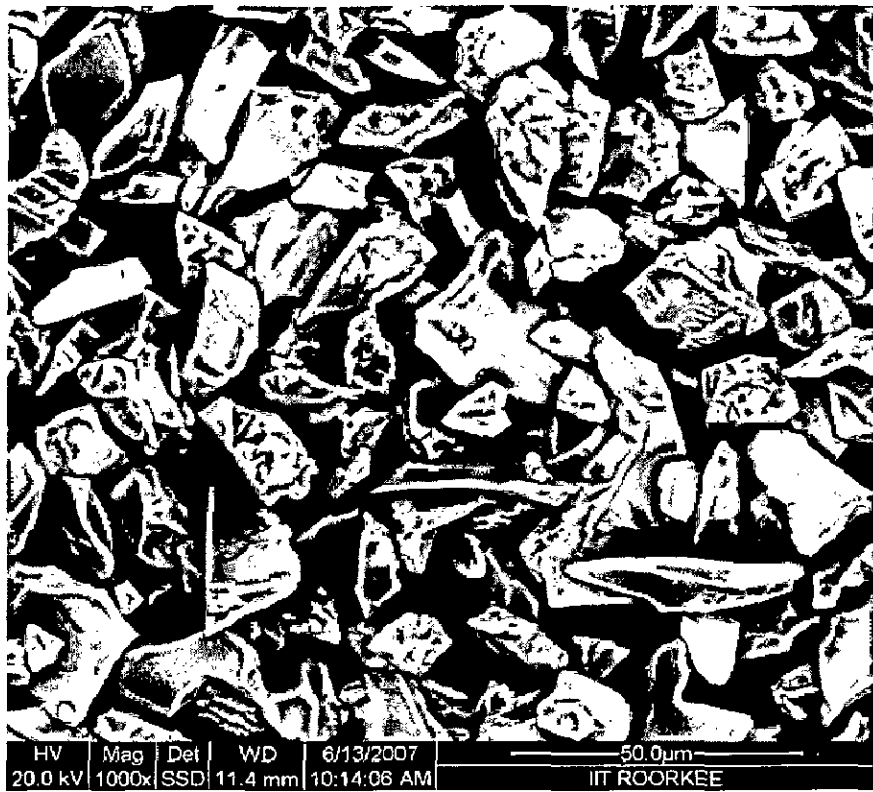
Fig. 4.2: Scanning electron micrographs showing morphology of Al_2O_3 -3wt% TiO_2 powder.

The morphology of powder has been evaluated using SEM. The scanning electron micrographs indicating morphology is shown in Fig. 4.2. Powder particles have irregular and

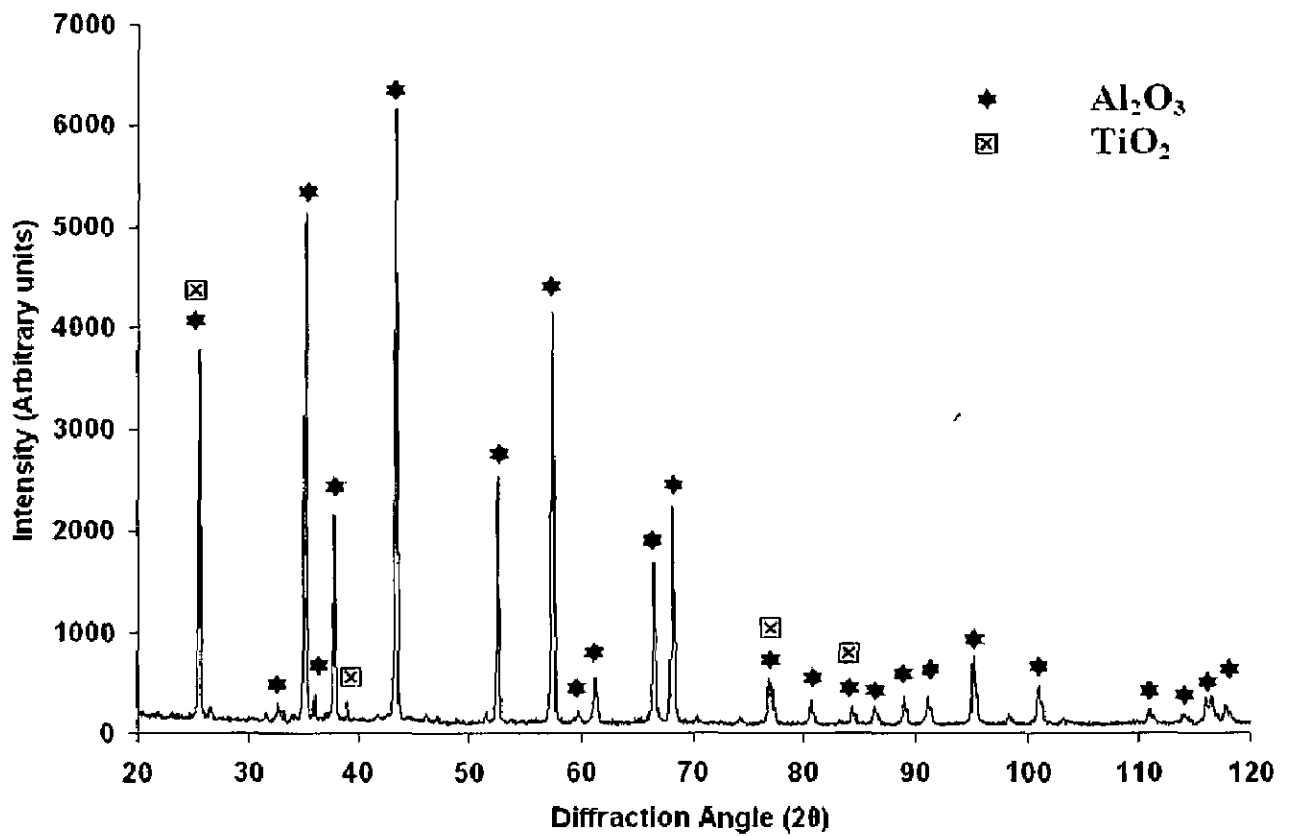
Fig. 4.3: X-ray Diffraction Profile of coating powder Al_2O_3 -3wt% TiO_2 .

angular shape. XRD analysis of the starting powders was conducted using Bruker AXS D-8 Advance Diffractometer (Germany) with $\text{CuK}\alpha$ radiation and nickel filter at 20 mA under a voltage of 35 kV and corresponding X-ray diffraction profiles of the coating powders are shown in Fig. 4.3. The main phase detected is Al_2O_3 and the minor phase is TiO_2 . The rhombohedral α - Al_2O_3 phase along with anatase TiO_2 phase appeared in the powder.

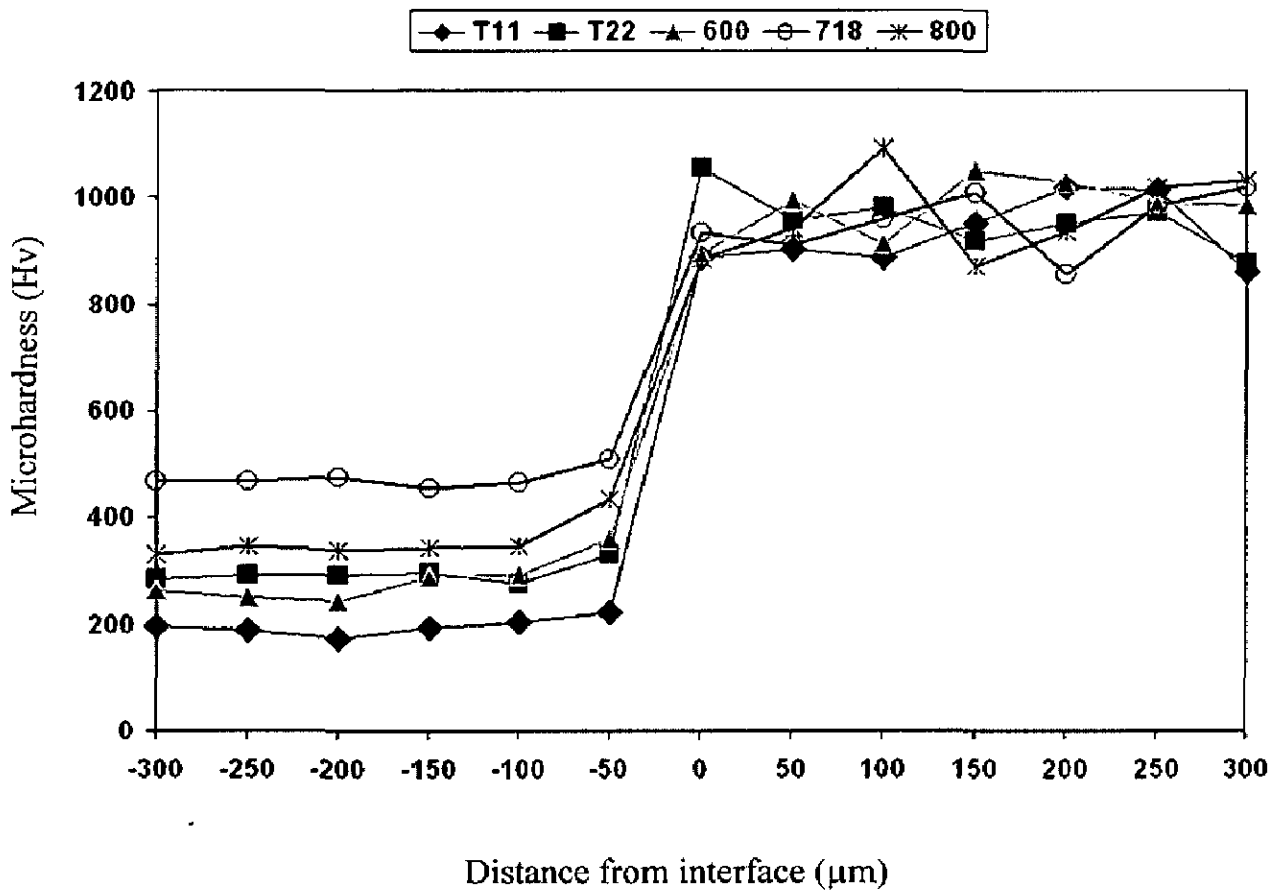
Fig. 4.6: Microhardness profiles of Al_2O_3 -3 wt% TiO_2 coating on different alloys along the cross-section.

Microhardness is the basic mechanical property of coatings, which are used to characterize the performance of coatings. Microhardness of the coatings on different substrate alloys has been measured along the cross-section. Profiles for microhardness versus distance from the coating-substrate interface are depicted in Fig. 4.6. The average microhardness values for T11, T22, Superni 600, Superni 718 and Superfer 800 superalloys are observed to be 194, 270, 290, 462 and 340 Hv respectively as shown in Fig. 4.7. Microhardness of the Al_2O_3 -3wt% TiO_2 coating has been found to be in a range of 862 to 1056 Hv. As velocity of powder particle was higher in D-gun spray process, the coating exhibited higher hardness.

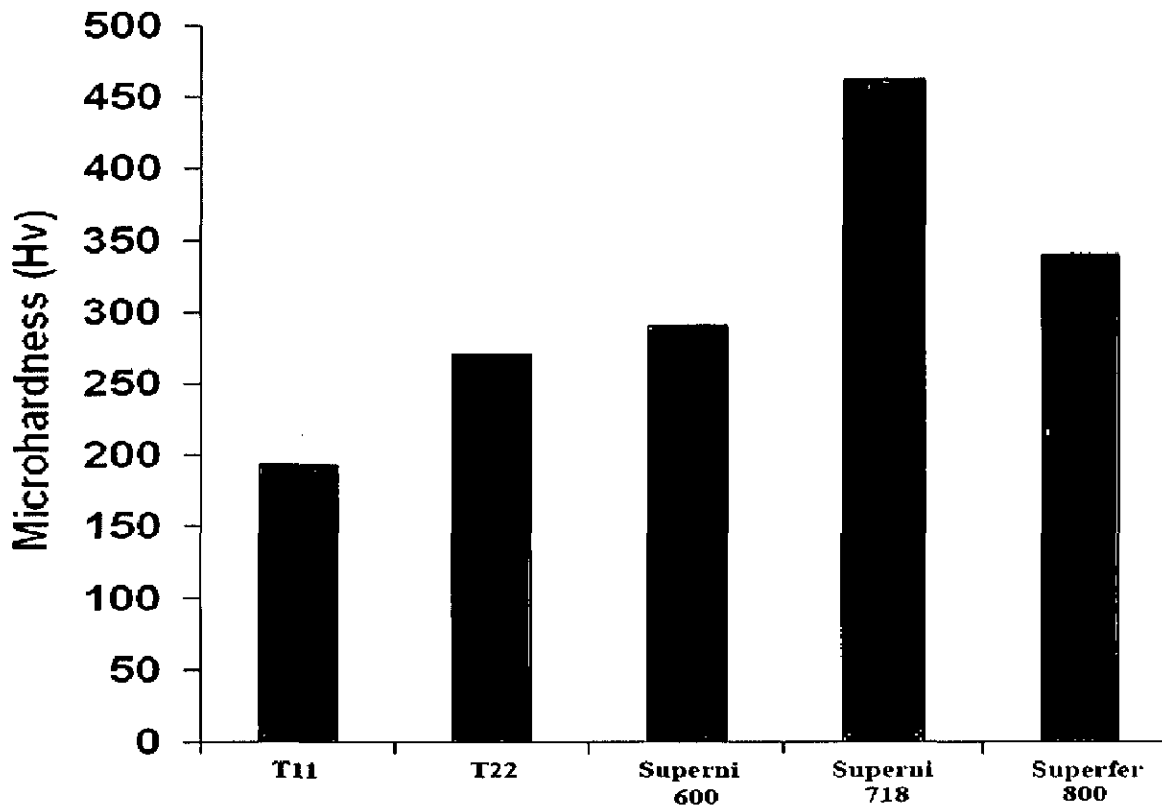
Fig. 4.7: Average microhardness values for T11, T22, Superni 600, Superni 718 and Superfer 800 alloys

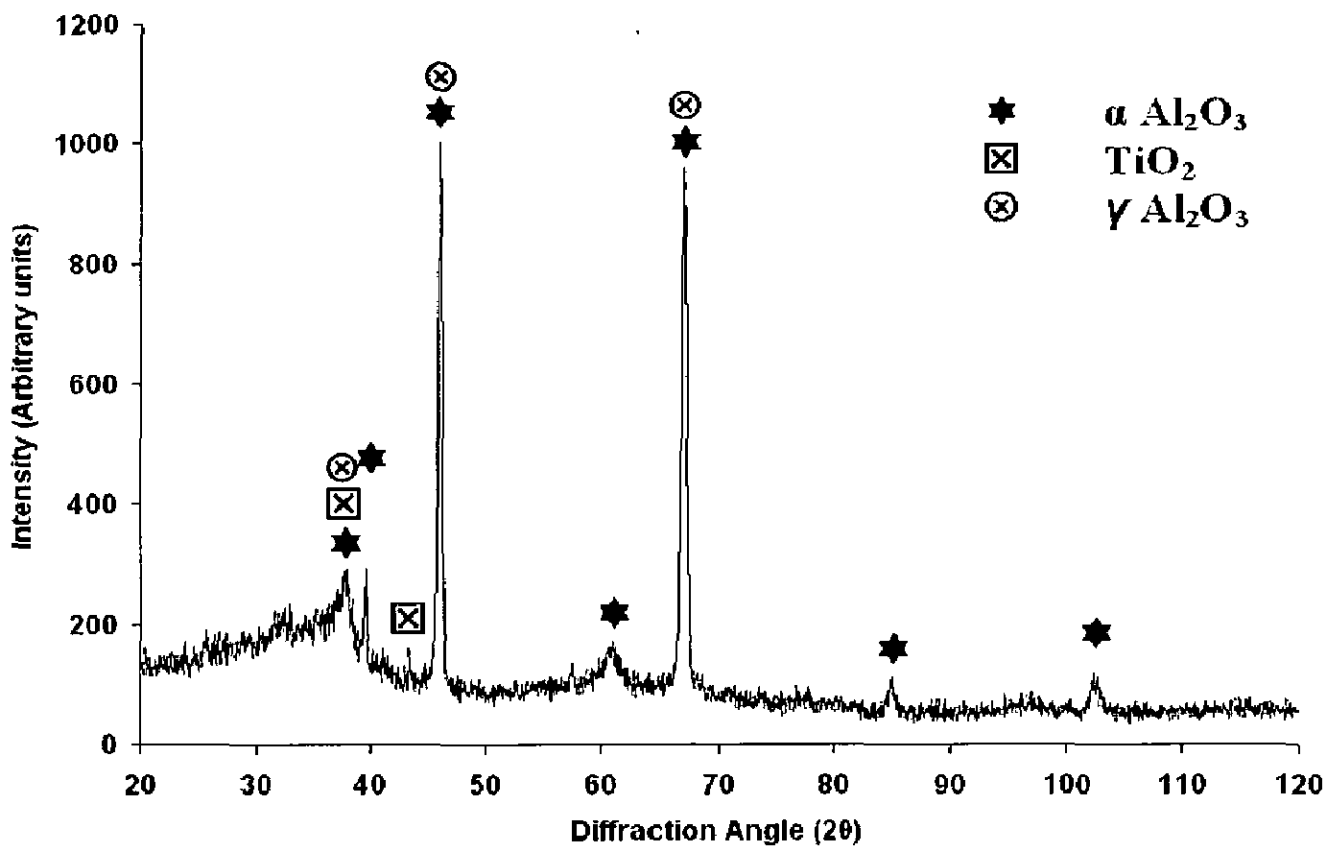
Fig. 4.11 X-ray diffraction pattern for the D-gun sprayed Al_2O_3 -3 wt% TiO_2 coated Boiler Steel T11.

detected in analysis. The XRD results are shown in Figs 4.11 to 4.15. In the XRD spectrum of all the coated substrates, TiO₂ phase has been confined to two peaks only. XRD phase analysis revealed that coating consisted not only of α -Al₂O₃ but also γ -Al₂O₃. The results of the XRD analysis of the initial spray powder and as-sprayed coating were in good agreement with the literature, as typical peaks consisted mostly of α -alumina phase (corundum) with few peaks of titania were detected. Partial transformation of α -alumina to γ -alumina in the deposited coating is due to the spray conditions. The formation of meta-stable alumina as γ (cubic), is due to the heat conditions during the cooling process (Levin et al., 1997; McPherson 1980). It is suggested that the preferential formation of γ -Al₂O₃ is attributed to the high cooling rate (about 10⁶ K/s) of the molten particles during spraying and easy nucleation of γ -Al₂O₃ from the melt superior to α -Al₂O₃ thanks to lower interfacial energy between crystal and liquid (McPherson 1989).

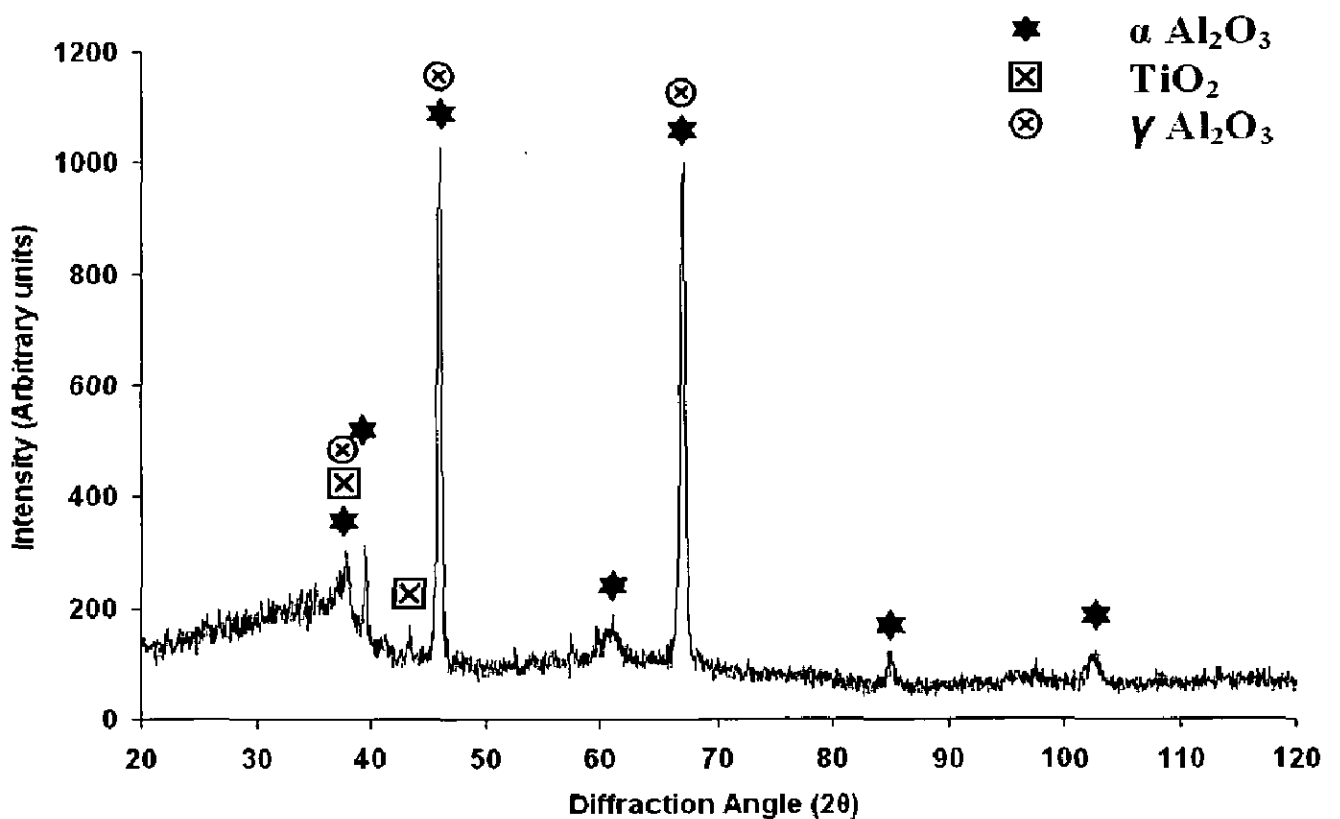
Fig. 4.12 X-ray diffraction pattern for the D-gun sprayed Al_2O_3 -3 wt% TiO_2 coated Boiler steel T22.

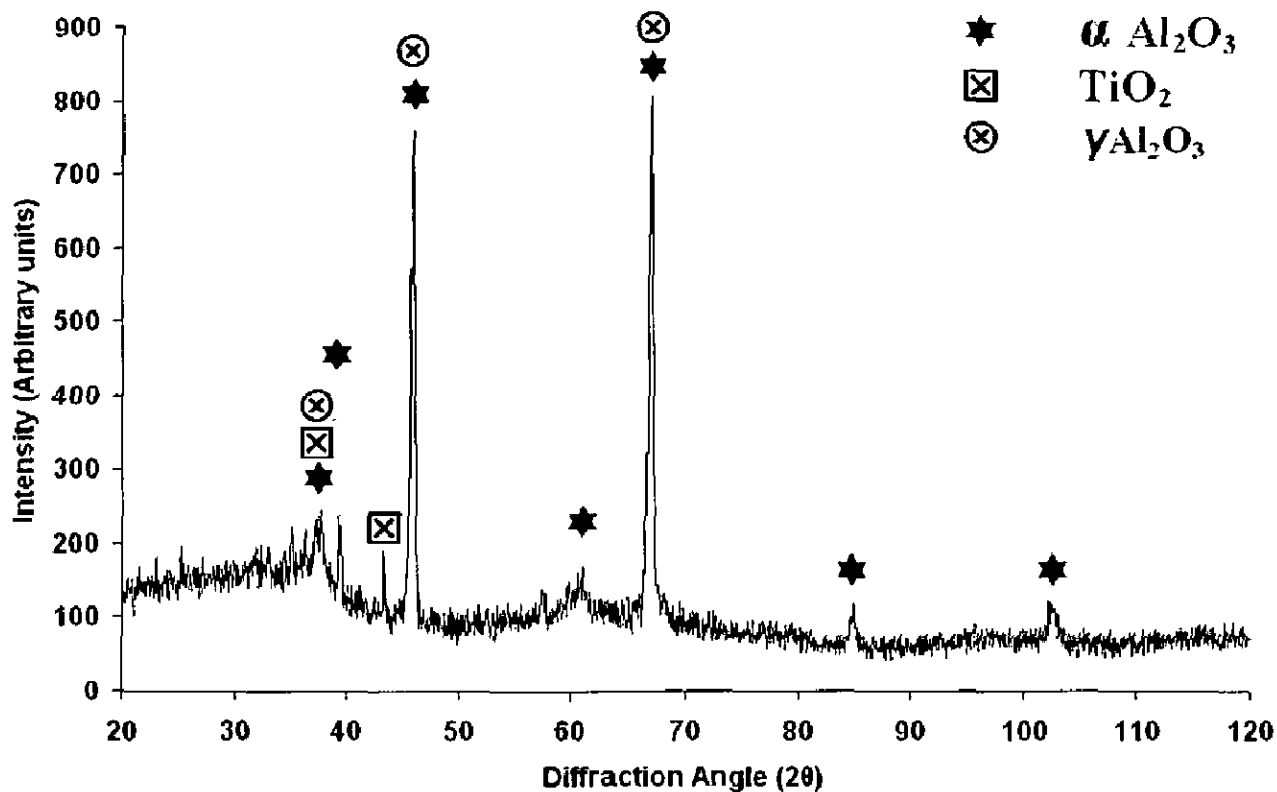
Fig. 4.13 X-ray diffraction pattern for the D-gun sprayed Al₂O₃-3 wt% TiO₂ coated superalloy Superni 600.
