STUDY OF DETONATION GUN COATED ALLOYS FOR RESISTANCE TO EROSION AND CORROSION

A THESIS

METALLURGICAL AND MATERIALS ENGINEERING

This thesis investigates the erosion and corrosion performance of Al_2O_3 -3 wt % TiO_2 thermal spray coatings deposited by detonation gun technique. As-sprayed coatings were characterized by using the combined techniques of optical microscopy, microhardness testing, X-ray diffractometry (XRD) and scanning electron microscopy/energy-dispersive analysis (SEM/EDX). The corrosion performance was evaluated in oxidising and molten salt environment and also in actual working conditions of boiler. The erosion performance was evaluated at room temperature conditions as well as under high temperature conditions, high erodent velocity, and actual boiler conditions. The corrosion behavior and morphological development were investigated by weight change kinetics, metallographs, depths of attack, metal thickness losses, and XRD analyses.

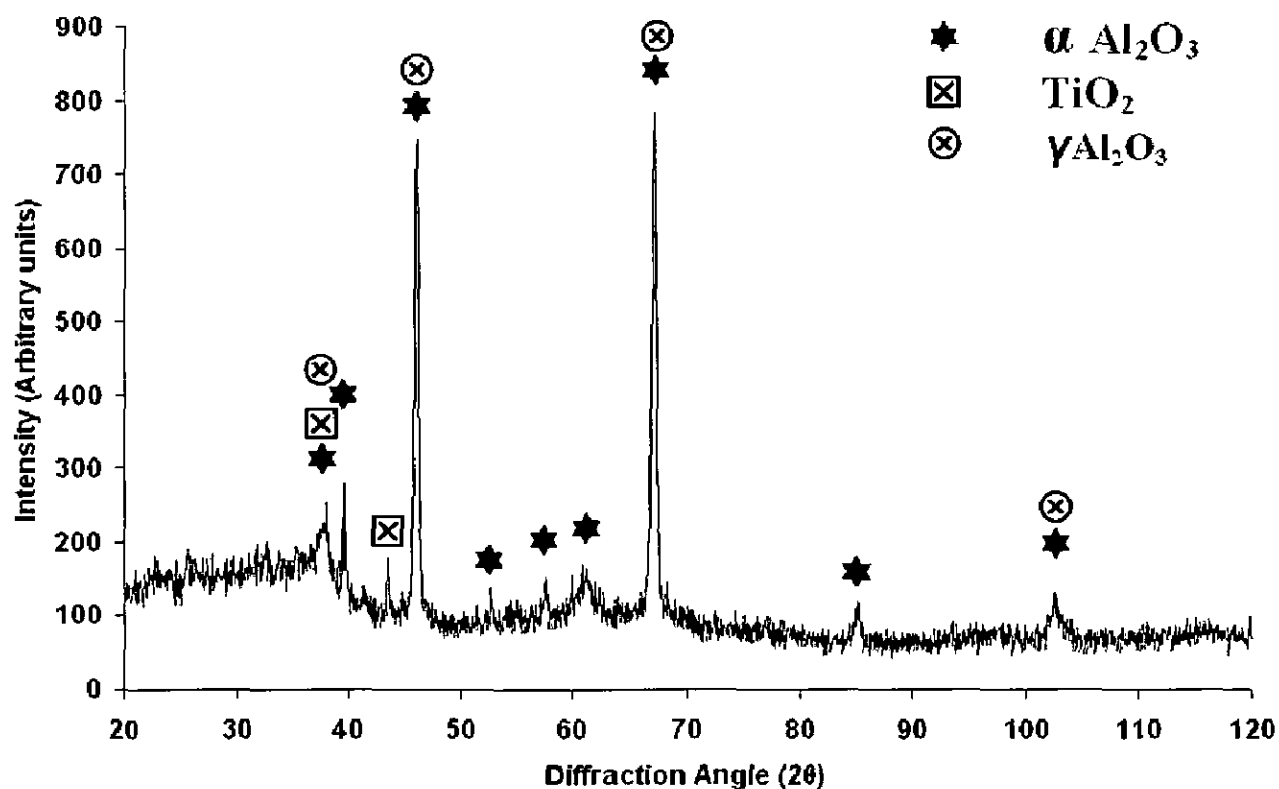
Fig. 4.14 X-ray diffraction pattern for the D-gun sprayed Al₂O₃-3 wt% TiO₂ coated superalloy Superni 718.

detected in analysis. The XRD results are shown in Figs 4.11 to 4.15. In the XRD spectrum of all the coated substrates, TiO₂ phase has been confined to two peaks only. XRD phase analysis revealed that coating consisted not only of α -Al₂O₃ but also γ -Al₂O₃. The results of the XRD analysis of the initial spray powder and as-sprayed coating were in good agreement with the literature, as typical peaks consisted mostly of α -alumina phase (corundum) with few peaks of titania were detected. Partial transformation of α -alumina to γ -alumina in the deposited coating is due to the spray conditions. The formation of meta-stable alumina as γ (cubic), is due to the heat conditions during the cooling process (Levin et al., 1997; McPherson 1980). It is suggested that the preferential formation of γ -Al₂O₃ is attributed to the high cooling rate (about 10⁶ K/s) of the molten particles during spraying and easy nucleation of γ -Al₂O₃ from the melt superior to α -Al₂O₃ thanks to lower interfacial energy between crystal and liquid (McPherson 1989).

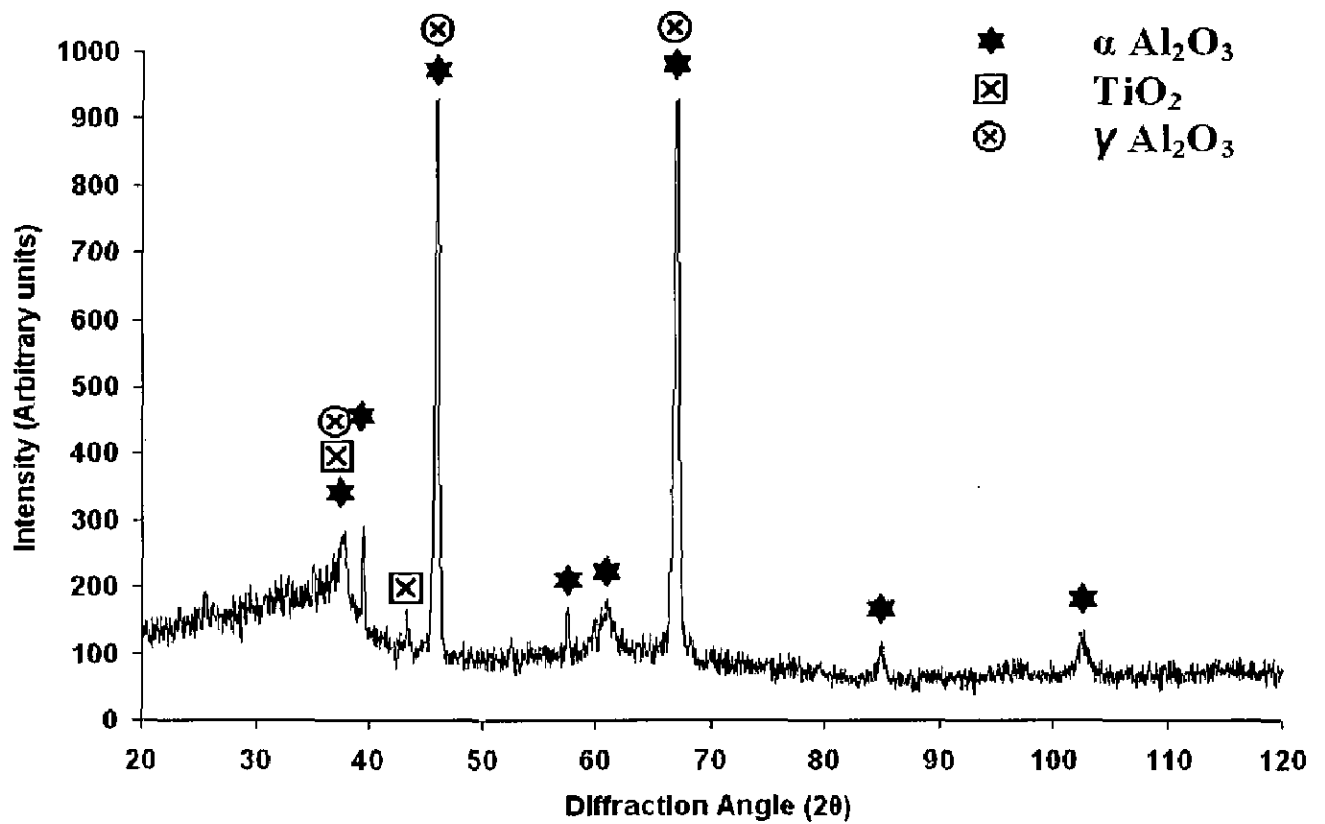
Fig. 4.15 X-ray diffraction pattern for the D-gun sprayed Al_2O_3 -3 wt% TiO_2 coated superalloy Superfer 800.

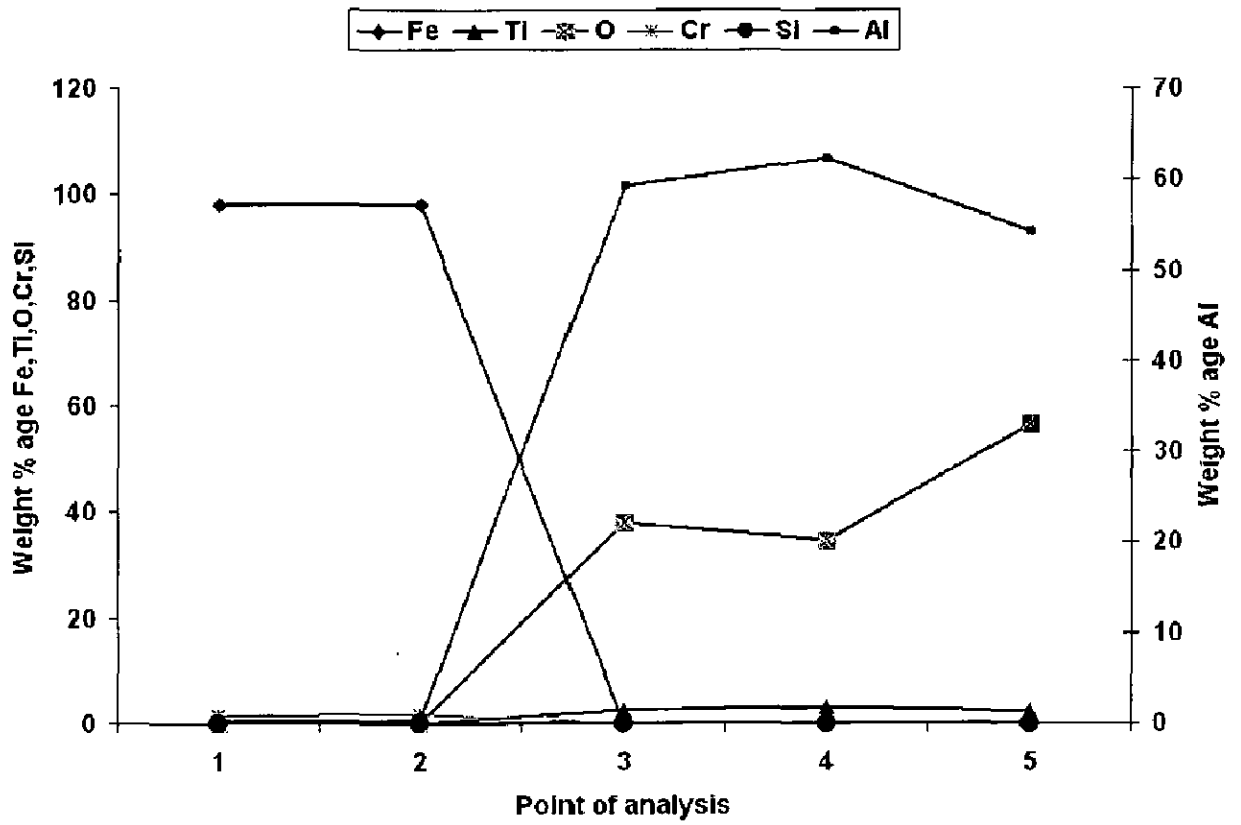
Fig. 4.18: Cross sectional morphology and elemental composition variation across the cross-section of Al_2O_3 -3 wt% TiO_2 coated T11 boiler steels

The BSE image and the EDX analysis across the cross section on Al₂O₃ -3 wt% TiO₂ coated alloys are shown in Fig. 4.18-4.22. In all the coated alloys the coating was quite intact and there were no cracks developed in the coating. Throughout the coating thickness, the composition is entirely of Alumina and Titania. From the cross-sectional microstructures, it can be seen that coatings consist of the lamella built up from the molten droplets impinging on the substrate. The composition contrast from backscattered electron micrographs illustrated that the Al₂O₃-3wt.% TiO₂ coating possessed distinct layered structure, i.e. aluminum-rich regions (grey) separated from titania rich regions (white). Coatings obtained with the powder exhibited a homogeneous layered structure. The white

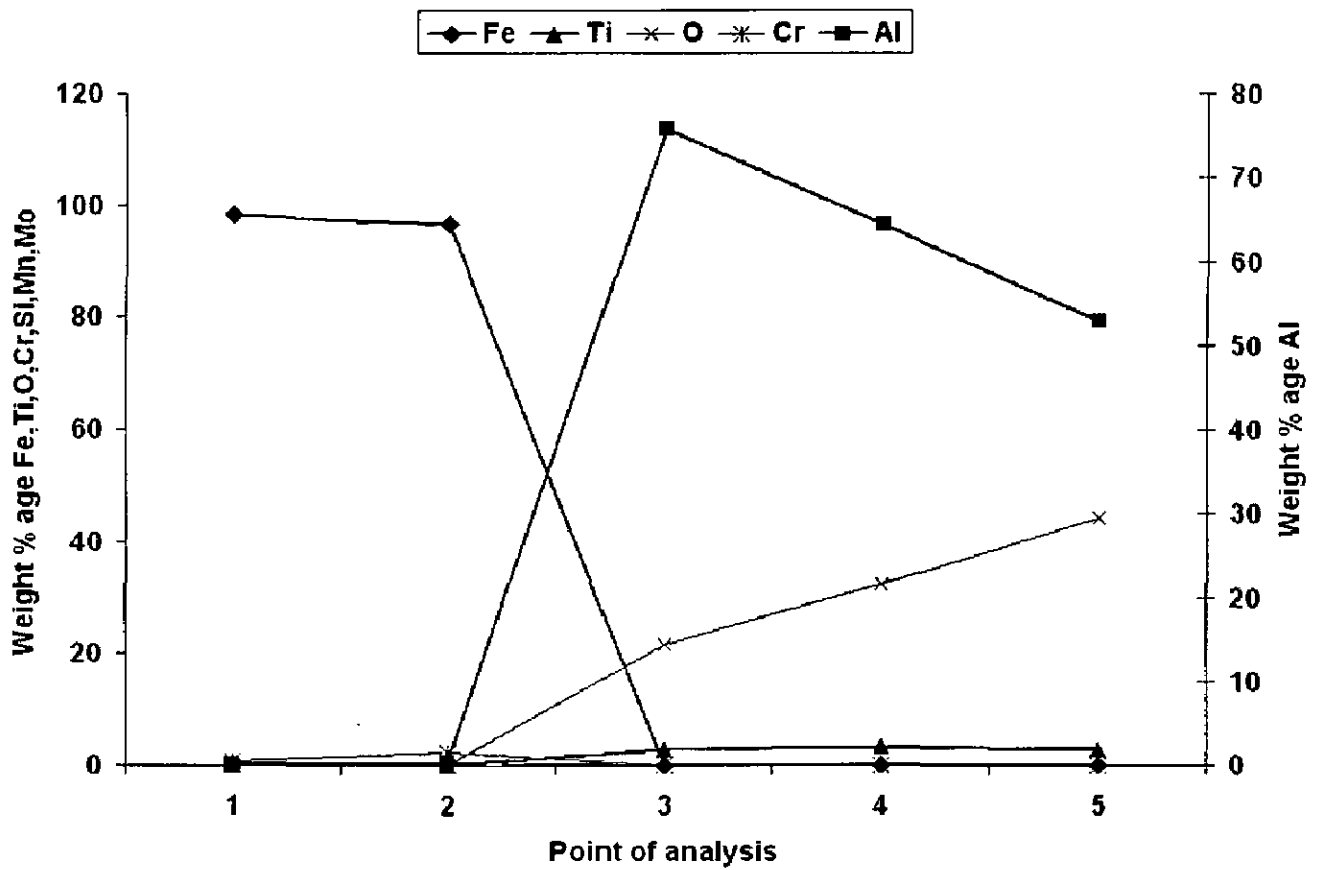
Fig. 4.19: Cross sectional morphology and elemental composition variation across the cross-section of Al_2O_3 -3 wt% TiO_2 coated T22 boiler steels

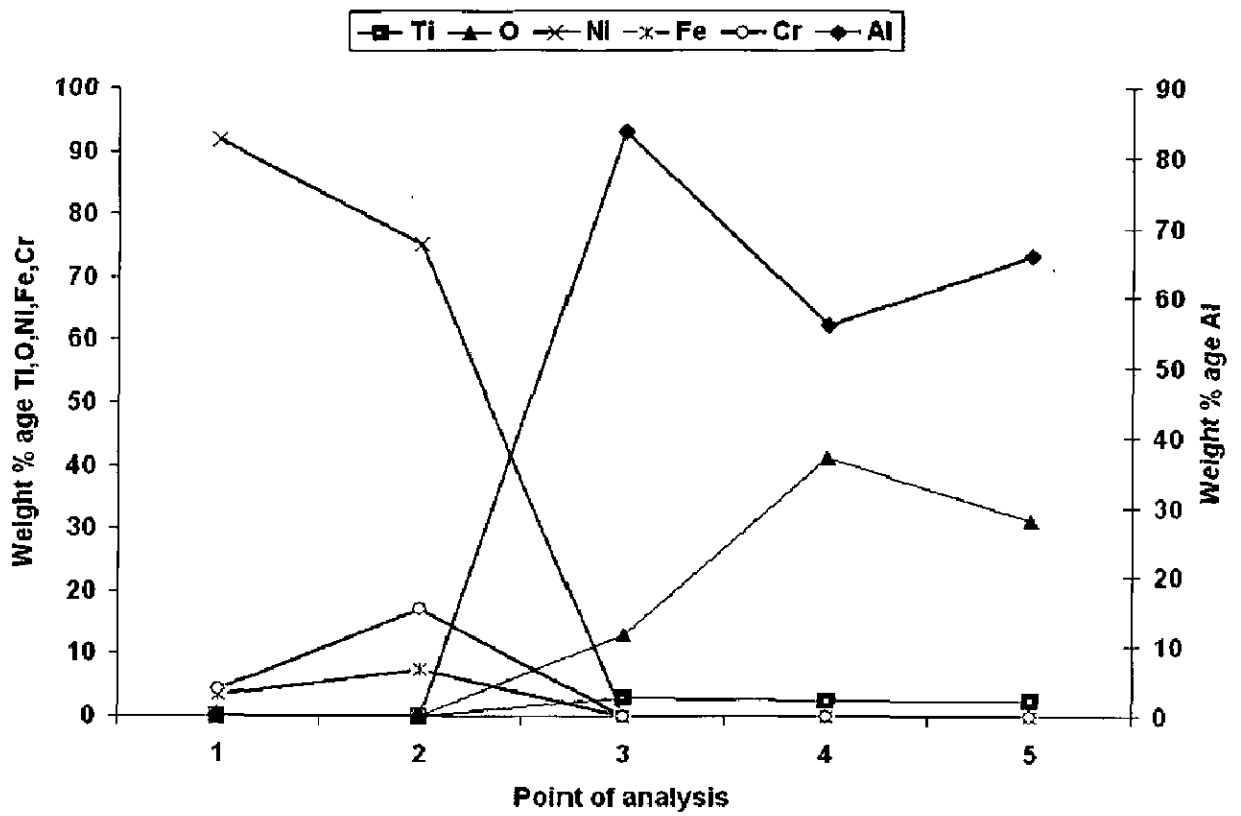
Fig. 4.20: Cross sectional morphology and elemental composition variation across the cross-section of Al₂O₃-3 wt% TiO₂ coated superalloy Superni 600.

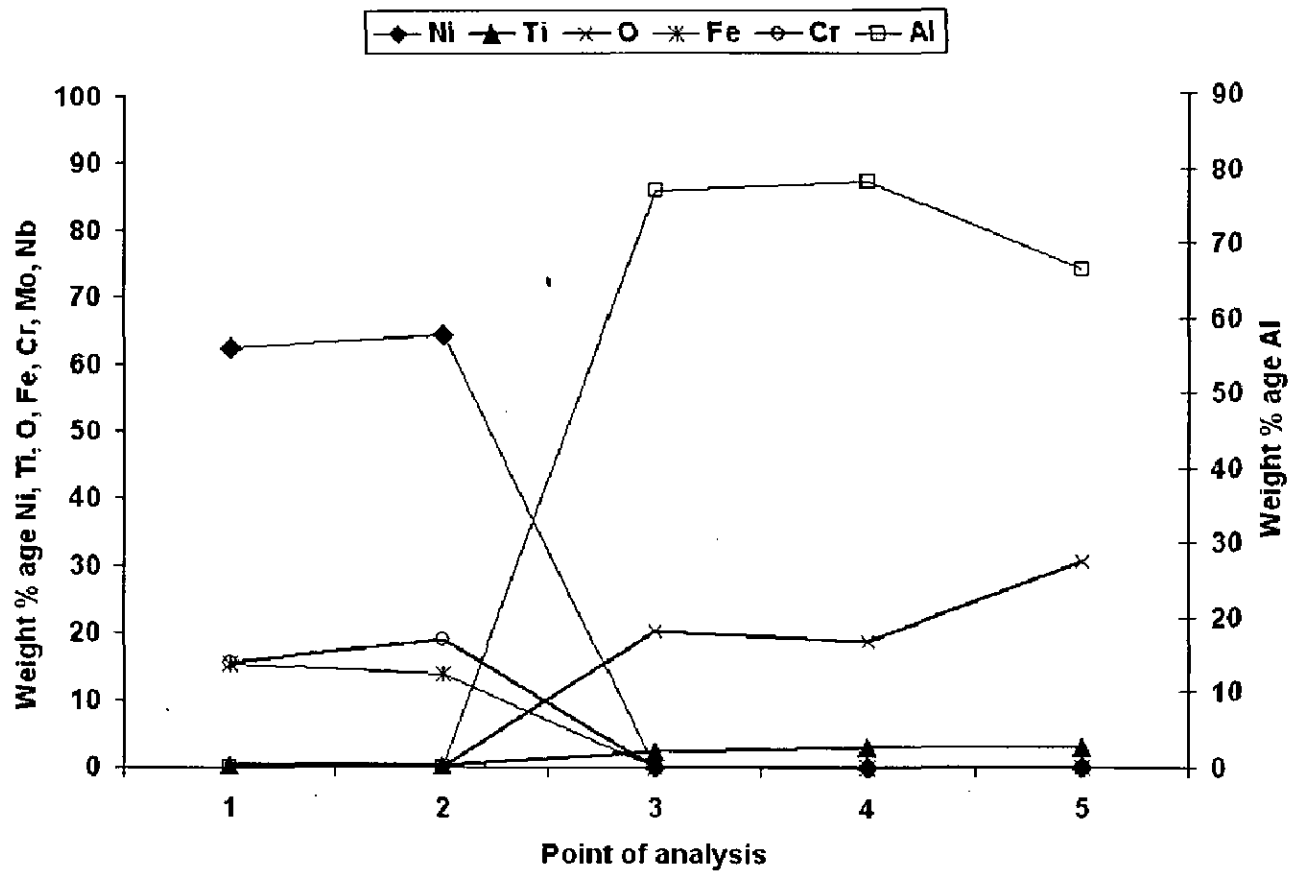
Fig. 4.21: Cross sectional morphology and elemental composition variation across the cross-section of Al_2O_3 -3 wt% TiO_2 coated superalloy Superni 718.

separated from titanium regions (white). The Al_2O_3 -3 wt.% TiO_2 coating exhibited a typical lamellar structure. The microstructure across the cross-section of the coatings is in good agreement with the literature. (Bluni and Mardar, 1996; Erickson et al., 1998; Westergard et al., 1998; Margadant et al., 2001 and Sidhu et al., 2004 and 2005). The EDX compositional analysis across the coating cross-section (Fig. 4.18-4.22) shows the homogeneous elemental concentration.

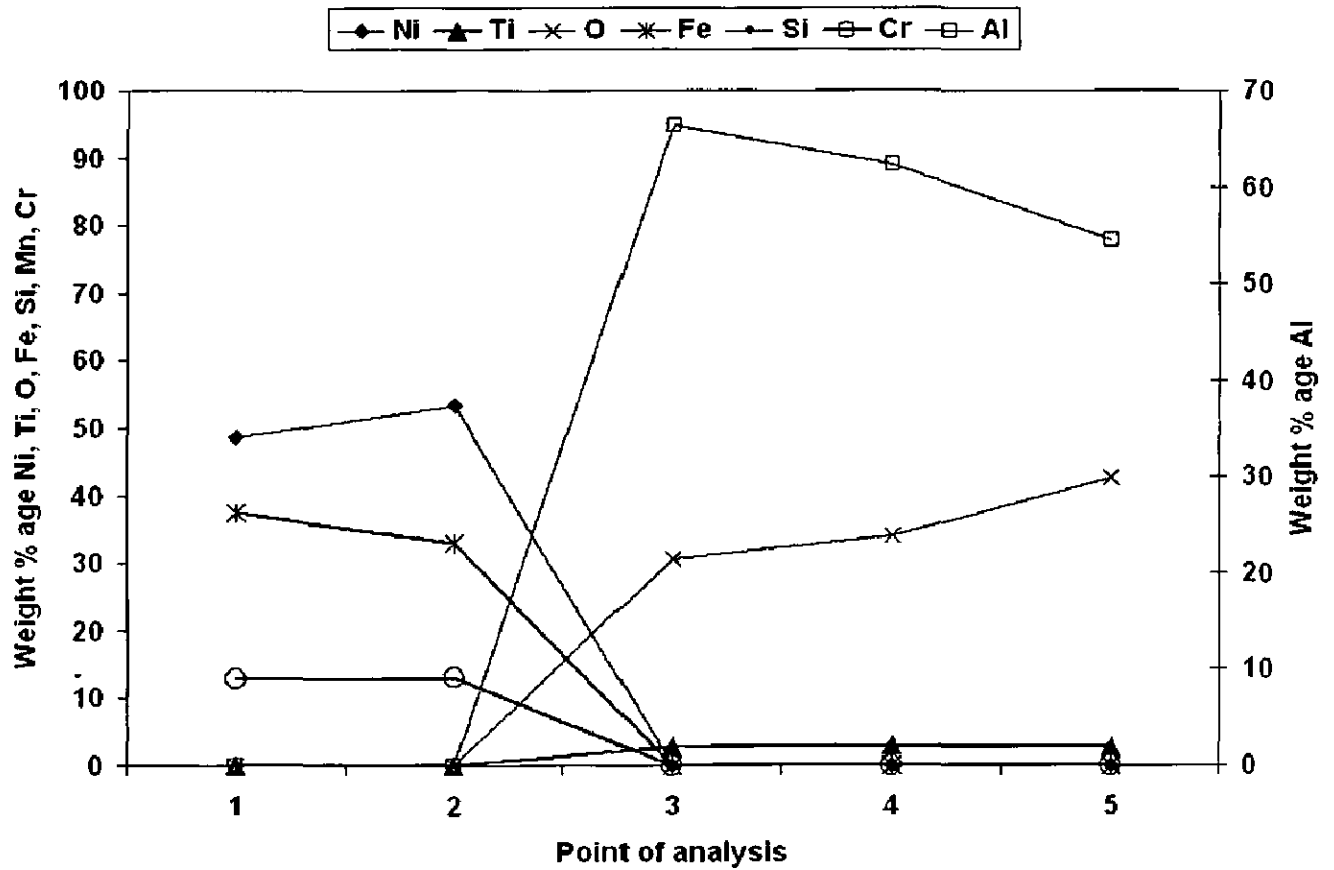
Fig.4.22: Cross sectional morphology and elemental composition variation across the cross-section of Al_2O_3 -3 wt% TiO_2 coated superalloy Superfer 800.

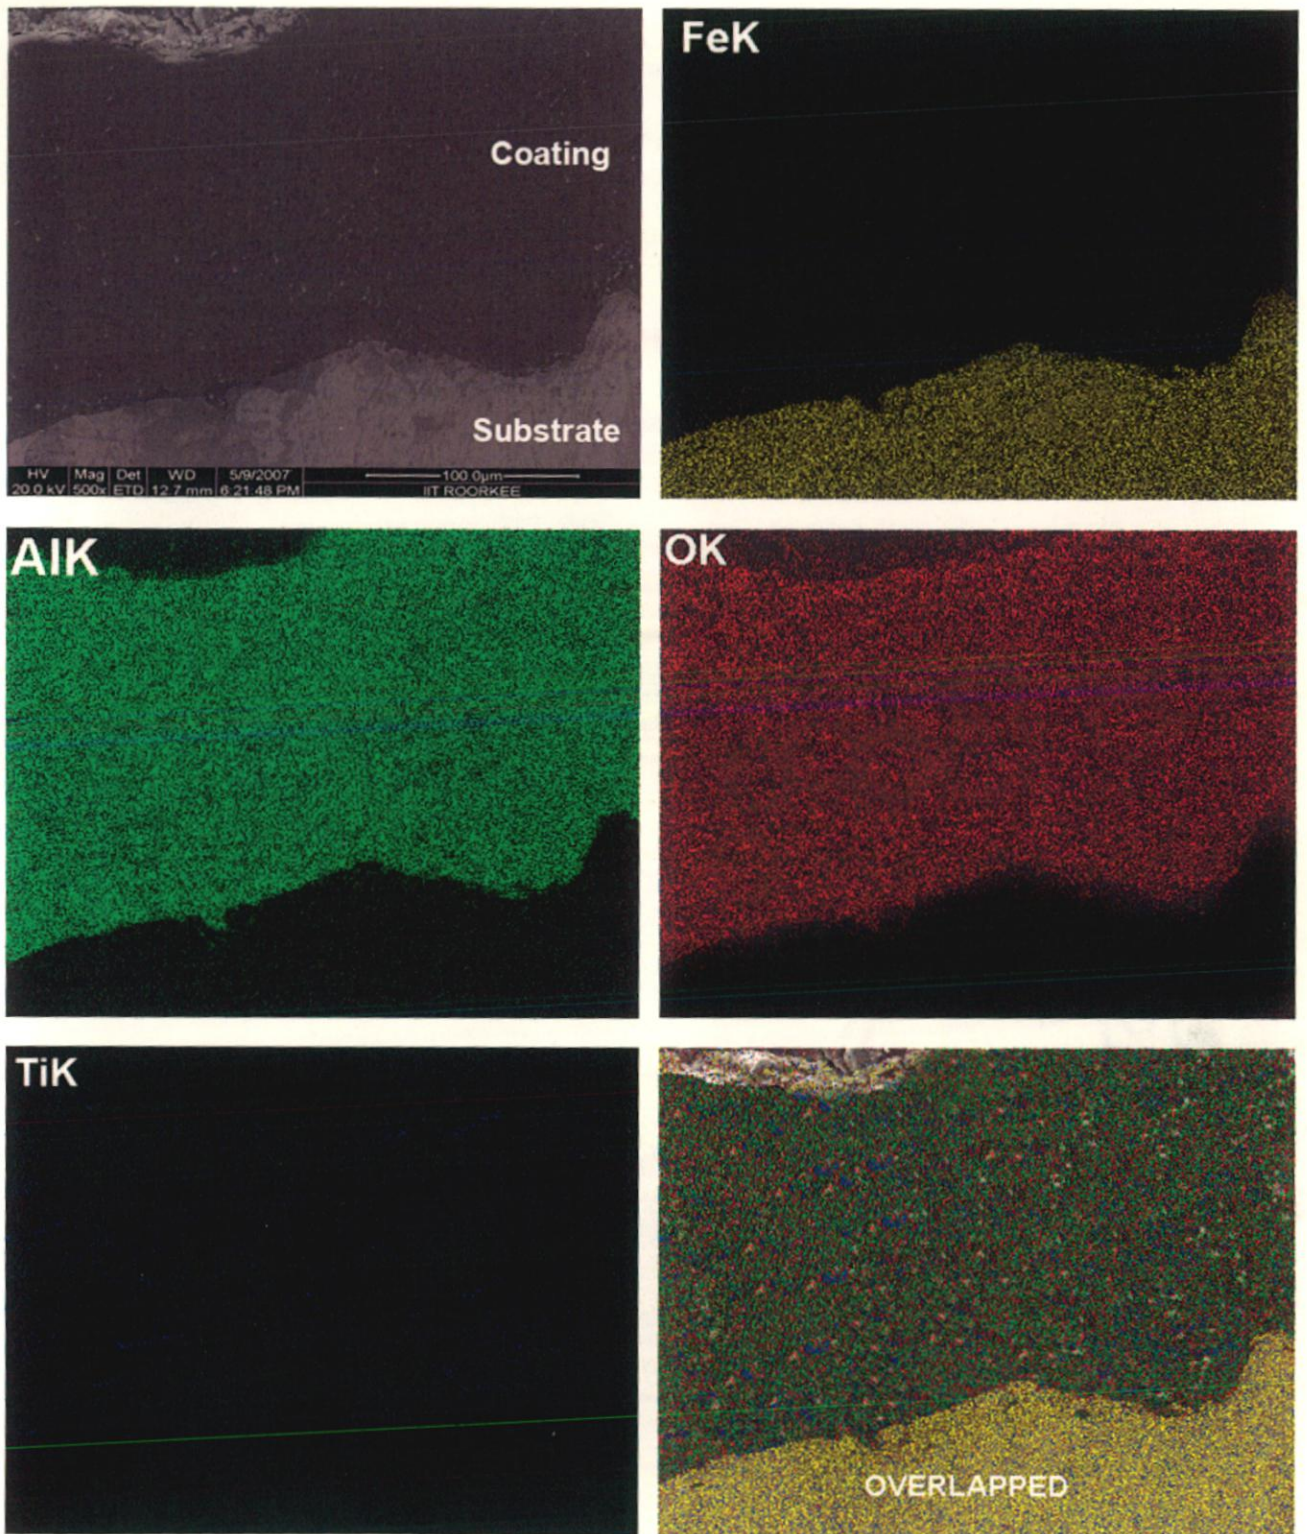
Fig.4.23: BSEI and elemental X-ray mappings of the cross-section of D-gun sprayed Al_2O_3 -3 Wt% TiO_2 coating on the boiler steel T11, 500X.

The X-ray mappings for the D-gun sprayed Al_2O_3 -3Wt% TiO_2 coatings are shown in Fig. 4.23 to 4.27, which indicate the presence of basic elements of the feedstock powder. The elemental mappings for all the coated alloys show that the basic elements of the alloy powder viz. Alumina and Titania are present in the coated region. The elemental mapping for the coating shows that the main phase in coatings is alumina. Titania is present at the splat boundaries as thin discontinuous streaks. Cross-sectional BSE image of the as-sprayed Al_2O_3 -3Wt% TiO_2 coating shows a typical lamellar structure consisting of mainly Al-rich splats with titanium mainly present at the splat boundaries.

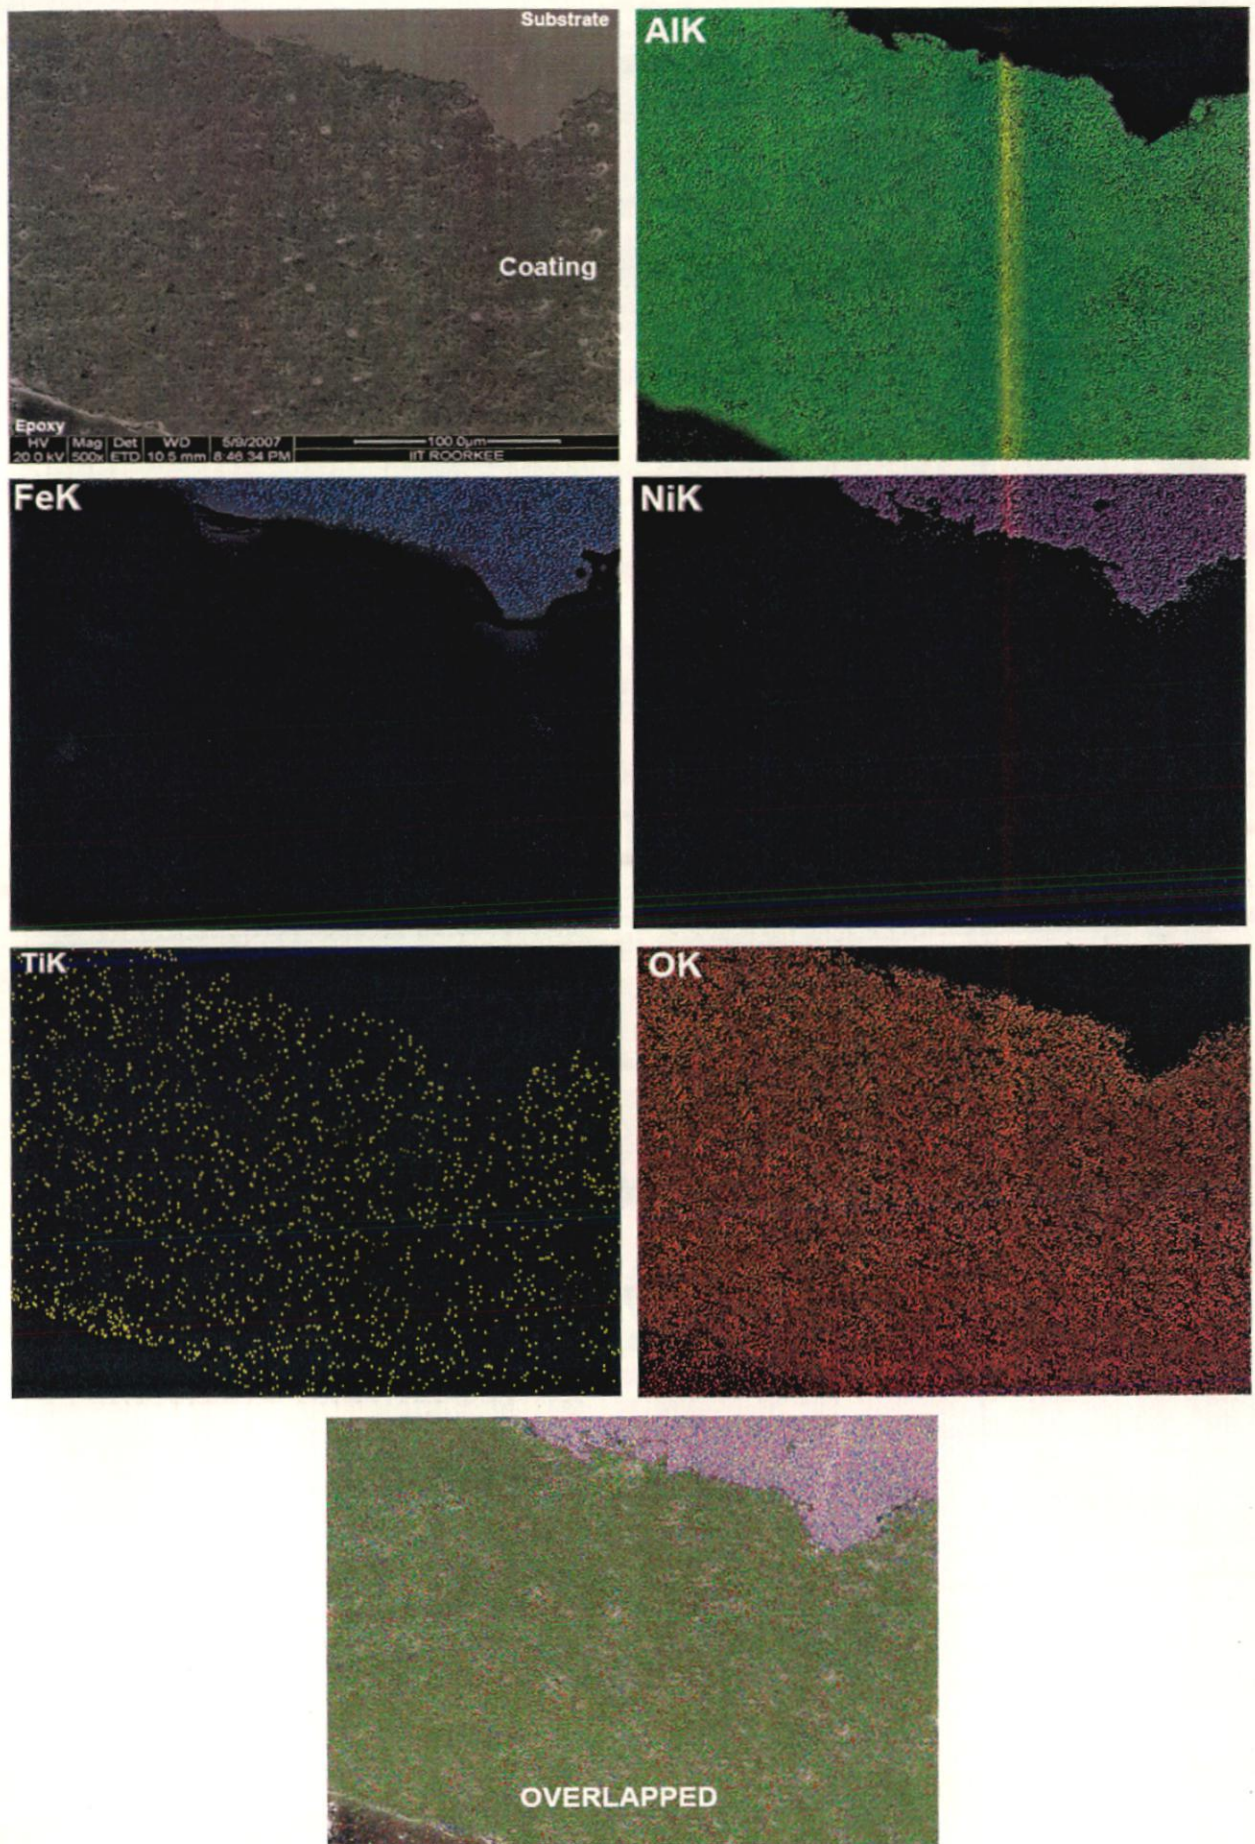
Fig.4.25: BSEI and elemental X-ray mappings of the cross-section of D-gun sprayed Al_2O_3 -3 Wt% TiO_2 coating on the superalloy Superni 600, 500X

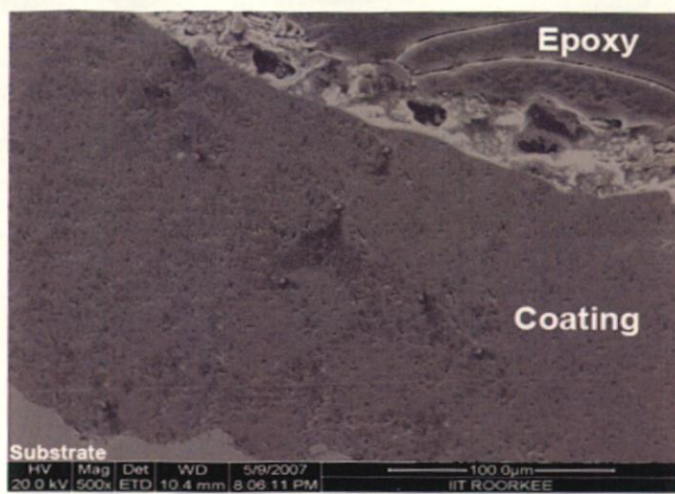
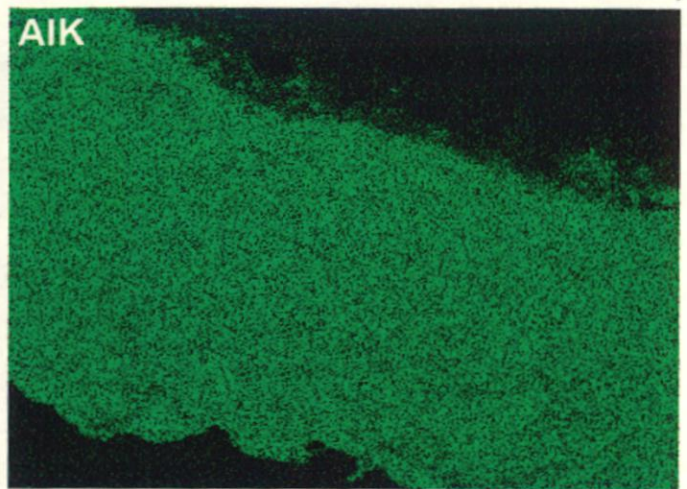
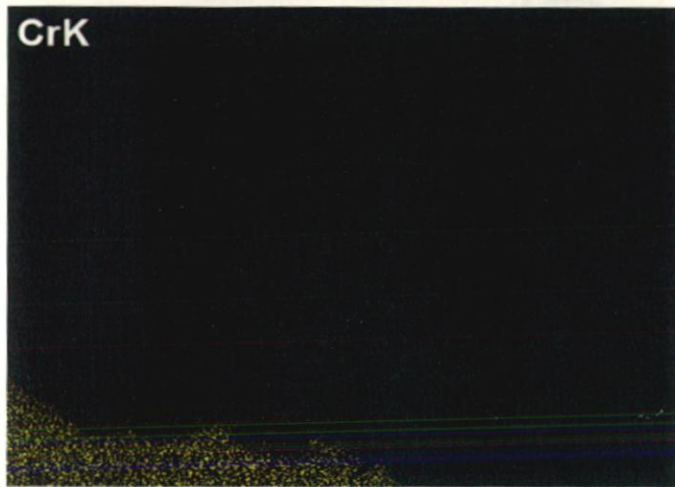
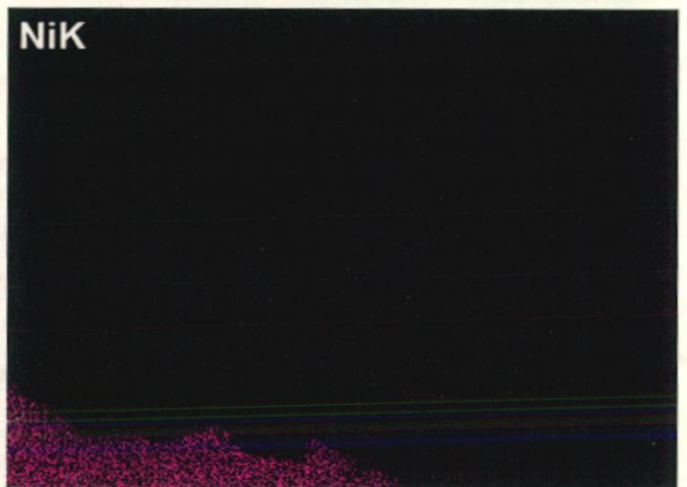
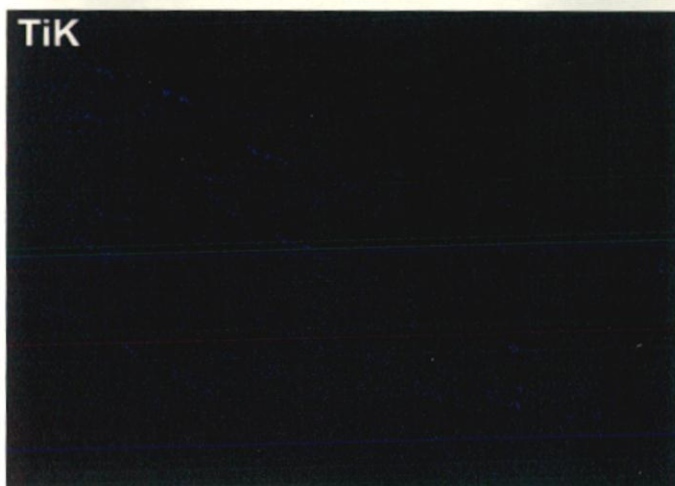
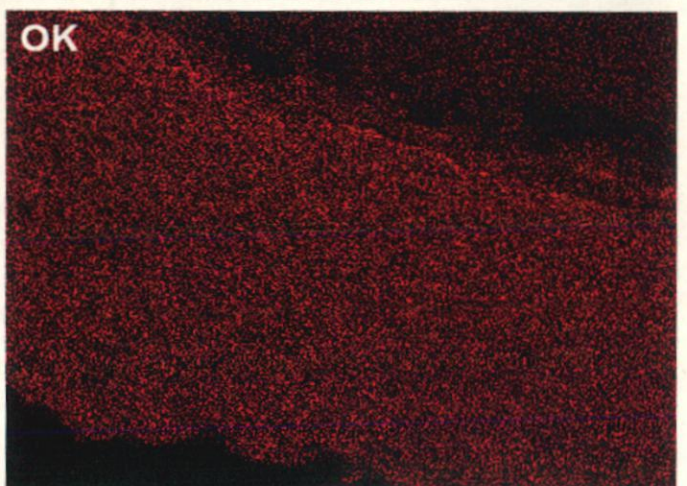
Fig.4.26: BSEI and elemental X-ray mappings of the cross-section of D-gun sprayed Al_2O_3 -3 Wt% TiO_2 coating on the superalloy Superni718, 500X

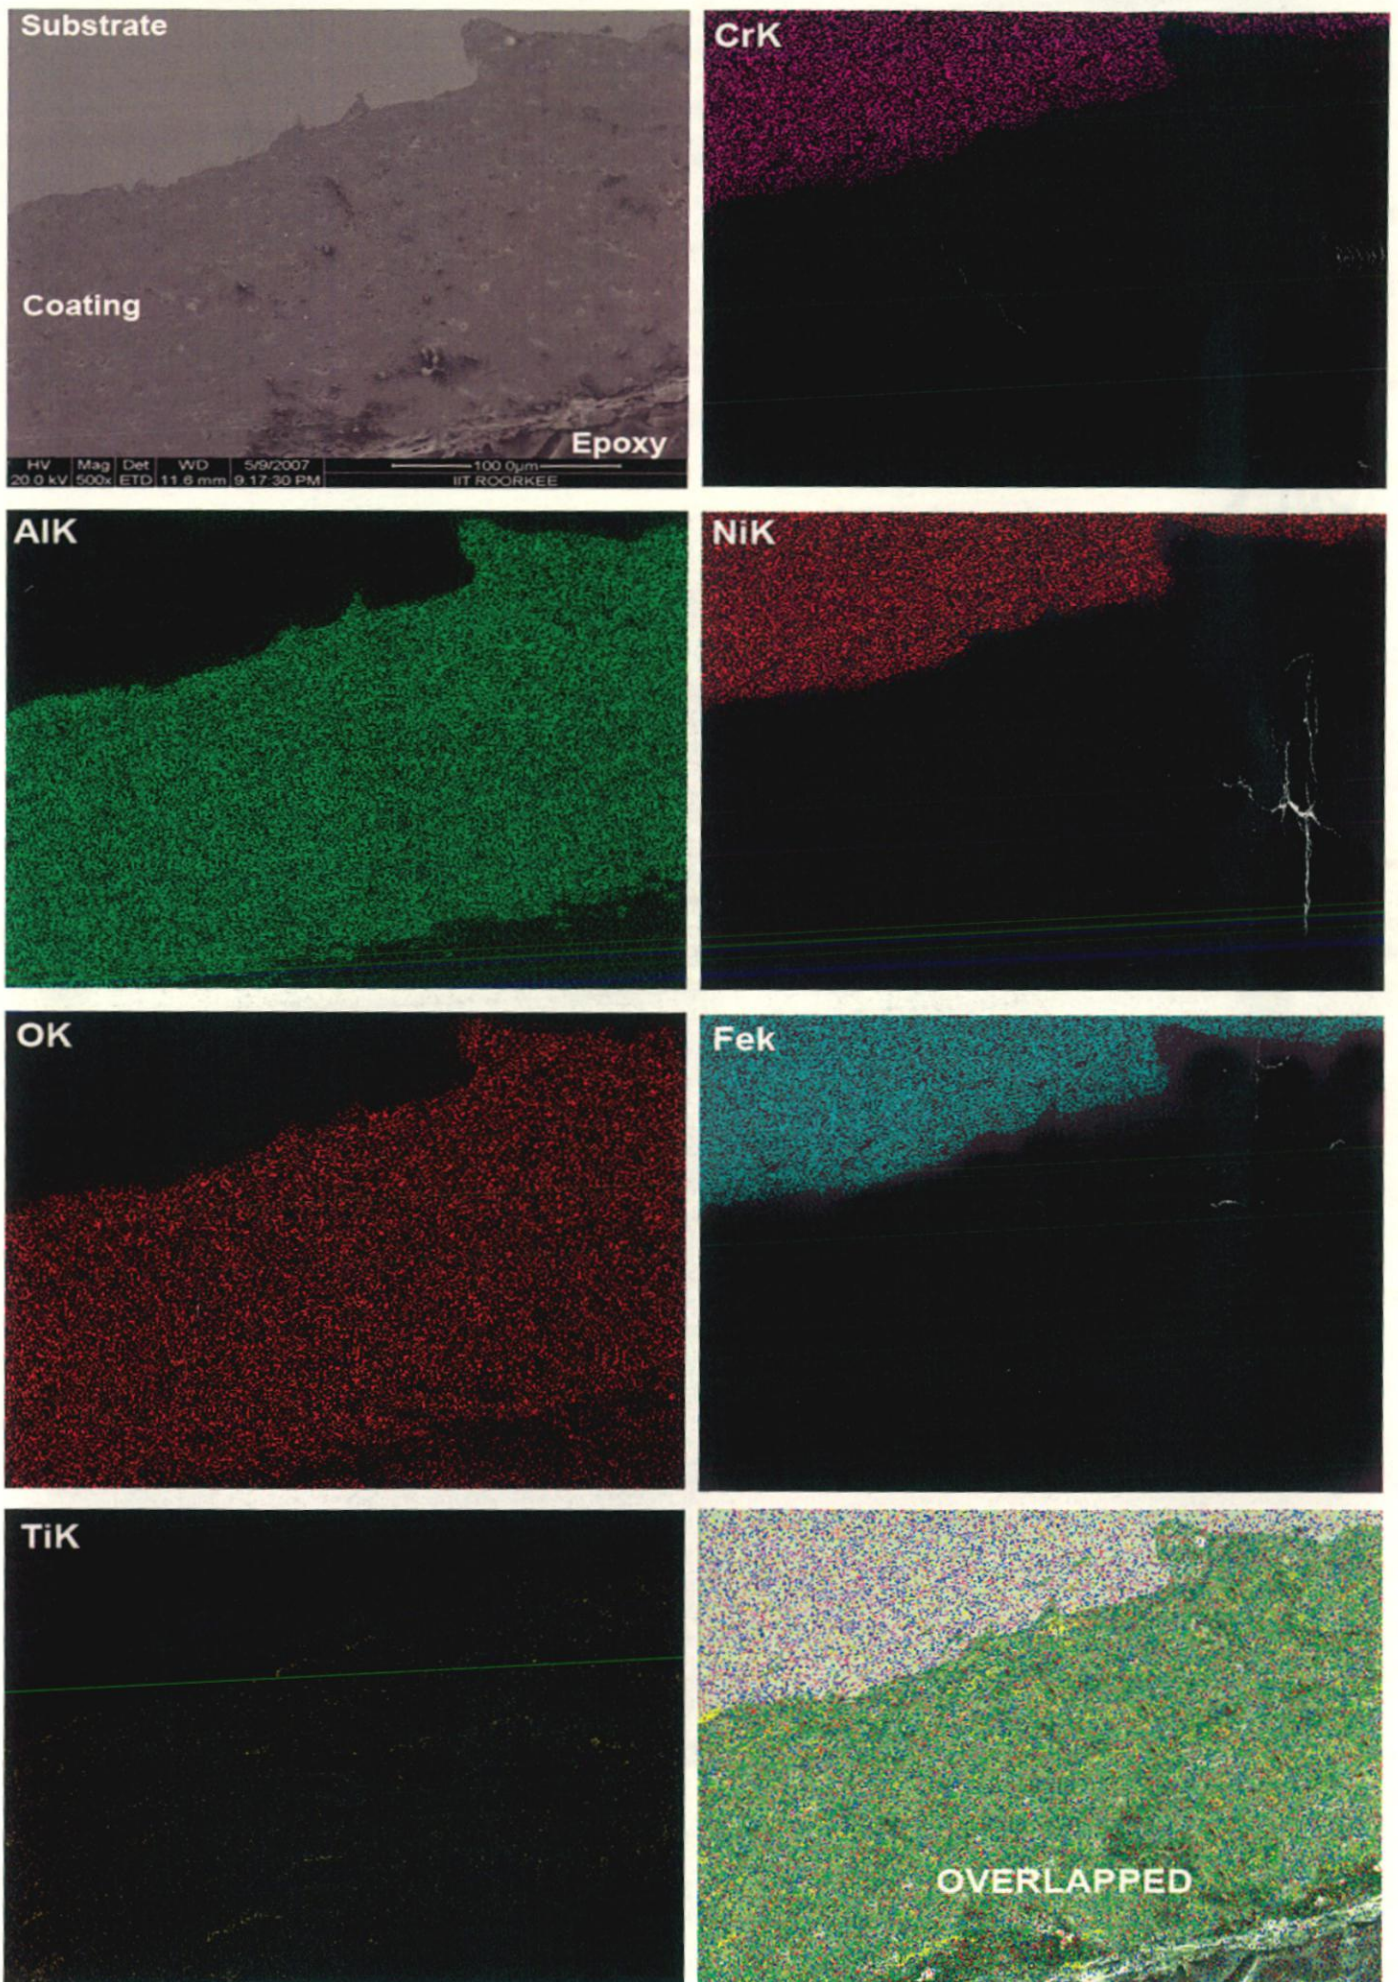
Fig.4.27: BSEI and elemental X-ray mappings of the cross-section of D-gun sprayed Al_2O_3 -3 Wt% TiO_2 coating on the superalloy Superfer 800, 500X

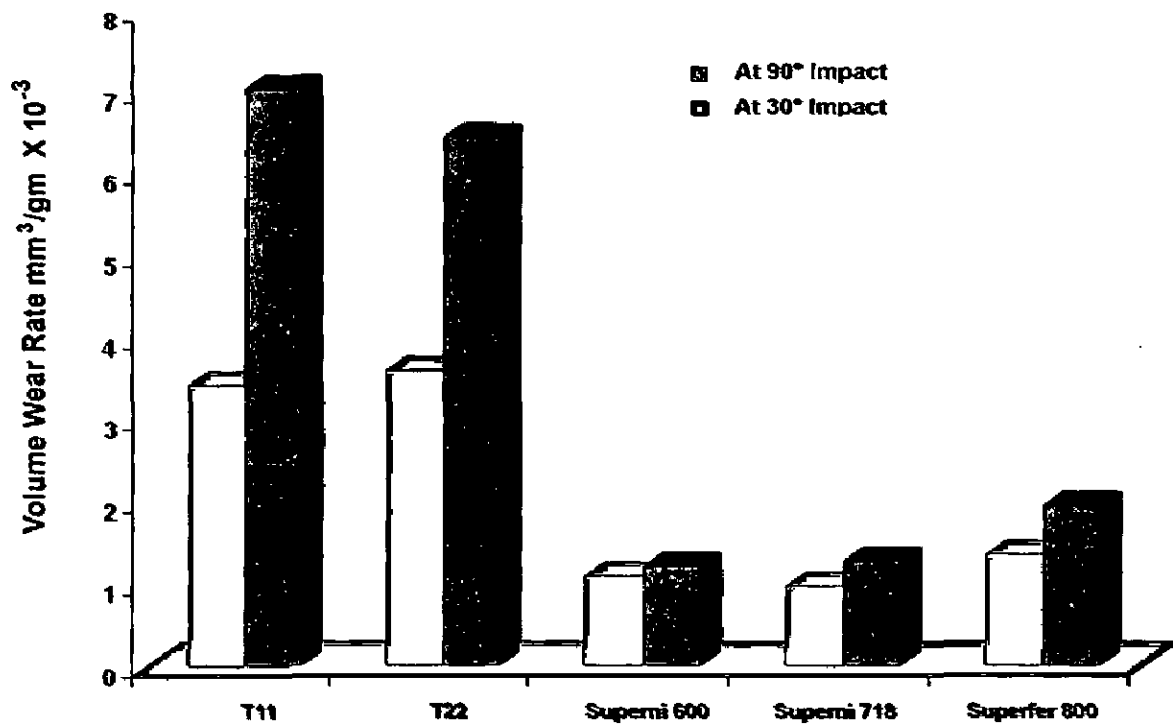
Fig. 5.7: Bar diagram showing the Volume erosion rates of substrate alloys under oblique and normal impact at condition 1.

The erosion rate of the uncoated boiler steels namely T11, T22 and superalloys namely Superni 600, Superni 718, and Superfer 800 superalloys at an impact velocity of 35 ms^{-1} and impingement angle of 30° and 90° at room temperature (condition 1) is shown in Fig. 5.7. From the graph, it can be inferred that the erosion rate of Boiler steels is comparatively higher than the superalloys at both the impact angles. Volume erosion rate of Superfer 800 superalloy is marginally higher than that for the other superalloys, whereas erosion rate of Superni 600 and 718 are lowest amongst all the superalloys tested at both the impact angles. The volume erosion rate for Boiler steels T11 and T22 is $3.419 \times 10^{-3} \text{ mm}^3/\text{gm}$ & $3.586 \times 10^{-3} \text{ mm}^3/\text{gm}$ and for superalloys Superni 600, Superni 718 and Superfer 800 is $1.086 \times 10^{-3} \text{ mm}^3/\text{gm}$, $0.975 \times 10^{-3} \text{ mm}^3/\text{gm}$ and $1.352 \times 10^{-3} \text{ mm}^3/\text{gm}$ respectively at 90° impact angle. While at 30° impact, the volume erosion rate for Boiler steels T11 and T22 is $7.052 \times 10^{-3} \text{ mm}^3/\text{gm}$ & $6.452 \times 10^{-3} \text{ mm}^3/\text{gm}$ and for superalloys Superni 600, Superni 718 and Superfer 800 is $1.211 \times 10^{-3} \text{ mm}^3/\text{gm}$, $1.281 \times 10^{-3} \text{ mm}^3/\text{gm}$ and $1.947 \times 10^{-3} \text{ mm}^3/\text{gm}$ respectively.

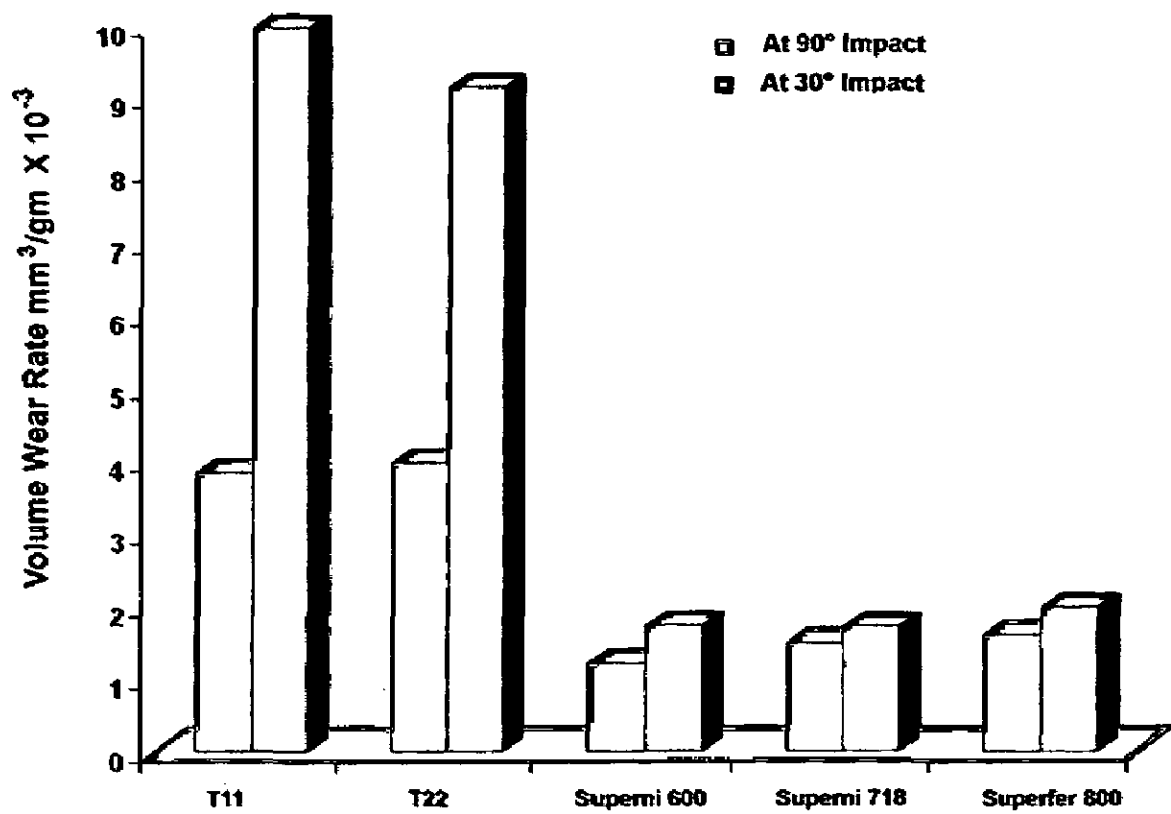
Fig. 5.8: Bar diagram showing the Volume erosion rates of substrate alloys under oblique and normal impact at condition 2.

At condition 2 i.e. when substrate temperature was 400°C and surrounding air at 900°C , there is substantial increase in volume erosion rate of all the alloys under testing as shown in Fig. 5.8. The volume erosion rate for Boiler steels T11 and T22 is $3.831 \times 10^{-3} \text{ mm}^3/\text{gm}$ & $3.975 \times 10^{-3} \text{ mm}^3/\text{gm}$ and for superalloys Superni 600, Superni 718 and Superfer 800 is $1.225 \times 10^{-3} \text{ mm}^3/\text{gm}$, $1.494 \times 10^{-3} \text{ mm}^3/\text{gm}$ and $1.608 \times 10^{-3} \text{ mm}^3/\text{gm}$ respectively at 90° impact angle. While at 30° impact, the volume erosion rate for Boiler steels T11 and T22 is $9.947 \times 10^{-3} \text{ mm}^3/\text{gm}$ & $9.127 \times 10^{-3} \text{ mm}^3/\text{gm}$ and for superalloys Superni 600, Superni 718 and Superfer 800 is $1.727 \times 10^{-3} \text{ mm}^3/\text{gm}$, $1.711 \times 10^{-3} \text{ mm}^3/\text{gm}$ and $1.977 \times 10^{-3} \text{ mm}^3/\text{gm}$ respectively.

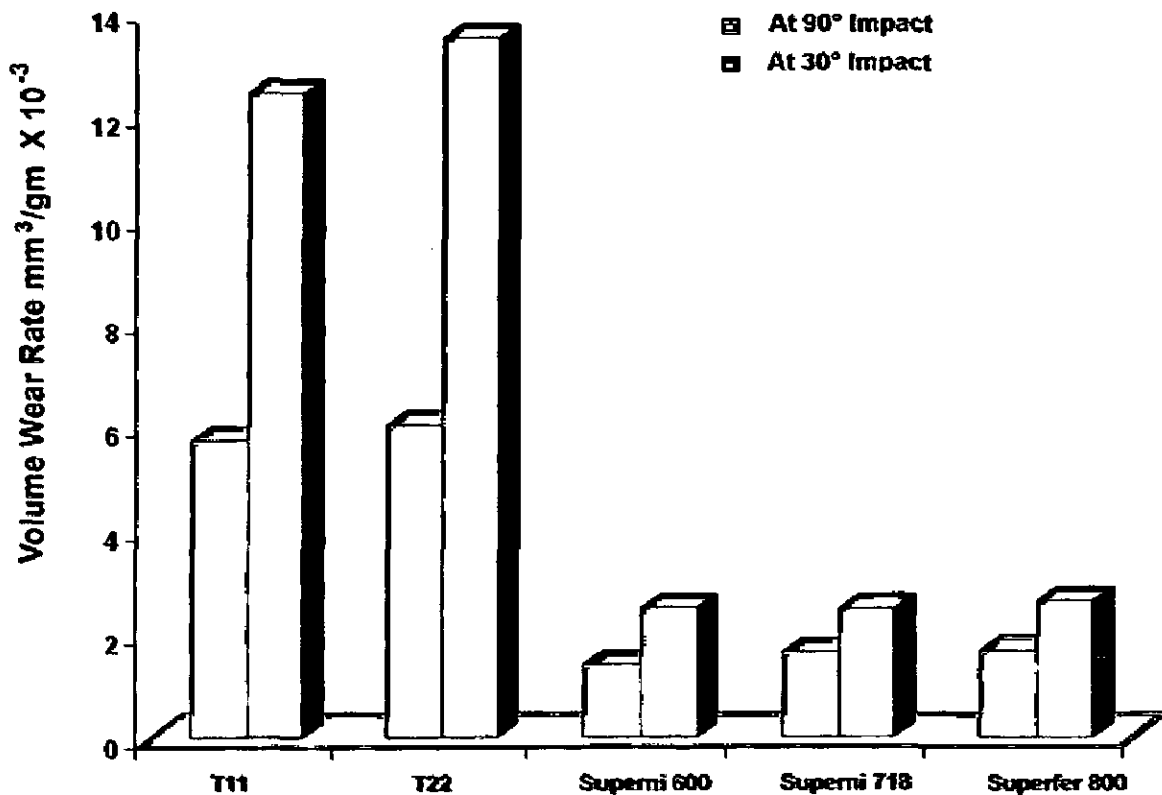
Fig. 5.9: Bar diagram showing the Volume erosion rates of substrate alloys under oblique and normal impact at condition 3.

On further increasing the substrate temperature to 600°C and surrounding temperature of 900°C , volume erosion rate is also increased as shown in Fig. 5.9. From the Fig. it is

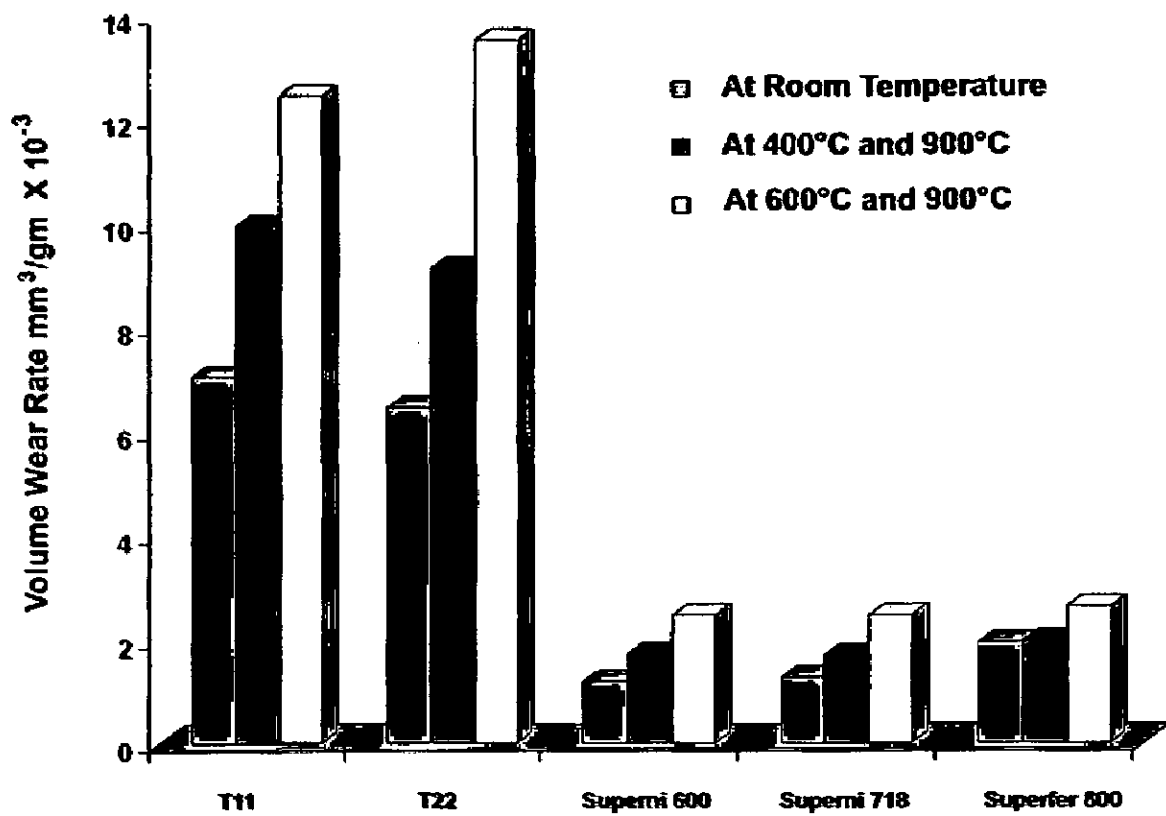
Fig. 5.10: Bar diagram showing the variation in Volume erosion rates of substrate alloys at 30° impact angle with change in test temperature

Fig. 5.10 Fig. 5.11 shows the variation in volume erosion rates of substrate alloys at 30° and 90° impact angles with change in test temperature. A tendency for increase in erosion rate with temperature has been observed in all alloys. So the temperature effect can be demonstrated on the basis of the observation that the erosion rate at acute impingement angle increases significantly with temperature, suggesting that alloys tends to show behaviour more typical of a ductile material at elevated temperatures.
