STUDY OF DETONATION GUN COATED ALLOYS FOR RESISTANCE TO EROSION AND CORROSION

A THESIS

METALLURGICAL AND MATERIALS ENGINEERING

This thesis investigates the erosion and corrosion performance of Al_2O_3 -3 wt % TiO_2 thermal spray coatings deposited by detonation gun technique. As-sprayed coatings were characterized by using the combined techniques of optical microscopy, microhardness testing, X-ray diffractometry (XRD) and scanning electron microscopy/energy-dispersive analysis (SEM/EDX). The corrosion performance was evaluated in oxidising and molten salt environment and also in actual working conditions of boiler. The erosion performance was evaluated at room temperature conditions as well as under high temperature conditions, high erodent velocity, and actual boiler conditions. The corrosion behavior and morphological development were investigated by weight change kinetics, metallographs, depths of attack, metal thickness losses, and XRD analyses.

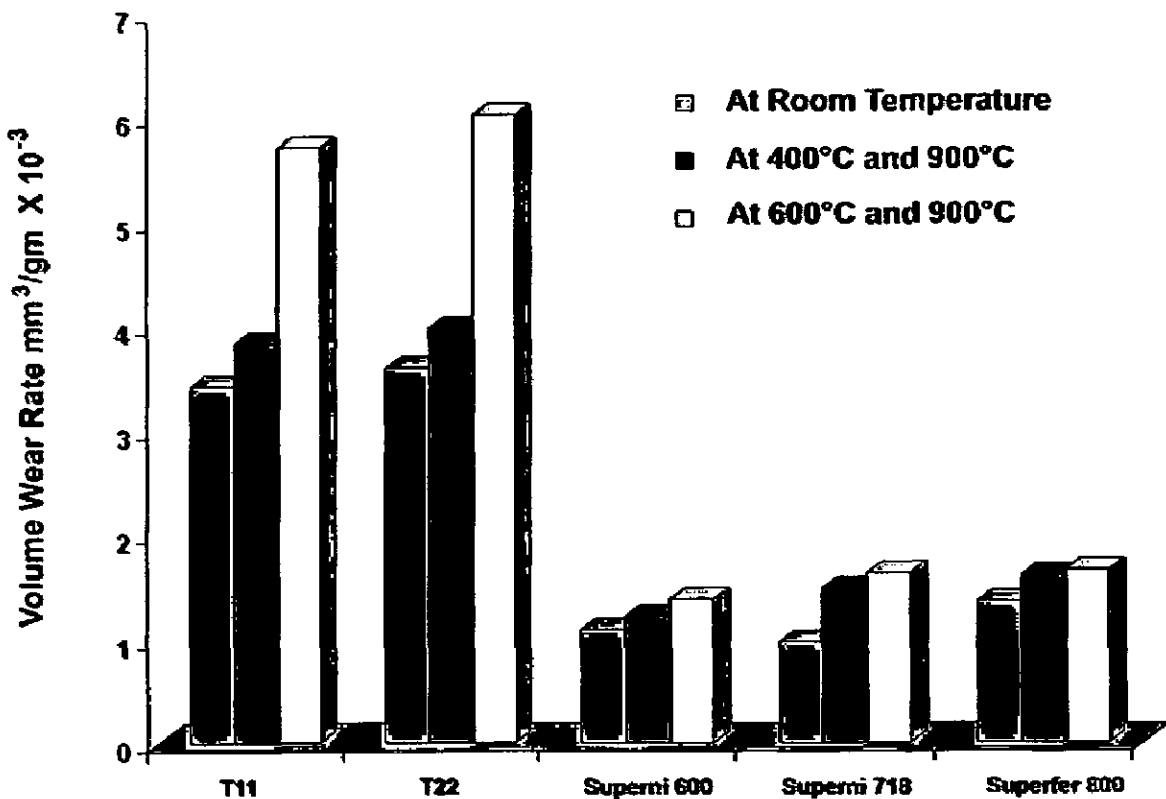
Fig. 5.11: Bar diagram showing the variation in Volume erosion rates of substrate alloys at 90° impact angle with change in test temperature.

Fig. 5.10 Fig. 5.11 shows the variation in volume erosion rates of substrate alloys at 30° and 90° impact angles with change in test temperature. A tendency for increase in erosion rate with temperature has been observed in all alloys. So the temperature effect can be demonstrated on the basis of the observation that the erosion rate at acute impingement angle increases significantly with temperature, suggesting that alloys tends to show behaviour more typical of a ductile material at elevated temperatures.

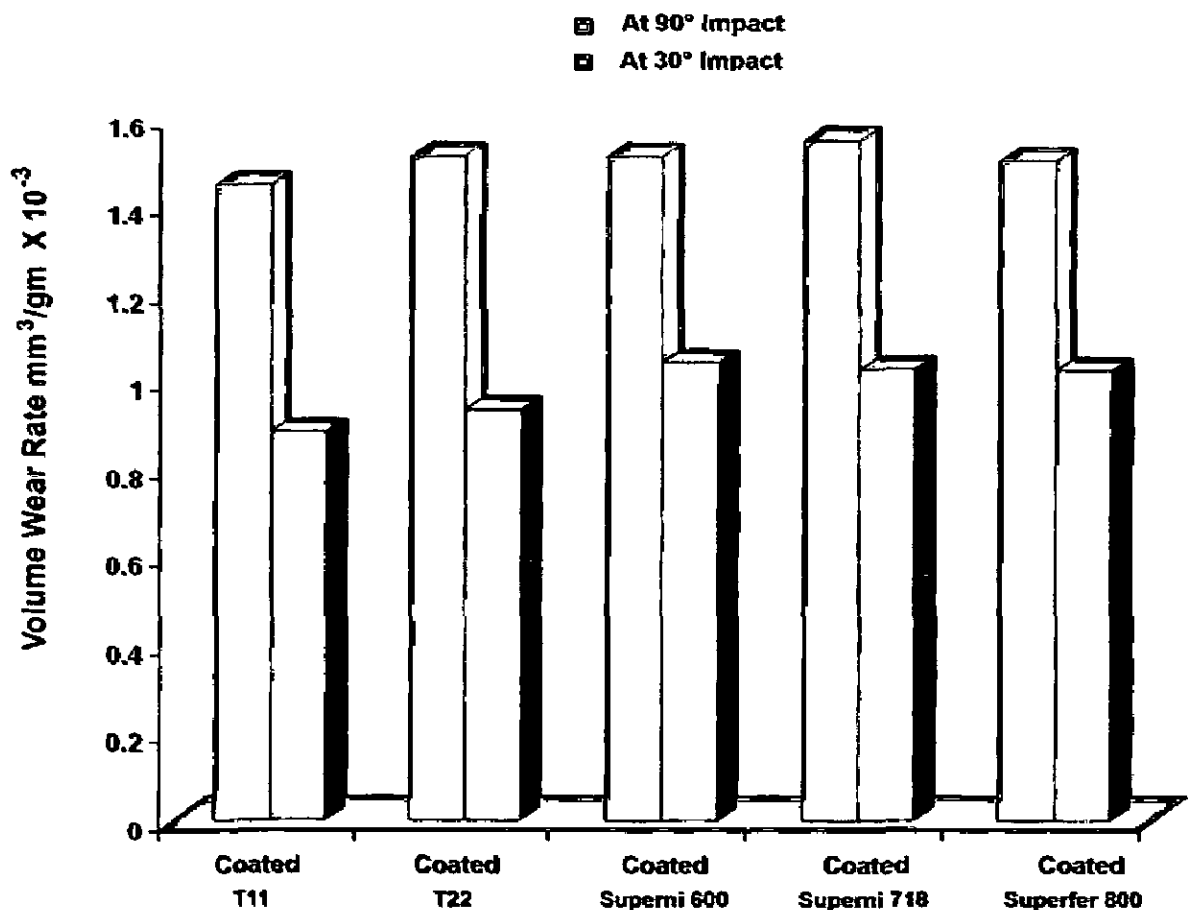
Fig. 5.24: Bar diagram showing the volume erosion rates of coated alloys under oblique and normal impact at condition 1

The erosion rate of the Al₂O₃-3 wt% TiO₂ coated boiler steels namely T11, T22 and superalloys namely Superni 600, Superni 718, and Superfer 800 superalloys at an impact velocity of 35ms-1 and impingement angle of 30° and 90° at room temperature (condition 1) is shown in Fig. 5.24. From the graph, it can be inferred that the erosion rate of coated alloys eroded at 90° impact angle is higher than the erosion rate at 30° impact angle. Volume wear rate of coated Supreni 718 superalloy is marginally higher than the other coated substrates at 90° impact angle while at 30° impact angle erosion rate of coated Superni 600 is marginally high.

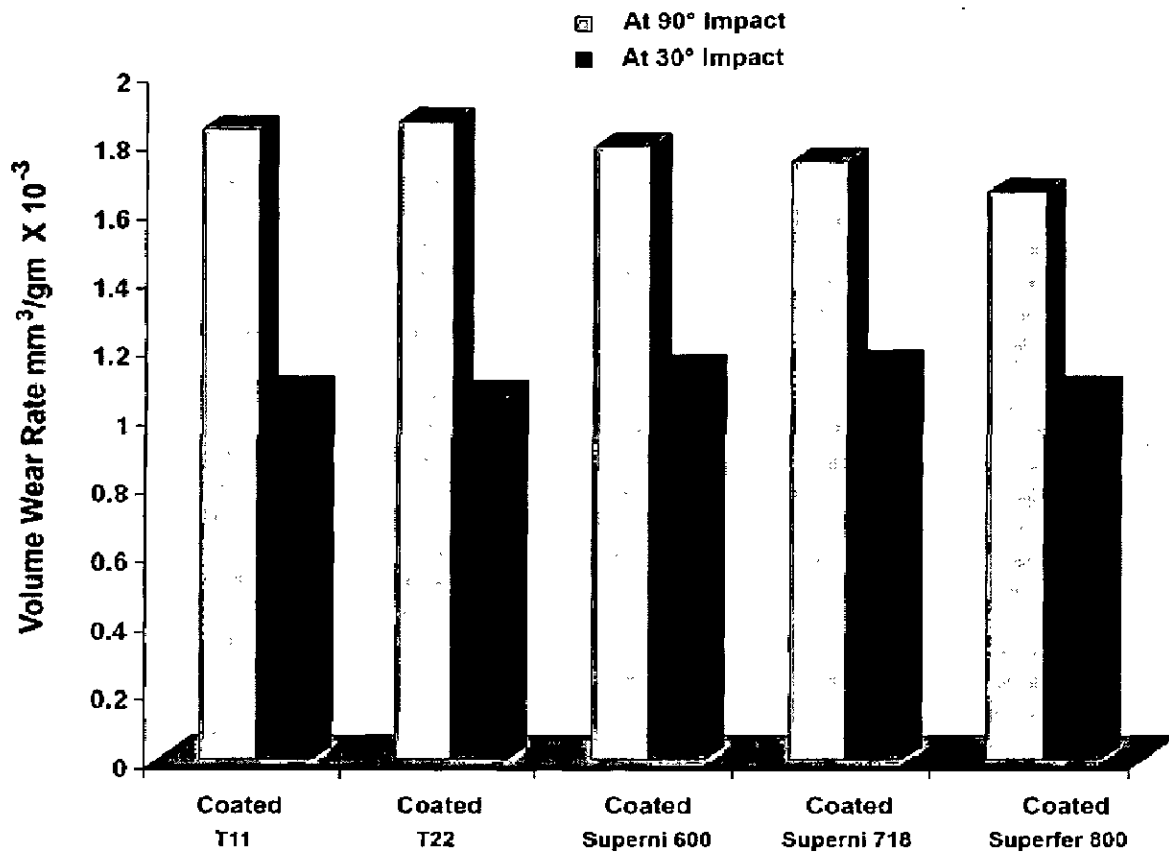
Fig. 5.25: Bar diagram showing the Volume erosion rates of coated alloys under oblique and normal impact at condition 2.

At condition 2 i.e. when substrate temperature was 400°C and surrounding air at 900°C, there is substantial increase in volume erosion rate as shown in Fig. 5.25. The volume erosion rate for Al₂O₃-3 wt% TiO₂ coated Boiler steels T11 and T22 is 1.836 x10⁻³ mm³/gm & 1.858 x10⁻³ mm³/gm and for Al₂O₃-3 wt% TiO₂ coated superalloys Superni 600, Superni 718 and Superfer 800 is 1.788 x10⁻³ mm³/gm, 1.742 x10⁻³ mm³/gm and 1.653 x10⁻³ mm³/gm respectively at 90° impact angle. While at 30° impact, the volume erosion rate for coated Boiler steels T11 and T22 is 1.077 x10⁻³ mm³/gm & 1.064 x10⁻³ mm³/gm and for coated superalloys Superni 600, Superni 718 and Superfer 800 is 1.141 x10⁻³ mm³/gm, 1.153 x10⁻³ mm³/gm and 1.075 x10⁻³ mm³/gm respectively.

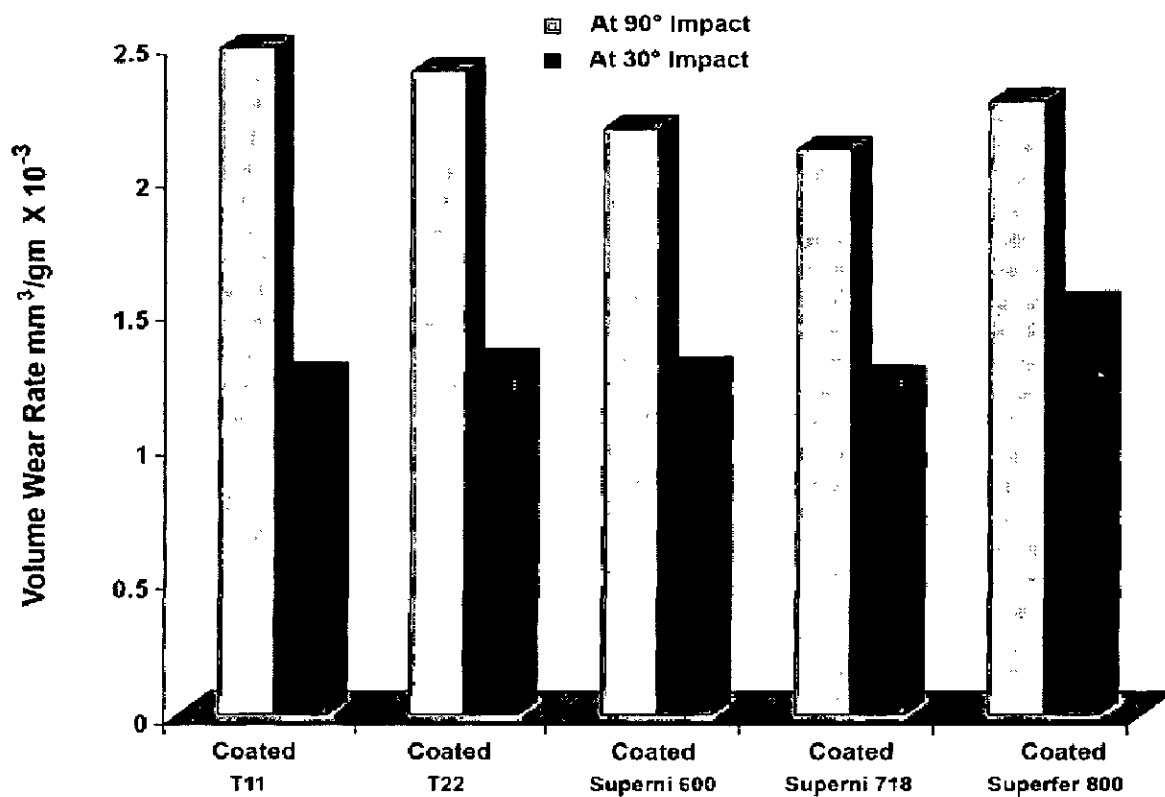
Fig. 5.26: Bar diagram showing the Volume erosion rates of coated alloys under oblique and normal impact at condition 3.

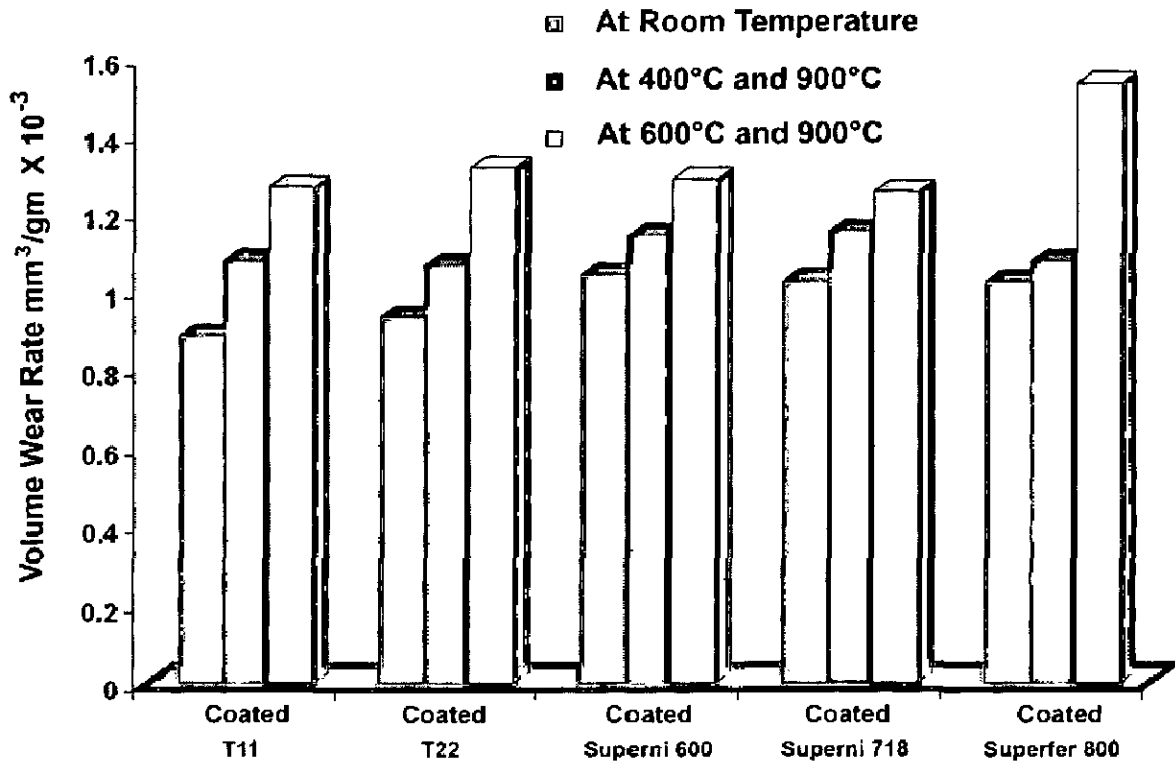
Fig. 5.27: Bar diagram showing the variation in Volume erosion rates of coated alloys at 30° impact angle with change in test temperature

Fig. 5.27 shows the variation in volume erosion rates of coated alloys at 30° impact angle with change in test temperature. As the testing temperature increases from room temperature to 400°C of substrate and 600°C of surroundings at 30° impact, the erosion rate has shown an increase. While in case of 90° impact, erosion volume rate has increased substantially as shown in Fig. 5.28. It has been observed that erosion rates of coated alloys impacted at low angles do not increase rapidly as the temperature increases, suggesting that alloys tend to show typically brittle behaviour at elevated temperatures. A tendency for erosion rate to increase with temperature has been observed in coated alloys. The erosion rate is less at 30° impact angle as compared to one at 90° impact angle. Similar behavior dependent on temperature has been observed by Mishra et al., (2008) and Lin et al., (2004).

Also with the increase in Temperature there is increase in erosion rate. At 30° impact angle, at room temperature erosion rate is (0.883 to 1.041 $\times 10^{-3}$ mm³/gm) and as the temperature is increased to 400°C of substrate and 900°C of the surrounding air, erosion rate has increased and varies between 1.064 $\times 10^{-3}$ mm³/gm and 1.153 $\times 10^{-3}$ mm³/gm on further increase in temperature erosion has increased to 1.253 $\times 10^{-3}$ mm³/gm to 1.53 $\times 10^{-3}$ mm³/gm as shown in Fig. 5.27.

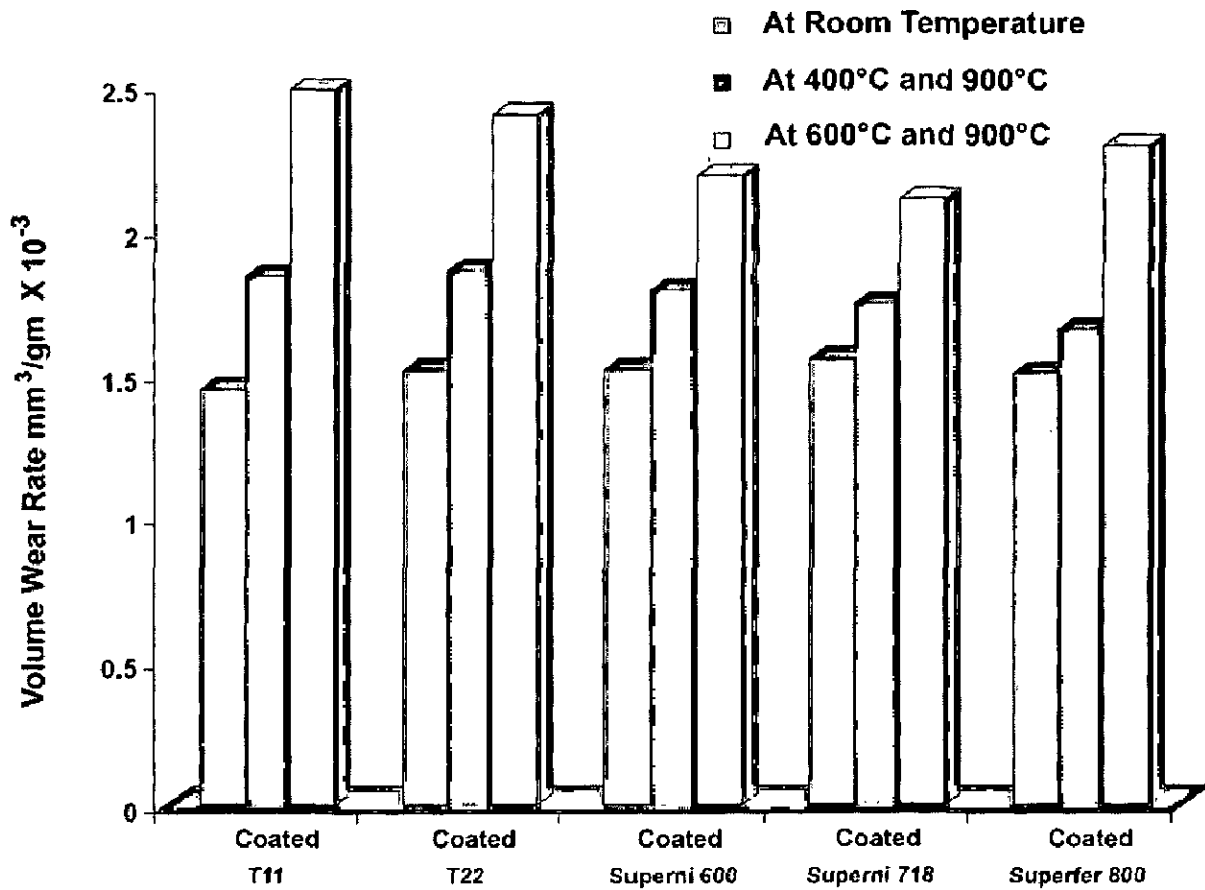
Fig. 5.28: Bar diagram showing the variation in Volume erosion rates of coated alloys at 90° impact angle with change in test temperature

While at 90° impact, the rise in erosion rate is much higher for given increase in temperature. At room temperature erosion rate lies between $1.447-155 \times 10^{-3} \text{mm}^3/\text{gm}$ and at condition 2, erosion rate lies between $1.653-1.858 \times 10^{-3} \text{mm}^3/\text{gm}$ and on further increase in temperature i.e at condition 3, erosion rate increases in the range of $2.108-2.486 \times 10^{-3} \text{mm}^3/\text{gm}$ as shown in Fig. 5.28.

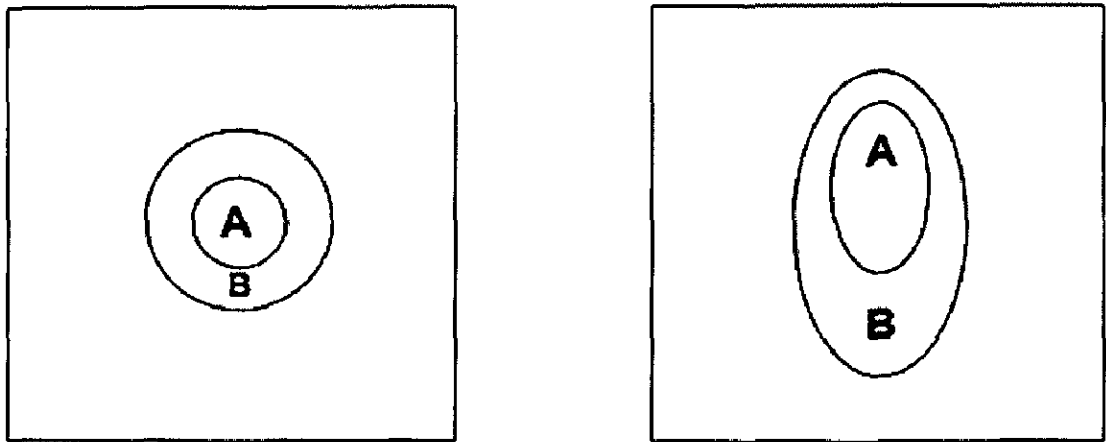
Fig. 5.35: Schematic diagram showing the erosion scar produced in general on the eroded surface at an impact angle of 90° and 30° ; Mark "A" represents a localized region of material removal and Mark "B" represents the peripheral region of the elastically loaded material

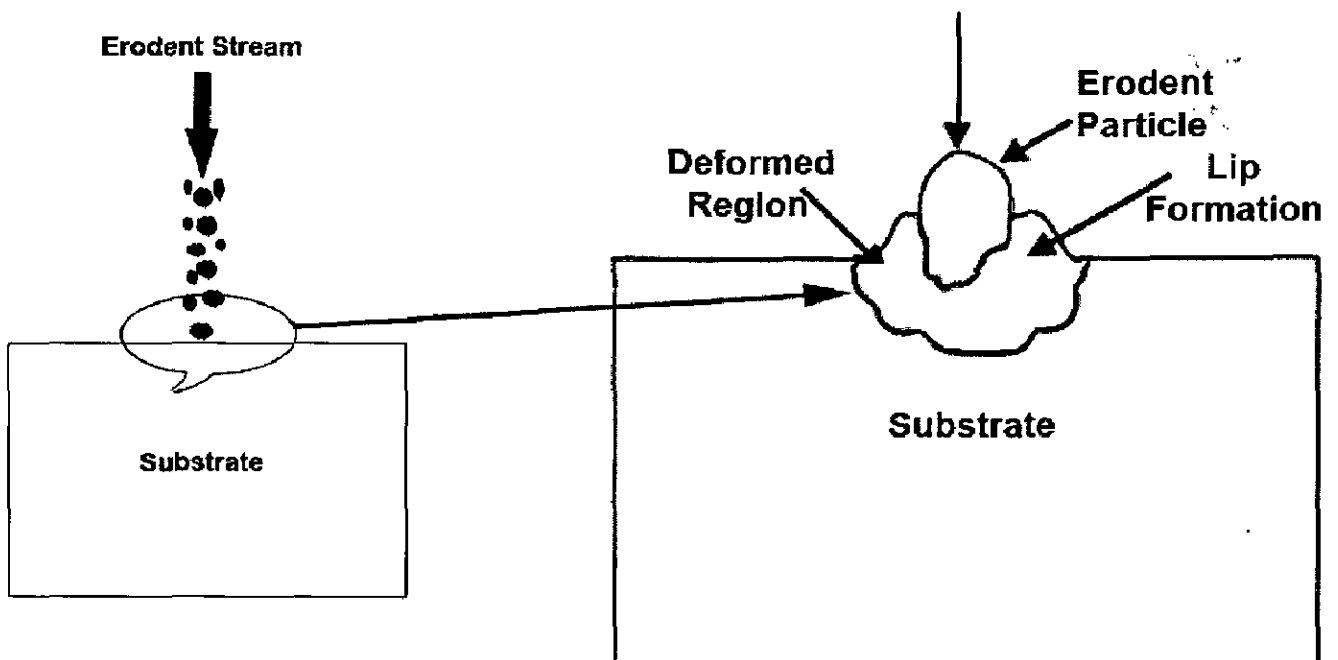
Fig. 5.36: Schematic diagram showing the metallic erosion

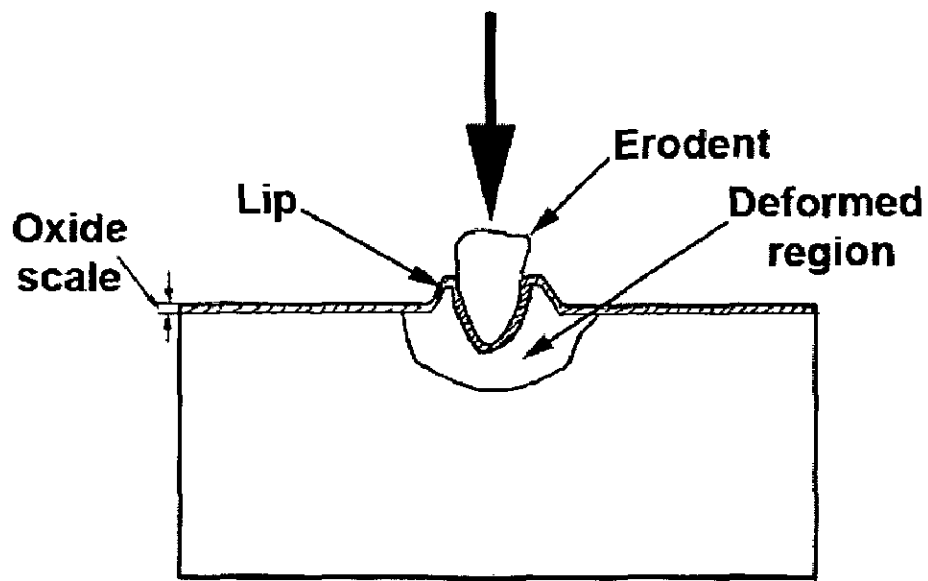
Fig. 5.37: Schematic diagram showing probable erosion mechanism at low temperature.

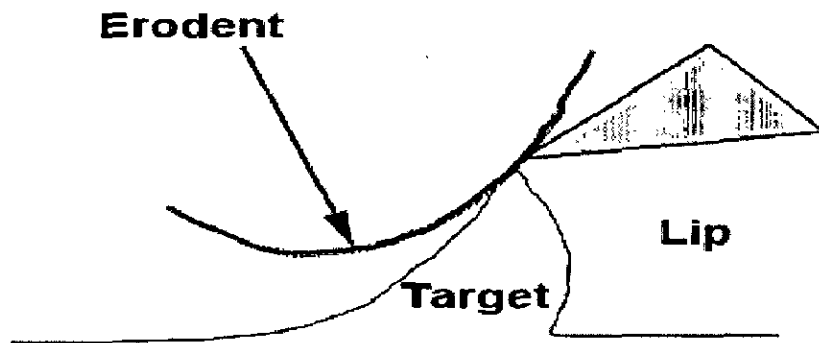
Fig. 5.38: Lip fracture mode in metallic erosion

In metals and alloys, during erosion, once the lip is formed, it is fractured by several modes. In the case of ductile metals like copper, brass, aluminium and iron, the lip fracture occurs by necking, and the resulting fracture is ductile (Quadir and Schewmon 1981; Christman and Schewmon, 1979). This mode of lip fracture is shown schematically in Fig. 5.38. The two modes of material removal considered above involve the fracture of pre-existing lips.

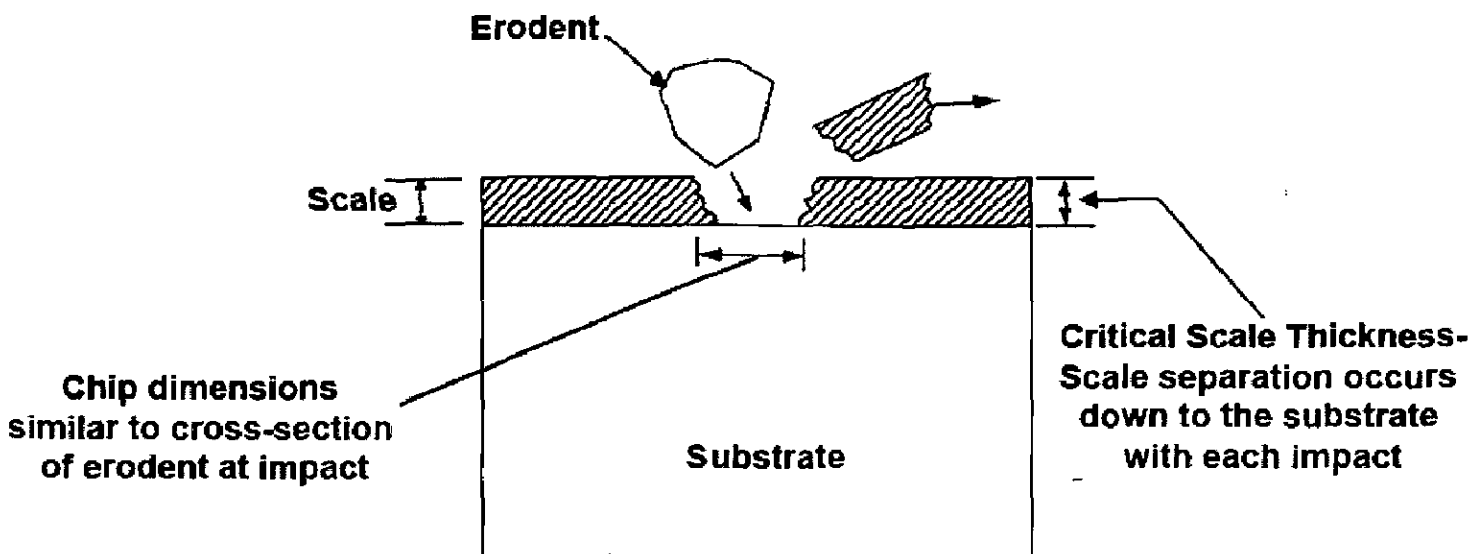
Fig. 5.39: Schematic oxide removal from the exposed surface at high temperature

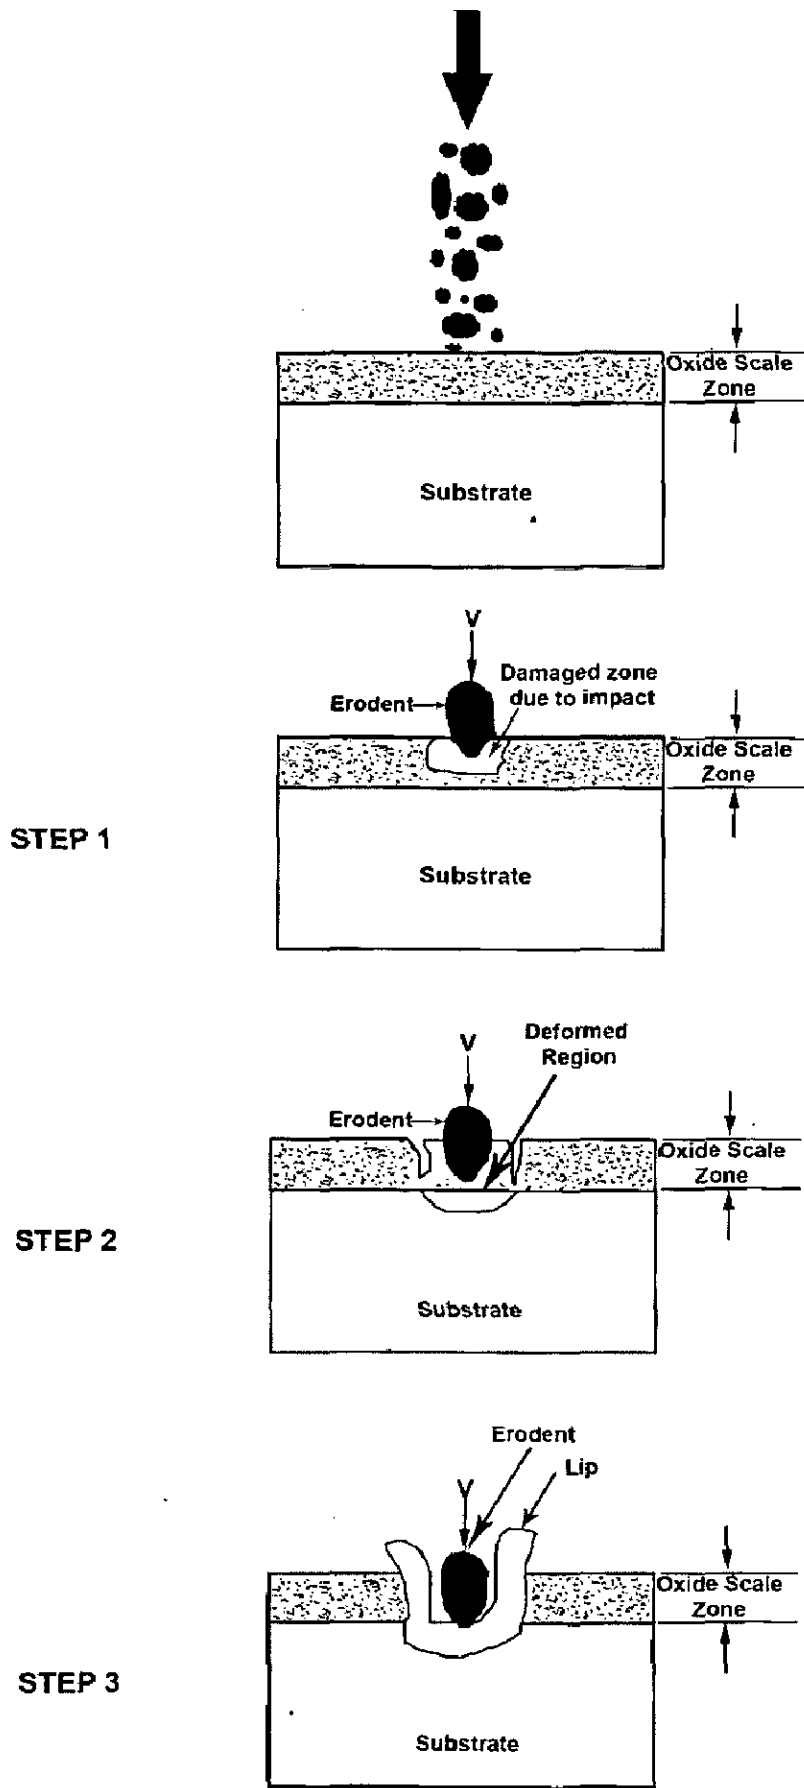
Fig. 5.40: Schematic diagram showing probable mechanism of oxidation affected Erosion showing deformed zone formed due to erodent impact.

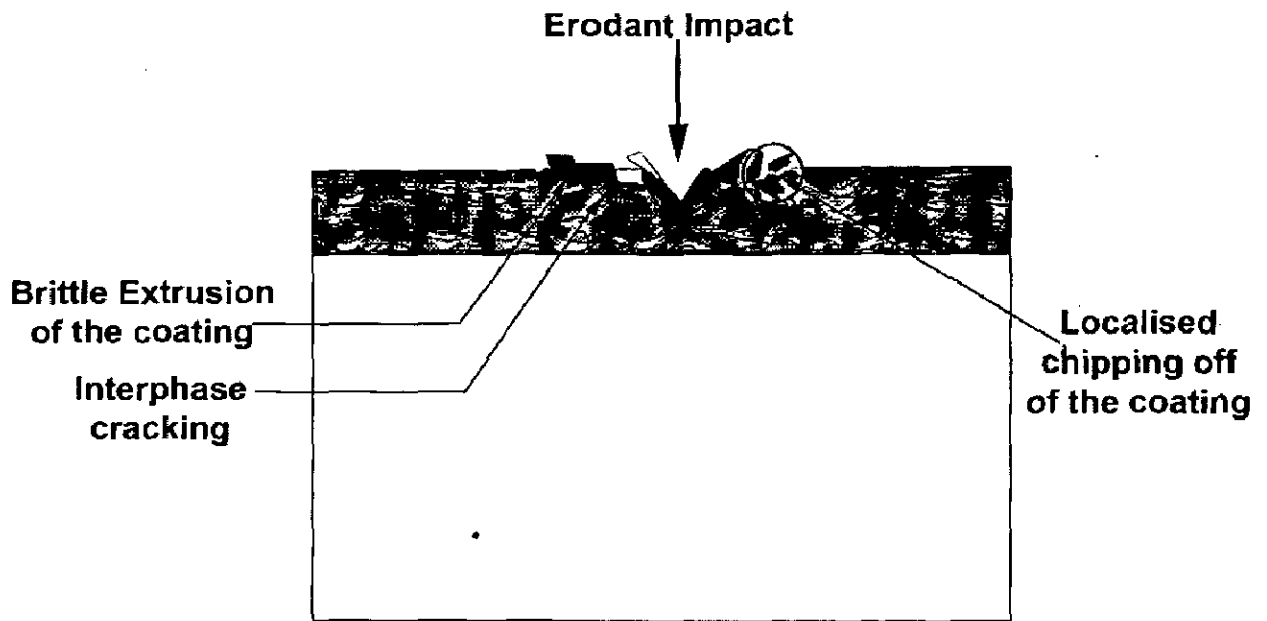
Fig. 5.41: Schematic representative erosion scar on coating showing different modes of erosion in coating

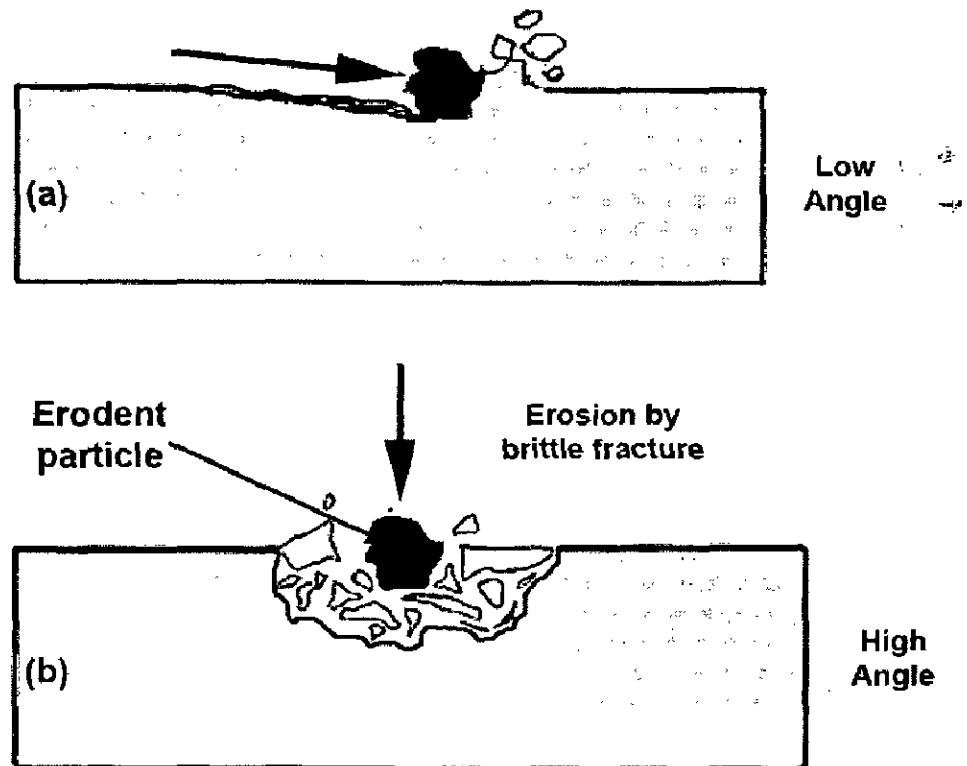
Fig. 5.42: Schematic representation of coating fracture dependent on impact angle (a) Low angle (b) High angle

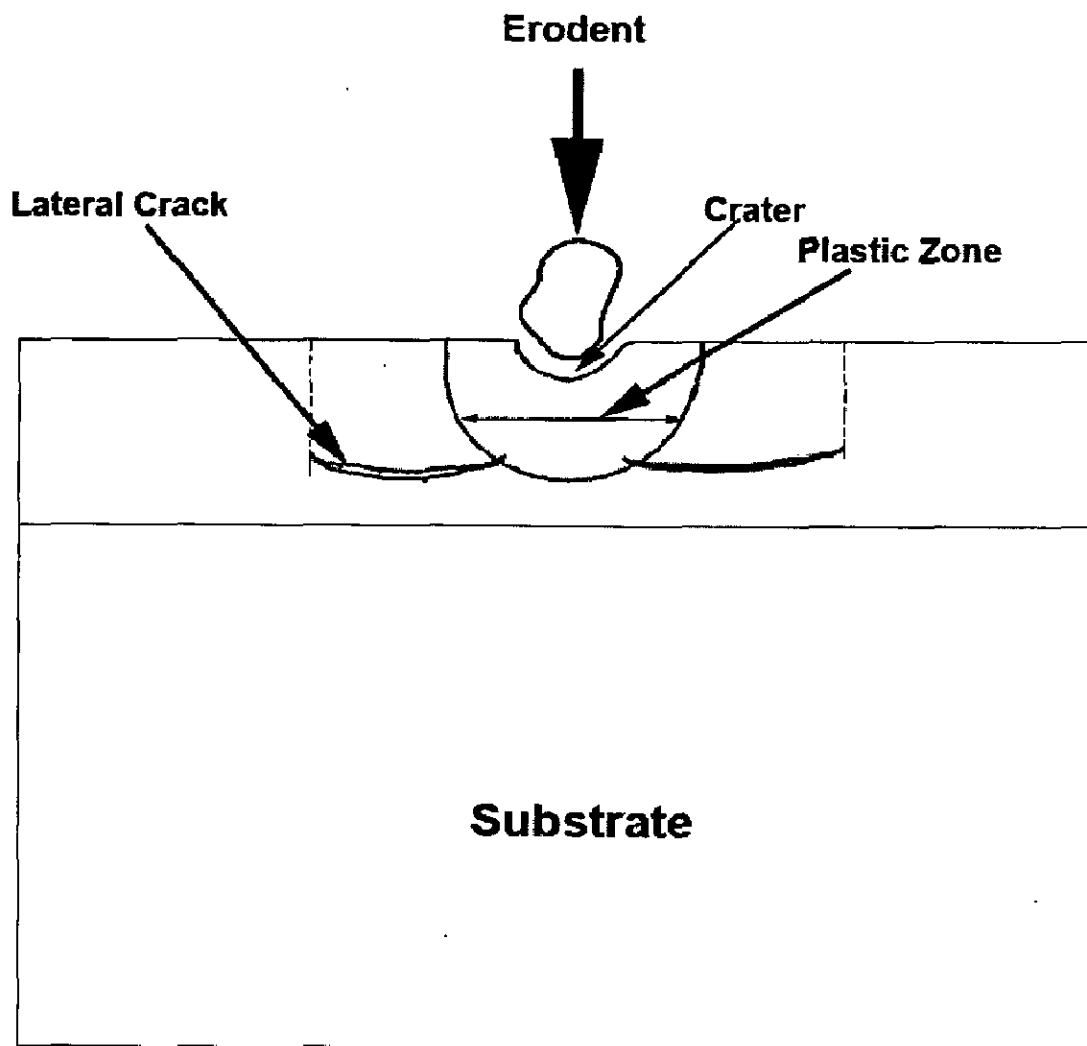
Fig. 5.43: Crack formed in bulk of a coating due to particle impingement

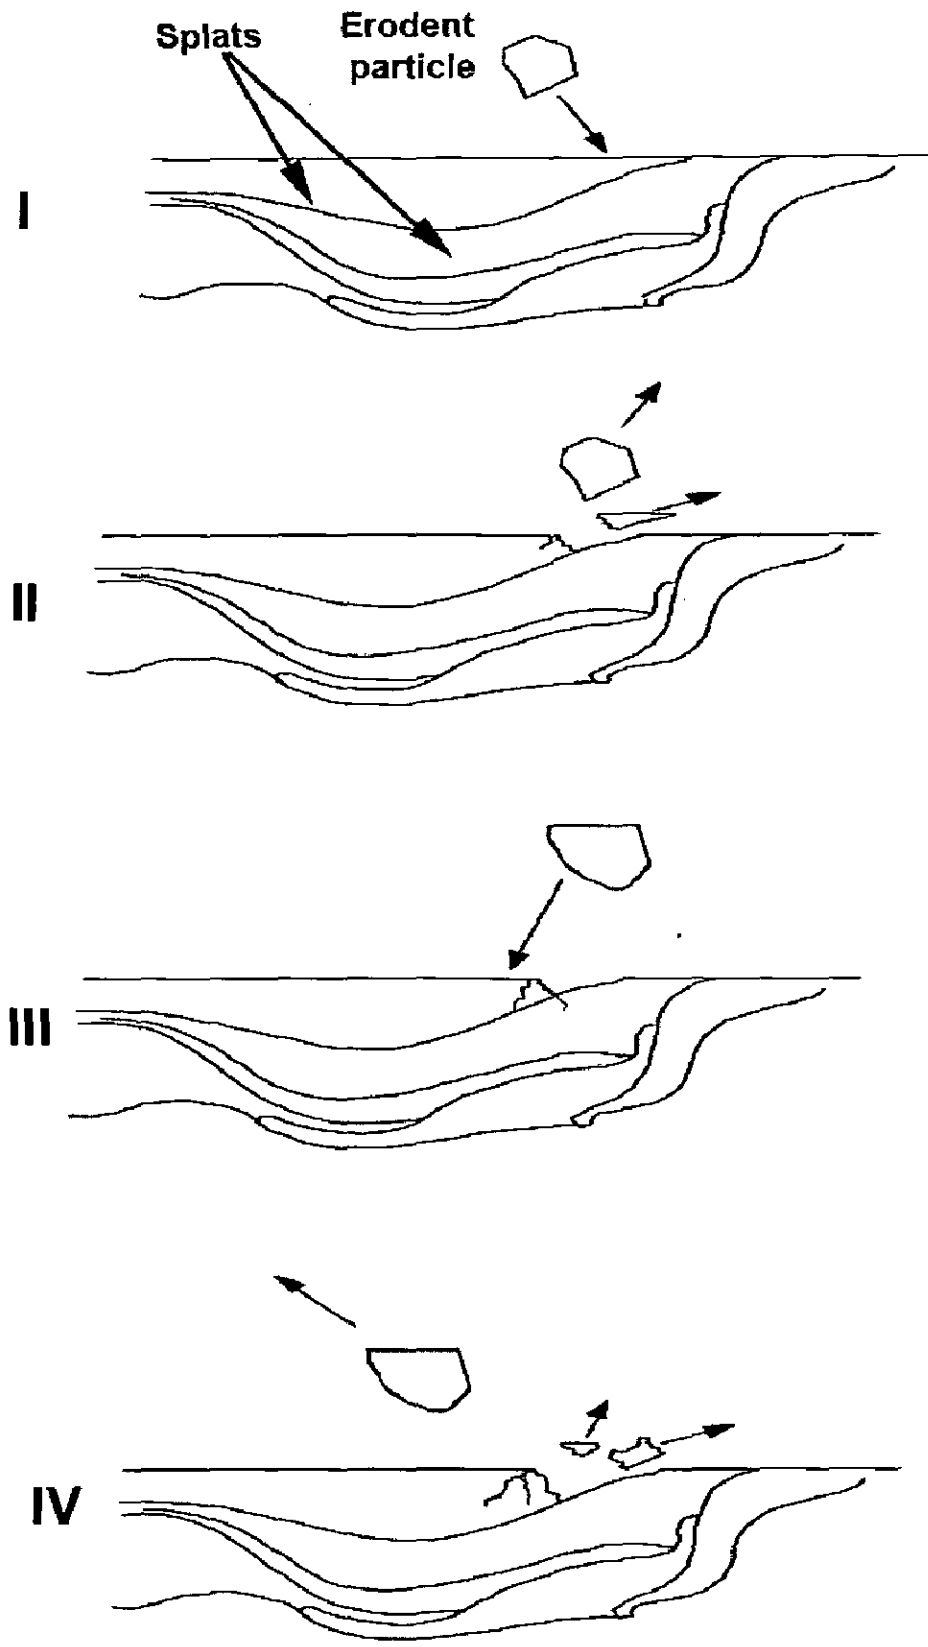
Fig. 5.44: Schematic of splat edge chipping mechanism due to particle impingement.

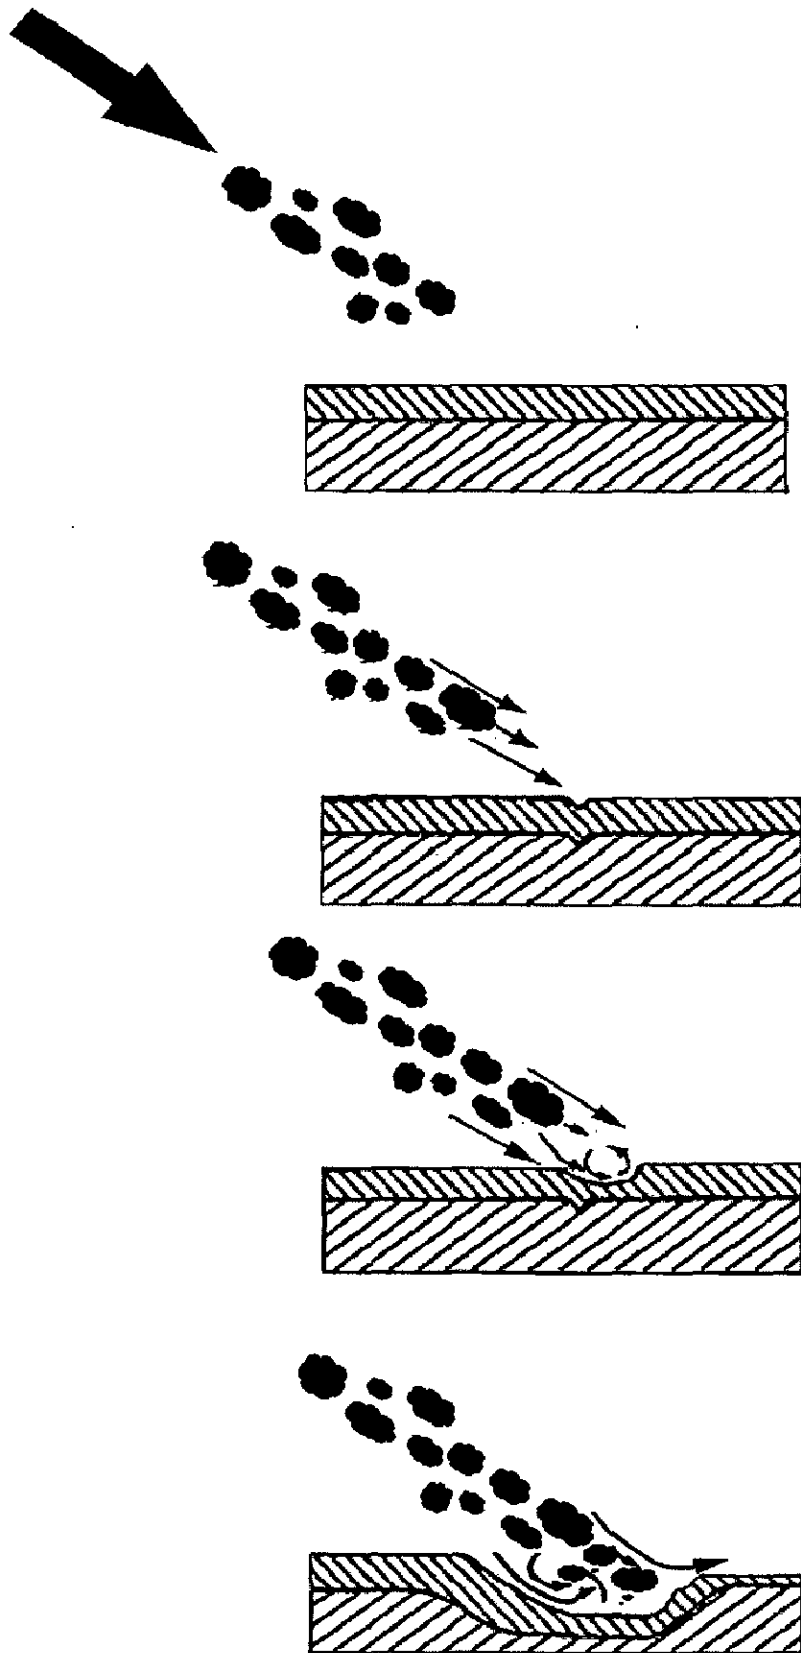
Fig. 5.45: Schematic diagram showing probable erosion mechanism of detonation gun sprayed Al_2O_3 -3 Wt% TiO_2 coatings at low impact angles due to particle impingement.

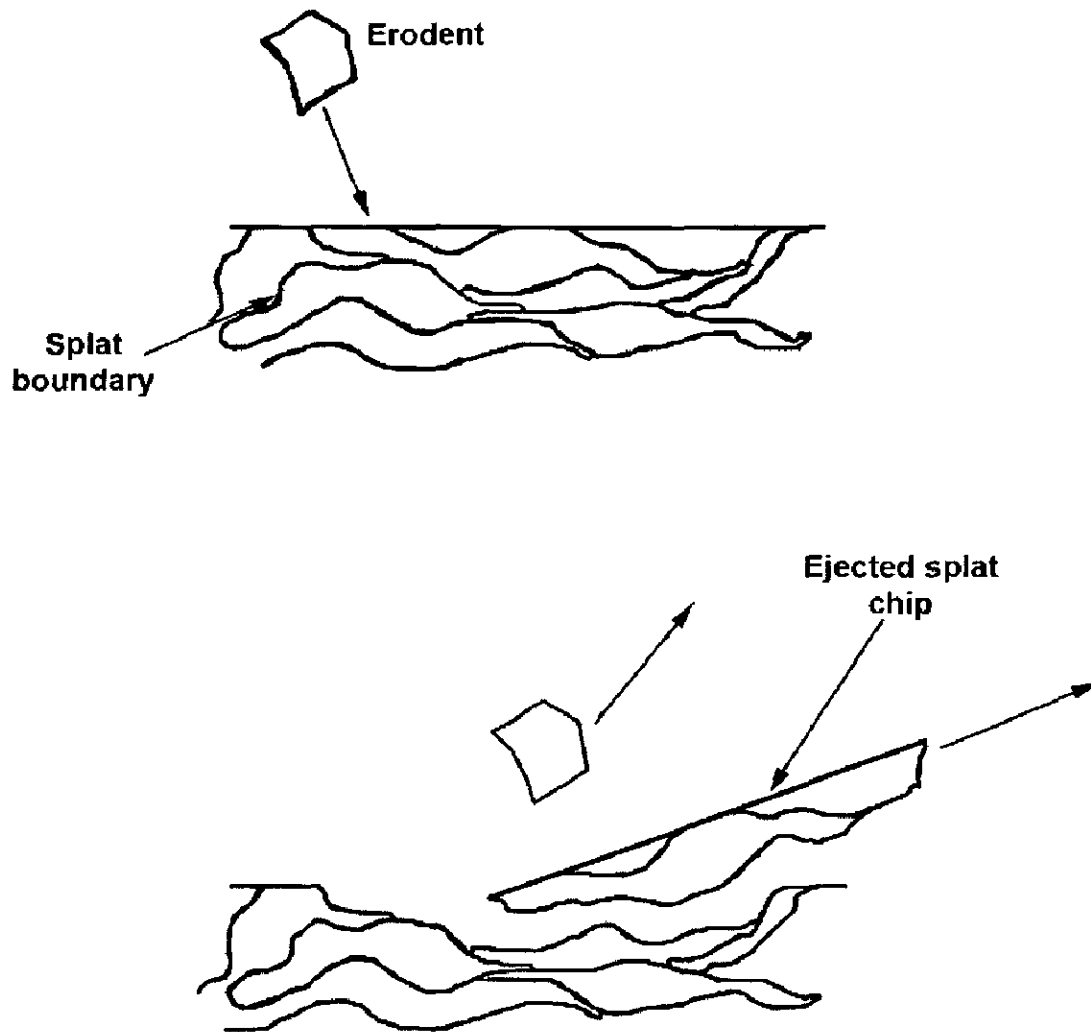
Fig. 5.46: Schematic illustrating the mechanism of gross splat chip formation during erosive impact as a result of low inter-splat adhesion.

The material removal mechanism for coated specimens at 90° impact was removal of fractured splats. Generally, only minor parts of individual splats were removed at each impact resulting in splat debonding with subsequent impacts. At higher temperature, the erosion mechanisms featured larger wear fragments, consisting of entire splats or clusters of splats. Erosion of coatings at low impact angles can be seen schematically in Fig. 5.45. At lower impact angle i.e. at 30° impact, the coatings showed a large amount of plastic deformation with little or no signs of splat debonding see Fig. 5.29. At higher temperature testing, especially at condition 3, number of cracks had developed in eroded surfaces. The link up of these cracks forms chips of material that are readily ejected by subsequent impacts in a manner similar to that of bulk brittle materials. Splat chip ejection is shown schematically in Fig. 5.46.

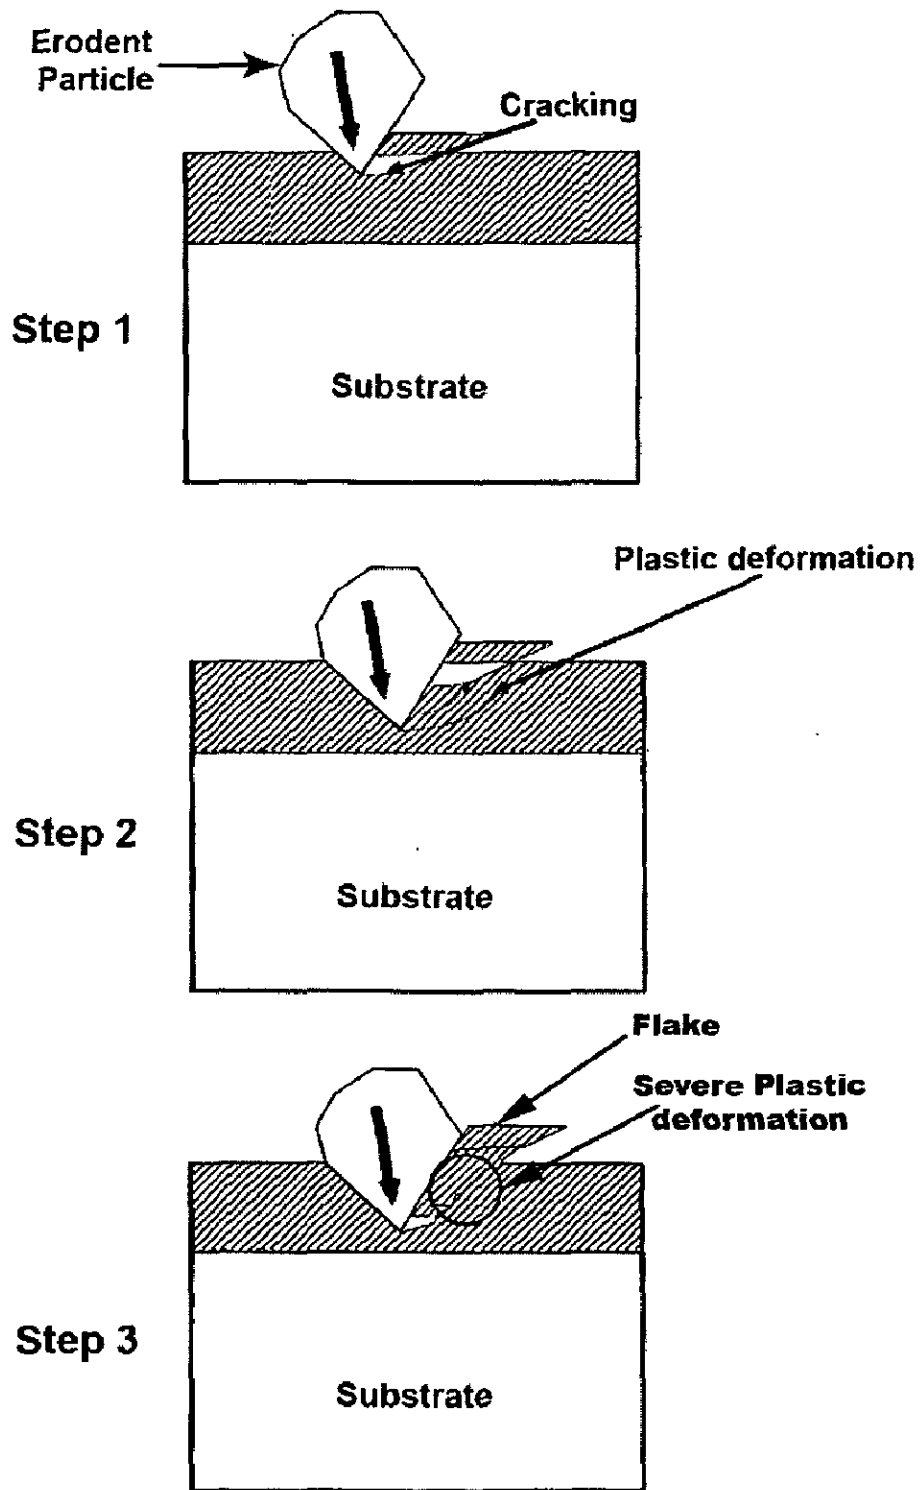
Fig. 5.47: Schematic illustrating the mechanism of flake formation during particle impact

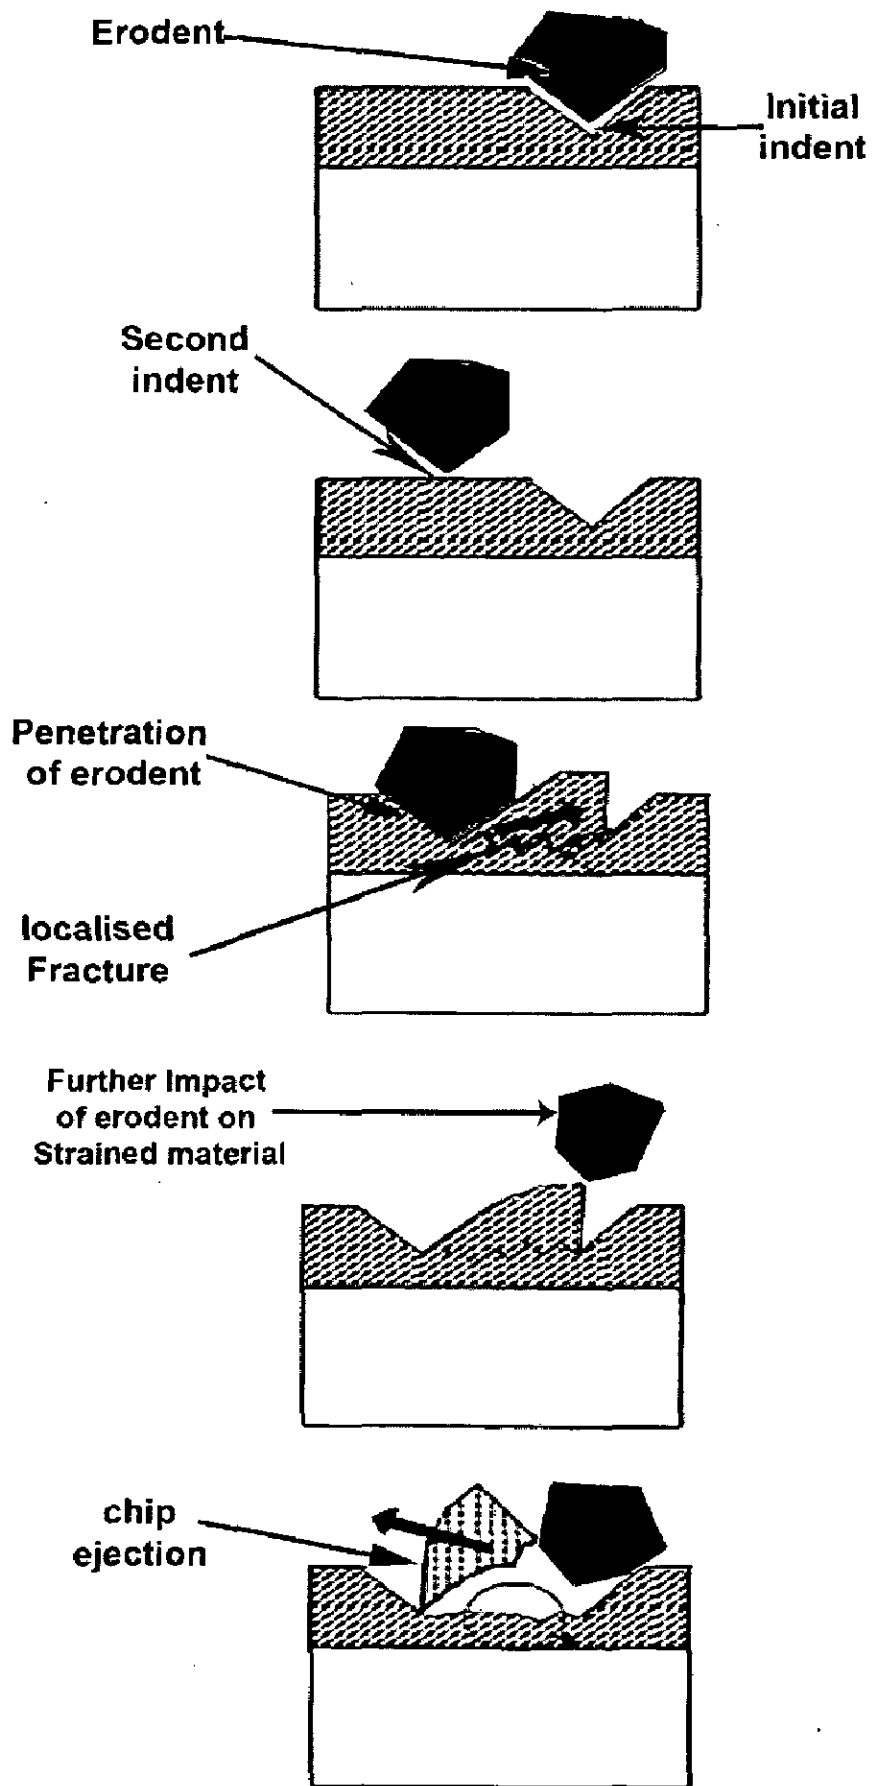
Fig. 5.48: Schematic representation of gross chip formation in the region between neighbouring indents, resulting from the large depth of erodent penetration.

chip formation generated by fracture of inter-indent regions of material laterally displaced by multiple erodent impacts in an apparent low cycle fatigue mechanism, Fig. 5.48.
