STUDY OF DETONATION GUN COATED ALLOYS FOR RESISTANCE TO EROSION AND CORROSION

A THESIS

METALLURGICAL AND MATERIALS ENGINEERING

This thesis investigates the erosion and corrosion performance of Al_2O_3 -3 wt % TiO_2 thermal spray coatings deposited by detonation gun technique. As-sprayed coatings were characterized by using the combined techniques of optical microscopy, microhardness testing, X-ray diffractometry (XRD) and scanning electron microscopy/energy-dispersive analysis (SEM/EDX). The corrosion performance was evaluated in oxidising and molten salt environment and also in actual working conditions of boiler. The erosion performance was evaluated at room temperature conditions as well as under high temperature conditions, high erodent velocity, and actual boiler conditions. The corrosion behavior and morphological development were investigated by weight change kinetics, metallographs, depths of attack, metal thickness losses, and XRD analyses.

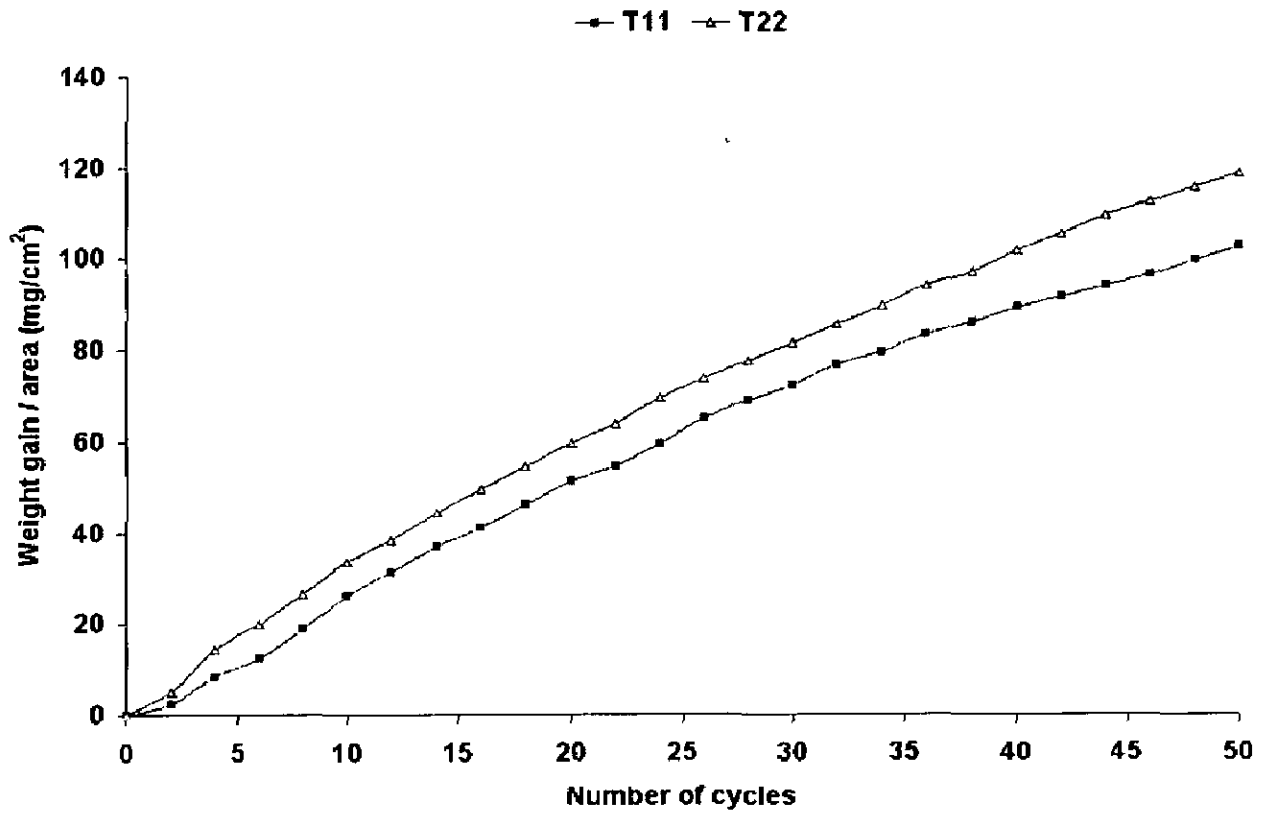
Fig. 6.4: Weight gain plot for uncoated steels exposed to air at 900°C for 50 cycles.

Boiler steels showed extensive spalling. T22 steel showed more weight gain than T11 steels. The total weight gain at the end of 50 cycles for T11 and T22 steels is 102.88 and 119.12 mg/cm² respectively.

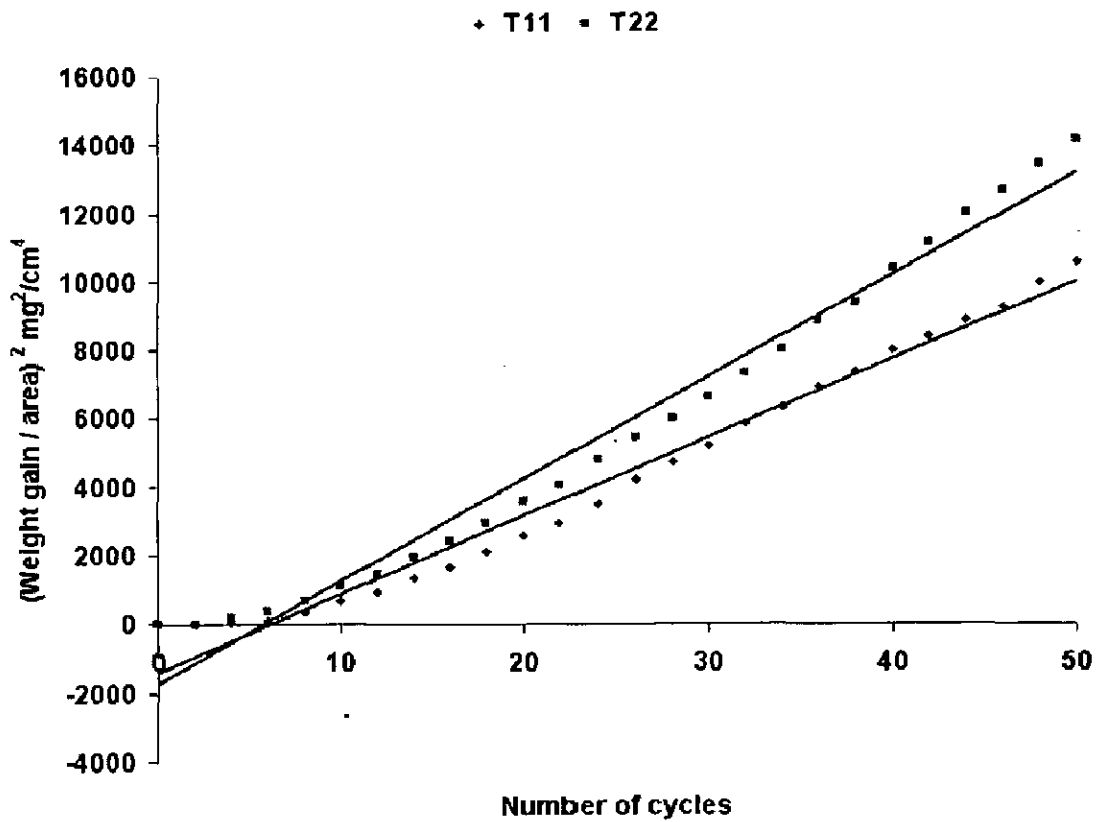
Fig. 6.5: Weight gain square (mg^2/cm^4) plot for uncoated steels exposed to air at 900°C for 50 cycles.

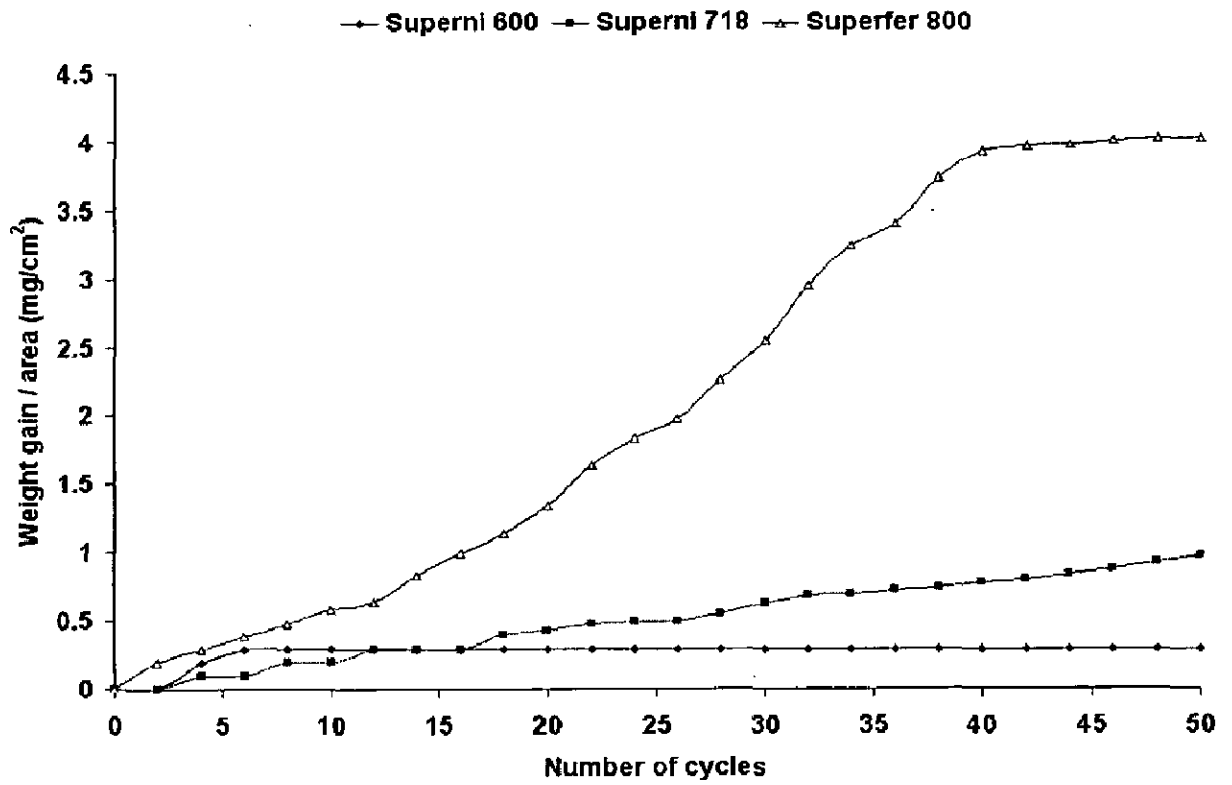
Fig. 6.6: Weight gain plot for uncoated superalloys exposed to air at 900°C for 50 cycles.

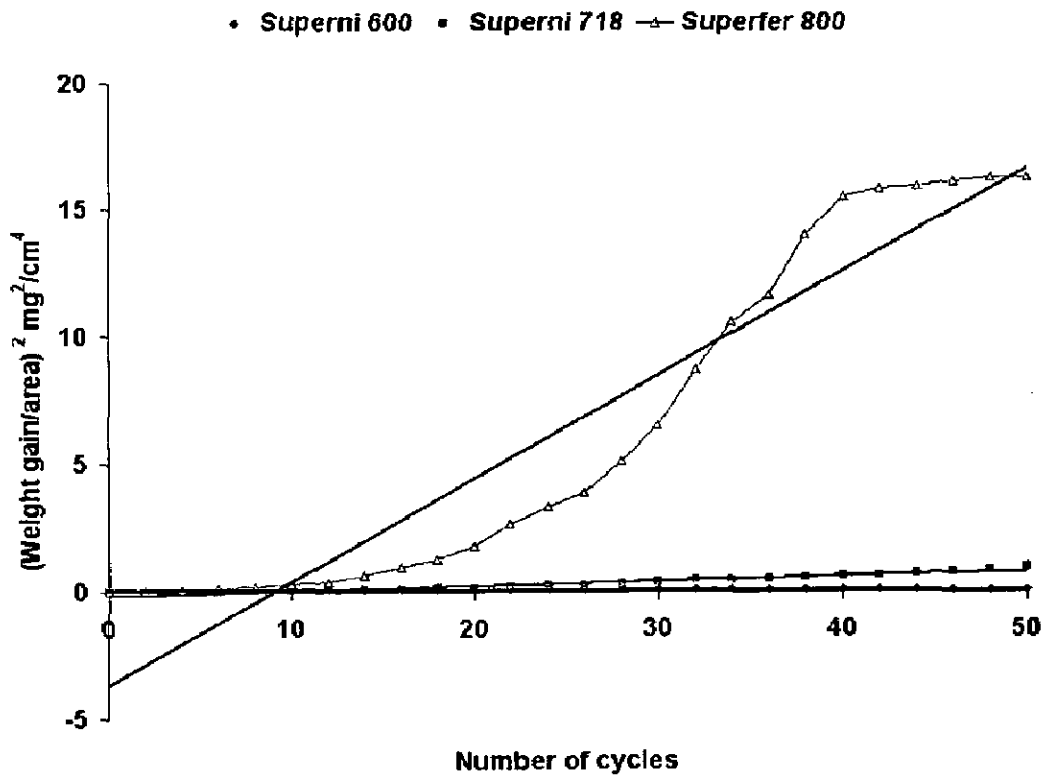
Fig.6.7: Weight gain square (mg^2/cm^4) plot for uncoated superalloys exposed to air at 900°C for 50 cycles.

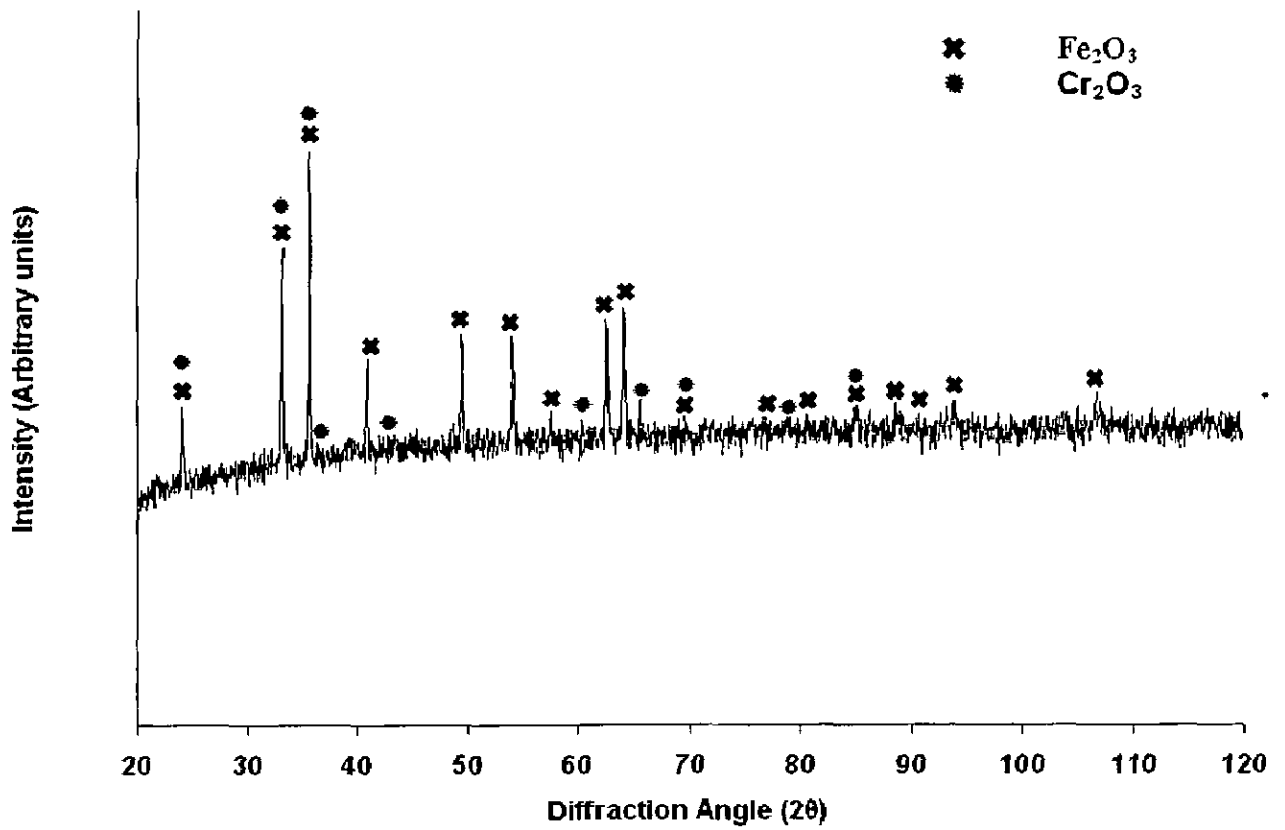
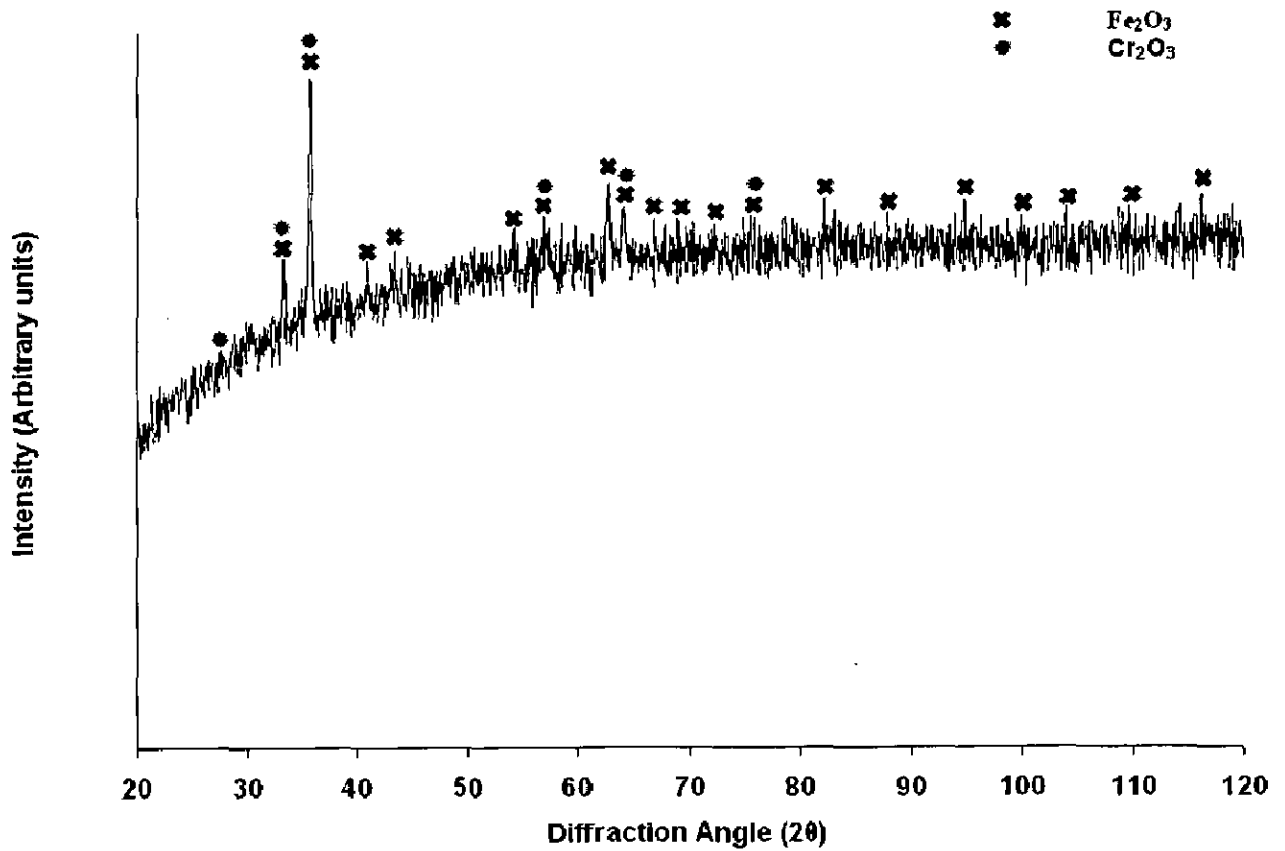
Fig. 6.8: X-ray diffraction profiles for T11 and T22 boiler steels subjected to cyclic oxidation in air at 900°C for 50 cycles.
 (a) T11 (b) T22

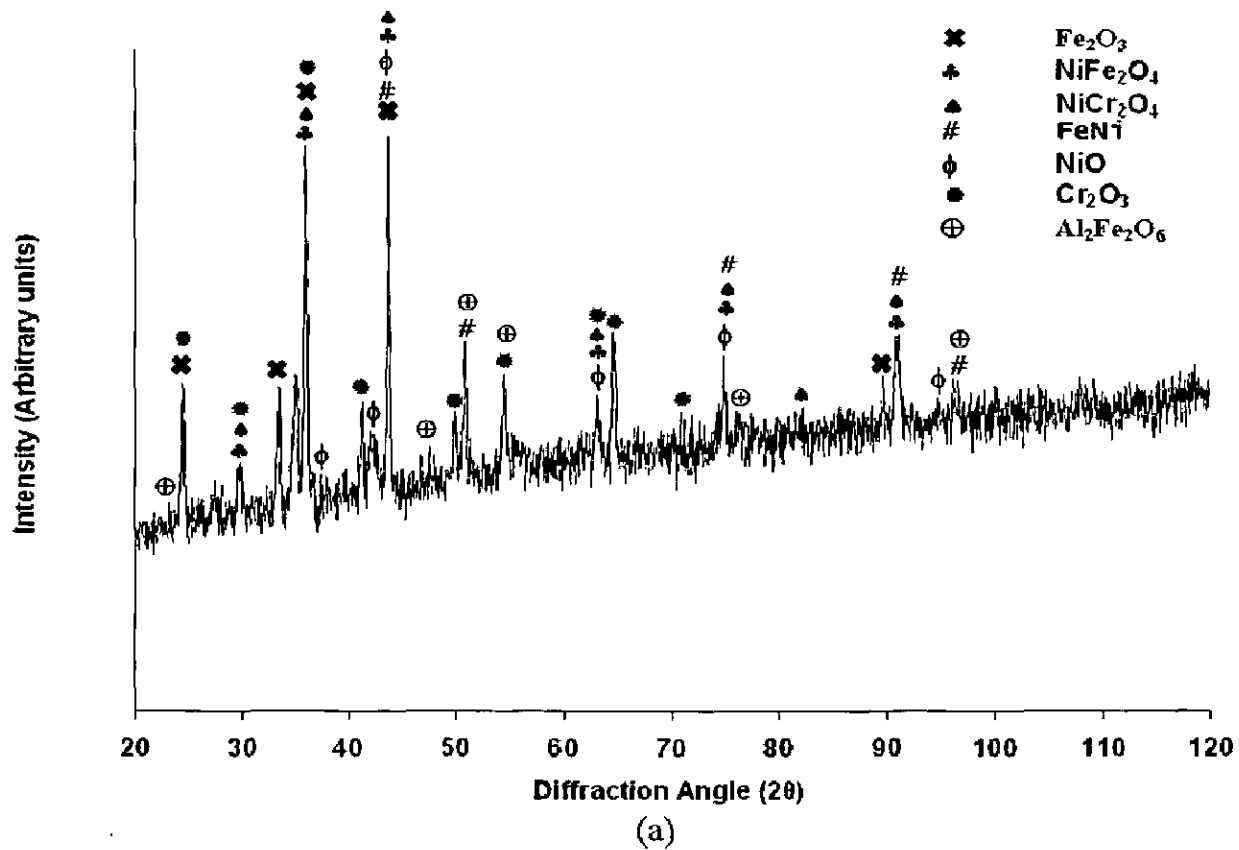
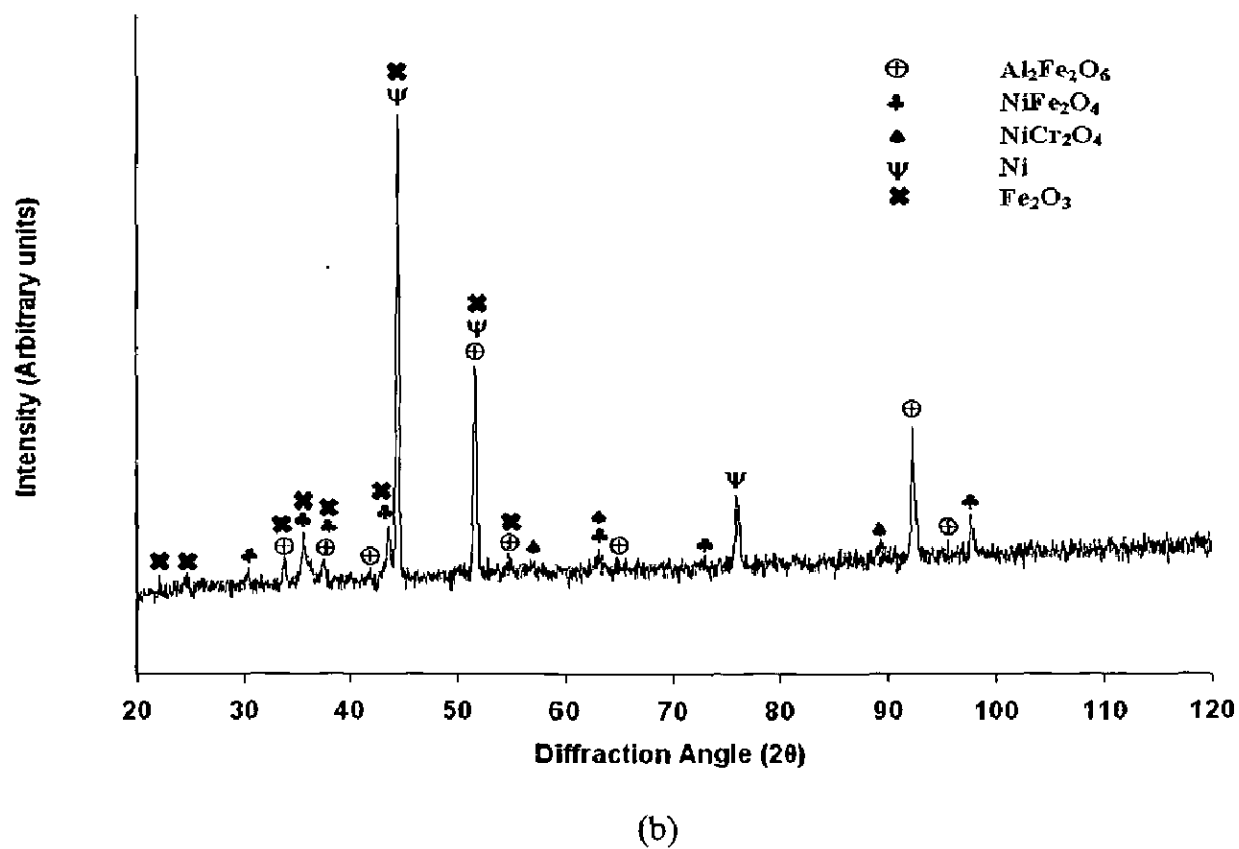
Fig.6.9: X-ray diffraction profiles for superalloys superni 600 and superni 718 subjected to cyclic oxidation in air at 900°C for 50 cycles.
 (a) Superni 600 (b) Superni 718

The X-ray diffractograms for the uncoated superalloys after exposure to air at 900°C for 50 cycles is shown in Figs. 6.9 and 6.10. Fe₂O₃, NiFe₂O₄, NiCr₂O₄ and Al₂Fe₂O₆ phases are found to be present in all the oxidised superalloys. The formation of NiO has been indicated in the scales of Superni 600 and Superfer 800.

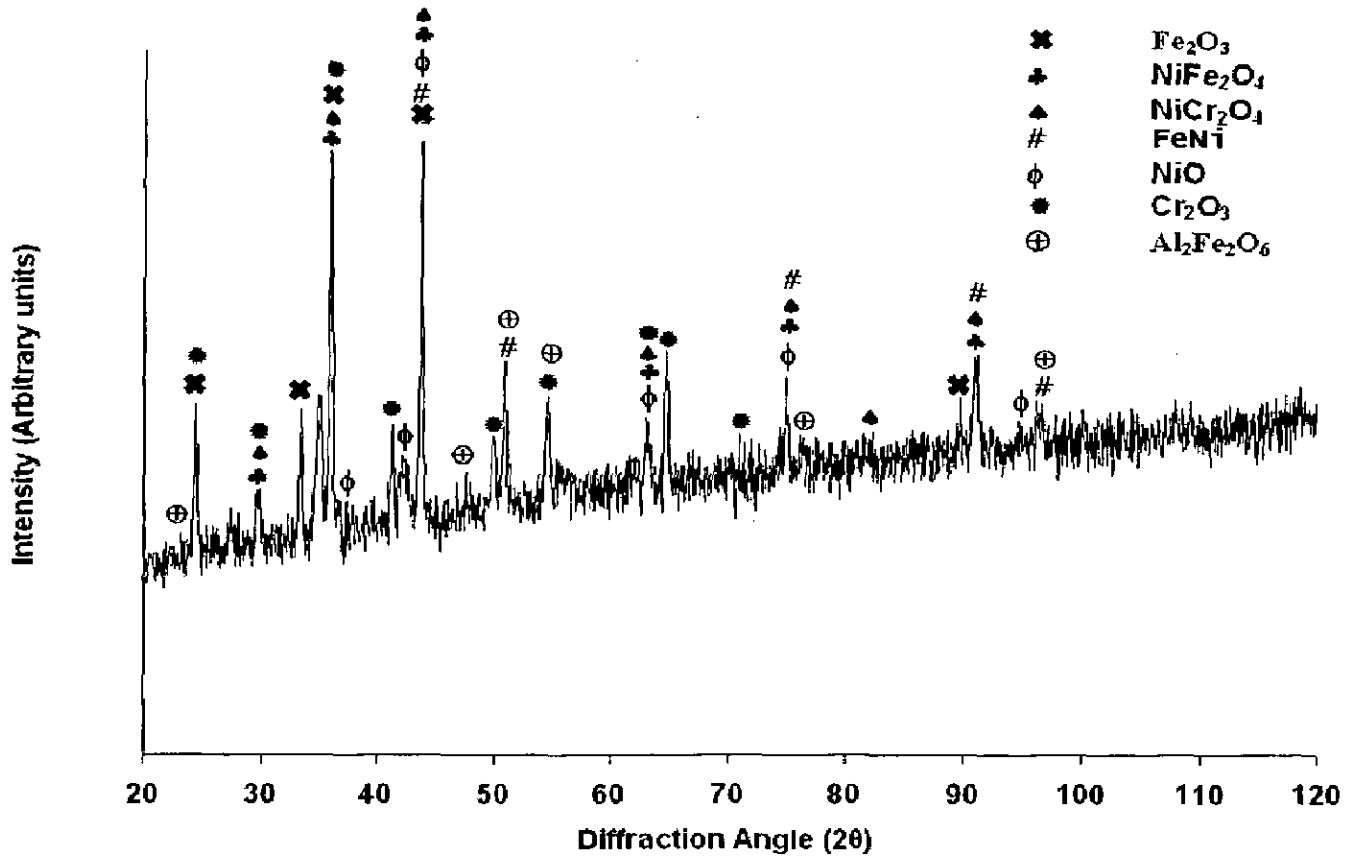
Fig. 6.10: X-ray diffraction profiles for superalloy Superfer 800 subjected to cyclic oxidation in air at 900°C for 50 cycles.

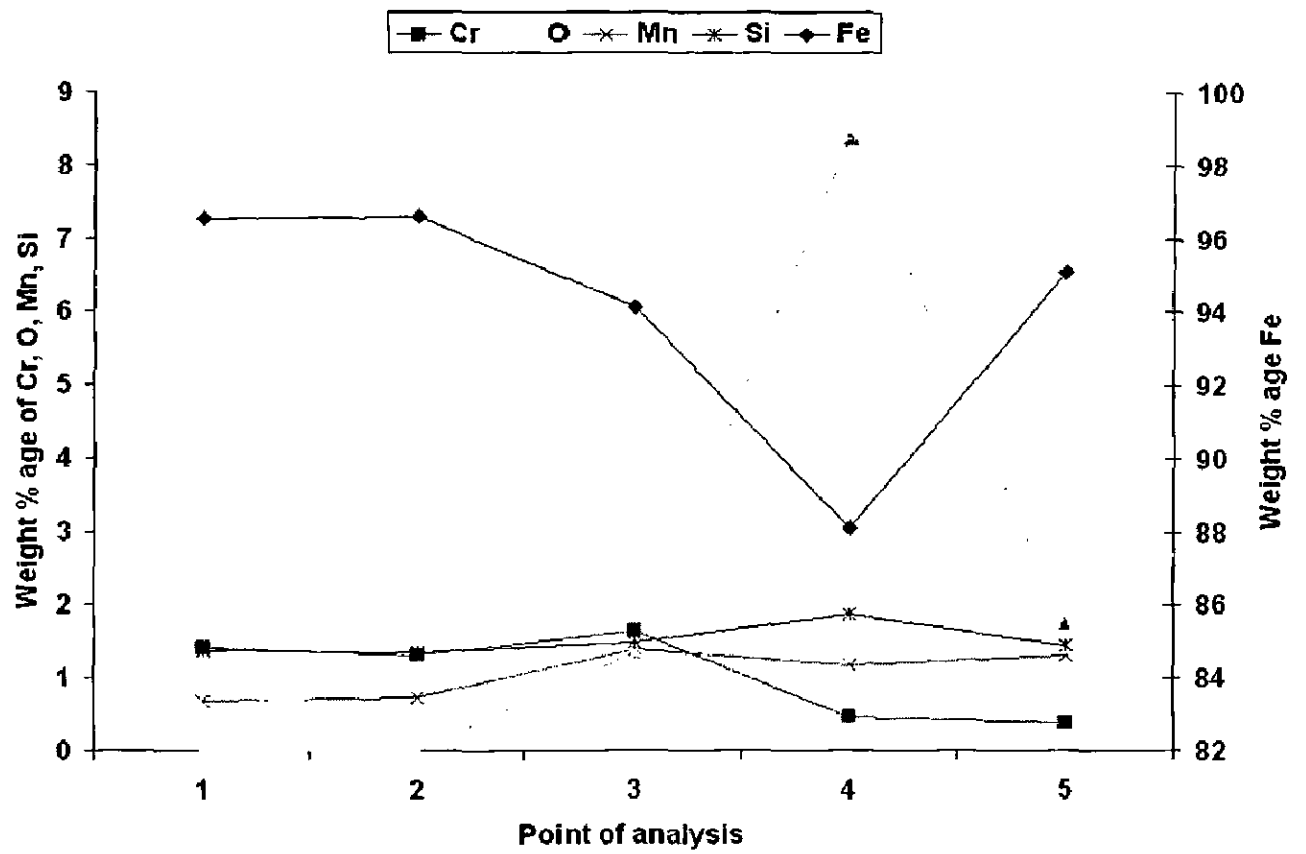
Fig.6.11: Cross sectional morphology and elemental composition variation across the cross-section of boiler steel T11 exposed air at 900°C for 50 cycles, 1000 X.

The BSE image and the EDX analysis across the cross section on uncoated alloys are shown in Fig.6.11 to Fig. 6.15. Throughout the scale higher percentage of Fe oxide is

there and also chromium oxide is present throughout the scale thickness though in small quantity. The results of oxide scale analysis across the cross-section for oxidised T11 and T22 boiler steels are plotted and shown in Fig. 6.11 and 6.12 along with micrographs. The scale was quite fragile and porous and was continuously peeled off from the surface. In Fig. 6.11, there is clear indication of internal oxidation. Also in case of T11 steel traces of Mn and Si have been revealed while in case of T22 steel traces of Mo have been revealed along with Mn and Si.

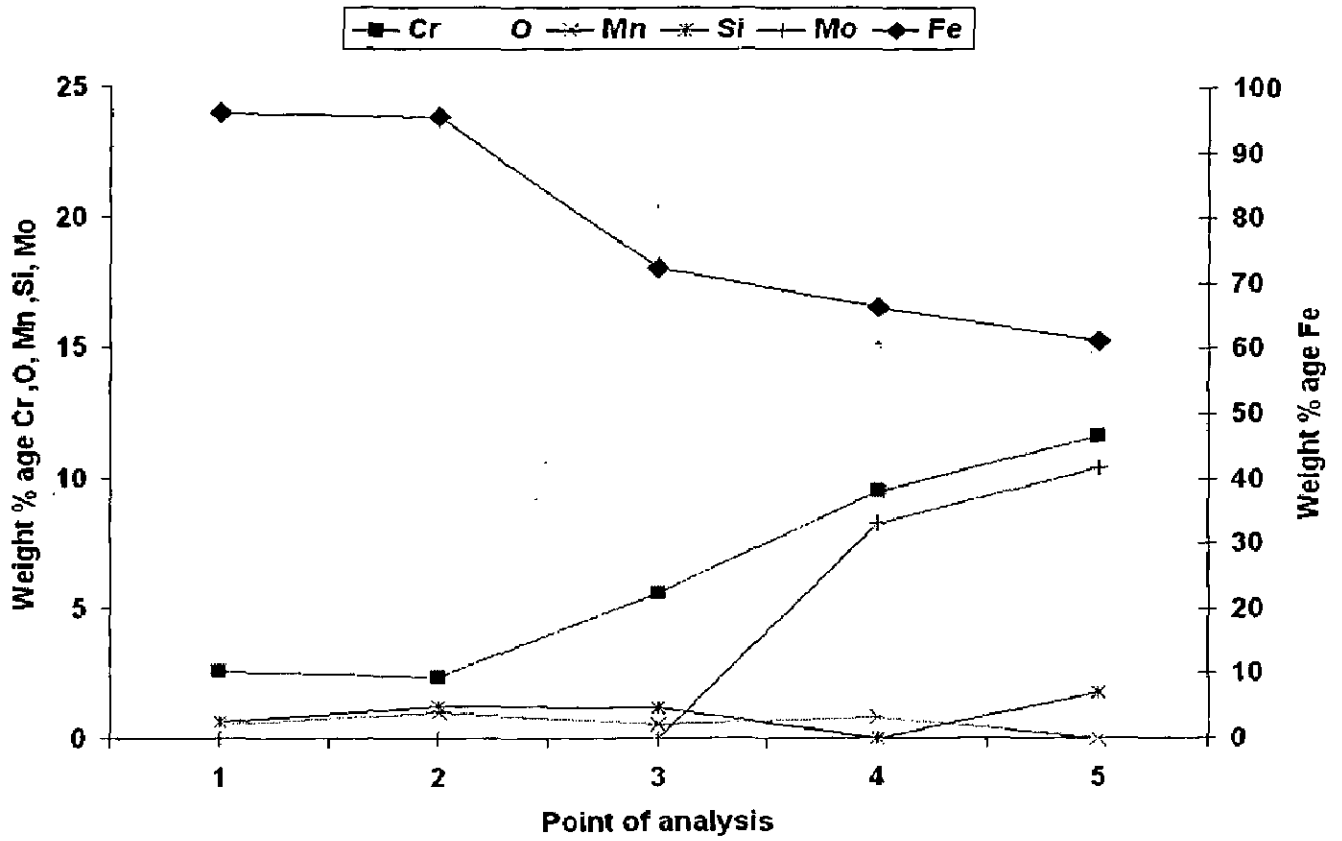
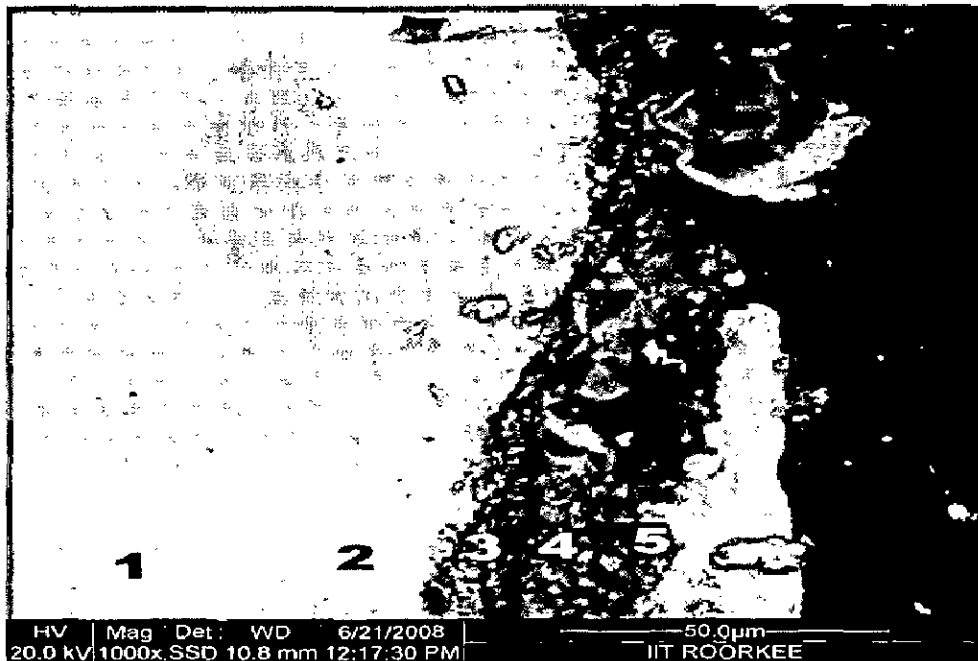
Fig.6.12: Cross sectional morphology and elemental composition variation across the cross-section of boiler steel T22 exposed air at 900°C for 50 cycles, 1000 X.

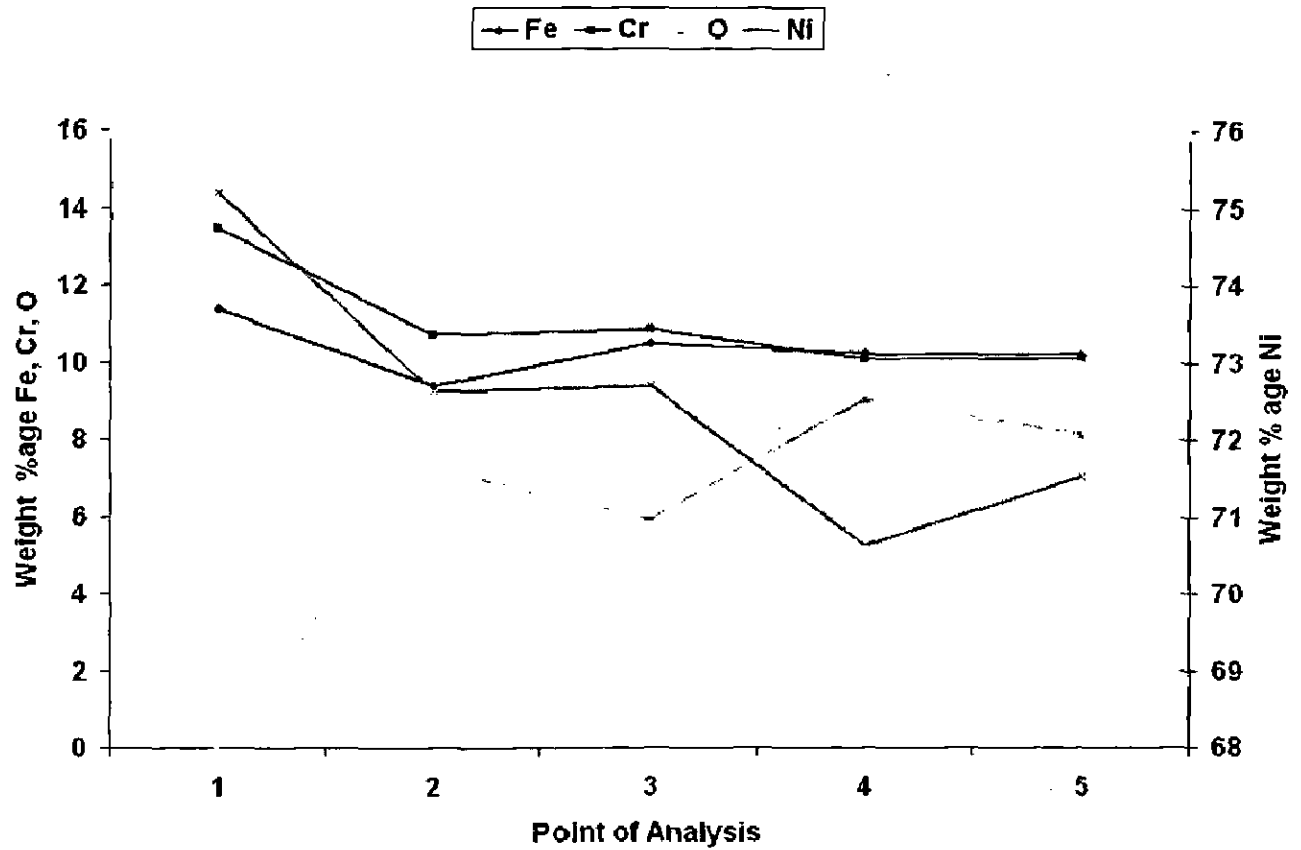
Fig 6.13: Cross sectional morphology and elemental composition variation across the cross-section of superalloy Superni 600 exposed air at 900°C for 50 cycles, 1000 X.

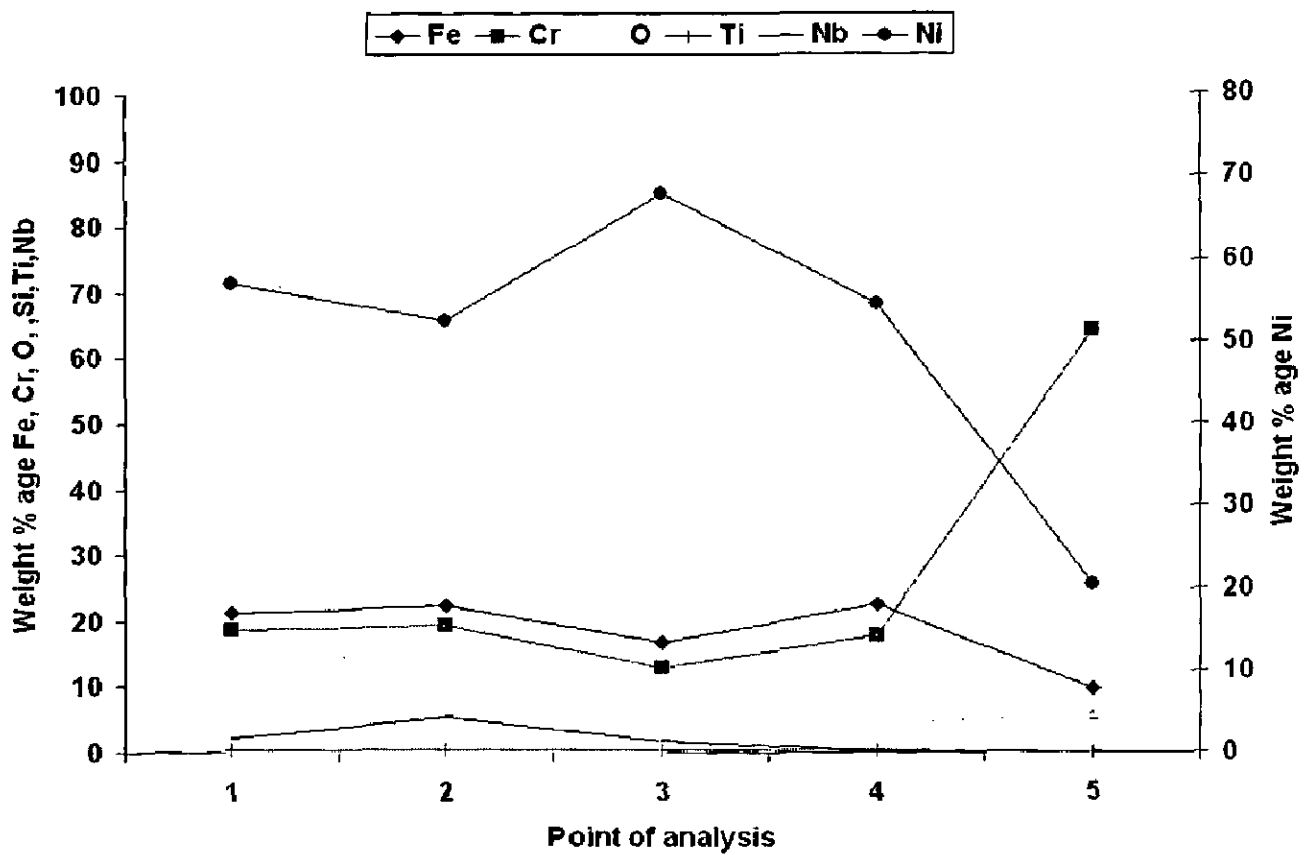
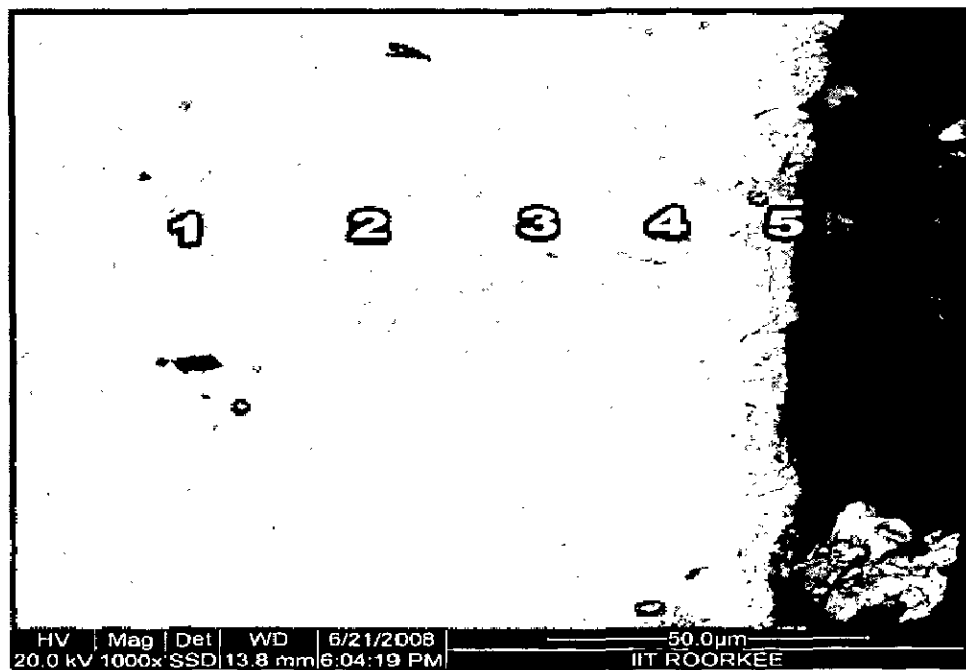
Fig 6.14: Cross sectional morphology and elemental composition variation across the cross-section of superalloy Superni 718 exposed air at 900°C for 50 cycles, 1000 X.

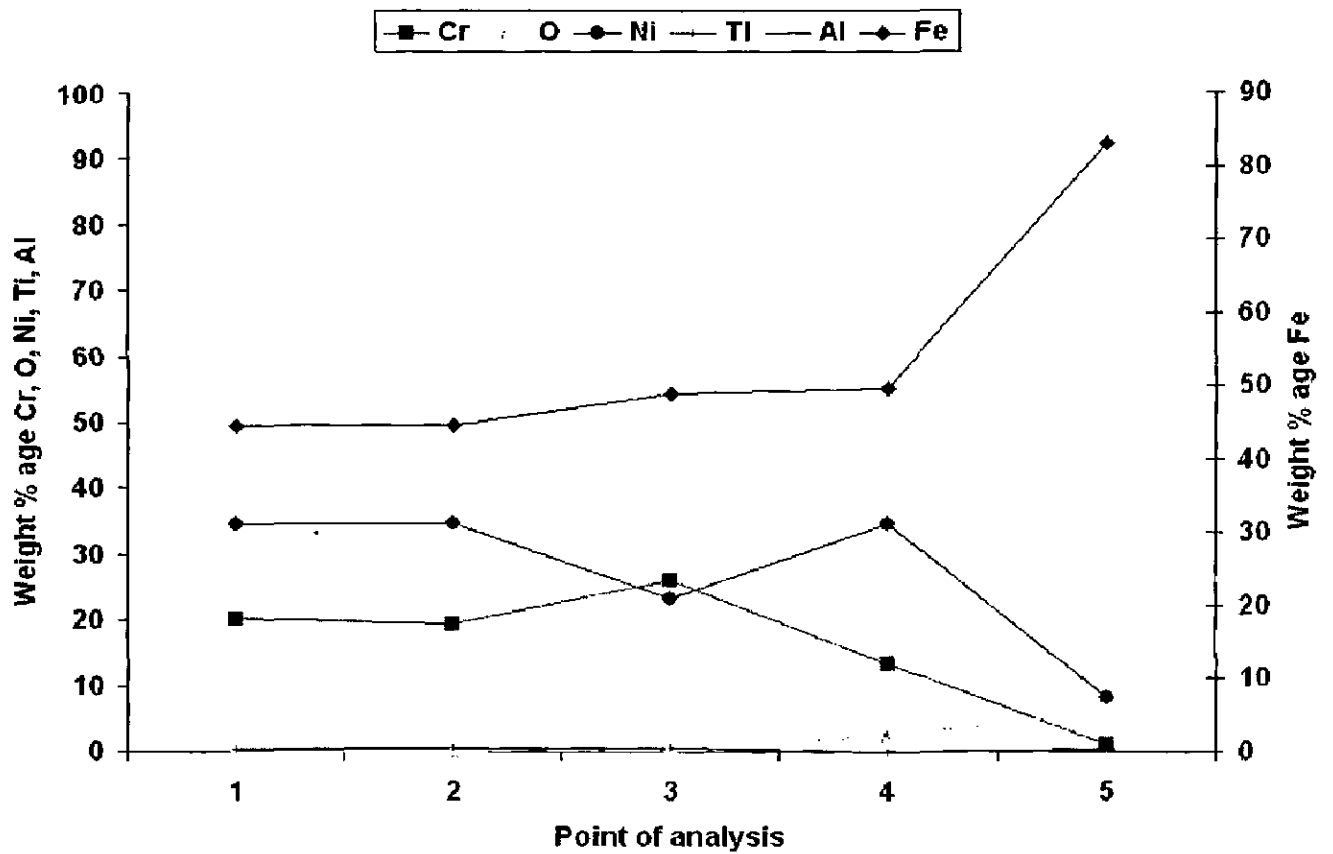
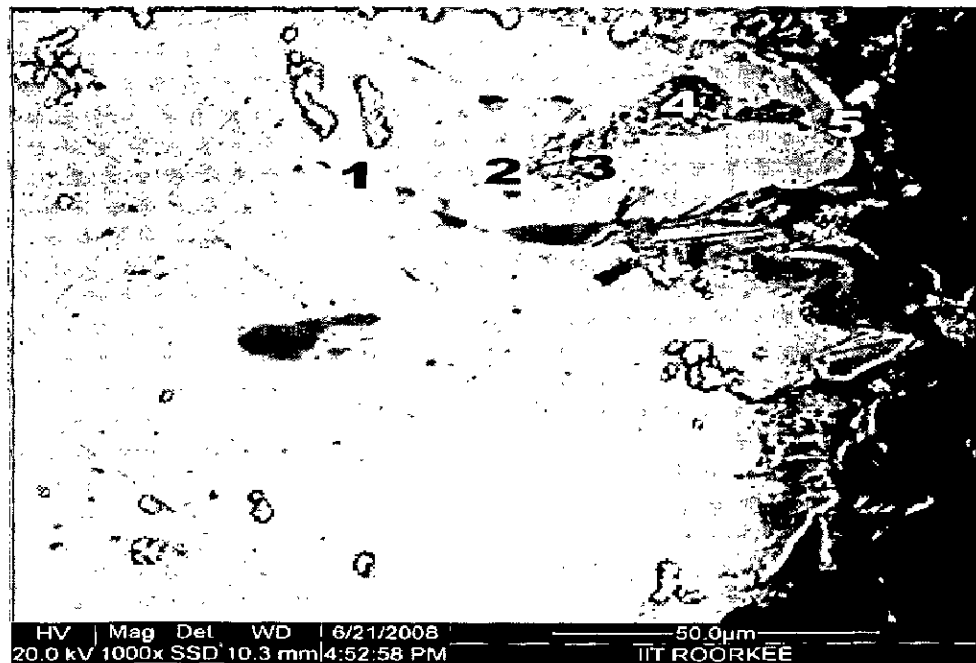
Fig.6.15: Cross sectional morphology and elemental composition variation across the cross-section of superalloy Superfer 800 exposed air at 900°C for 50 cycles, 1000 X.

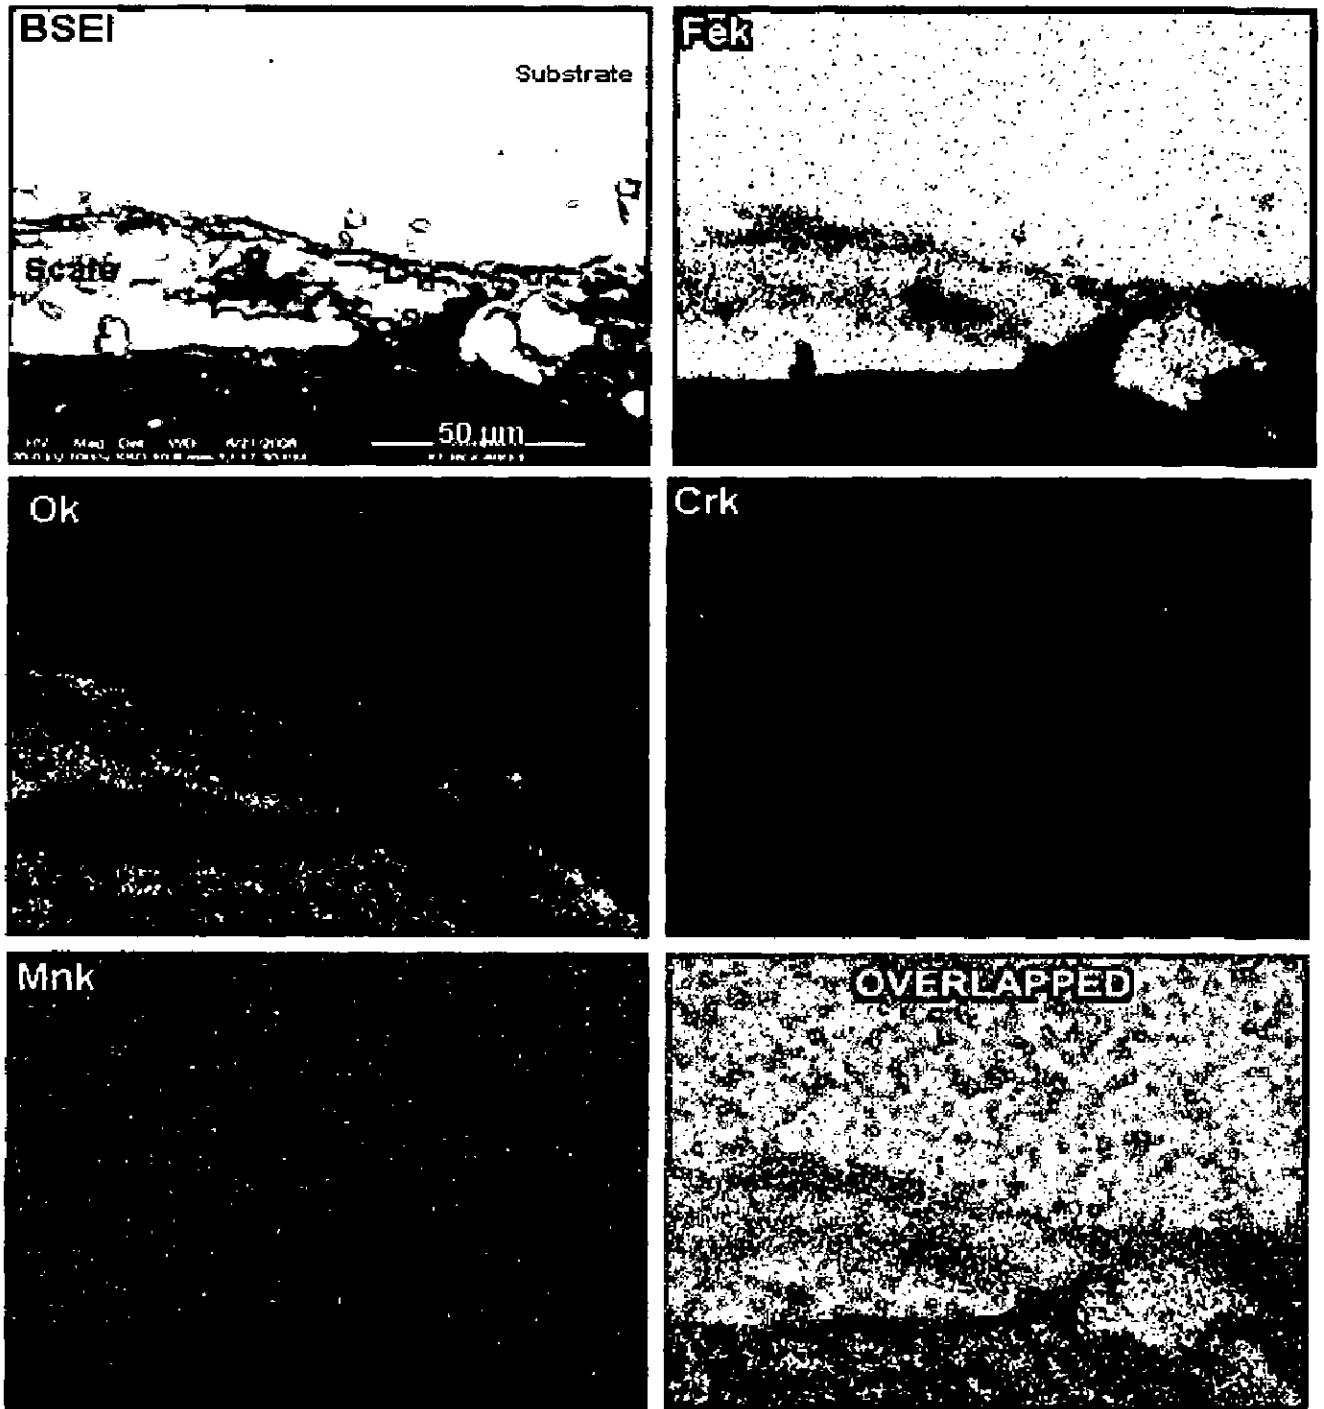
Fig. 6.17: BSEI and X-ray mapping of the cross-section of boiler steel T22 subjected to cyclic oxidation in air at 900°C for 50 cycles.

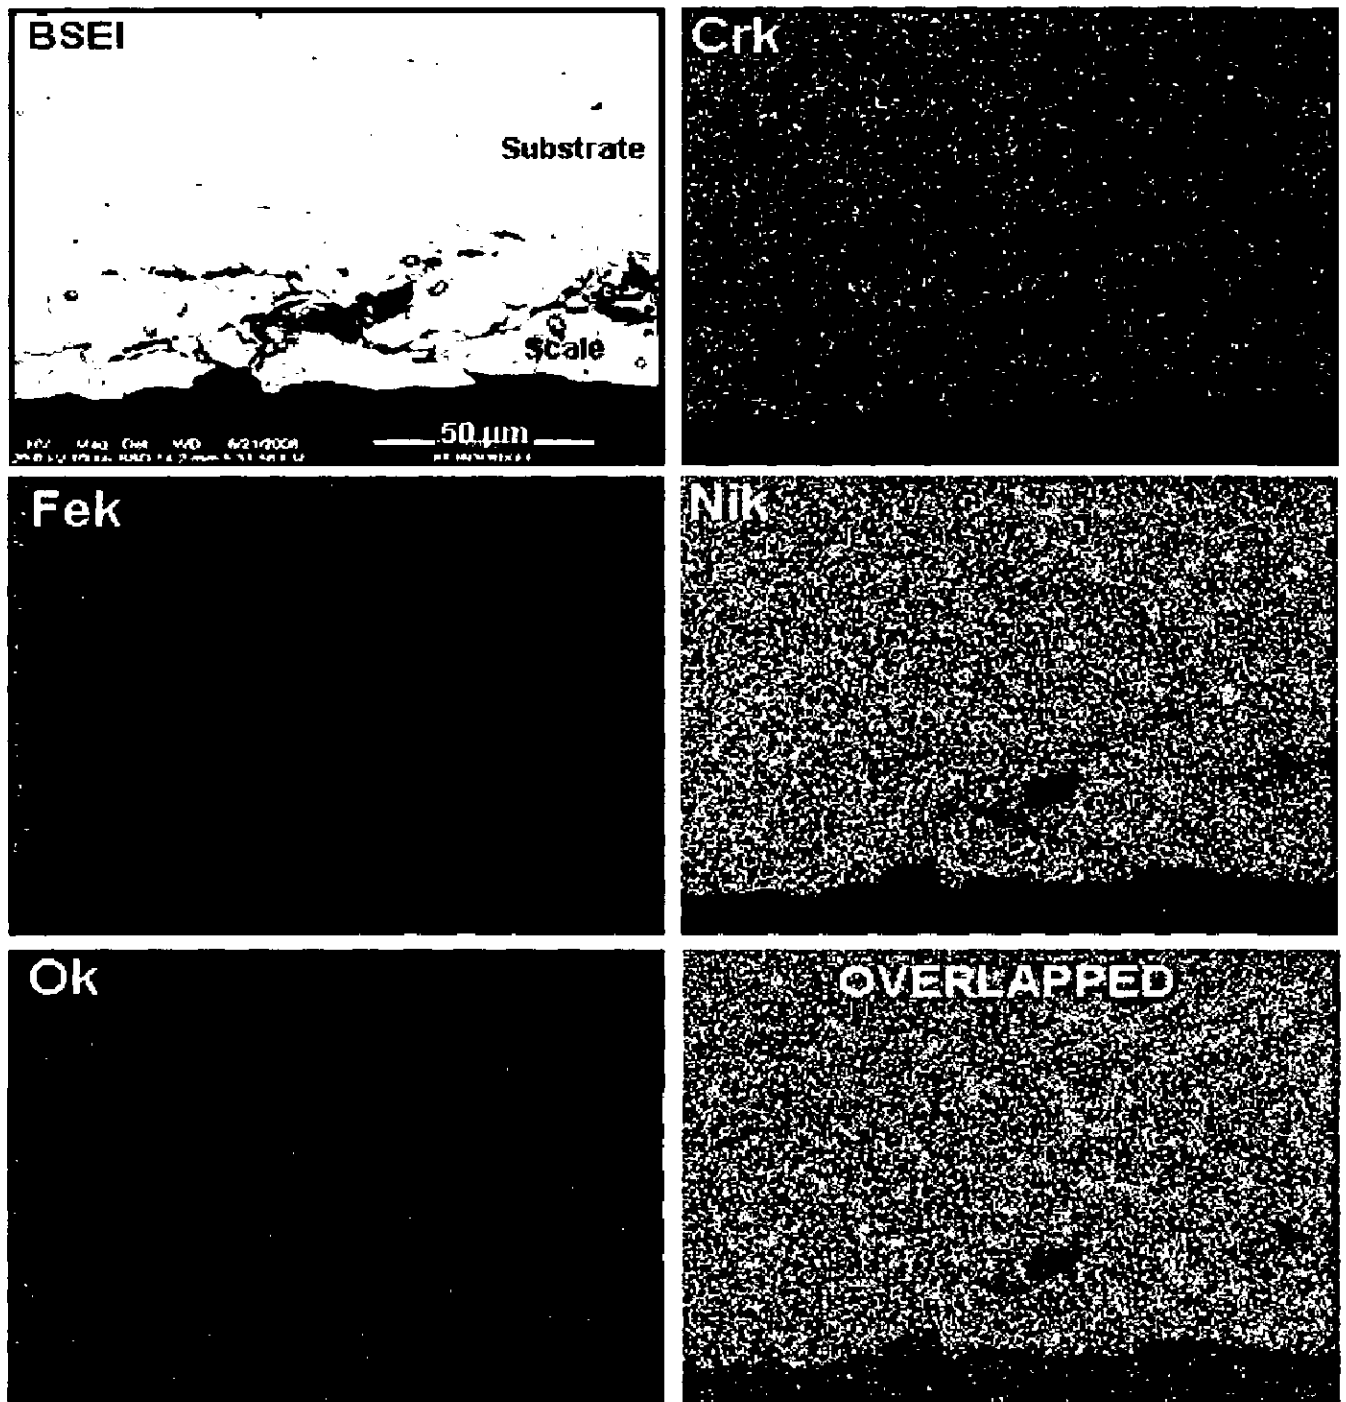
Fig.6.18: BSEI and X-ray mapping of the cross-section of superalloy Superni 600 subjected to cyclic oxidation in air at 900°C for 50 cycles.
